**REPORT NUMBER: SINCAP-MGA-2013-009**

**NEW CAR ASSESSMENT PROGRAM (NCAP)  
Moving Deformable Barrier Side Impact Test**

**GENERAL MOTORS LLC  
2013 Chevrolet Malibu 1LS 4-Dr Sedan  
NHTSA No.: GD0100**

**FINAL REPORT**

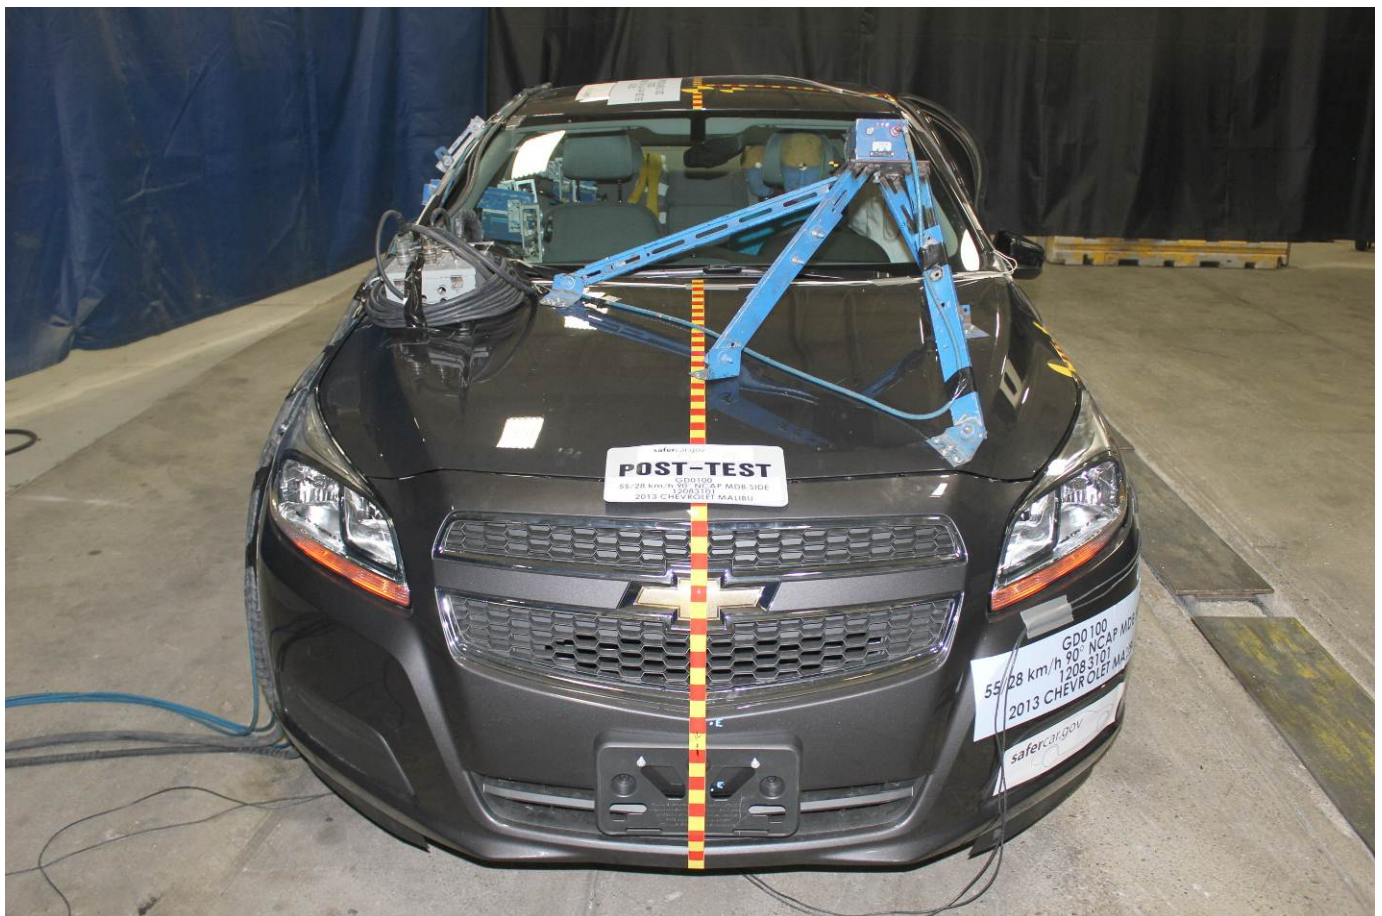
Post-Test Frontal View of Test Vehicle

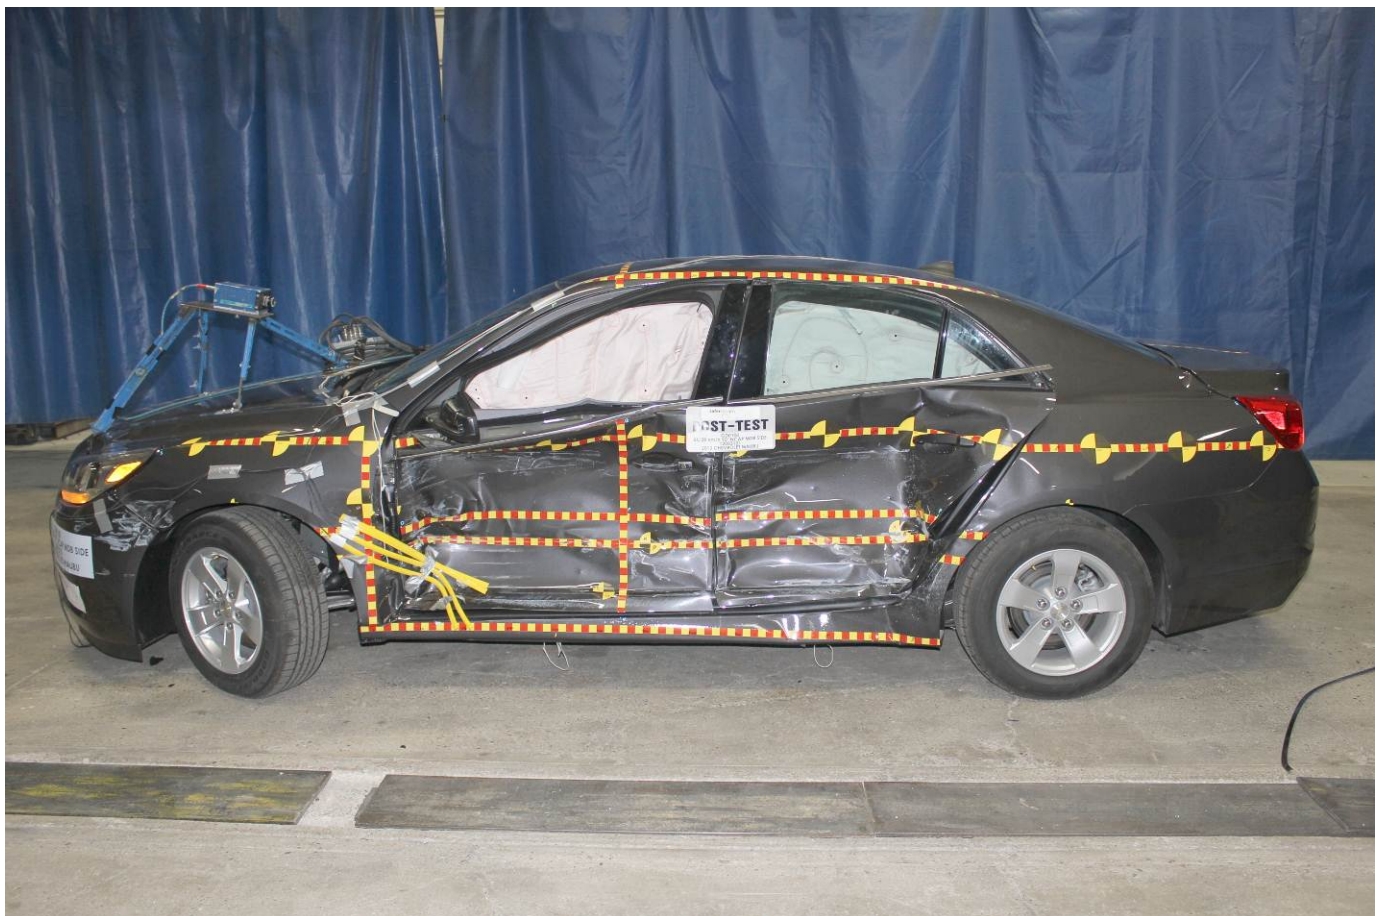
Post-Test Left Side View of Test Vehicle

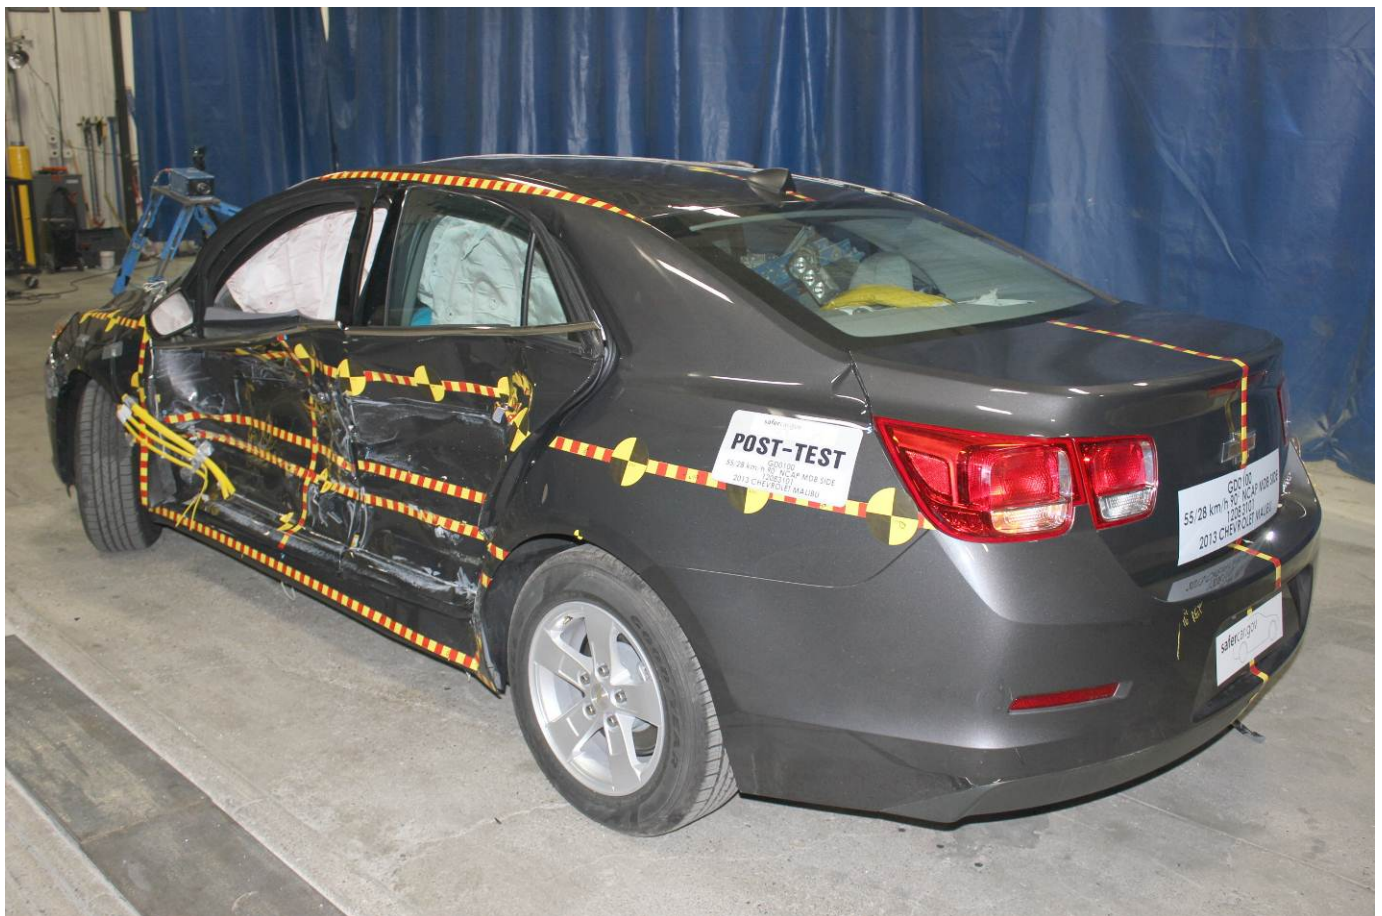
Post-Test Left Three-Quarter Rear View of Test Vehicle

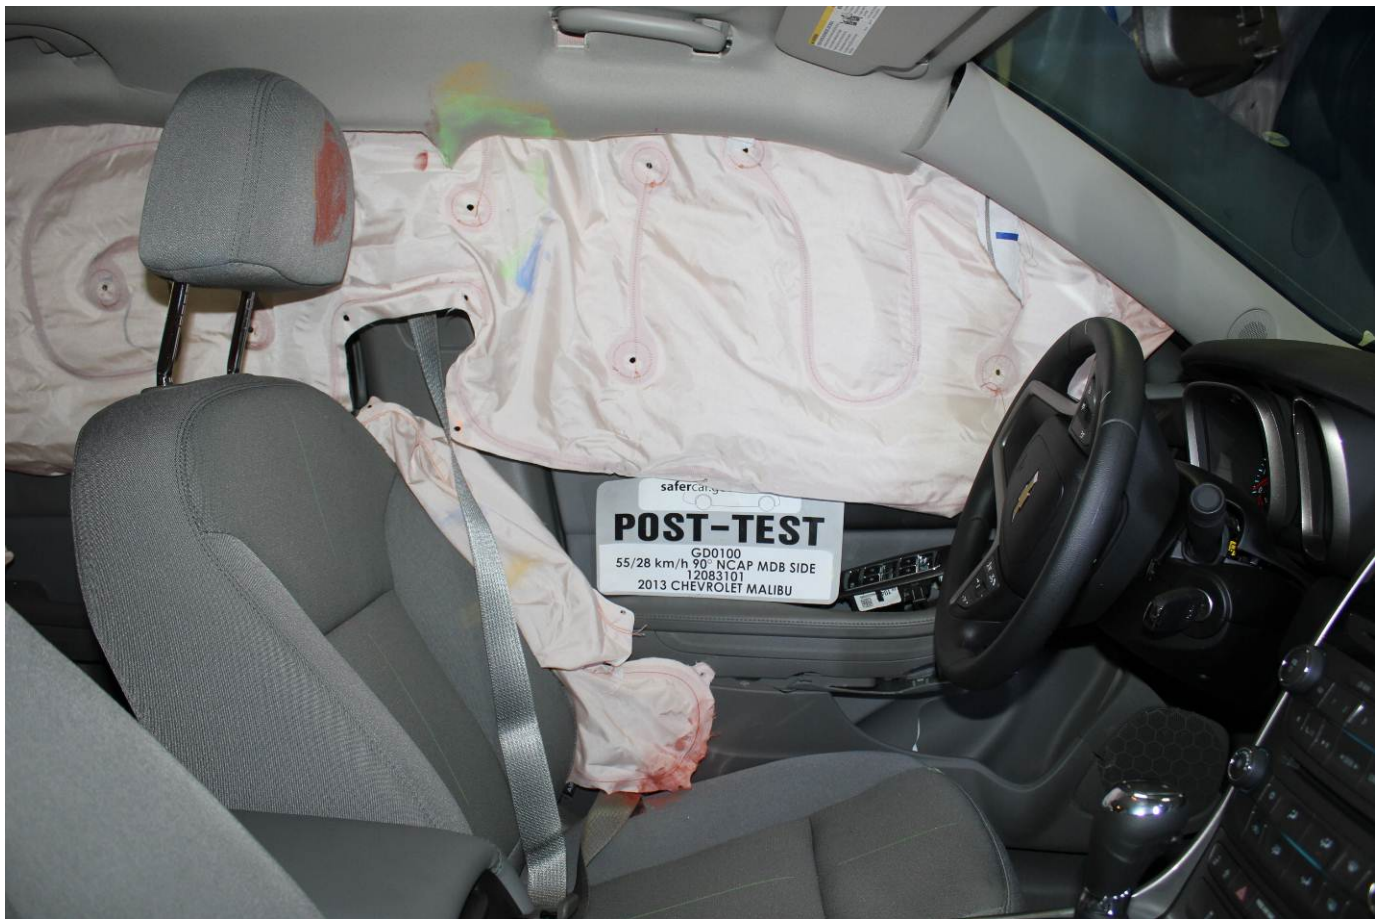
Post-Test Driver Inner Door Panel View

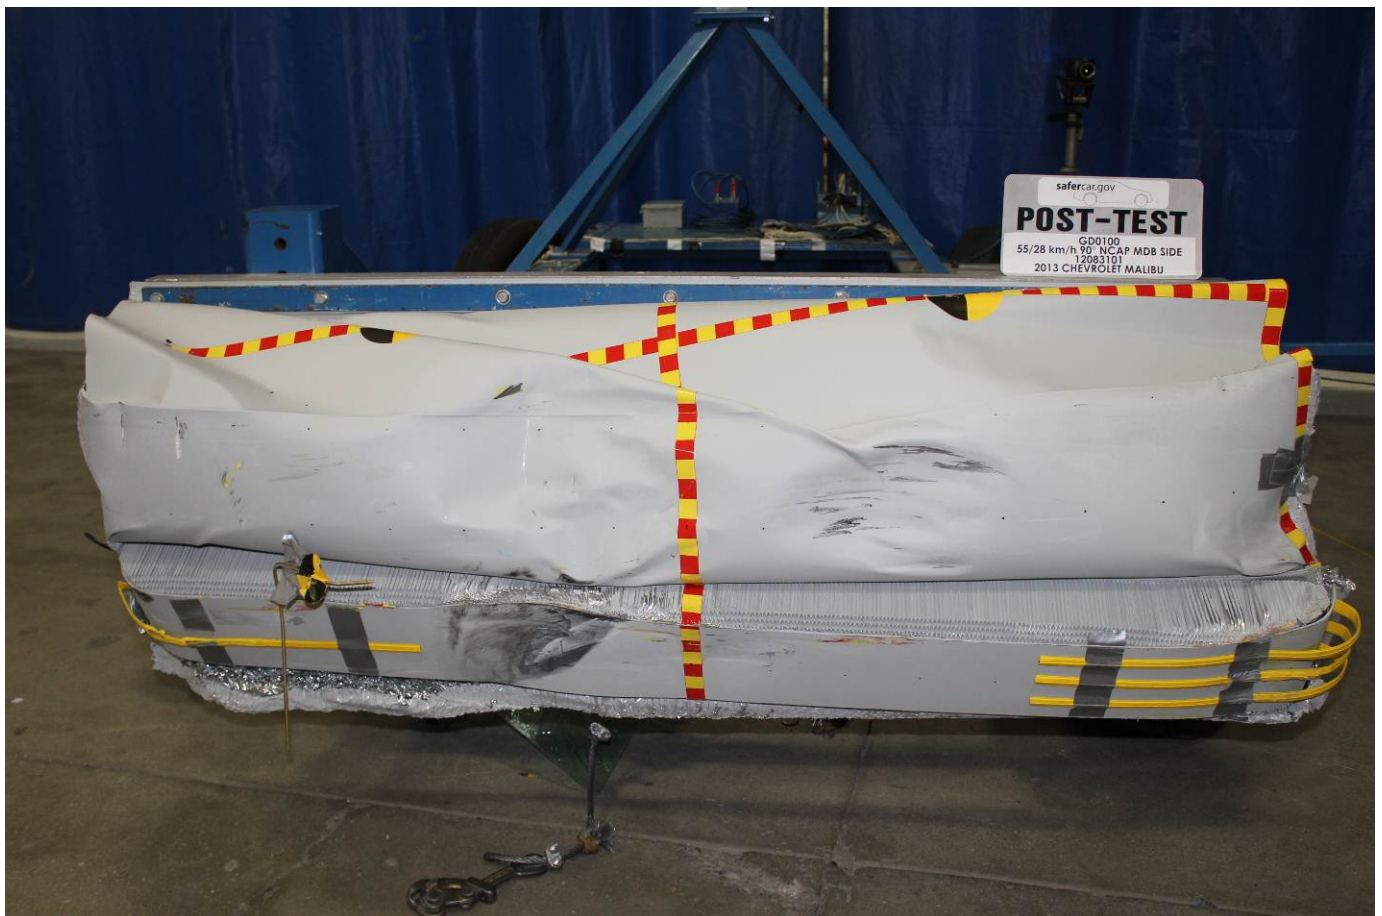
Post-Test Front View of MDB Impactor Face

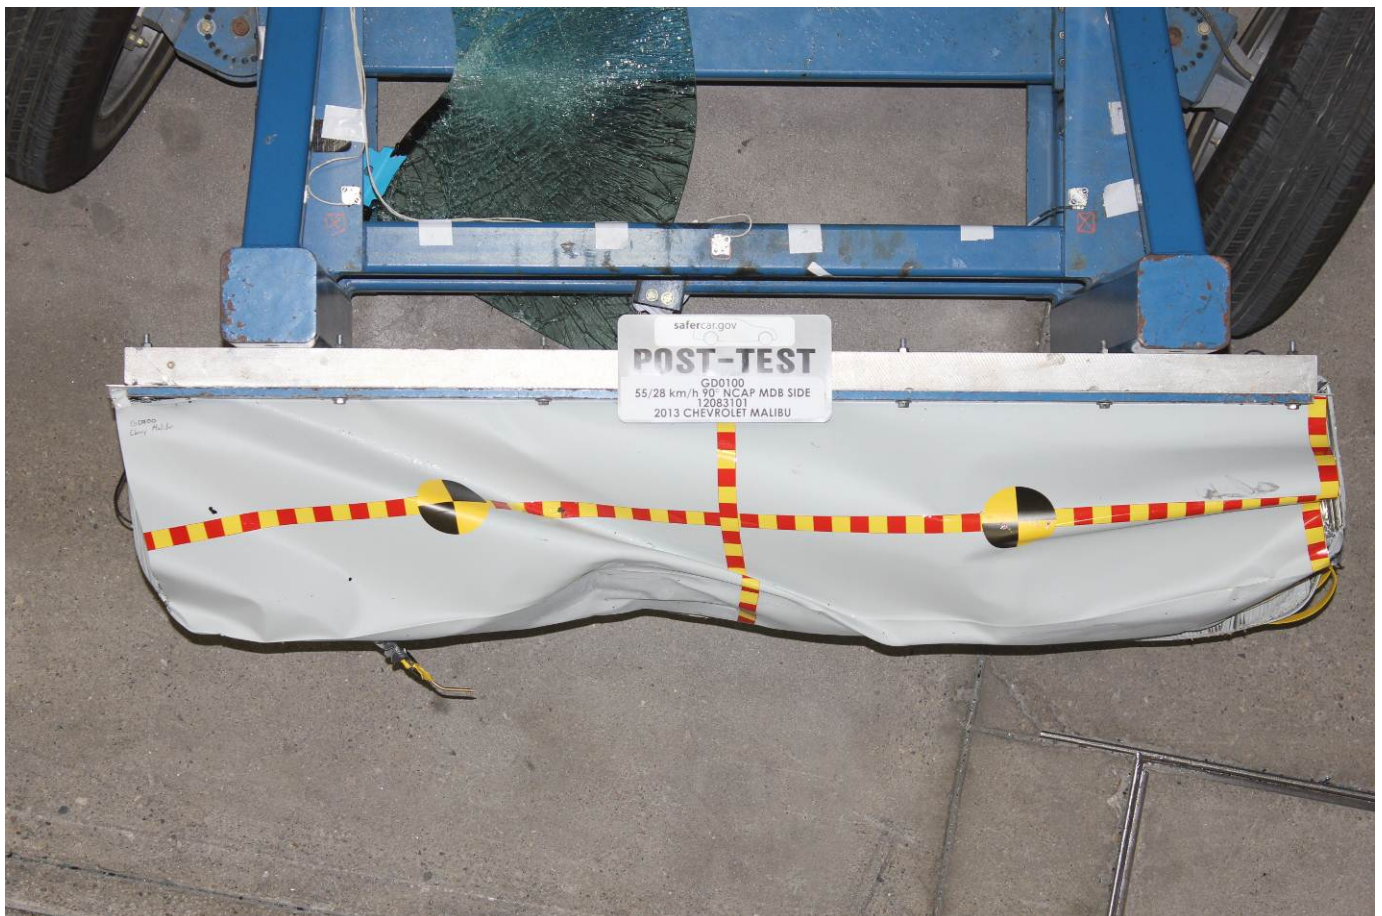
Post-Test Top View of MDB Impactor Face

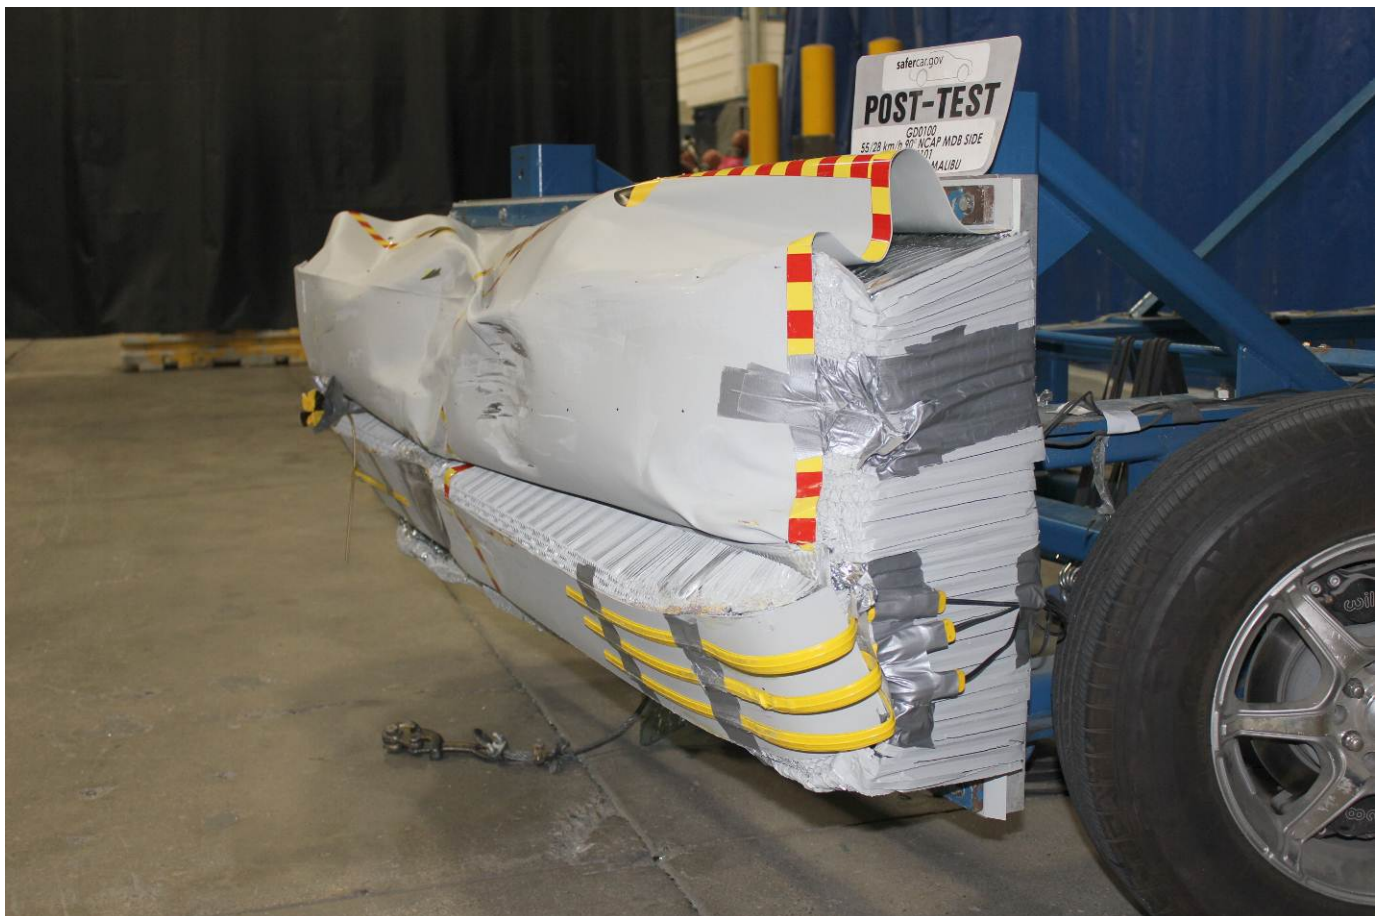
Post-Test Left Side View of MDB Impactor Face
