**REPORT NUMBER: NCAP-MGA-2013-010**

**NEW CAR ASSESSMENT PROGRAM (NCAP)  
Frontal Barrier Impact Test**

**TOYOTA MOTOR MANUFACTURING, KENTUCKY, INC.  
2013 Toyota Venza LE AWD 4-Dr SUV  
NHTSA No.: YD5101**

**FINAL REPORT**

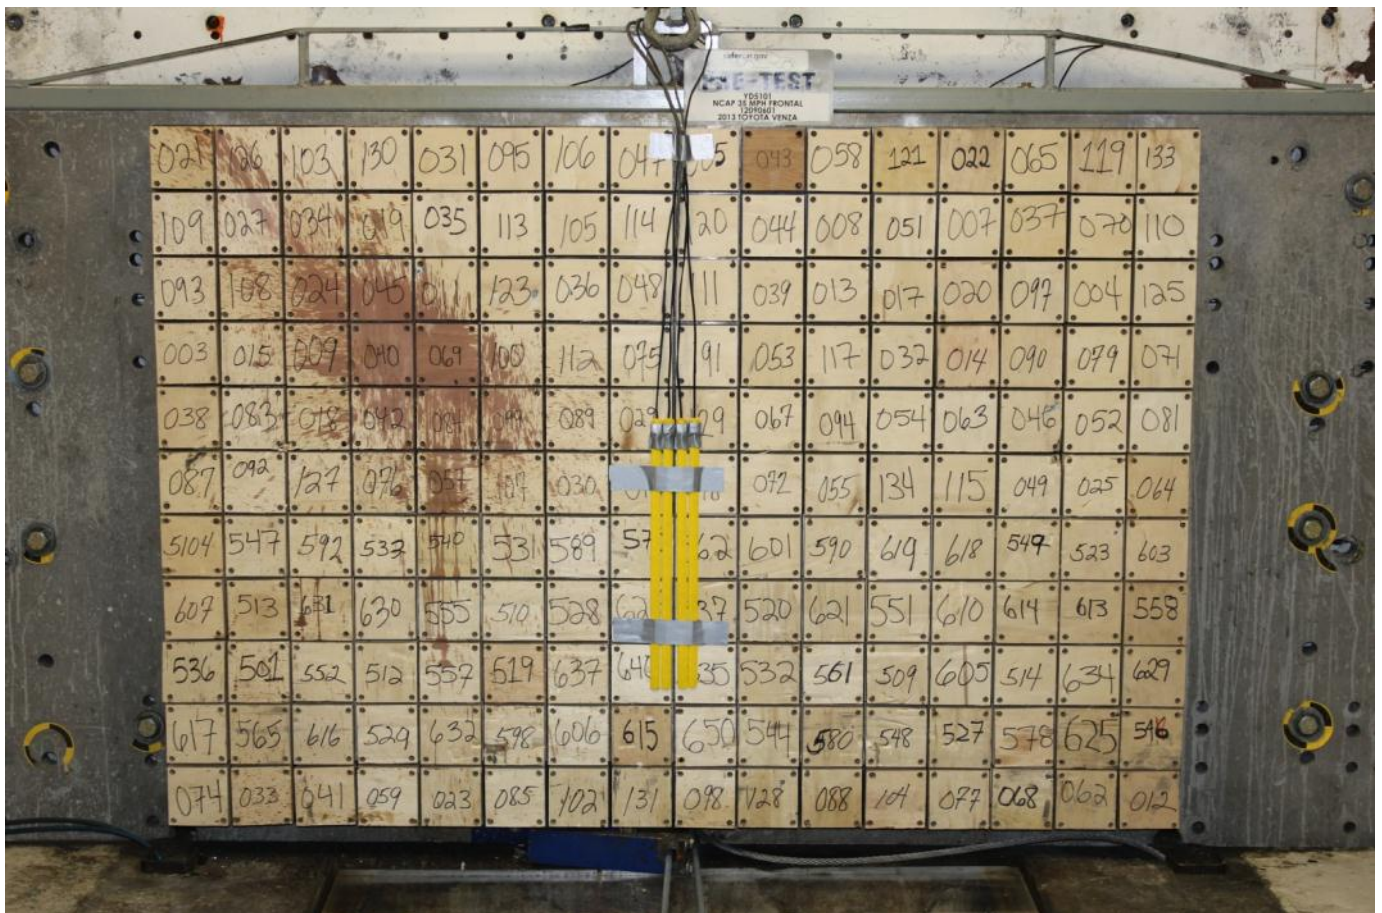
Load Cell Wall

A load cell barrier consisting of 176 load cells was impacted by a 2013 Toyota Venza LE AWD 4-Dr SUV at a velocity of 56.2 km/h. The test was performed at MGA Research Corporation on September 6, 2012. Pre-and post-test photographs of the vehicle and dummies can be found in Appendix A.

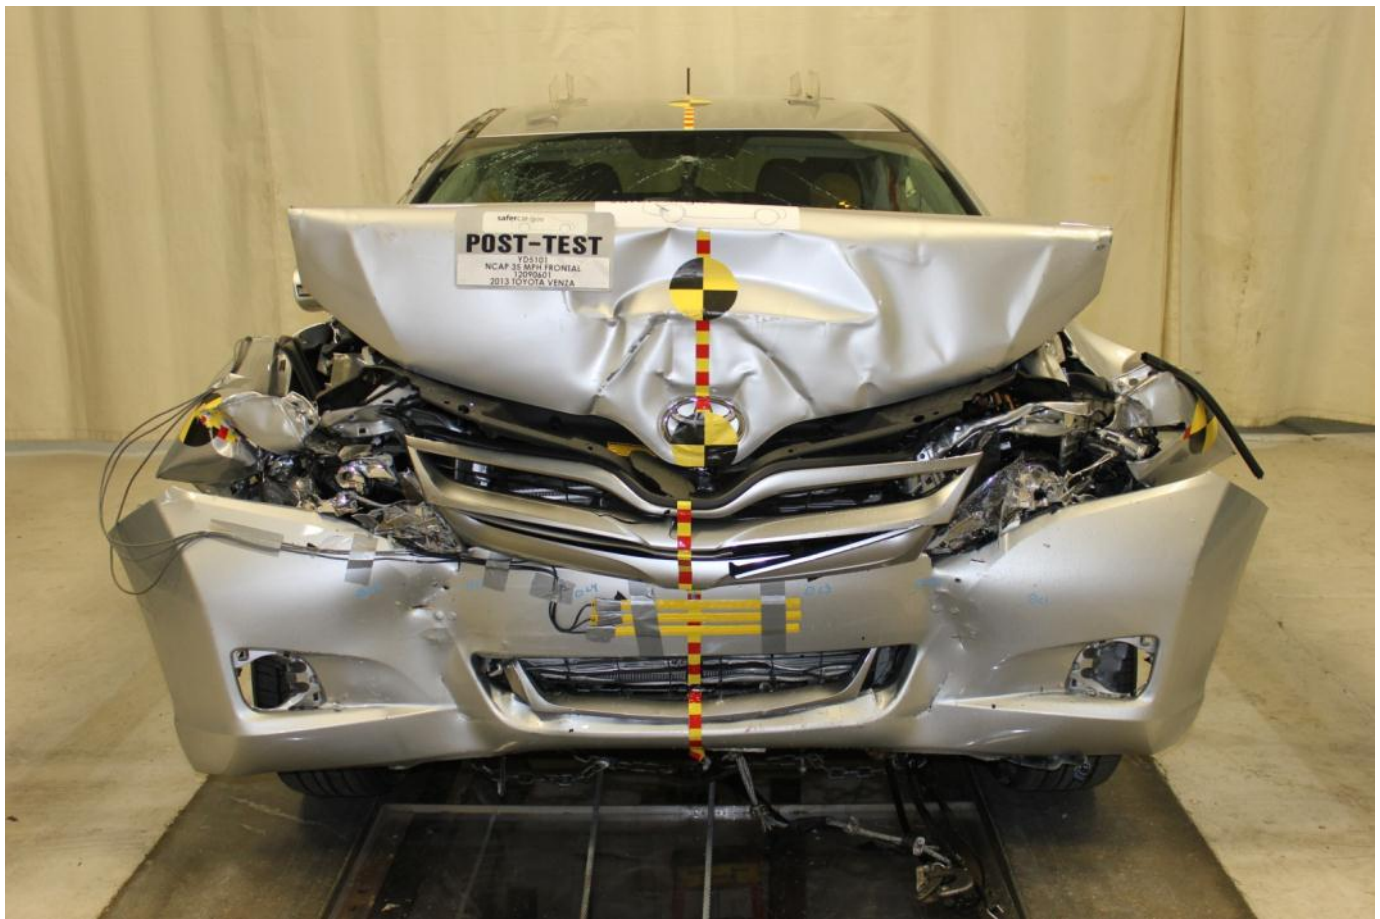
Post-Test Front View of Test Vehicle

The maximum static crush of the vehicle was 623 mm and both the driver and passenger side doors remained closed during the impact event and were operable after the impact.

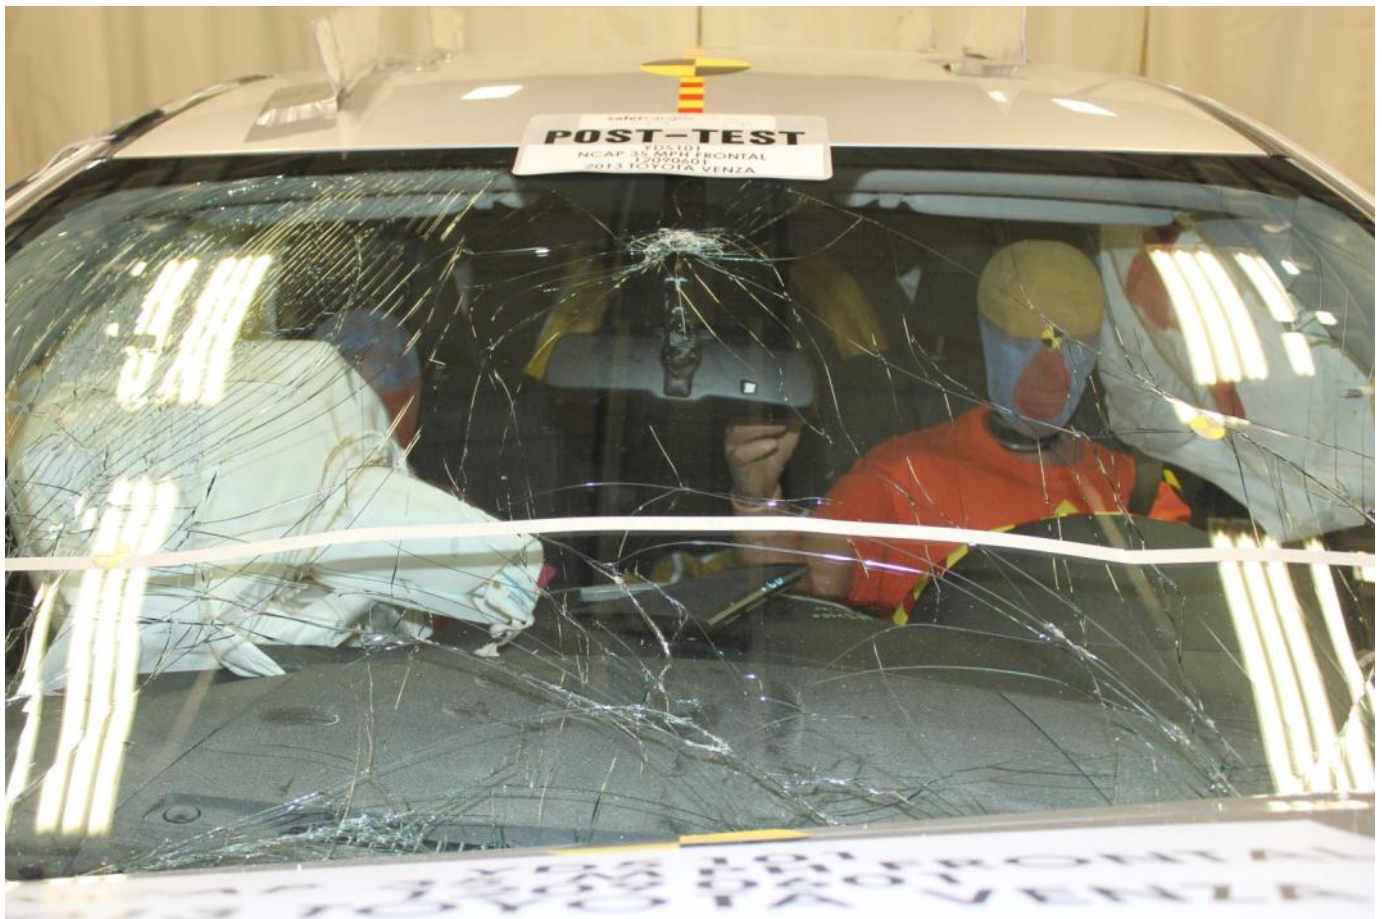
Post-Test Windshield View

There was 100 percent windshield retention and no intrusion into the protected zone of the windshield during the event. There was no Stoddard Solvent leakage after the event or during any phase of the static rollover.

| Critical Areas of Performance | Observations and Conclusions |
|---|---|
| Windshield Damage | Cracked |

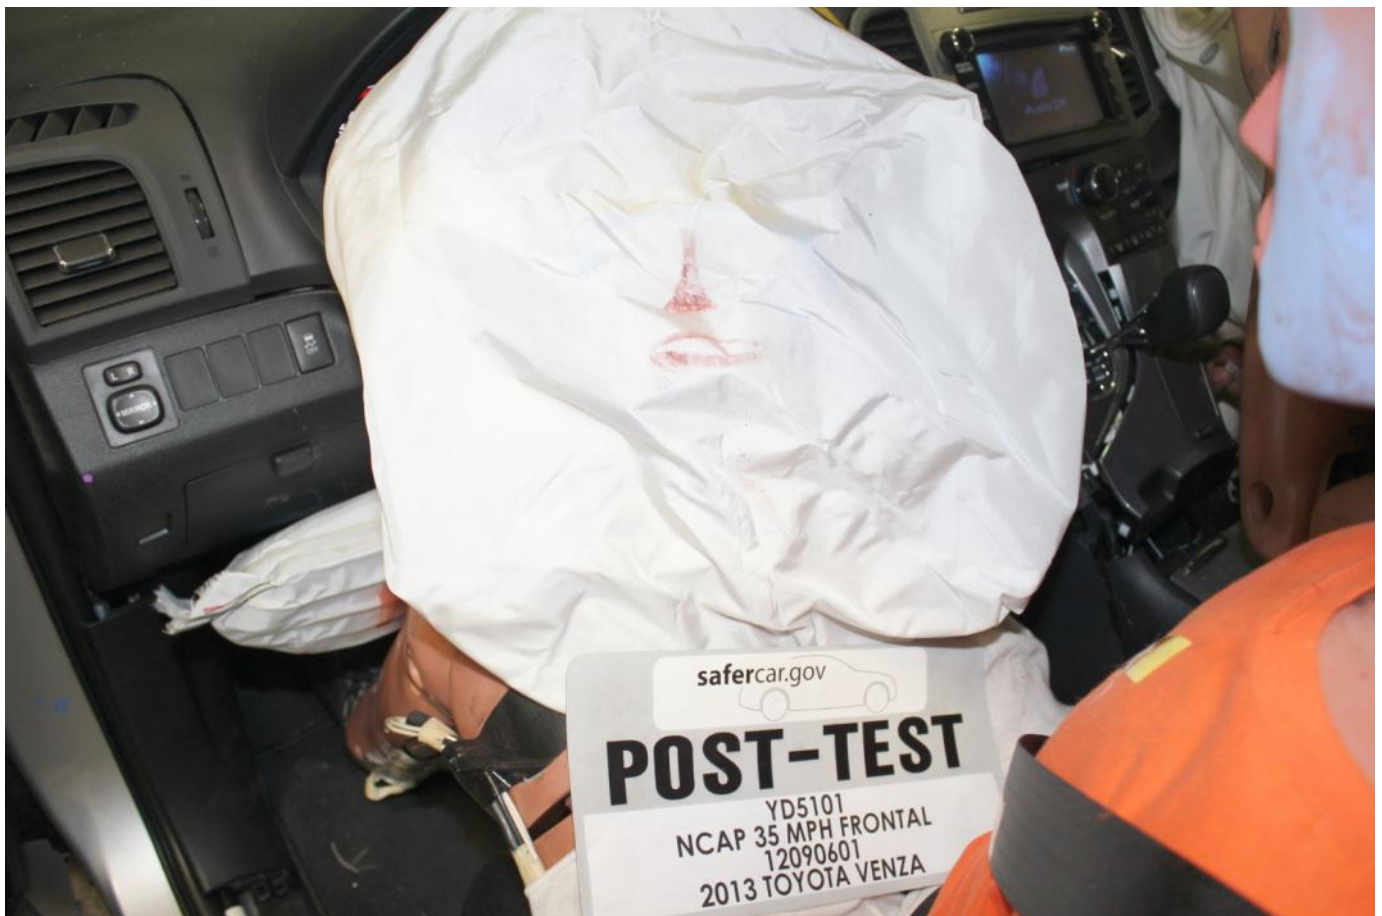
Post-Test Driver Dummy Contact with Airbag

The driver's visible contact points were as follows: The driver's head and chest contacted the airbag. The driver's head also contacted the headrest, curtain airbag, and side header. The driver's knees contacted the knee airbag and steering column. The passenger's visible contact points were as follows: The passenger's head and chest contacted the airbag. The passenger's head also contacted the headrest and the curtain airbag. The passenger's knees contacted the glove box.

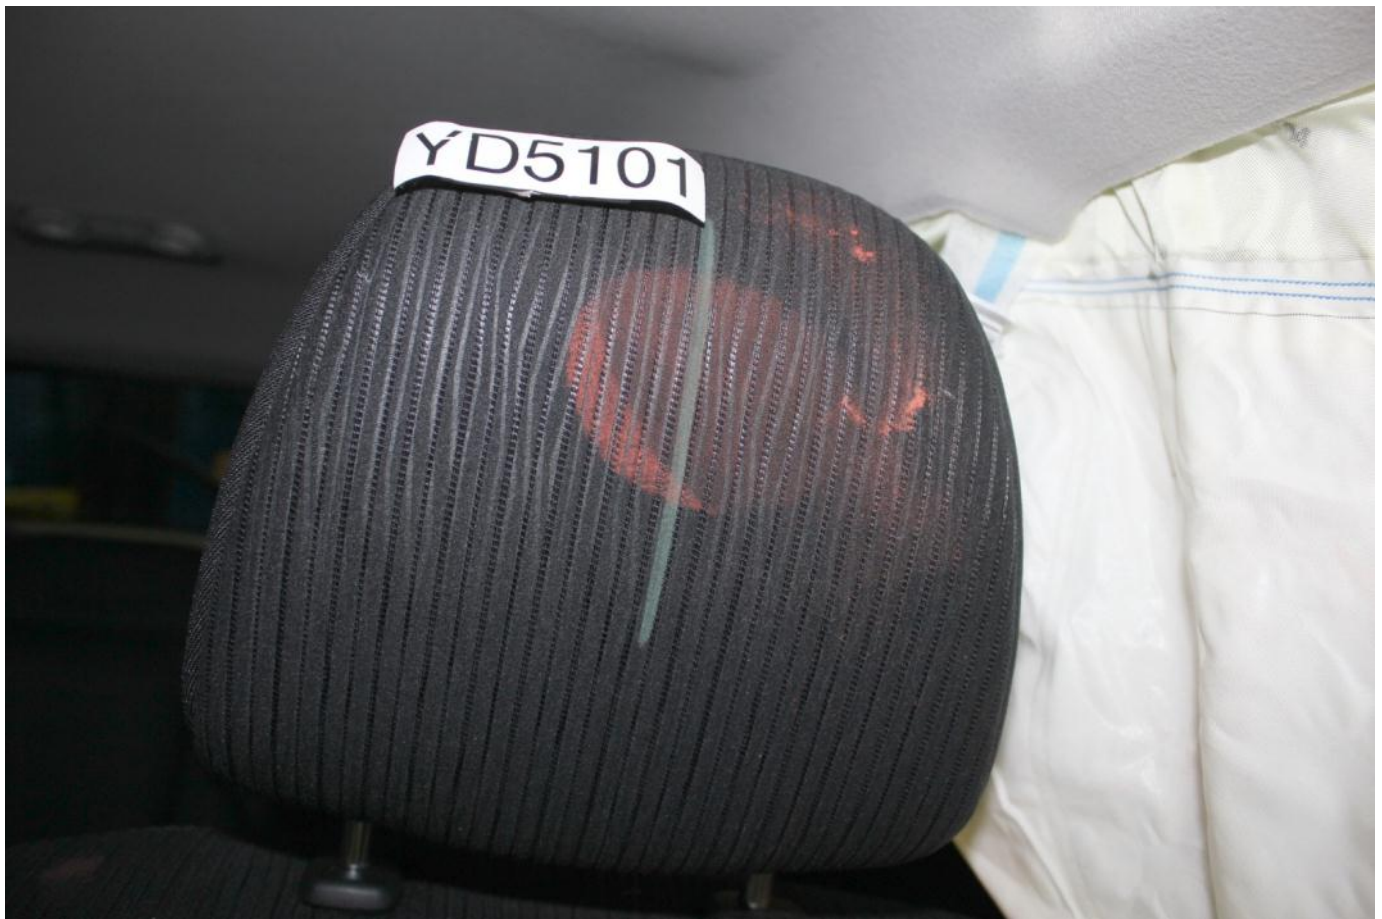
Post-Test Driver Dummy Contact with Headrest

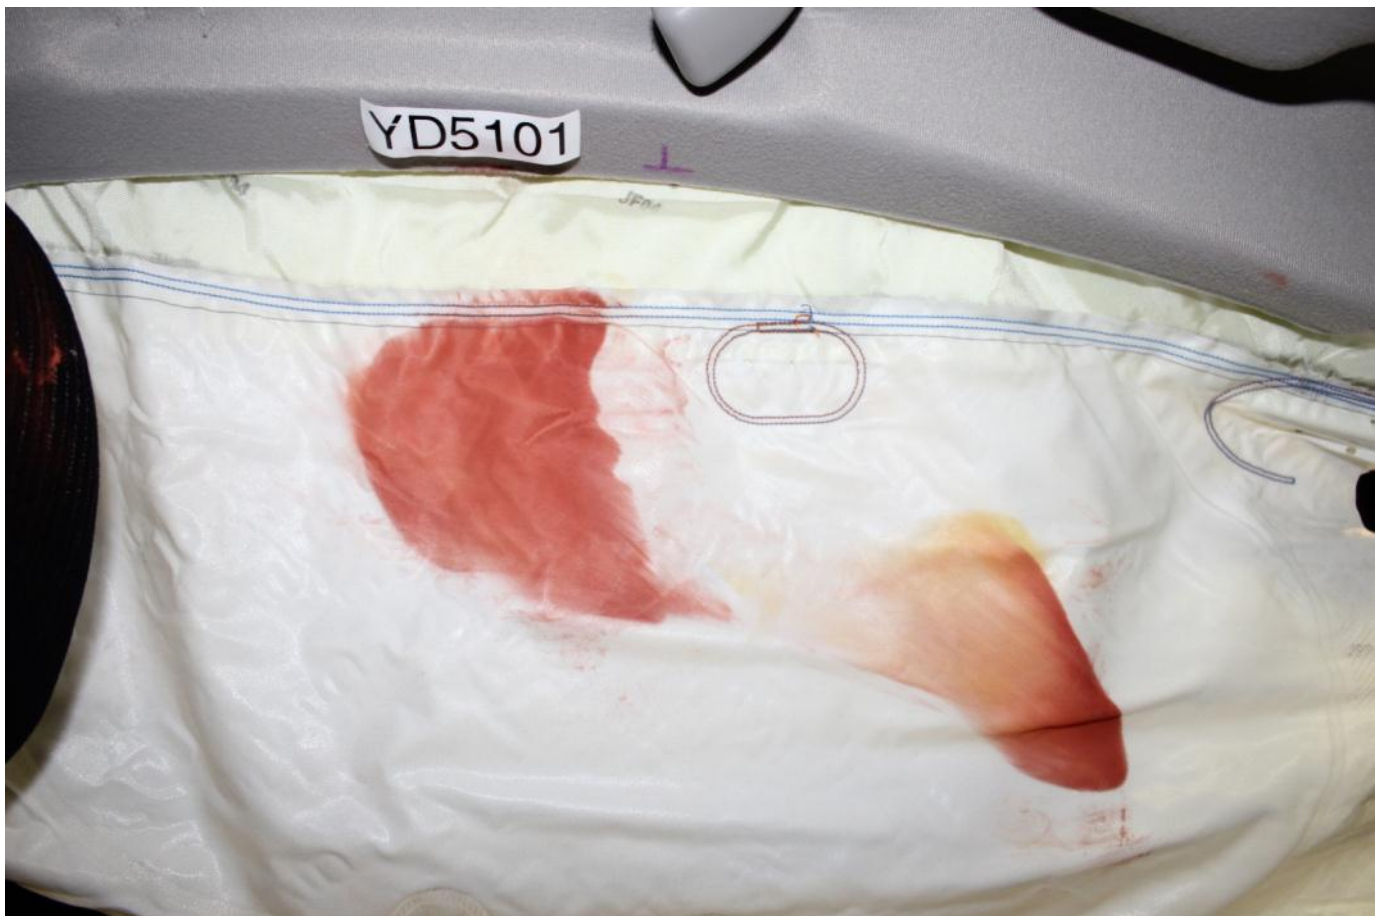
Post-Test Driver Dummy Contact with Curtain Airbag

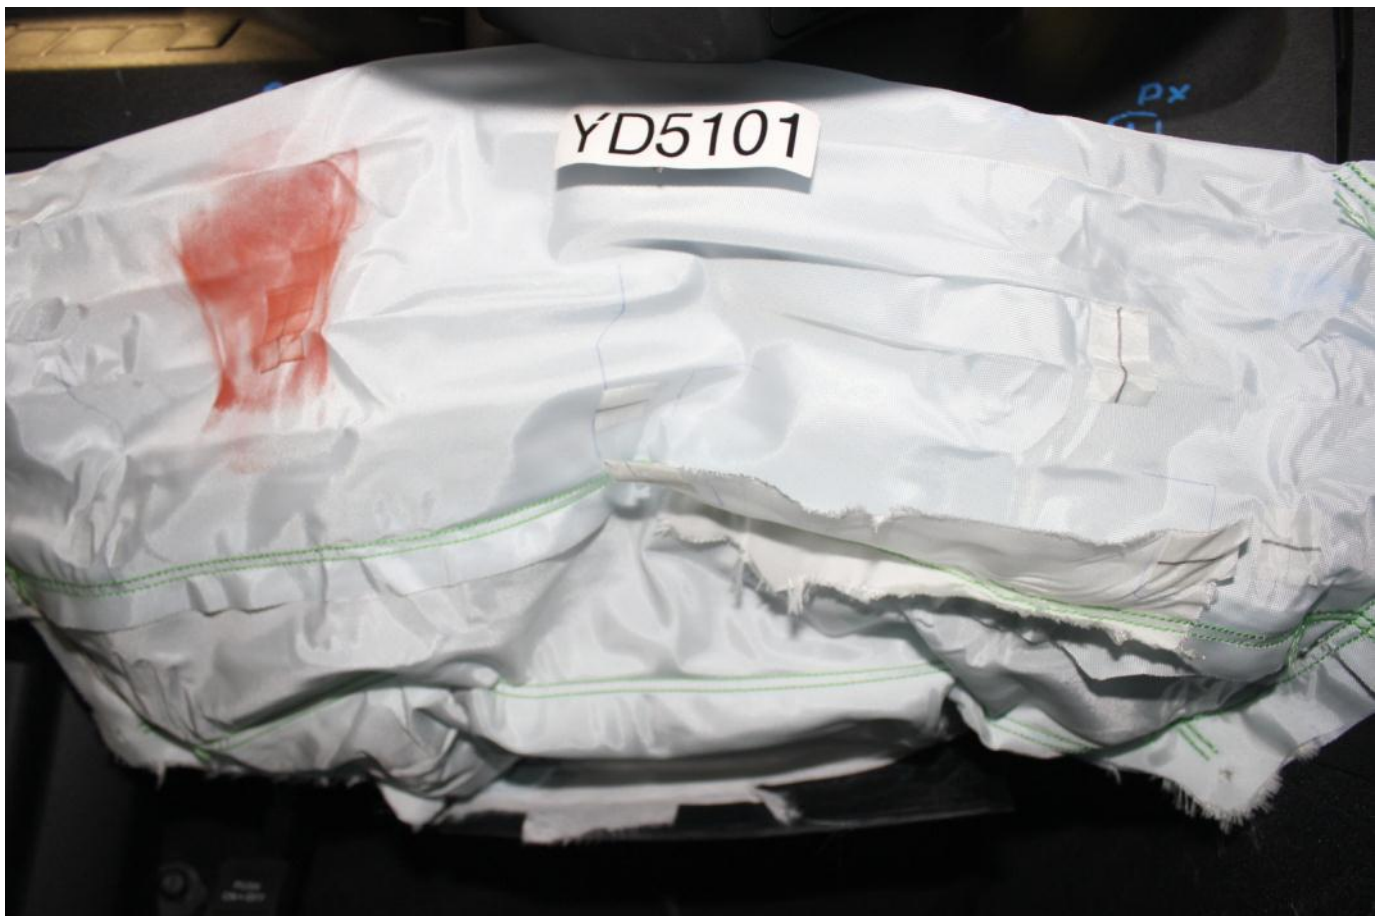
Post-Test Driver Dummy Contact with Knee Airbag

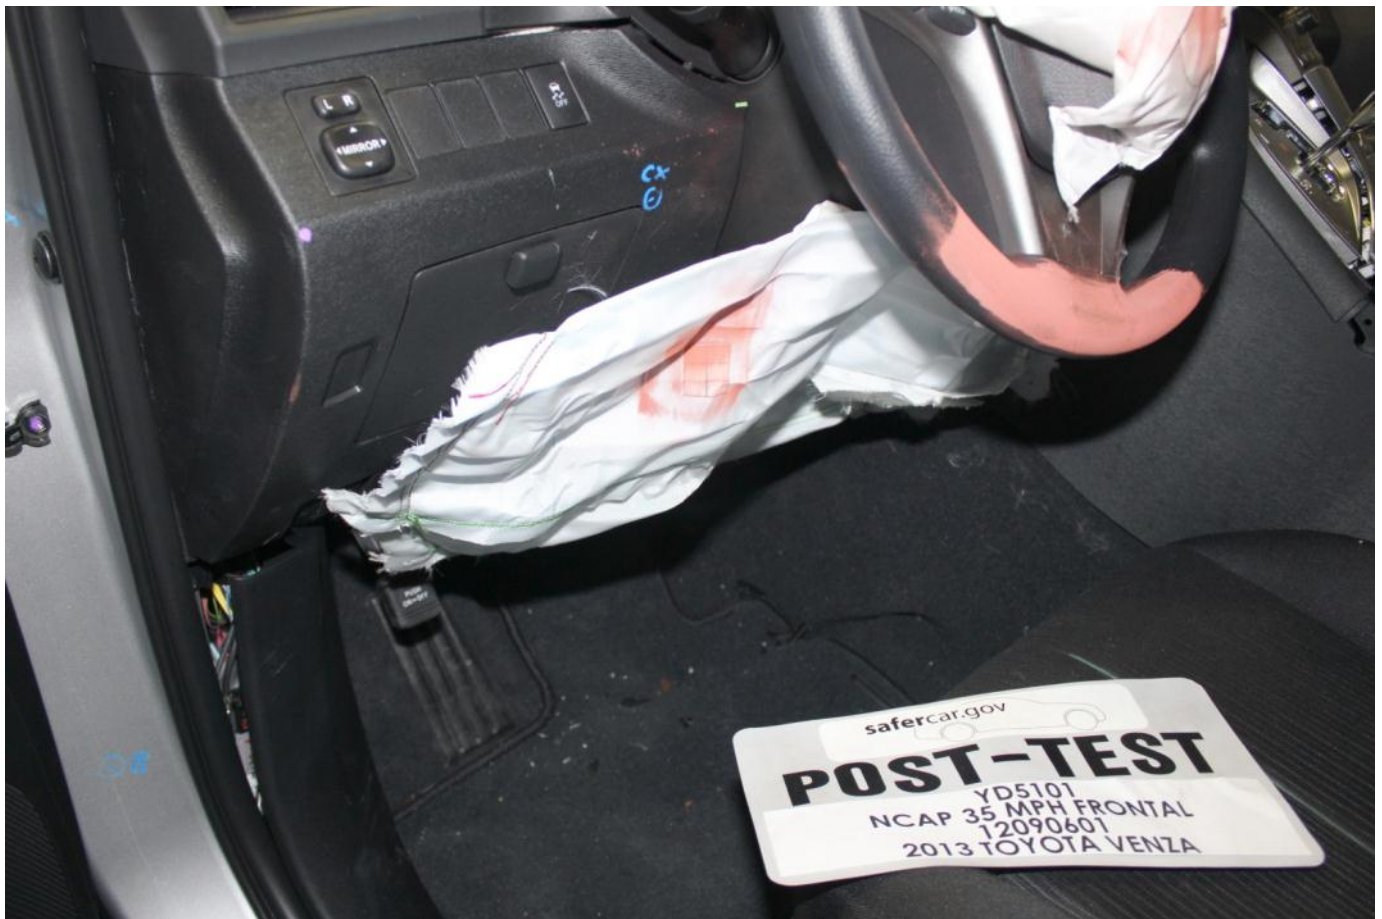
Post-Test Driver Dummy Contact with Steering Column

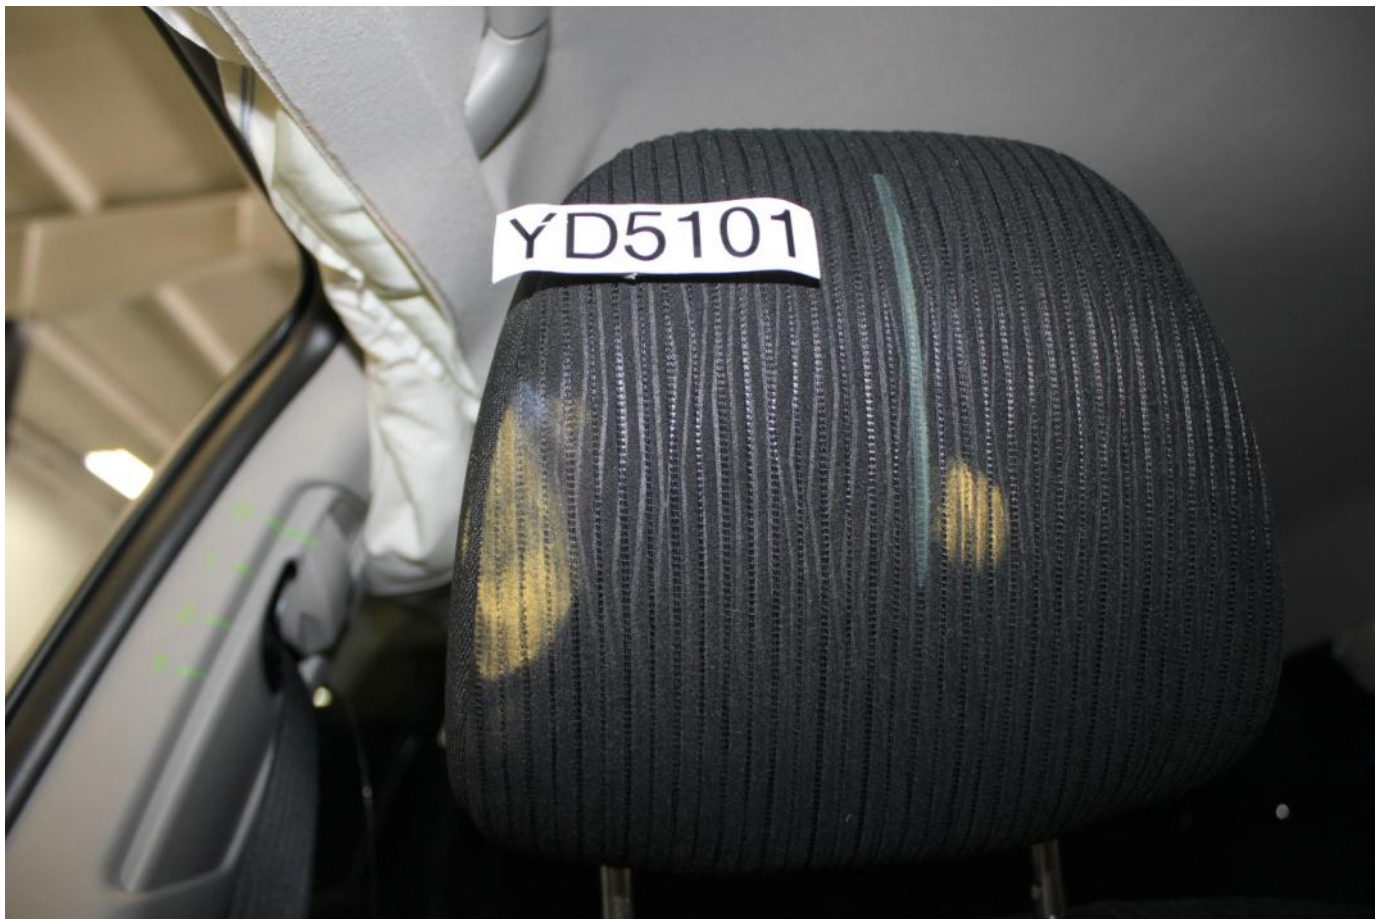
Post-Test Passenger Dummy Contact with Headrest

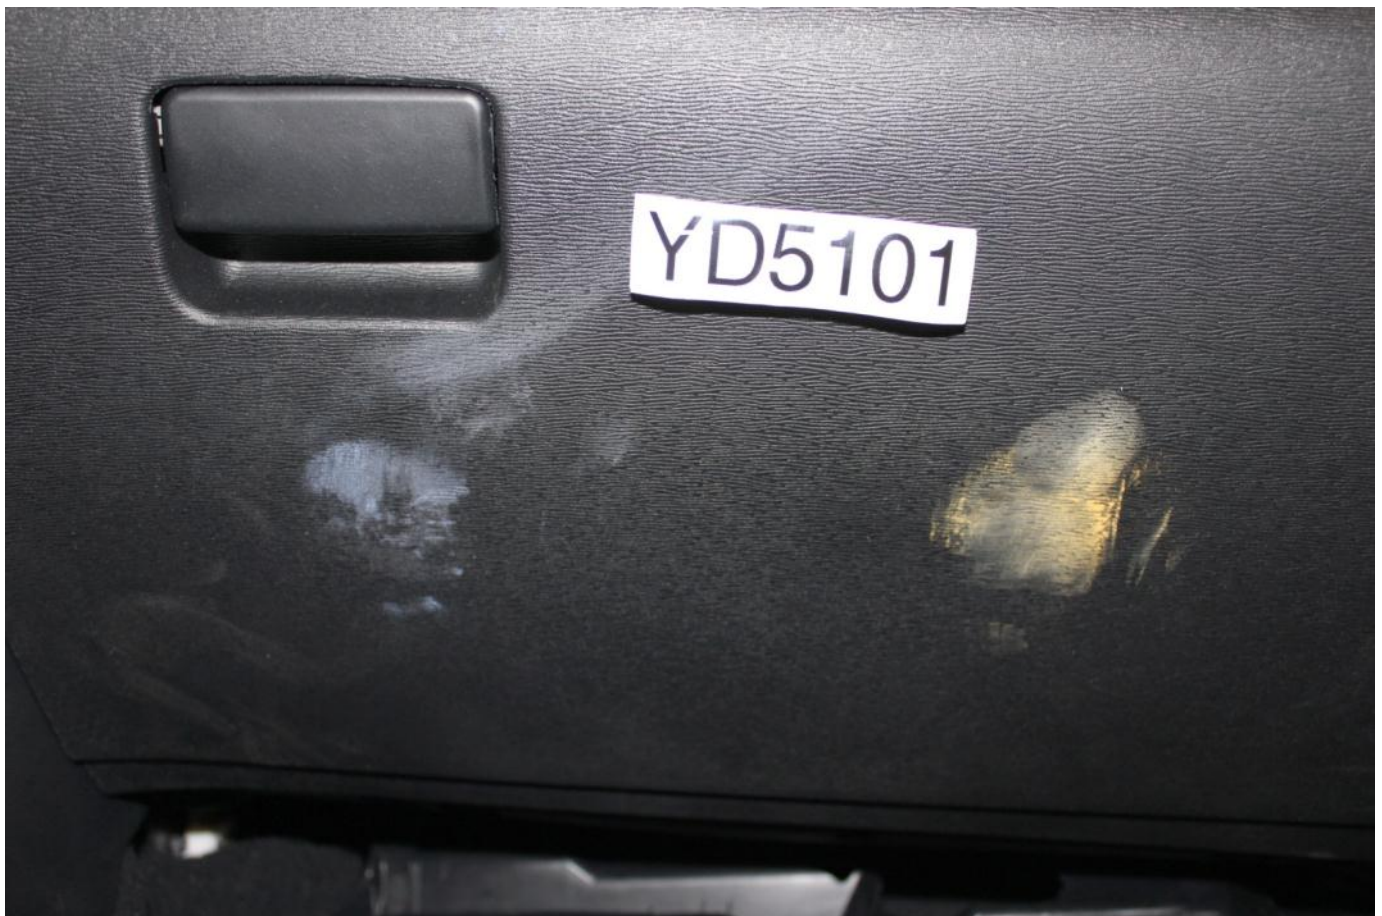
Post-Test Passenger Dummy Contact with Glove Box

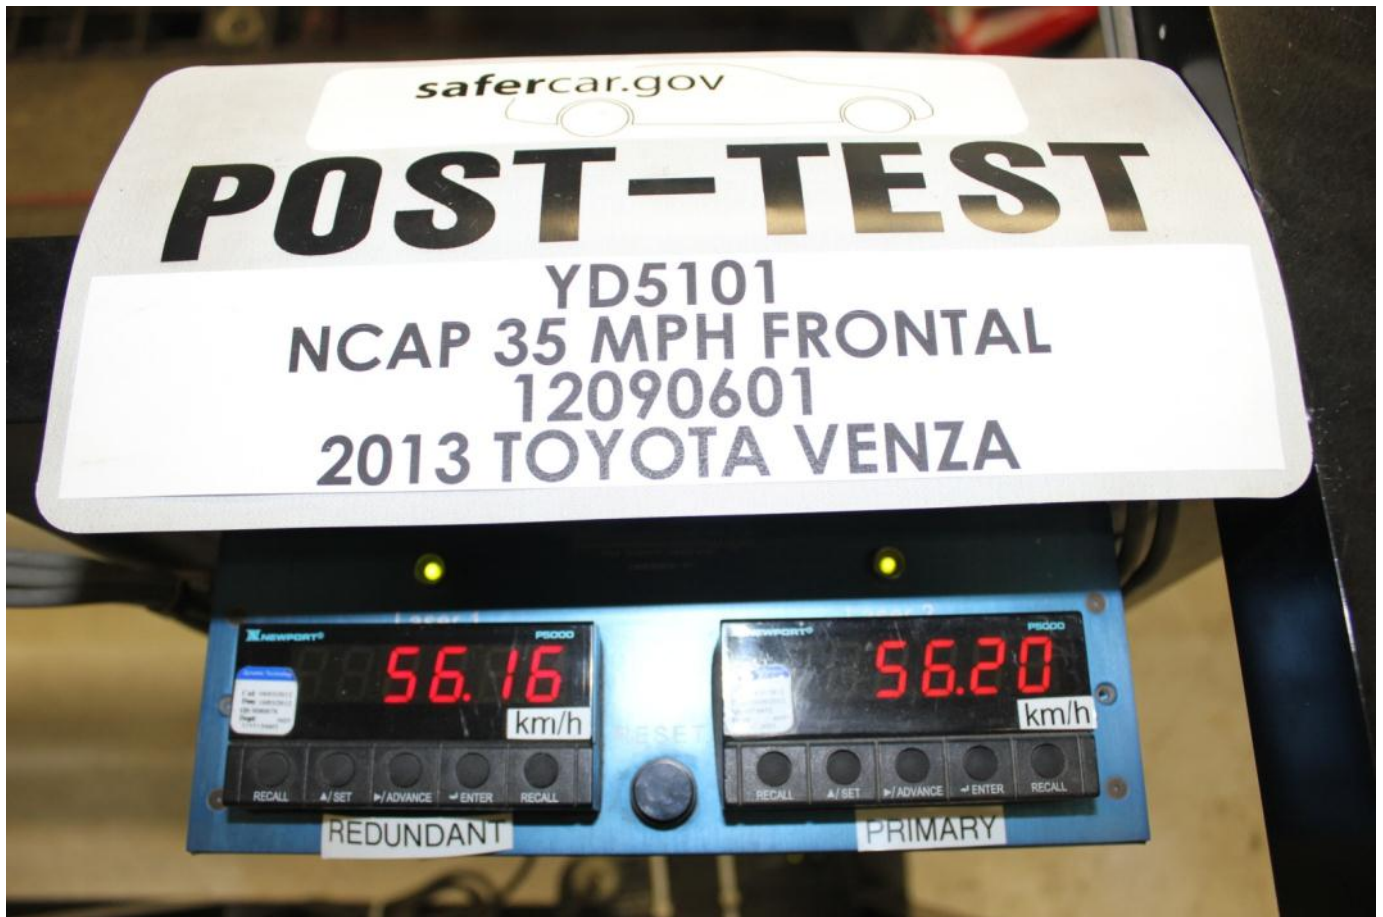
Post-Test Speed Trap Read-Out

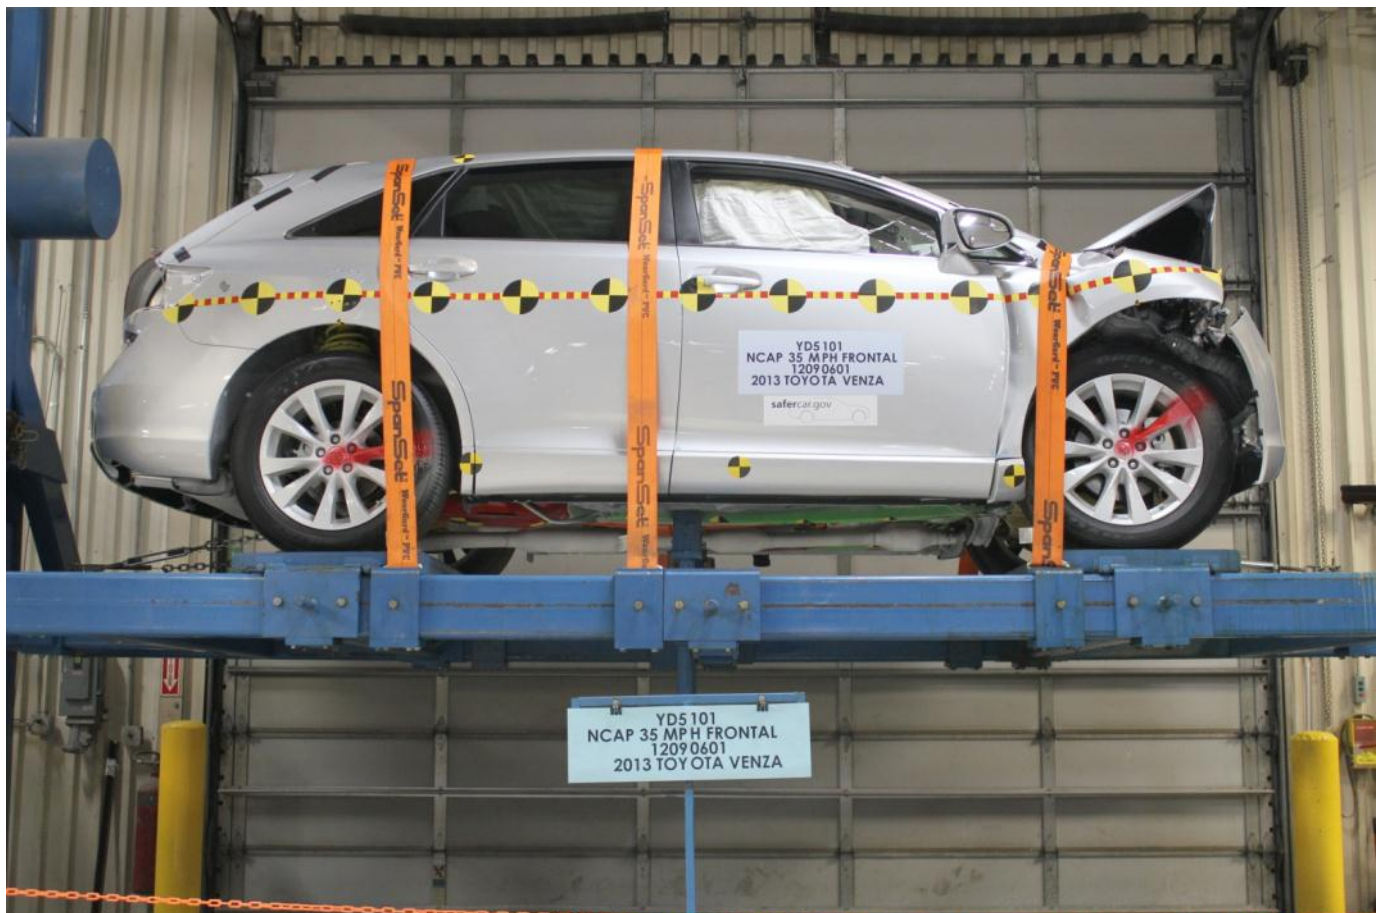
Vehicle at 0° on Static Rollover Device

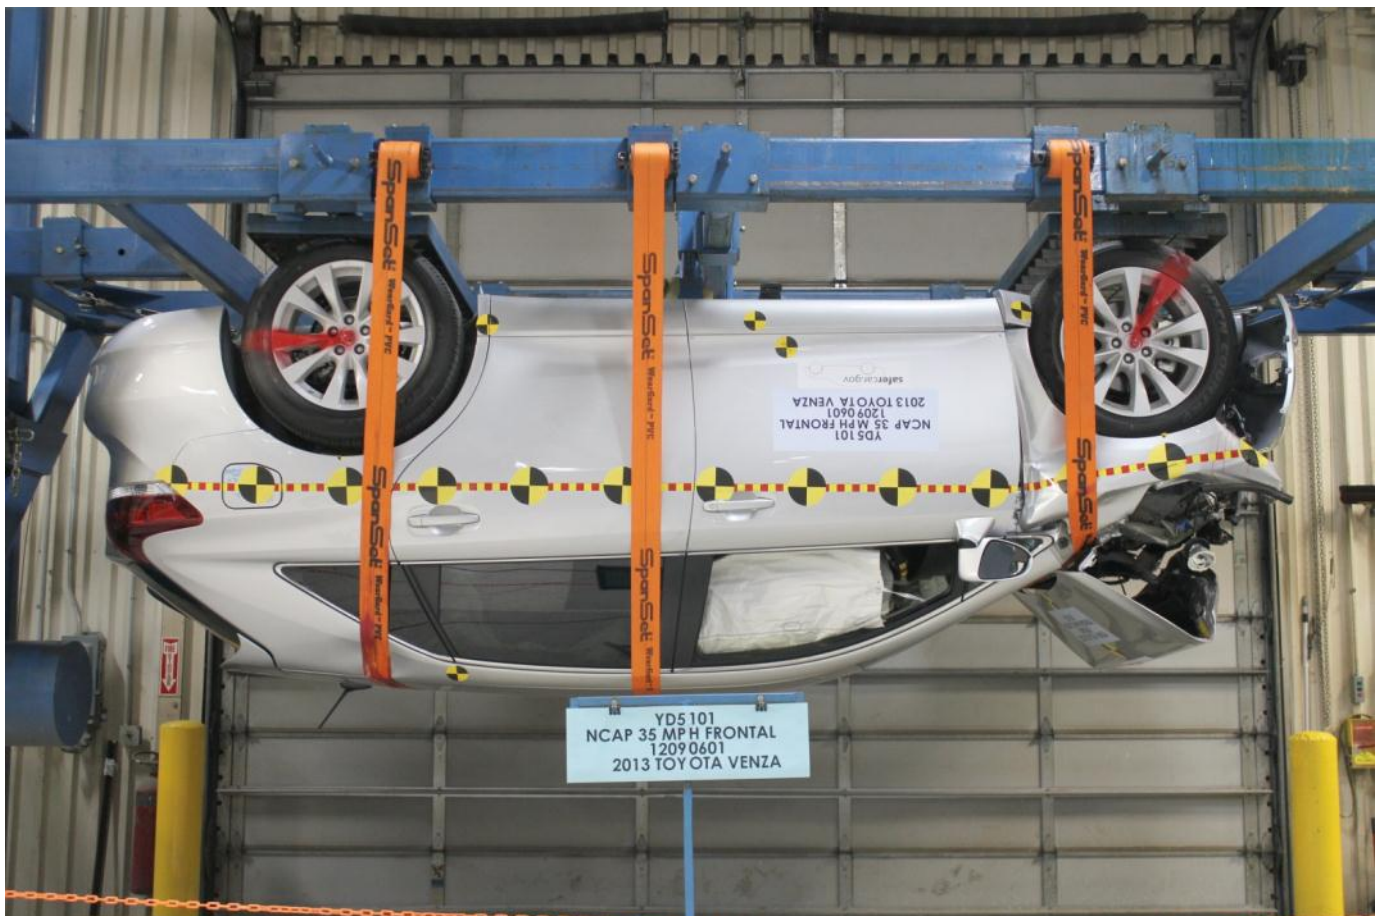
Vehicle at 180° on Static Rollover Device

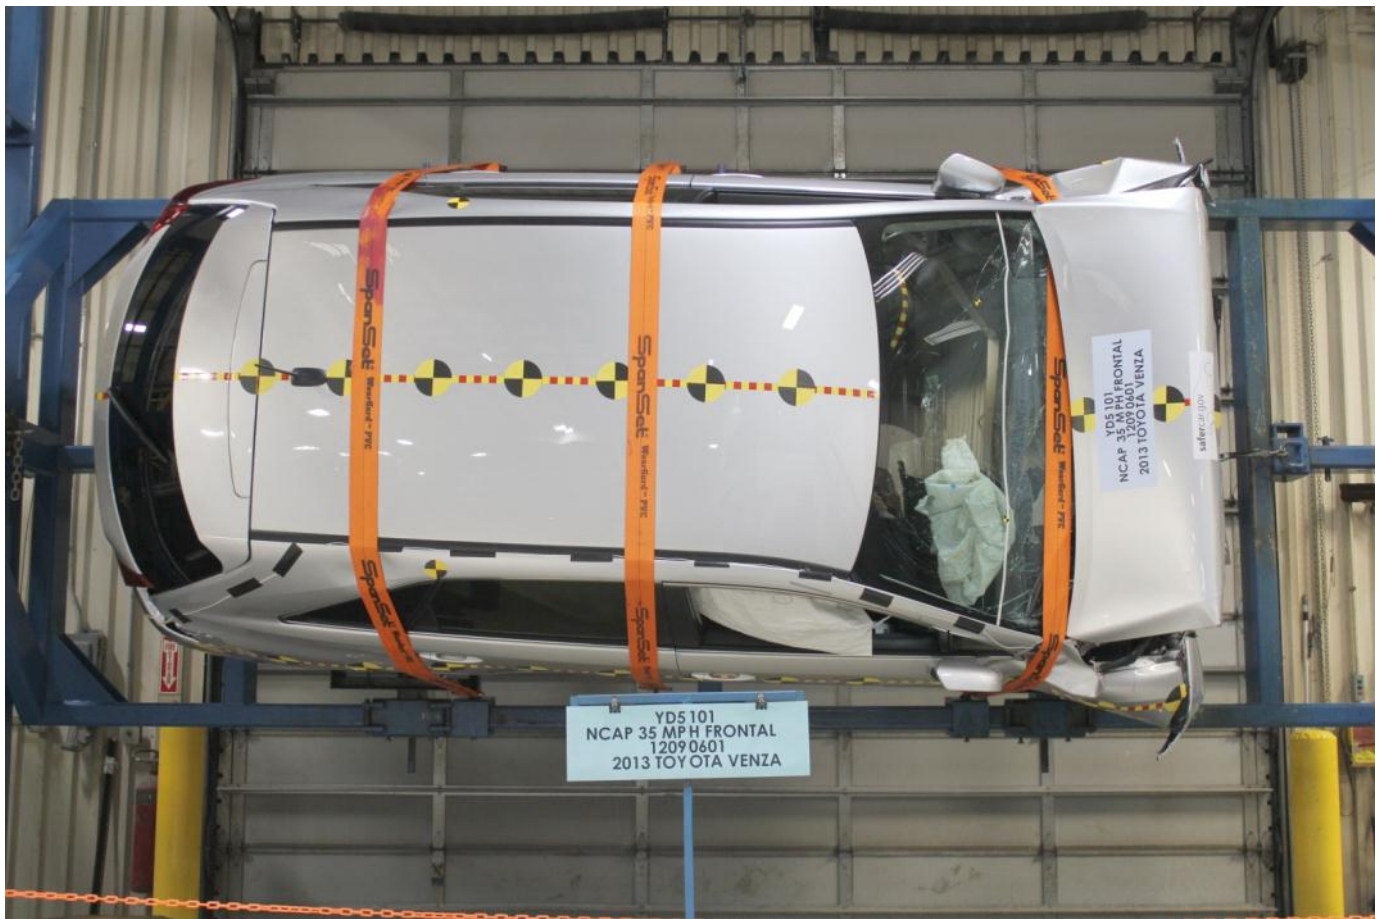
Vehicle at 270° on Static Rollover Device
