**REPORT NUMBER: NCAP-MGA-2013-015**

**NEW CAR ASSESSMENT PROGRAM (NCAP)  
Frontal Barrier Impact Test**

**VOLKSWAGEN AG GERMANY  
2013 Volkswagen Tiguan S AWD SUV  
NHTSA No.: MD5802**

**MGA RESEARCH CORPORATION  
5000 Warren Road  
Burlington, WI 53105**

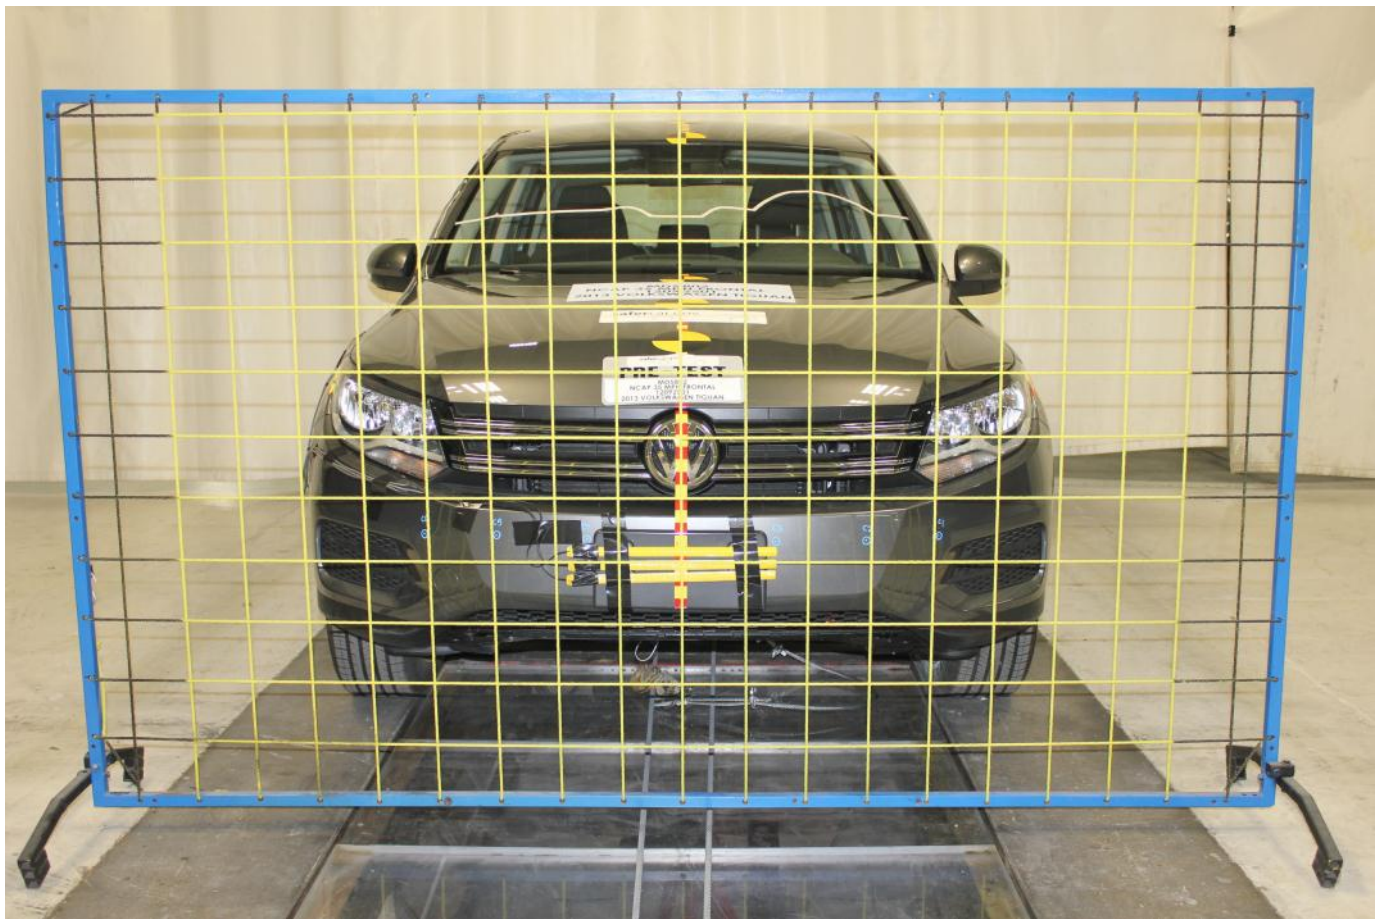
Load Cell Location

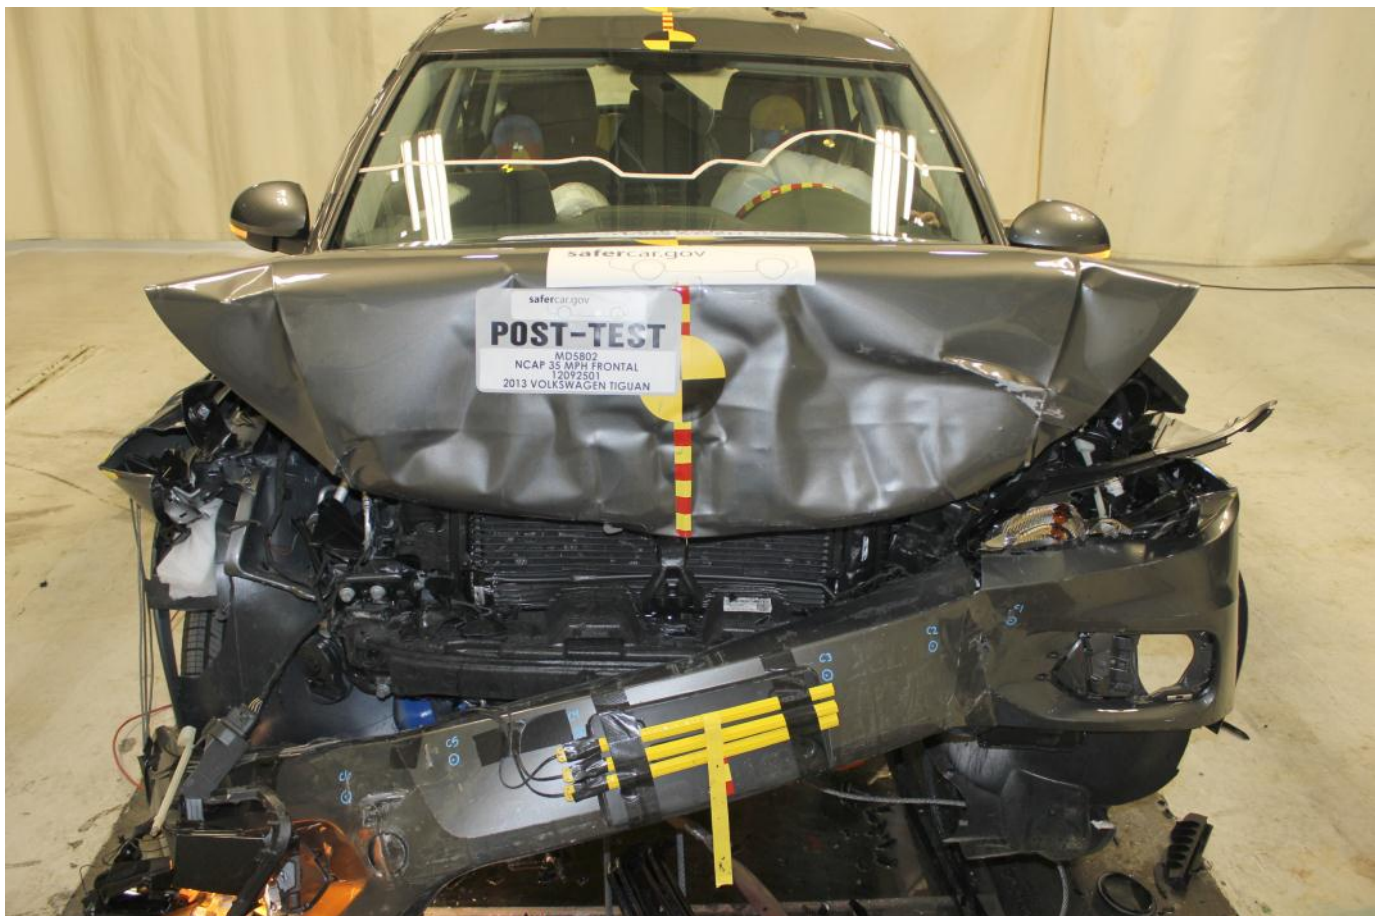
Post-Test Front View of Test Vehicle

The maximum static crush of the vehicle was 401 mm and both the driver and passenger side doors remained closed during the impact event and were operable after the impact.

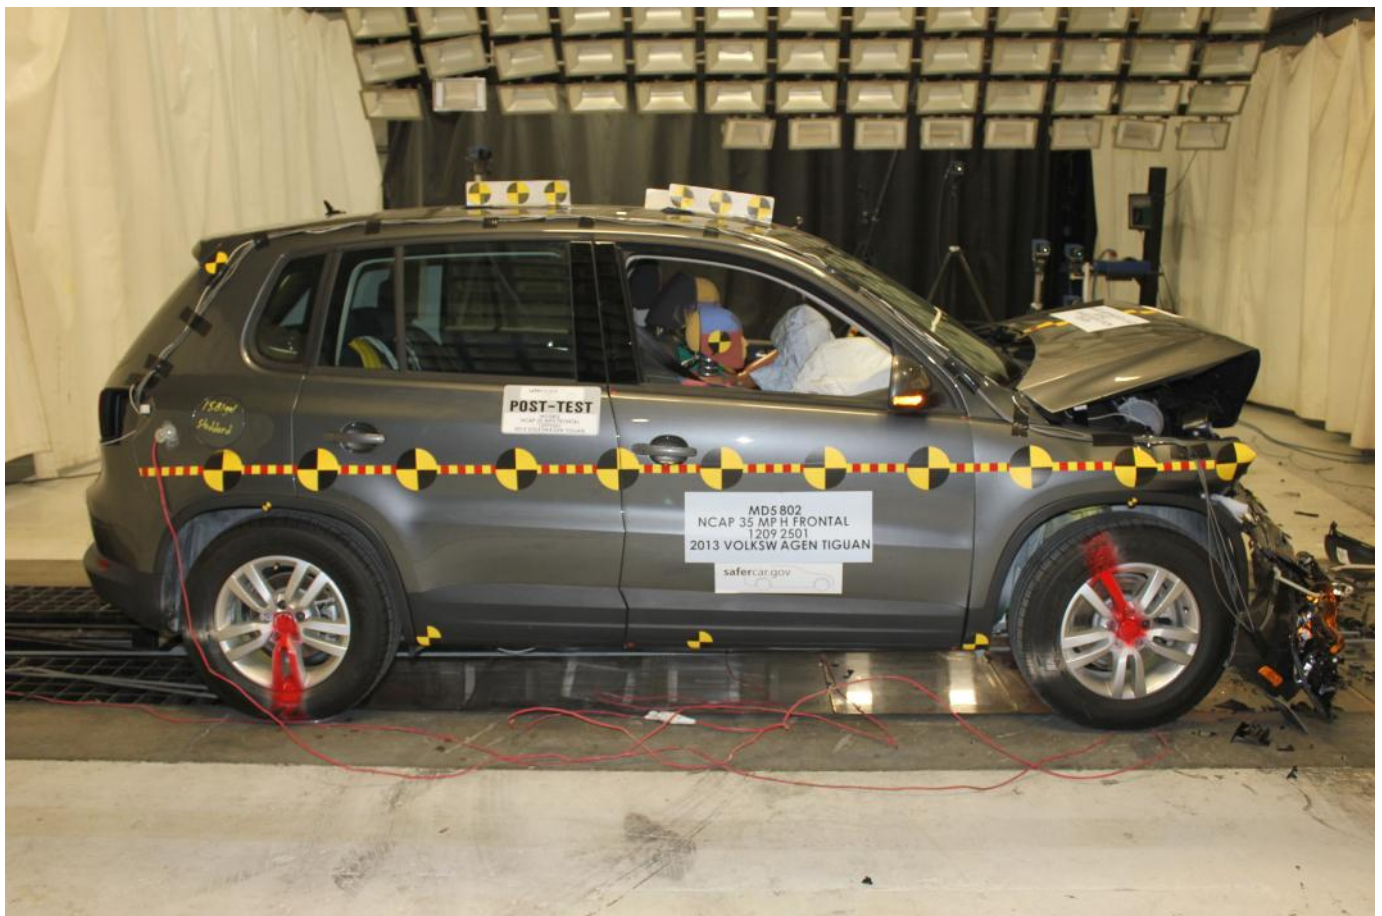
Post-Test Right View of Test Vehicle

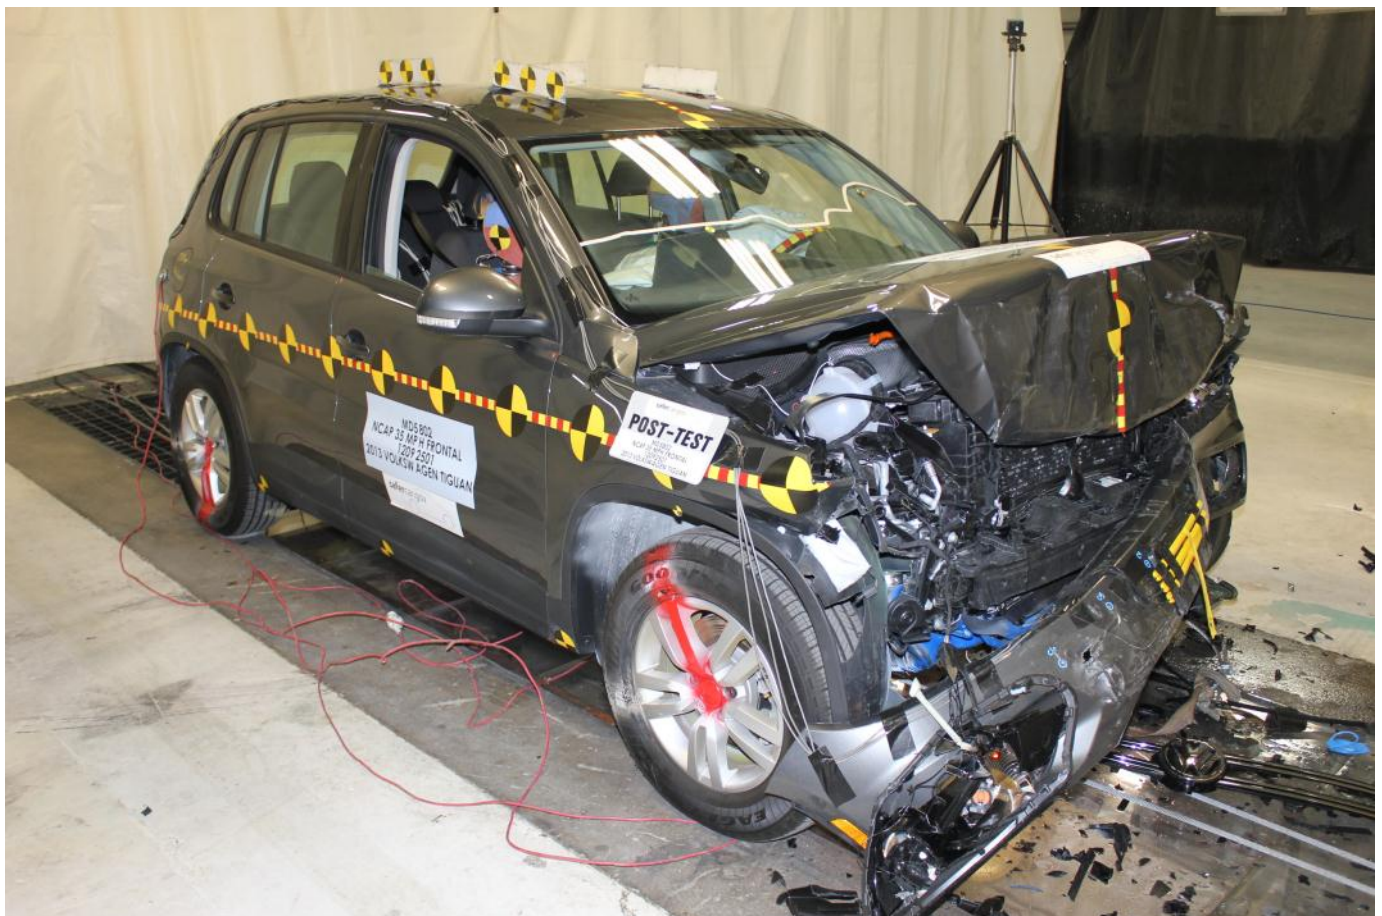
Post-Test Right Front 3-4 View

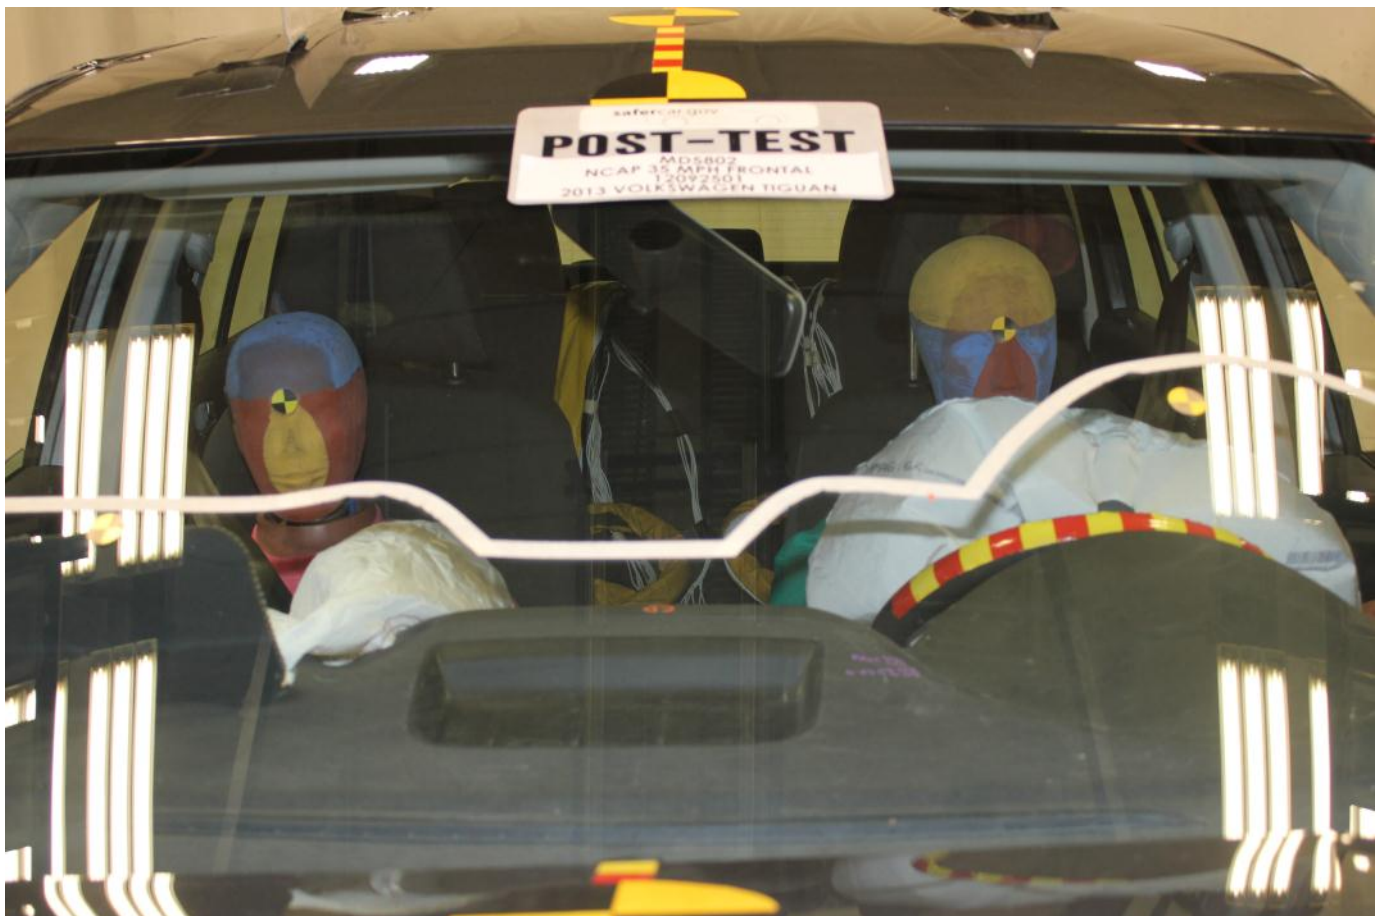
Post-Test Windshield View

There was 100 percent windshield retention and no intrusion into the protected zone of the windshield during the event. There was no Stoddard Solvent leakage after the event or during any phase of the static rollover.

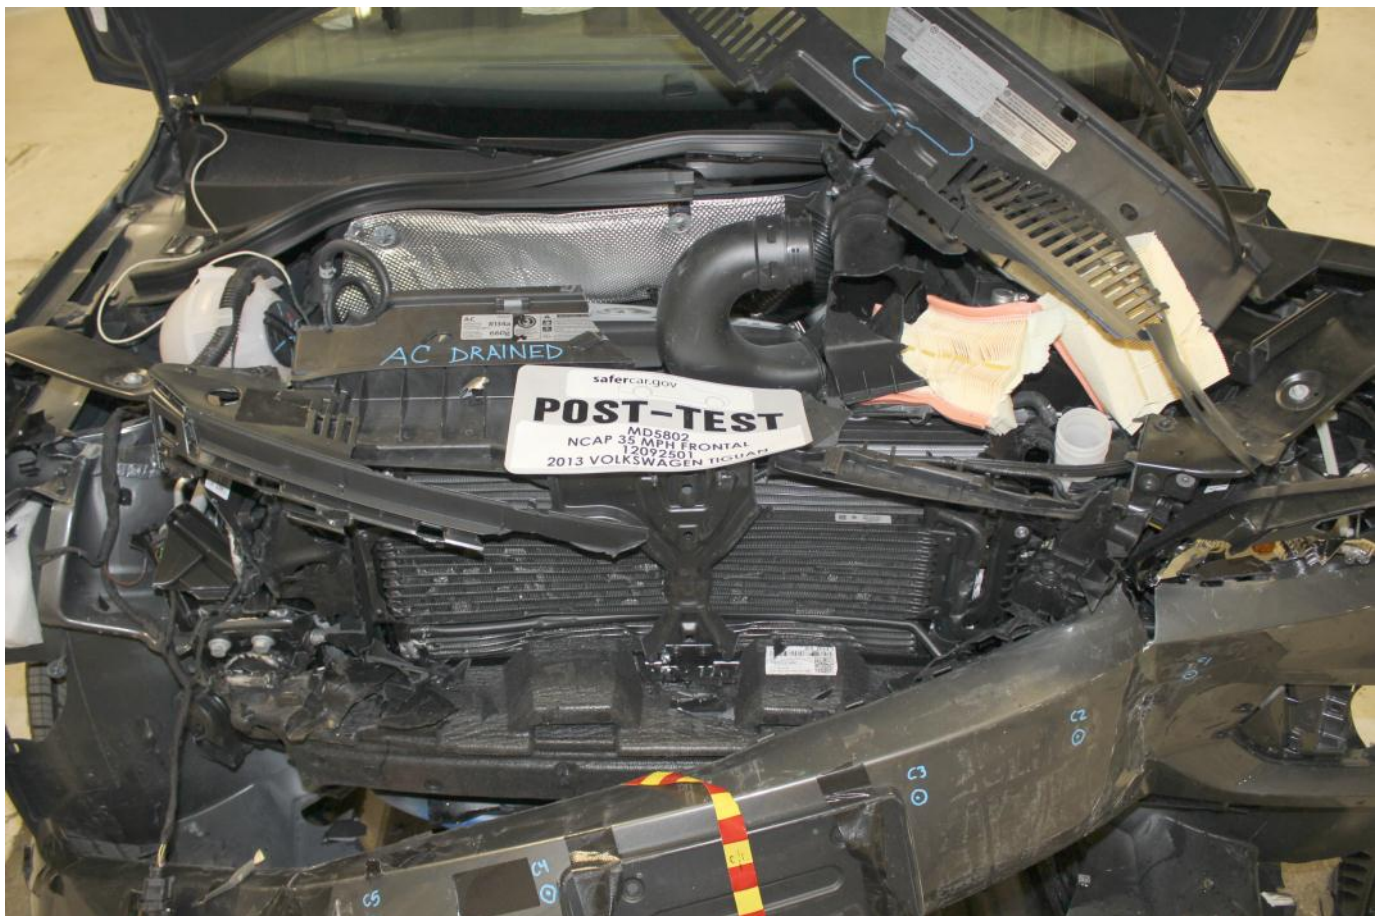
Post-Test Engine Compartment View

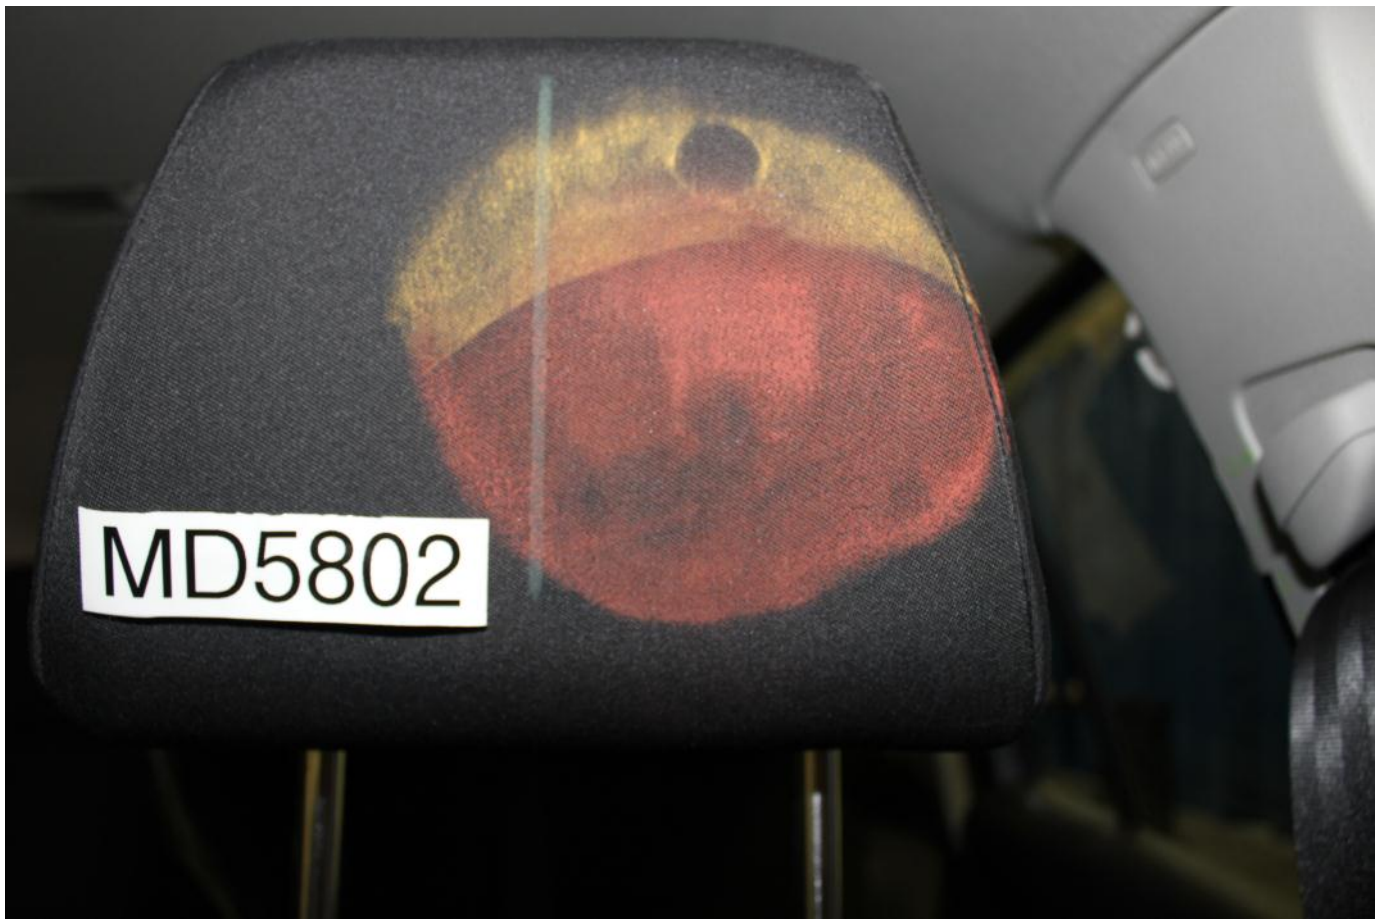
Post-Test Driver Dummy Contact with Headrest

The driver's visible contact points were as follows: The driver's head and chest contacted the airbag. The driver's head also contacted the headrest. The driver's knees contacted the knee bolster and steering column. The passenger's visible contact points were as follows: The passenger's head and chest contacted the airbag. The passenger's head also contacted the headrest. The passenger's knees contacted the glove box.

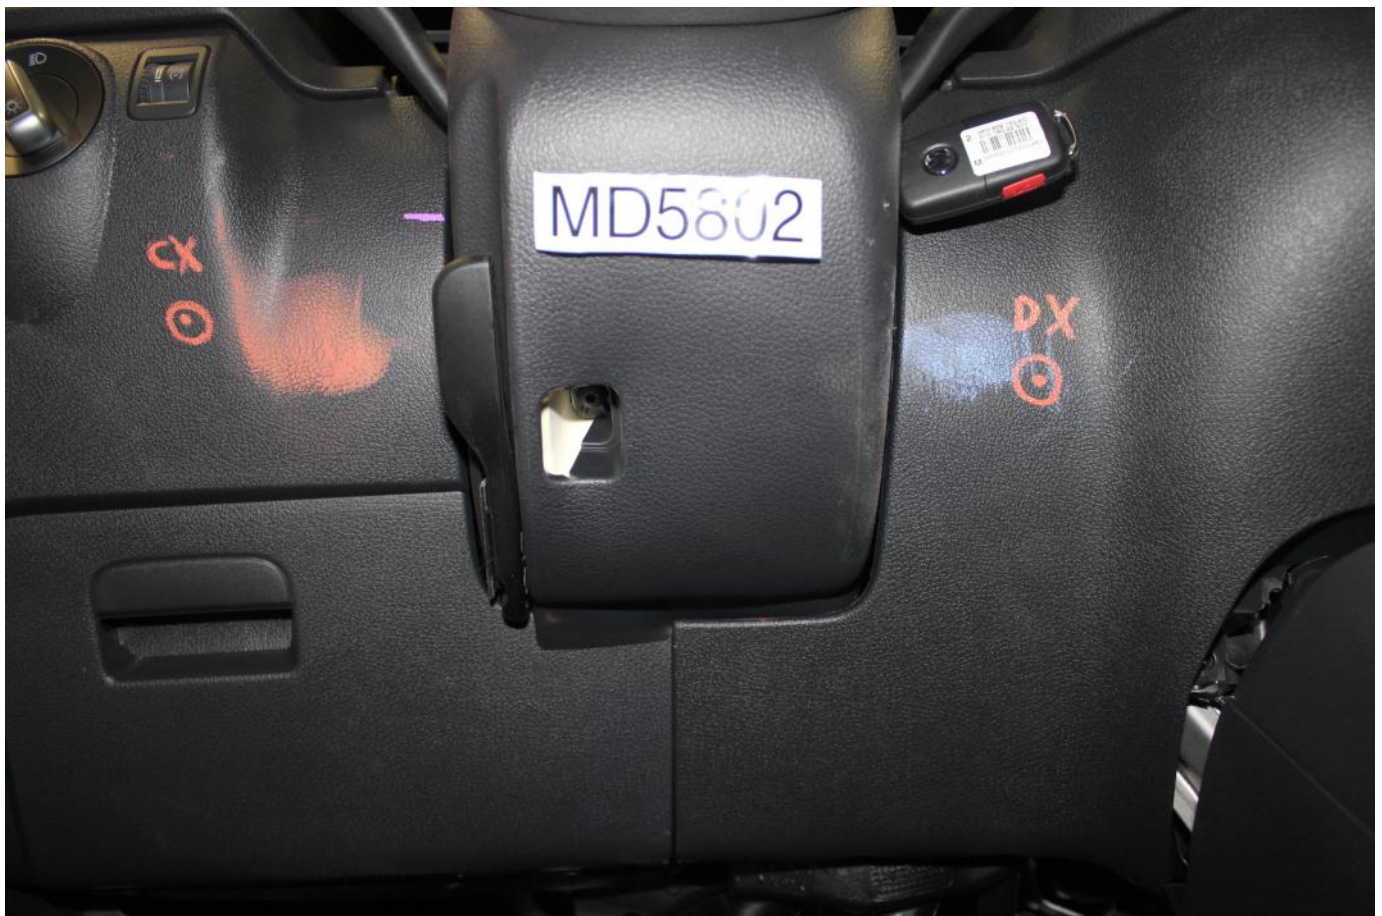
Post-Test Driver Dummy Contact with Knee Bolster

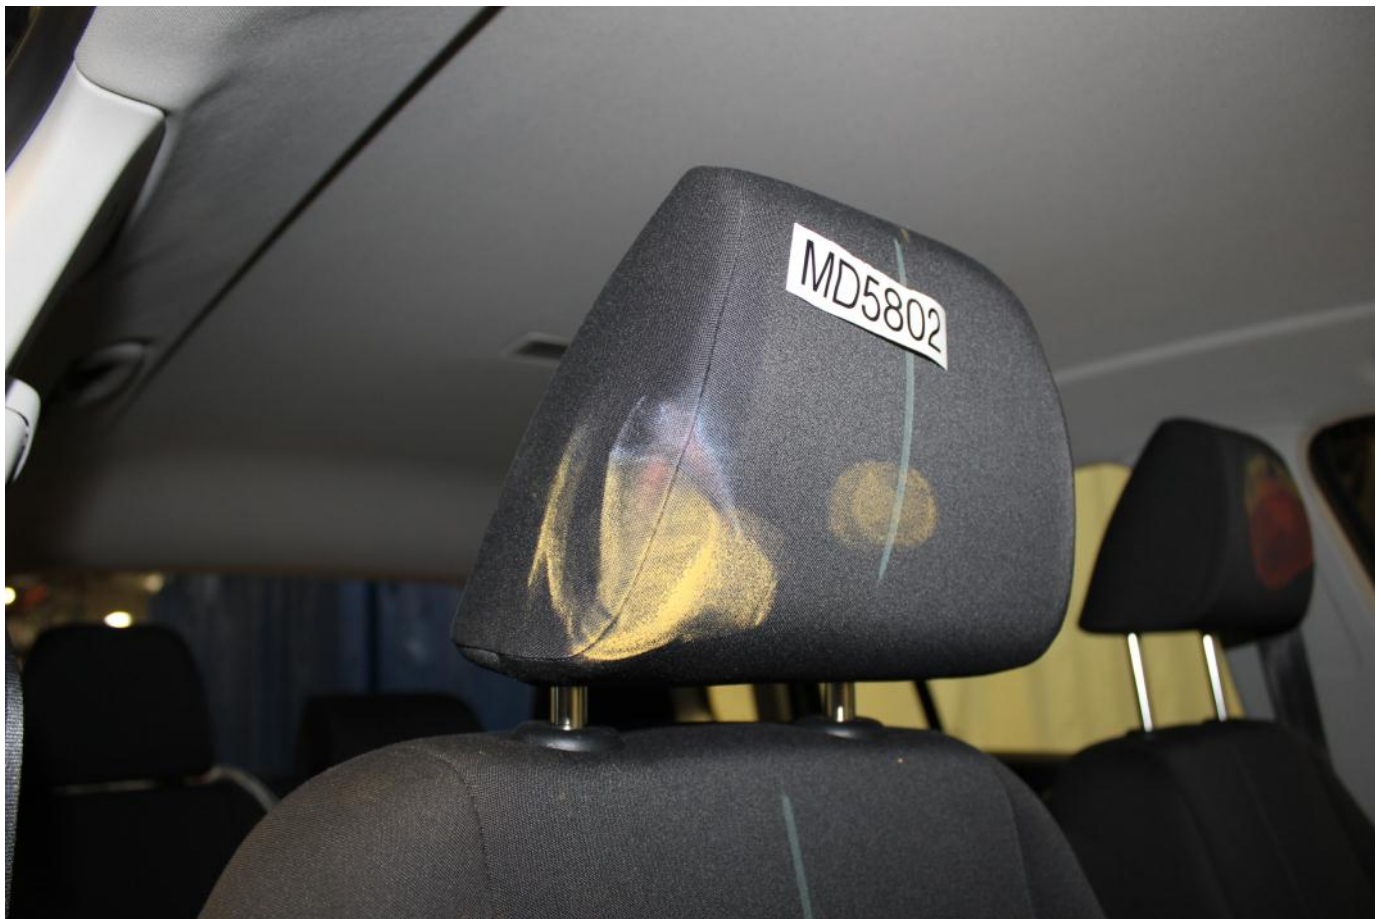
Post-Test Passenger Dummy Contact with Headrest
