**REPORT NUMBER: SINCAP-MGA-2013-014**

**NEW CAR ASSESSMENT PROGRAM (NCAP)  
Moving Deformable Barrier Side Impact Test**

**VOLKSWAGEN AG GERMANY  
2013 Volkswagen Tiguan S SUV  
NHTSA No.: MD5804**

**FINAL REPORT**

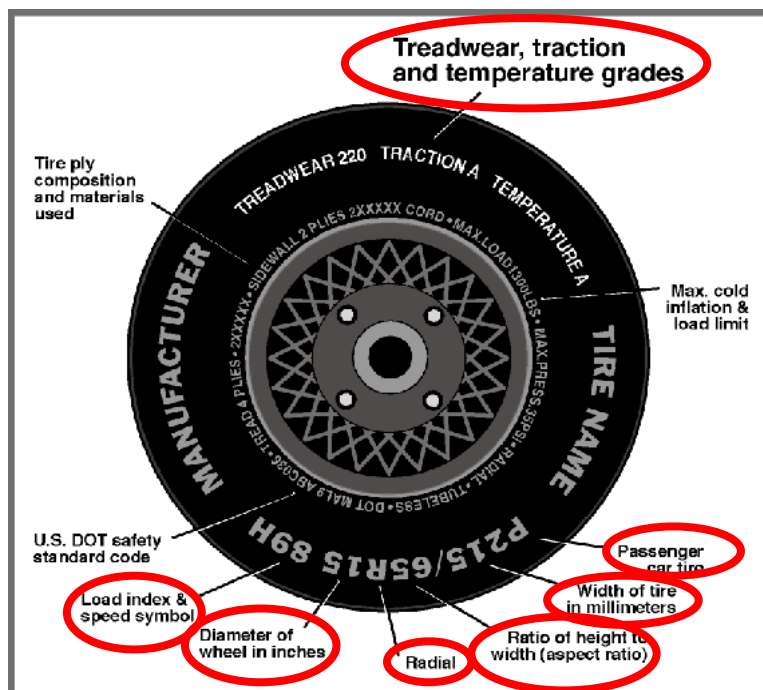
#### VEHICLE TIRE INFORMATION

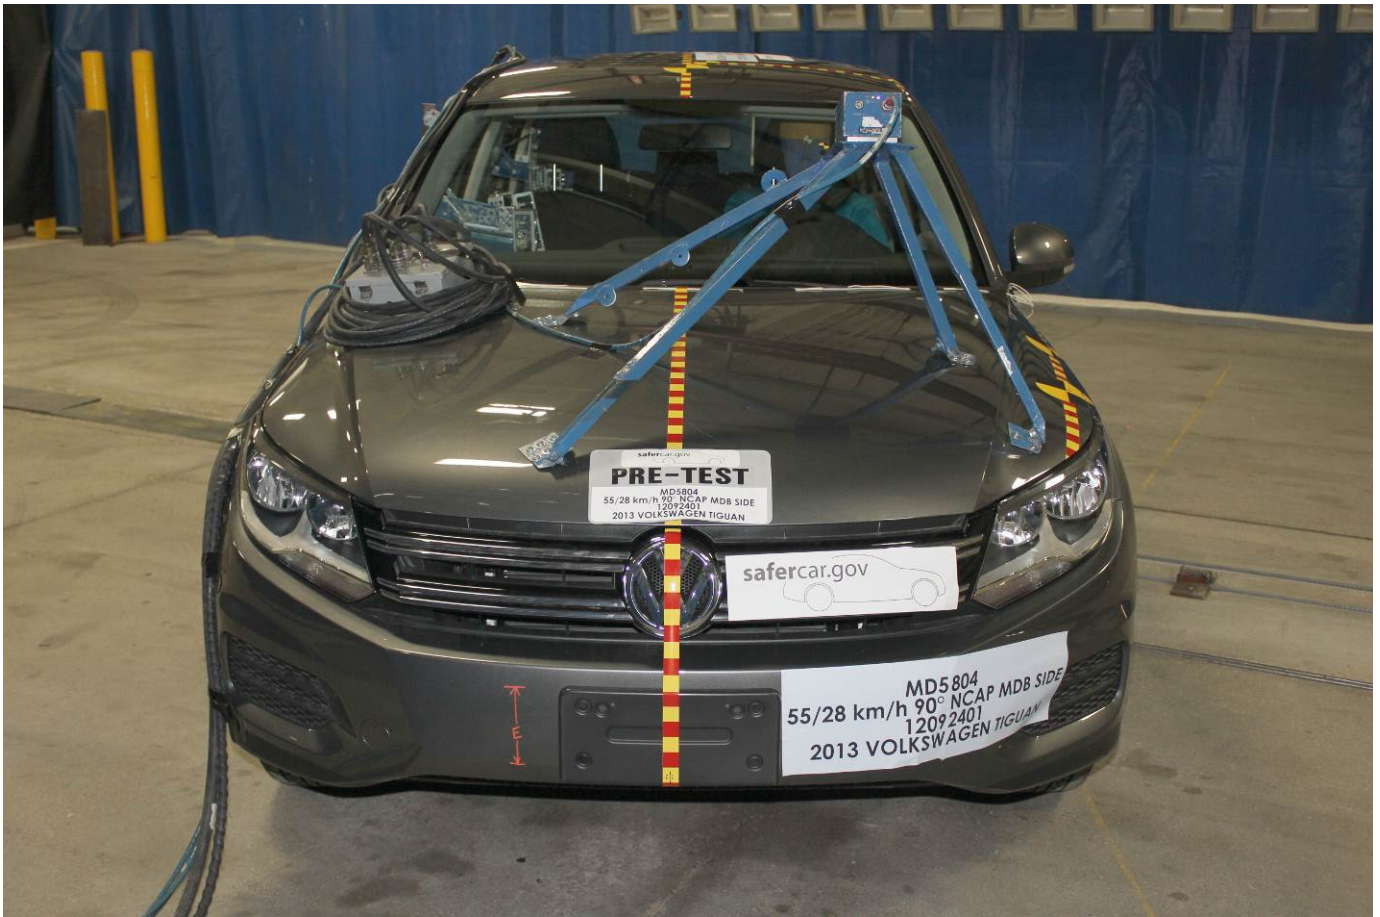
Pre-Test Frontal View of Test Vehicle

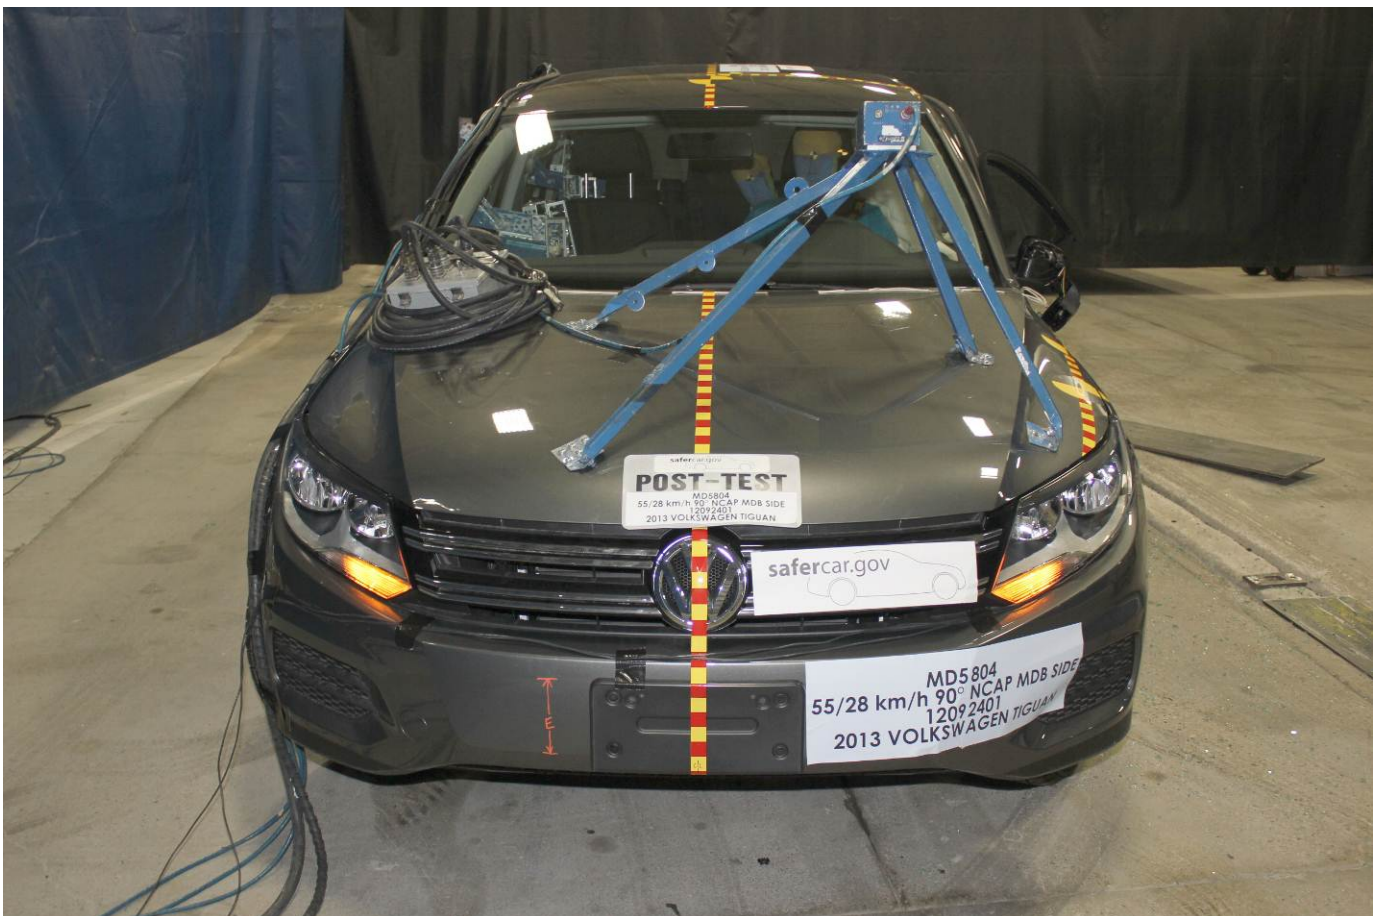
Post-Test Frontal View of Test Vehicle

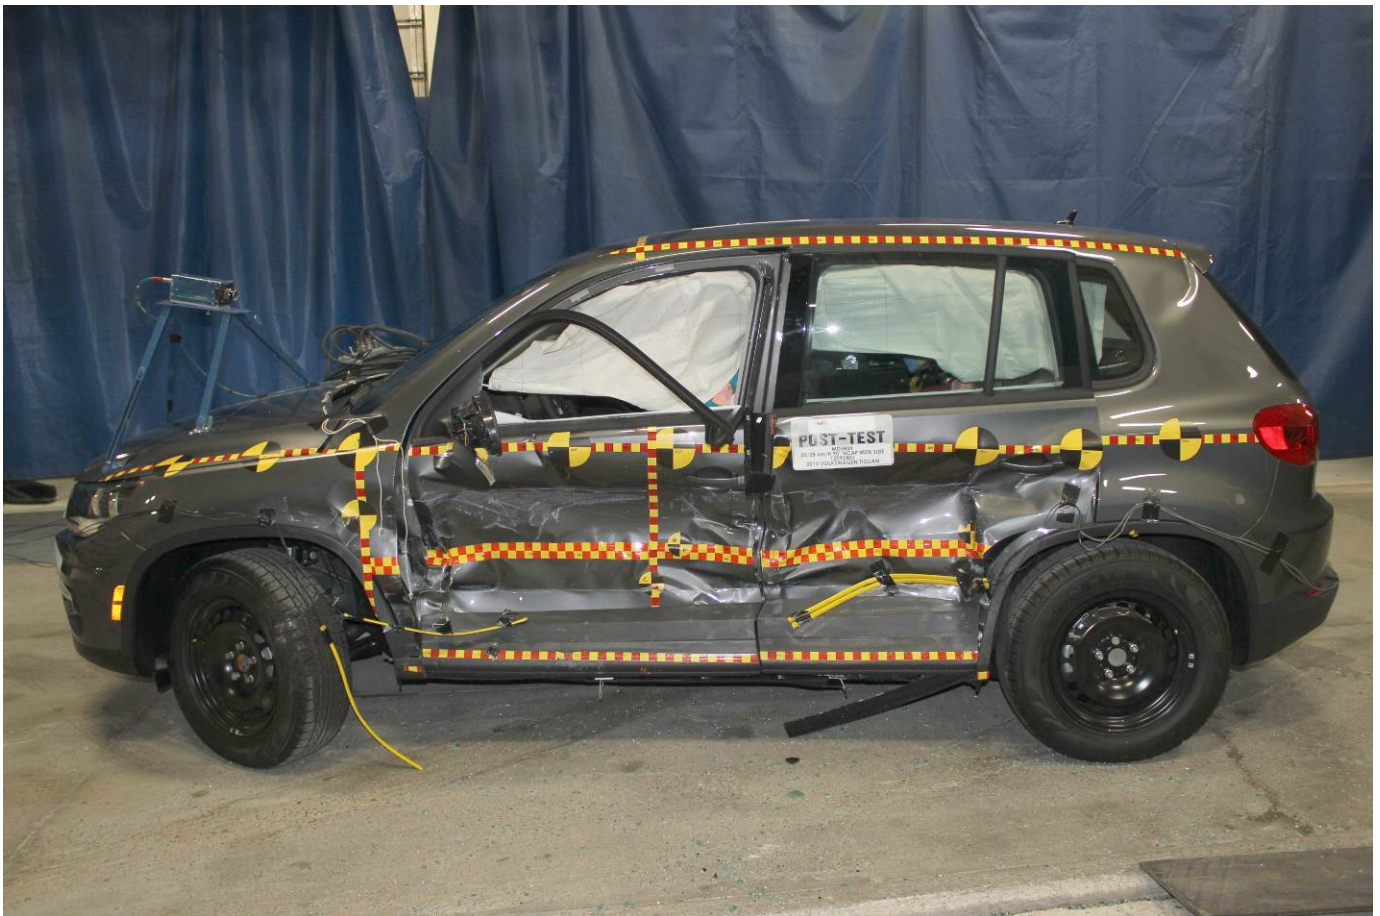
Post-Test Left Side View of Test Vehicle

Critical Areas of Performance	Observations and Conclusions
Pillar Performance	No Separation
Sill Separation	None
Windshield Damage	None
Side Window Damage	Left Front Window Broke
Other Notable Effects	None

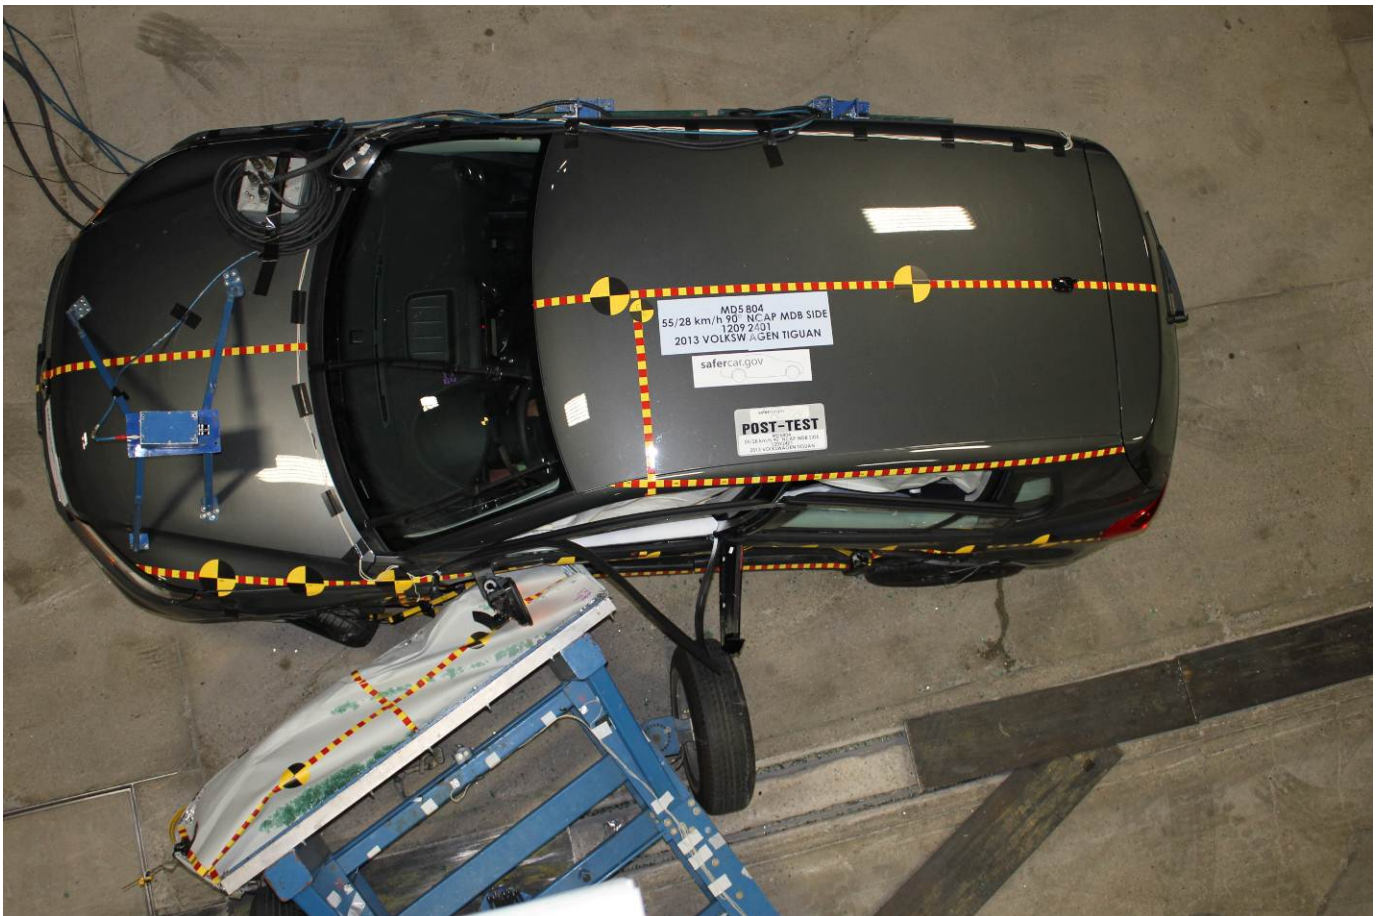
Post-Test Overhead View of Test Area

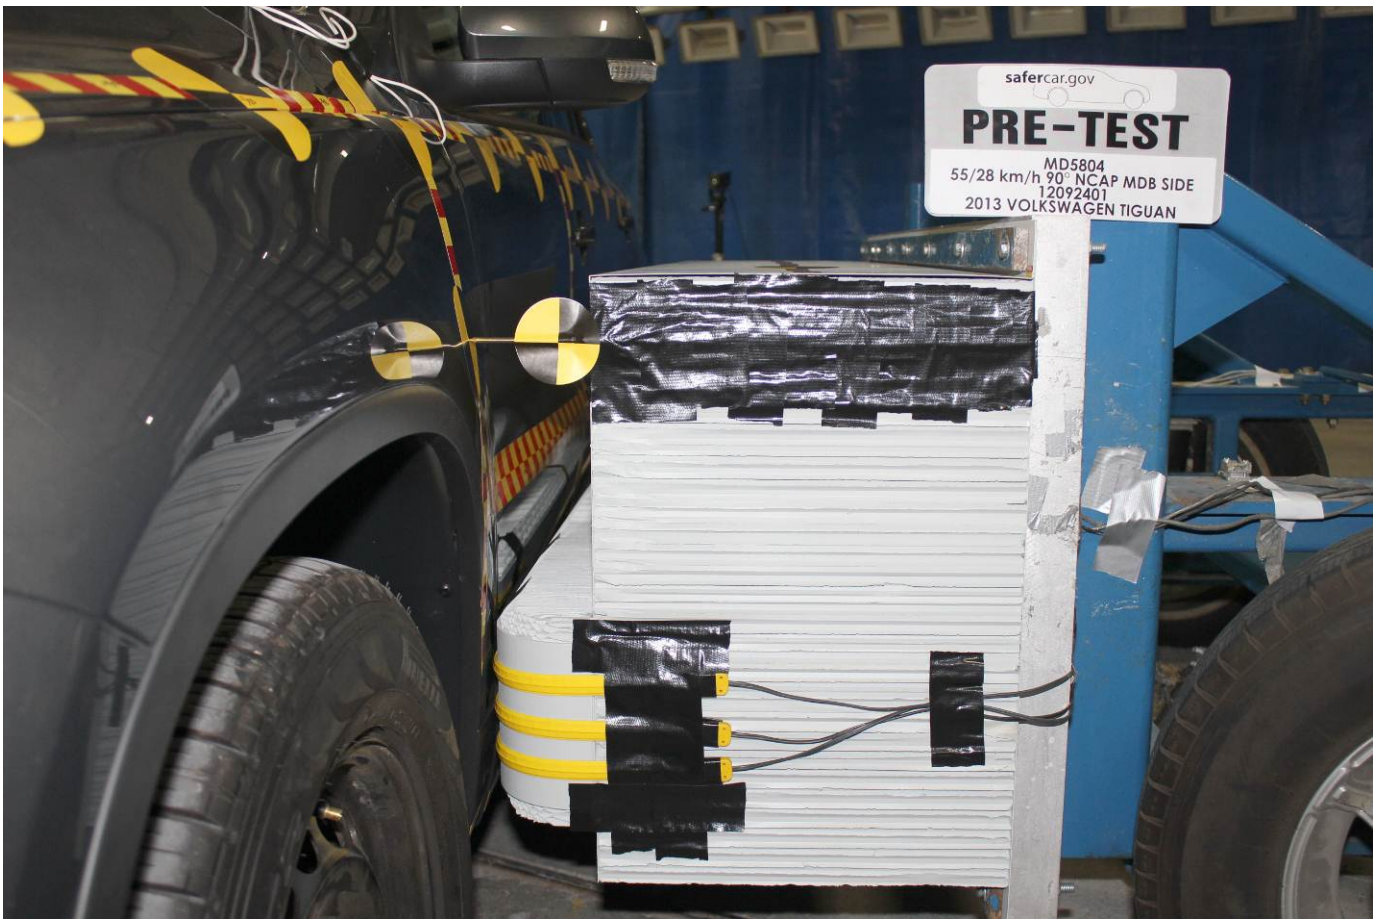
Pre-Test Left Side View of MDB Positioned Against Side of Test Vehicle

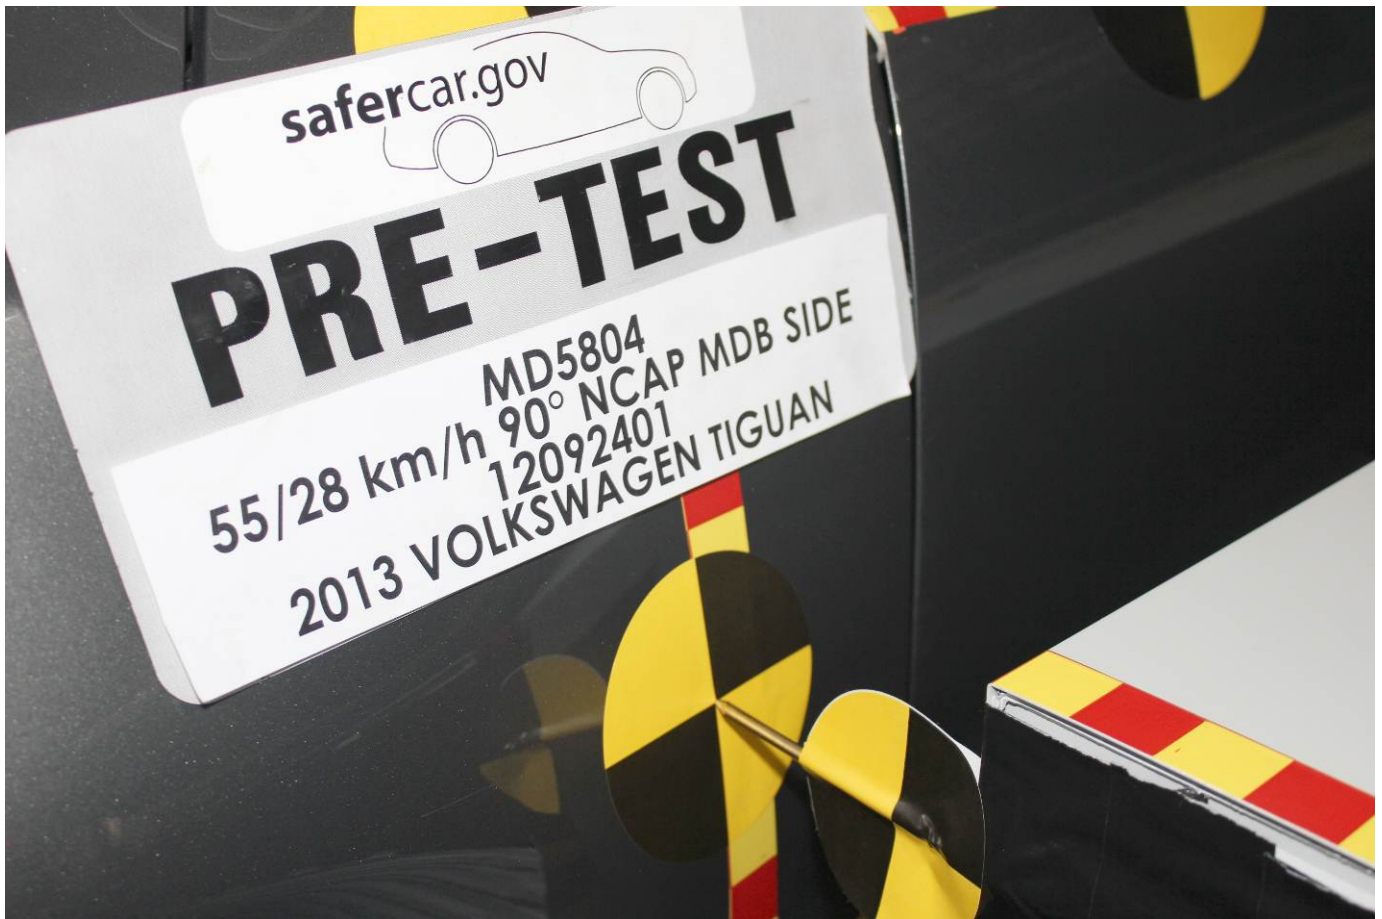
Pre-Test Close-Up View of Impact Point Target

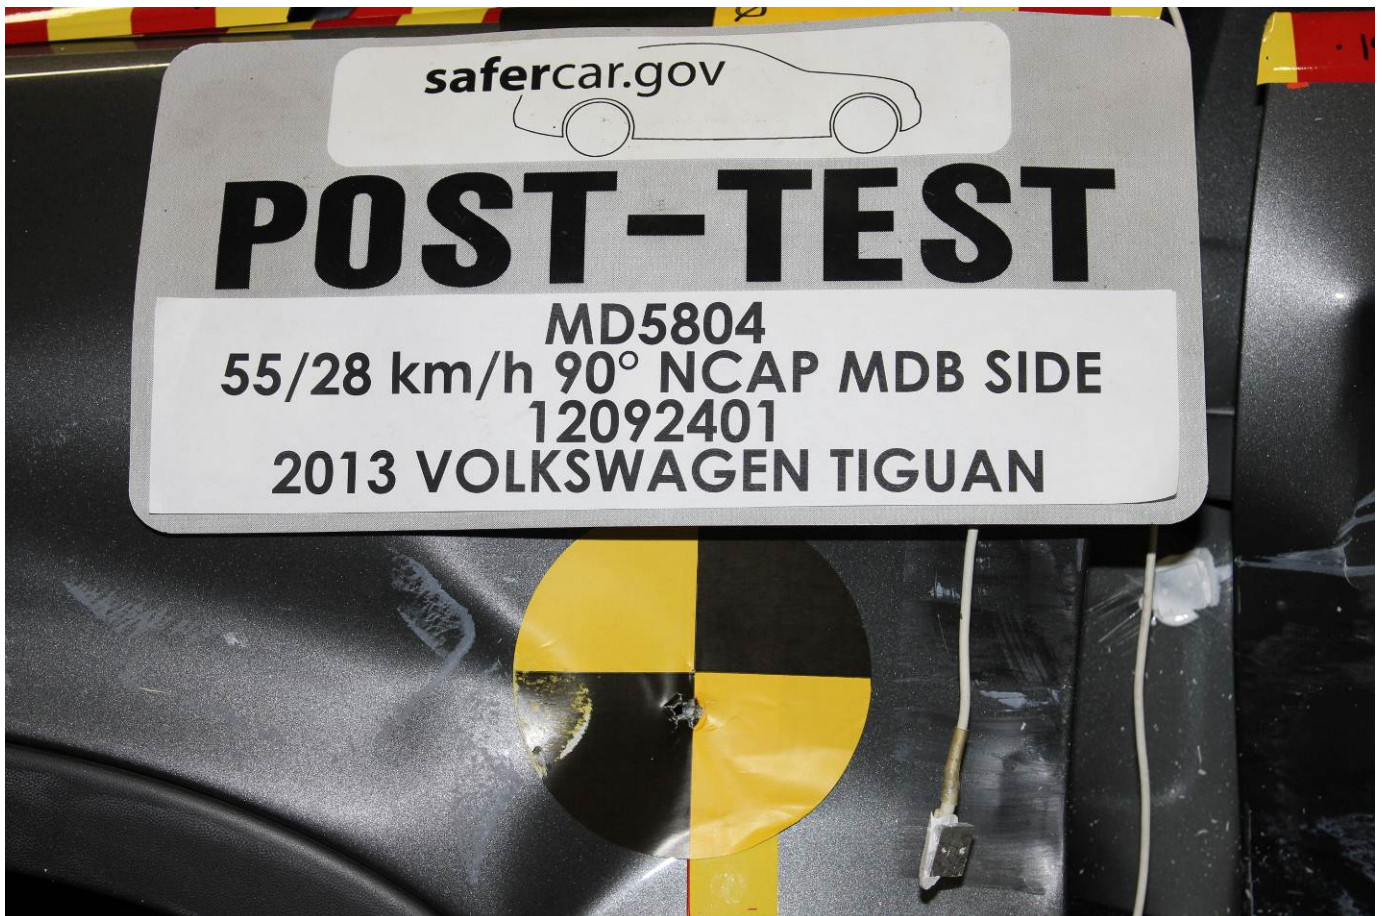
Post-Test Close-Up View of Impact Point Target

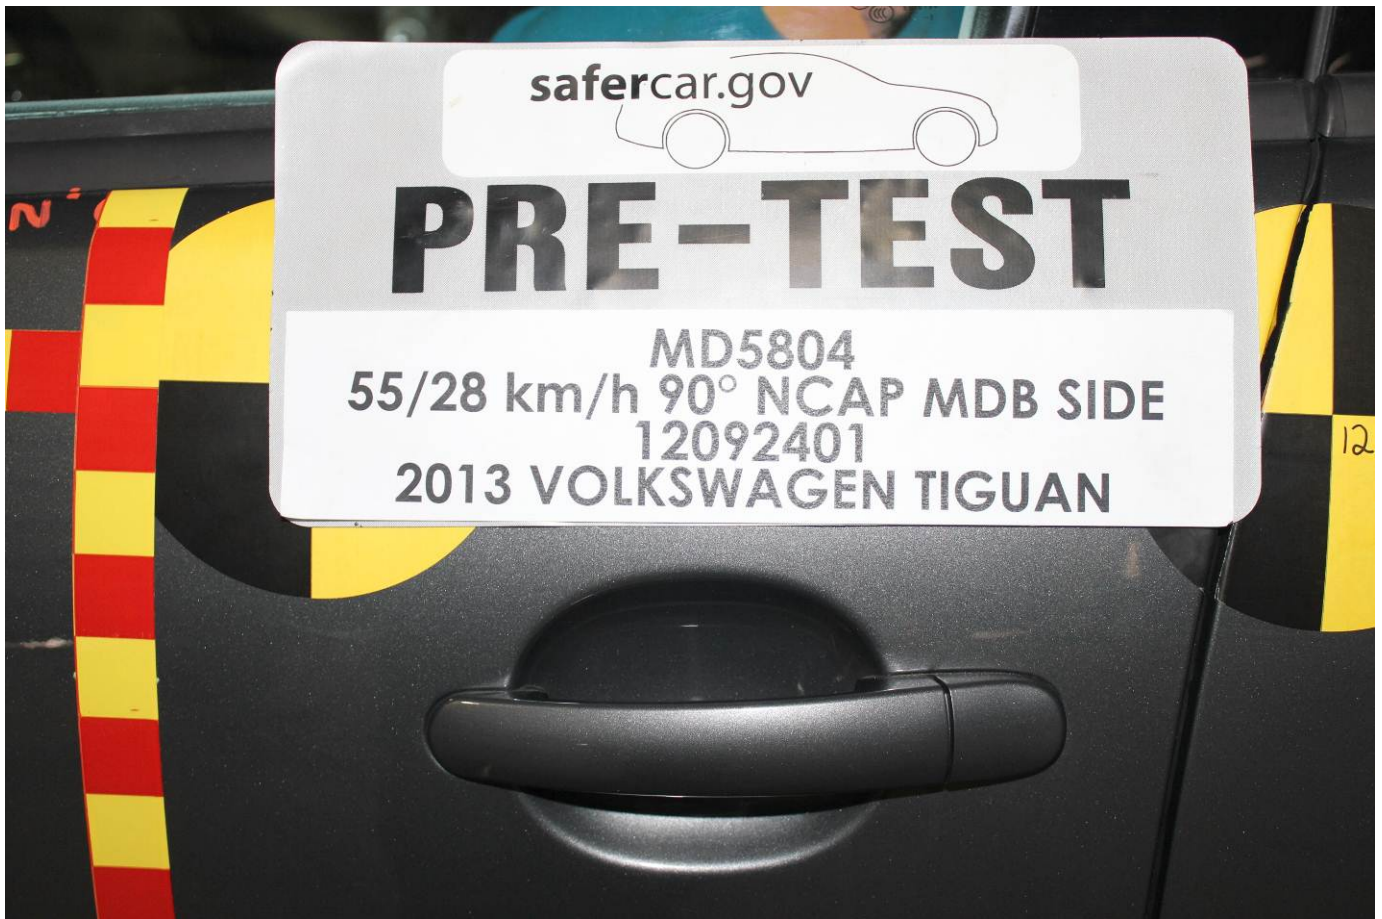
Pre-Test Left Front Door Latch Close-Up

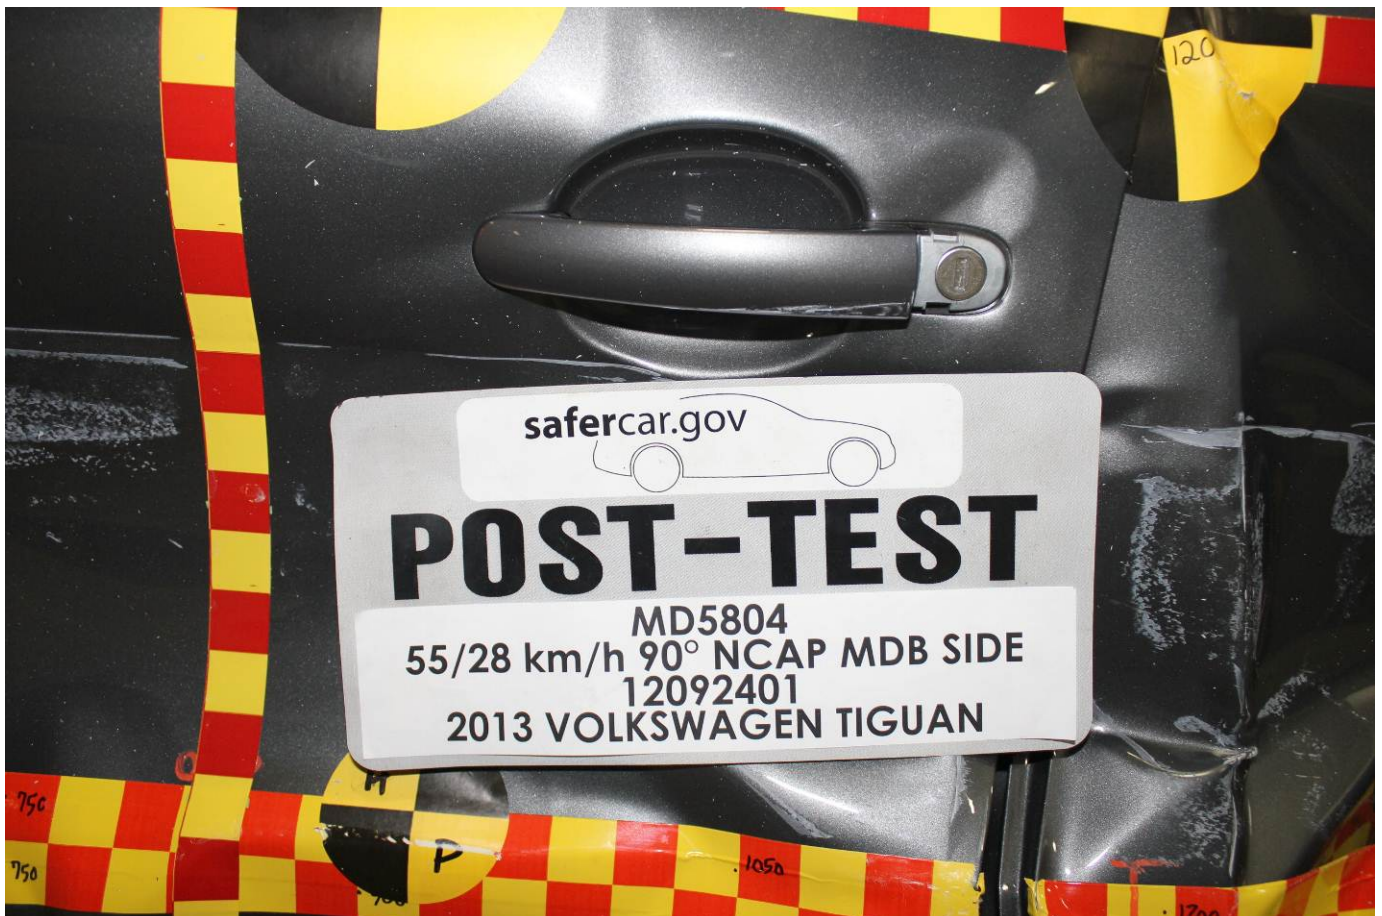
Post-Test Left Front Door Latch Close-Up

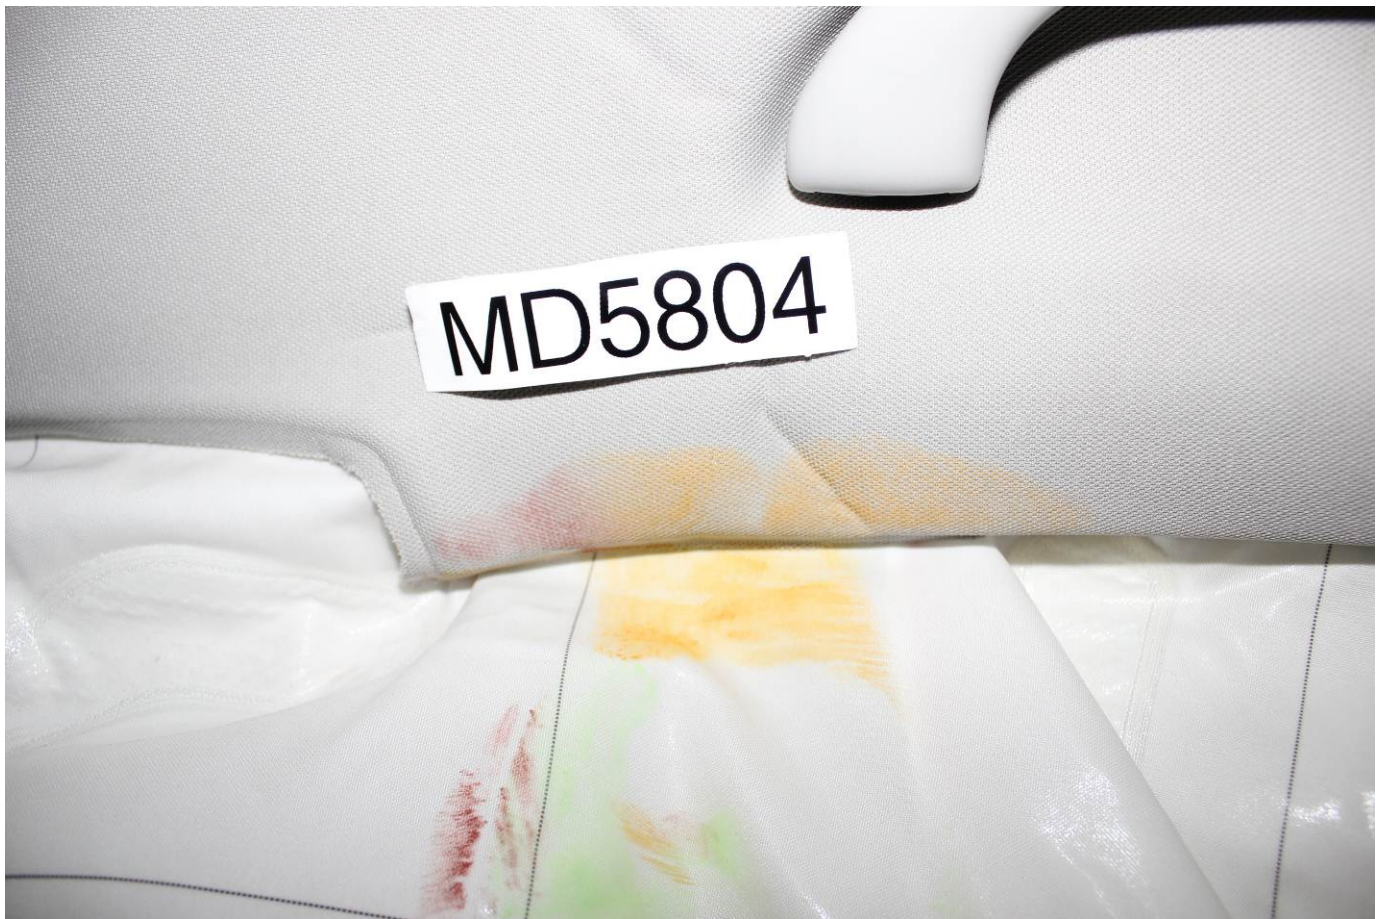
Post-Test Driver Dummy Close-up Head Contact with Vehicle Interior View

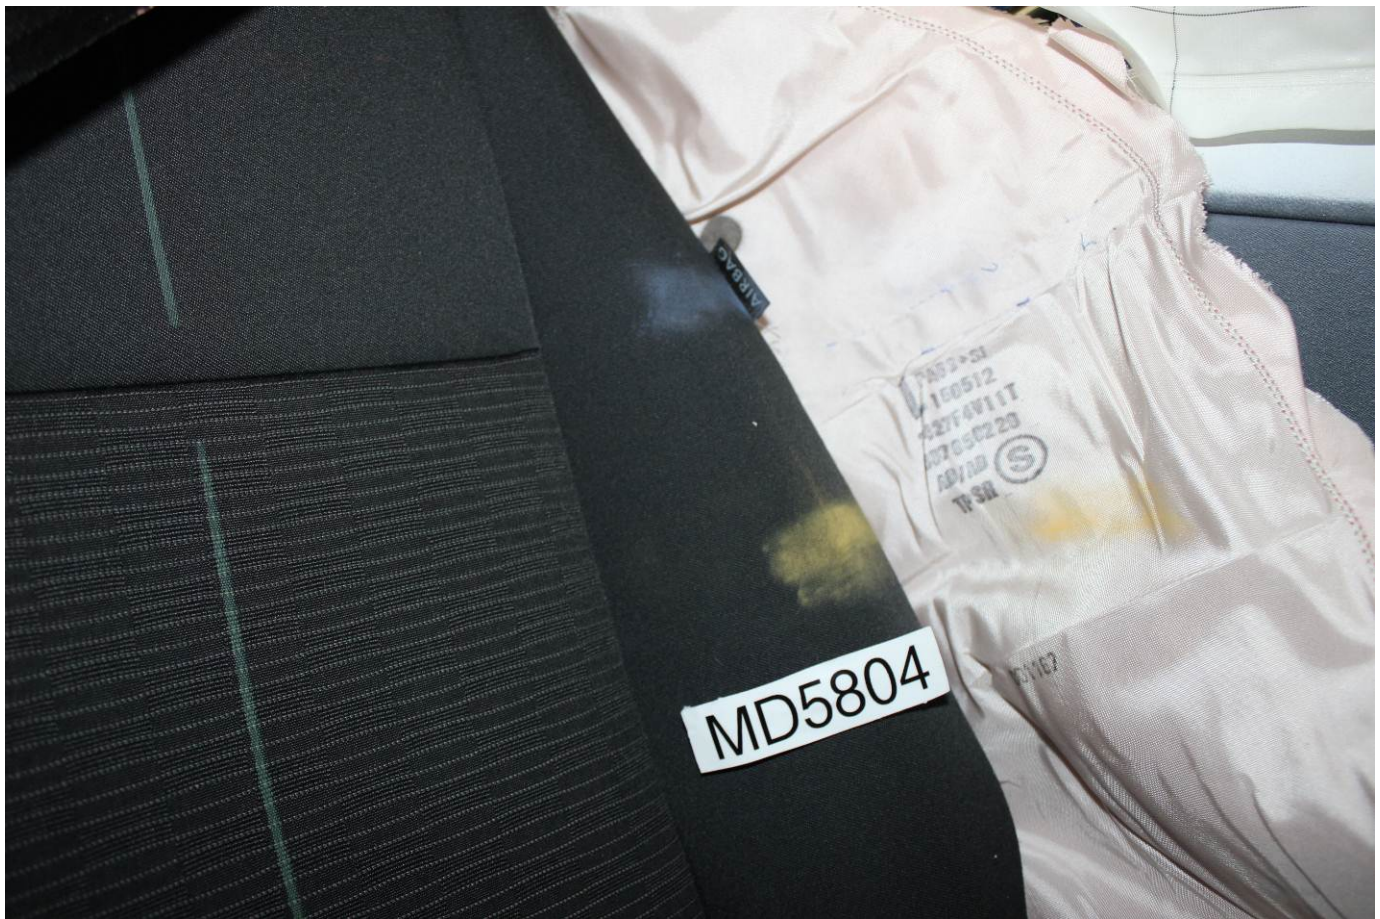
Post-Test Driver Dummy Close-up Head Contact with Side Airbag View

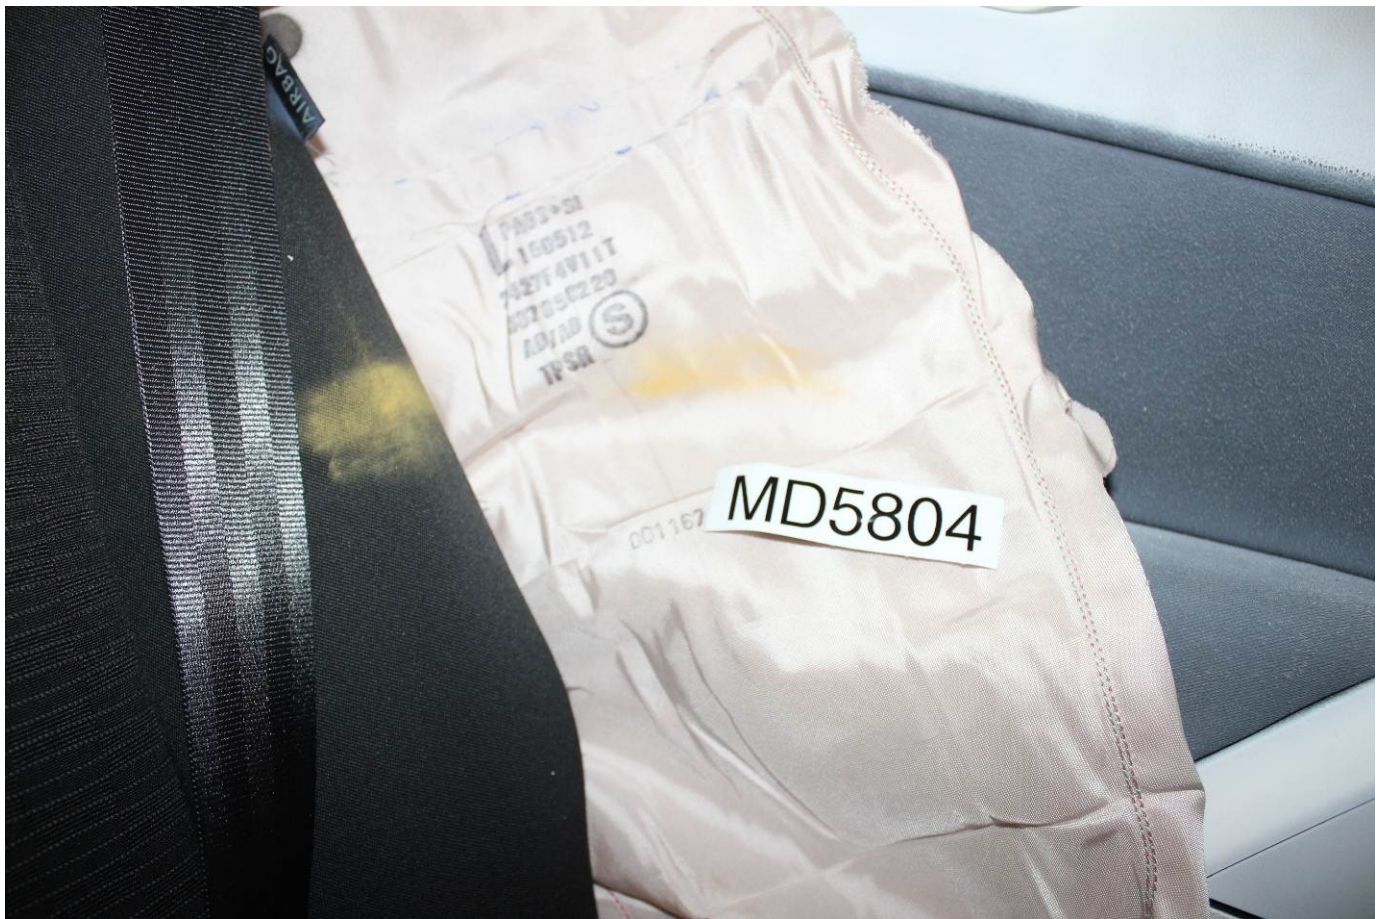
Post-Test Driver Dummy Close-up Torso Contact with Side Airbag View

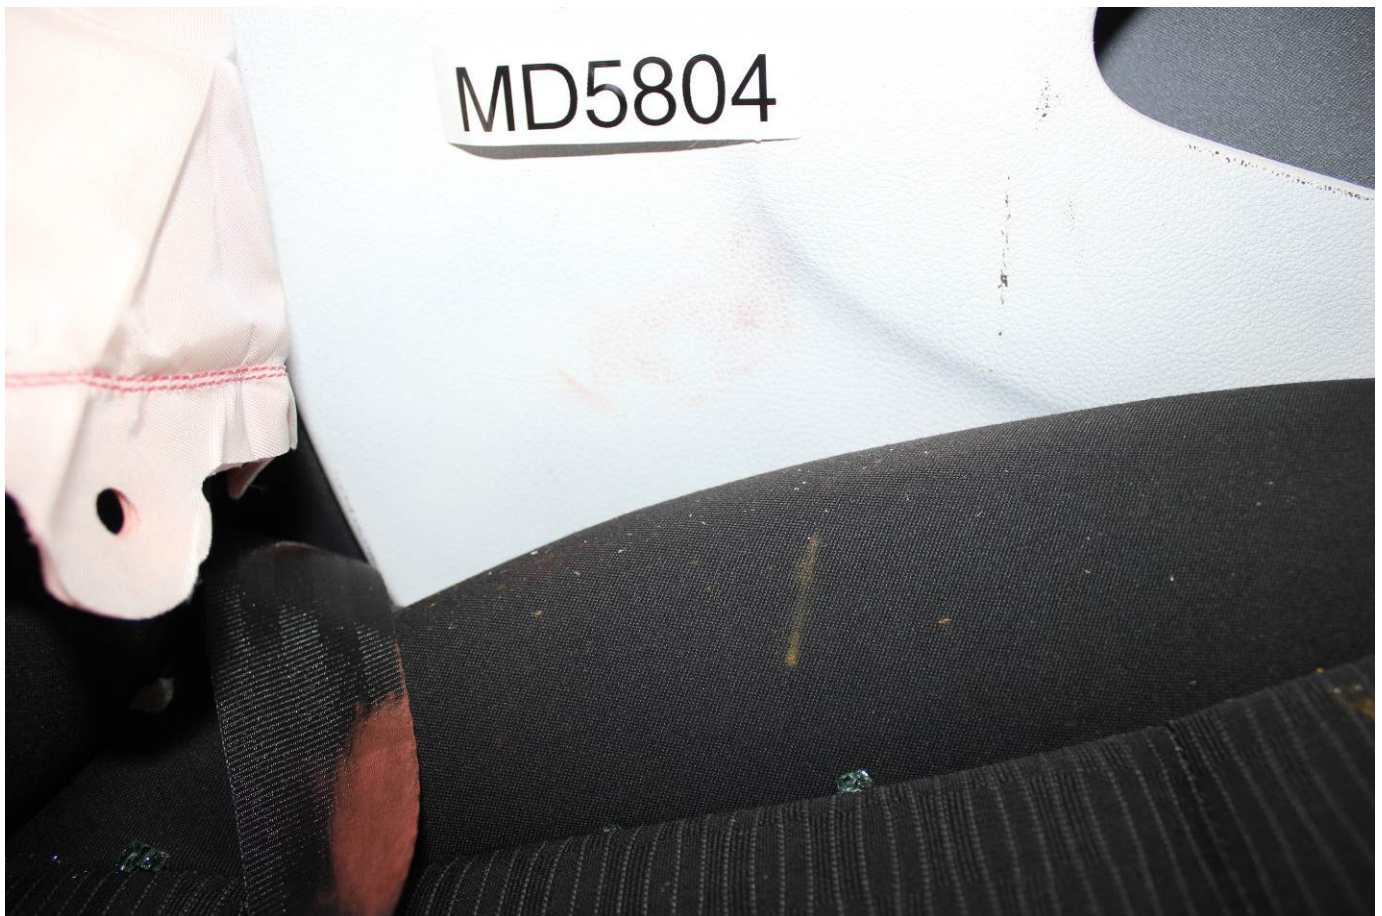
Post-Test Driver Dummy Close-up Torso Contact with Side Airbag View

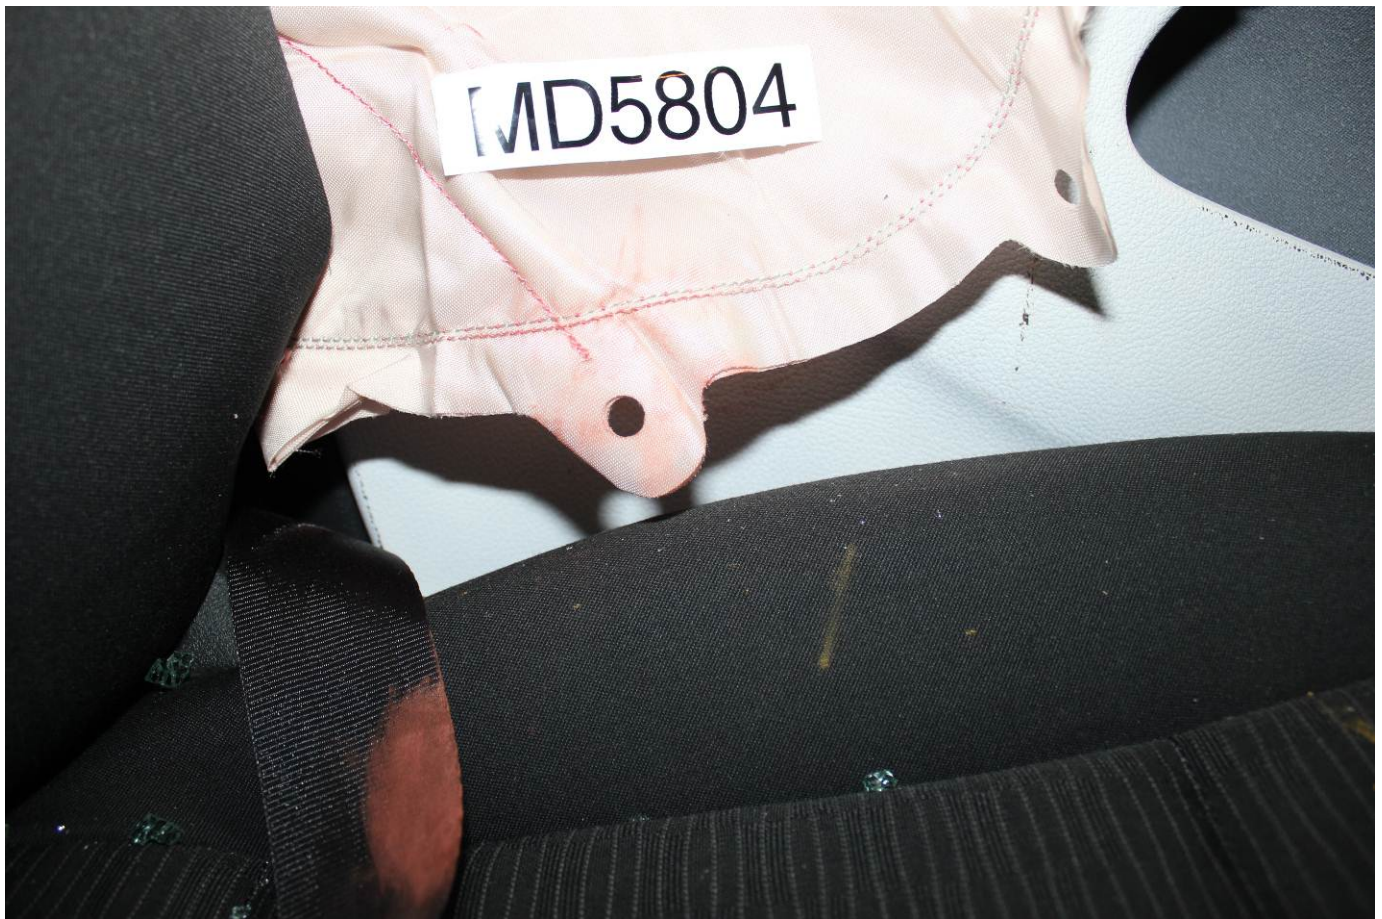
Post-Test Driver Dummy Close-up Pelvis Contact with Vehicle Interior View

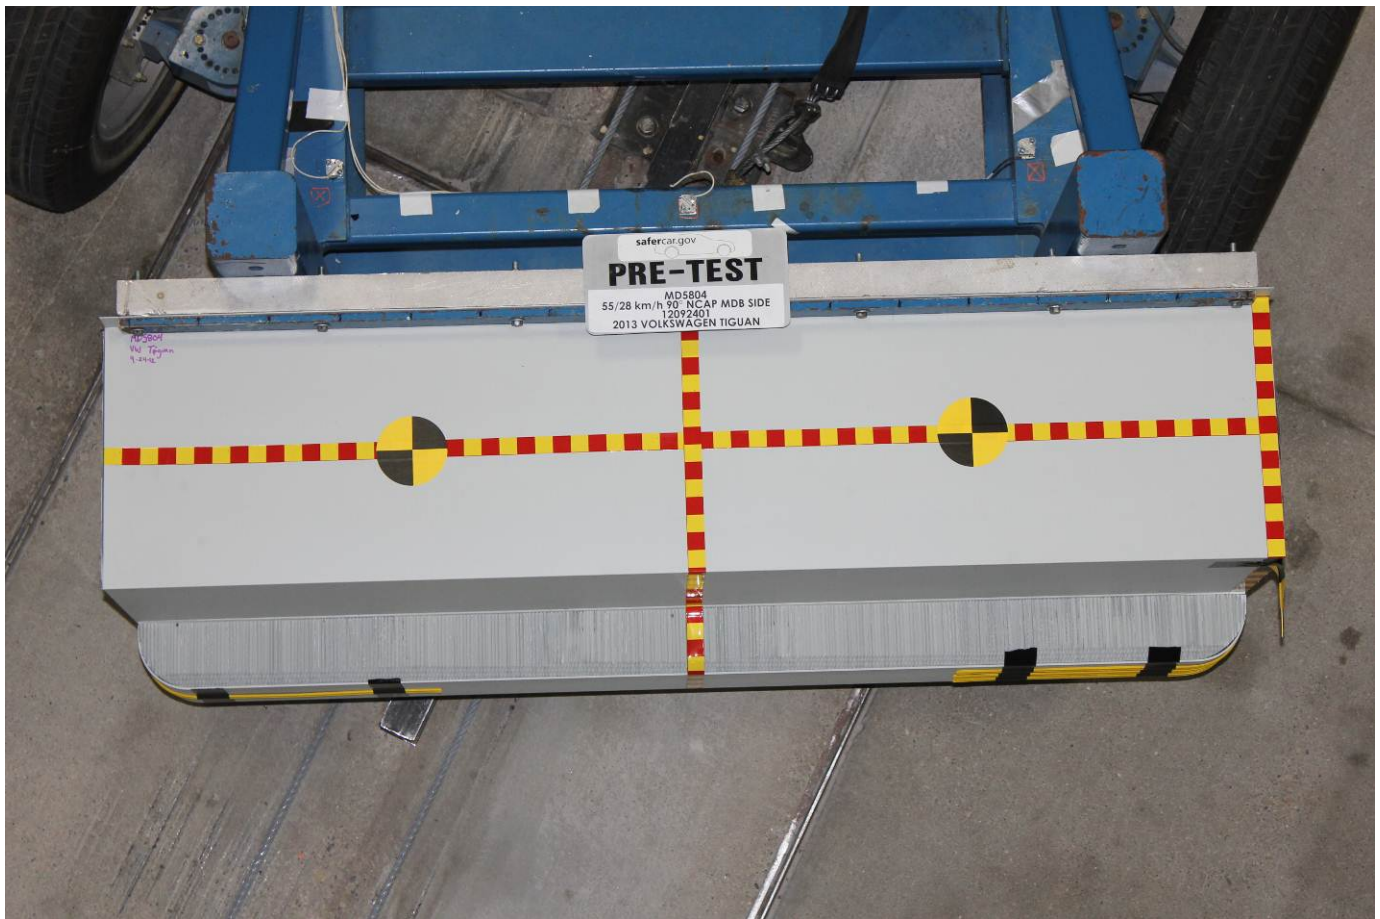
Post-Test Front View of MDB Impactor Face

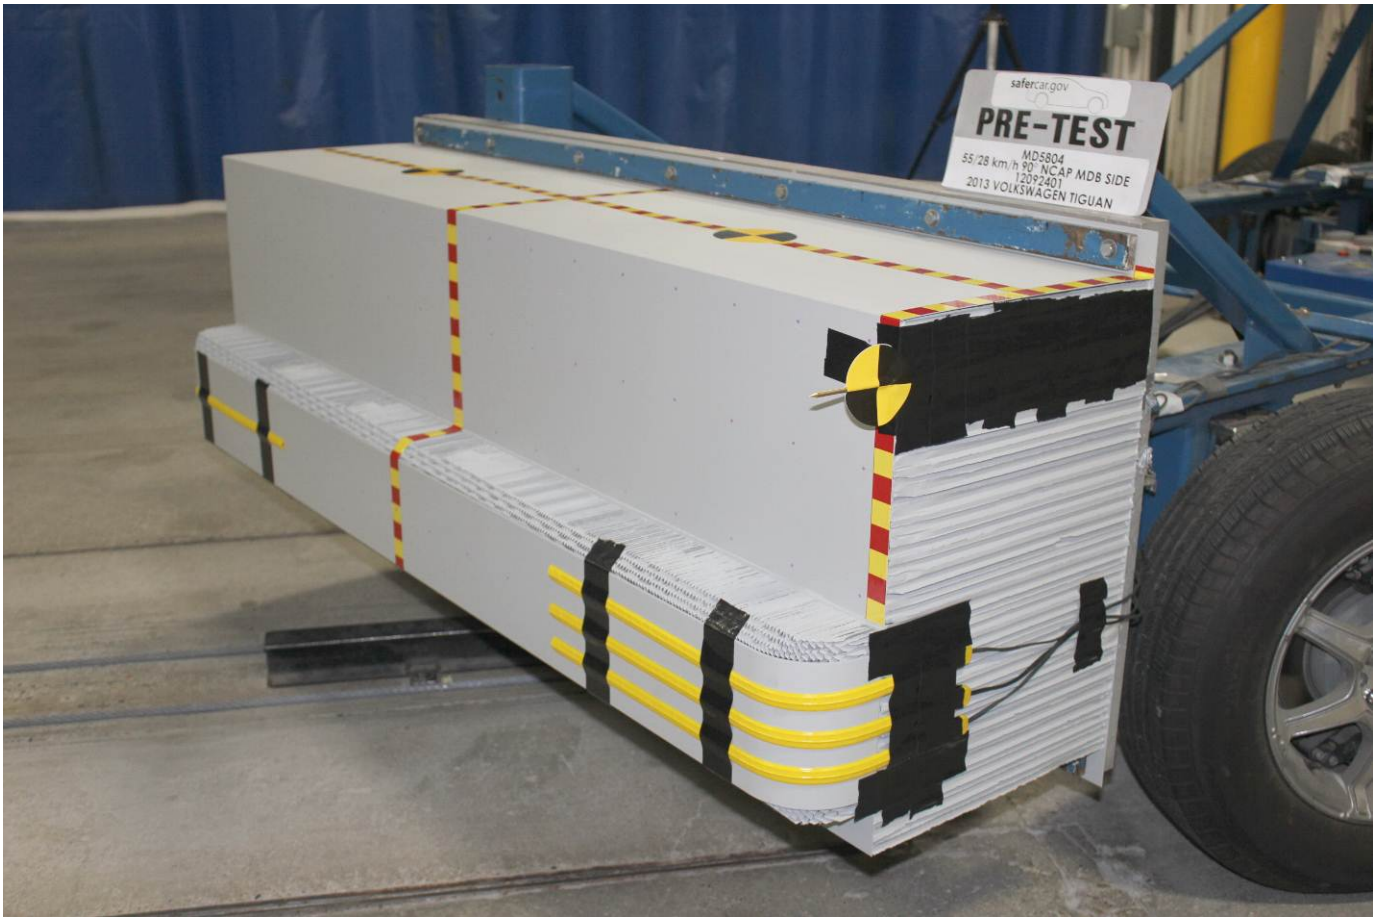
Post-Test Top View of MDB Impactor Face

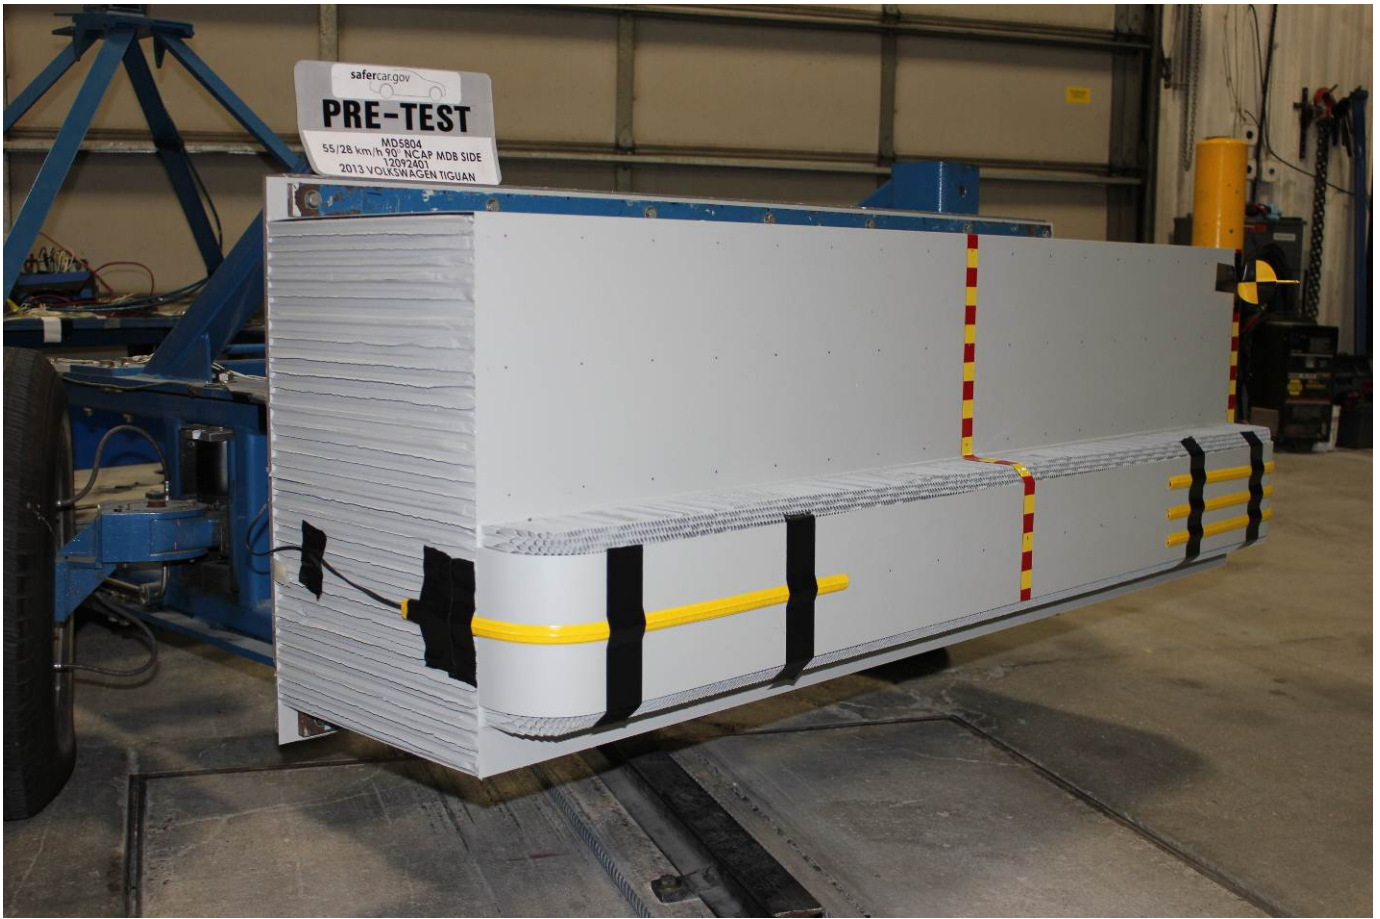
Post-Test Left Side View of MDB Impactor Face
