**REPORT NUMBER: SINCAP-MGA-2013-014**

**NEW CAR ASSESSMENT PROGRAM (NCAP)  
Moving Deformable Barrier Side Impact Test**

**VOLKSWAGEN AG GERMANY  
2013 Volkswagen Tiguan S SUV  
NHTSA No.: MD5804**

**FINAL REPORT**

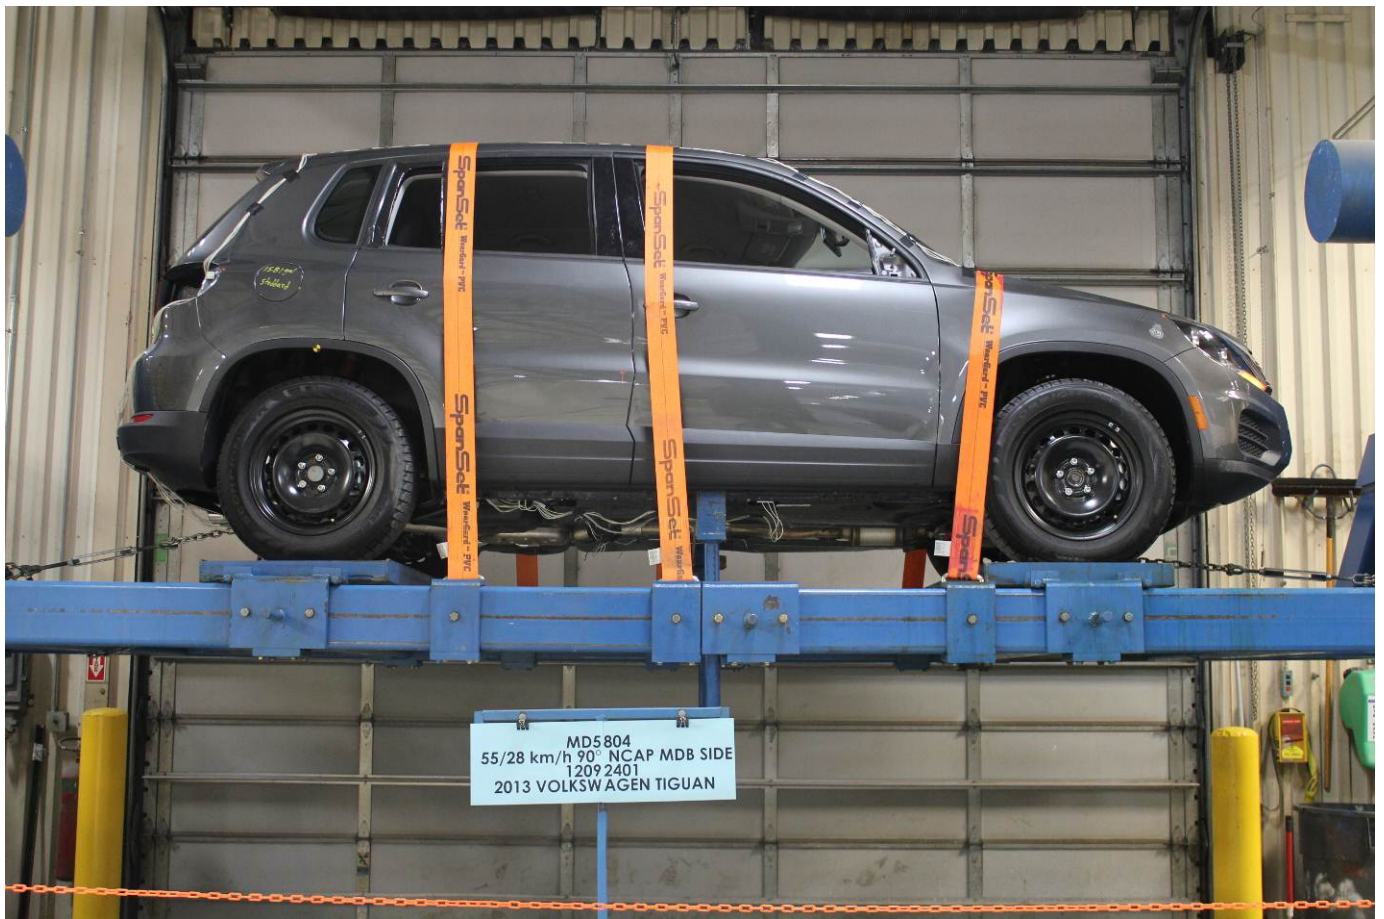
MD5 804  
55/28 km/h 90° NCAP MDB SIDE  
1209 2401  
2013 VOLKSWAGEN TIGUAN

FMVSS No. 301 Static Rollover 0 Degrees

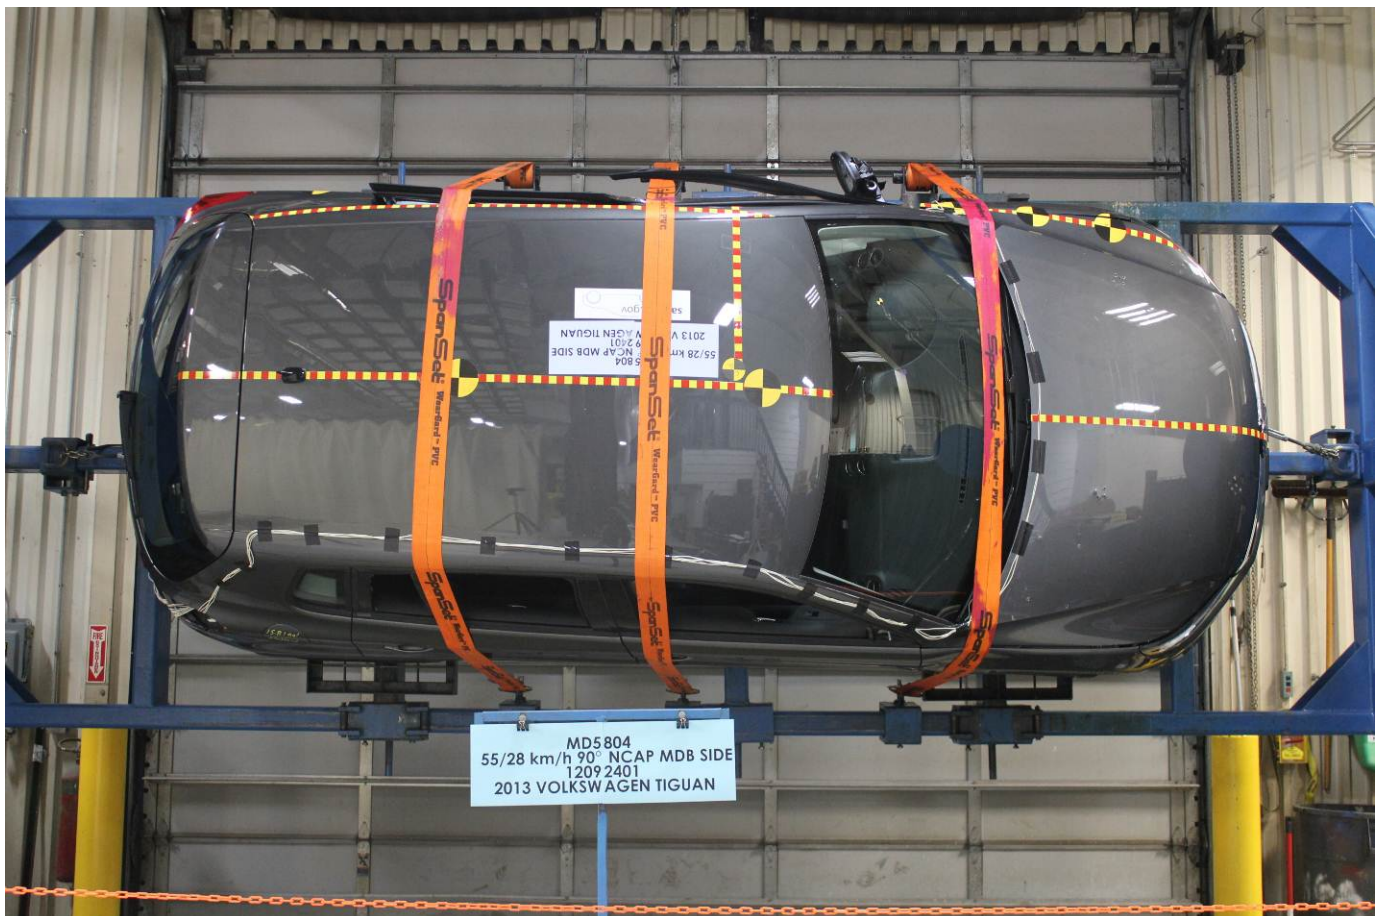
MD5 804  
55/28 km/h 90° NCAP MDB SIDE  
1209 2401  
2013 VOLKSWAGEN TIGUAN

FMVSS No. 301 Static Rollover 90 Degrees
