**FINAL REPORT NUMBER: SPNCAP-TRC-13-001**

**NEW CAR ASSESSMENT PROGRAM (NCAP)  
SIDE IMPACT POLE TEST**

**General Motors LLC  
2013 Chevrolet Silverado 2500 2WD LT EXT  
NHTSA NUMBER: MD0115**

**PREPARED BY:  
Transportation Research Center Inc.  
10820 State Route 347  
P. O. Box B-67  
East Liberty, OH 43319**

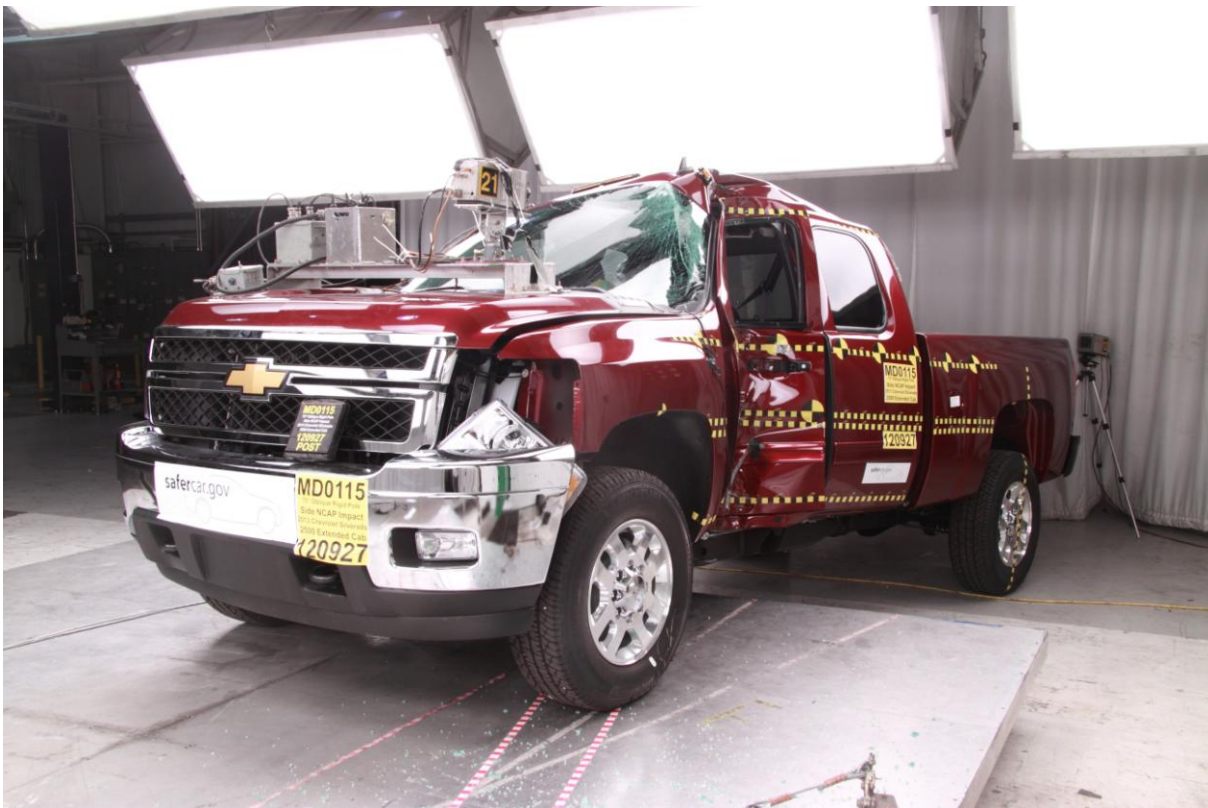
**006** Post-Test Left Front 3/4 View of Test Vehicle

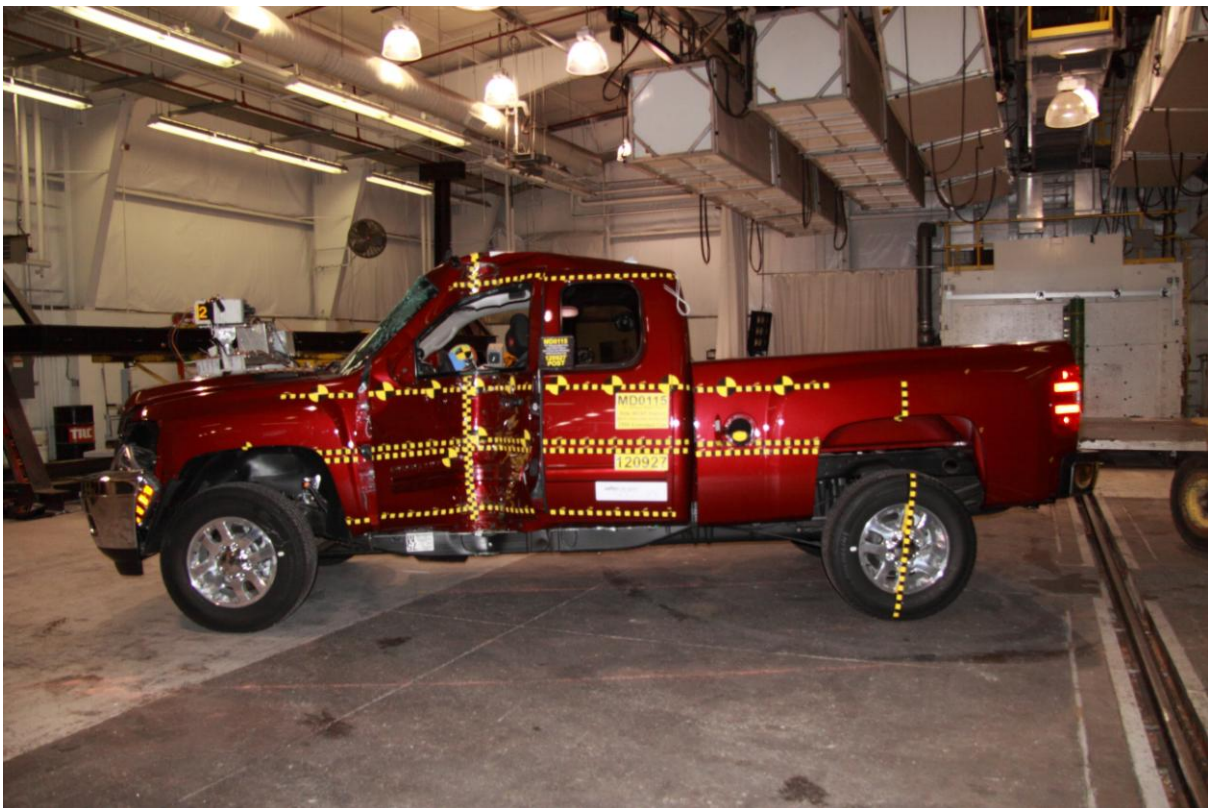
**008** Post-Test Left Side View of Test Vehicle

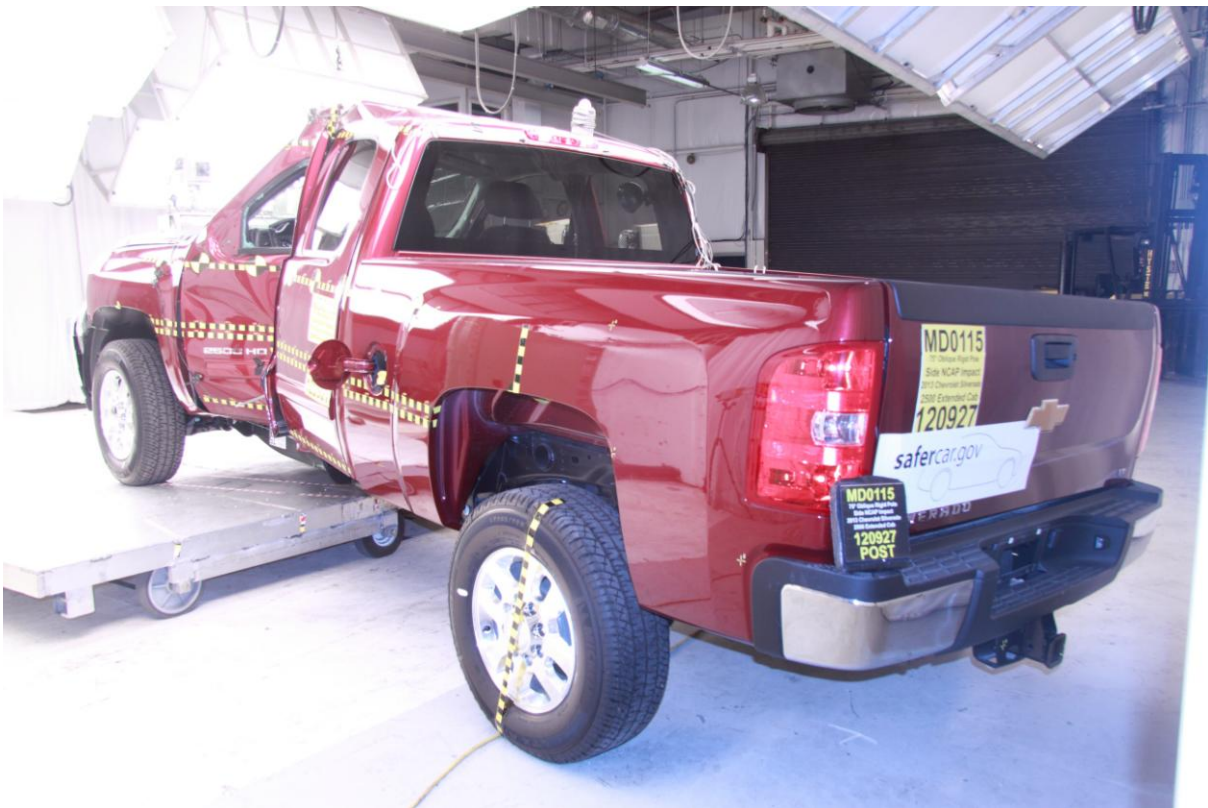
**010** Post-Test Left Rear 3/4 View of Test Vehicle

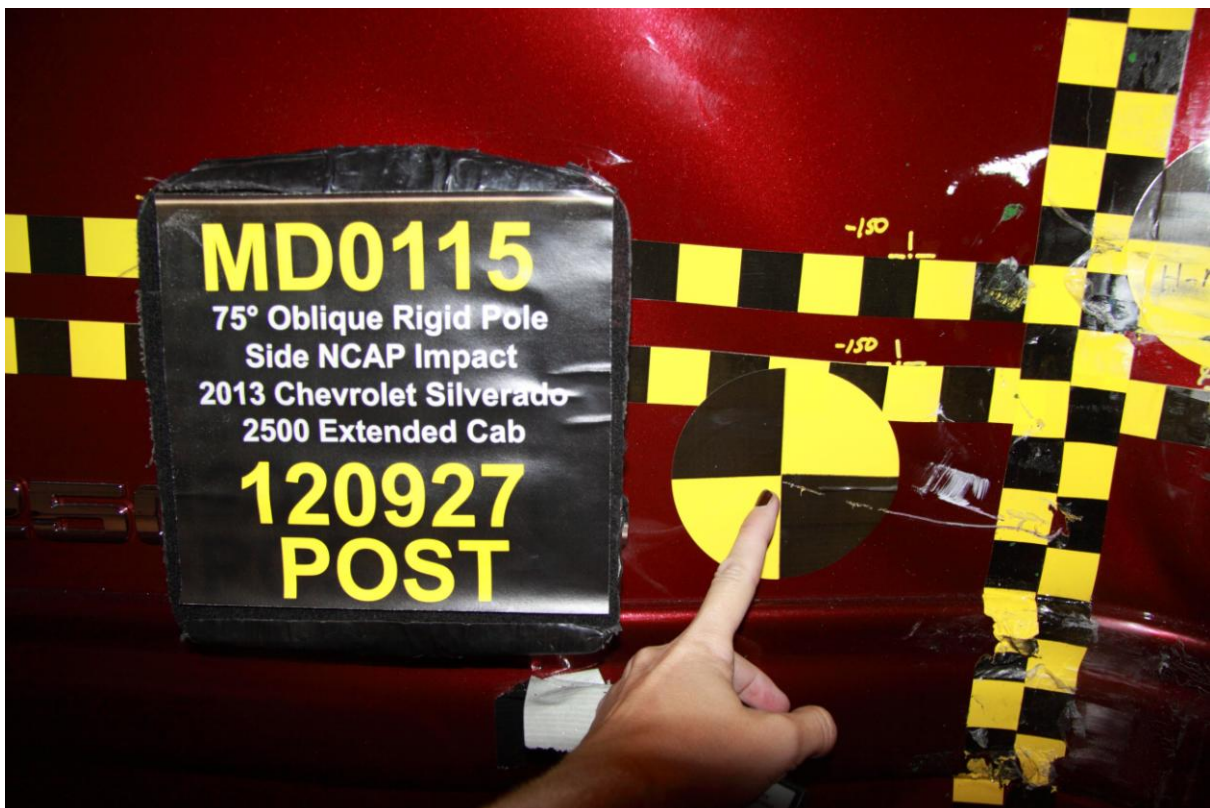
**020** Post-Test Close-Up View of Impact Point Target Showing Impact Location

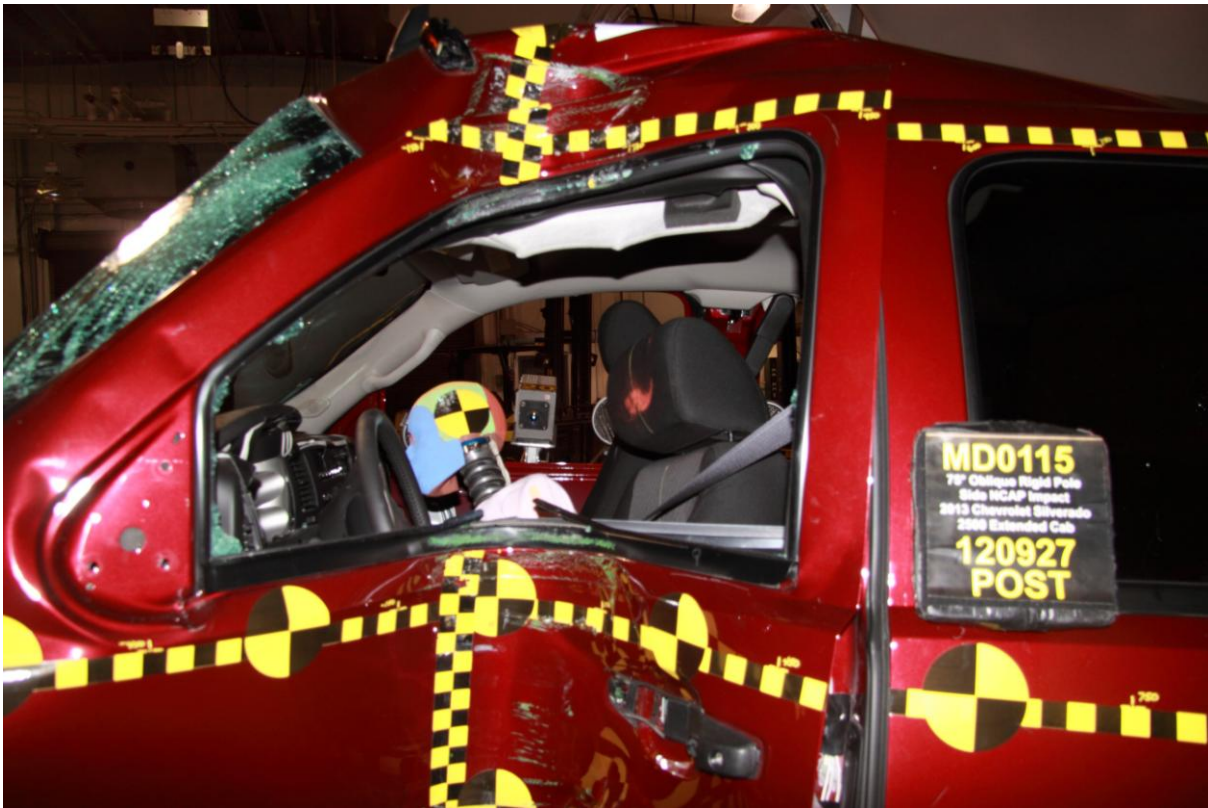
**025** Post-Test Left Side View of Dummy Shoulder and Door Top View

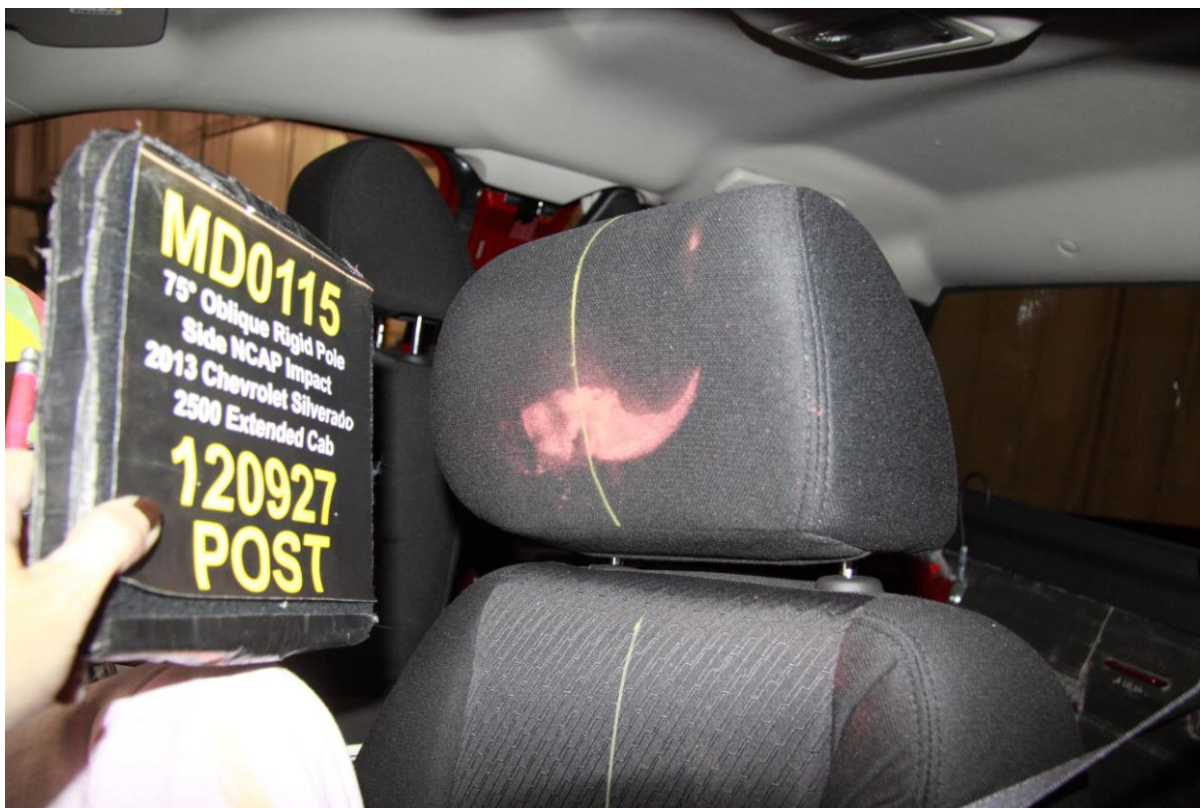
**046** Post-Test Dummy Close-Up Head Contact with Vehicle View

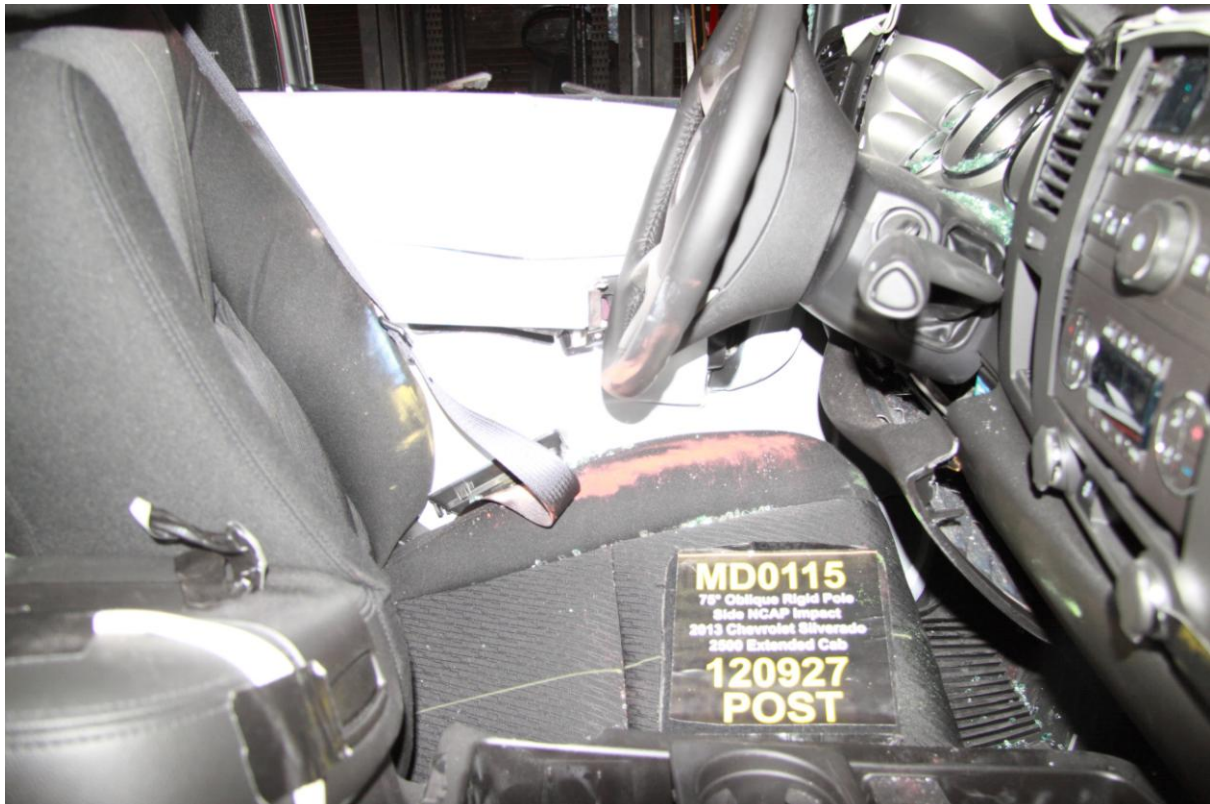
**048** Post-Test Dummy Close-Up Torso Contact with Vehicle Interior View

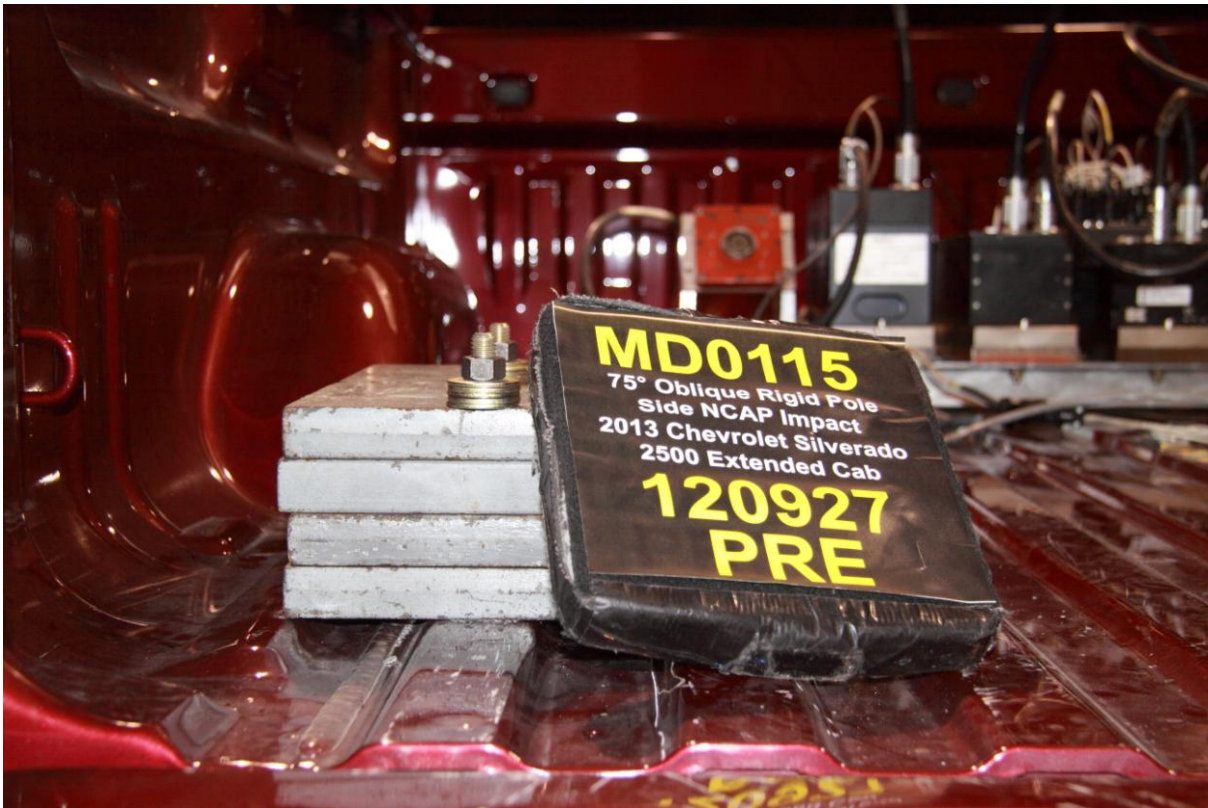
061a Pre-Test Ballast View

| Component Description | Weight (kg) |
|---|---|
| Ballast; steel plate mounted in truck bed | 102.1 |

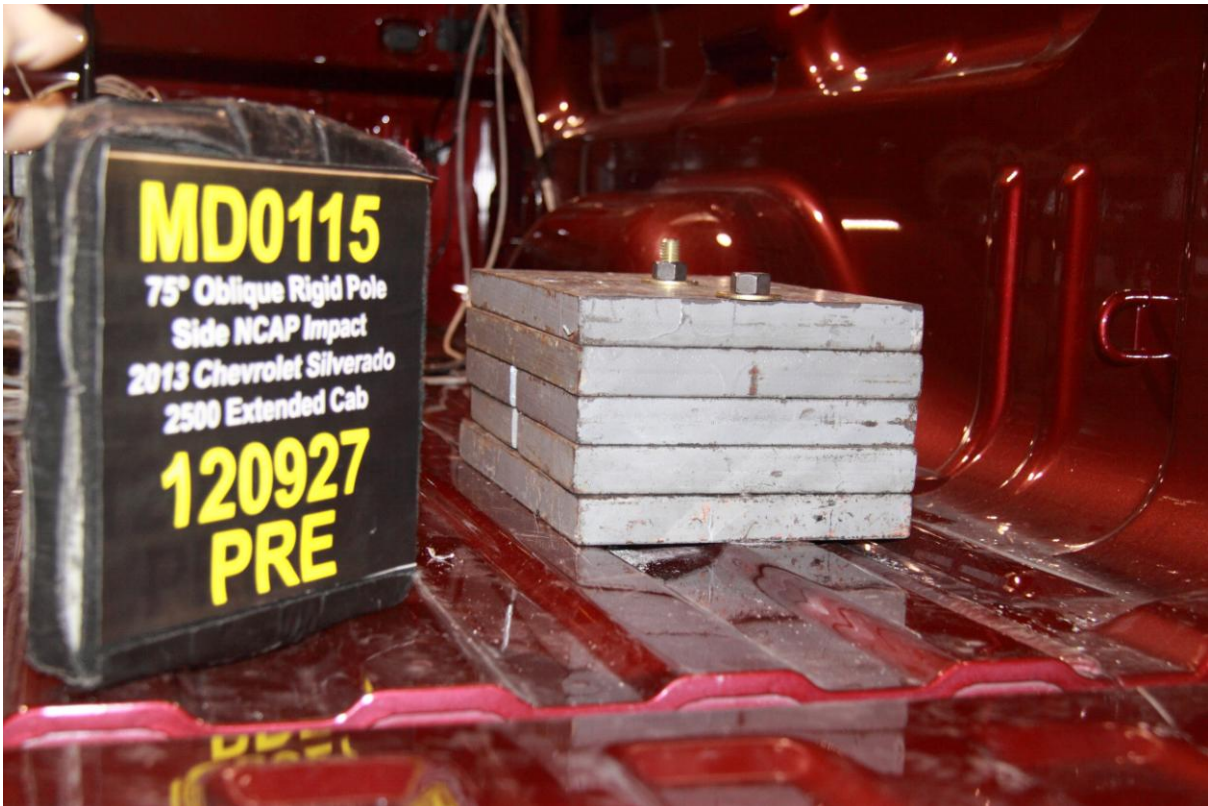
061b Pre-Test Ballast View

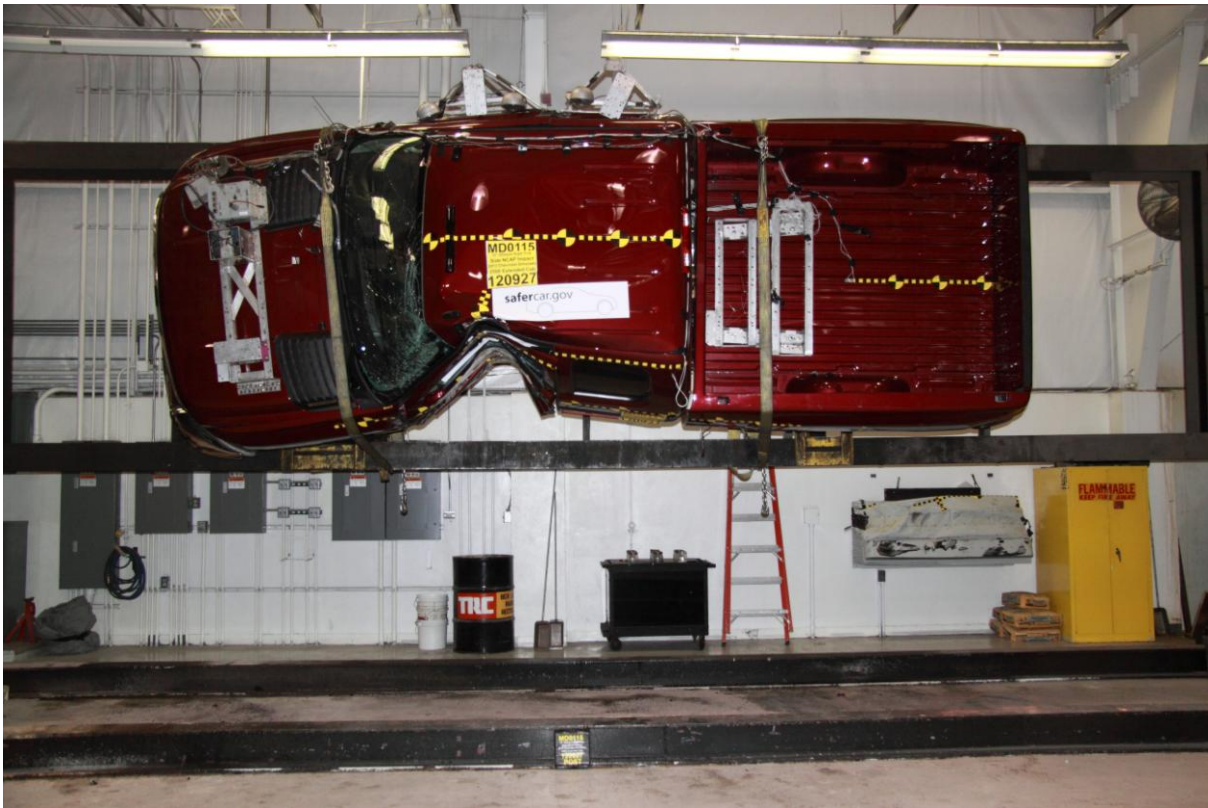
**064** FMVSS No. 301 Static Rollover 90 Degrees

All doors remained closed throughout the test. No fuel spillage occurred during the impact or the static rollover test which followed. Injury values for both ATDs were within the established performance thresholds.

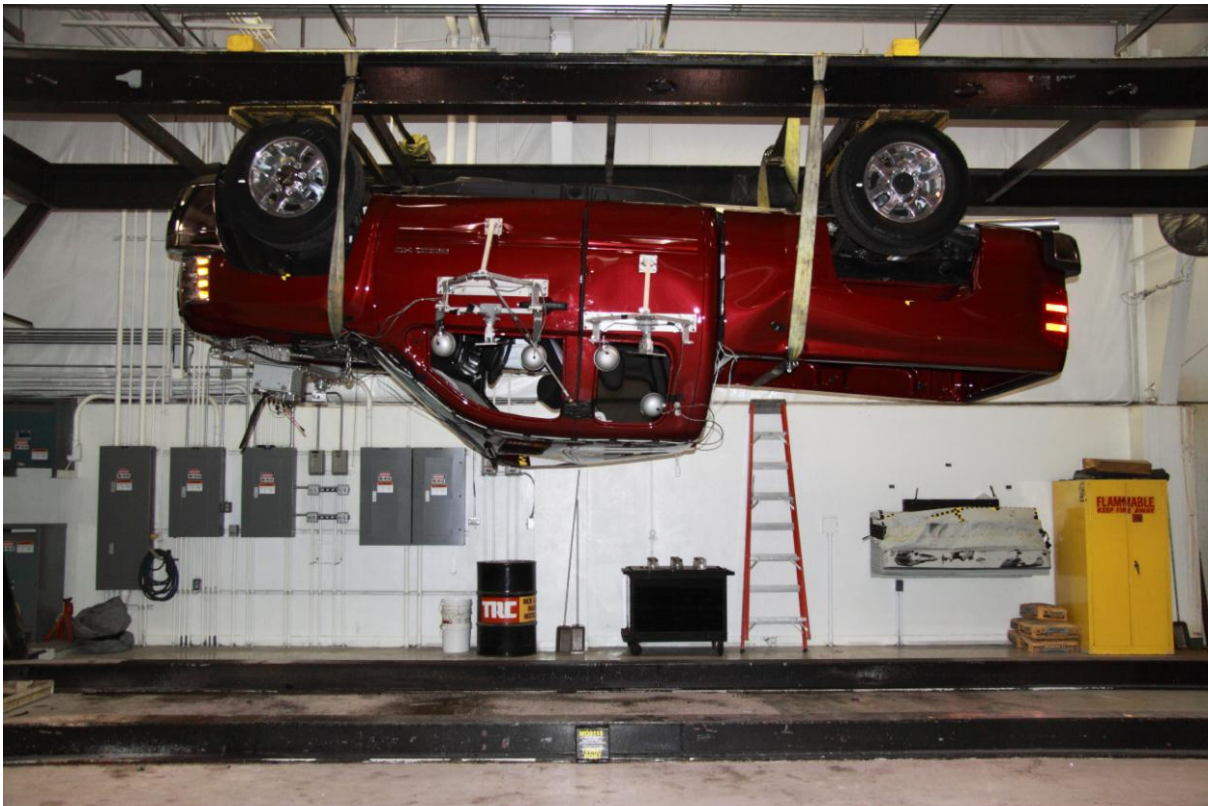
**065** FMVSS No. 301 Static Rollover 180 Degrees

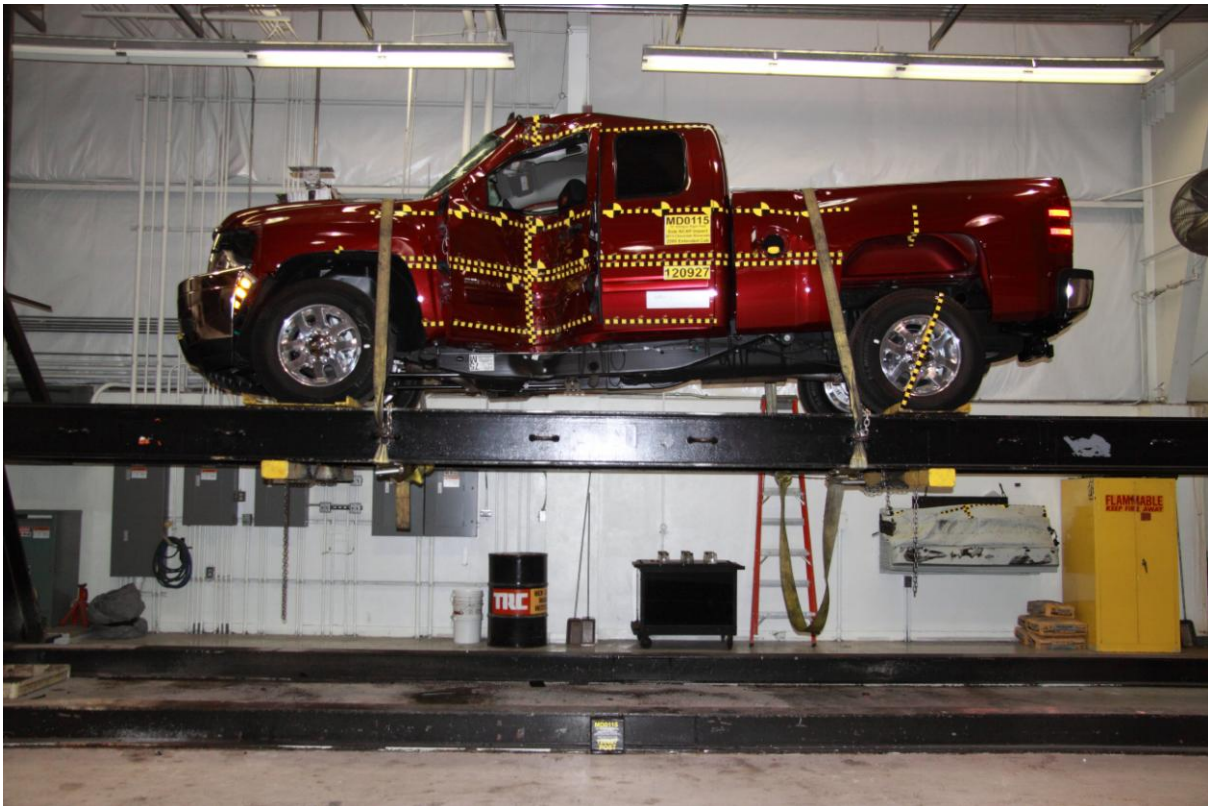
**067** FMVSS No. 301 Static Rollover 360 Degrees
