**REPORT NUMBER: SPNCAP-MGA-2013-016**

**NEW CAR ASSESSMENT PROGRAM (NCAP)  
Side Impact Pole Test**

**GENERAL MOTORS OF CANADA LTD.  
2013 Cadillac XTS 4-Dr Sedan  
NHTSA No.: MD0112**

**MGA RESEARCH CORPORATION  
5000 Warren Road  
Burlington, WI 53105**

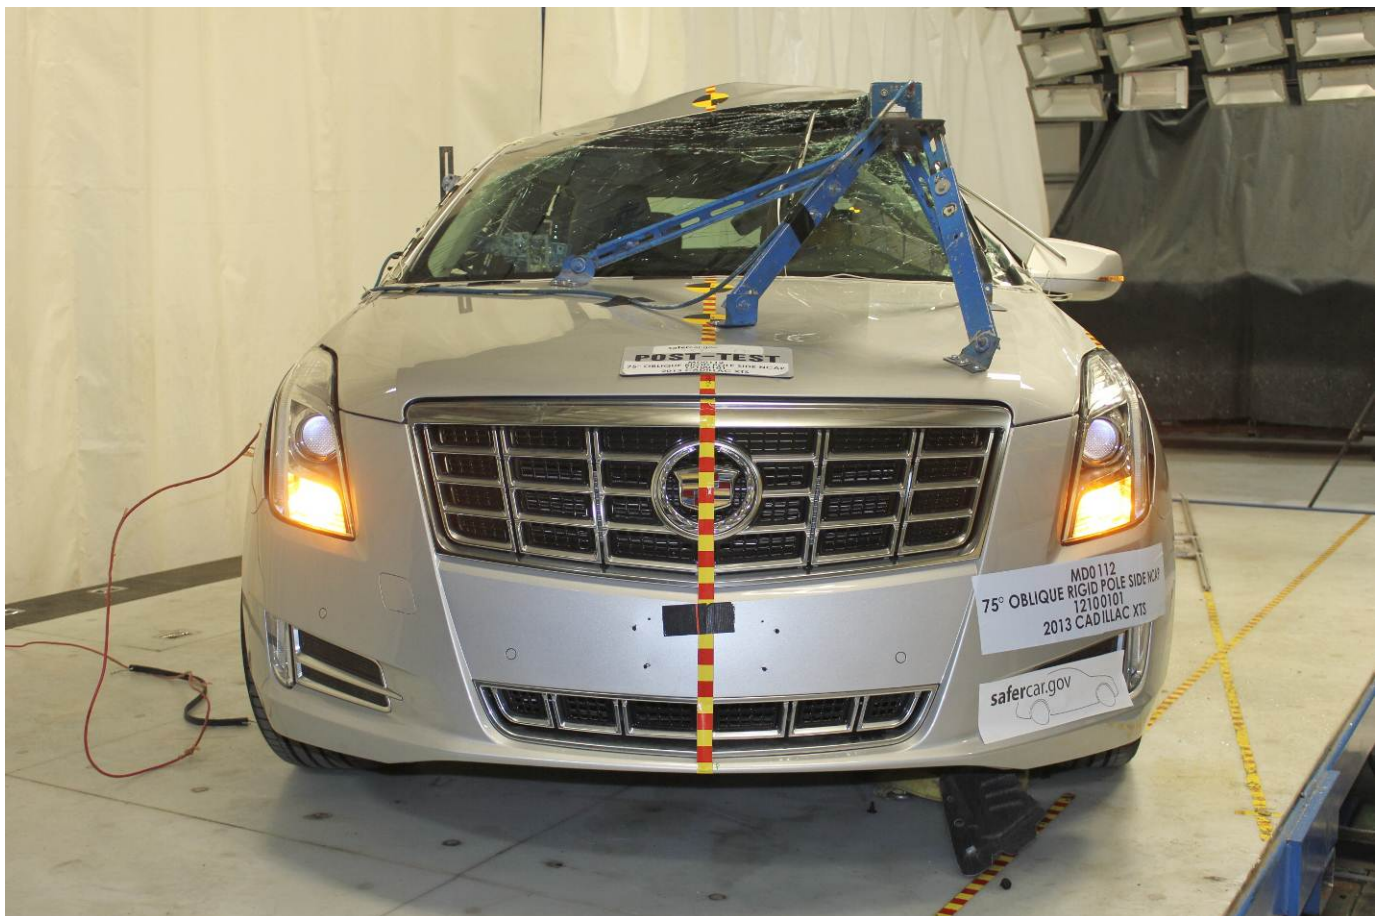
Post-Test Frontal View of Test Vehicle

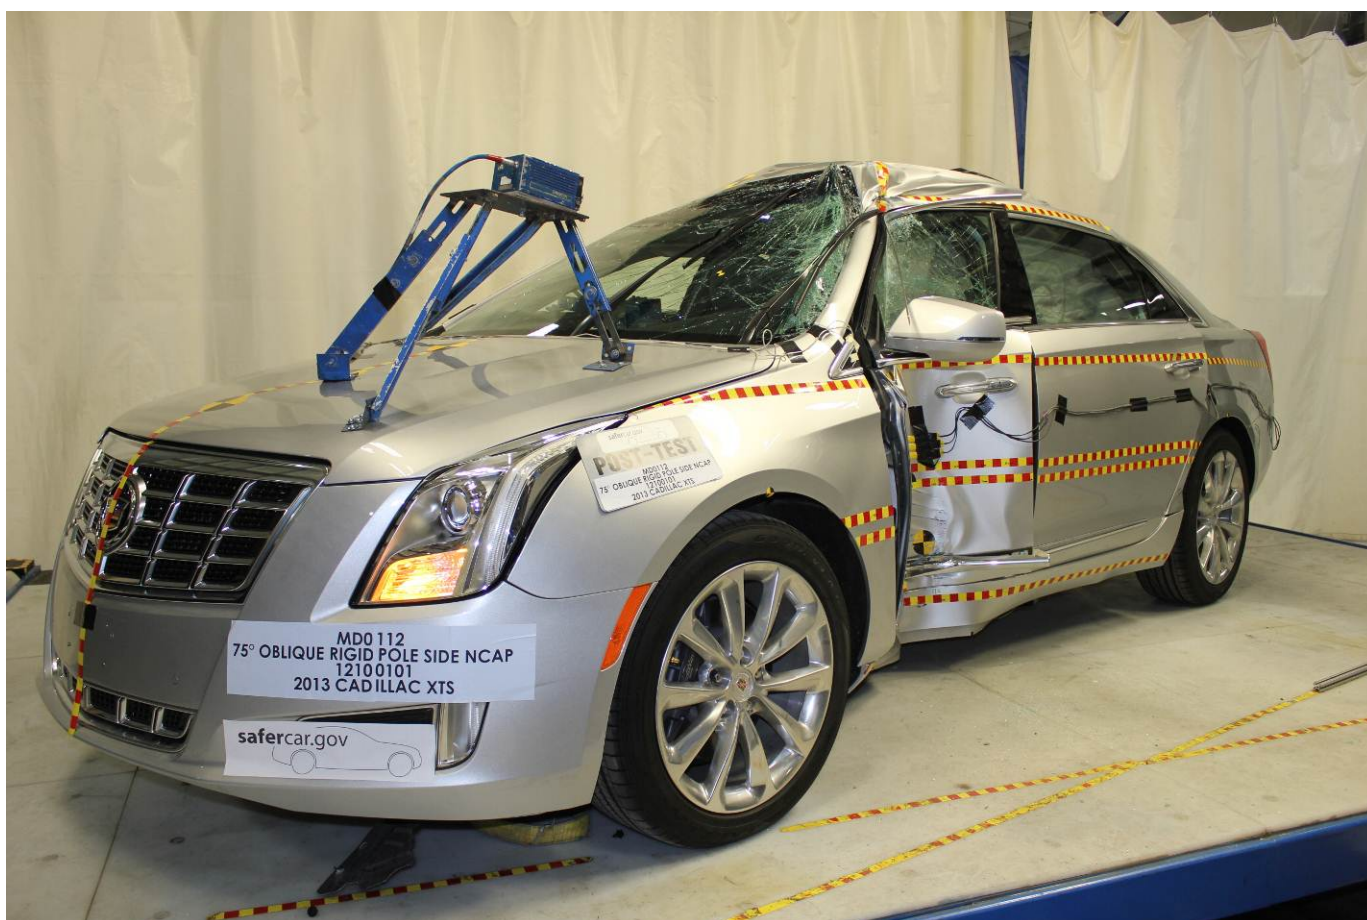
Post-Test Left Front  $\frac{3}{4}$  View of Test Vehicle

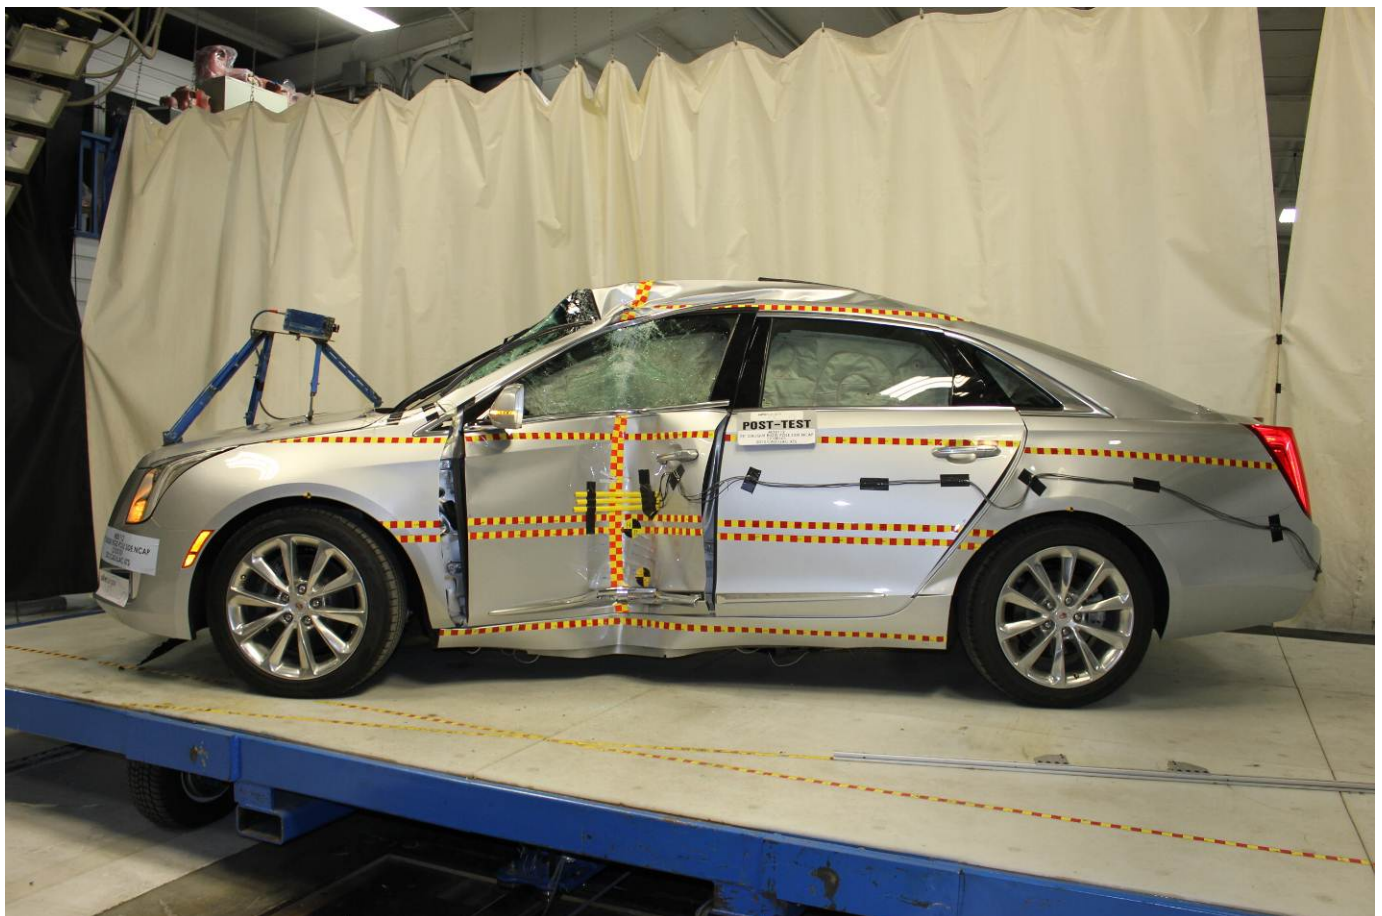
Post-Test Left Side View of Test Vehicle

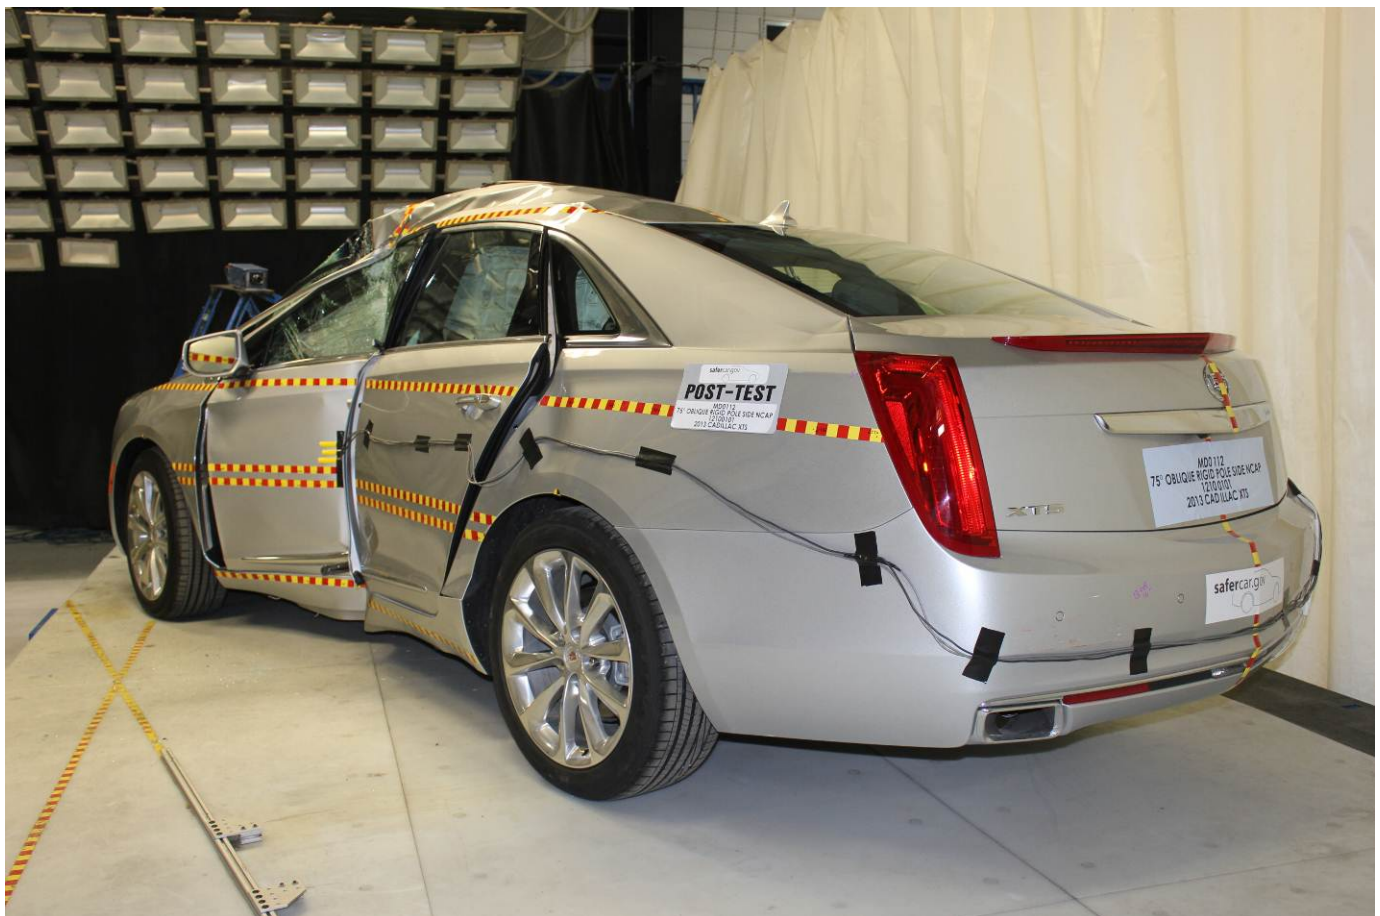
Post-Test Left Rear  $\frac{3}{4}$  View of Test Vehicle

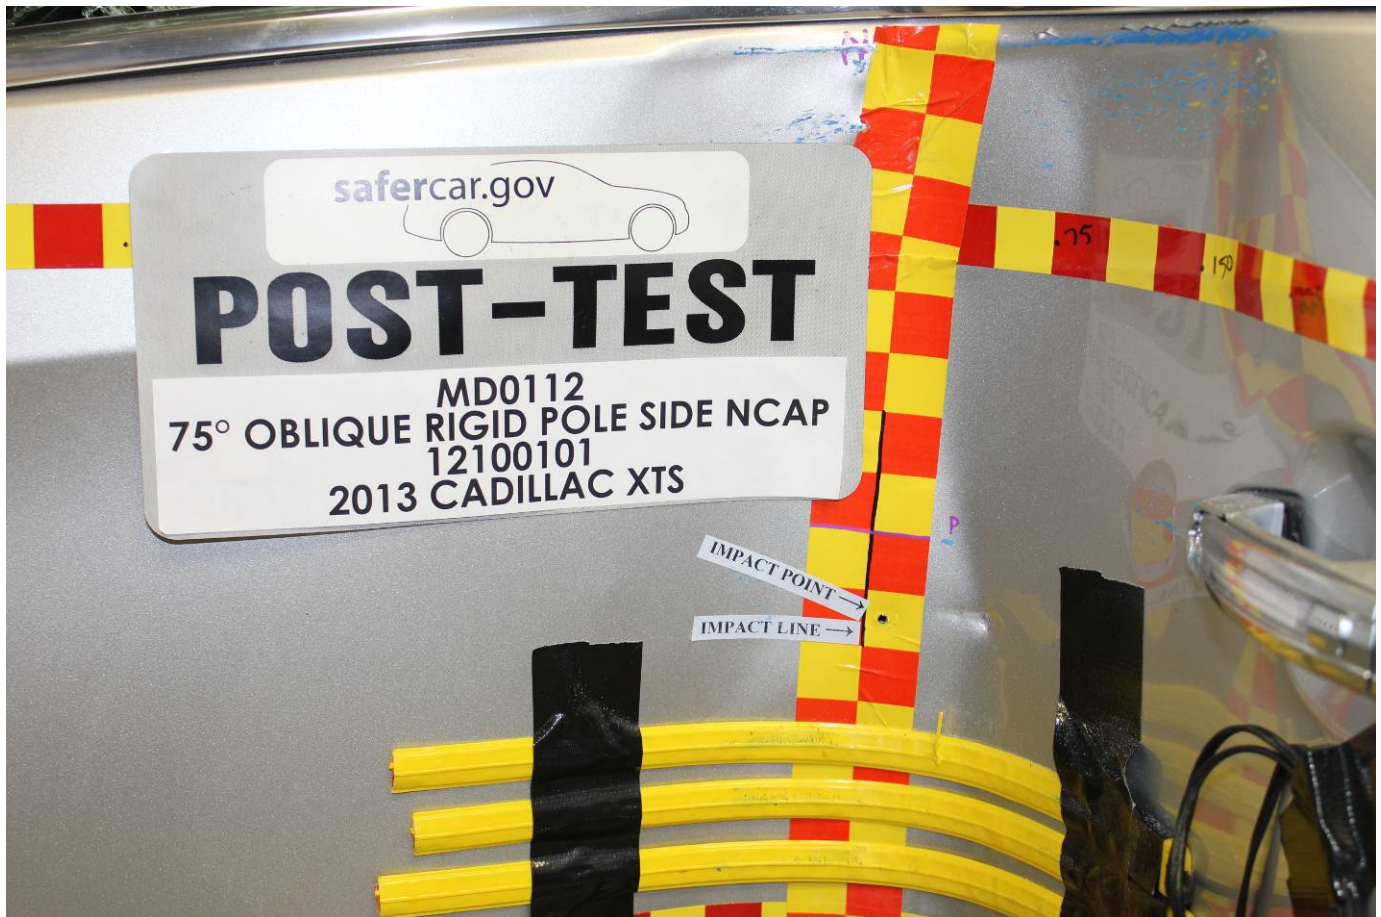
Post-Test Close-Up View of Impact Point Target Showing Impact Location

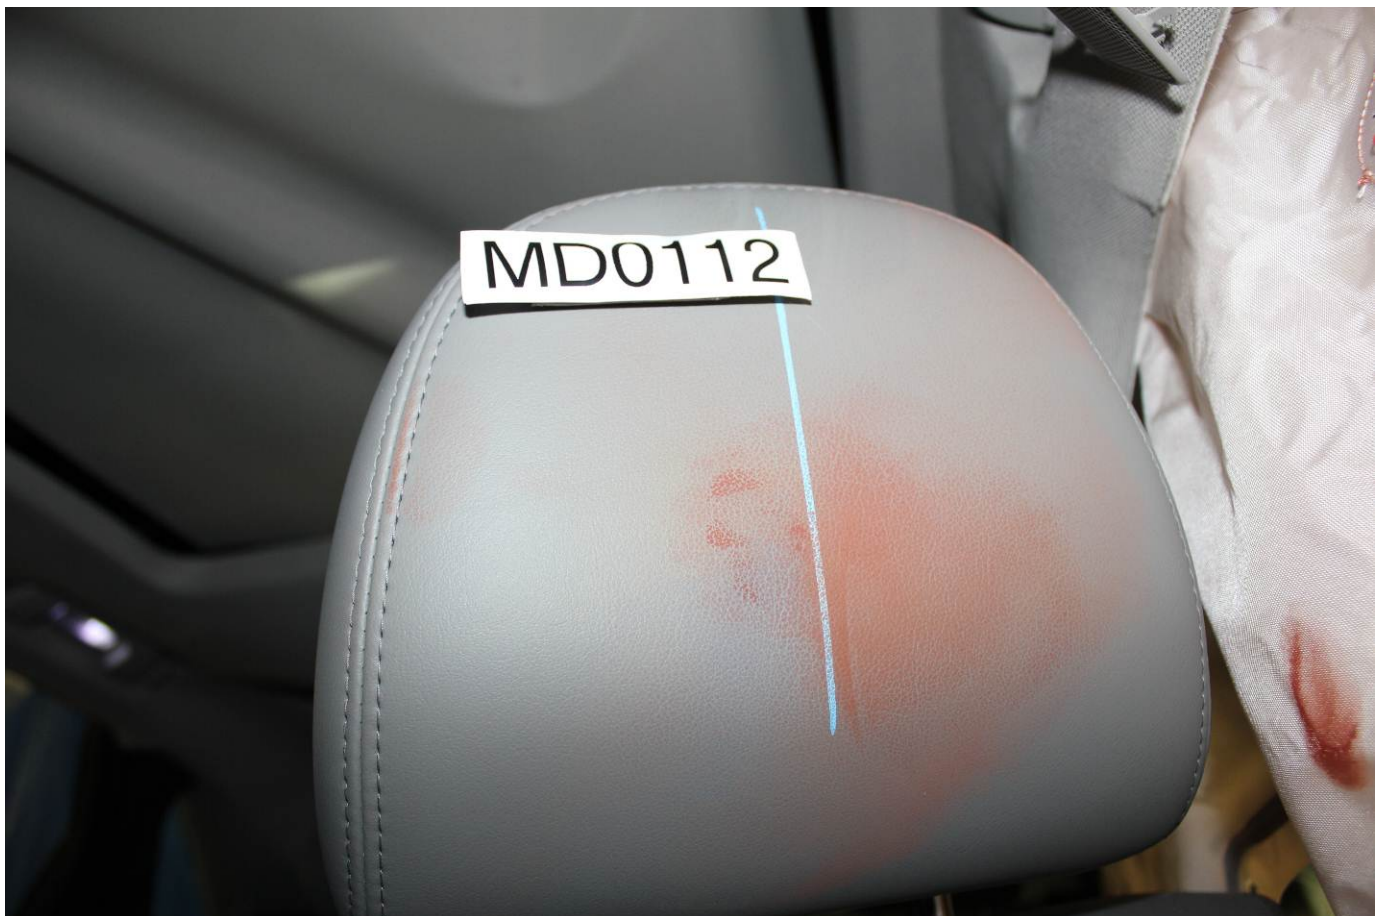
Post-Test Dummy Close-Up Head Contact with Vehicle Interior View

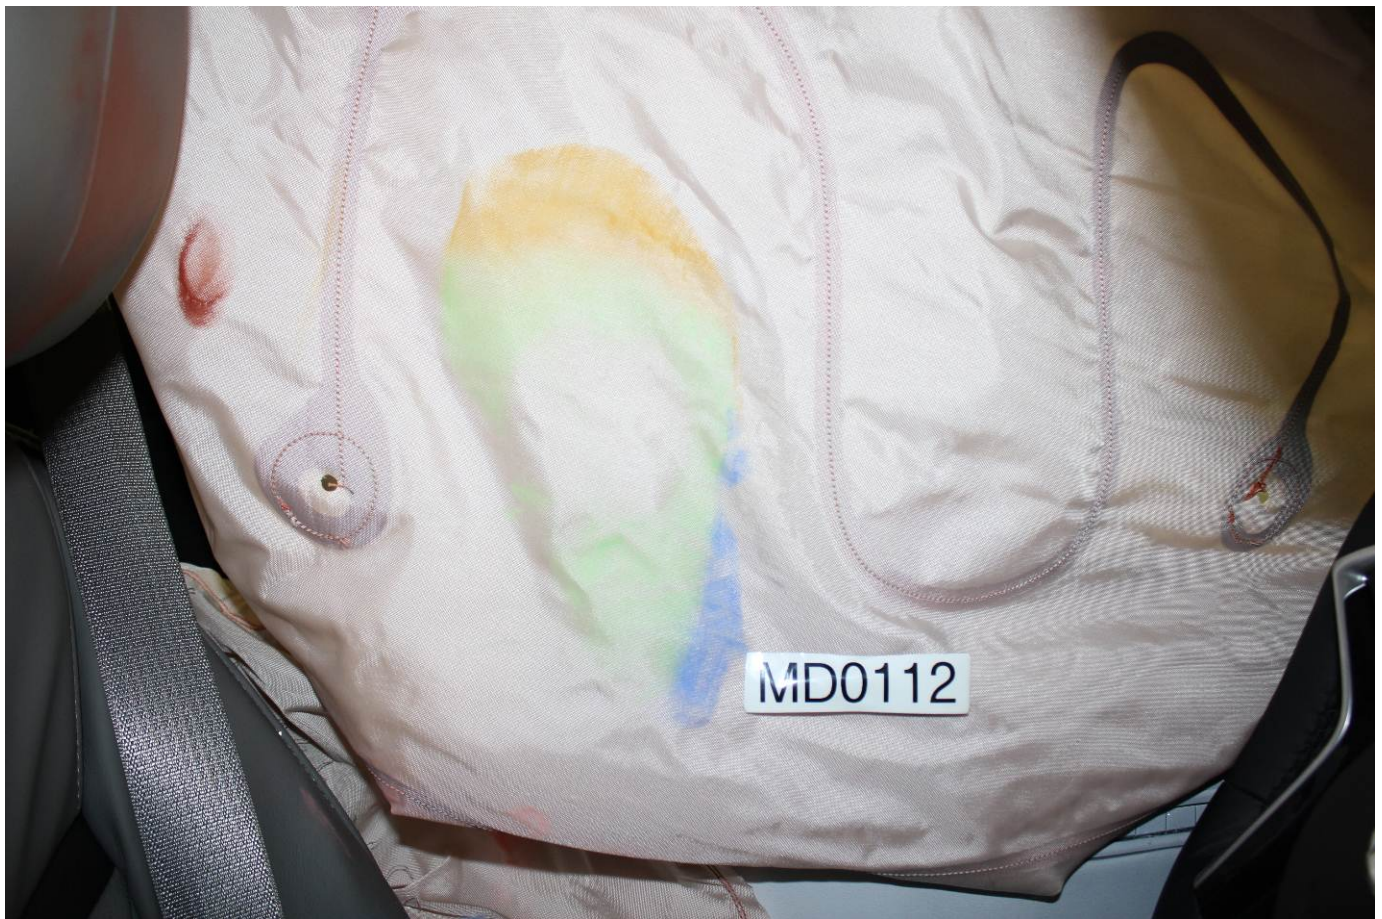
Post-Test Dummy Close-Up Head Contact with Side Air Bag View

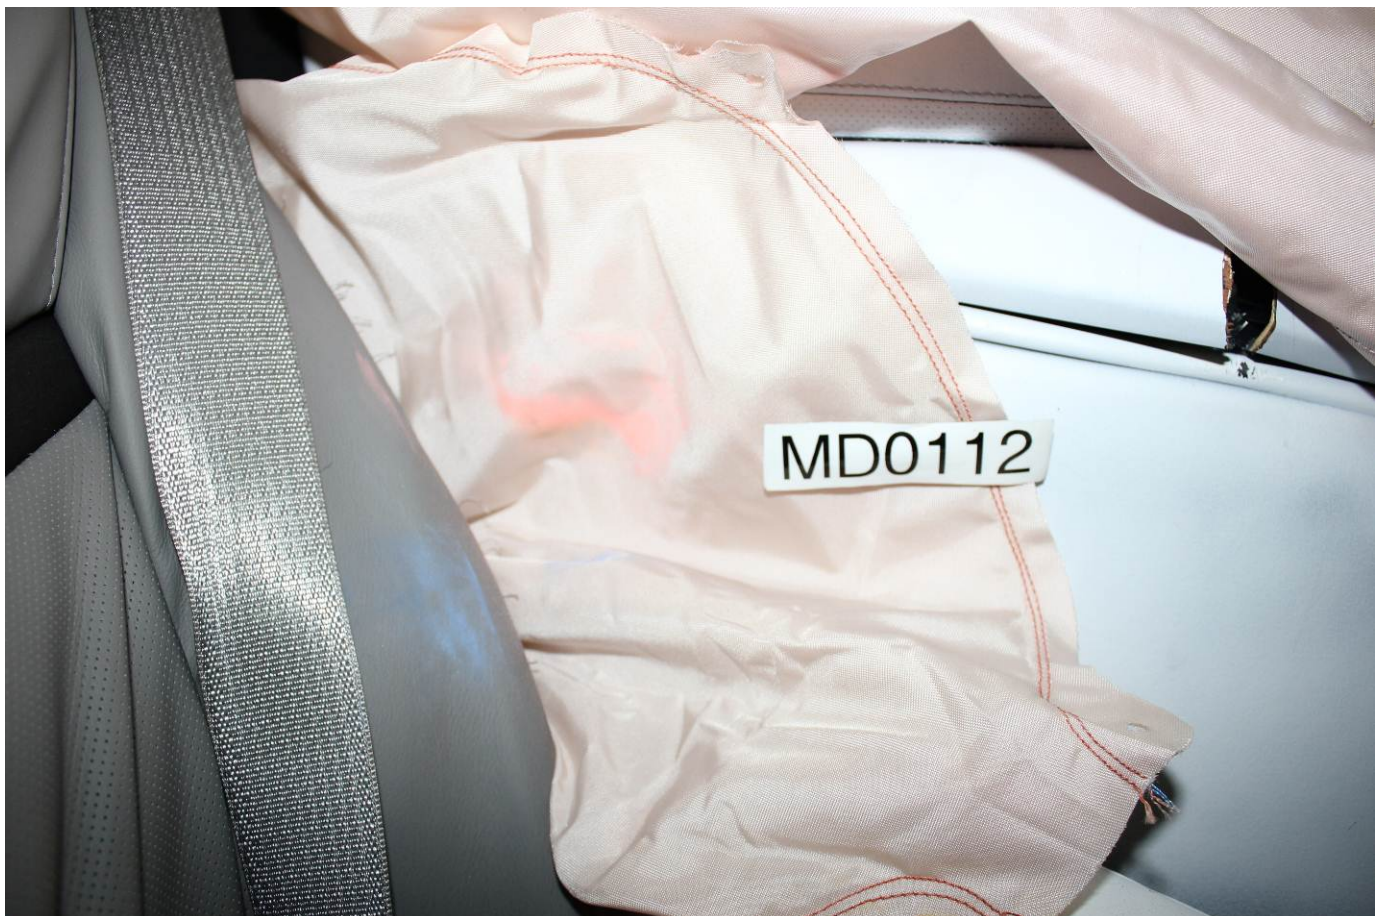
Post-Test Dummy Close-Up Torso Contact with Side Air Bag View

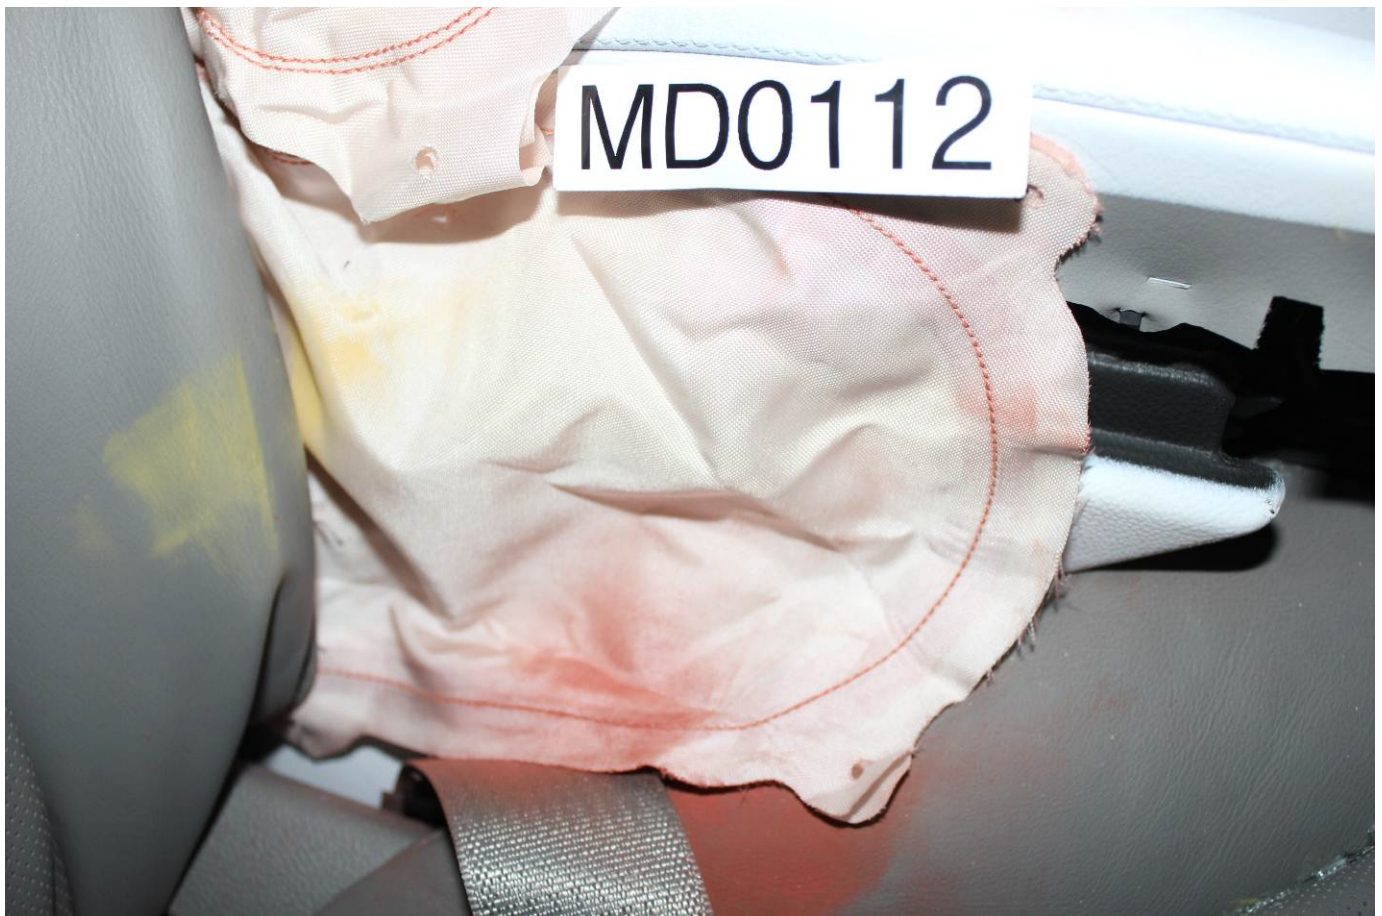
Post-Test Dummy Close-Up Pelvis Contact with Side Air Bag View

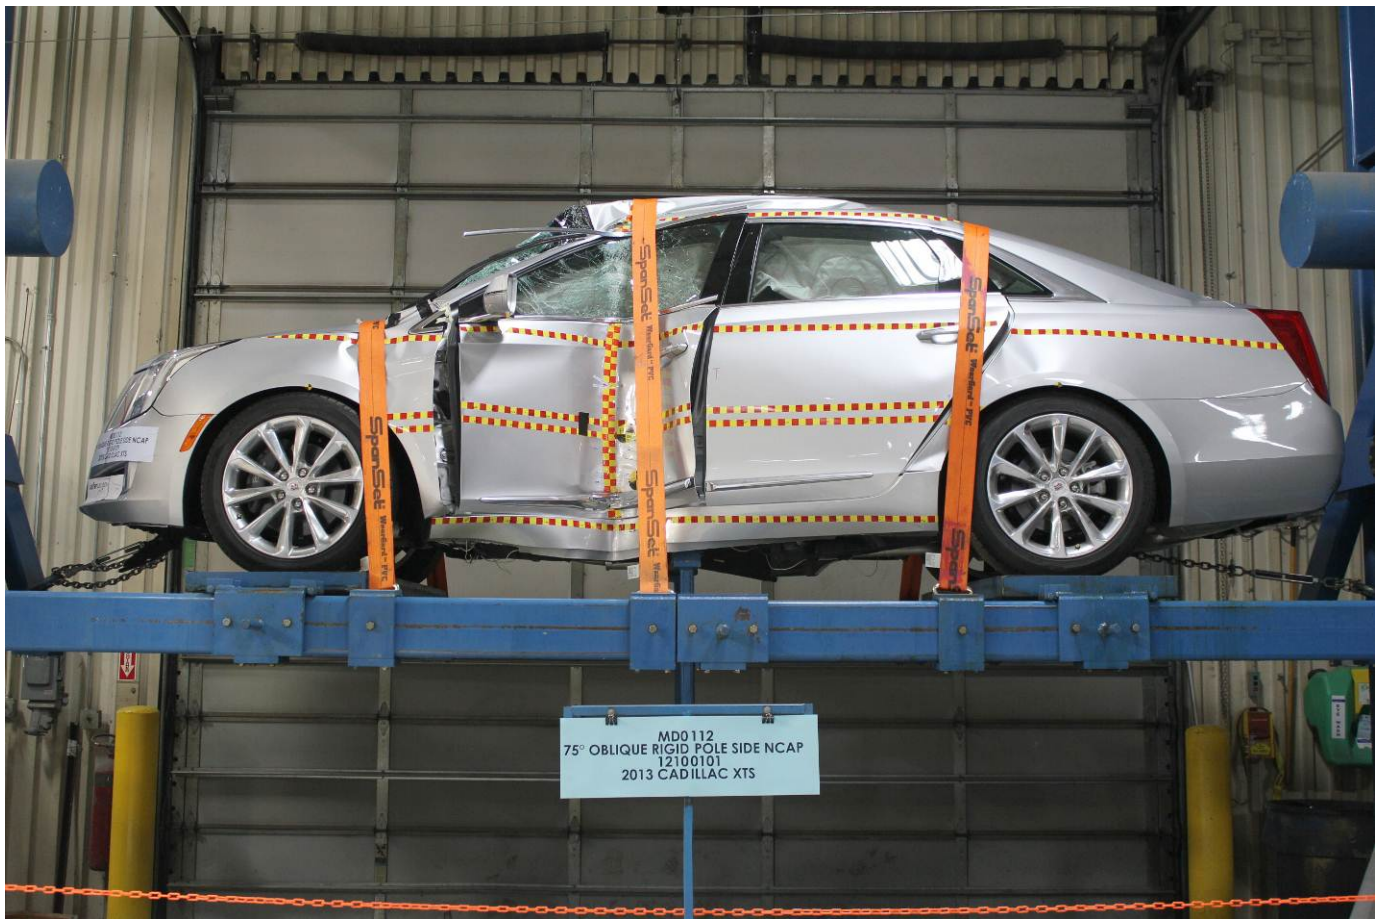
FMVSS No. 301 Static Rollover 0 Degrees

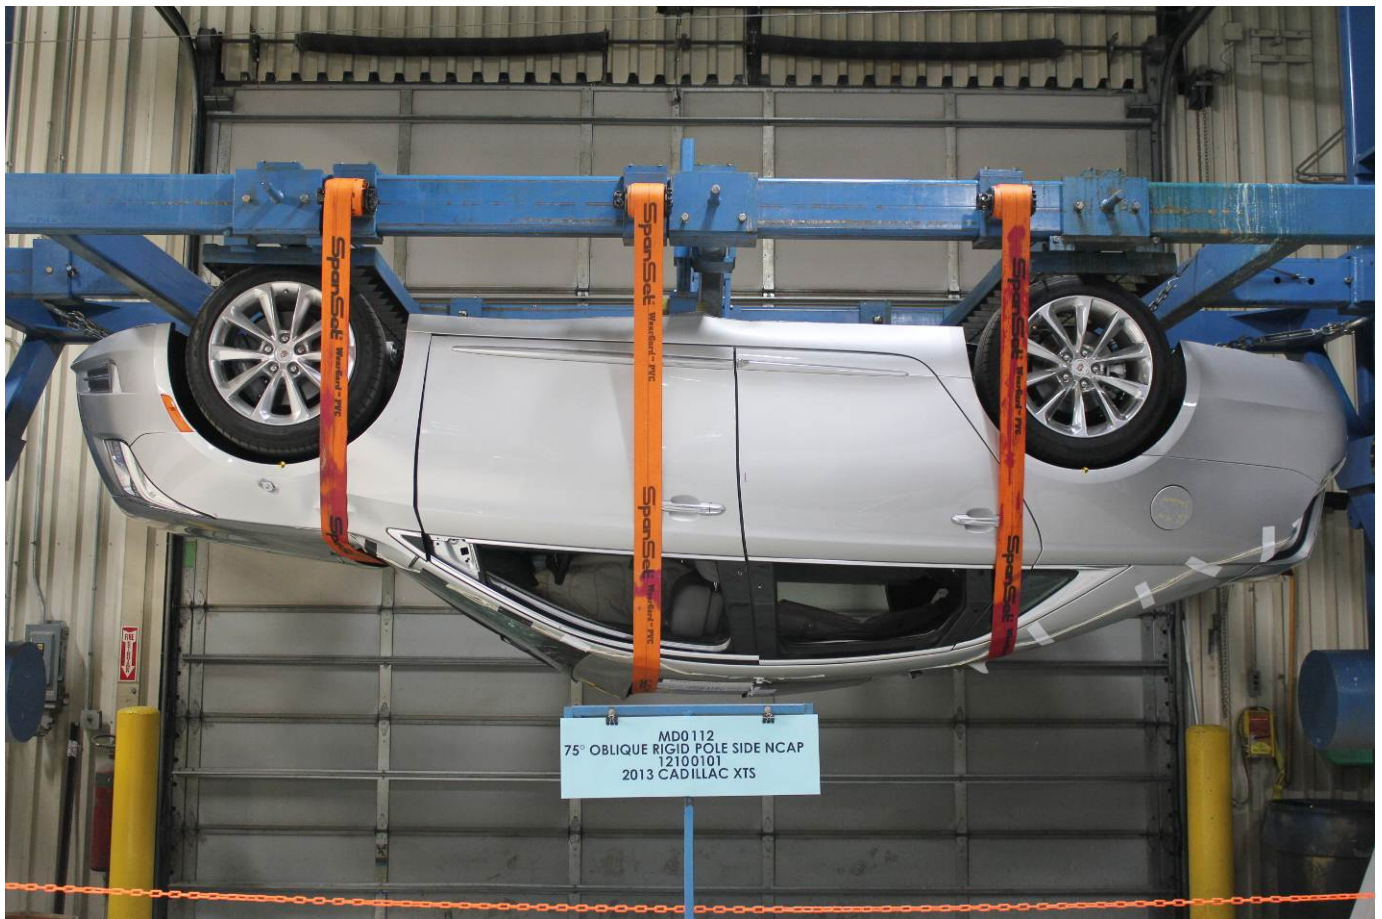
FMVSS No. 301 Static Rollover 180 Degrees

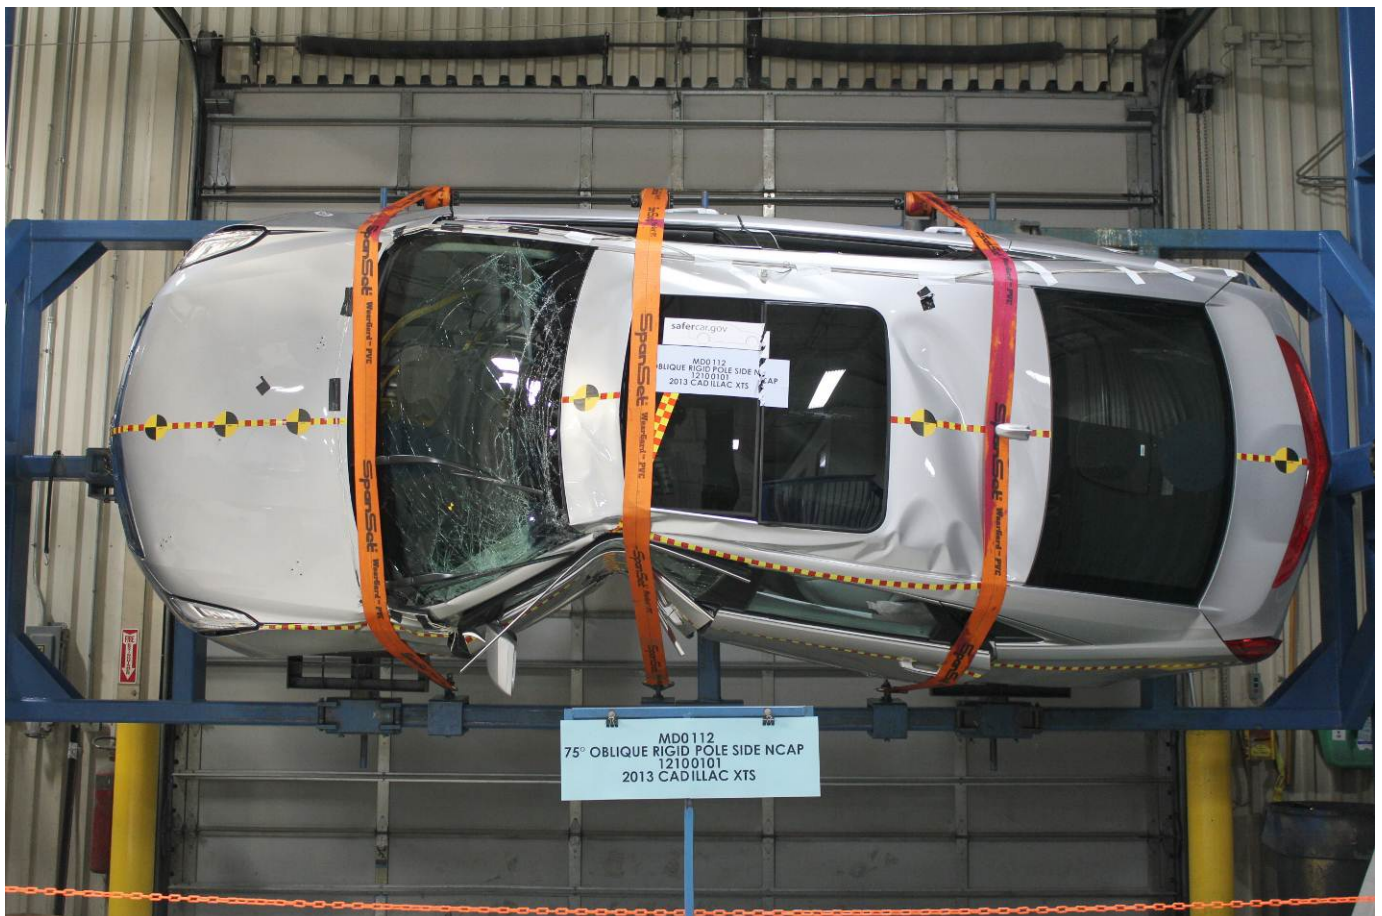
FMVSS No. 301 Static Rollover 270 Degrees

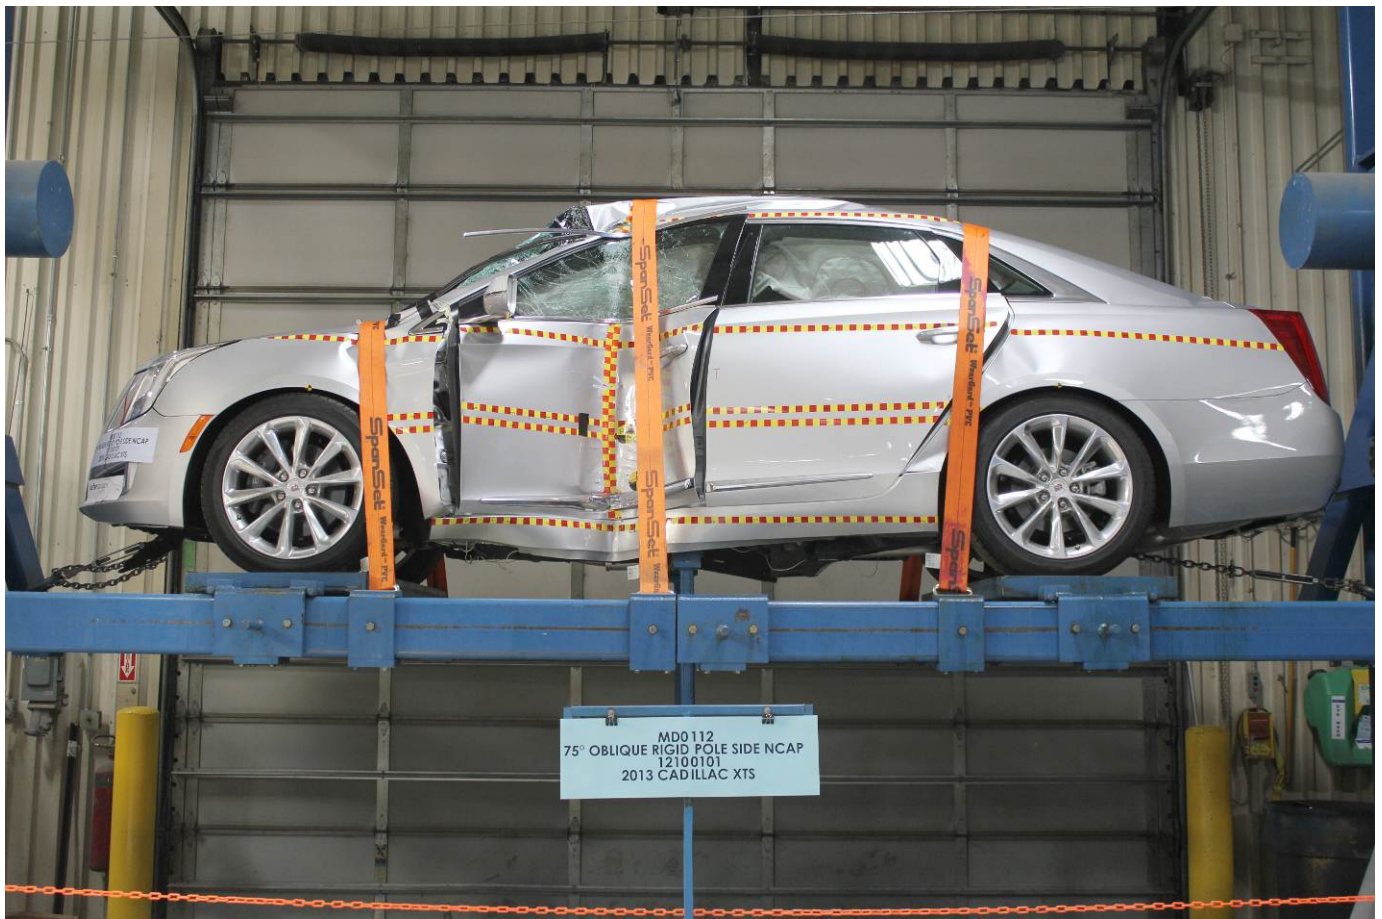
FMVSS No. 301 Static Rollover 360 Degrees
