**REPORT NUMBER: SINCAP-MGA-2013-020**

**NEW CAR ASSESSMENT PROGRAM (NCAP)  
Moving Deformable Barrier Side Impact Test**

**KIA MOTORS MANUFACTURING GEORGIA, INC.  
FOR HYUNDAI MOTOR COMPANY  
2013 Hyundai Santa Fe Sport SUV  
NHTSA No.: MD0505**

**FINAL REPORT**

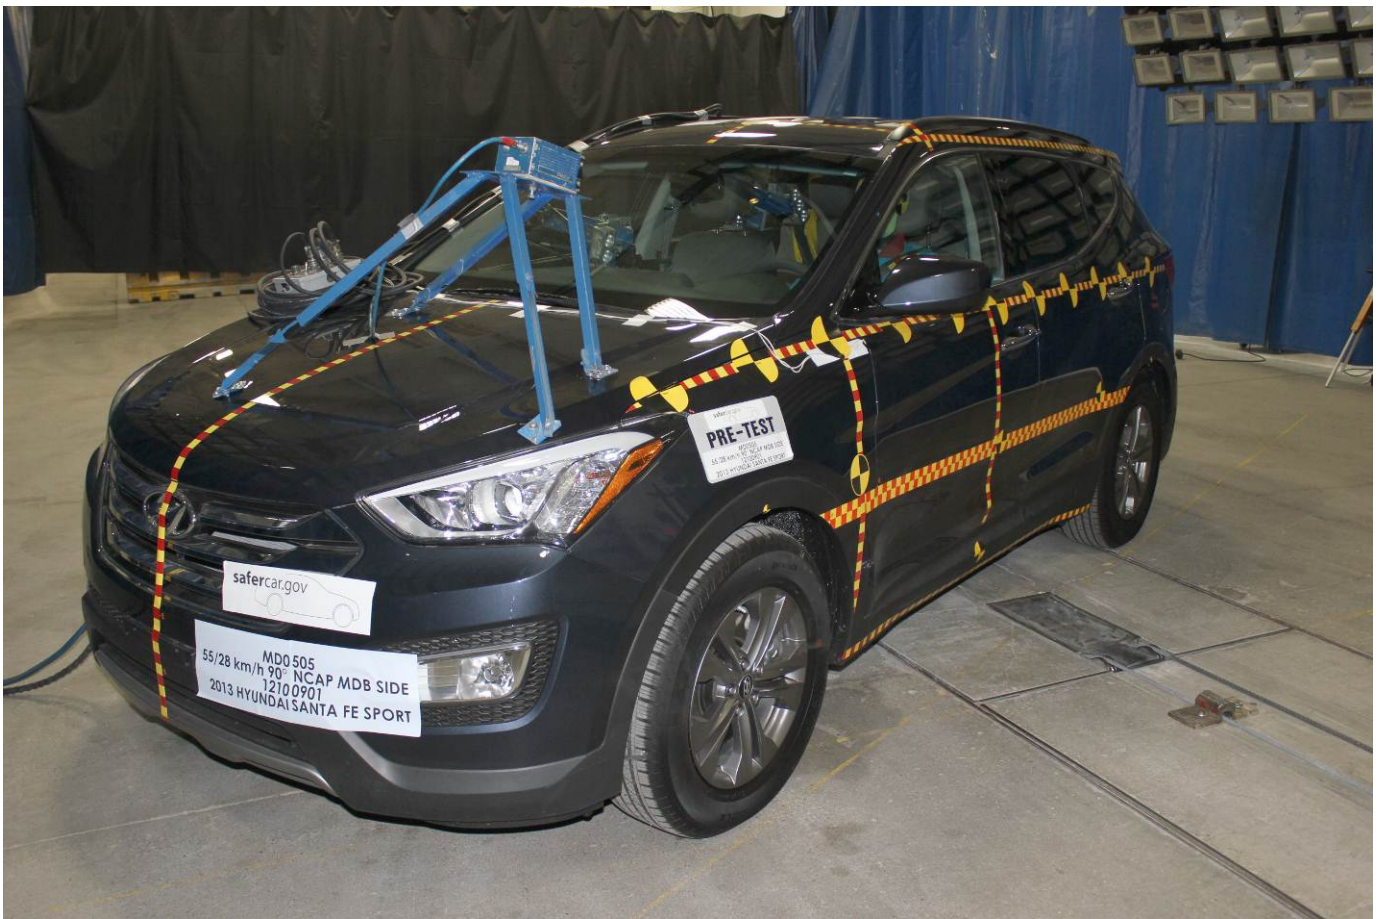
Pre-Test Left Front Three-Quarter View of Test Vehicle

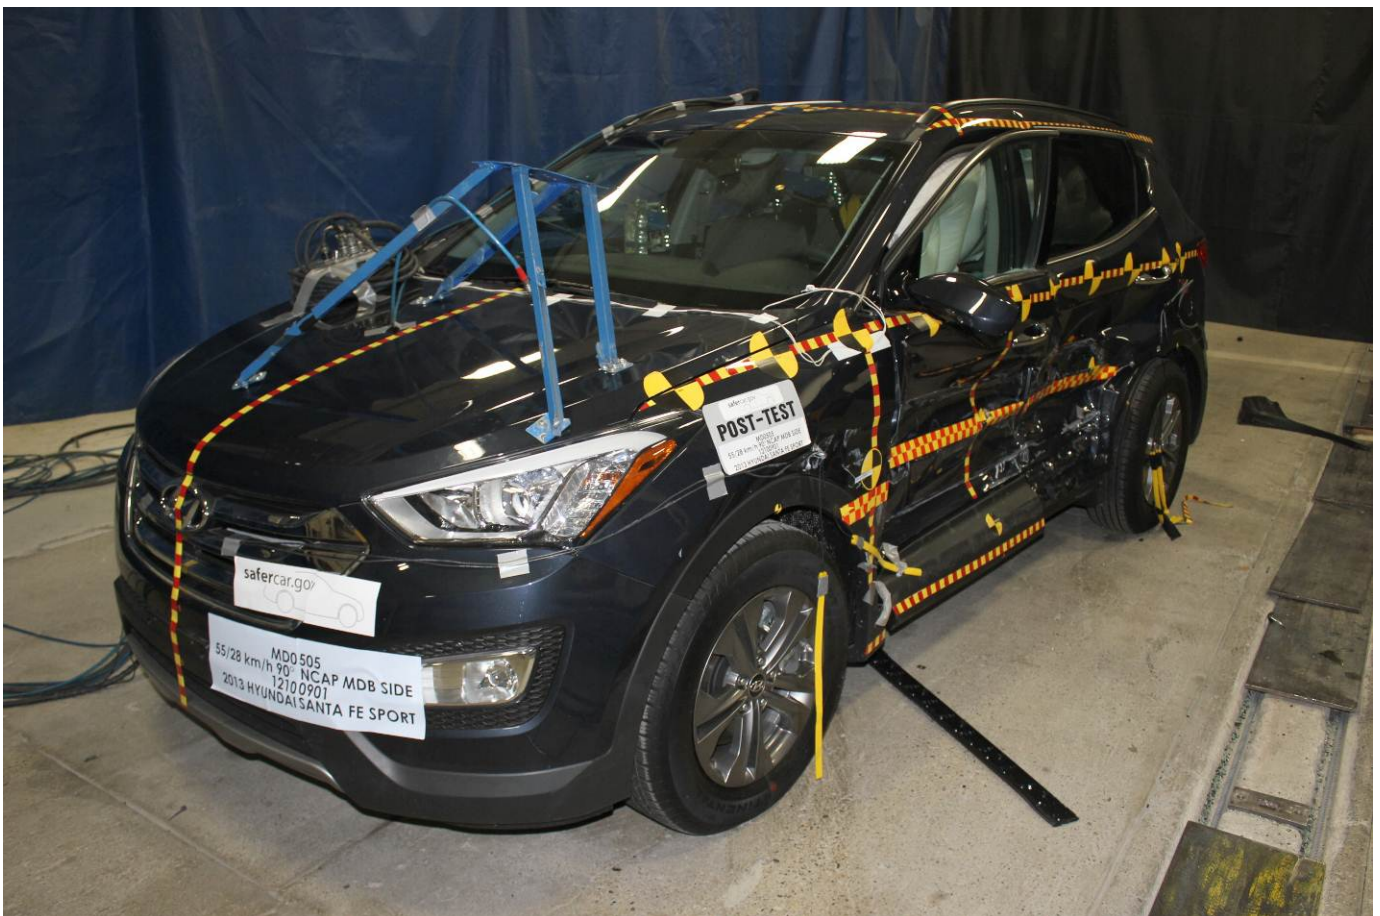
Post-Test Left Front Three-Quarter View of Test Vehicle

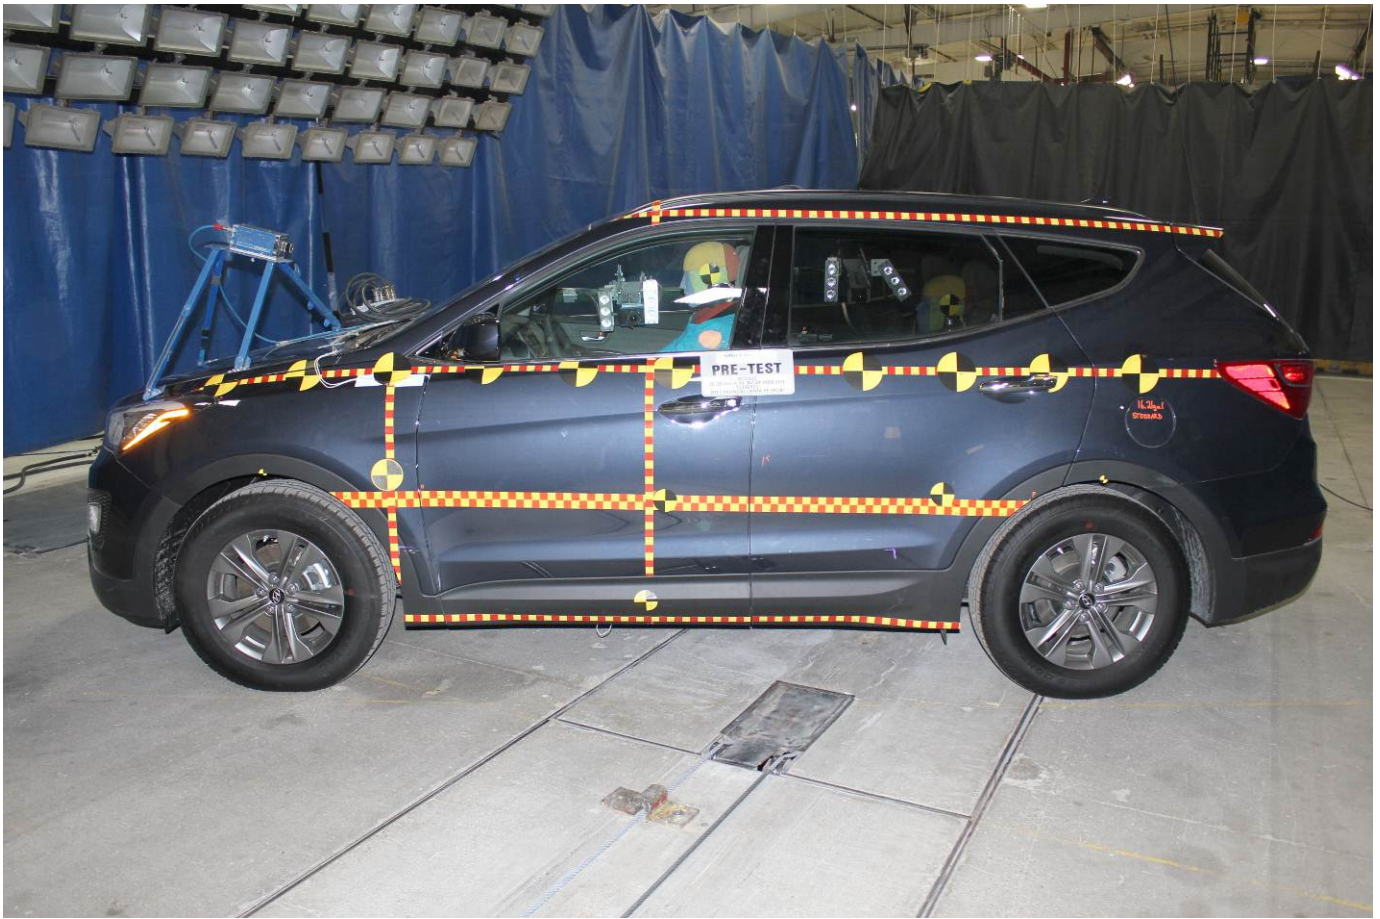
Pre-Test Left Side View of Test Vehicle

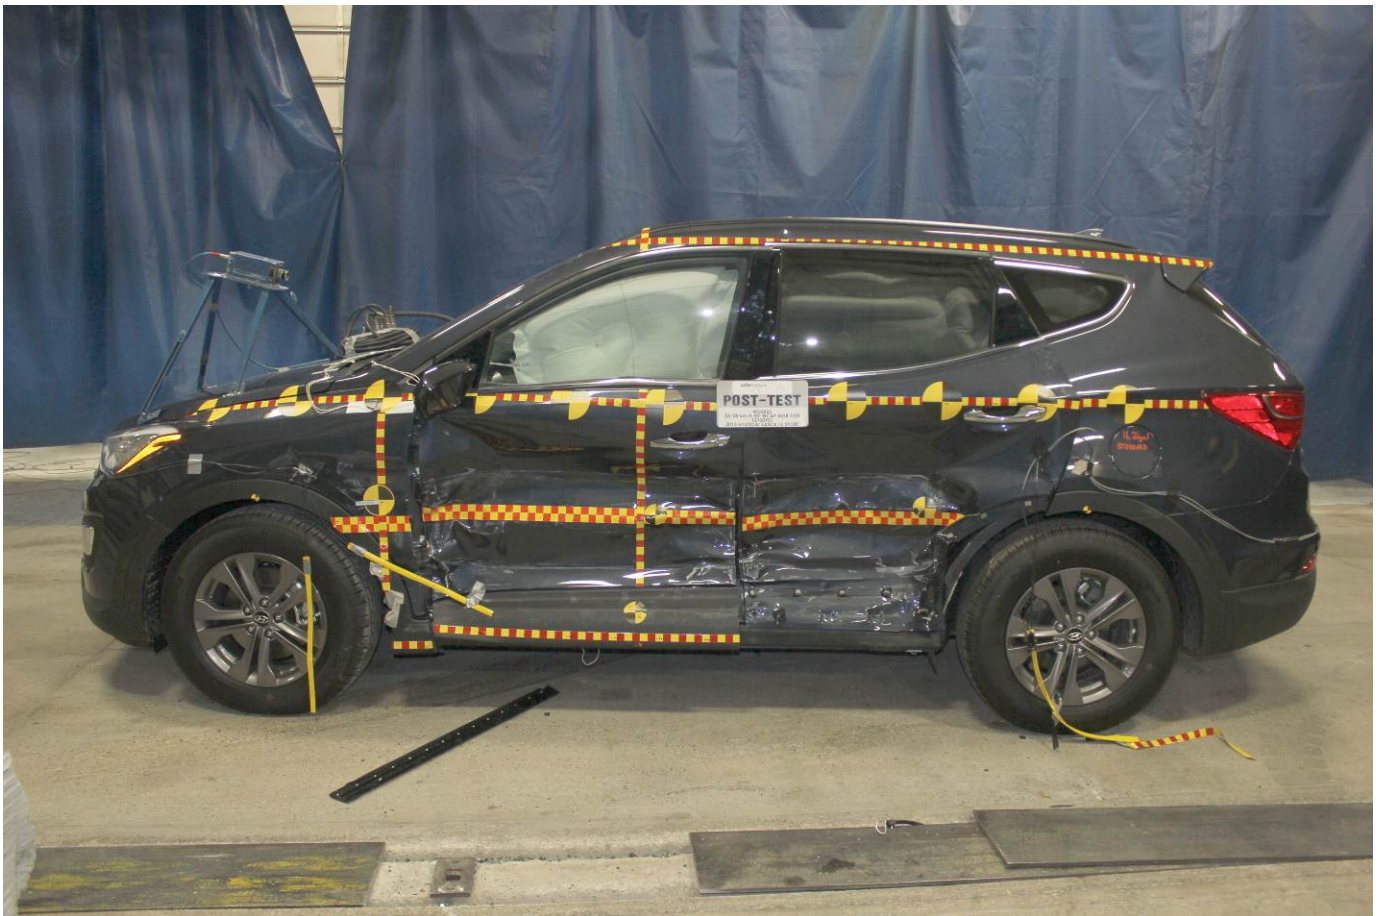
Post-Test Left Side View of Test Vehicle

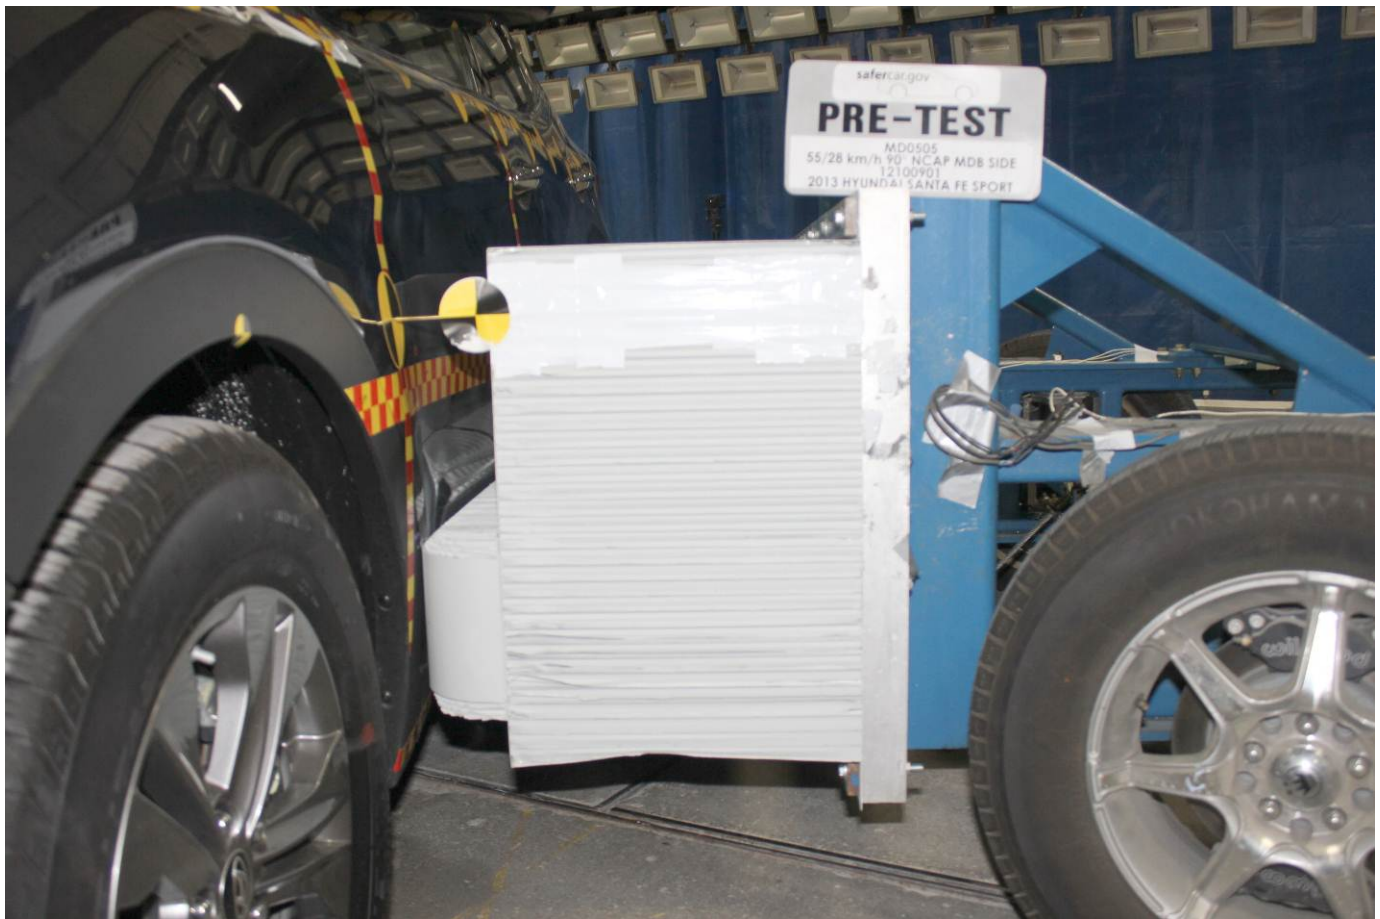
Pre-Test Left Side View of MDB Positioned Against Side of Test Vehicle

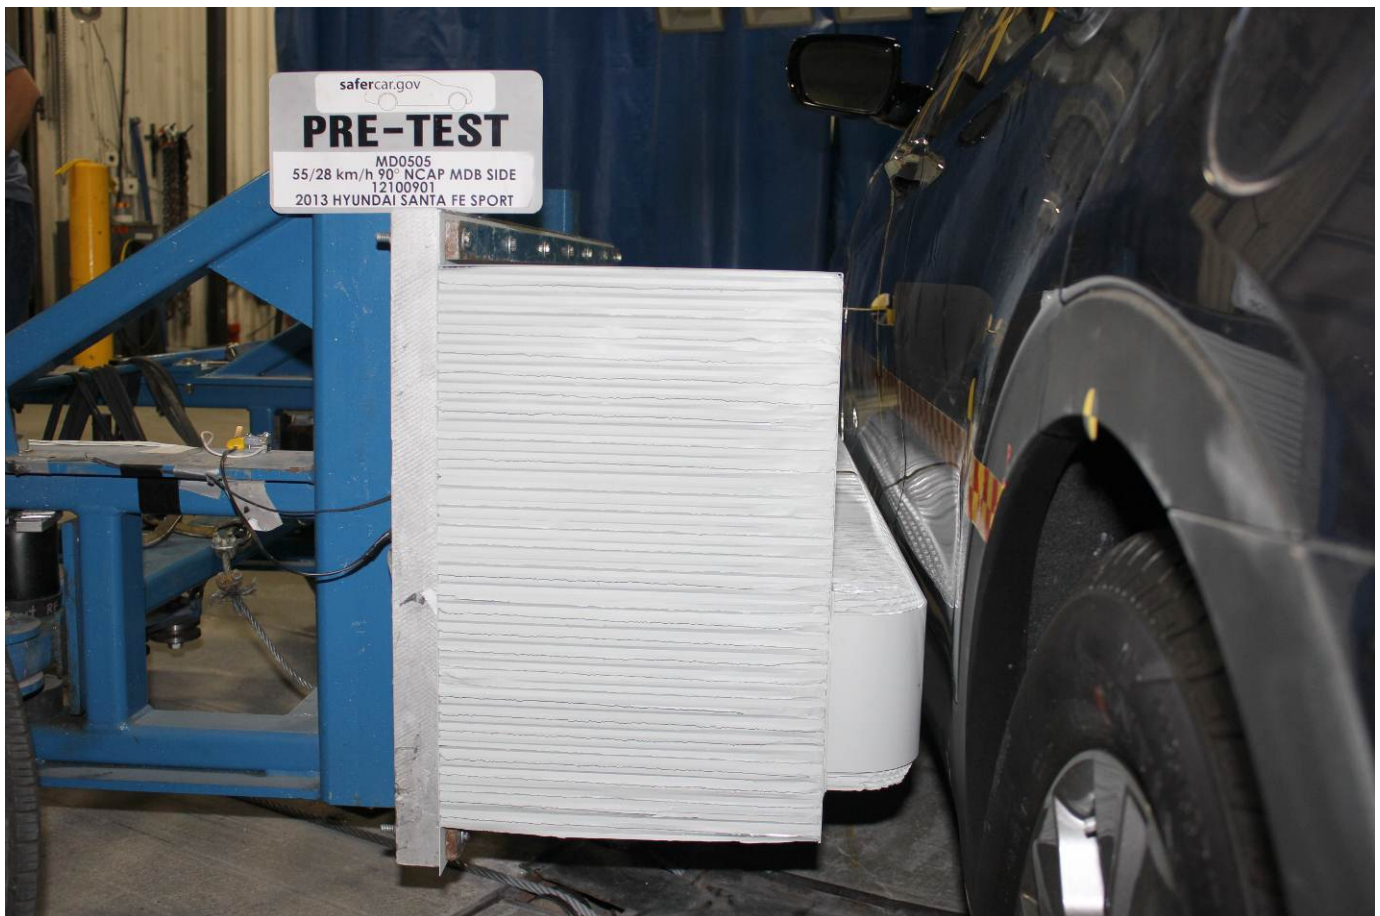
Pre-Test Right Side View of MDB Positioned Against Side of Test Vehicle

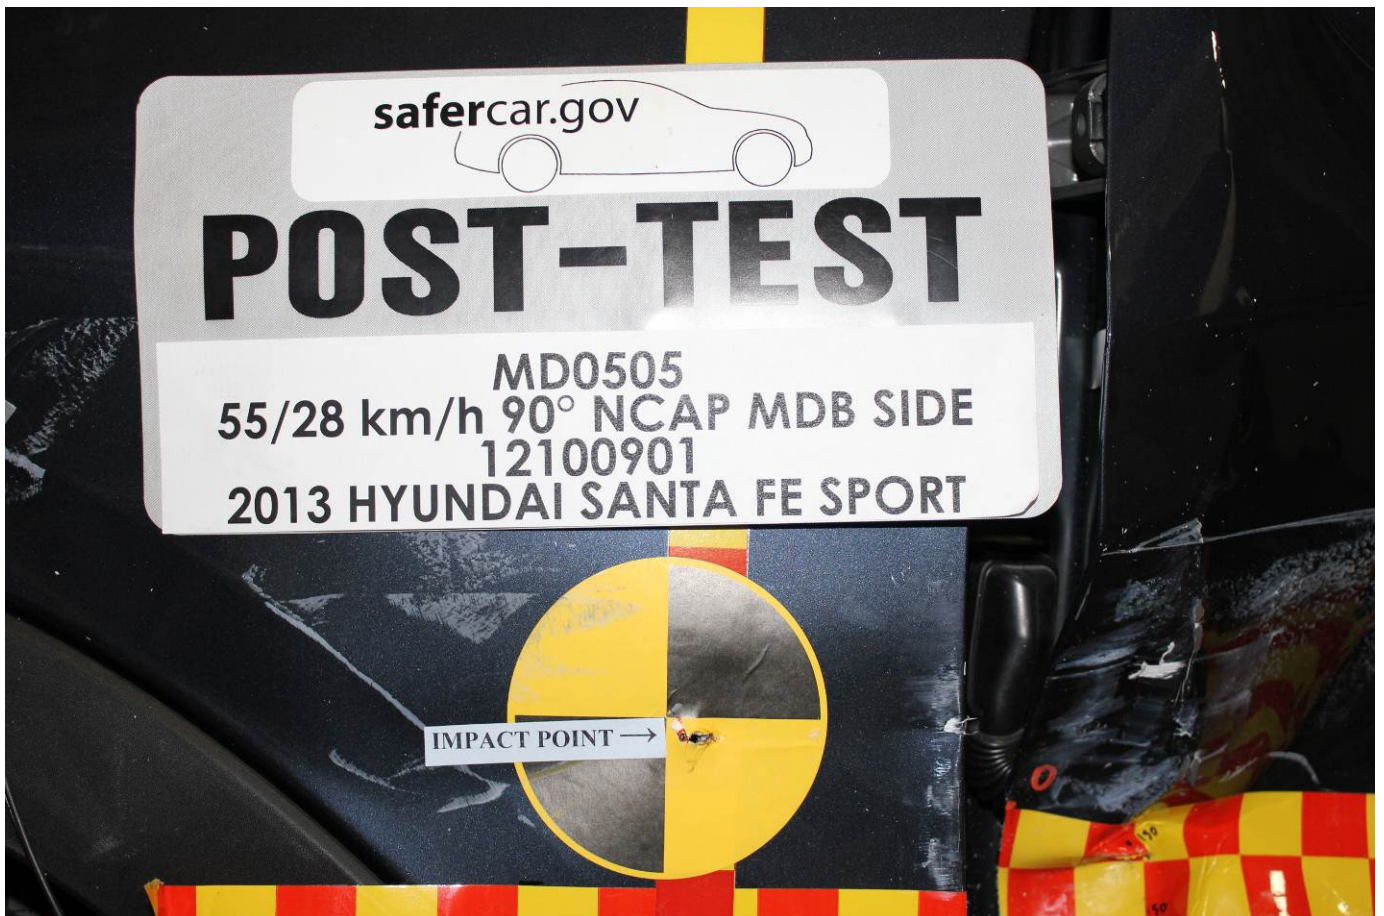
Post-Test Close-Up View of Impact Point Target

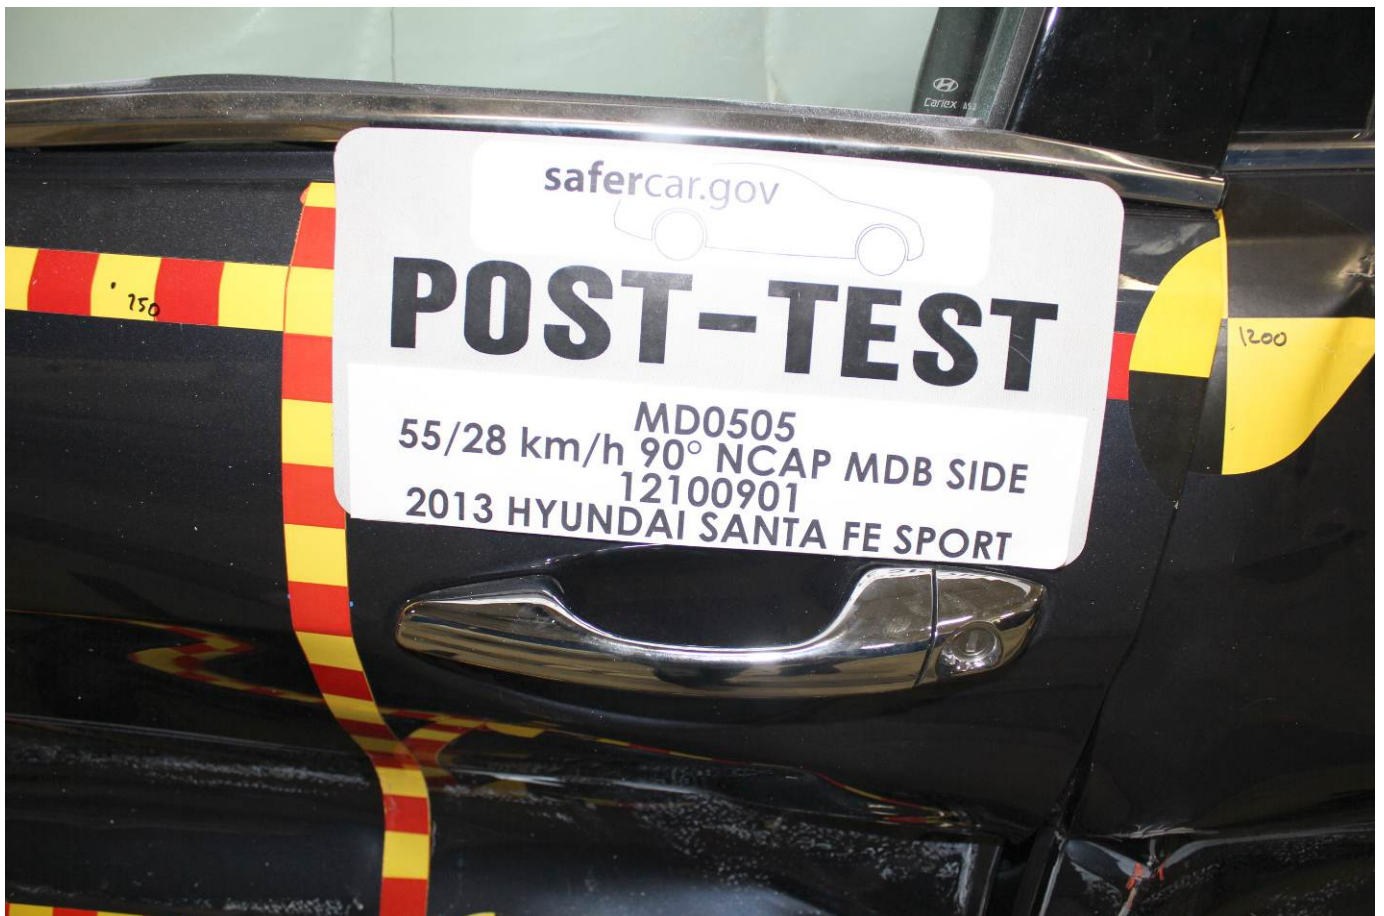
Post-Test Left Front Door Latch Close-Up

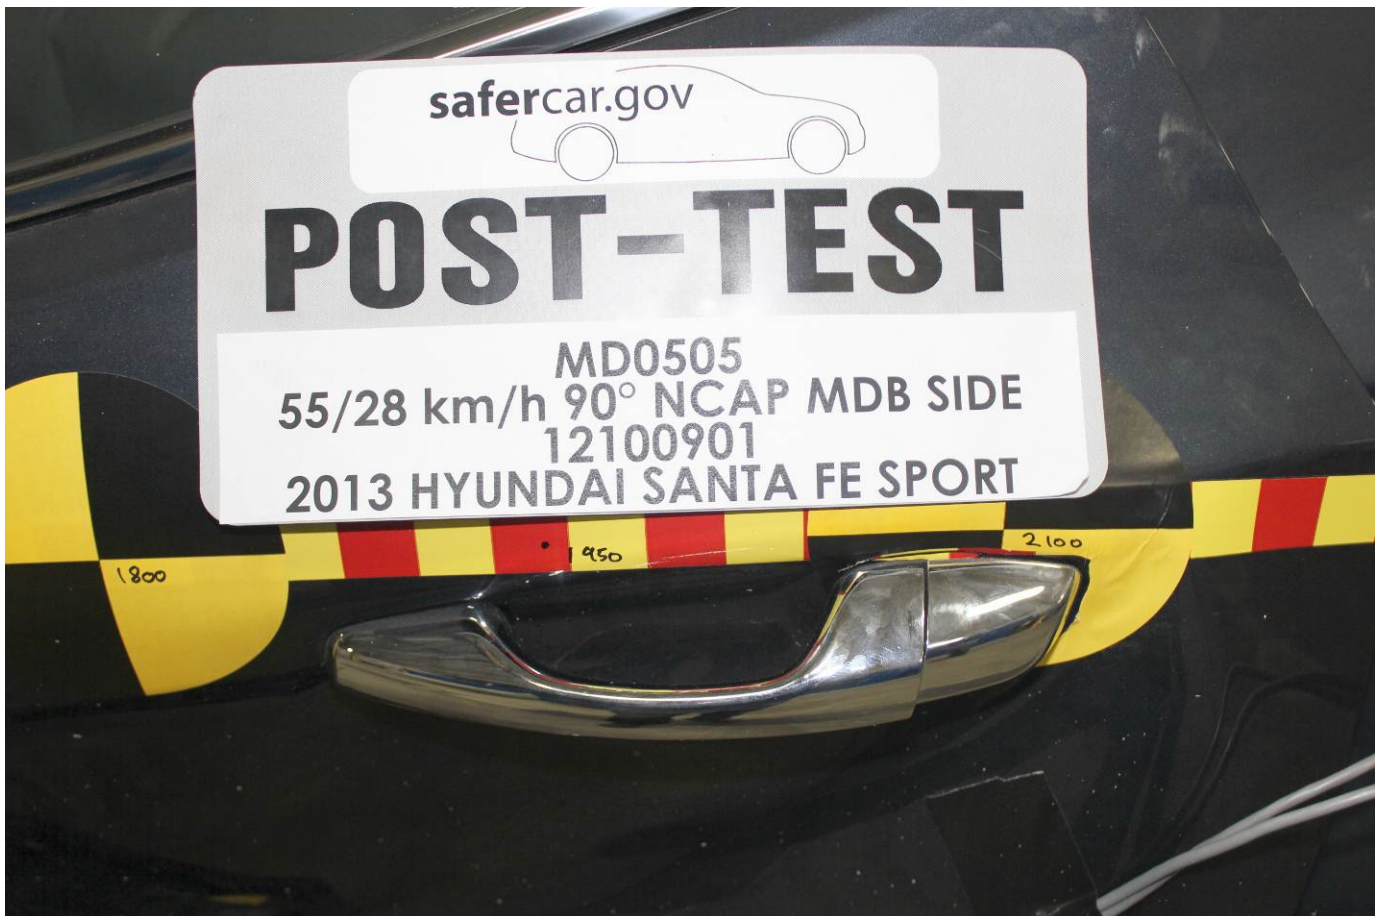
Post-Test Left Rear Door Latch Close-Up

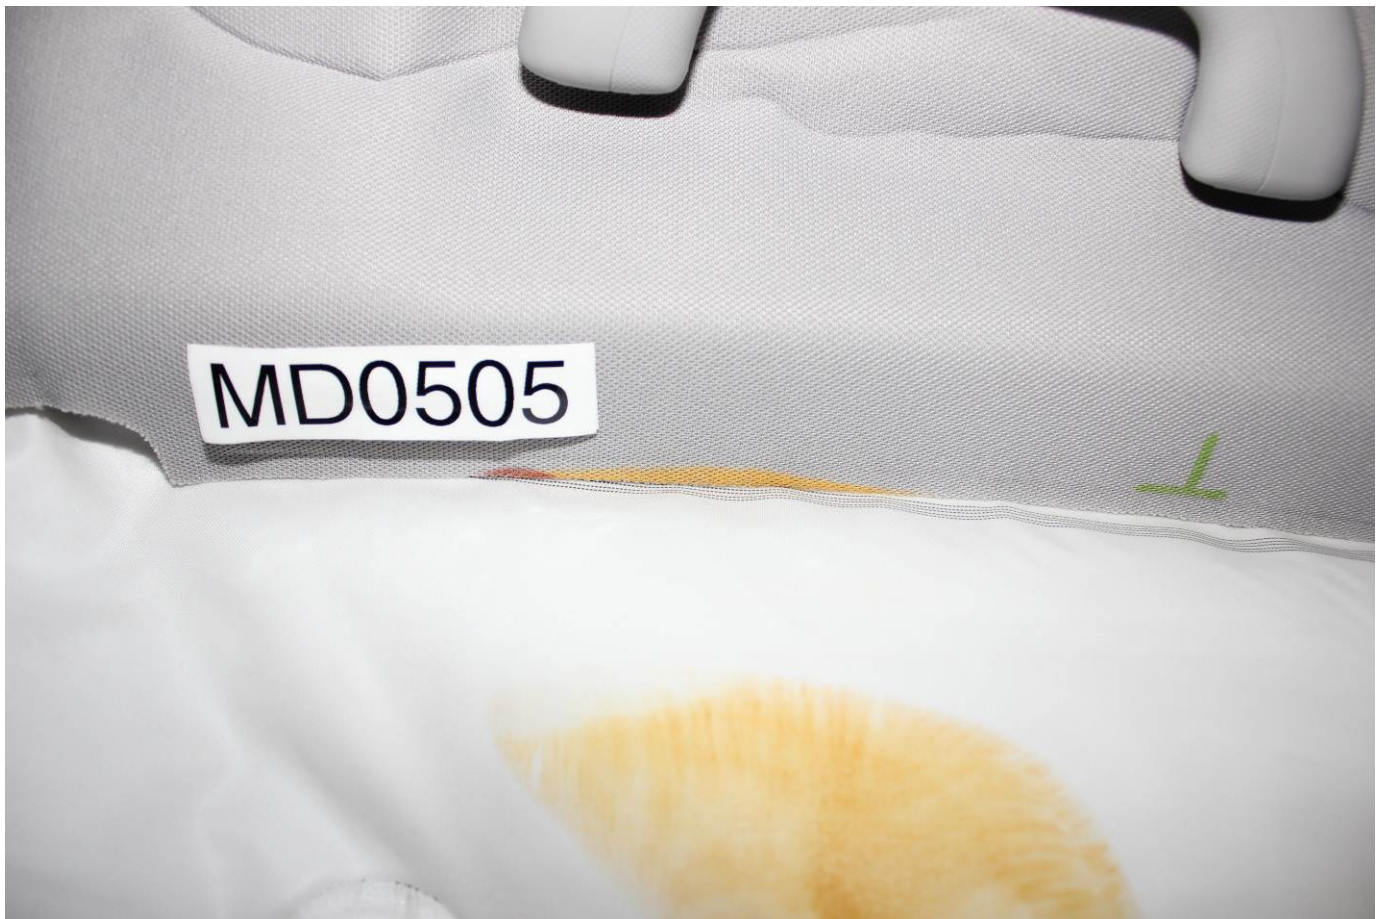
Post-Test Driver Dummy Close-up Head Contact with Vehicle Interior View

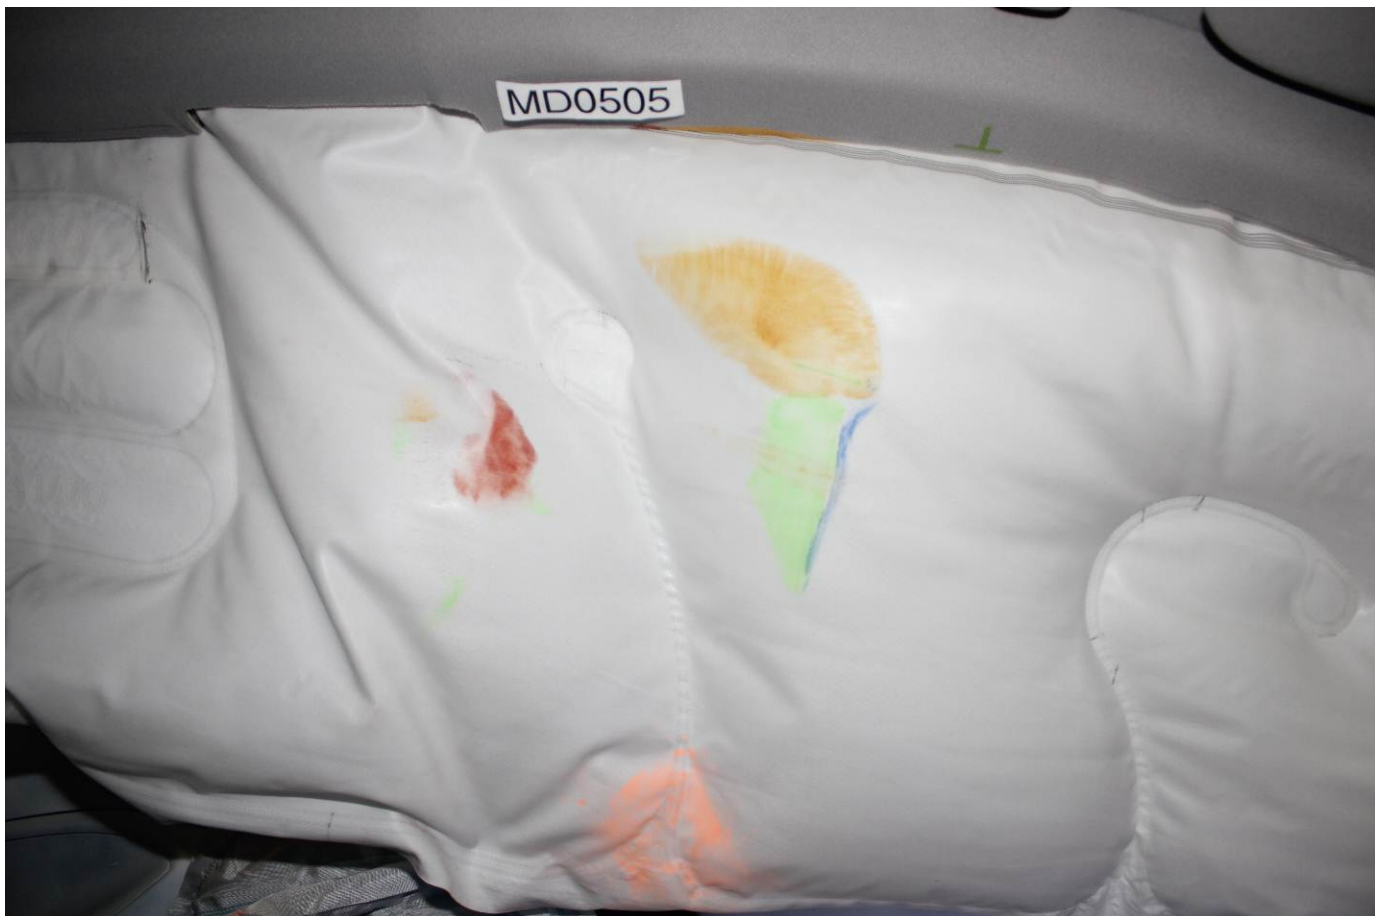
Post-Test Driver Dummy Close-up Head Contact with Side Airbag View

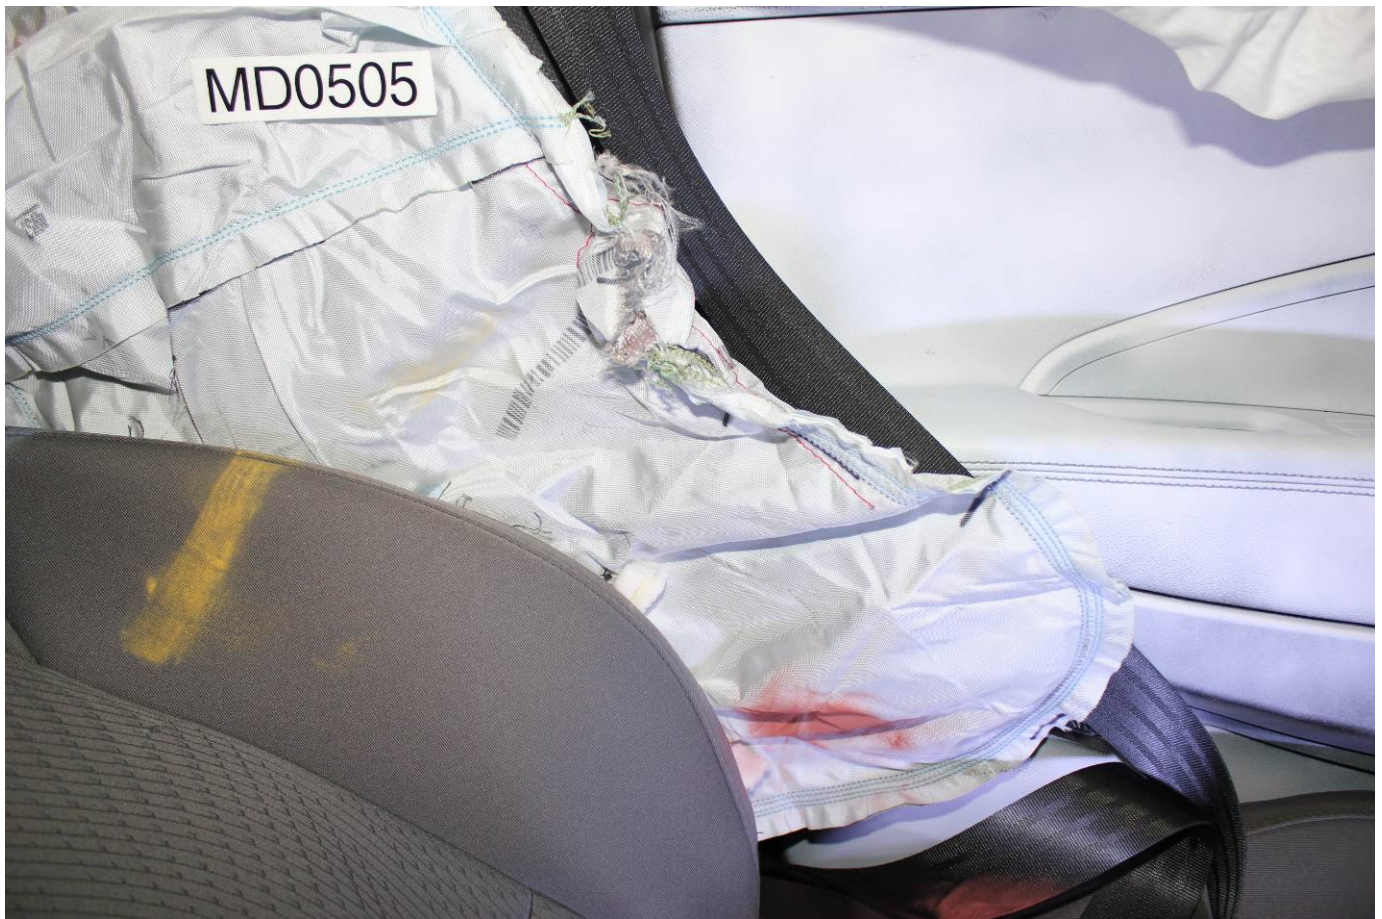
Post-Test Driver Dummy Close-up Torso Contact with Vehicle Interior View

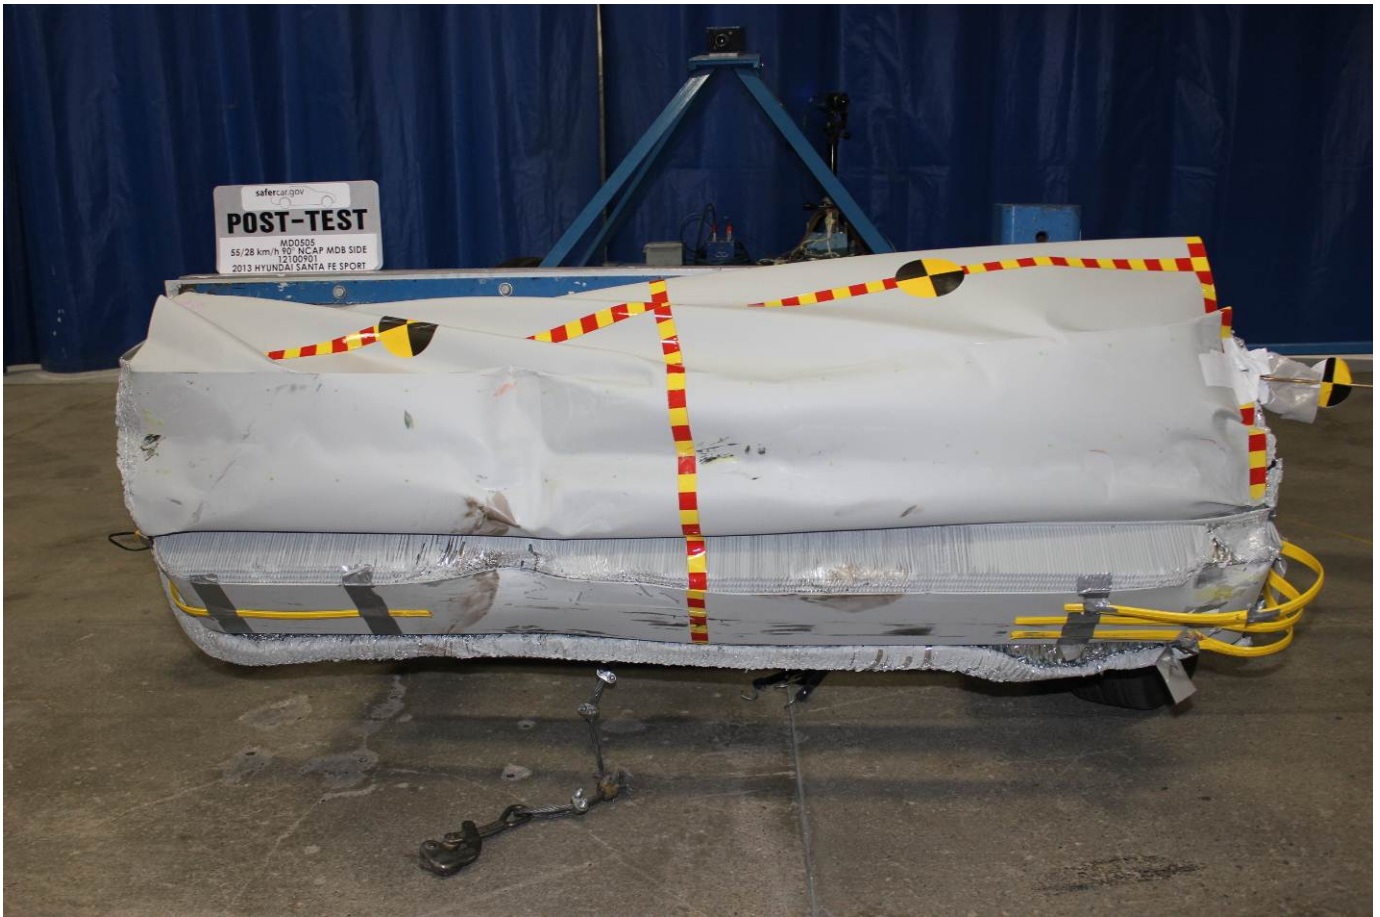
Post-Test Front View of MDB Impactor Face

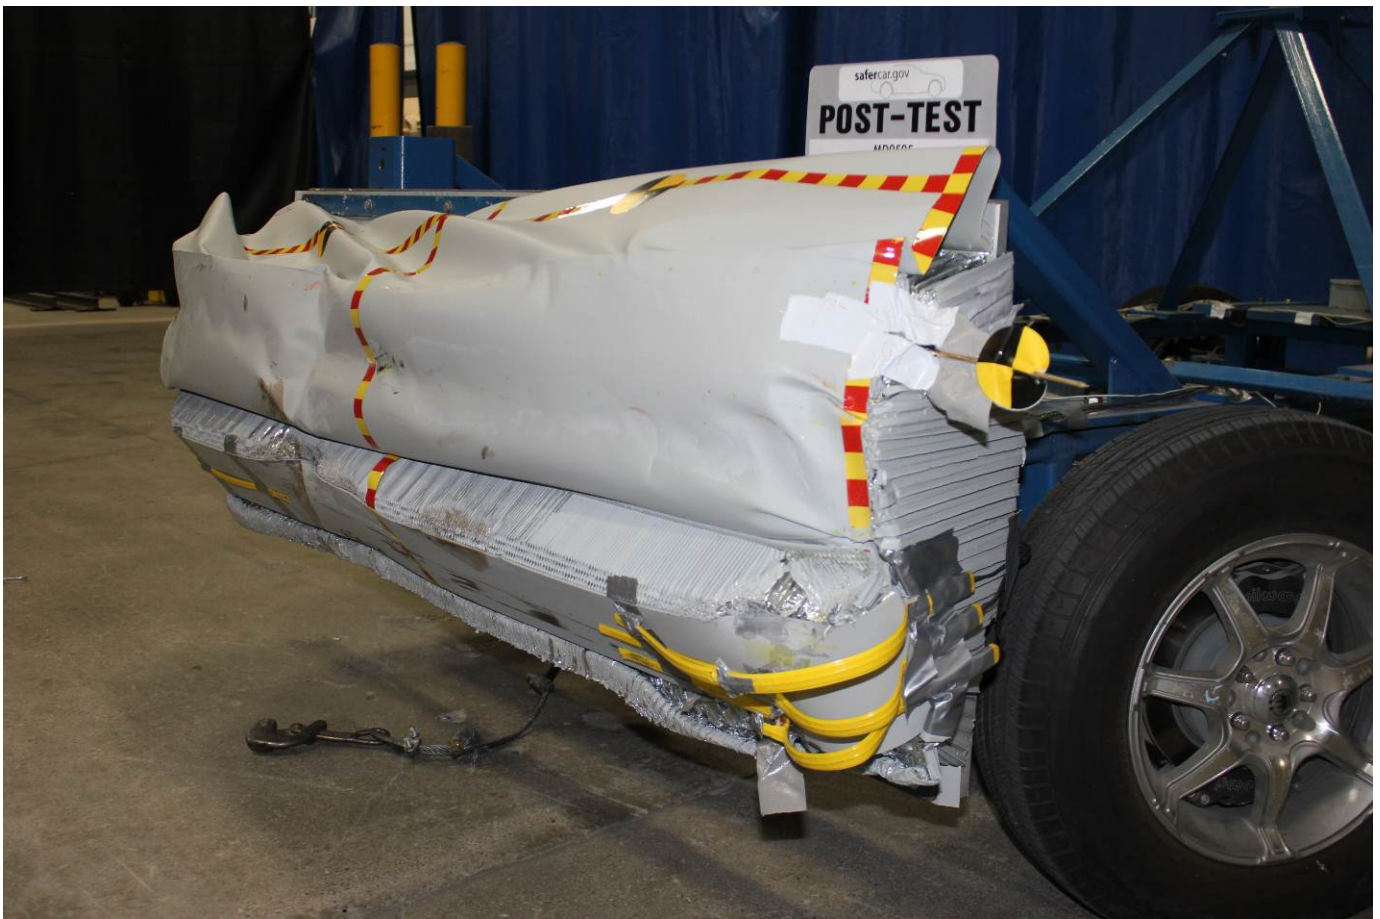
Post-Test Left Side View of MDB Impactor Face

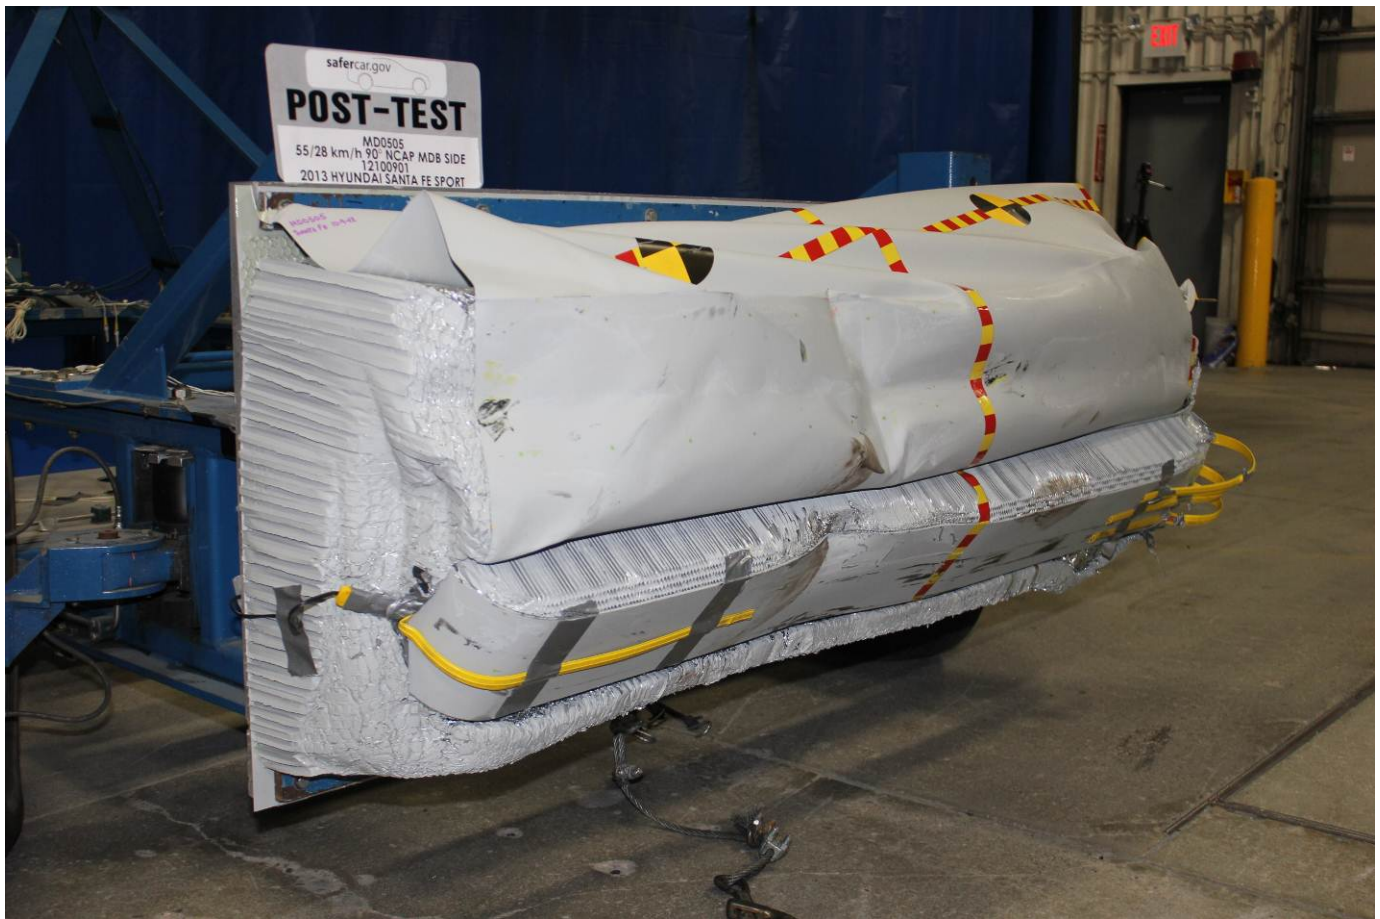
Post-Test Right Side View of MDB Impactor Face

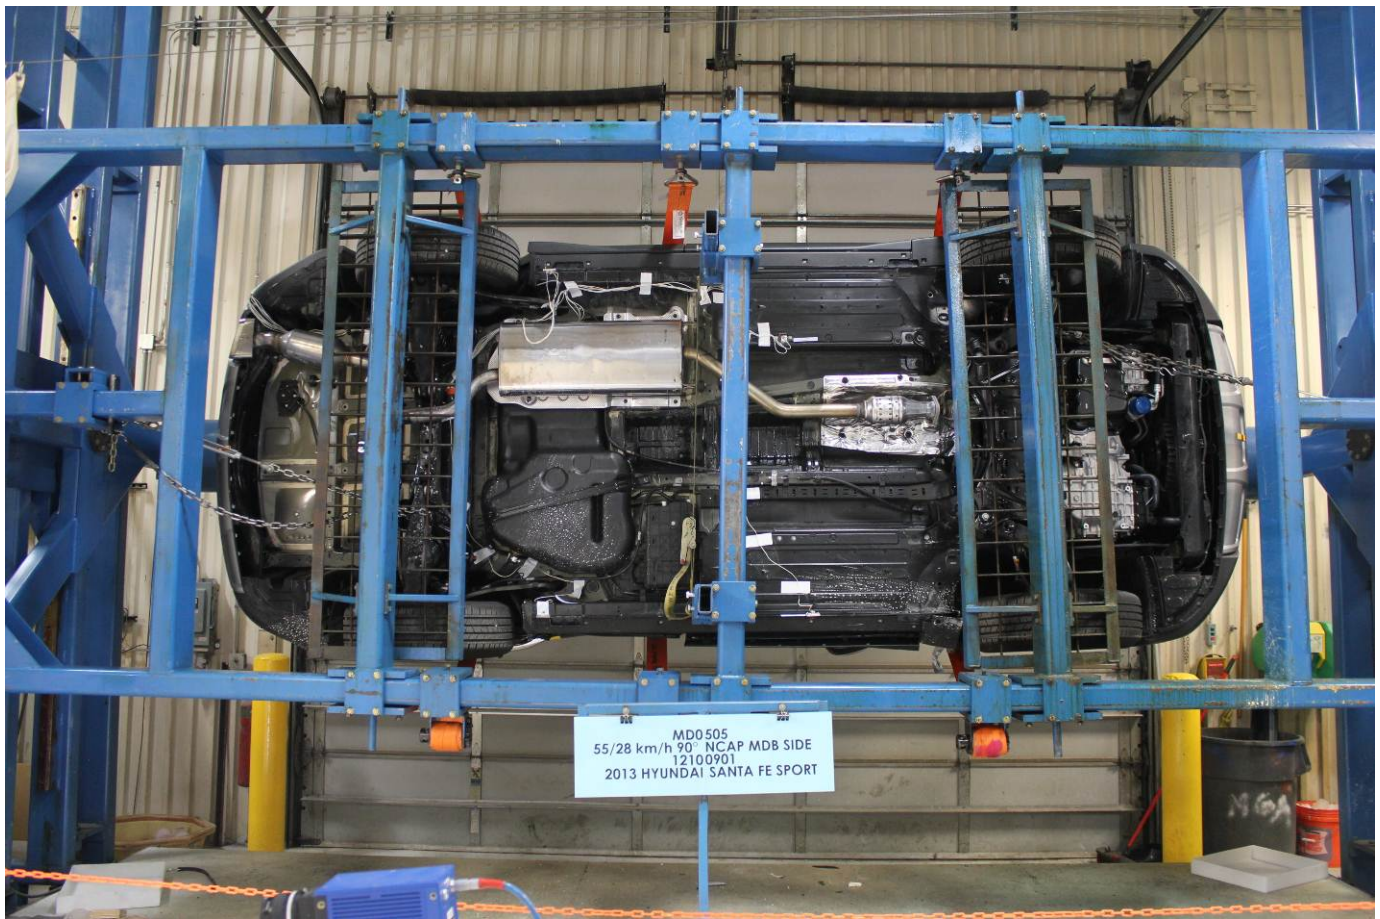
FMVSS No. 301 Static Rollover 90 Degrees

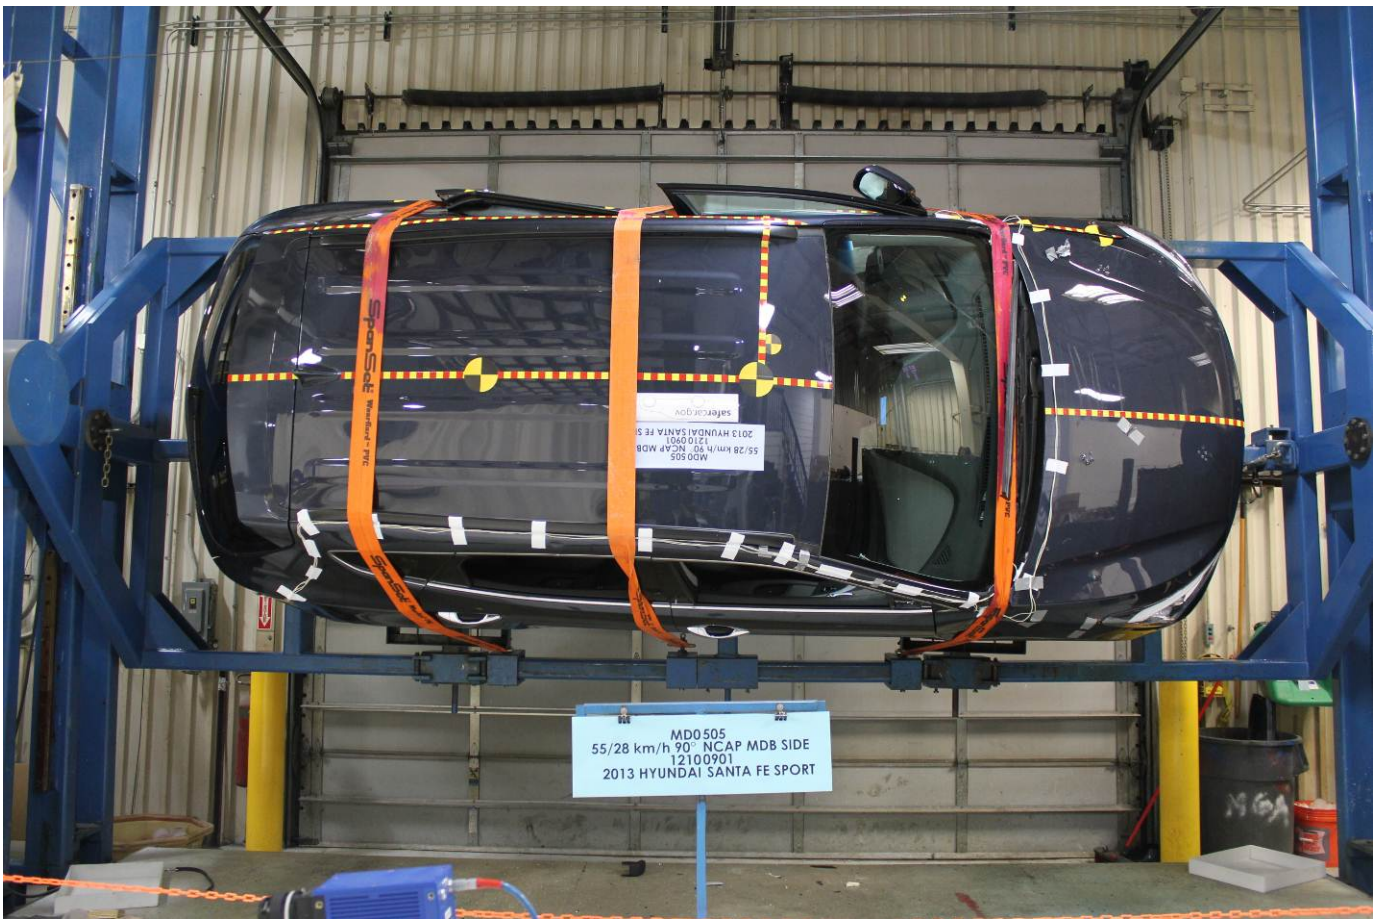
FMVSS No. 301 Static Rollover 270 Degrees
