**REPORT NUMBER: SINCAP-MGA-2013-020**

**NEW CAR ASSESSMENT PROGRAM (NCAP)  
Moving Deformable Barrier Side Impact Test**

**KIA MOTORS MANUFACTURING GEORGIA, INC.  
FOR HYUNDAI MOTOR COMPANY  
2013 Hyundai Santa Fe Sport SUV  
NHTSA No.: MD0505**

**FINAL REPORT**

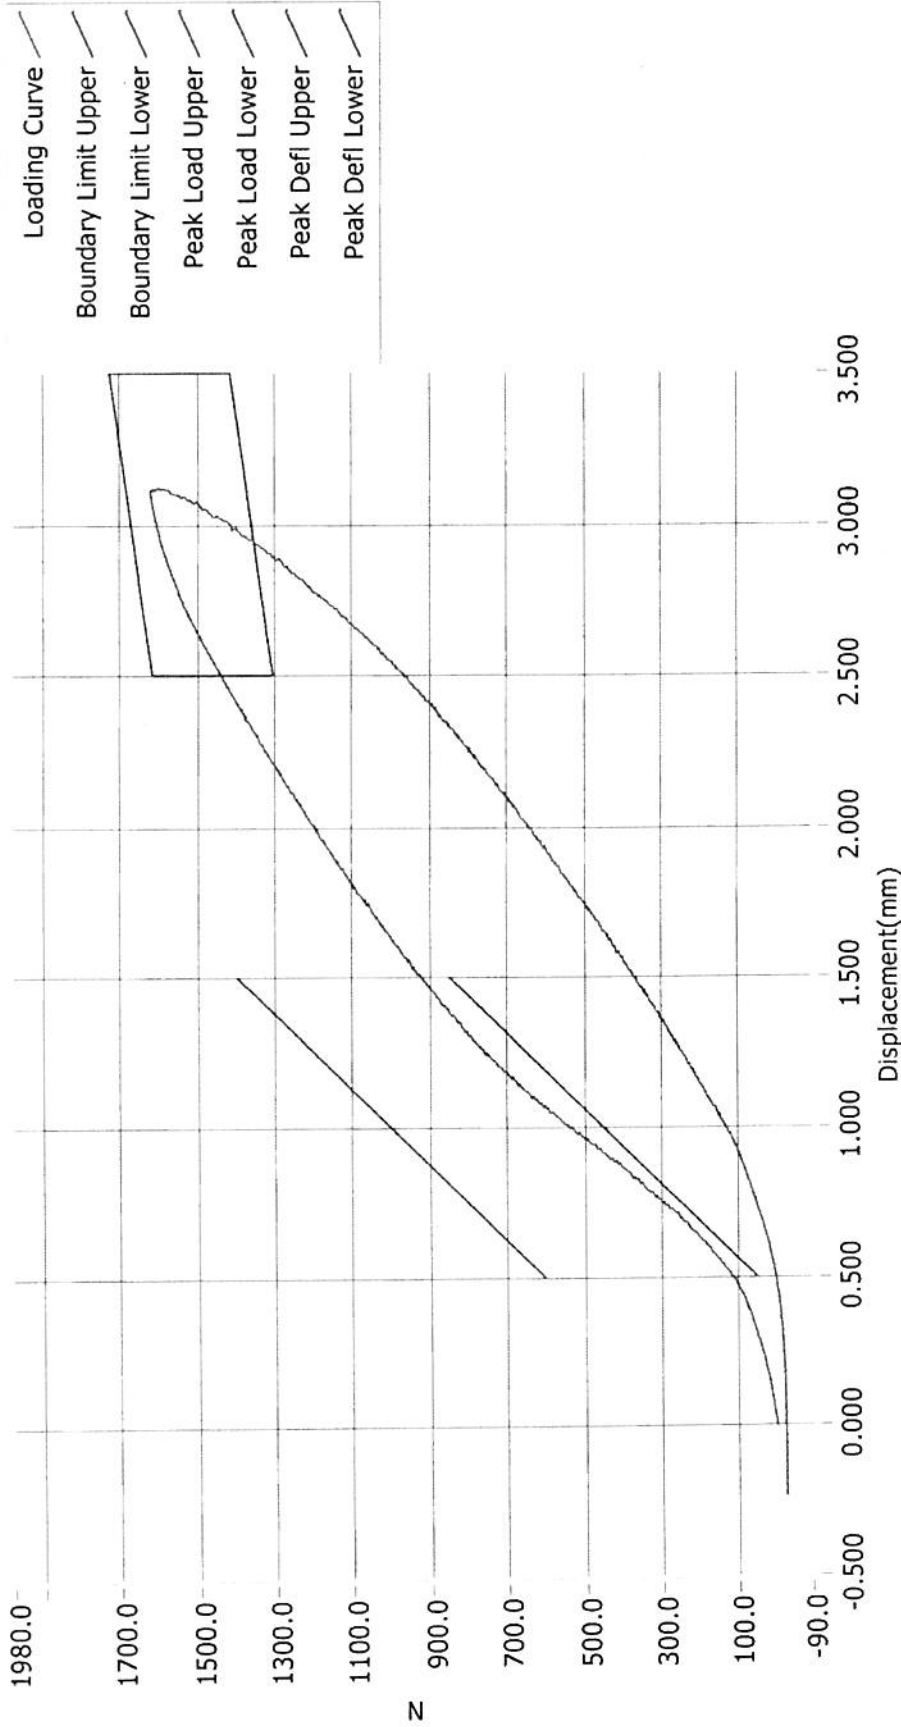
# Resultant Data - SIDIIs Plug Compression

<u>Test ID</u>	<u>Part Serial Number</u>	<u>Test Date</u>	<u>Test Time</u>
	49087	12/7/2011	9:28 PM
<u>Cert ID</u>	<u>ATD Serial Number</u>	<u>ATD Type</u>	
	N/A	SIDIIs

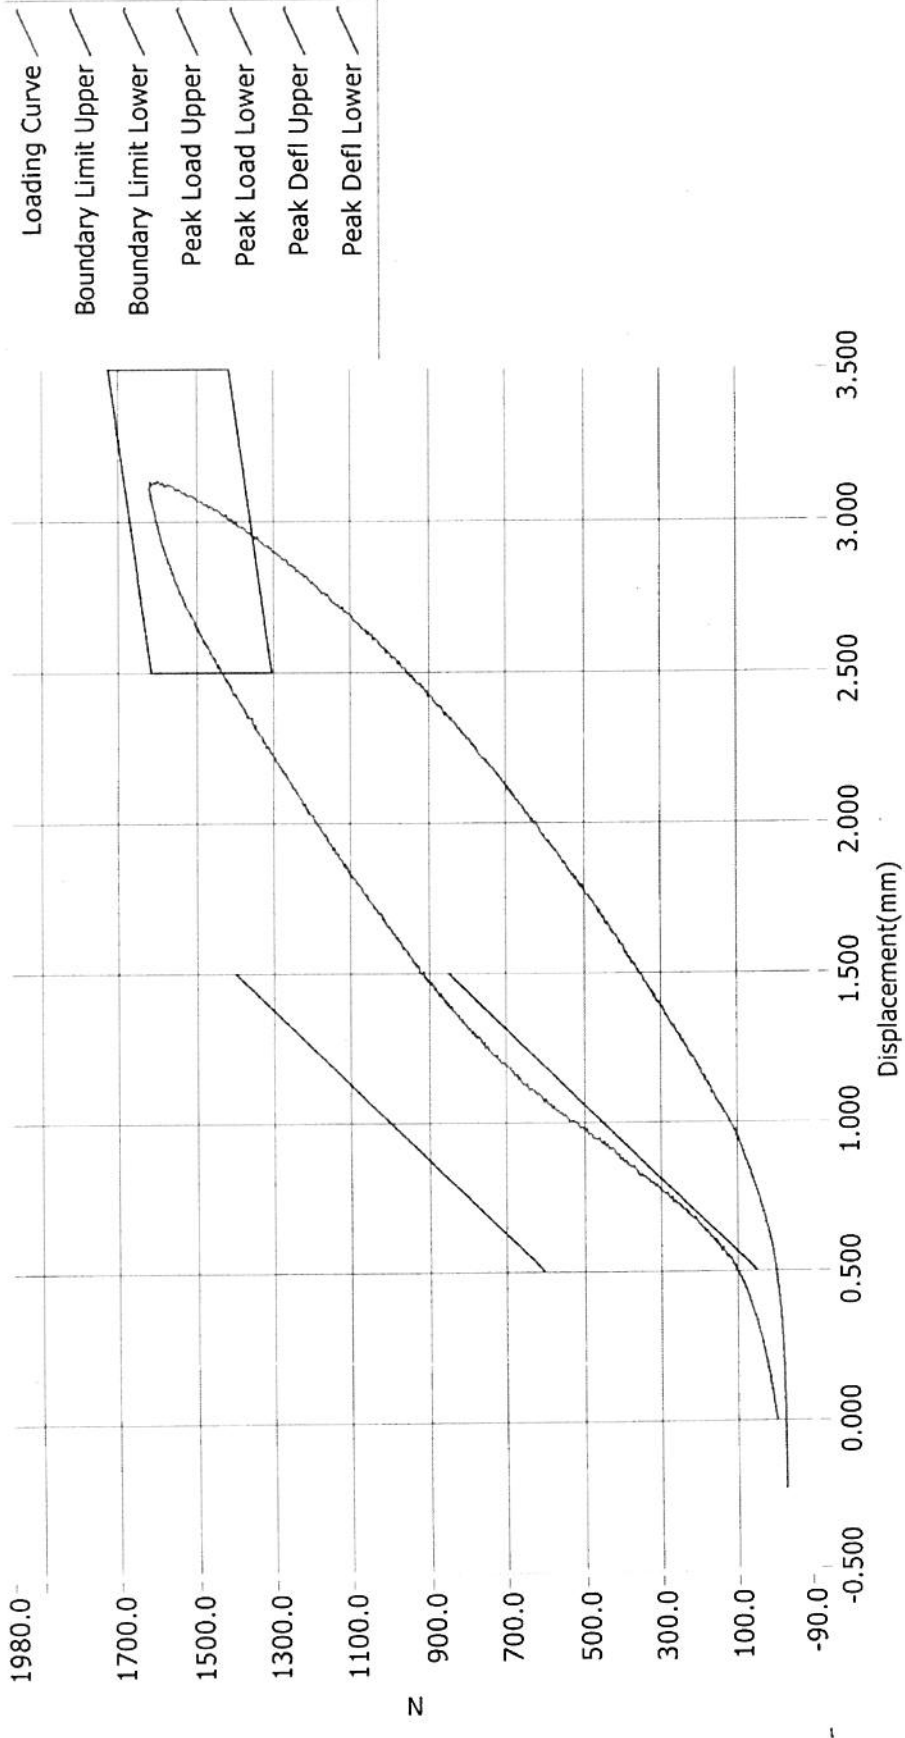
# Resultant Data - SIDIIs Plug Compression

<u>Test ID</u>	<u>Part Serial Number</u>	<u>Test Date</u>	<u>Test Time</u>
	49161	12/8/2011	1:02 AM
<u>Cert ID</u>	<u>ATD Serial Number</u>	<u>ATD Type</u>	
	N/A	SIDIIs
