**REPORT NUMBER: NCAP-MGA-2013-021**

**NEW CAR ASSESSMENT PROGRAM (NCAP)  
Frontal Barrier Impact Test**

**KIA MOTORS MANUFACTURING GEORGIA, INC.  
FOR HYUNDAI MOTOR COMPANY  
2013 Hyundai Santa Fe Sport AWD SUV  
NHTSA No.: MD0503**

**MGA RESEARCH CORPORATION  
5000 Warren Road  
Burlington, WI 53105**

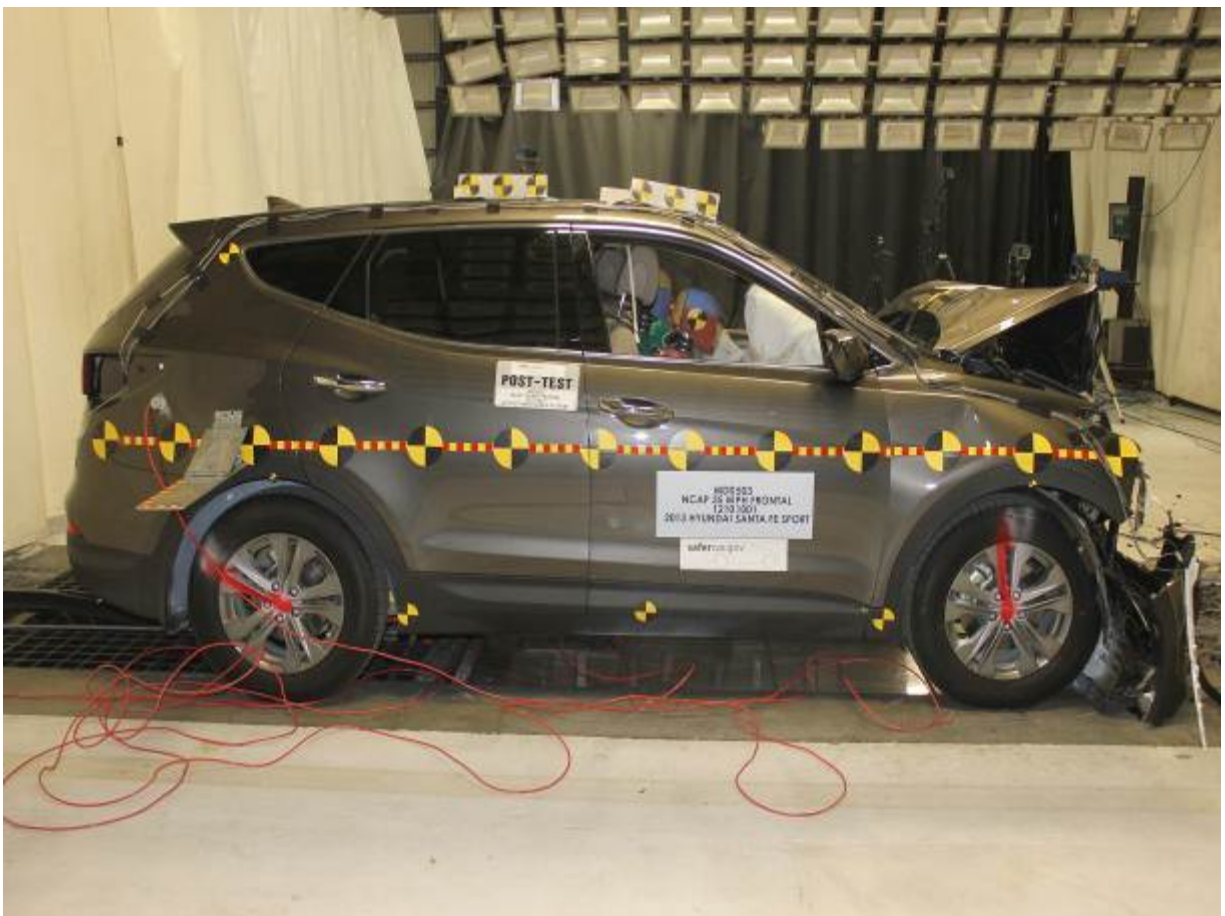
Post-Test Right View of Test Vehicle

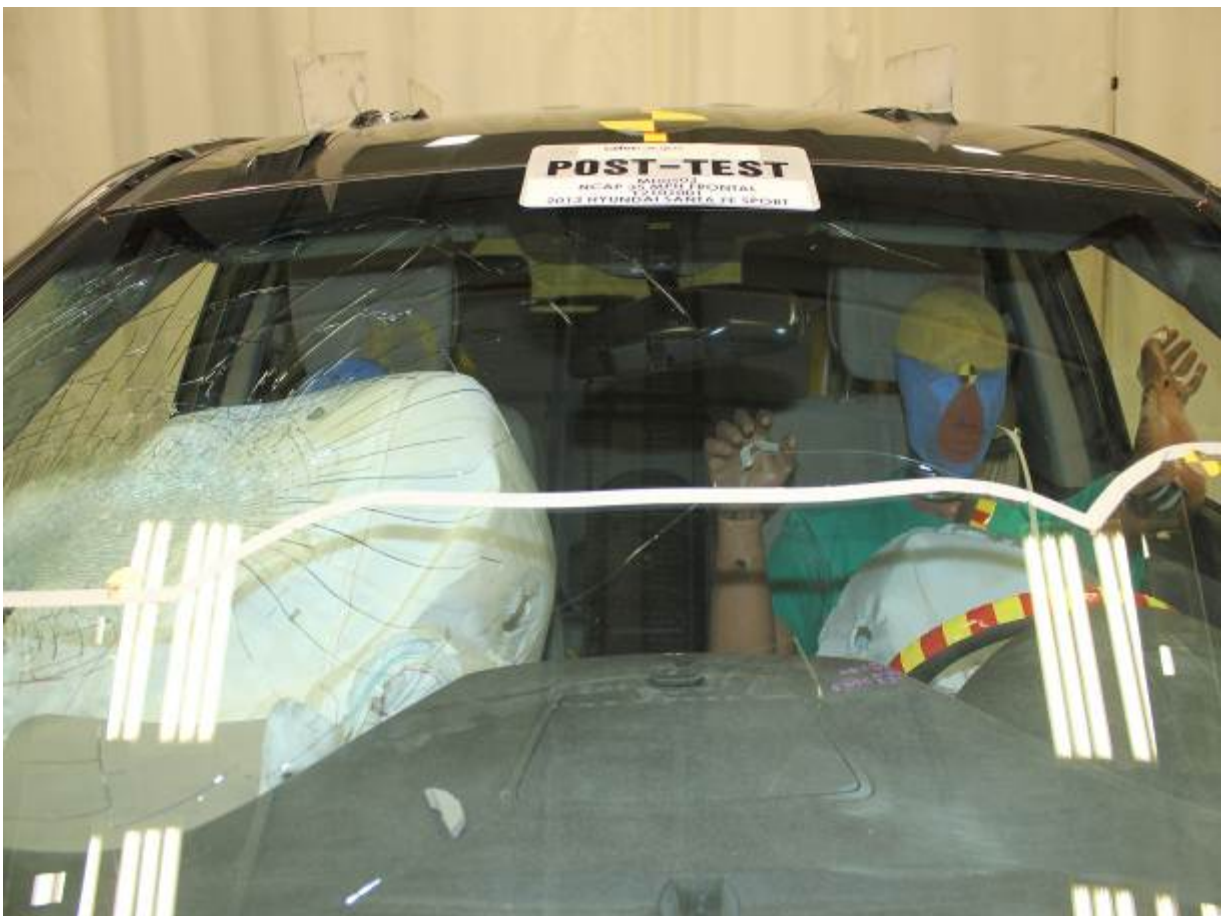
Post-Test Windshield View

There was 100 percent windshield retention and no intrusion into the protected zone of the windshield during the event. There was no Stoddard Solvent leakage after the event or during any phase of the static rollover.

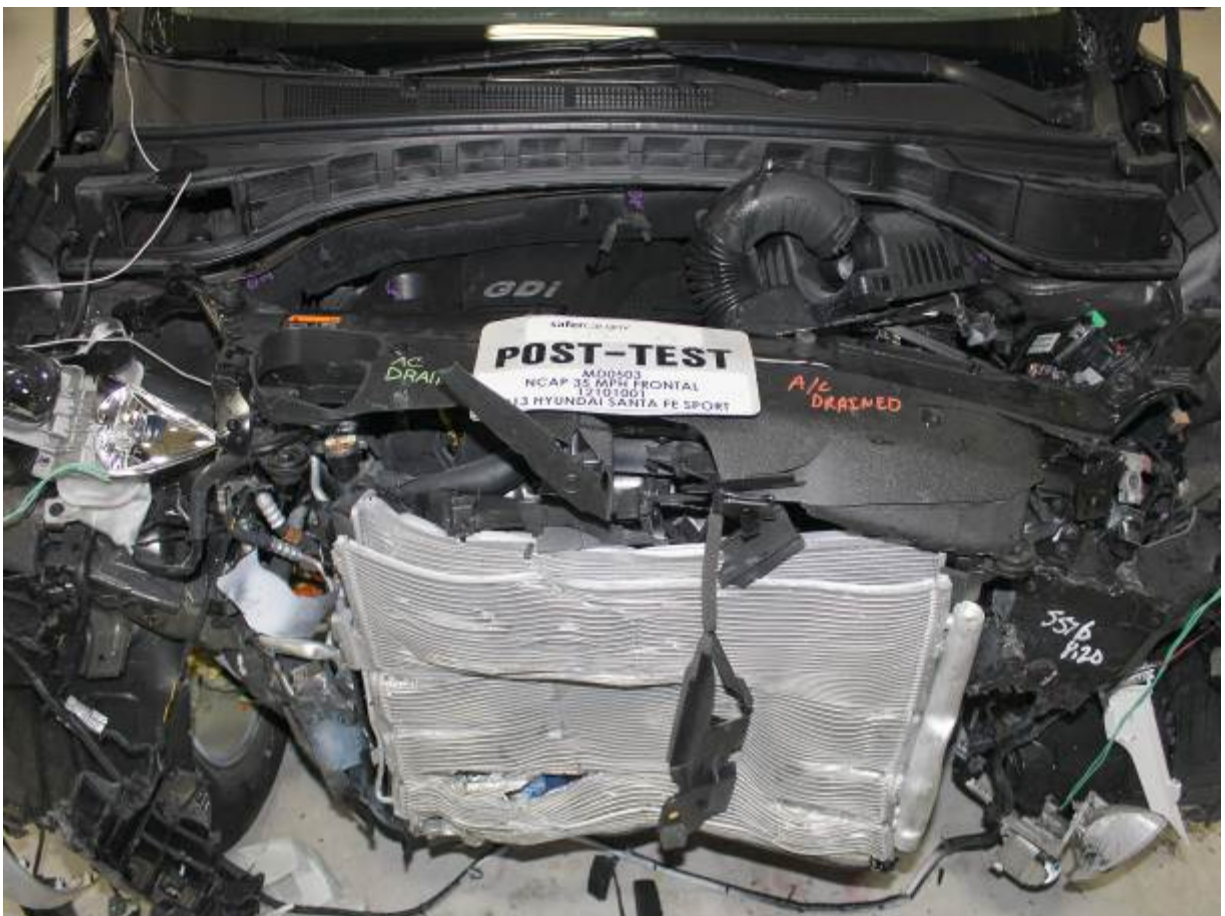
Post-Test Engine Compartment View

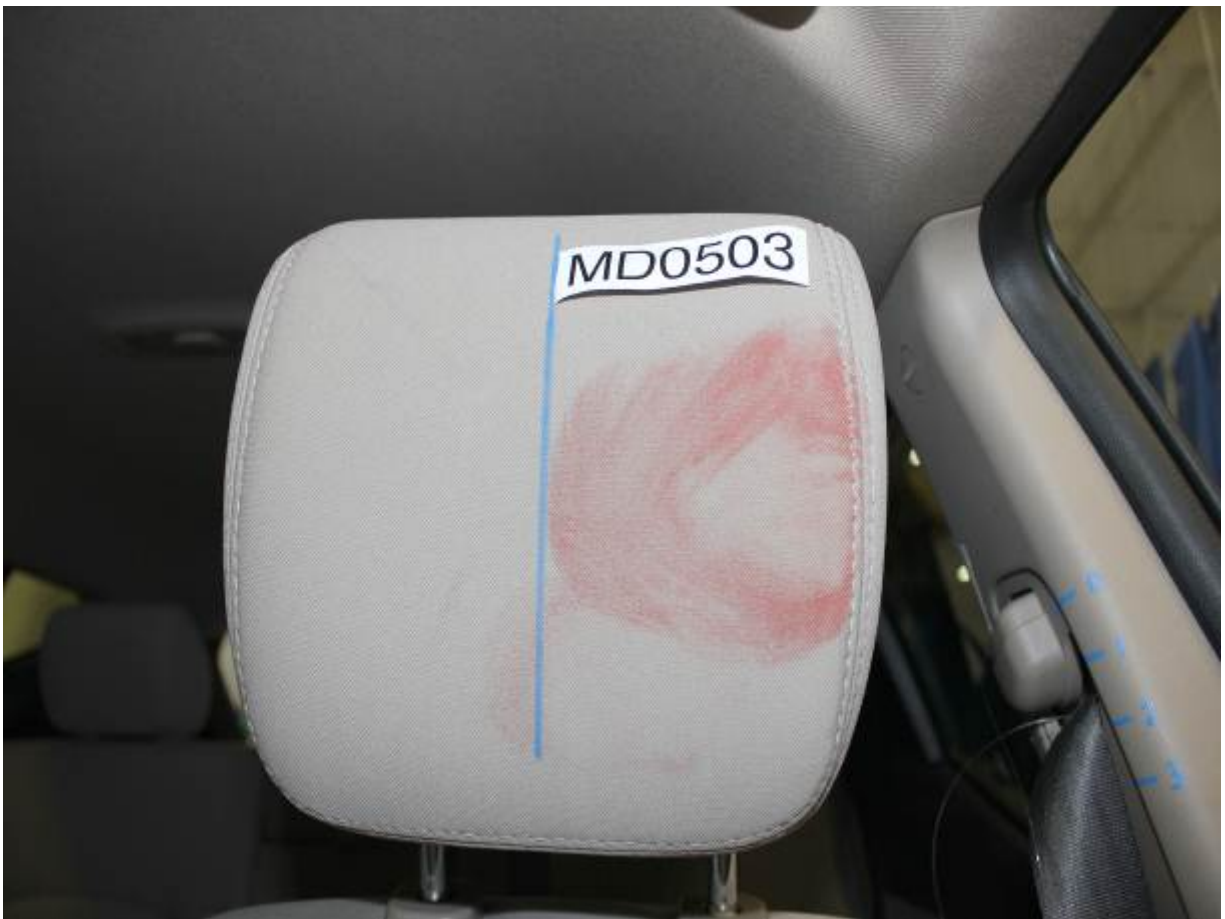
Post-Test Driver Dummy Contact with Headrest

The driver's visible contact points were as follows: The driver's head and chest contacted the airbag. The driver's head also contacted the headrest. The driver's knees contacted the knee airbag and knee bolster. The passenger's visible contact points were as follows: The passenger's head and chest contacted the airbag. The passenger's head also contacted the headrest. The passenger's knees contacted the glove box.

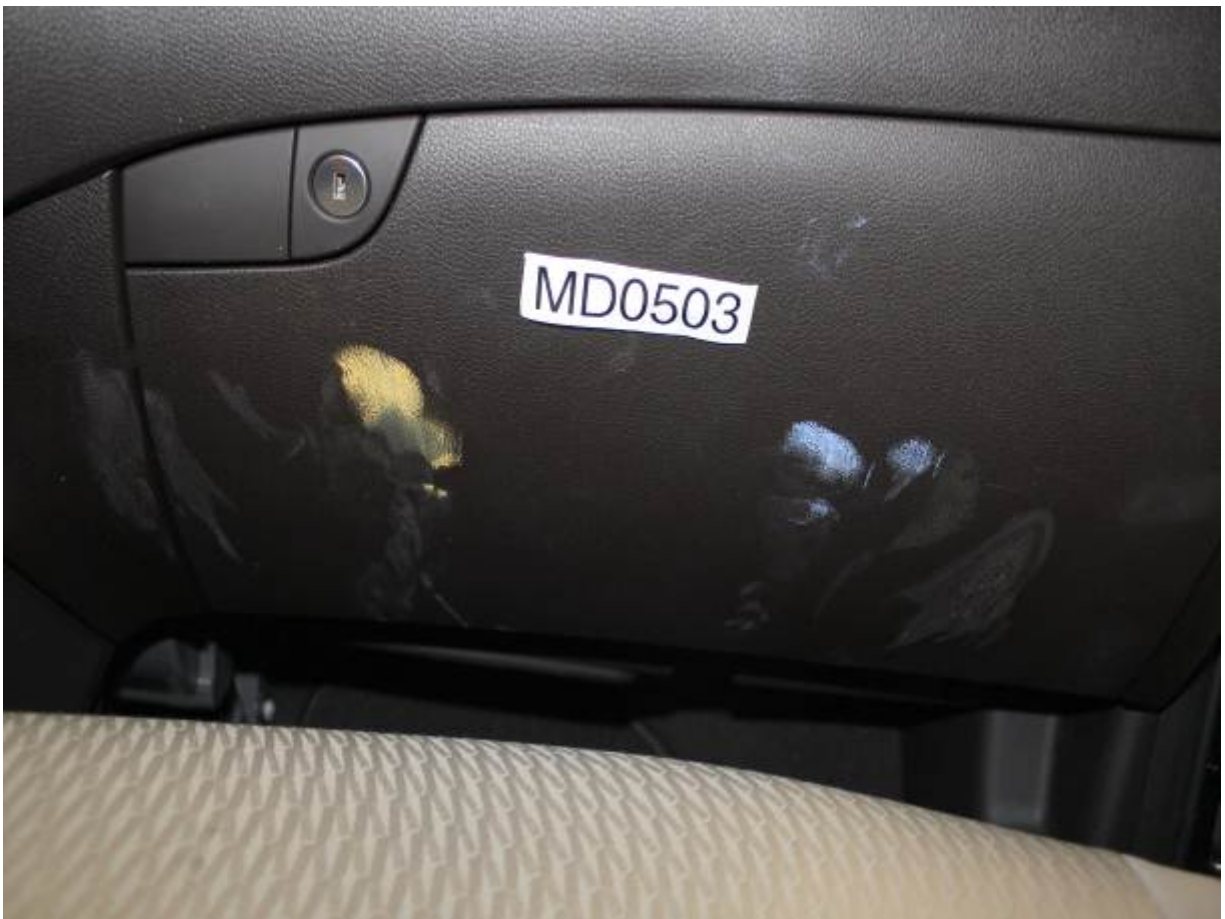
Post-Test Passenger Dummy Contact with Glove Box

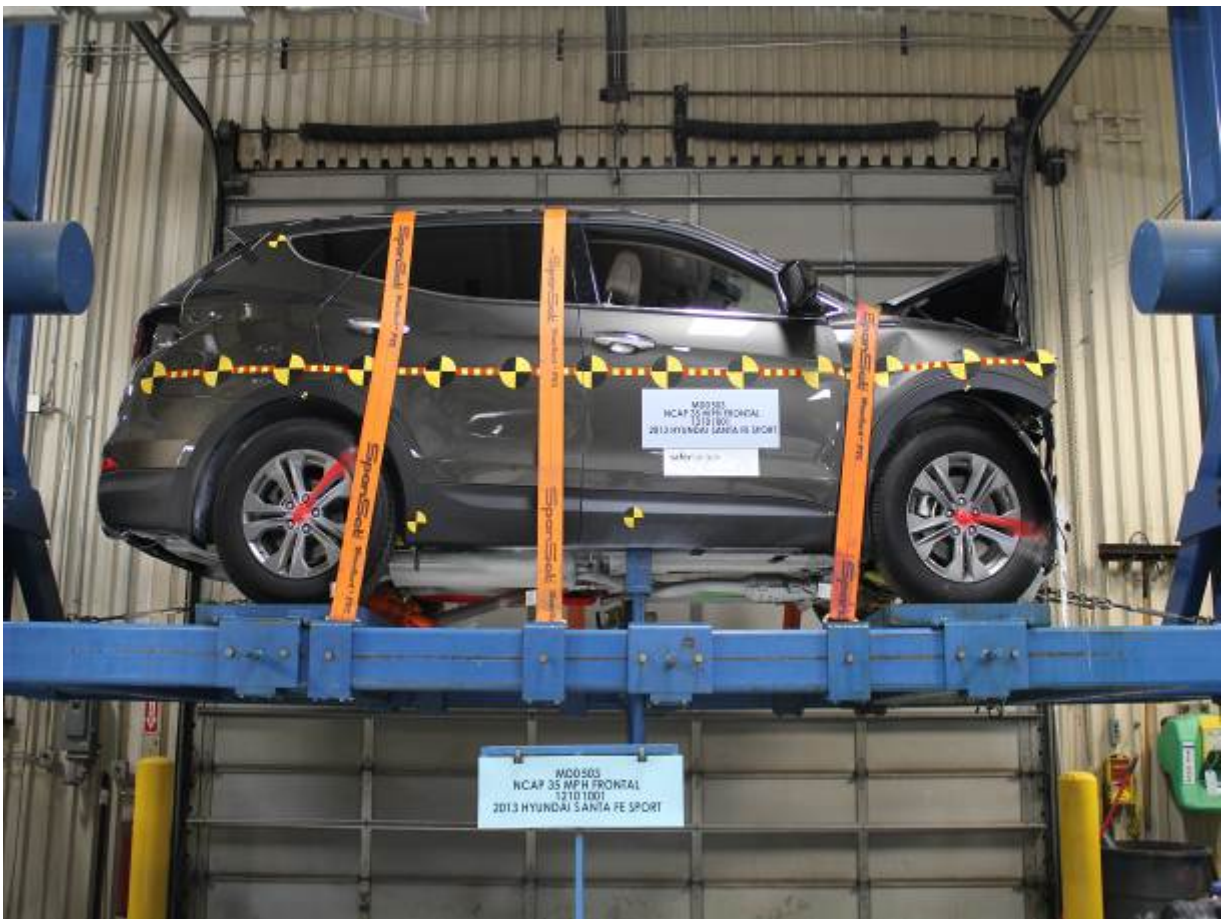
Vehicle at 0° on Static Rollover Device

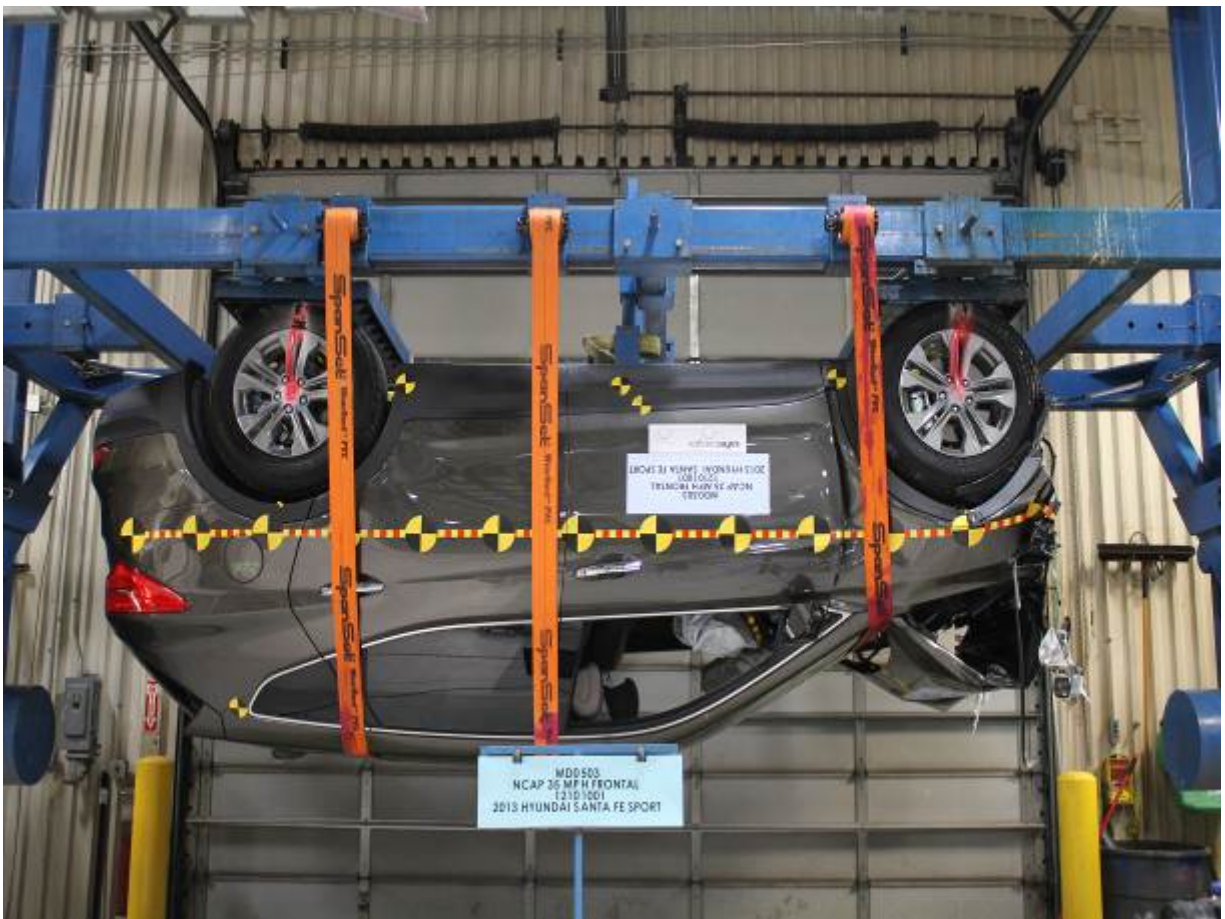
Vehicle at 180° on Static Rollover Device

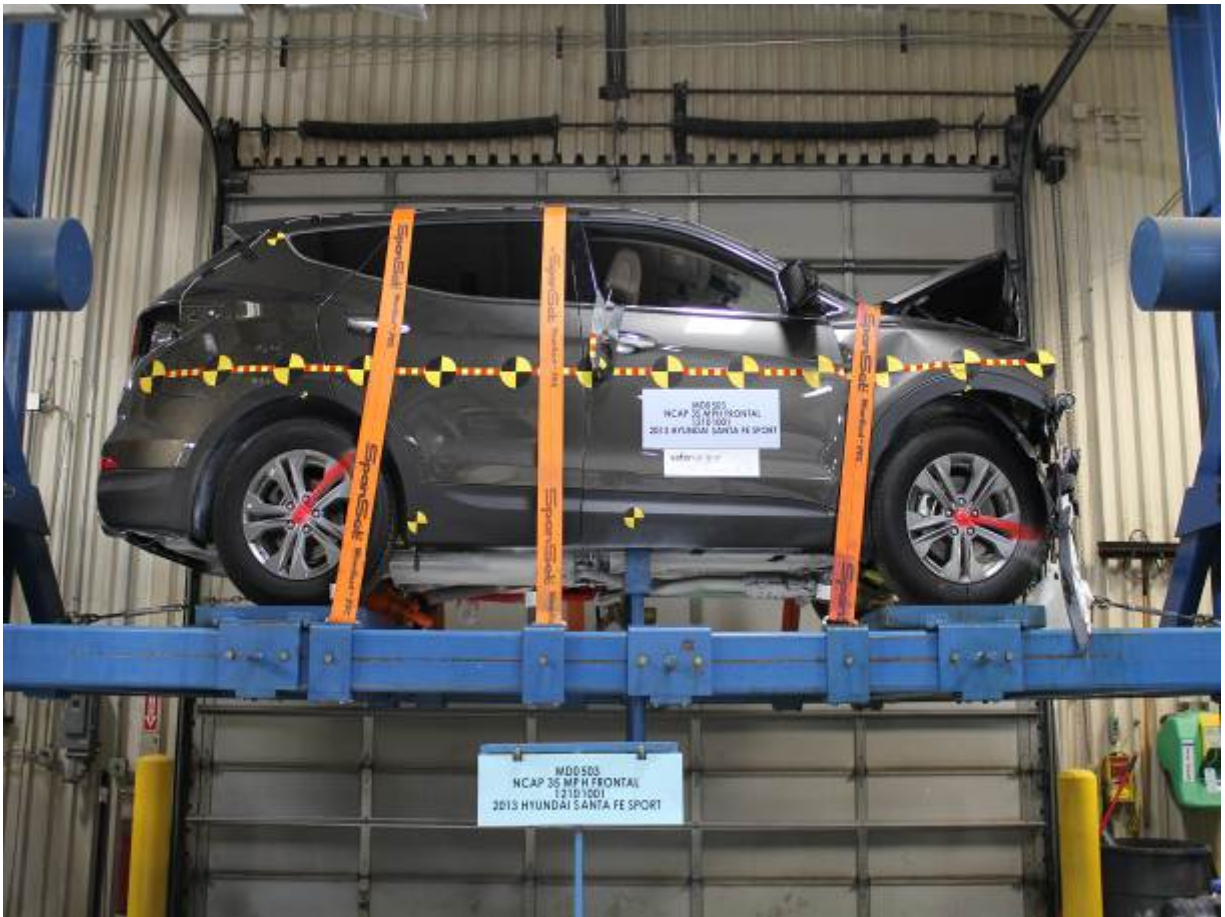
Vehicle at 360° on Static Rollover Device
