REPORT NUMBER: SINCAP-CAL-12-007

**NEW CAR ASSESSMENT PROGRAM (NCAP)
MOVING DEFORMABLE BARRIER SIDE IMPACT TEST**

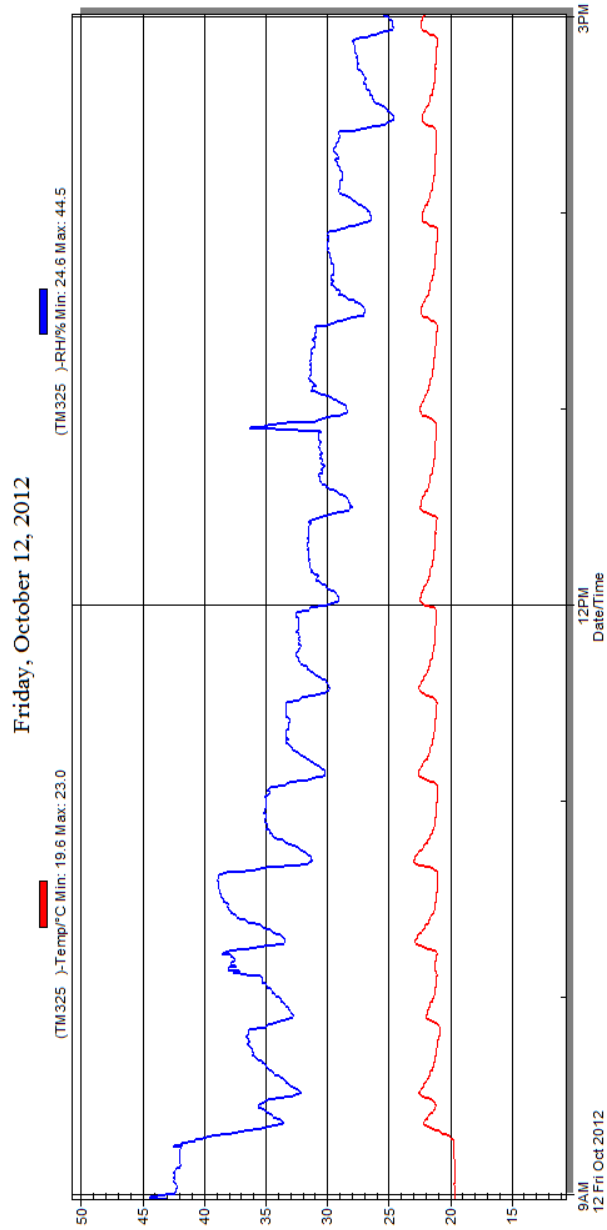
Temperature and Humidity Stabilization Chart/Data for Dummies and Test Vehicle

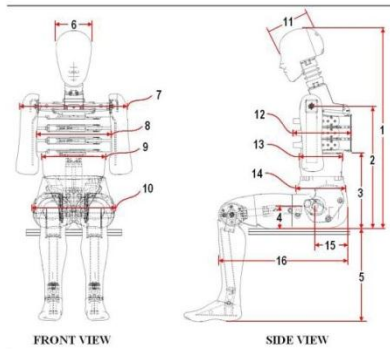
Dim. No.	Description	Specification (mm)	Result (mm)	Pass/Fail
1	Sitting Height	900-918	913	Pass
2	Seat to Shoulder Joint	558-572	562	Pass
3	Seat to Lower Face of Thoracic Spine Box	346-356	355	Pass
4	Seat to Hip Joint (center of bolt)	97-103	100	Pass
5	Sole to Seat, Sitting	433-451	445	Pass
6	Head Width	152-158	155	Pass
7	Shoulder/Arm Width	461-479	468	Pass
8	Thorax Width	322-332	327	Pass
9	Abdomen Width	273-287	284	Pass
10	Pelvis Lap Width	359-373	371	Pass
11	Head Depth	196-206	201	Pass
12	Thorax Depth	262-272	269	Pass
13	Abdomen Depth	194-204	200	Pass
14	Pelvis Depth	235-245	238	Pass
15	Back of Buttocks to Hip Joint (center of bolt)	150-160	156	Pass
16	Back of Buttocks to Front Knee	597-615	607	Pass

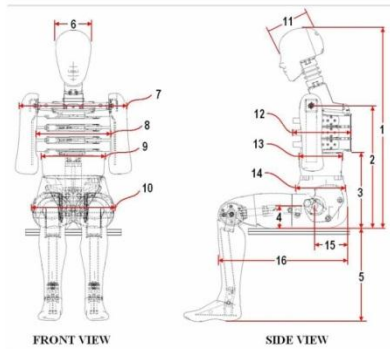
Dim. No.	Description	Specification (mm)	Result (mm)	Pass/Fail
1	Sitting Height	900-918	913	Pass
2	Seat to Shoulder Joint	558-572	562	Pass
3	Seat to Lower Face of Thoracic Spine Box	346-356	355	Pass
4	Seat to Hip Joint (center of bolt)	97-103	100	Pass
5	Sole to Seat, Sitting	433-451	440	Pass
6	Head Width	152-158	156	Pass
7	Shoulder/Arm Width	461-479	467	Pass
8	Thorax Width	322-332	327	Pass
9	Abdomen Width	273-287	284	Pass
10	Pelvis Lap Width	359-373	371	Pass
11	Head Depth	196-206	201	Pass
12	Thorax Depth	262-272	269	Pass
13	Abdomen Depth	194-204	199	Pass
14	Pelvis Depth	235-245	238	Pass
15	Back of Buttocks to Hip Joint (center of bolt)	150-160	156	Pass
16	Back of Buttocks to Front Knee	597-615	607	Pass
