**REPORT NUMBER: NCAP-MGA-2013-023**

**NEW CAR ASSESSMENT PROGRAM (NCAP)  
Frontal Barrier Impact Test**

**HONDA MFG. OF INDIANA, LLC  
2013 Acura ILX 4-Dr Sedan  
NHTSA No.: HD5300**

**MGA RESEARCH CORPORATION  
5000 Warren Road  
Burlington, WI 53105**

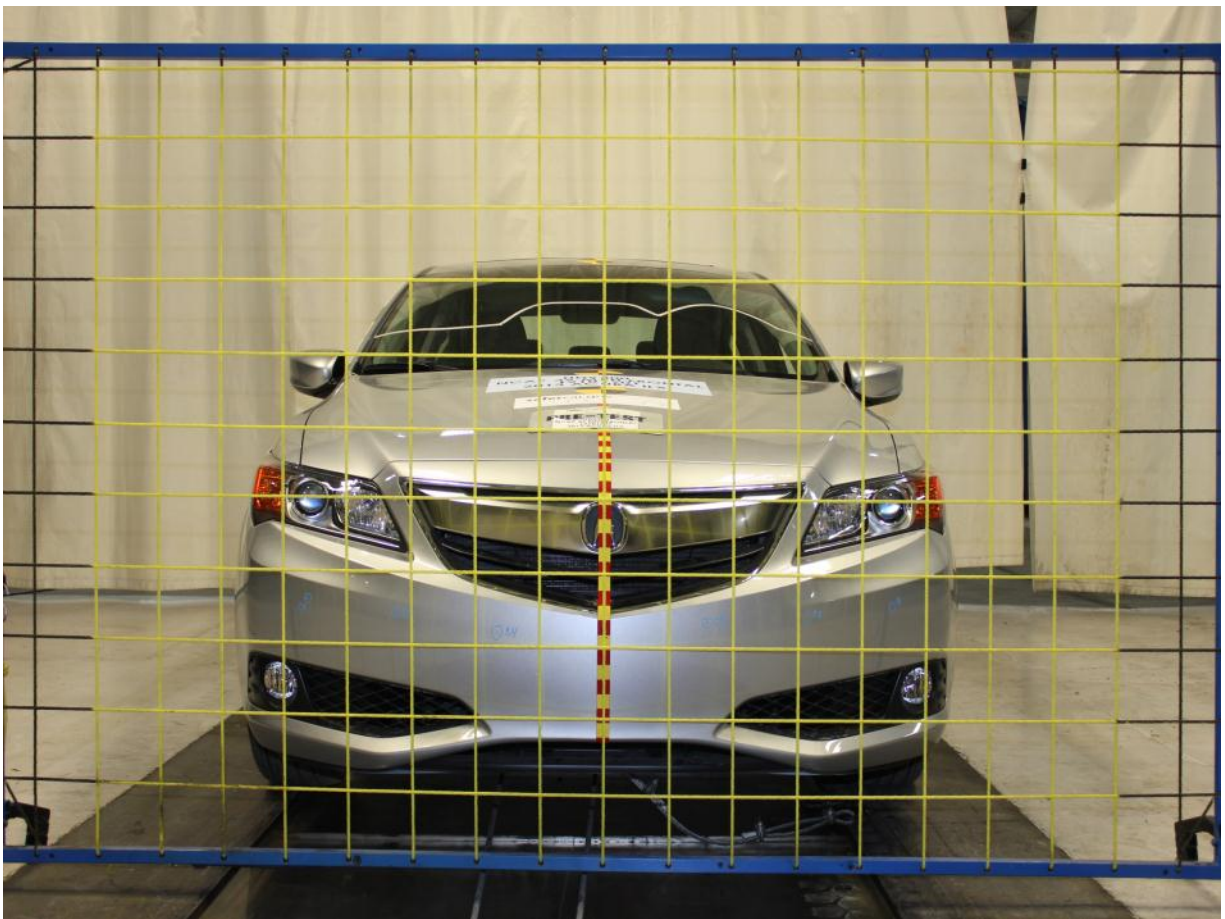
Load Cell Location

A load cell barrier consisting of 176 load cells was impacted by a 2013 Acura ILX 4-Dr Sedan at a velocity of 56.4 km/h. The test was performed at MGA Research Corporation on October 17, 2012. Pre-and post-test photographs of the vehicle and dummies can be found in Appendix A.

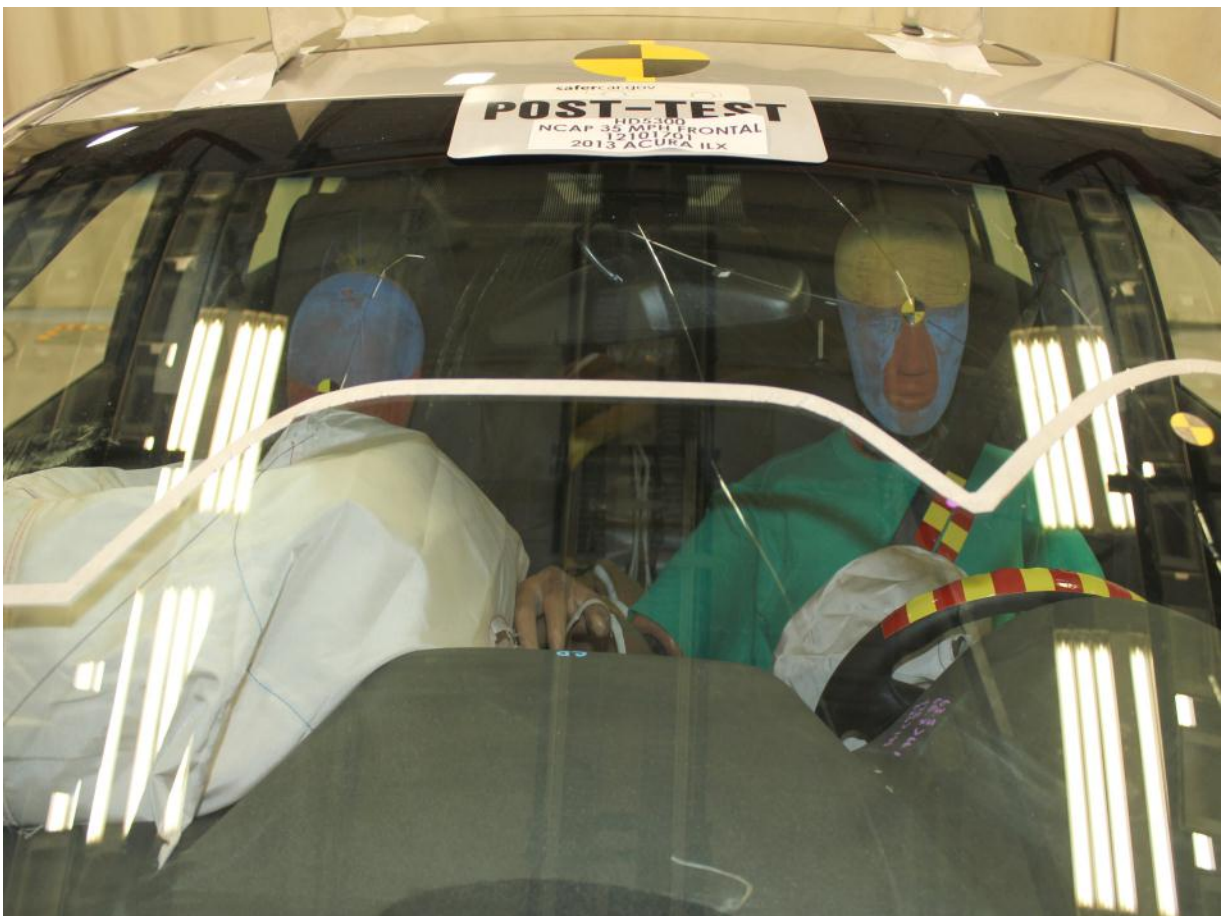
Post-Test Windshield View

There was 100 percent windshield retention and no intrusion into the protected zone of the windshield during the event. There was no Stoddard Solvent leakage after the event or during any phase of the static rollover.

| Critical Areas of Performance | Observations and Conclusions |
|---|---|
| Windshield Damage | Cracked |

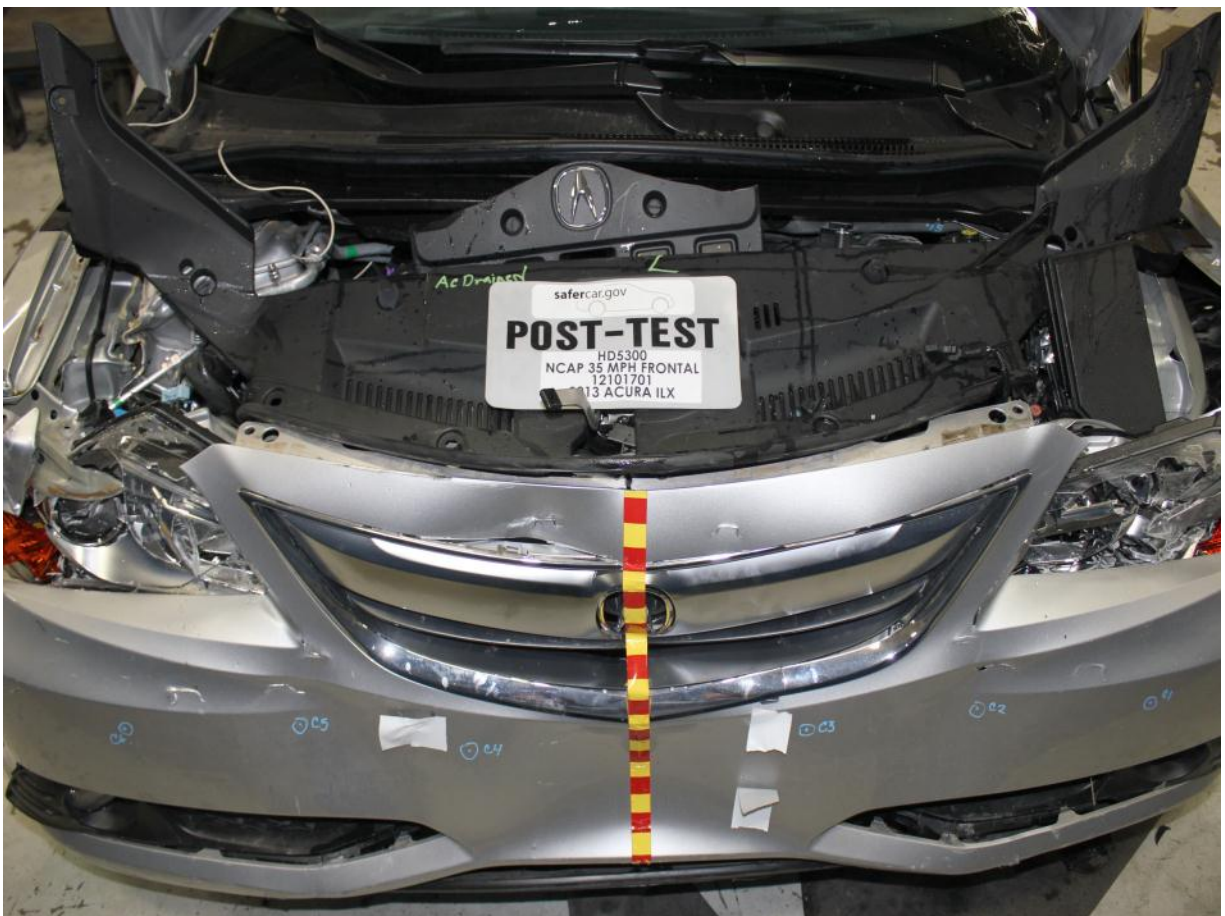
Post-Test Engine Compartment View

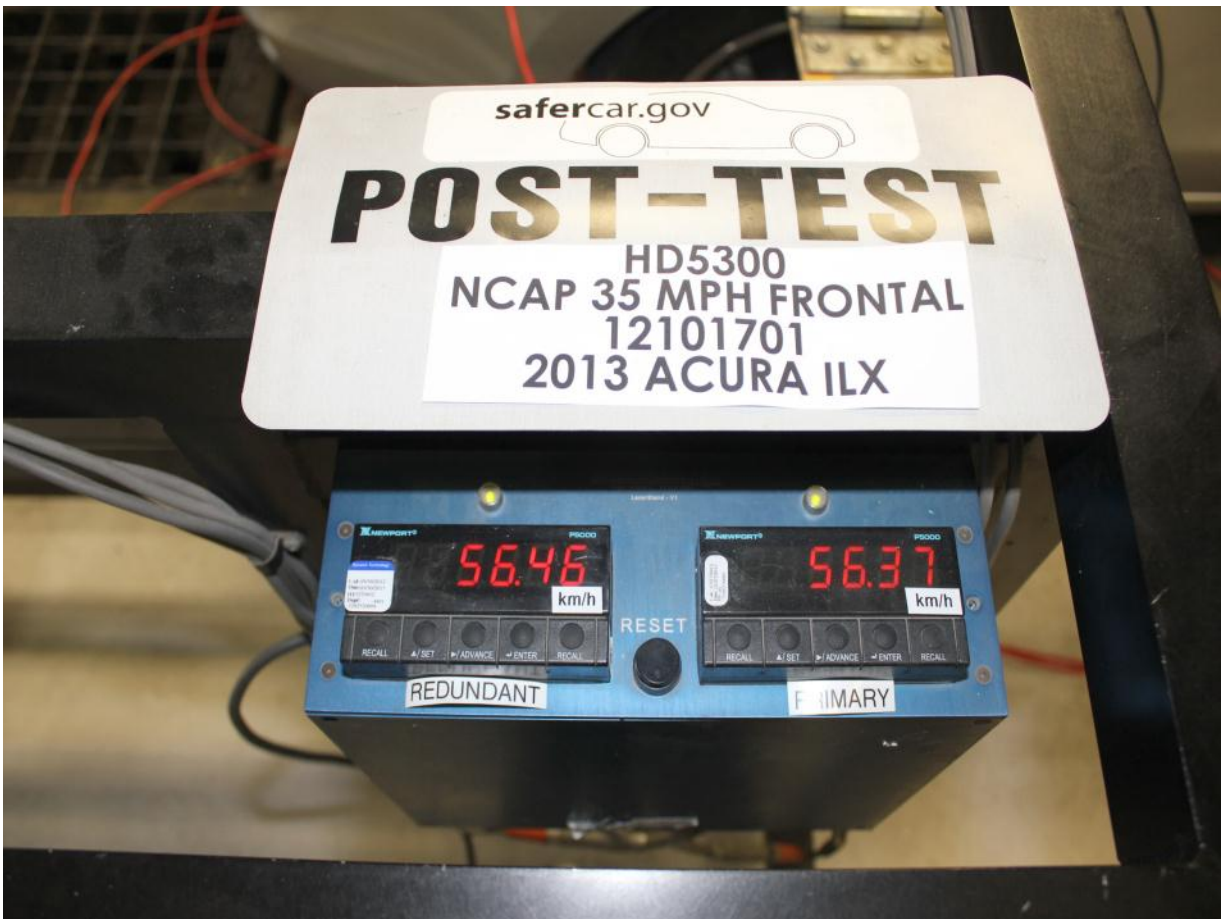
Post-Test Speed Trap Read-Out

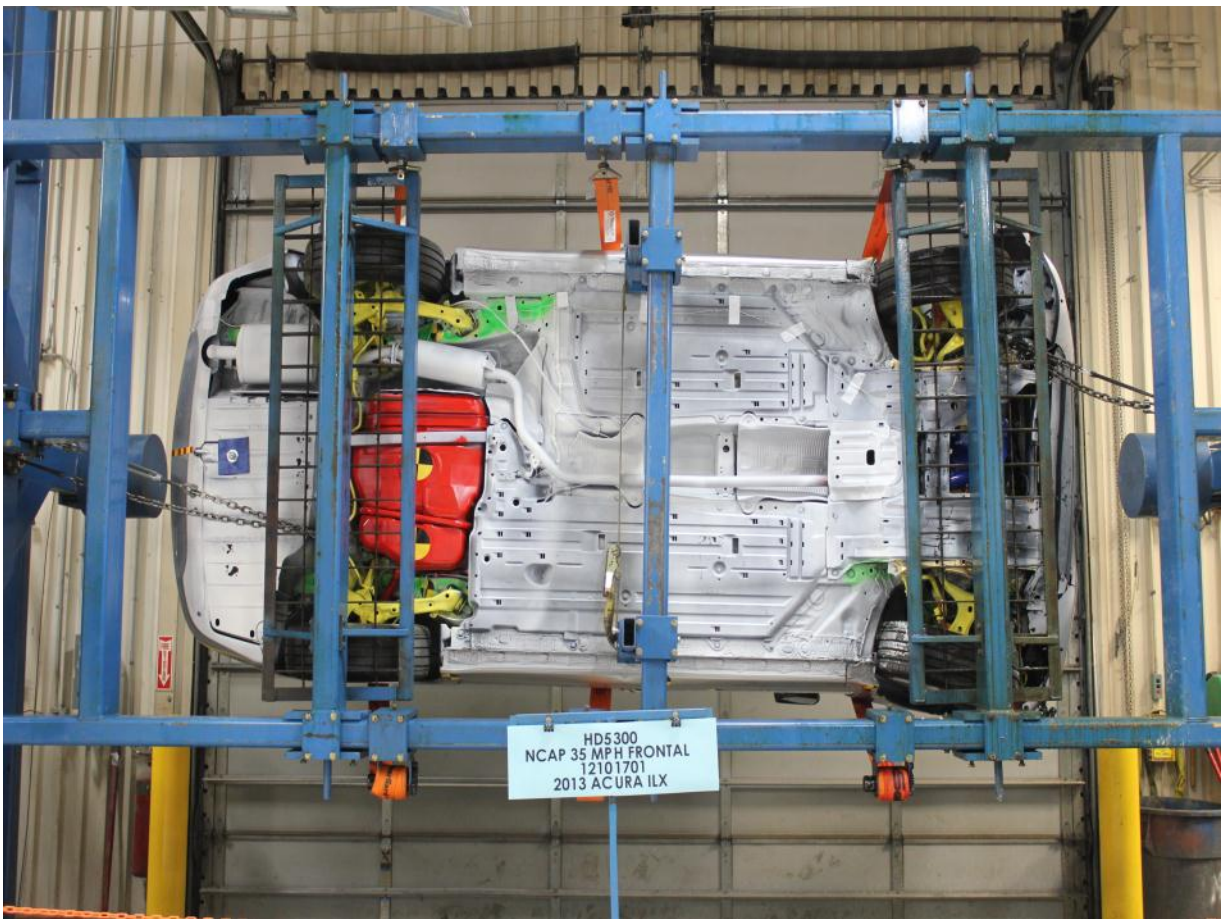
Vehicle at 0° on Static Rollover Device

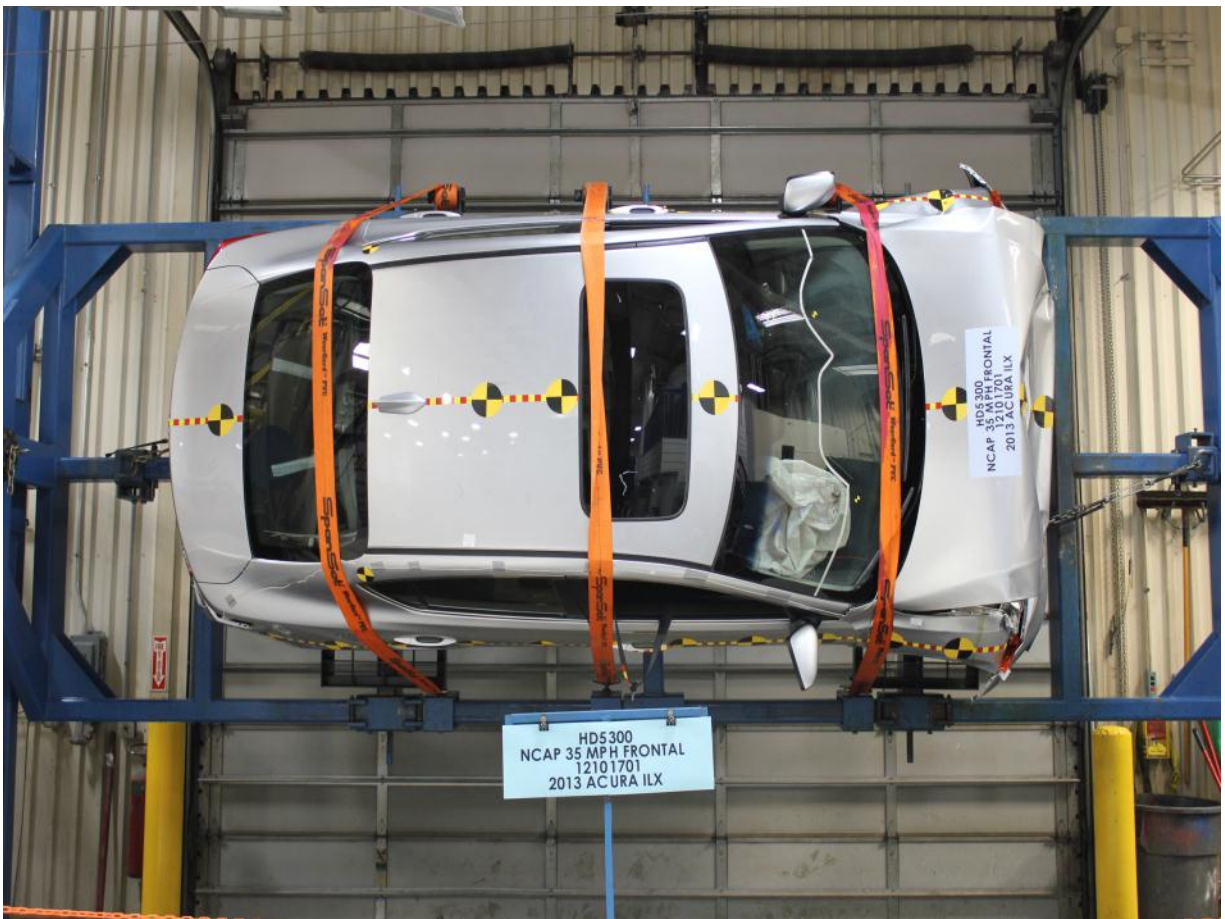
Vehicle at 270° on Static Rollover Device
