**REPORT NUMBER: SPNCAP-MGA-2013-024**

**NEW CAR ASSESSMENT PROGRAM (NCAP)  
Side Impact Pole Test**

**HONDA MFG. OF INDIANA, LLC  
2013 Acura ILX 4-Dr Sedan  
NHTSA No.: HD5301**

**FINAL REPORT**

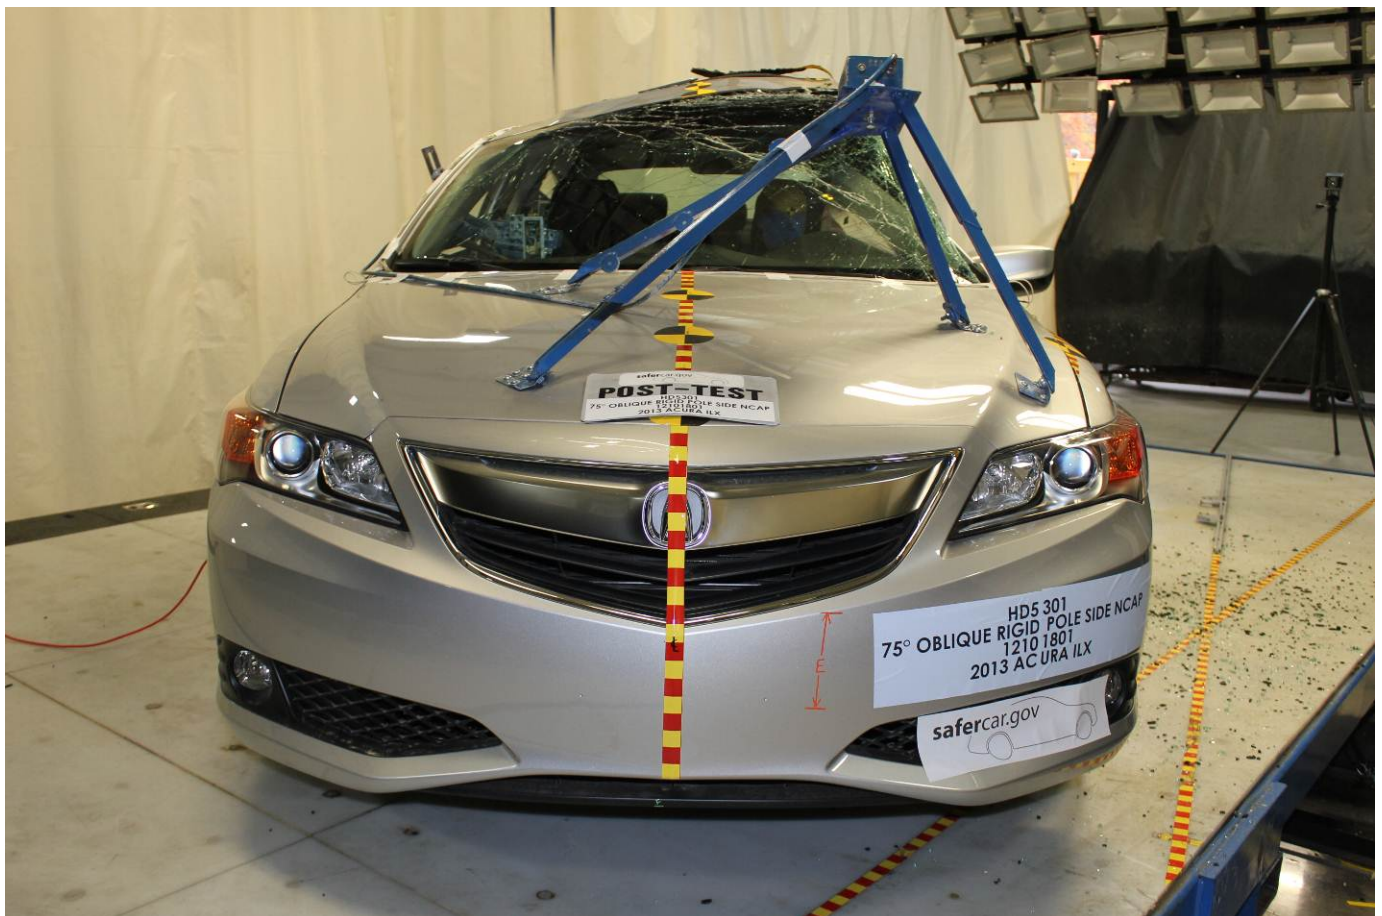
Post-Test Frontal View of Test Vehicle

| Critical Areas of Performance | Observations and Conclusions |
|---|---|
| Windshield Damage | Cracked |

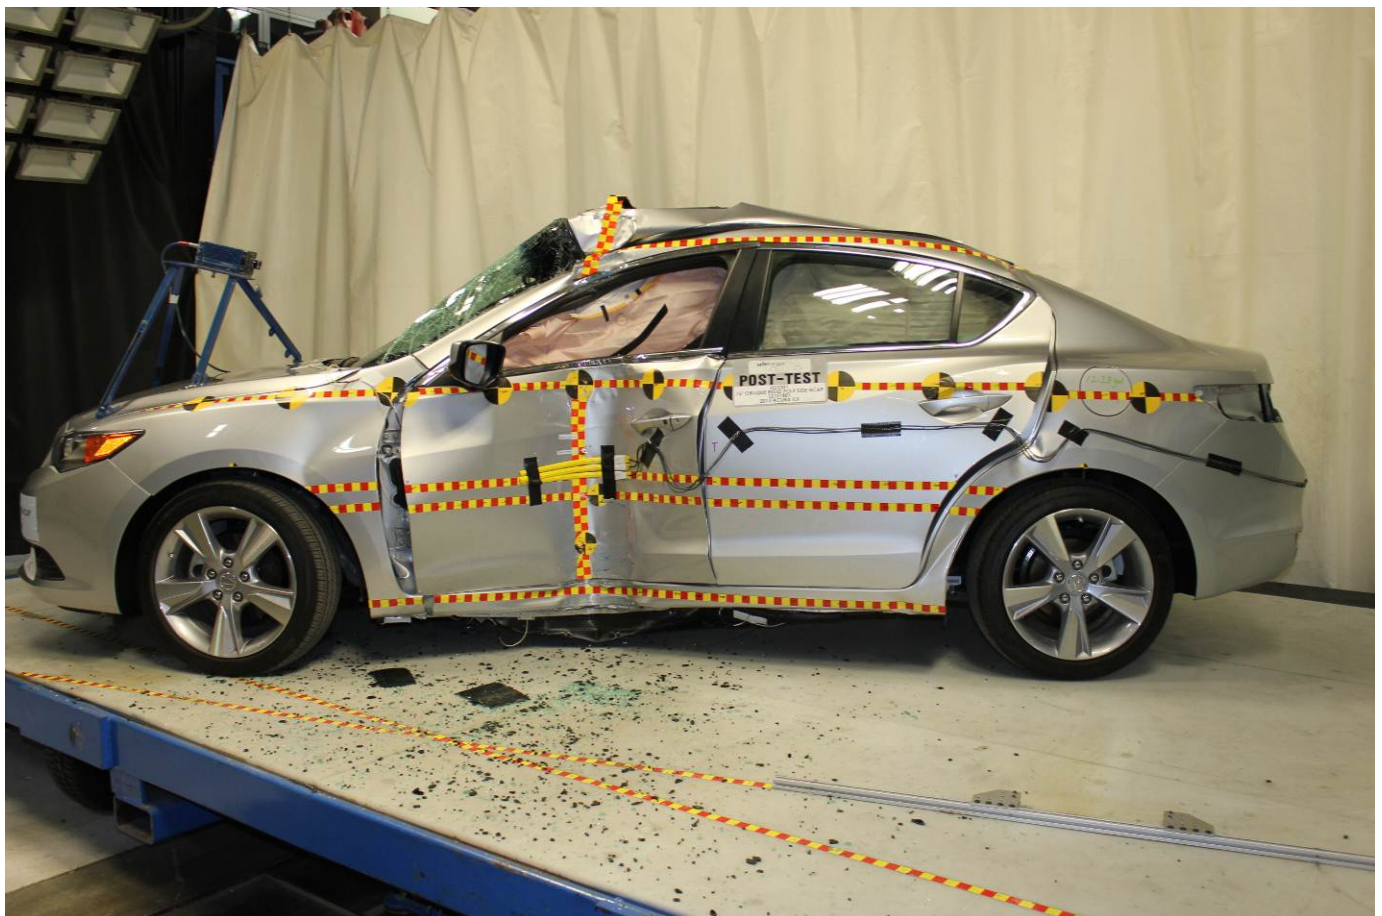
Post-Test Left Side View of Test Vehicle

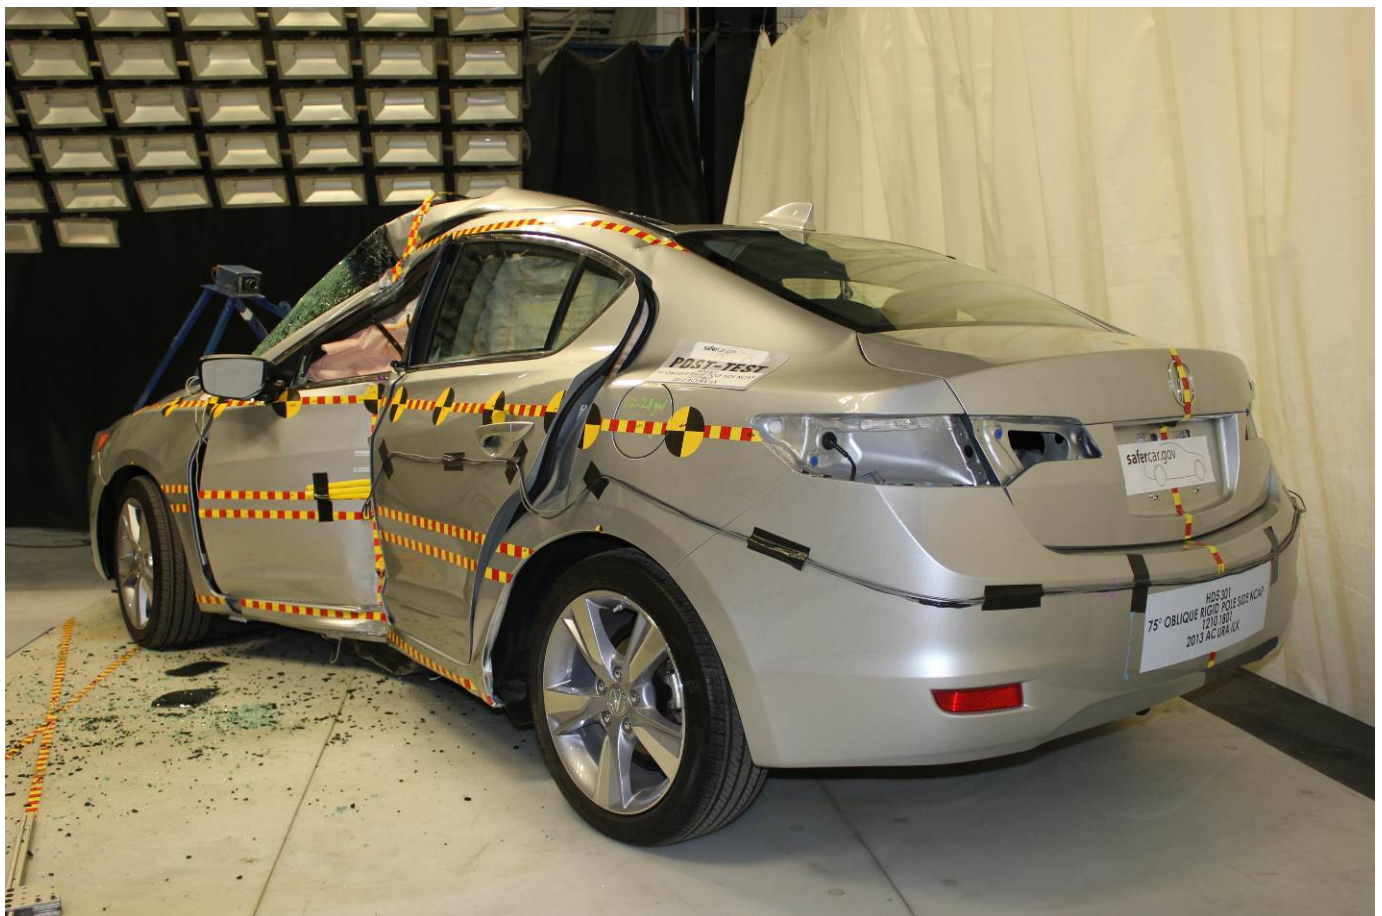
Post-Test Left Rear  $\frac{3}{4}$  View of Test Vehicle

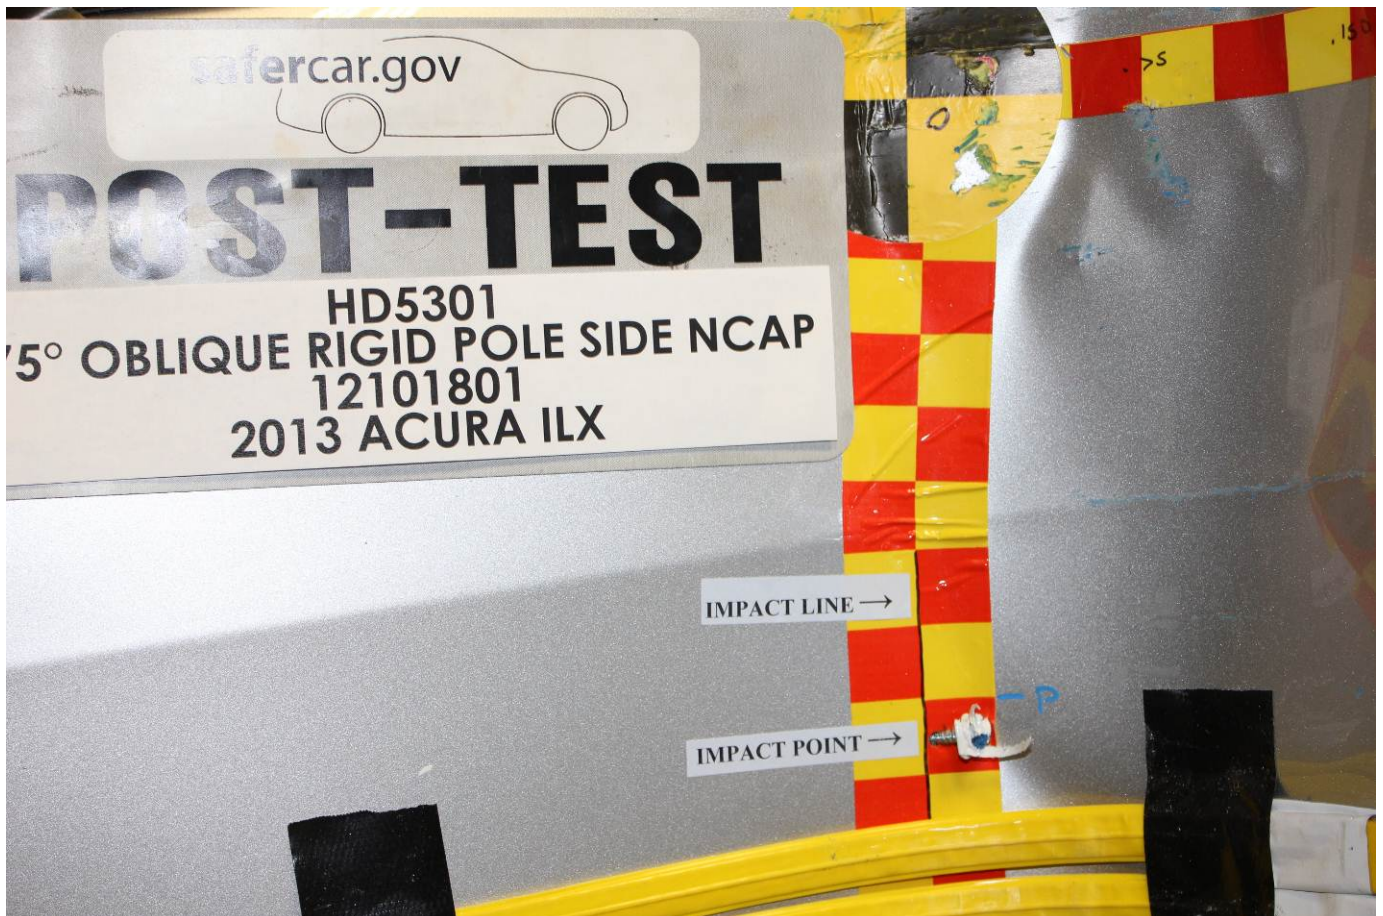
Post-Test Close-Up View of Impact Point Target Showing Impact Location

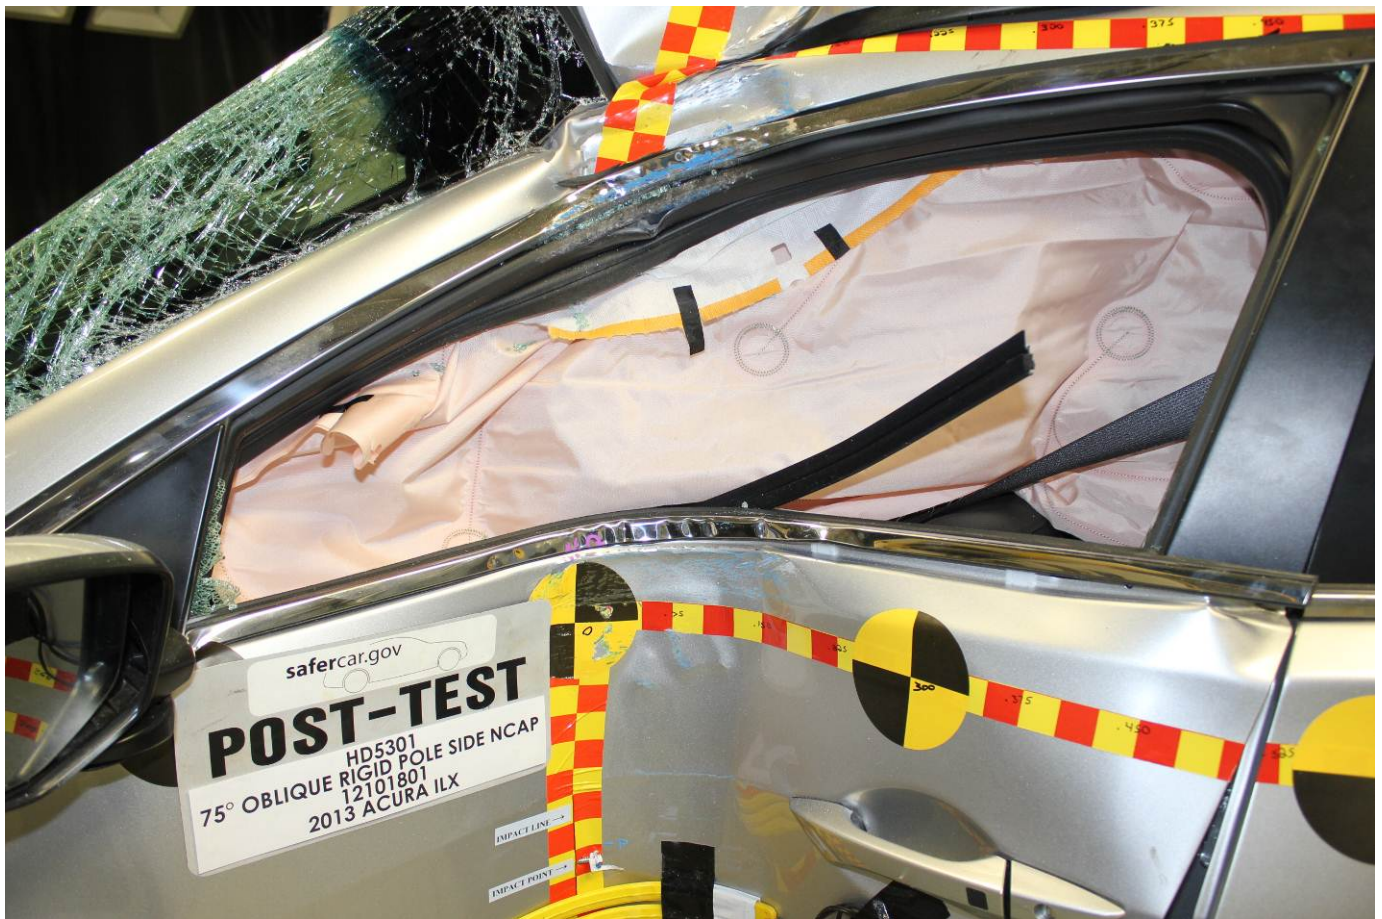
Post-Test Left Side View of Dummy Shoulder and Door Top View

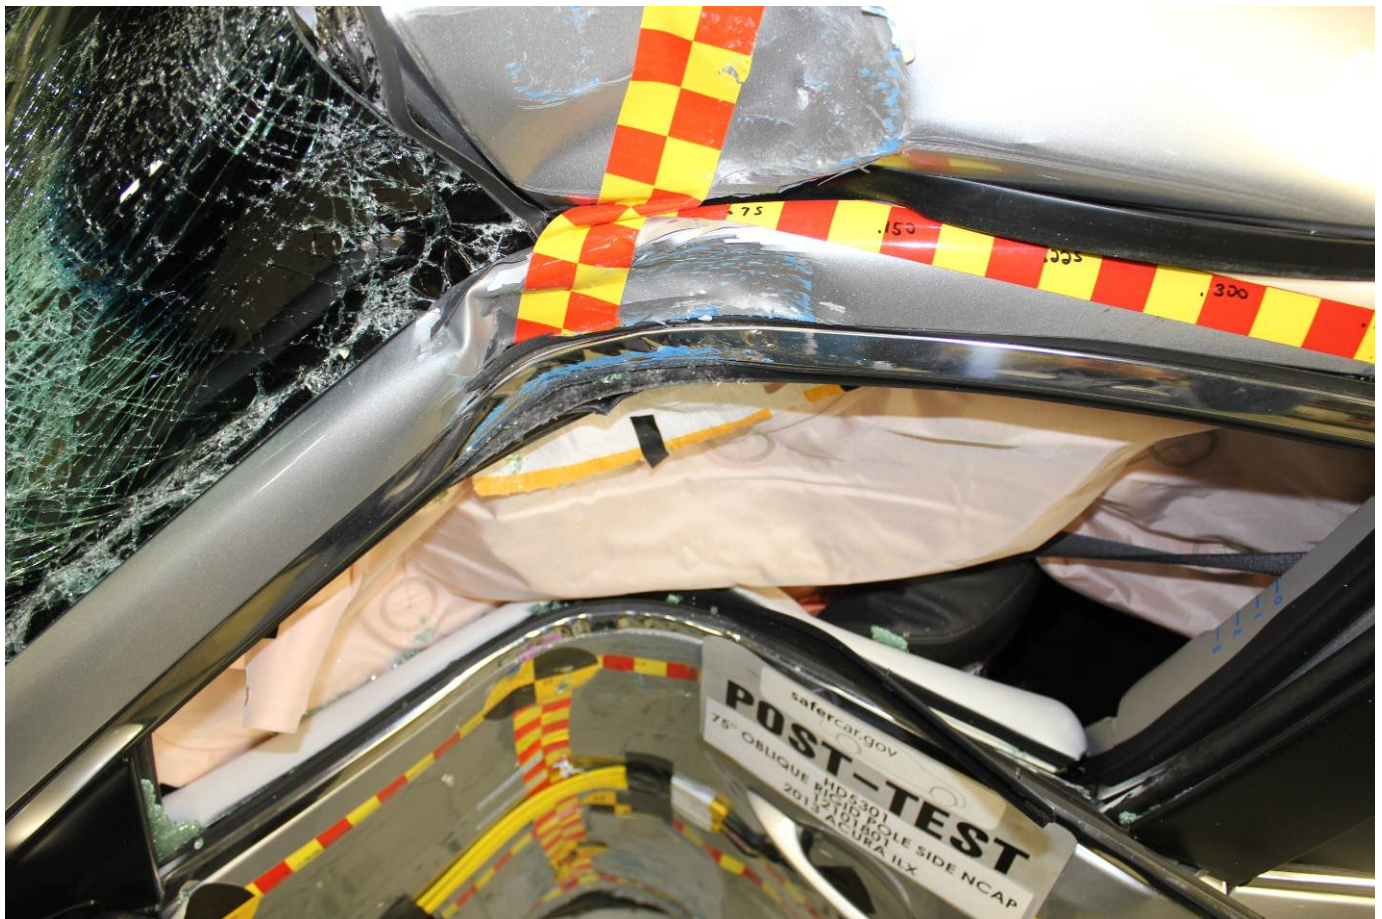
Post-Test Dummy and Door Clearance View

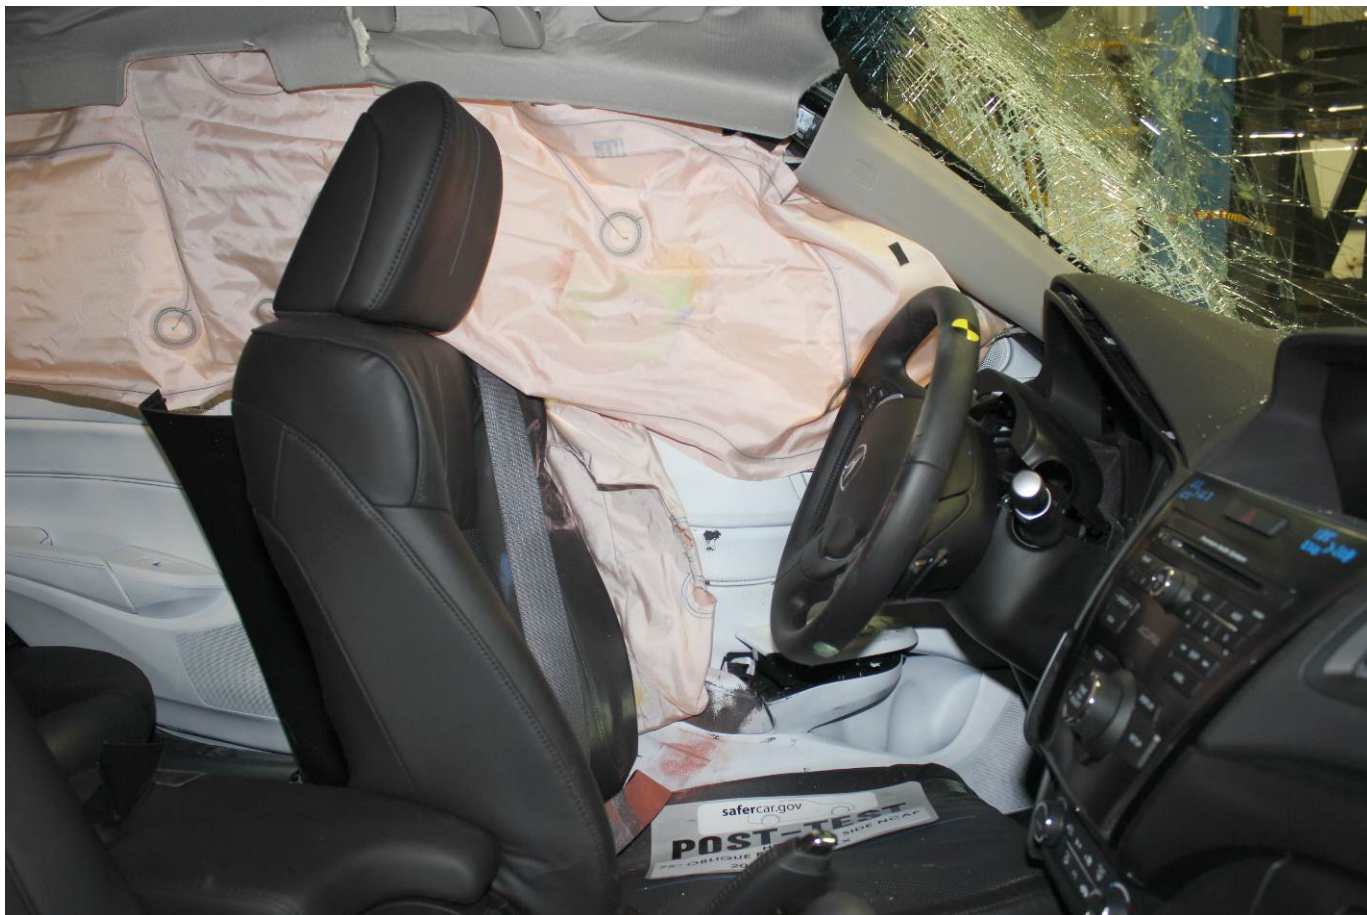
Post-Test Inner Door Panel View Showing Dummy Contact Location

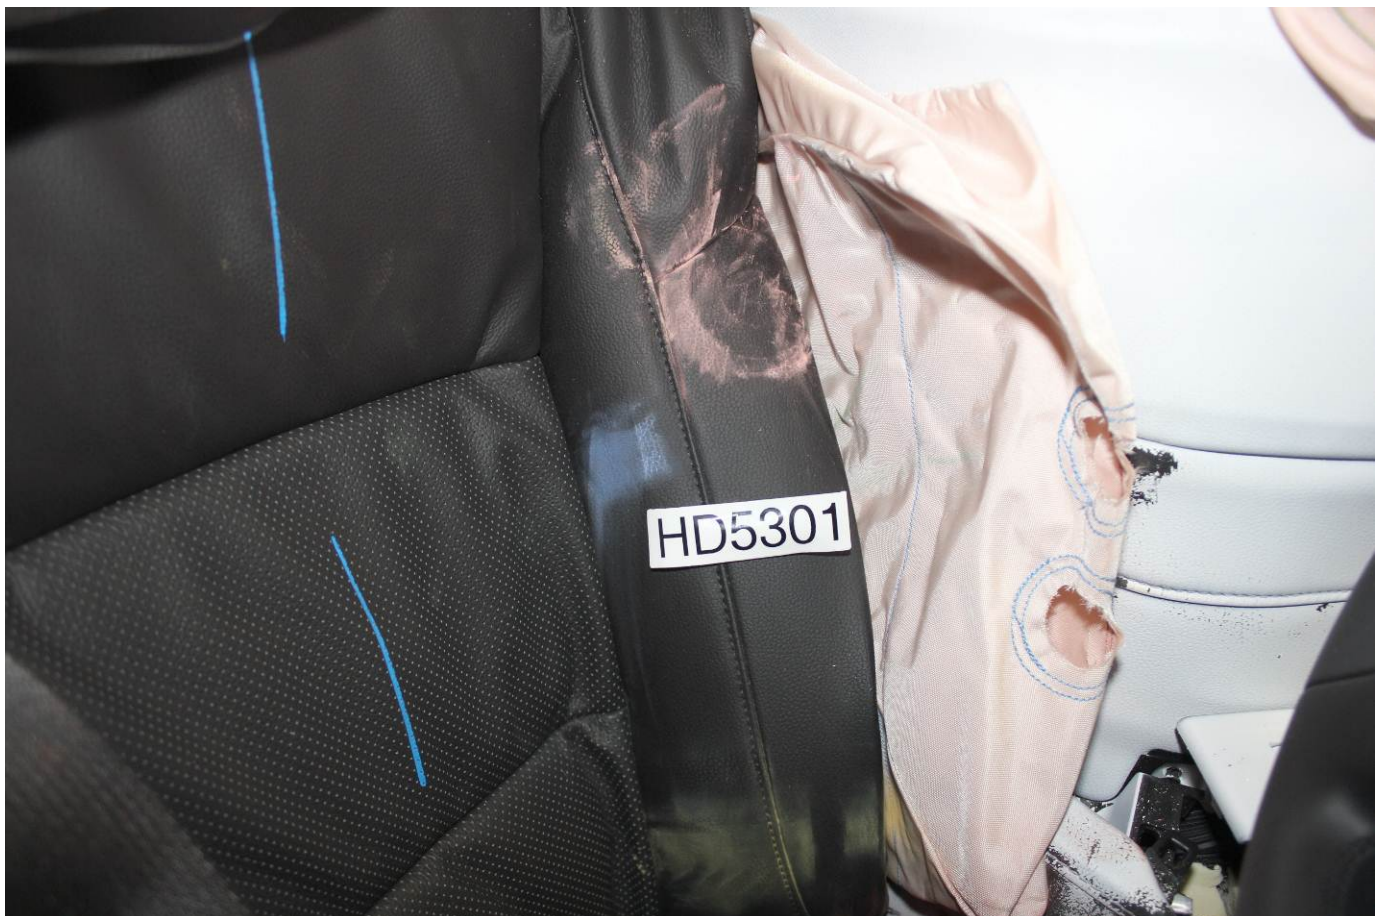
Post-Test Dummy Close-Up Torso Contact with Vehicle Interior View

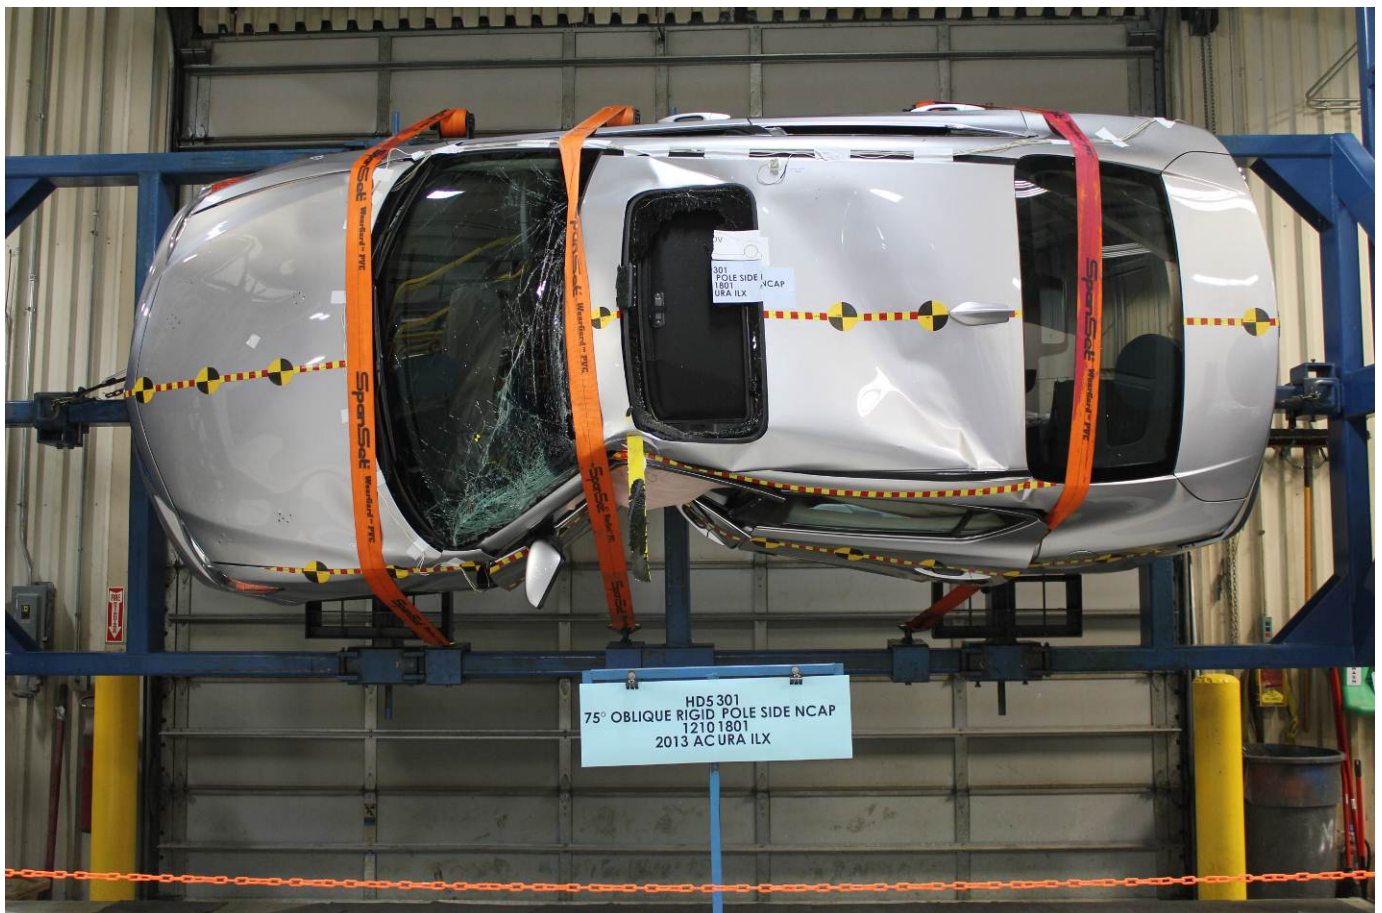
FMVSS No. 301 Static Rollover 90 Degrees

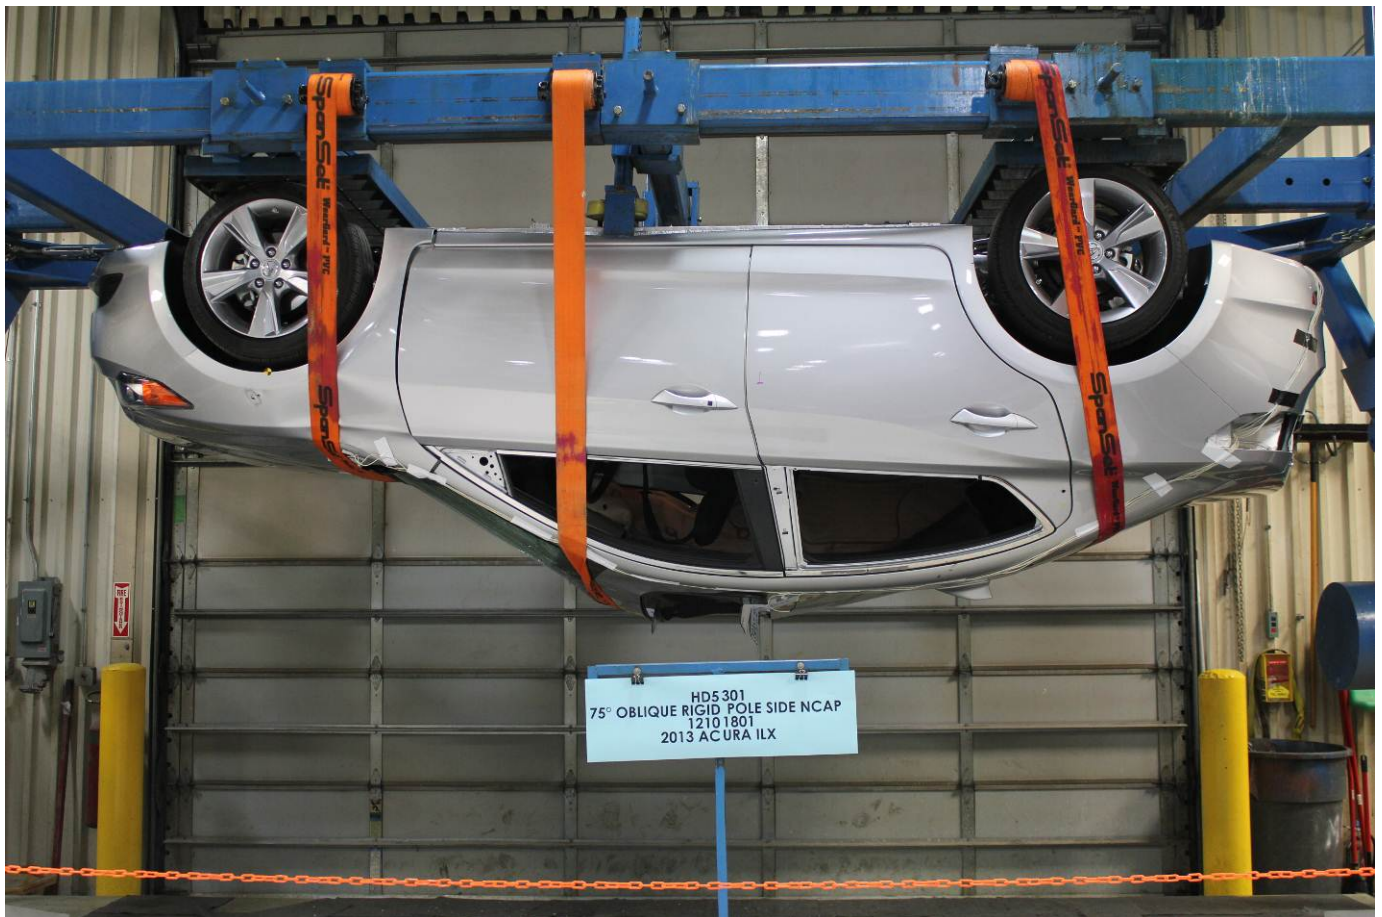
FMVSS No. 301 Static Rollover 180 Degrees

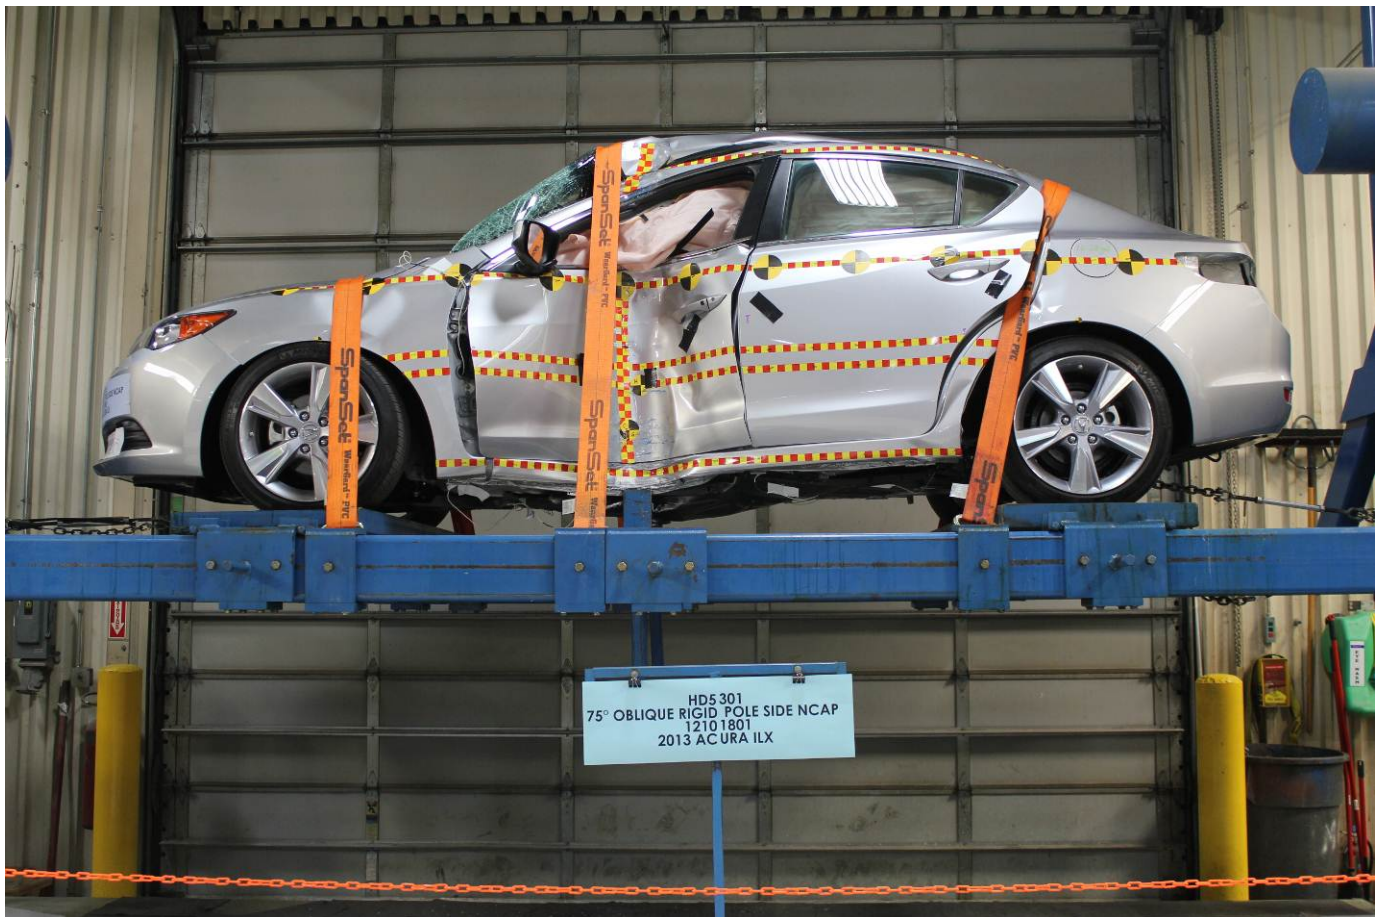
FMVSS No. 301 Static Rollover 360 Degrees

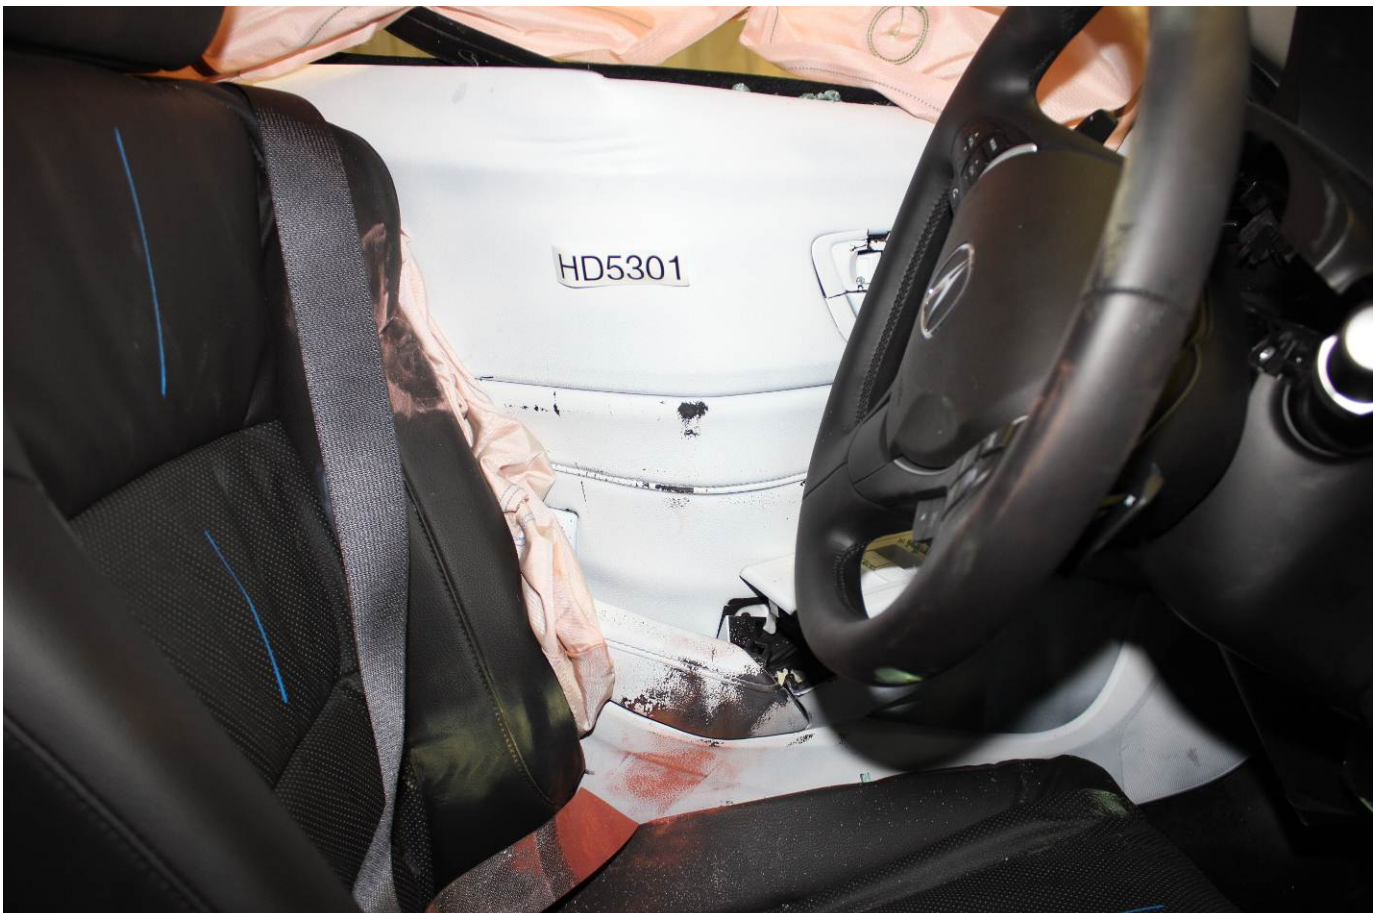
Post-Test View of Shattered Vehicle Inner Door Panel
