**REPORT NUMBER: SINCAP-MGA-2013-025**

**NEW CAR ASSESSMENT PROGRAM (NCAP)  
Moving Deformable Barrier Side Impact Test**

**HONDA MFG. OF INDIANA, LLC  
2013 Acura ILX Hybrid 4-Dr Sedan  
NHTSA No.: HD5302**

**MGA RESEARCH CORPORATION  
5000 Warren Road  
Burlington, WI 53105**

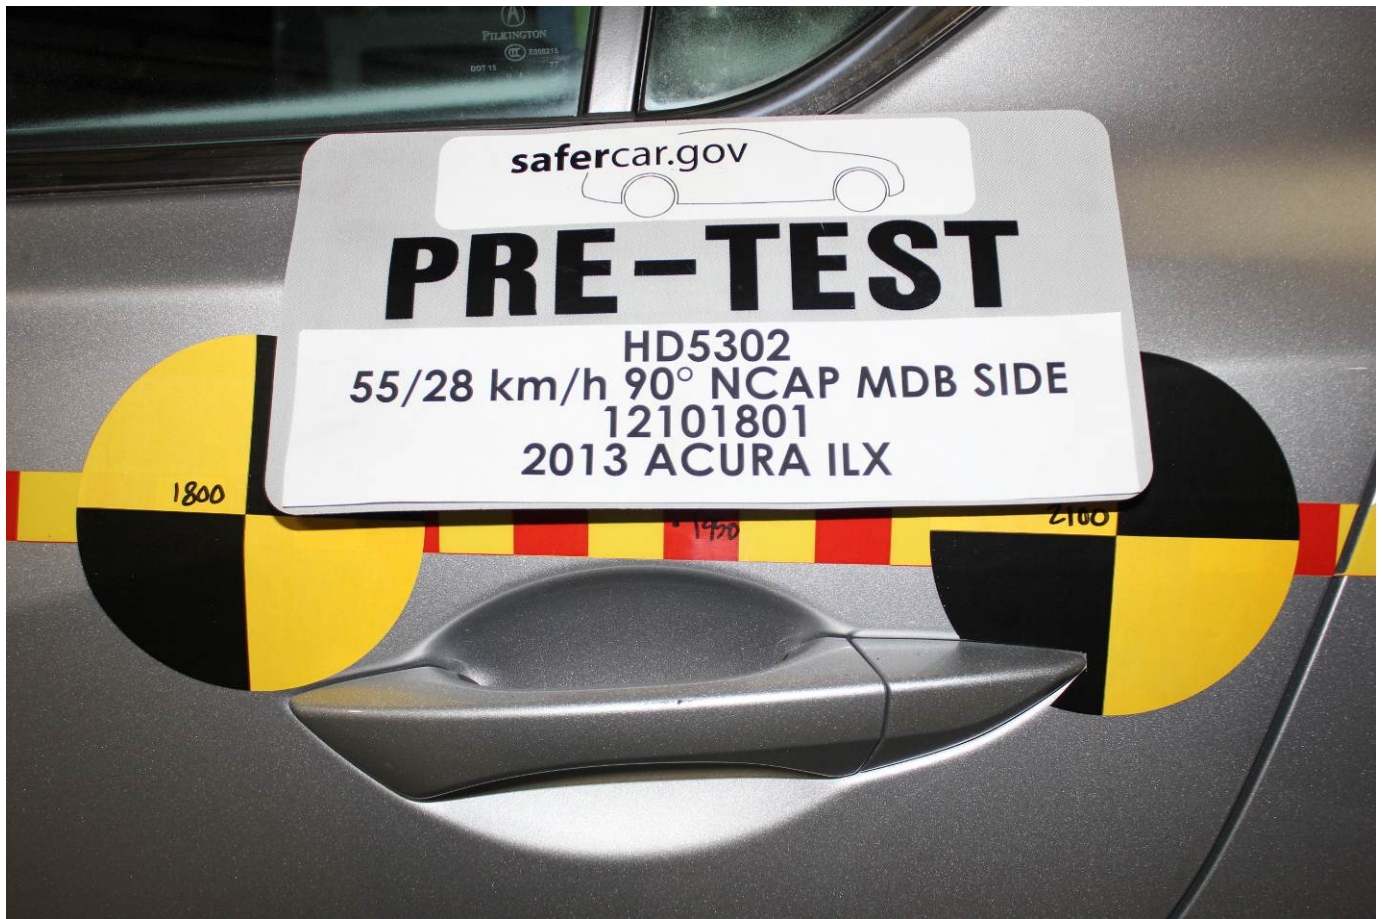
Post-Test Left Front Door Latch Close-Up
