**FINAL REPORT NUMBER: SPNCAP-TRC-13-004**

**NEW CAR ASSESSMENT PROGRAM (NCAP)  
SIDE IMPACT POLE TEST**

**Chrysler Group LLC  
2013 Jeep Compass Sport FWD MPV  
NHTSA NUMBER: MD0308**

**PREPARED BY:  
Transportation Research Center Inc.  
10820 State Route 347  
P. O. Box B-67  
East Liberty, OH 43319**

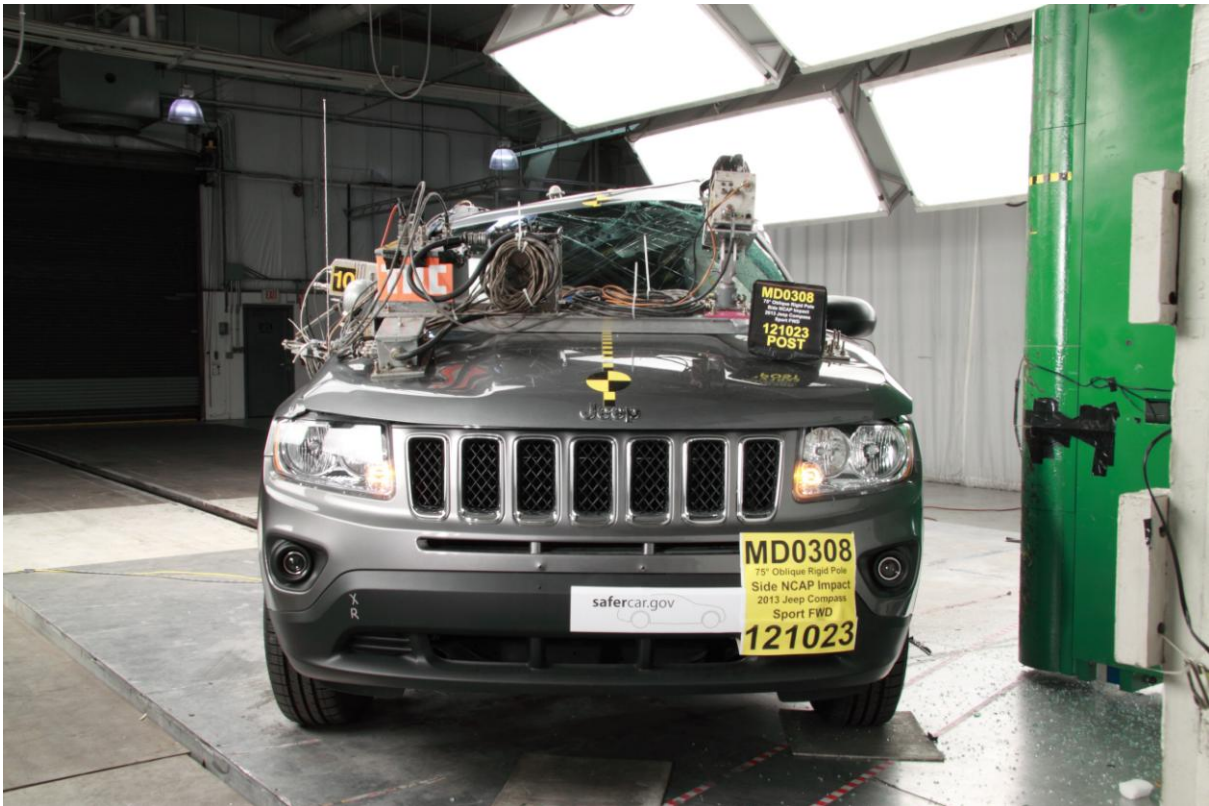
**004** Post-Test Frontal View of Test Vehicle

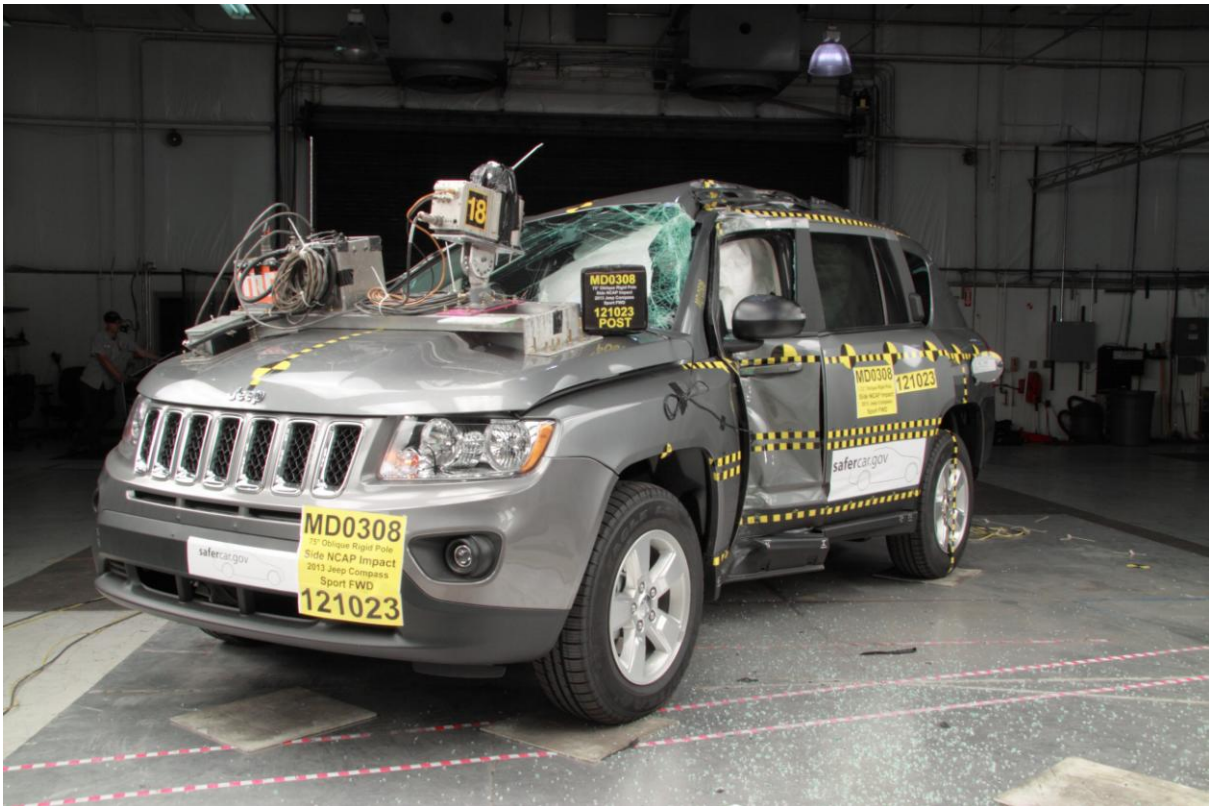
006 Post-Test Left Front 3/4 View of Test Vehicle

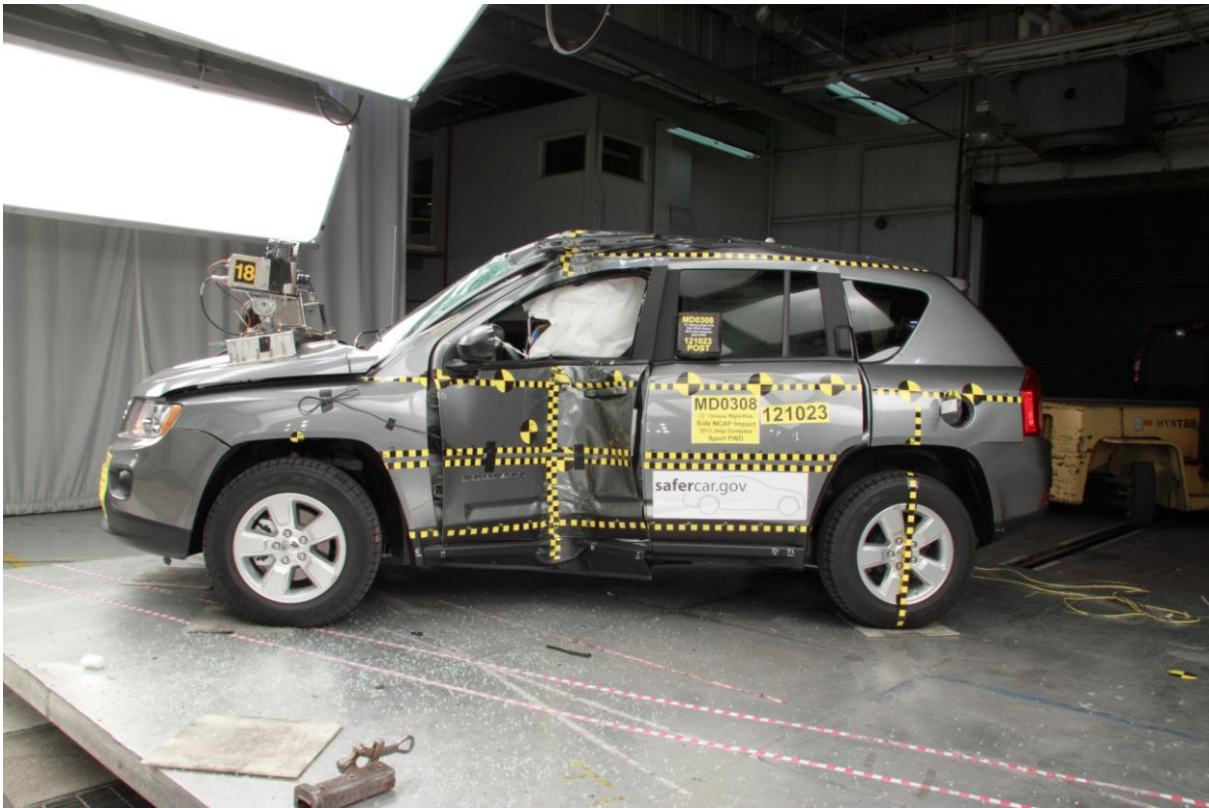
**008** Post-Test Left Side View of Test Vehicle

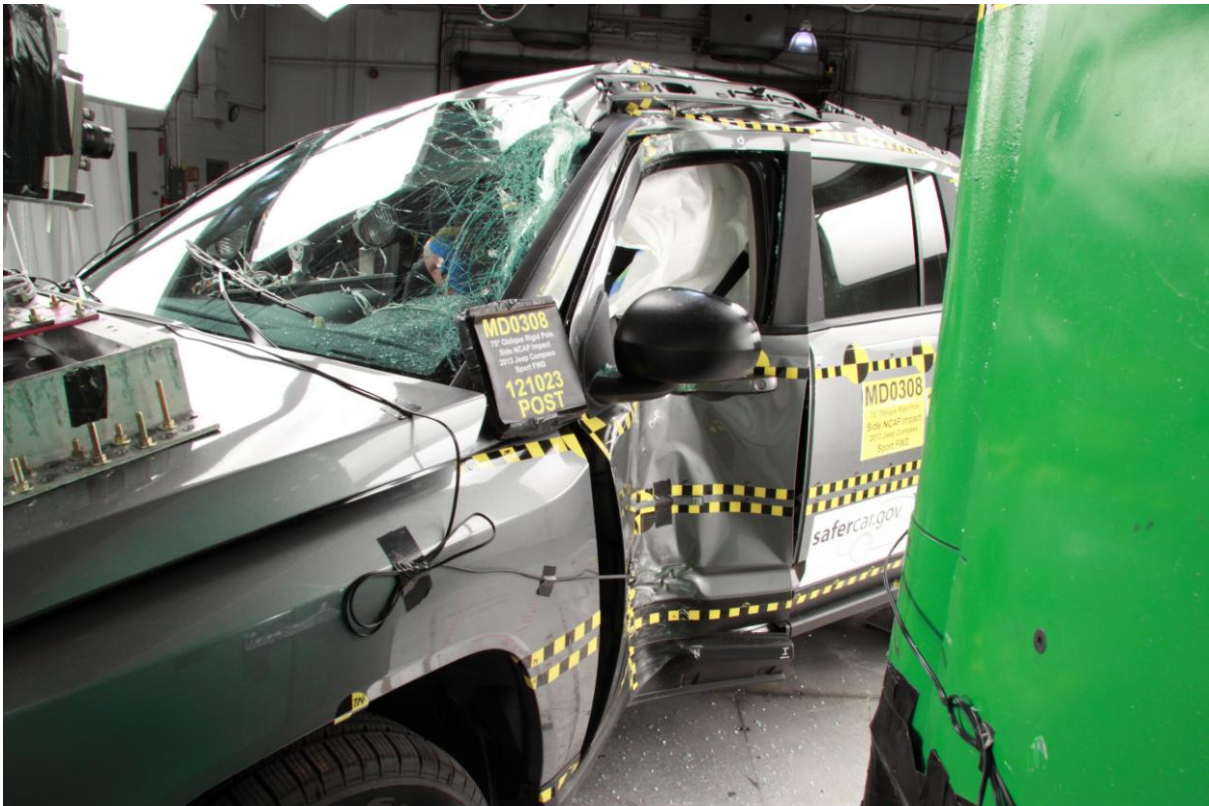
**017a** Post-Test Left Side View of Pole Positioned Against Side of Vehicle

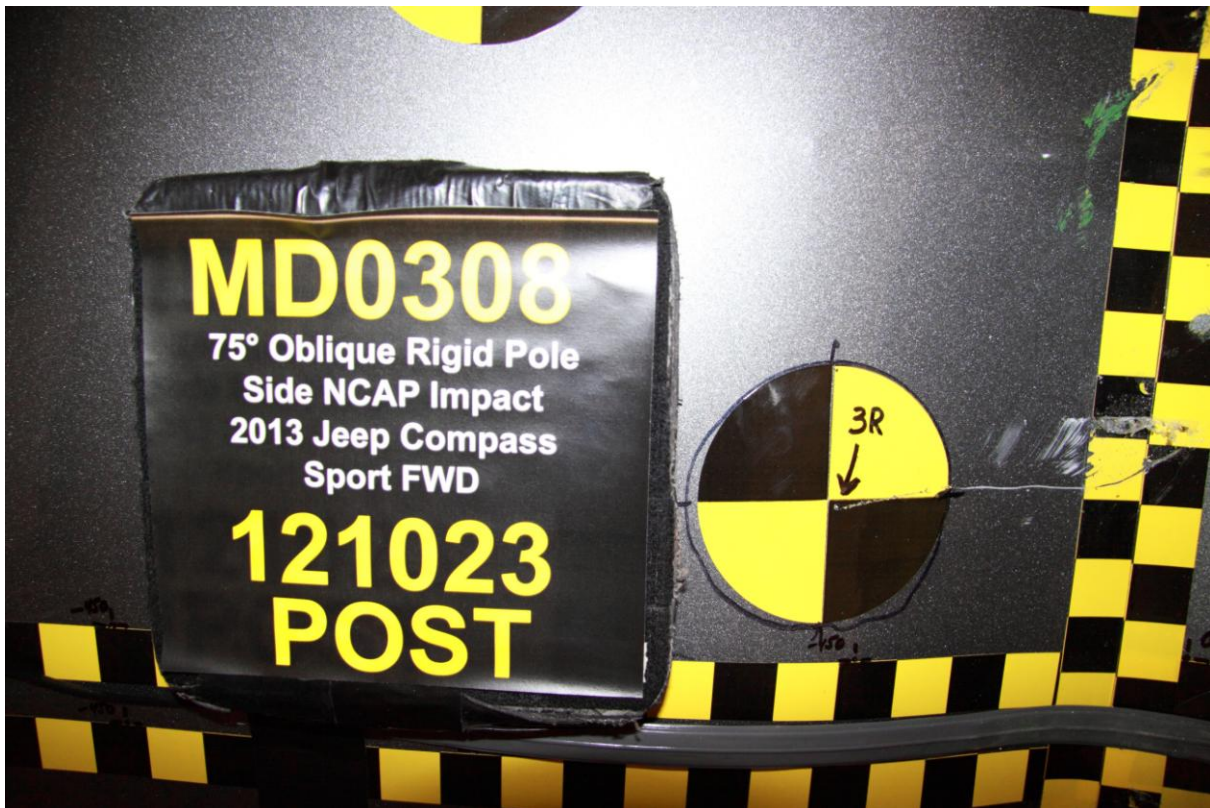
020 Post-Test Close-Up View of Impact Point Target Showing Impact Location

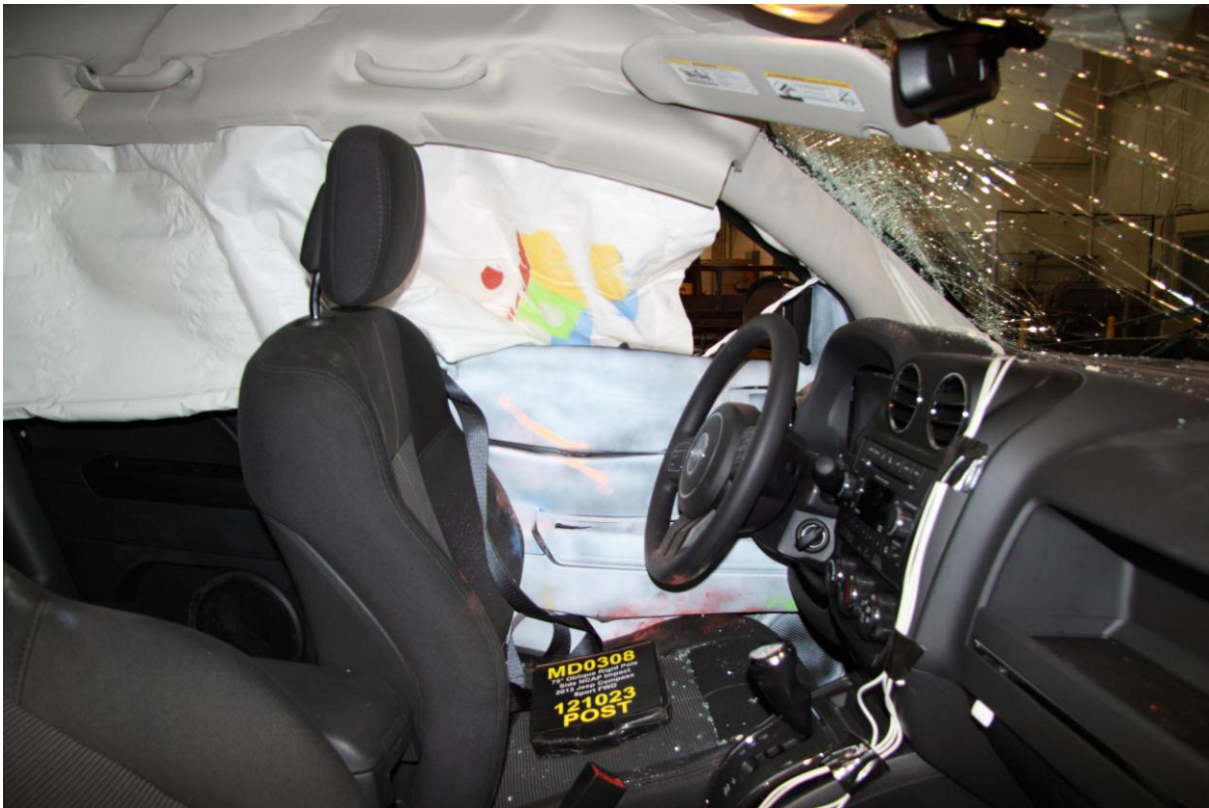
**045** Post-Test Inner Driver Door Panel View Showing Dummy Contact Location

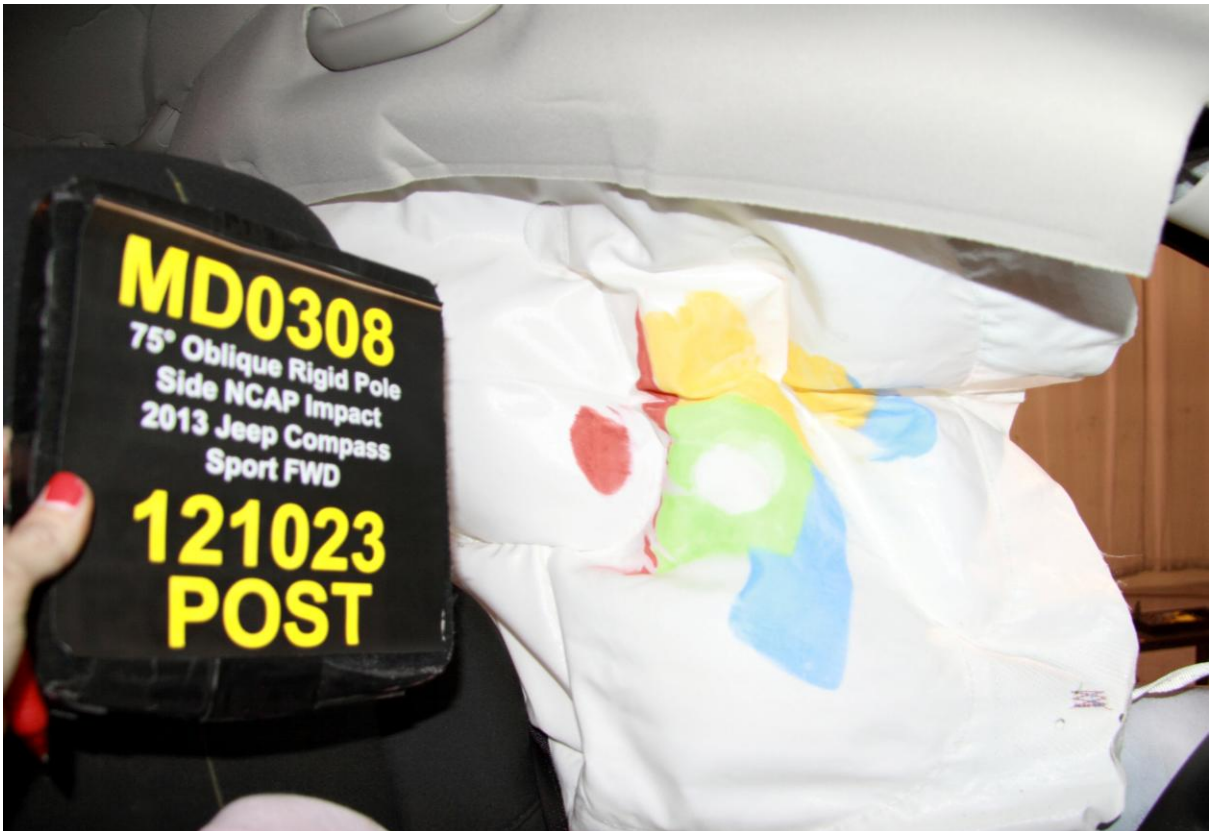
**046** Post-Test Dummy Close-Up Head Contact with Vehicle View

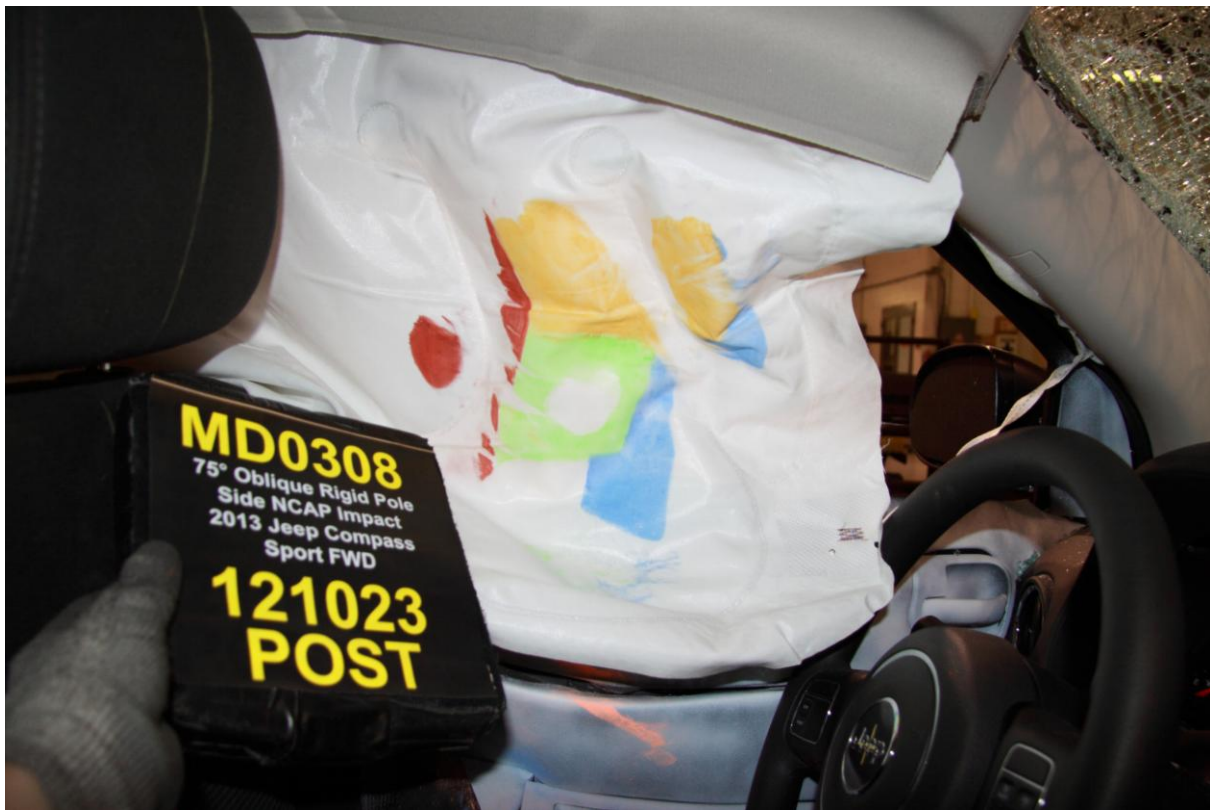
**047** Post-Test Dummy Close-Up Head Contact with Side Airbag View

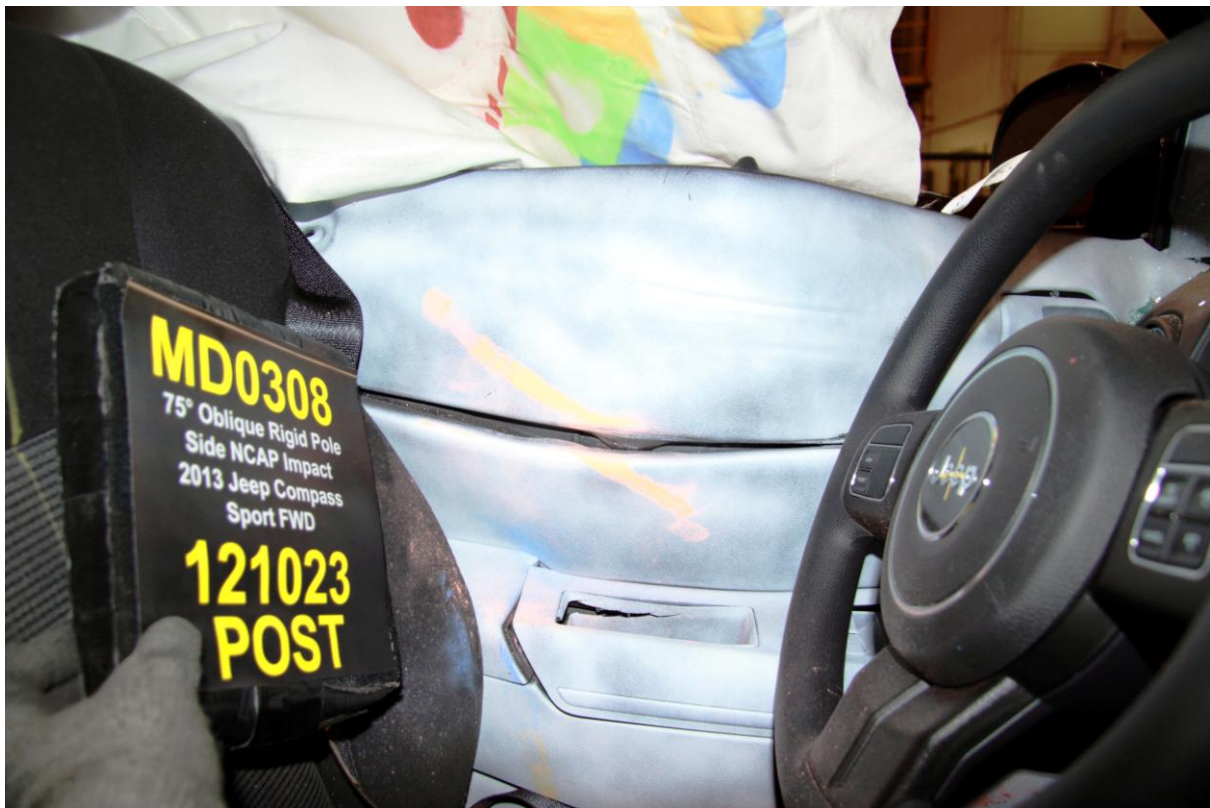
**048** Post-Test Dummy Close-Up Torso Contact with Vehicle Interior View

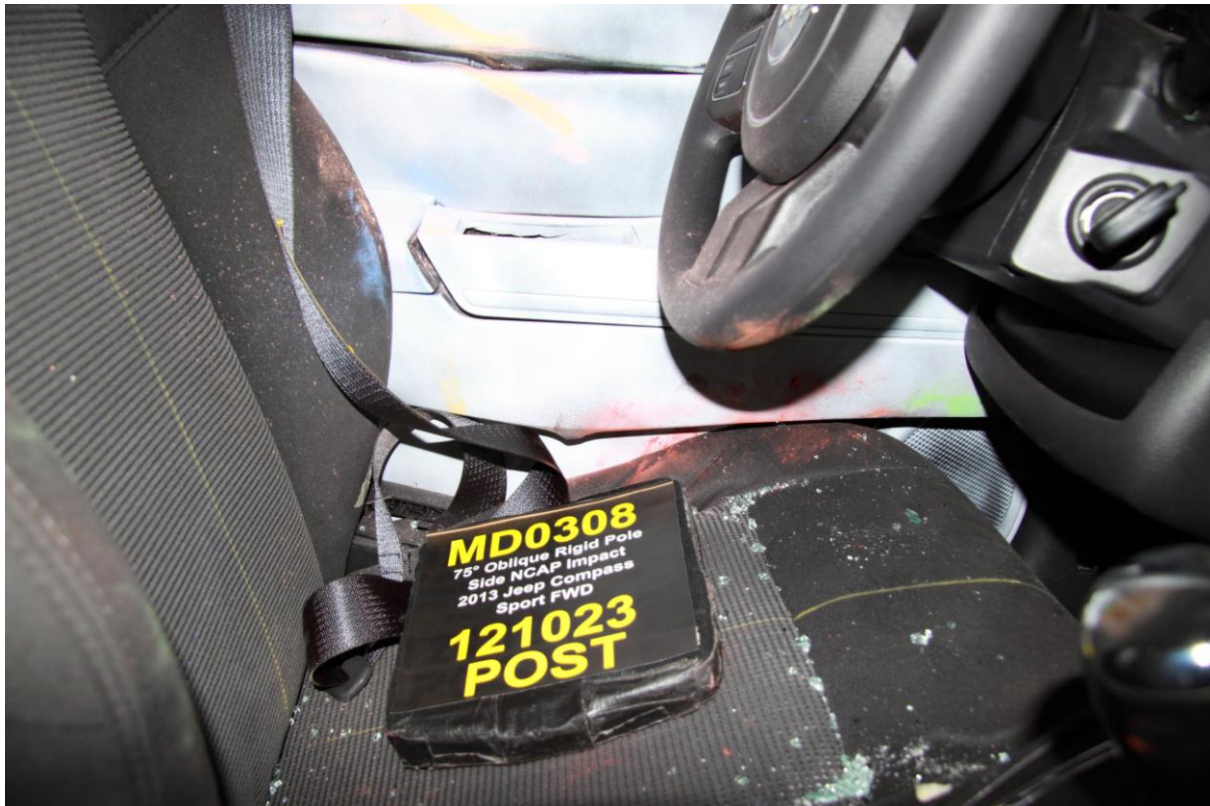
**050** Post-Test Dummy Close-Up Pelvis Contact View

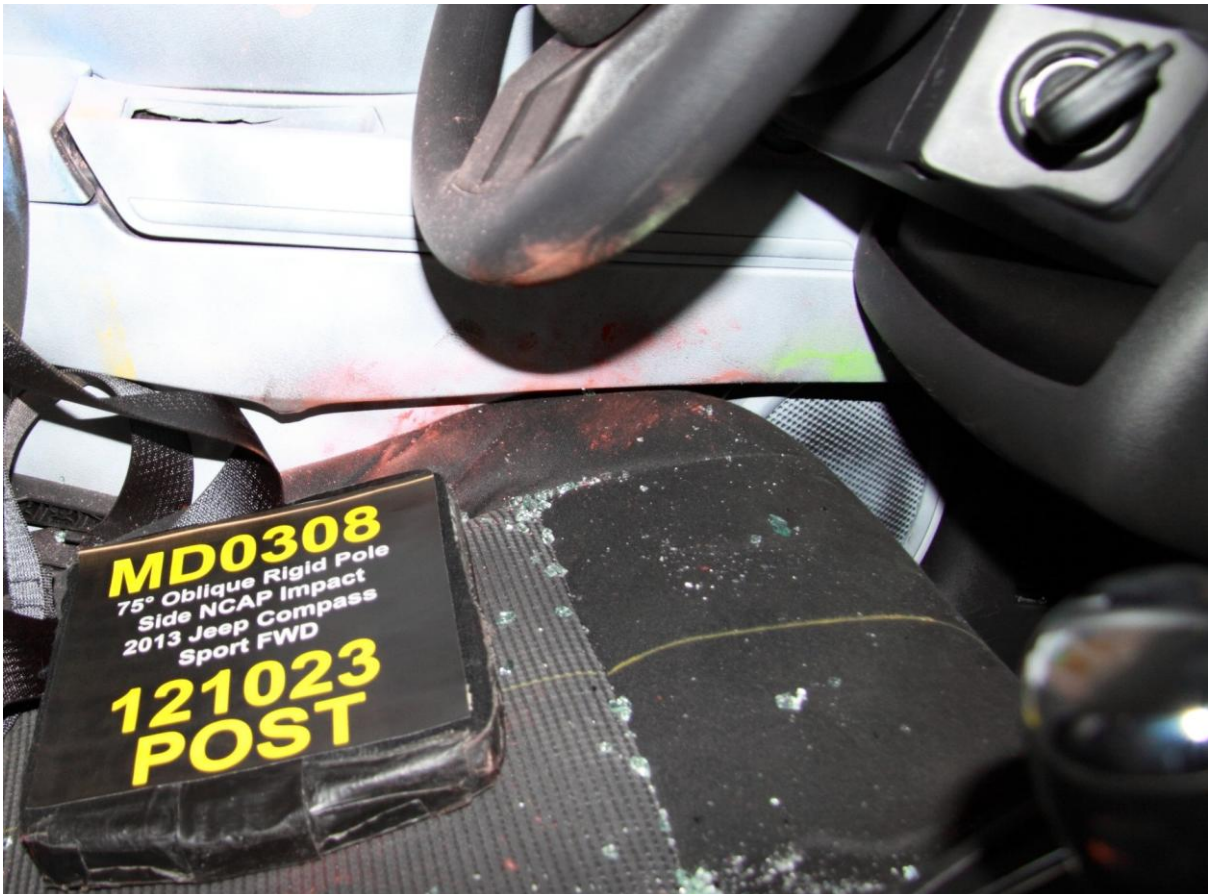
**052** Post-Test Dummy Close-Up Knee Contact with Vehicle Interior View

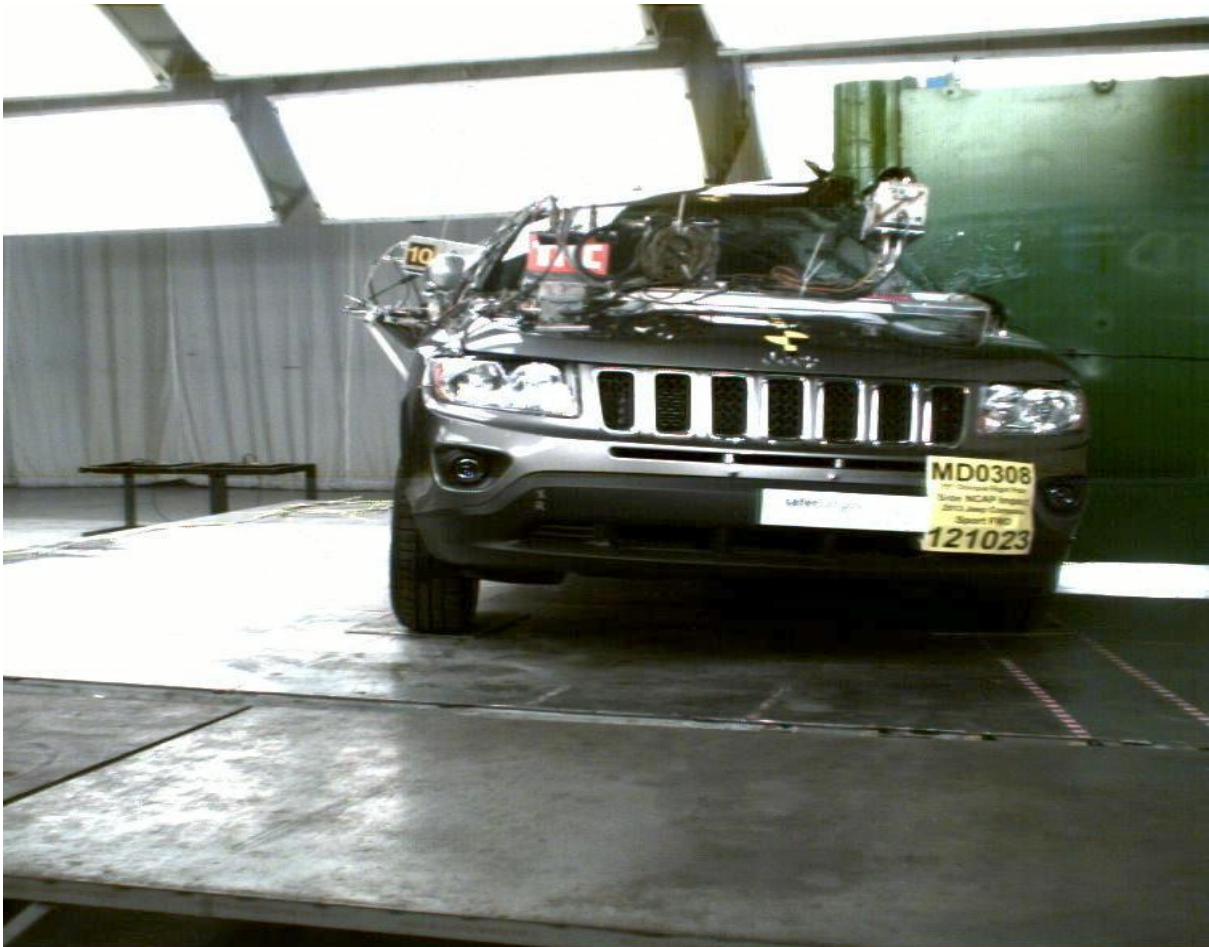
**068** Impact Event

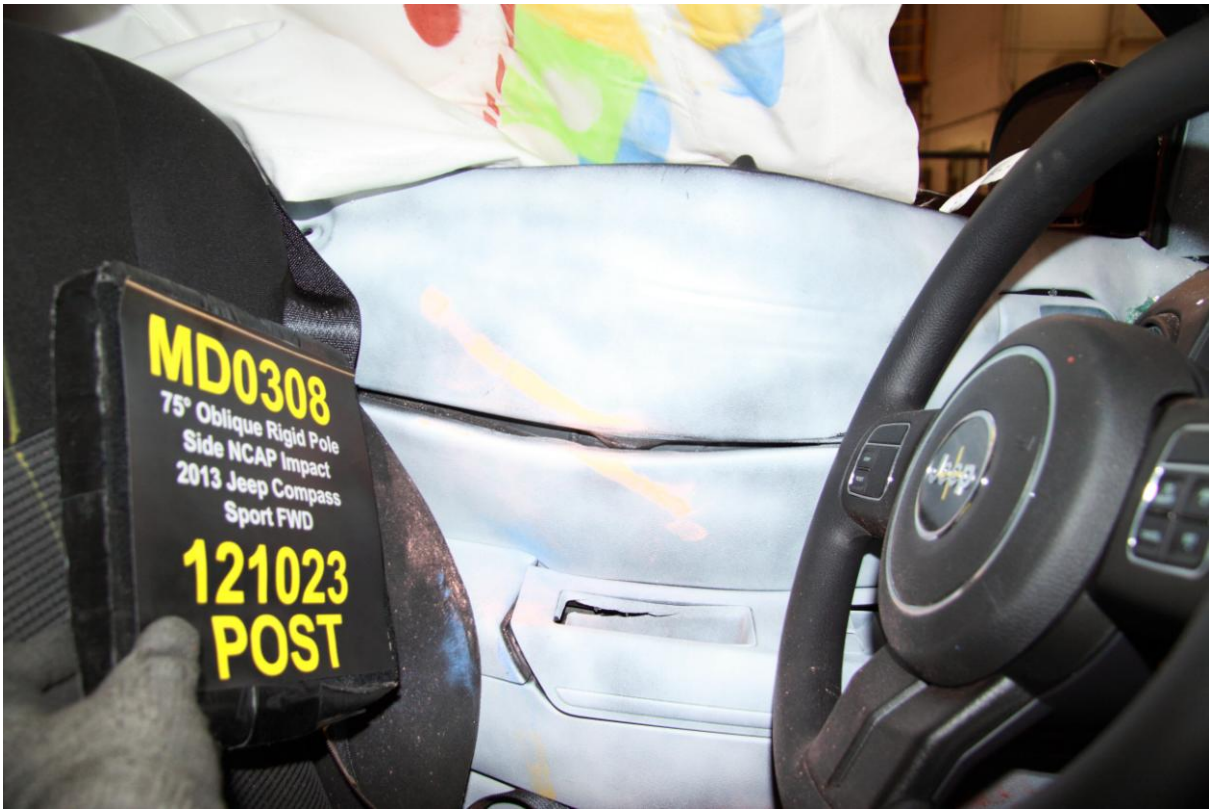
071 Post-Test View of Shattered Vehicle Inner Door Panel
