REPORT NUMBER: NCAP-KAR-13-021

**NEW CAR ASSESSMENT PROGRAM (NCAP)
FRONTAL BARRIER IMPACT TEST**

**HONDA OF AMERICA MFG., INC
2013 HONDA ACCORD EX-L 4-DOOR SEDAN**

NHTSA NUMBER: MD5303

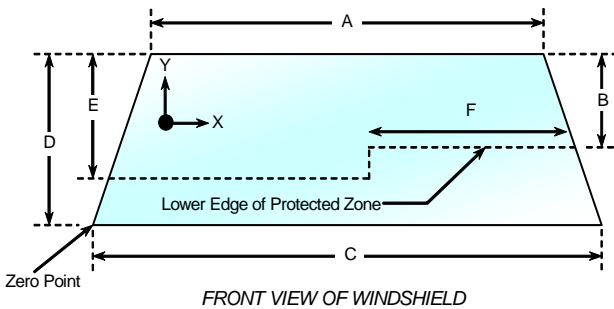
Measurement	Pre-Test (mm)	Post-Test (mm)	% Retention
Left Side	2071	2071	100.0%
Right Side	2071	2071	100.0%
Total	4142	4142	100.0%

Item	Units	Value
A	mm	1168
B	mm	407
C	mm	1430
D	mm	772
E	mm	555
F	mm	365

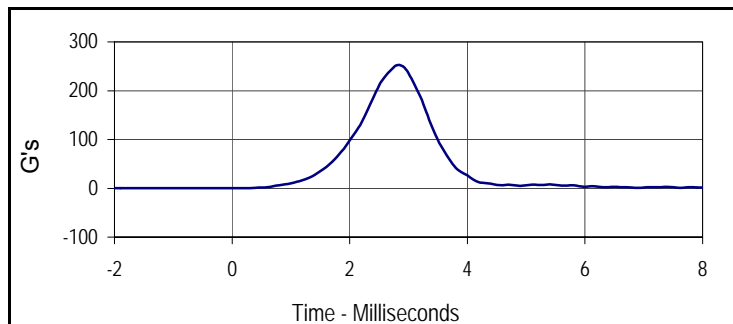
Curve Description			
Head Resultant			
Plot No.	Type	SAE Class	Units
001	RES	1000	G's
Max	Time	Min	Time
251.9	2.8	0.0	-0.4

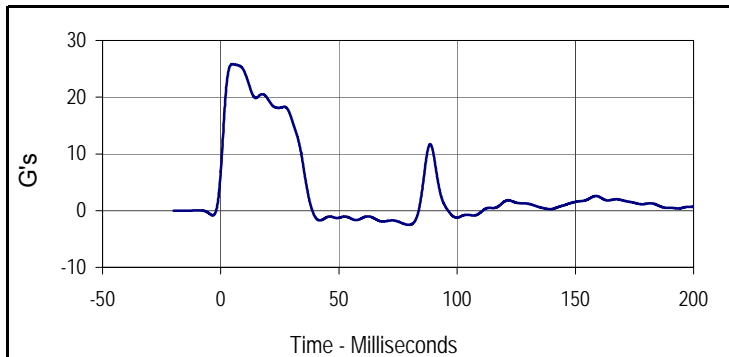
Curve Description			
Pendulum Deceleration			
Plot No.	Type	SAE Class	Units
001	FIL	60	G's
Max	Time	Min	Time
25.8	5.0	-2.5	79.6

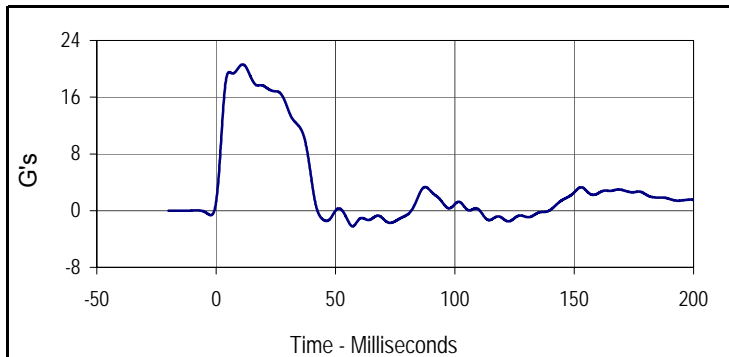
Curve Description			
Pendulum Deceleration			
Plot No.	Type	SAE Class	Units
001	FIL	60	G's
Max	Time	Min	Time
20.6	11.1	-2.2	57.2

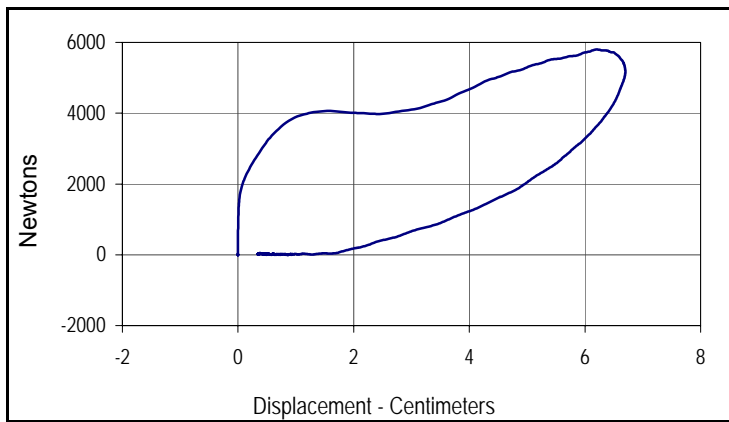
Curve Description			
Probe Force vs. Chest Deflection			
Plot No.	Type	SAE Class	Hysteresis
001	FIL	180	71.9
Peak Probe Force		Peak Chest Deflection	
5798		6.70

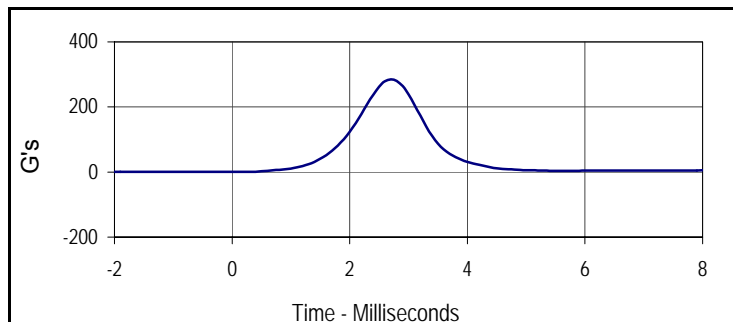
Curve Description			
Head Resultant			
Plot No.	Type	SAE Class	Units
001	RES	1000	G's
Max	Time	Min	Time
285.2	2.7	0.2	0.2

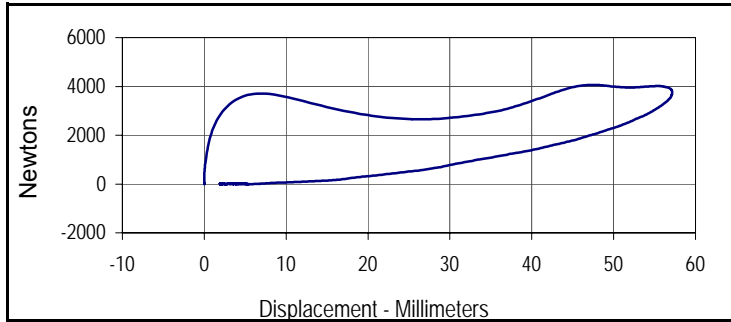
Curve Description			
Probe Force vs. Chest Deflection			
Plot No.	Type	SAE Class	Hysteresis
001	FIL	180	70.1
Peak Probe Force		Peak Chest Deflection	
4062.4		57.1

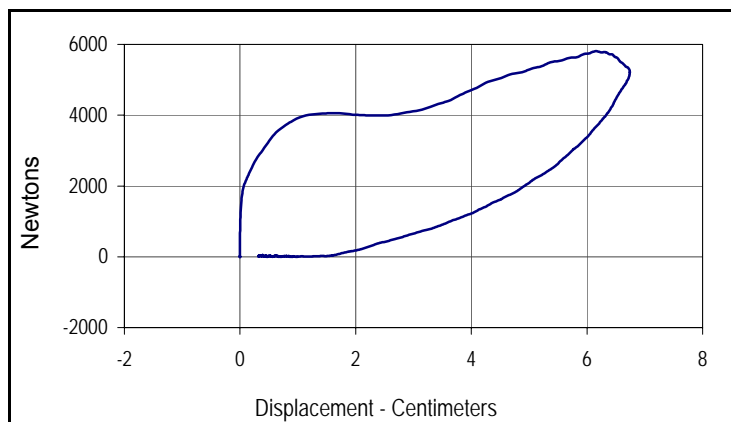
Curve Description			
Probe Force vs. Chest Deflection			
Plot No.	Type	SAE Class	Hysteresis
001	FIL	180	70.9
Peak Probe Force		Peak Chest Deflection	
5808		6.74

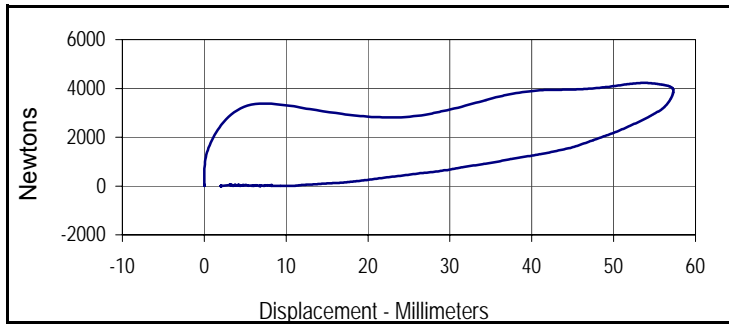
Curve Description			
Probe Force vs. Chest Deflection			
Plot No.	Type	SAE Class	Hysteresis
001	FIL	180	73.1
Peak Probe Force		Peak Chest Deflection	
4224.2		57.3
