**REPORT NUMBER: NCAP-MGA-2013-028**

**NEW CAR ASSESSMENT PROGRAM (NCAP)  
Frontal Barrier Impact Test**

**TOYOTA MOTOR CORPORATION  
2013 Lexus ES 350 4-Dr Sedan  
NHTSA No.: YD5106**

**MGA RESEARCH CORPORATION  
5000 Warren Road  
Burlington, WI 53105**

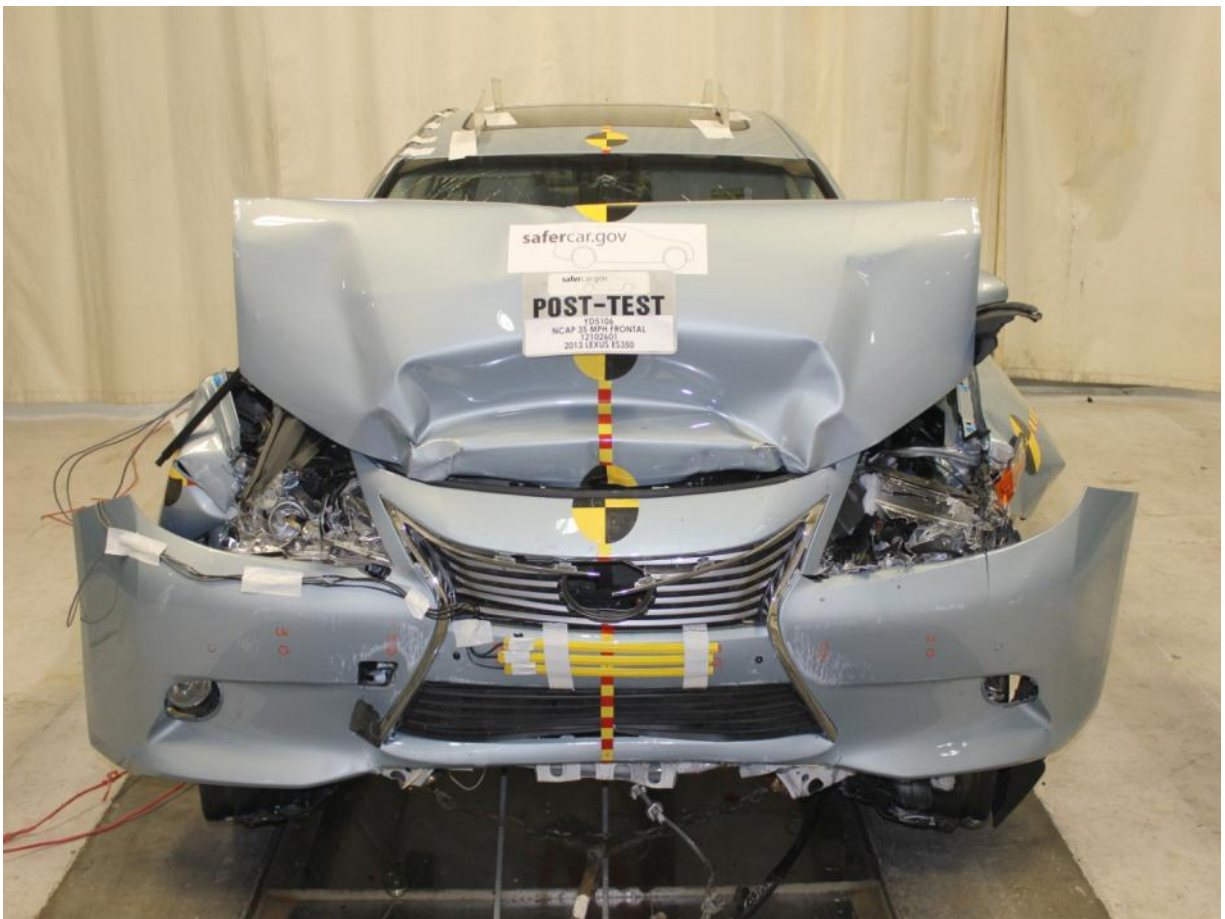
Post-Test Front View of Test Vehicle

The maximum static crush of the vehicle was 532 mm and both the driver and passenger side doors remained closed during the impact event and were operable after the impact.

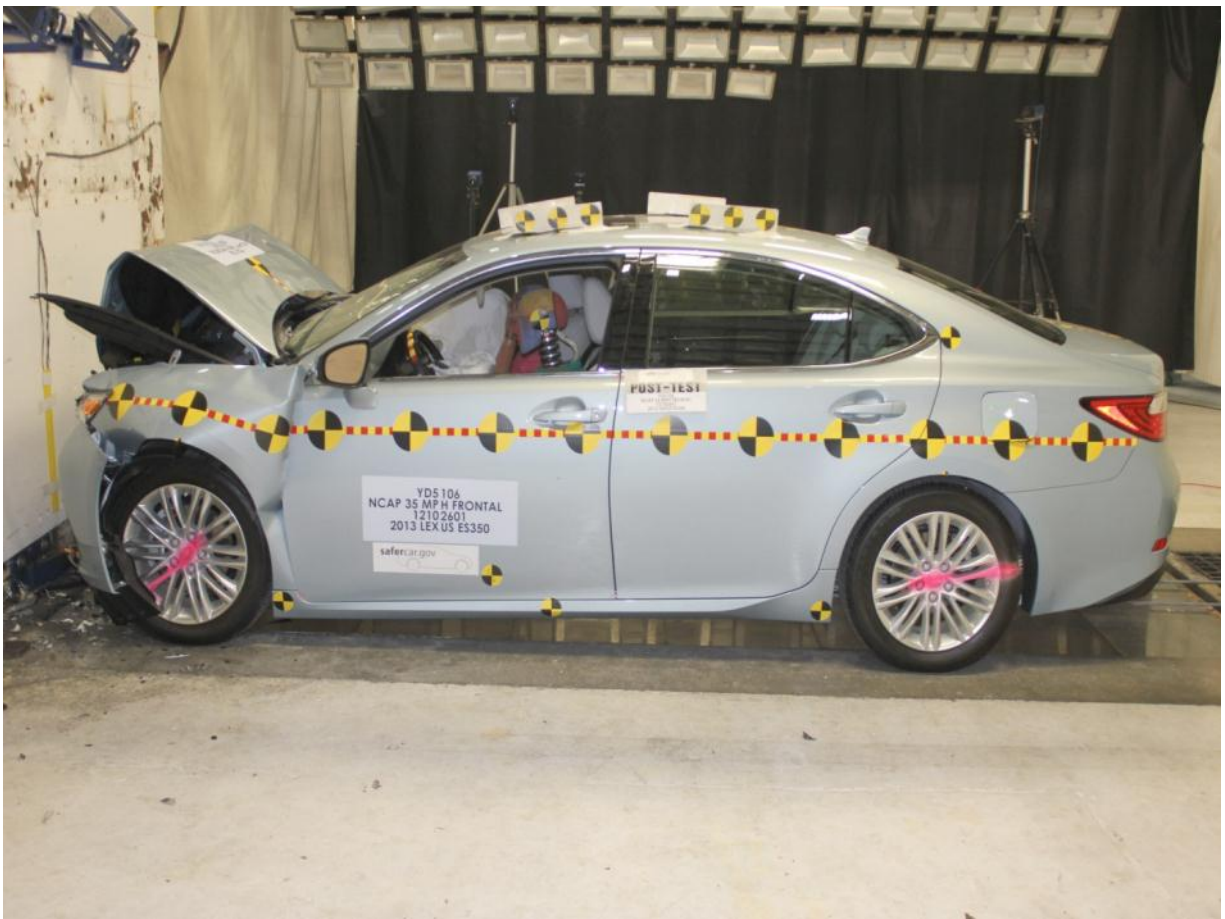
Post-Test Left View of Test Vehicle

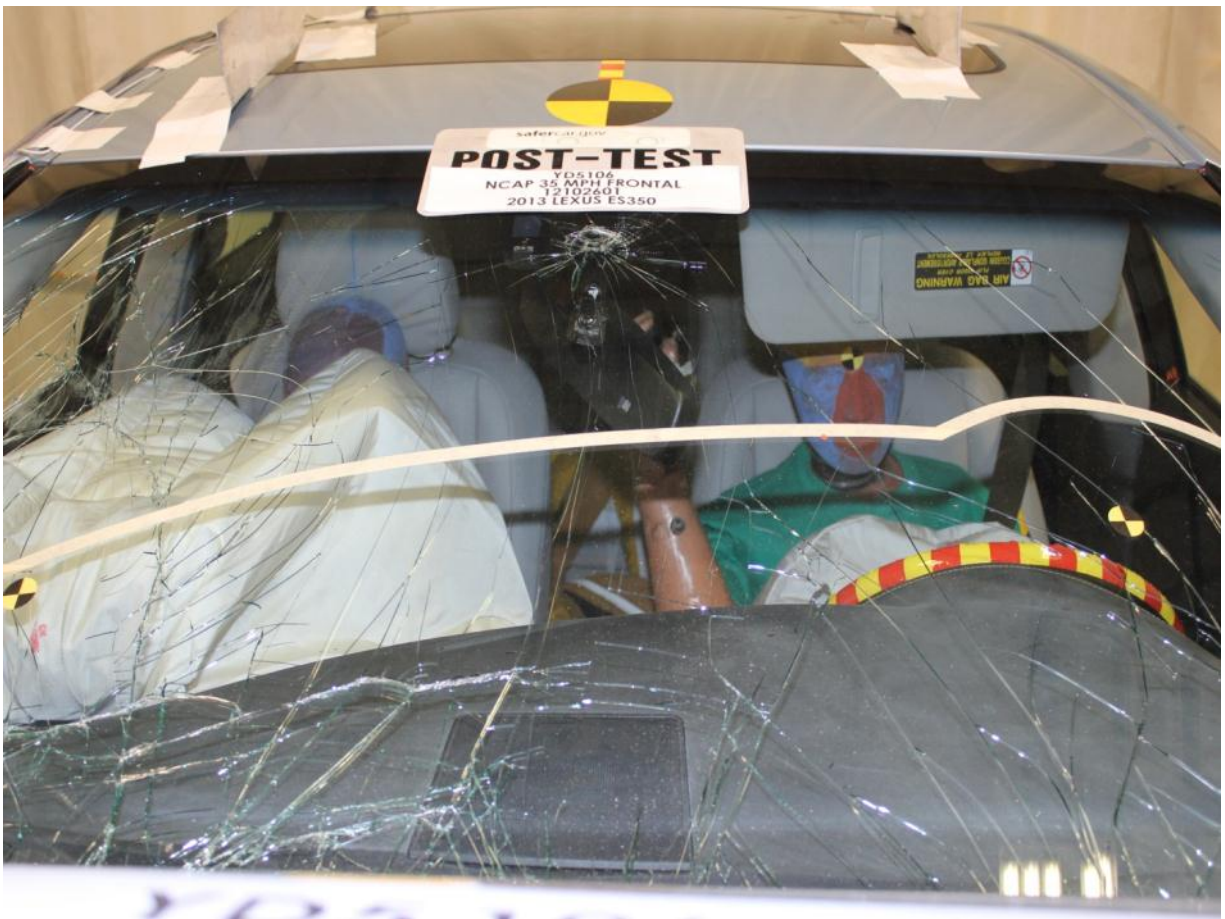
Post-Test Windshield View

There was 100 percent windshield retention and no intrusion into the protected zone of the windshield during the event. There was no Stoddard Solvent leakage after the event or during any phase of the static rollover.

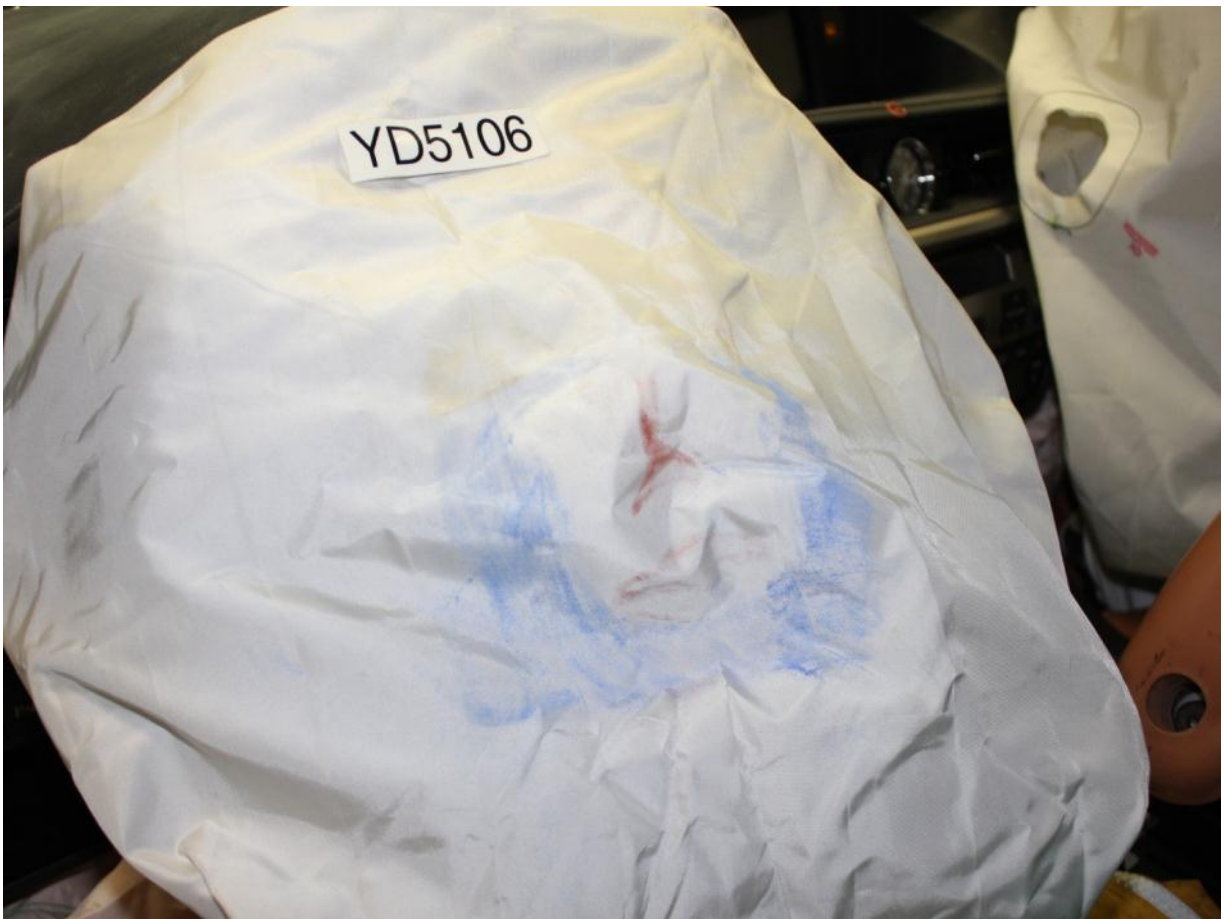
Post-Test Driver Dummy Contact with Airbag

The driver's visible contact points were as follows: The driver's head and chest contacted the airbag. The driver's head also contacted the headrest. The driver's knees contacted the knee airbag. The passenger's visible contact points were as follows: The passenger's head and chest contacted the airbag. The passenger's head also contacted the headrest. The passenger's knees contacted the knee airbag.

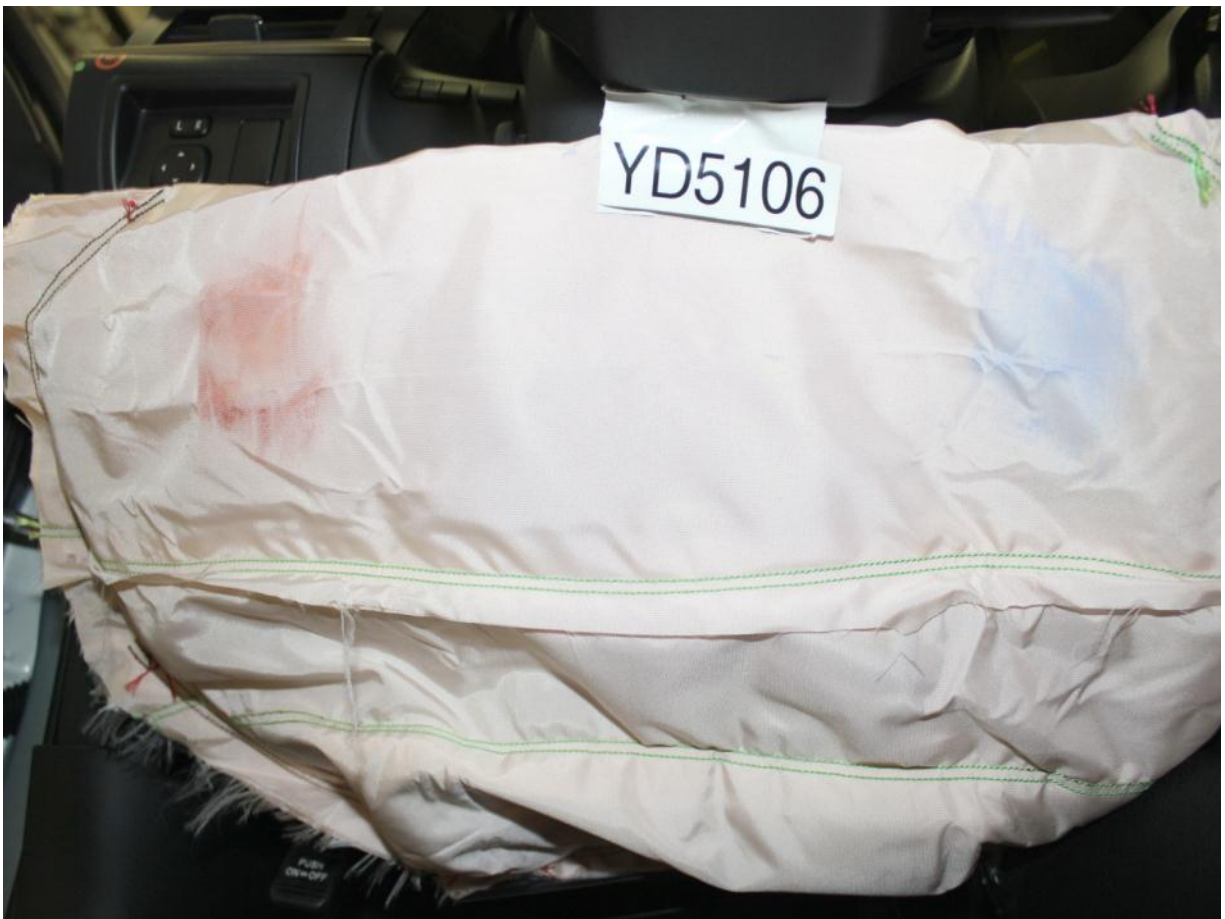
Post-Test Driver Dummy Contact with Knee Airbag

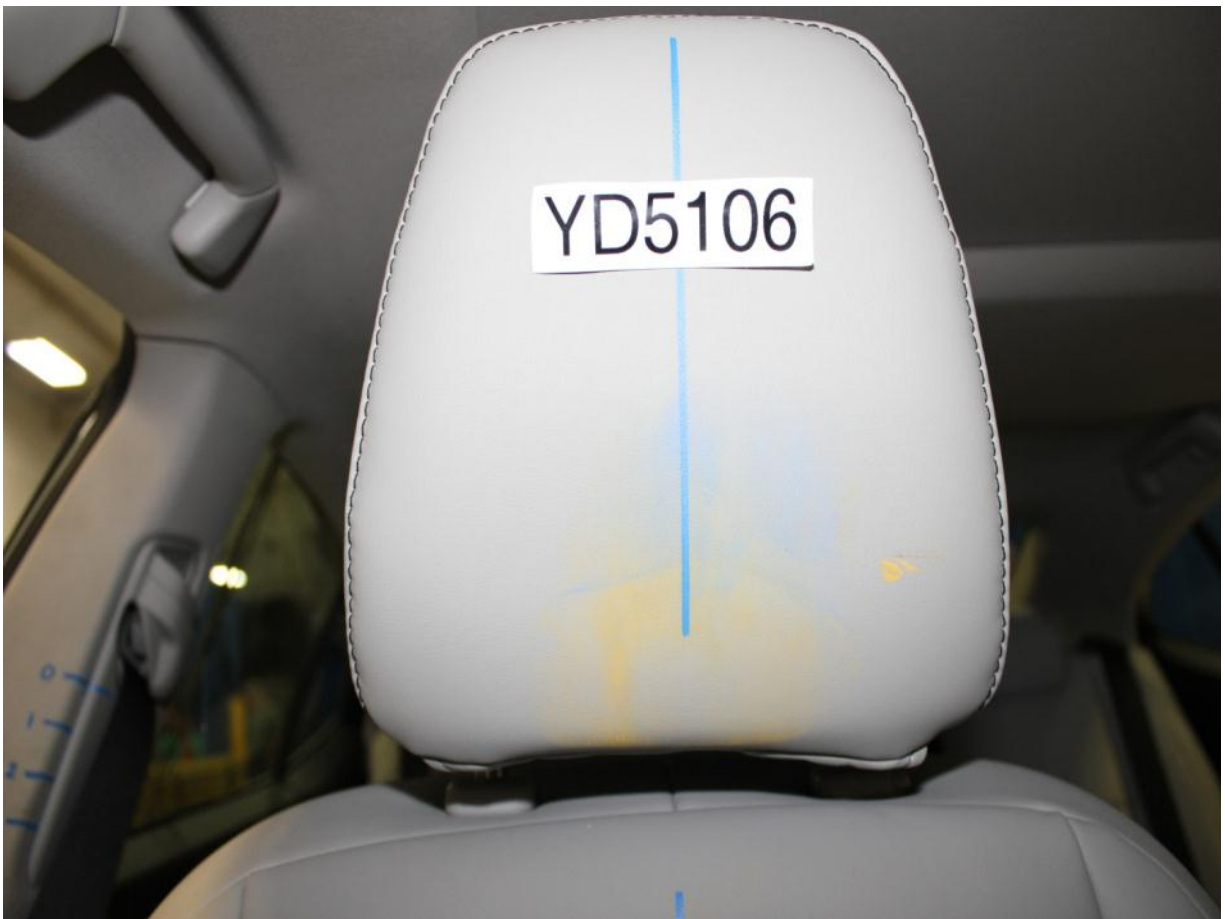
Post-Test Passenger Dummy Contact with Headrest

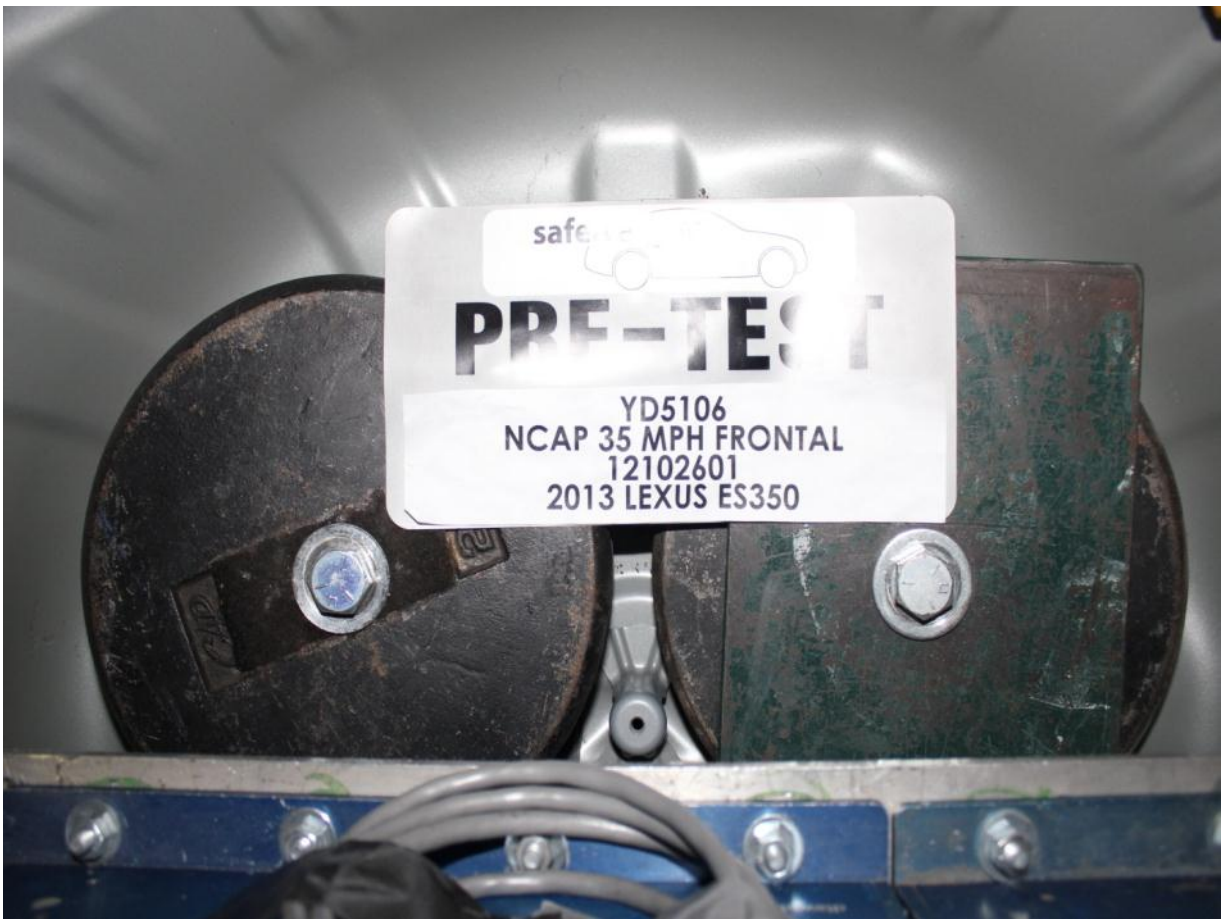
Ballast Installed in Vehicle
