**REPORT NUMBER: SINCAP-MGA-2013-027**

**NEW CAR ASSESSMENT PROGRAM (NCAP)  
Moving Deformable Barrier Side Impact Test**

**TOYOTA MOTOR CORPORATION  
2013 Lexus ES 350 4-Dr Sedan  
NHTSA No.: YD5108**

**FINAL REPORT**

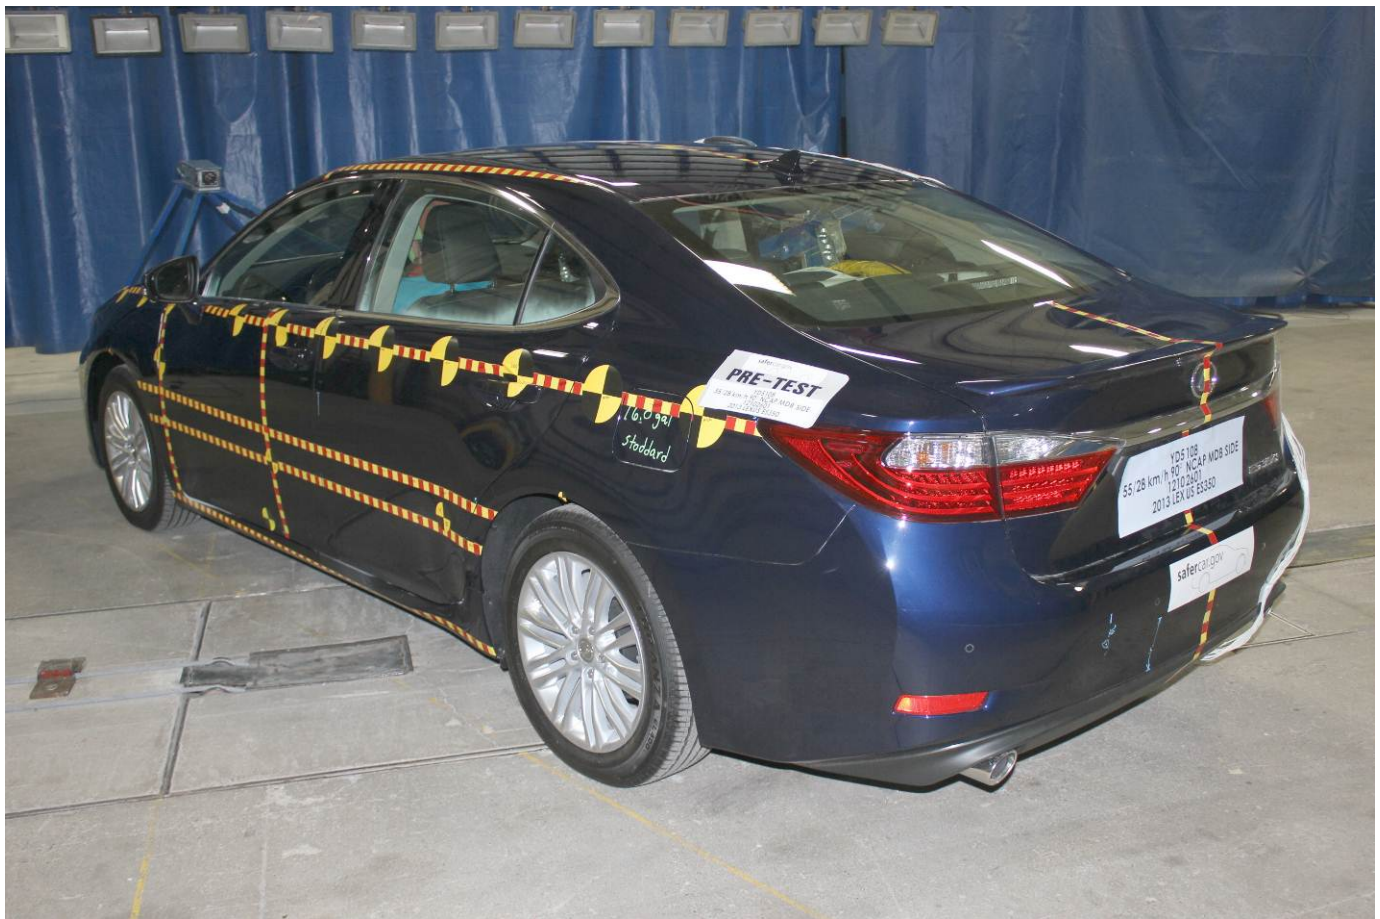
Post-Test Left Side View of Test Vehicle

| Critical Areas of Performance | Observations and Conclusions |
|---|---|
| Side Window Damage | Left Front Window Broke |

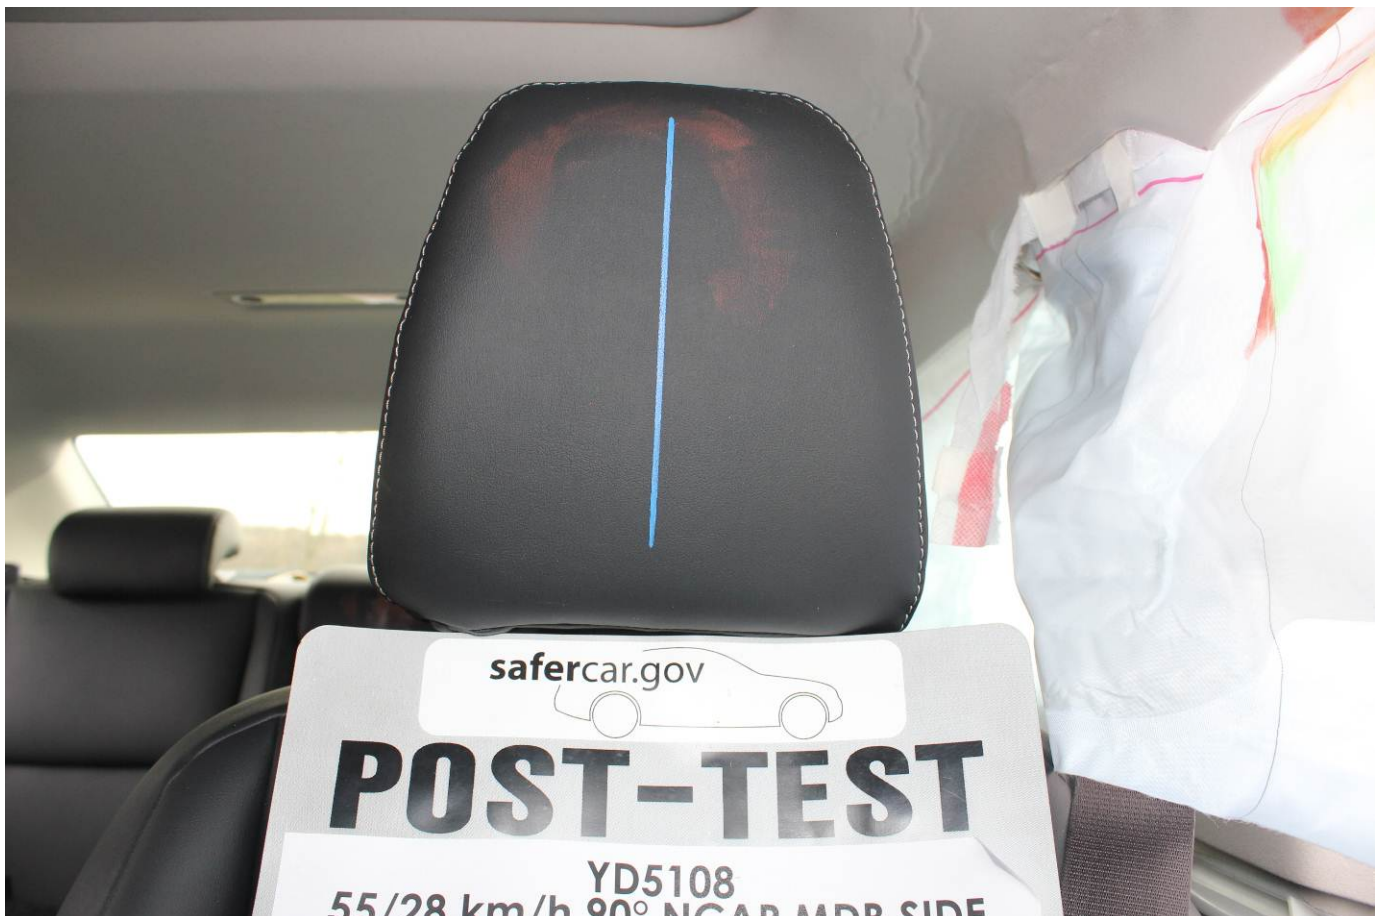
Post-Test Driver Dummy Close-up Head Contact with Vehicle Interior View

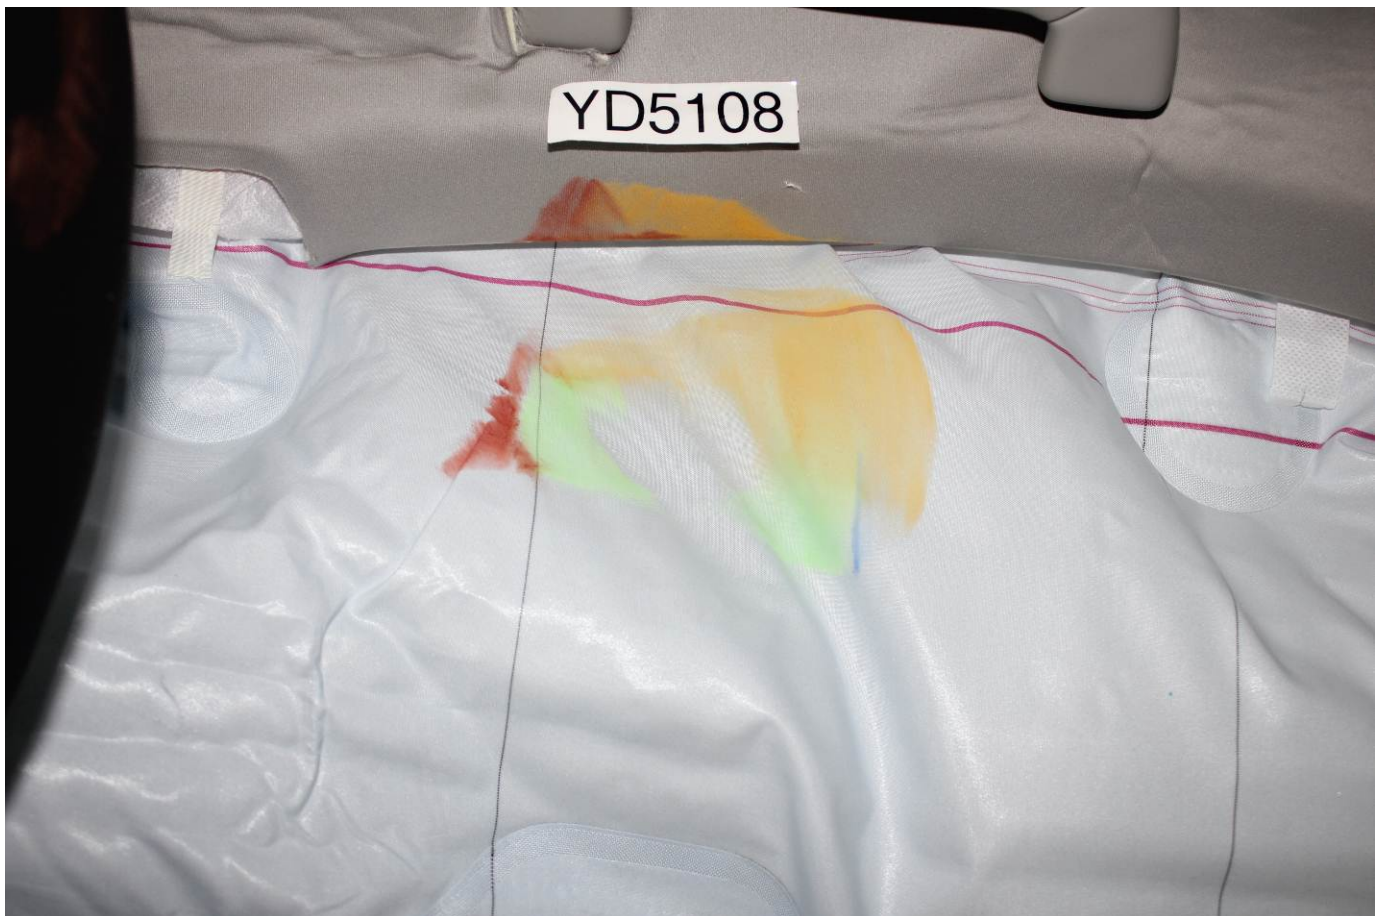
Post-Test Driver Dummy Close-up Head Contact with Side Airbag View

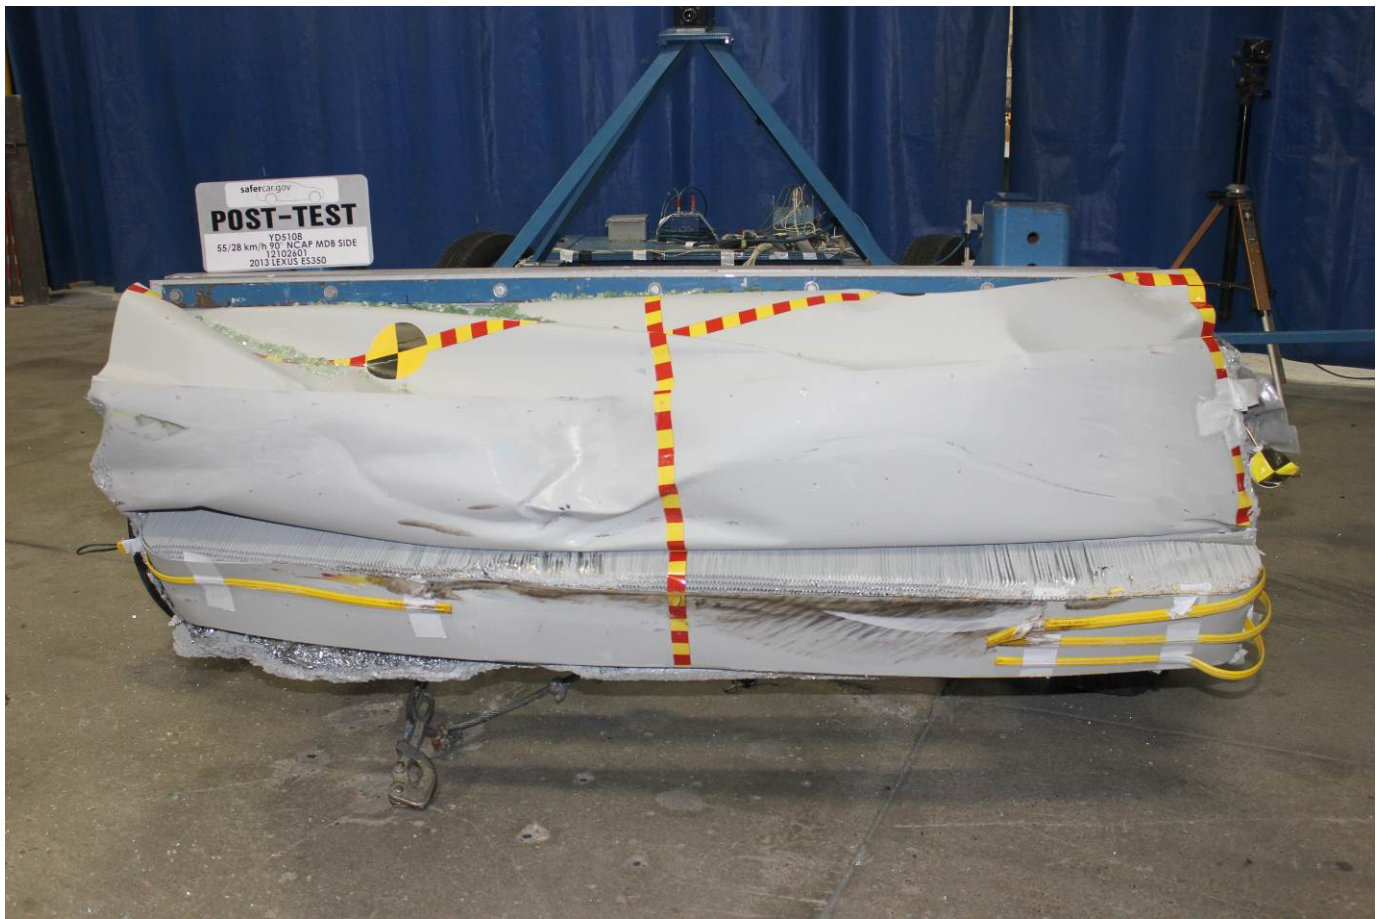
Post-Test Front View of MDB Impactor Face
