**REPORT NUMBER: SINCAP-CAL-12-010**

**NEW CAR ASSESSMENT PROGRAM (NCAP)  
MOVING DEFORMABLE BARRIER SIDE IMPACT TEST**

**FUJI Heavy Industries LTD  
2013 Subaru Outback  
Five Door Hatchback**

**NHTSA No: SD5501**

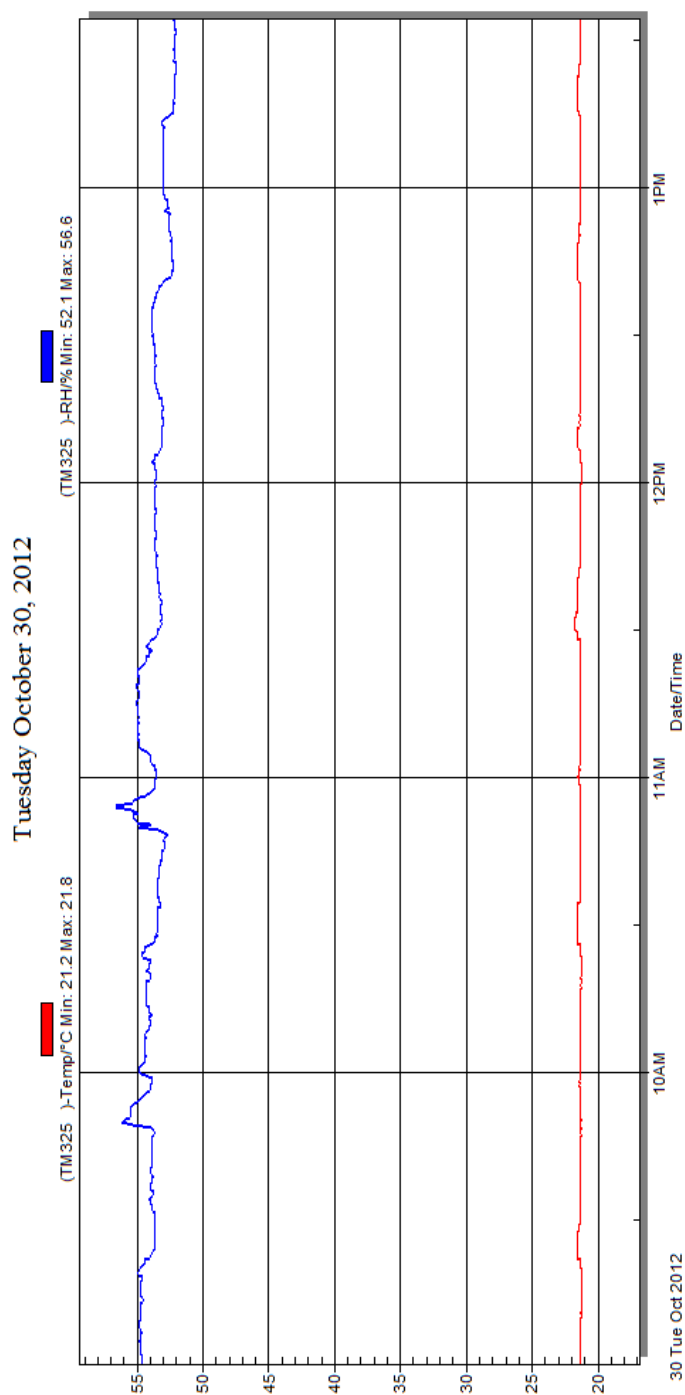
**Temperature and Humidity Stabilization Chart/Data for Dummies and Test Vehicle**

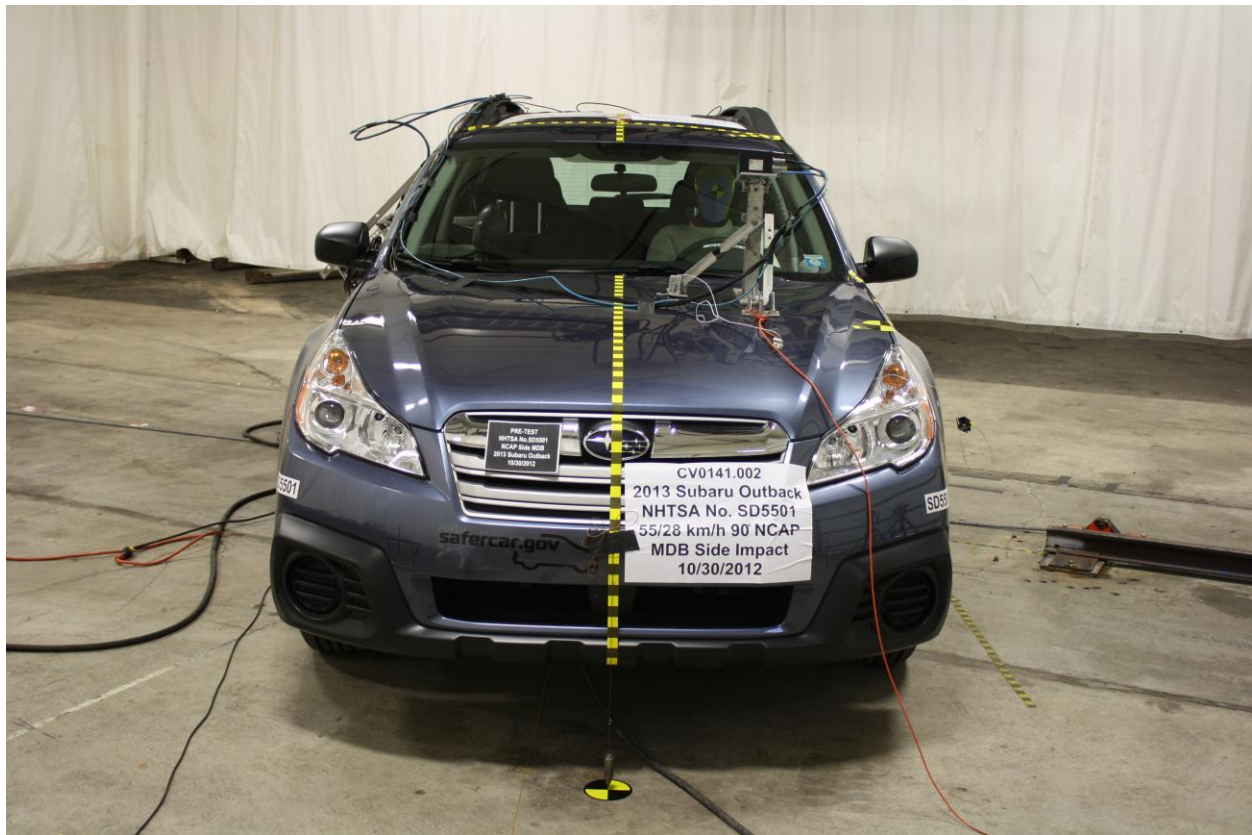
**Figure A-3: Pre-Test Frontal View of Test Vehicle**

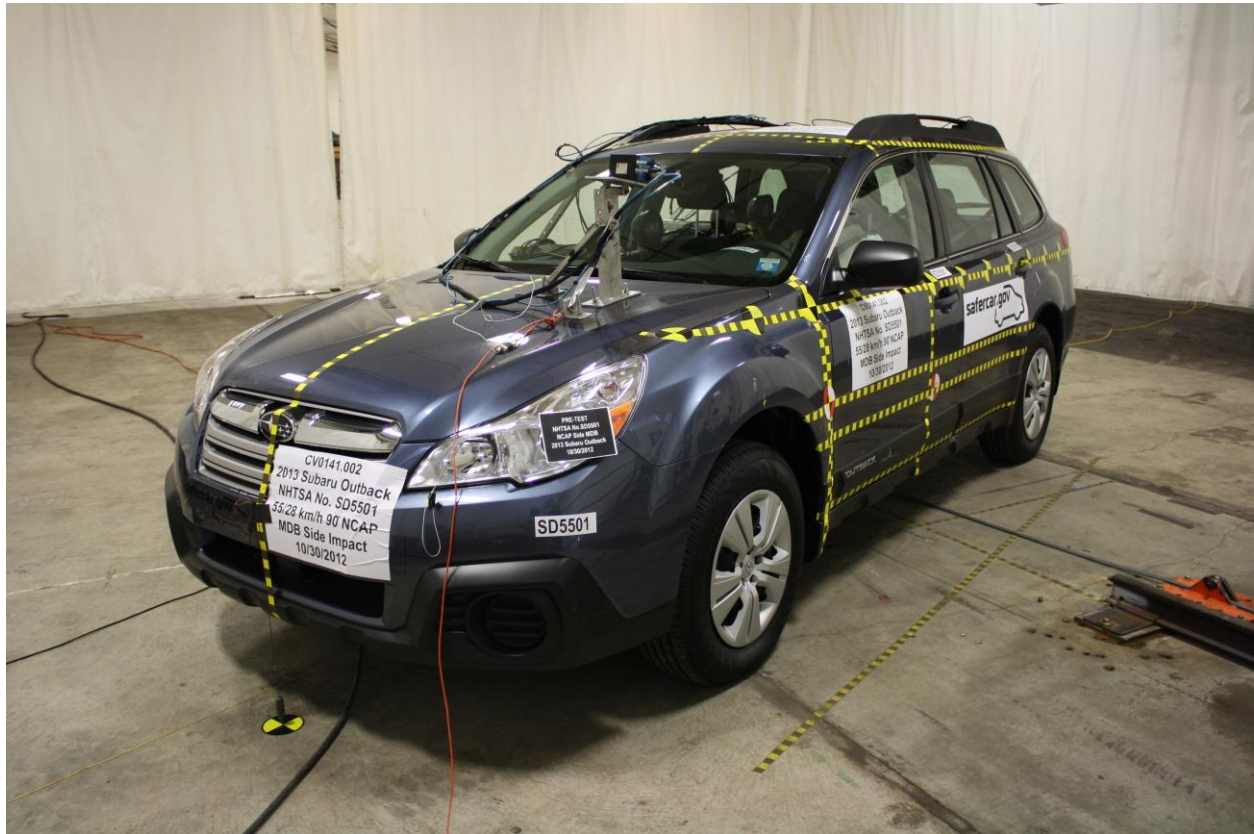
**Figure A-5: Pre-Test Left Front  $\frac{3}{4}$  View of Test Vehicle**

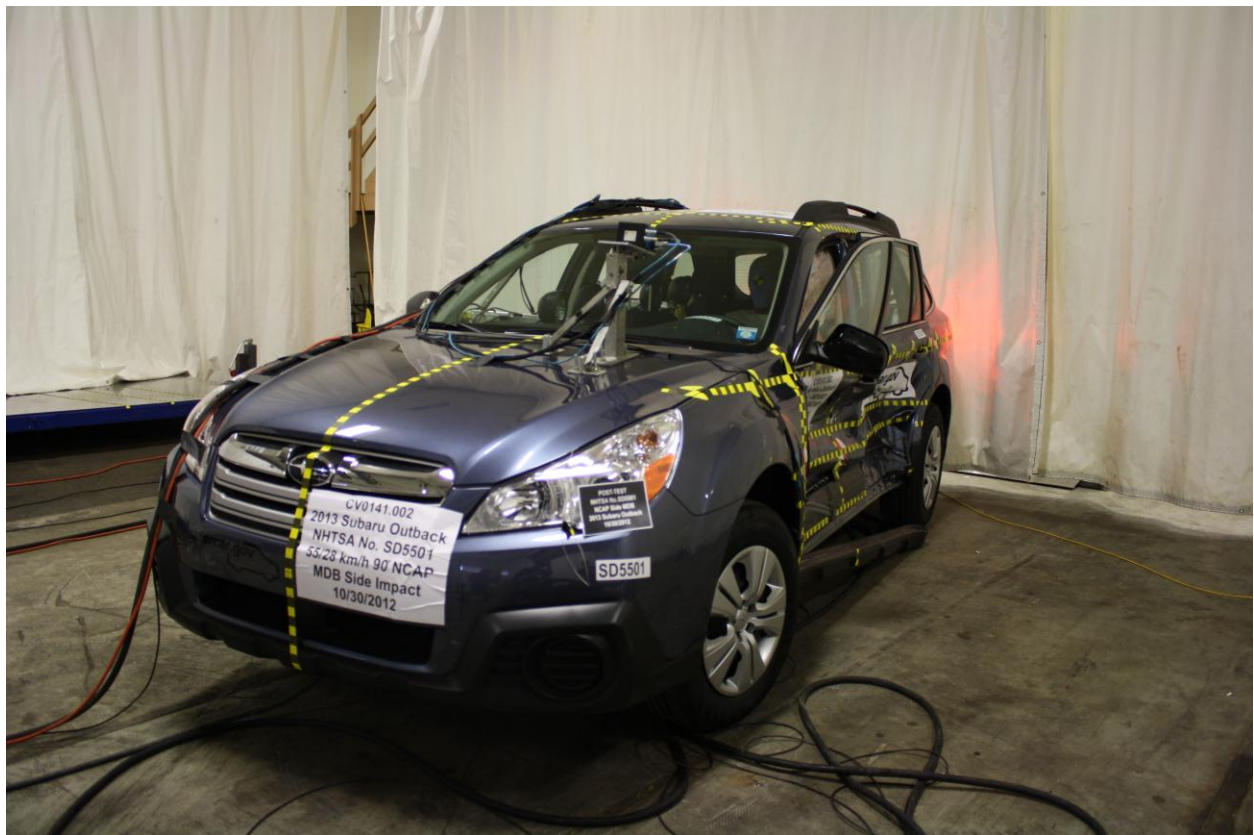
**Figure A-6: Post-Test Left Front  $\frac{3}{4}$  View of Test Vehicle**

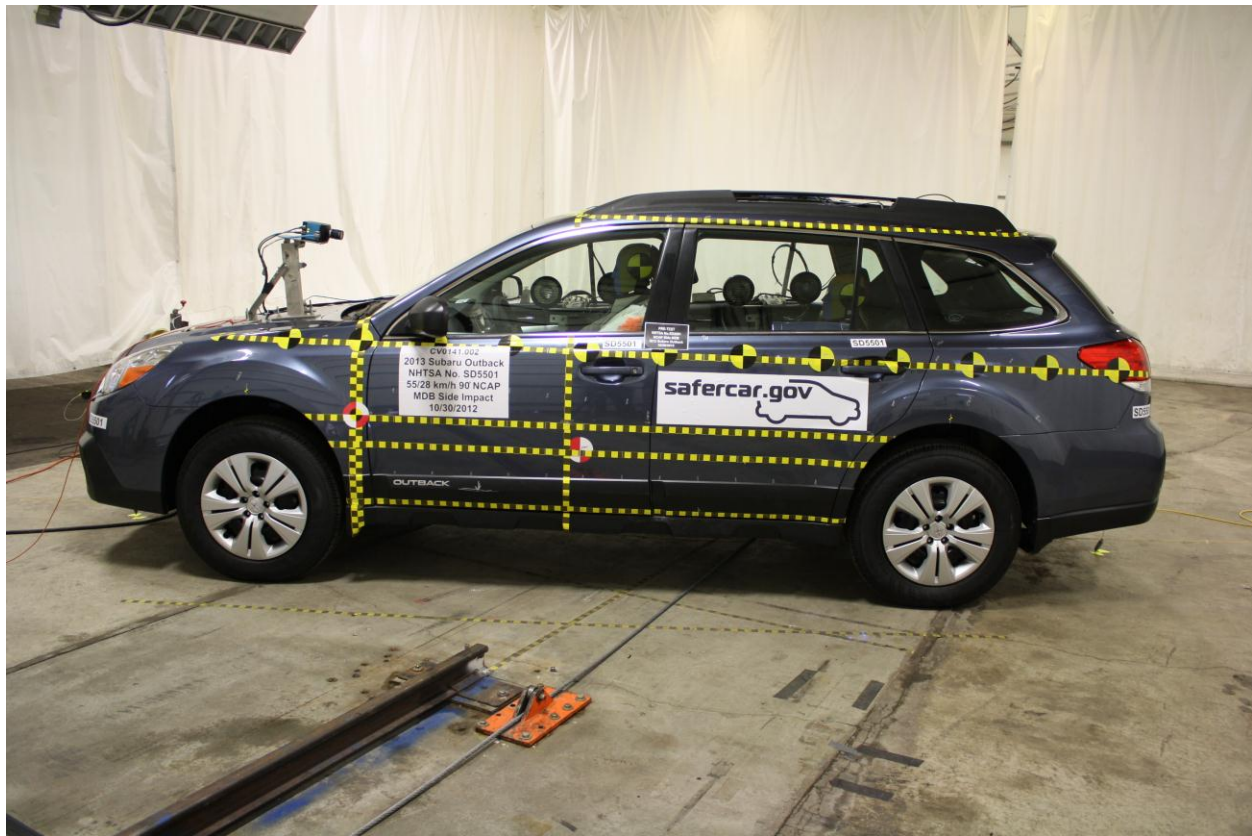
**Figure A-7: Pre-Test Left Side View of Test Vehicle**

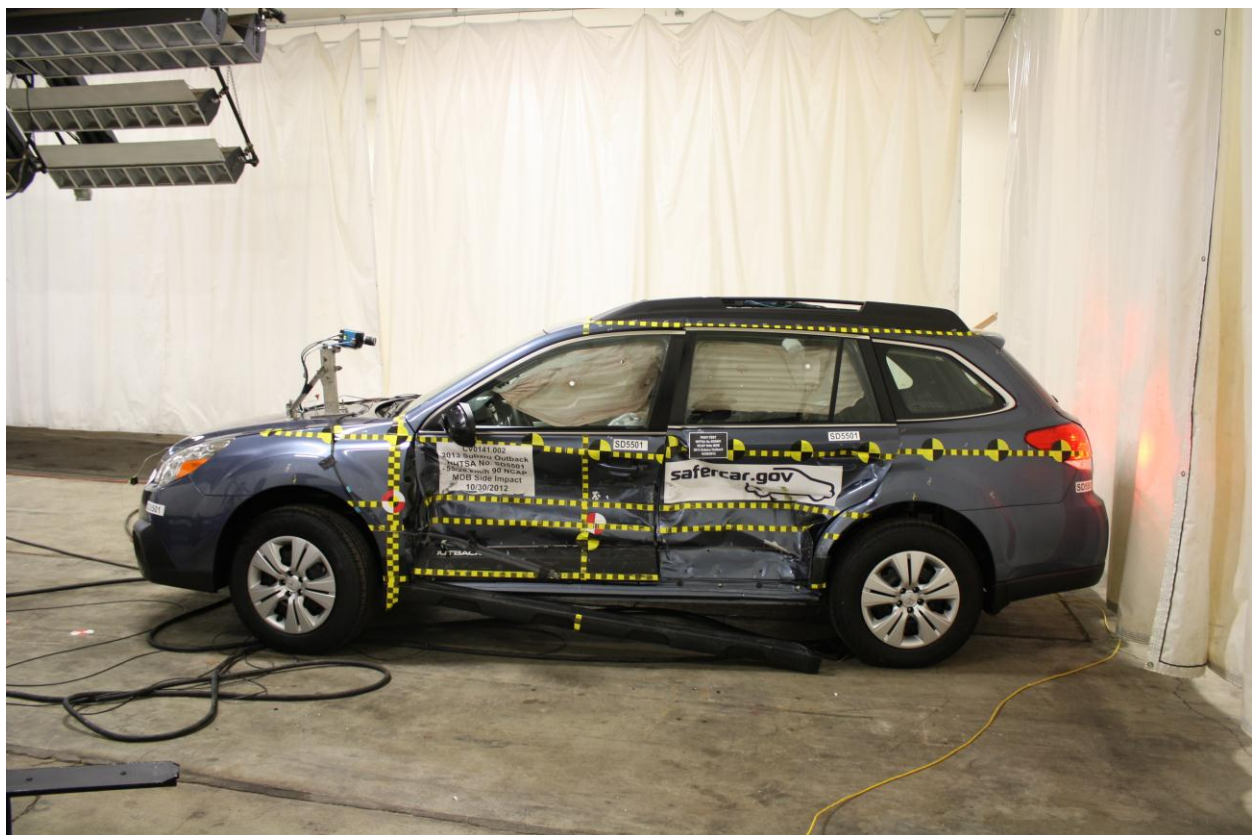
**Figure A-8: Post-Test Left Side View of Test Vehicle**

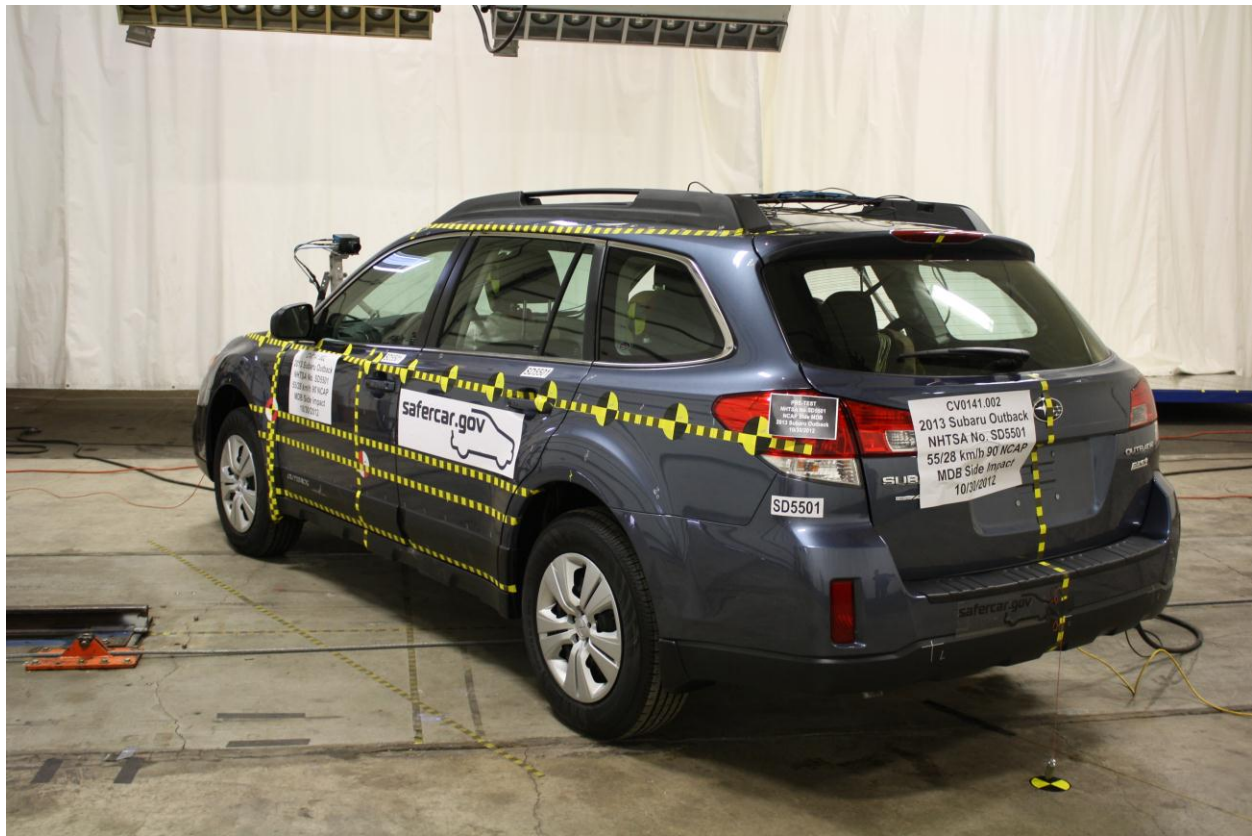
**Figure A-9: Pre-Test Left Rear  $\frac{3}{4}$  View of Test Vehicle**

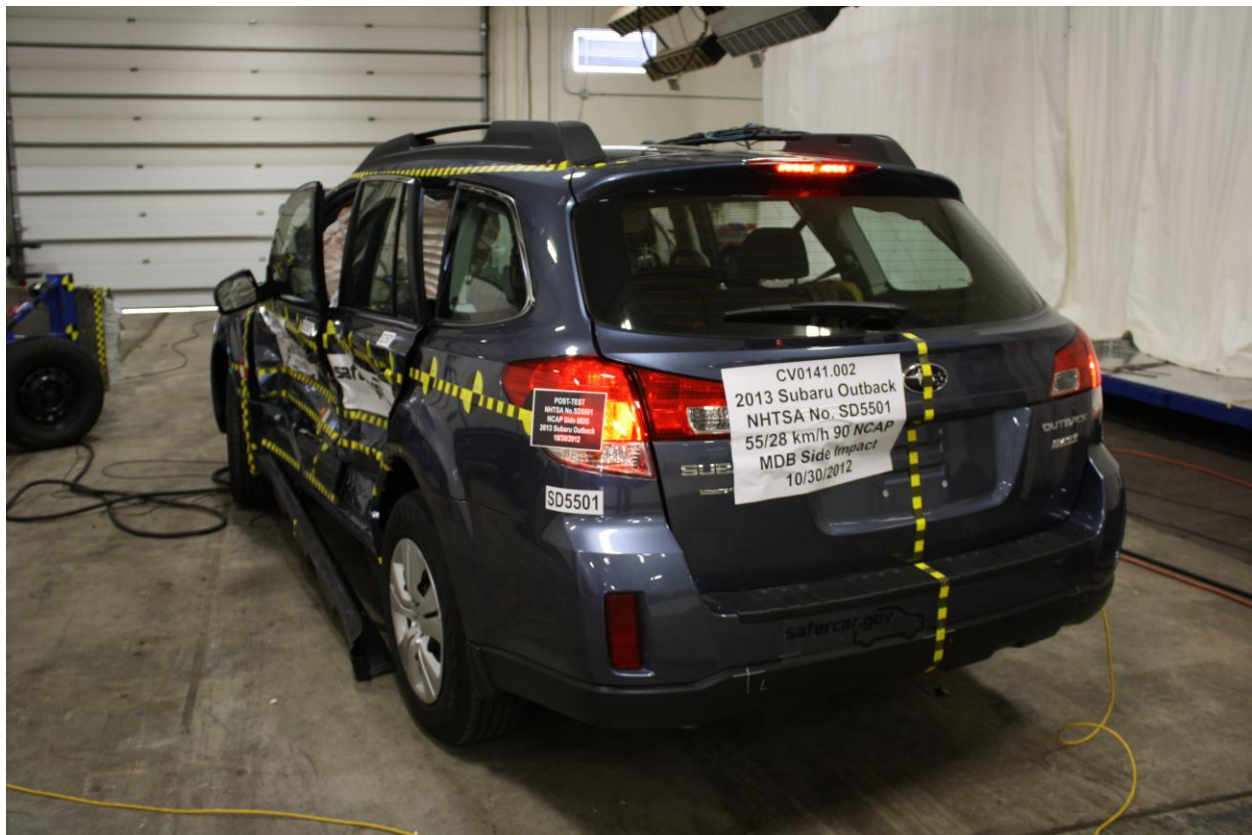
**Figure A-10: Post-Test Left Rear  $\frac{3}{4}$  View of Test Vehicle**

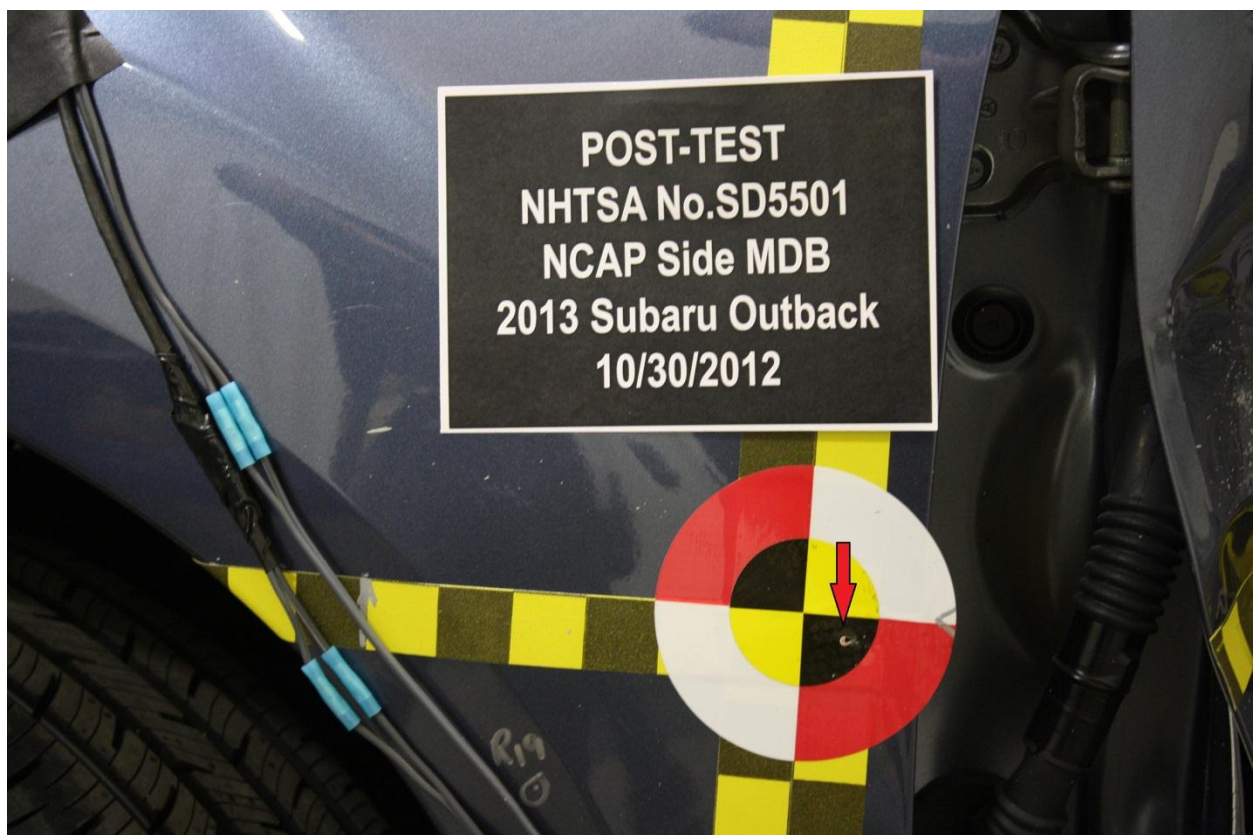
Figure A-20: Post-Test Close-up View of Impact Point Target

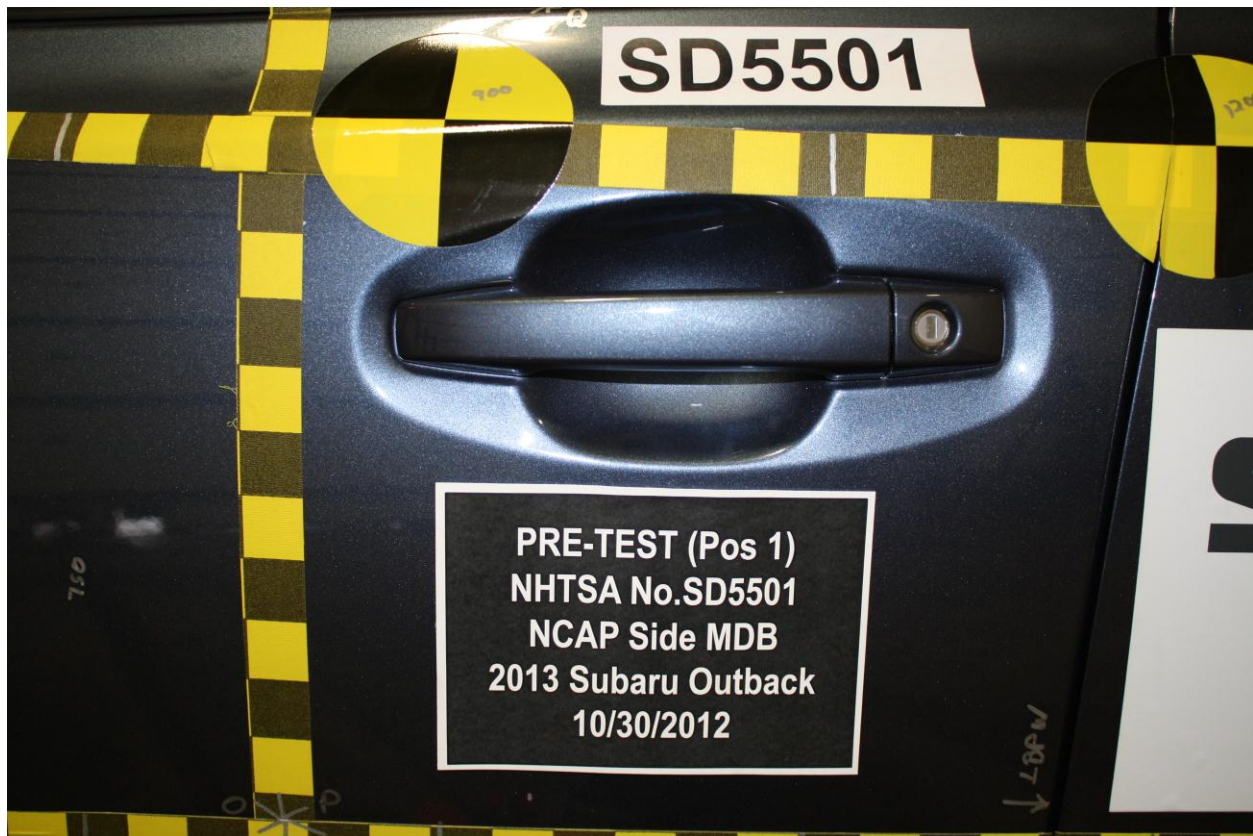
Figure A-21: Pre-Test Left Front Door Latch Close-Up

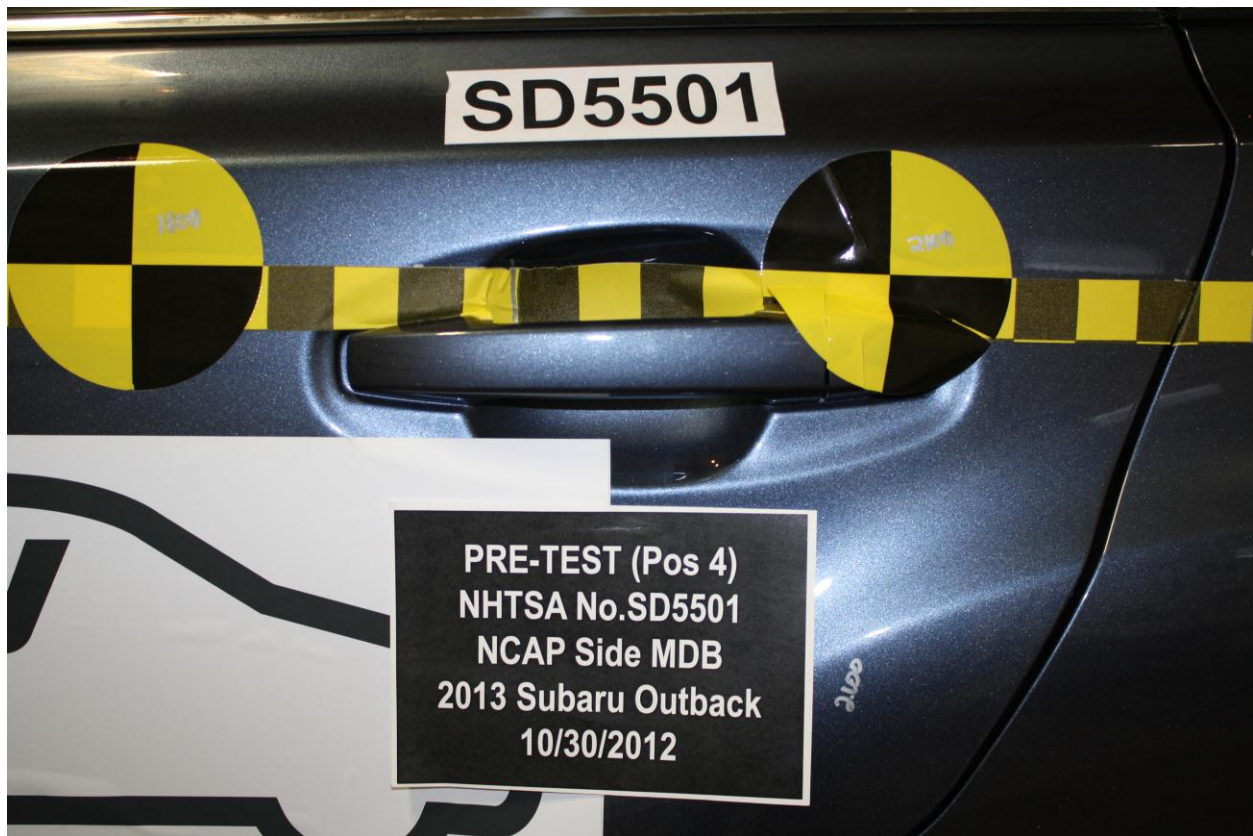
**Figure A-23: Pre-Test Left Rear Door Latch Close-Up**

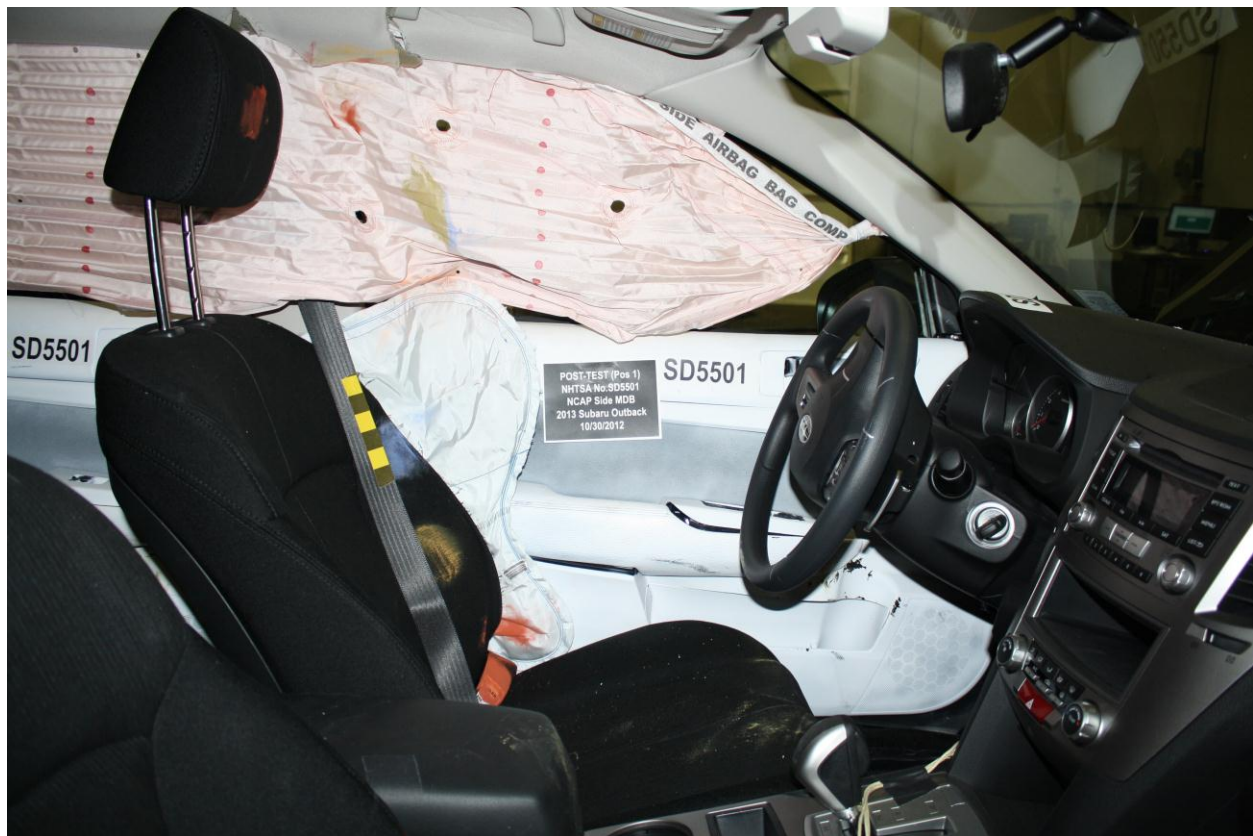
**Figure A-47: Post-Test Driver Inner Door Panel View**

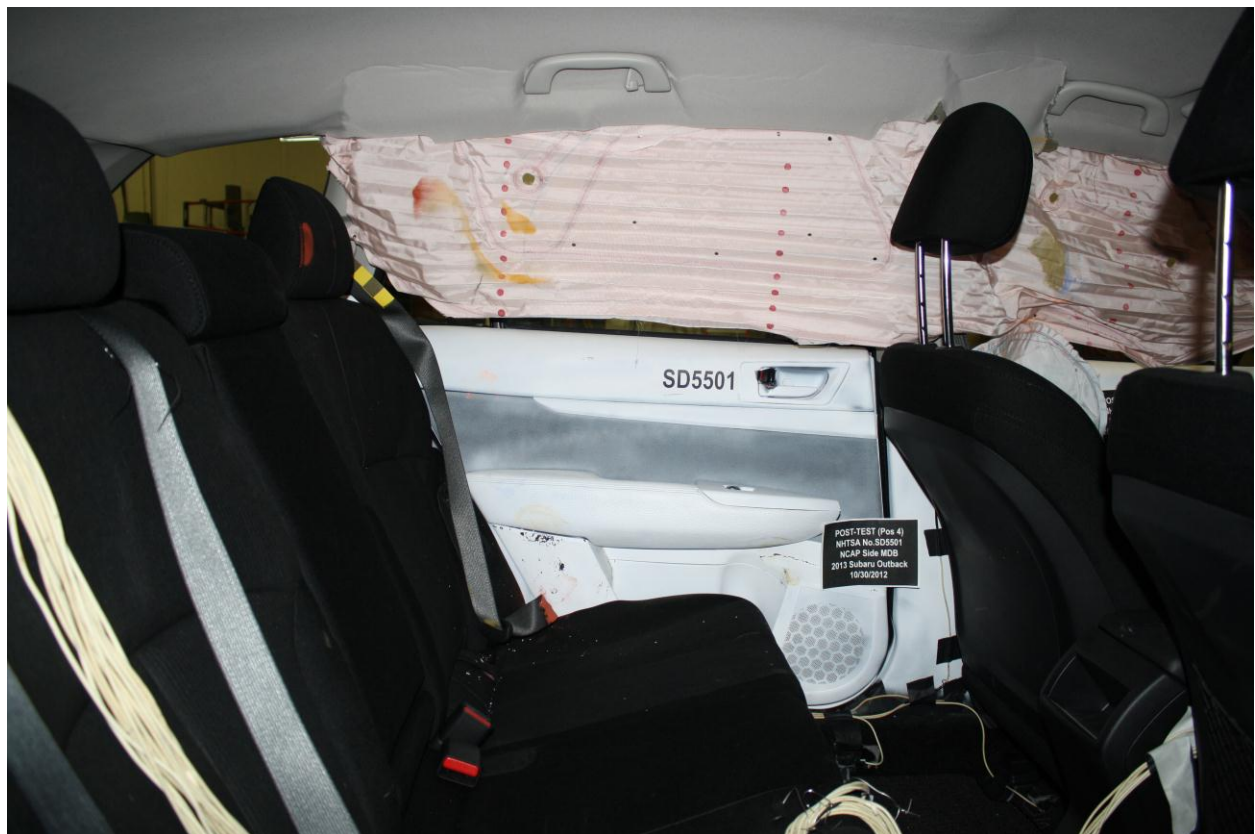
**Figure A-74: Post-Test Passenger Inner Door Panel View**

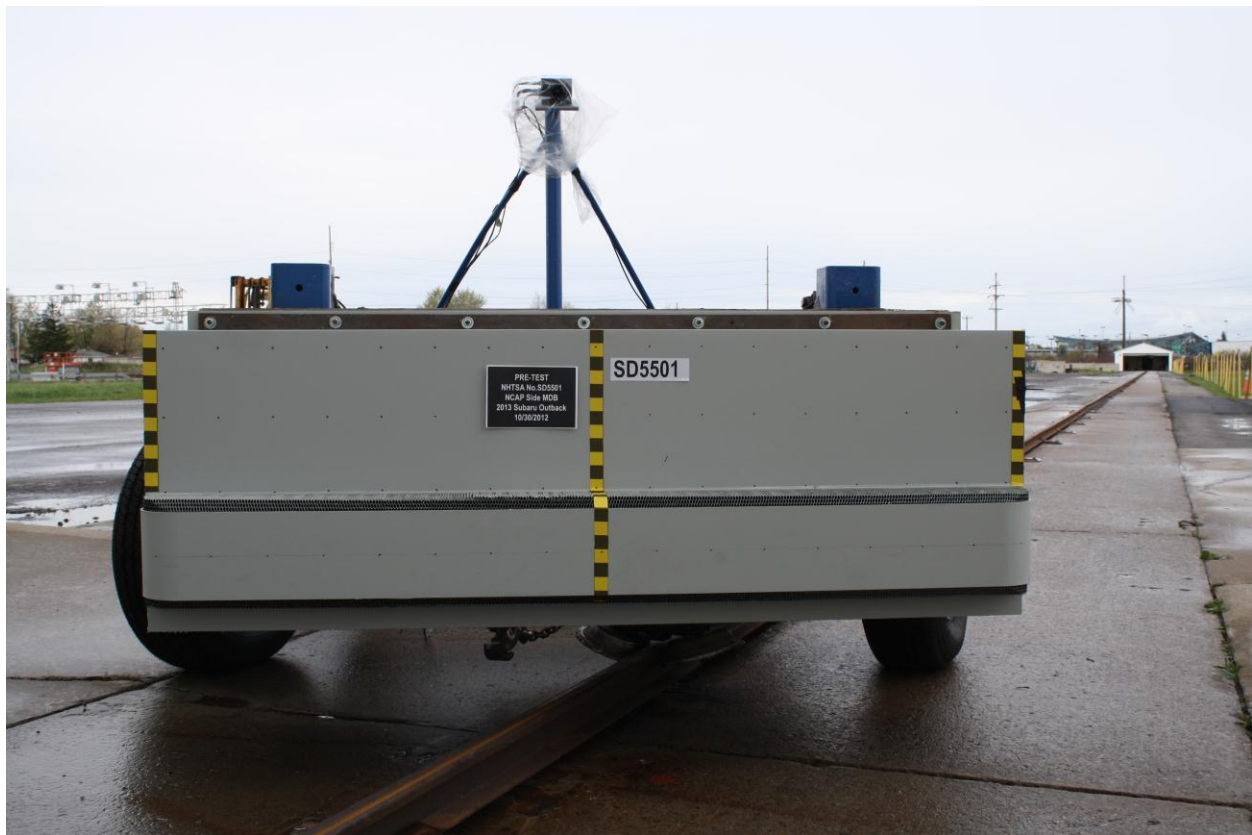
**Figure A-84: Pre-Test Front View of MDB Impactor Face**

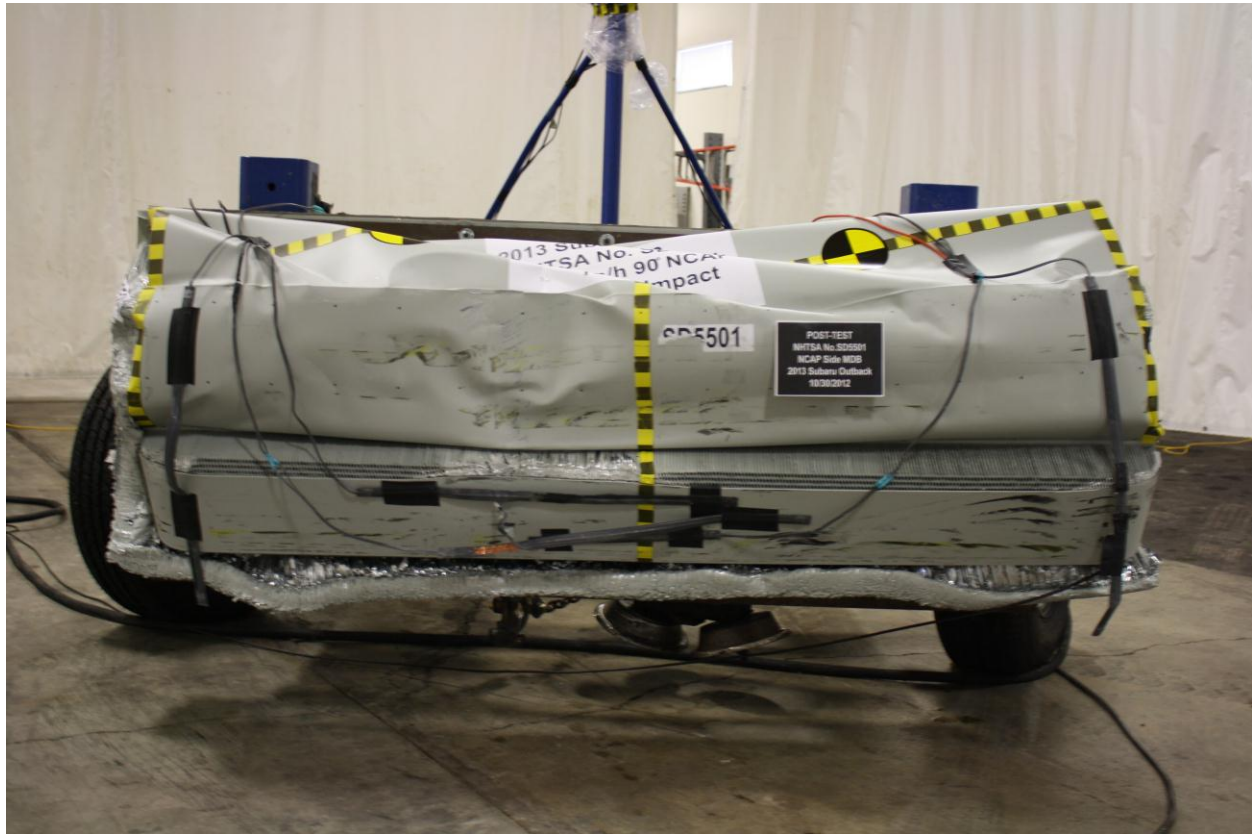
**Figure A-85: Post-Test Front View of MDB Impactor Face**

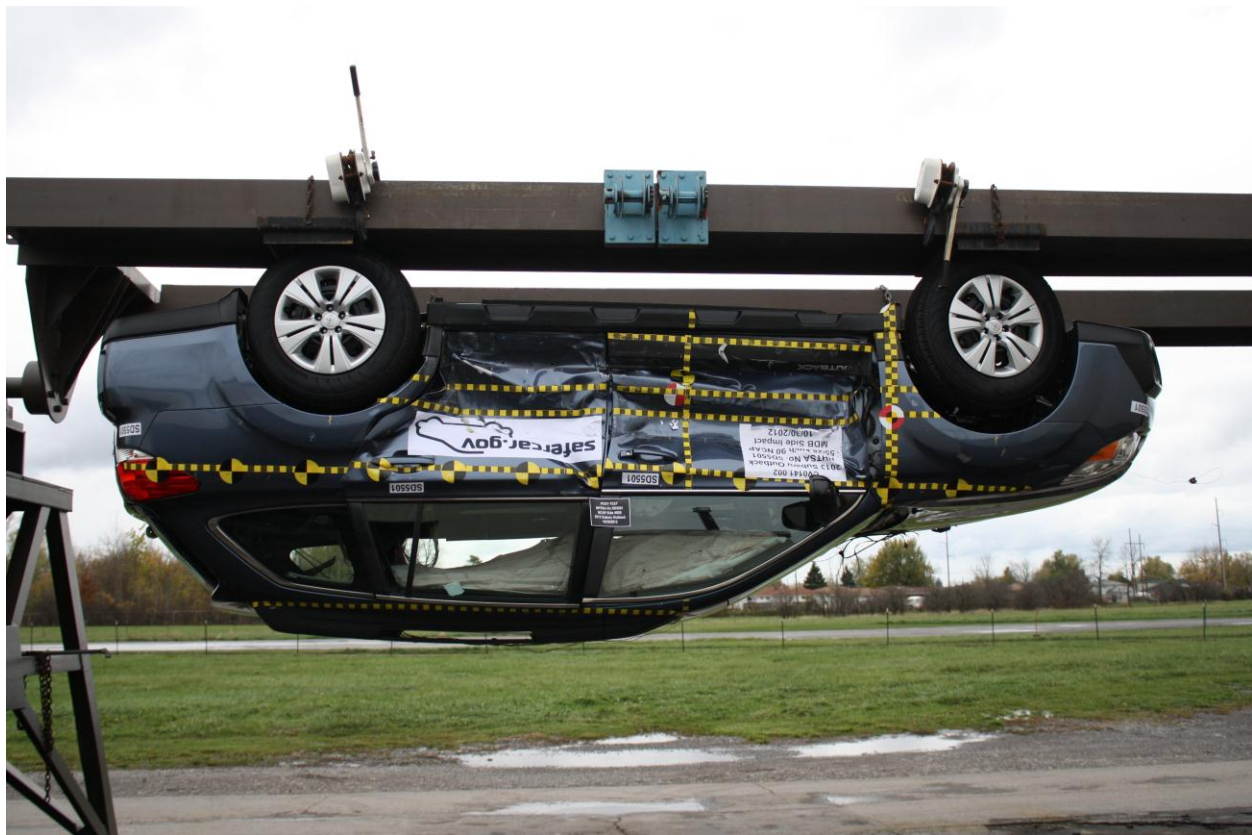
**Figure A-98: FMVSS No. 301 Static Rollover 180 Degrees**

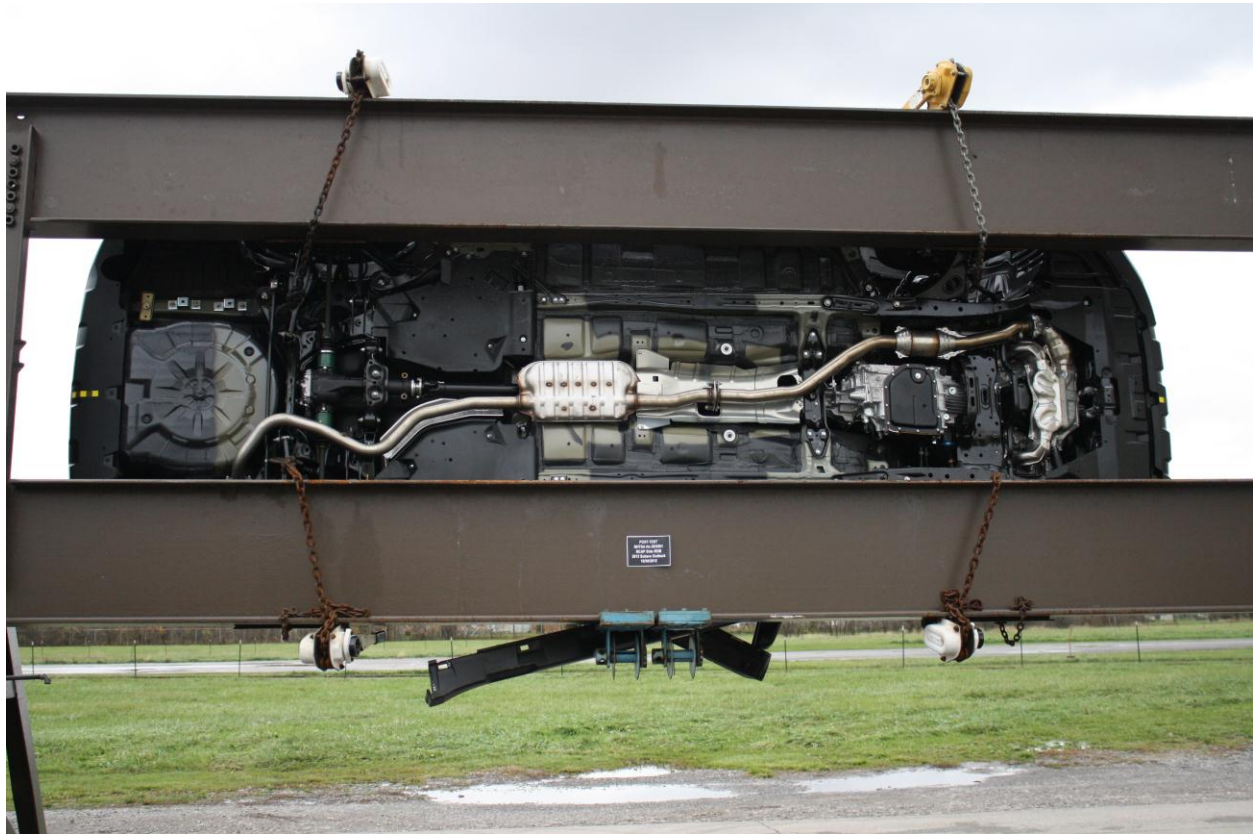
**Figure A-99: FMVSS No. 301 Static Rollover 270 Degrees**

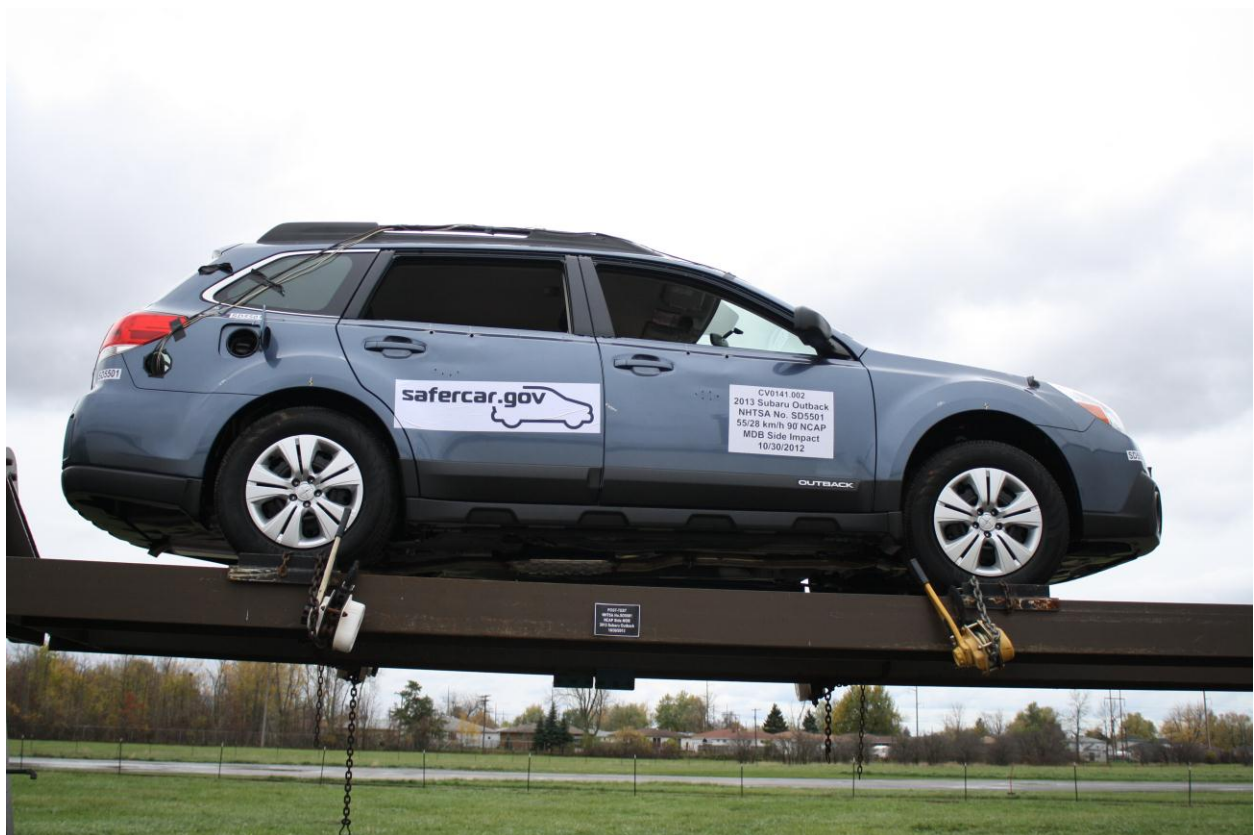
**Figure A-100: FMVSS No. 301 Static Rollover 360 Degrees**

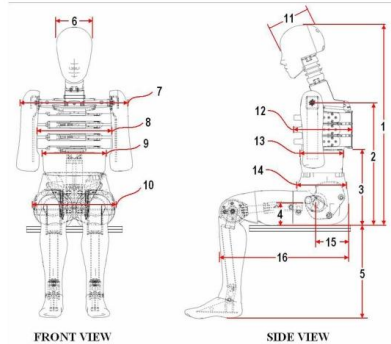
NHTSA SN F033

## ES-2re External Measurements

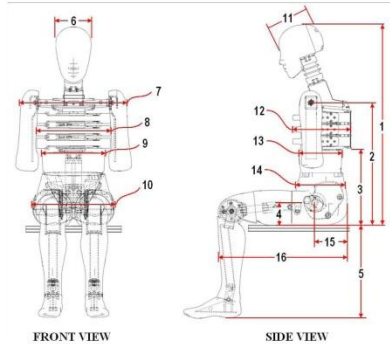
NHTSA SN F033

## ES-2re External Measurements
