**REPORT NUMBER: NCAP-MGA-2013-029**

**NEW CAR ASSESSMENT PROGRAM (NCAP)  
Frontal Barrier Impact Test**

**GENERAL MOTORS LLC  
2013 Chevrolet Cruze LS 4-Dr Sedan  
NHTSA No.: GD0101**

**MGA RESEARCH CORPORATION  
5000 Warren Road  
Burlington, WI 53105**

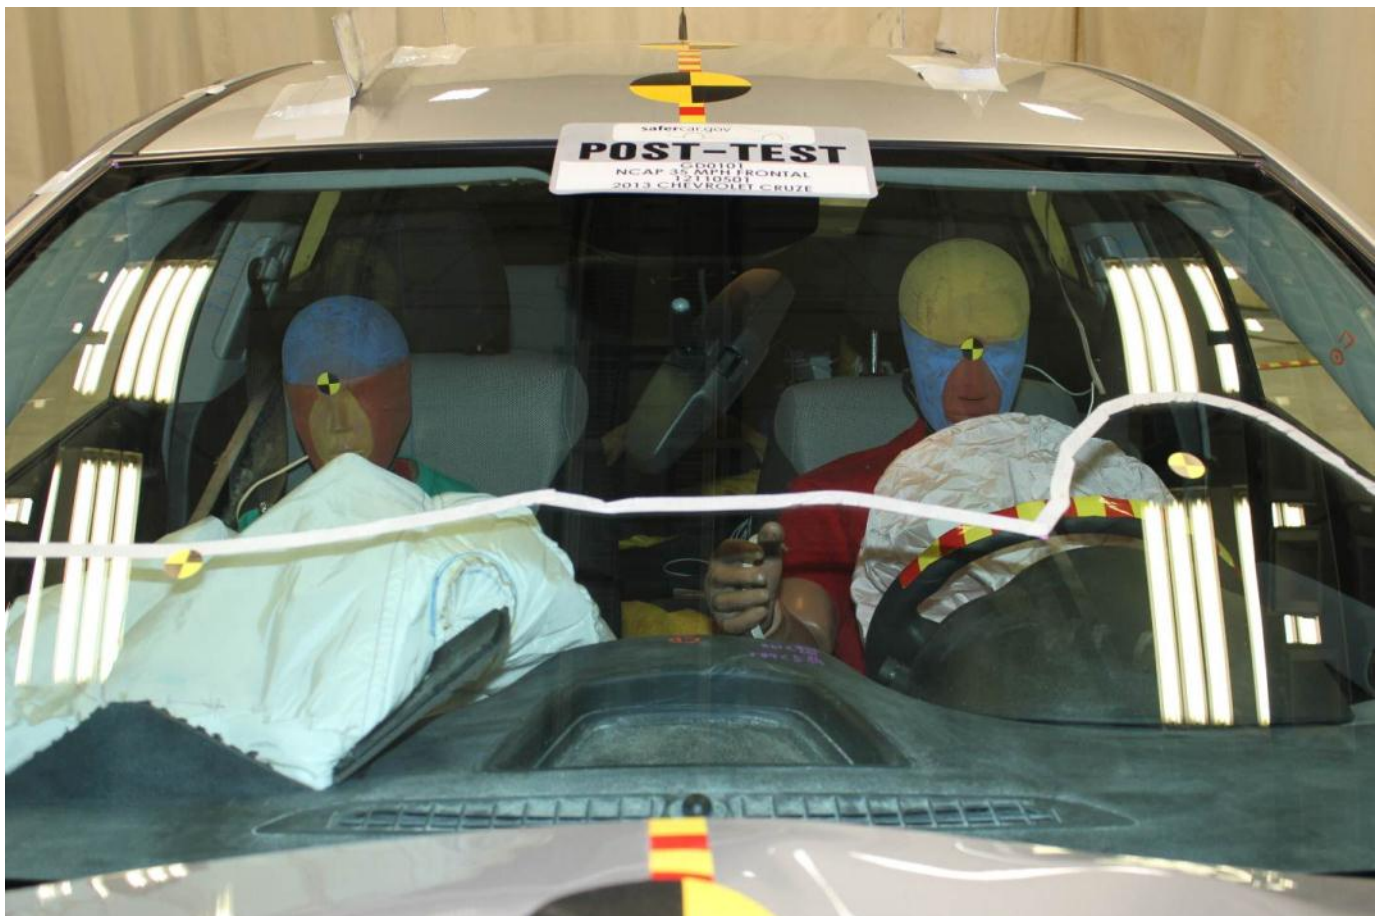
Post-Test Windshield View

There was 100 percent windshield retention and no intrusion into the protected zone of the windshield during the event. There was no Stoddard Solvent leakage after the event or during any phase of the static rollover.

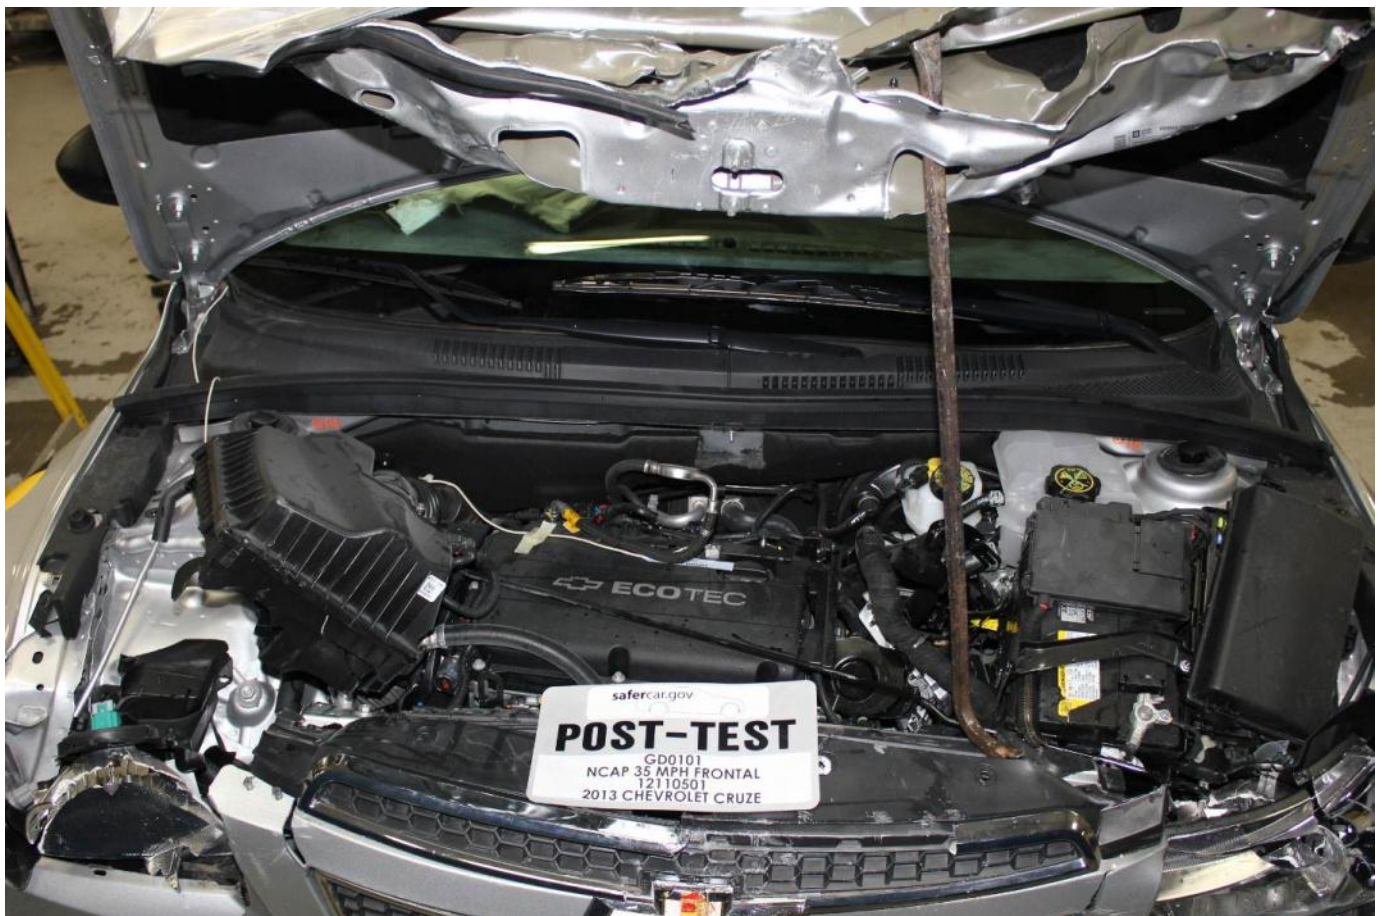
Post-Test Engine Compartment View

Top of Engine X has no valid data after 12 ms.  
The load cell barrier data was not collected for this test.

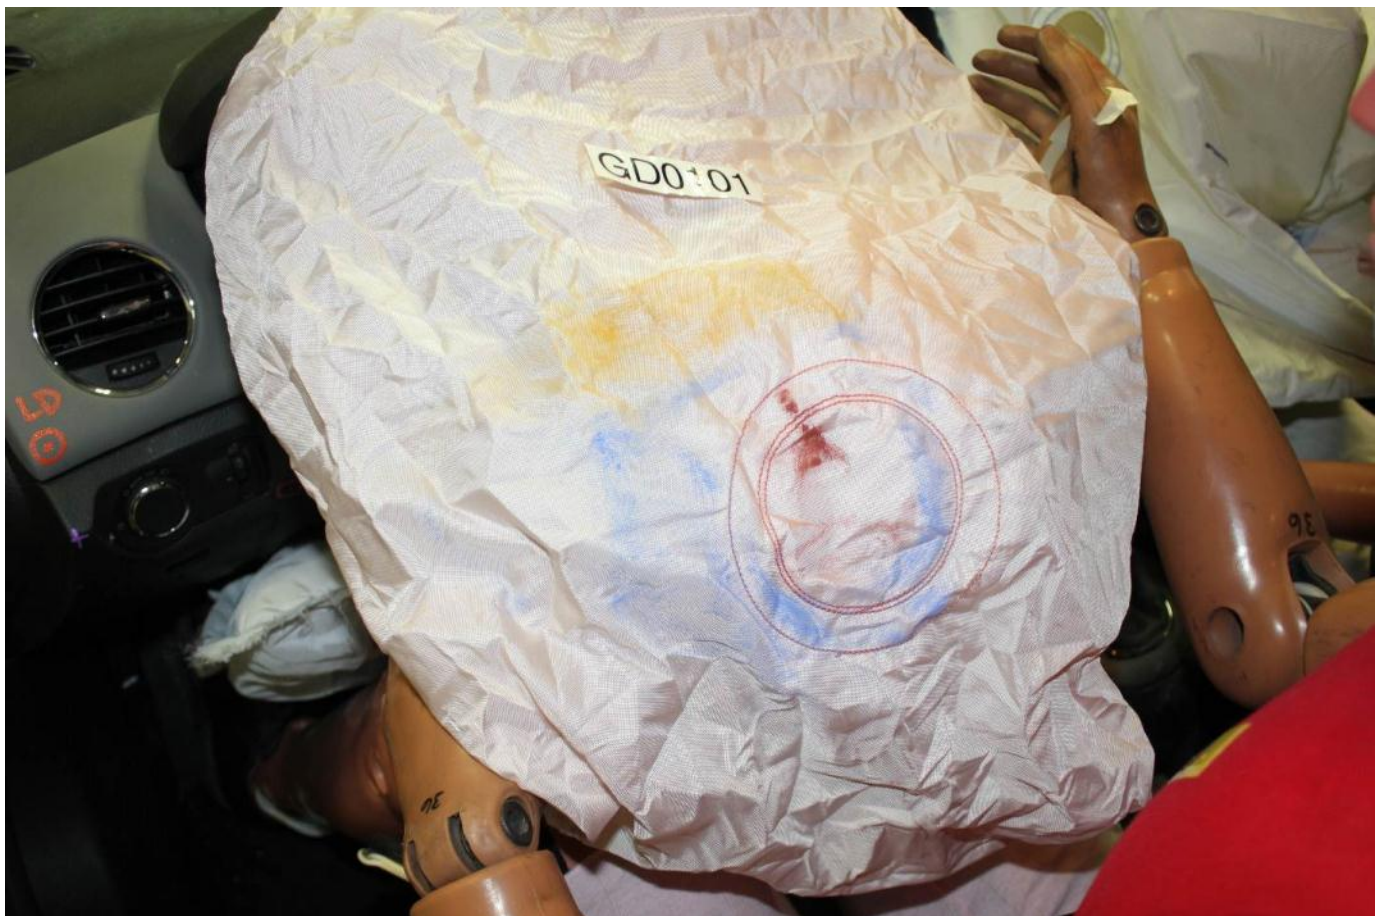
Post-Test Driver Dummy Contact with Airbag

The driver's visible contact points were as follows: The driver's head and chest contacted the airbag. The driver's head also contacted the headrest. The driver's knees contacted the knee airbag. The passenger's visible contact points were as follows: The passenger's head and chest contacted the airbag. The passenger's head also contacted the headrest. The passenger's knees contacted the knee airbag.
