**REPORT NUMBER: NCAP-KAR-13-022**

**NEW CAR ASSESSMENT PROGRAM (NCAP)  
FRONTAL BARRIER IMPACT TEST**

**GENERAL MOTORS LLC  
2013 CADILLAC ATS AWD 4-DOOR SEDAN**

**FINAL REPORT**

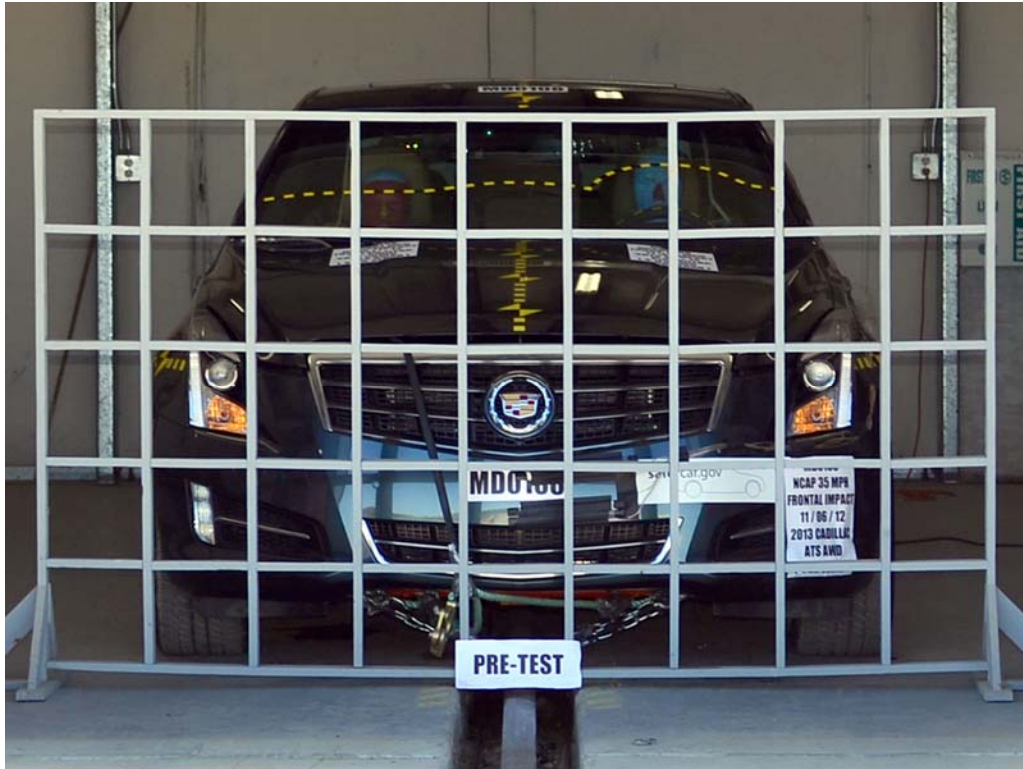
FIGURE 1. Load Cell Location

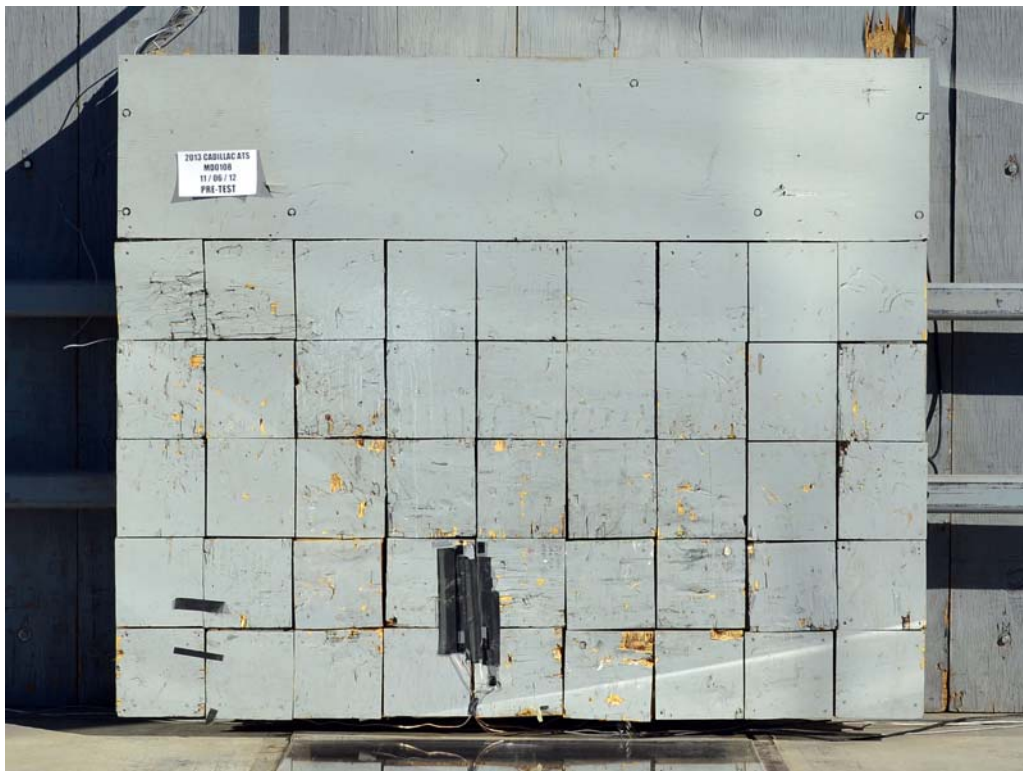
FIGURE 2. Load Cell Wall

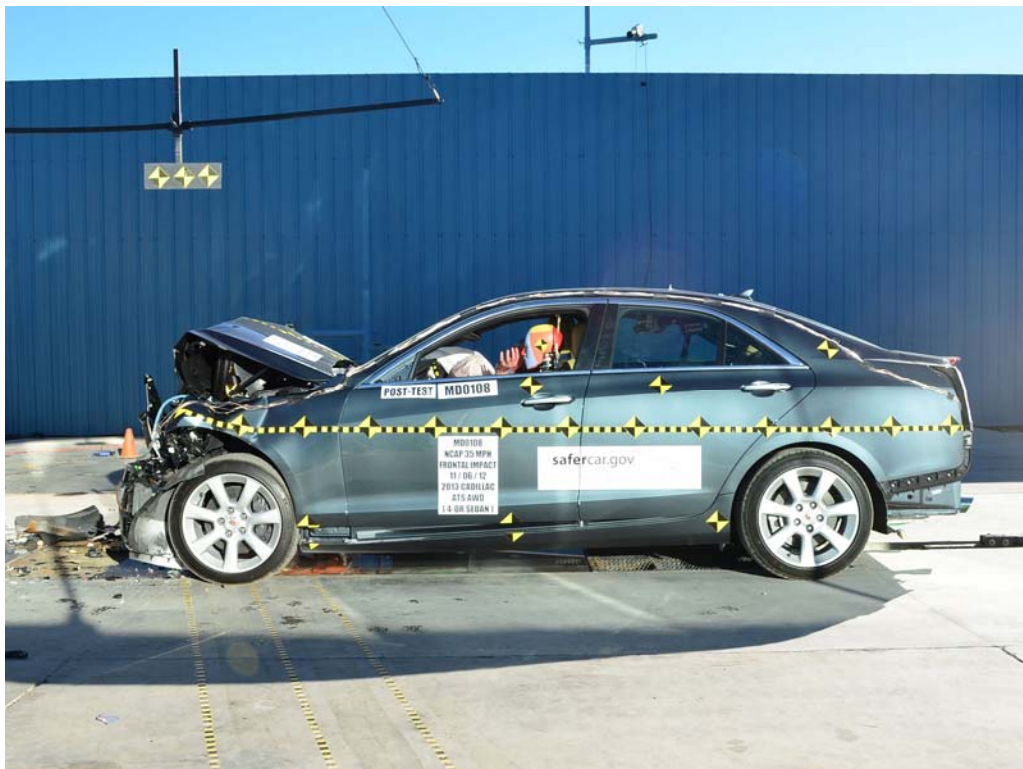
FIGURE 10. Post-Test Left View of Test Vehicle

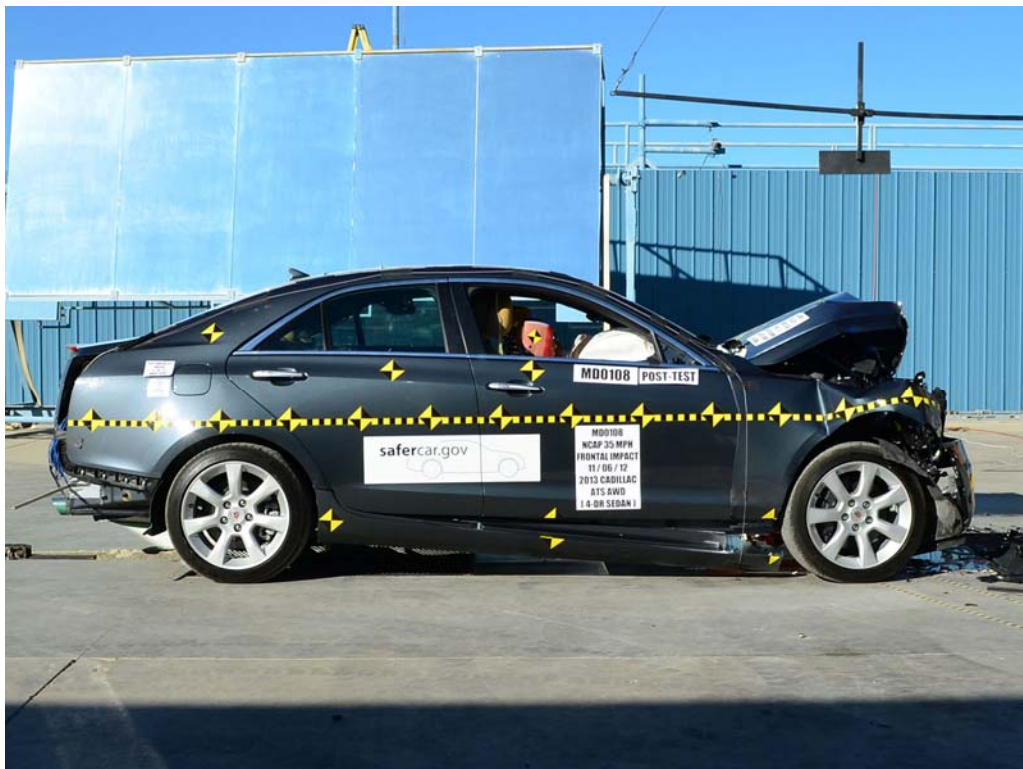
FIGURE 12. Post-Test Right View of Test Vehicle

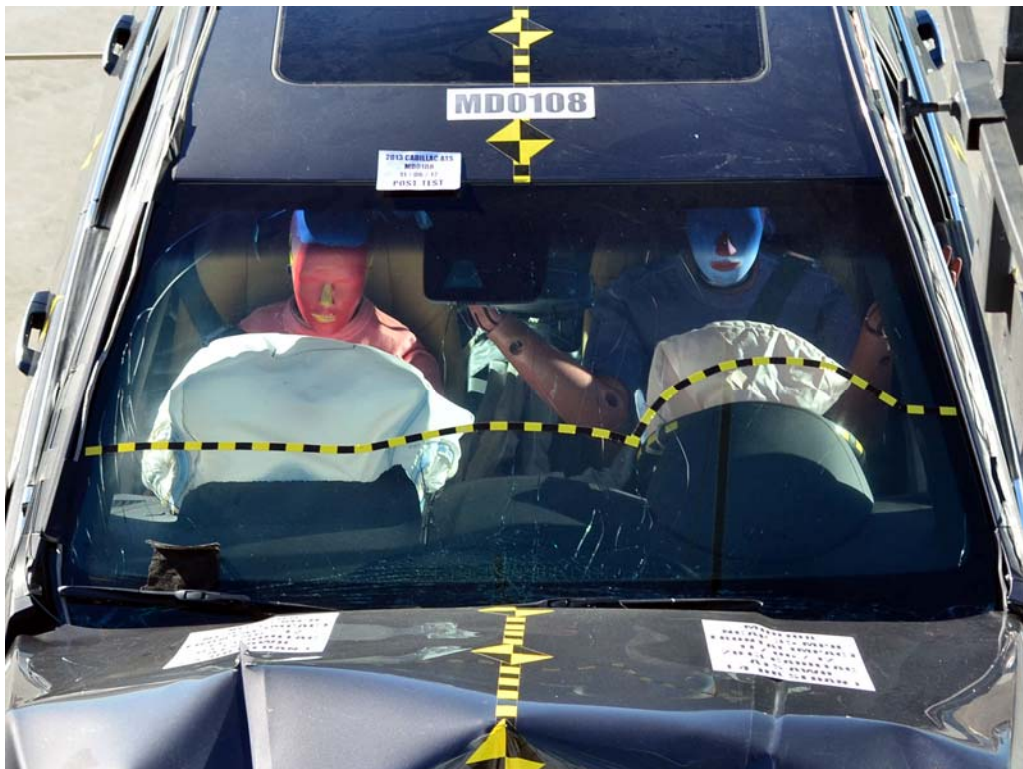
FIGURE 18. Post-Test Windshield View

There was 100% windshield retention and no intrusion into the protected zone of the windshield during the event. There was no Stoddard solvent leakage after the event or during any phase of the static rollover.

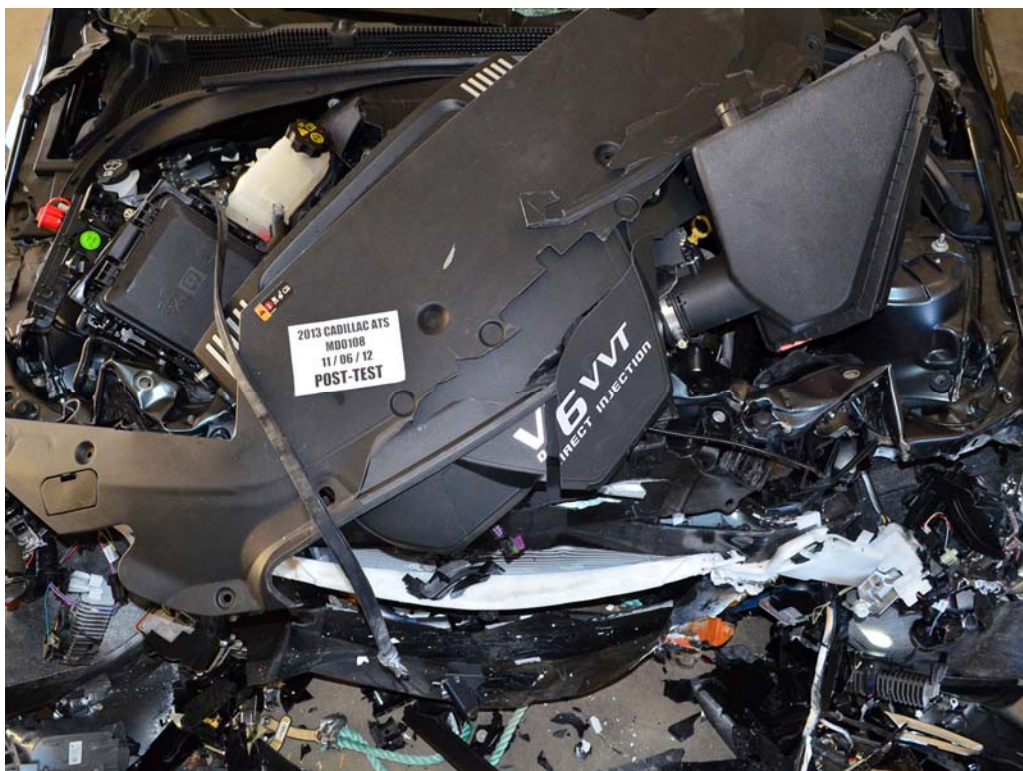
FIGURE 20. Post-Test Engine Compartment View

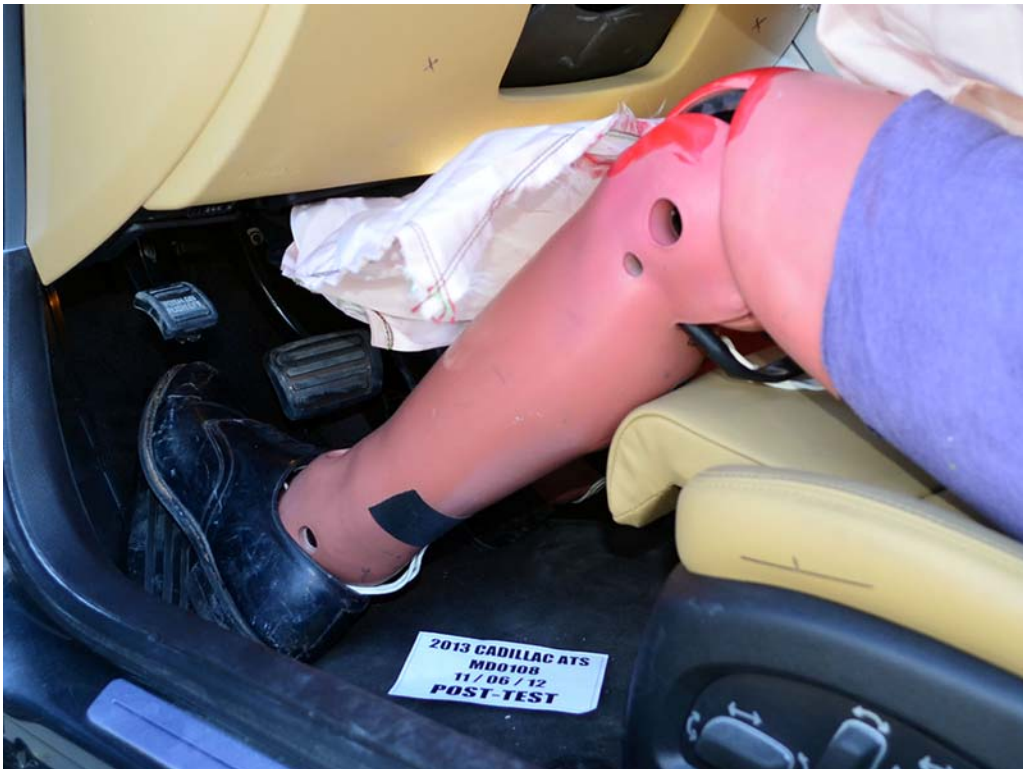
FIGURE 40. Post-Test Driver Dummy Feet

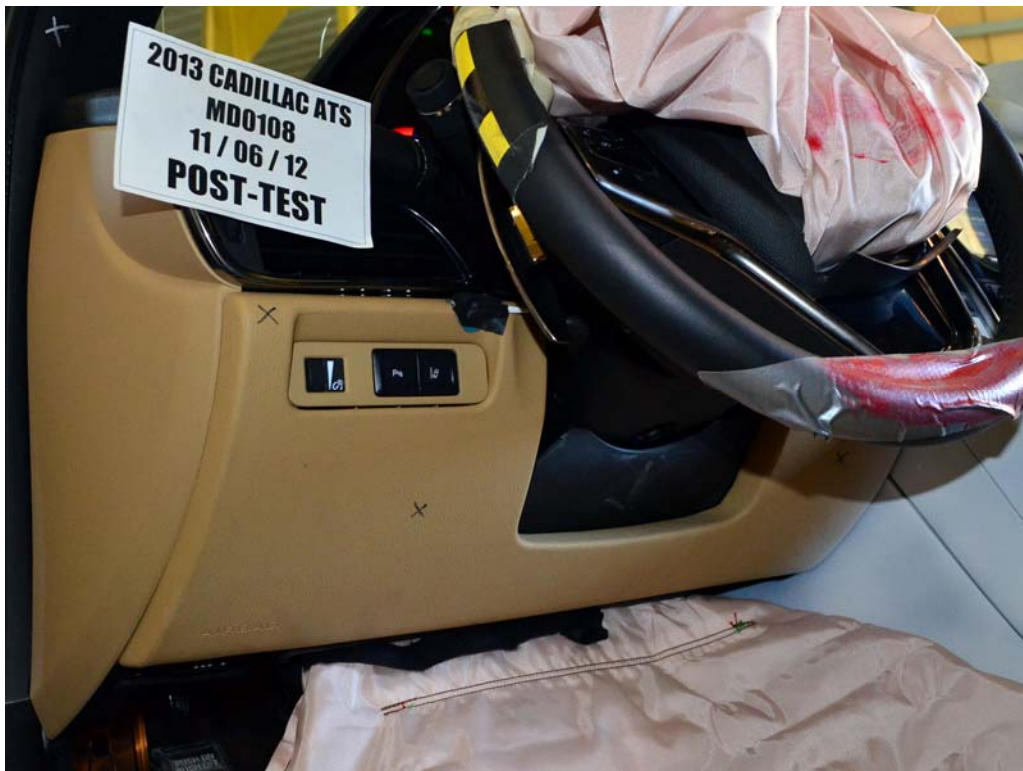
FIGURE 42. Post-Test Driver's Side Knee Bolster

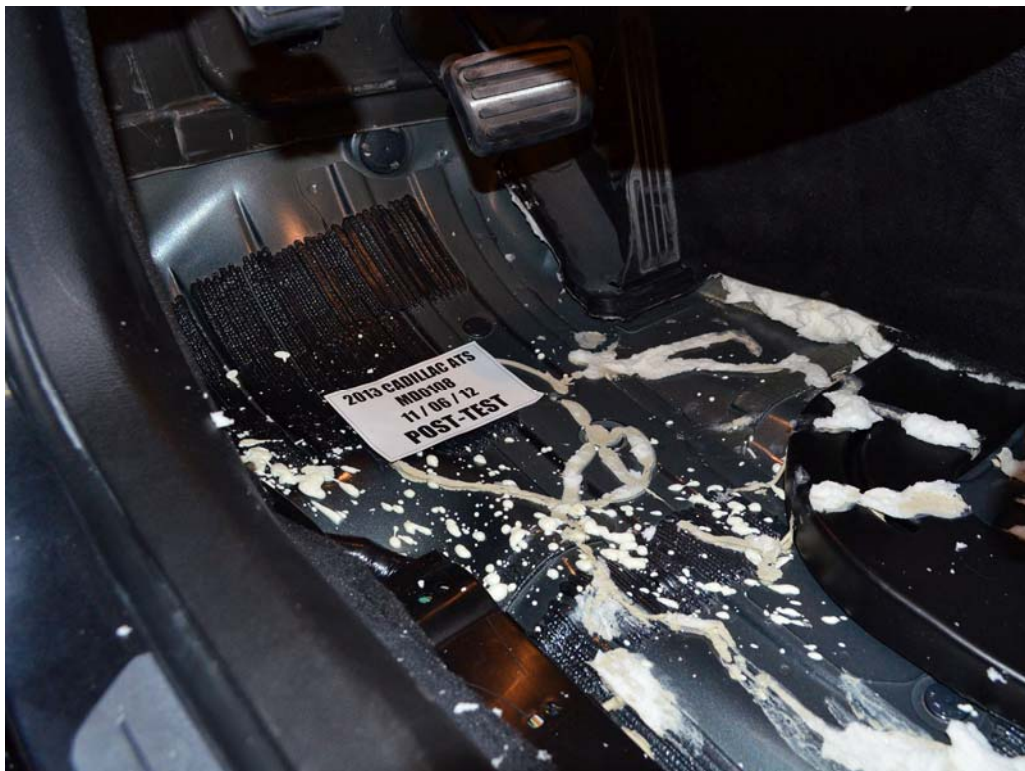
FIGURE 44. Post-Test Driver's Side Floorpan

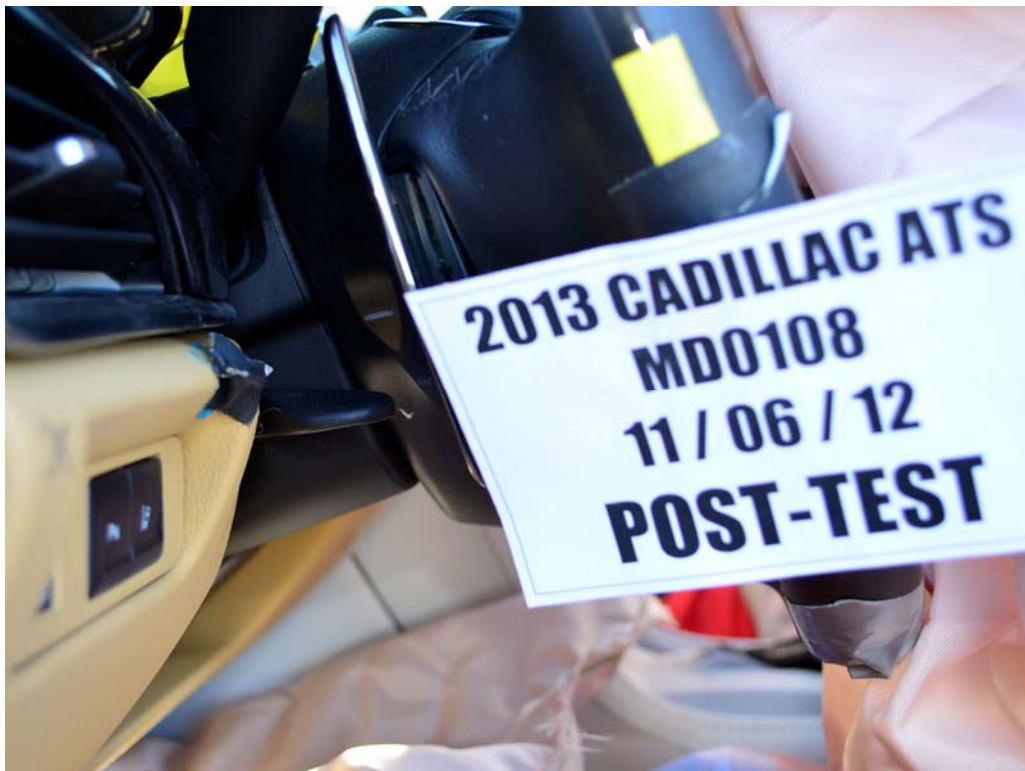
FIGURE 49. Post-Test View of the Steering Wheel

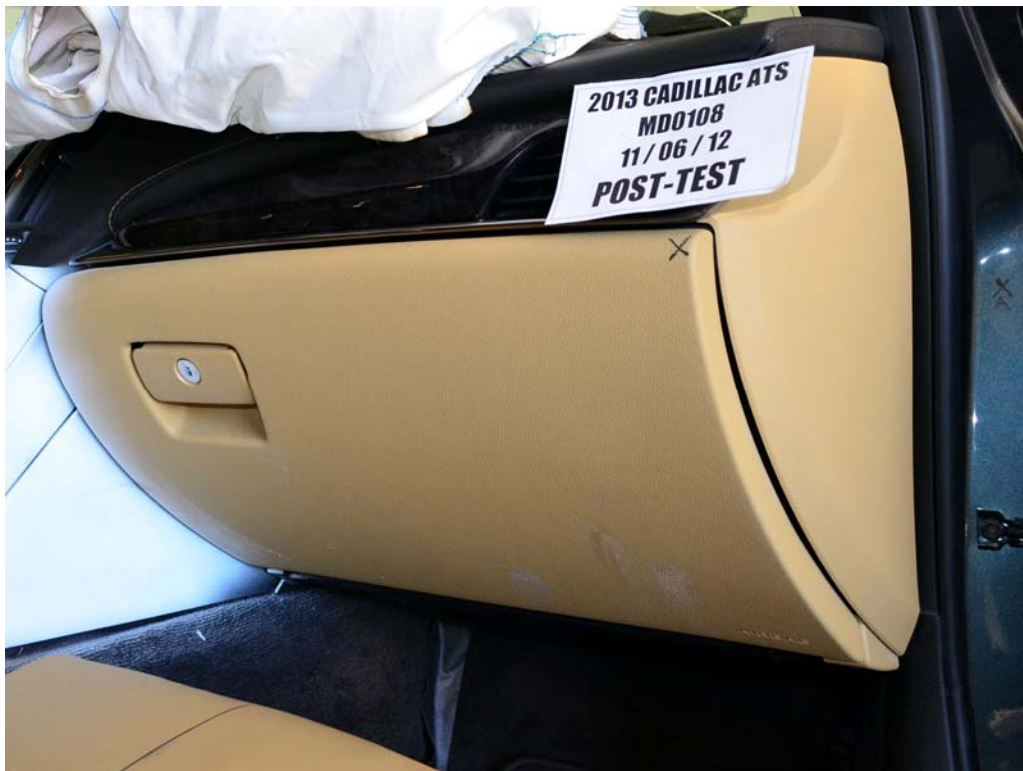
FIGURE 63. Post-Test Passenger's Side Knee Bolster

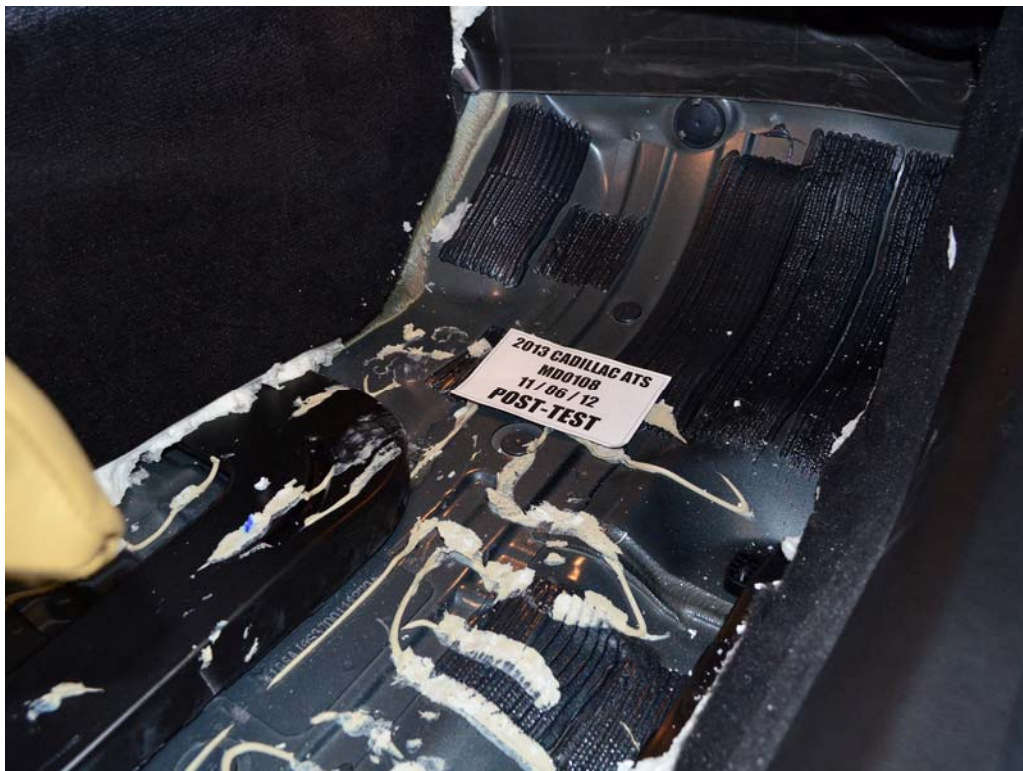
FIGURE 65. Post-Test Passenger's Side Floorpan
