**REPORT NUMBER: NCAP-MGA-2013-030**

**NEW CAR ASSESSMENT PROGRAM (NCAP)  
Frontal Barrier Impact Test**

**CHRYSLER GROUP LLC  
2013 Dodge Challenger SXT 2-Dr Coupe  
NHTSA No.: MD0300**

**FINAL REPORT**

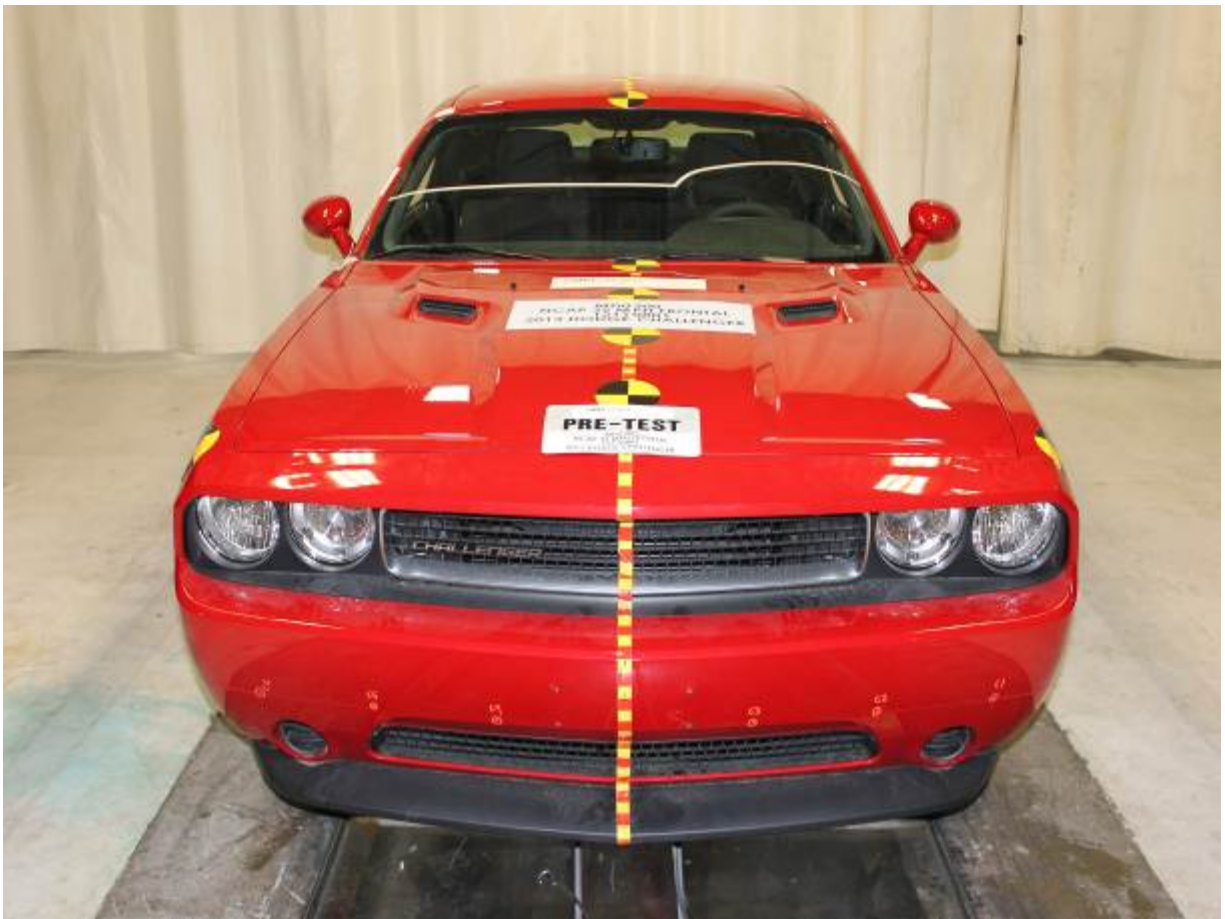
Pre-Test Front View of Test Vehicle

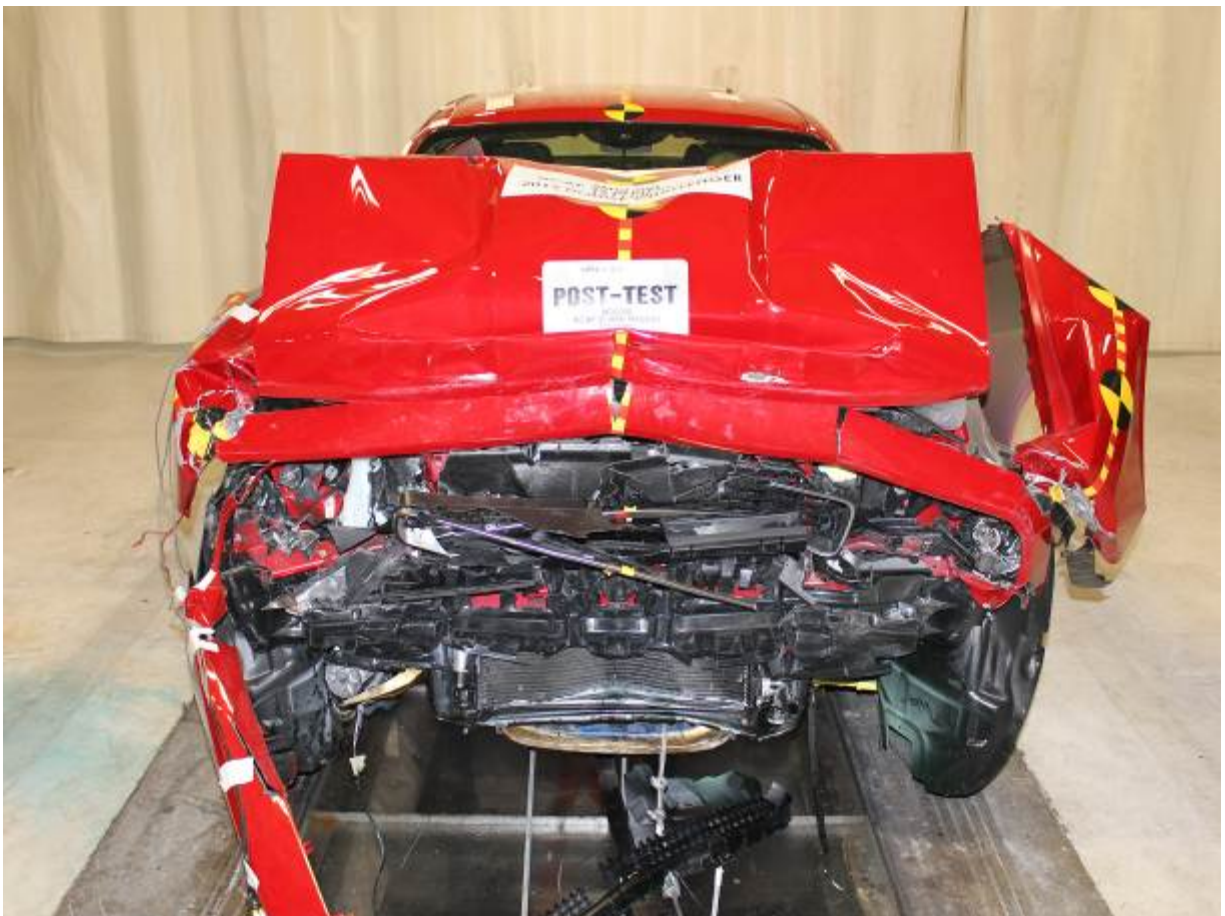
Post-Test Front View of Test Vehicle

The maximum static crush of the vehicle was 740 mm and both the driver and passenger side doors remained closed during the impact event and were operable after the impact.

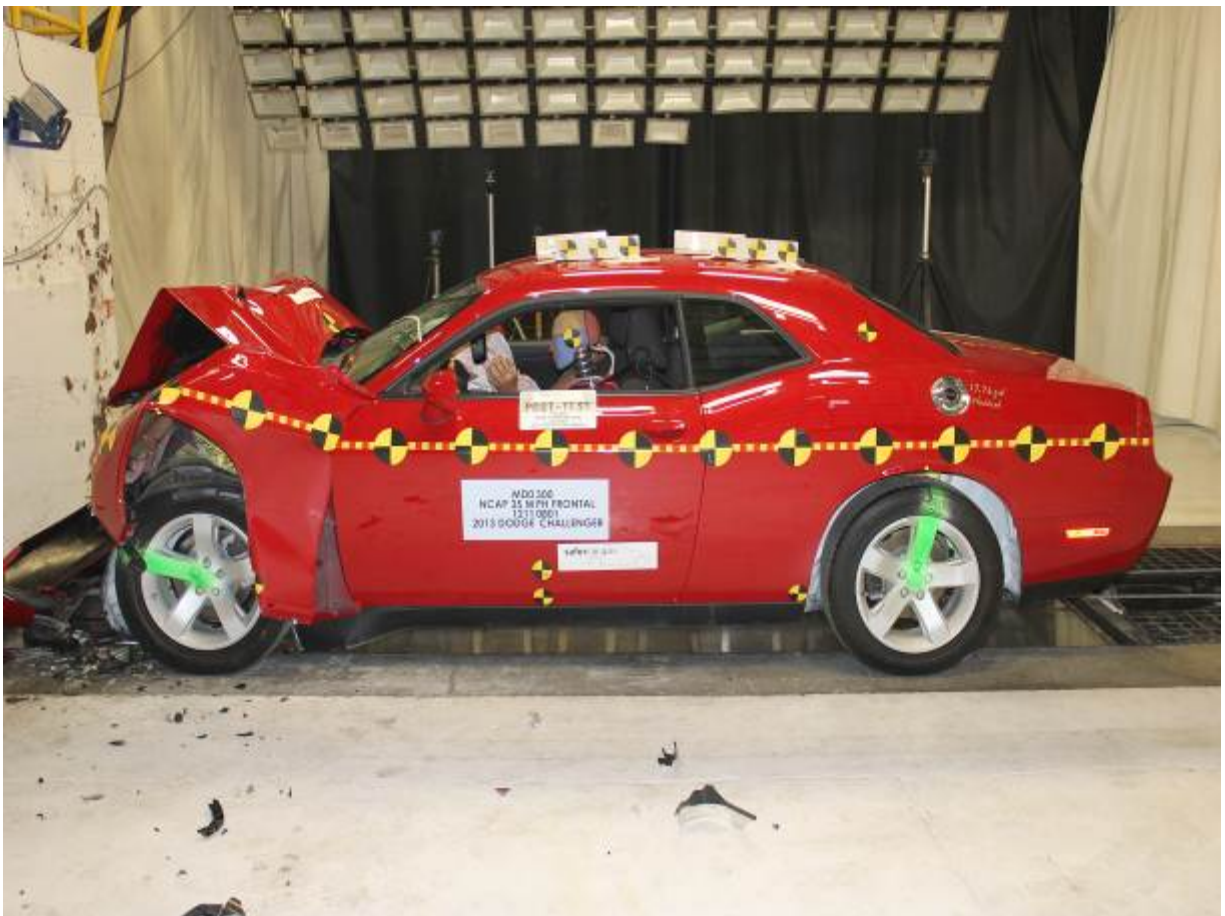
Post-Test Left View of Test Vehicle

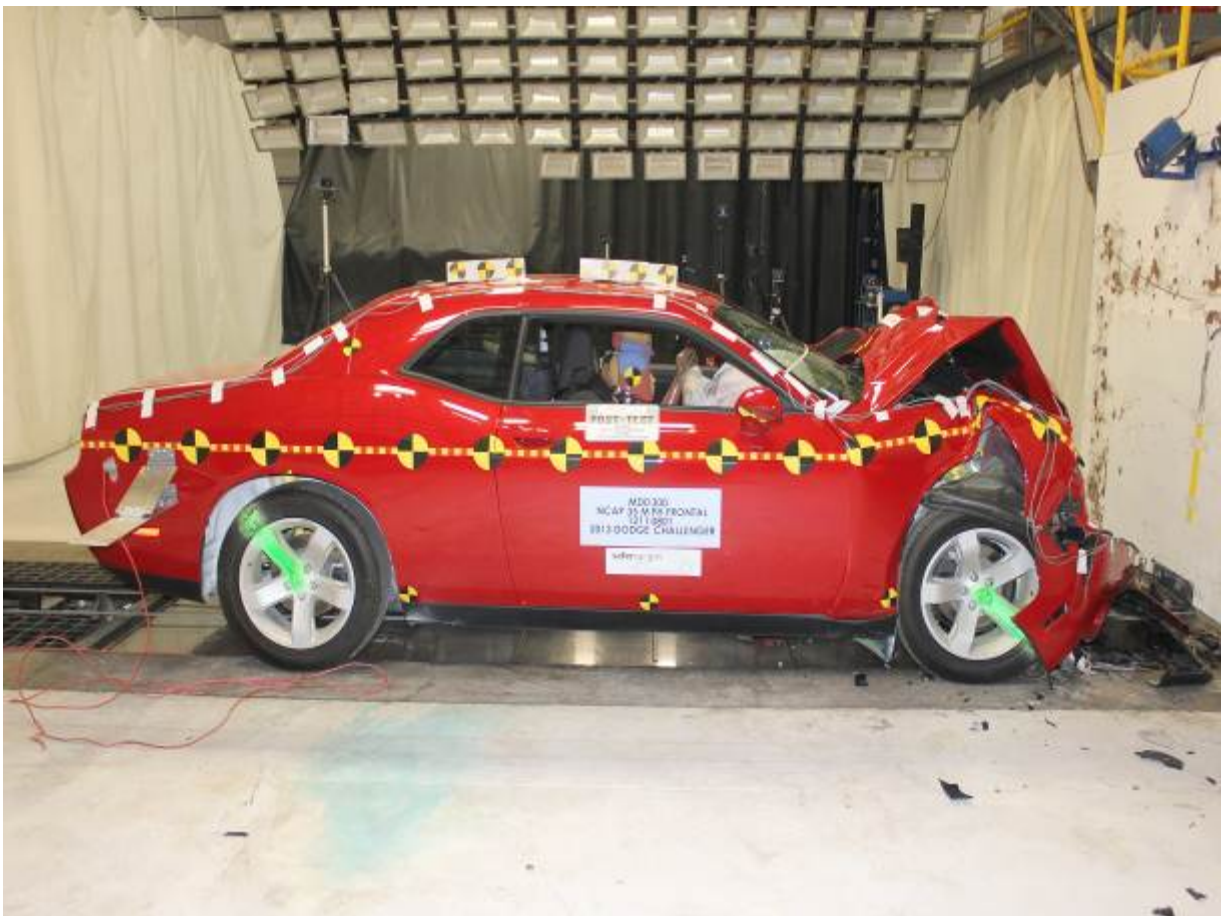
Post-Test Right View of Test Vehicle

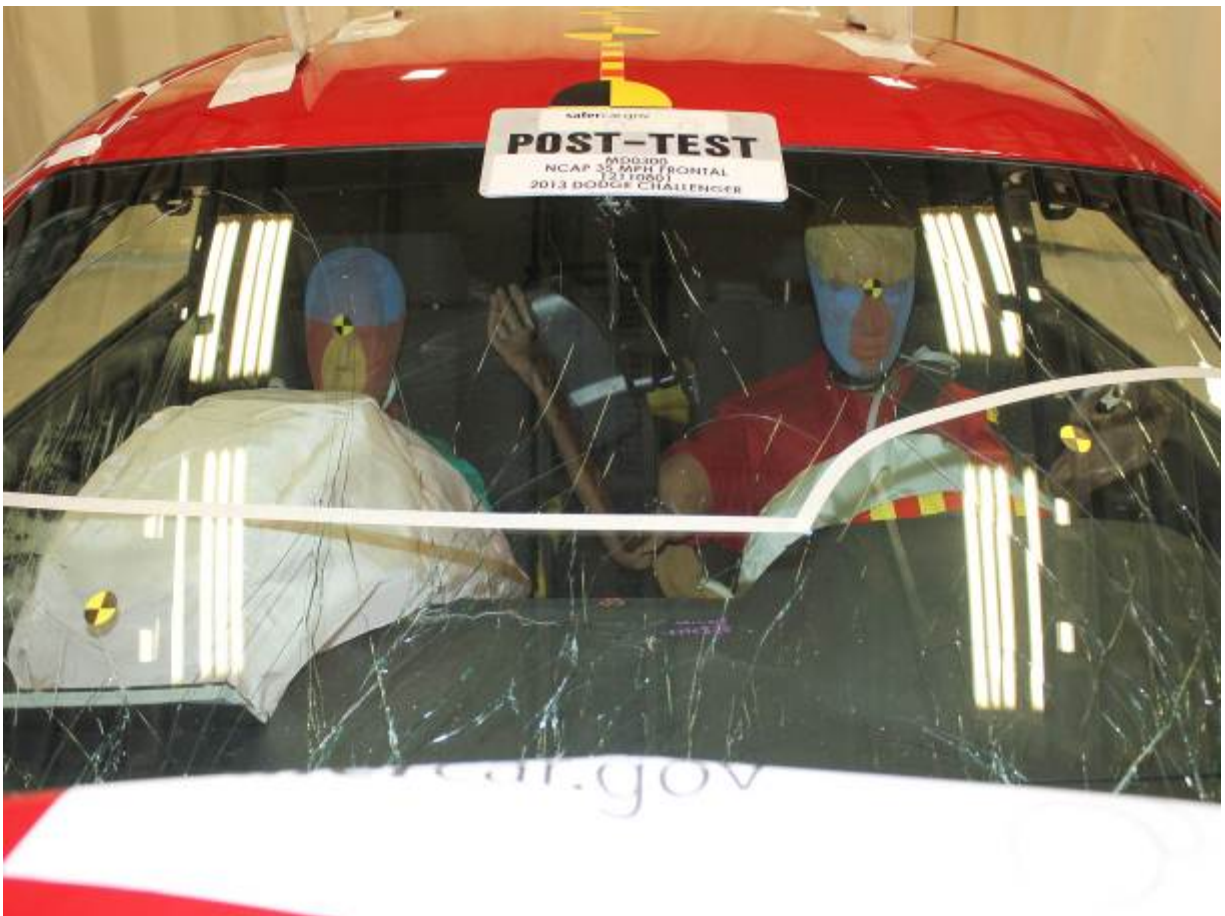
Post-Test Windshield View

There was 100 percent windshield retention and no intrusion into the protected zone of the windshield during the event. There was no Stoddard Solvent leakage after the event or during any phase of the static rollover.

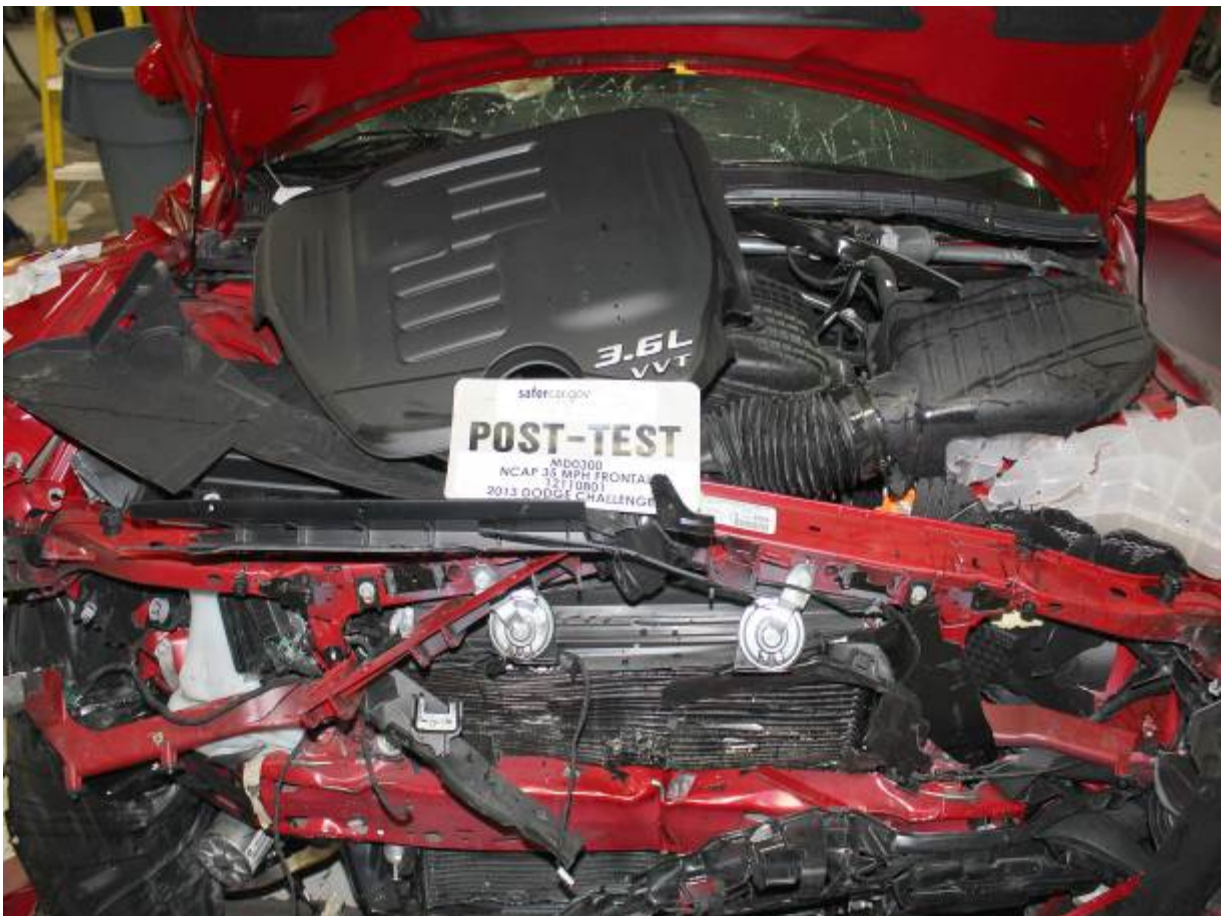
Post-Test Engine Compartment View

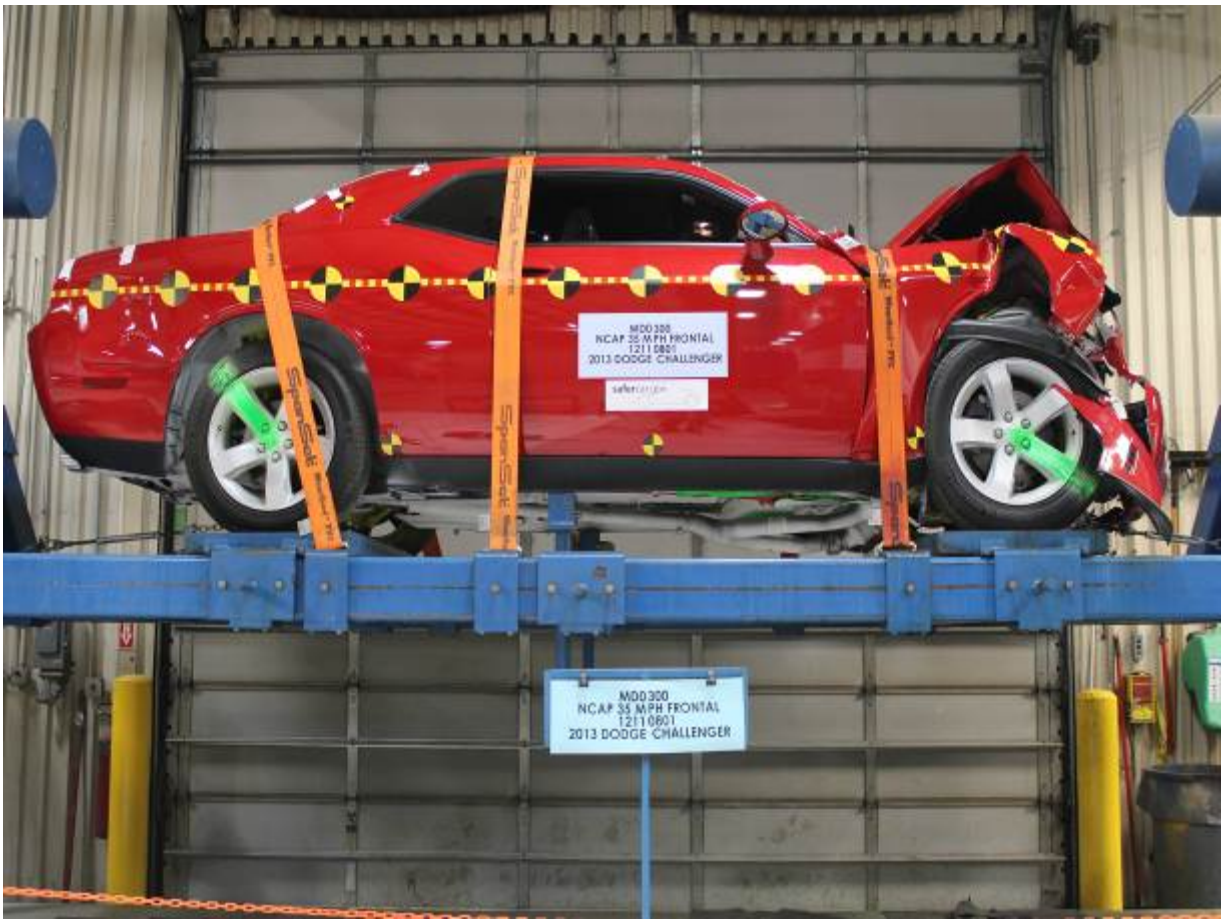
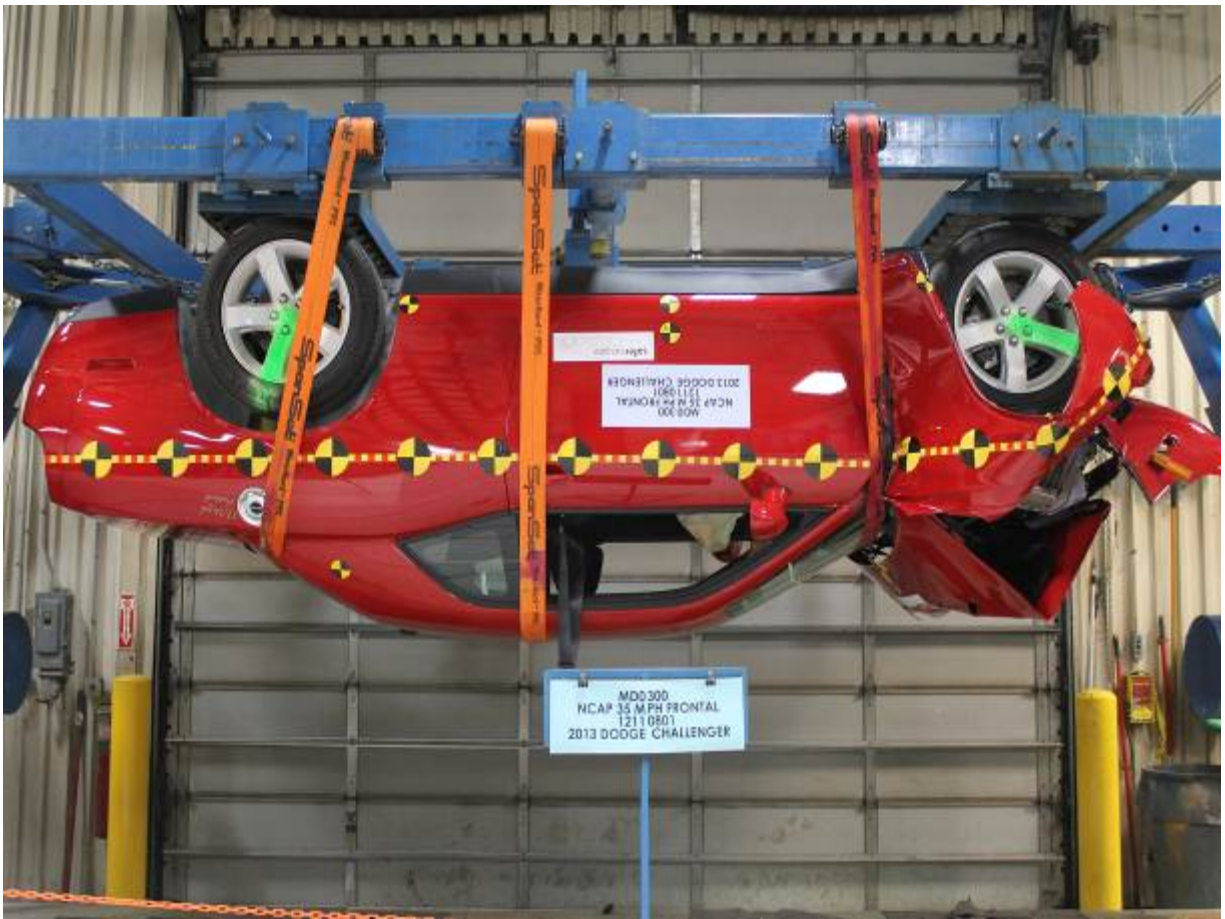
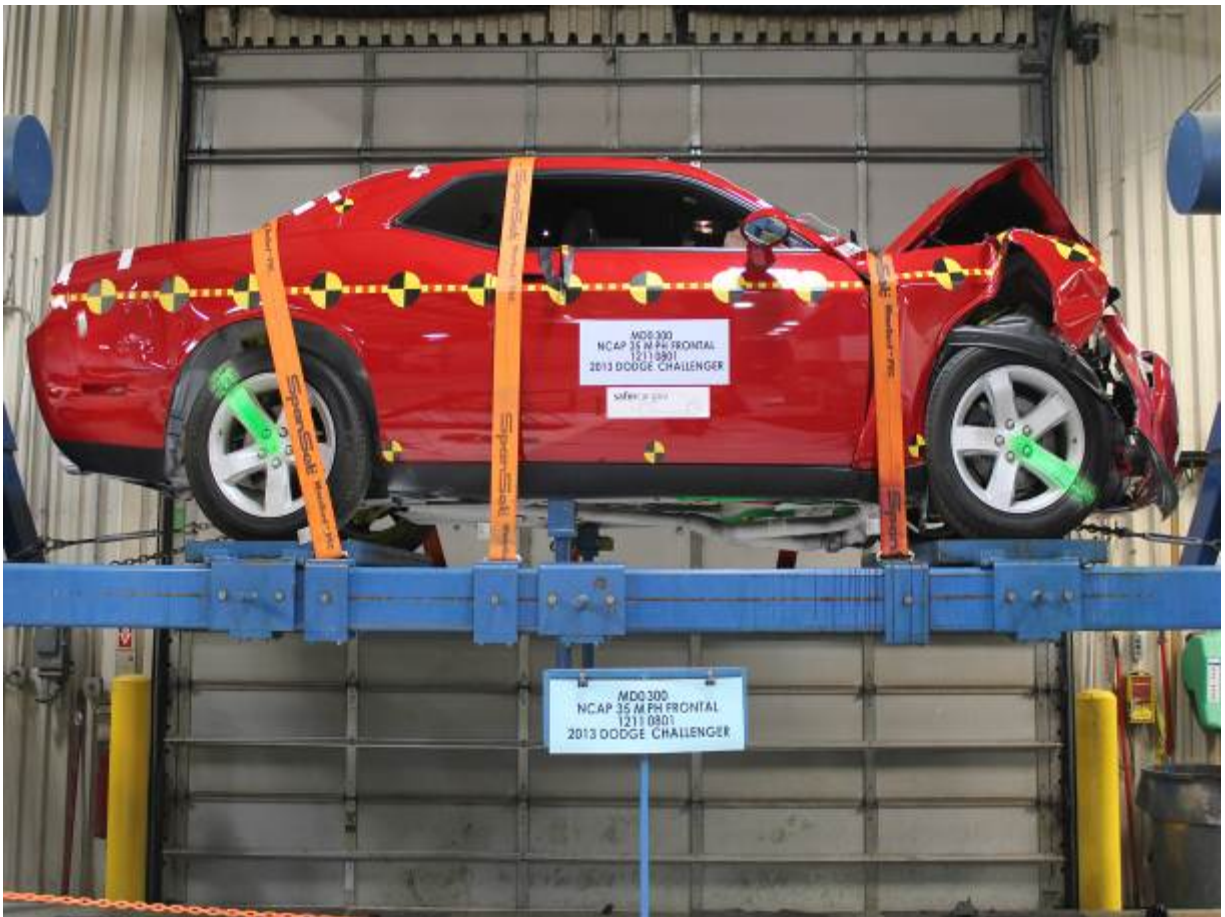
Vehicle at 0° on Static Rollover Device

Vehicle at 90° on Static Rollover Device

Vehicle at 180° on Static Rollover Device

Vehicle at 270° on Static Rollover Device

Vehicle at 360° on Static Rollover Device
