REPORT NUMBER: NCAP-CAL-13-013

**NEW CAR ASSESSMENT PROGRAM (NCAP)
FRONTAL BARRIER IMPACT TEST**

**Toyota Motor Manufacturing, Texas, Inc
2013 Toyota Tacoma 4x4
Access Cab Pickup**

NHTSA No: MD5118

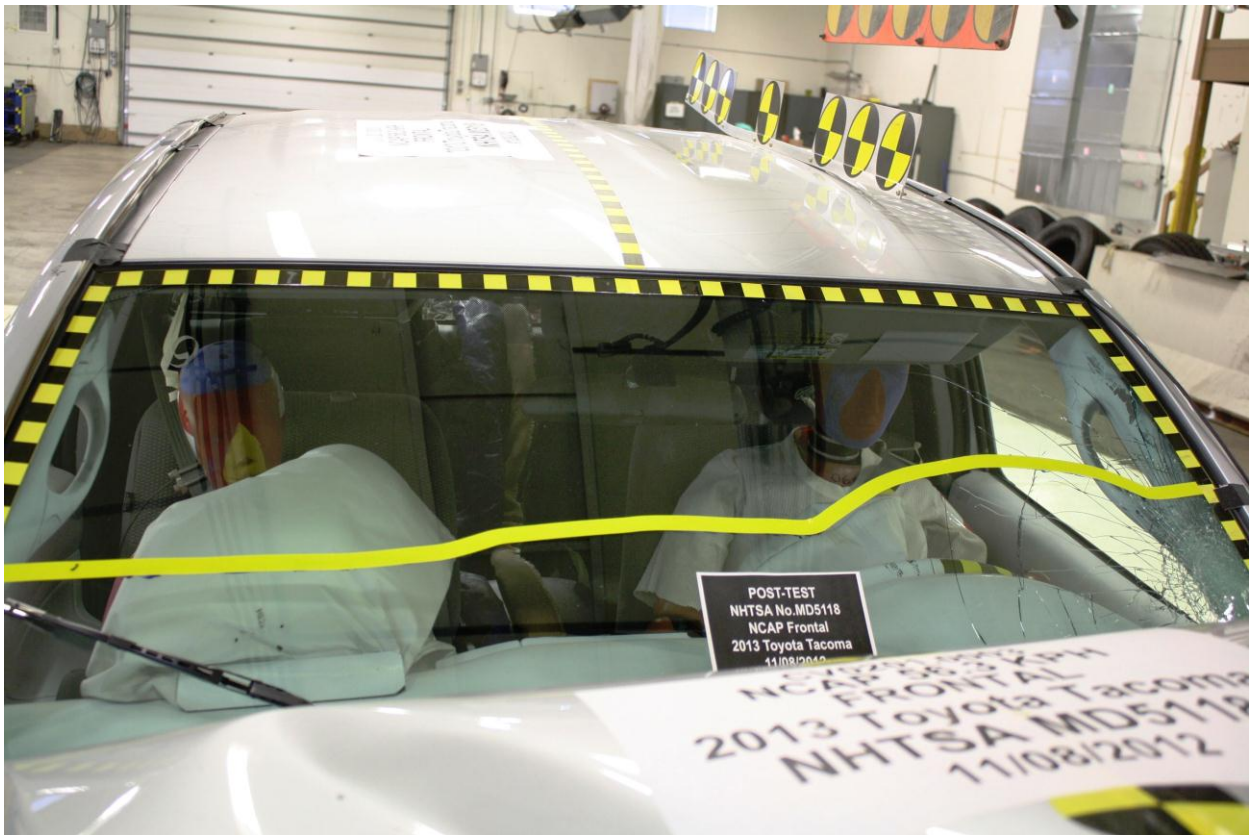
Figure A-18: Post-Test Windshield View

Critical Areas of Performance	Observations and Conclusions
Windshield Damage	Cracks along driver's side
Window Damage	None
Other Notable Effects	Passenger headrest released from seat

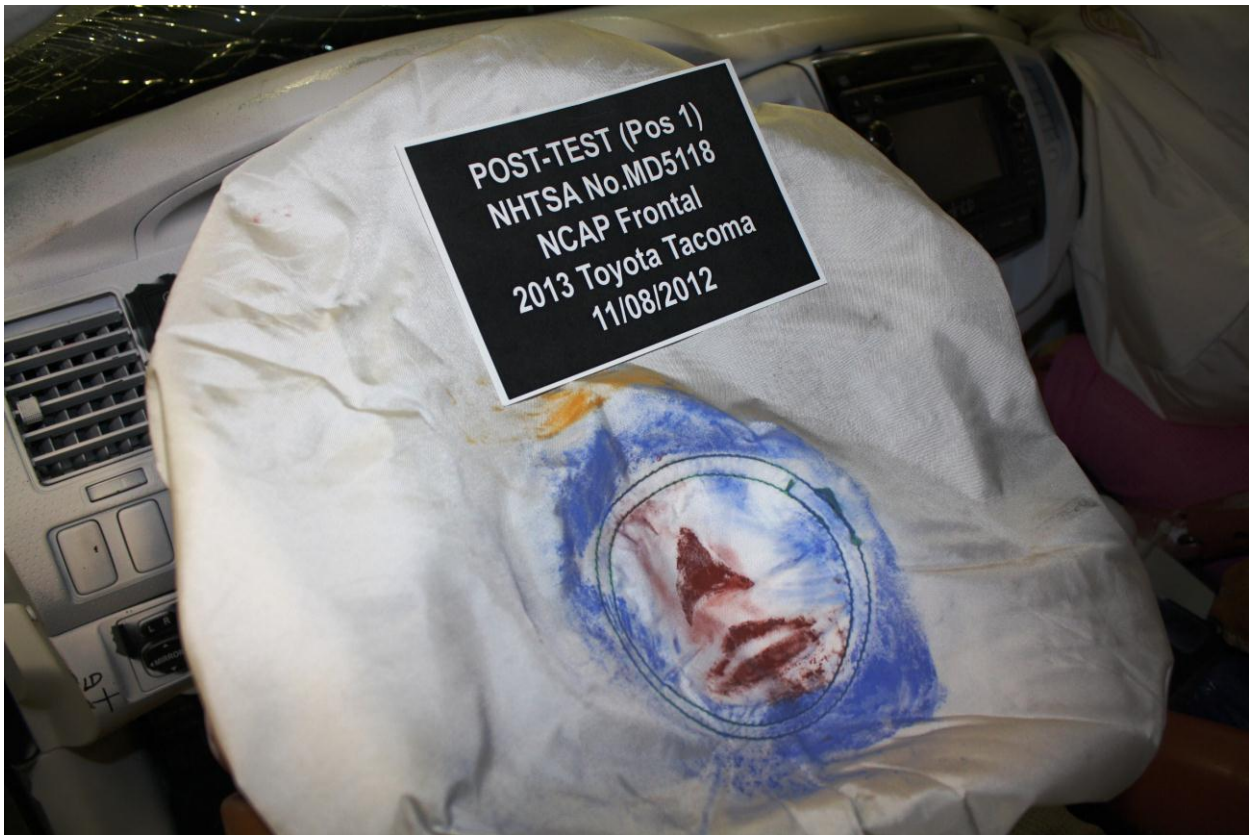
Figure A-46: Post-Test Driver Dummy Contact With Airbag

The driver's visible contact points were as follows: The driver's head contacted the frontal airbag and then the head restraint. The upper torso contacted the frontal airbag. Both knees contacted the knee bolster.
