REPORT NUMBER: SPNCAP-MGA-2013-031

**NEW CAR ASSESSMENT PROGRAM (NCAP)
Side Impact Pole Test**

**CHRYSLER GROUP LLC
2013 Dodge Challenger SXT 2-Dr Coupe
NHTSA No.: MD0301**

**MGA RESEARCH CORPORATION
5000 Warren Road
Burlington, WI 53105**

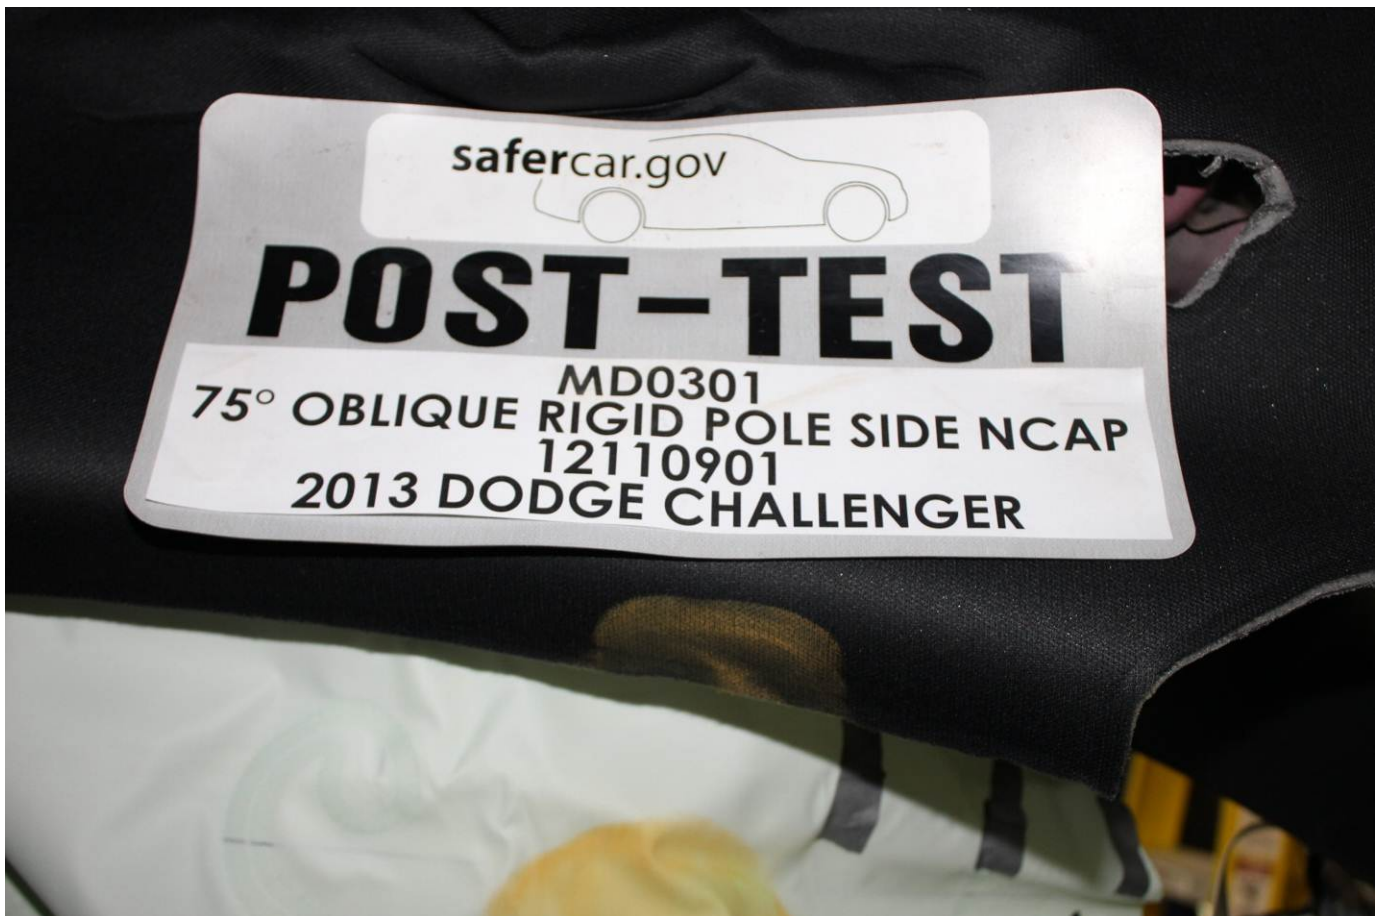
Post-Test Dummy Close-Up Head Contact with Vehicle Interior View

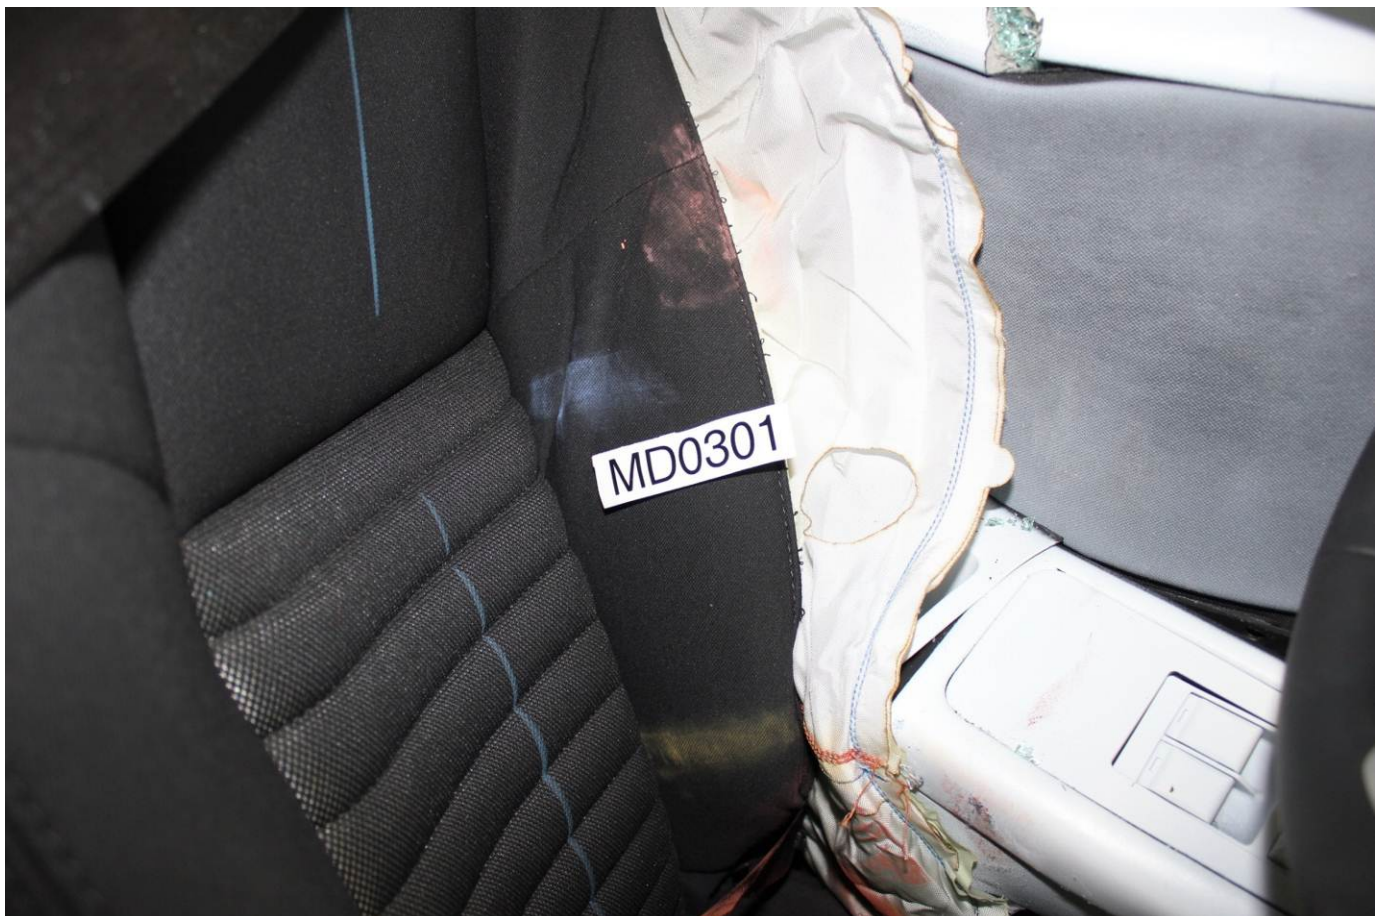
Post-Test Dummy Close-Up Head Contact with Side Air Bag View

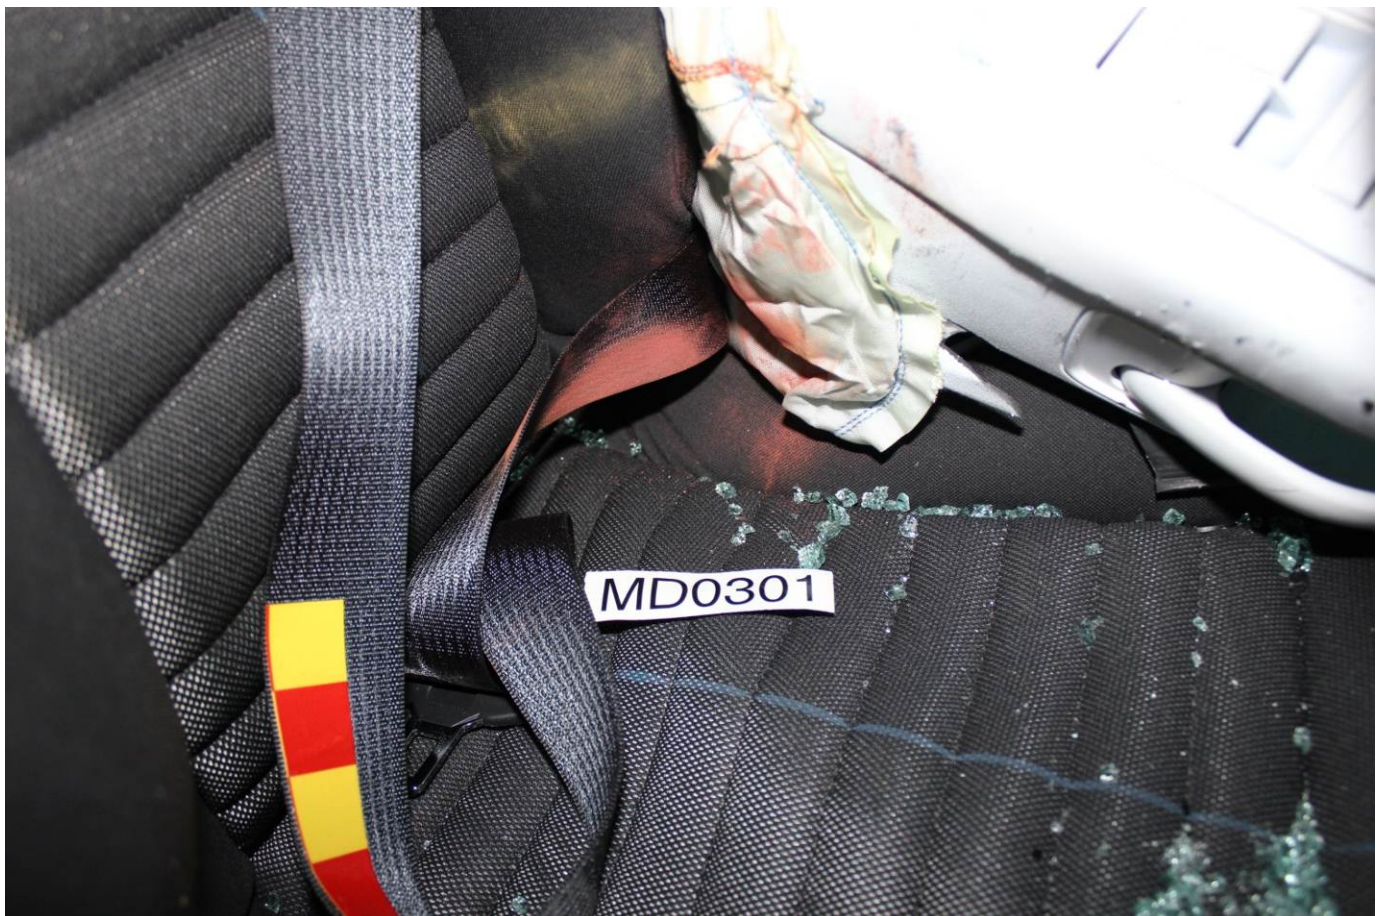
Post-Test Dummy Close-Up Torso Contact with Side Air Bag View

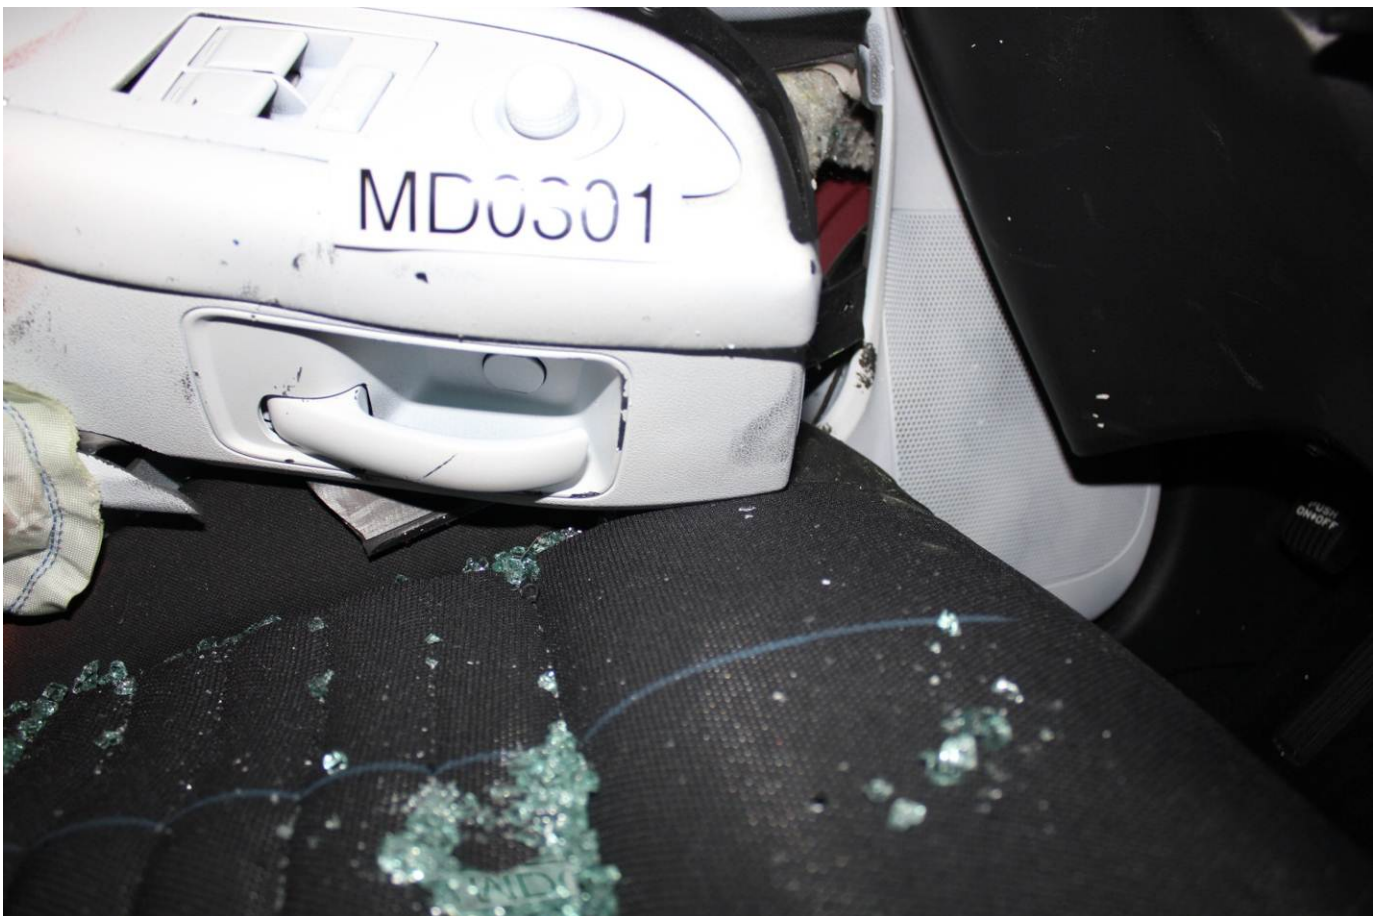
Post-Test Dummy Close-Up Pelvis Contact with Side Air Bag View

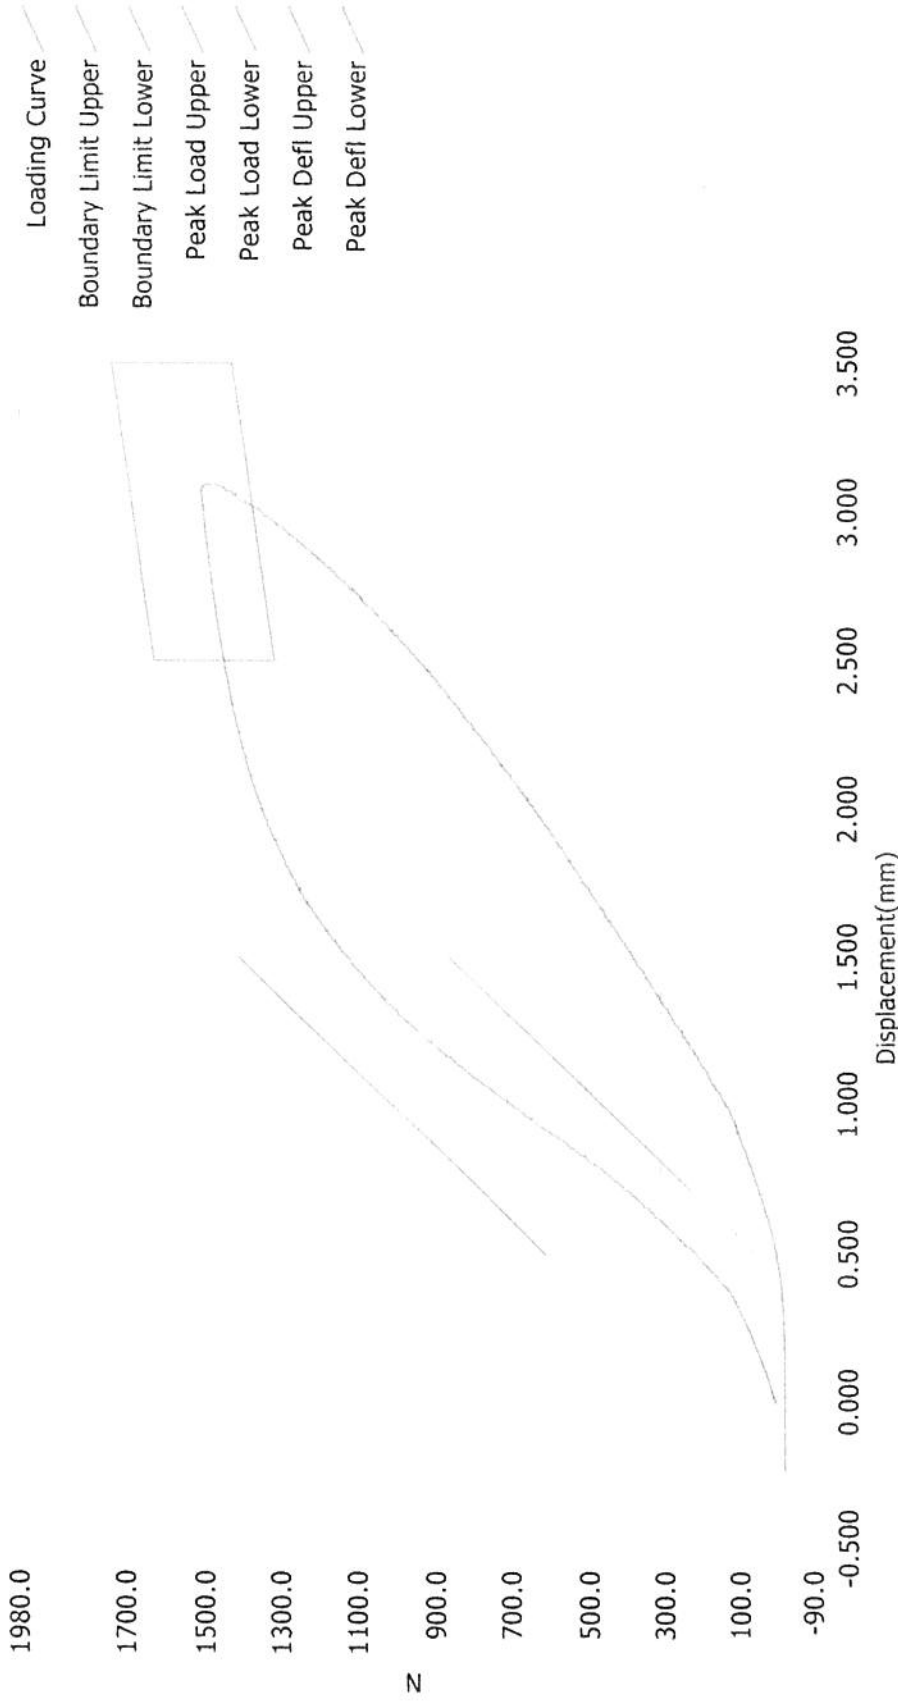
Resultant Data - SIDIIs Plug Compression

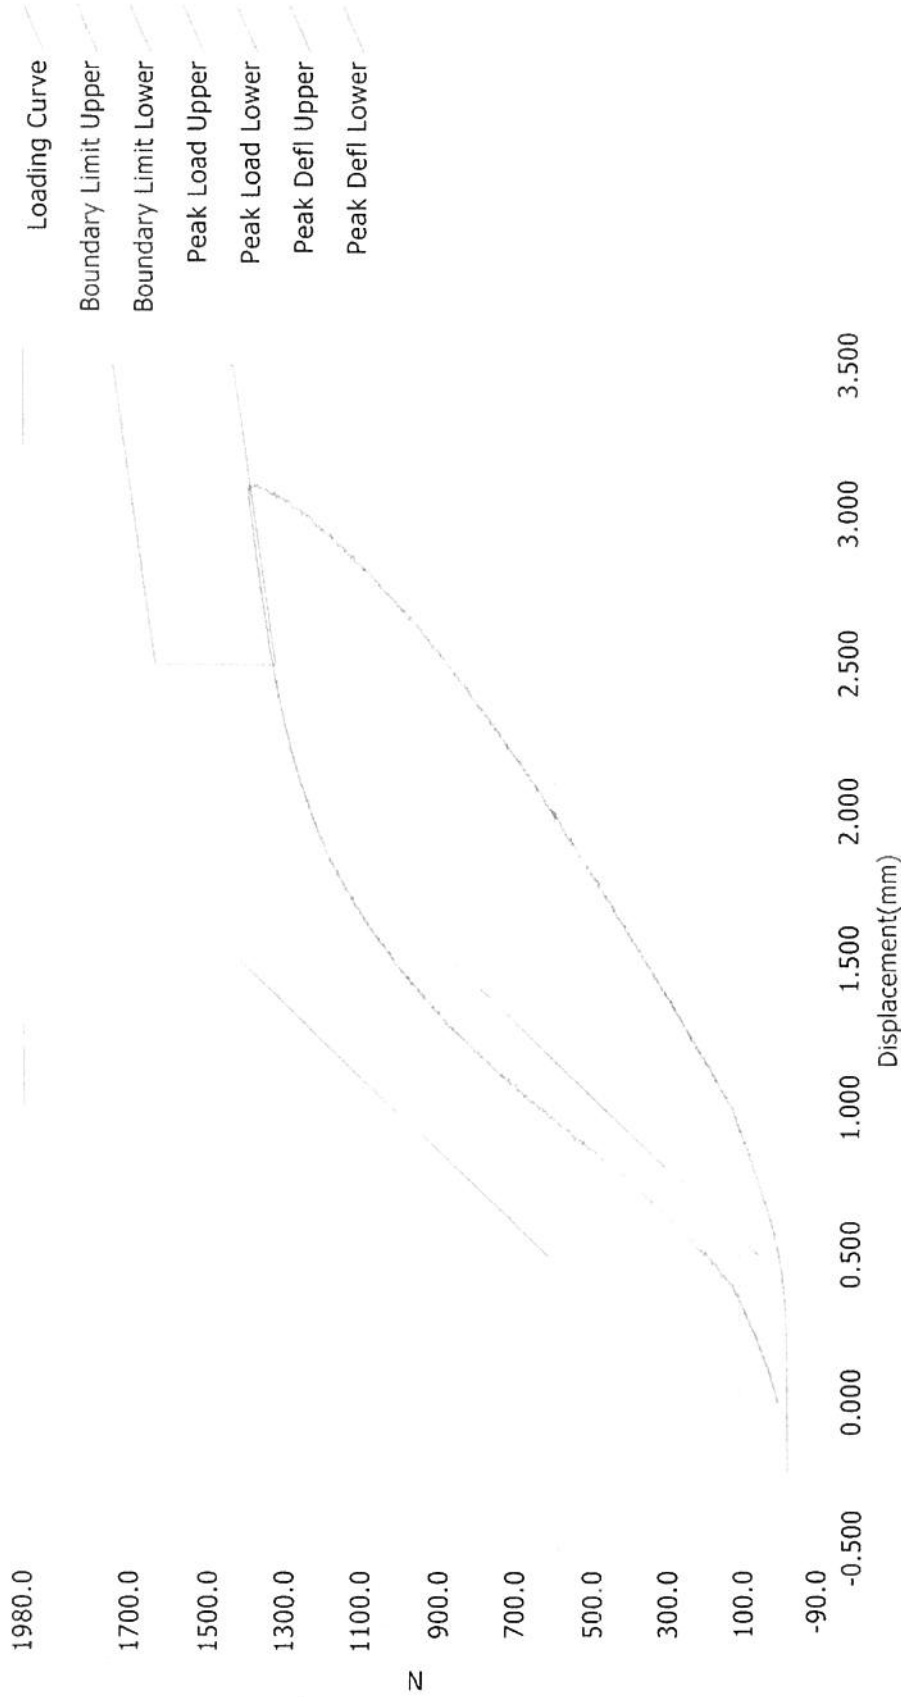
Resultant Data - SIDIIs Plug Compression
