**REPORT NUMBER: SINCAP-MGA-2013-034**

**NEW CAR ASSESSMENT PROGRAM (NCAP)  
Moving Deformable Barrier Side Impact Test**

**NISSAN MOTOR CO., LTD.  
2013 Infiniti JX35 SUV  
NHTSA No.: ND5205**

**FINAL REPORT**

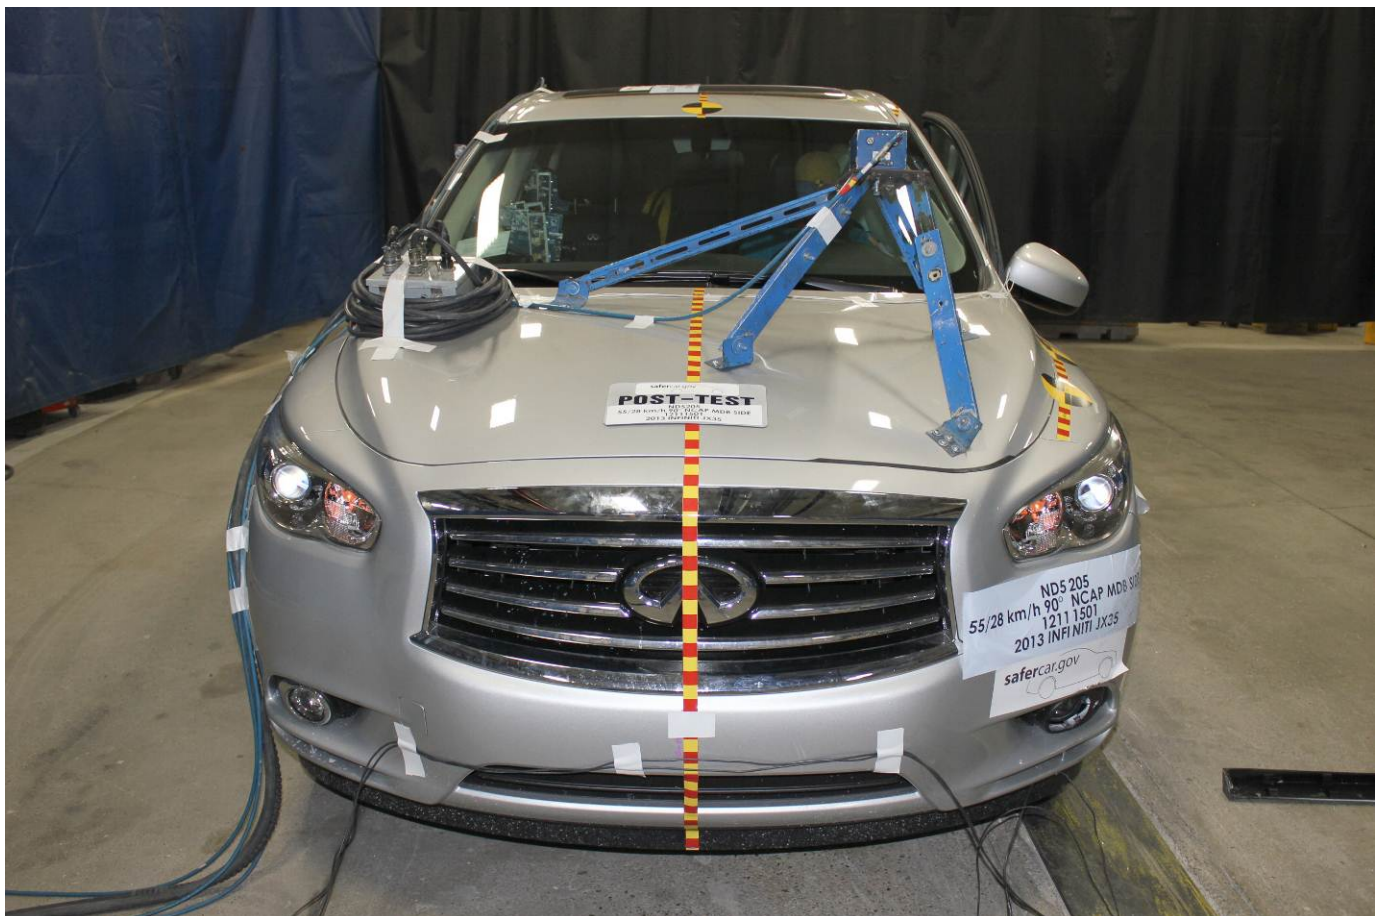
Post-Test Frontal View of Test Vehicle

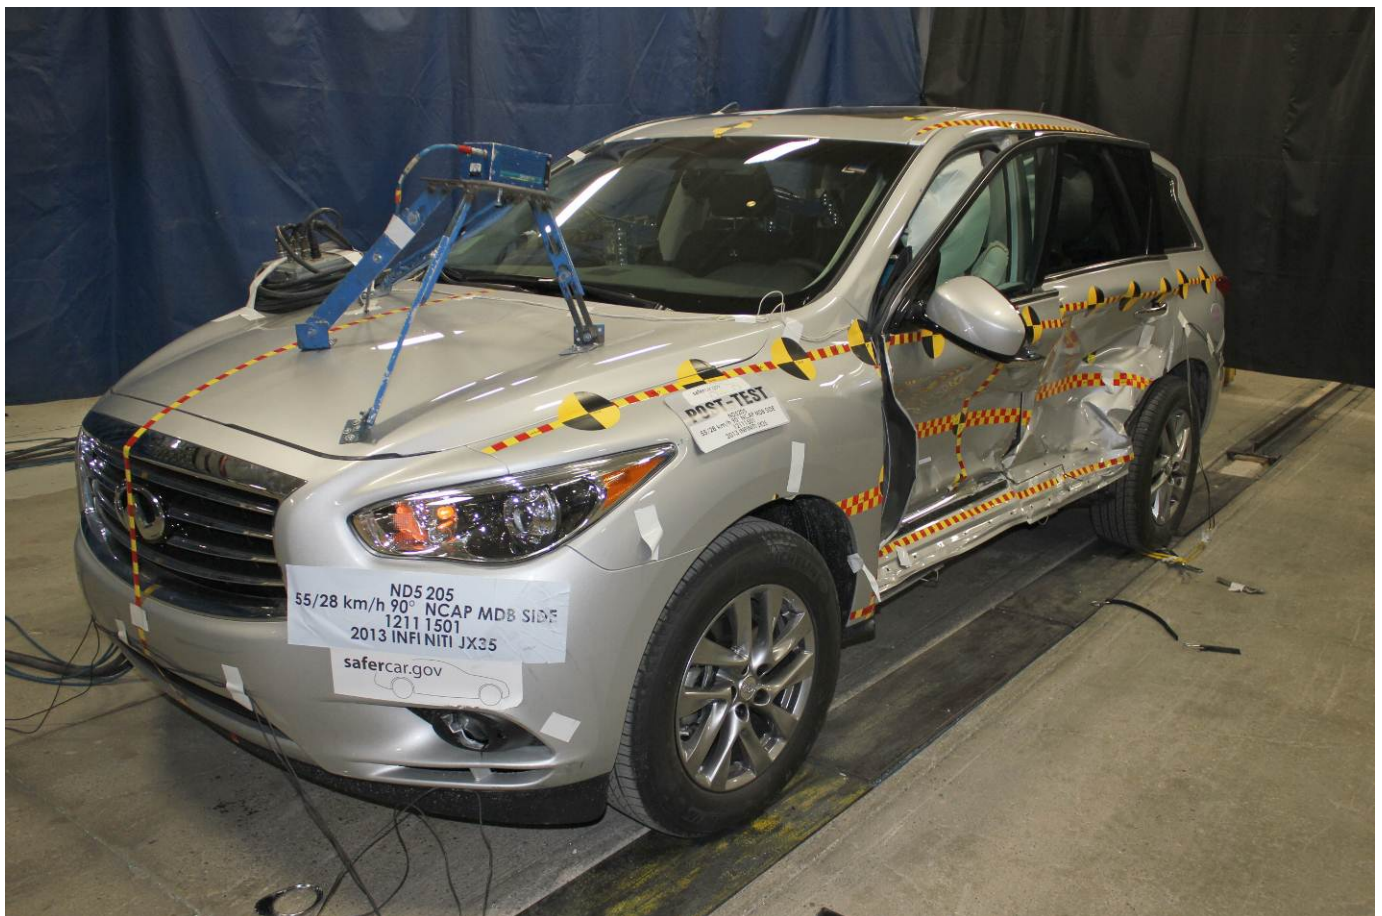
Post-Test Left Front Three-Quarter View of Test Vehicle

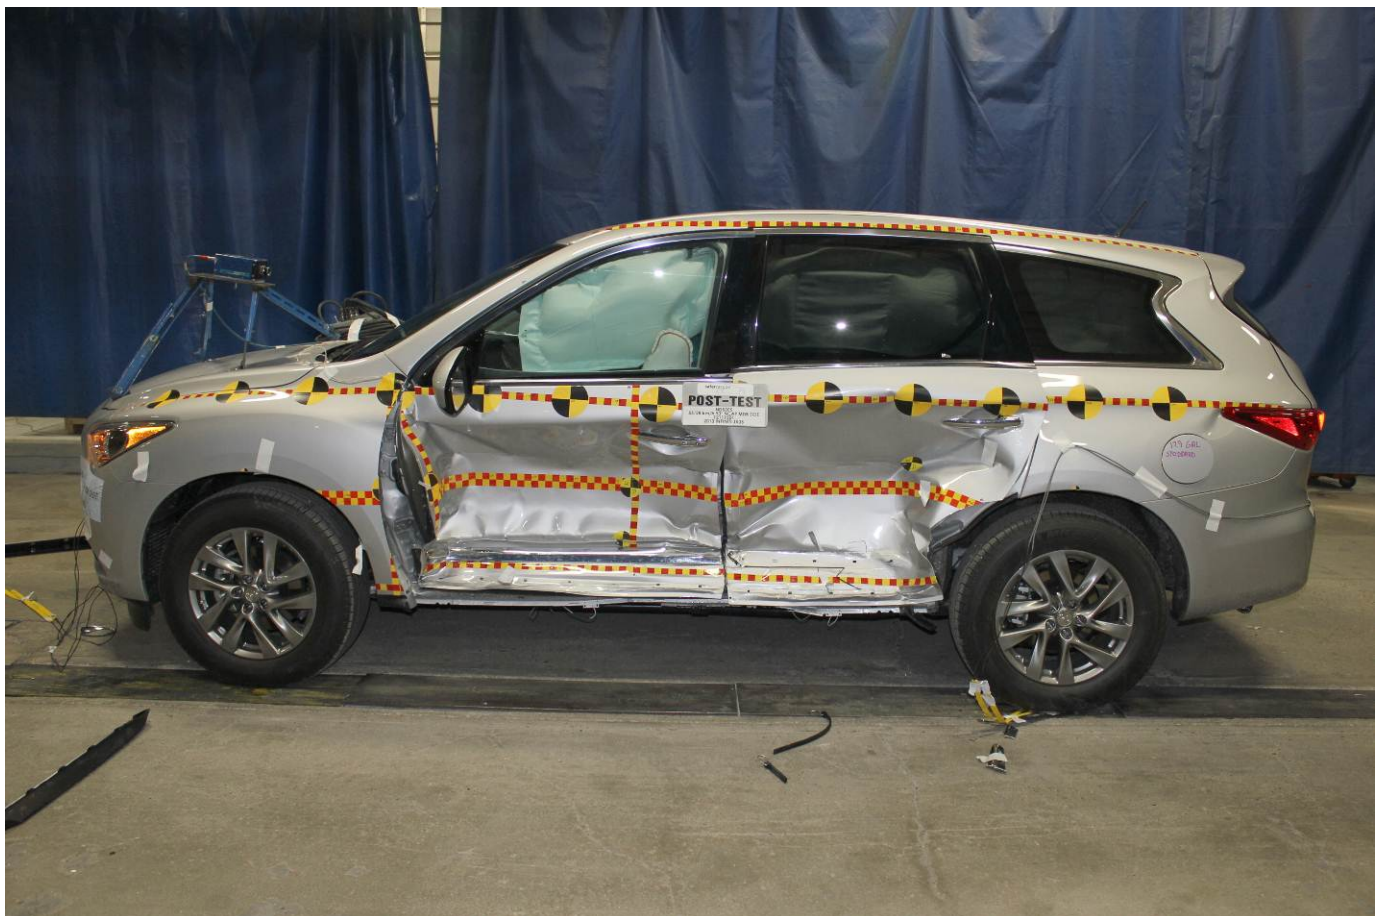
Post-Test Left Side View of Test Vehicle

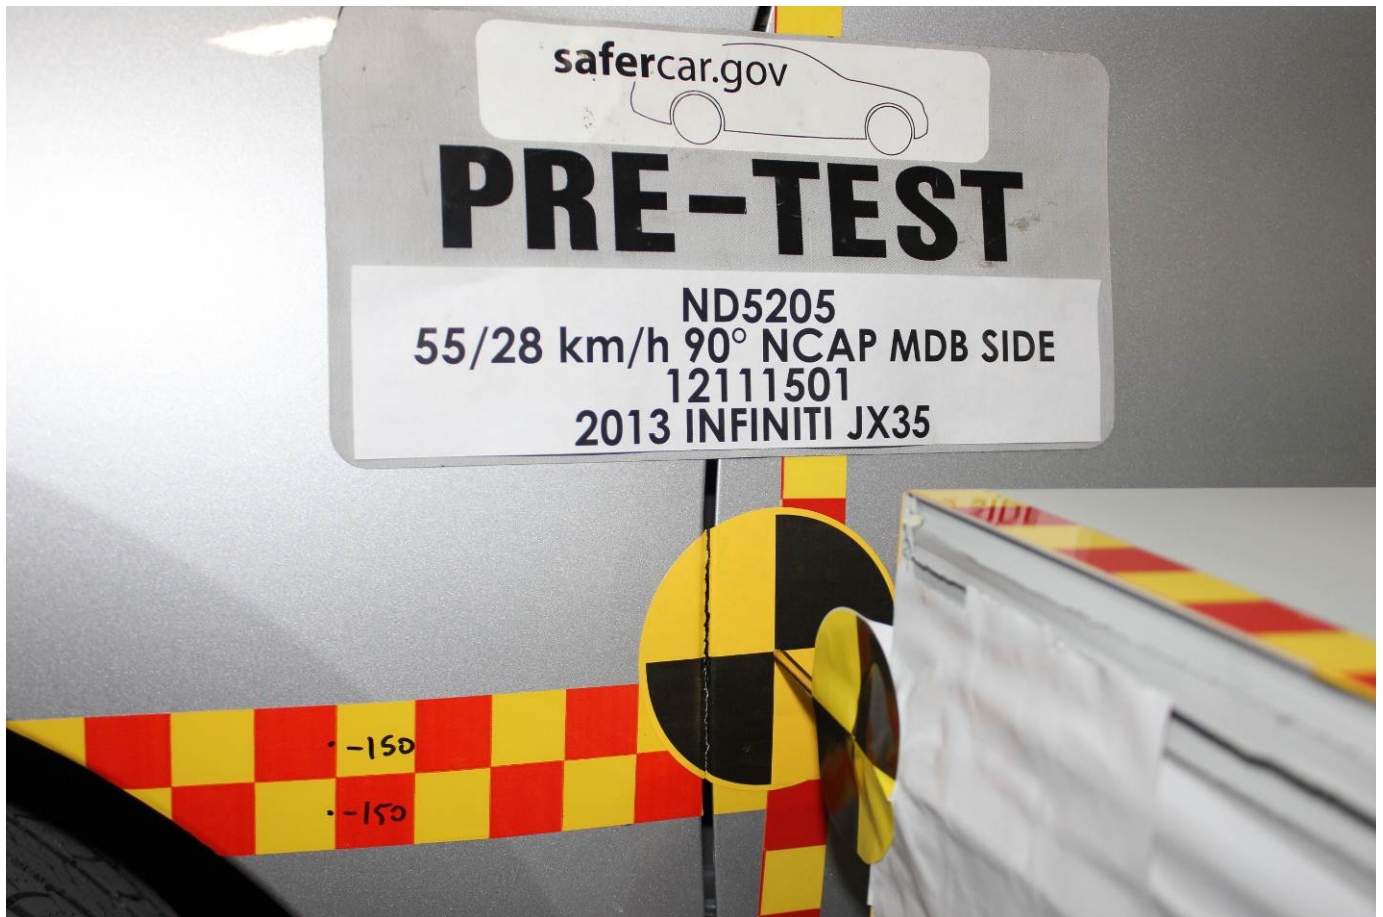
Pre-Test Right Side View of MDB Positioned Against Side of Test Vehicle

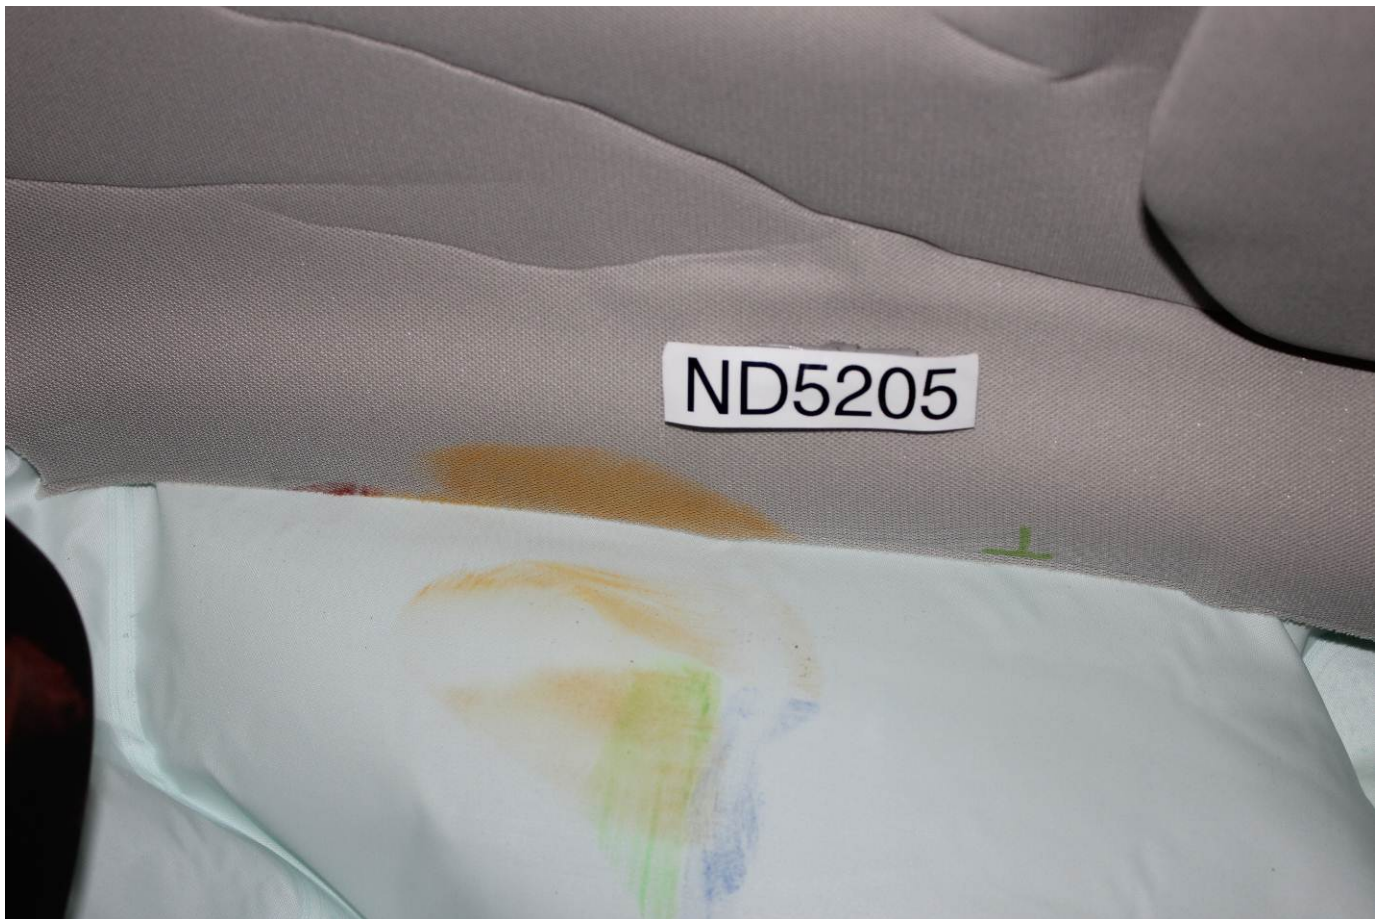
Post-Test Driver Dummy Close-up Head Contact with Vehicle Interior View

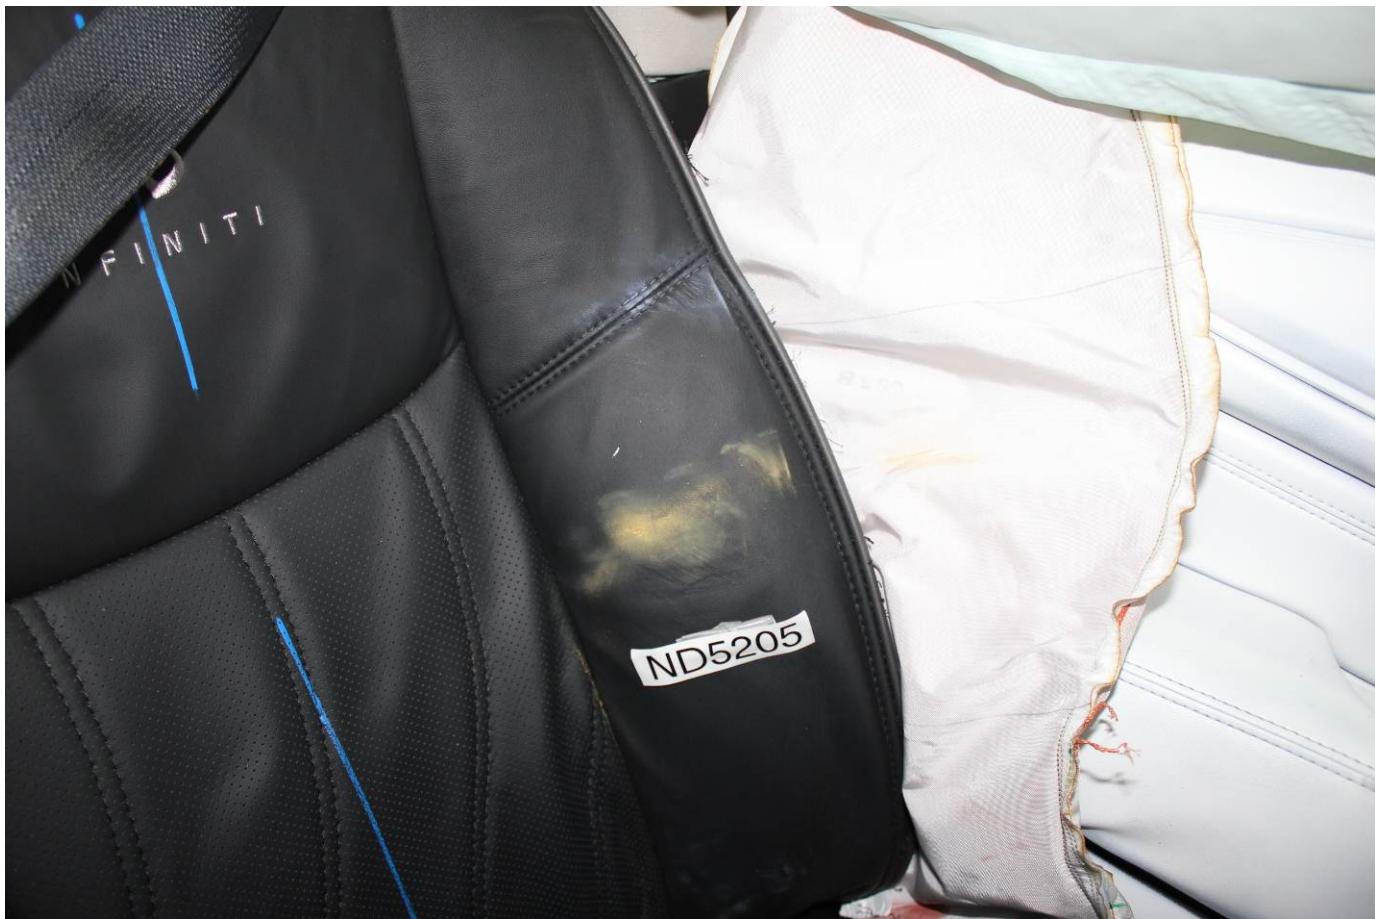
Post-Test Driver Dummy Close-up Head Contact with Side Airbag View

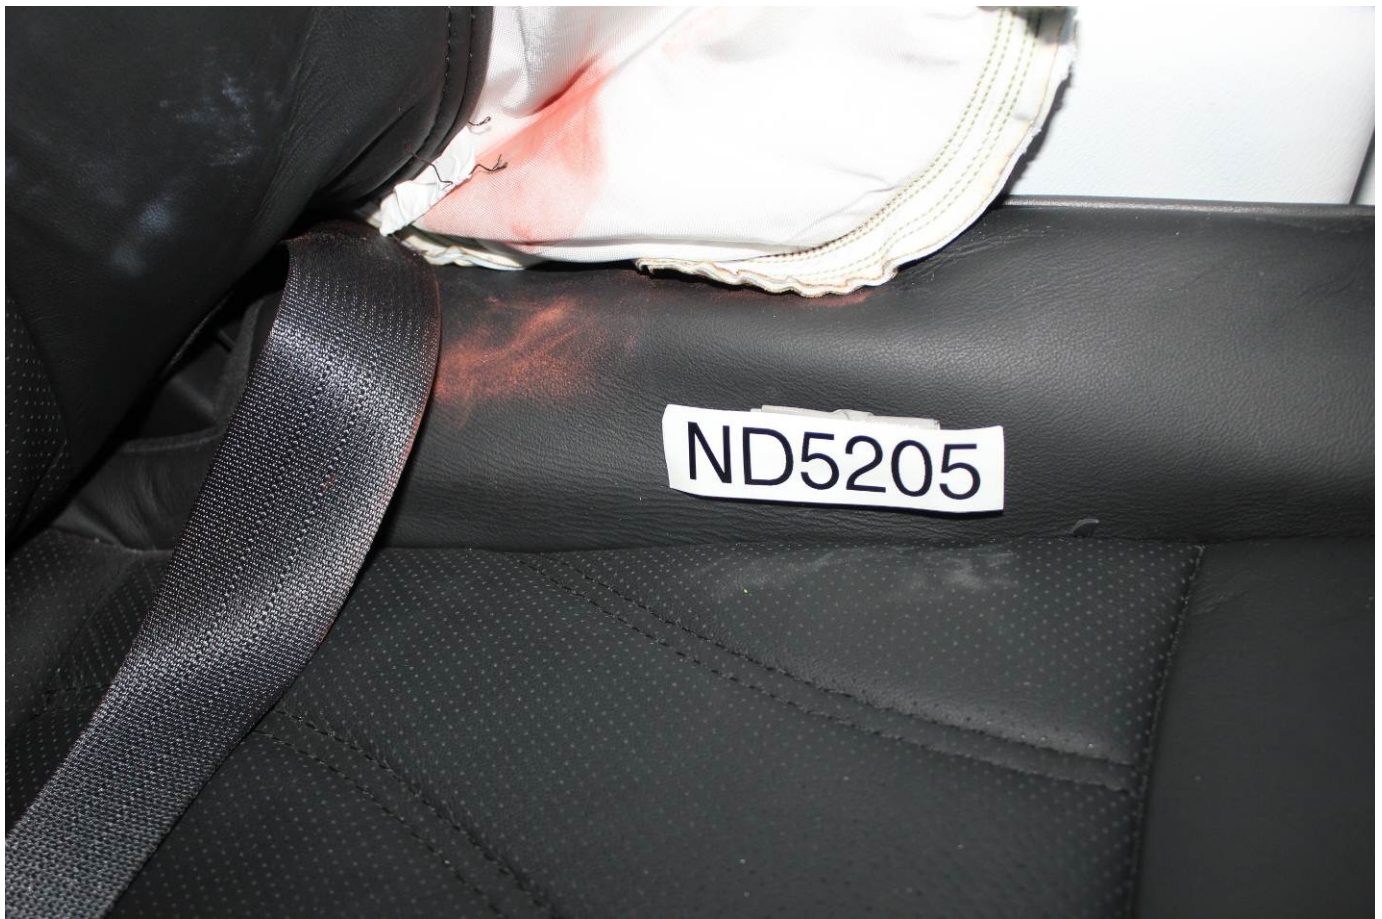
Post-Test Driver Dummy Close-up Torso Contact with Side Airbag View

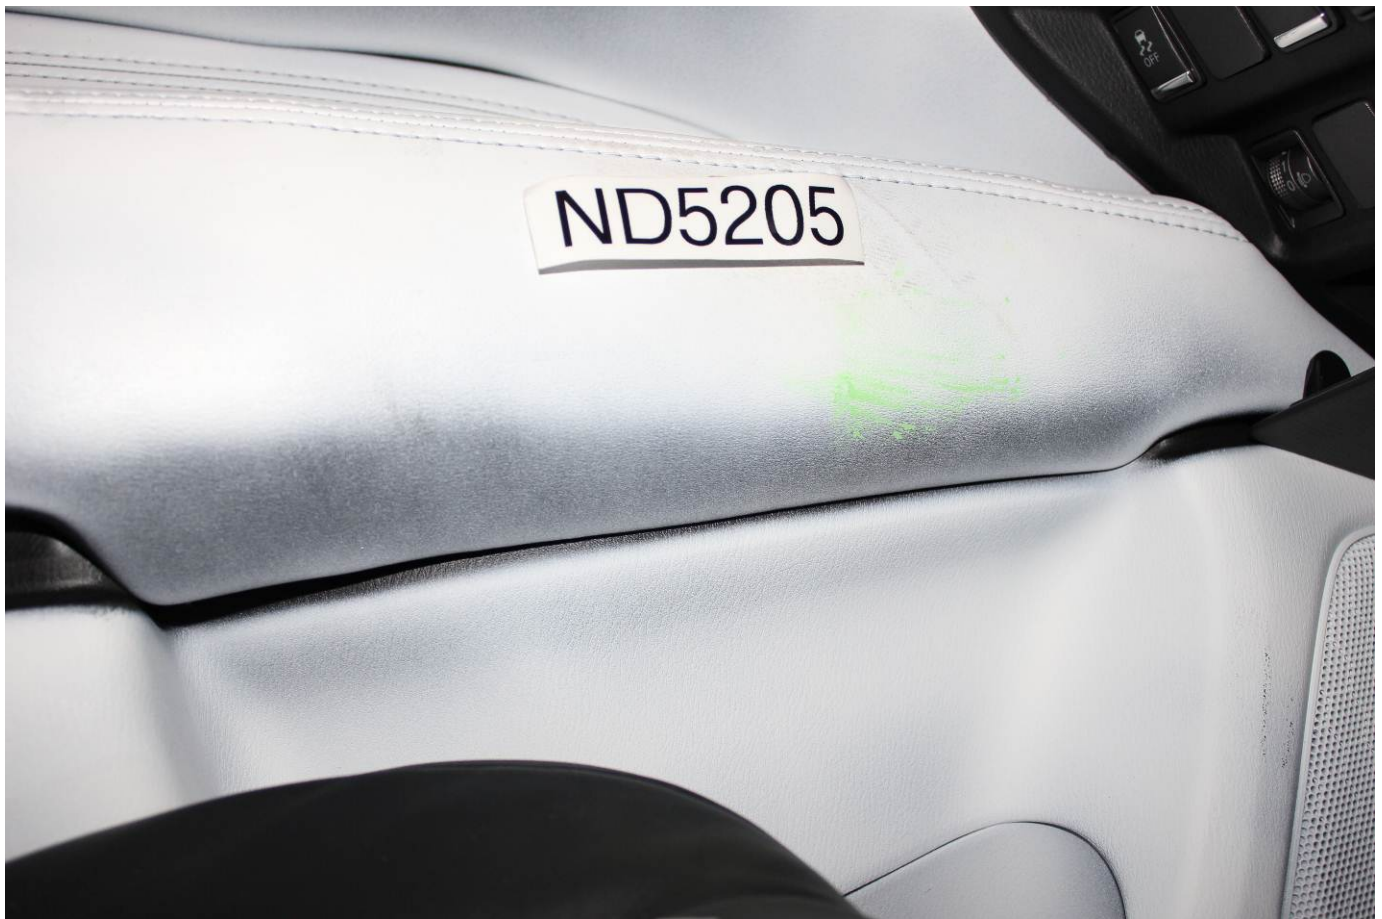
Post-Test Driver Dummy Close-up Pelvis Contact with Side Airbag View

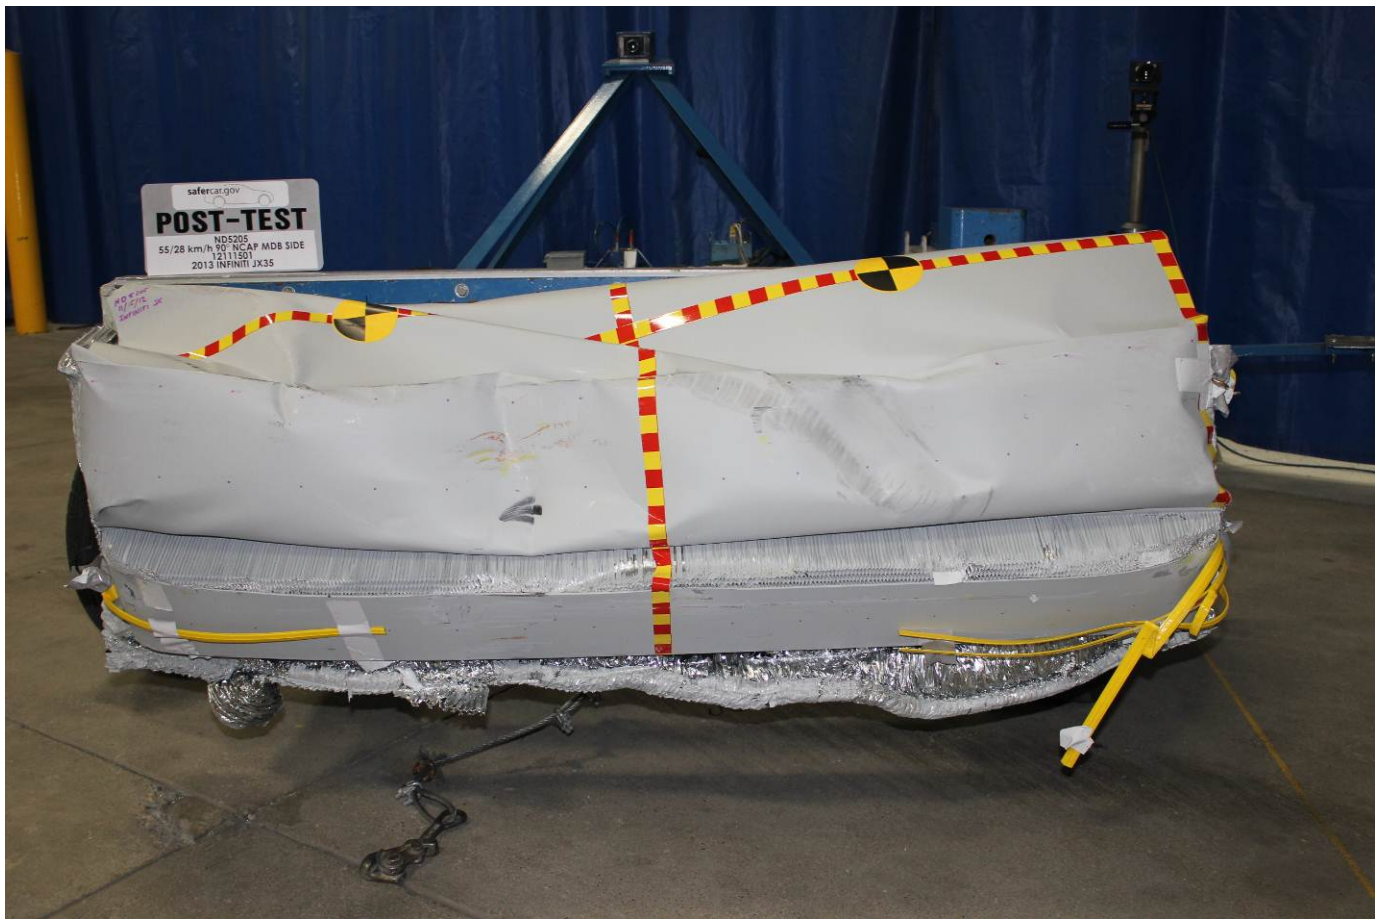
Pre-Test Front View of MDB Impactor Face
