**REPORT NUMBER: SPNCAP-KAR-13-025**

**NEW CAR ASSESSMENT PROGRAM (NCAP)  
SIDE IMPACT POLE TEST**

**TOYOTA MOTOR CORPORATION  
2013 LEXUS IS250 4-DOOR SEDAN**

**FINAL REPORT**

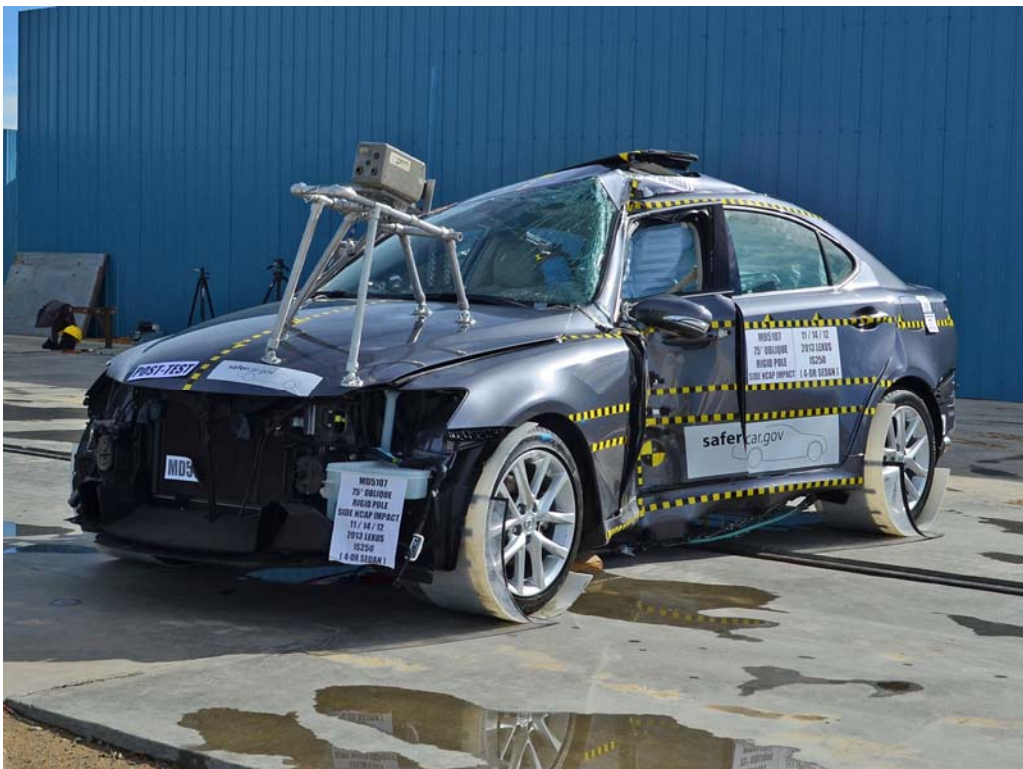
FIGURE 6. Post-Test Left Front  $\frac{3}{4}$  View of Test Vehicle

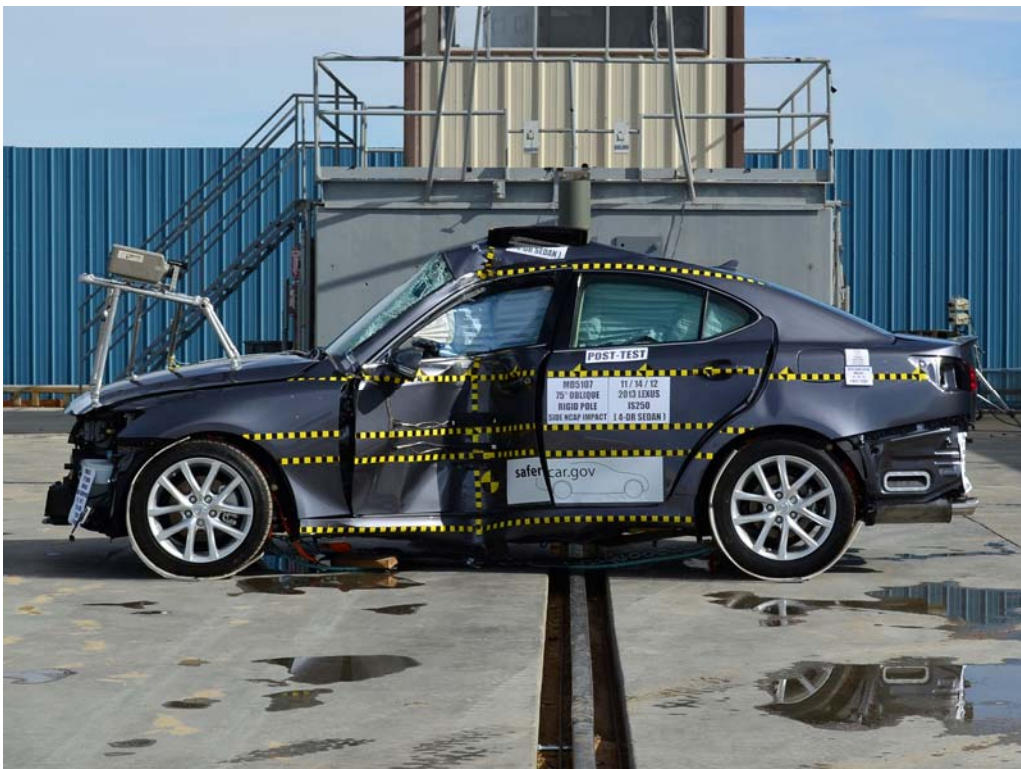
FIGURE 8. Post-Test Left Side View of Test Vehicle

Both the front and rear doors on the struck side of the vehicle remained closed and latched. There was no separation at the hinges or latches. Both doors on the non-struck side remained closed and latched. There were no ATD values that exceeded limits.

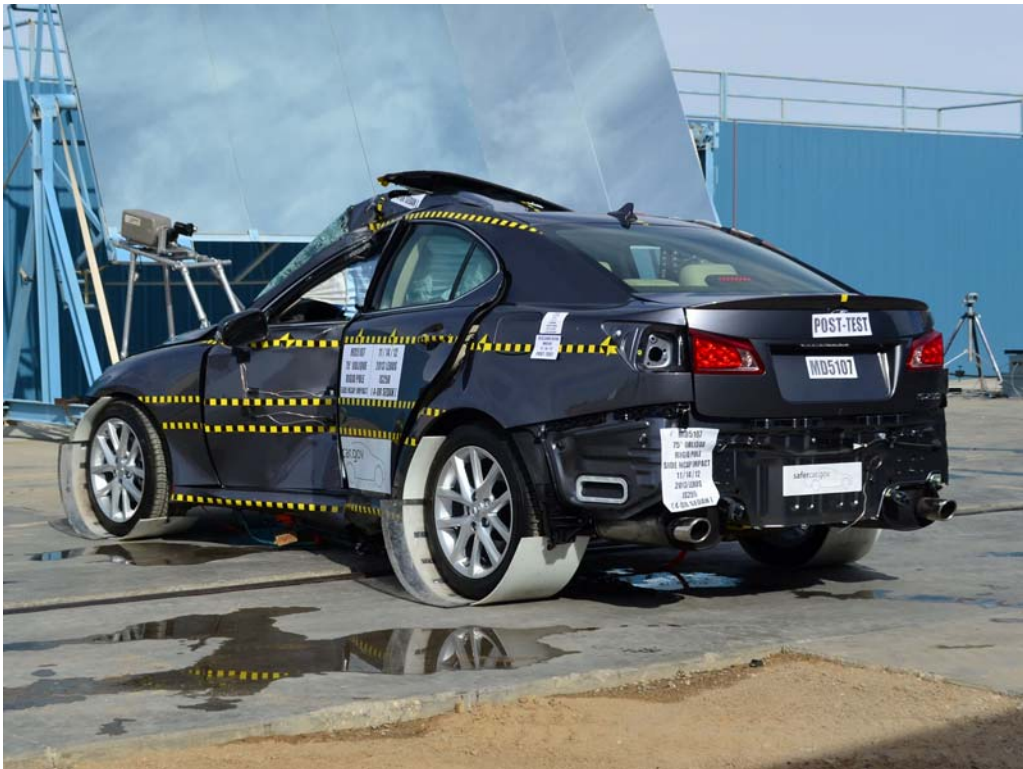
FIGURE 10. Post-Test Left Rear  $\frac{3}{4}$  View of Test Vehicle

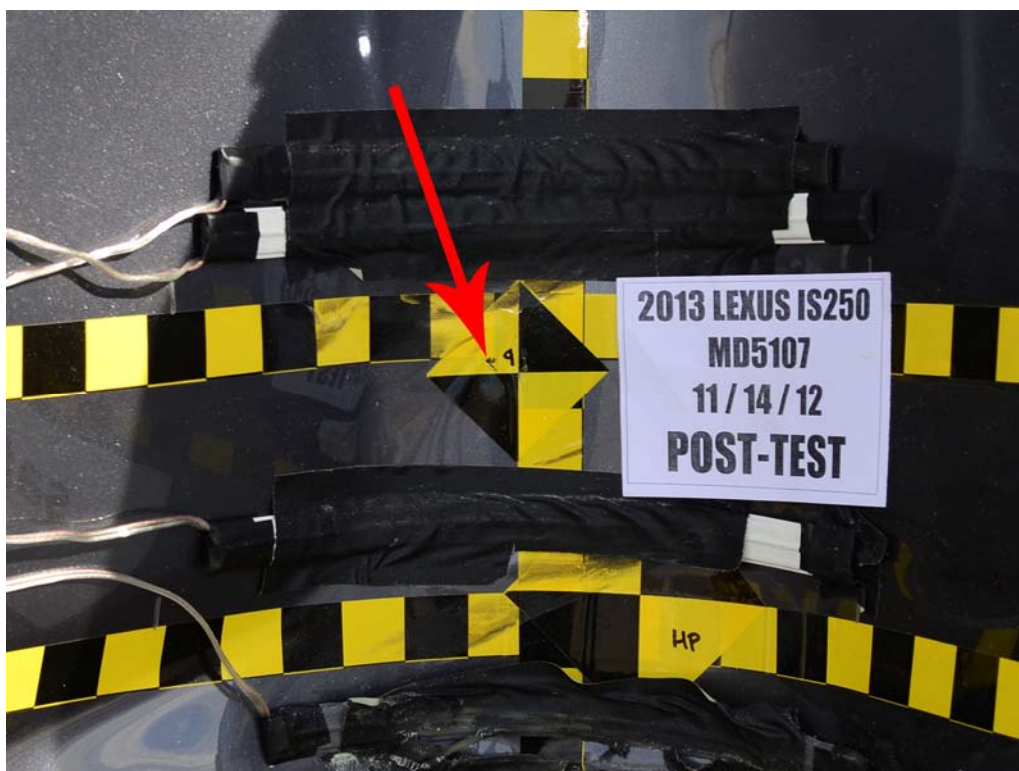
FIGURE 20. Post-Test Close-Up View of Impact Point Target  
Showing Impact Location

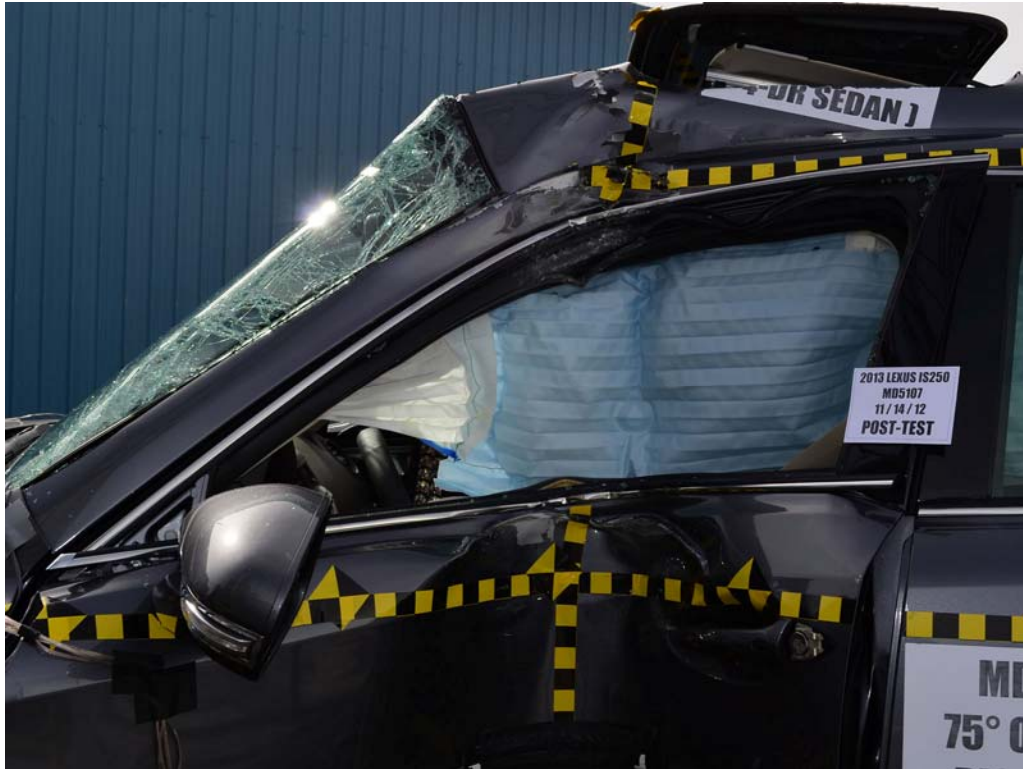
FIGURE 25. Post-Test Left Side View of Dummy Shoulder and Door Top View

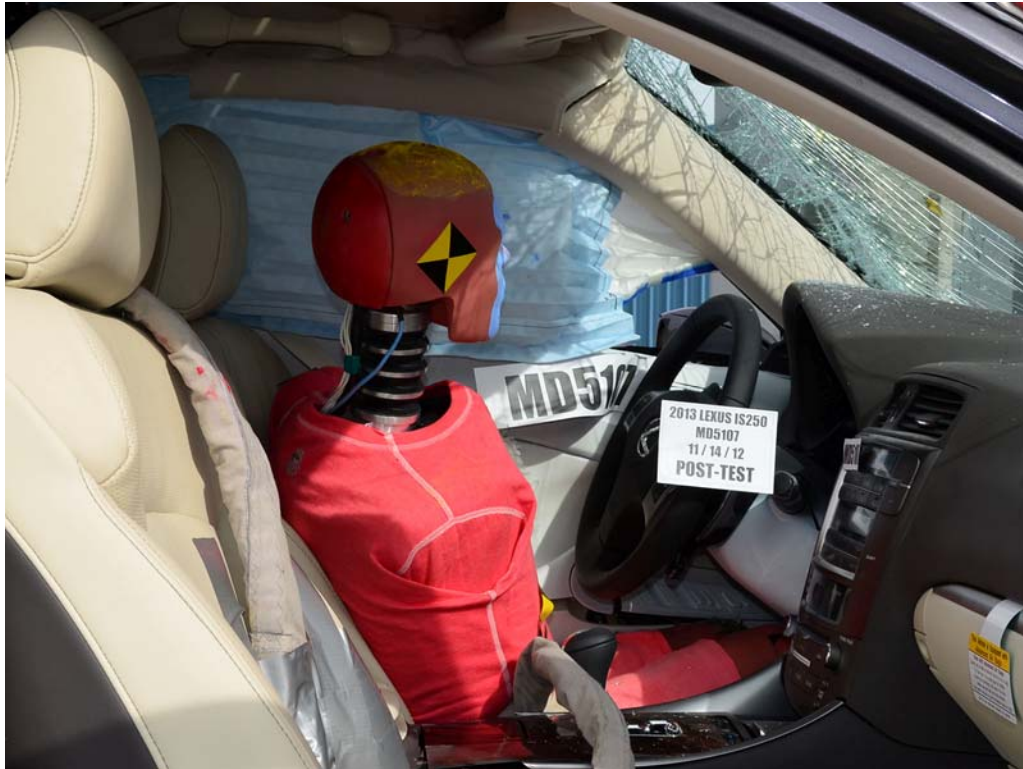
FIGURE 43. Post-Test Right Side View of Dummy and Front Seat Occupant Compartment

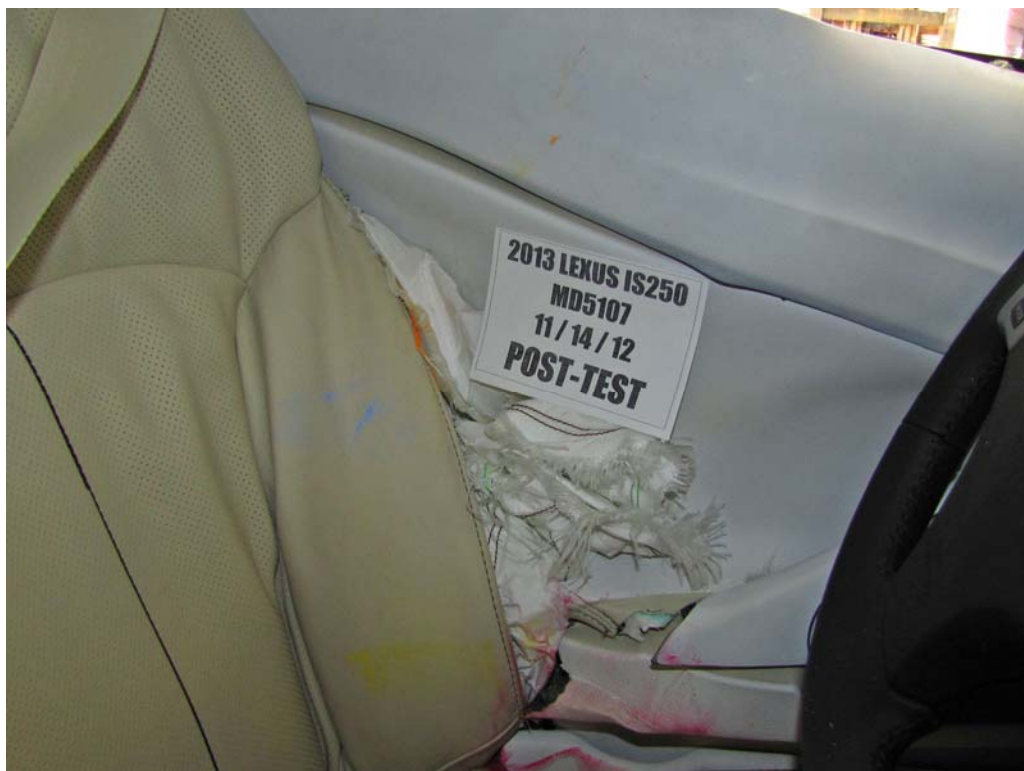
FIGURE 48. Post-Test Dummy Close-Up Torso Contact with Vehicle Interior View

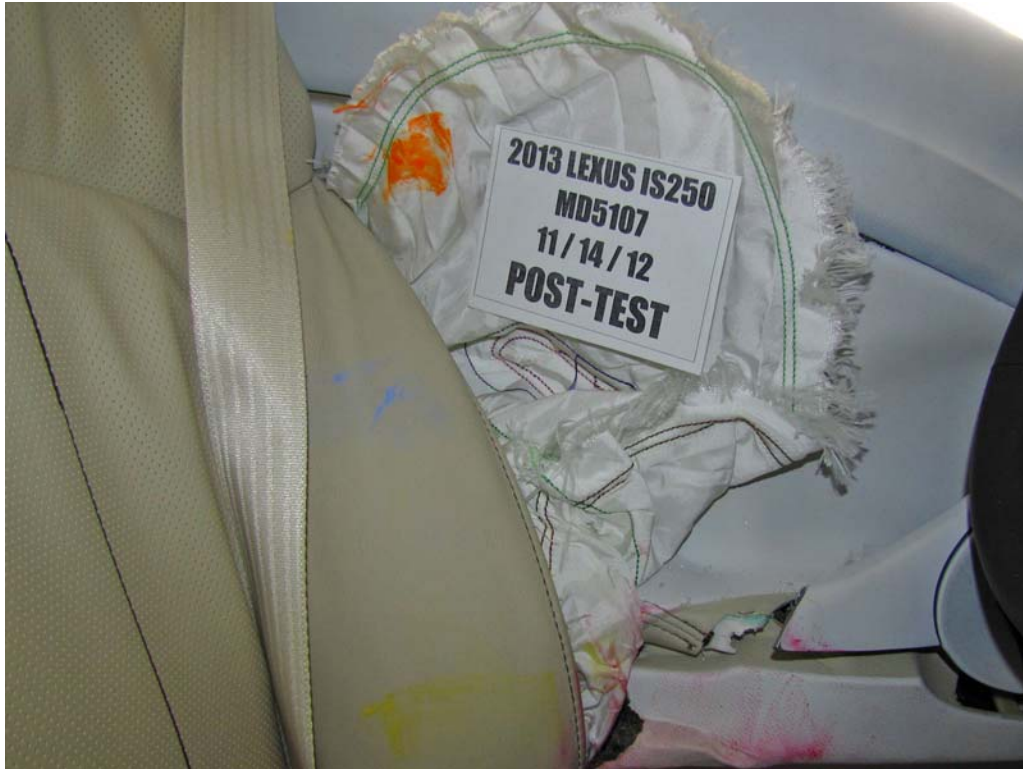
FIGURE 49. Post-Test Dummy Close-Up Torso Contact with Side Airbag View

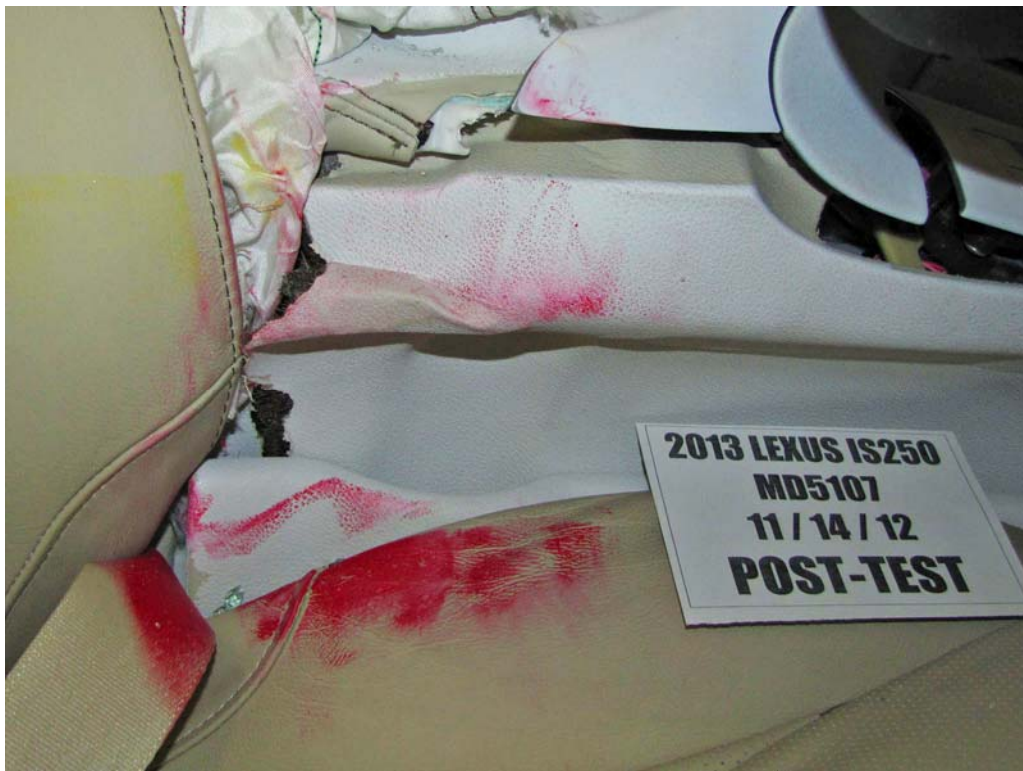
FIGURE 50. Post-Test Dummy Close-Up Pelvis Contact with Vehicle Interior View

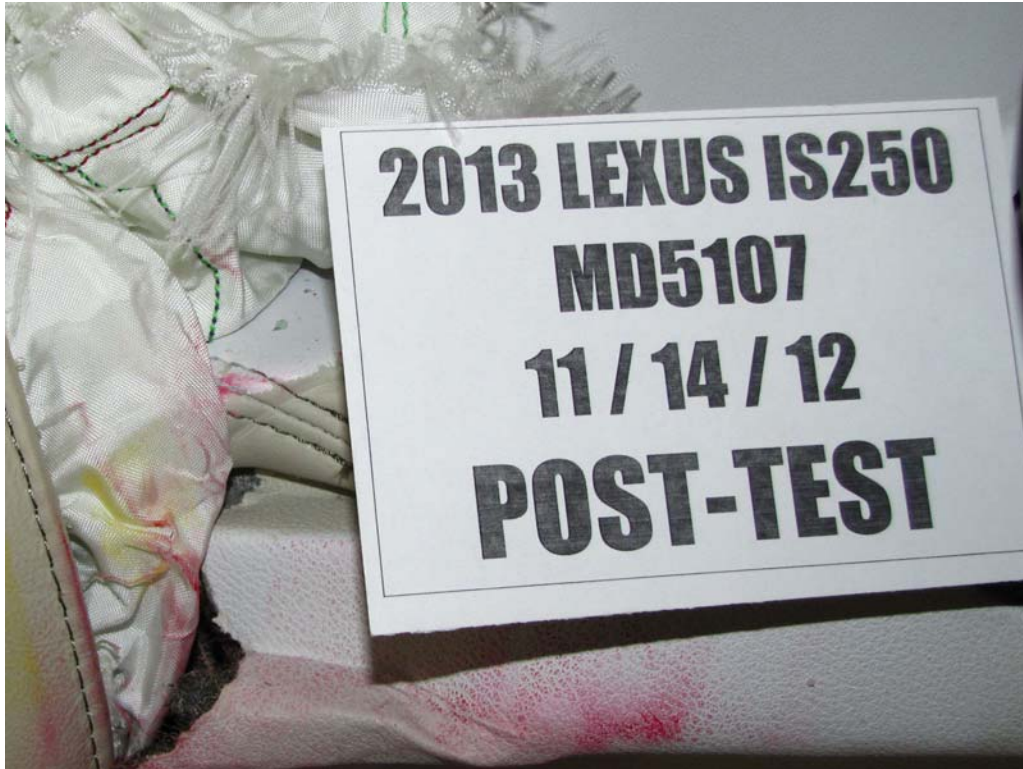
FIGURE 51. Post-Test Dummy Close-Up Pelvis Contact with Side Airbag View

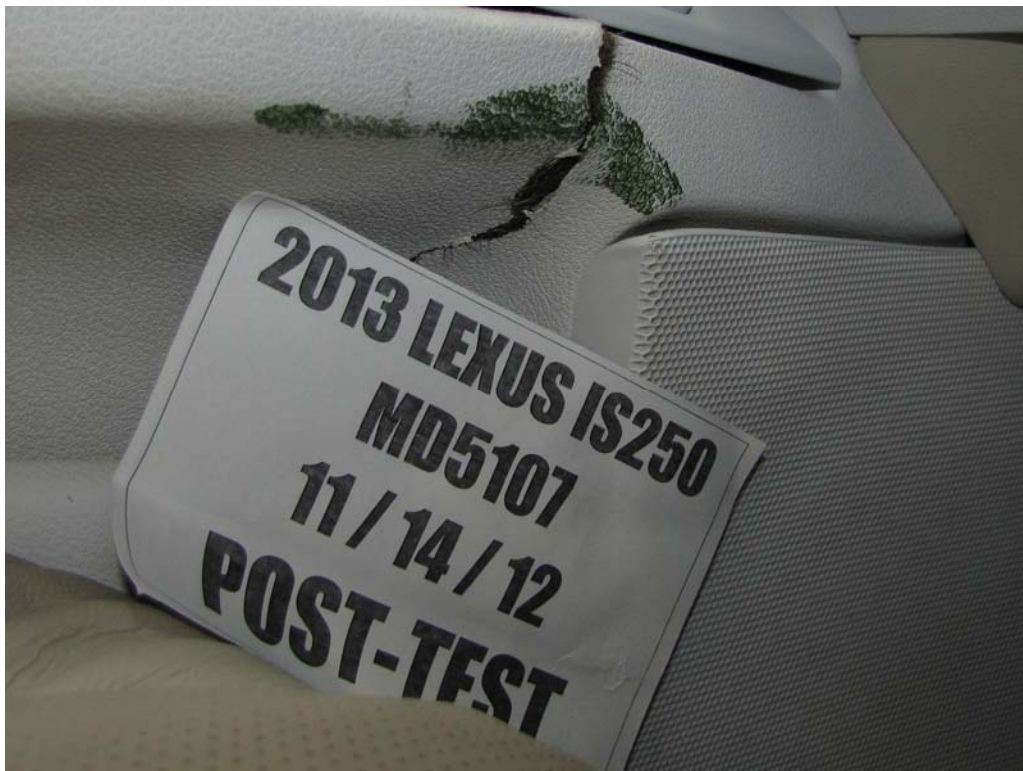
FIGURE 52. Post-Test Dummy Close-Up Knee Contact with Vehicle Interior View

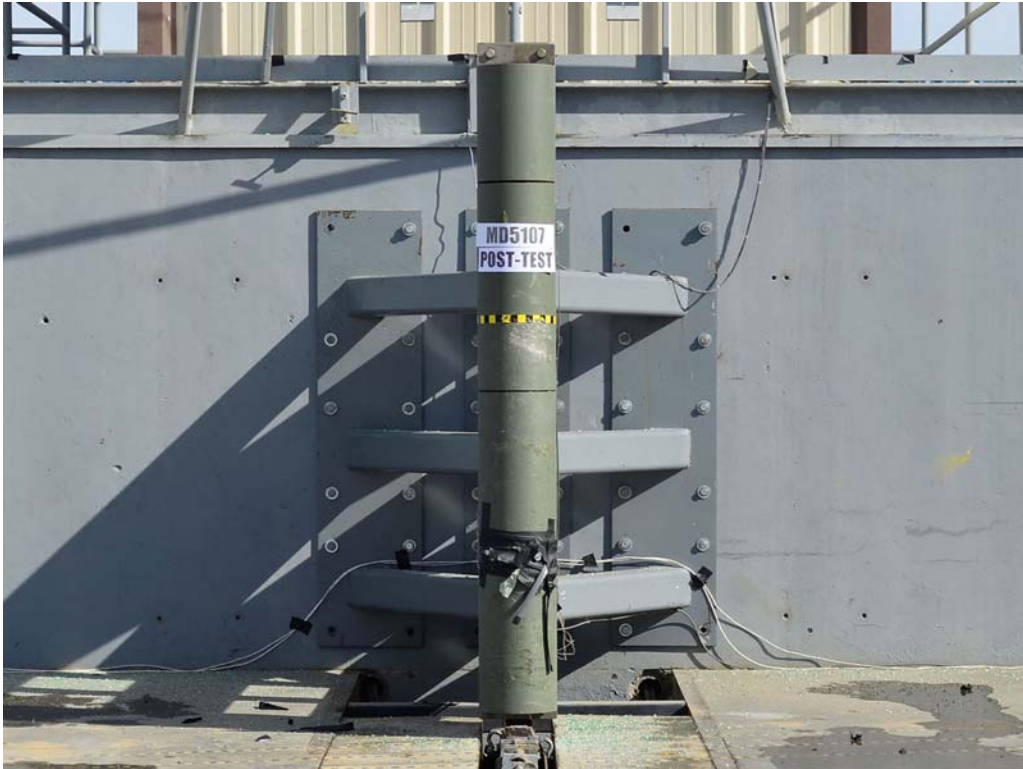
FIGURE 58. Post-Test Pole Barrier Front View

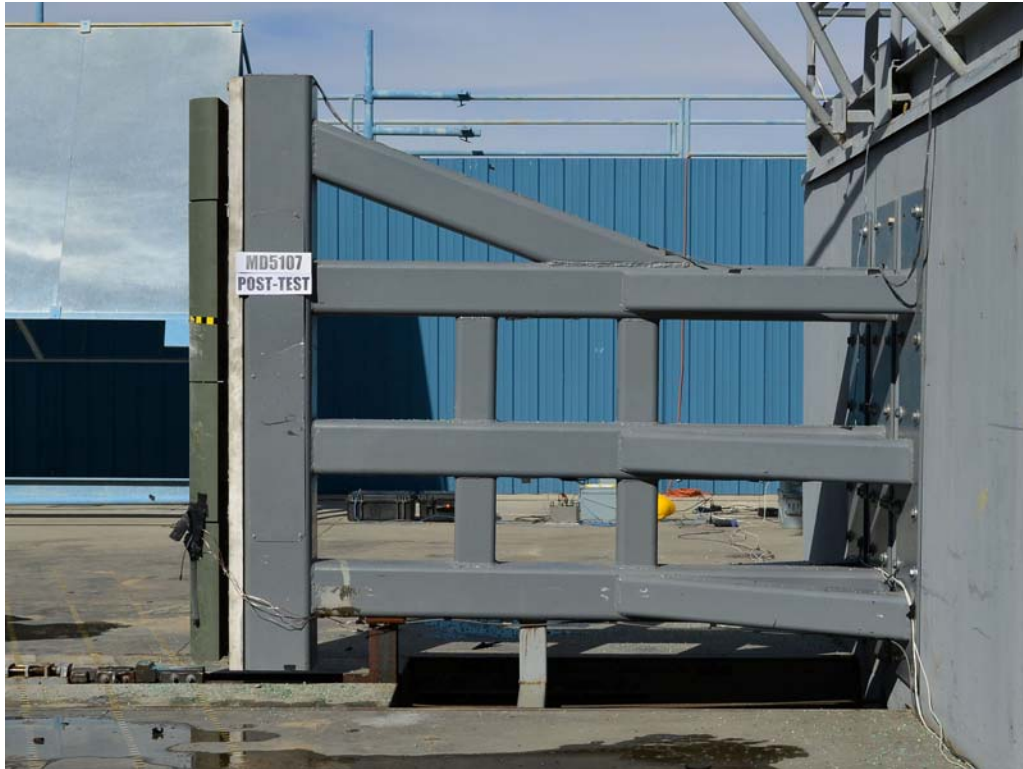
FIGURE 60. Post-Test Pole Barrier Side View

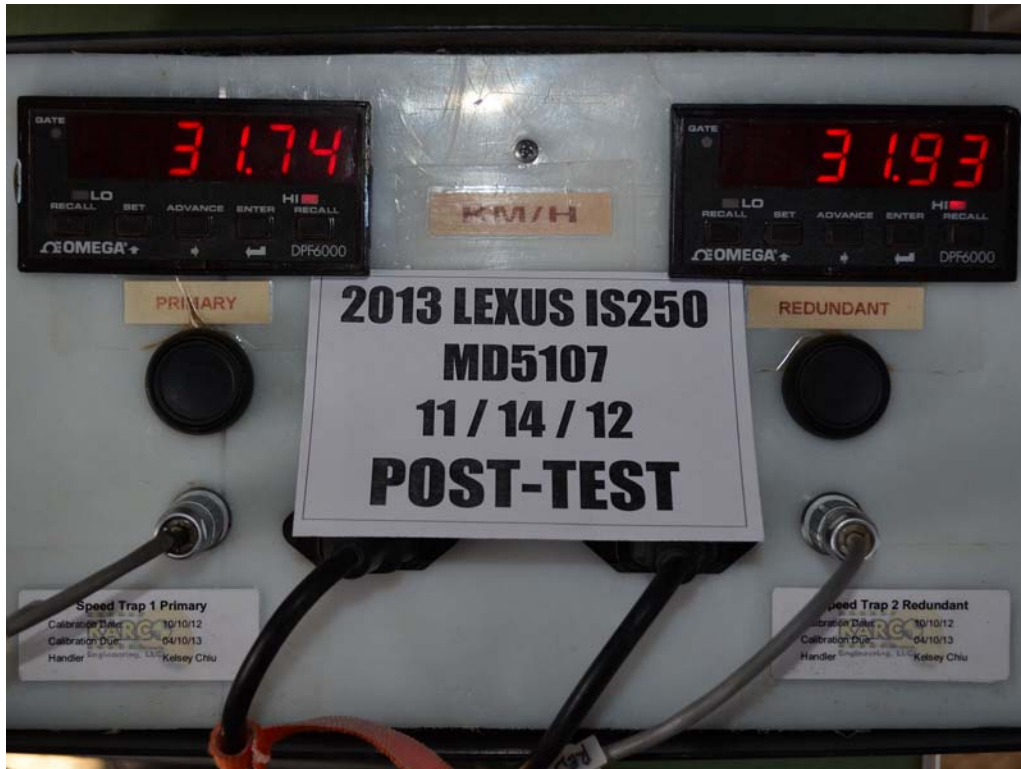
FIGURE 62. Post-Test Primary and Redundant Speed Trap Read-Out

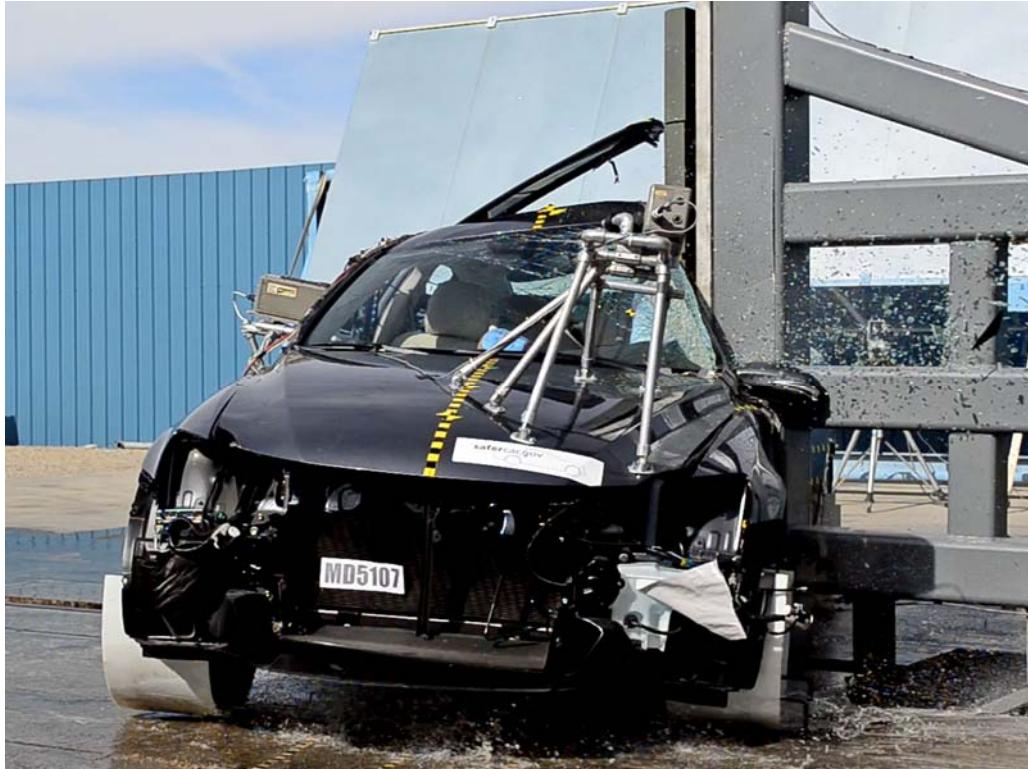
FIGURE 68. Impact Event

A rigid pole side impact test was conducted on a 2013 Lexus IS250 4-door sedan. The subject vehicle was towed into the rigid pole at an angle of 75.2° and a velocity of 31.7 km/h. The test was conducted by KARCO Engineering, LLC. in Adelanto, California on November 14, 2012. Pre- and post-test photographs of the test vehicle and side impact dummy (SID-IIs) are included in Appendix A of this report.
