REPORT NUMBER: SINCAP-CAL-12-015

**NEW CAR ASSESSMENT PROGRAM (NCAP)
MOVING DEFORMABLE BARRIER SIDE IMPACT TEST**

**FUJI HEAVY INDUSTRIES LTD
2013 Subaru Legacy
Four Door Sedan**

NHTSA No: QD5101

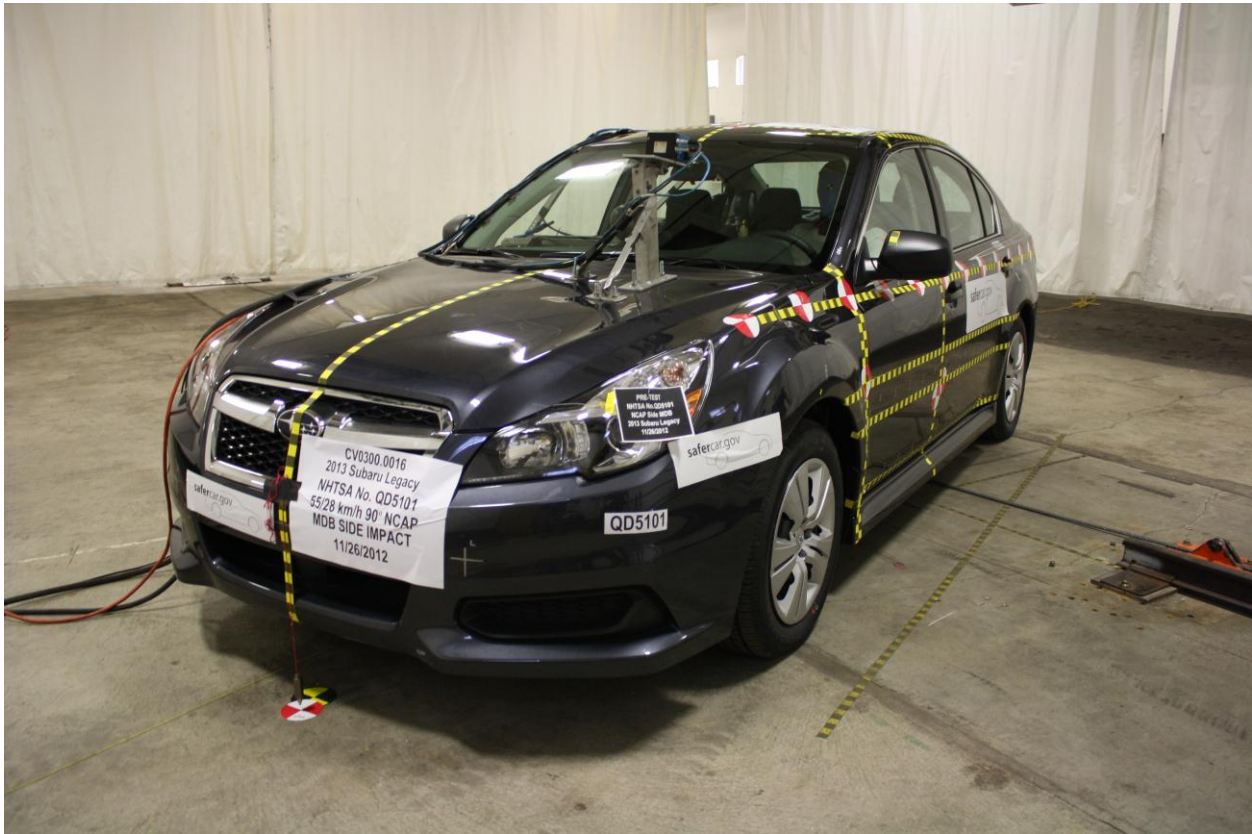
Figure A-5: Pre-Test Left Front $\frac{3}{4}$ View of Test Vehicle

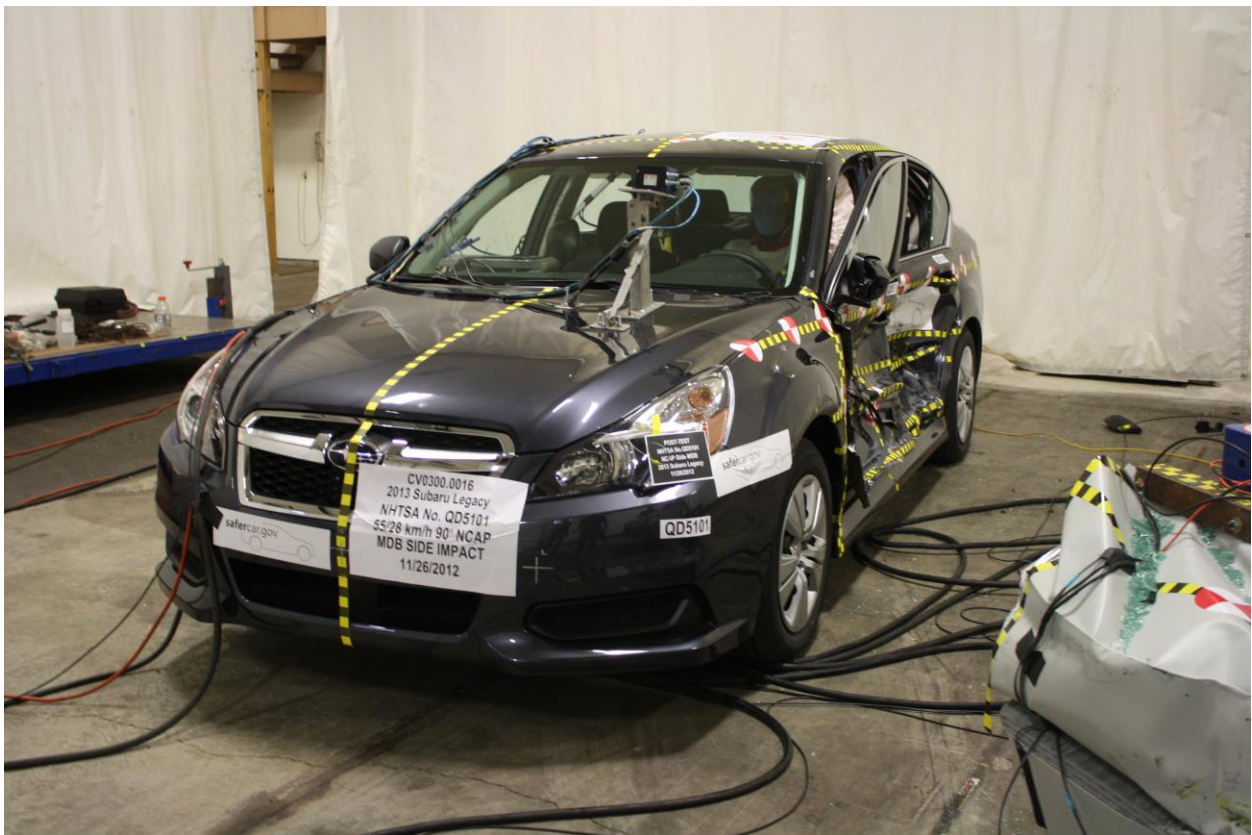
Figure A-6: Post-Test Left Front $\frac{3}{4}$ View of Test Vehicle

Critical Areas of Performance	Observations and Conclusions
Pillar Performance	Remained in good condition
Sill Separation	Bent inwards but remained on vehicle
Windshield Damage	None
Side Window Damage	Rear passenger window shattered during impact
Other Notable Effects	None

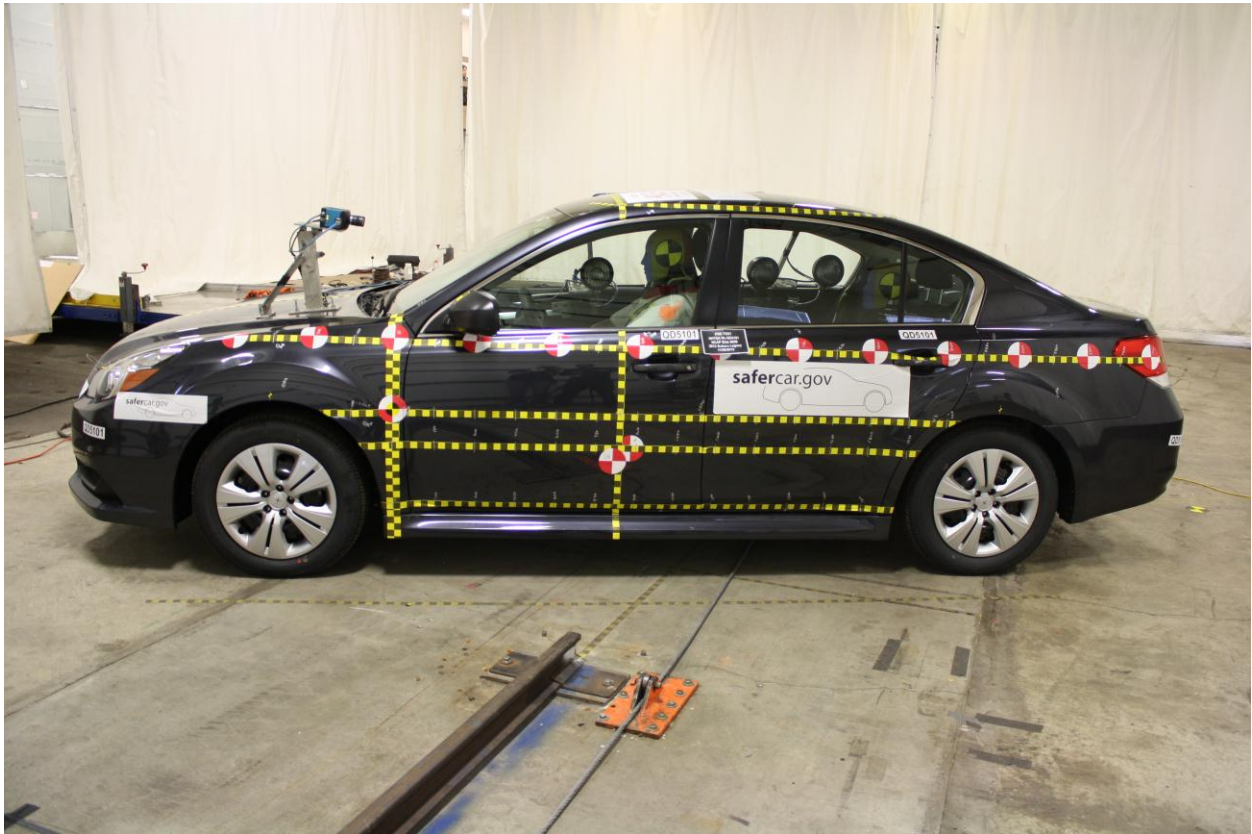
Figure A-7: Pre-Test Left Side View of Test Vehicle

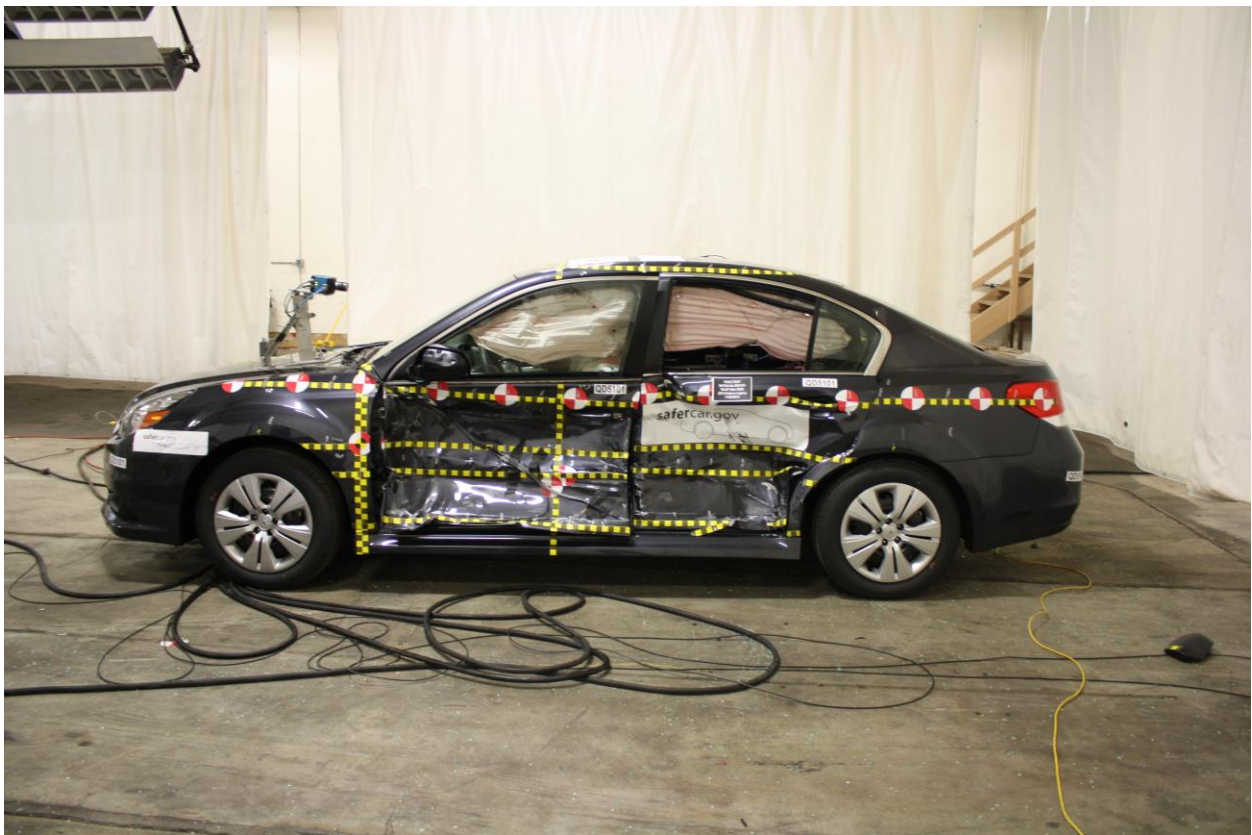
Figure A-8: Post-Test Left Side View of Test Vehicle

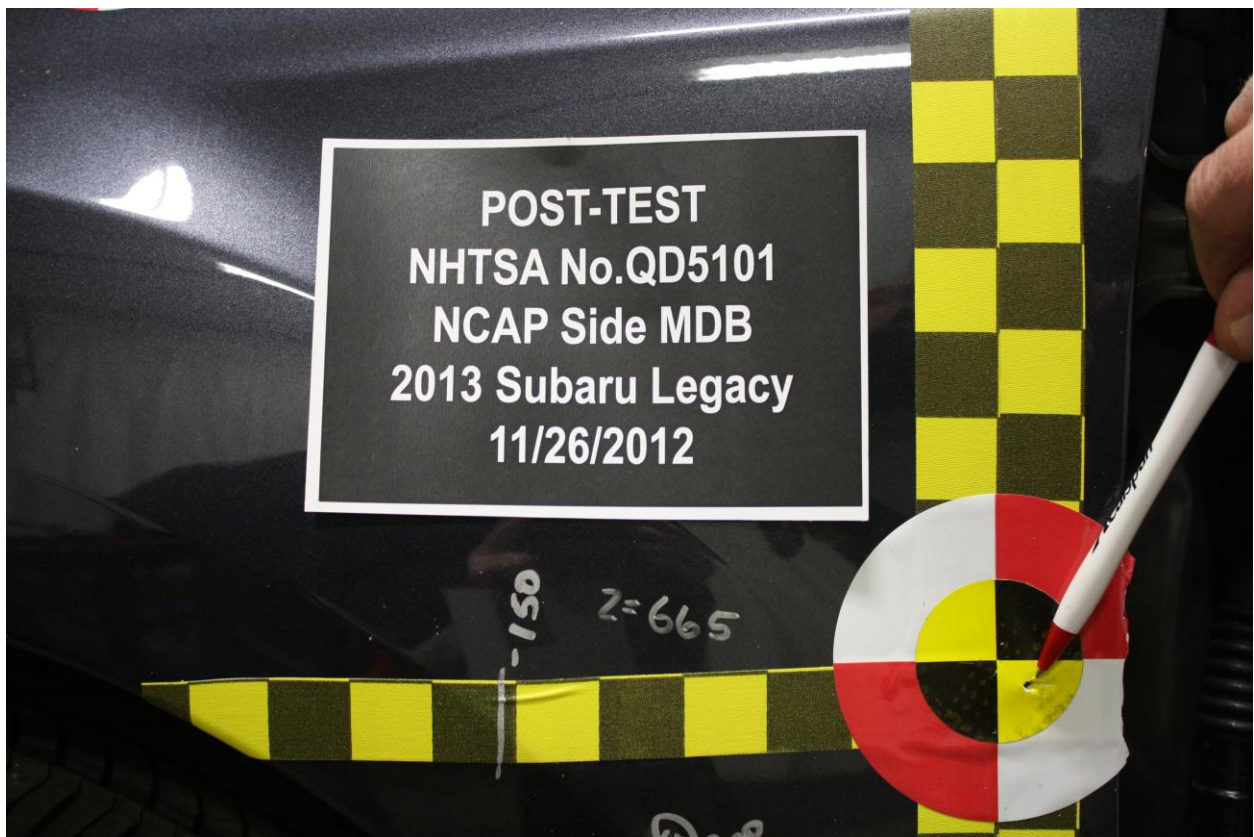
Figure A-20: Post-Test Close-up View of Impact Point Target

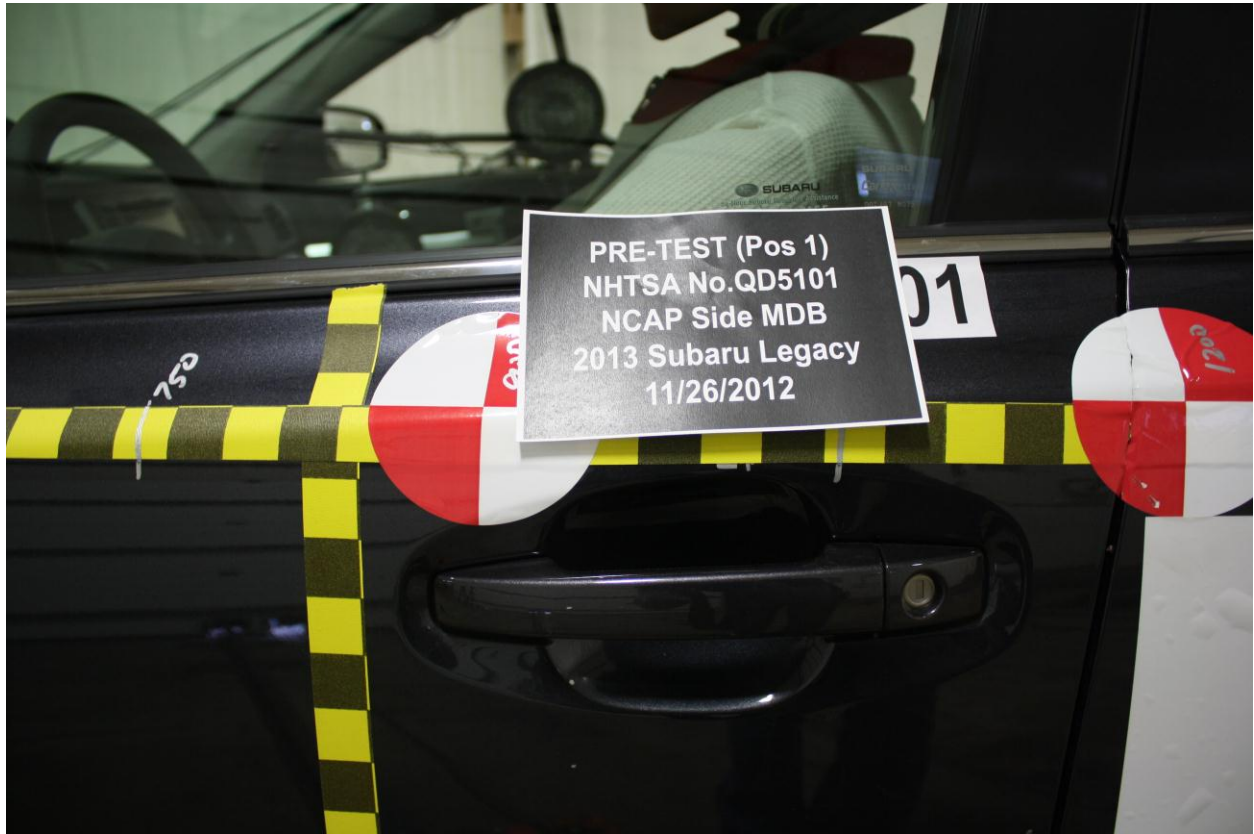
Figure A-21: Pre-Test Left Front Door Latch Close-Up

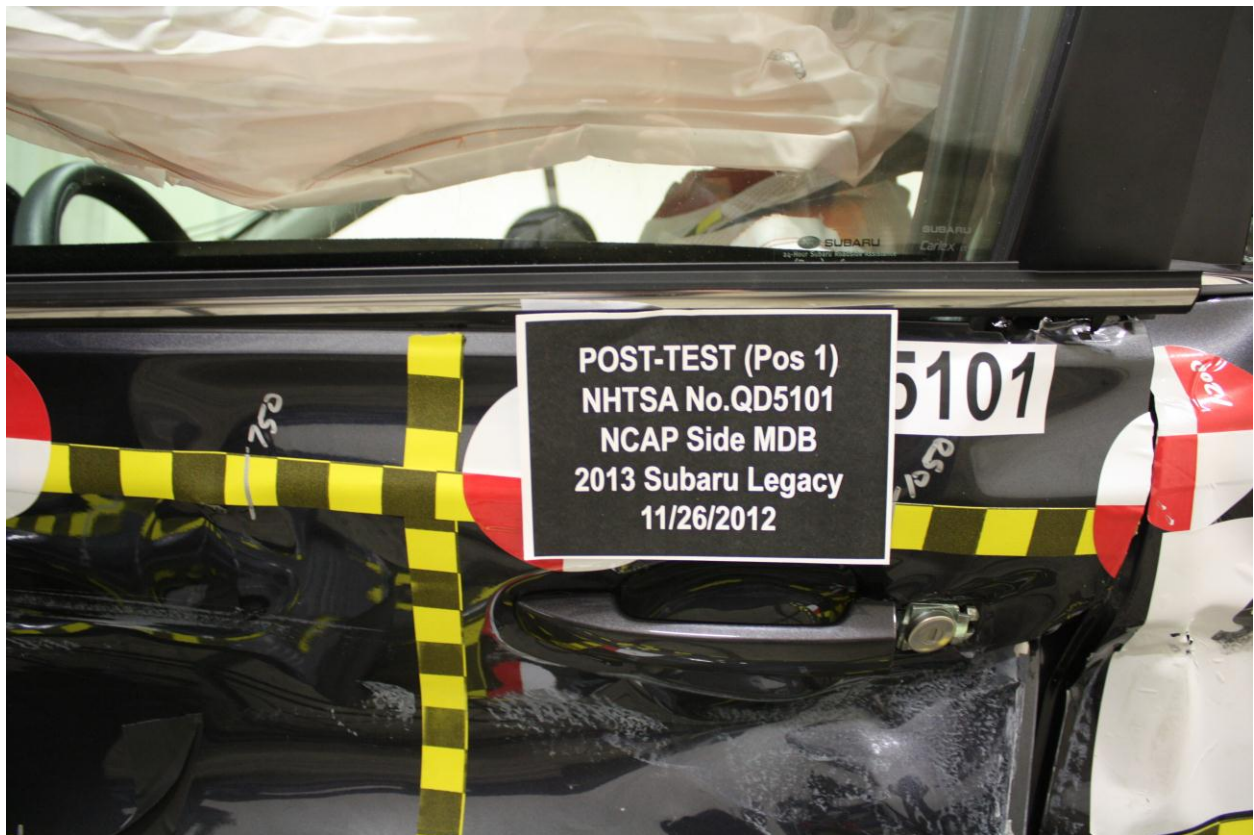
Figure A-22: Post-Test Left Front Door Latch Close-Up

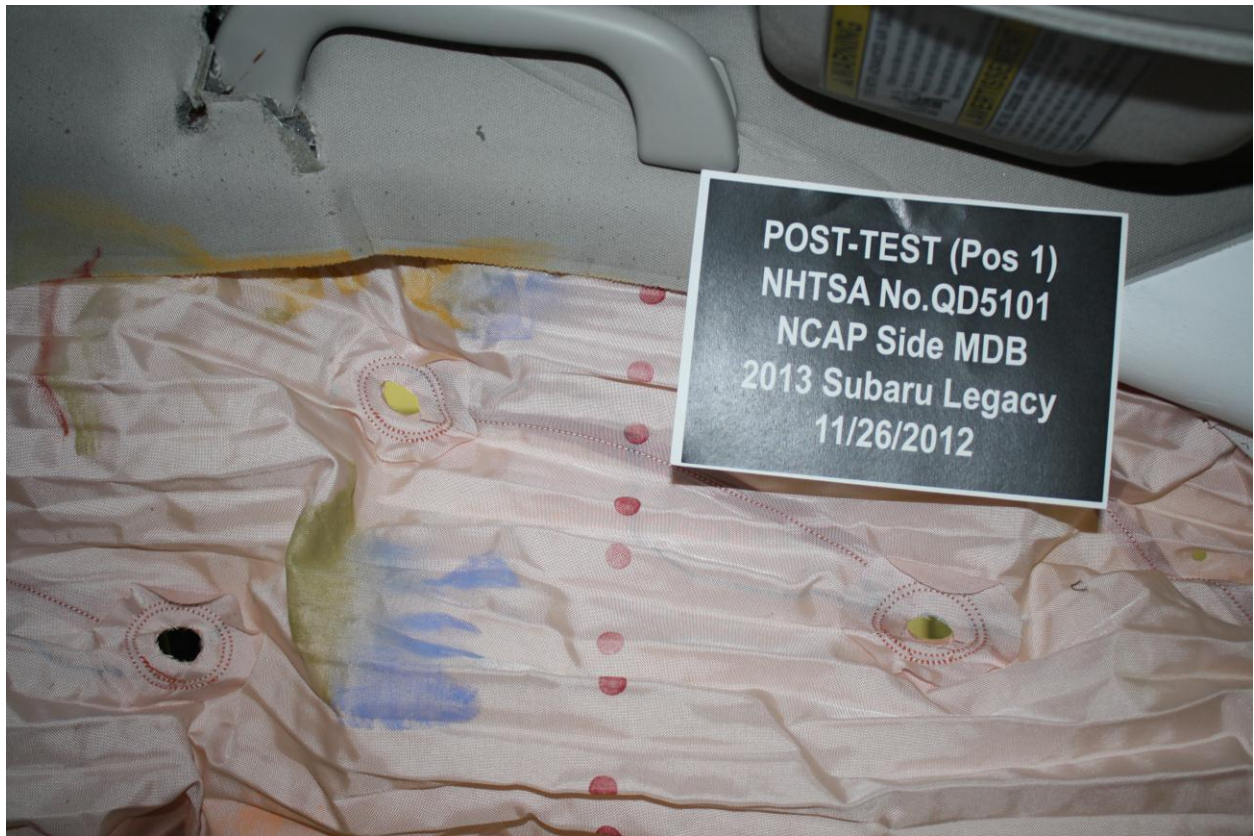
Figure A-49: Post-Test Driver Dummy Close-Up Head Contact with Side Airbag View

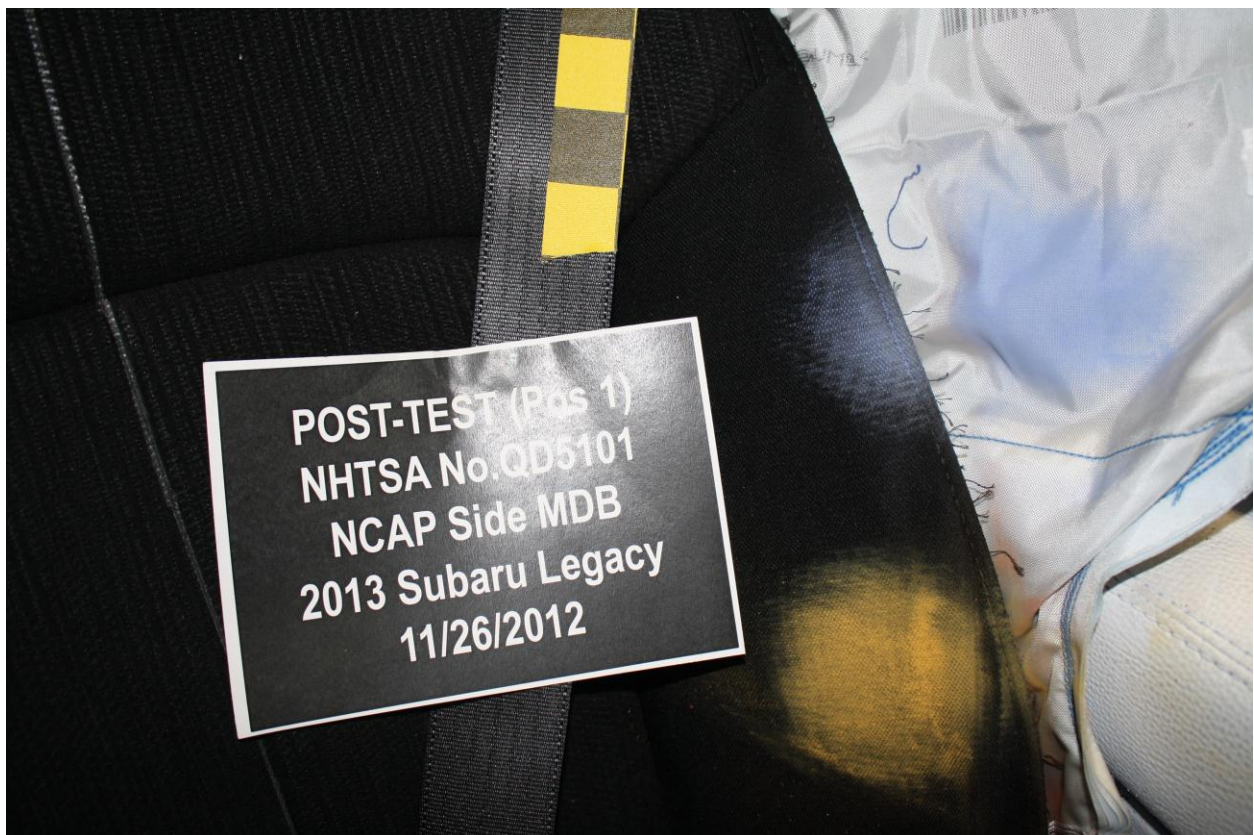
Figure A-50: Post-Test Driver Dummy Close-Up Torso Contact with Vehicle Interior View

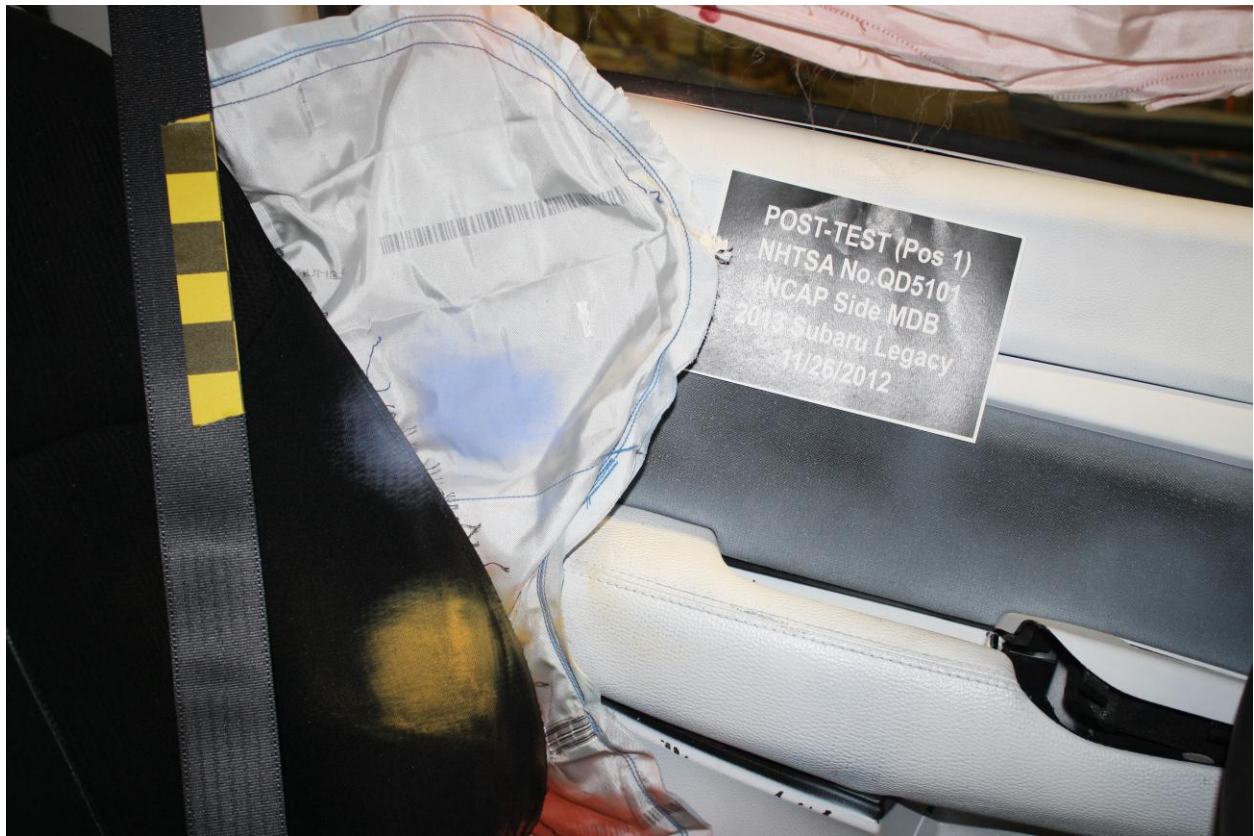
Figure A-51: Post-Test Driver Dummy Close-Up Torso Contact with Side Airbag View

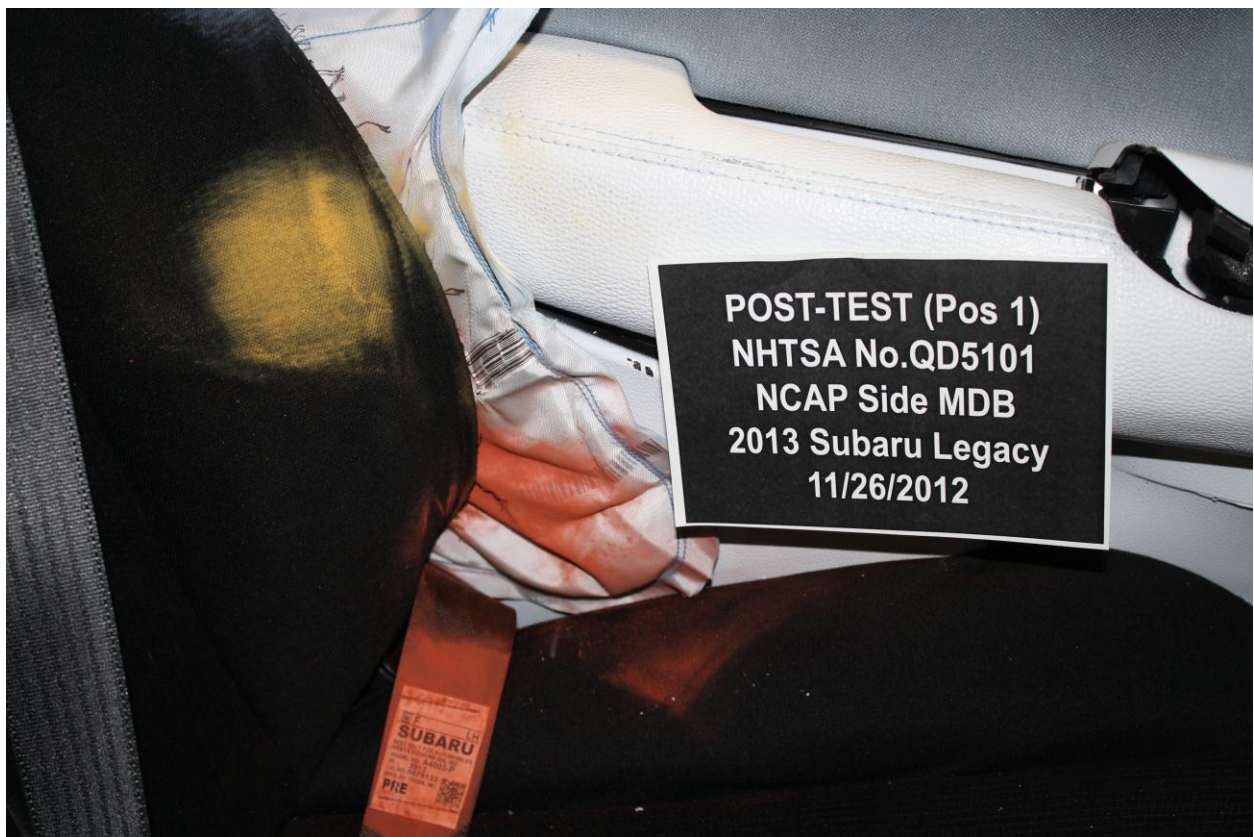
Figure A-52: Post-Test Driver Dummy Close-Up Pelvis Contact View

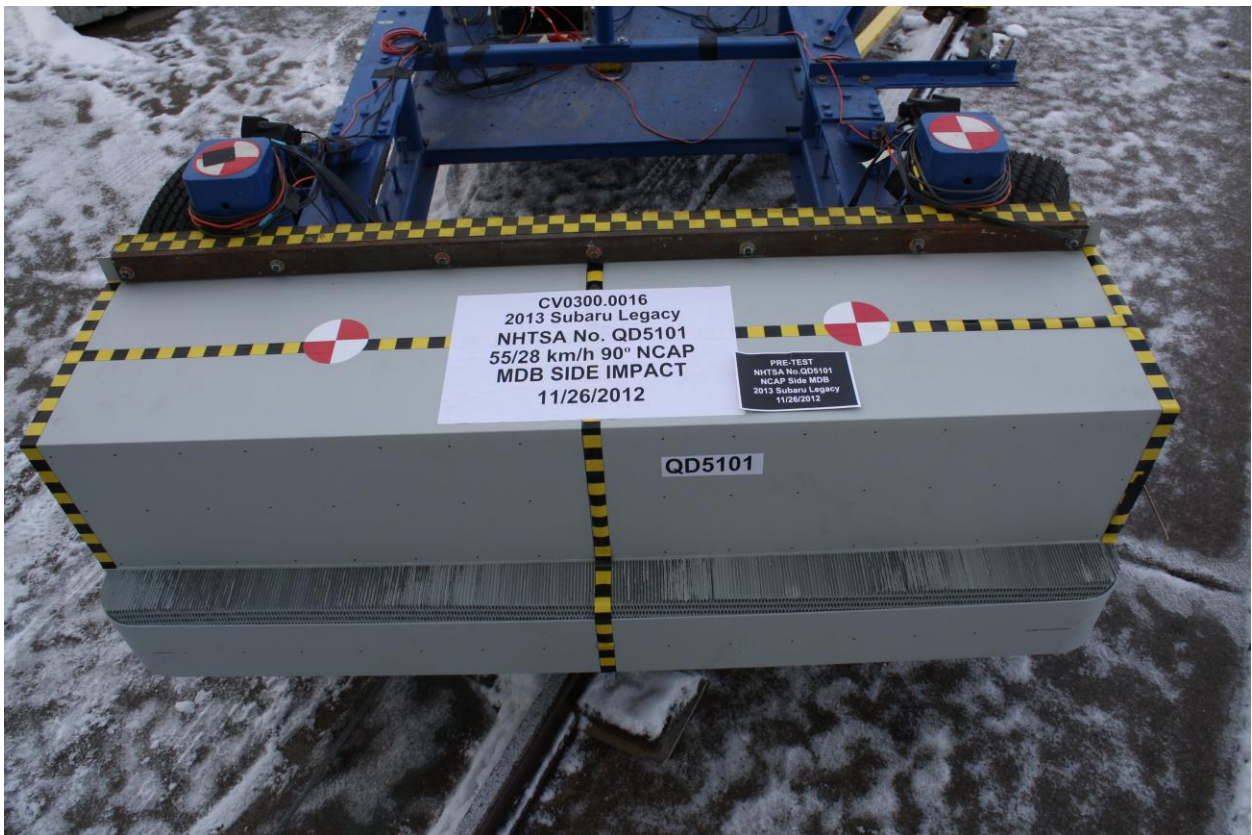
Figure A-86: Pre-Test Top View of MDB Impactor Face

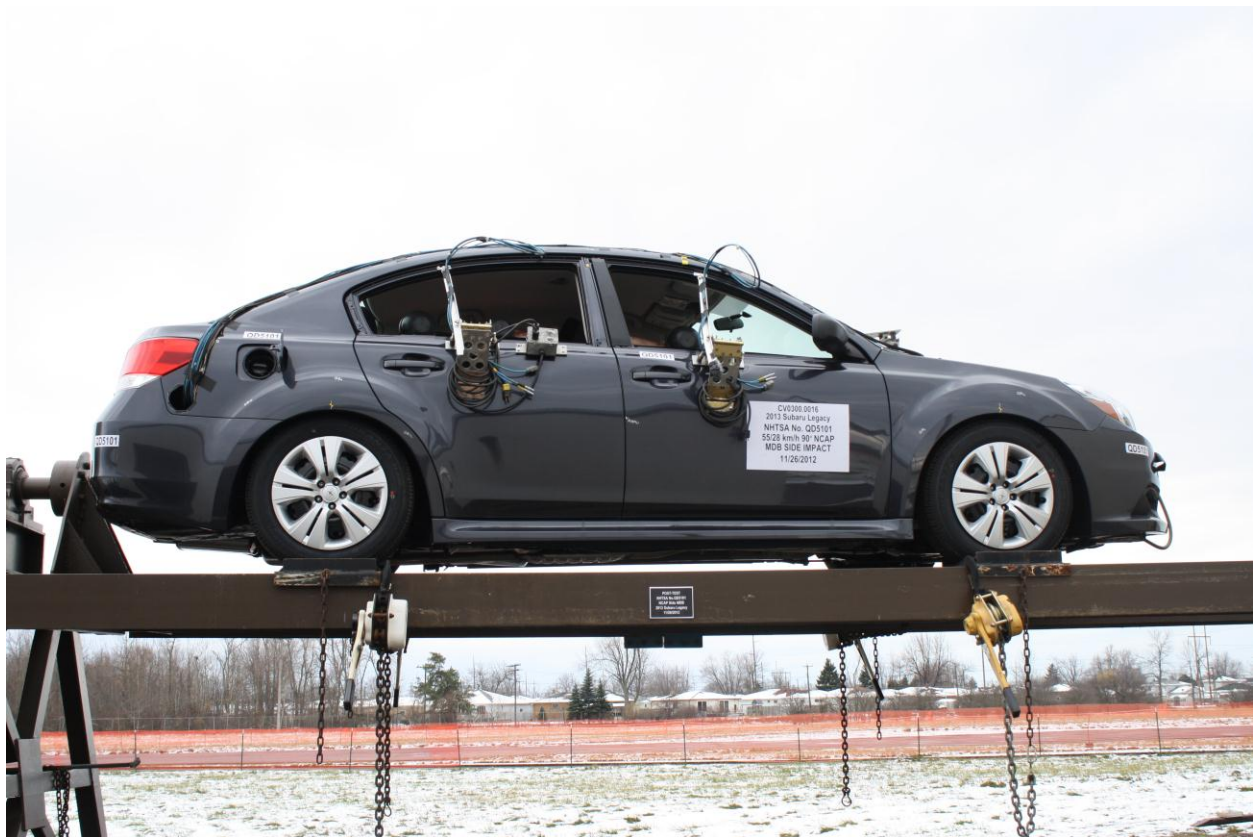
Figure A-96: FMVSS No. 301 Static Rollover 0 Degrees

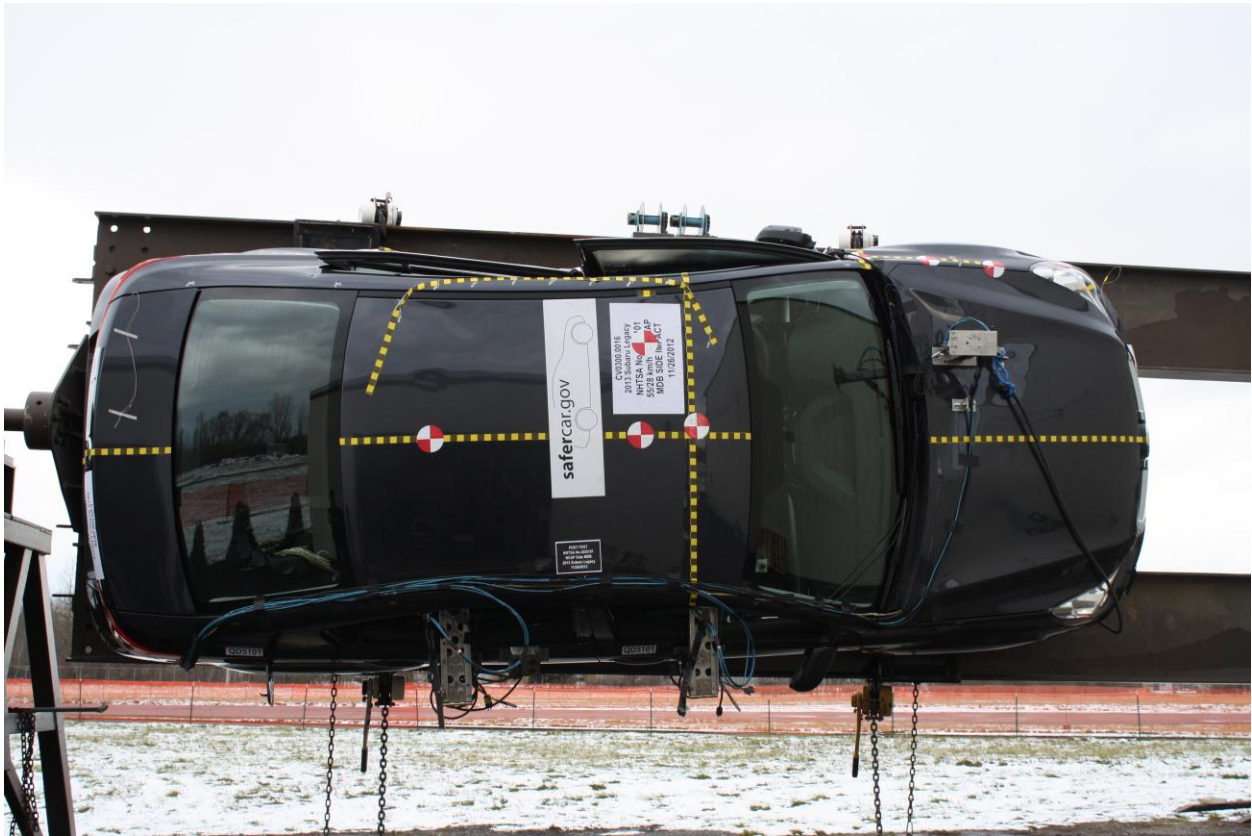
Figure A-97: FMVSS No. 301 Static Rollover 90 Degrees

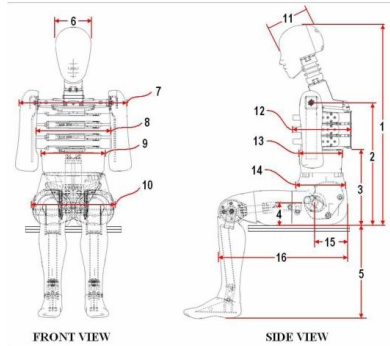
ES-2re External Measurements

Dim. No.	Description	Specification (mm)	Result (mm)	Pass/Fail
1	Sitting Height	900-918	915	Pass
2	Seat to Shoulder Joint	558-572	564	Pass
3	Seat to Lower Face of Thoracic Spine Box	346-356	354	Pass
4	Seat to Hip Joint (center of bolt)	97-103	100	Pass
5	Sole to Seat, Sitting	433-451	444	Pass
6	Head Width	152-158	155	Pass
7	Shoulder/Arm Width	461-479	465	Pass
8	Thorax Width	322-332	326	Pass
9	Abdomen Width	273-287	284	Pass
10	Pelvis Lap Width	359-373	367	Pass
11	Head Depth	196-206	199	Pass
12	Thorax Depth	262-272	270	Pass
13	Abdomen Depth	194-204	200	Pass
14	Pelvis Depth	235-245	237	Pass
15	Back of Buttocks to Hip Joint (center of bolt)	150-160	155	Pass
16	Back of Buttocks to Front Knee	597-615	601	Pass

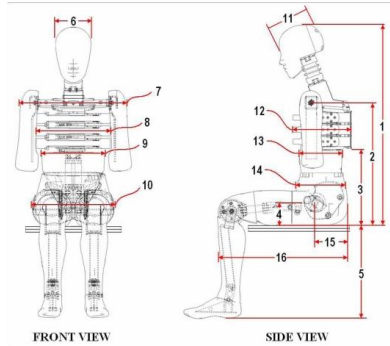
ES-2re External Measurements

Dim. No.	Description	Specification (mm)	Result (mm)	Pass/Fail
1	Sitting Height	900-918	913	Pass
2	Seat to Shoulder Joint	558-572	563	Pass
3	Seat to Lower Face of Thoracic Spine Box	346-356	354	Pass
4	Seat to Hip Joint (center of bolt)	97-103	100	Pass
5	Sole to Seat, Sitting	433-451	445	Pass
6	Head Width	152-158	155	Pass
7	Shoulder/Arm Width	461-479	465	Pass
8	Thorax Width	322-332	326	Pass
9	Abdomen Width	273-287	284	Pass
10	Pelvis Lap Width	359-373	367	Pass
11	Head Depth	196-206	200	Pass
12	Thorax Depth	262-272	269	Pass
13	Abdomen Depth	194-204	200	Pass
14	Pelvis Depth	235-245	237	Pass
15	Back of Buttocks to Hip Joint (center of bolt)	150-160	155	Pass
16	Back of Buttocks to Front Knee	597-615	602	Pass
