**REPORT NUMBER: NCAP-KAR-13-018**

**NEW CAR ASSESSMENT PROGRAM (NCAP)  
FRONTAL BARRIER IMPACT TEST**

**VOLKSWAGEN DE MEXICO S.A. DE C.V.  
2013 VOLKSWAGEN BEETLE 2-DOOR COUPE**

**FINAL REPORT**

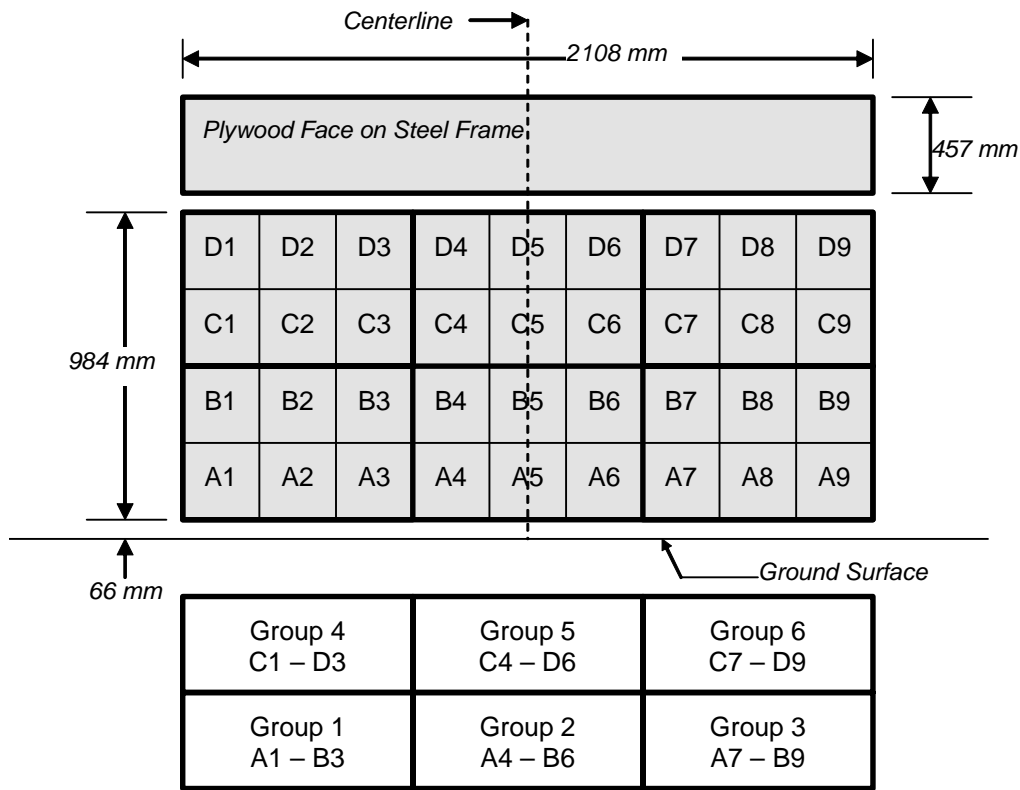
**36 Load Cell Rigid Barrier (NHTSA Standard)  
Load Cell Locations on Fixed Barrier**

6 Groups of 6 Load Cells Each

A load cell barrier consisting of 36 load cells was impacted by a 2013 Volkswagen Beetle 2-door coupe at a velocity of 56.82 km/h. The test was performed at KARCO Engineering, LLC. on November 27, 2012. Pre- and post-test photographs of the vehicle and dummies can be found in Appendix A of this report.

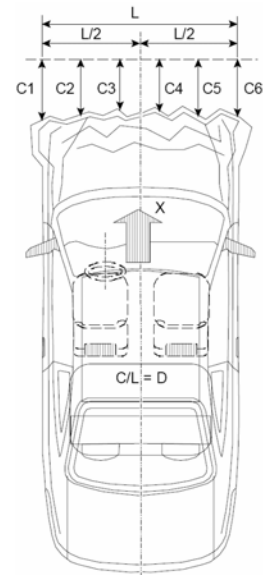
**CRUSH PROFILE**

Collision Deformation Classification: 12FDEW1  
 Midpoint of Damage: Vehicle Centerline  
 Damage Region Length (mm): 1395  
 Impact Mode: Full Frontal

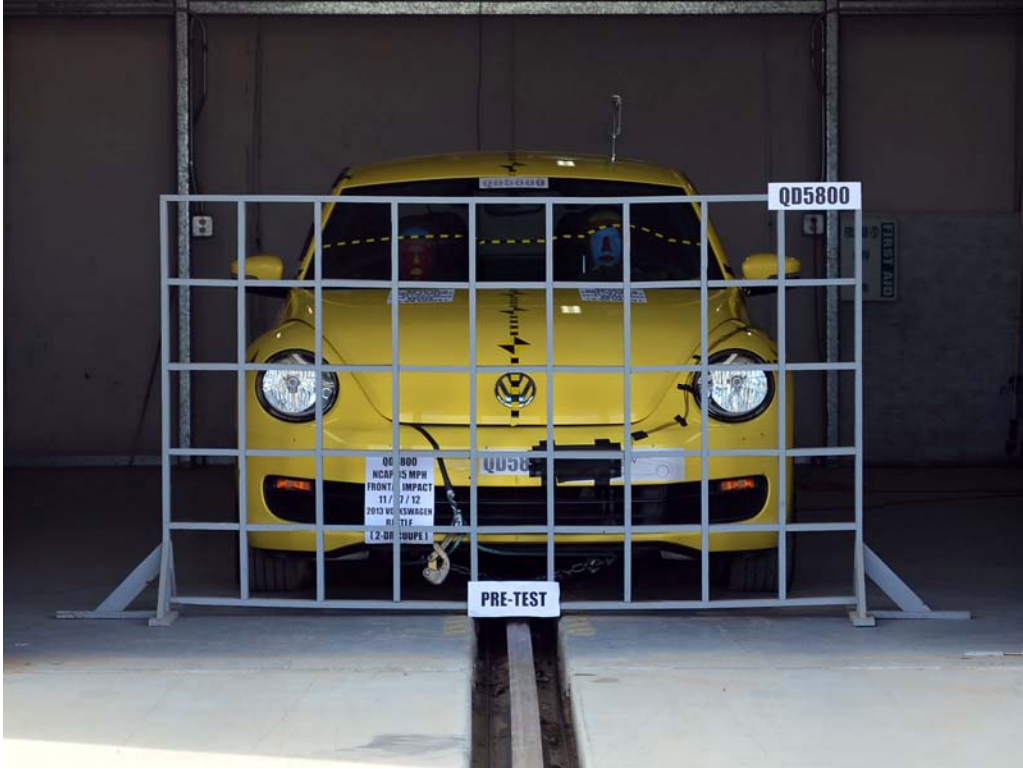
FIGURE 1. Load Cell Location

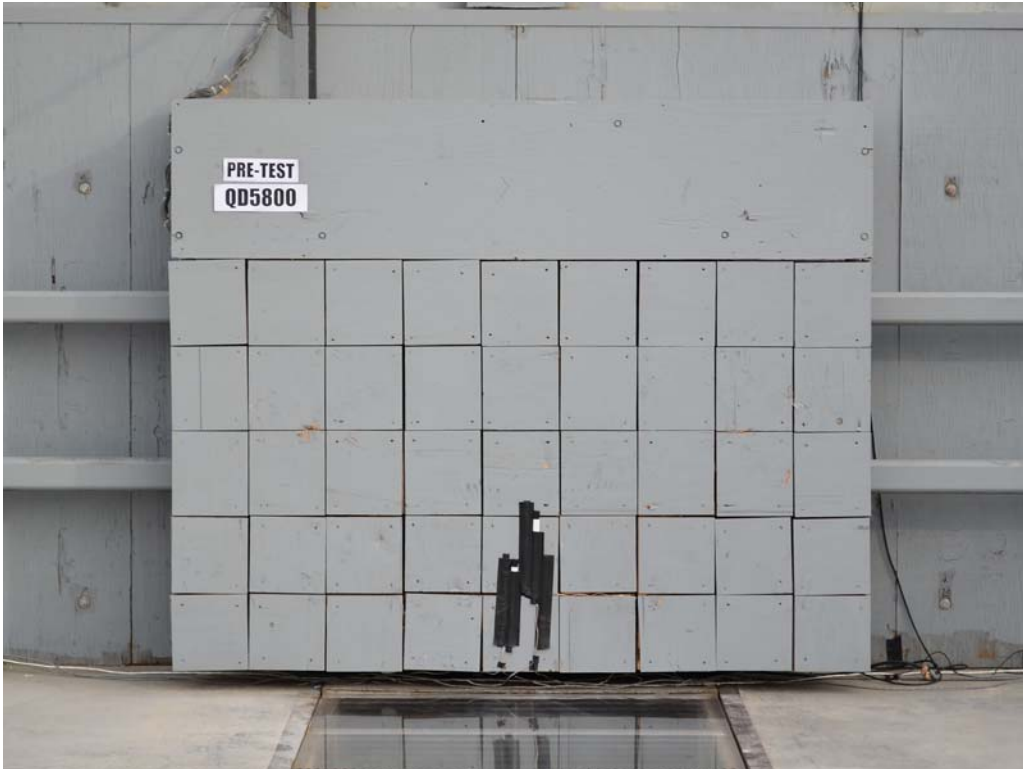
FIGURE 2. Load Cell Wall

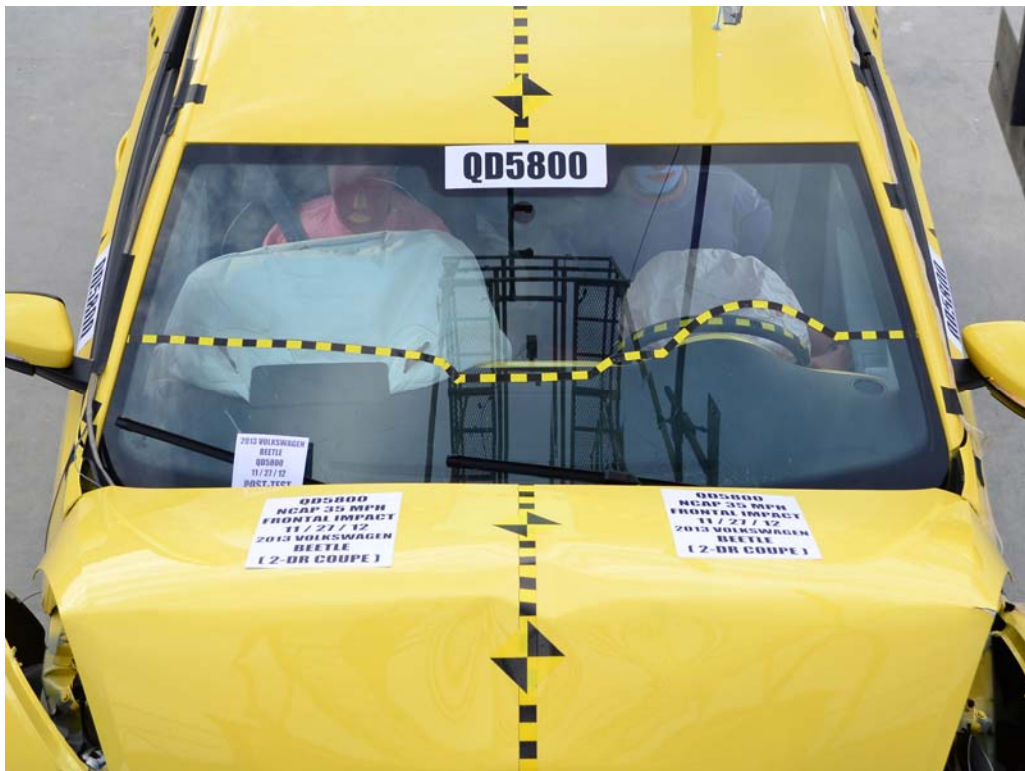
FIGURE 18. Post-Test Windshield View

There was 100% windshield retention and no intrusion into the protected zone of the windshield during the event. There was no Stoddard solvent leakage after the event or during any phase of the static rollover.

Measurement	Pre-Test (mm)	Post-Test (mm)	% Retention
Left Side	2091	2091	100.0%
Right Side	2091	2091	100.0%
Total	4182	4182	100.0%

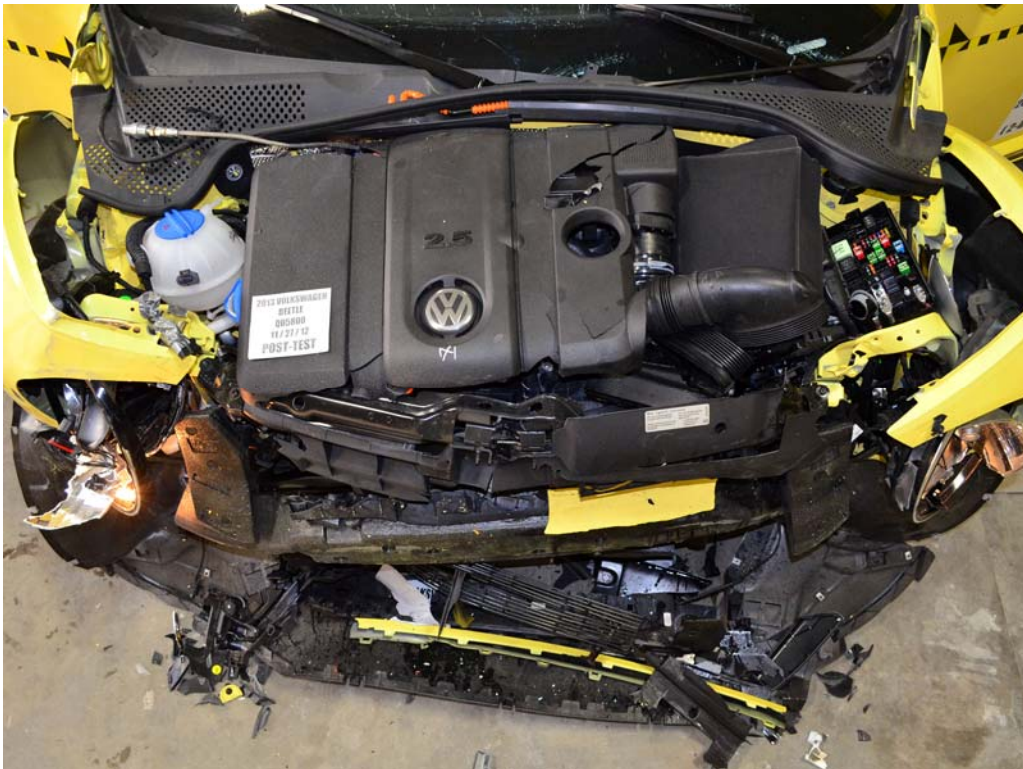
FIGURE 20. Post-Test Engine Compartment View

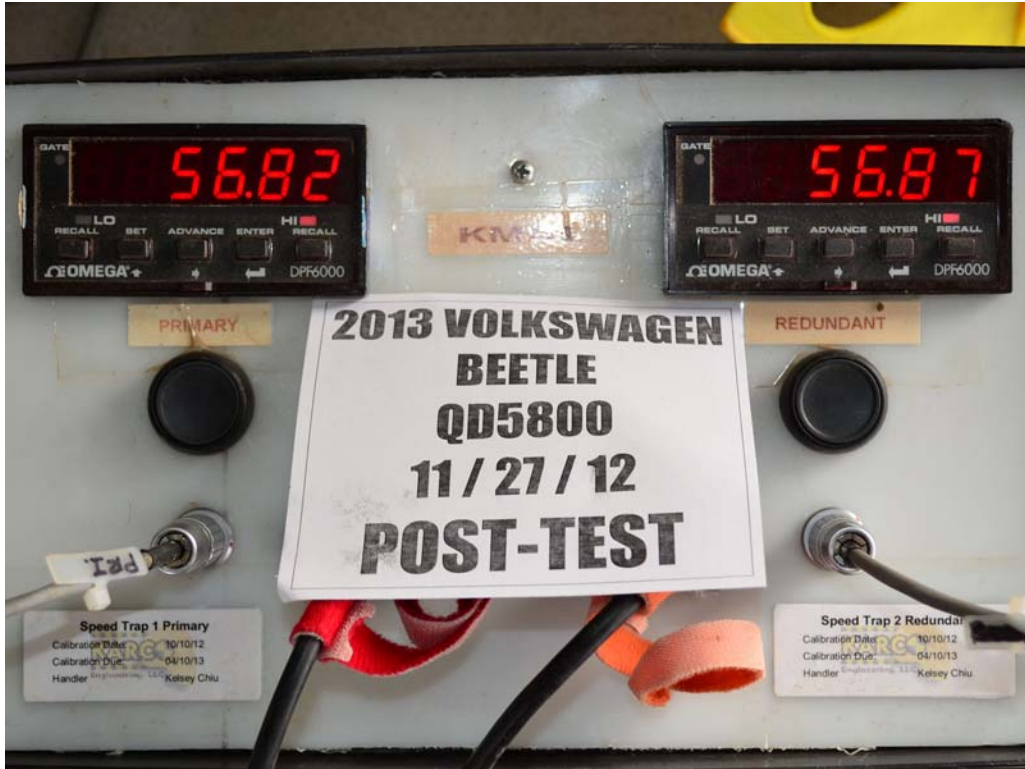
FIGURE 69. Post-Test Speed Trap Read-Out

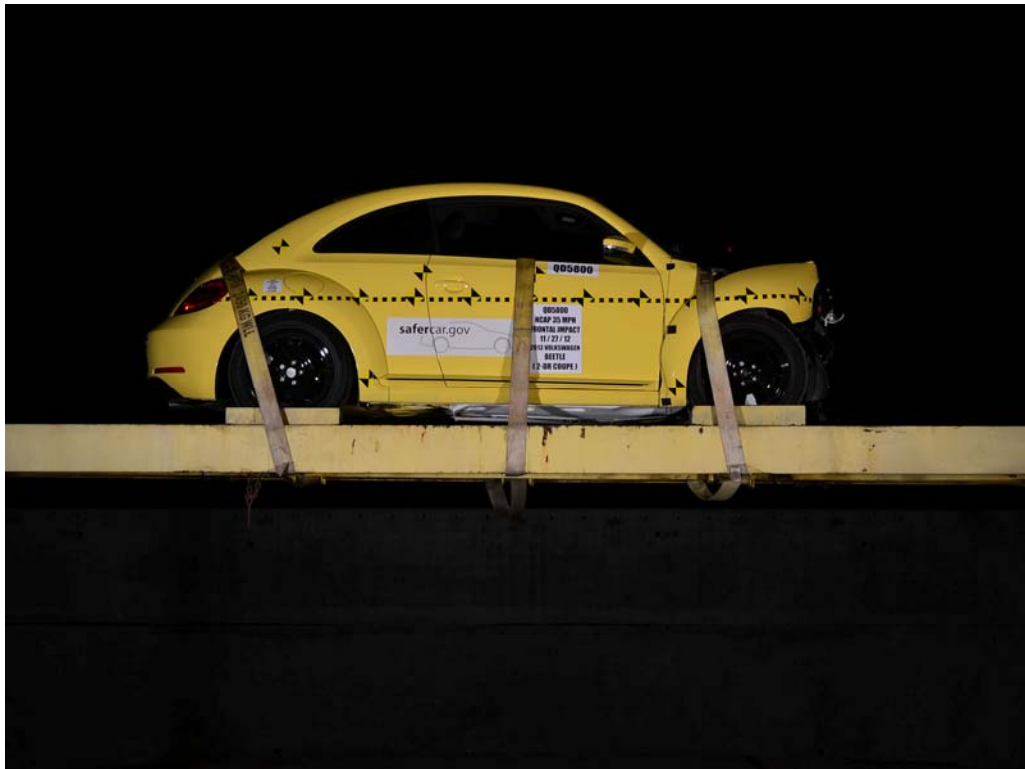
FIGURE 70. Vehicle at 0° on Static Rollover Device
