**REPORT NUMBER: NCAP-MGA-2013-036**

**NEW CAR ASSESSMENT PROGRAM (NCAP)  
Frontal Barrier Impact Test**

**GENERAL MOTORS DE MEXICO, S. DE R.L. DE C.V.  
2013 Cadillac SRX AWD SUV  
NHTSA No.: GD0102**

**FINAL REPORT**

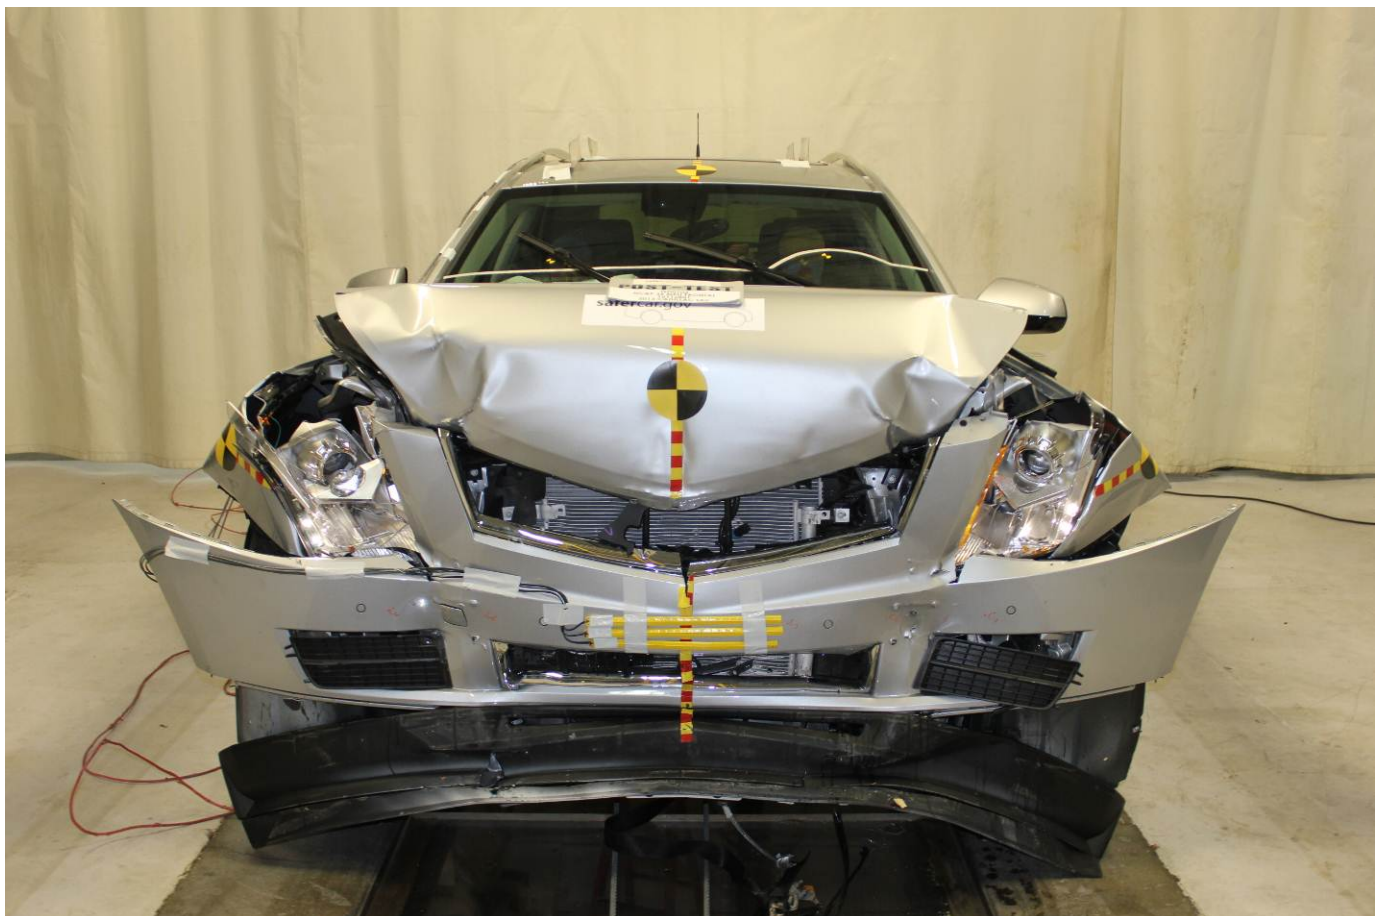
Post-Test Front View of Test Vehicle

The maximum static crush of the vehicle was 594 mm and both the driver and passenger side doors remained closed during the impact event and were operable after the impact.

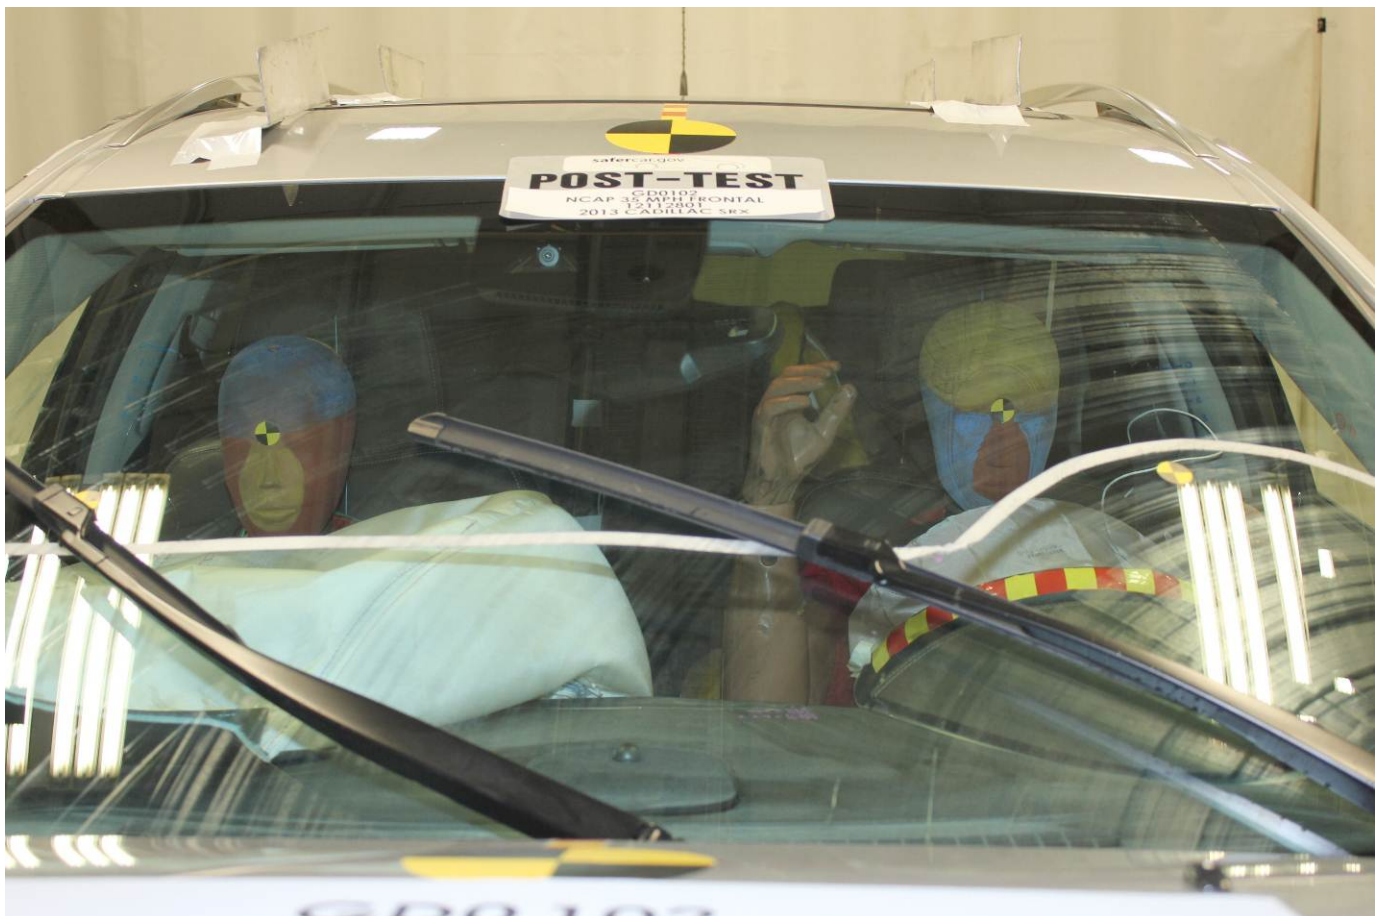
Post-Test Windshield View

There was 100 percent windshield retention and no intrusion into the protected zone of the windshield during the event. There was no Stoddard Solvent leakage after the event or during any phase of the static rollover.

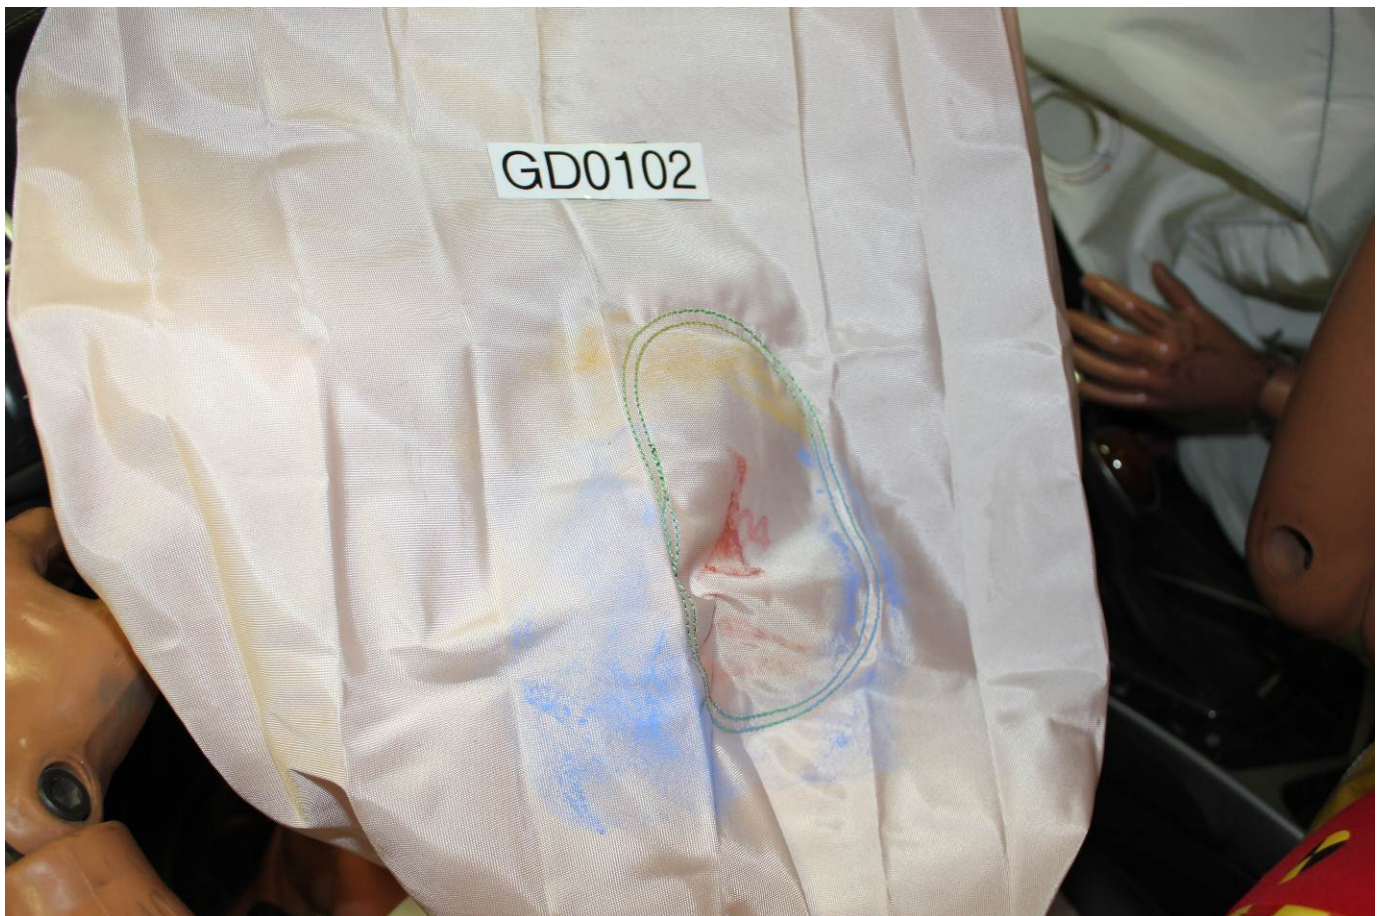
Post-Test Driver Dummy Contact with Airbag

The driver's visible contact points were as follows: The driver's head and chest contacted the airbag. The driver's head also contacted the headrest. The driver's knees contacted the knee bolster. The passenger's visible contact points were as follows: The passenger's head and chest contacted the airbag. The passenger's head also contacted the headrest. The passenger's knees contacted the glove box.

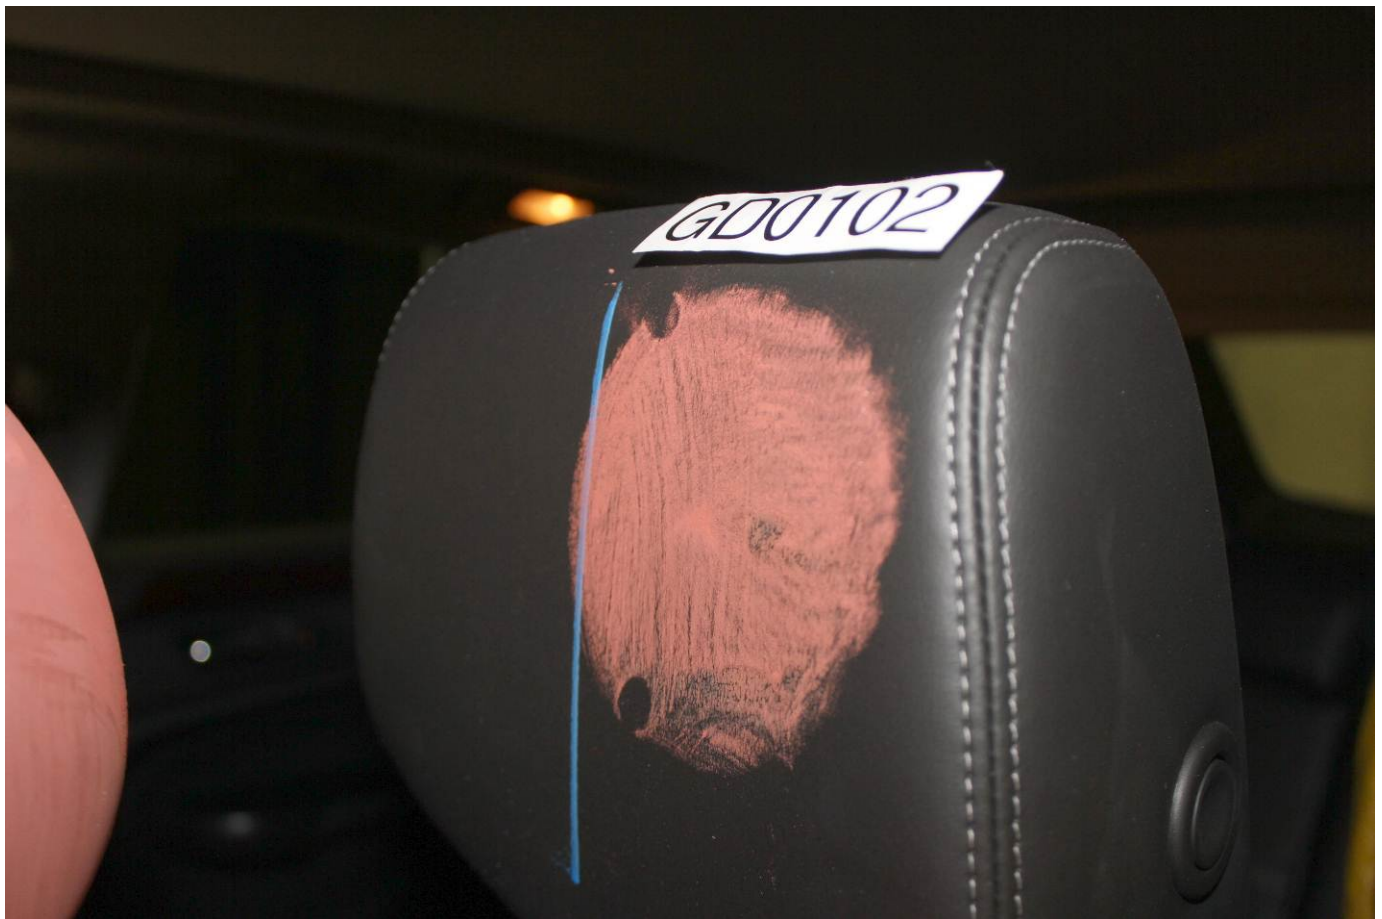
Post-Test Driver Dummy Contact with Headrest

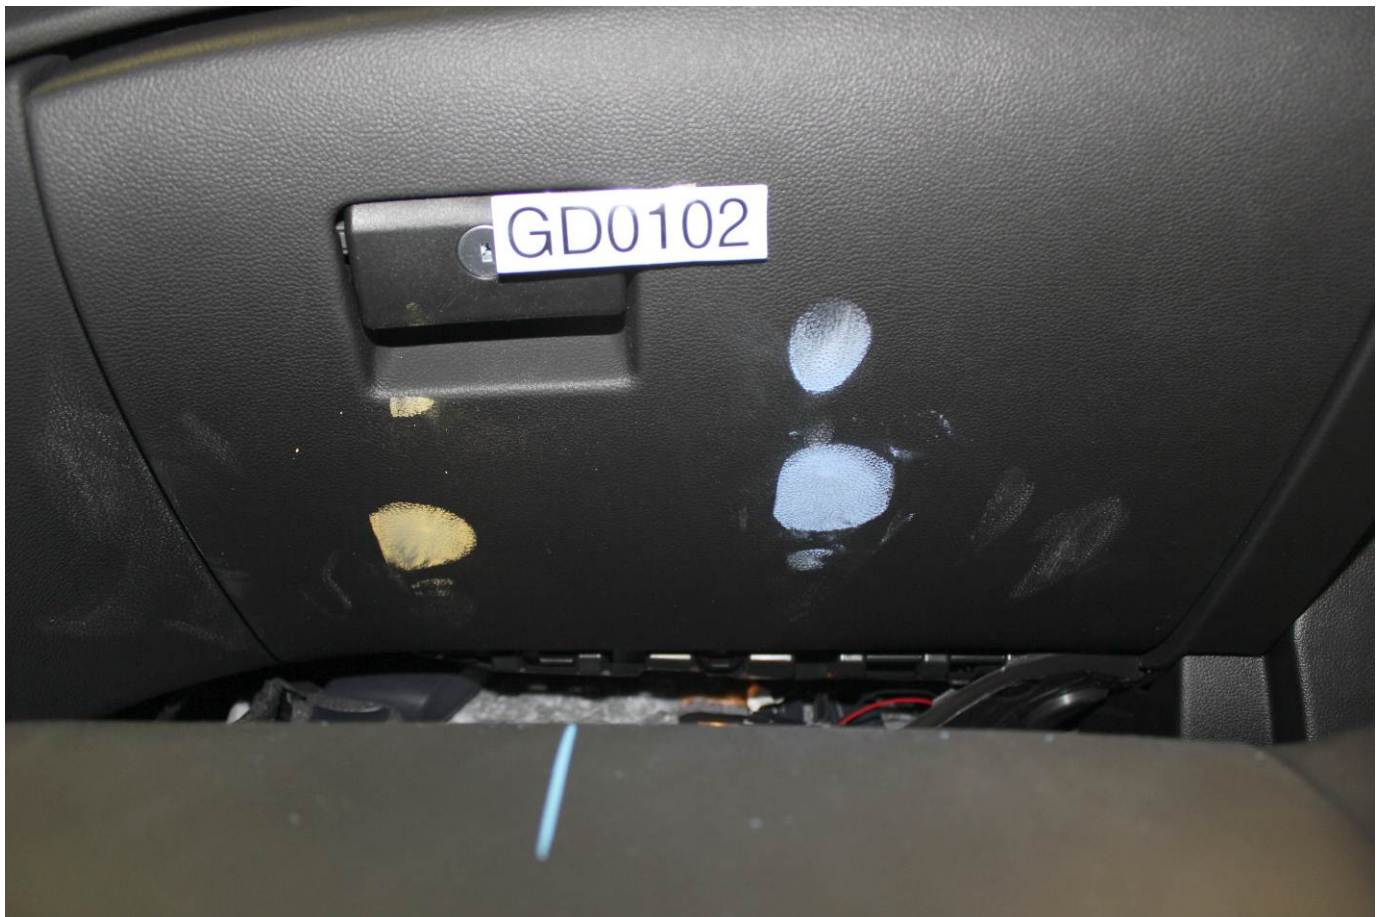
Post-Test Passenger Dummy Contact with Glovebox

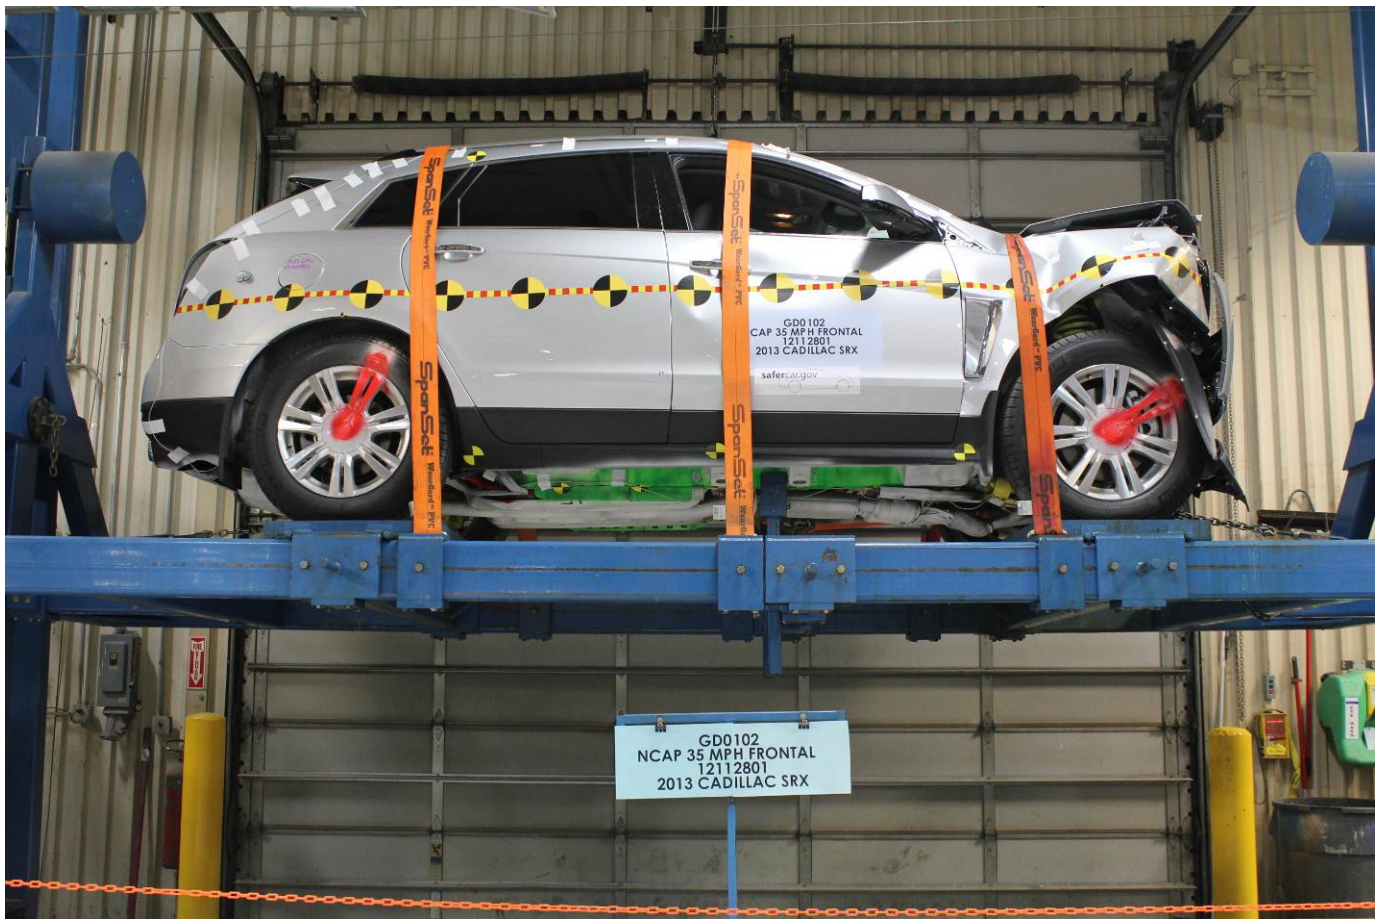
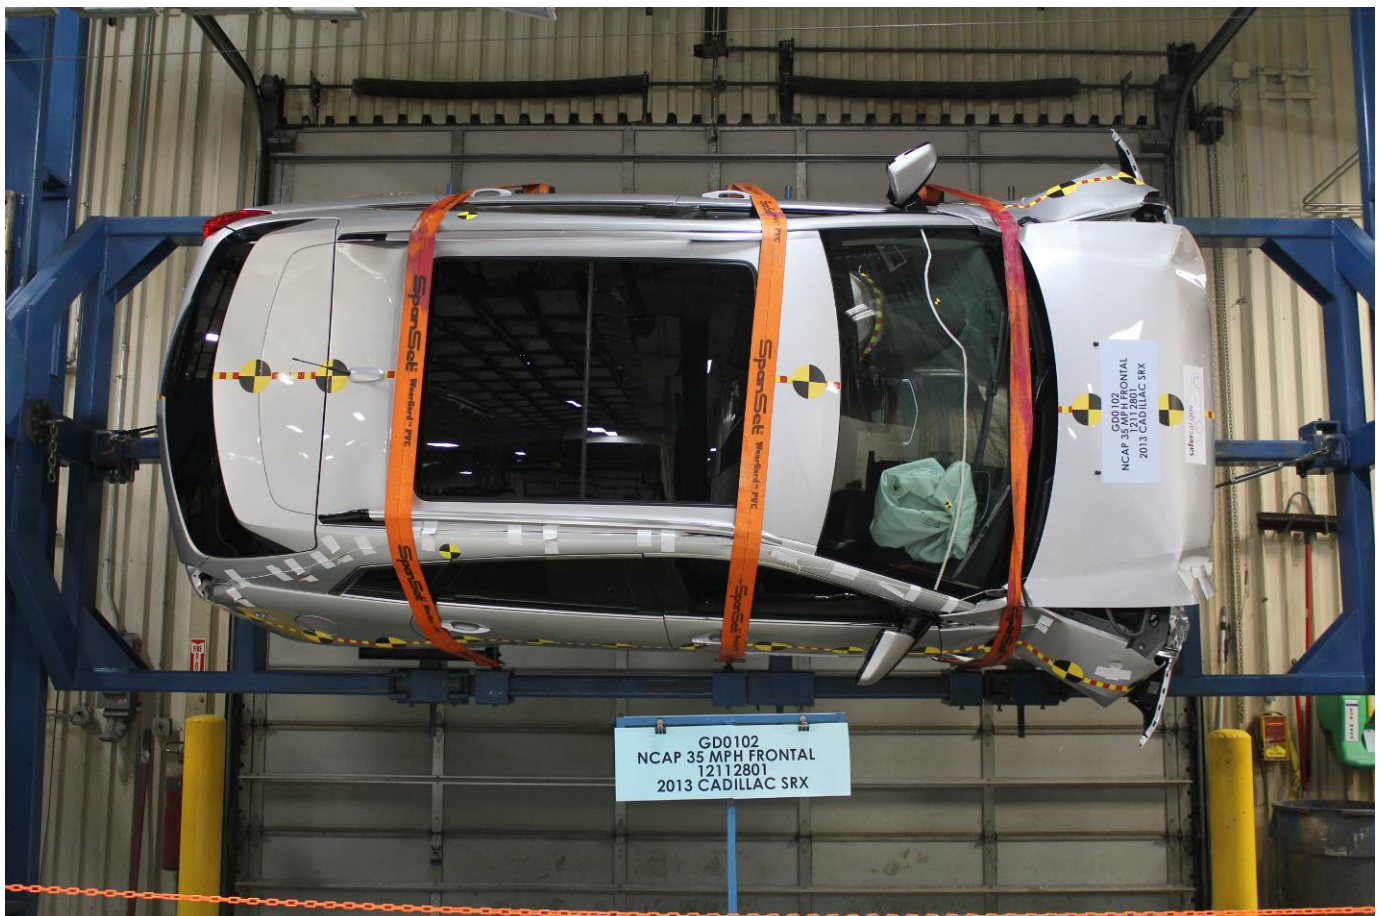
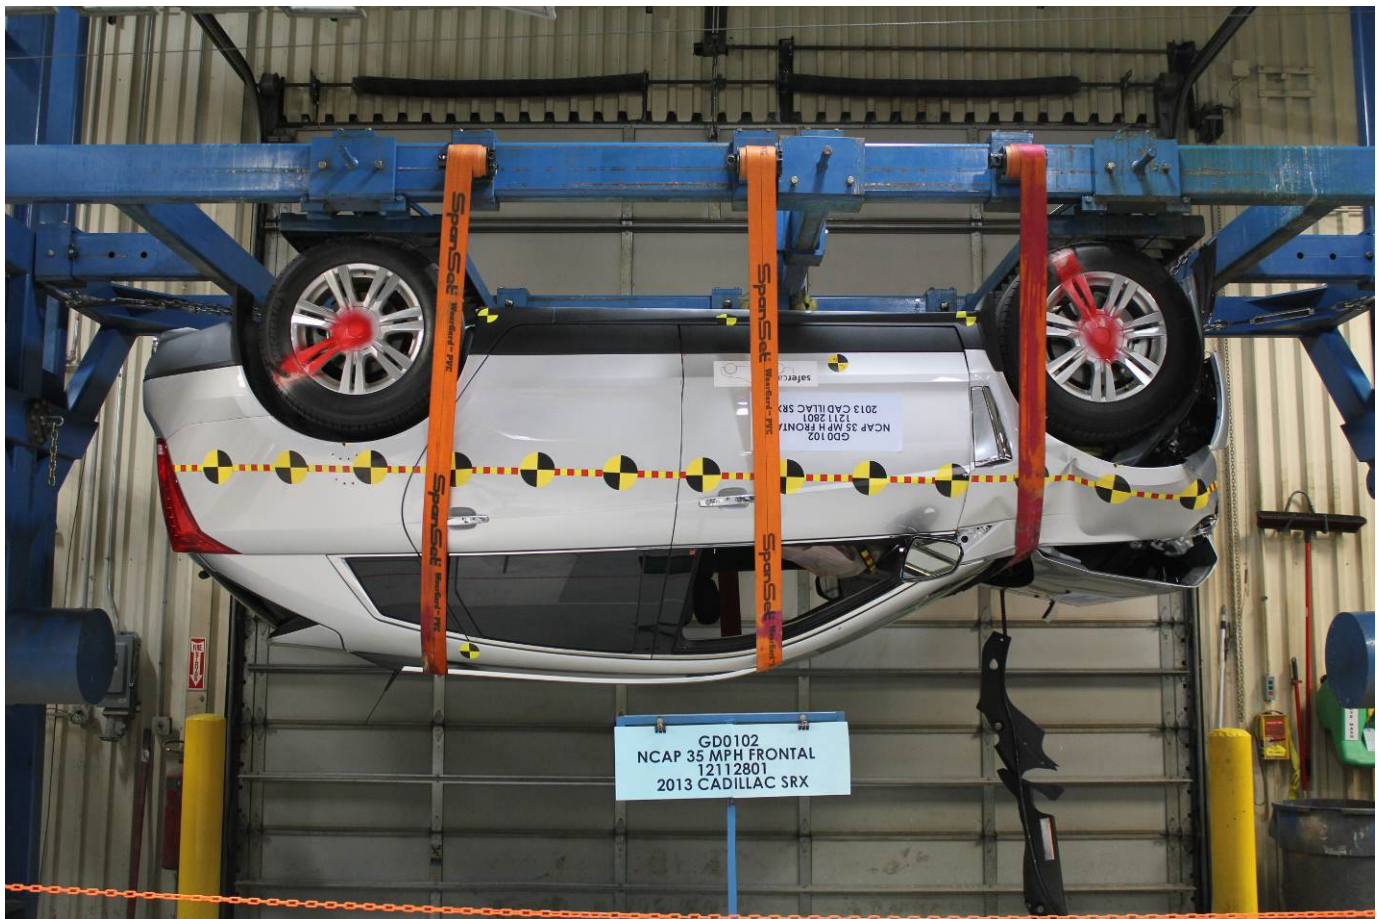
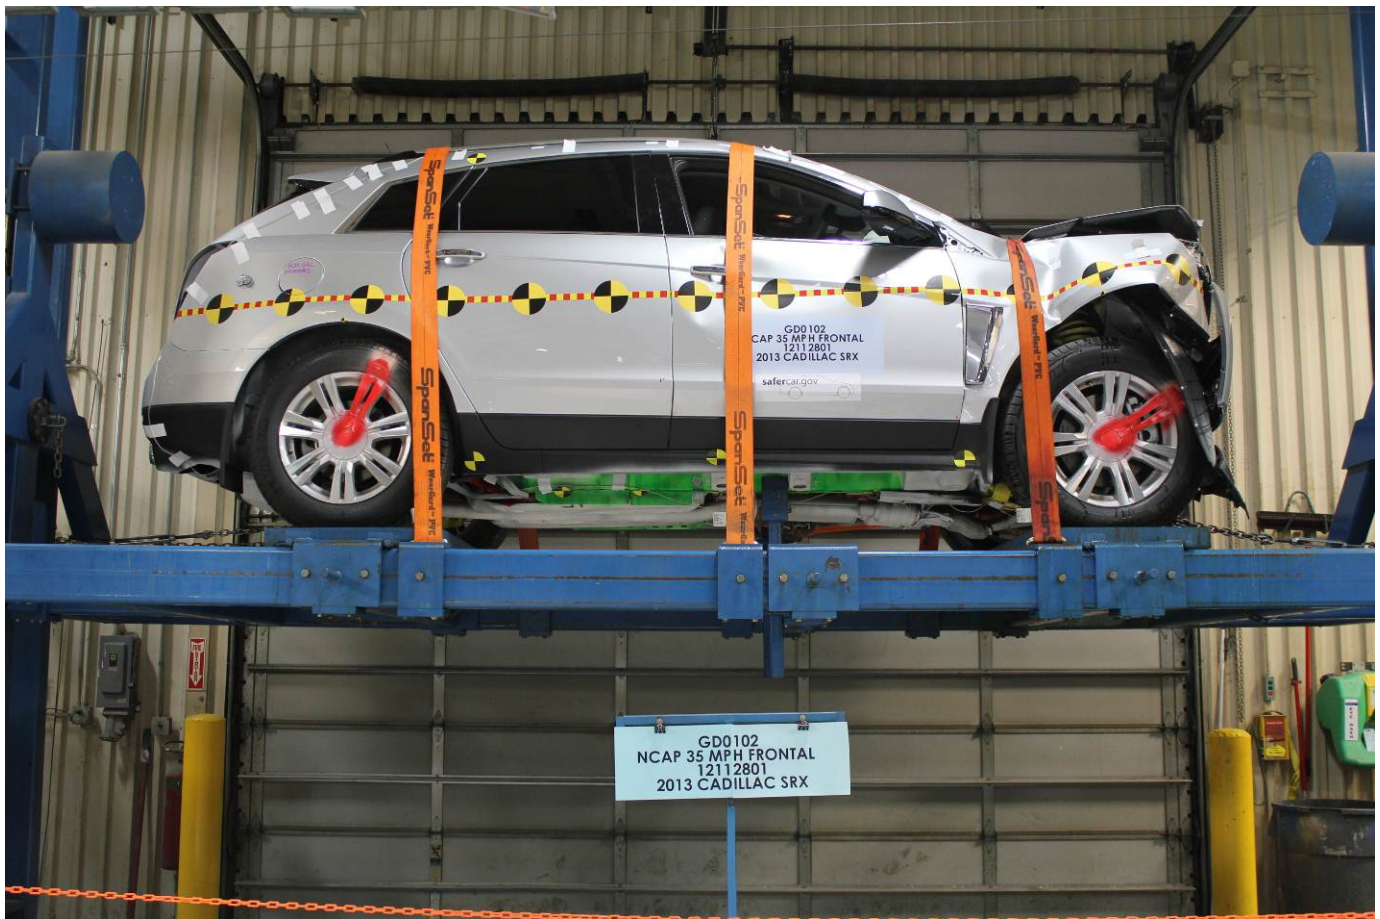
Vehicle at 0° on Static Rollover Device

Vehicle at 90° on Static Rollover Device

Vehicle at 180° on Static Rollover Device

Vehicle at 270° on Static Rollover Device

Vehicle at 360° on Static Rollover Device
