REPORT NUMBER: SPNCAP-MCW-13-003

NEW CAR ASSESSMENT PROGRAM (SPNCAP)  
SIDE IMPACT POLE TEST

CHRYSLER GROUP, LLC  
2013 RAM 1500 4-DOOR CREW CAB PICKUP  
NHTSA NUMBER: MD 0313

FINAL REPORT

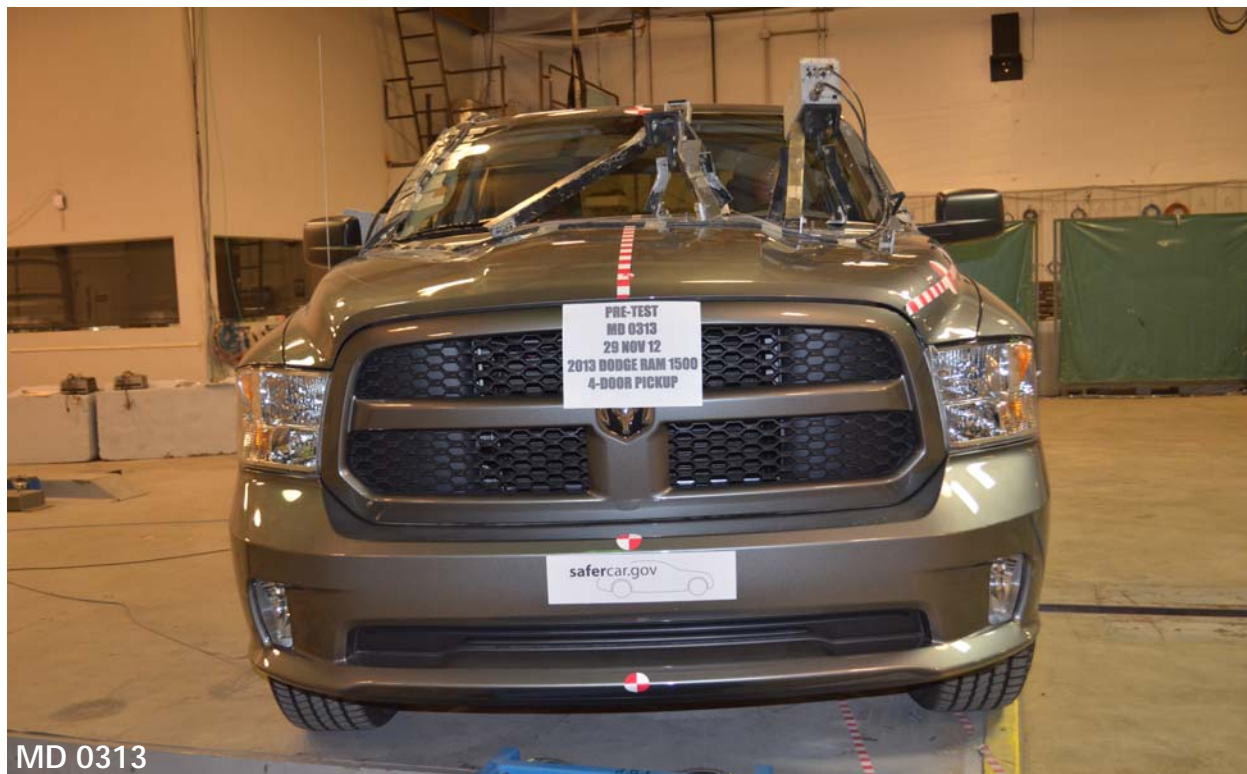
Figure 003: Pre-Test Frontal View of Test Vehicle

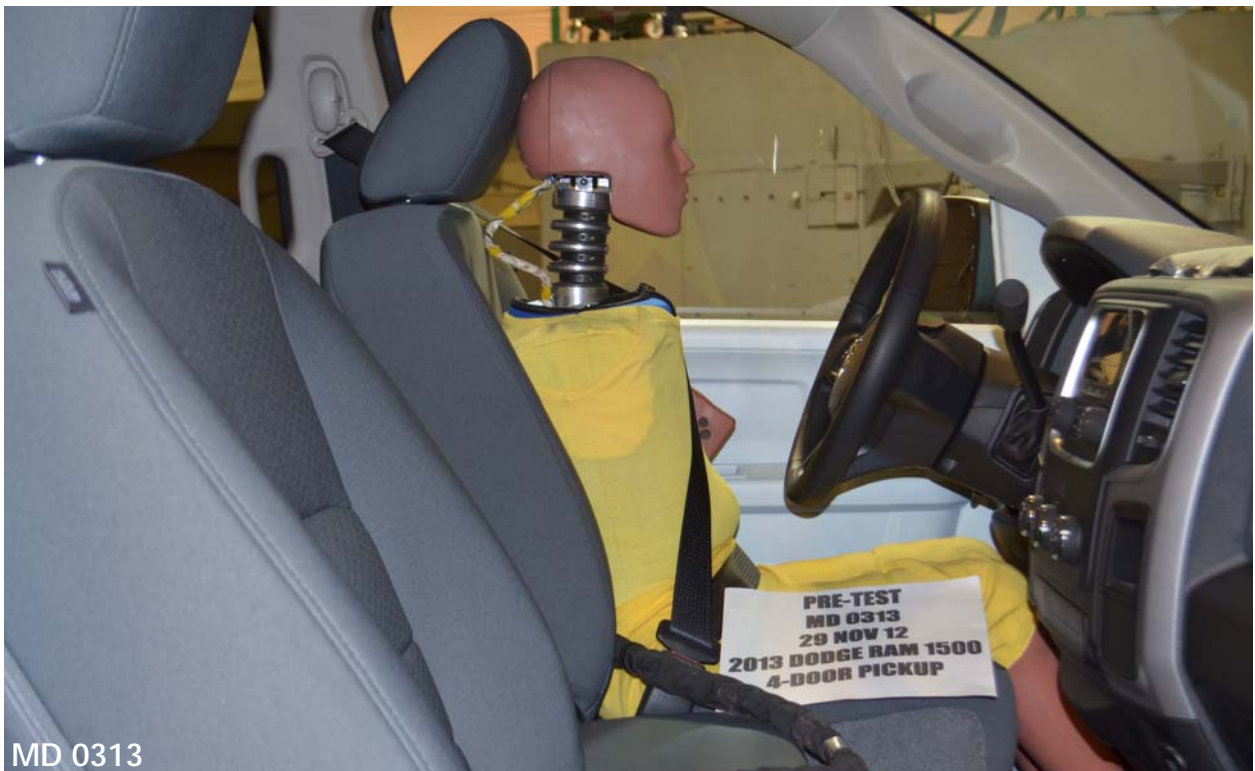
Figure 040: Pre-Test Dummy and Door Clearance View

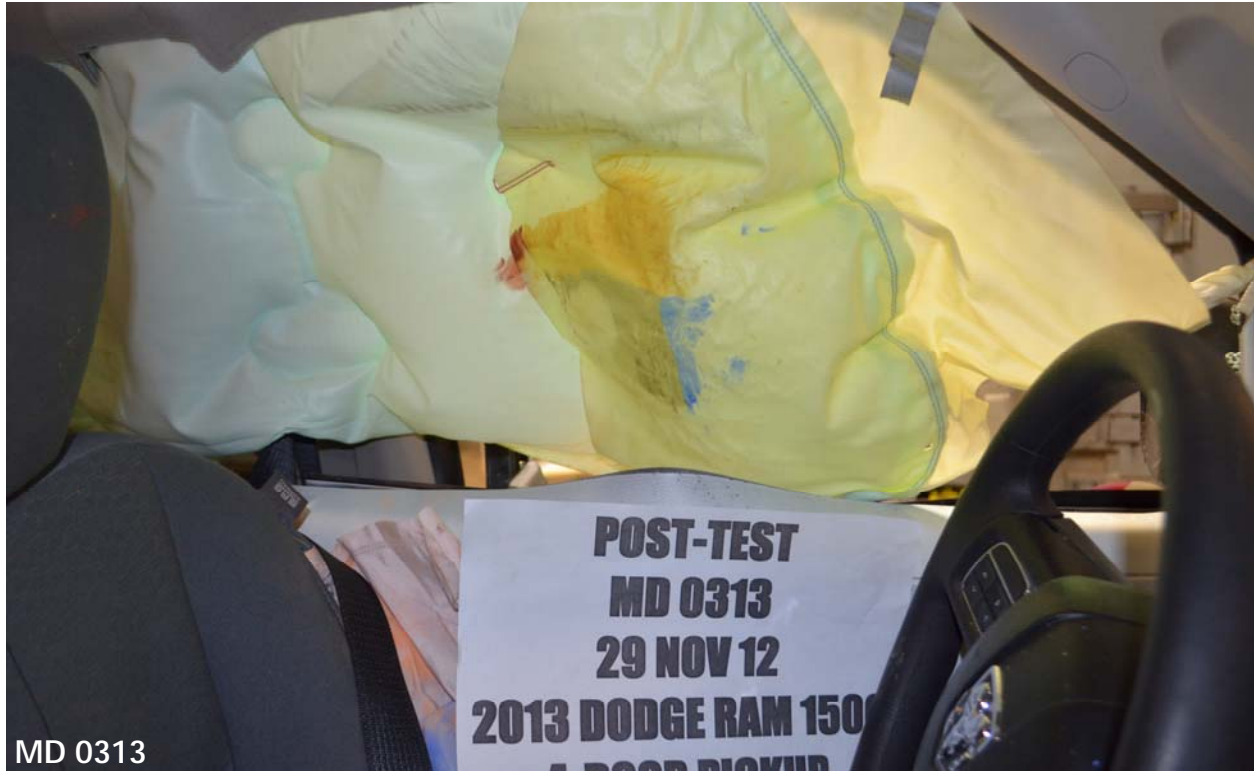
Figure 046 Post-Test Dummy Close-Up Head Contact with Vehicle Interior View

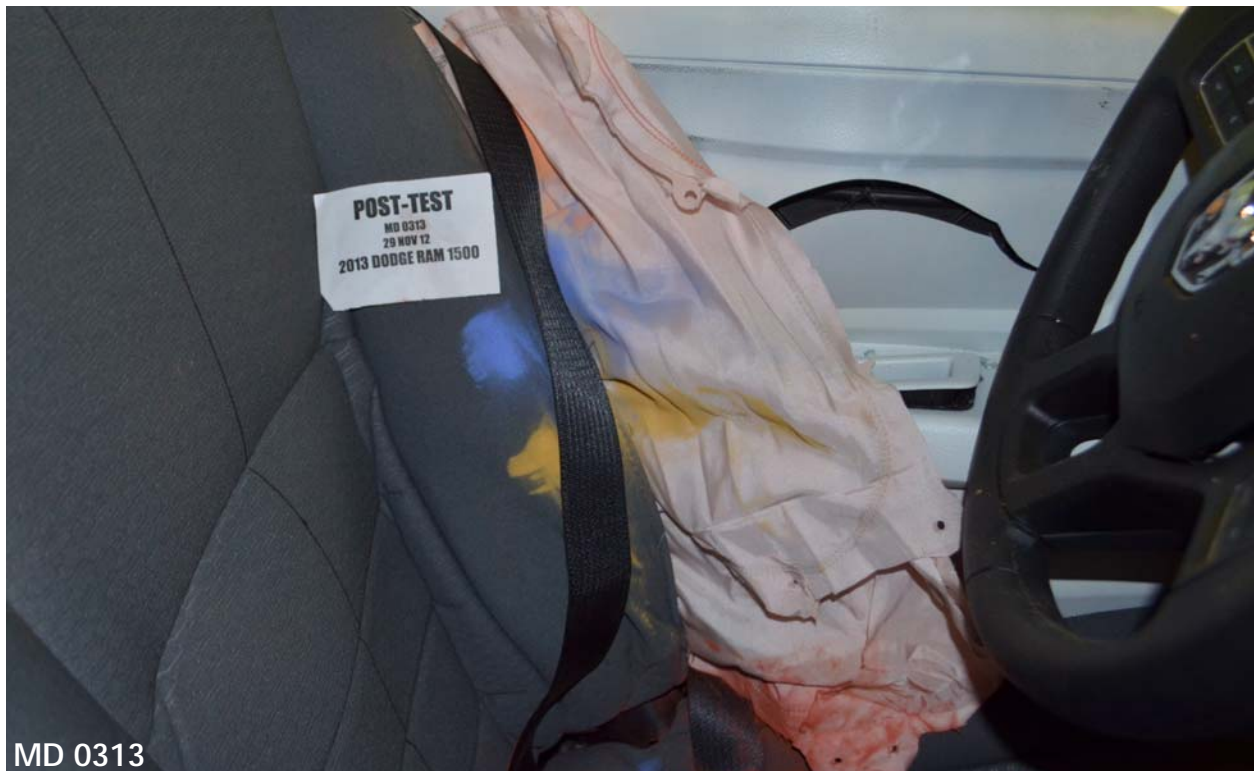
Figure 047: Post-Test Dummy Close-Up Head Contact with Side Air bag View
