**REPORT NUMBER: NCAP-KAR-13-028**

**NEW CAR ASSESSMENT PROGRAM (NCAP)  
FRONTAL BARRIER IMPACT TEST**

**NISSAN MOTOR CORPORATION  
2013 NISSAN SENTRA S 4-DOOR SEDAN**

**FINAL REPORT**

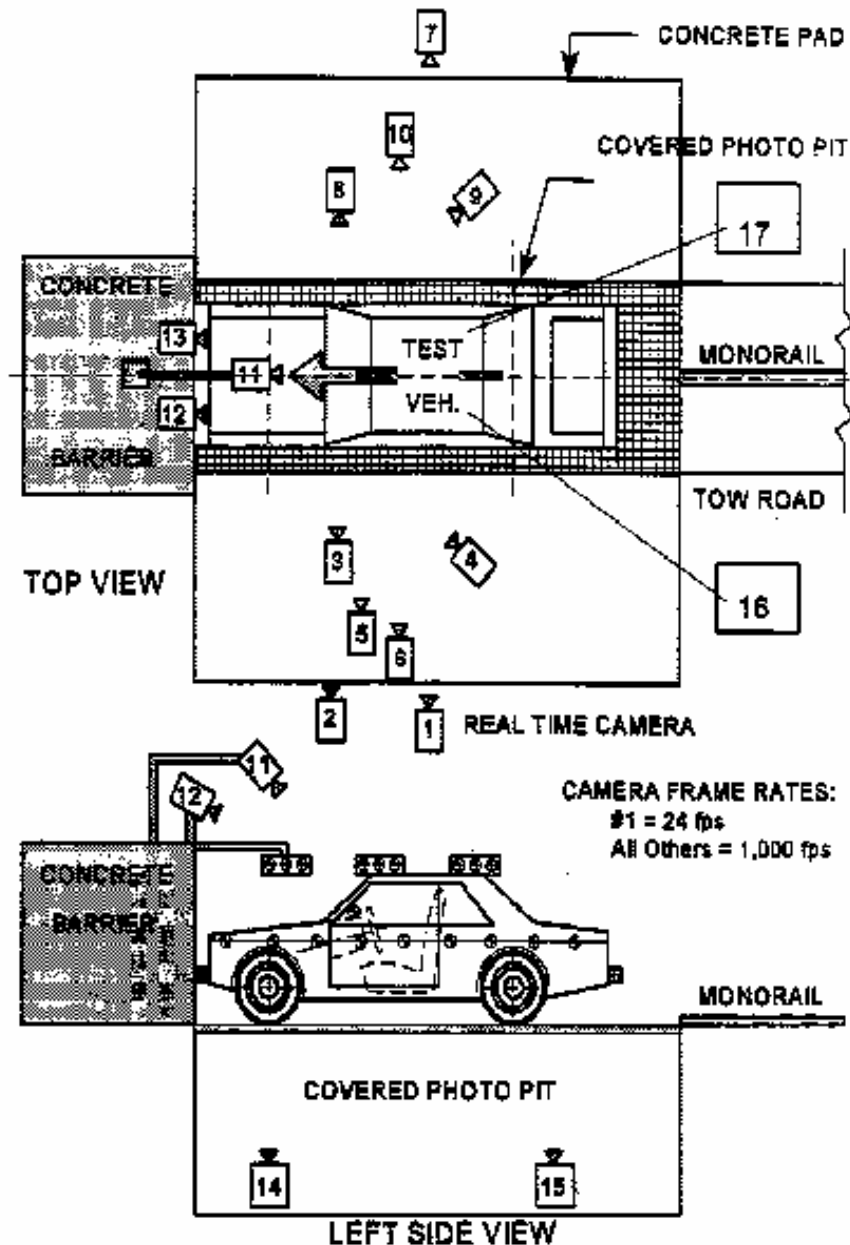
### CAMERA POSITIONS FOR FRONTAL IMPACTS

Three (3) real-time cameras and sixteen (16) high-speed cameras were used to document the frontal barrier impact event. Camera locations and other pertinent camera information can be found in Data Sheet 6 of this report.

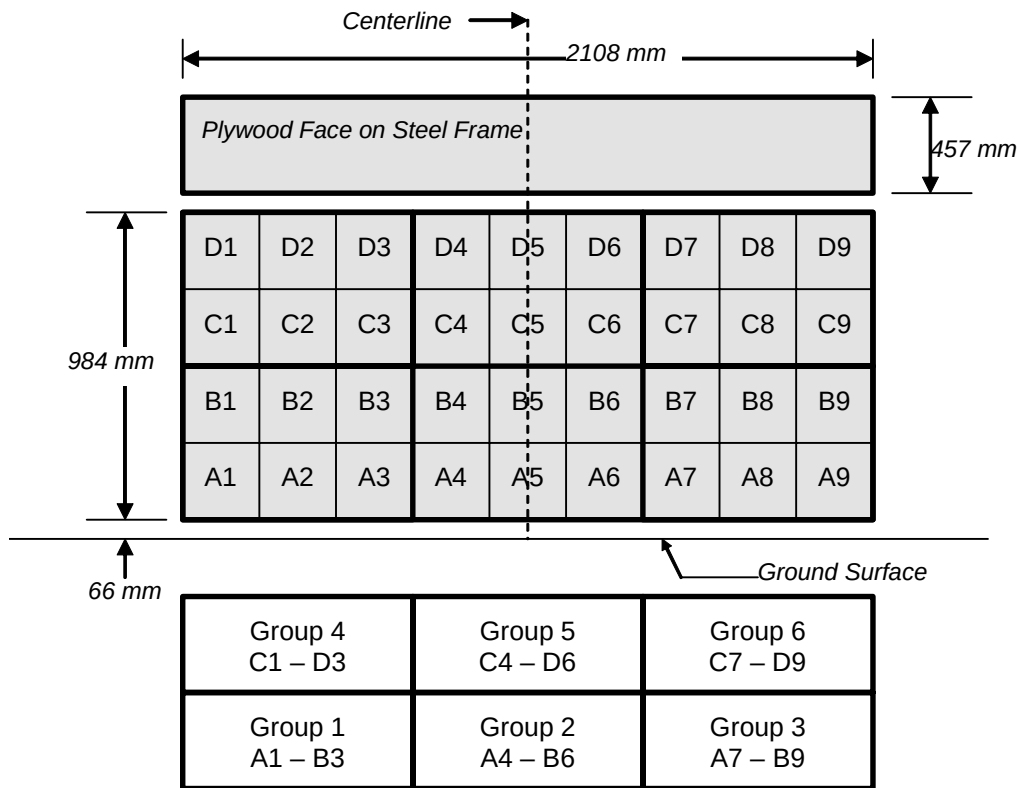
#### 36 Load Cell Rigid Barrier (NHTSA Standard) Load Cell Locations on Fixed Barrier

6 Groups of 6 Load Cells Each

A load cell barrier consisting of 36 load cells was impacted by a 2013 Nissan Sentra S 4-door sedan at a velocity of 56.15 km/h. The test was performed at KARCO Engineering, LLC. on December 4, 2012. Pre- and post-test photographs of the vehicle and dummies can be found in Appendix A of this report.

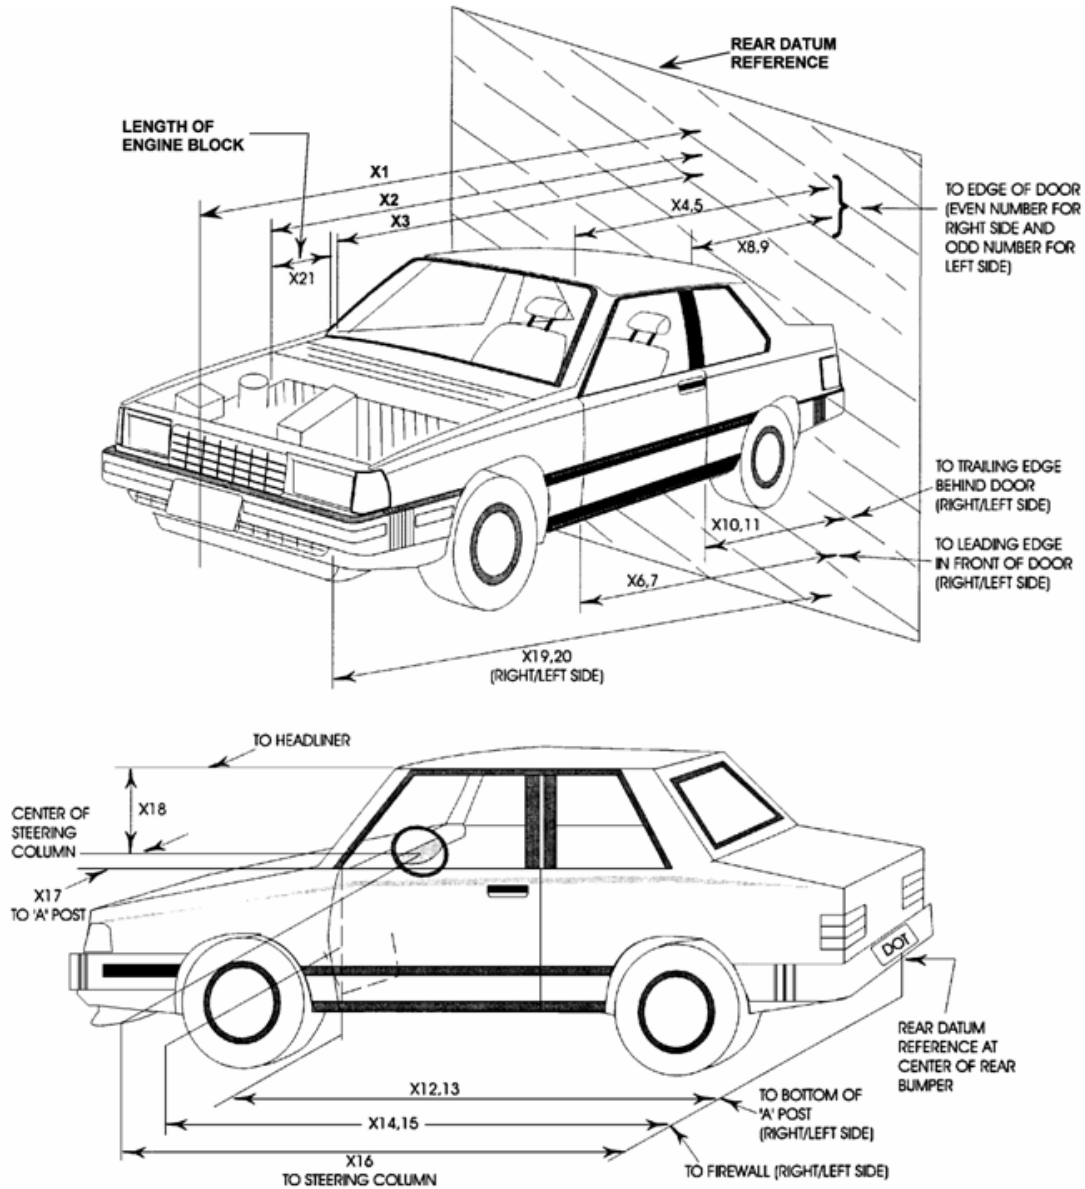
# **DATA SHEET NO. 12** **VEHICLE PROFILE MEASUREMENTS**

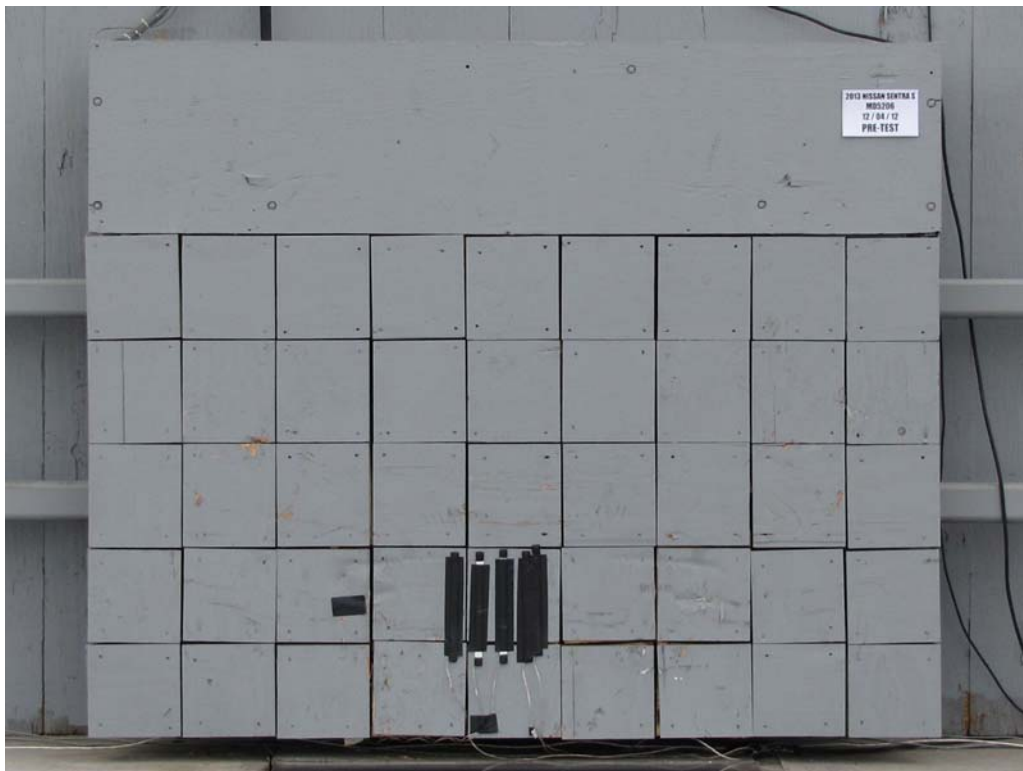
FIGURE 2. Load Cell Wall

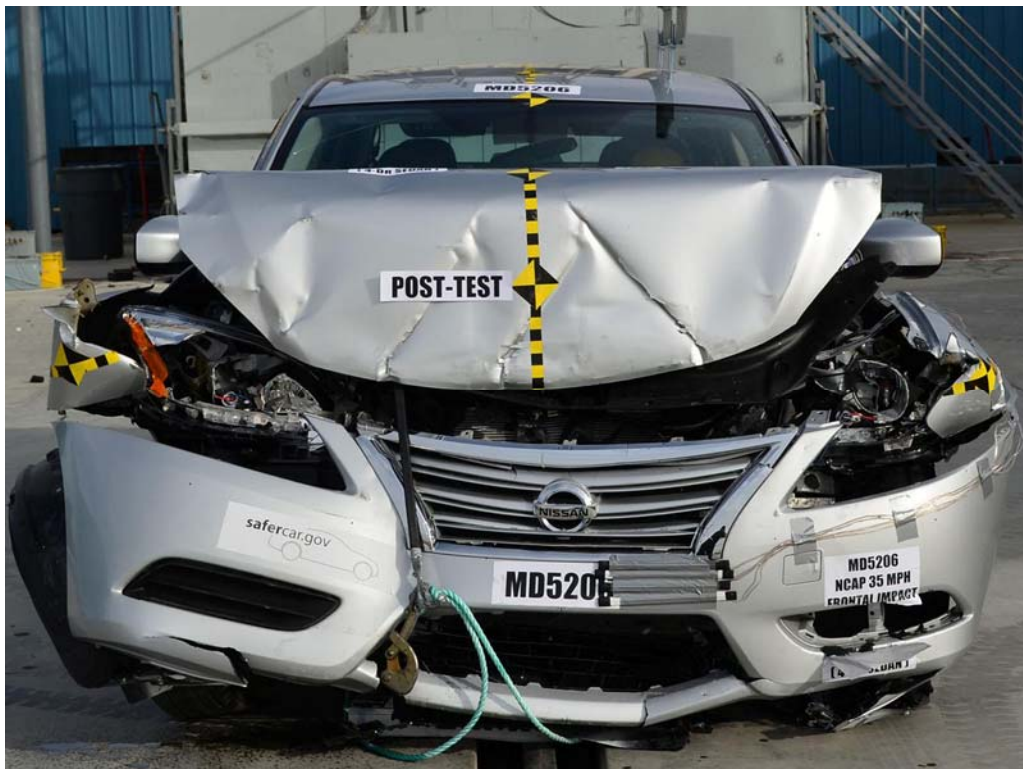
FIGURE 8. Post-Test Front View of Test Vehicle

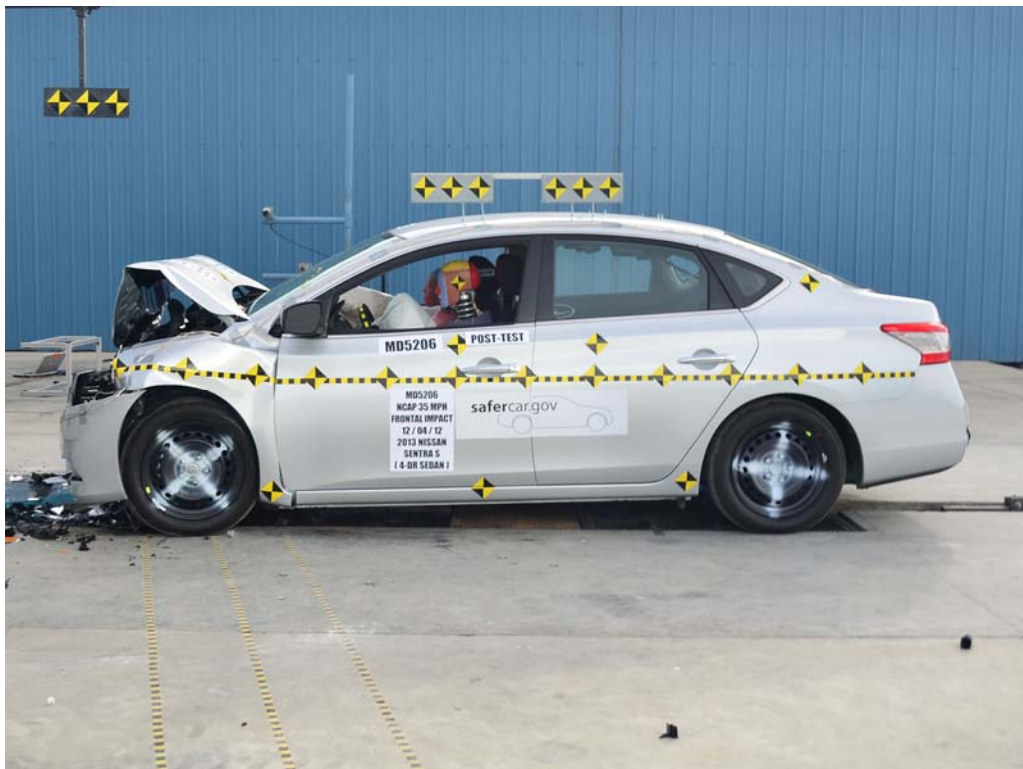
FIGURE 10. Post-Test Left View of Test Vehicle

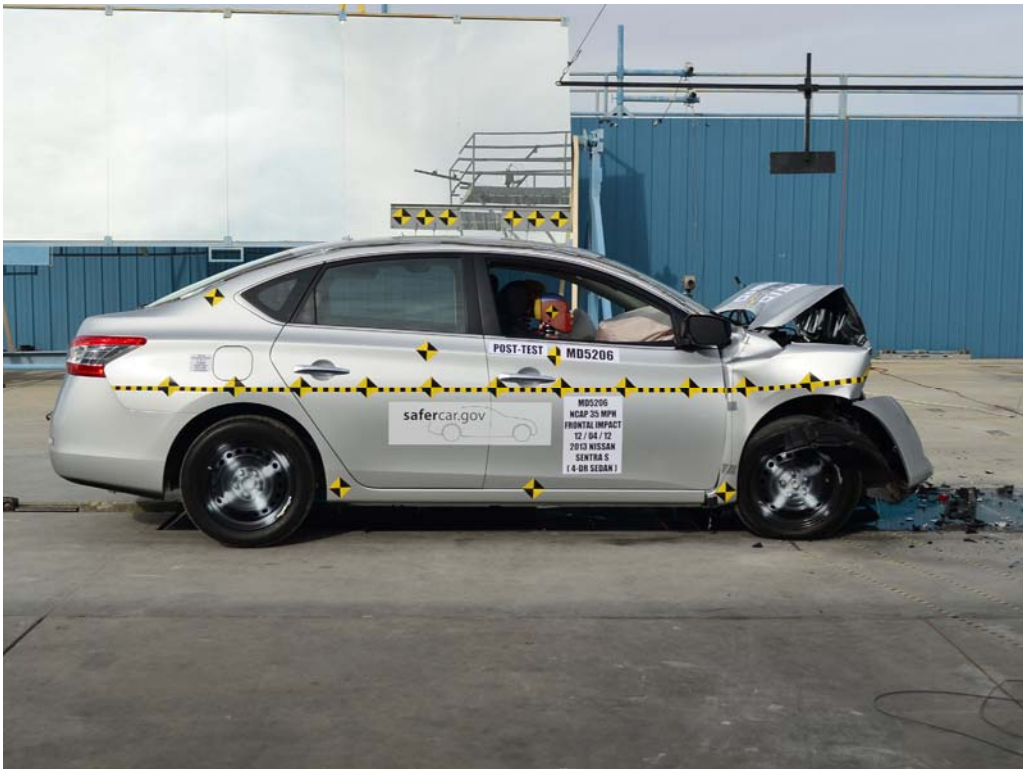
FIGURE 12. Post-Test Right View of Test Vehicle

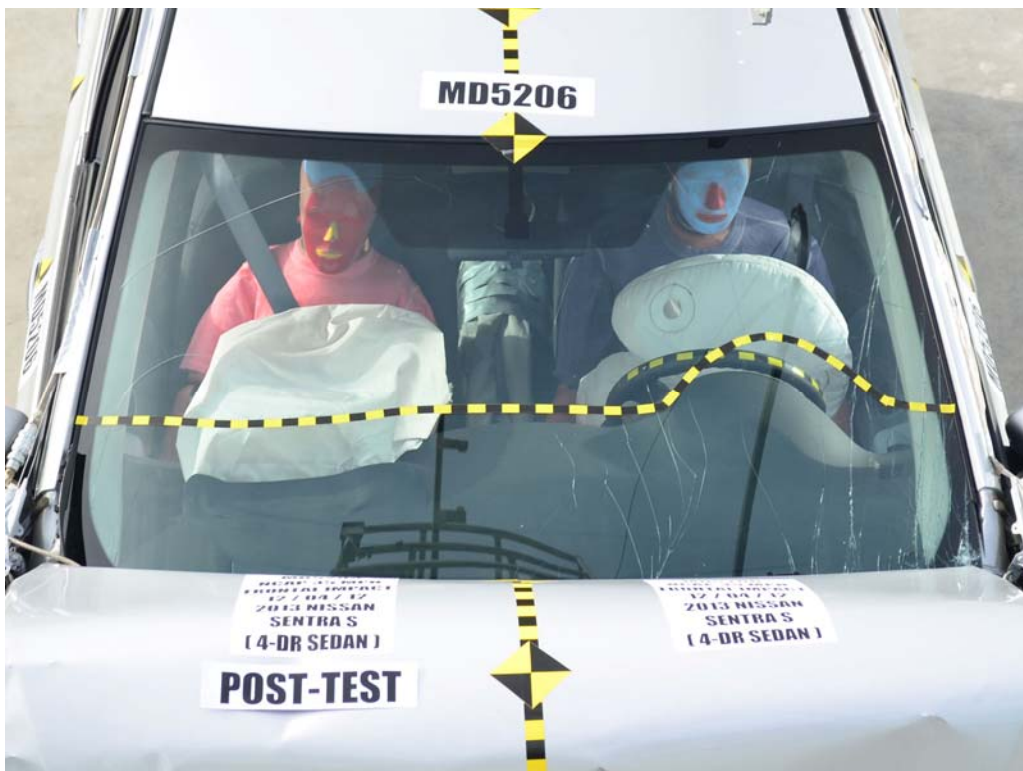
FIGURE 18. Post-Test Windshield View

There was 97.8 % windshield retention and no intrusion into the protected zone of the windshield during the event. There was no Stoddard solvent leakage after the event or during any phase of the static rollover.

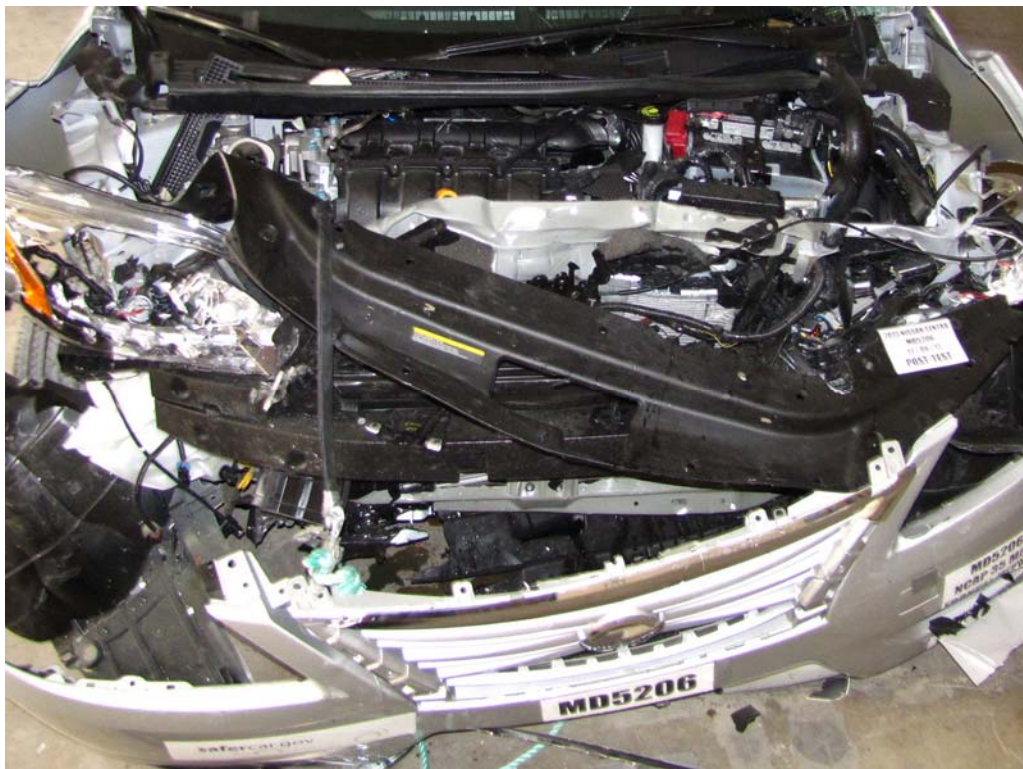
FIGURE 20. Post-Test Engine Compartment View

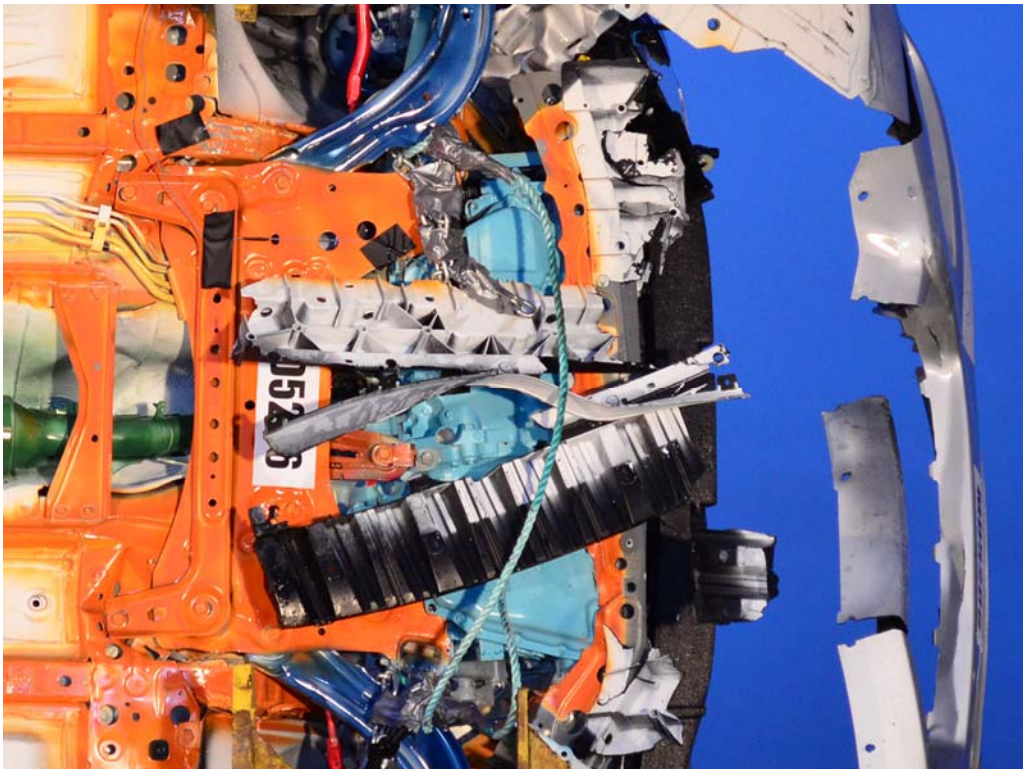
FIGURE 24. Post-Test Front Underbody View

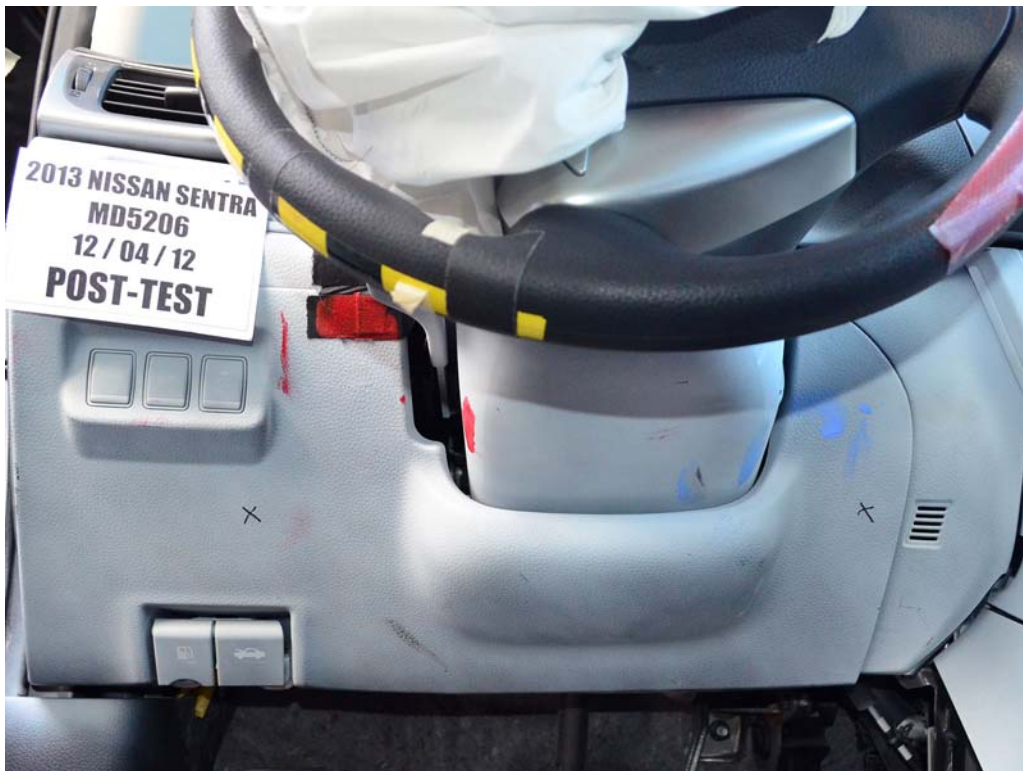
FIGURE 42. Post-Test Driver's Side Knee Bolster

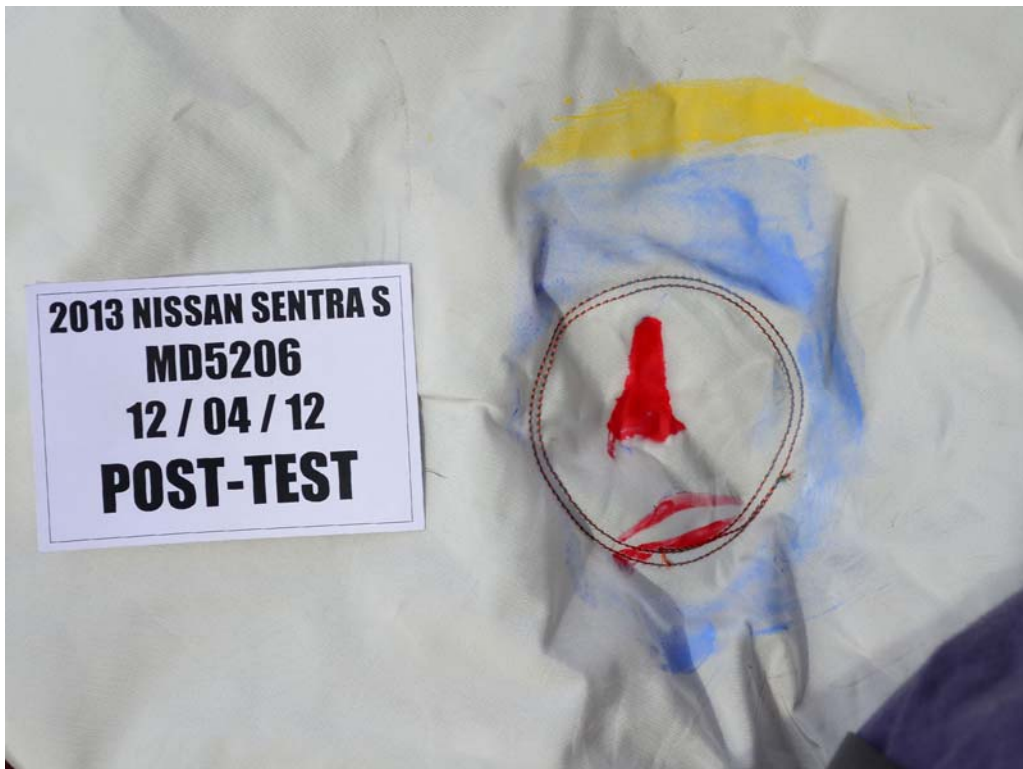
FIGURE 46. Post-Test Driver Dummy Contact With Airbag

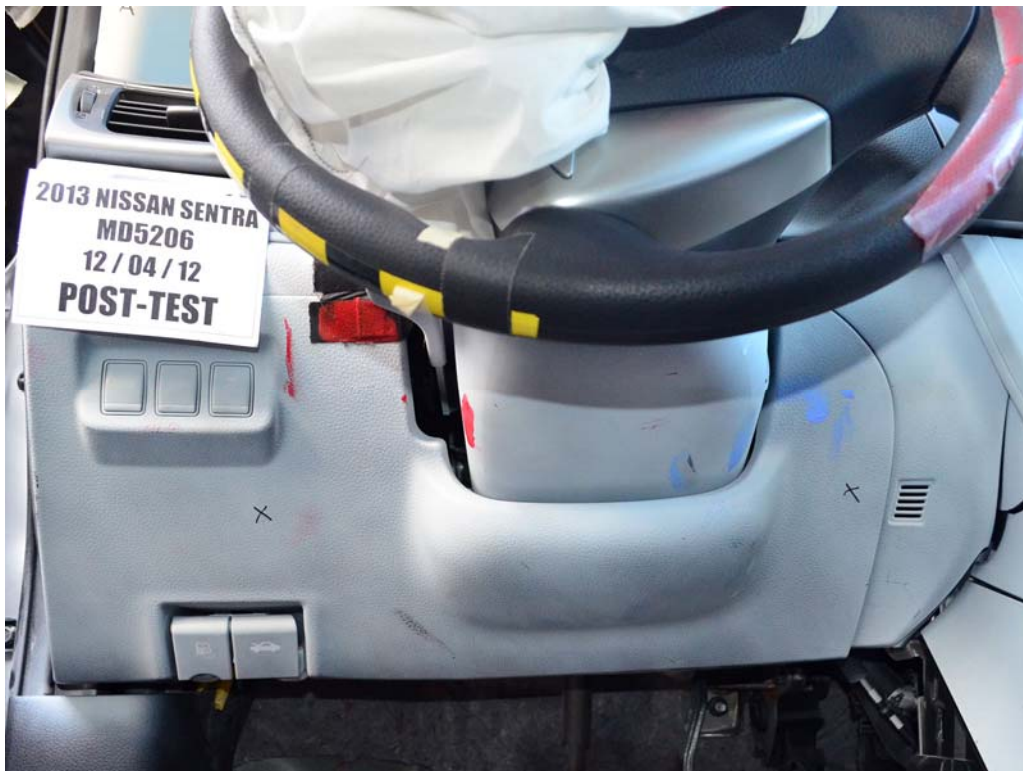
FIGURE 47a. Post-Test Driver Dummy Contact With Knee Bolster

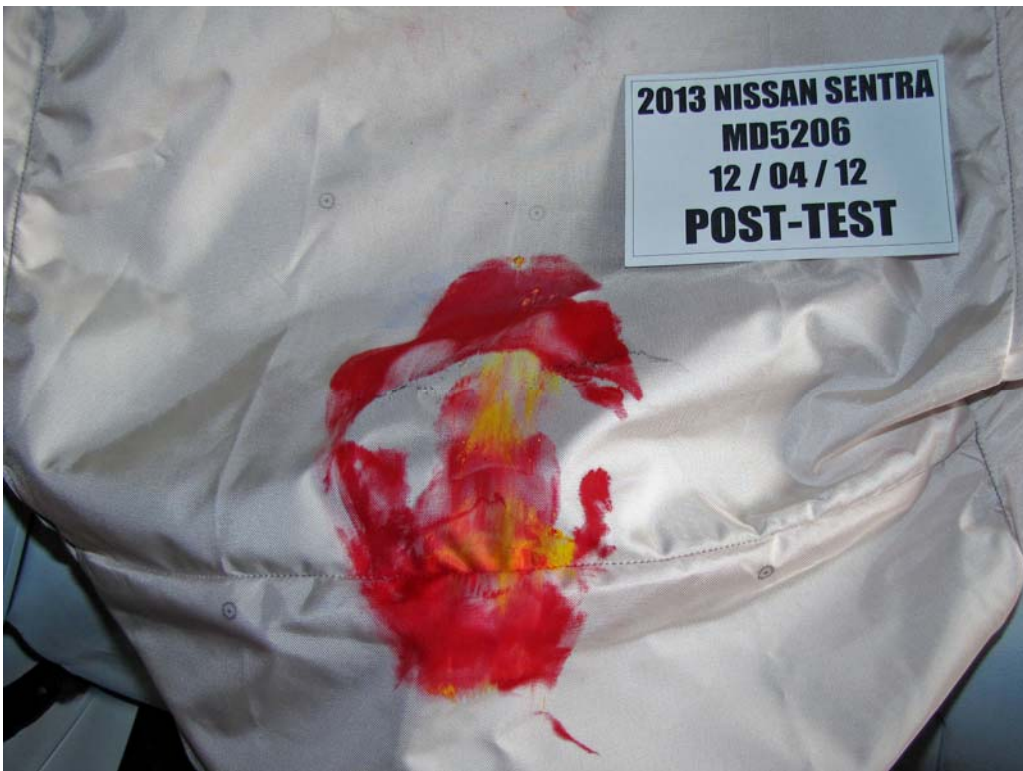
FIGURE 66. Post-Test Passenger Dummy Contact With Airbag

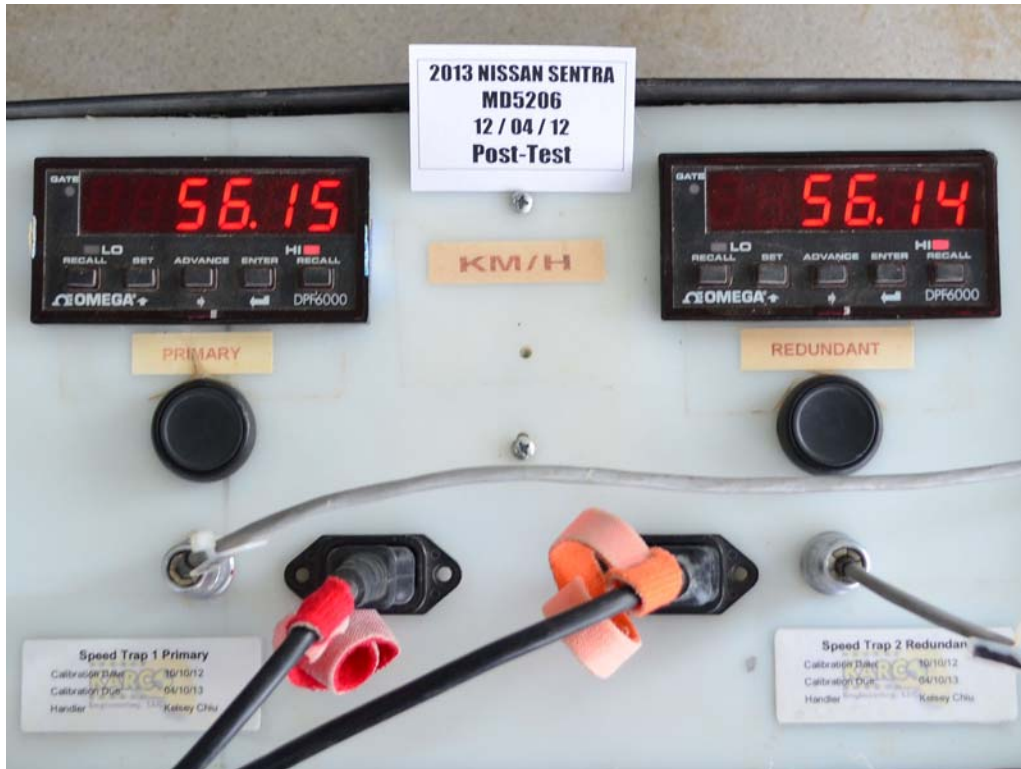
FIGURE 69. Post-Test Speed Trap Read-Out

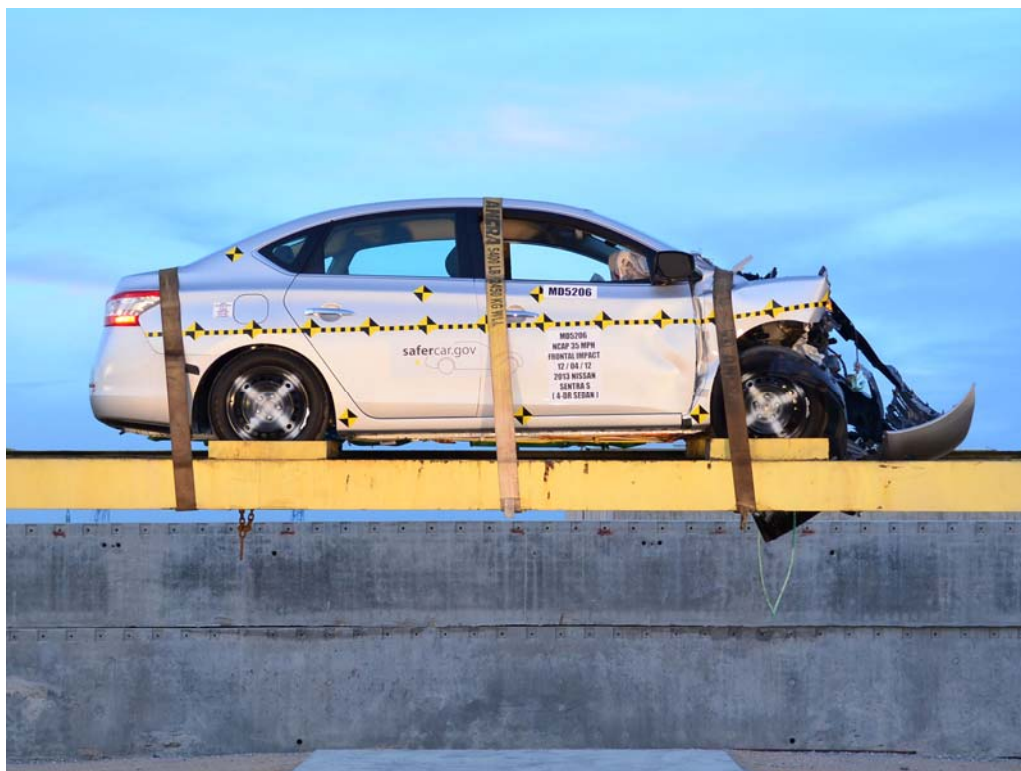
FIGURE 70. Vehicle at 0° on Static Rollover Device
