REPORT NUMBER: SINCAP-MGA-2013-037

**NEW CAR ASSESSMENT PROGRAM (NCAP)
Moving Deformable Barrier Side Impact Test**

**FORD MOTOR COMPANY
2013 Ford C-MAX Hybrid SE 5-Dr Hatchback
NHTSA No.: MD0207**

**MGA RESEARCH CORPORATION
5000 Warren Road
Burlington, WI 53105**

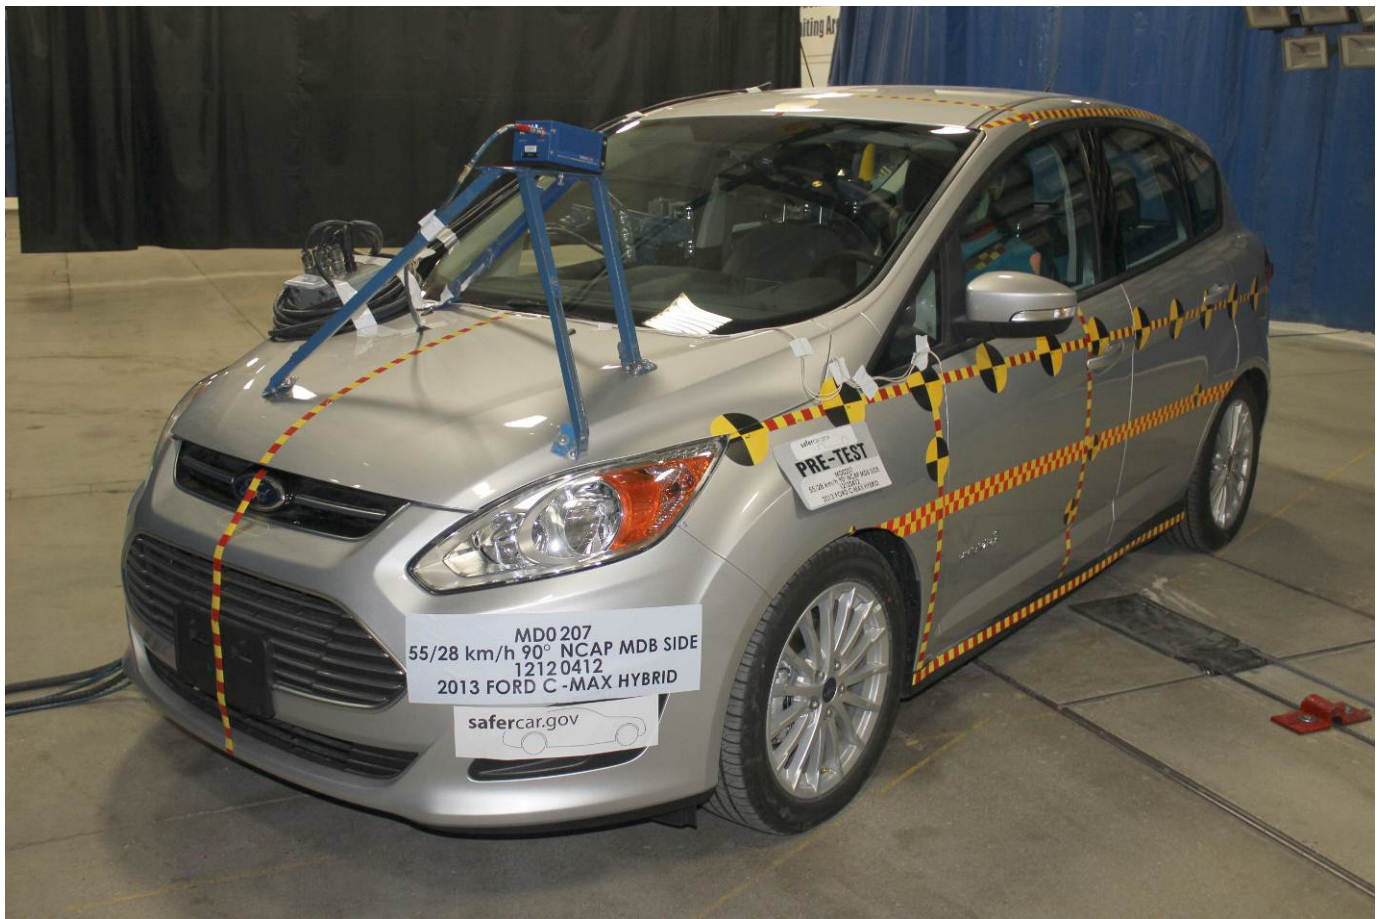
Pre-Test Left Front Three-Quarter View of Test Vehicle

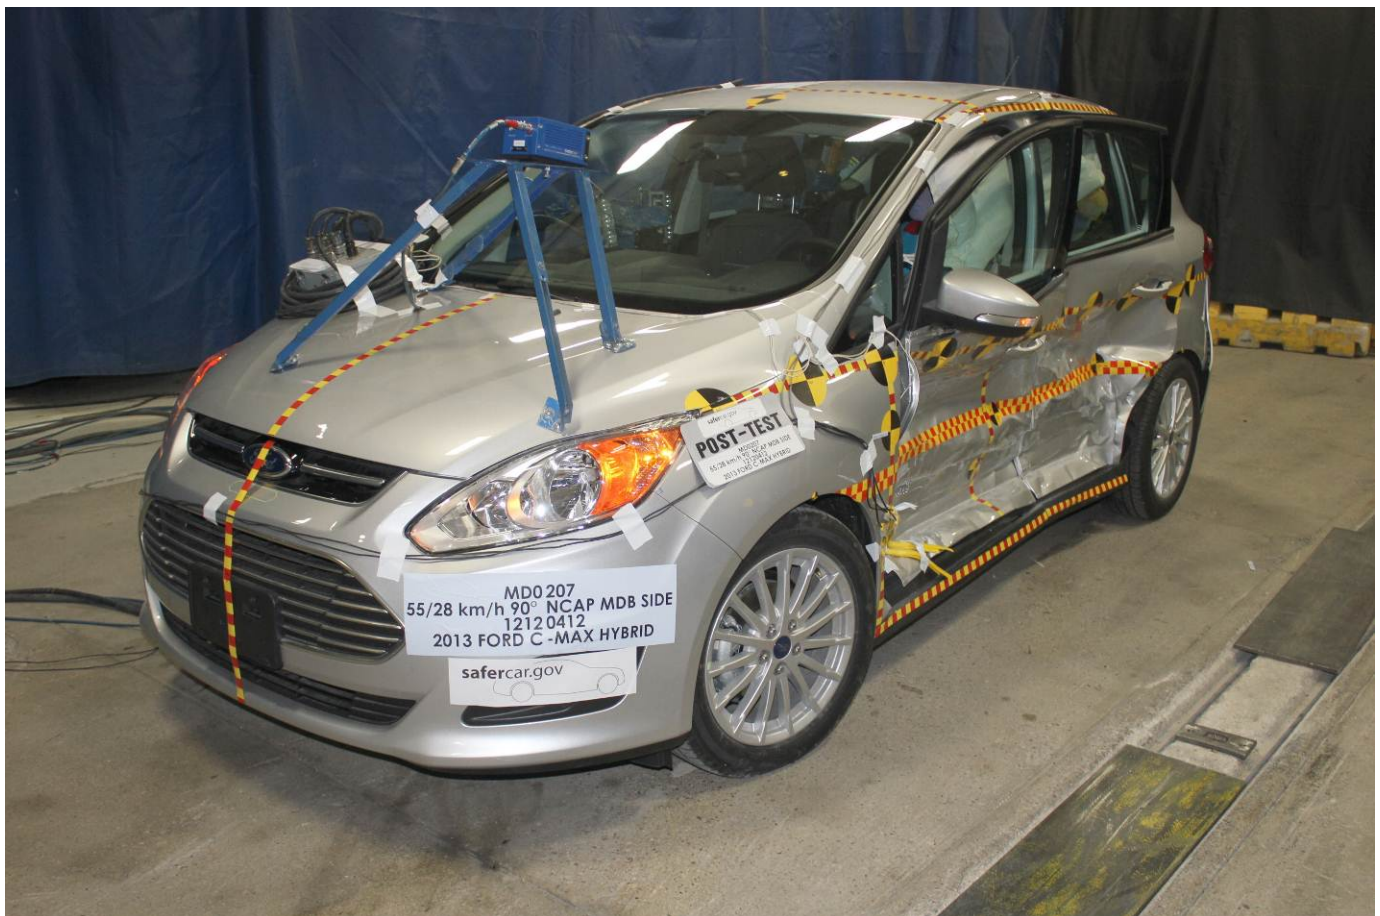
Post-Test Left Front Three-Quarter View of Test Vehicle

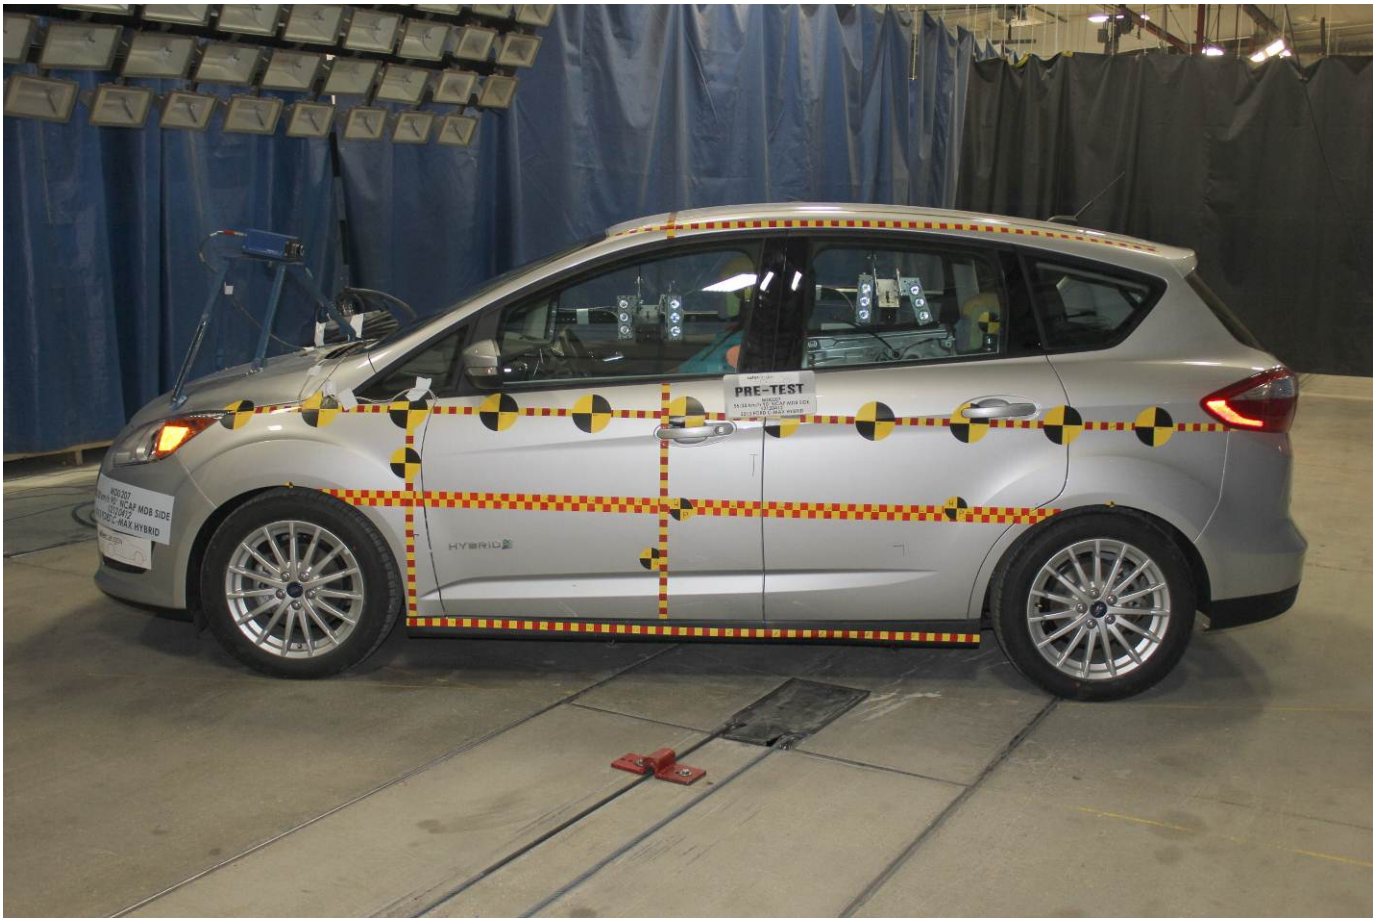
Pre-Test Left Side View of Test Vehicle

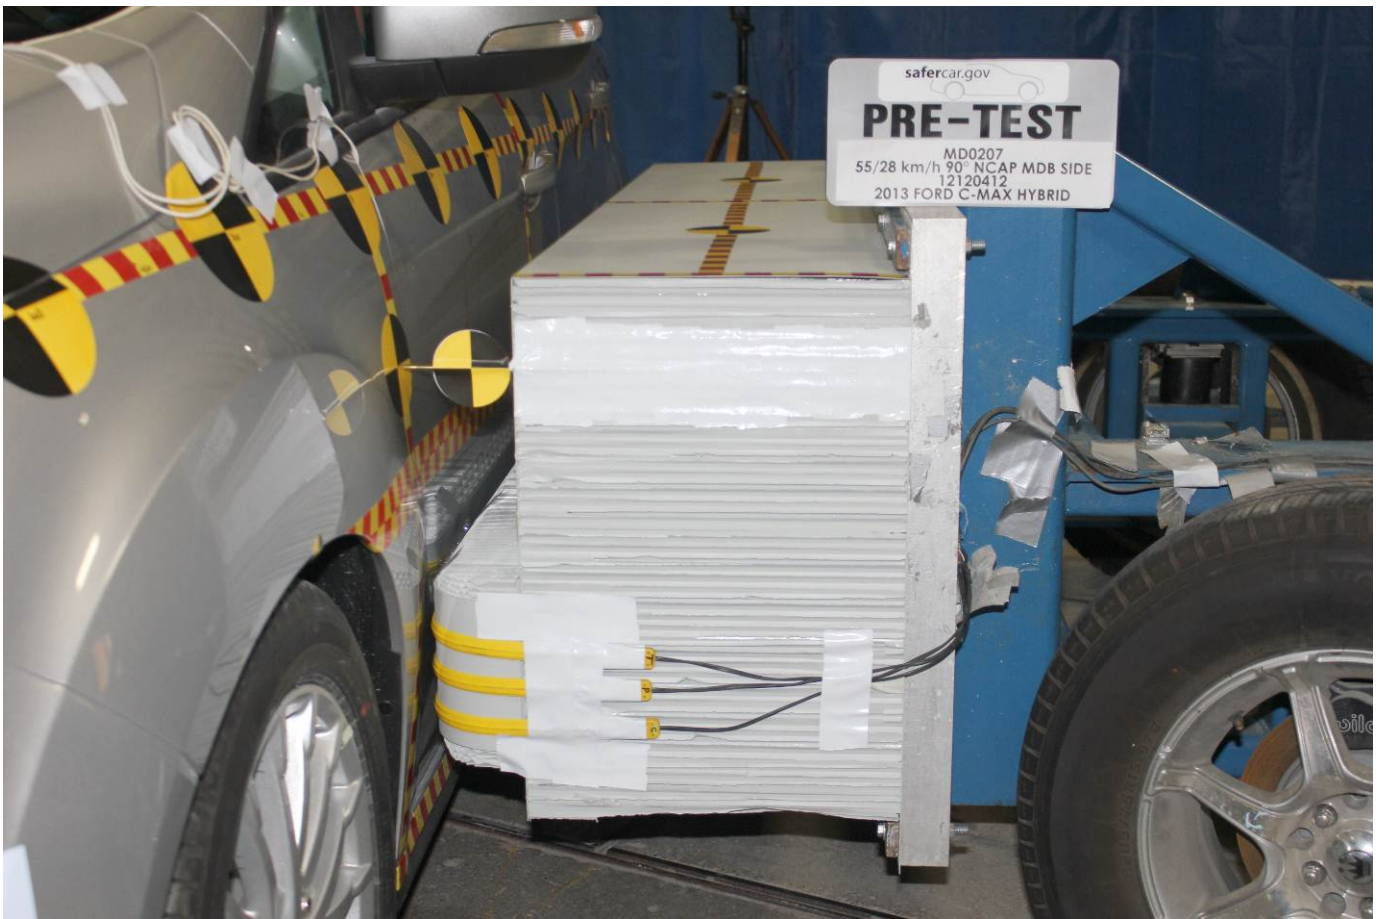
Pre-Test Left Side View of MDB Positioned Against Side of Test Vehicle

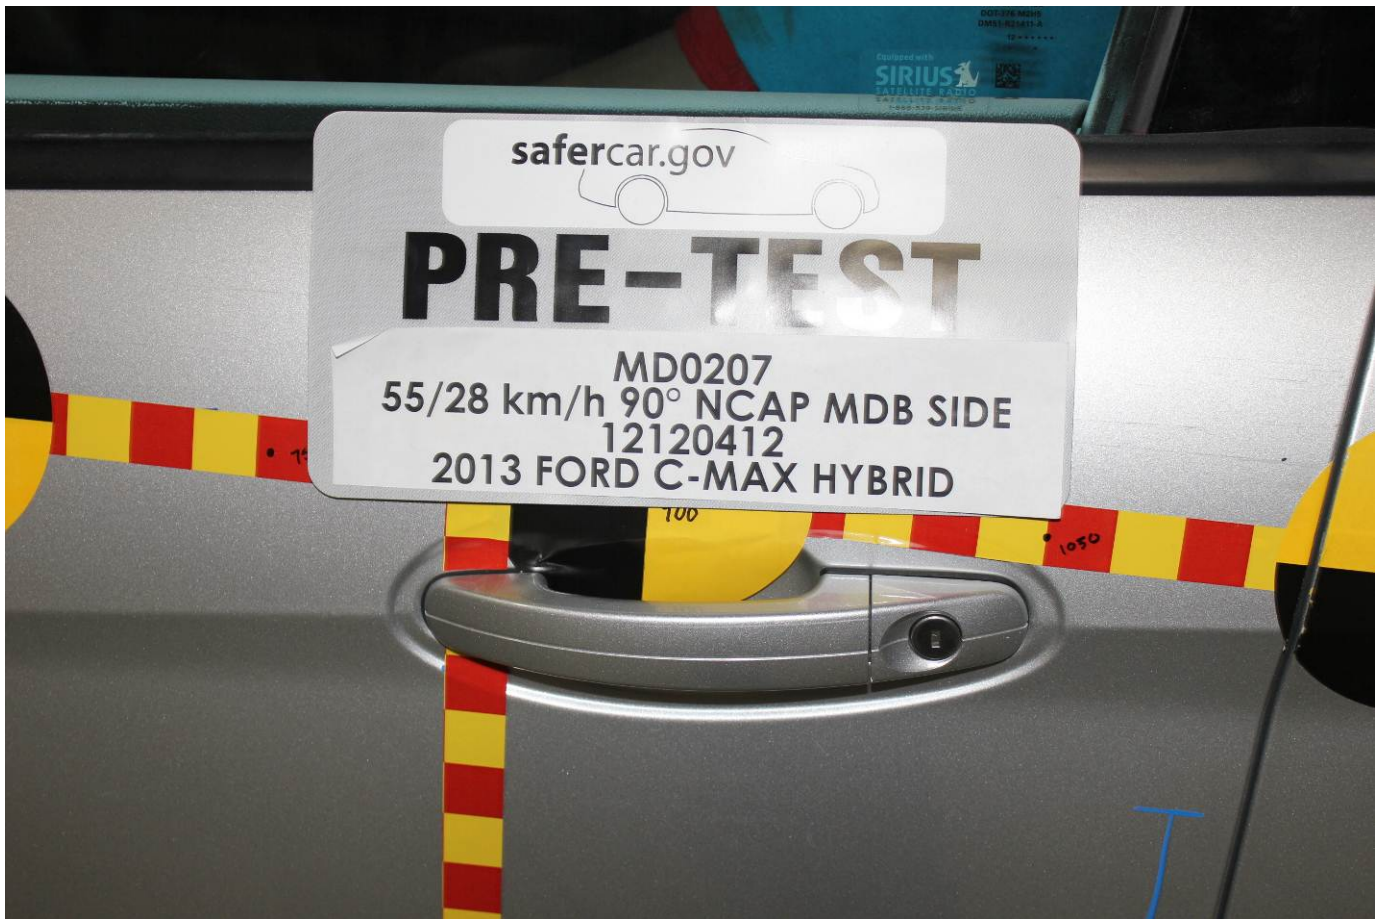
Pre-Test Left Front Door Latch Close-Up

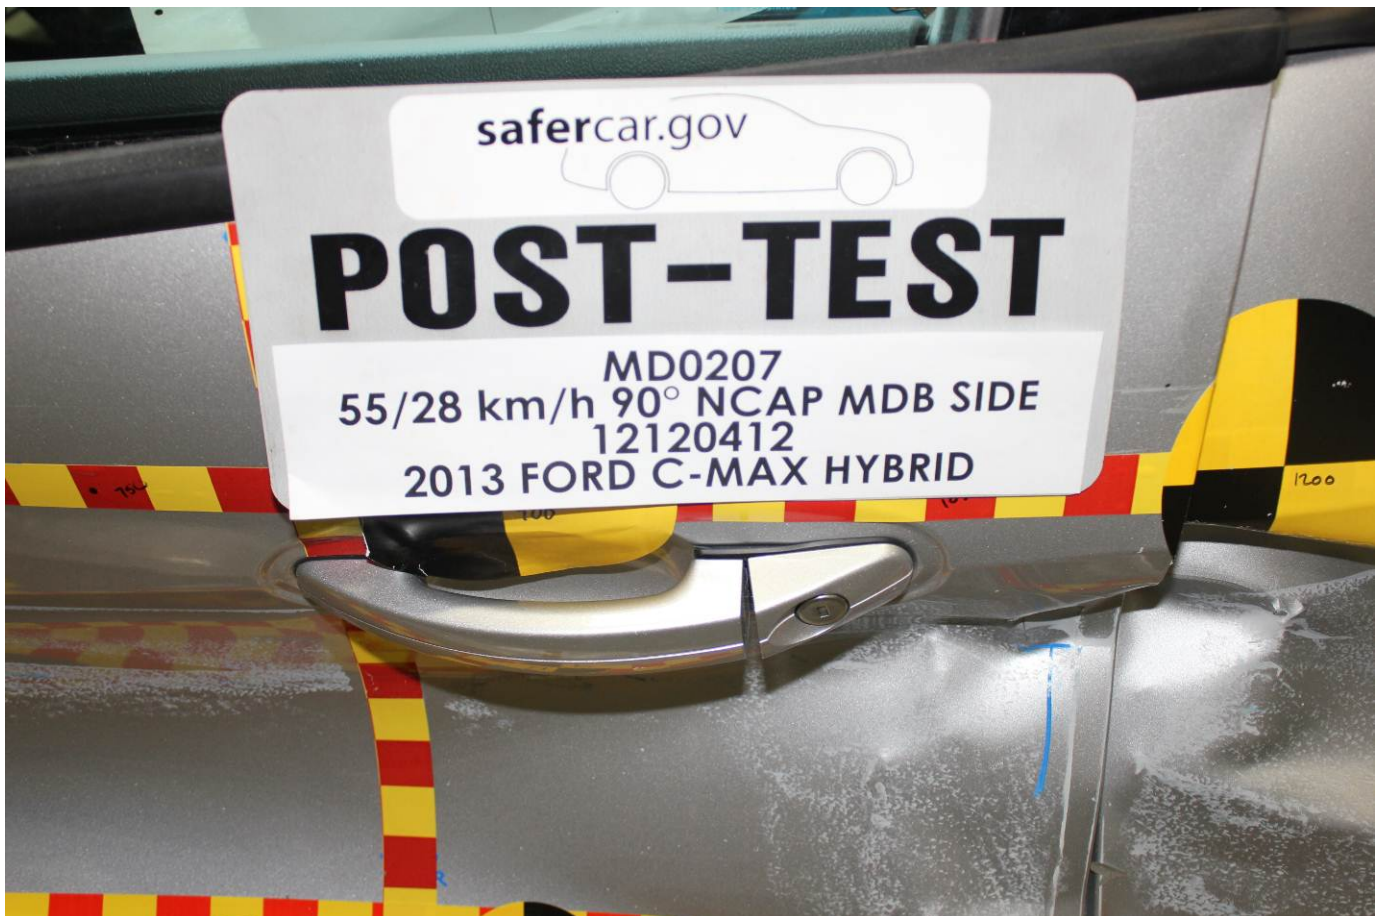
Post-Test Left Front Door Latch Close-Up

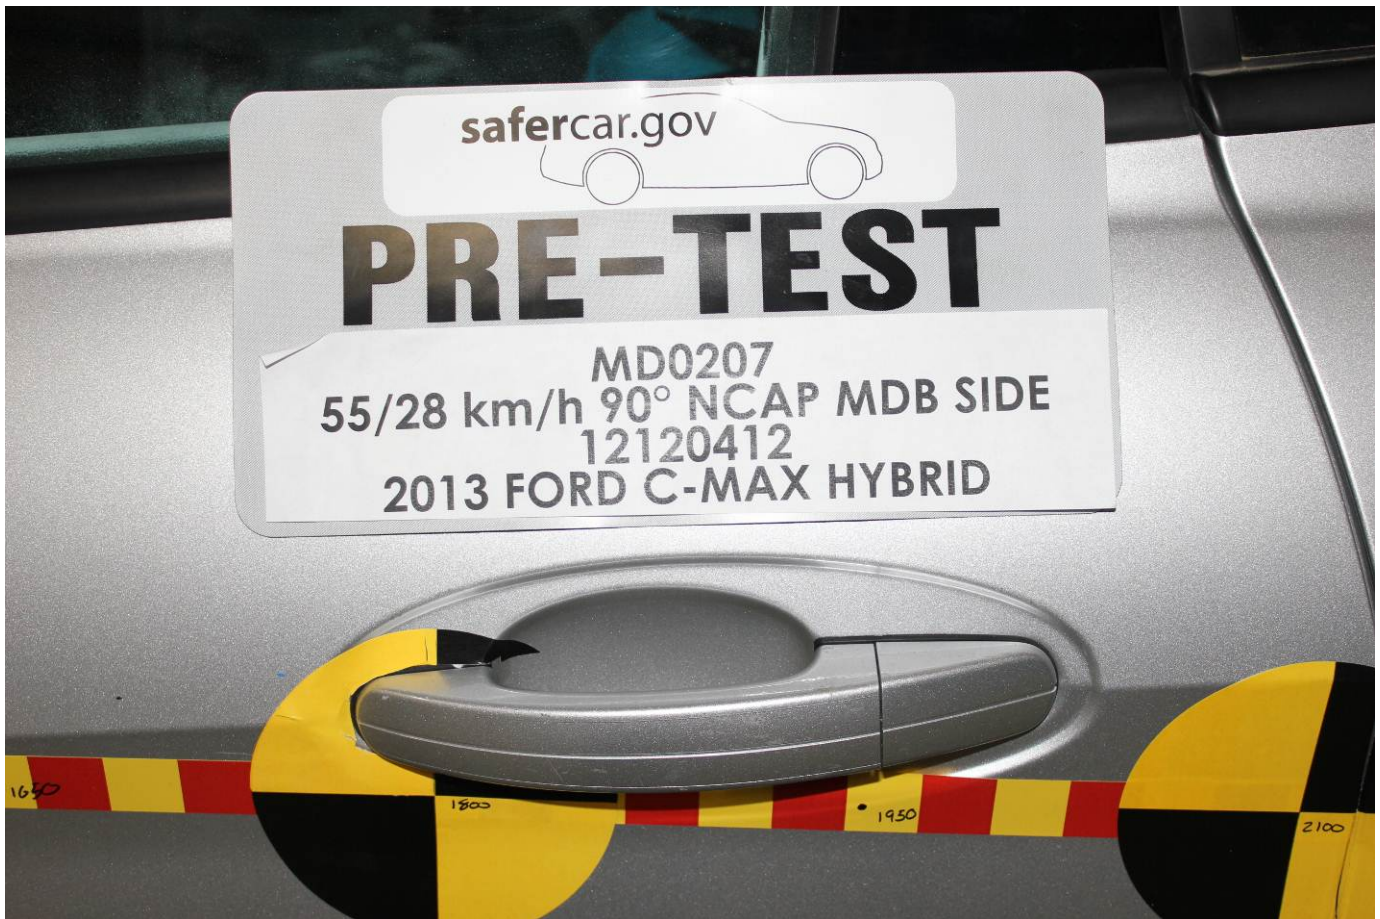
Pre-Test Left Rear Door Latch Close-Up

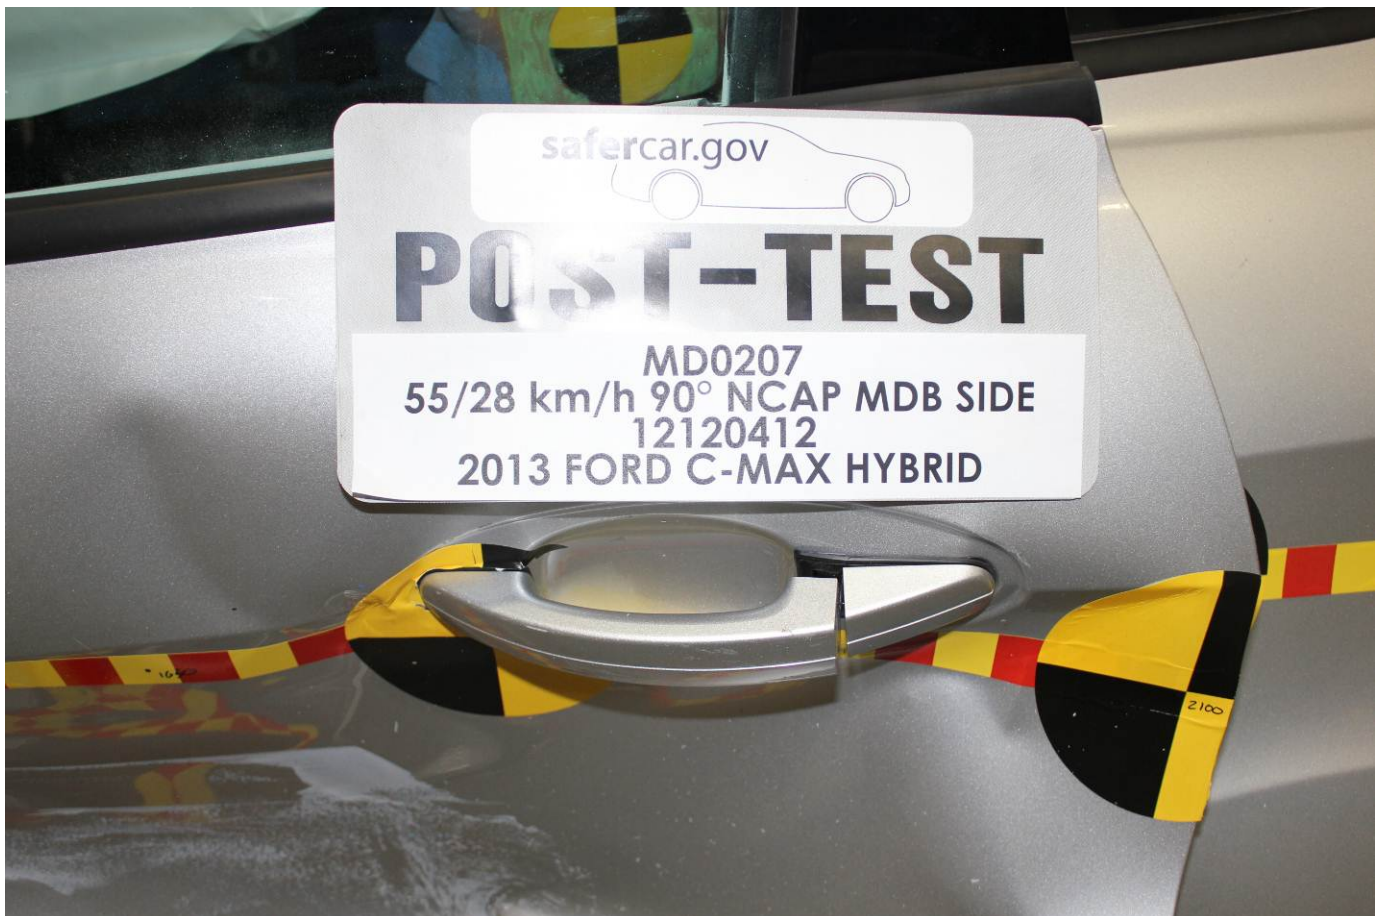
Post-Test Left Rear Door Latch Close-Up

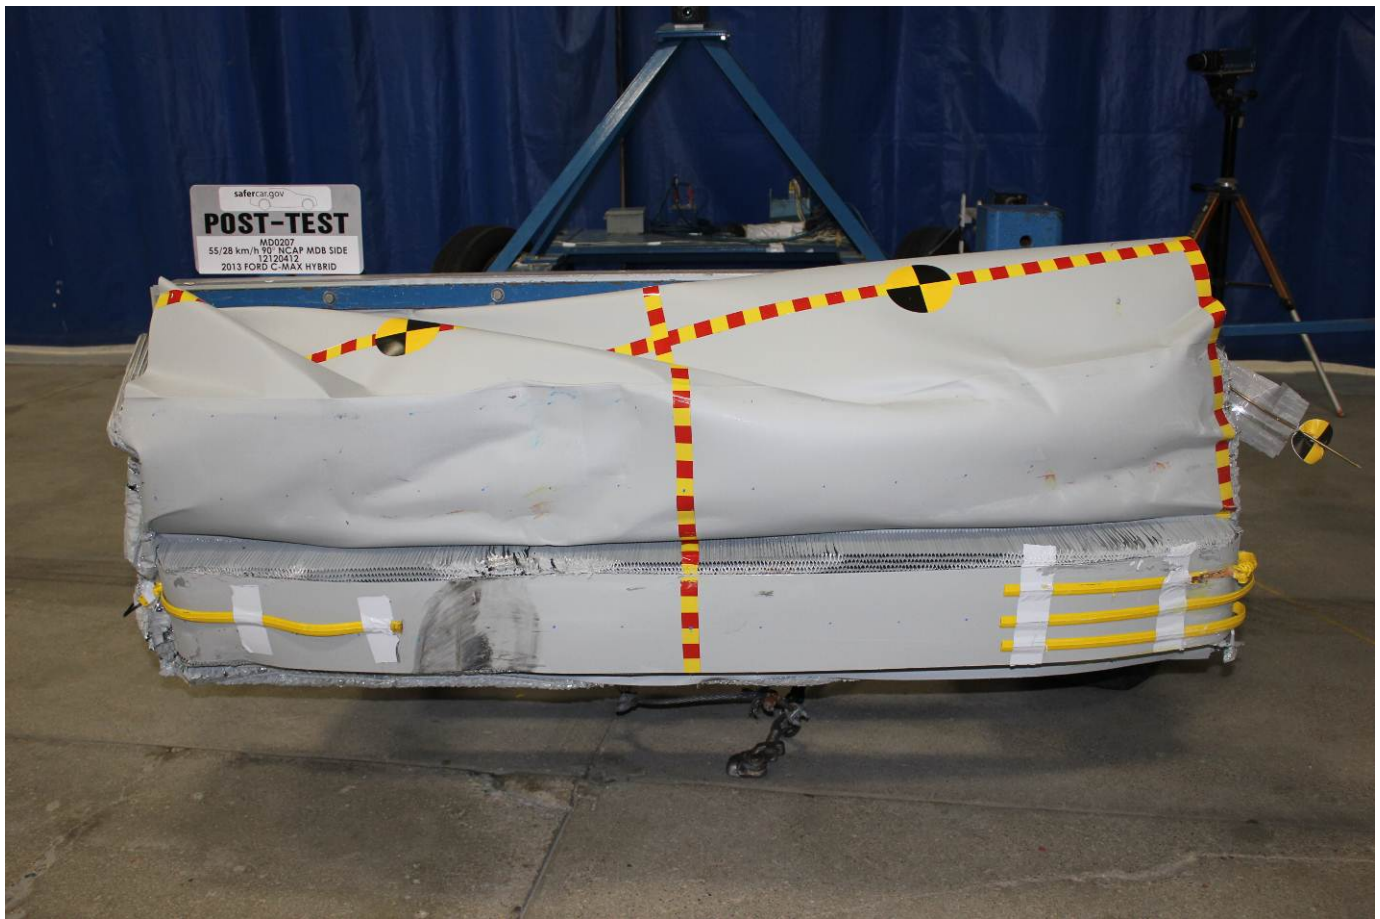
Post-Test Front View of MDB Impactor Face

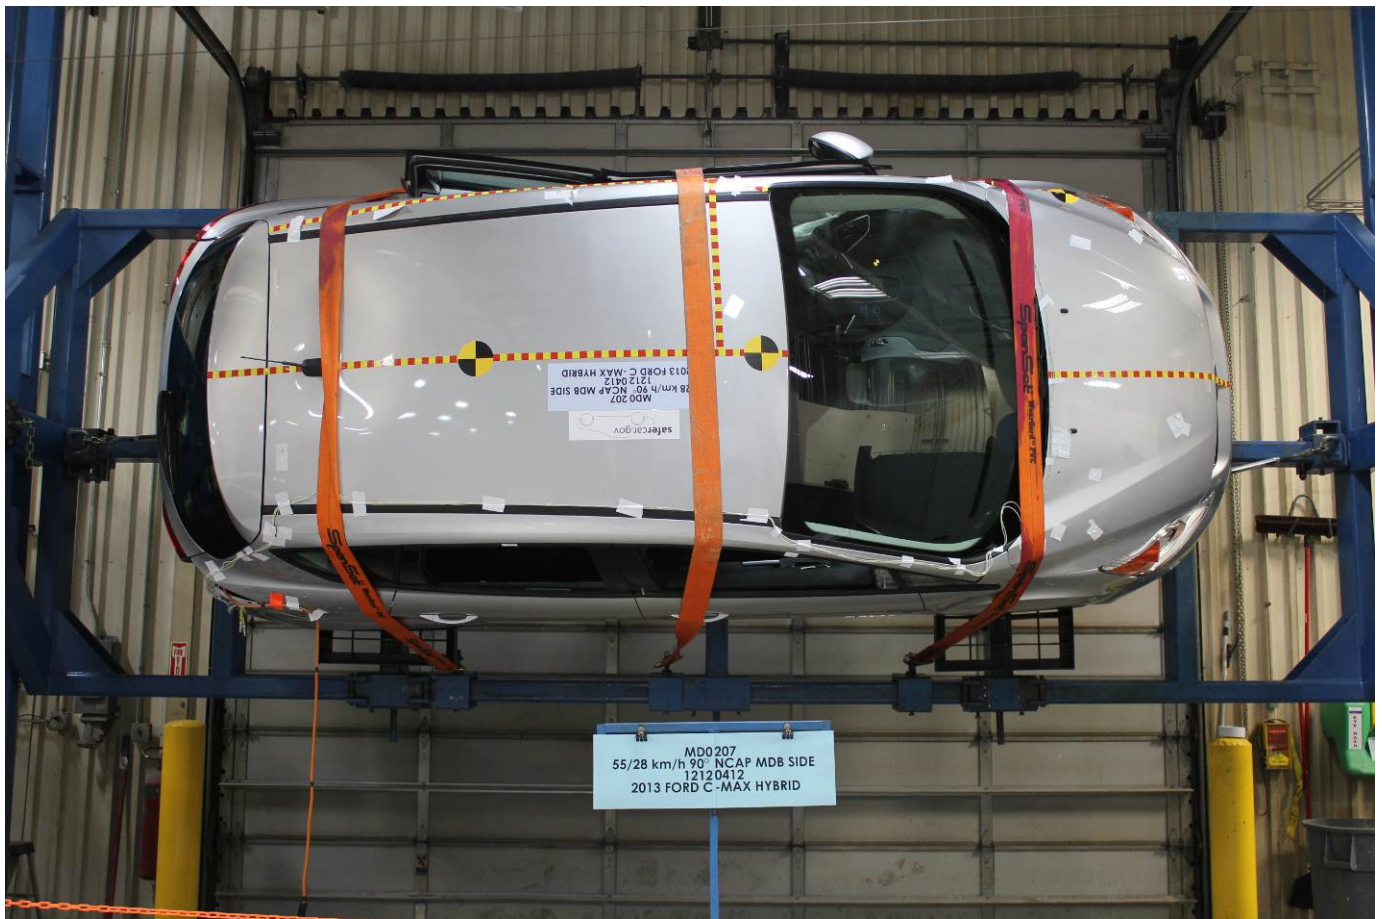
FMVSS No. 301 Static Rollover 90 Degrees

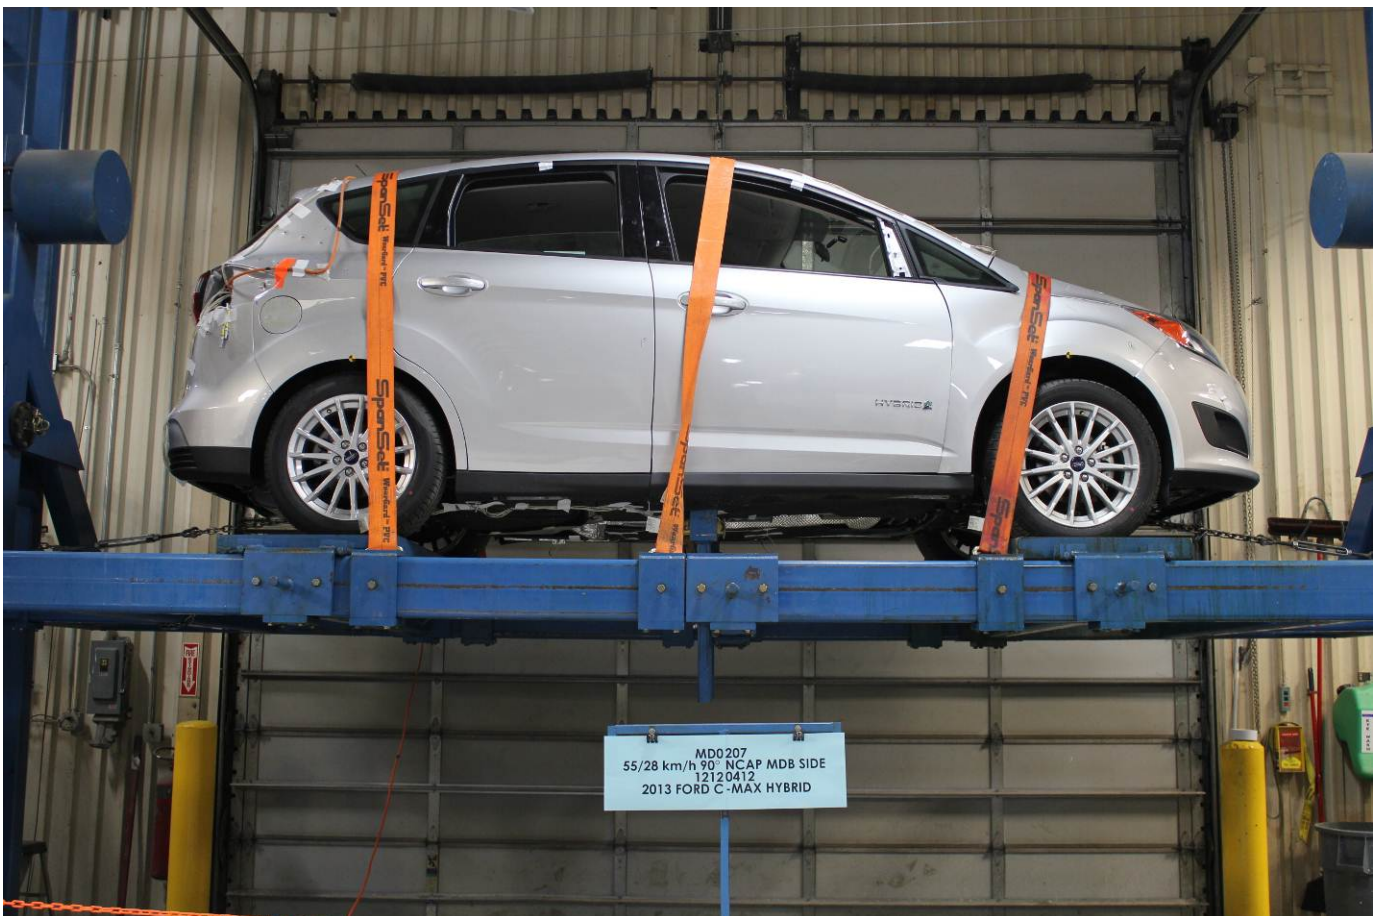
FMVSS No. 301 Static Rollover 360 Degrees
