REPORT NUMBER: SPNCAP-MGA-2013-038

**NEW CAR ASSESSMENT PROGRAM (NCAP)
Side Impact Pole Test**

**FORD MOTOR COMPANY
2013 Ford C-MAX Hybrid SE 5-Dr Hatchback
NHTSA No.: MD0206**

**MGA RESEARCH CORPORATION
5000 Warren Road
Burlington, WI 53105**

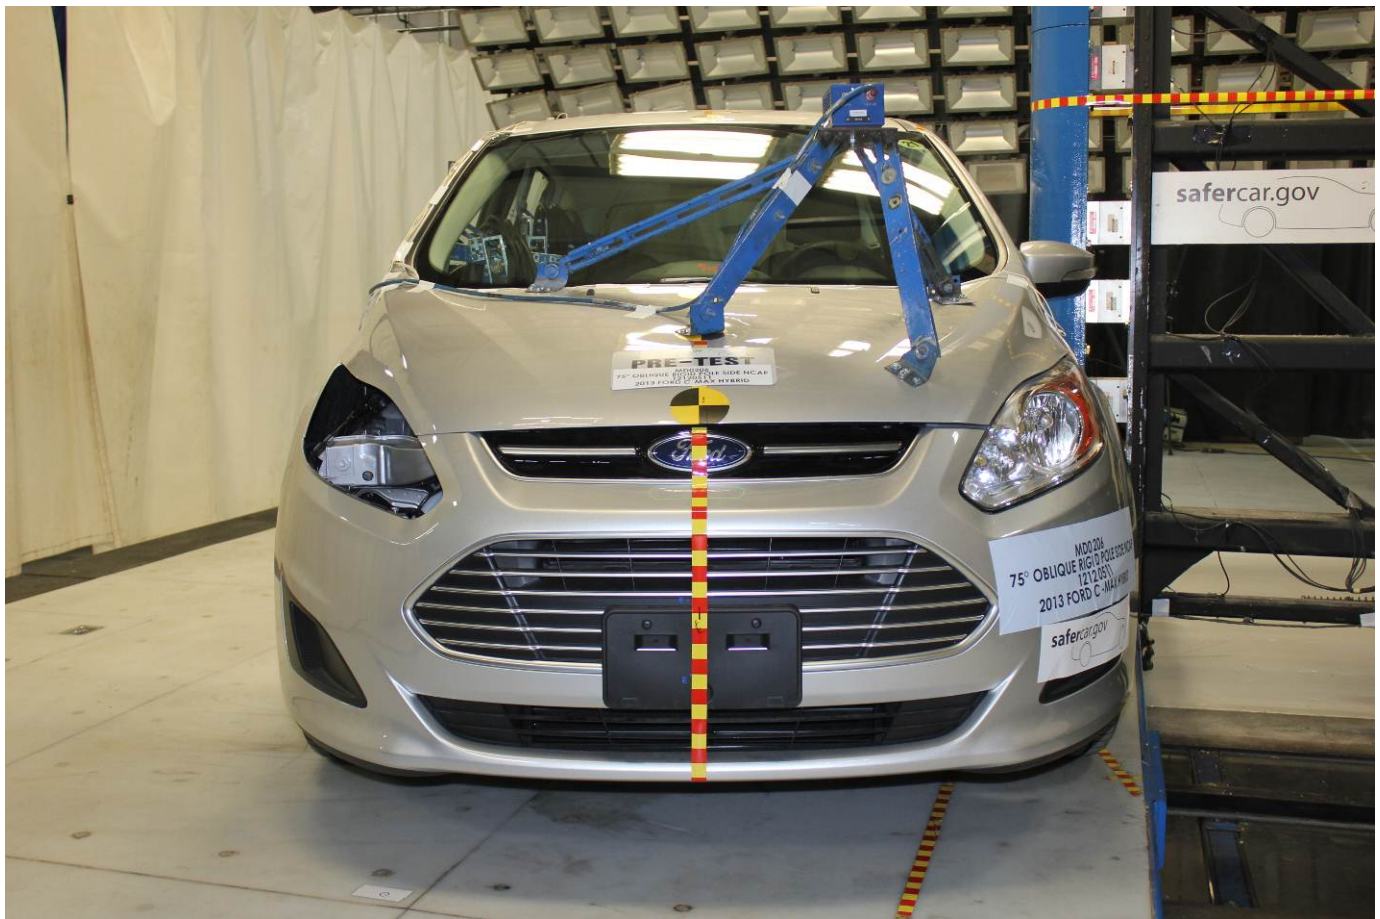
Pre-Test Frontal View of Test Vehicle

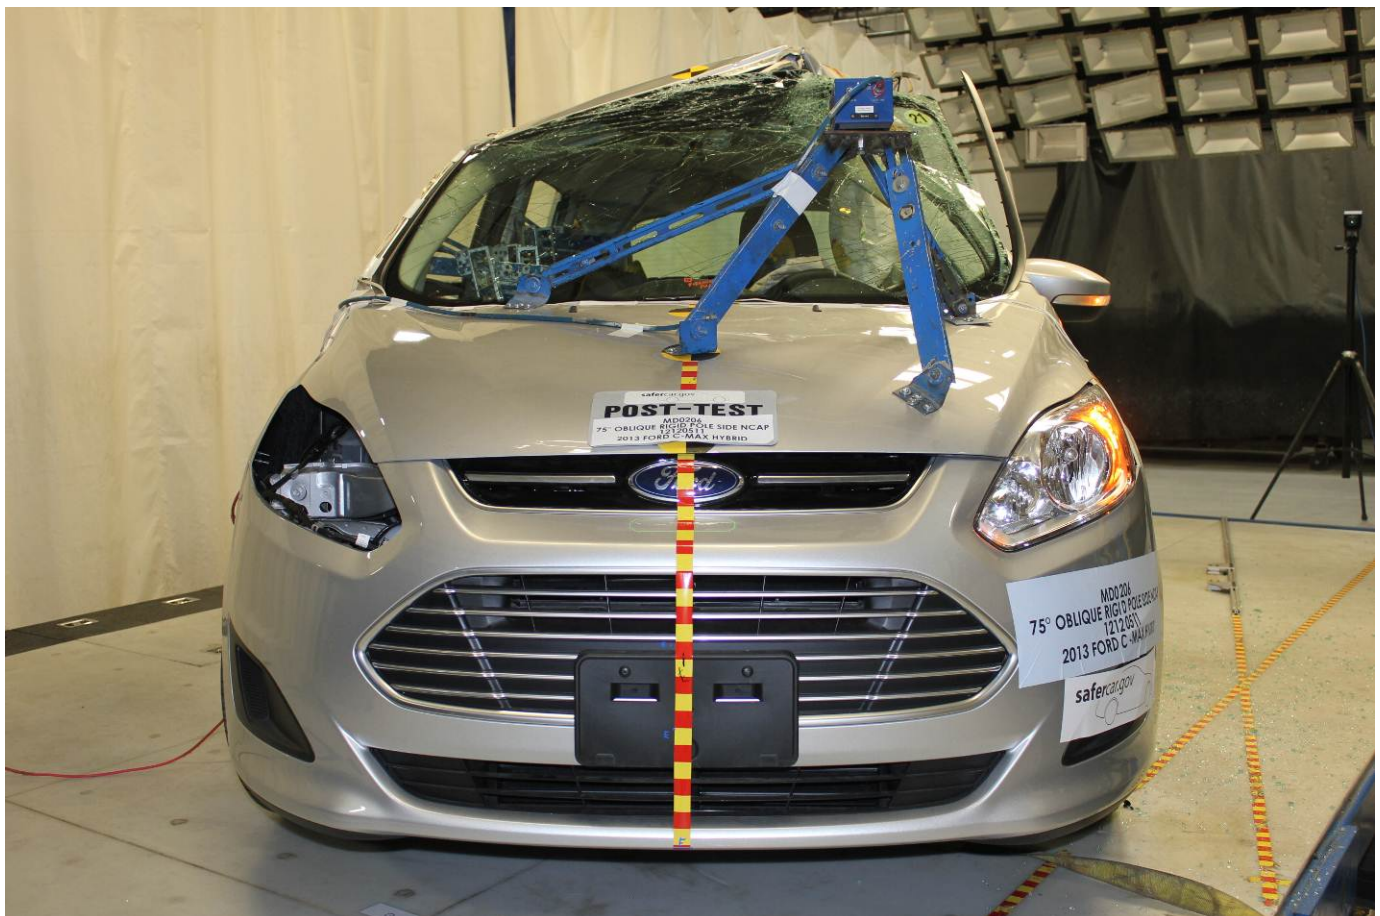
Post-Test Frontal View of Test Vehicle

Critical Areas of Performance	Observations and Conclusions
Pillar Performance	No Separation
Sill Separation	None
Windshield Damage	Cracked
Side Window Damage	Left Front Window Broken
Other Notable Effects	None

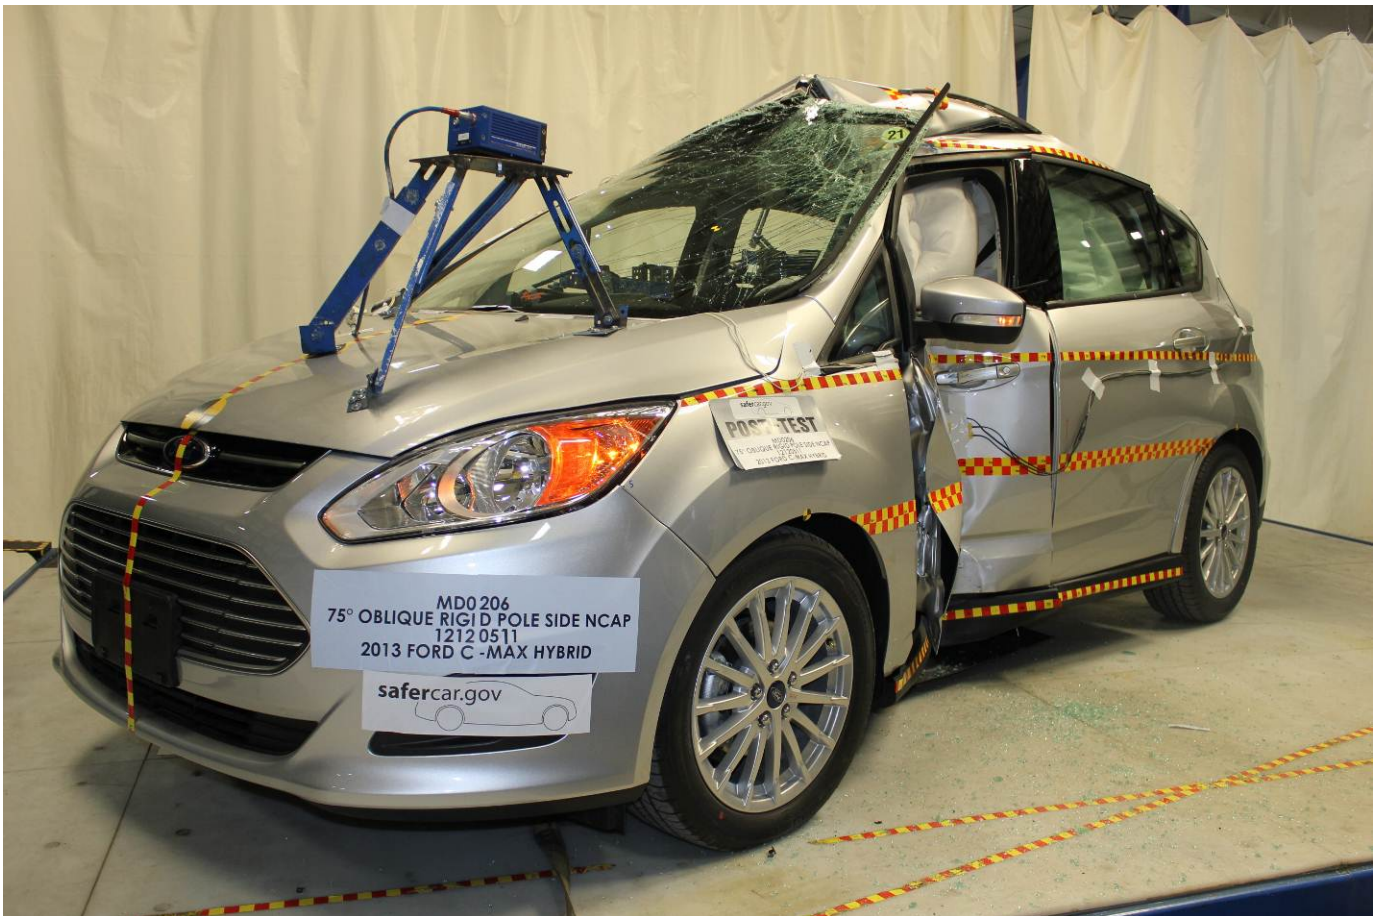
Post-Test Left Front ¾ View of Test Vehicle

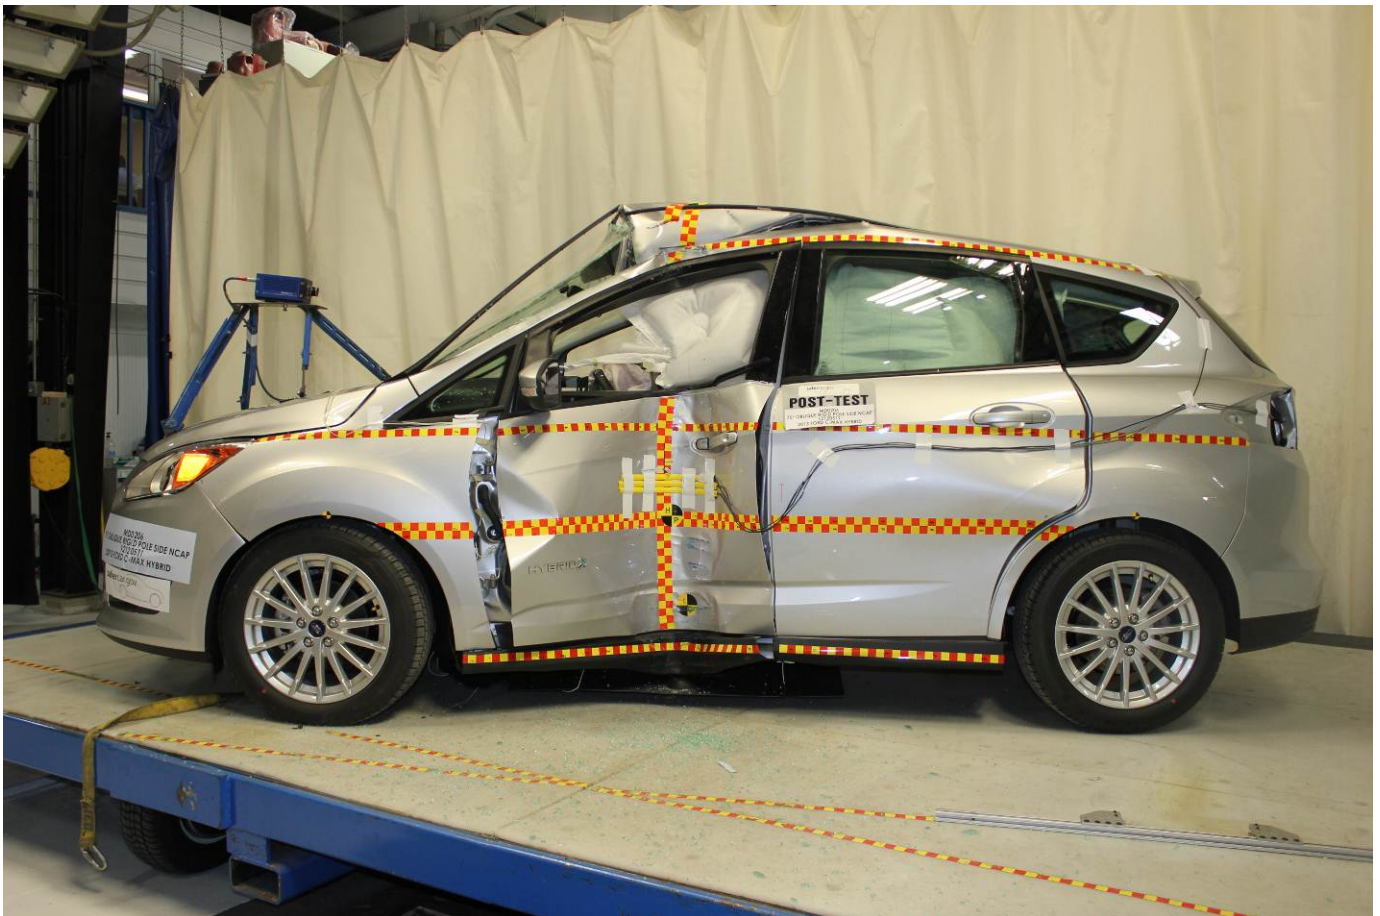
Post-Test Left Side View of Test Vehicle

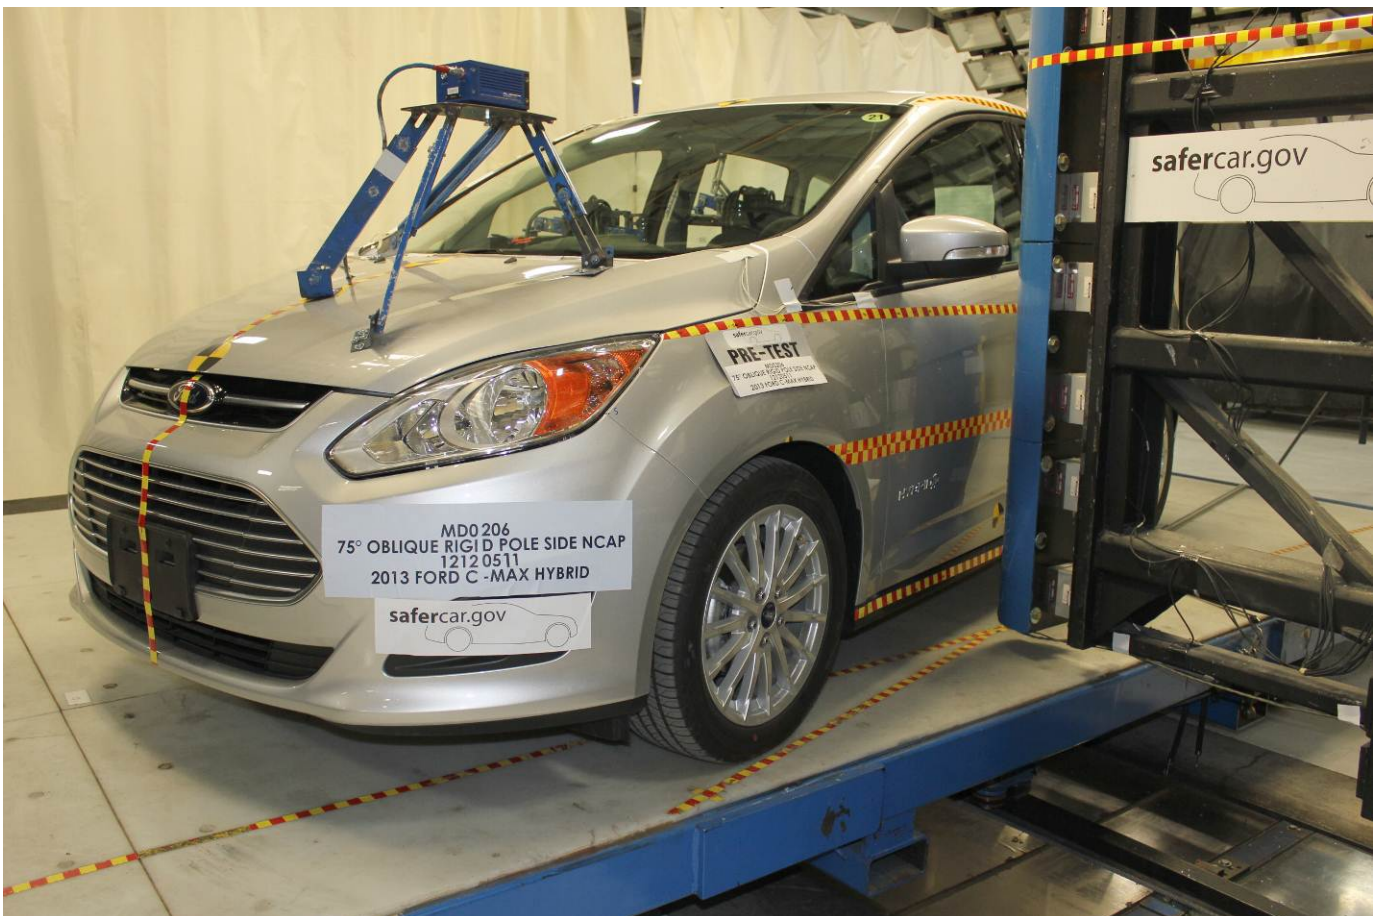
Pre-Test Left Side View of Pole Positioned Against Side of Vehicle

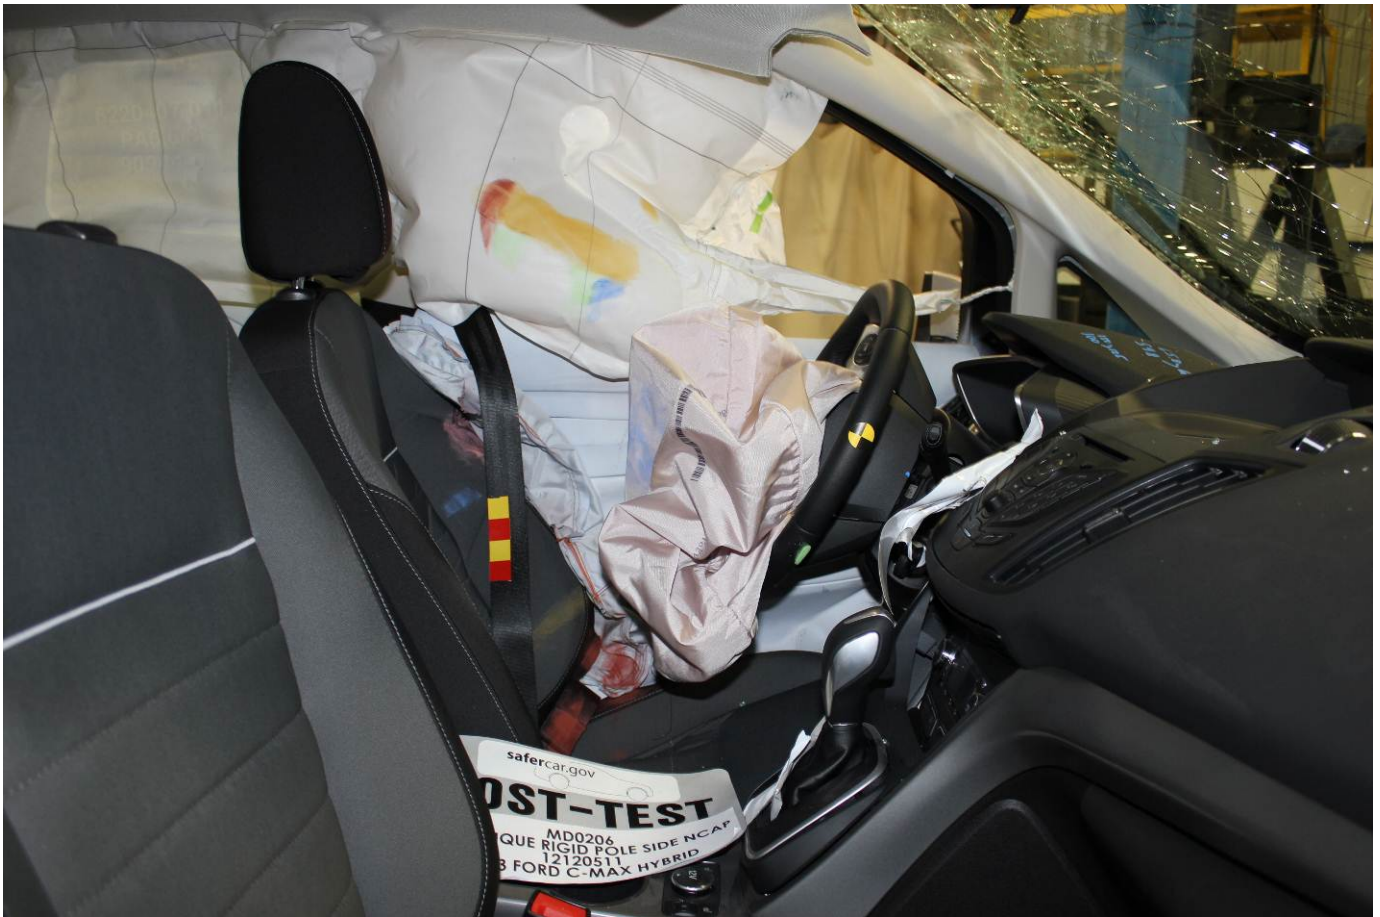
Post-Test Inner Door Panel View Showing Dummy Contact Location

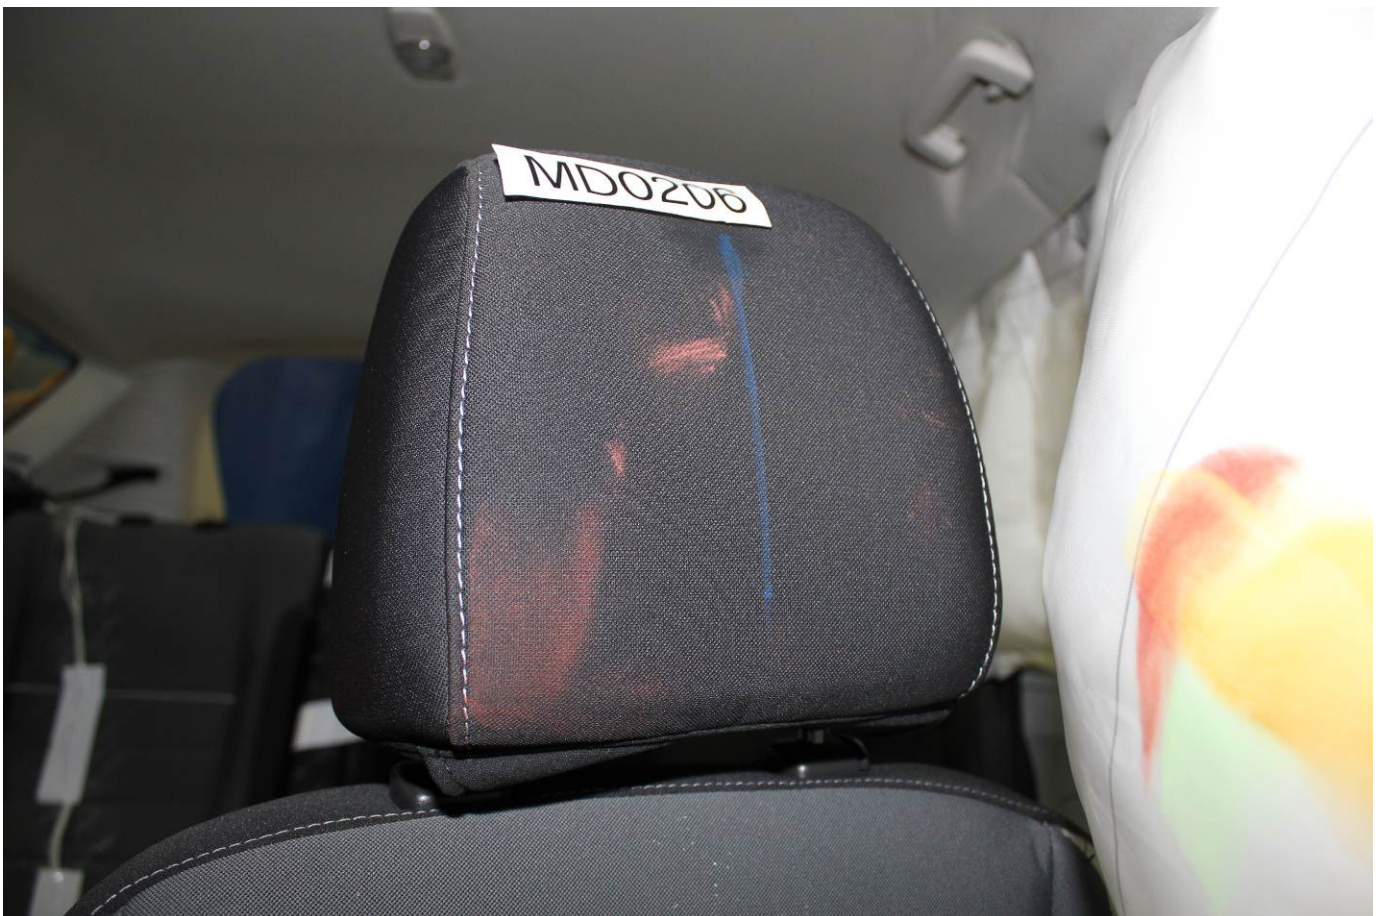
Post-Test Dummy Close-Up Head Contact with Vehicle Interior View

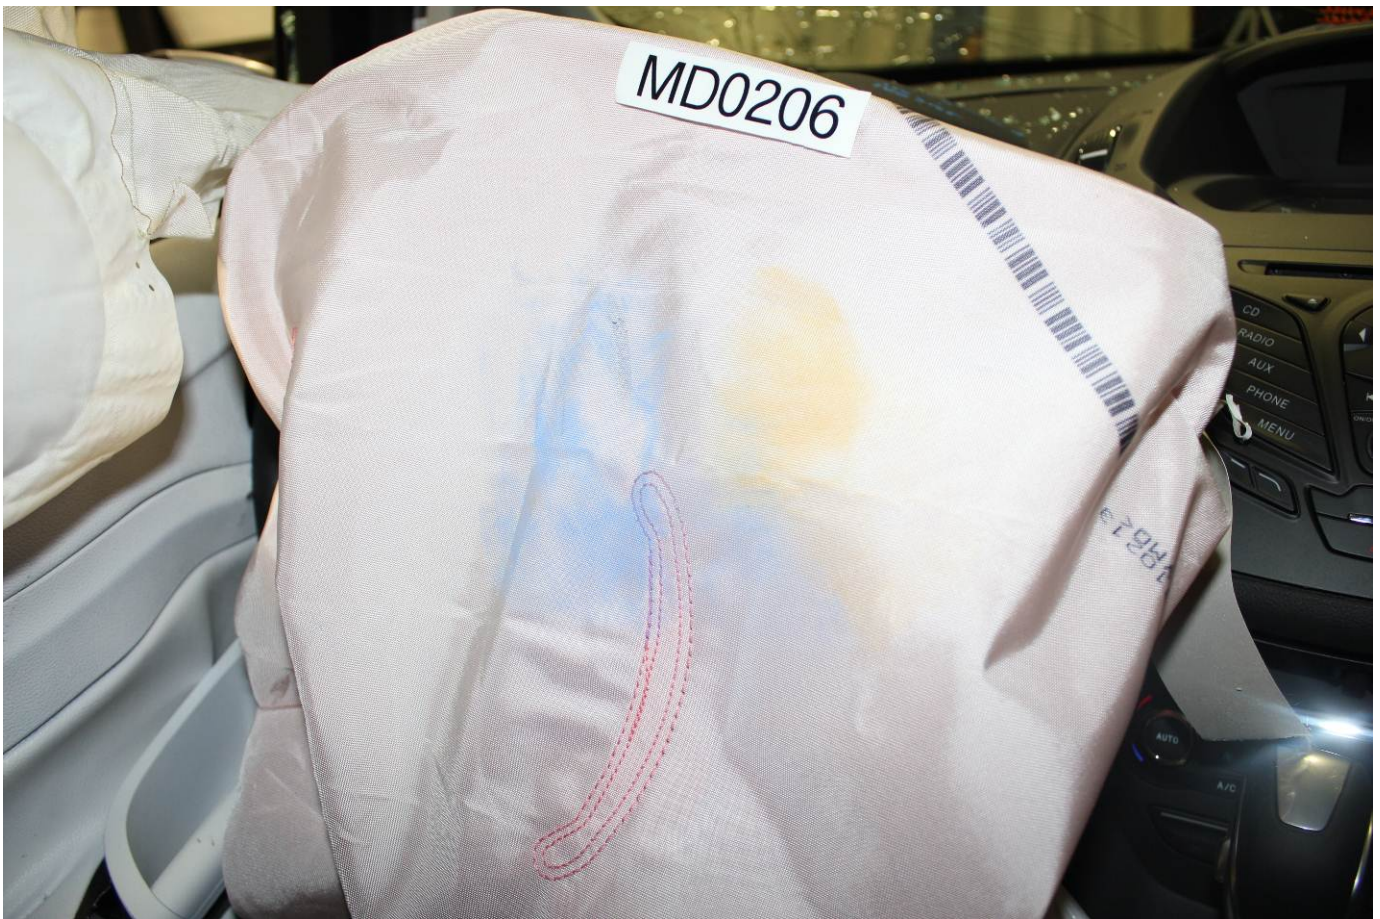
Post-Test Dummy Close-Up Head Contact with Frontal Airbag View

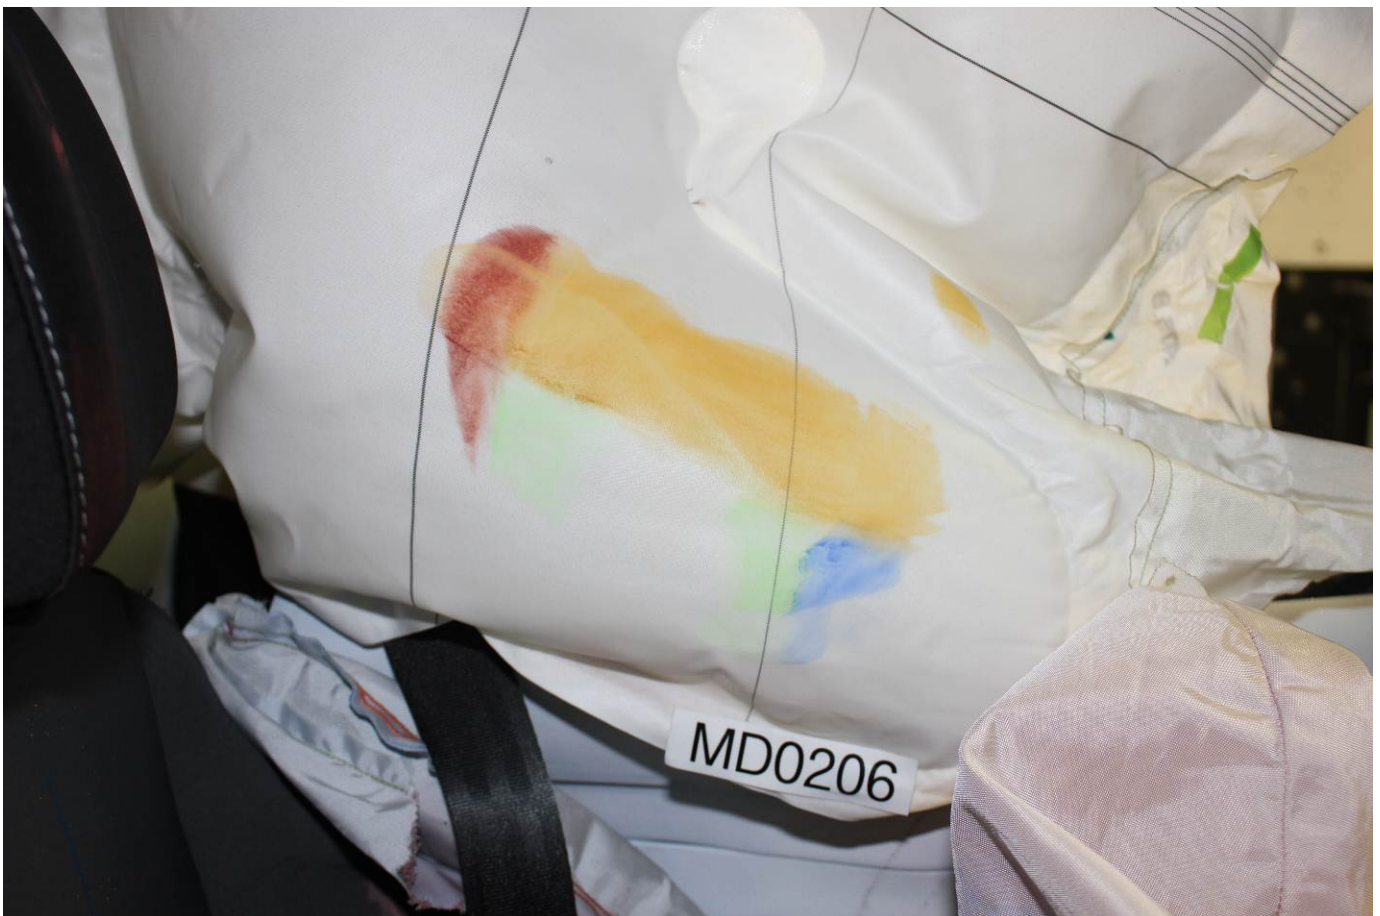
Post-Test Dummy Close-Up Head Contact with Side Air Bag View

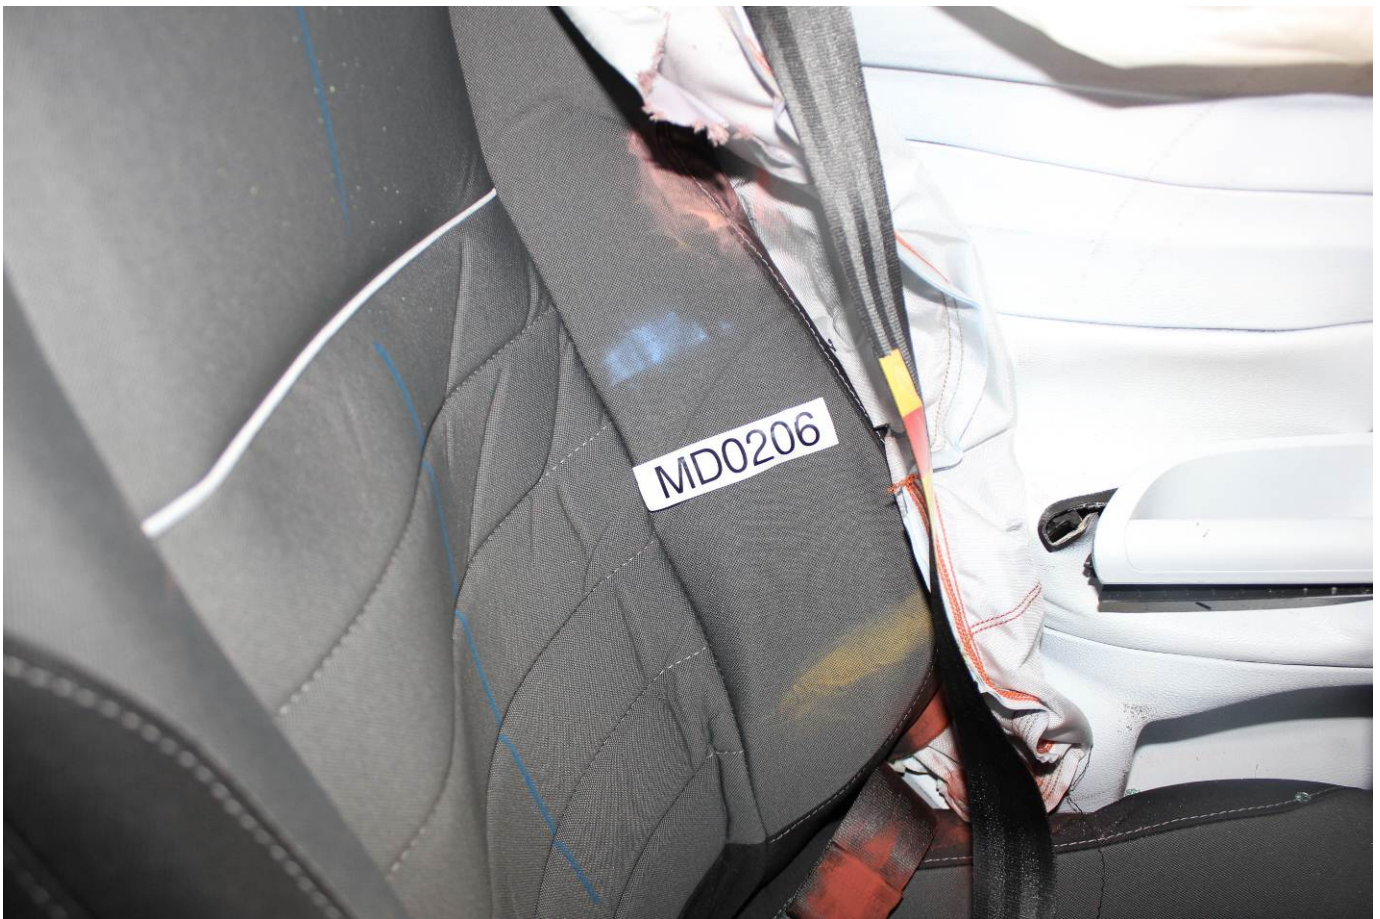
Post-Test Dummy Close-Up Torso Contact with Vehicle Interior View

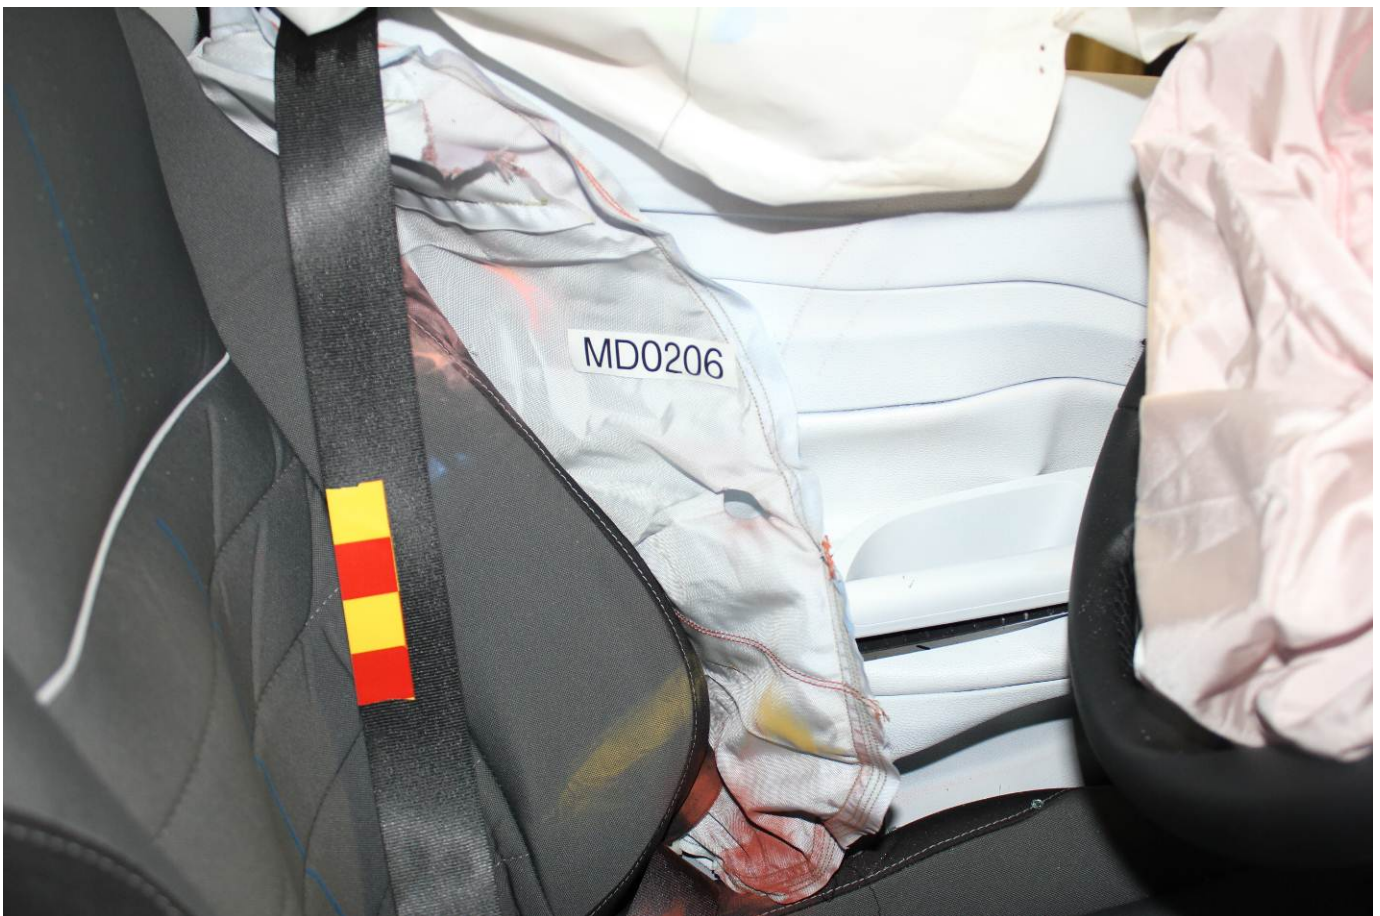
Post-Test Dummy Close-Up Torso Contact with Side Air Bag View

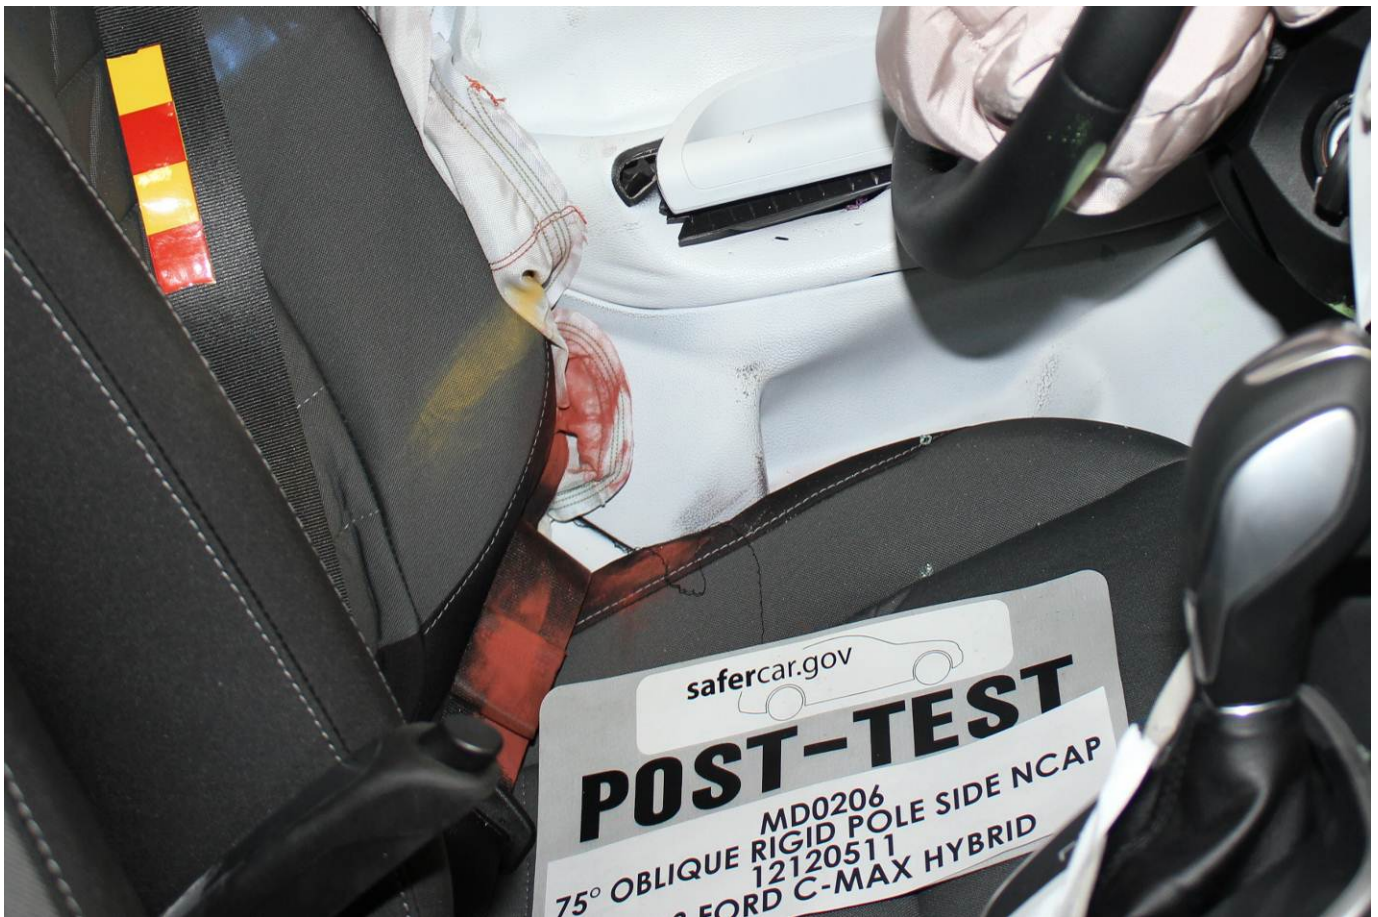
Post-Test Dummy Close-Up Pelvis Contact with Vehicle Interior View

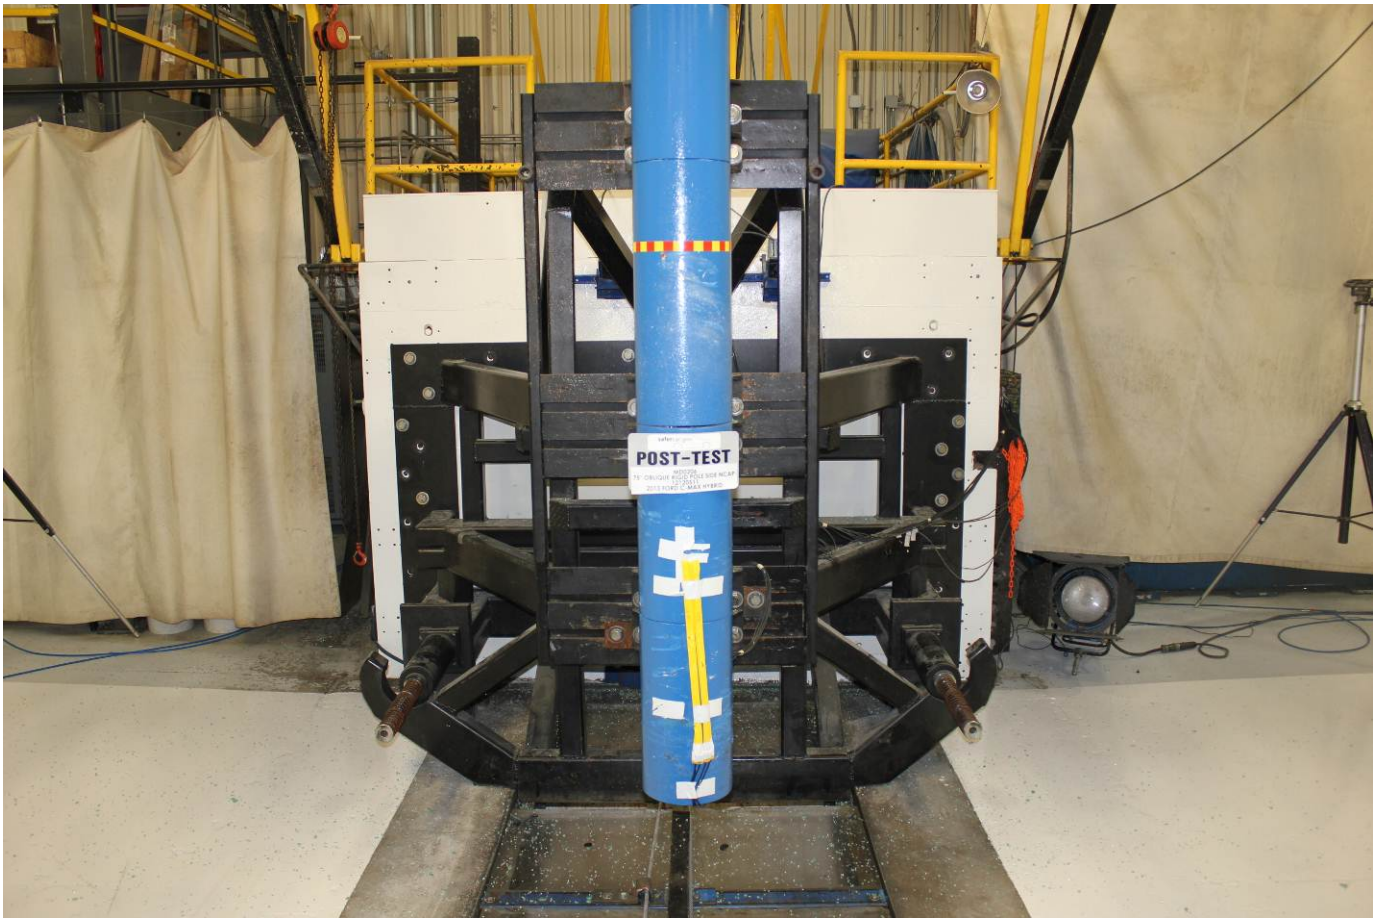
Post-Test Pole Barrier Front View
