REPORT NUMBER: SPNCAP-MGA-2013-040

**NEW CAR ASSESSMENT PROGRAM (NCAP)
Side Impact Pole Test**

**FORD MOTOR COMPANY
2013 Ford Fusion SE Hybrid 4-Dr Sedan
NHTSA No.: MD0218**

**MGA RESEARCH CORPORATION
5000 Warren Road
Burlington, WI 53105**

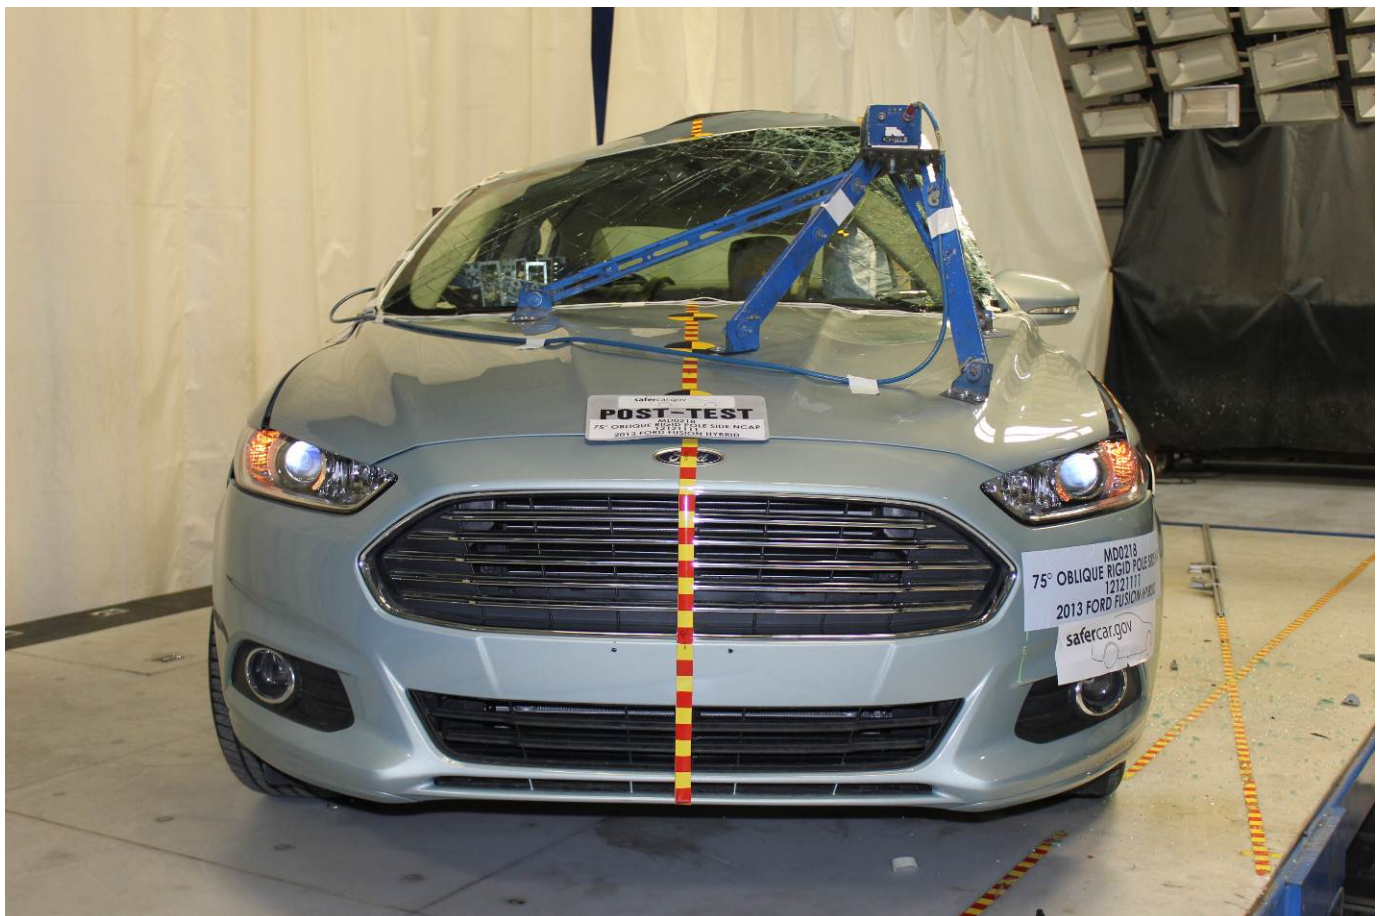
Post-Test Frontal View of Test Vehicle

Critical Areas of Performance	Observations and Conclusions
Pillar Performance	No Separation
Sill Separation	None
Windshield Damage	Cracked
Side Window Damage	Left Front Window Broken
Other Notable Effects	None

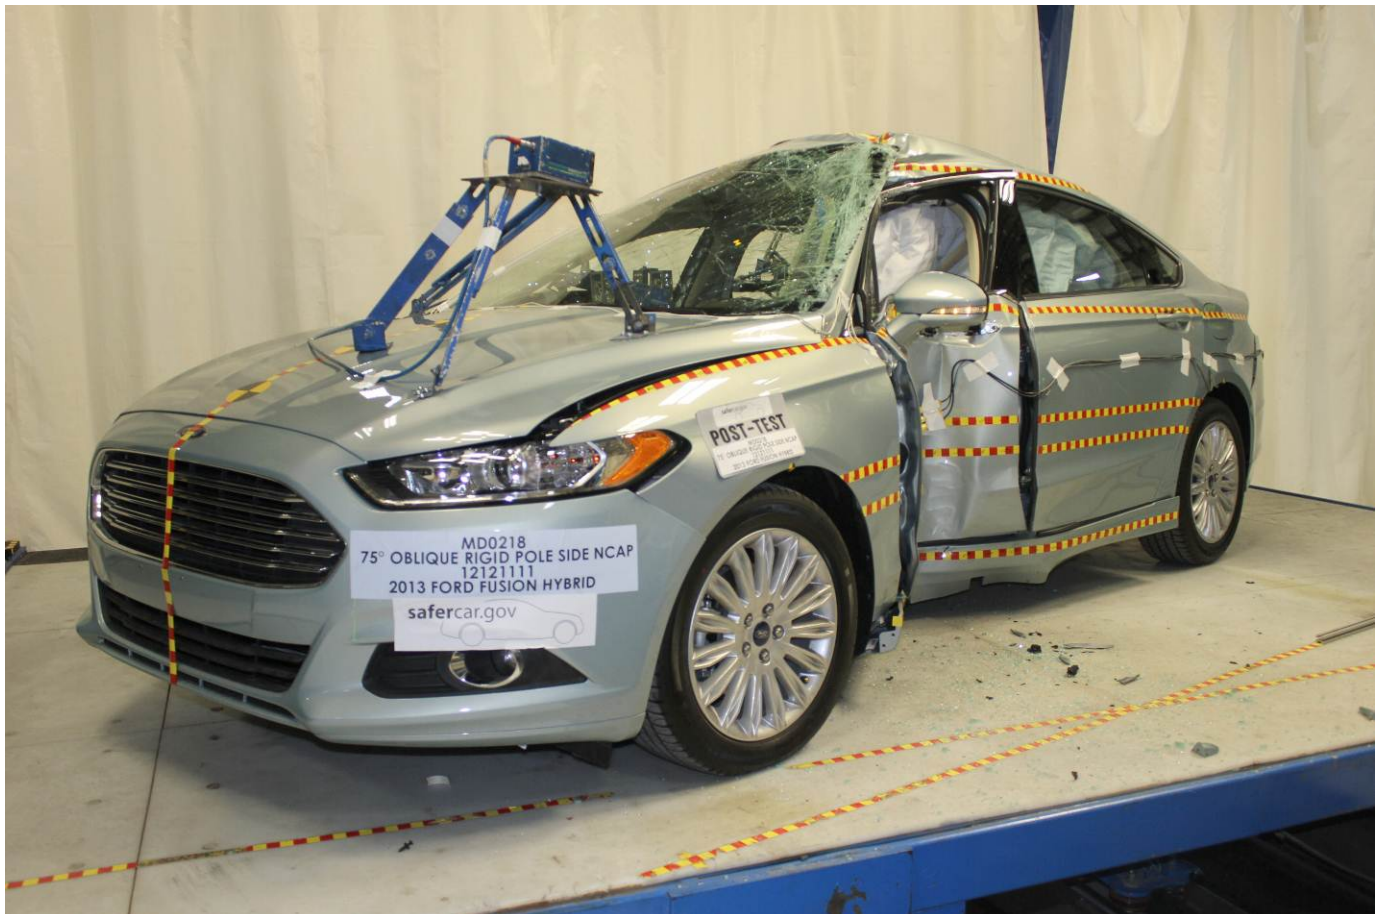
Post-Test Left Front ¾ View of Test Vehicle

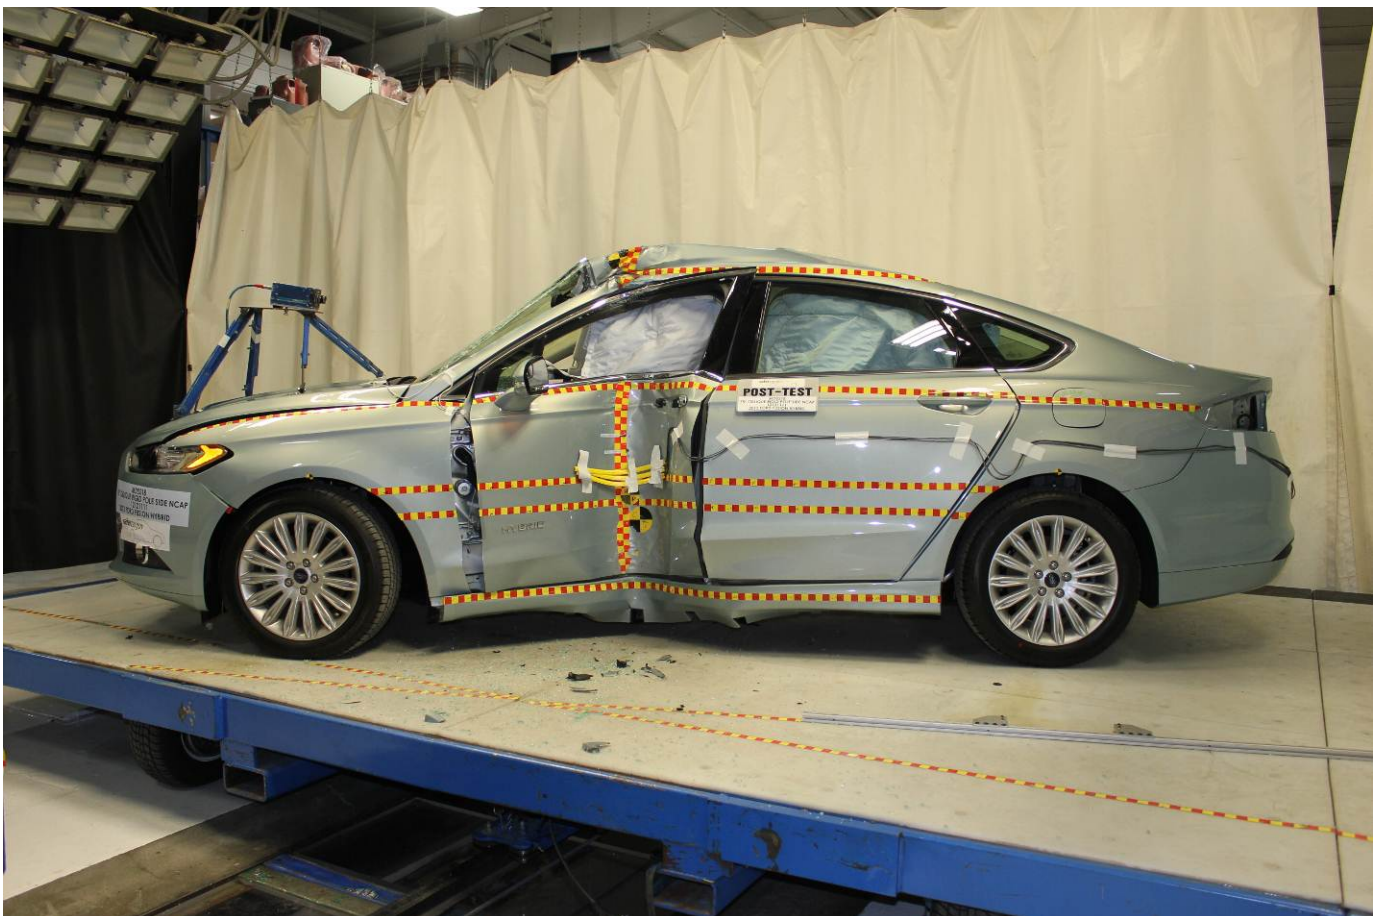
Post-Test Left Side View of Test Vehicle

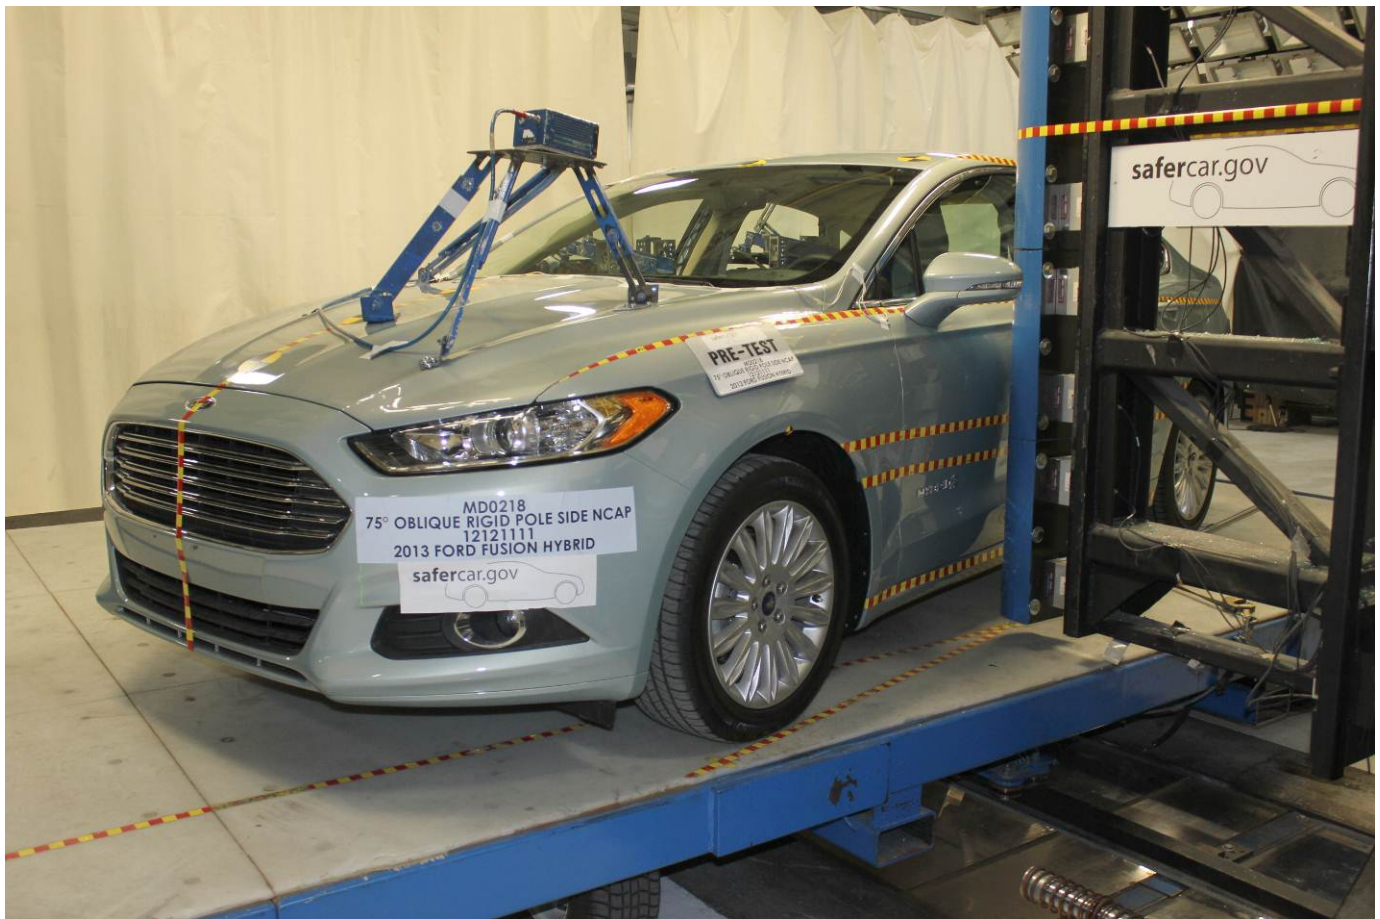
Pre-Test Left Side View of Pole Positioned Against Side of Vehicle

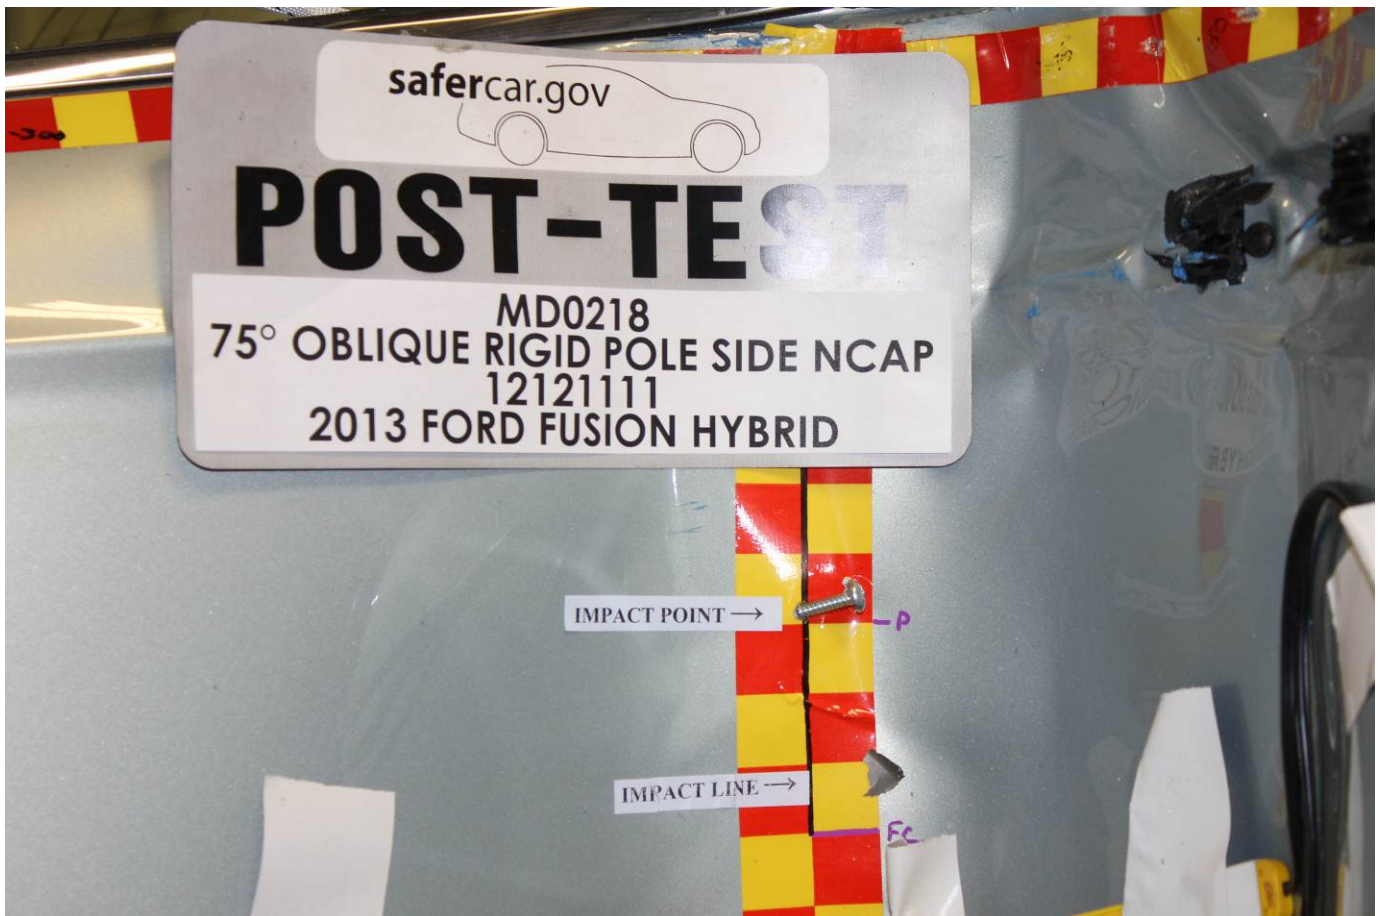
Post-Test Close-Up View of Impact Point Target Showing Impact Location

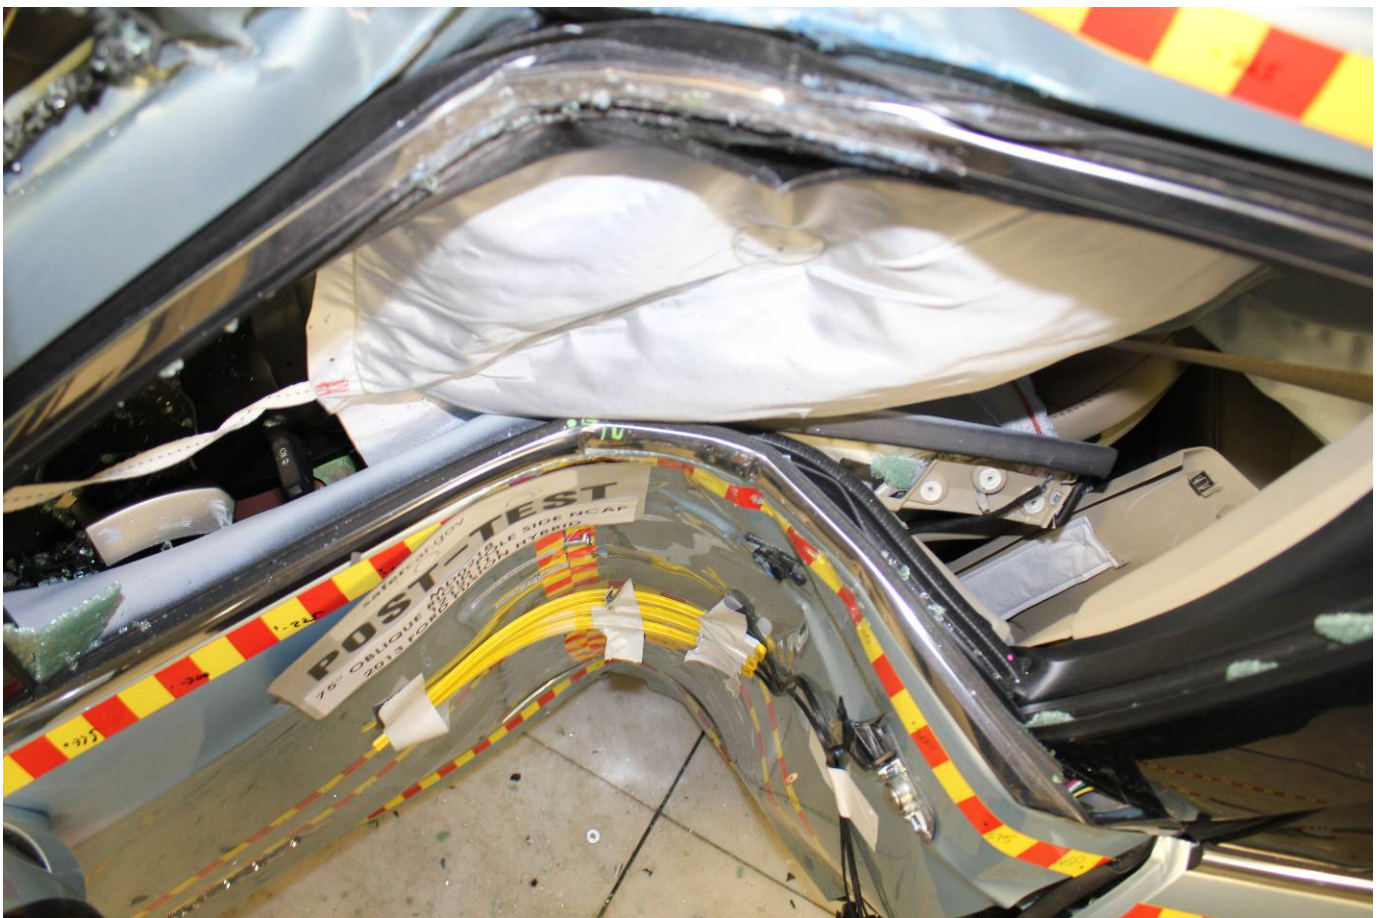
Post-Test Dummy and Door Clearance View

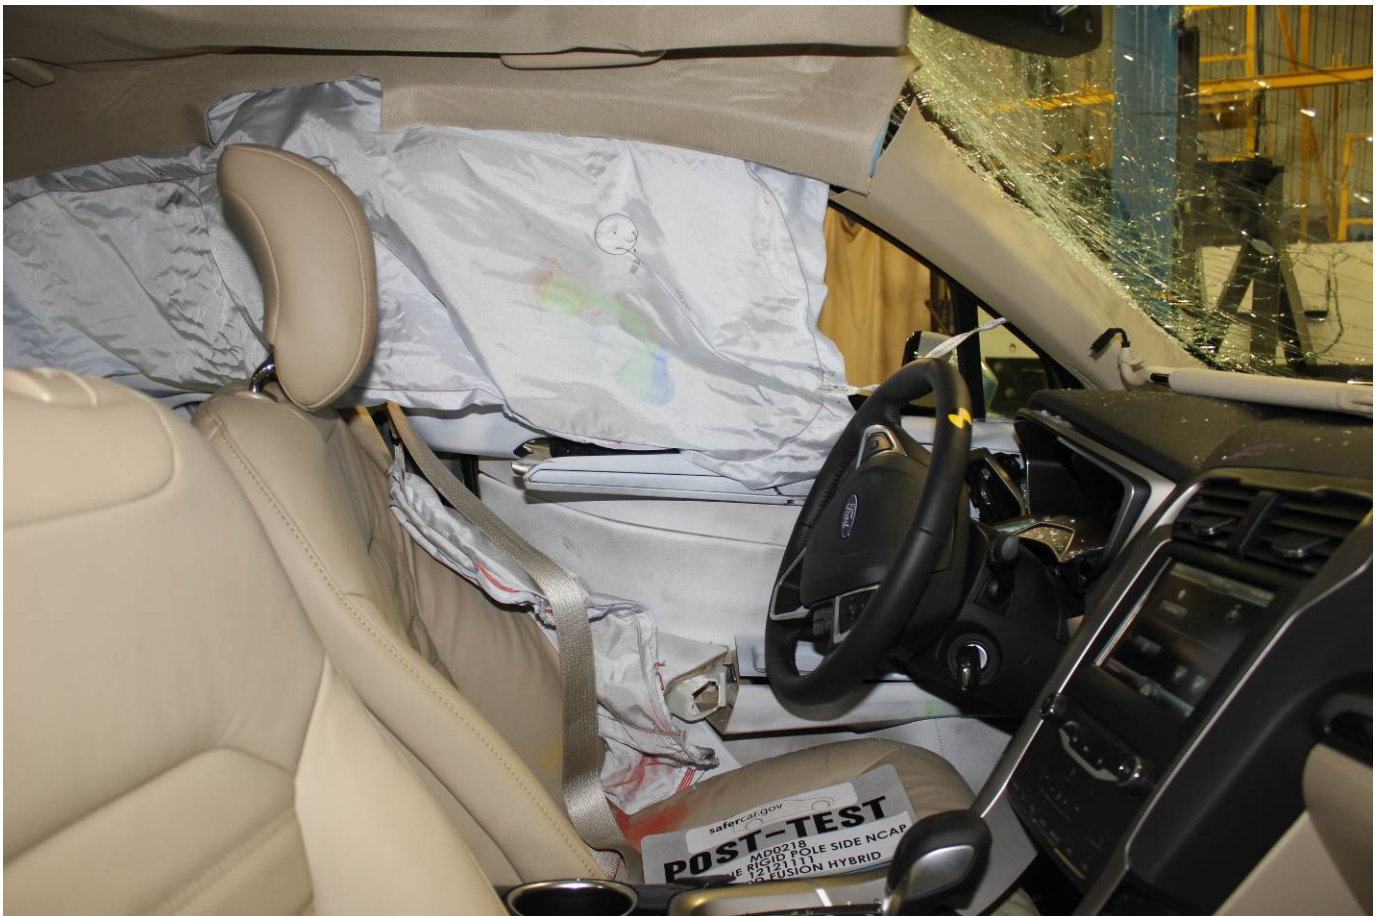
Post-Test Inner Door Panel View Showing Dummy Contact Location

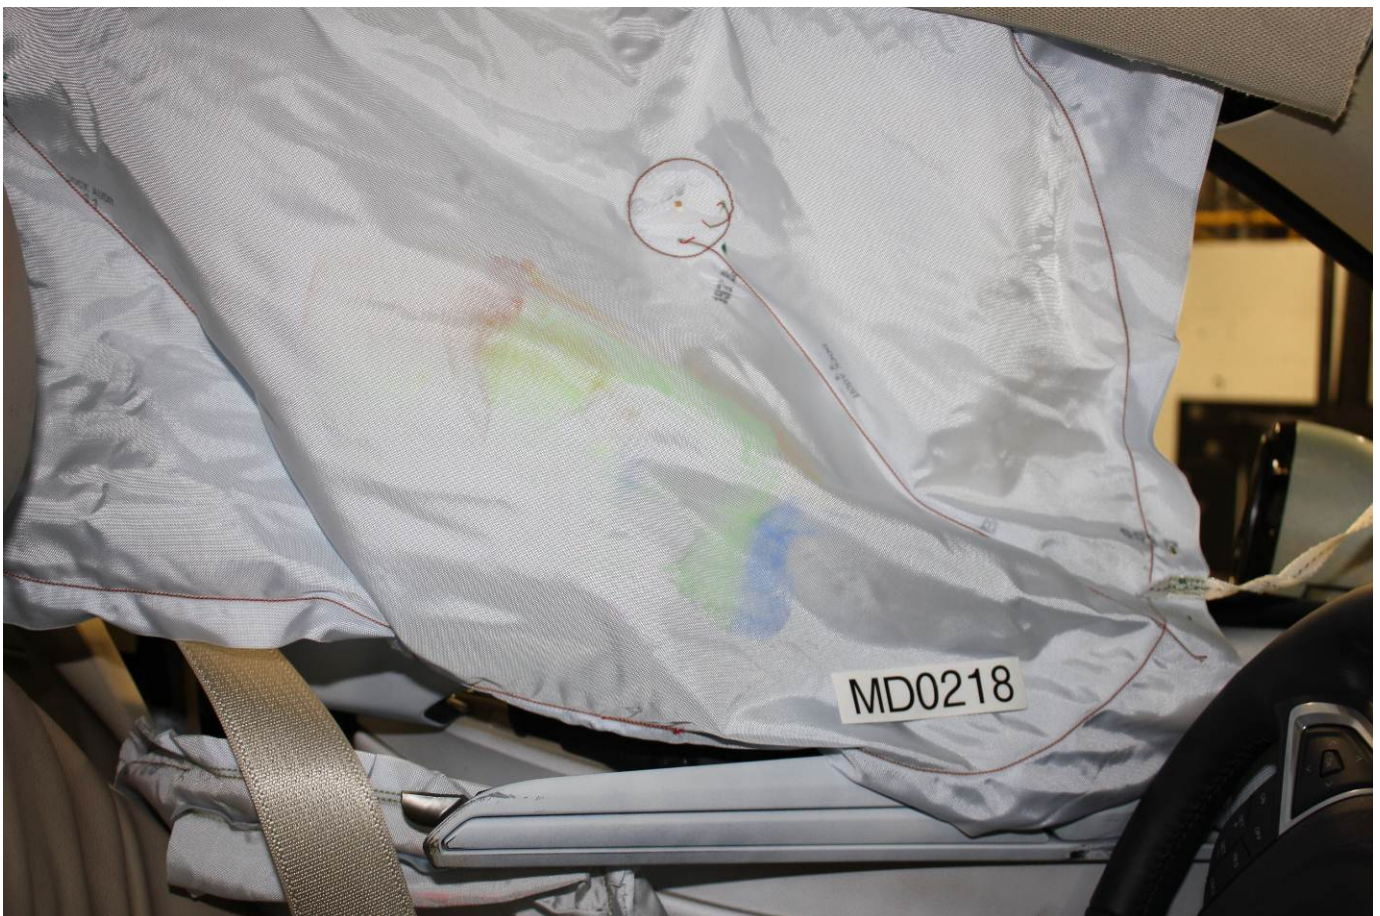
Post-Test Dummy Close-Up Head Contact with Side Air Bag View

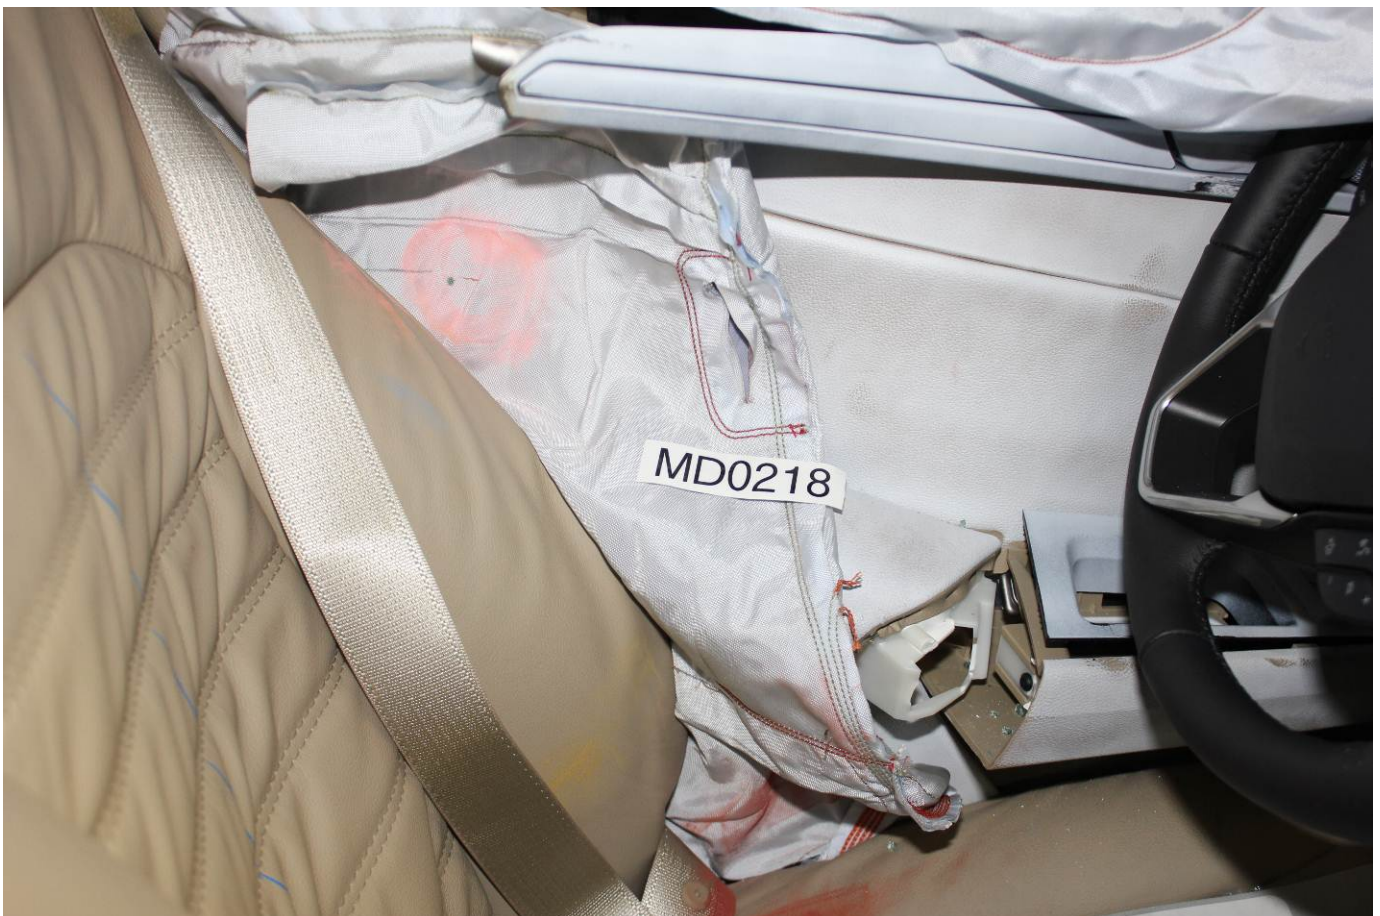
Post-Test Dummy Close-Up Torso Contact with Side Air Bag View

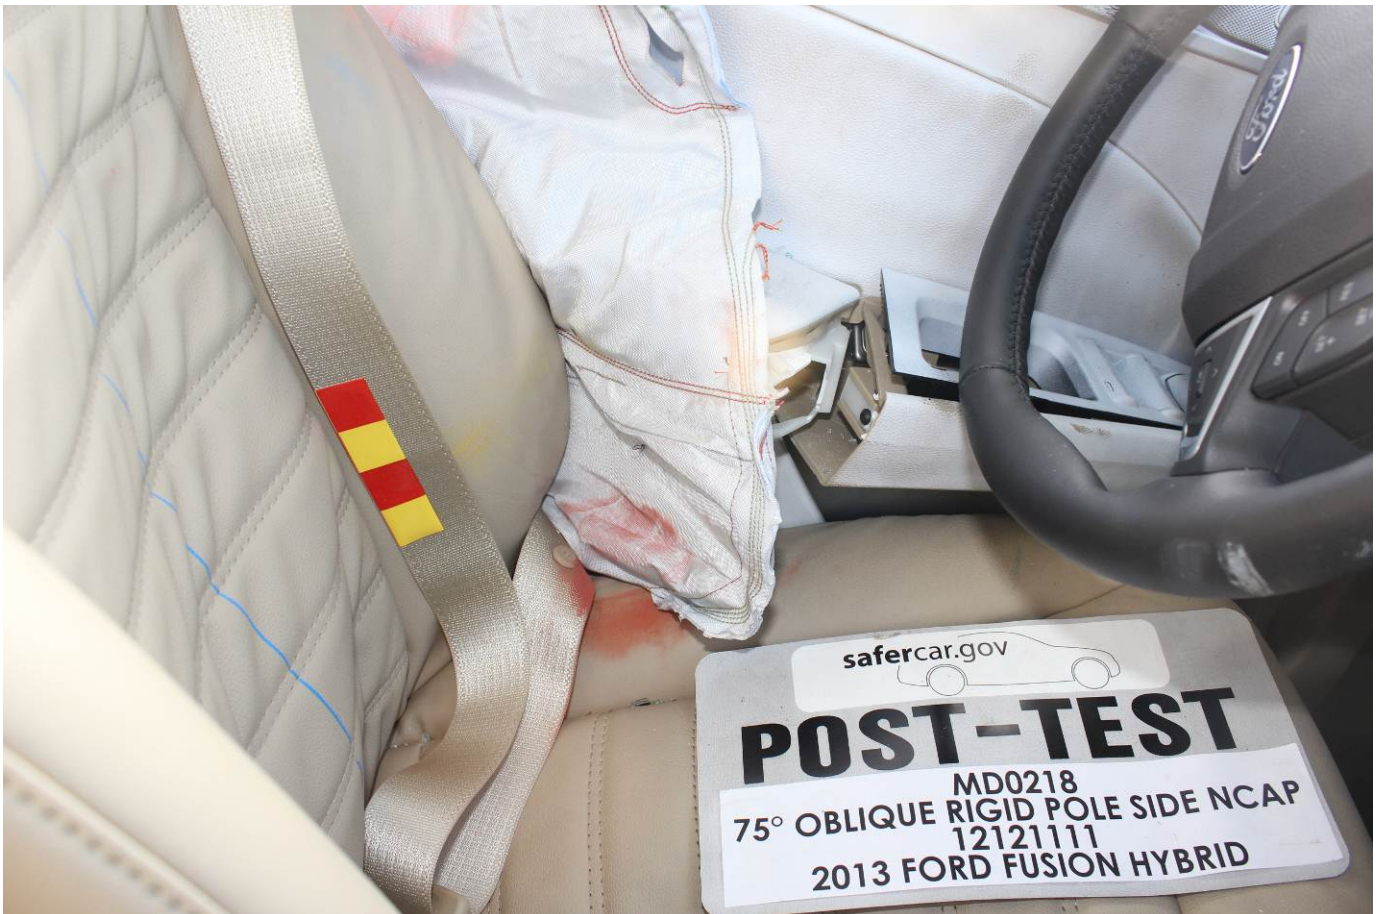
Post-Test Dummy Close-Up Pelvis Contact with Side Air Bag View

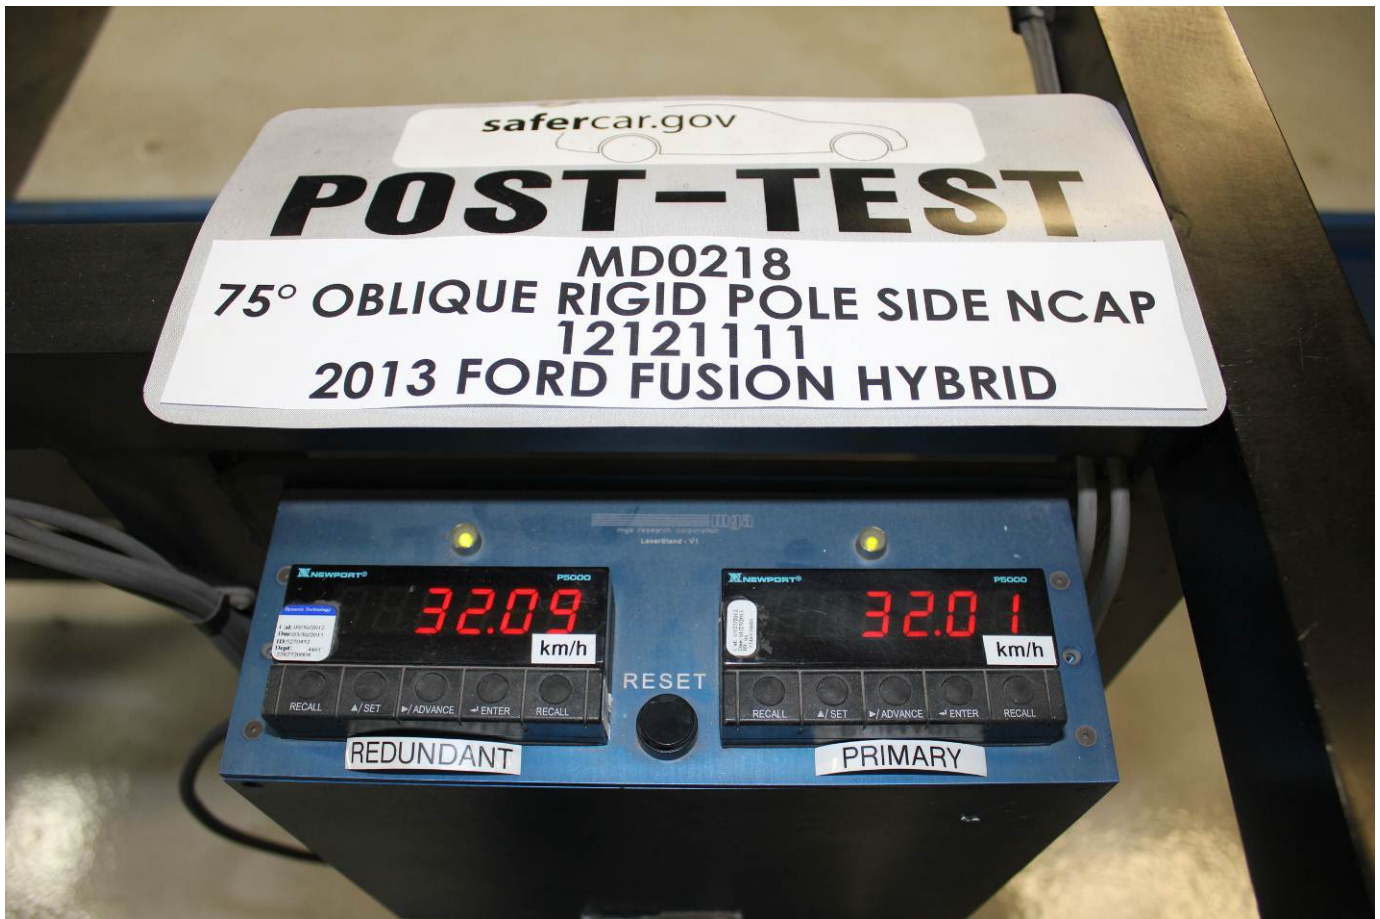
Post-Test Primary and Redundant Speed Trap Read-Out
