REPORT NUMBER: SPNCAP-KAR-13-031

**NEW CAR ASSESSMENT PROGRAM (NCAP)
SIDE IMPACT POLE TEST**

**DAIMLER AG STUTTGART
2013 MERCEDES- BENZ C250 4-DOOR SEDAN**

NHTSA No: MD0507

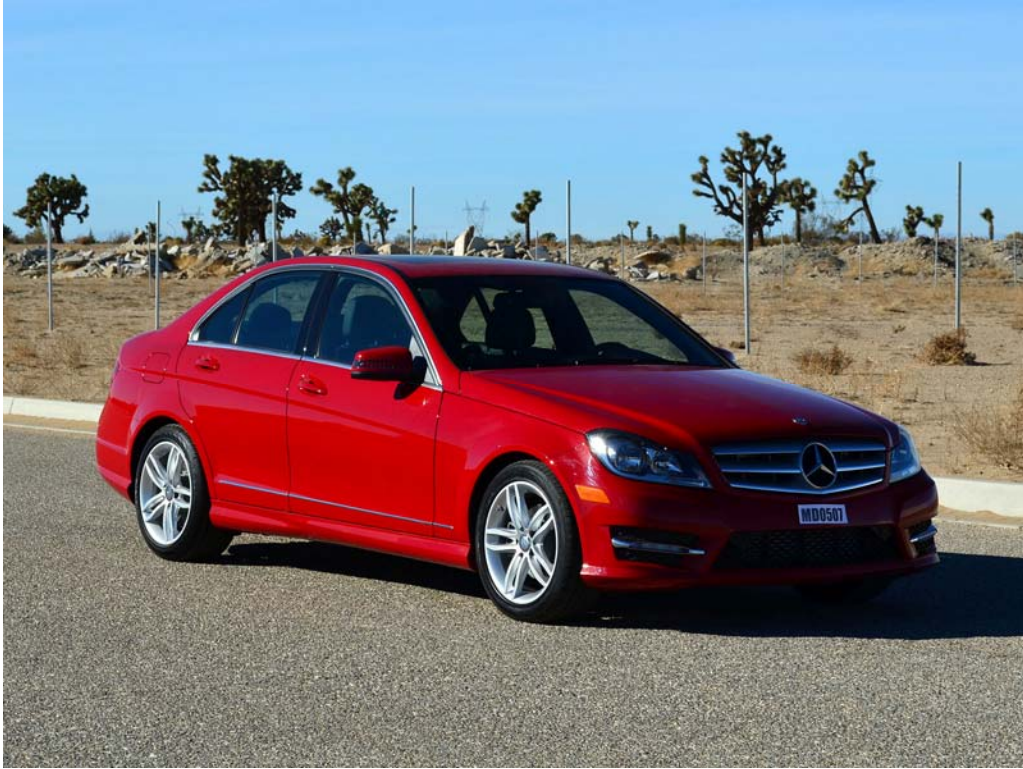
FIGURE 1. As-Delivered Right Front $\frac{3}{4}$ View of Test Vehicle

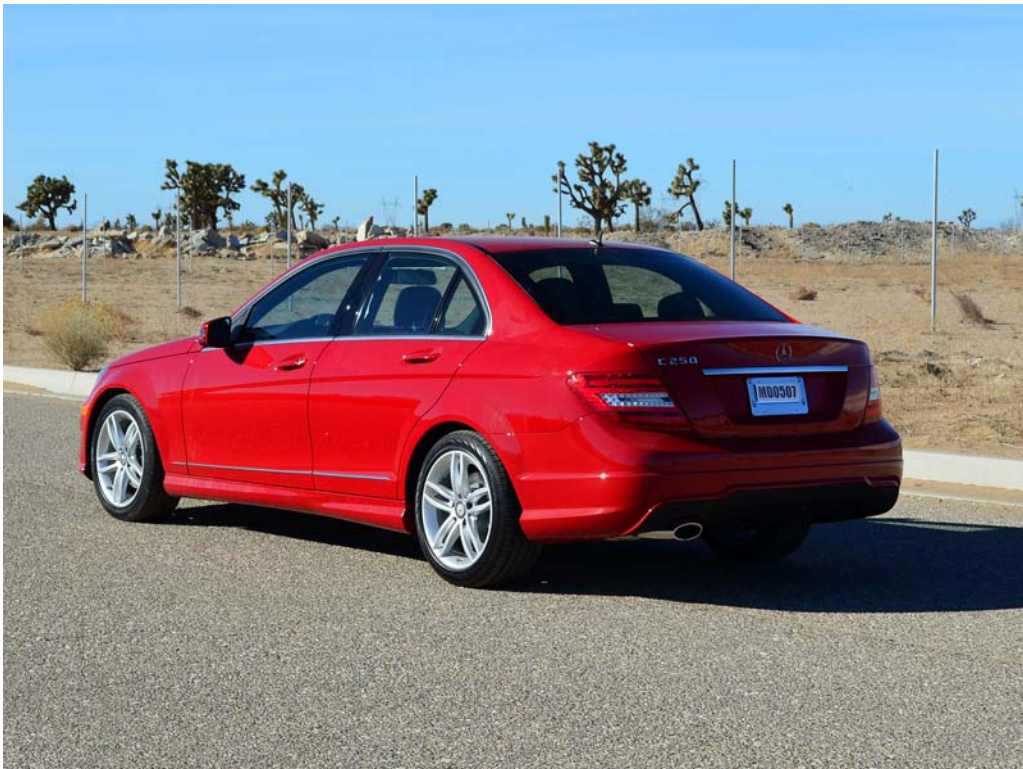
FIGURE 2. As-Delivered Left Rear $\frac{3}{4}$ View of Test Vehicle

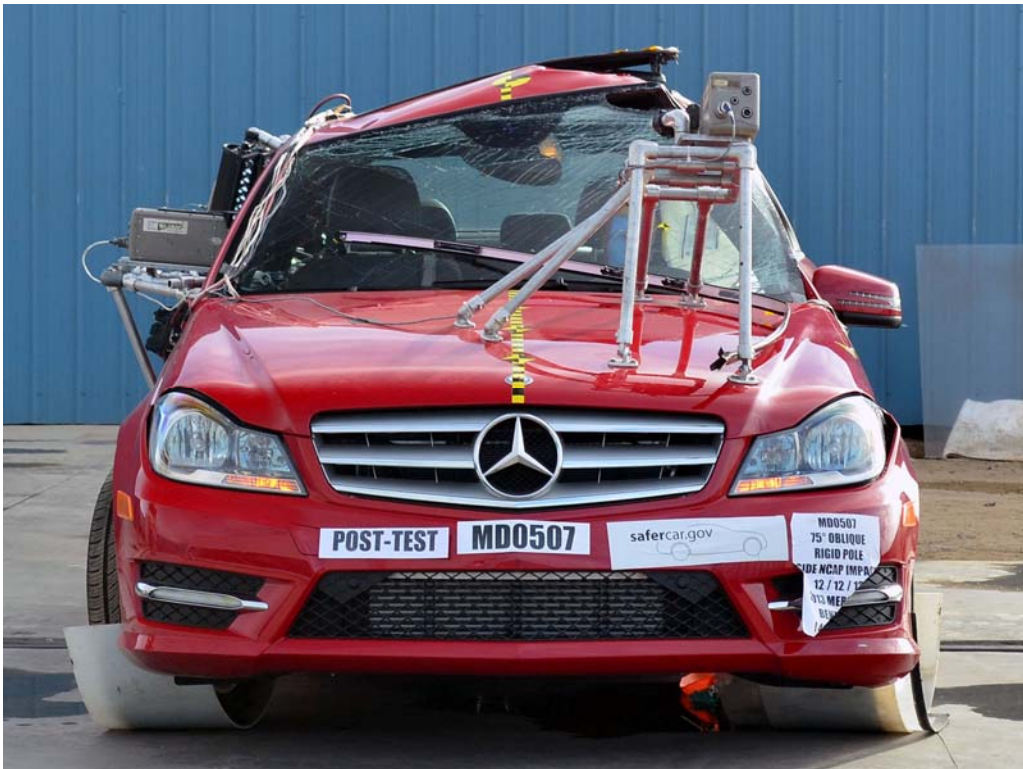
FIGURE 4. Post-Test Frontal View of Test Vehicle

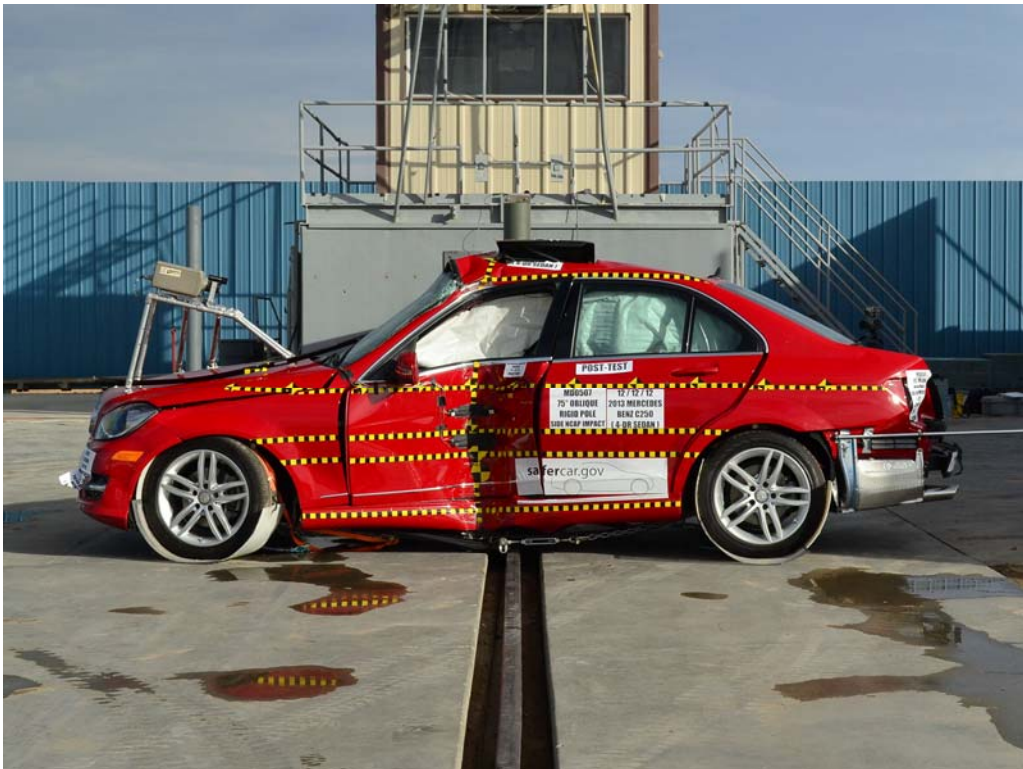
FIGURE 8. Post-Test Left Side View of Test Vehicle

Both the front and rear doors on the struck side of the vehicle remained closed and latched. There was no separation at the hinges or latches. Both doors on the non-struck side remained closed and latched. There were no ATD values that exceeded limits.

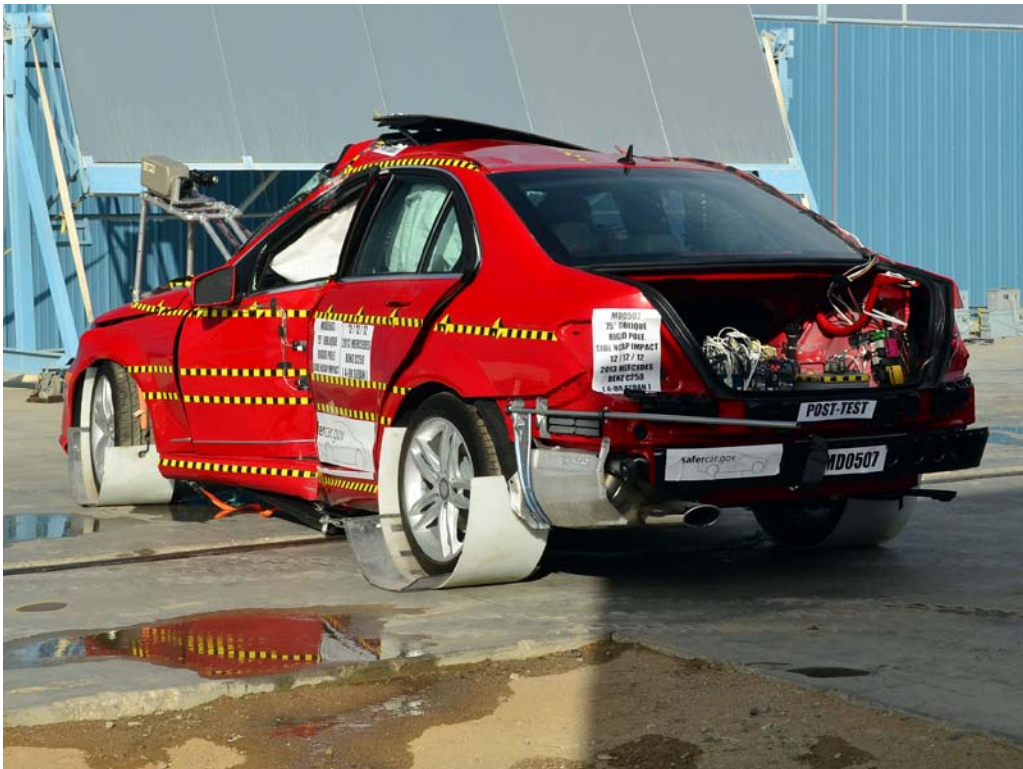
FIGURE 10. Post-Test Left Rear $\frac{3}{4}$ View of Test Vehicle

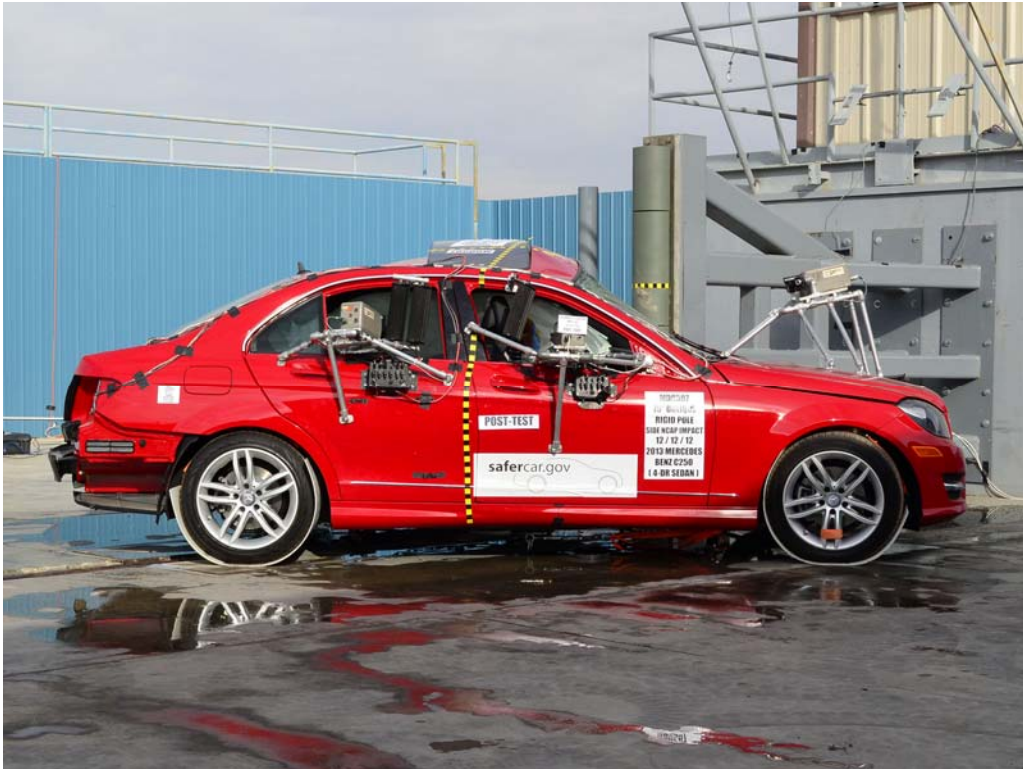
FIGURE 14. Post-Test Right Side View of Test Vehicle

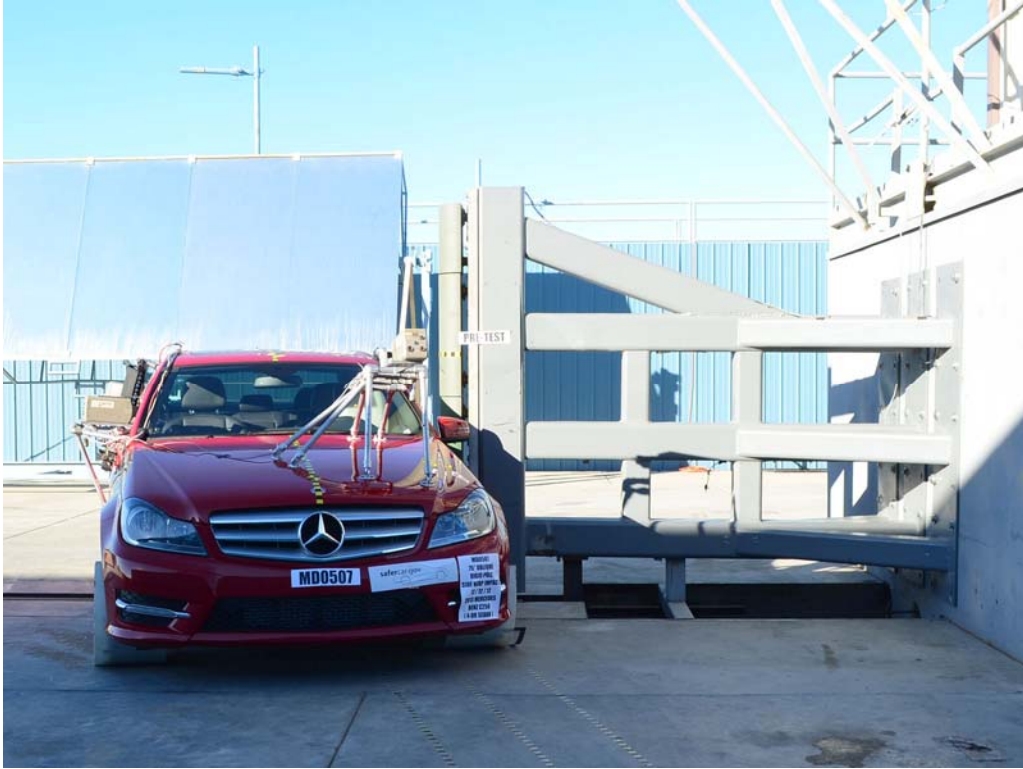
FIGURE 17. Pre-Test Left Side View of Pole
Positioned Against Side of Vehicle

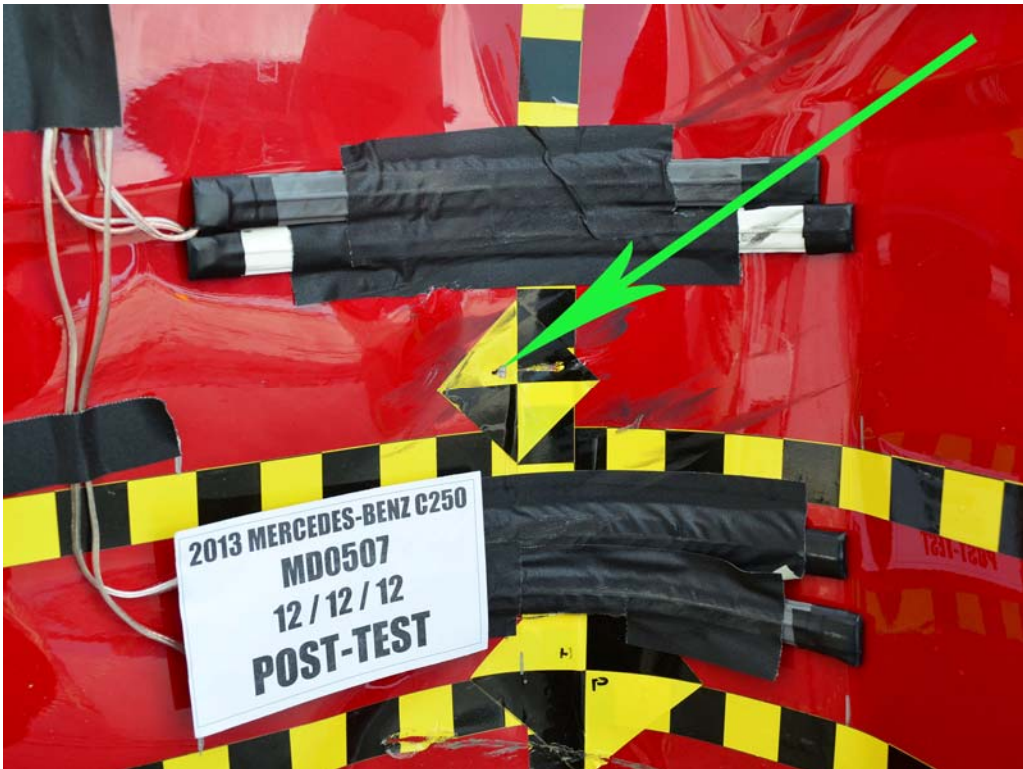
FIGURE 20. Post-Test Close-Up View of Impact Point Target
Showing Impact Location

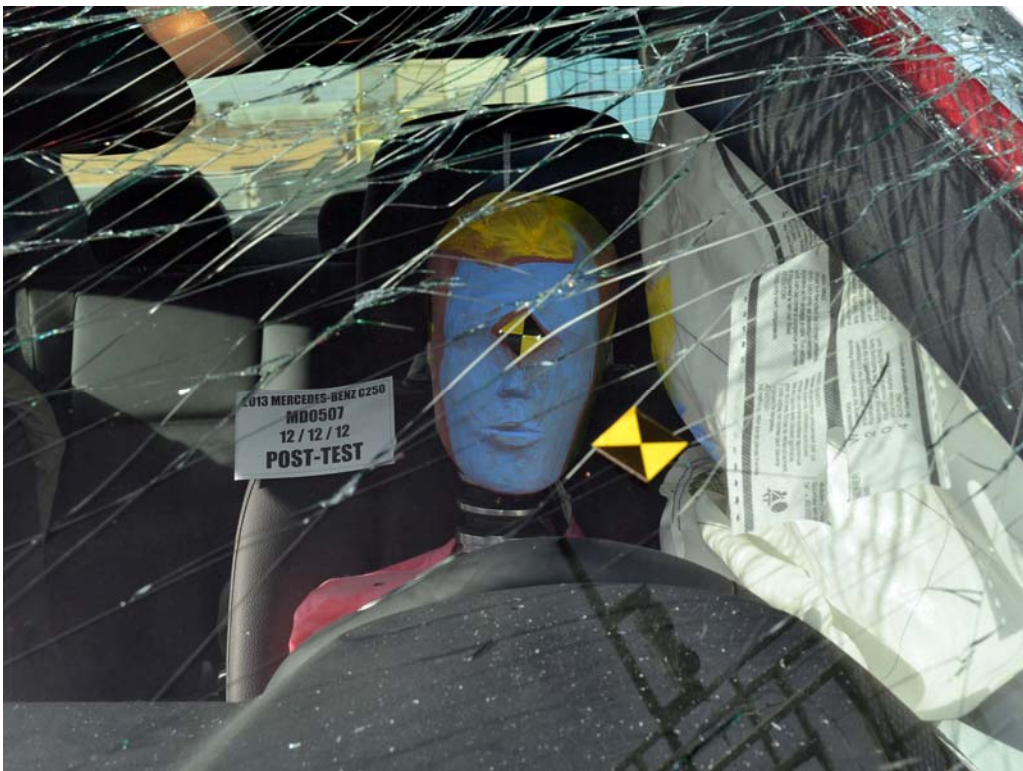
FIGURE 22. Post-Test Front Close-Up View of Dummy

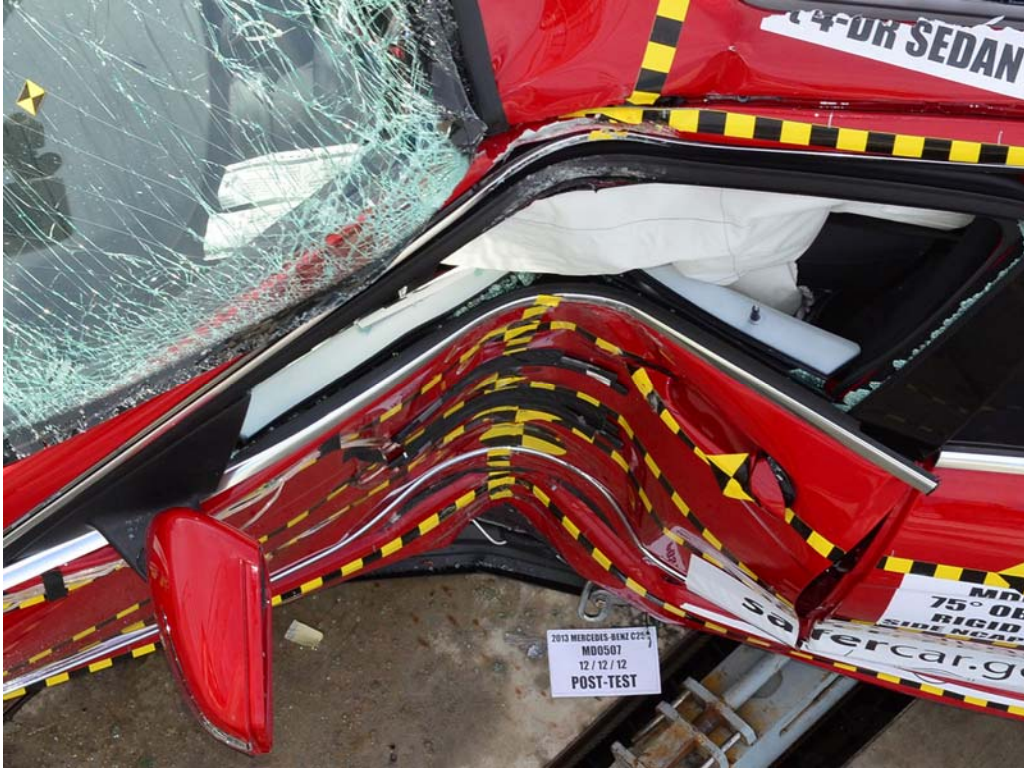
FIGURE 41. Post-Test Dummy and Door Clearance

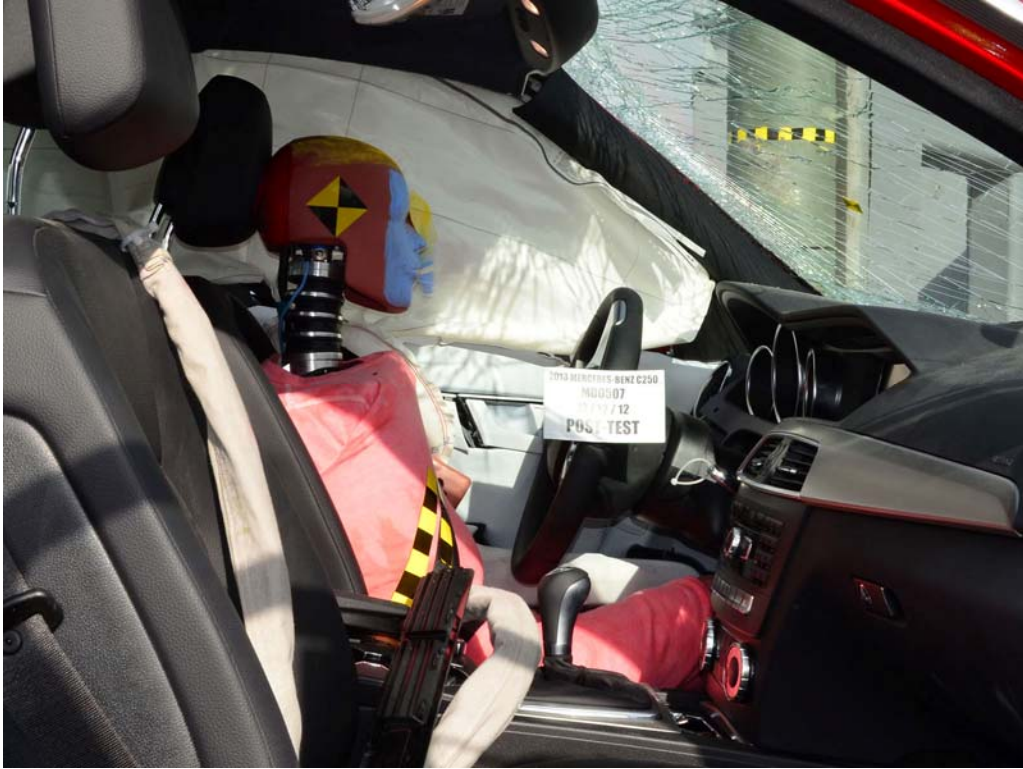
FIGURE 43. Post-Test Right Side View of Dummy and Front Seat Occupant Compartment

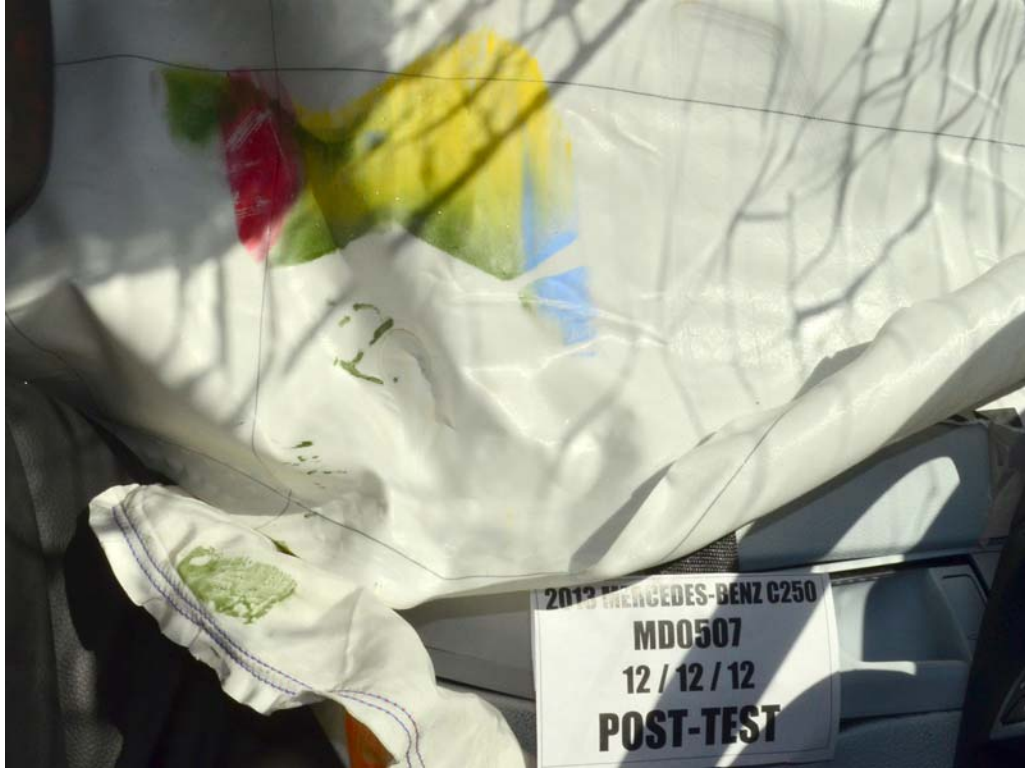
FIGURE 47. Post-Test Dummy Close-Up Head Contact with Side Airbag View

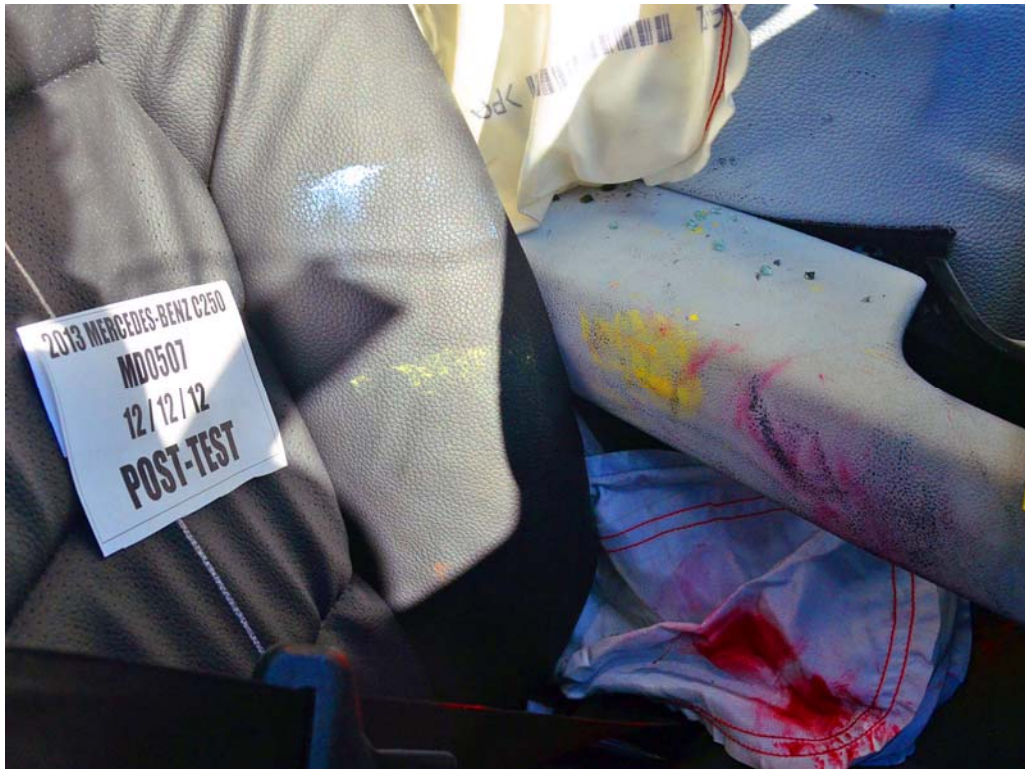
FIGURE 48. Post-Test Dummy Close-Up Torso Contact with Vehicle Interior View

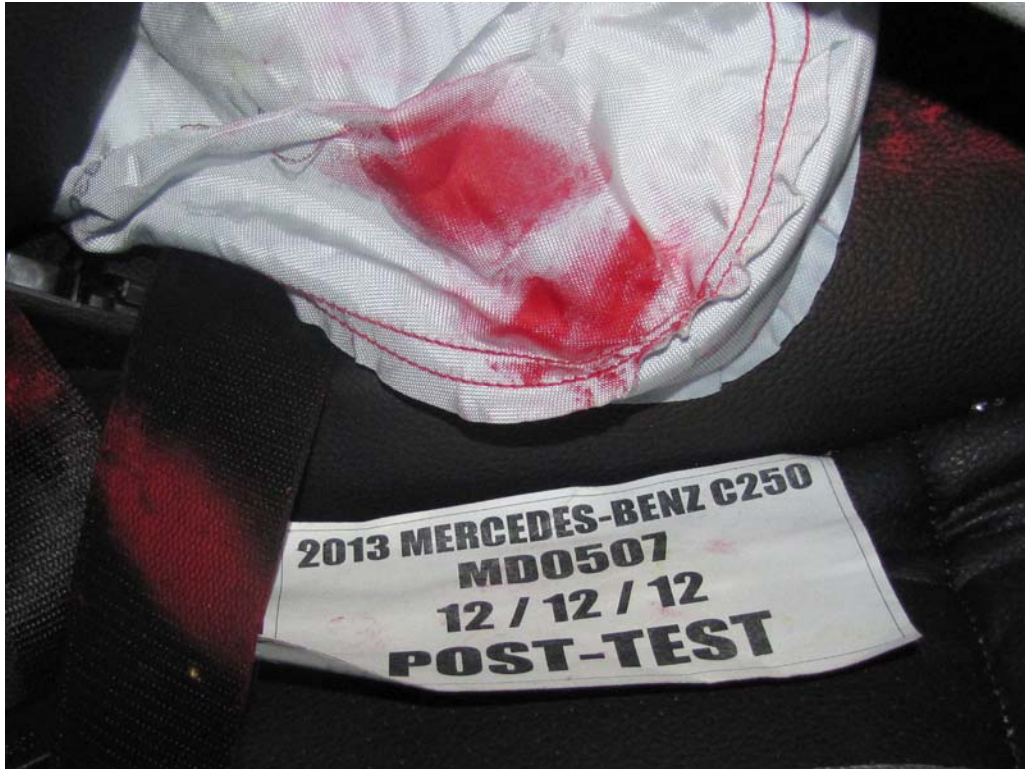
FIGURE 51. Post-Test Dummy Close-Up Pelvis Contact with Side Airbag View

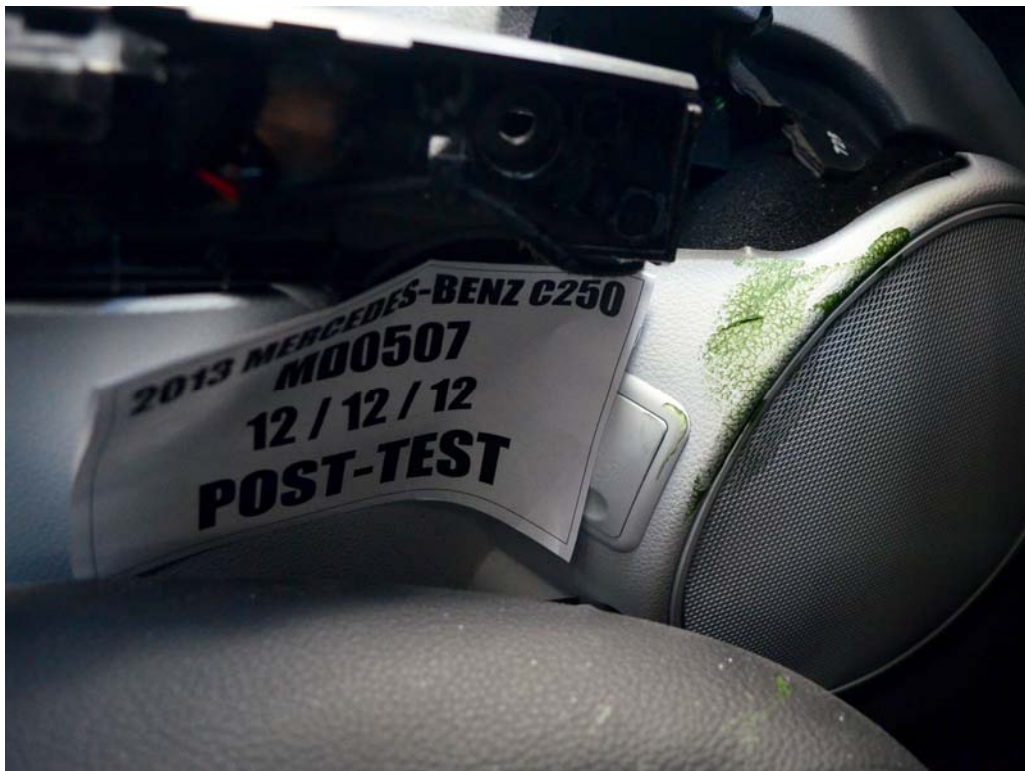
FIGURE 52. Post-Test Dummy Close-Up Knee Contact with Vehicle Interior View

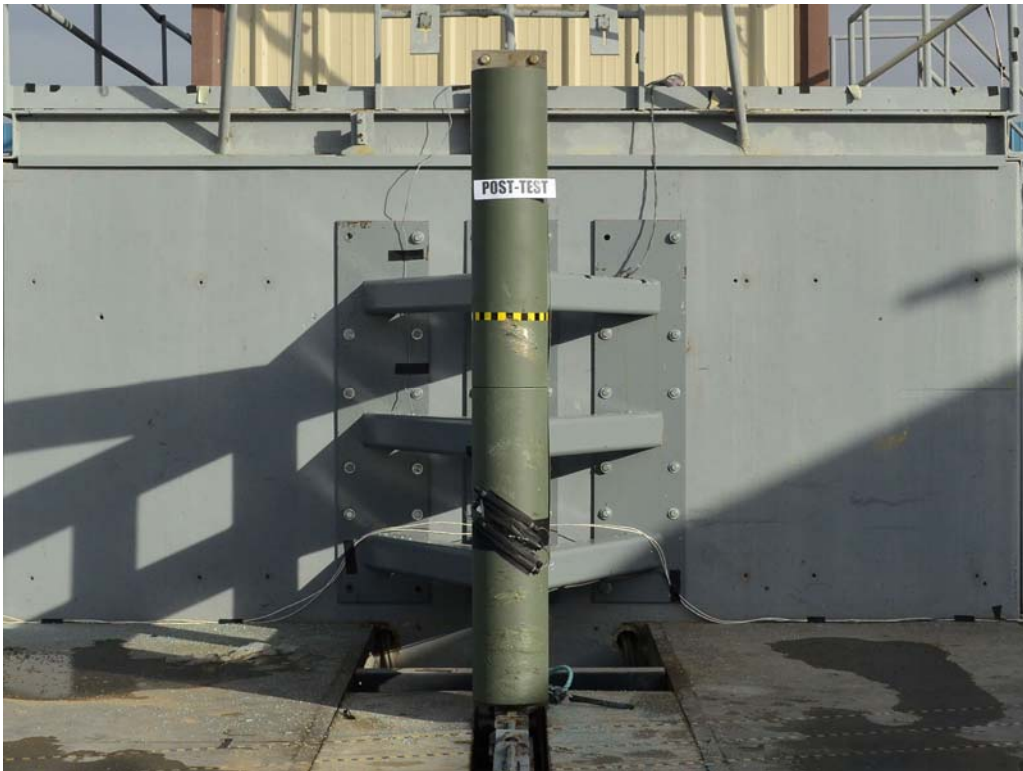
FIGURE 58. Post-Test Pole Barrier Front View

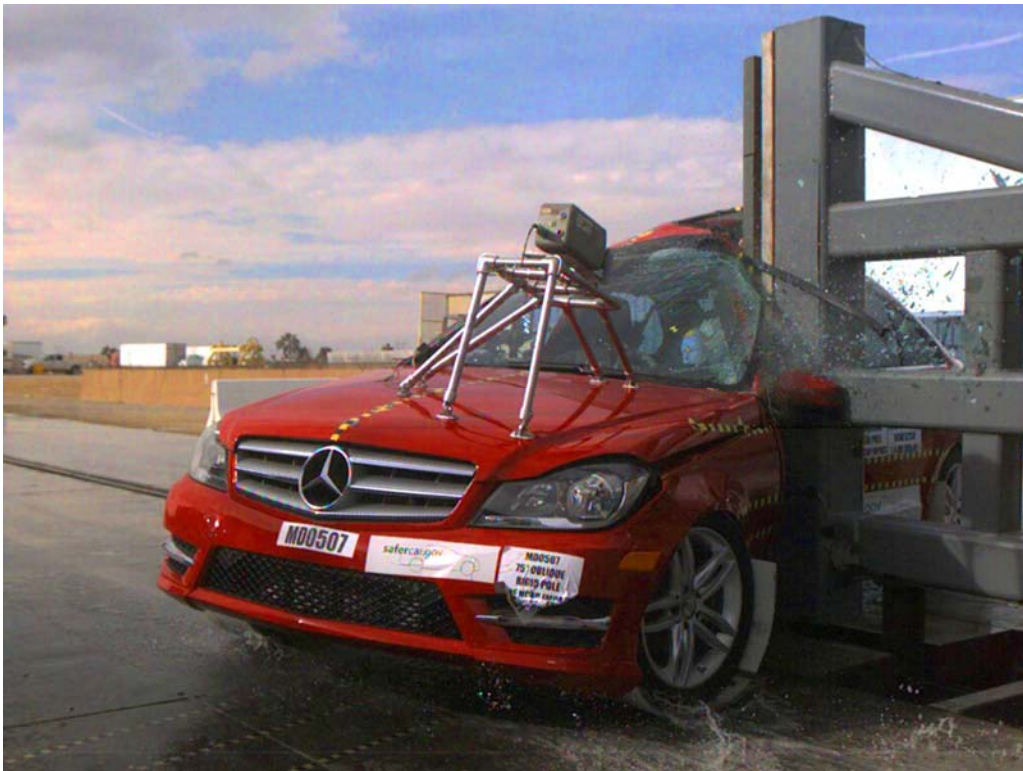
FIGURE 68. Impact Event

A rigid pole side impact test was conducted on a 2013 Mercedes-Benz C250 4-door sedan. The subject vehicle was towed into the rigid pole at an angle of 75.2° and a velocity of 31.56 km/h. The test was conducted by KARCO Engineering, LLC. in Adelanto, California on December 12, 2012. Pre- and post-test photographs of the test vehicle and side impact dummy (SID-IIs) are included in Appendix A of this report.

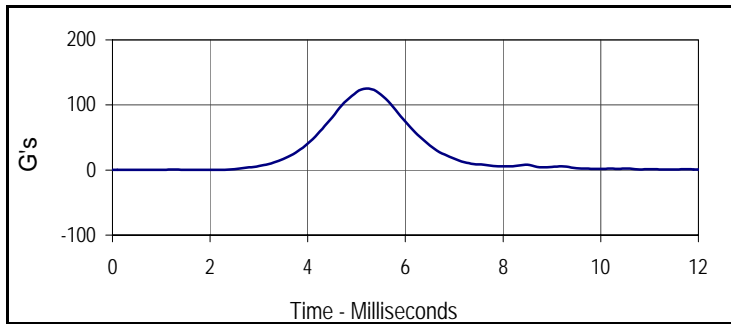
Curve Description			
Head Resultant			
Plot No.	Type	SAE Class	Units
001	RES	1000	G's
Max	Time	Min	Time
125.3	5.2	0.2	0.9

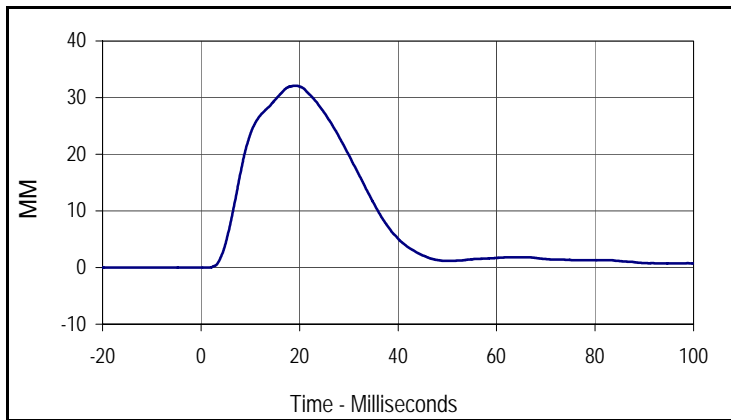
Curve Description			
Shoulder Deflection			
Plot No.	Type	SAE Class	Units
001	FIL	600	MM
Max	Time	Min	Time
32.1	19.2	0.0	-19.1

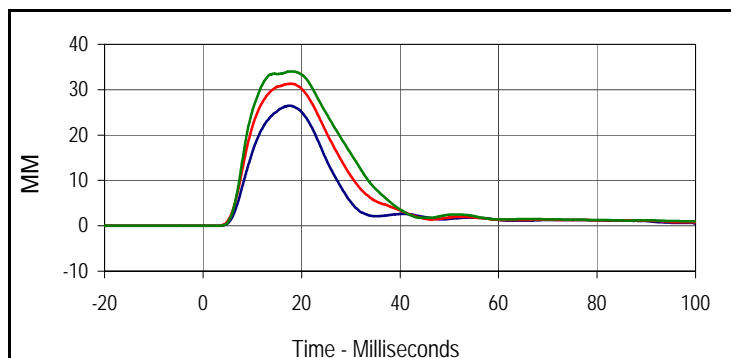
Curve Description			
Upper Thorax Deflection			
Plot No.	Type	SAE Class	Units
001	FIL	600	MM
Max	Time	Min	Time
26.5	17.5	0.0	-20.0
Middle Thorax Deflection			
Max	Time	Min	Time
31.3	17.8	0.0	-16.5
Lower Thorax Deflection			
Max	Time	Min	Time
34.0	17.7	0.0	-13.3

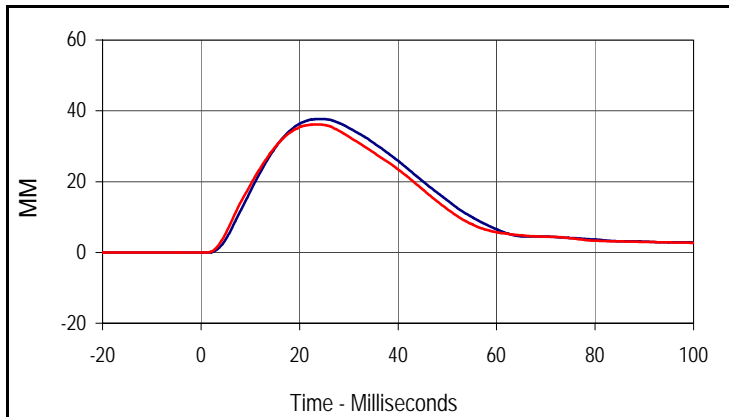
Curve Description			
Upper Abdominal Rib Deflection			
Plot No.	Type	SAE Class	Units
001	FIL	600	MM
Max	Time	Min	Time
37.7	24.0	0.0	-20.0
Curve Description			
Lower Abdominal Rib Deflection			
Plot No.	Type	SAE Class	Units
002	FIL	600	MM
Max	Time	Min	Time
36.1	23.1	0.0	0.5

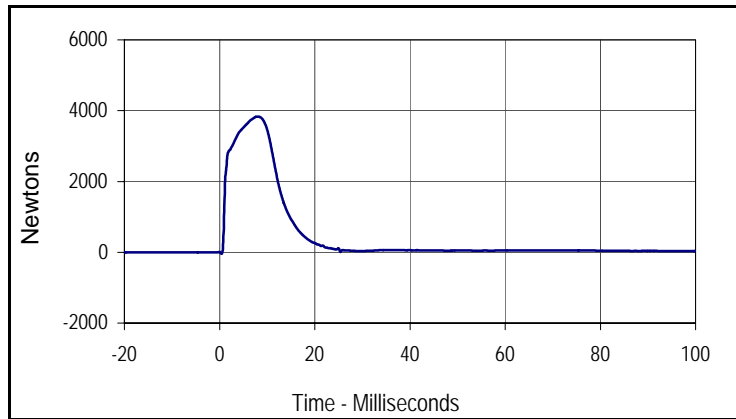
Curve Description			
Pelvis Acetabulum Force			
Plot No.	Type	SAE Class	Units
001	FIL	600	Newtons
Max	Time	Min	Time
3832.6	7.9	-36.8	0.5

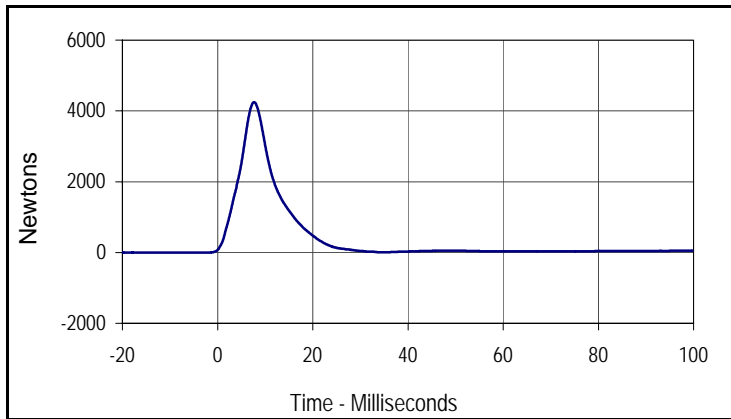
Curve Description			
Pelvis Iliac Force			
Plot No.	Type	SAE Class	Units
001	FIL	600	Newtons
Max	Time	Min	Time
4247.9	7.6	-3.0	-6.3

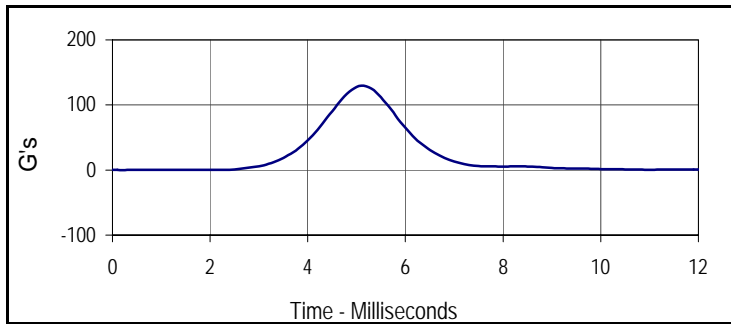
Curve Description			
Head Resultant			
Plot No.	Type	SAE Class	Units
001	RES	1000	G's
Max	Time	Min	Time
129.7	5.1	0.0	0.2

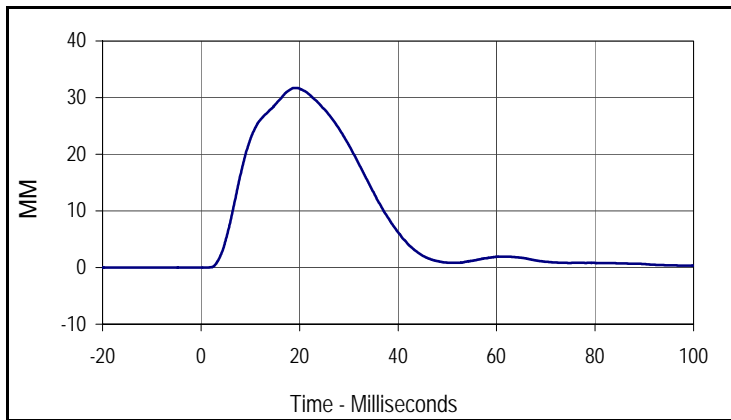
Curve Description			
Shoulder Deflection			
Plot No.	Type	SAE Class	Units
001	FIL	600	MM
Max	Time	Min	Time
31.7	18.8	0.0	-13.3

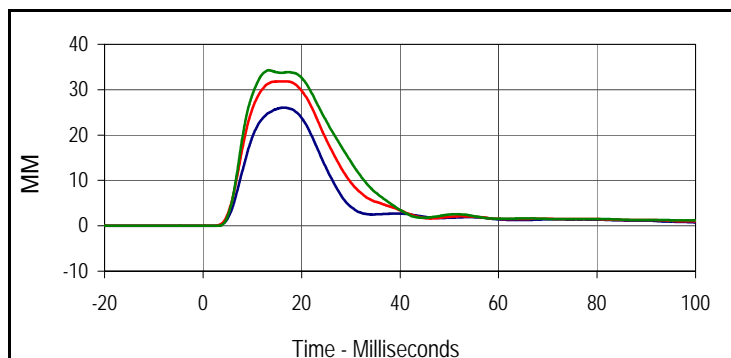
Curve Description			
Upper Thorax Deflection			
Plot No.	Type	SAE Class	Units
001	FIL	600	MM
Max	Time	Min	Time
26.1	16.4	0.0	1.0
Middle Thorax Deflection			
Max	Time	Min	Time
31.8	16.5	0.0	-18.4
Lower Thorax Deflection			
Max	Time	Min	Time
34.3	13.3	0.0	-19.6

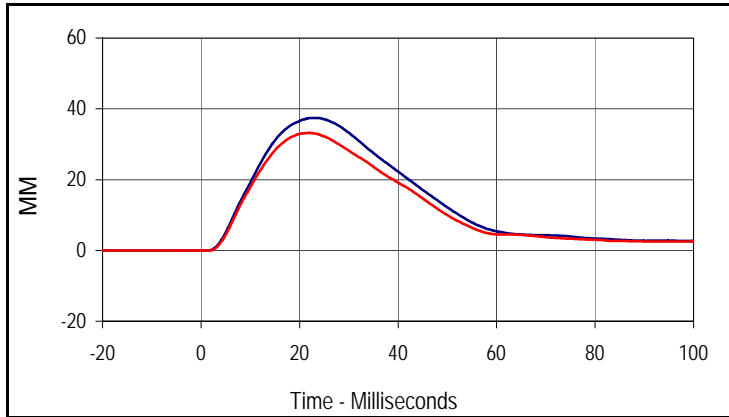
Curve Description			
Upper Abdominal Rib Deflection			
Plot No.	Type	SAE Class	Units
001	FIL	600	MM
Max	Time	Min	Time
37.4	23.2	0.0	0.8
Curve Description			
Lower Abdominal Rib Deflection			
Plot No.	Type	SAE Class	Units
002	FIL	600	MM
Max	Time	Min	Time
33.2	22.0	0.0	1.0

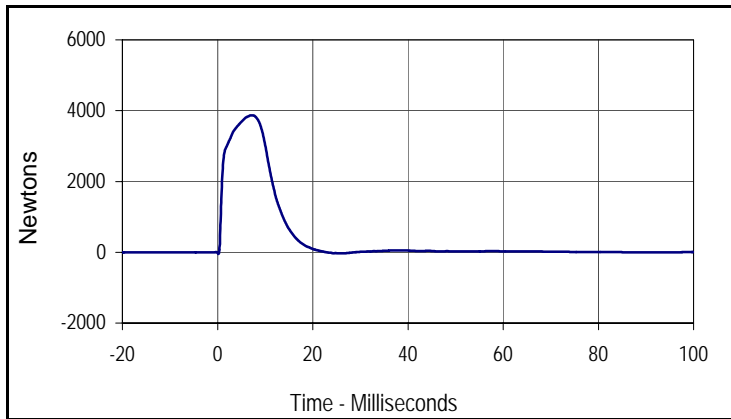
Curve Description			
Pelvis Acetabulum Force			
Plot No.	Type	SAE Class	Units
001	FIL	600	Newtons
Max	Time	Min	Time
3870.3	7.2	-50.5	0.2

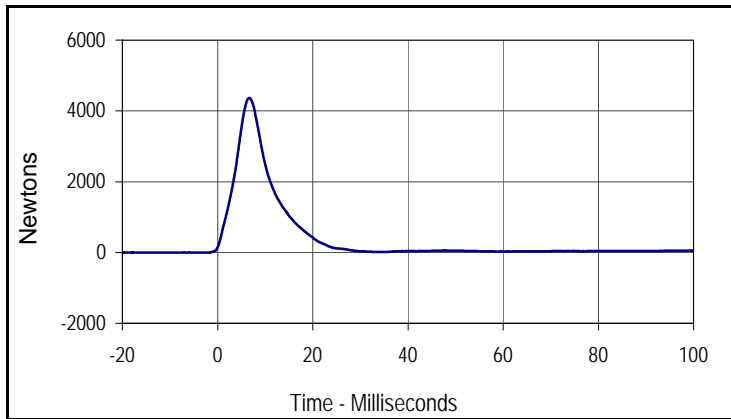
Curve Description			
Pelvis Iliac Force			
Plot No.	Type	SAE Class	Units
001	FIL	600	Newtons
Max	Time	Min	Time
4360.3	6.7	-1.4	-12.3
