REPORT NUMBER: SPNCAP-MCW-13-005

NEW CAR ASSESSMENT PROGRAM (SPNCAP)
SIDE IMPACT POLE TEST

CHRYSLER GROUP, LLC
2013 RAM 1500 4-DOOR QUAD CAB PICKUP
NHTSA NUMBER: MD 0315

FINAL REPORT

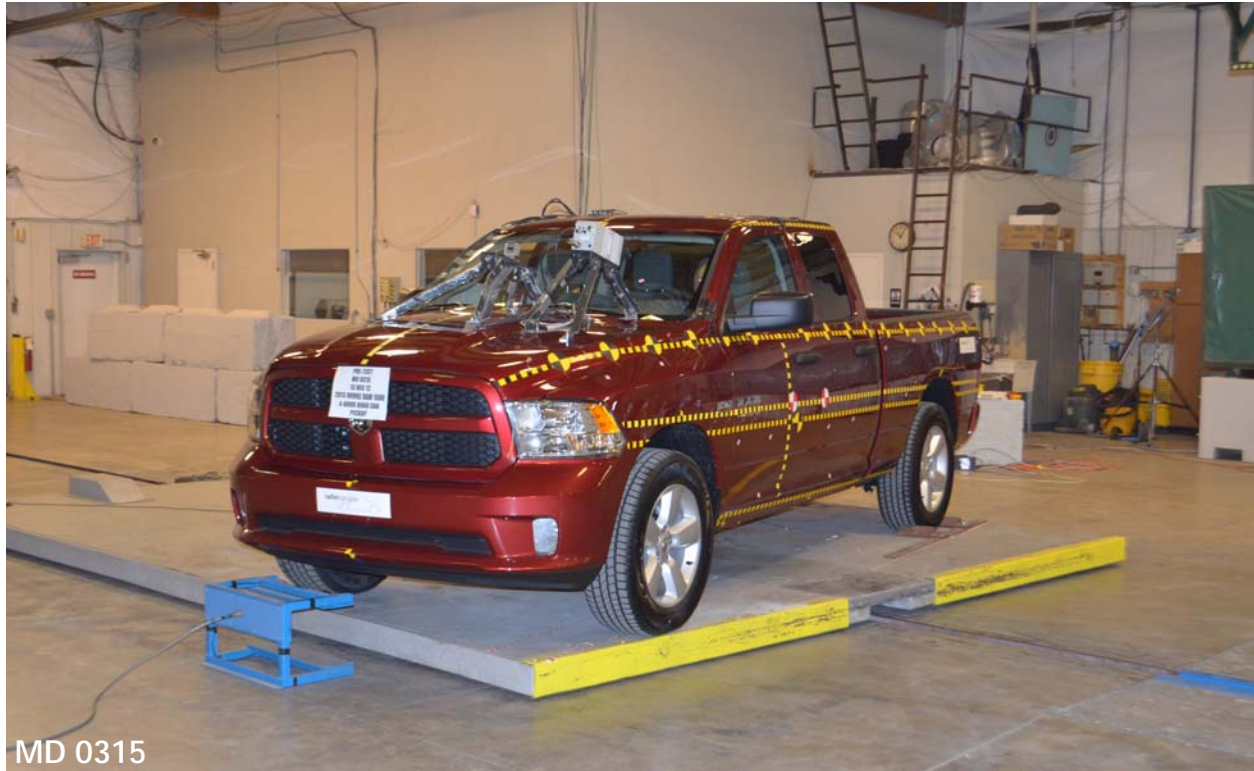
Figure 004: Post-Test Frontal View of Test Vehicle

POST TEST STRUCTURAL OBSERVATIONS	
Critical Areas of Performance	Observations/Conclusions
Pillar Performance	No Separation
Sill Separation	Max Sill Separation of ~165 mm at C-Pillar at Roof Line
Windshield Damage	Cracking Along Entire Windshield; Heaviest Concentration along Upper Impacted Side
Window Damage	Front Window Shattered at Impact
Other Notable Effects	None Noted

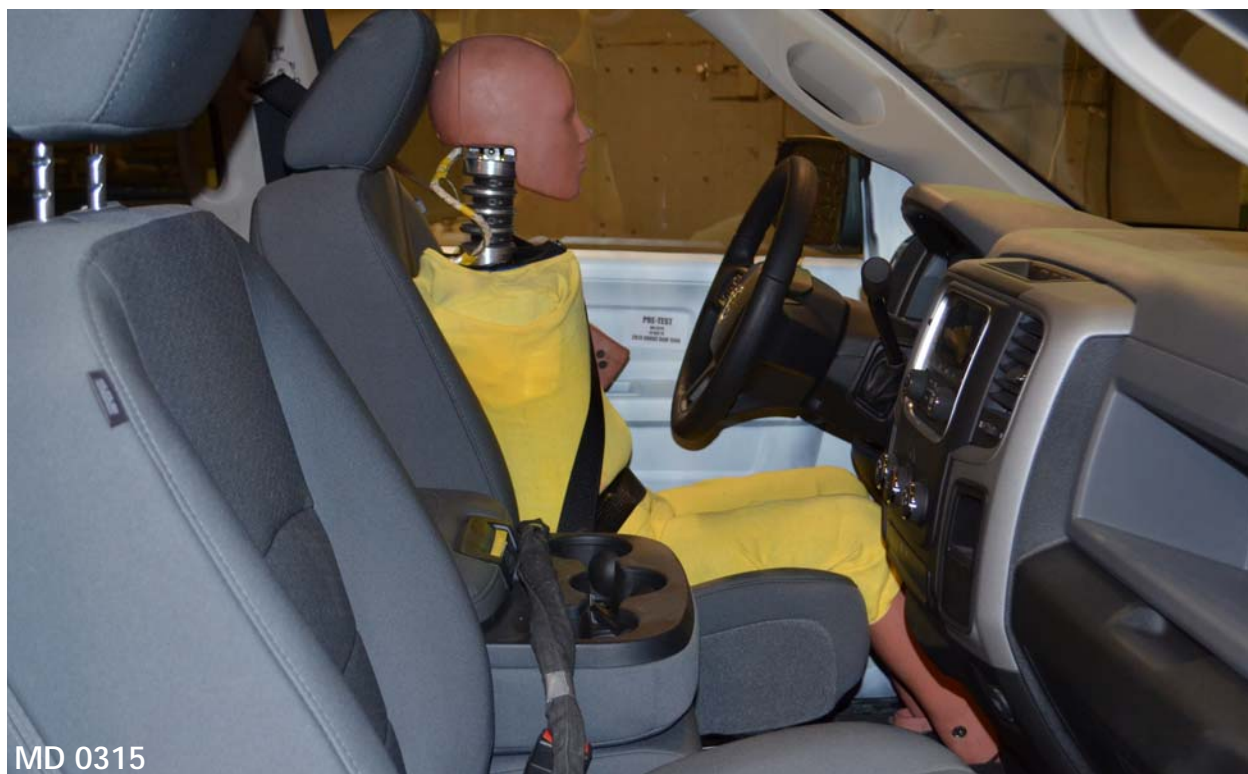
Figure 041: Post-Test Dummy and Door Clearance View

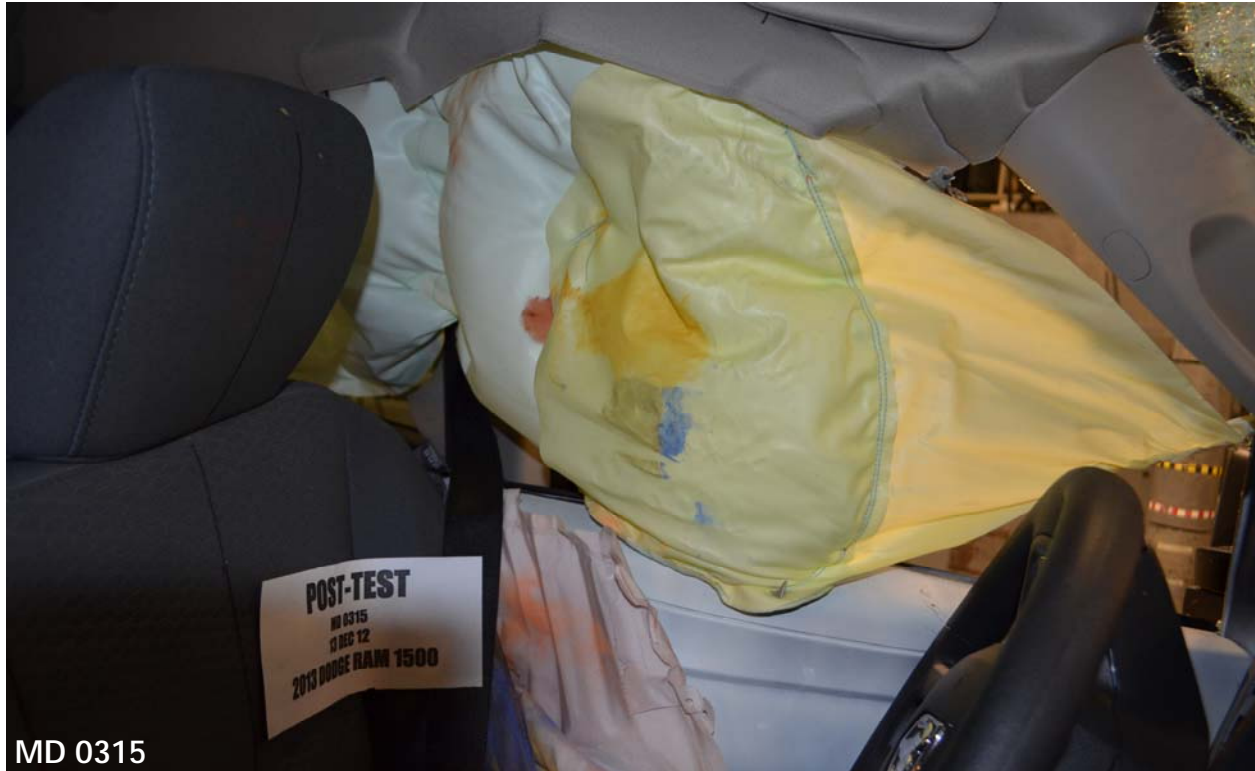
Figure 047: Post-Test Dummy Close-Up Head Contact with Side Air bag View

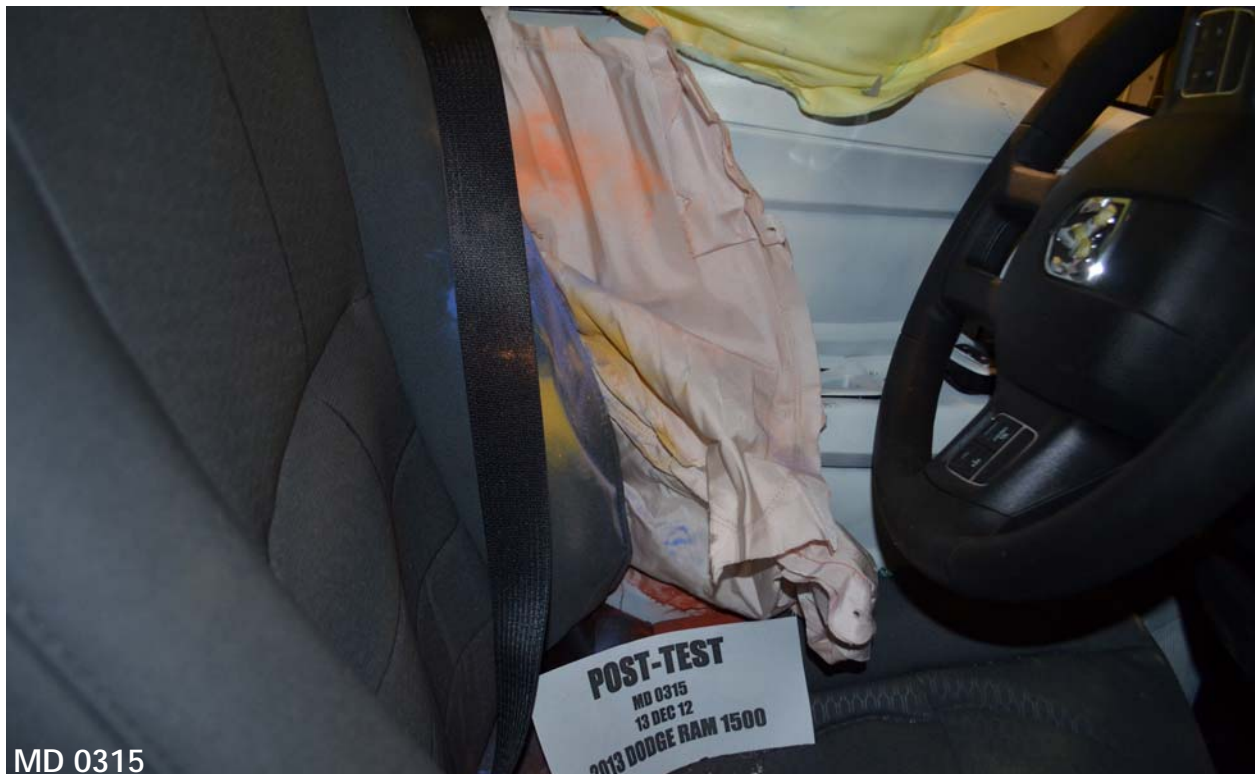
Figure 048: Post-Test Dummy Close-Up Torso Contact with Vehicle Interior View

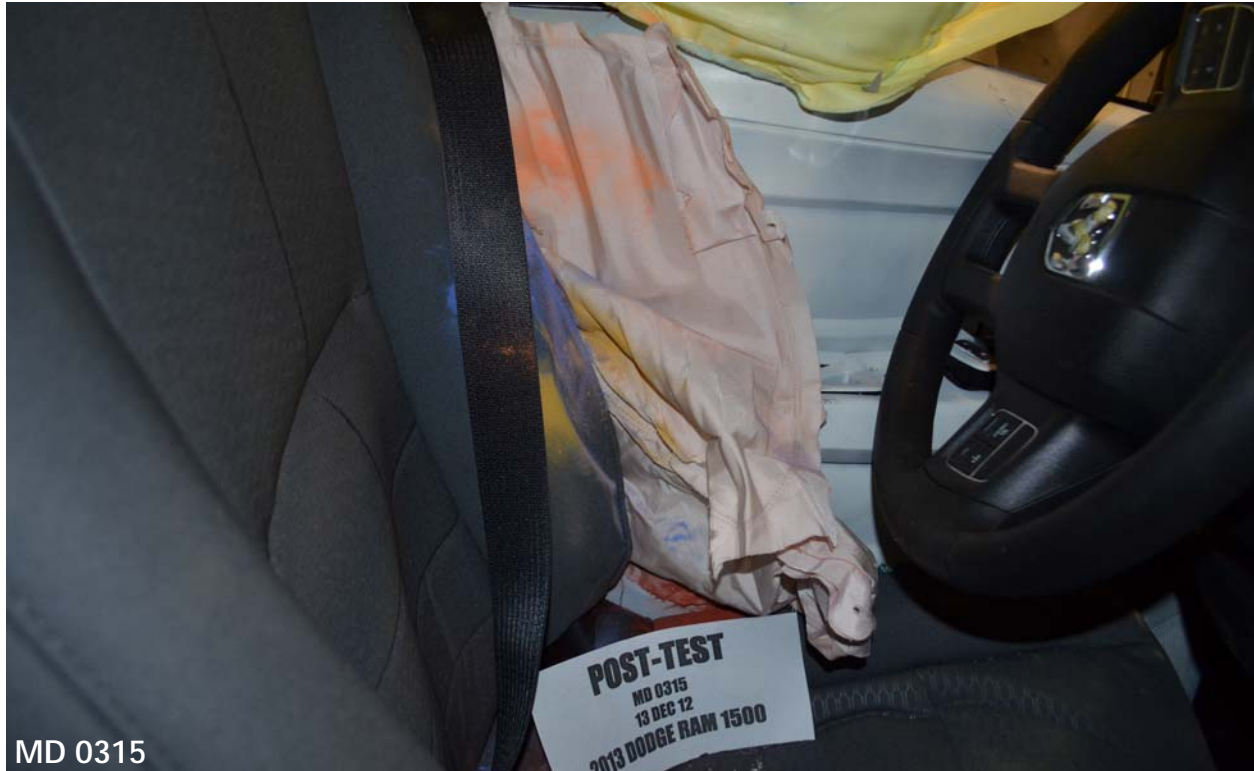
Figure 049: Post-Test Dummy Close-Up Torso Contact with Side Air bag View

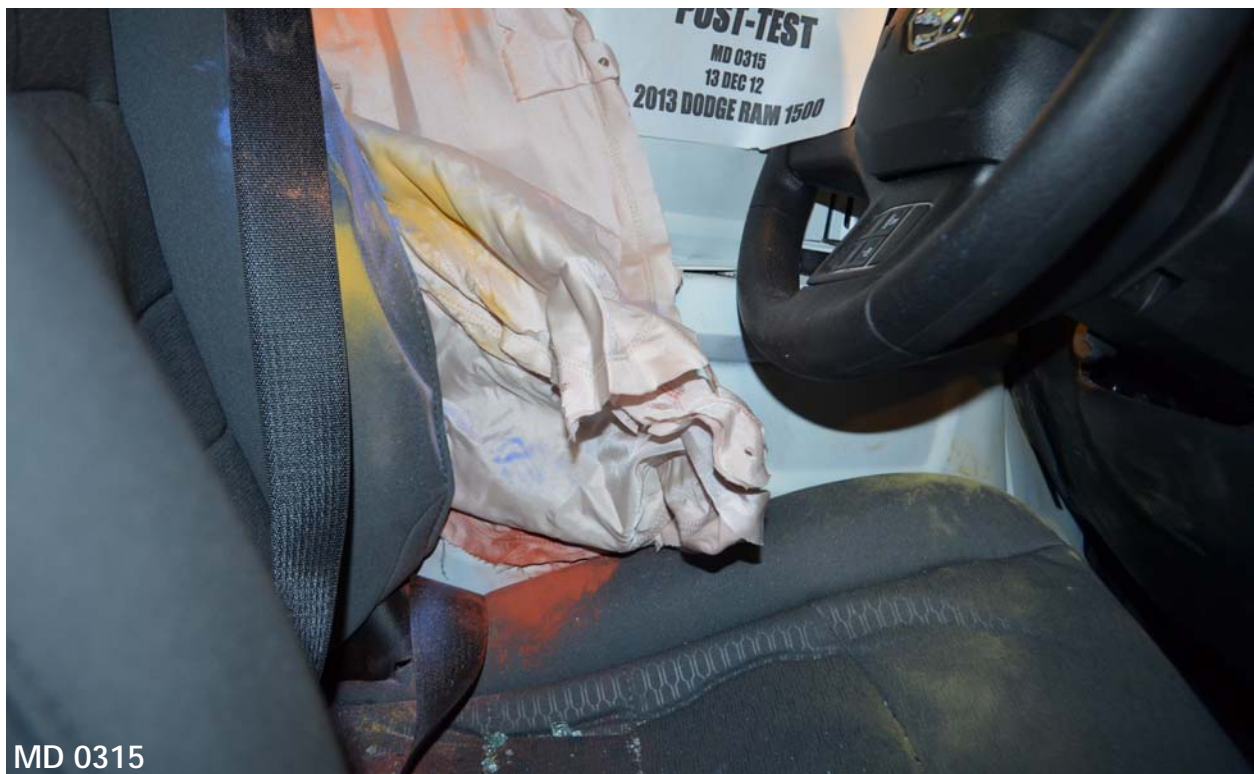
Figure 050: Post-Test Dummy Close-Up Pelvis Contact with Vehicle Interior View

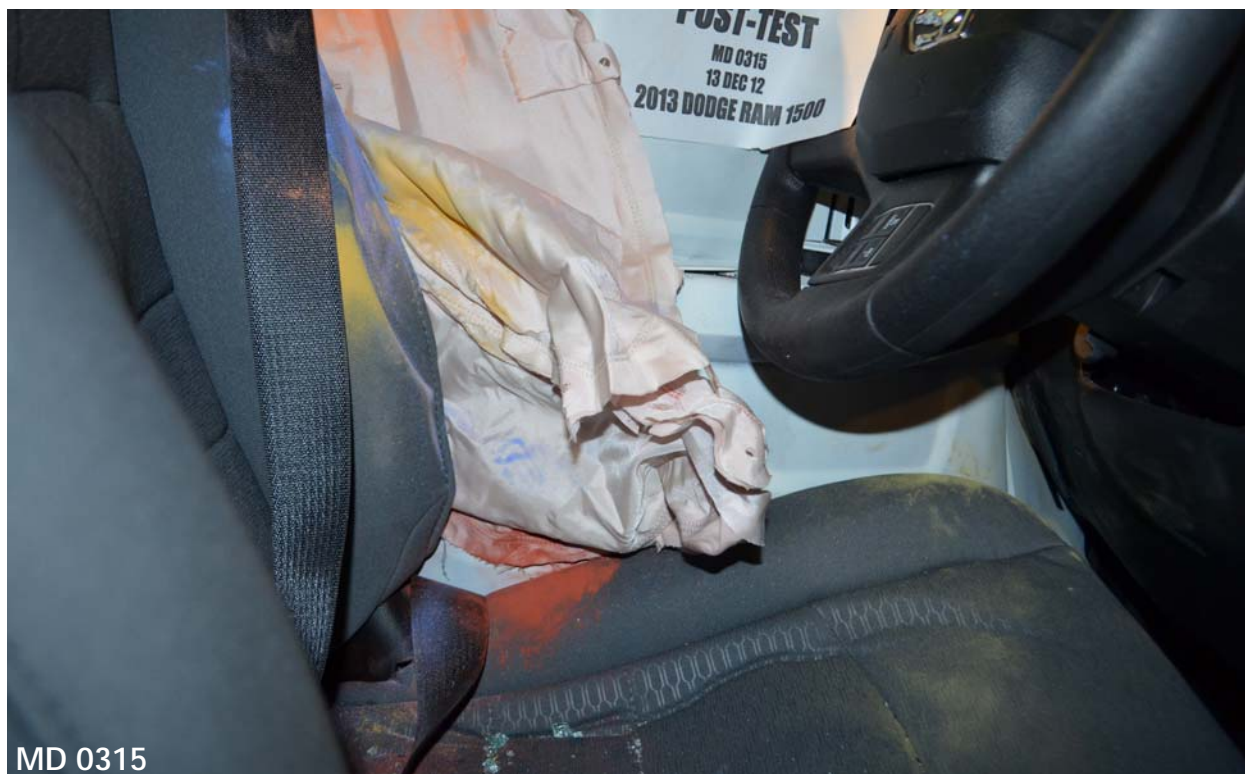
Figure 051: Post-Test Dummy Close-Up Pelvis Contact with Side Air bag View
