**REPORT NUMBER: NCAP305I-MGA-2013-006**

**NEW CAR ASSESSMENT PROGRAM (NCAP)  
FMVSS No. 305 Indicant Test**

**FORD MOTOR COMPANY  
2013 Ford Fusion SE Hybrid 4-Dr Sedan  
NHTSA NUMBER: MD0219**

**FINAL REPORT**

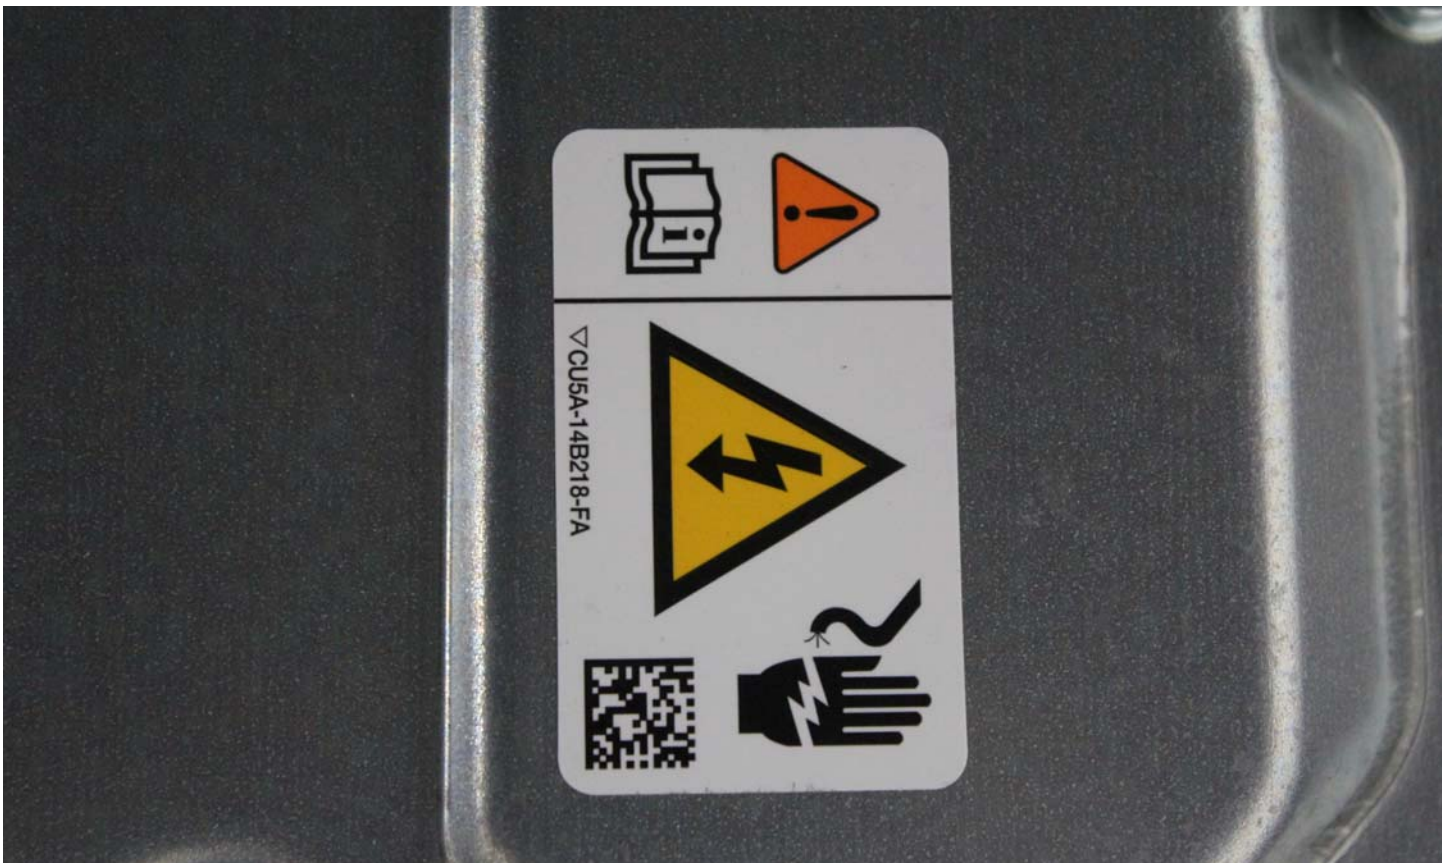
No. 002 Power Inverter Warning Label

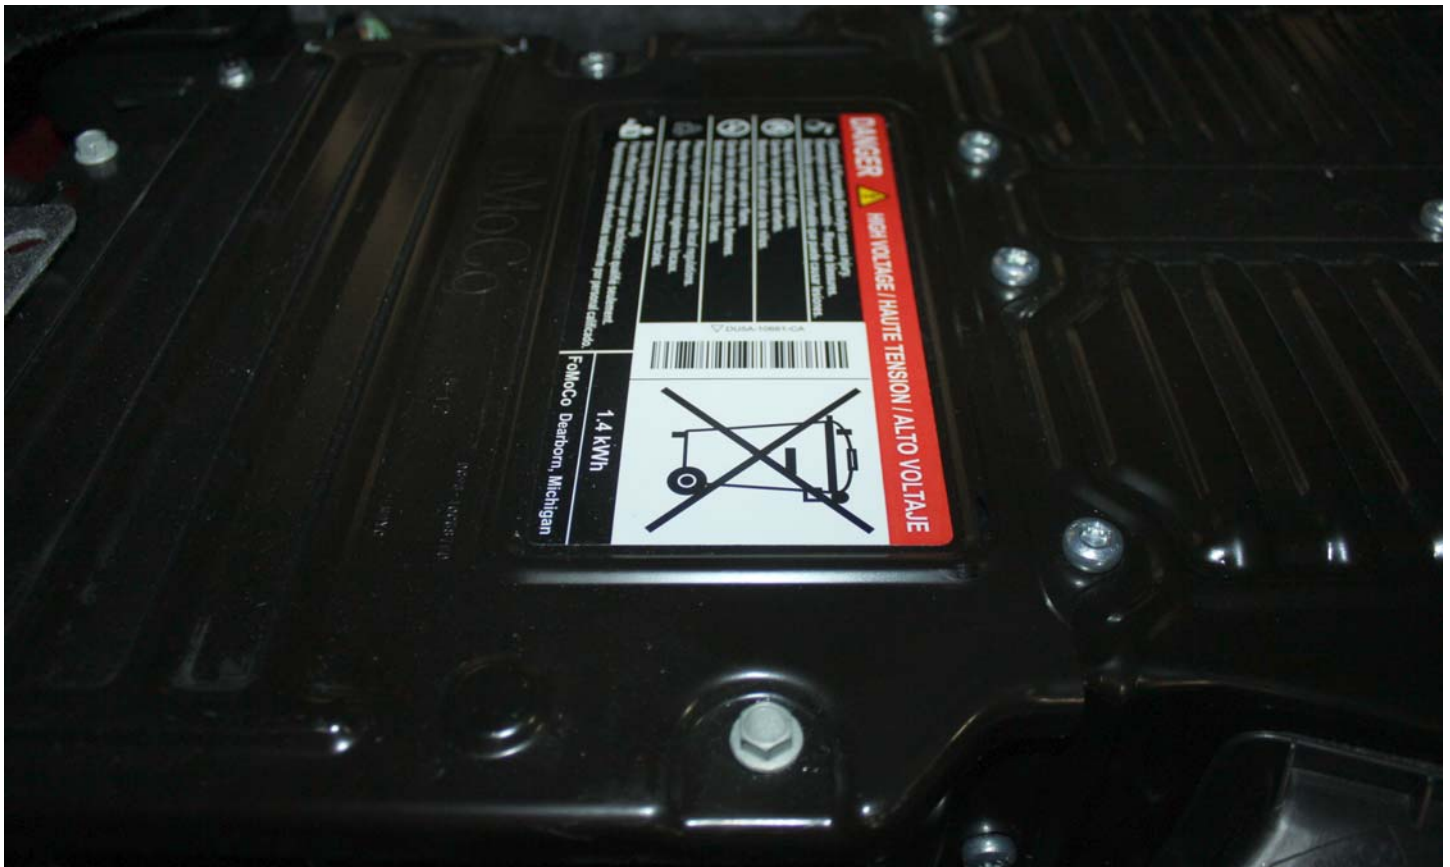
No. 005 Other Vehicle Label(s) Related to Electrical Propulsion System

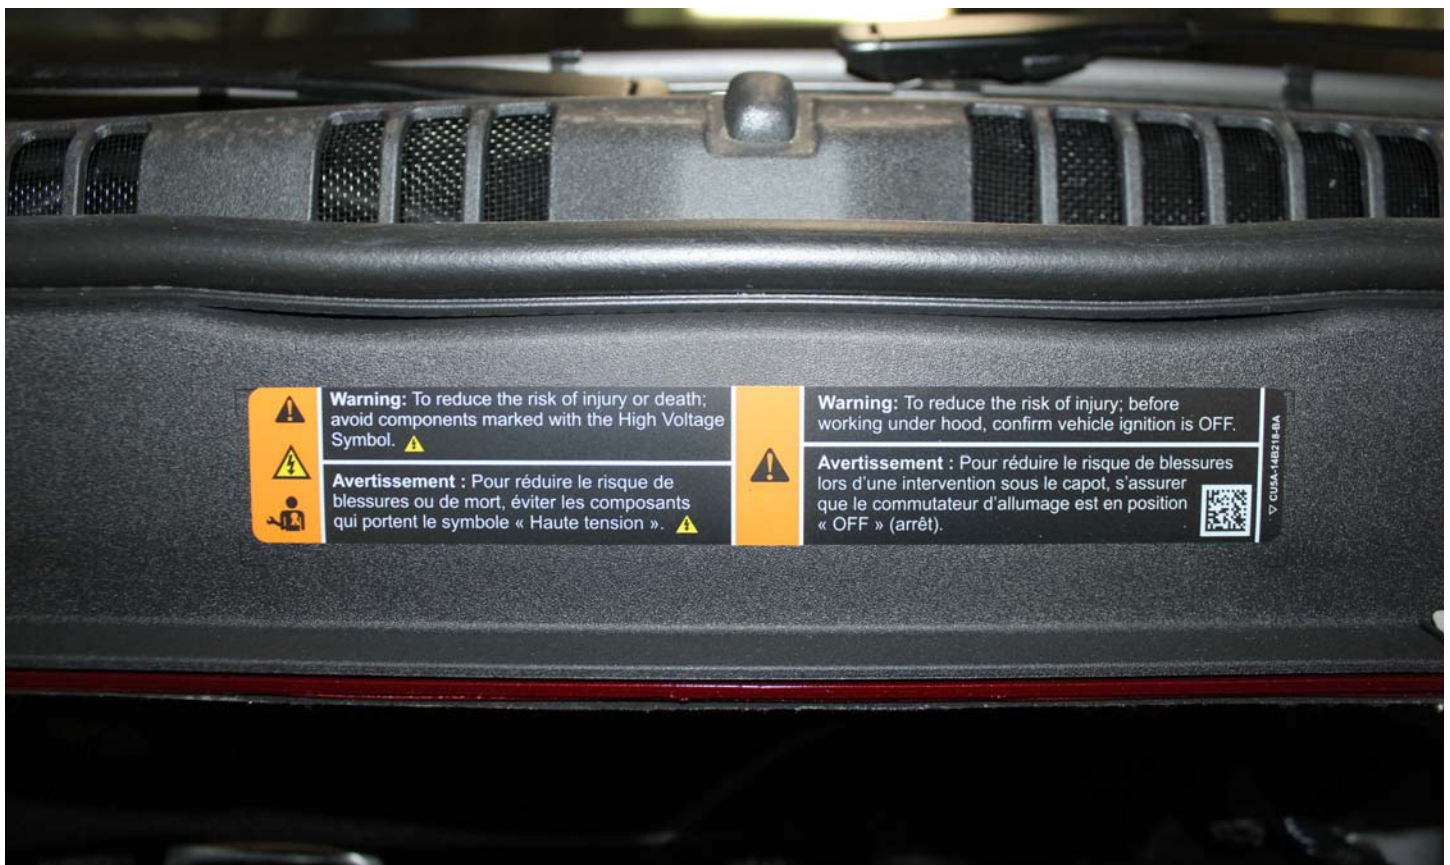
No. 005a Other Vehicle Label(s) Related to Electrical Propulsion System

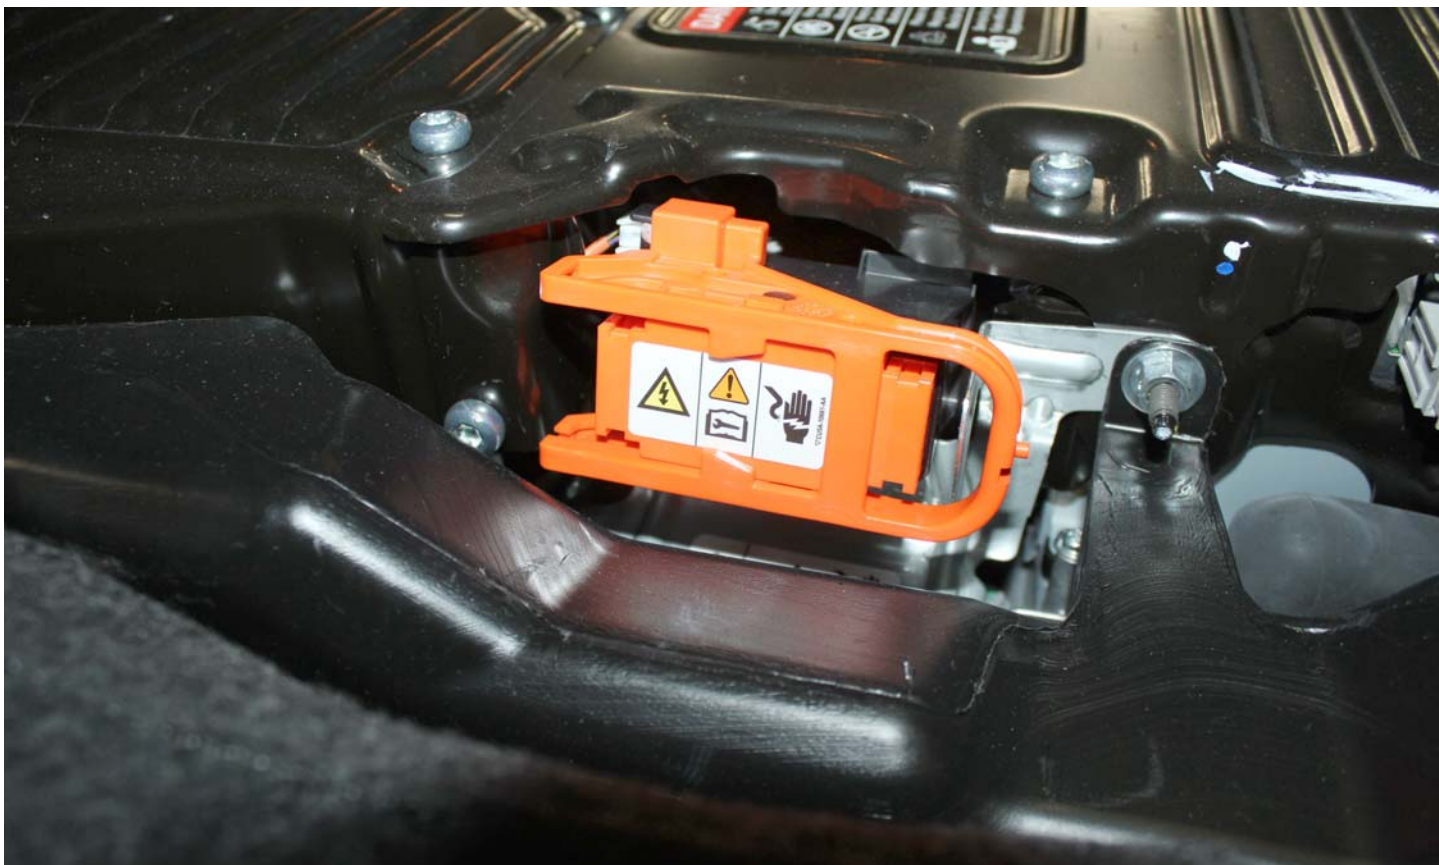
No. 006 Manual High Voltage Service Disconnect in Place

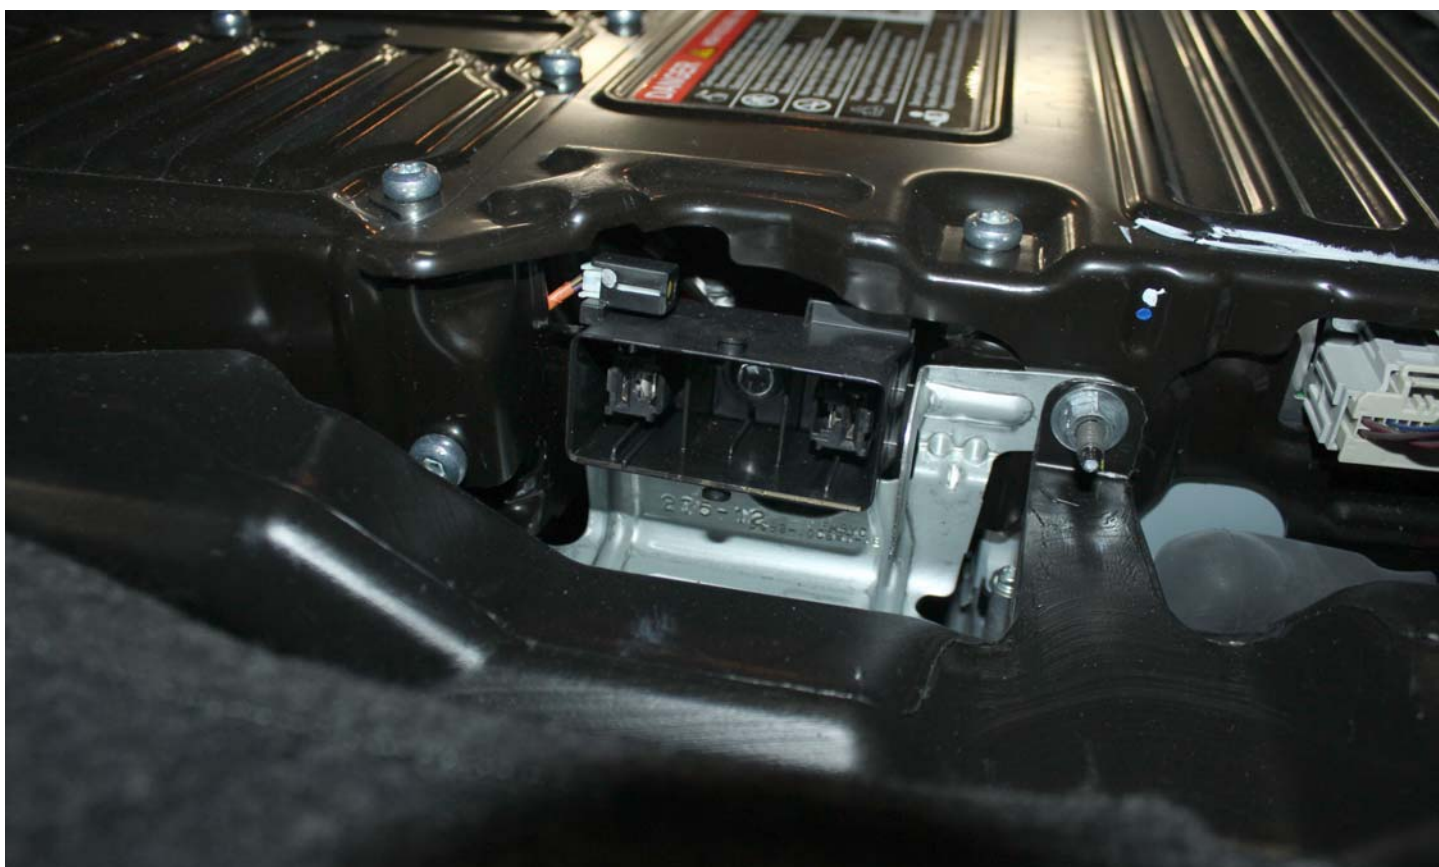
No. 007 Manual High Voltage Service Disconnect Removed

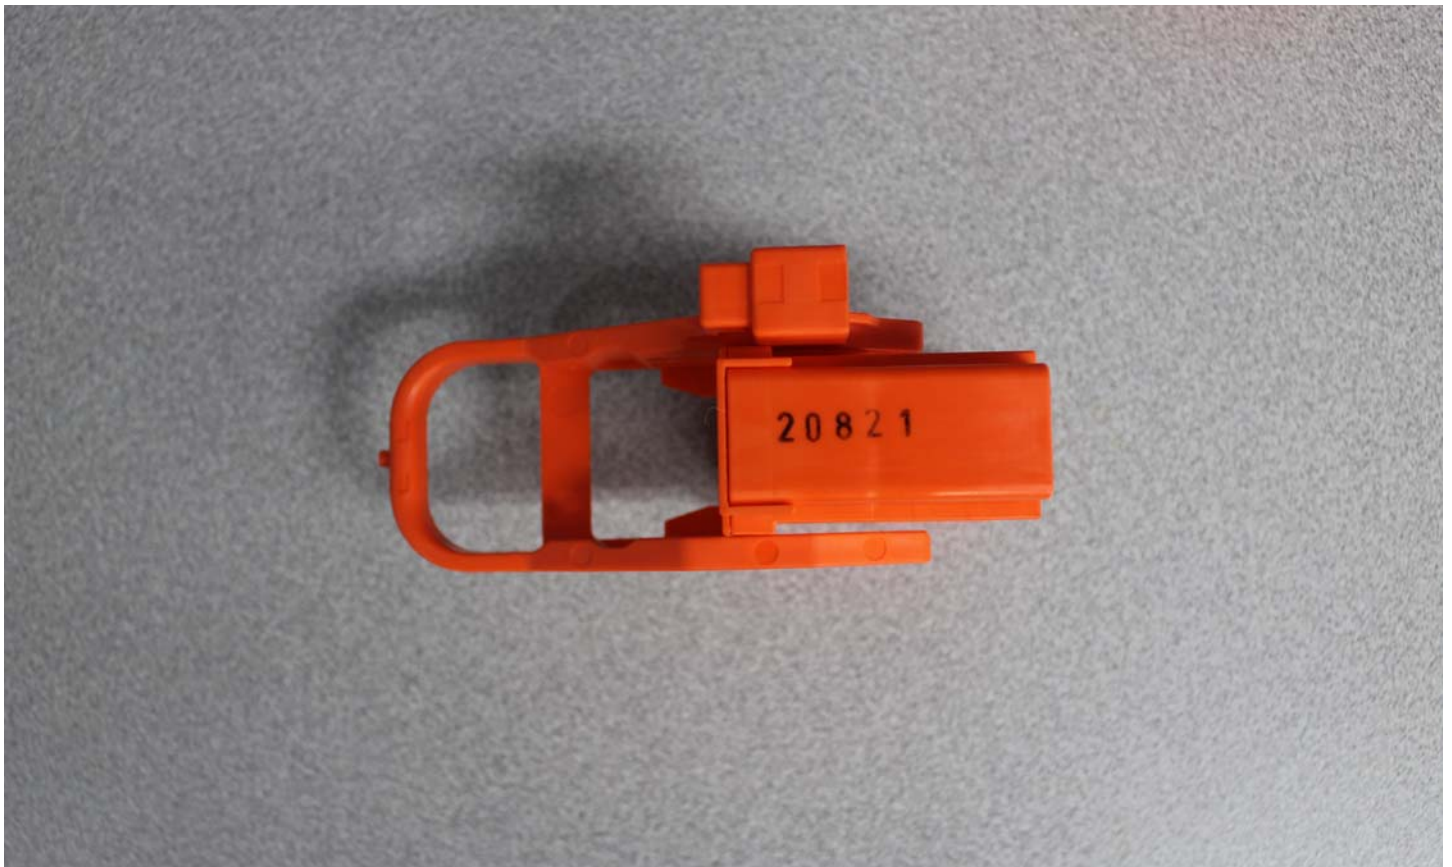
No. 008 Manual High Voltage Service Disconnect Removed

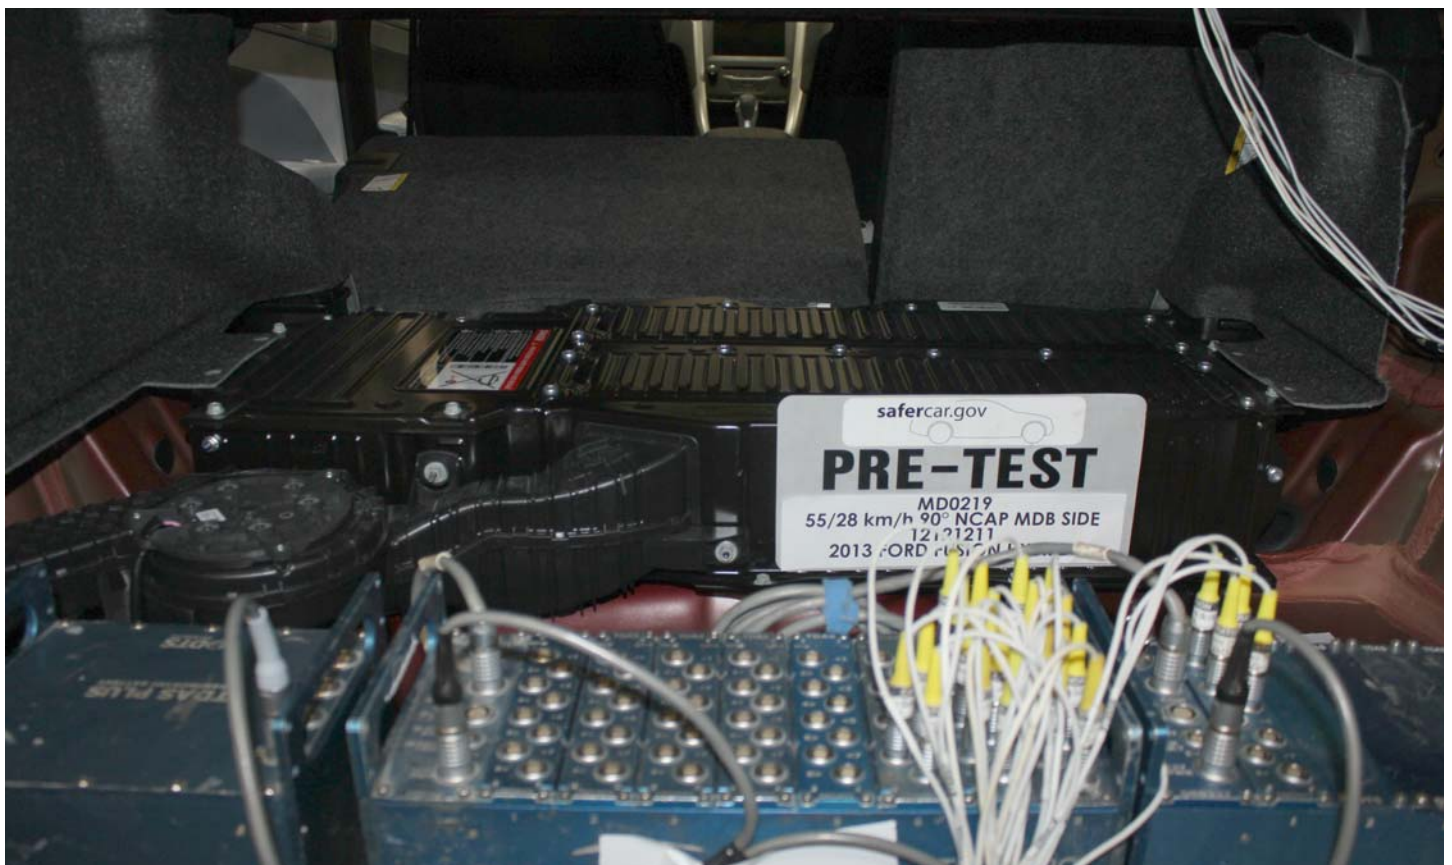
No. 009 Pre-Impact View of Propulsion Battery

| | The high voltage battery is mounted behind the rear seat. | |

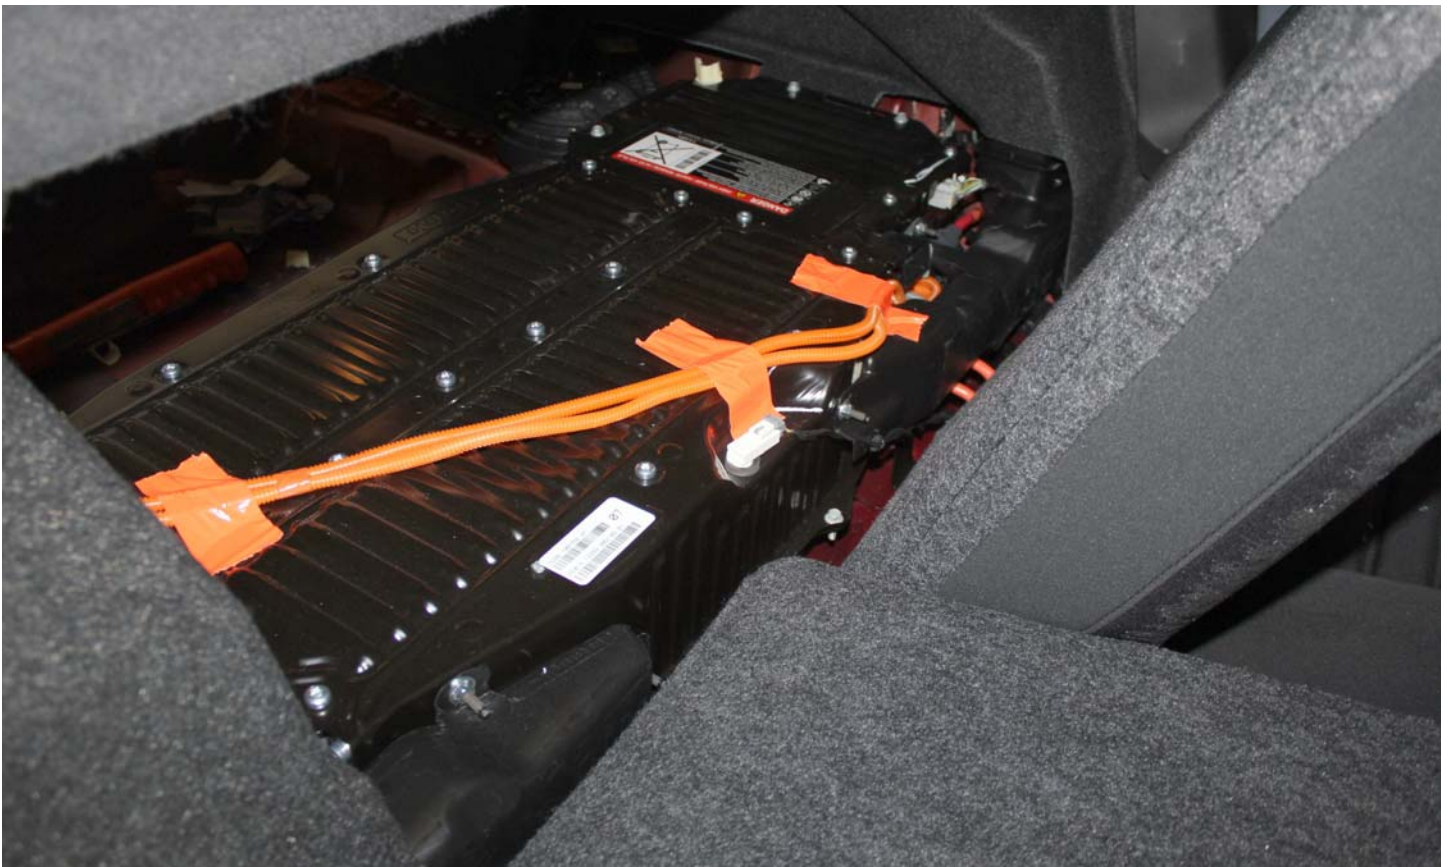
No. 010 Post-Impact Front View of Propulsion Battery

| | Yes, Pass | No, Fail |
|---|---|---|
| All Components of Electrical Energy Storage/Conversion Device remained attached to the vehicle with at least one mounting location. | X | |

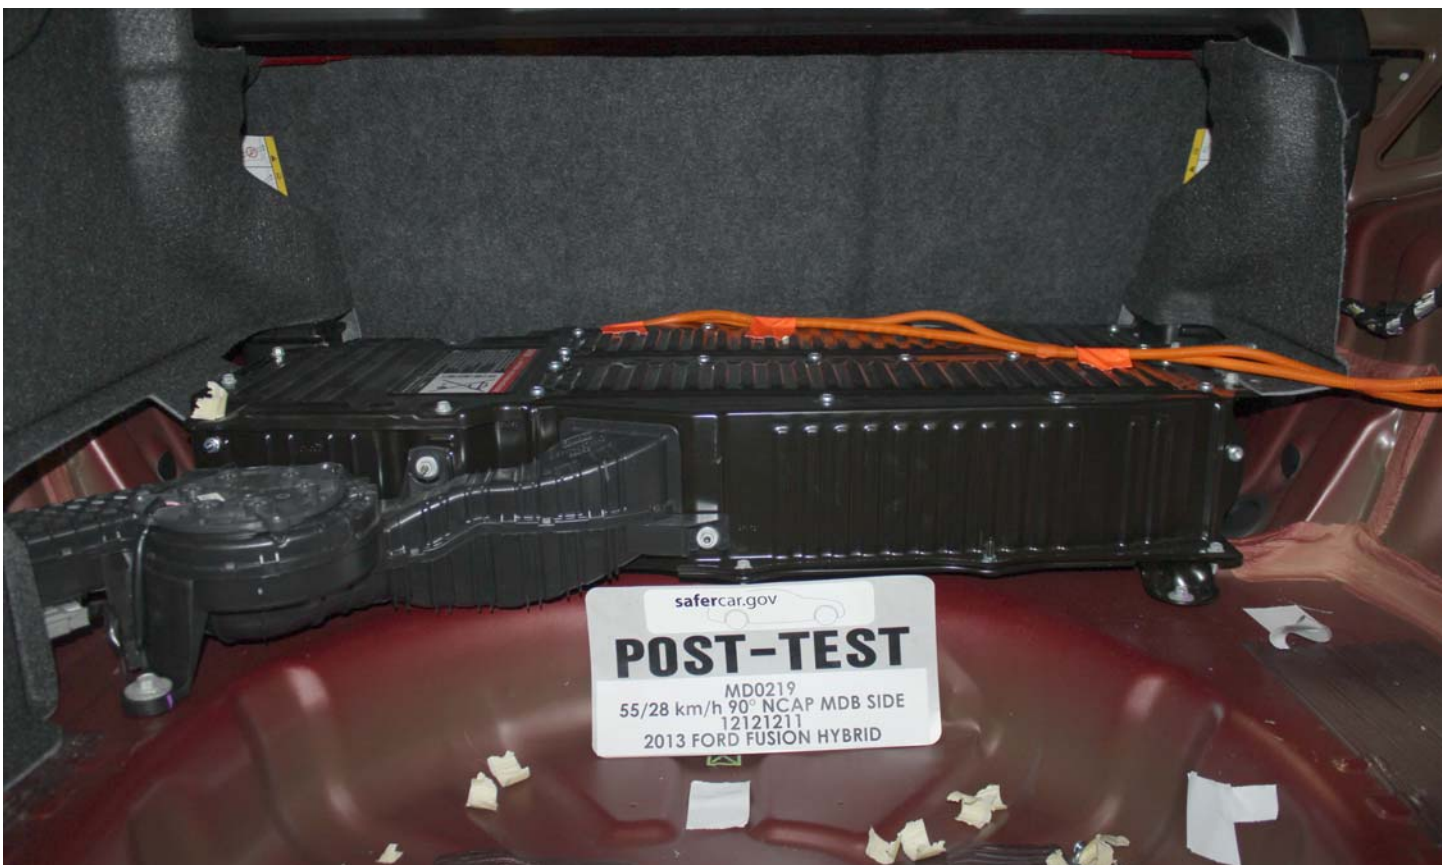
No. 011 Post-Impact Rear View of Propulsion Battery

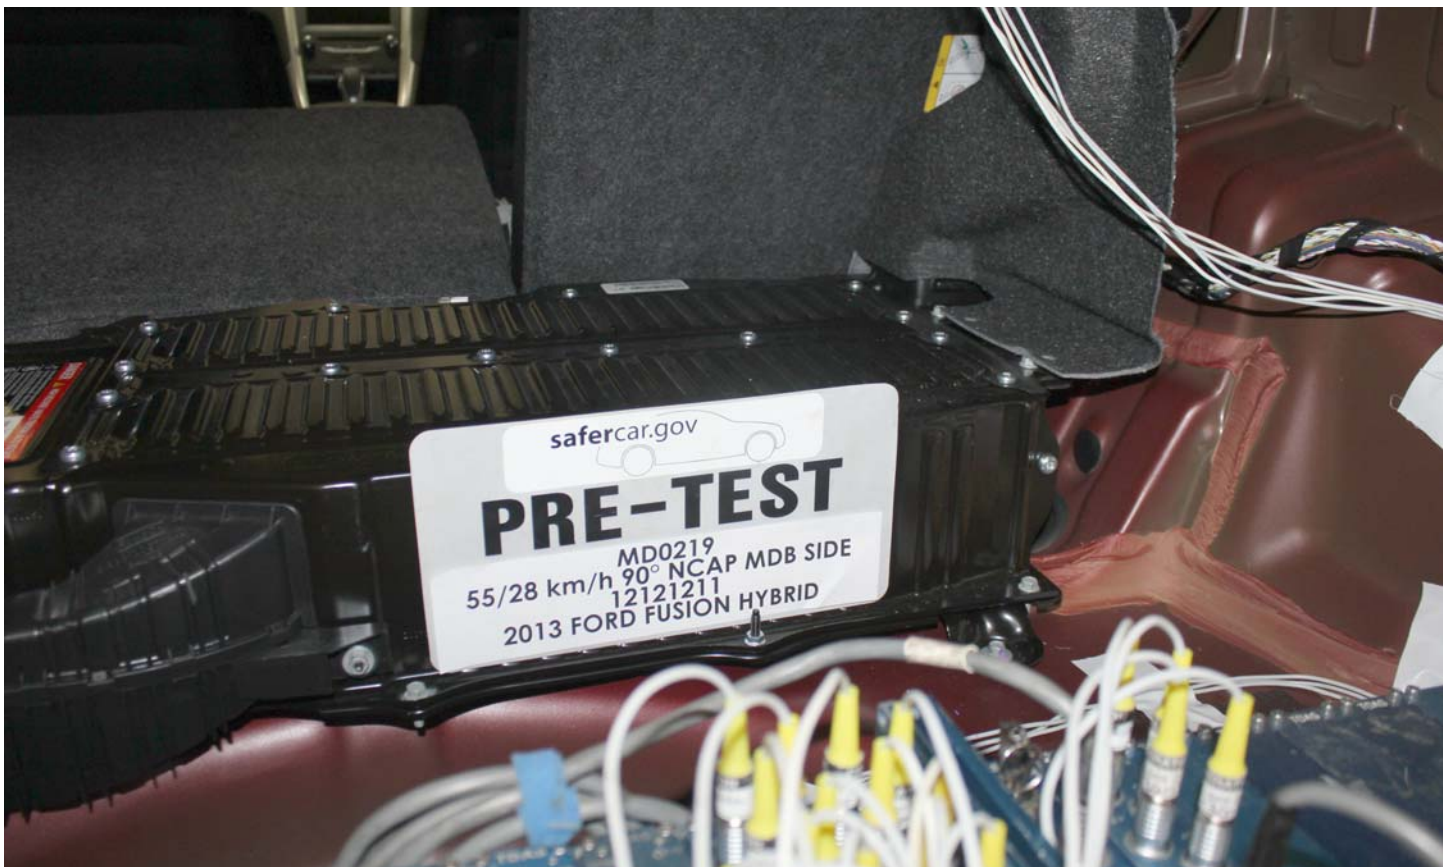
No. 012 Pre-Impact View of Battery Box(s) or Container(s) Which Holds Individual Battery Modules

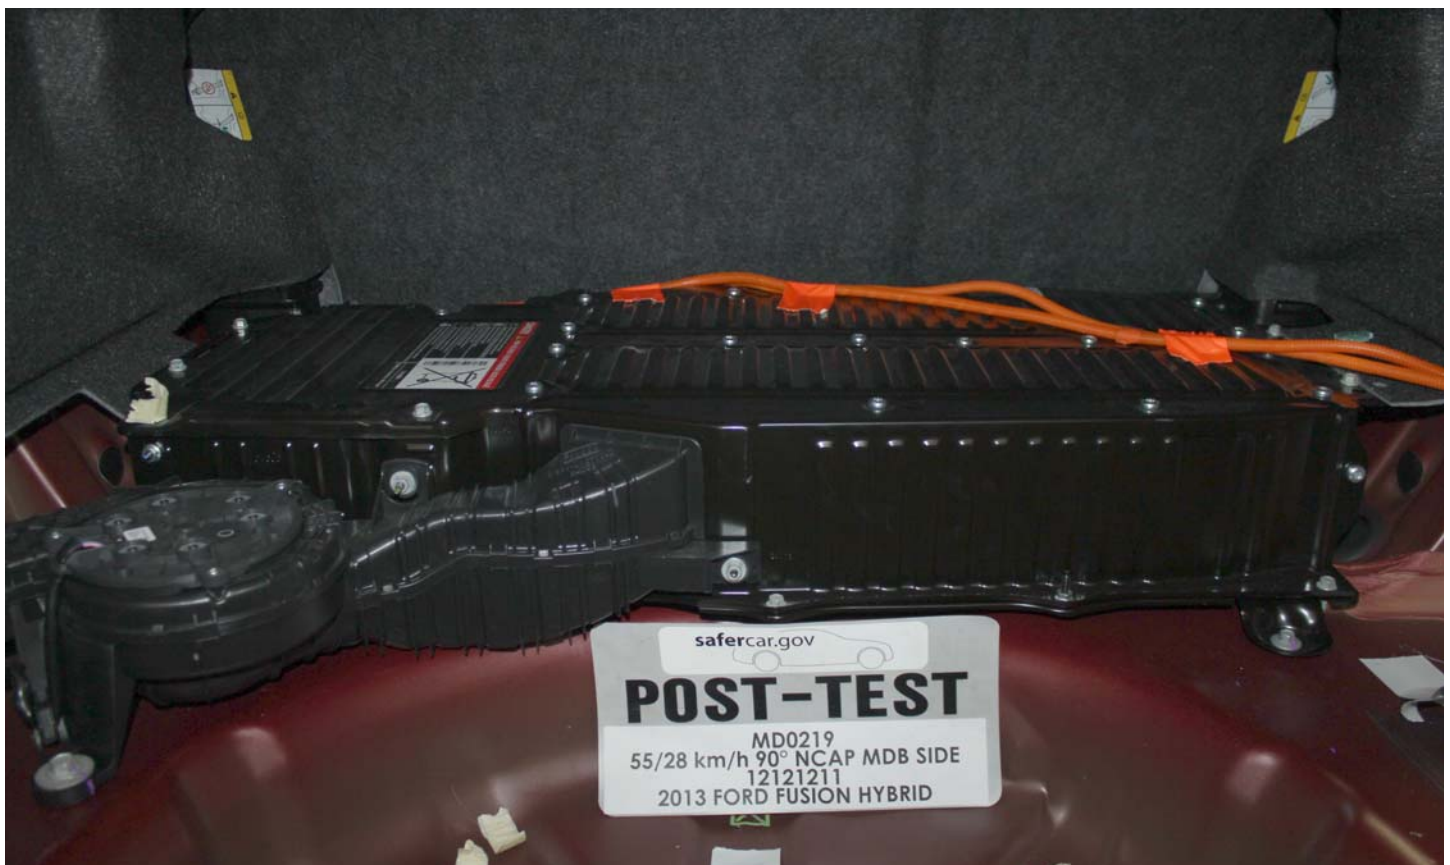
No. 013 Post-Impact View of Battery Box(s) or Container(s) Which Holds Individual Battery Modules

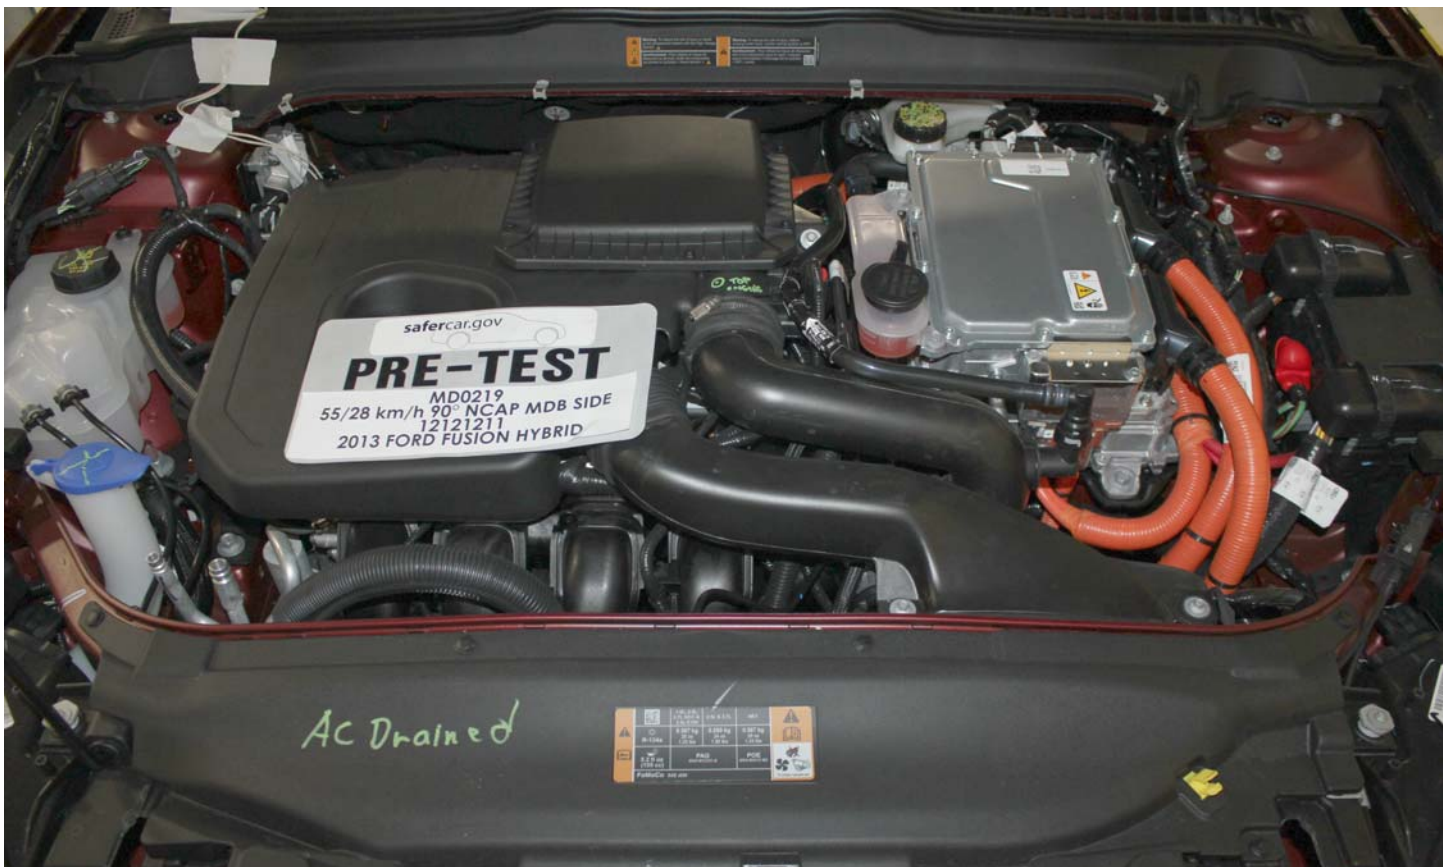
No. 016 Pre-Impact View of Electric Propulsion Drive

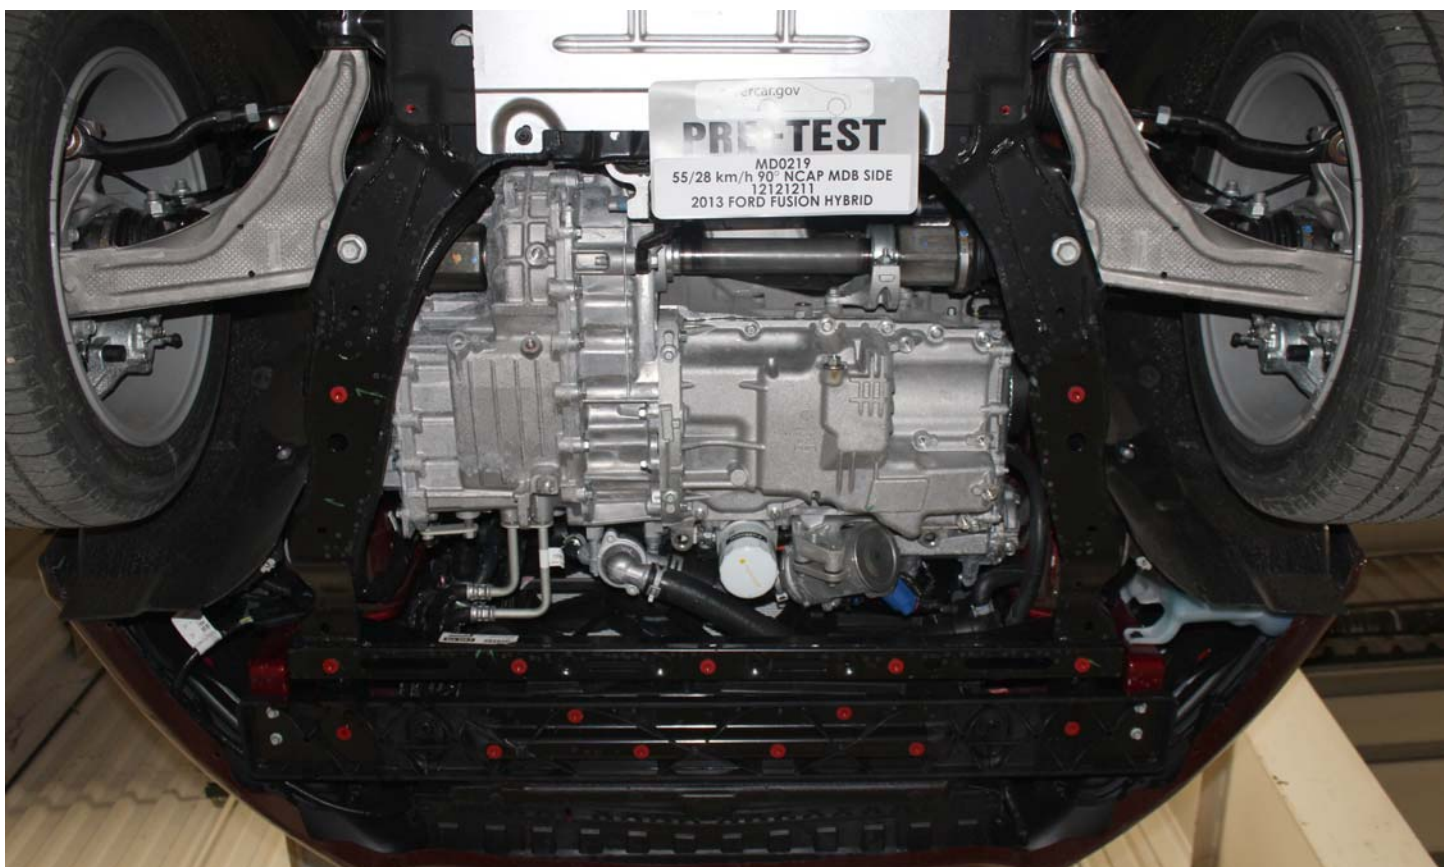
No. 016a Pre-Impact View of Electric Propulsion Drive

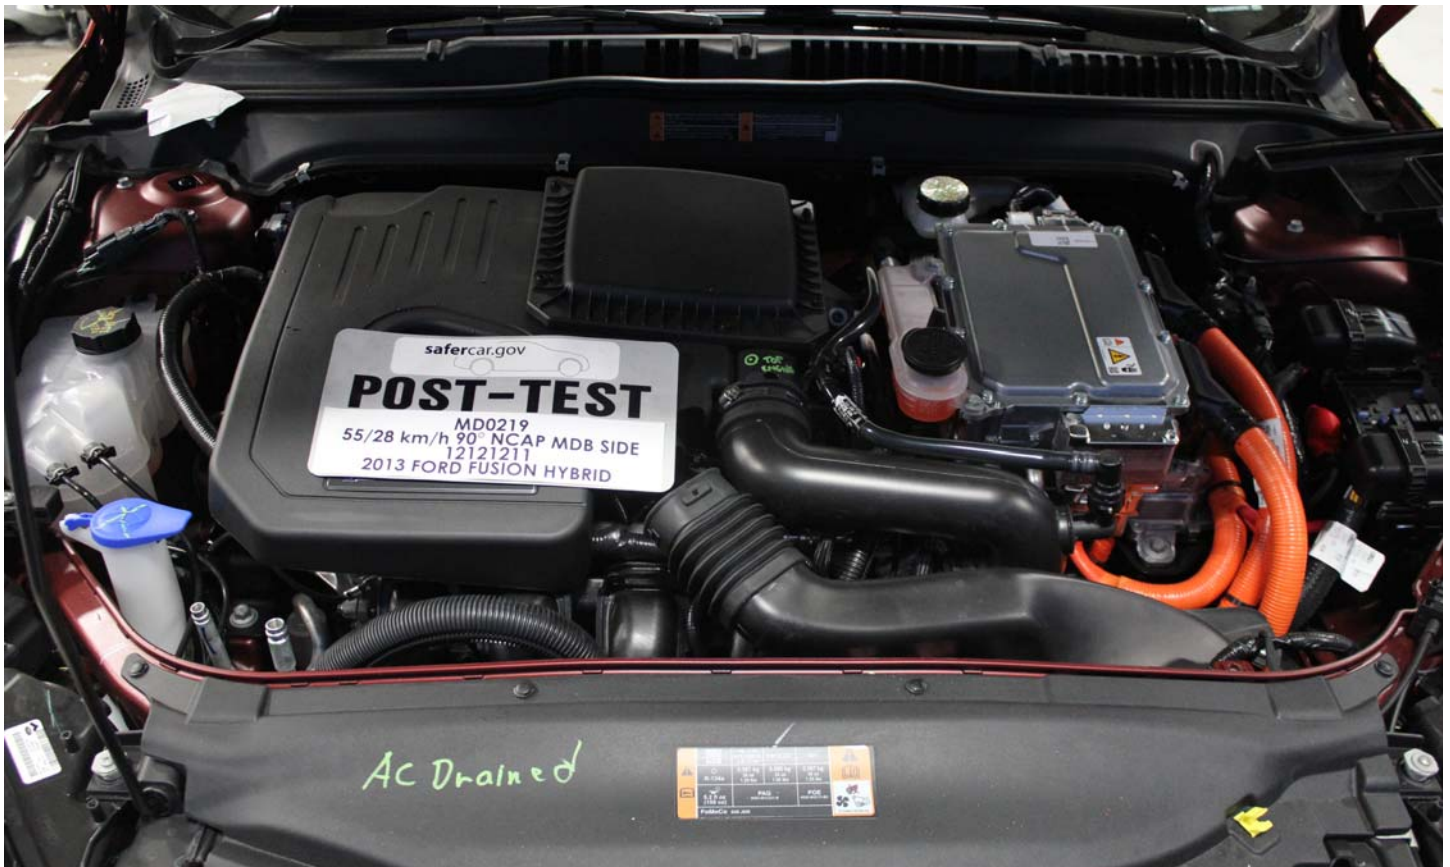
No. 017 Post-Impact View of Electric Propulsion Drive

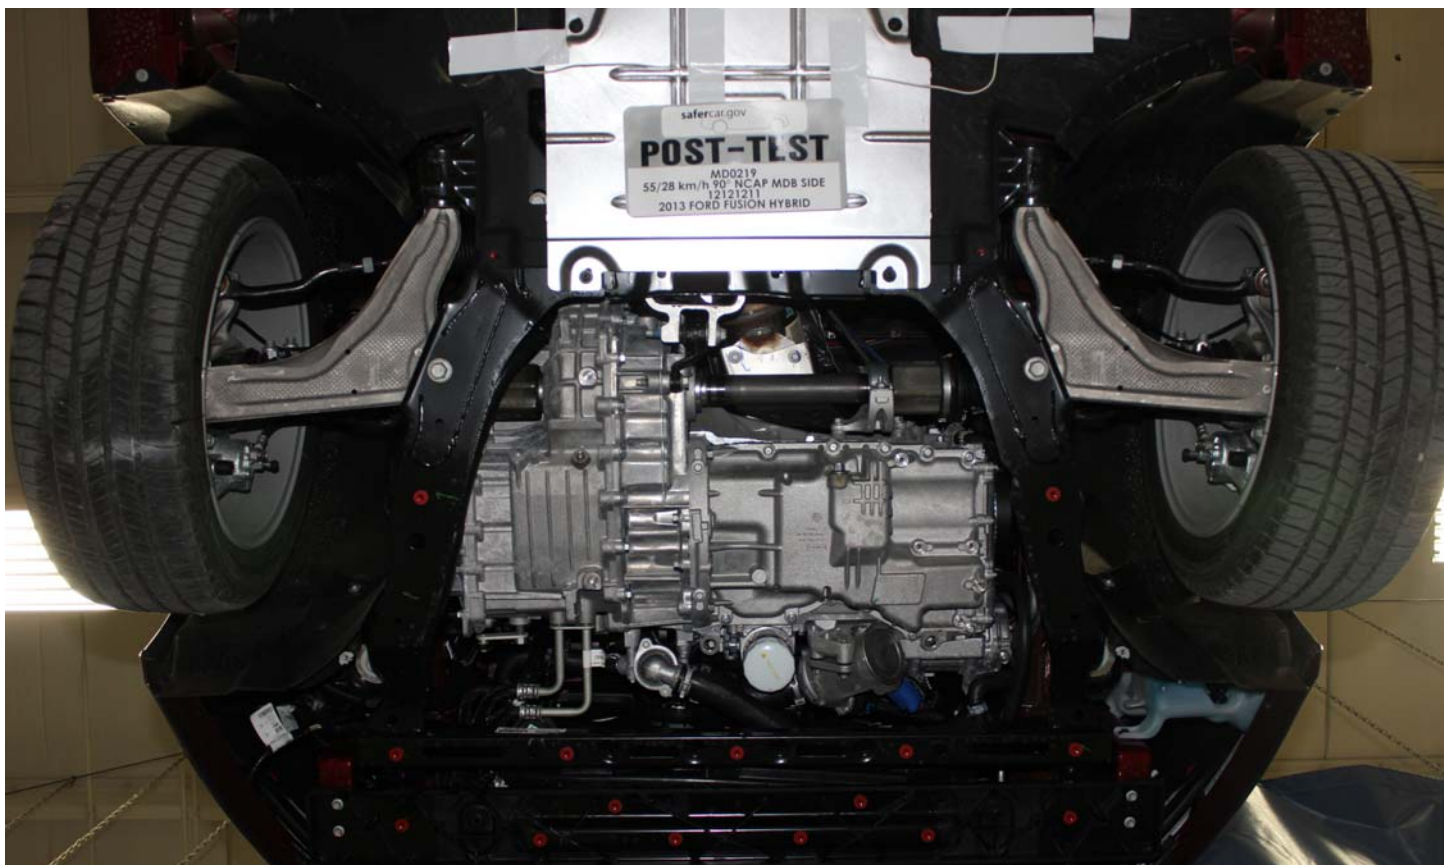
No. 017a Post-Impact View of Electric Propulsion Drive

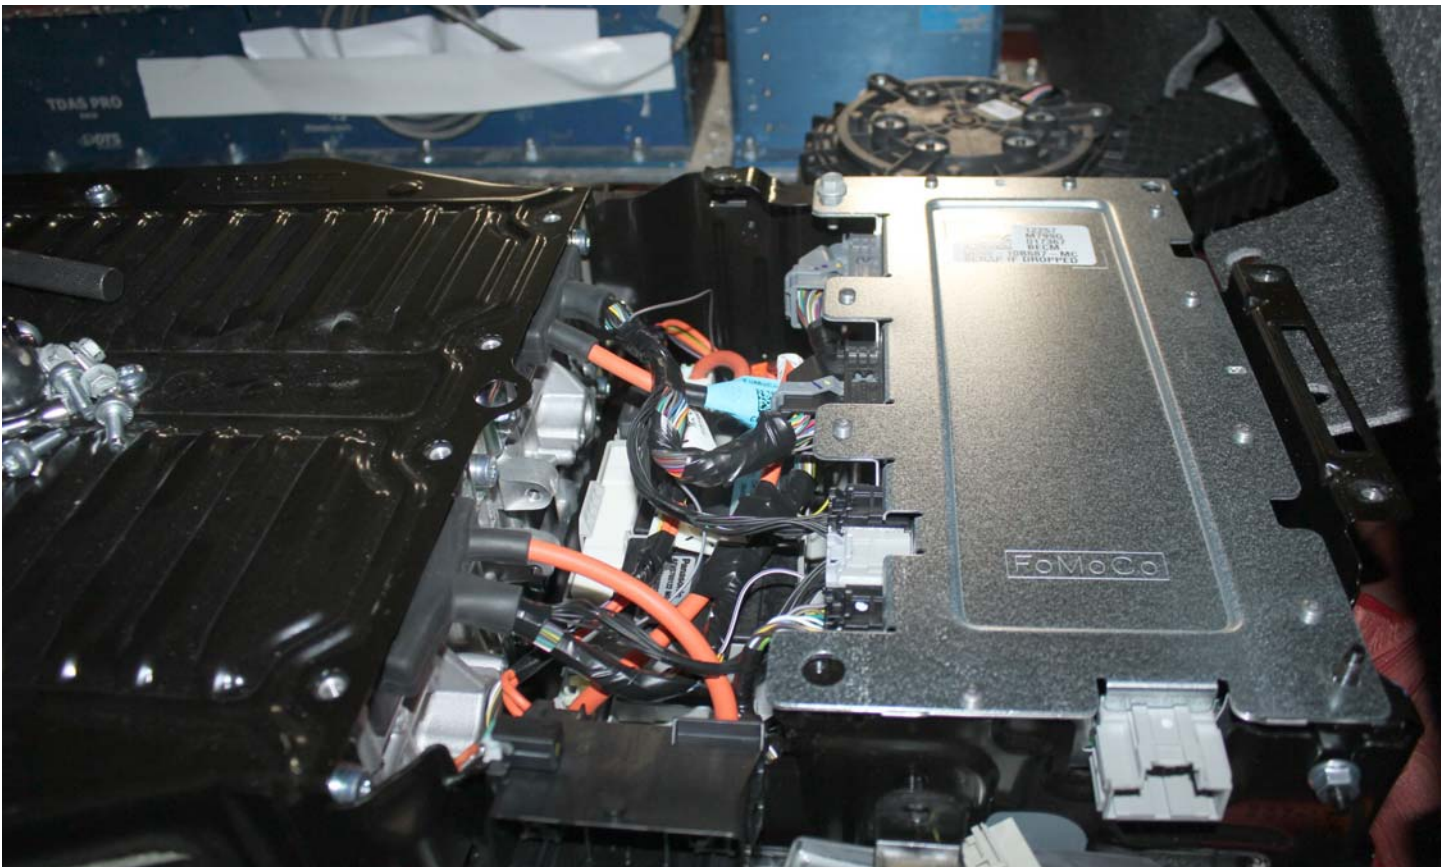
No. 018 Pre-Impact View of High Voltage Interconnect(s)

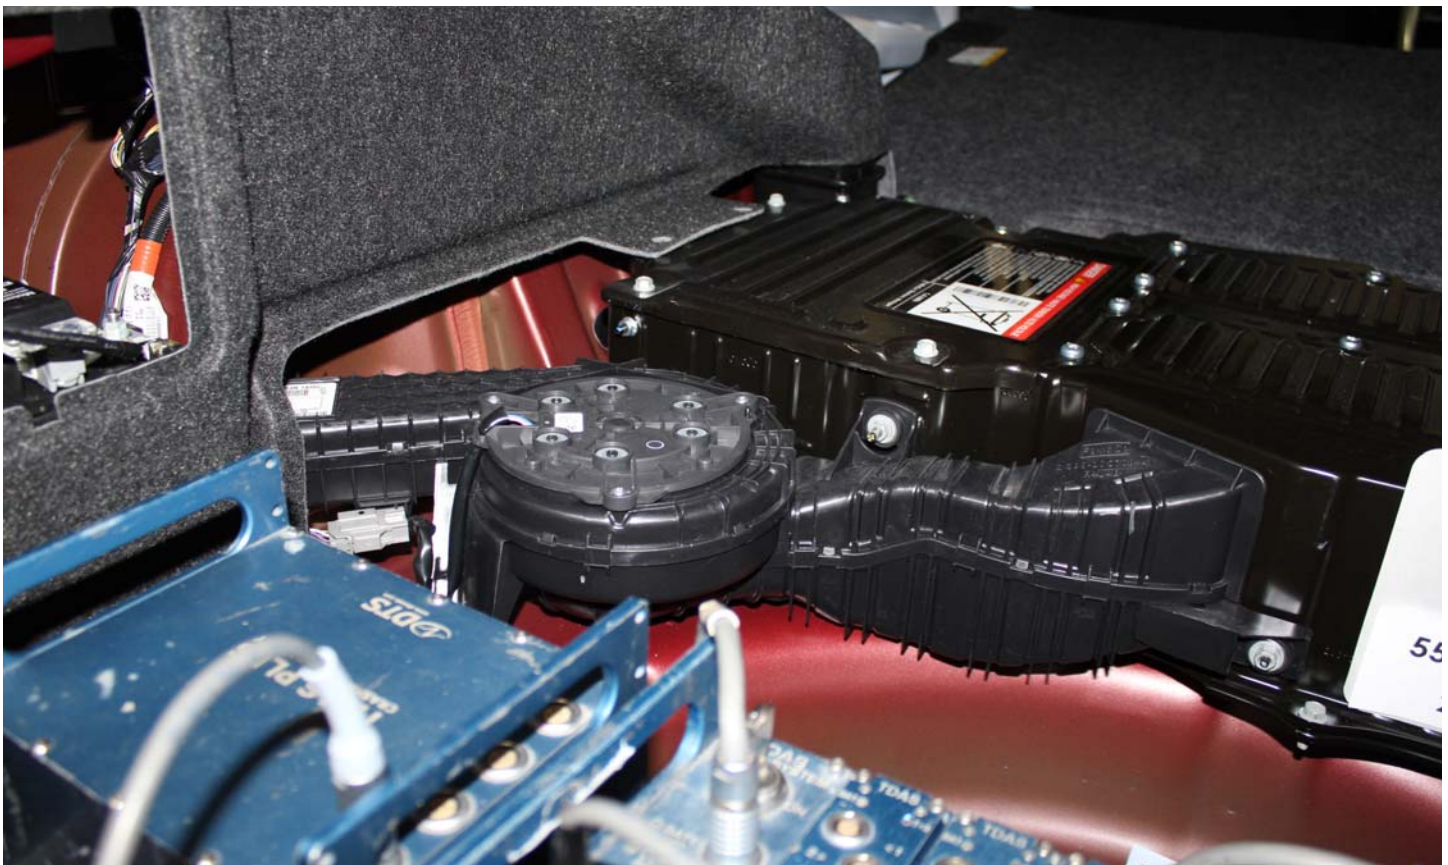
No. 019 Pre-Impact View Propulsion Battery Venting System(s)

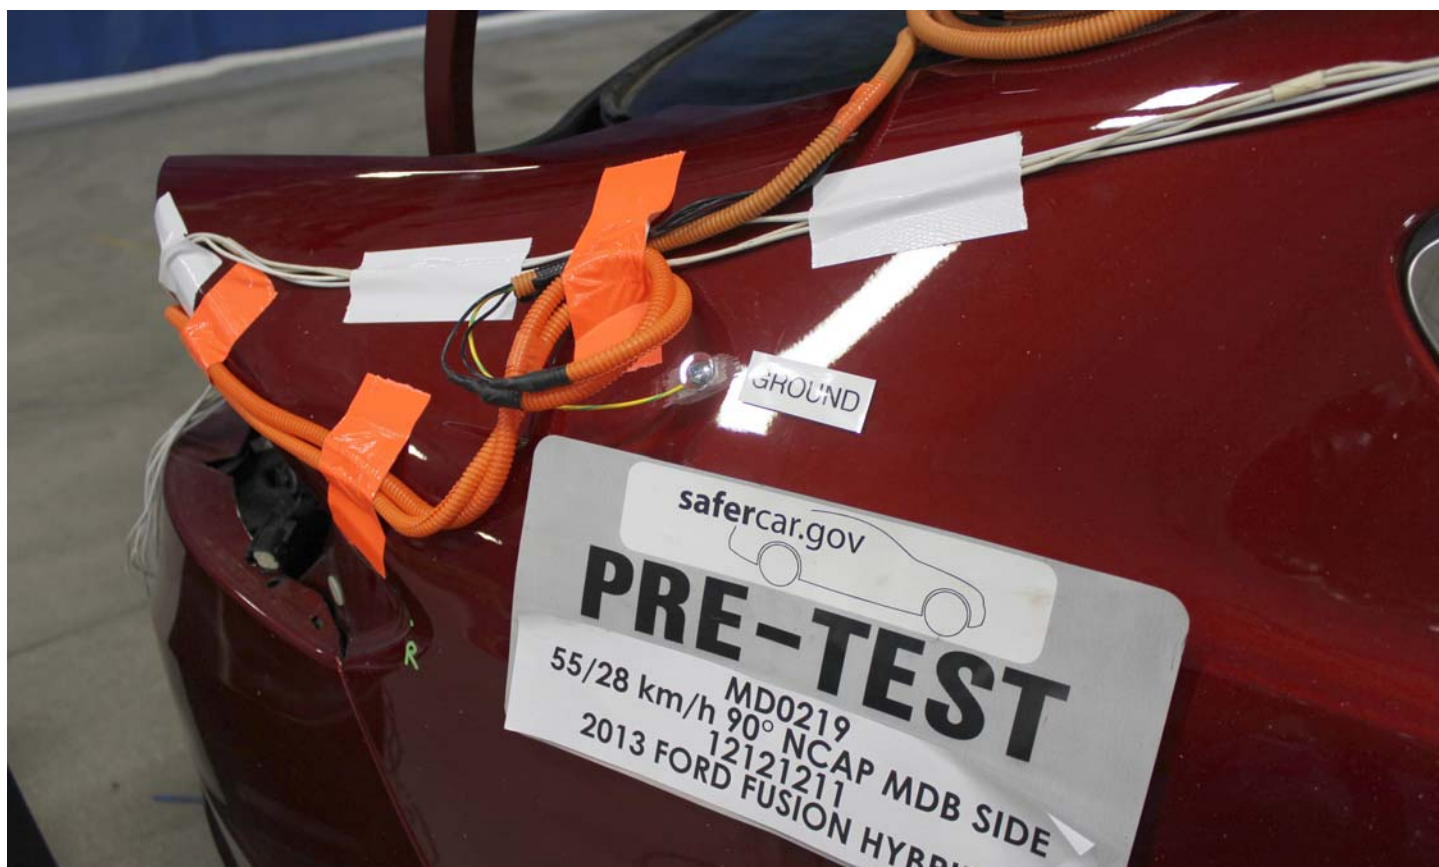
No. 021 Pre-Impact View of Ground Lead Attached

| Details of Vehicle Chassis Ground Point(s) & Location(s) | Right Rear Side of Vehicle Body<br><br>Point was removed before ground was attached. |
