**REPORT NUMBER: NCAP305I-MGA-2013-006**

**NEW CAR ASSESSMENT PROGRAM (NCAP)  
FMVSS No. 305 Indicant Test**

**FORD MOTOR COMPANY  
2013 Ford Fusion SE Hybrid 4-Dr Sedan  
NHTSA NUMBER: MD0219**

**FINAL REPORT**

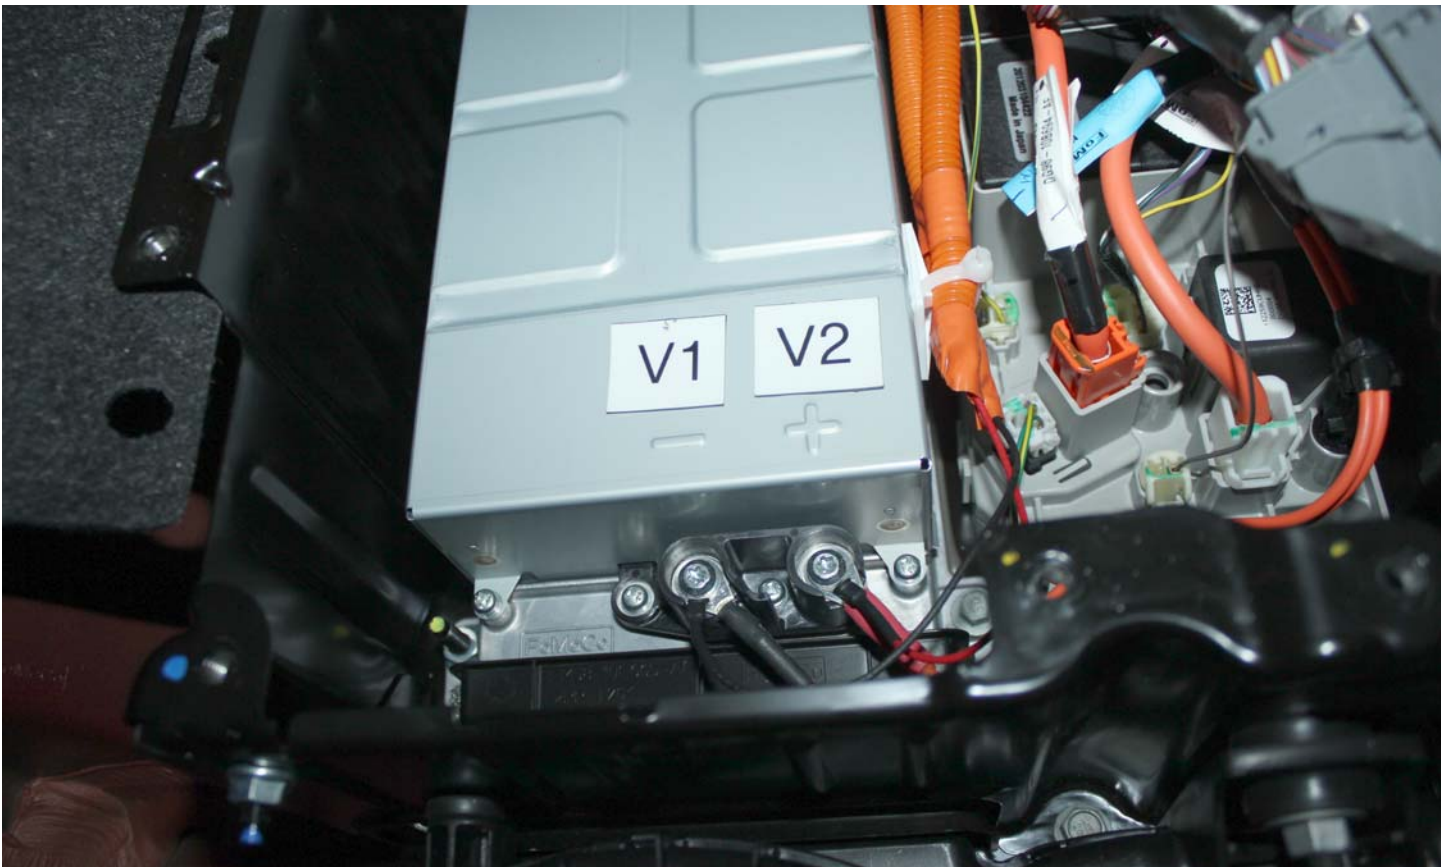
No. 022 Pre-Impact View of High Voltage Leads Attached

| Details of Electric Energy Storage/Conversion System Test Points: | + and – Terminal Used at Terminal Ends of DCDC Converter |

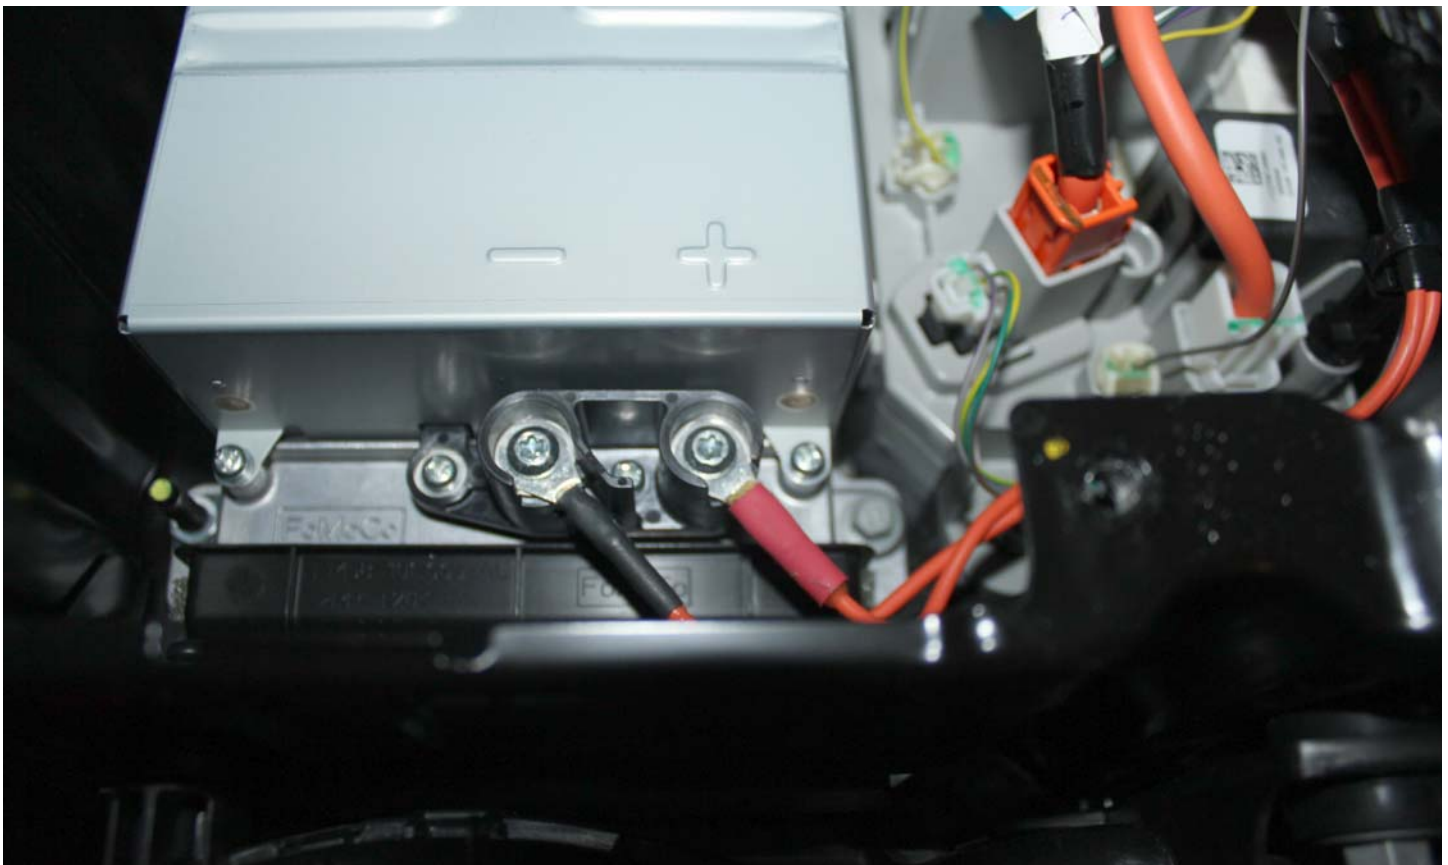
No. 023 Pre-Impact Close-Up View of High Voltage Leads Attached

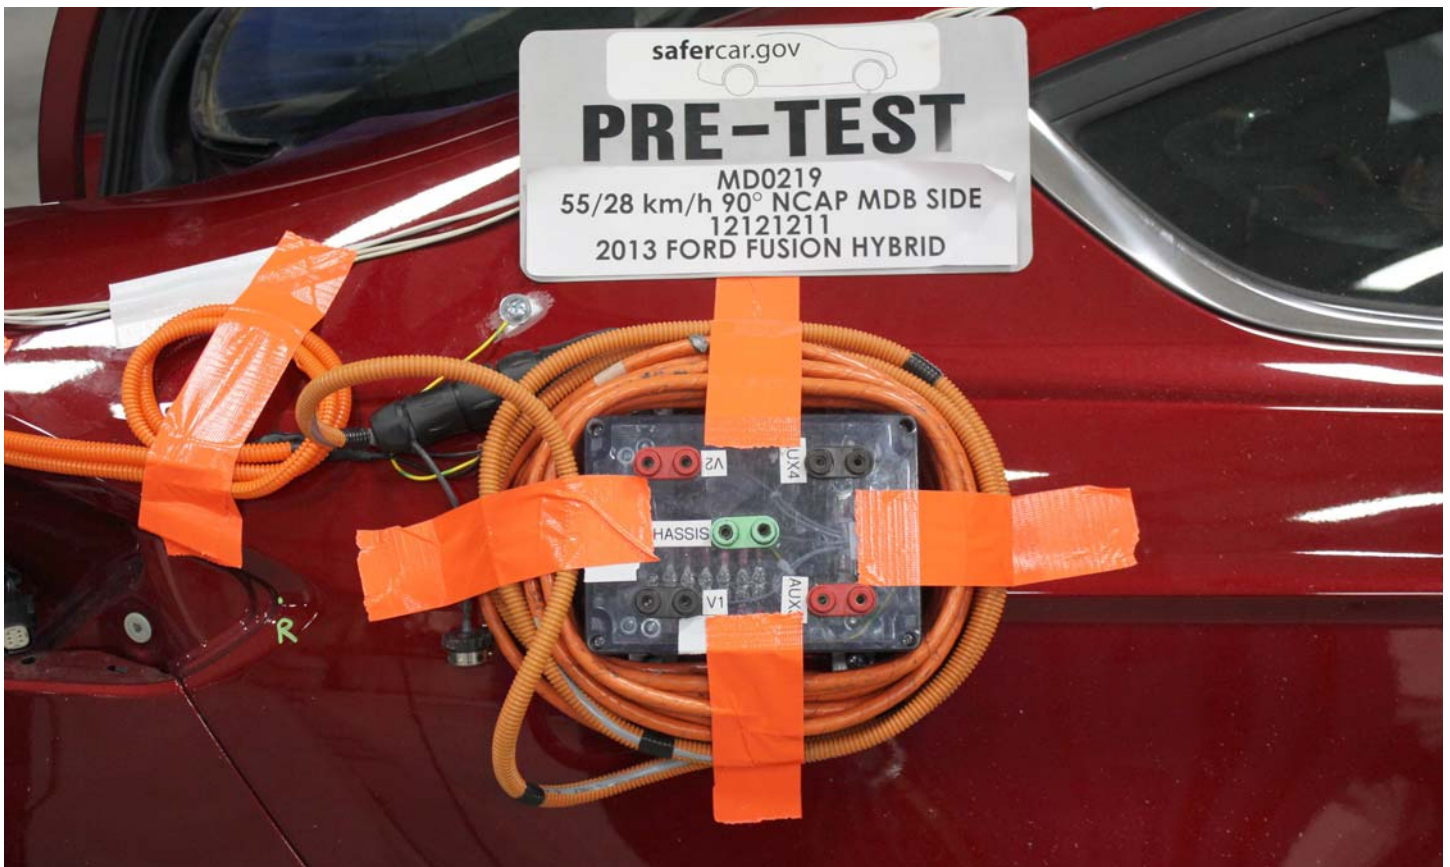
No. 024 Pre-Impact View of Installed Impact Interface Port

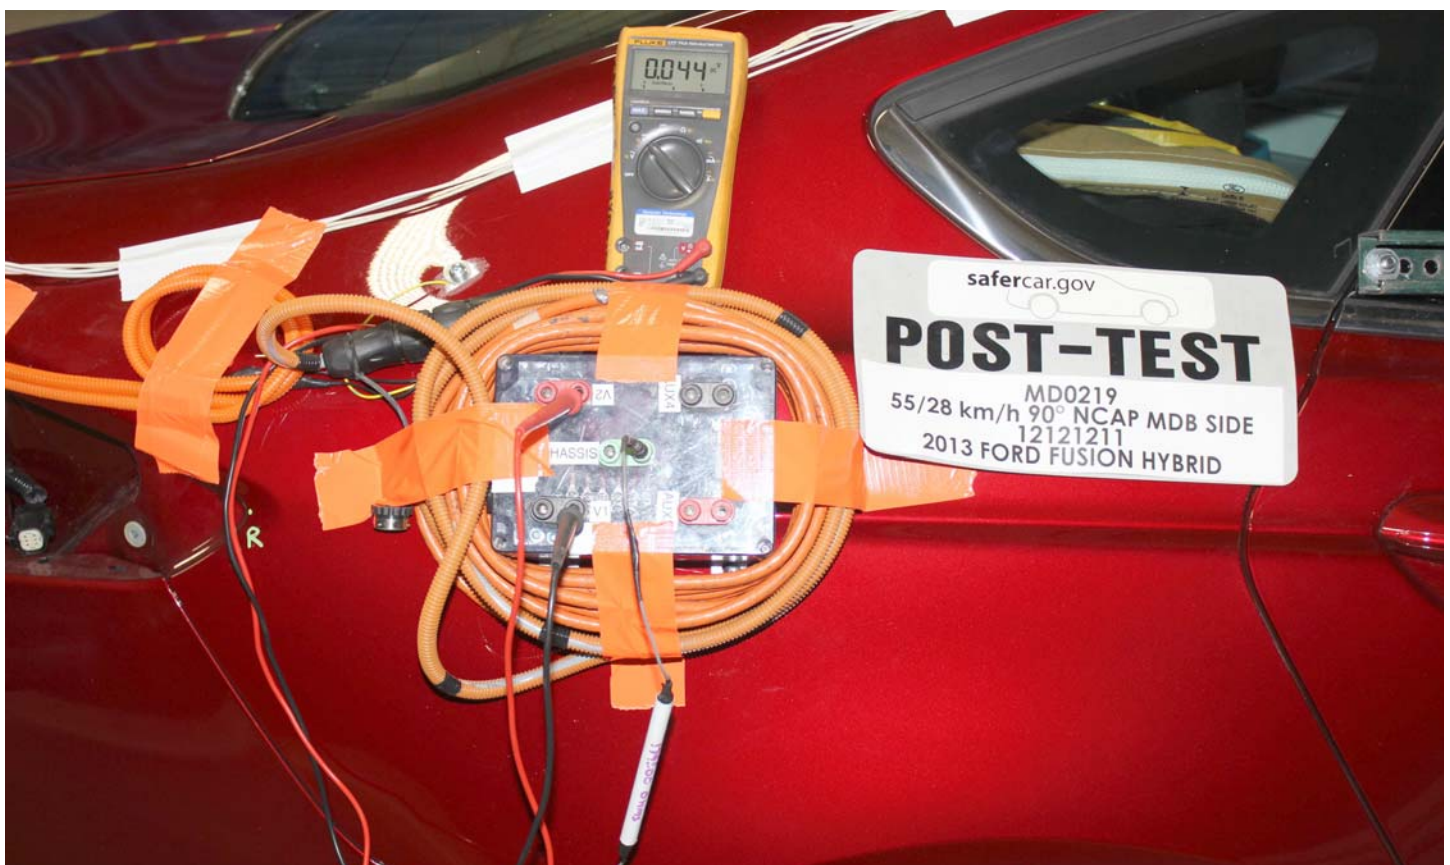
No. 025 Post-Impact View of Installed Impact Interface Port

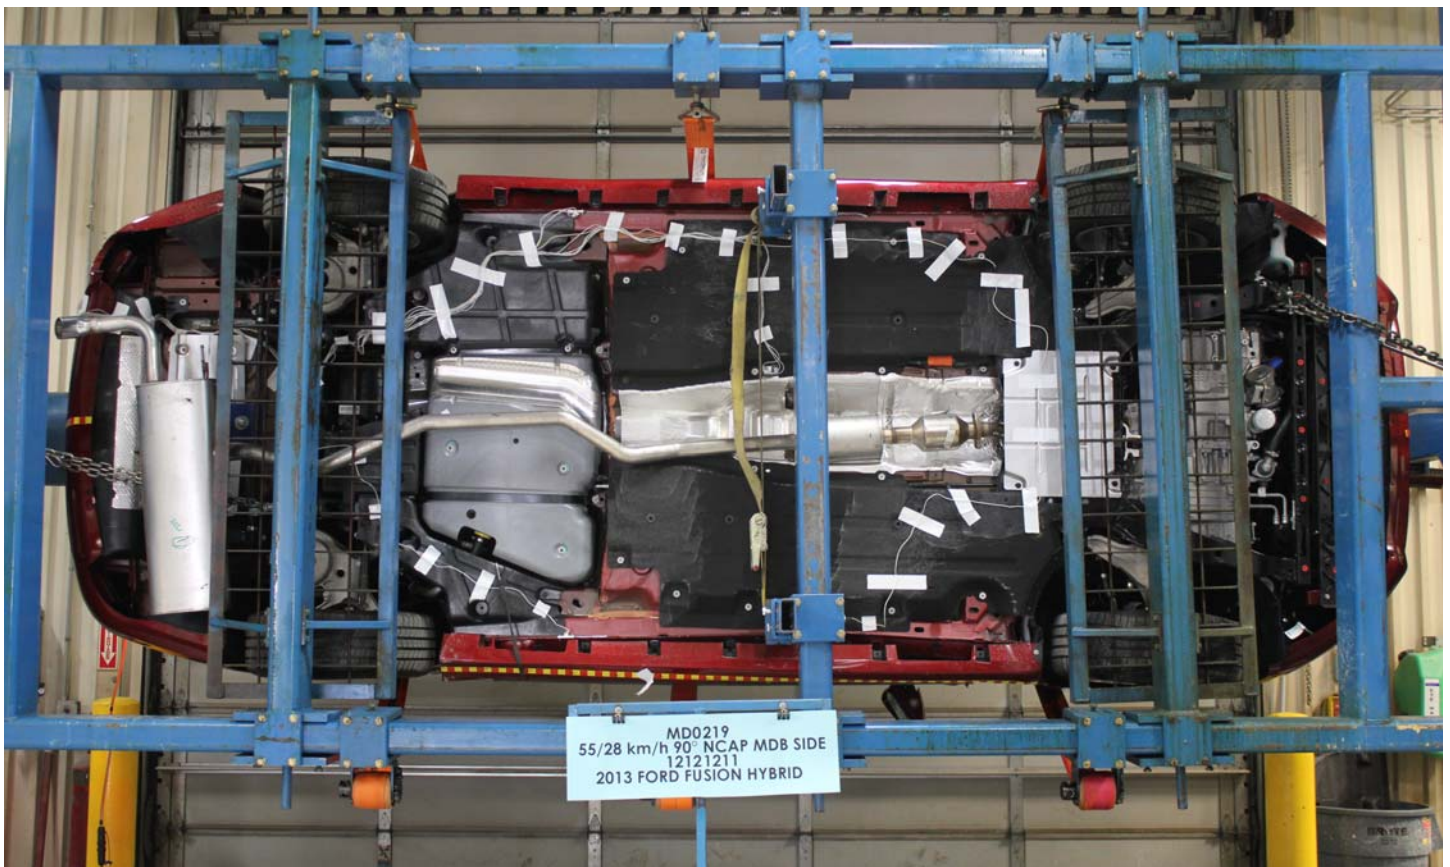
No. 028 FMVSS No. 305 Static Rollover at 90°

| Rollover Stage | Electric Energy Storage/Conversion<br>Device Electrolyte Spillage (L) | Spillage Location |
|---|---|---|
| 0° to 90° | 0 | Not Applicable |

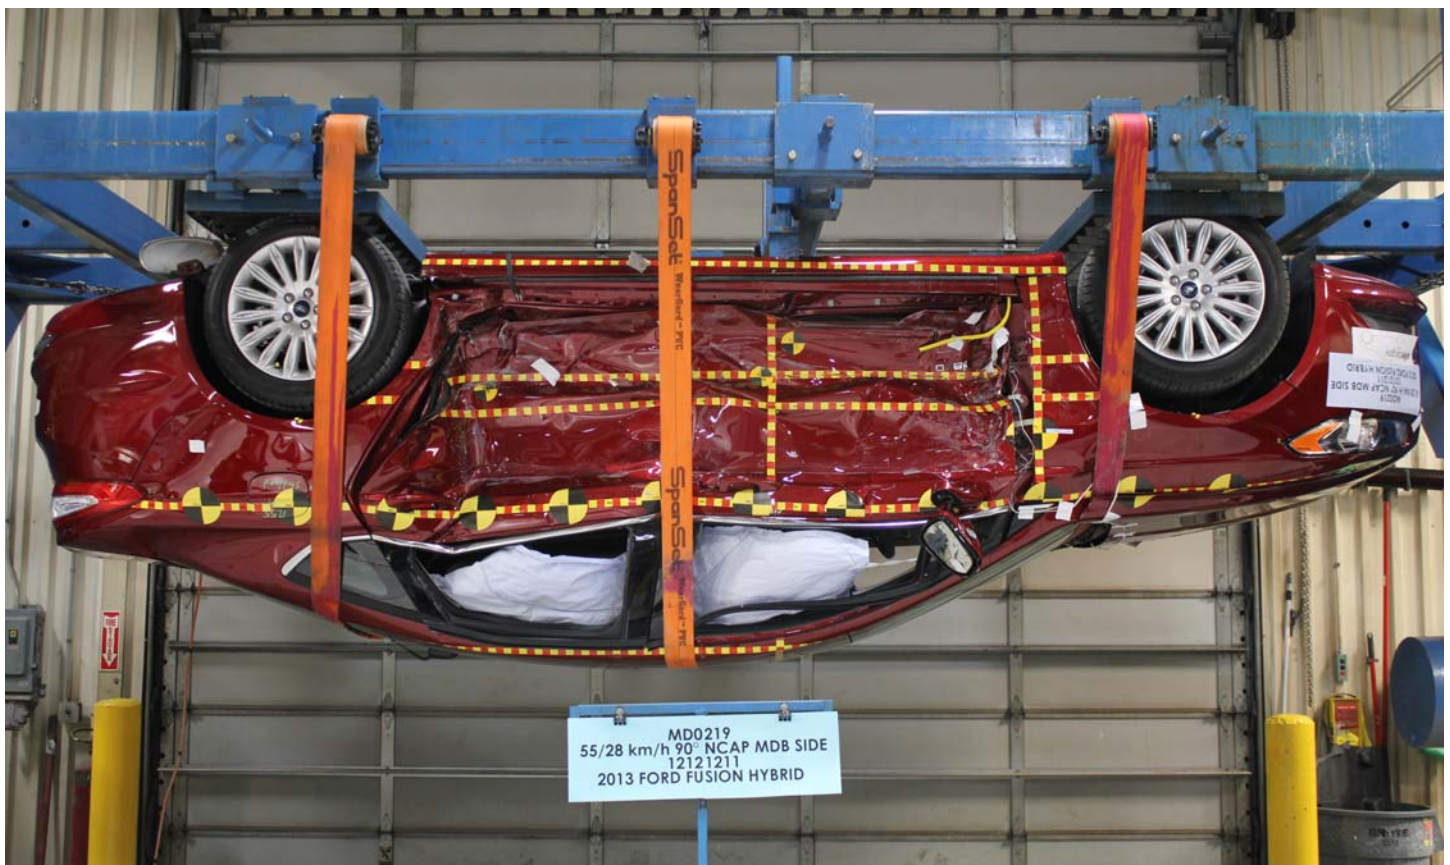
No. 029 FMVSS No. 305 Static Rollover at 180°

| Rollover Stage | Electric Energy Storage/Conversion<br>Device Electrolyte Spillage (L) | Spillage Location |
|---|---|---|
| 90° to 180° | 0 | Not Applicable |

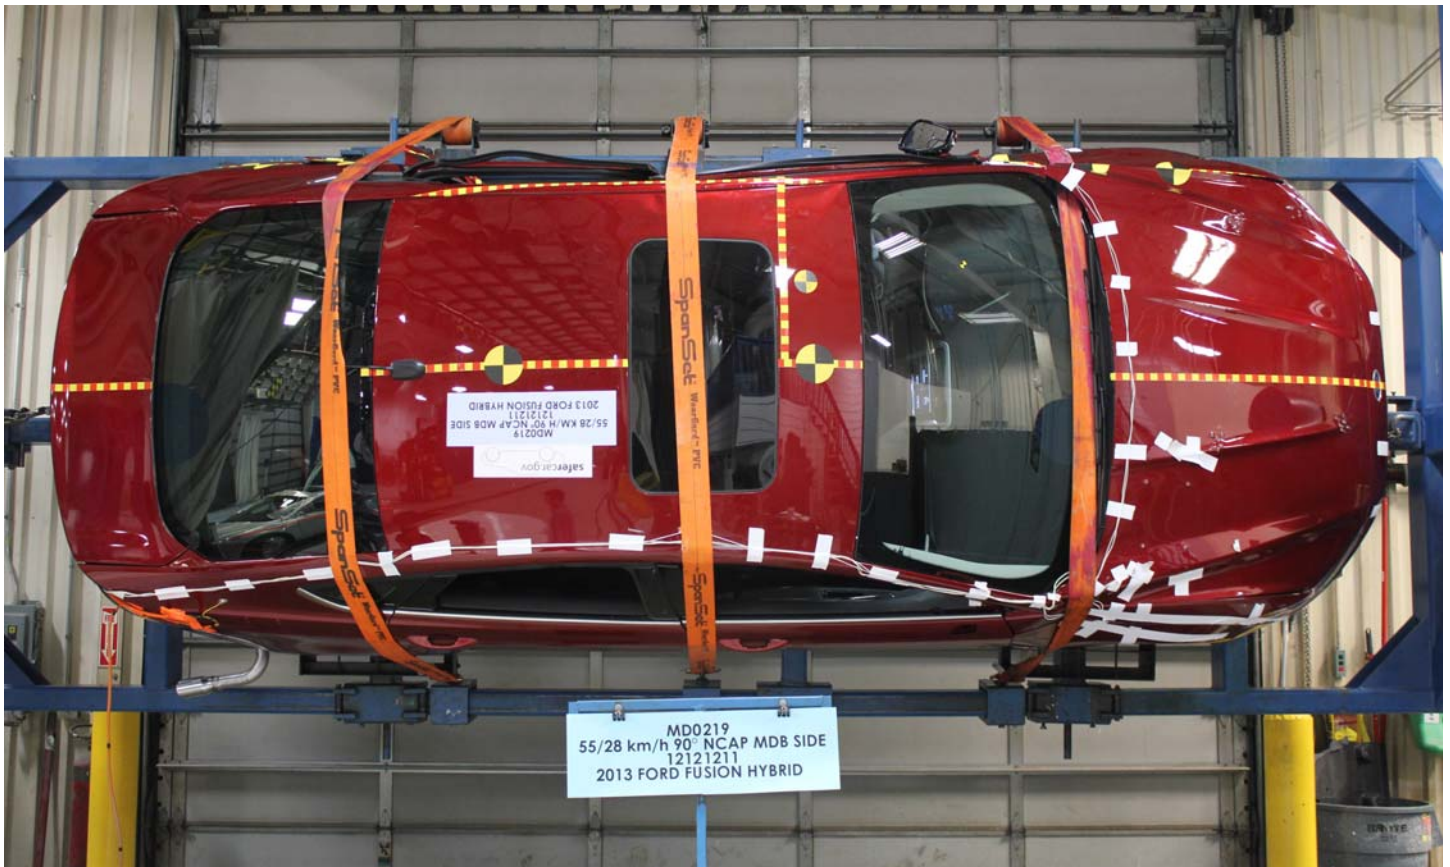
No. 030 FMVSS No. 305 Static Rollover at 270°

| Rollover Stage | Electric Energy Storage/Conversion<br>Device Electrolyte Spillage (L) | Spillage Location |
|---|---|---|
| 180° to 270° | 0 | Not Applicable |

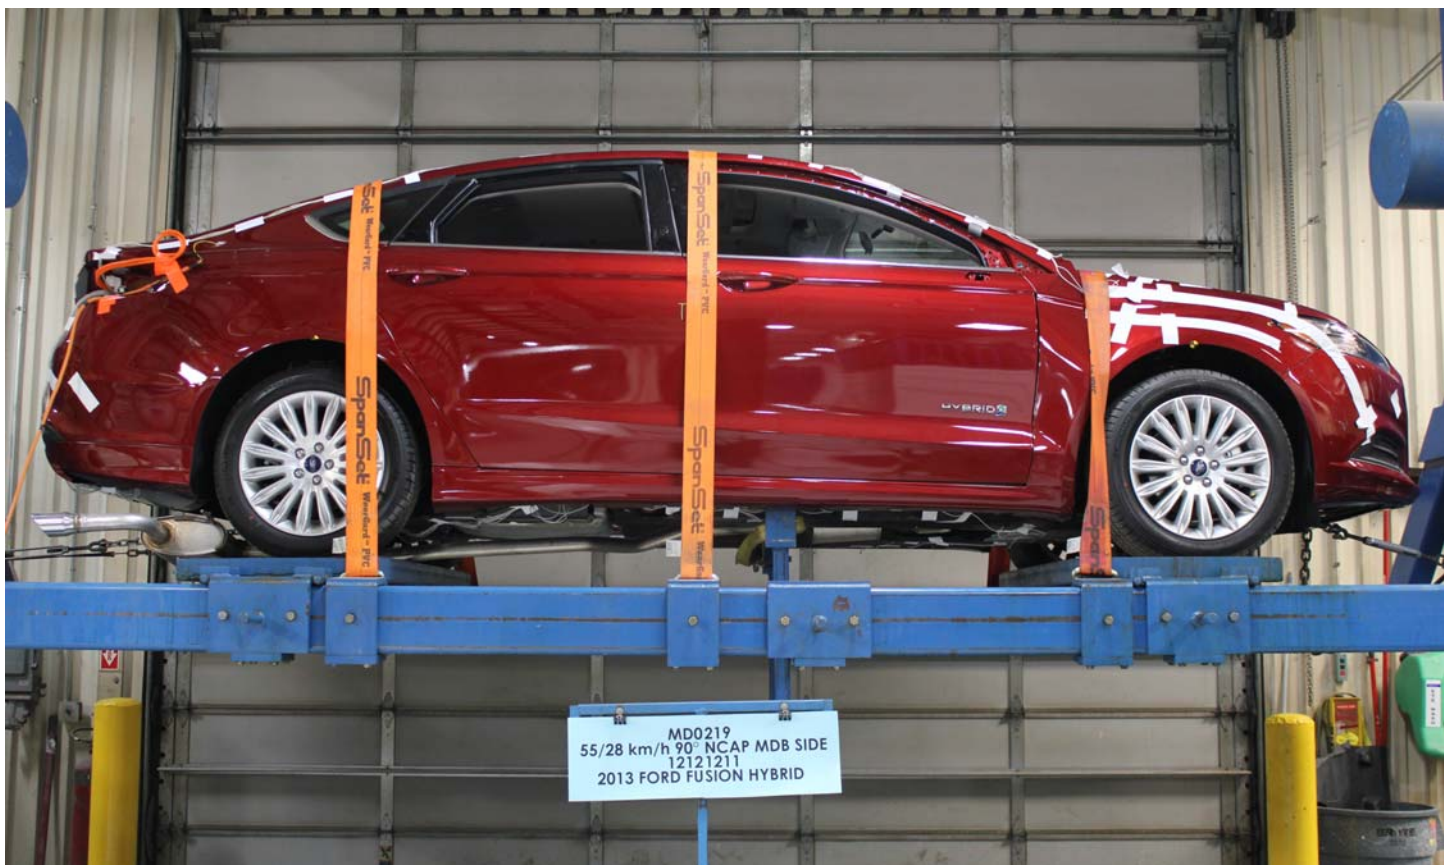
No. 031 FMVSS No. 305 Static Rollover at 360°

| Rollover Stage | Electric Energy Storage/Conversion<br>Device Electrolyte Spillage (L) | Spillage Location |
|---|---|---|
| 270° to 360° | 0 | Not Applicable |

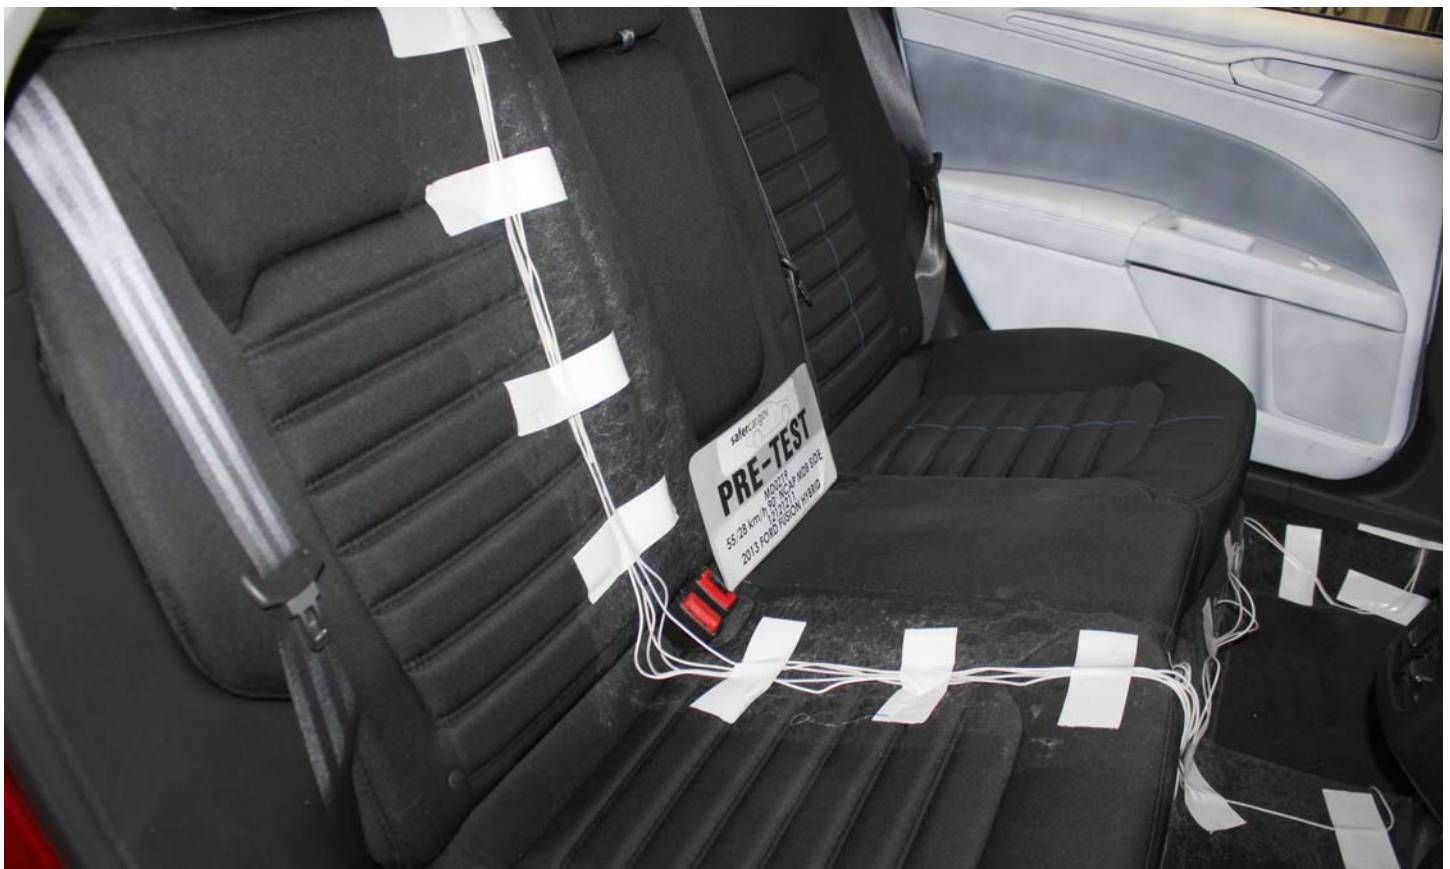
No. 032 Pre-Impact View of the Vehicle Passenger Compartment Adjacent to Propulsion Battery

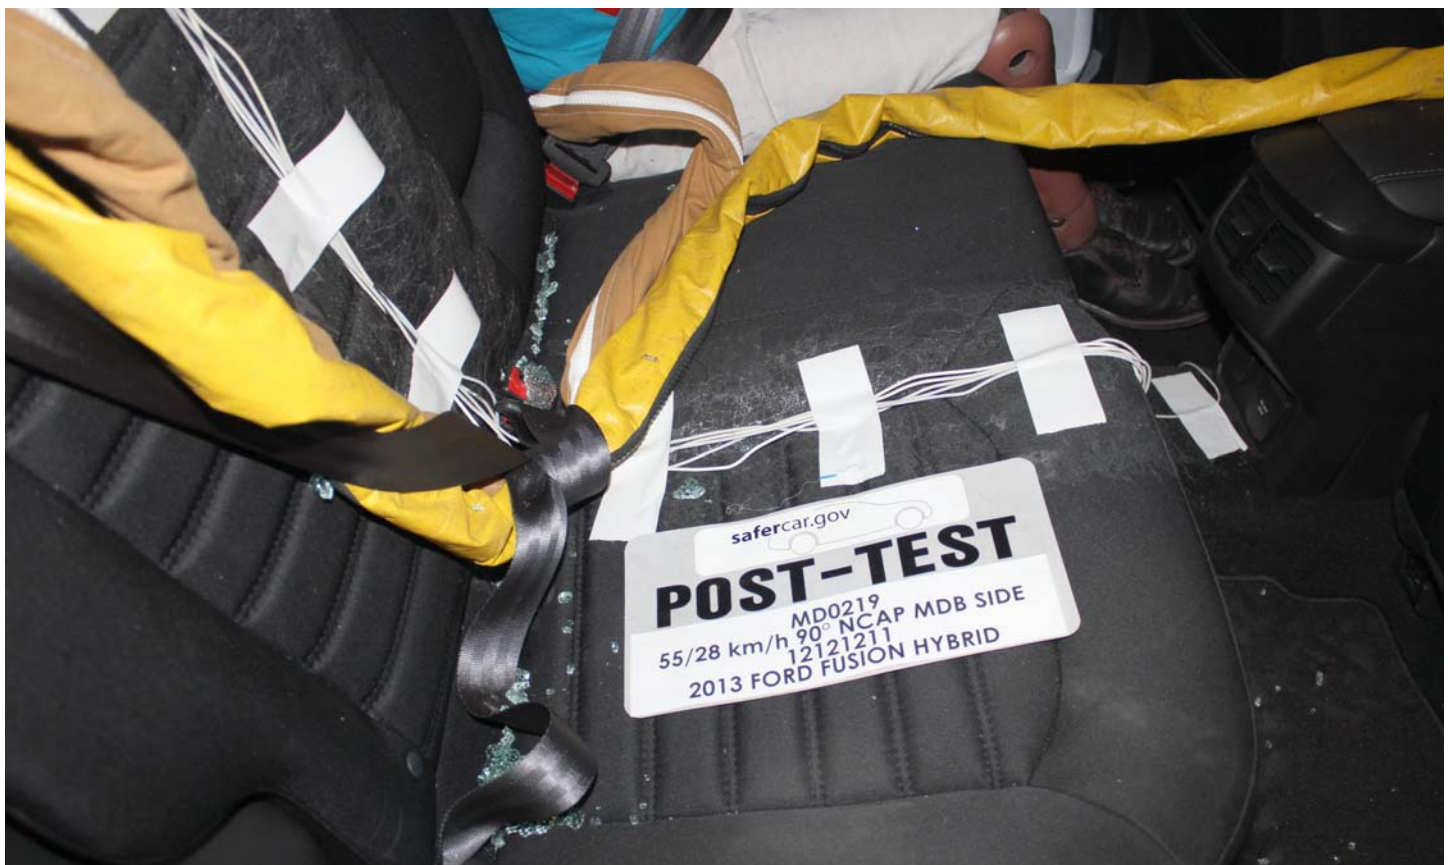
No. 033 Post-Impact View of the Vehicle Passenger Compartment Adjacent to Propulsion Battery

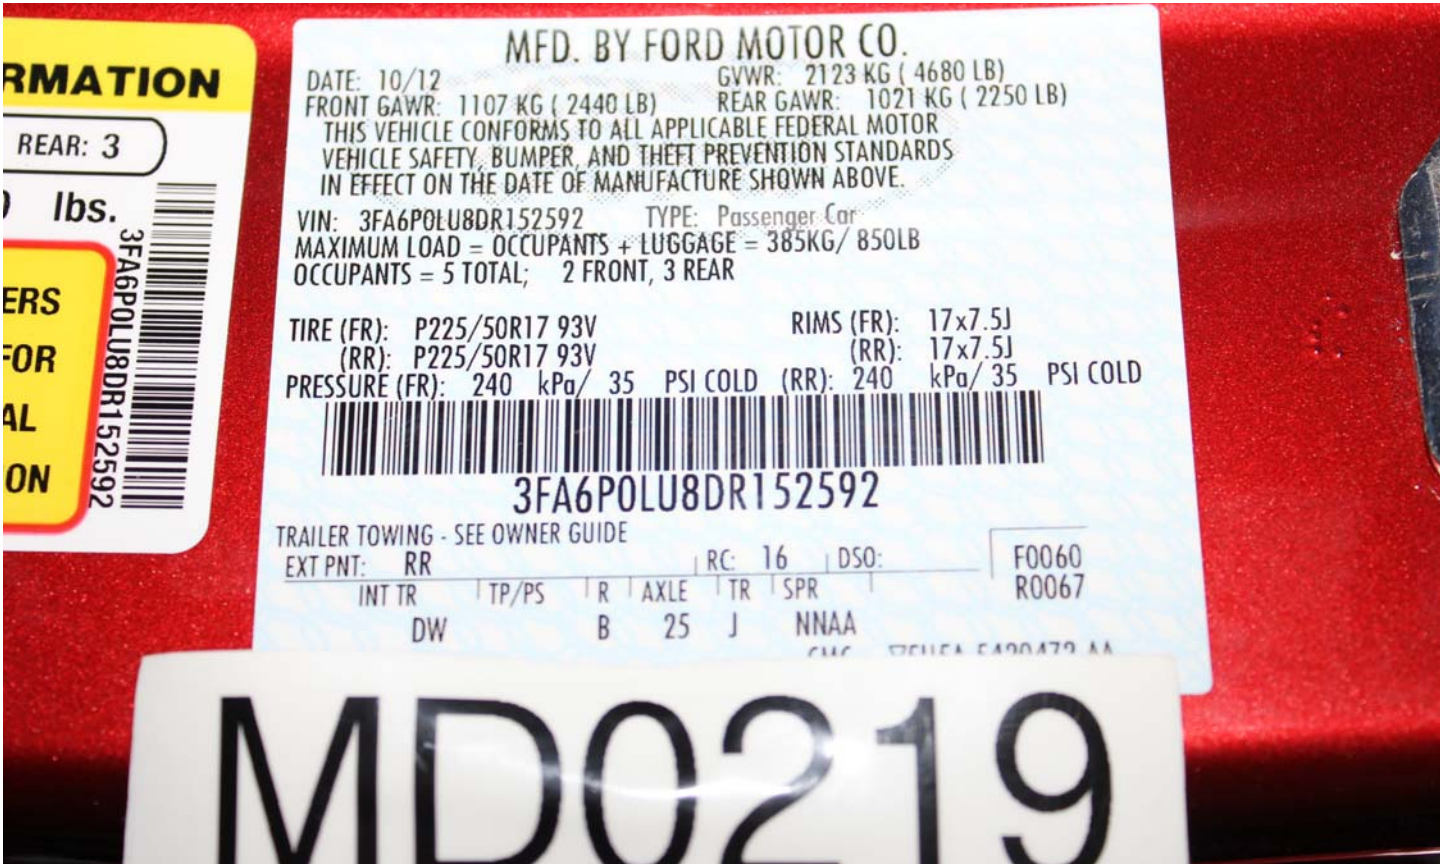
No. 041 Vehicle's Certification Label

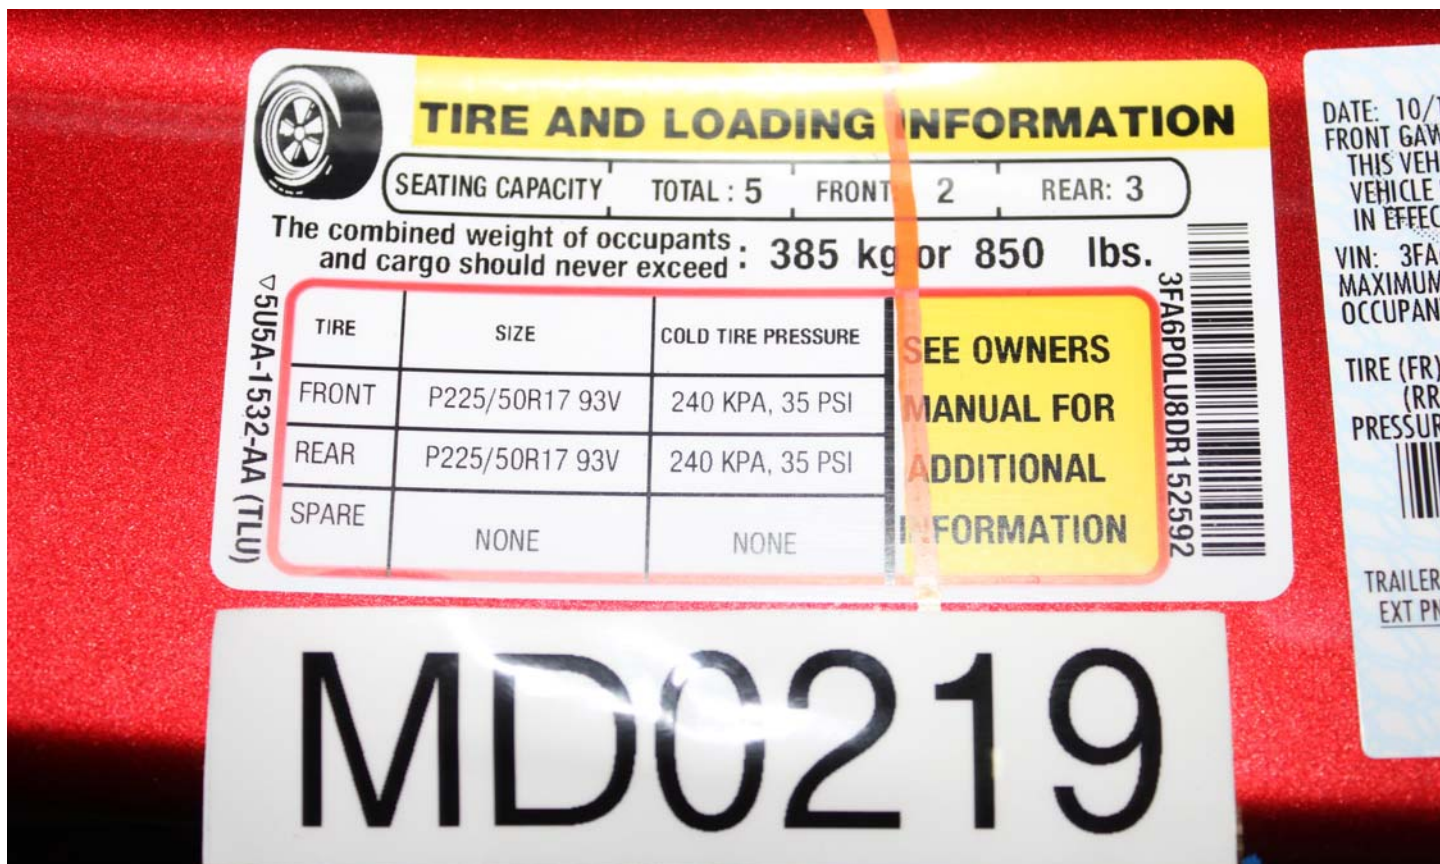
No. 042 Vehicle's Tire Information Placard
