**REPORT NUMBER: SINCAP-MGA-2013-041**

**NEW CAR ASSESSMENT PROGRAM (NCAP)  
Moving Deformable Barrier Side Impact Test**

**FORD MOTOR COMPANY  
2013 Ford Fusion SE Hybrid 4-Dr Sedan  
NHTSA No.: MD0219**

**FINAL REPORT**

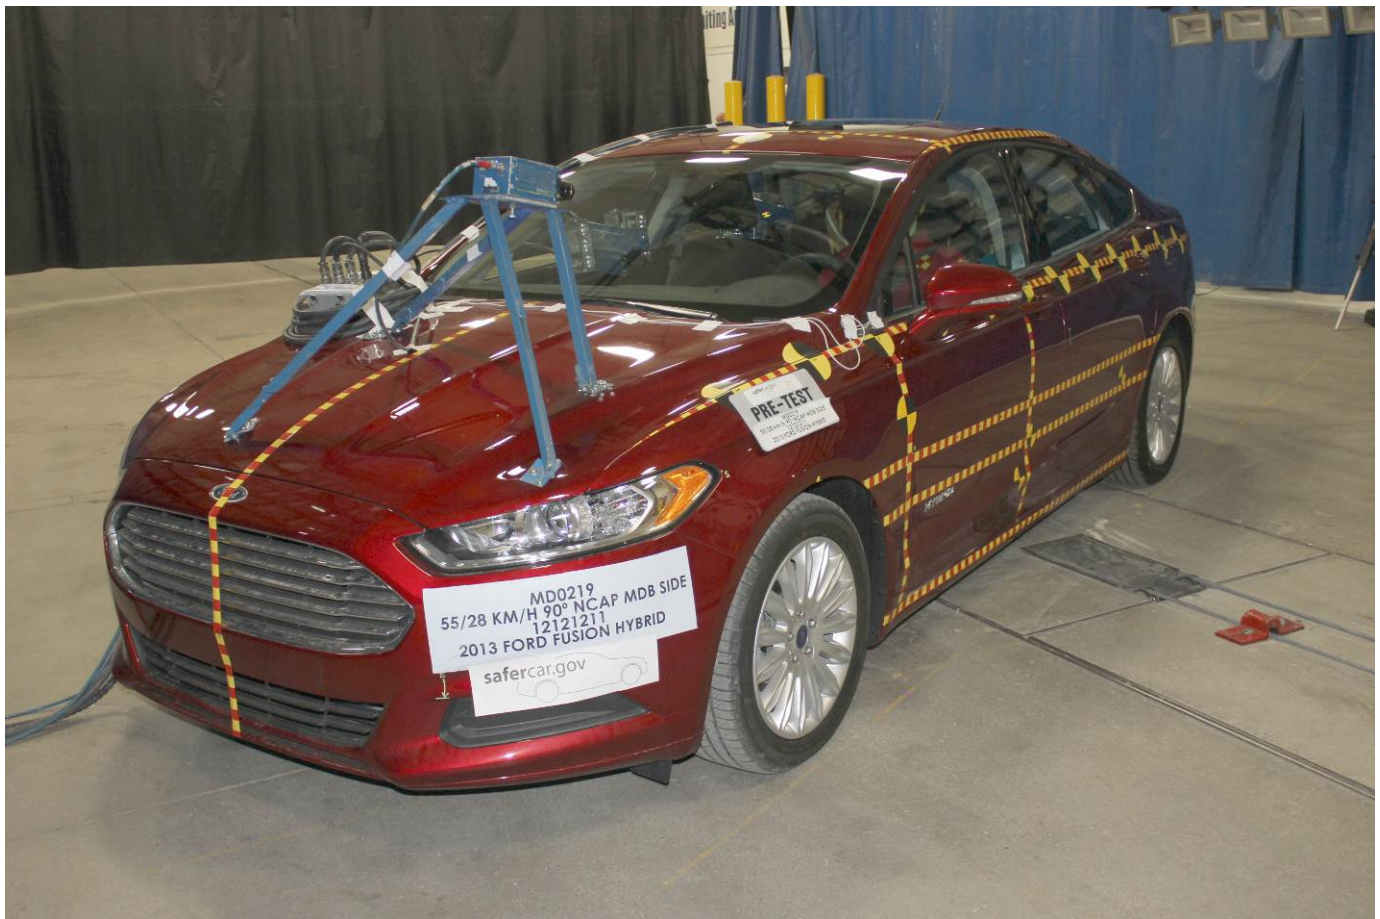
Post-Test Left Front Three-Quarter View of Test Vehicle

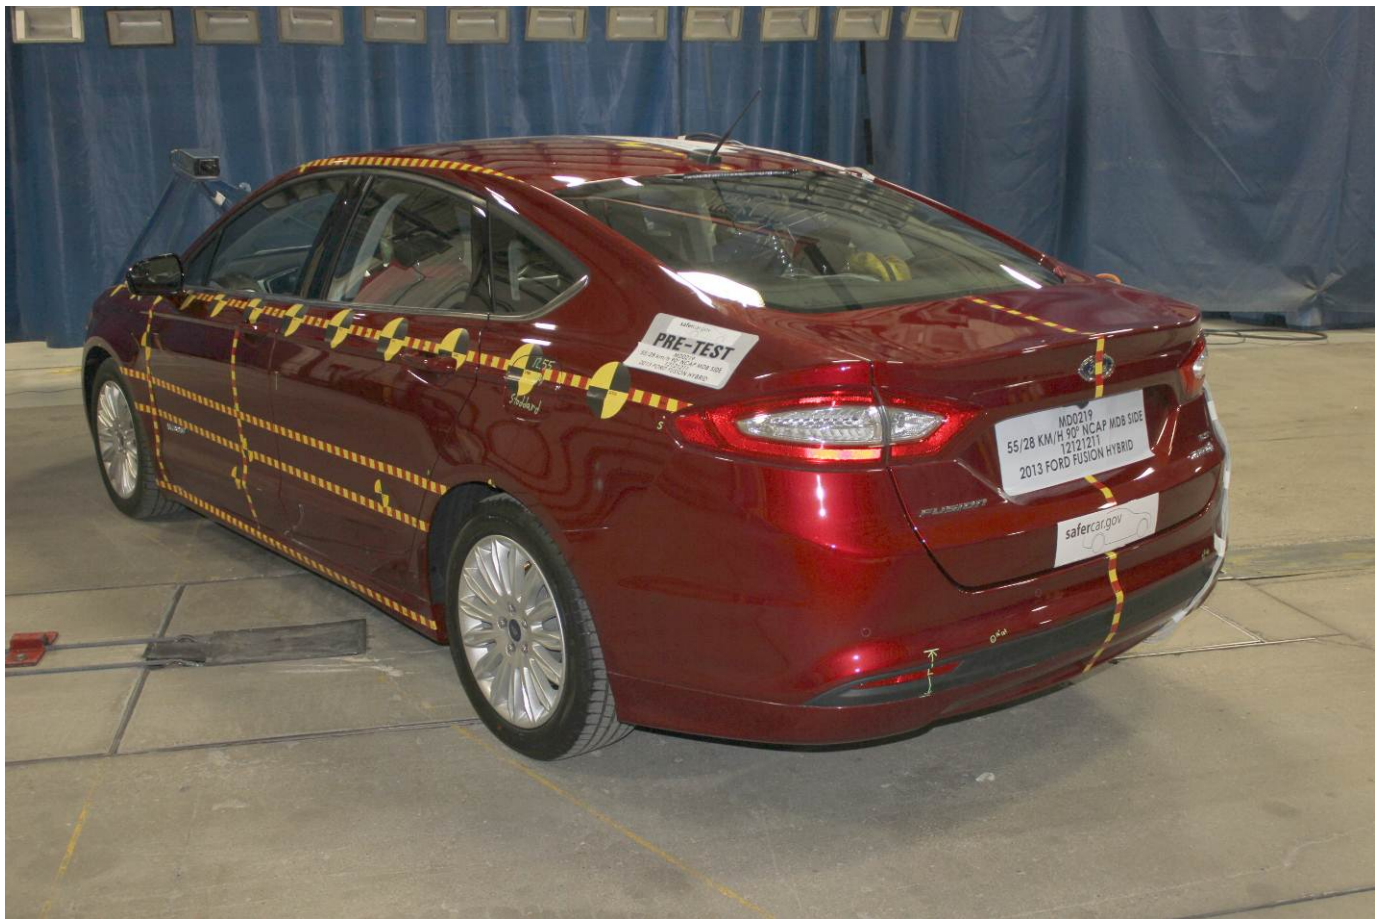
Post-Test Left Side View of Test Vehicle

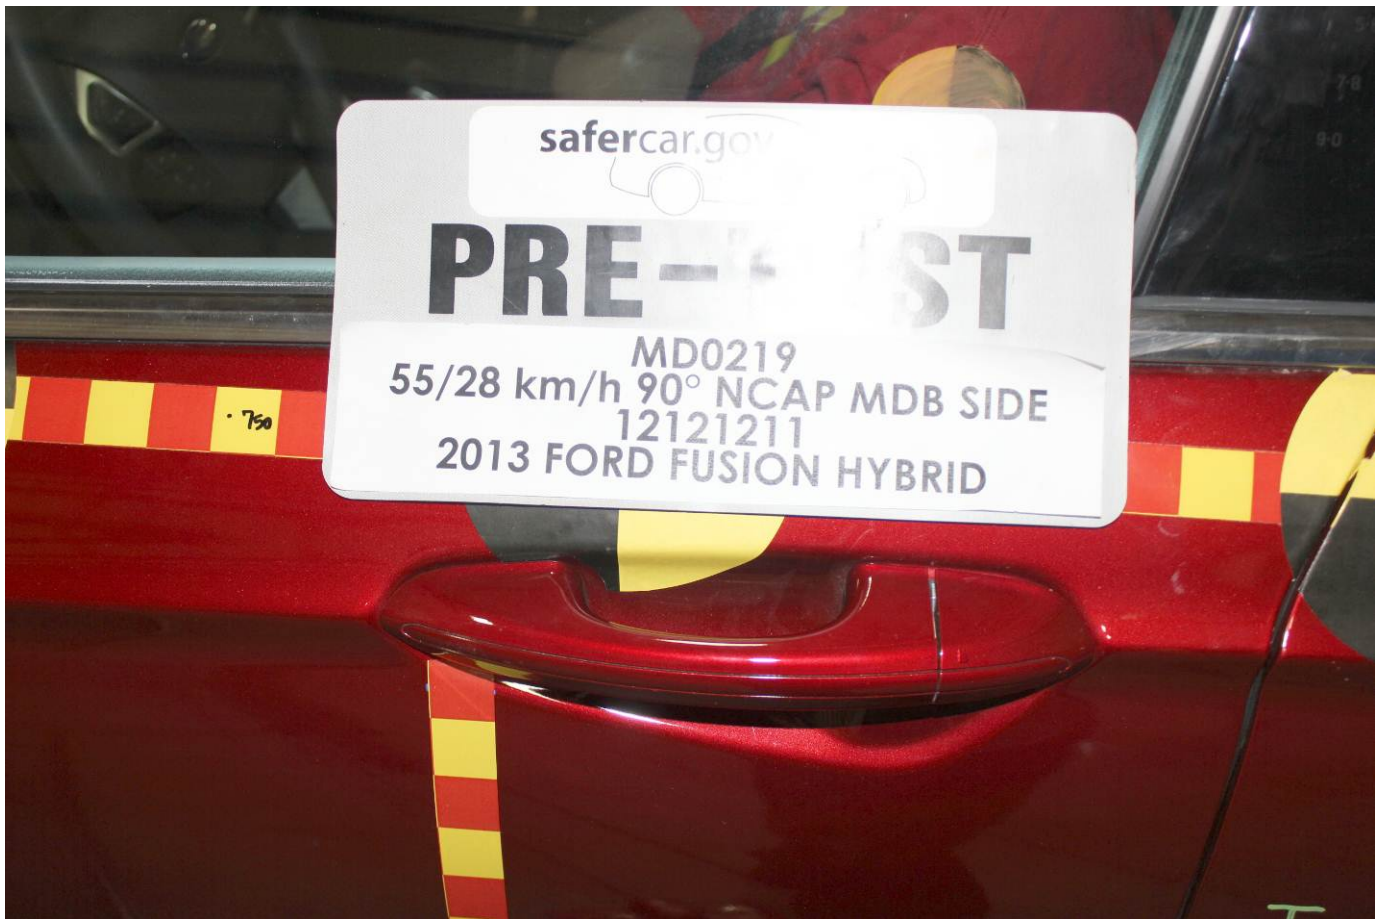
Post-Test Close-Up View of Impact Point Target

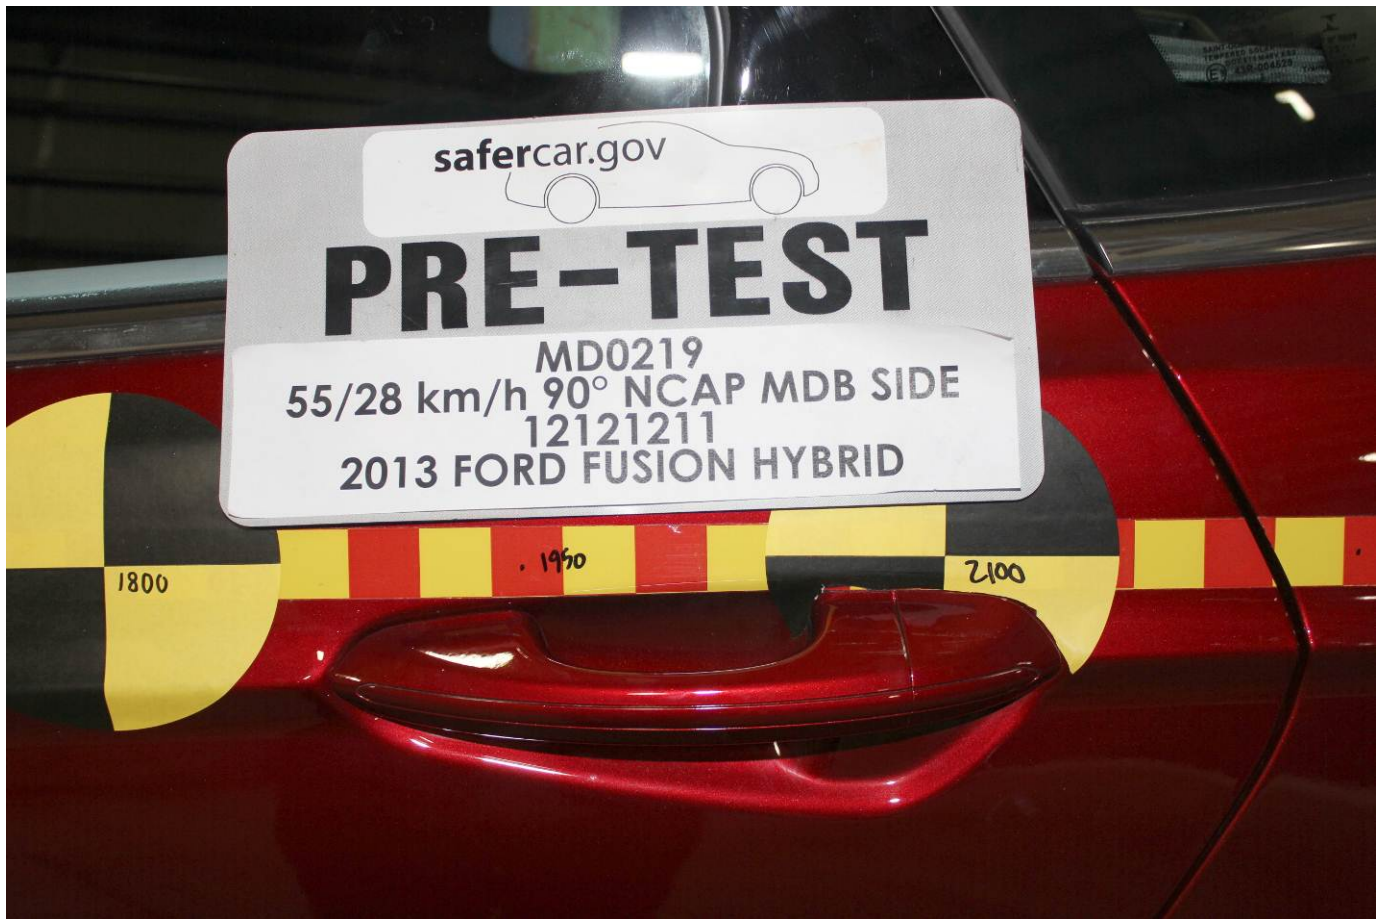
Post-Test Left Front Door Latch Close-Up
