REPORT NUMBER: SINCAP-KAR-13-032

**NEW CAR ASSESSMENT PROGRAM (NCAP)
MOVING DEFORMABLE BARRIER SIDE IMPACT TEST**

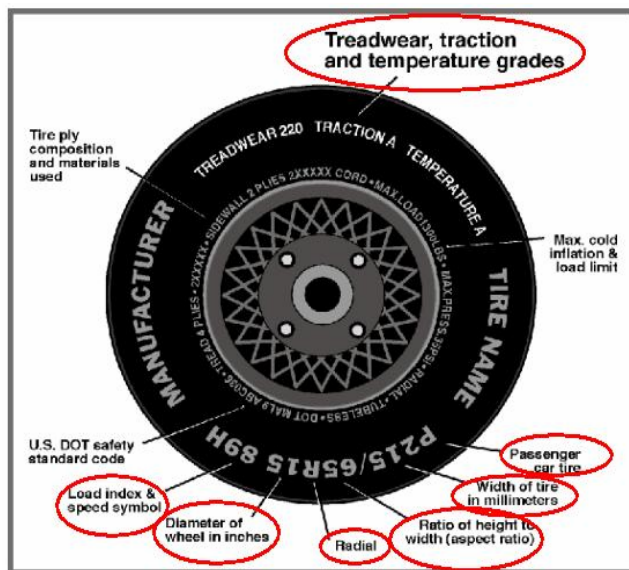
VEHICLE TIRE INFORMATION
