REPORT NUMBER: NCAP-KAR-13-034

**NEW CAR ASSESSMENT PROGRAM (NCAP)
FRONTAL BARRIER IMPACT TEST**

**FORD MOTOR CO.
2013 FORD FOCUS ELECTRIC 5-DOOR HATCHBACK**

**PREPARED BY:
KARCO ENGINEERING, LLC.
9270 HOLLY ROAD
ADELANTO, CA 92301**

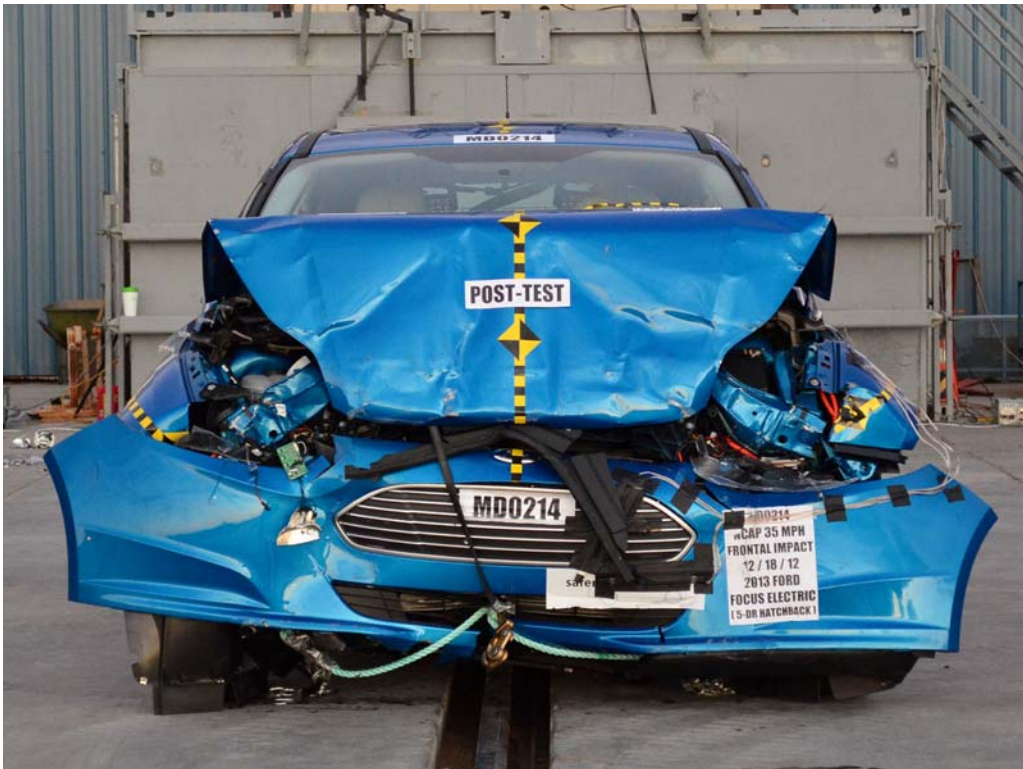
FIGURE 8. Post-Test Front View of Test Vehicle

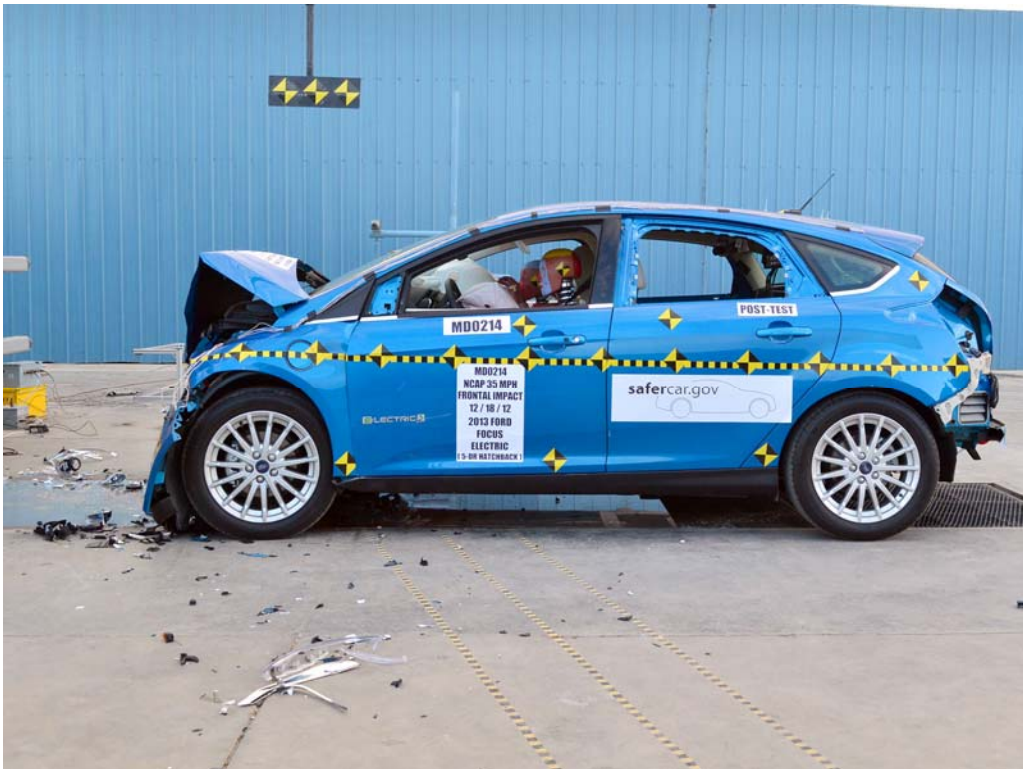
FIGURE 10. Post-Test Left View of Test Vehicle

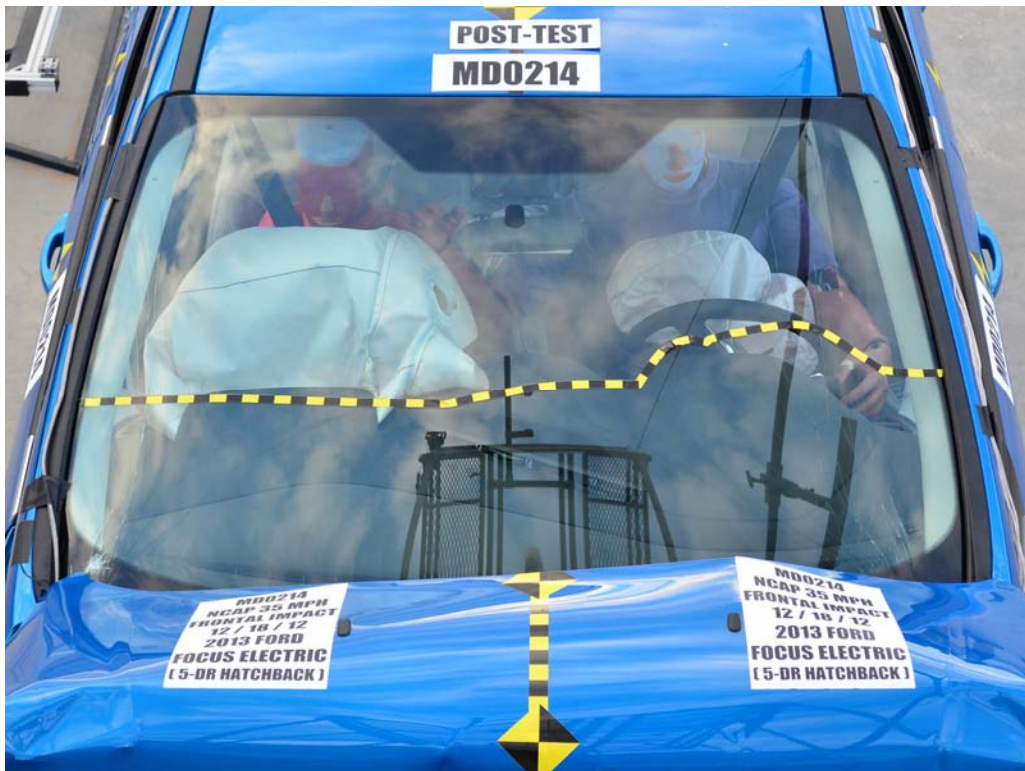
FIGURE 18. Post-Test Windshield View

| Critical Areas of Performance | Observations and Conclusions |
|---|---|
| Windshield Damage | Broken |

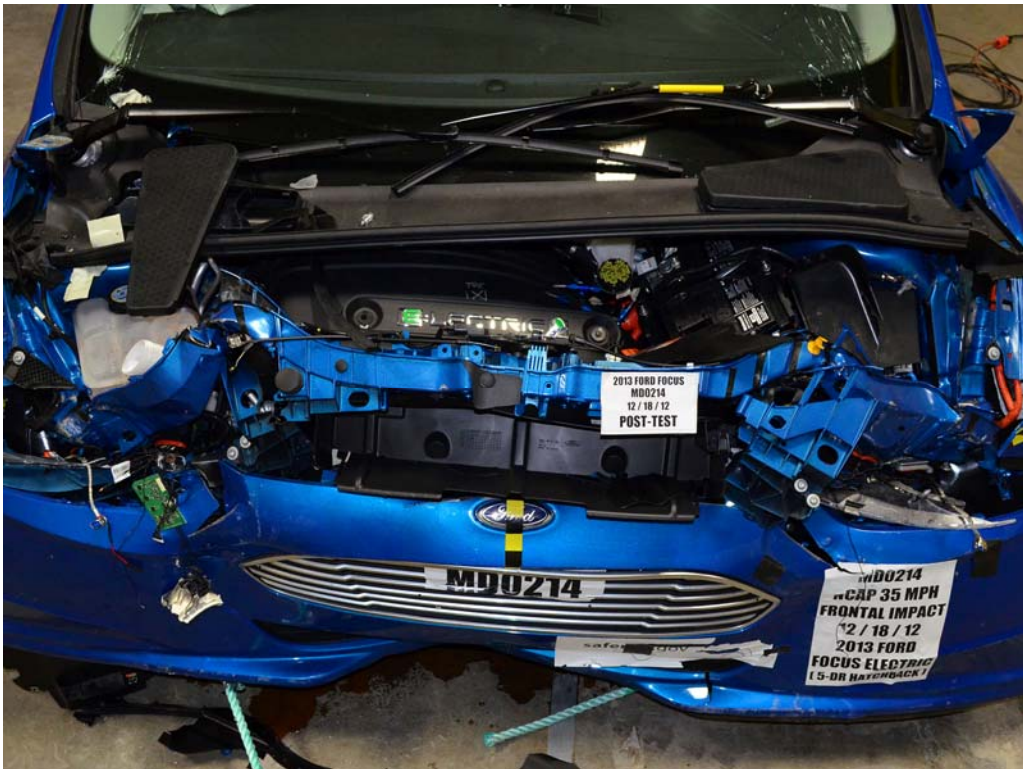
FIGURE 20. Post-Test Engine Compartment View

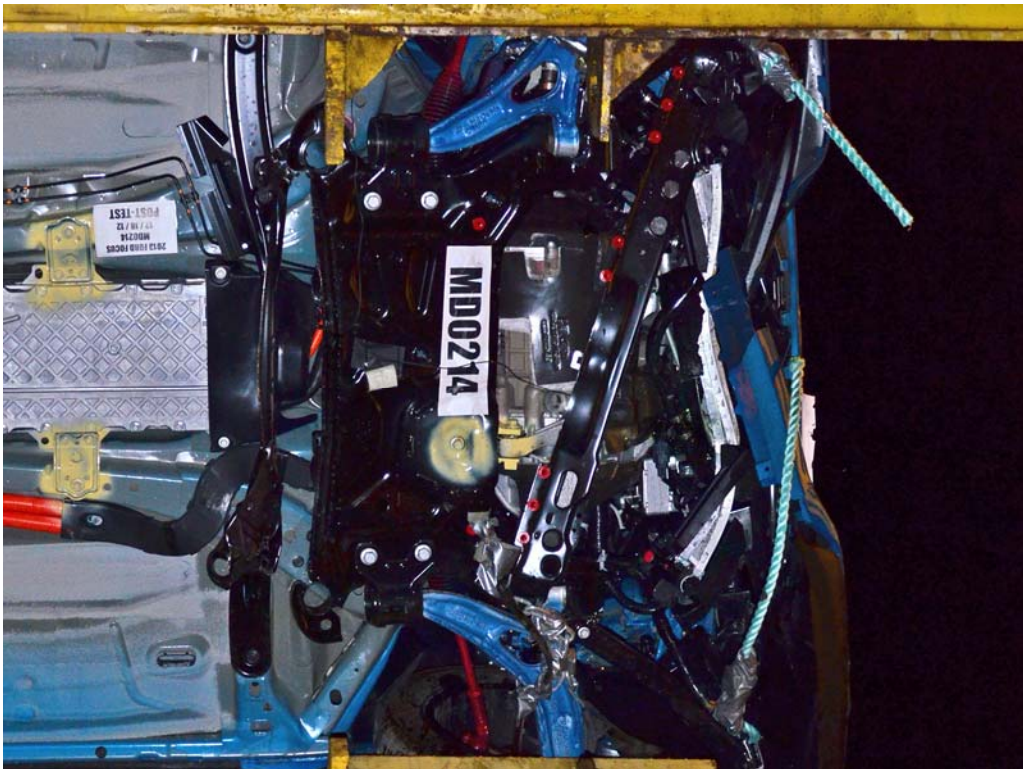
FIGURE 24. Post-Test Front Underbody View

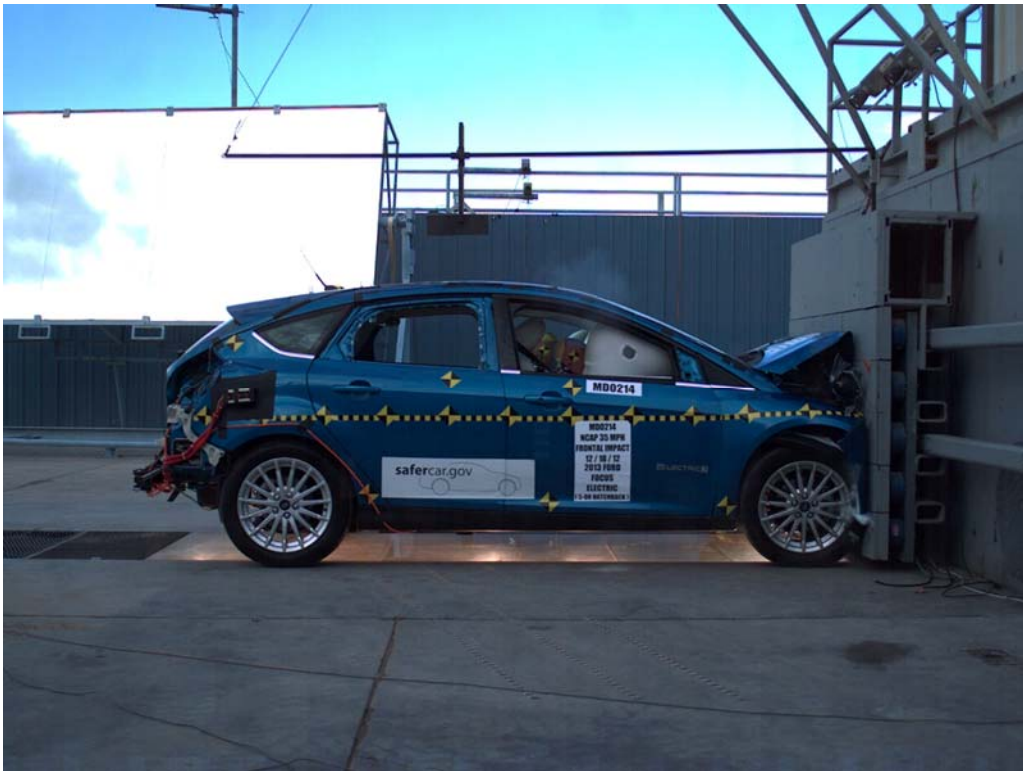
FIGURE 75. 2013 Ford Focus Electric Frontal Impact Event
