**REPORT NUMBER: NCAP-MGA-2013-045**

**NEW CAR ASSESSMENT PROGRAM (NCAP)  
Frontal Barrier Impact Test**

**MERCEDES-BENZ U.S. INTL., INC  
2013 Mercedes-Benz ML350 AWD SUV  
NHTSA No.: MD0509**

**FINAL REPORT**

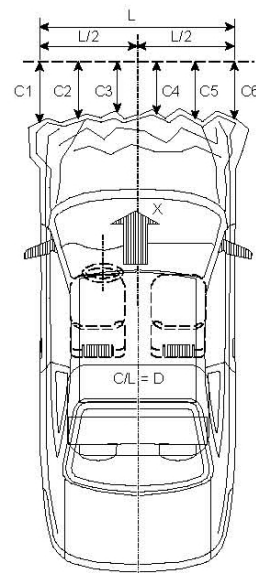
Midpoint of Damage: Centerline

Damage Region Length (mm): 1400

Impact Mode: Frontal

No.	Measurement Description	Units	Pre-Test	Post-Test	Difference
C1	Crush zone 1 at left side	mm	4628	4271	357
C2	Crush zone 2 at left side	mm	4716	4247	469
C3	Crush zone 3 at left side	mm	4755	4245	510
C4	Crush zone 4 at right side	mm	4755	4226	529
C5	Crush zone 5 at right side	mm	4716	4217	499
C6	Crush zone 6 at right side	mm	4628	4221	407
L	C1 TO C6	mm	1400	1378	22

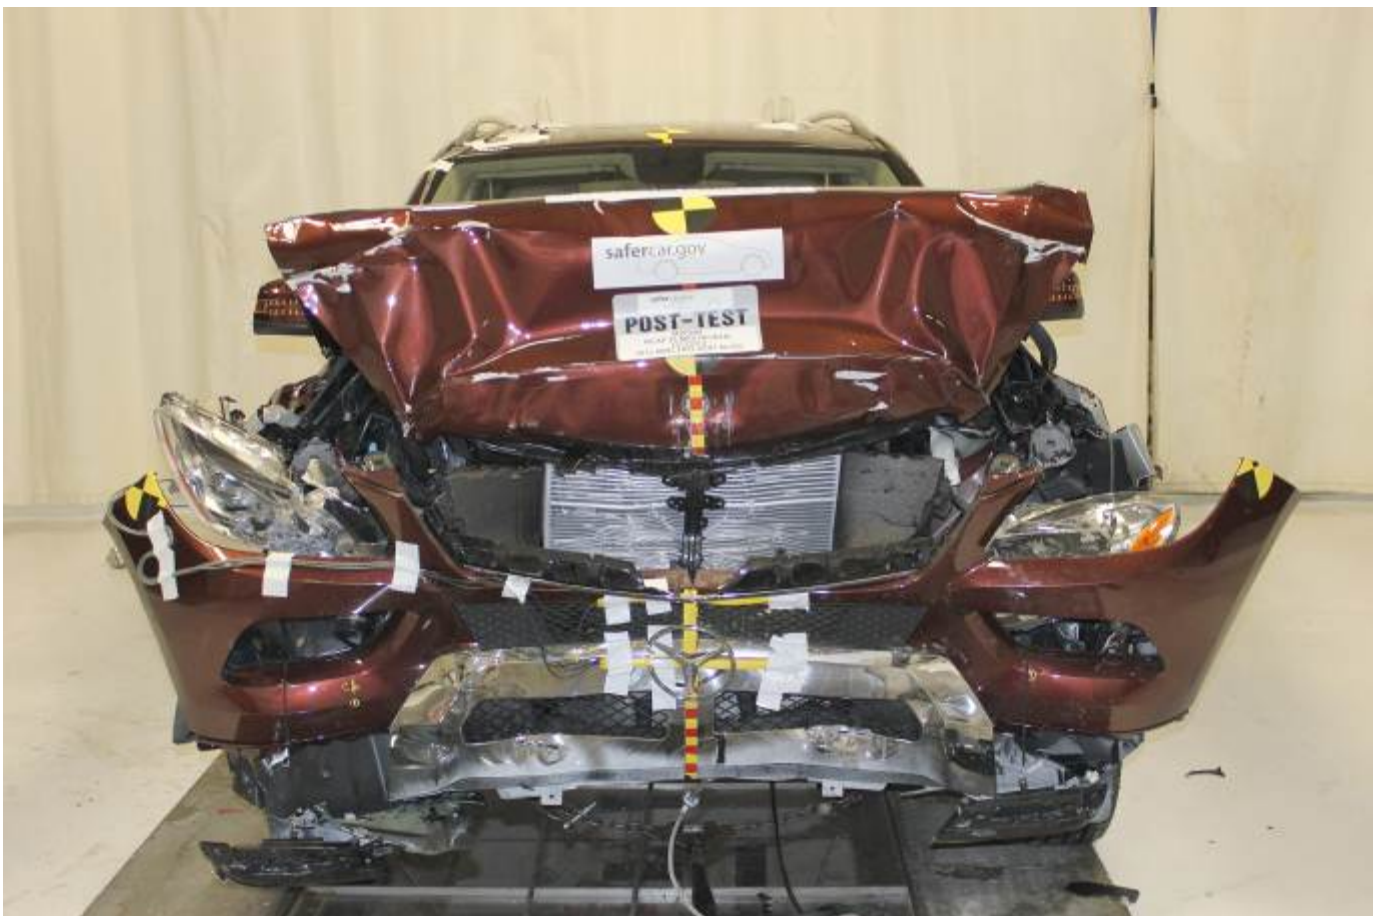
The maximum static crush of the vehicle was 554 mm and both the driver and passenger side doors remained closed during the impact event and were operable after the impact.

Post-Test Front View of Test Vehicle

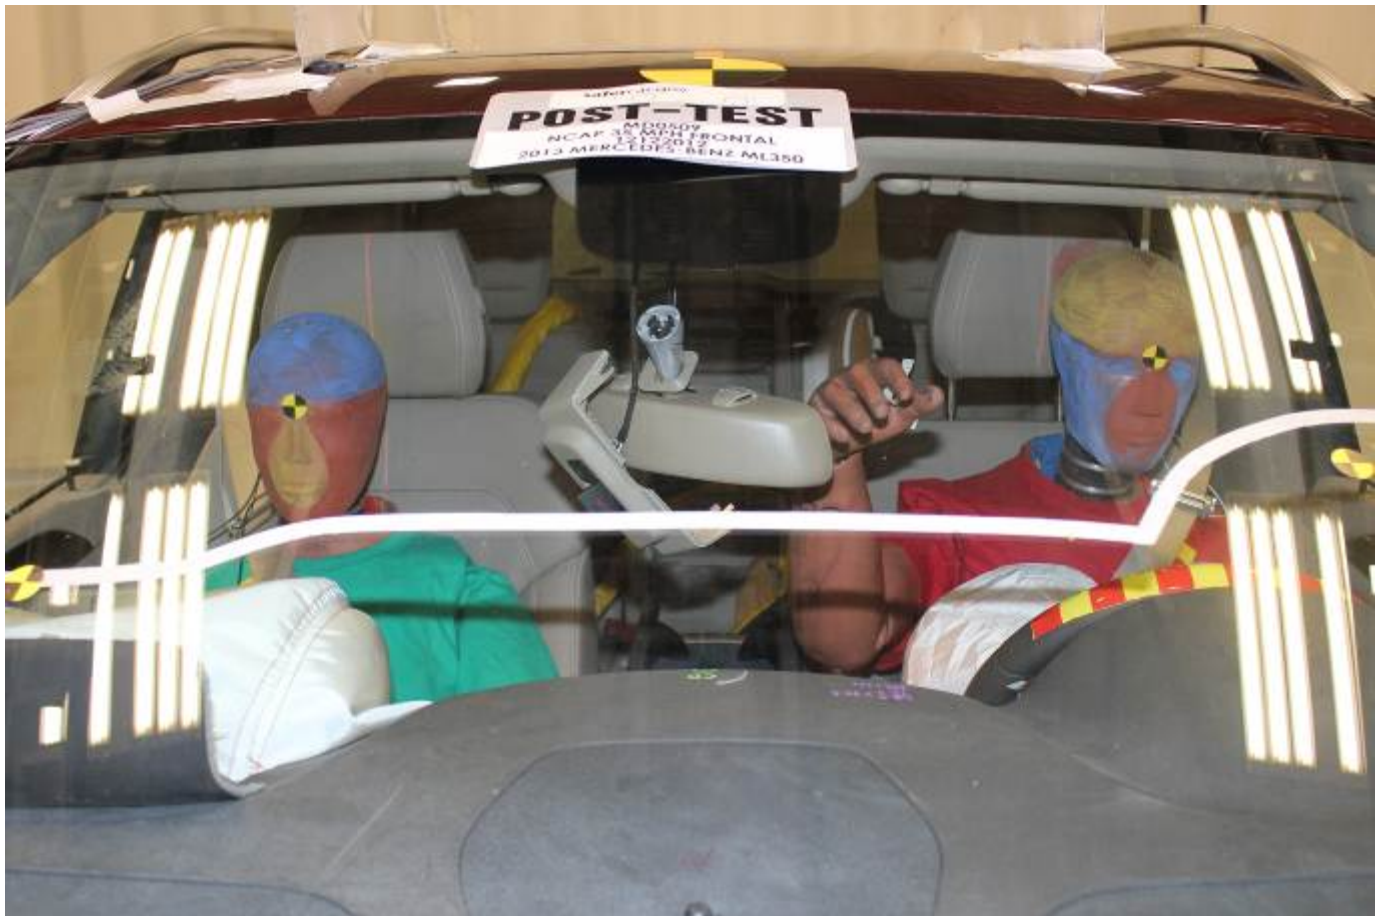
There was 100 percent windshield retention and no intrusion into the protected zone of the windshield during the event. There was no Stoddard Solvent leakage after the event or during any phase of the static rollover.

Post-Test Windshield View

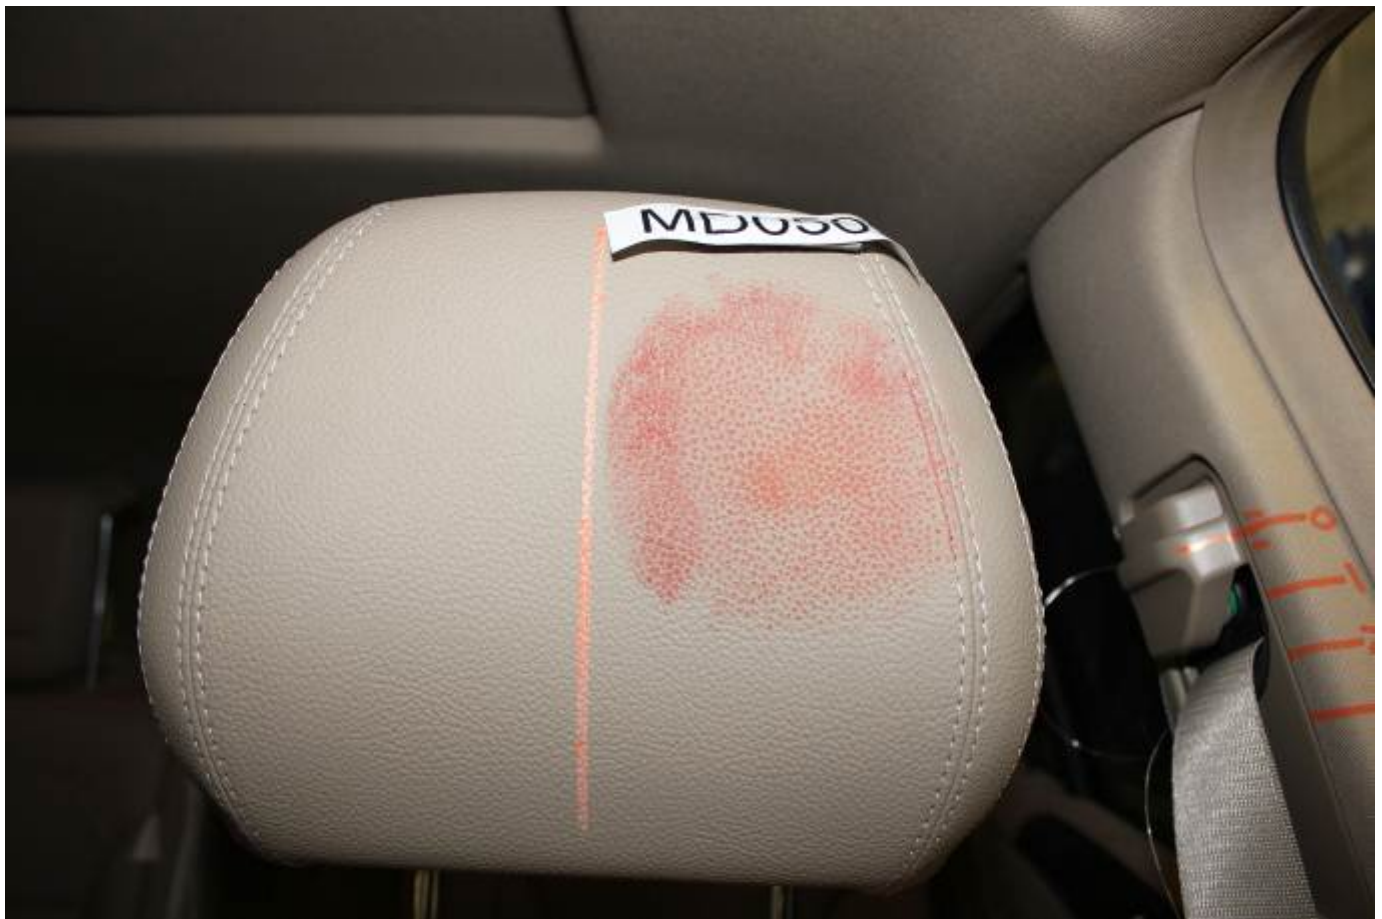
The driver's visible contact points were as follows: The driver's head and chest contacted the airbag. The driver's head also contacted the headrest. The driver's knees contacted the knee airbag. The passenger's visible contact points were as follows: The passenger's head and chest contacted the airbag. The passenger's head also contacted the headrest. The passenger's knees contacted the glove box.

Post-Test Driver Dummy Contact with Headrest

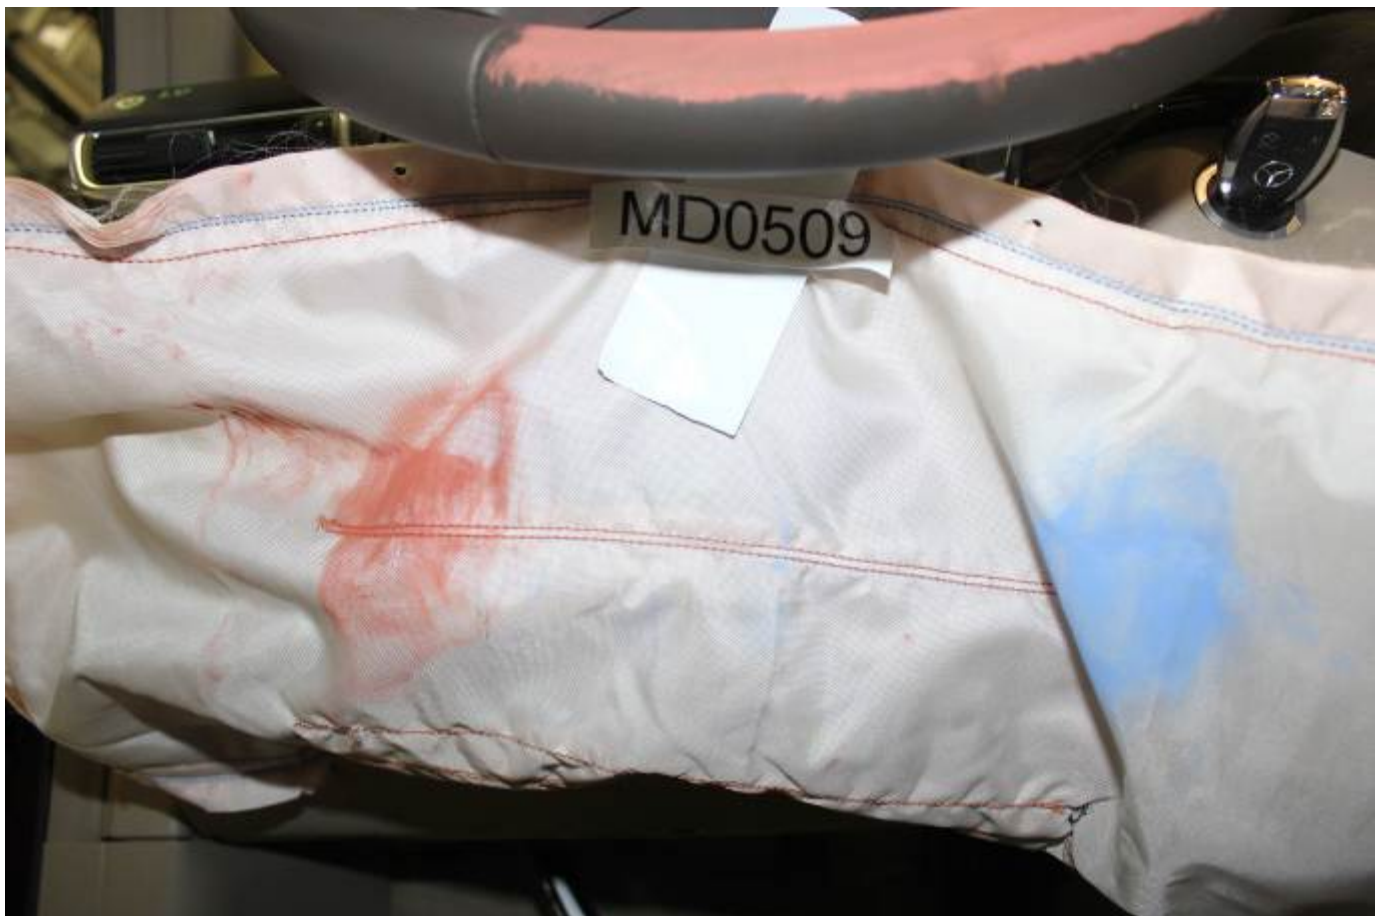
Post-Test Driver Dummy Contact with Knee Airbag

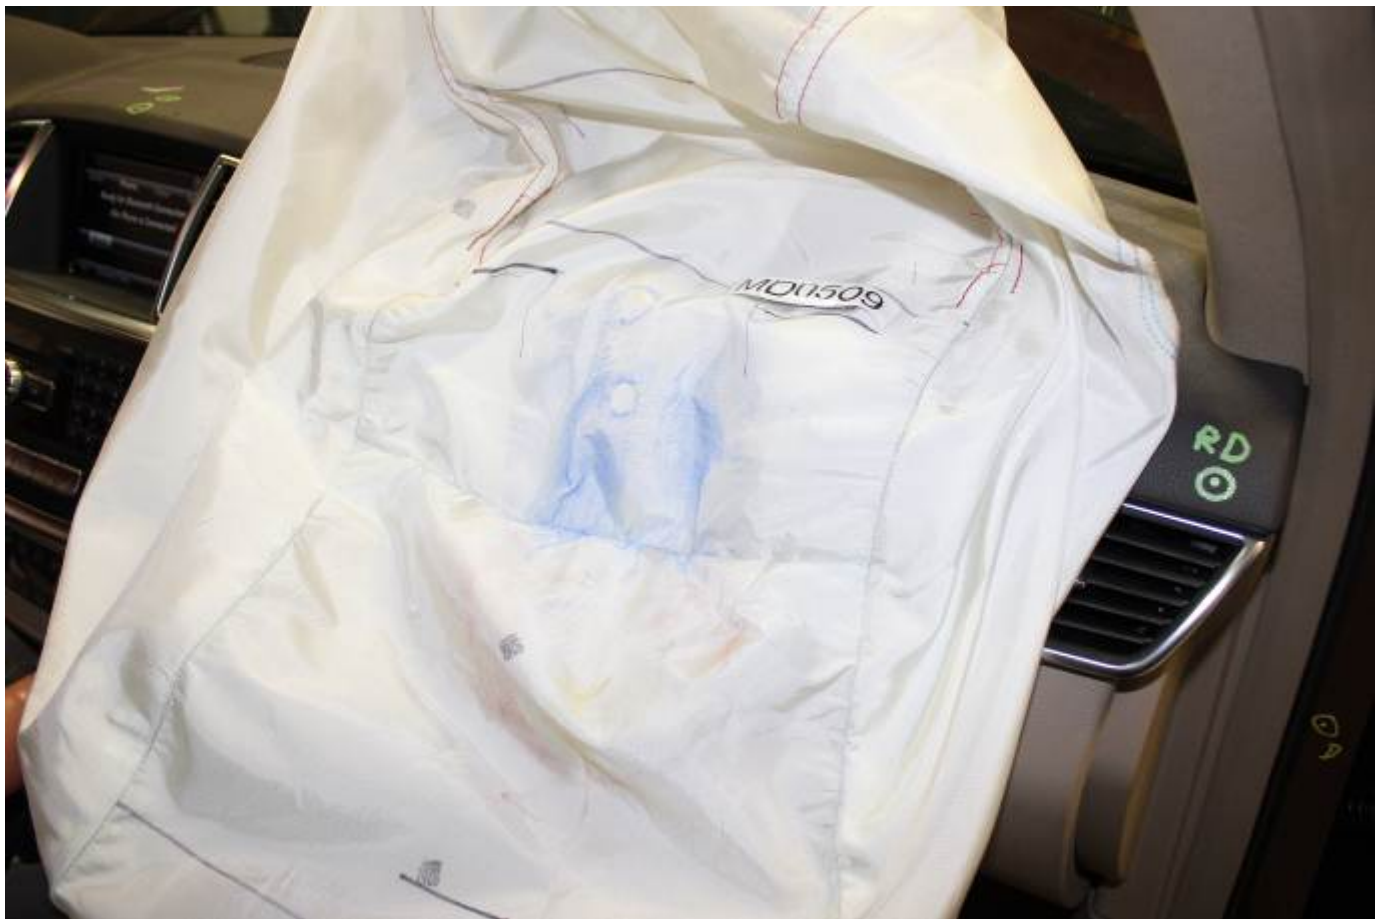
Post-Test Passenger Dummy Contact with Airbag

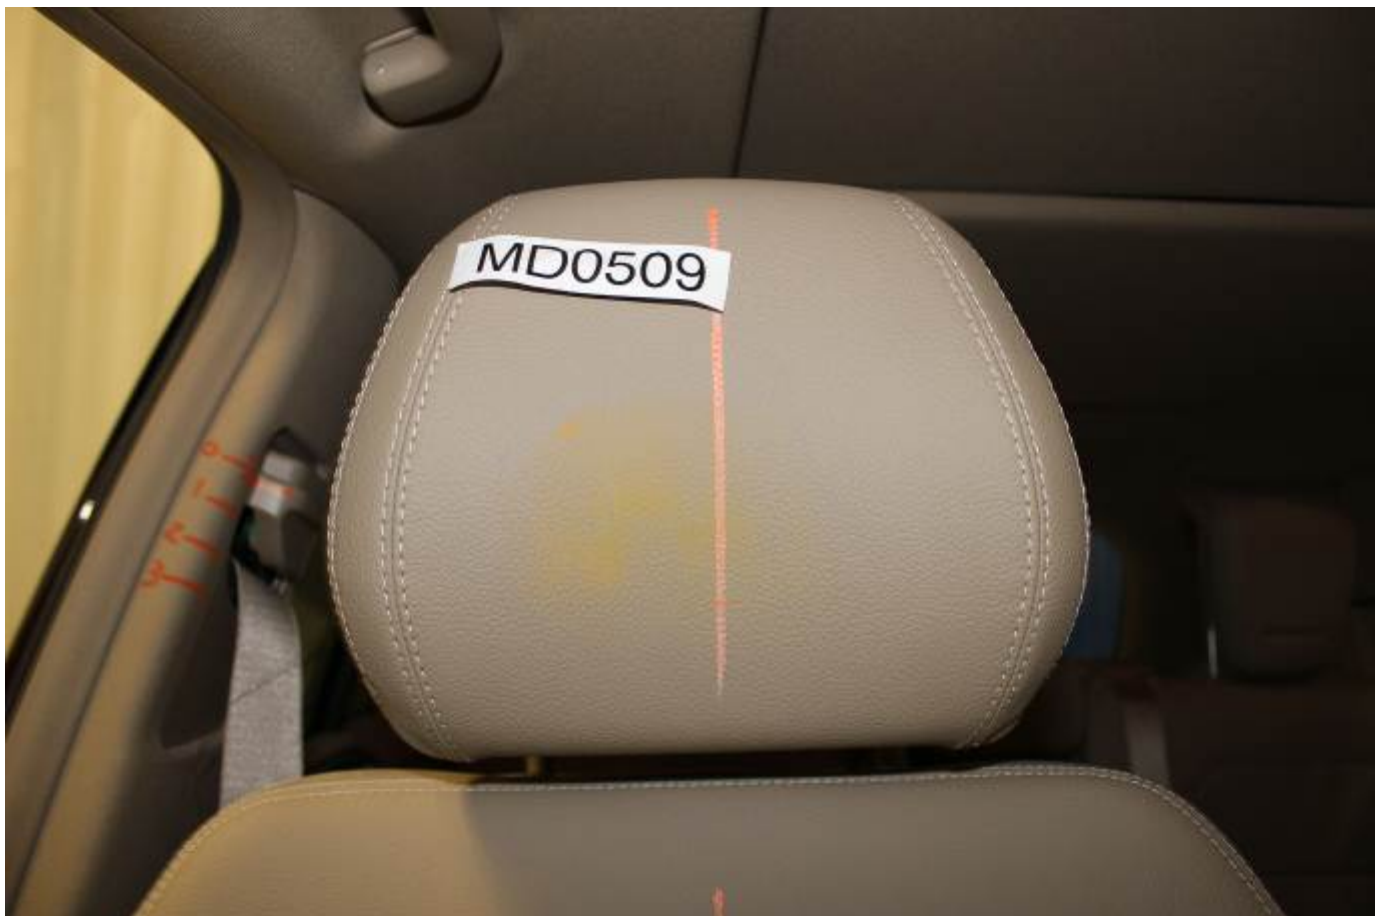
Post-Test Passenger Dummy Contact with Headrest

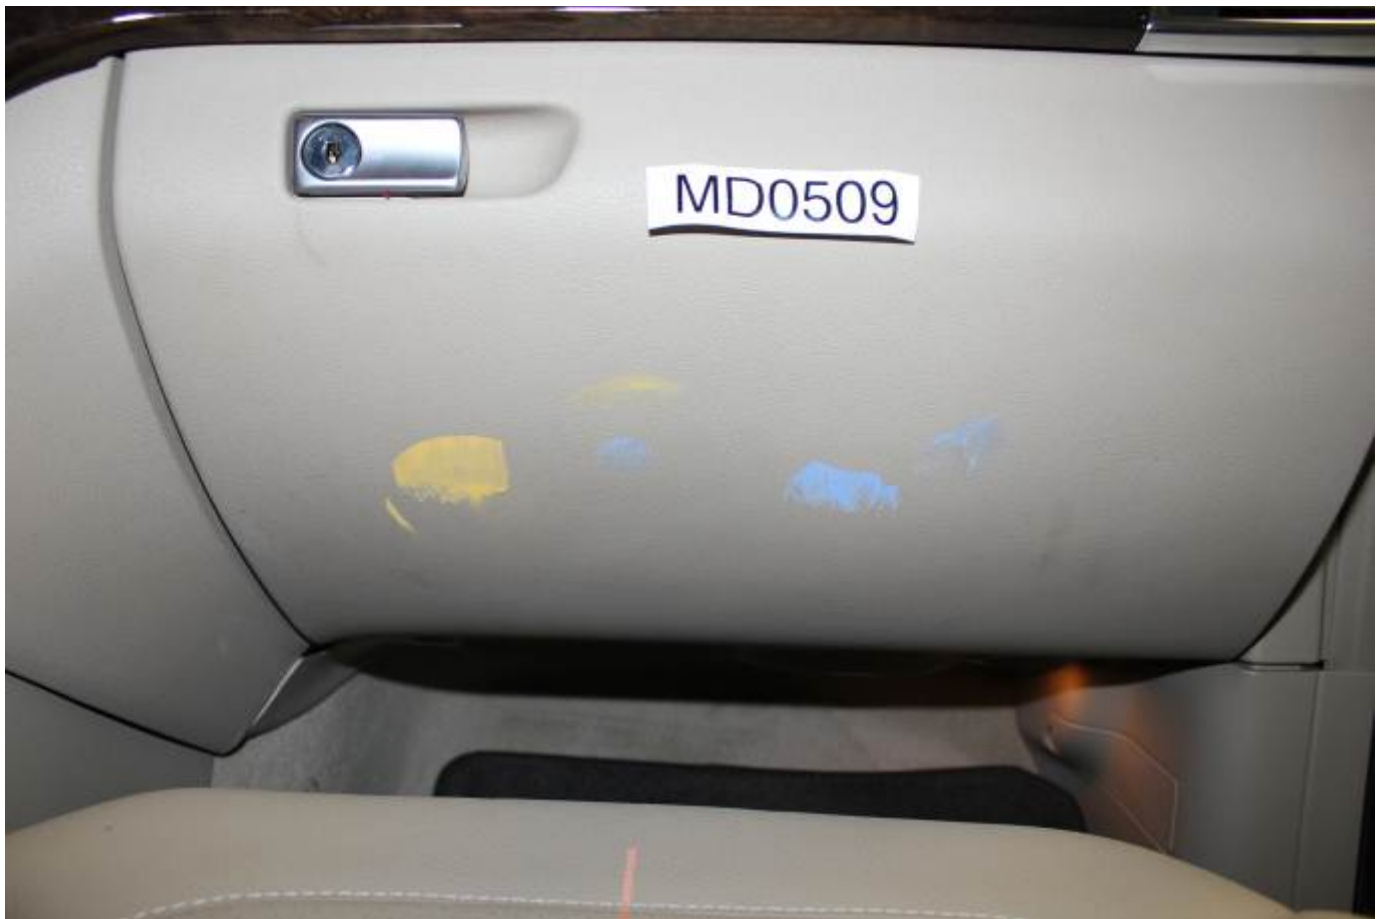
Post-Test Passenger Dummy Contact with Glove Box
