**REPORT NUMBER: TWG-MGA-2013-002**

**SIDE AIRBAG OUT-OF-POSITION INJURY  
TECHNICAL WORKING GROUP**

**MAZDA MOTOR CORPORATION  
2013 Mazda CX-5 Sport All Wheel Drive 5-Dr SUV  
NHTSA No.: MD5400TWG2**

**FINAL REPORT**

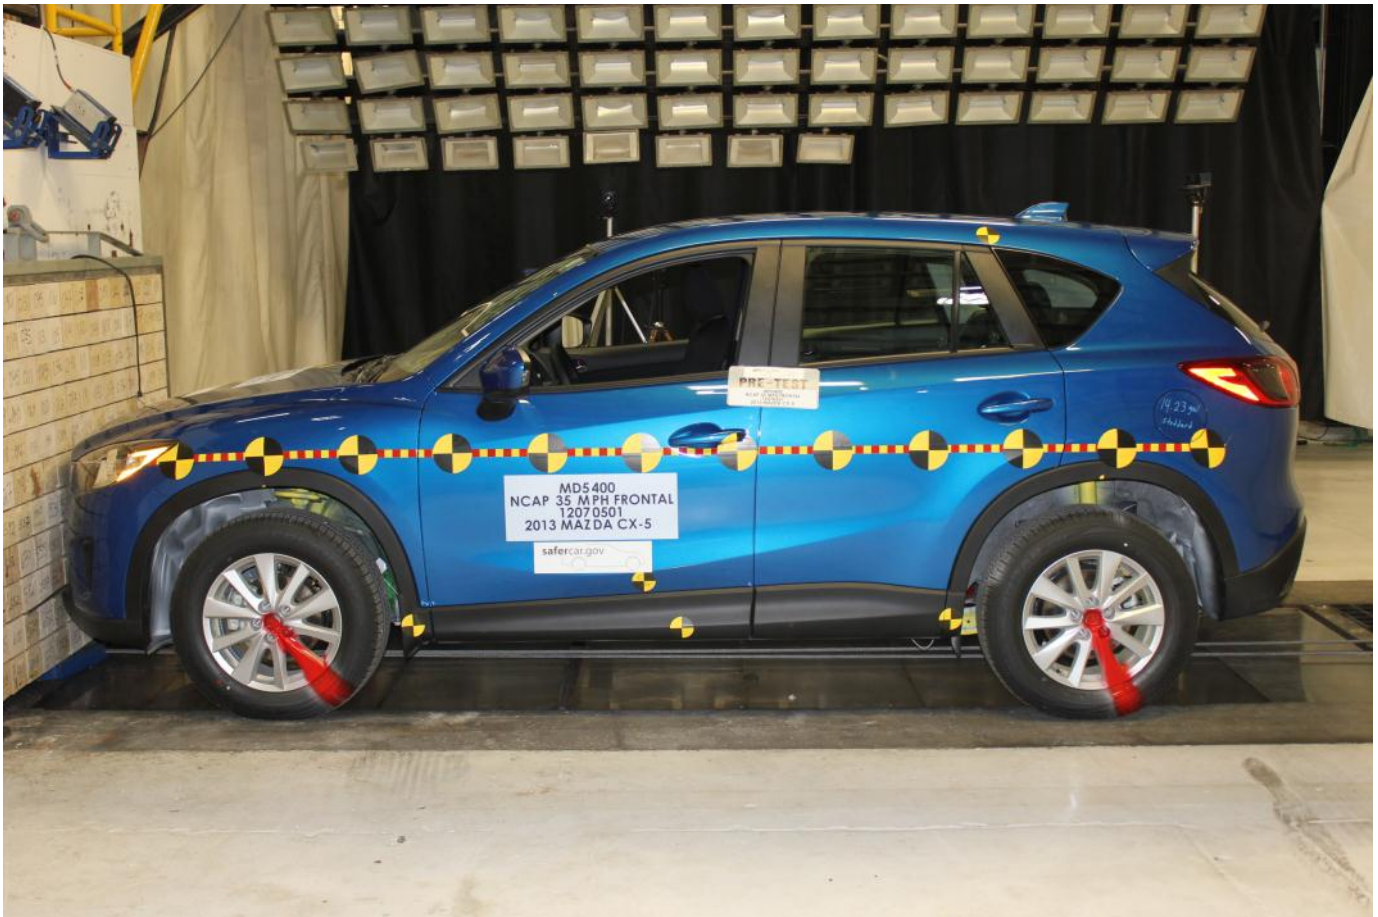
Pre-Test Vehicle Left Side View

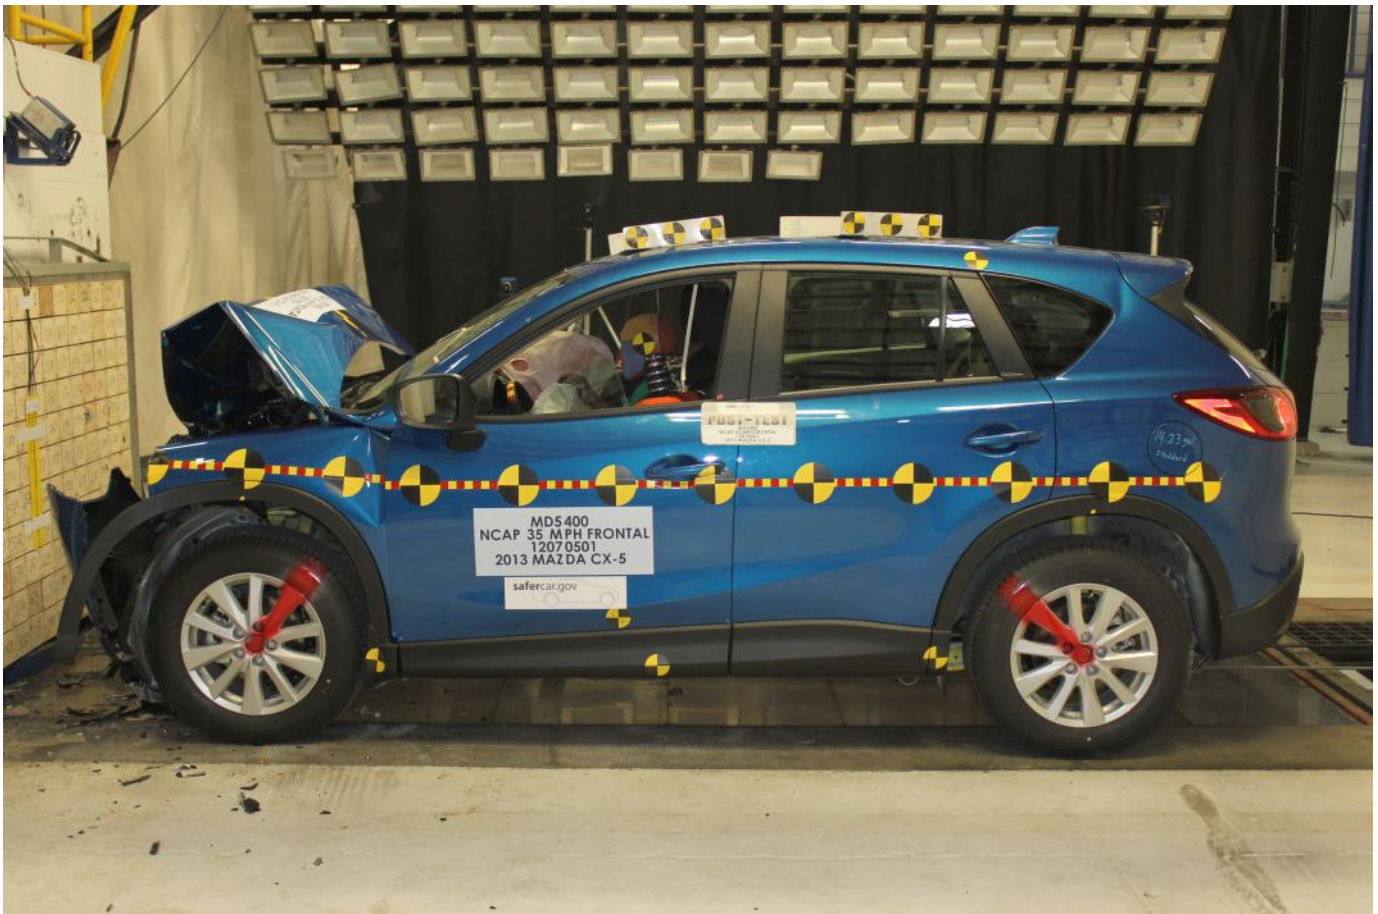
Post-Test Vehicle Left Side View

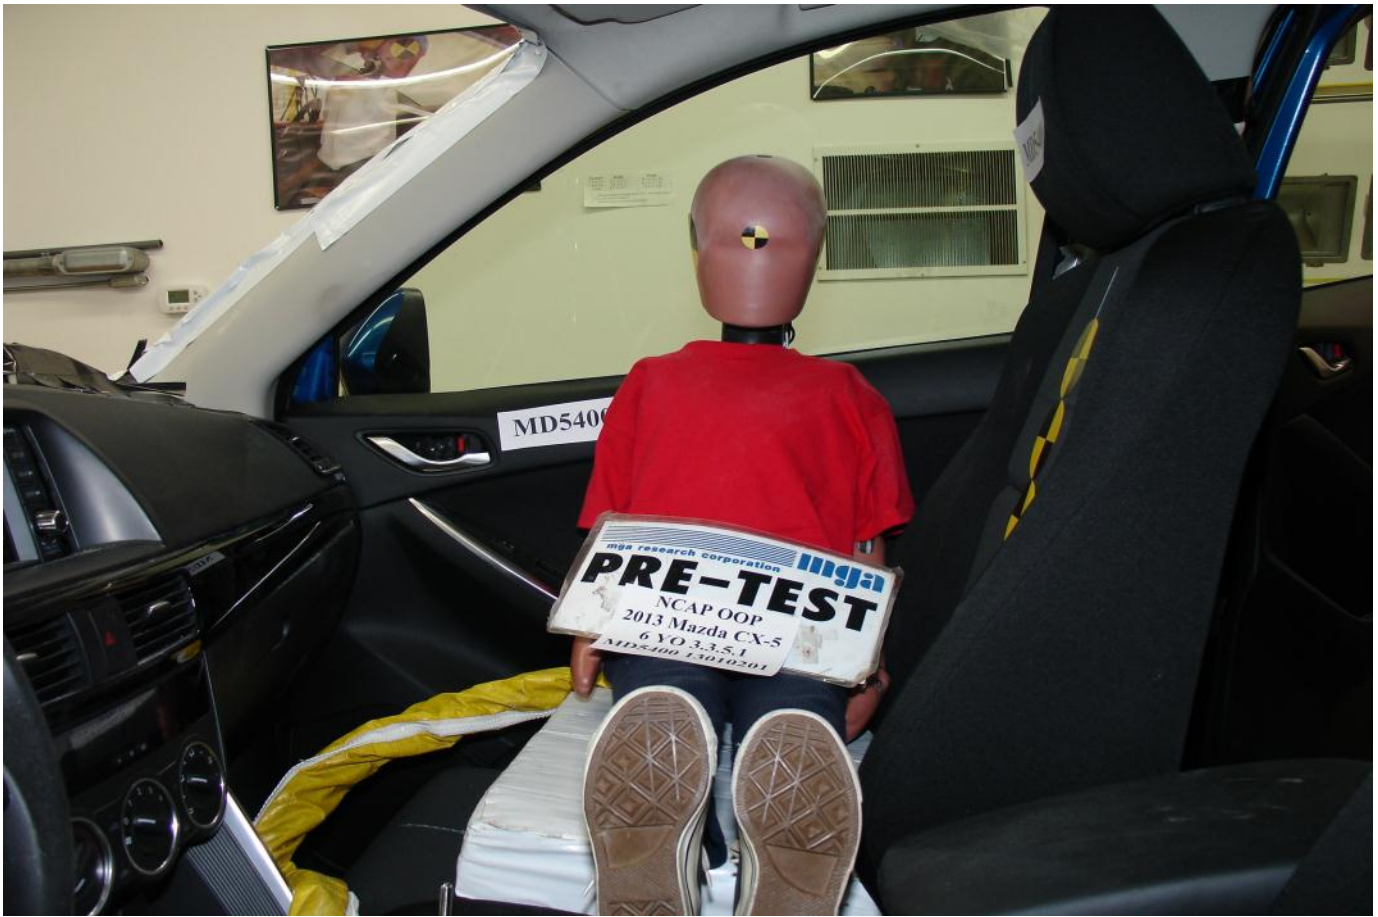
Pre-Test 6-Year-Old Child Dummy Left Side View

The Hybrid III 6-Year-Old child dummy was placed in the right front passenger seat along the outboard edge of the foam block, facing inboard with its legs extended and arms hanging at its sides. The seat track was positioned forward to maximize the cushion to head interaction. The dummy's pelvis was slid outboard until the dummy's back contacted the door trim panel or armrest and the center of gravity of the head was centered in the deployment trajectory of the airbag. The head remained in its neutral orientation. A vertical plane through the centerline of the dummy's shoulder bolts was parallel to the vehicle centerline. The dummy's arms were bent at the elbow until the fingertips contacted the foam block.

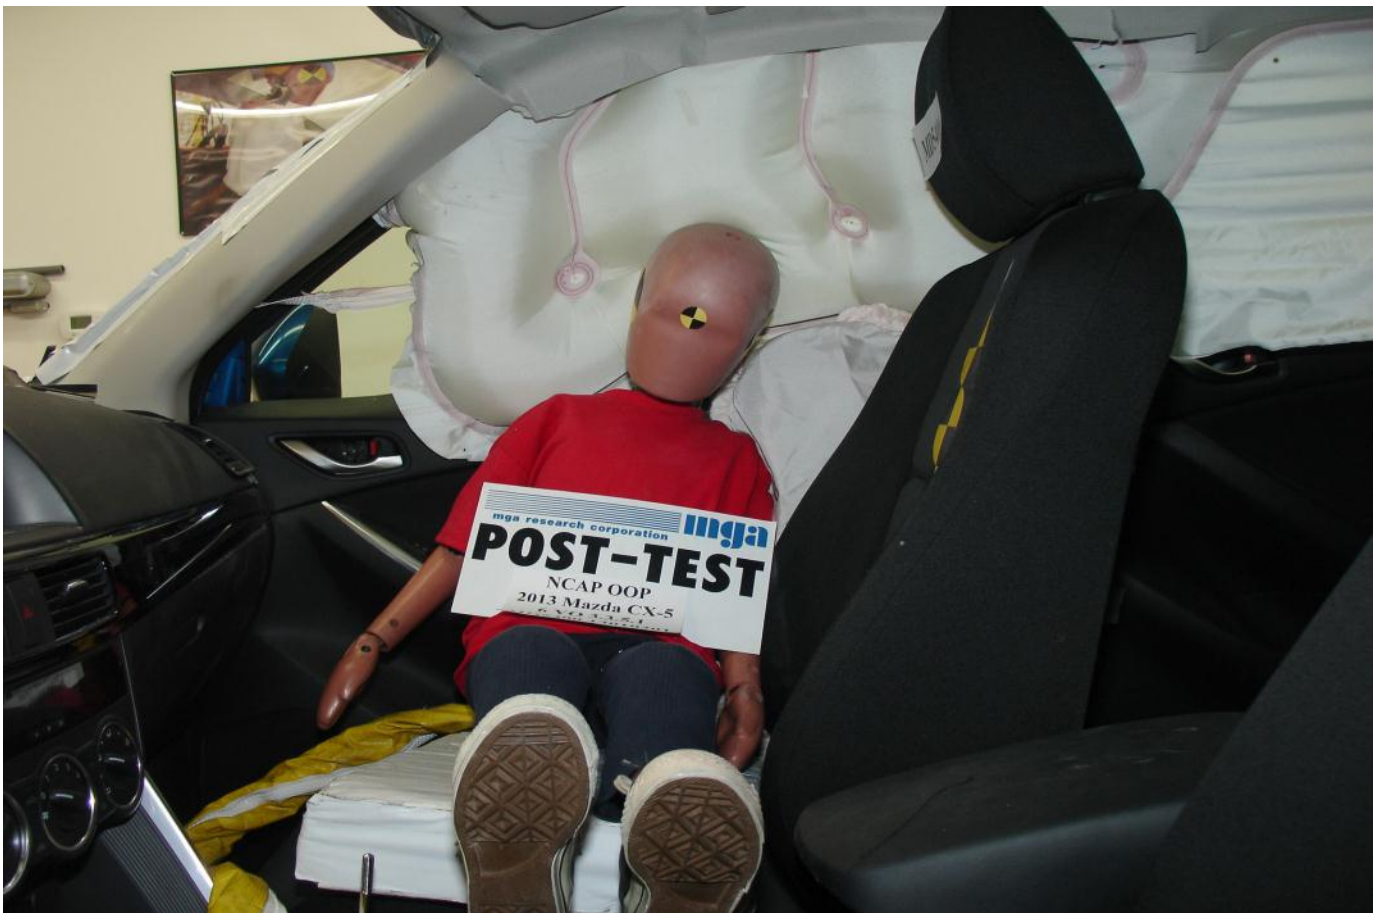
Post-Test 6-Year-Old Child Dummy Left Side View

- Curtain airbag to top and back of head
- Torso bag to left shoulder and left torso

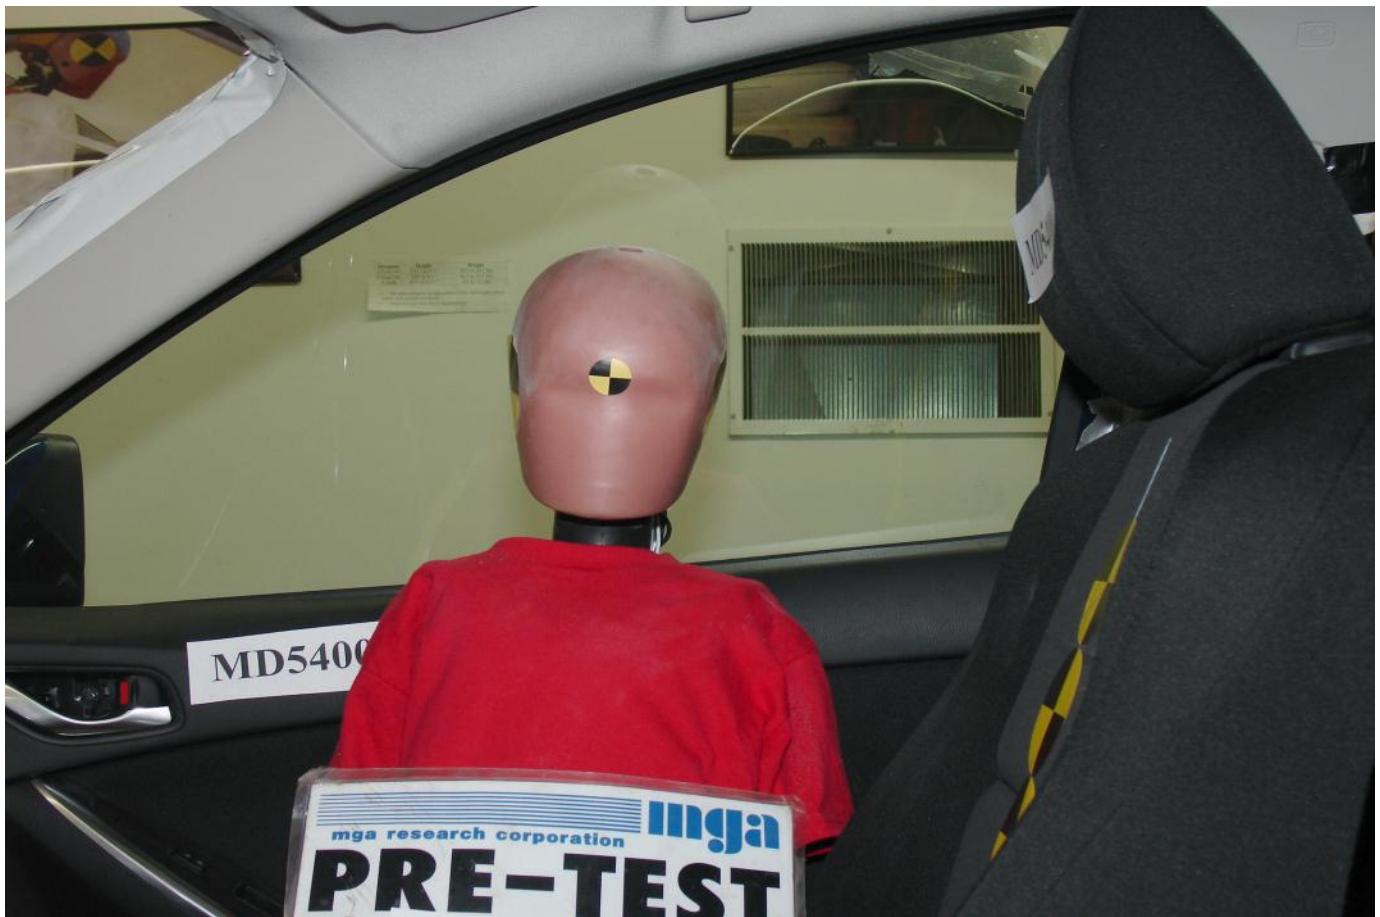
Pre-Test 6-Year-Old Child Dummy Left Side Closeup View

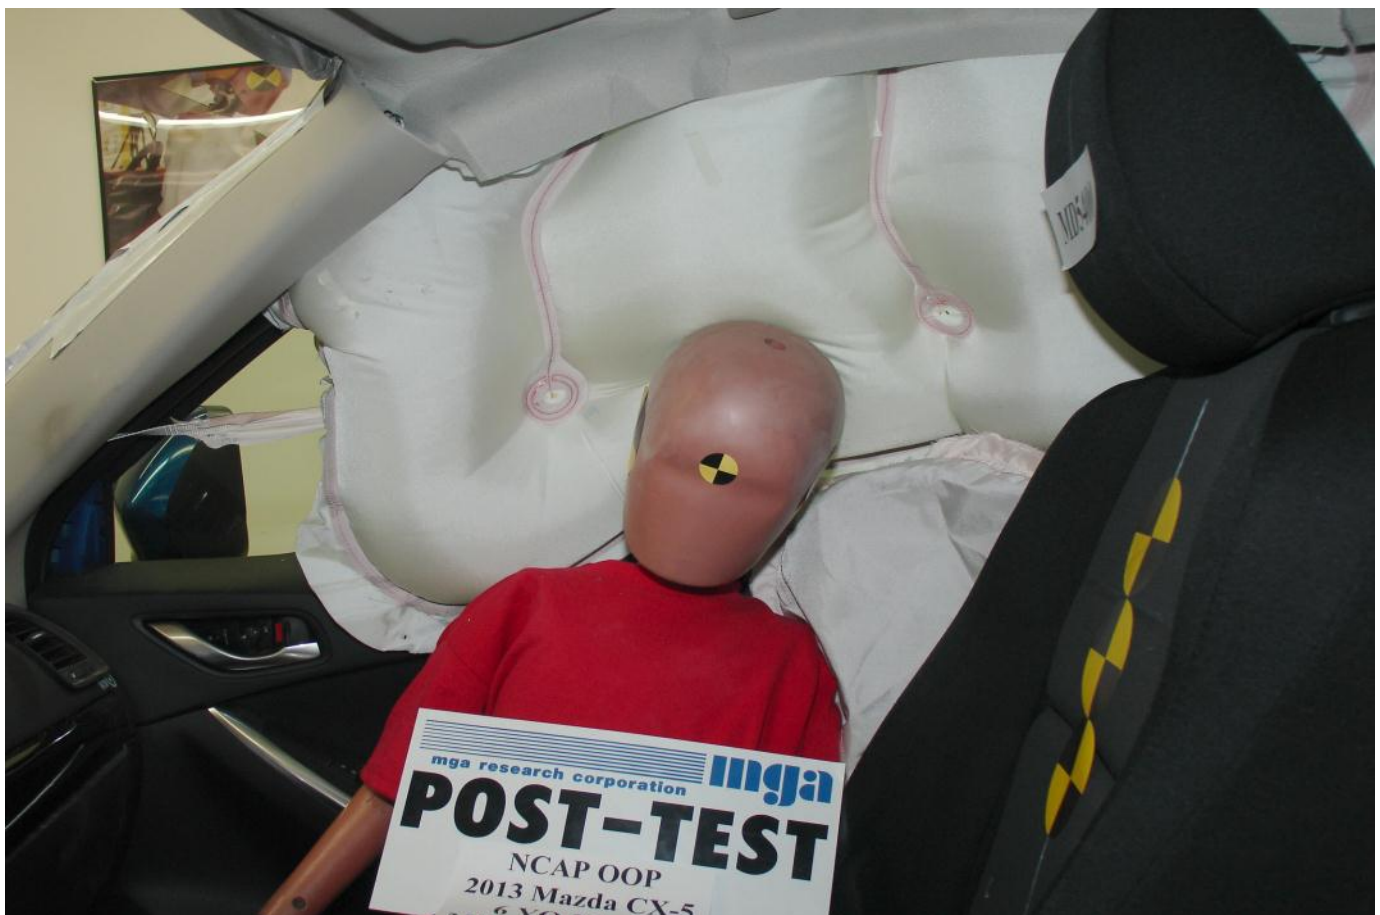
Post-Test 6-Year-Old Child Dummy Left Side Closeup View

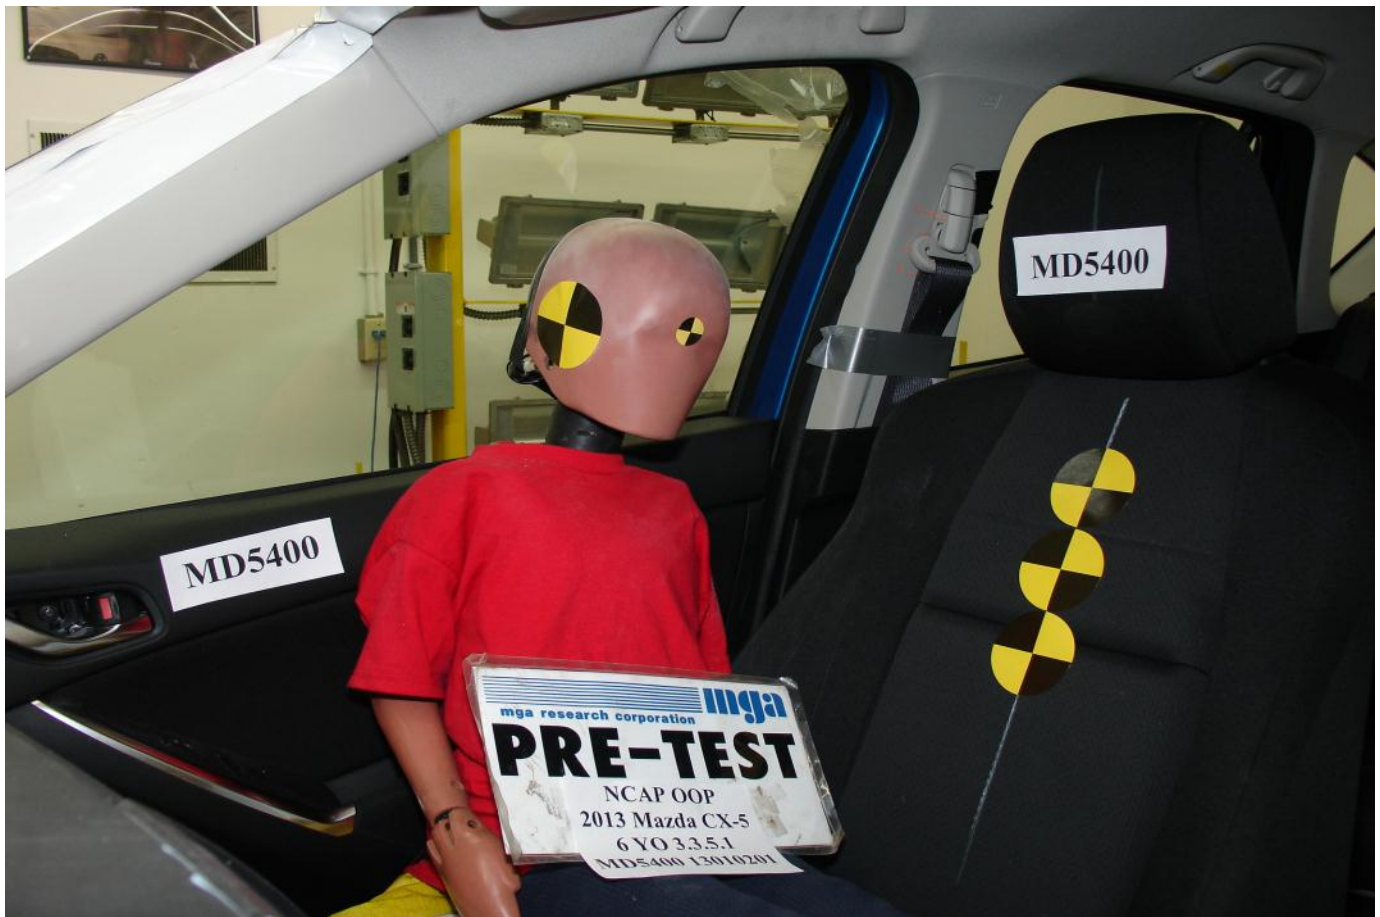
Pre-Test 6-Year-Old Child Dummy Left 3/4 Front View

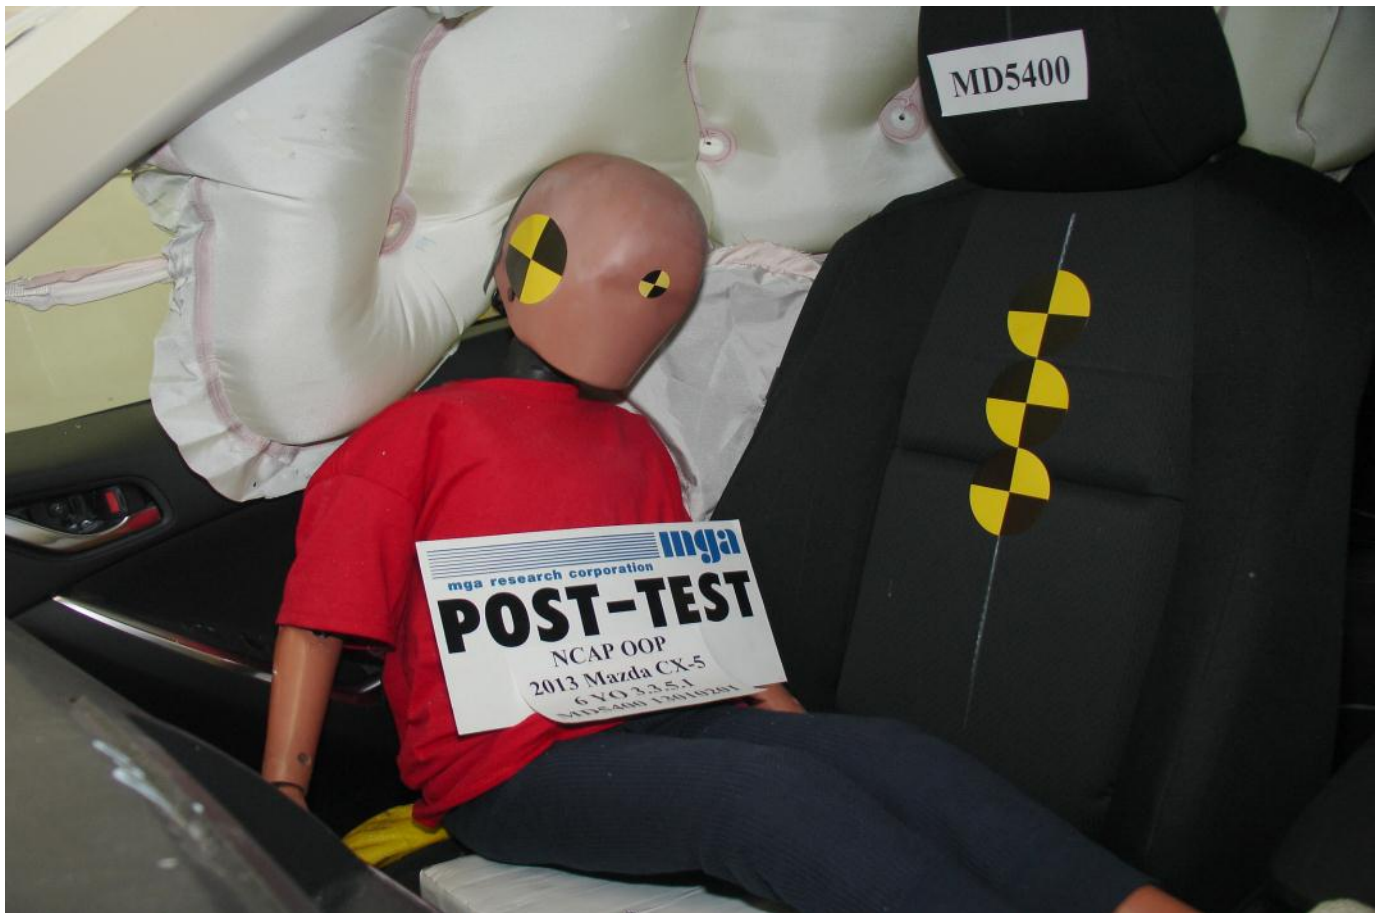
Post-Test 6-Year-Old Child Dummy Left 3/4 Front View

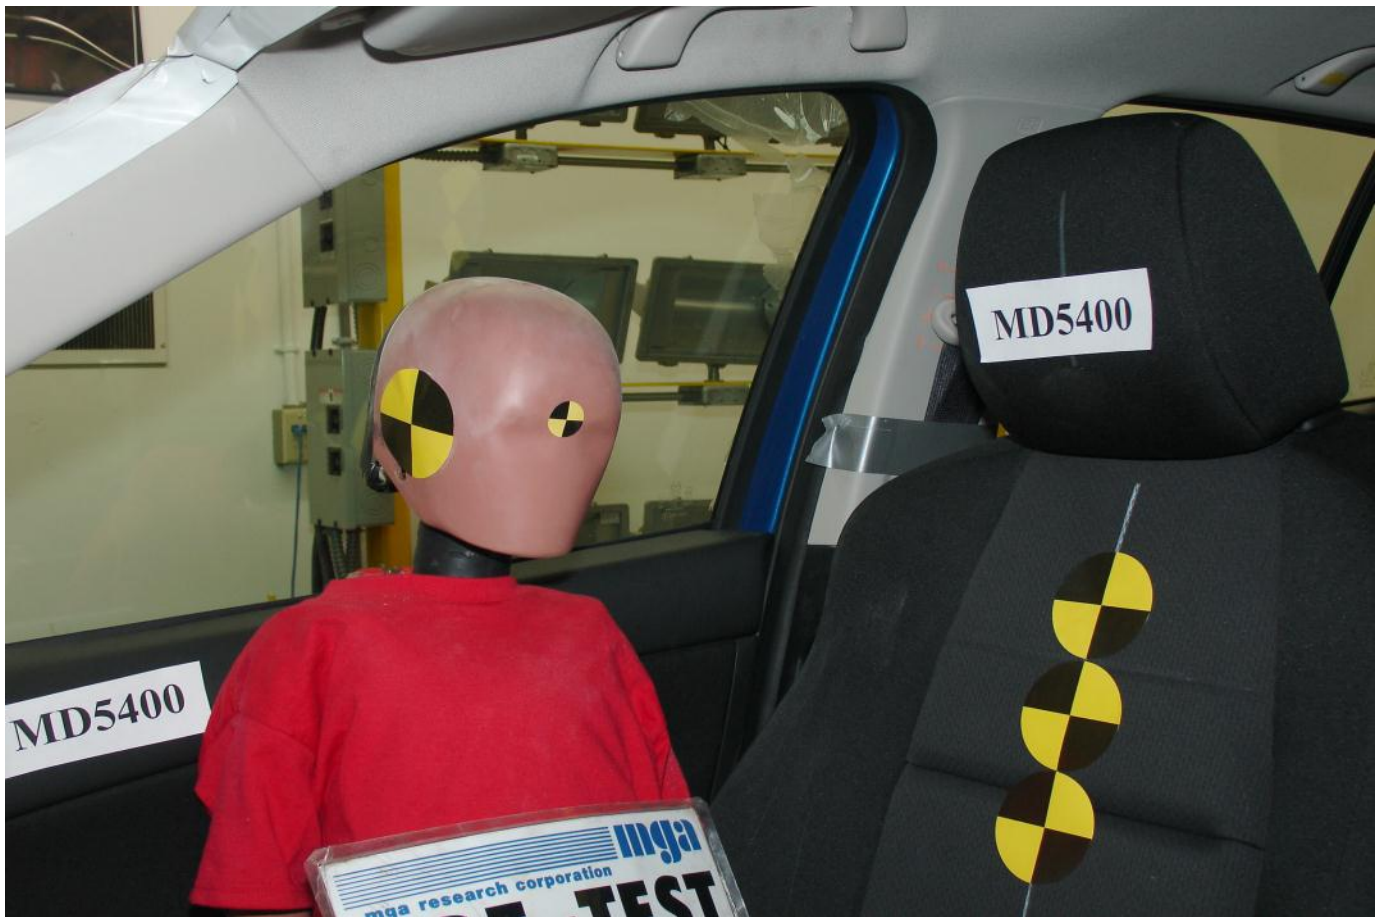
Pre-Test 6-Year-Old Child Dummy Left  $\frac{3}{4}$  Front Closeup View

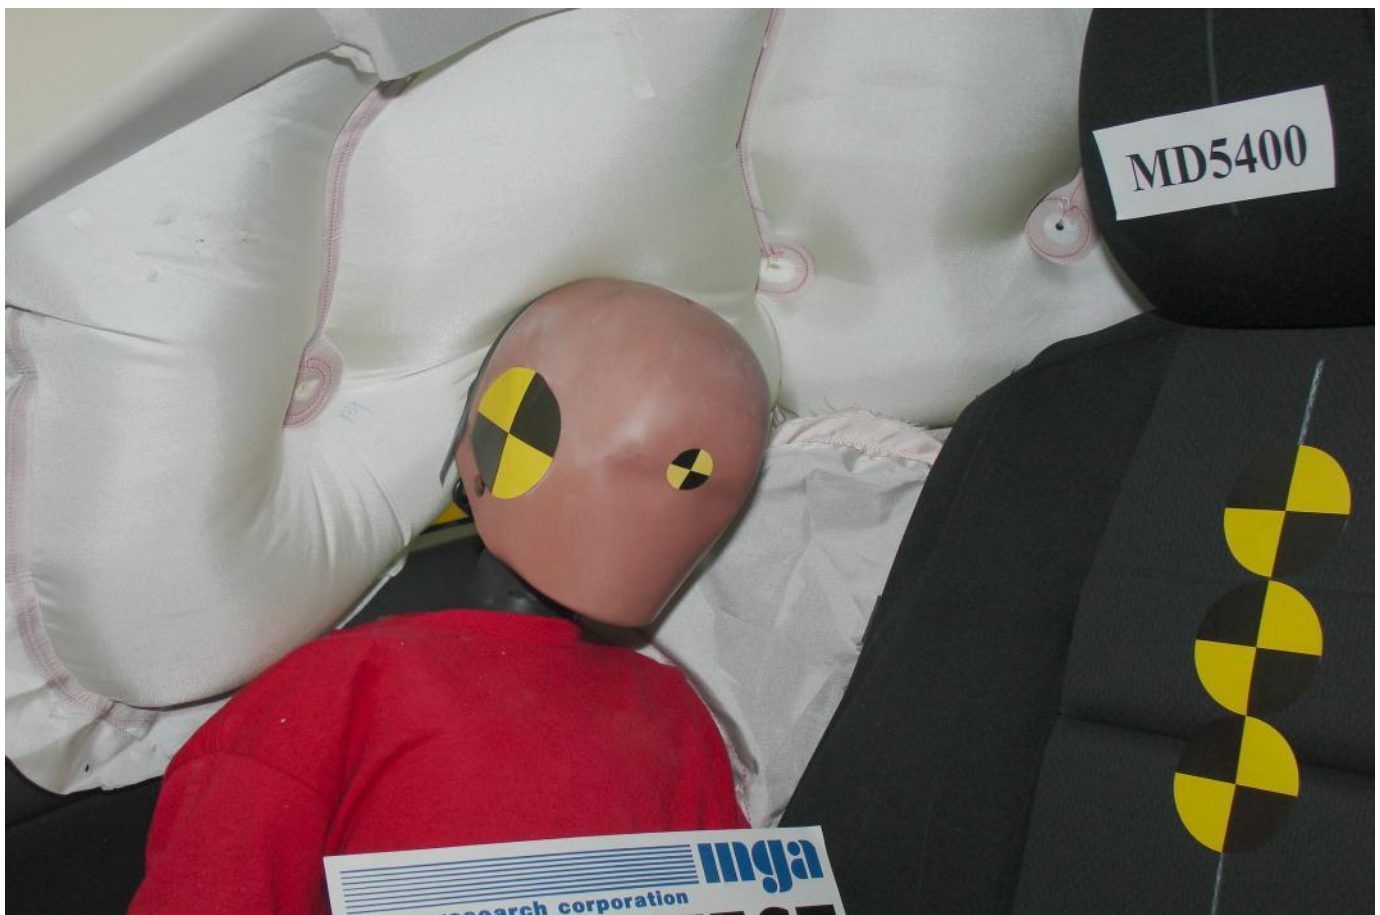
Post-Test 6-Year-Old Child Dummy Left  $\frac{3}{4}$  Front Closeup View

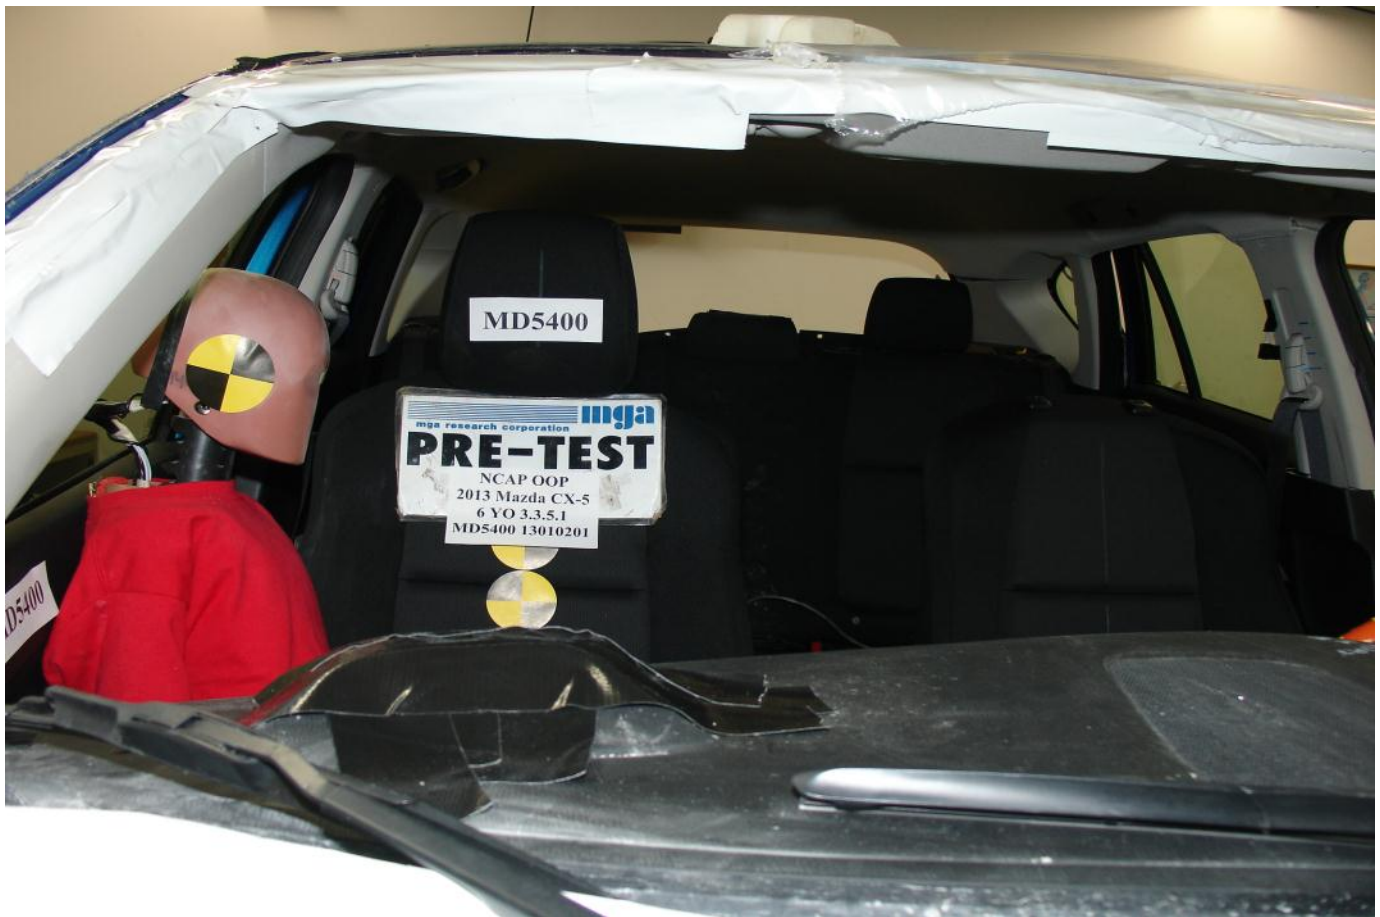
Pre-Test 6-Year-Old Child Dummy Front View

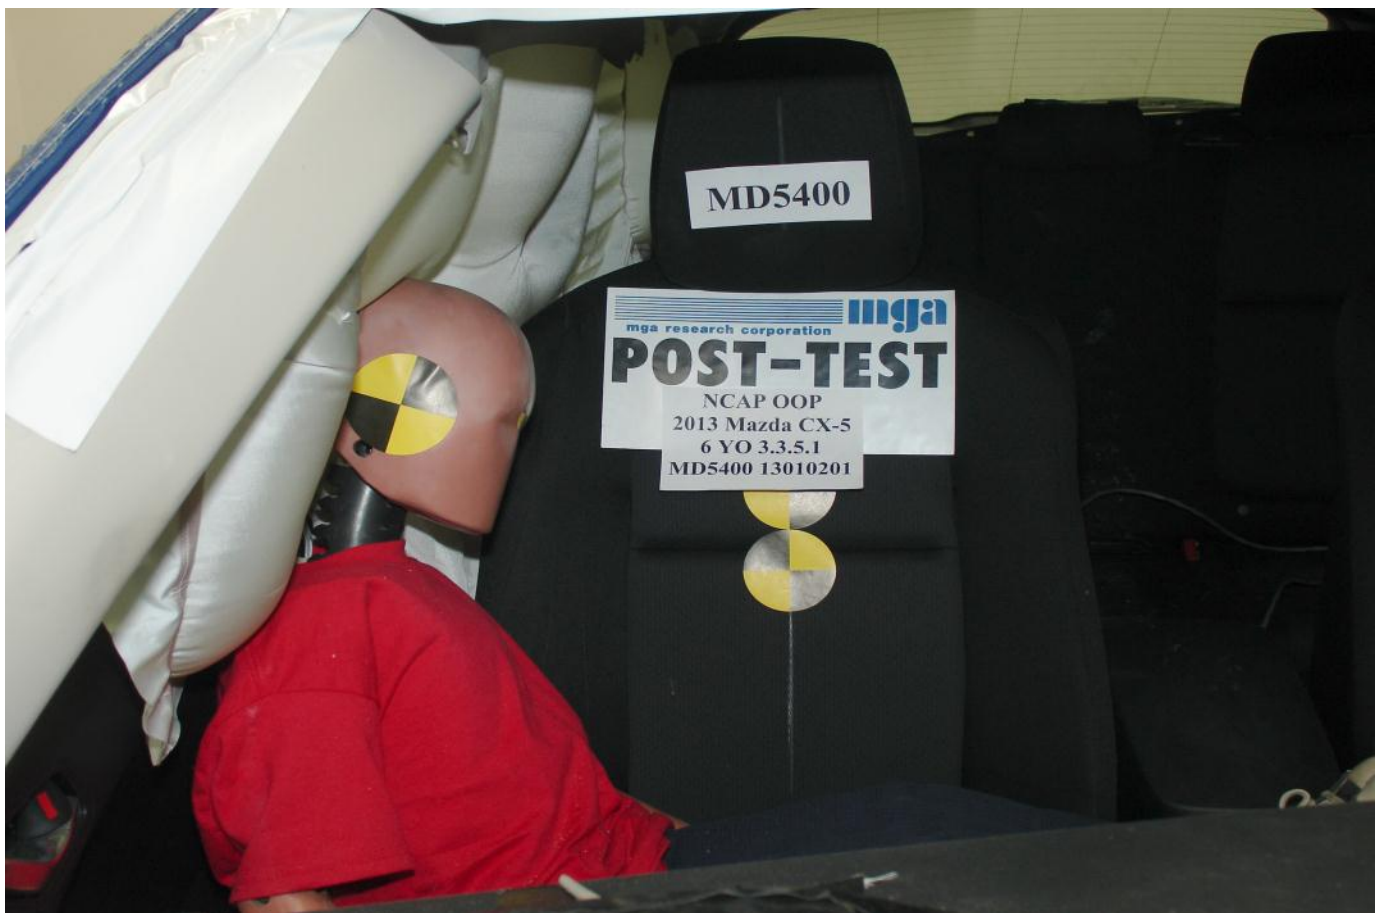
Post-Test 6-Year-Old Child Dummy Front View

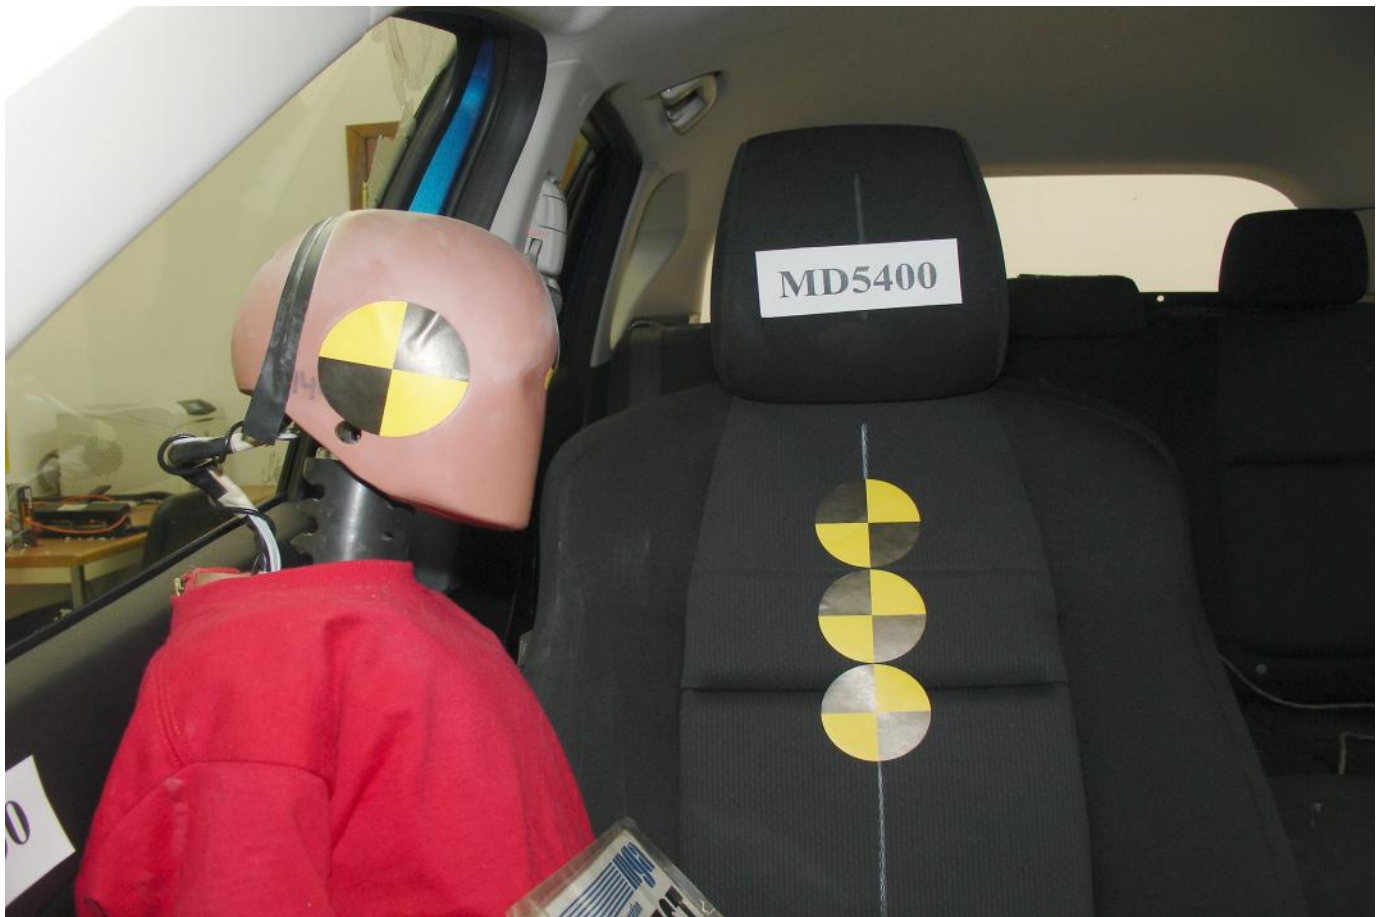
Pre-Test 6-Year-Old Child Dummy Front Closeup View

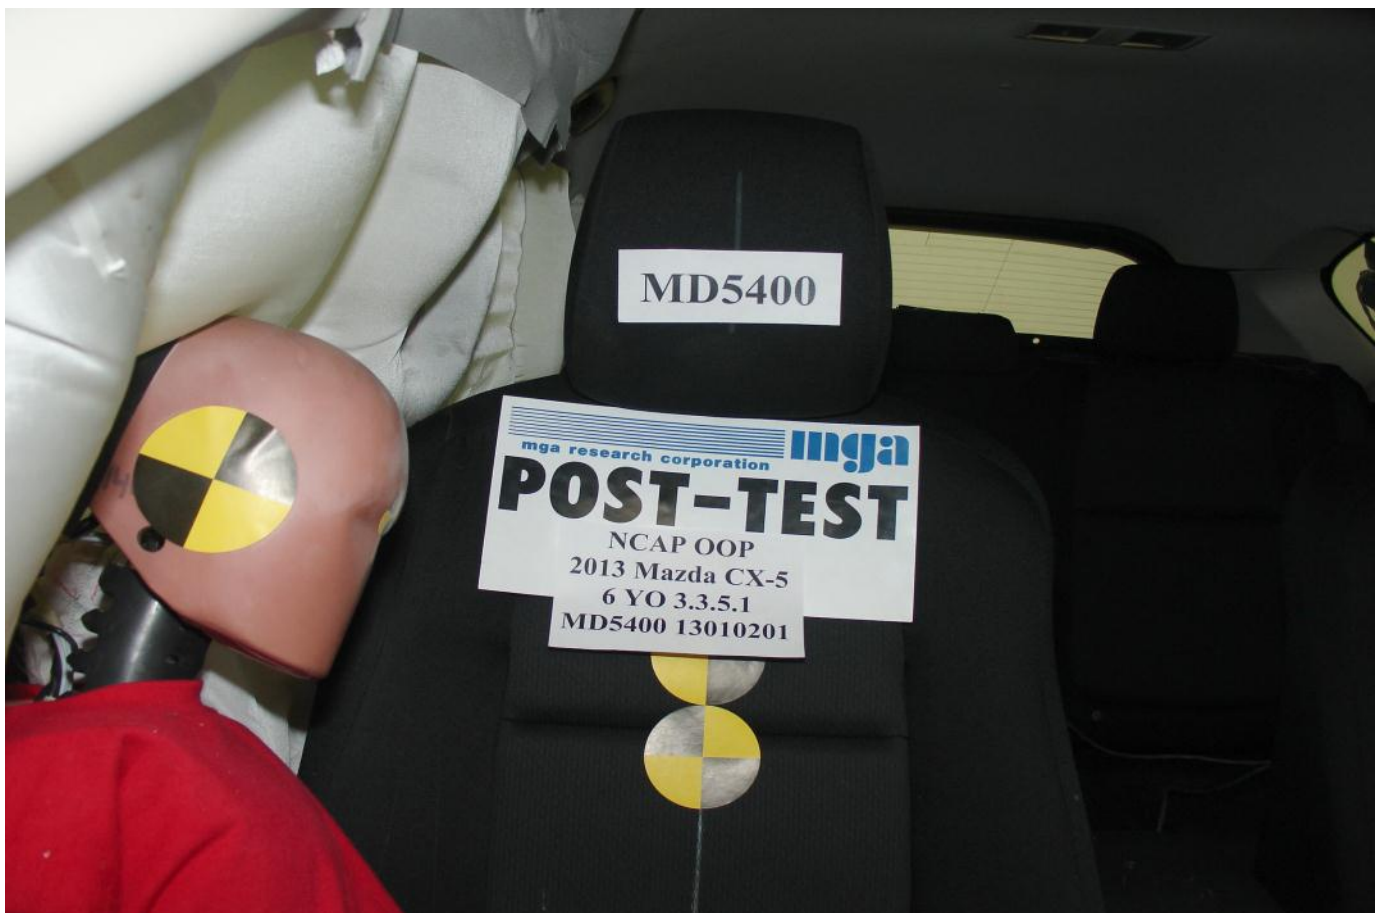
Post-Test 6-Year-Old Child Dummy Front Closeup View

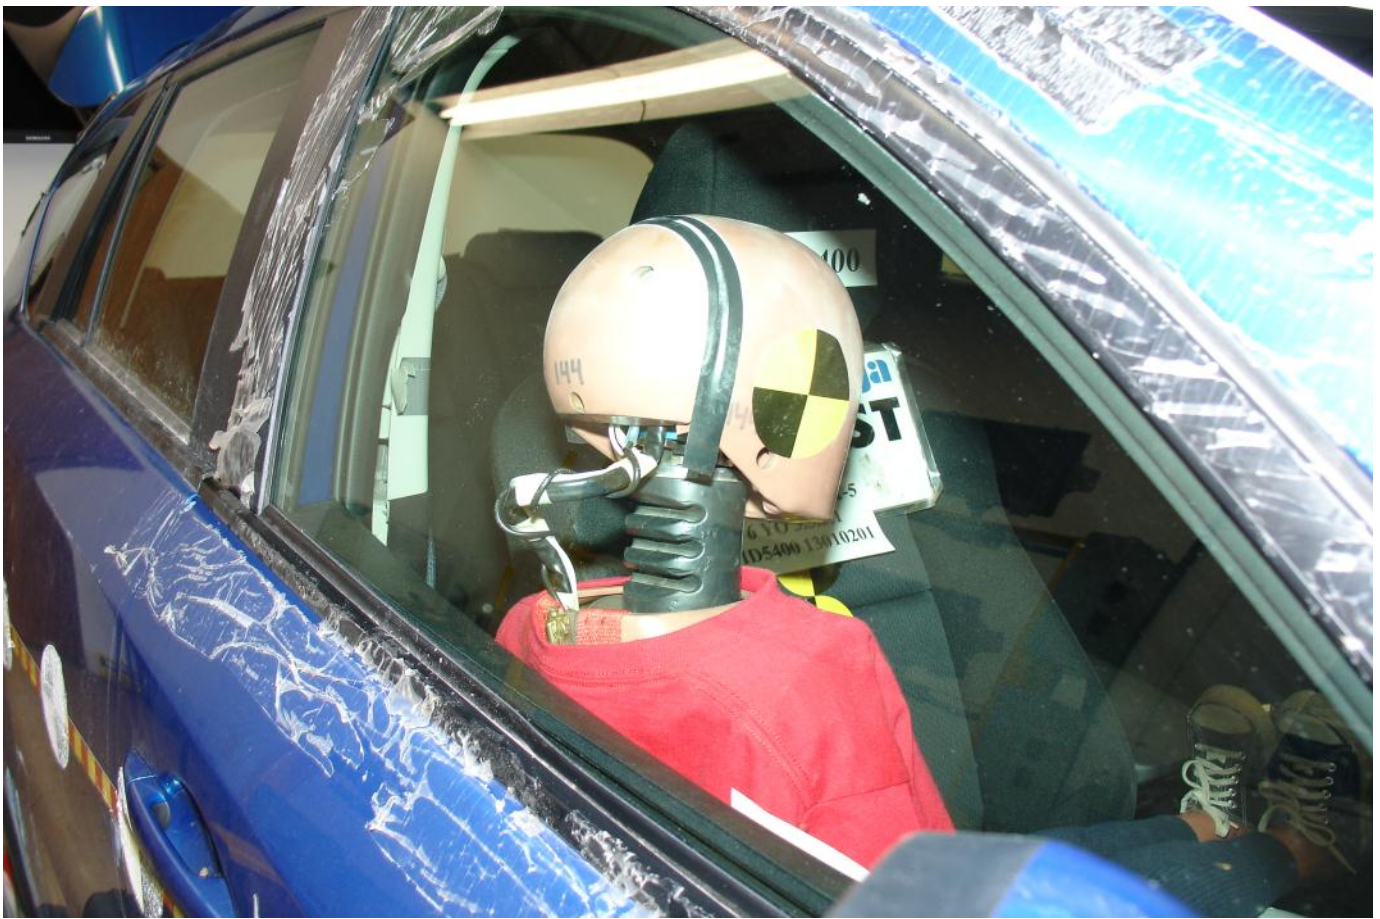
Pre-Test 6-Year-Old Child Dummy Right 3/4 Front View

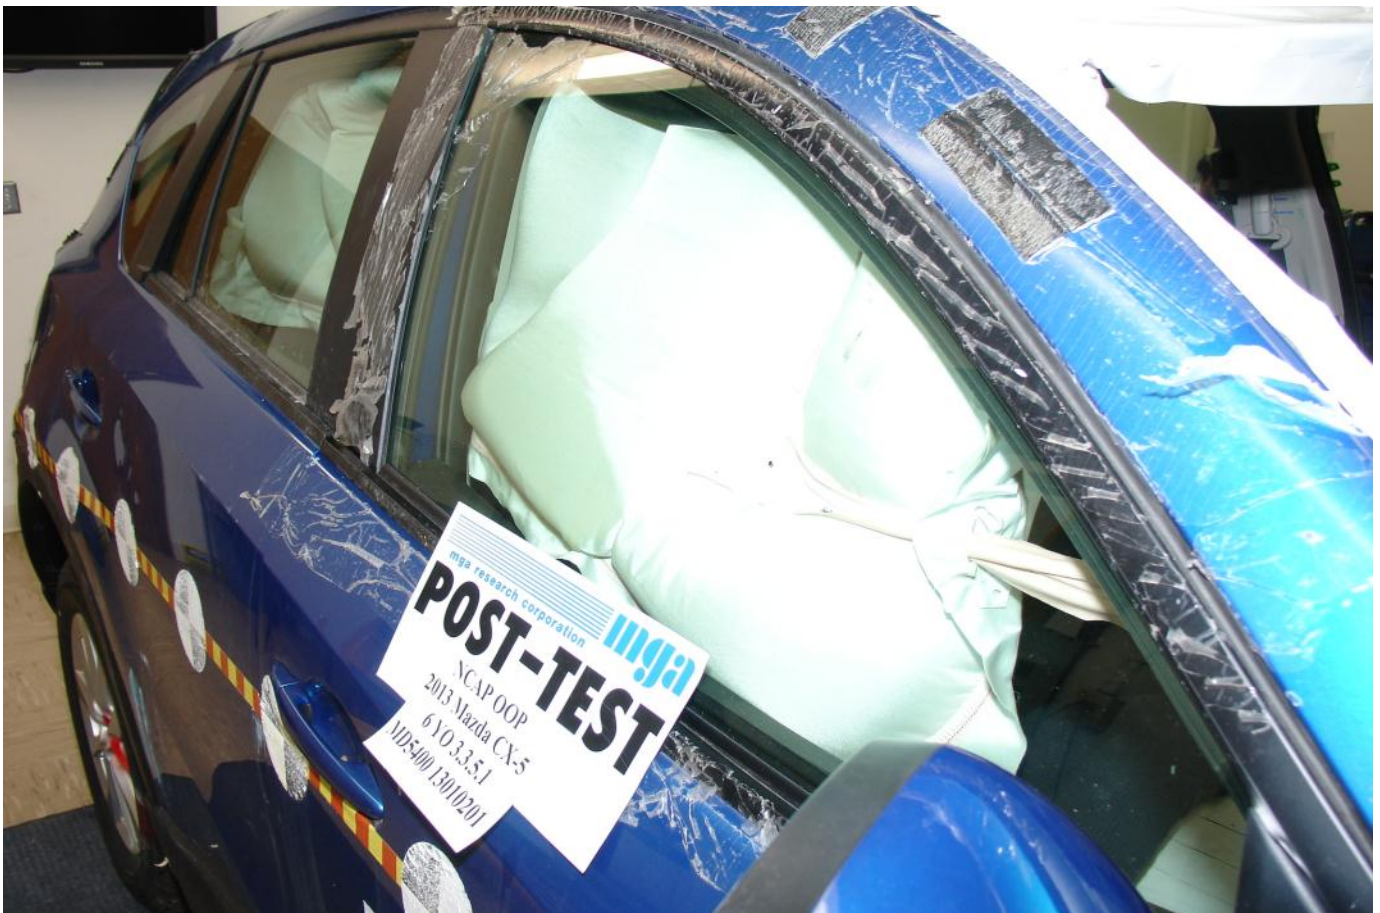
Post-Test 6-Year-Old Child Dummy Right 3/4 Front View

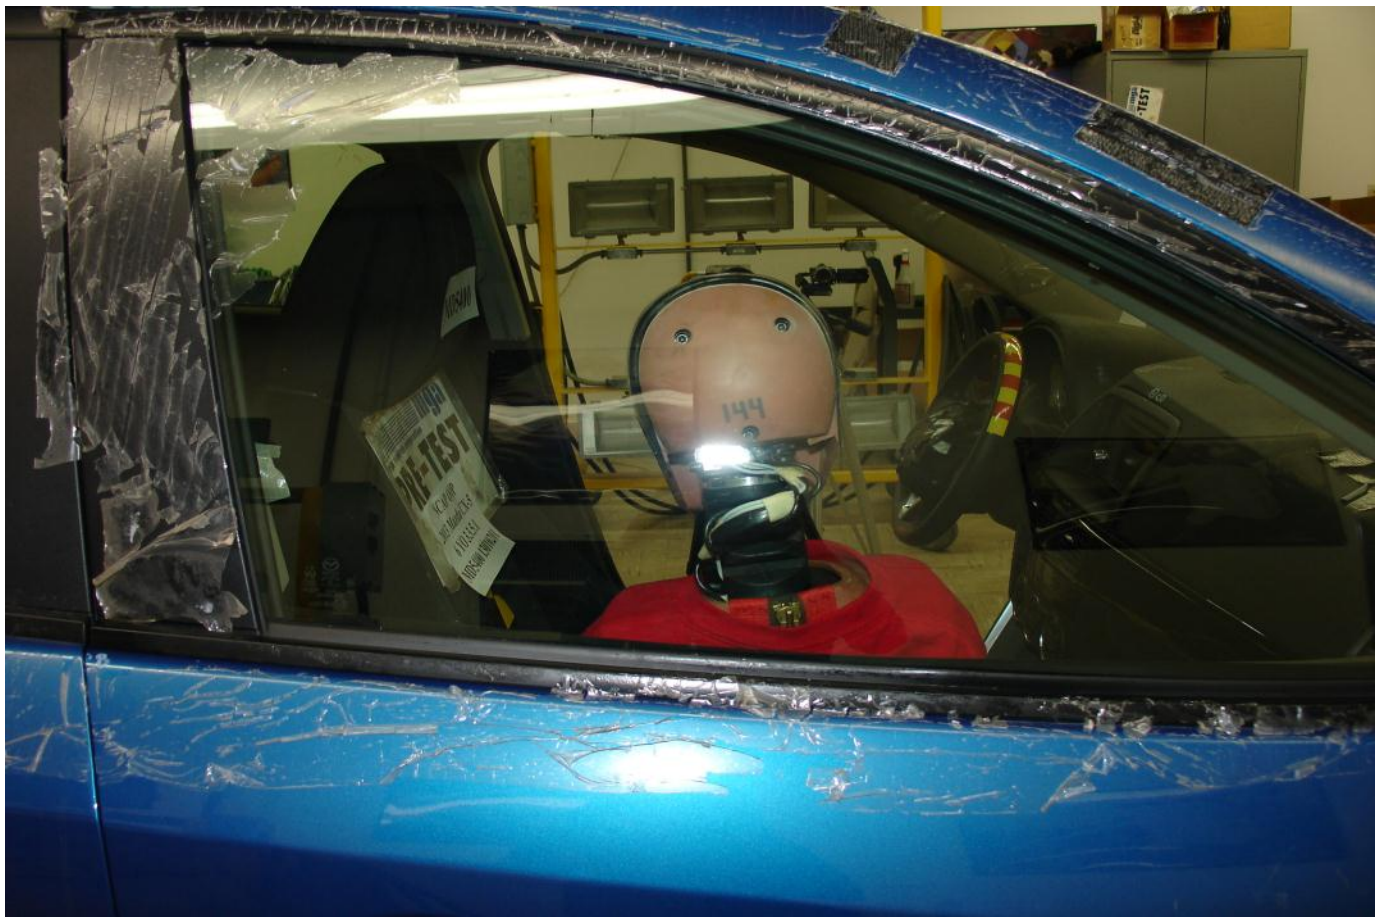
Pre-Test 6-Year-Old Child Dummy Right Side View

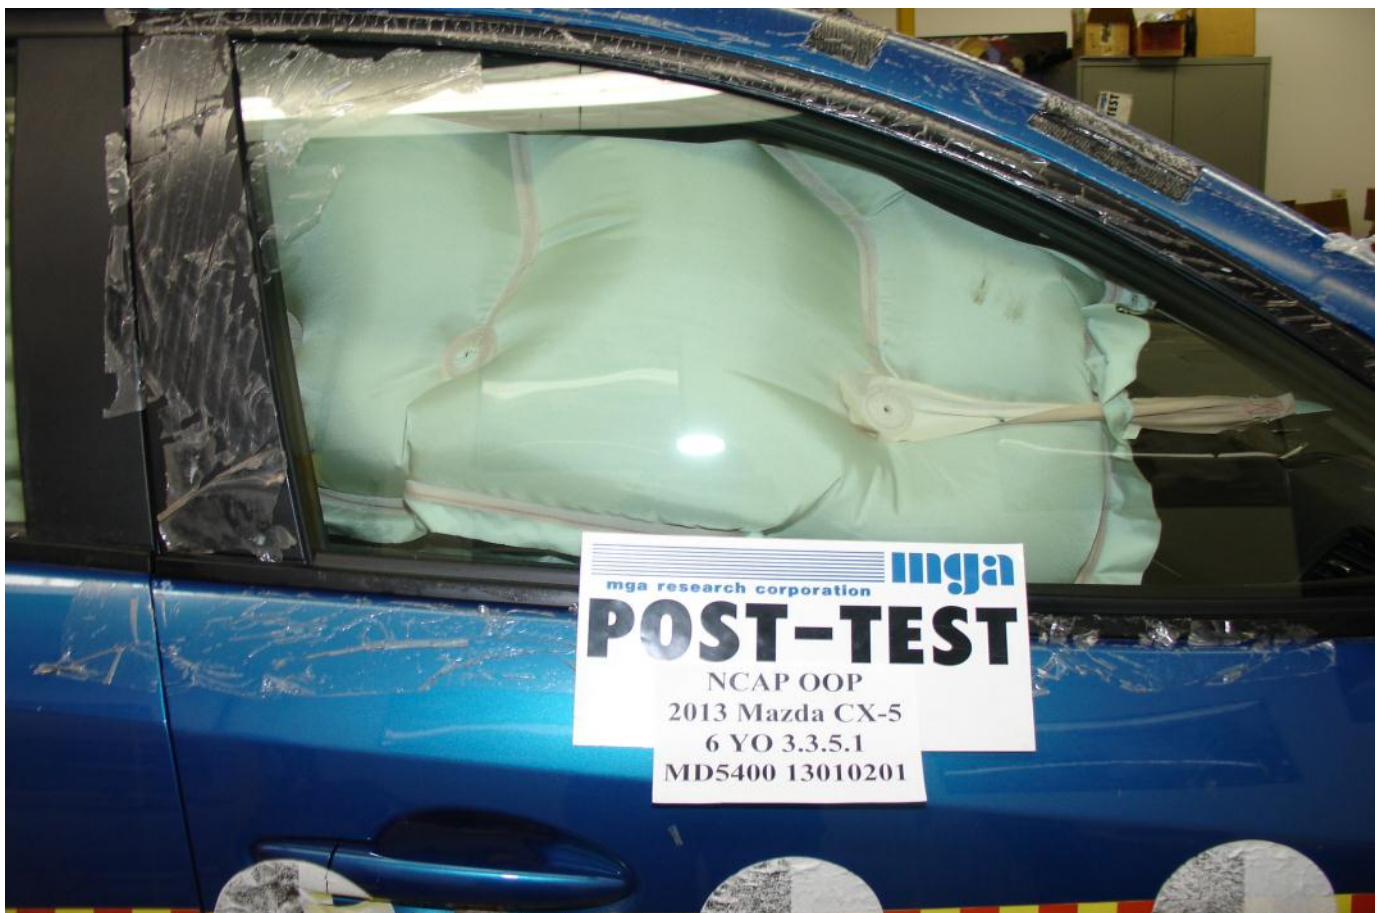
Post-Test 6-Year-Old Child Dummy Right Side View
