**REPORT NUMBER: TWG-MGA-2013-002**

**SIDE AIRBAG OUT-OF-POSITION INJURY  
TECHNICAL WORKING GROUP**

**MAZDA MOTOR CORPORATION  
2013 Mazda CX-5 Sport All Wheel Drive 5-Dr SUV  
NHTSA No.: MD5400TWG2**

**FINAL REPORT**

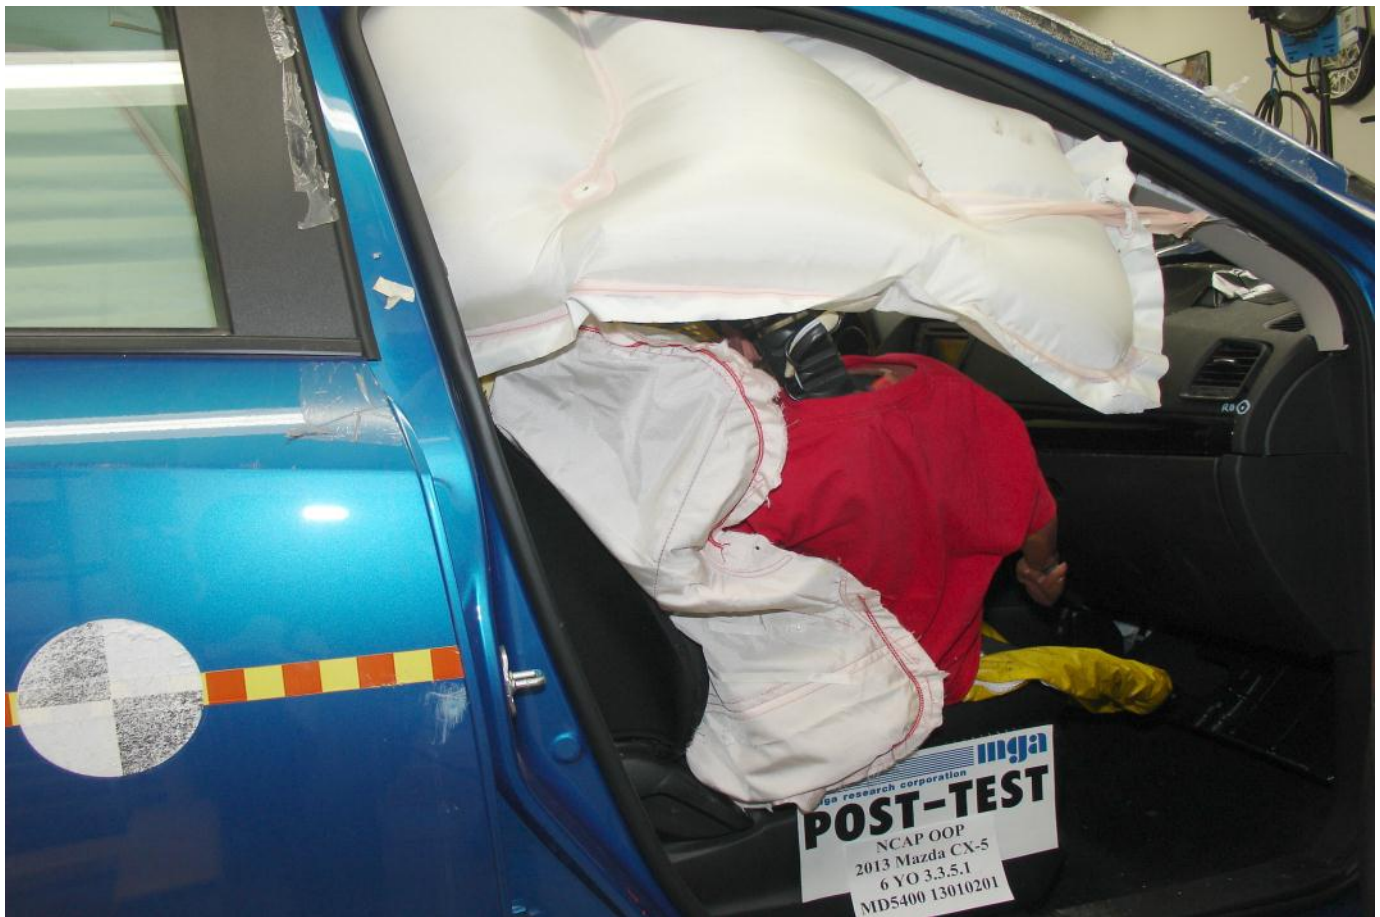
Post-Test 6-Year-Old Child Dummy Right Side View With Door Open

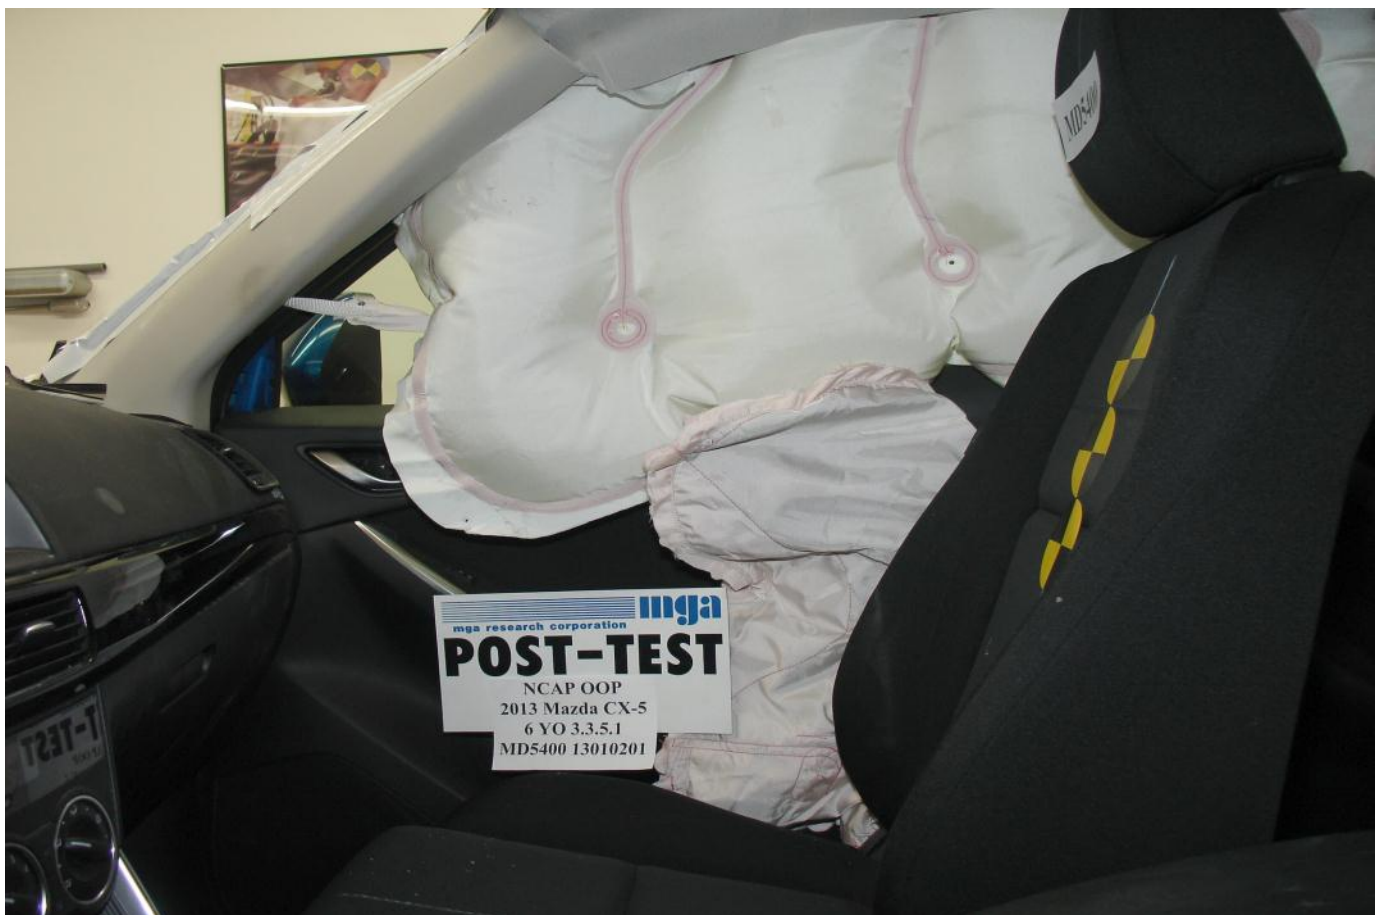
Post-Test Curtain Airbag Left Side View

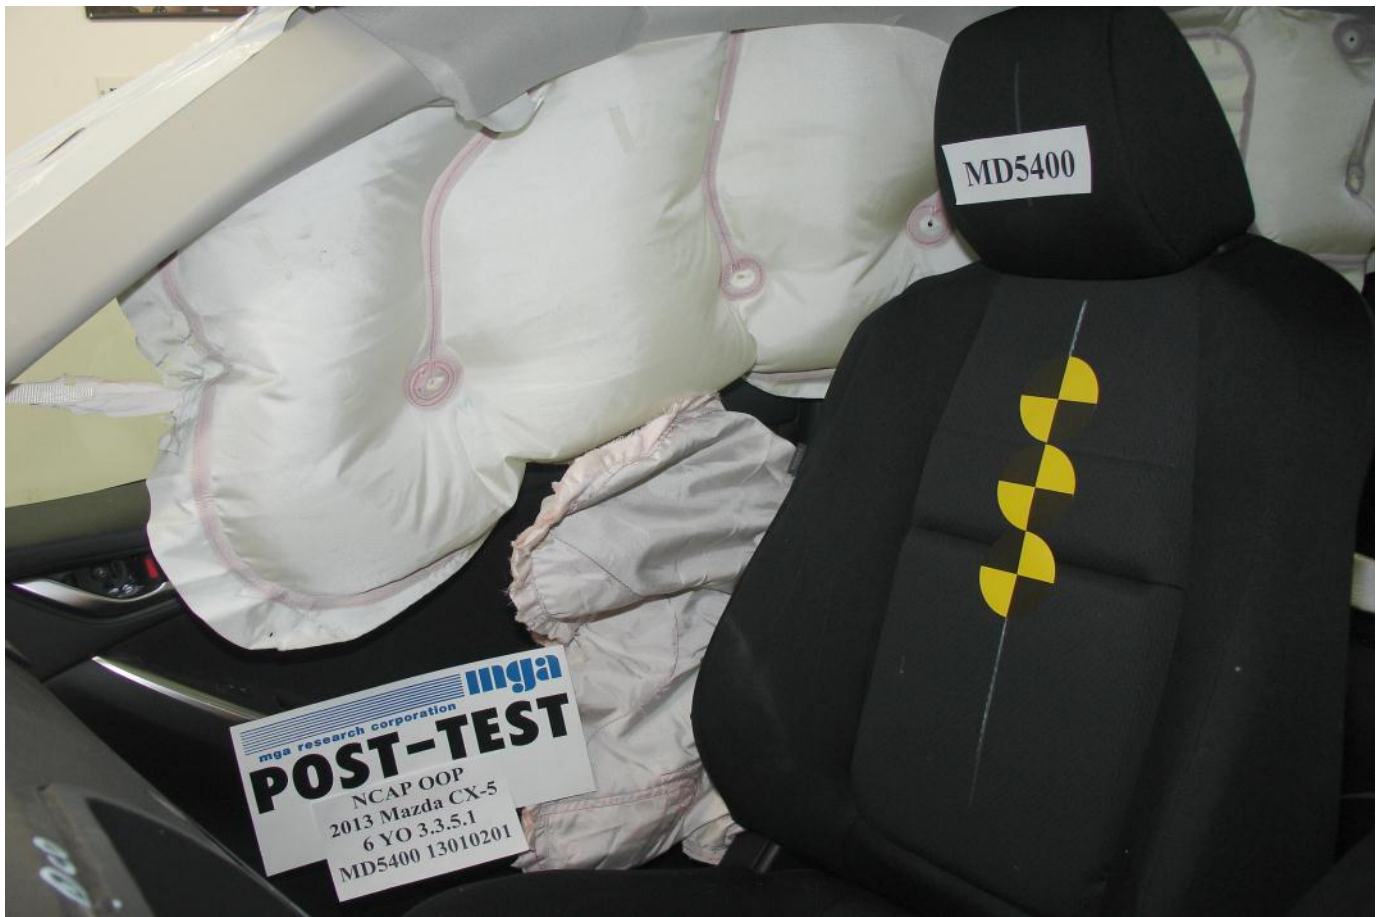
Post-Test Curtain Airbag Left 3/4 Front View

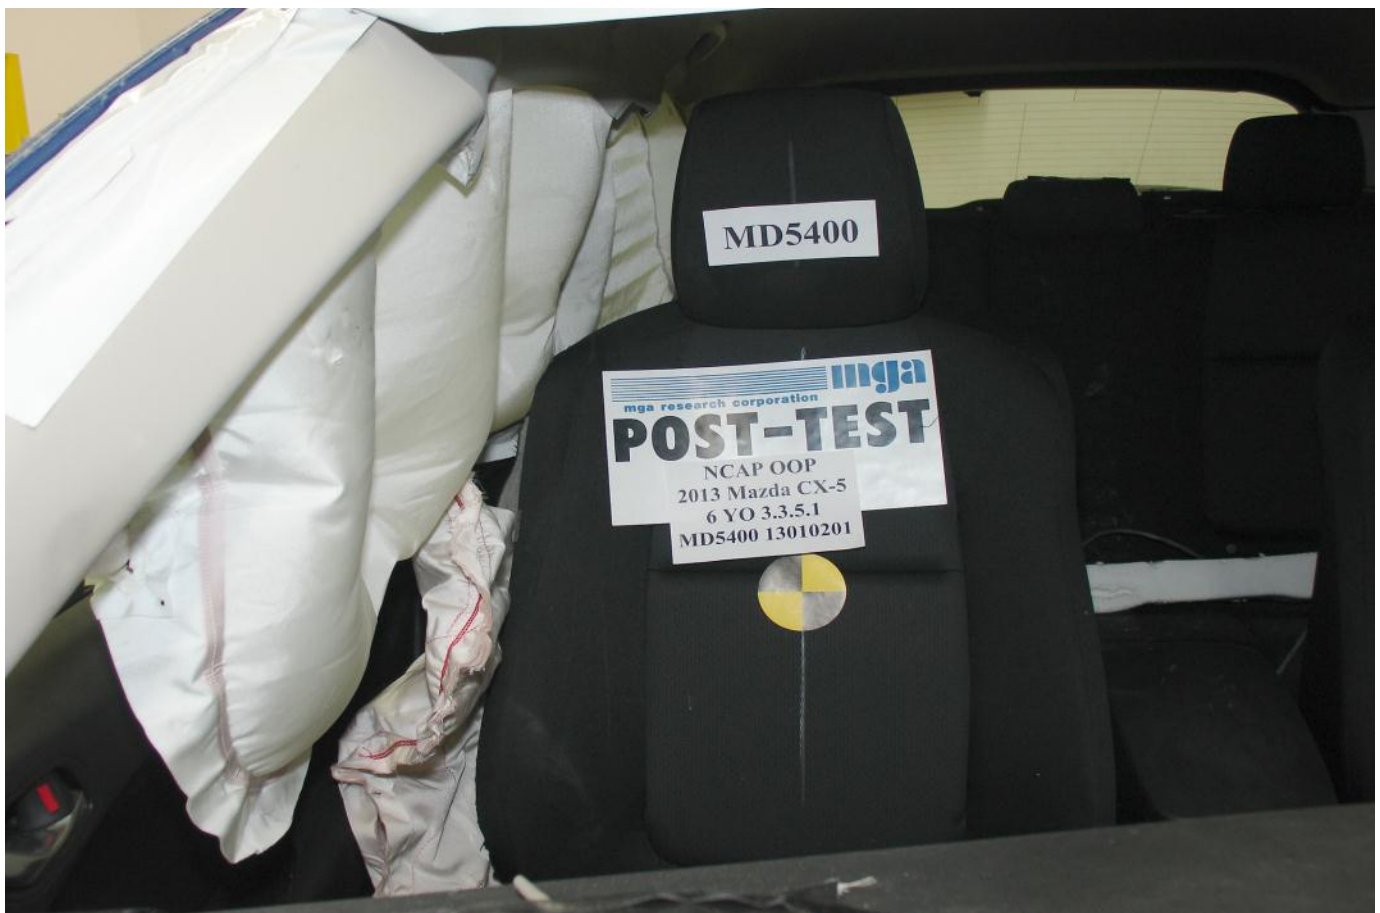
Post-Test Curtain Airbag Front View

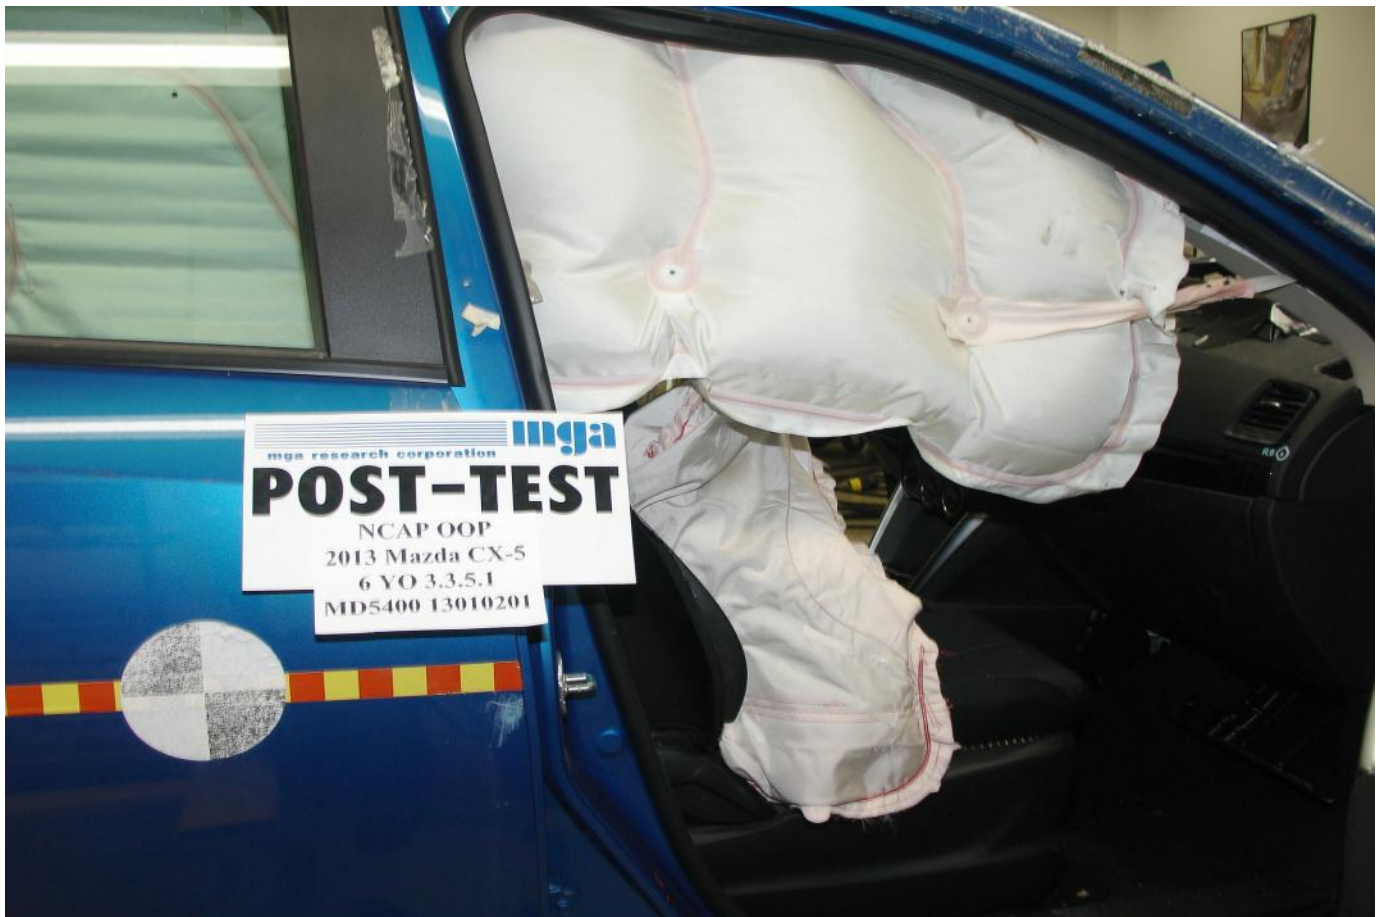
Post-Test Curtain Airbag Right Side View With Door Open
