**REPORT NUMBER: TWG-MGA-2013-003**

**SIDE AIRBAG OUT-OF-POSITION INJURY  
TECHNICAL WORKING GROUP**

**KIA MOTORS MANUFACTURING GEORGIA, INC.  
FOR HYUNDAI MOTOR COMPANY  
2013 Hyundai Santa Fe Sport AWD SUV  
NHTSA No.: MD0503TWG2**

**FINAL REPORT**

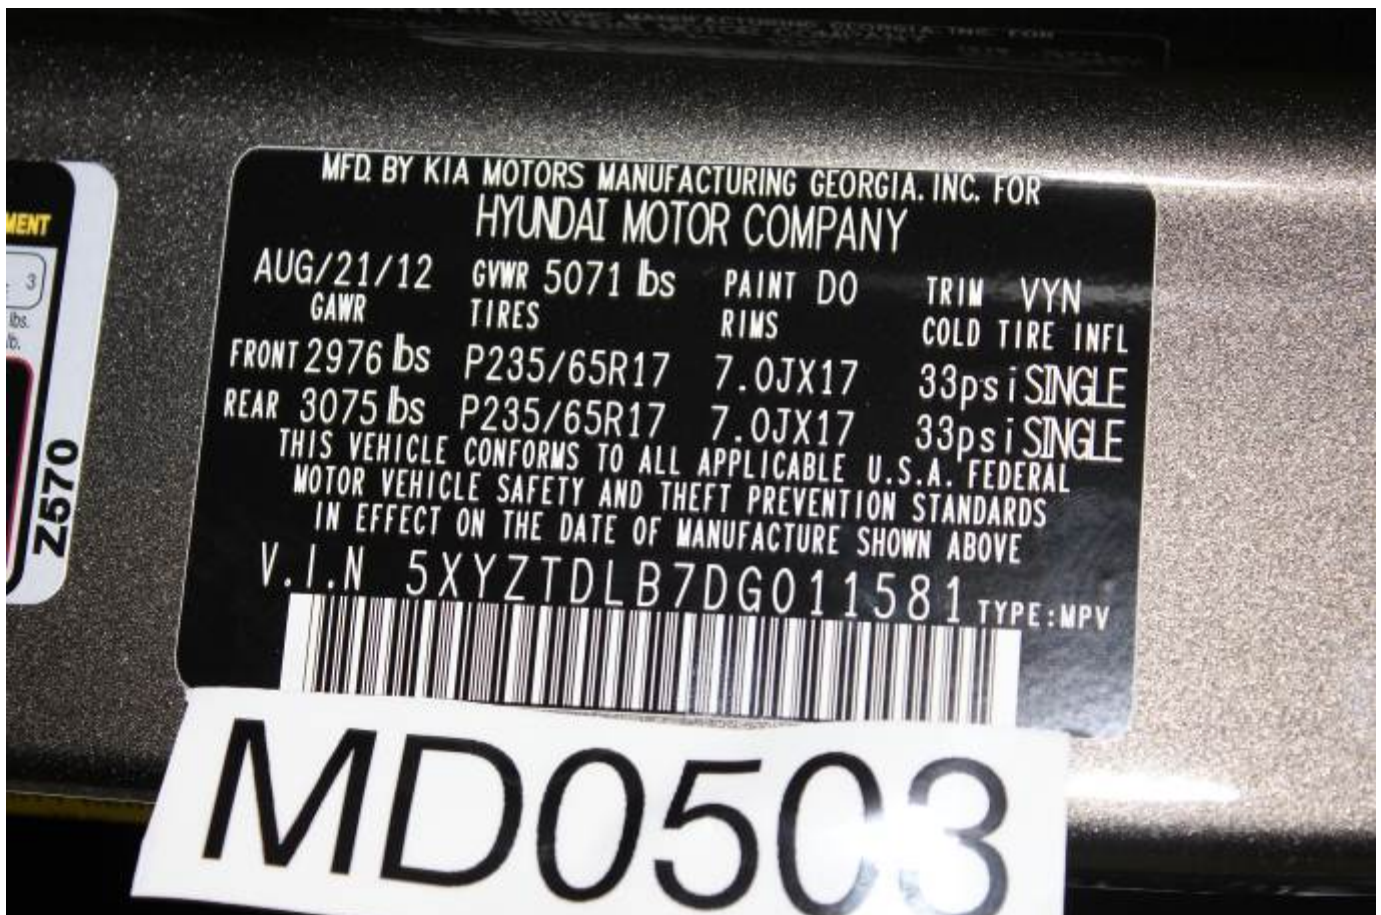
Vehicle Certification Placard

**DATA FROM CERTIFICATION LABEL**

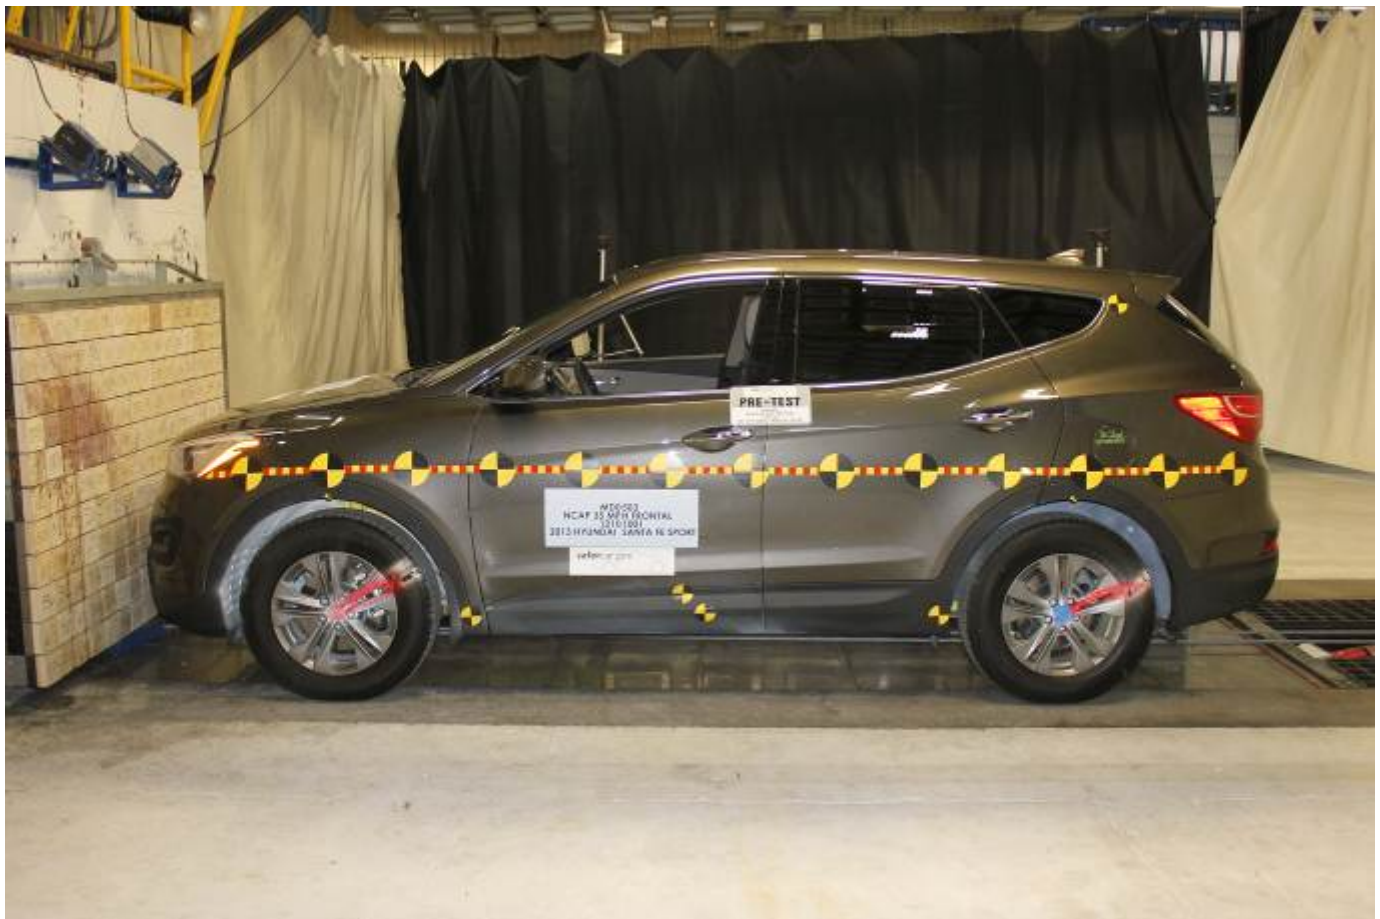
Pre-Test Vehicle Left Side View

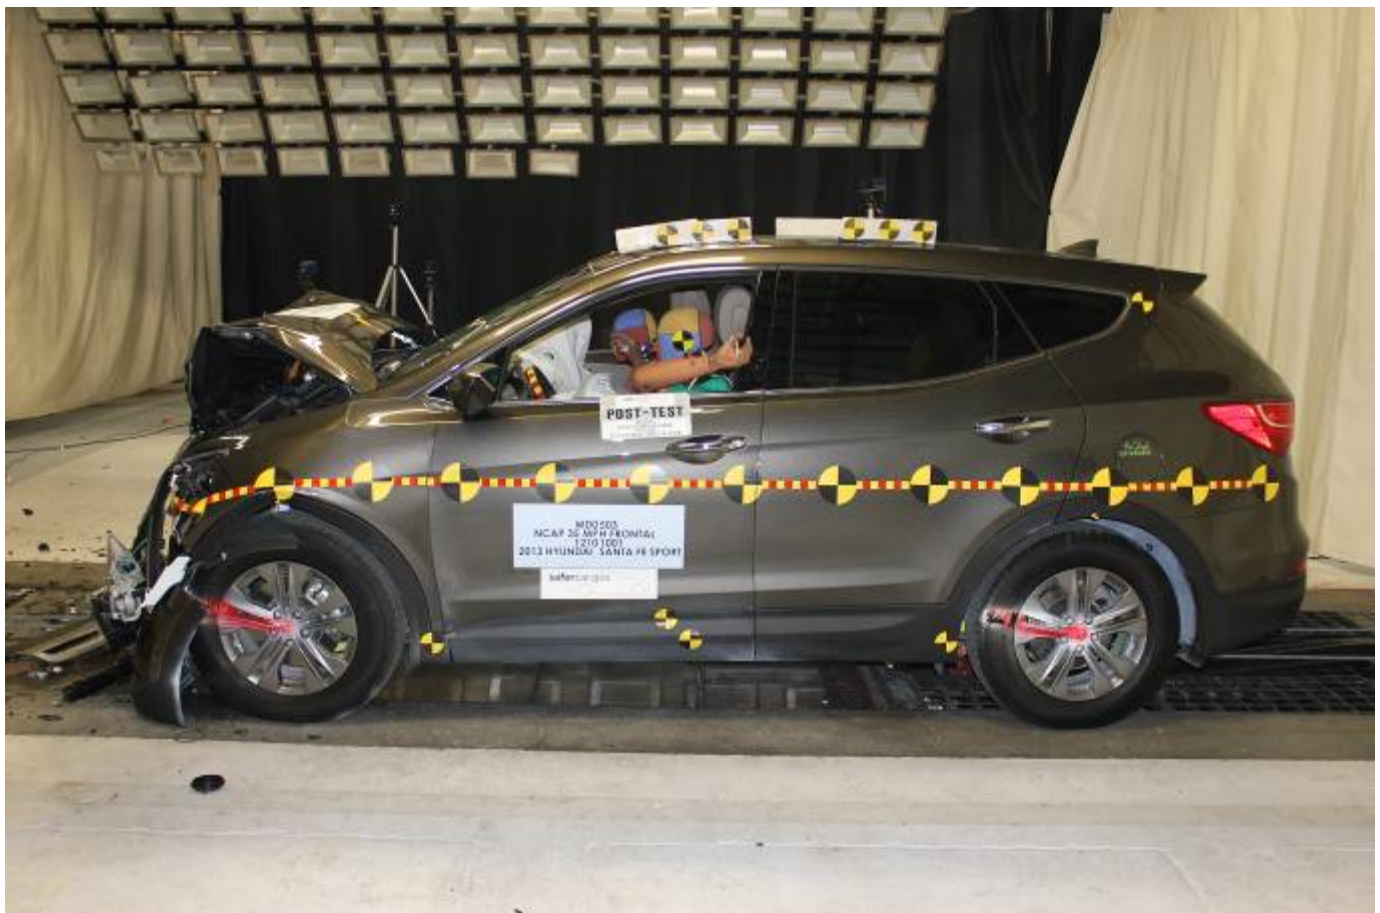
Post-Test Vehicle Left Side View

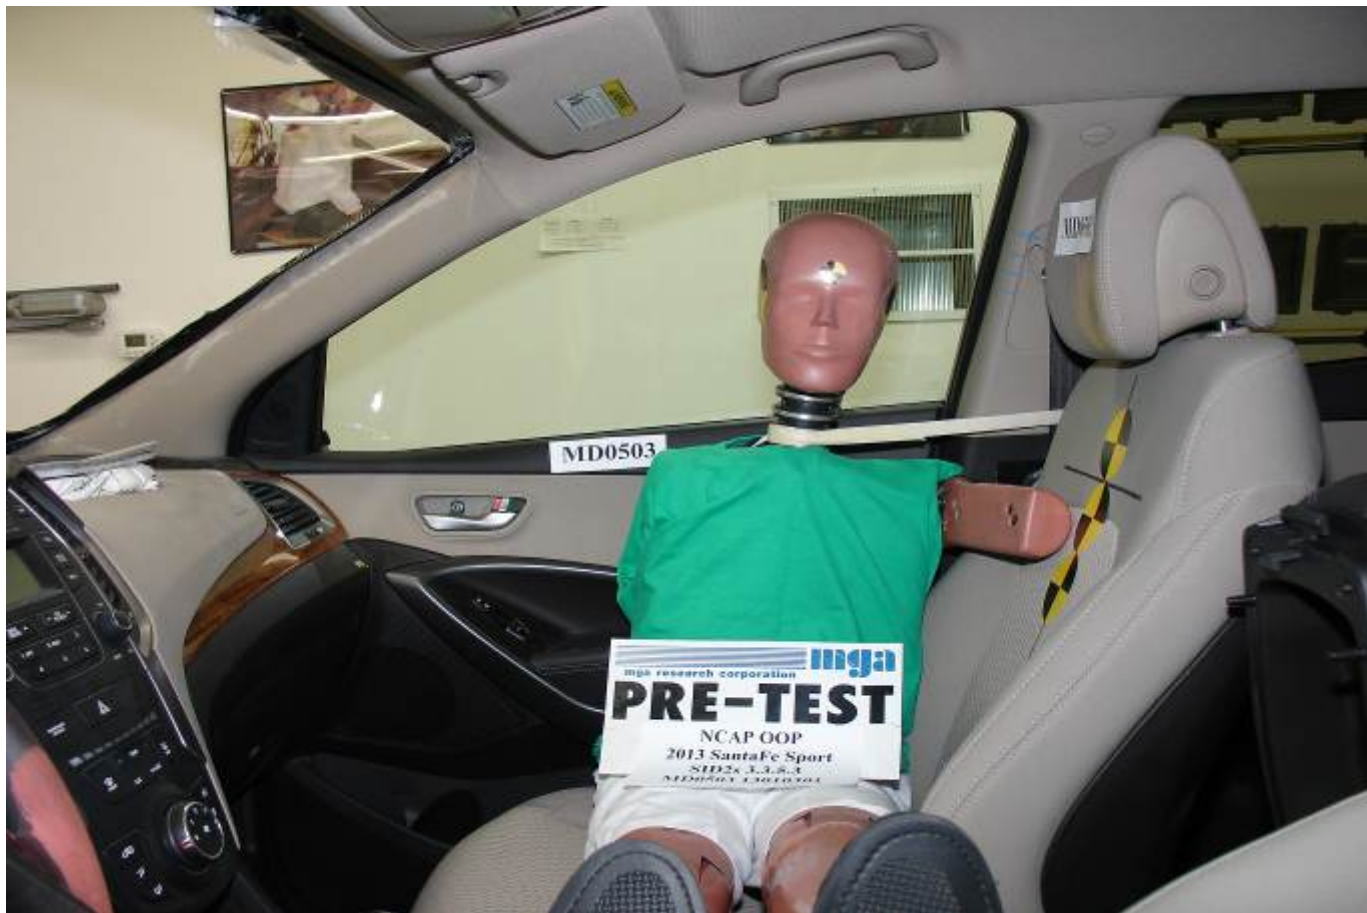
Pre-Test SID-IIs Dummy Left Side View

The SID-IIs dummy was placed in the right front passenger seat facing toward the center of the vehicle with its arm against the seatback. The arm was rotated horizontally in the forward direction with respect to the dummy. The seat track was adjusted forward to minimize the vertical distance between the dummy's head and curtain airbag. The dummy's pelvis was slid outboard until the dummy's back contacted the door trim panel or armrest and the CG of the head was centered in the deployment trajectory of the airbag. The vertical plane through the centerline of the dummy's rib-stiffener and shoulder bolt was parallel to the centerline of the vehicle. Masking tape was wrapped around the dummy's neck bracket to hold the dummy in place.

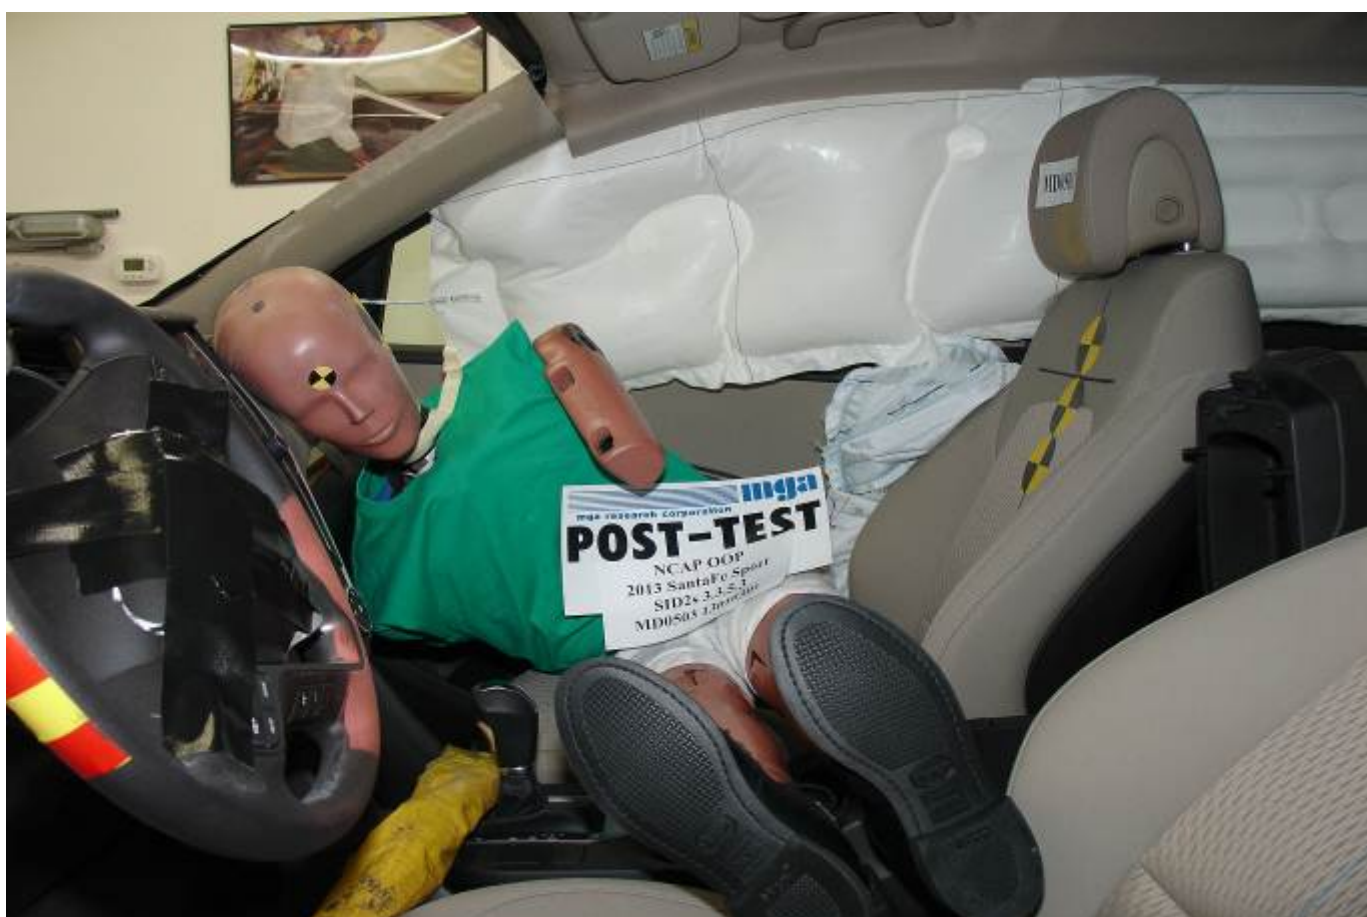
Post-Test SID-IIs Dummy Left Side View

- Curtain airbag to top and back of head
- Right shoulder to dash
- Torso bag to left torso and left pelvis

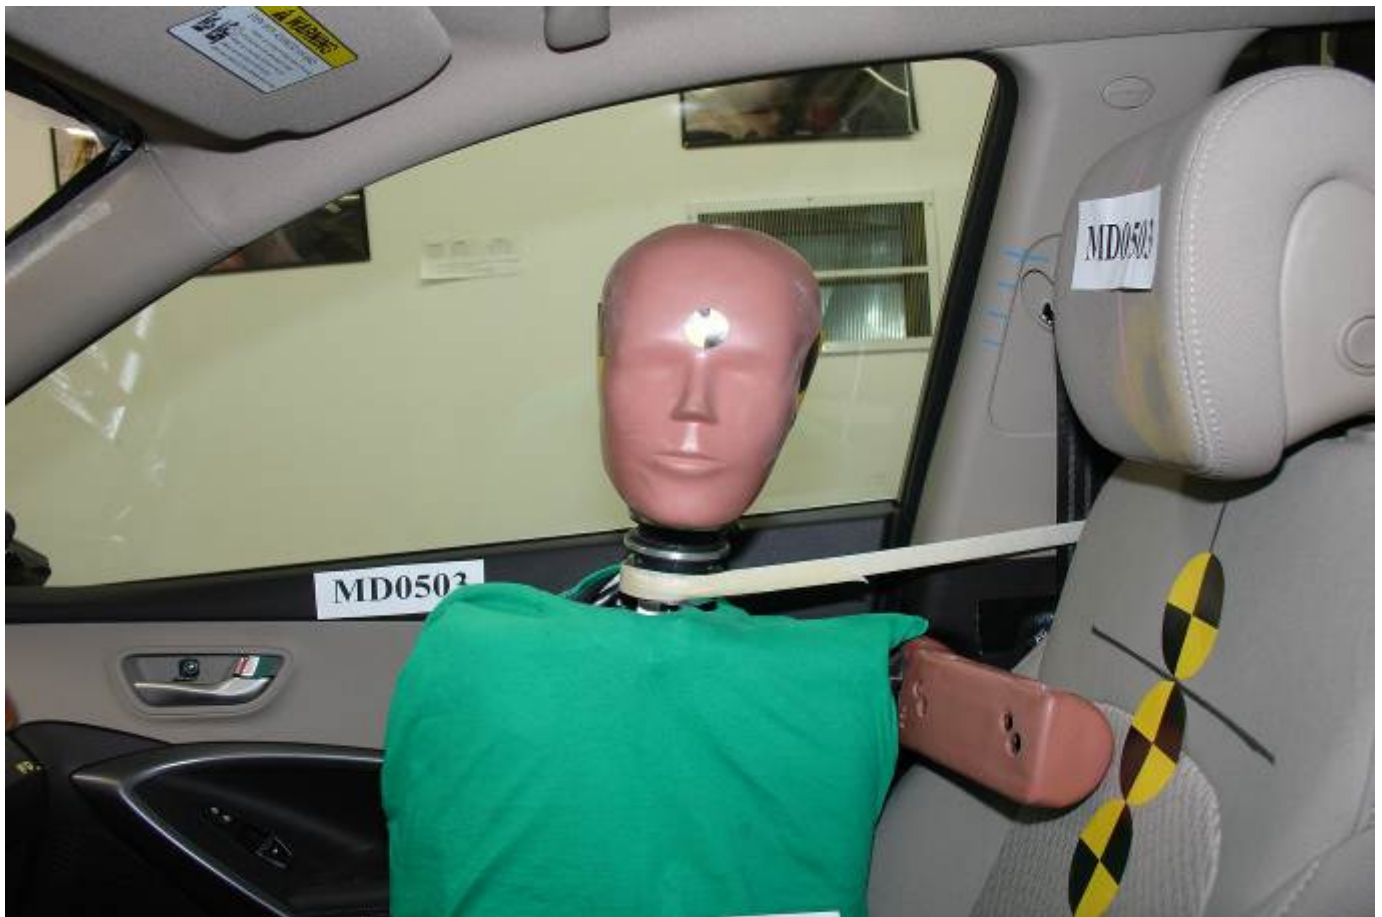
Pre-Test SID-IIs Dummy Left Side Closeup View

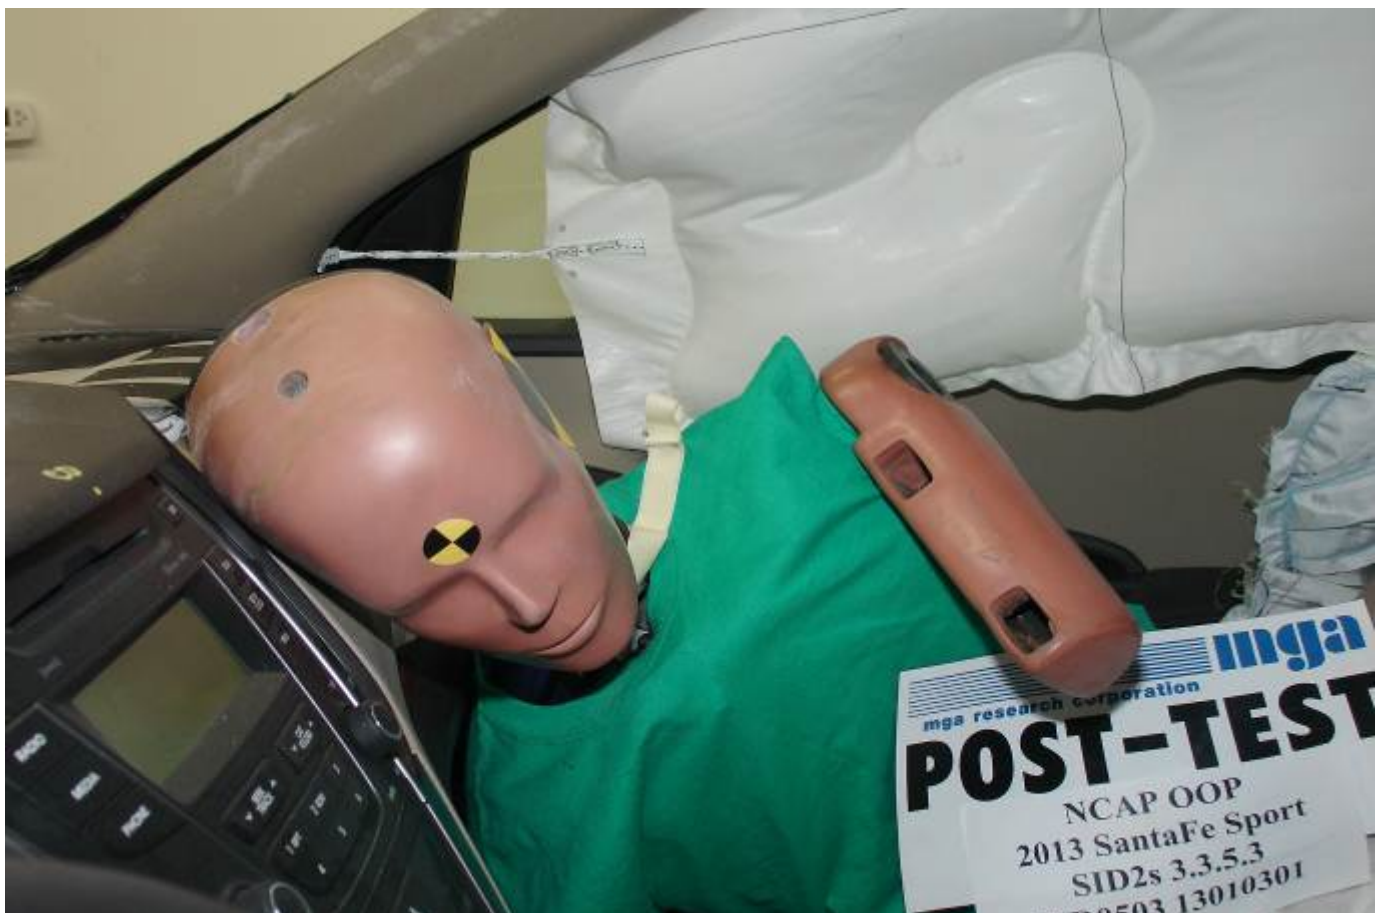
Post-Test SID-IIs Dummy Left Side Closeup View

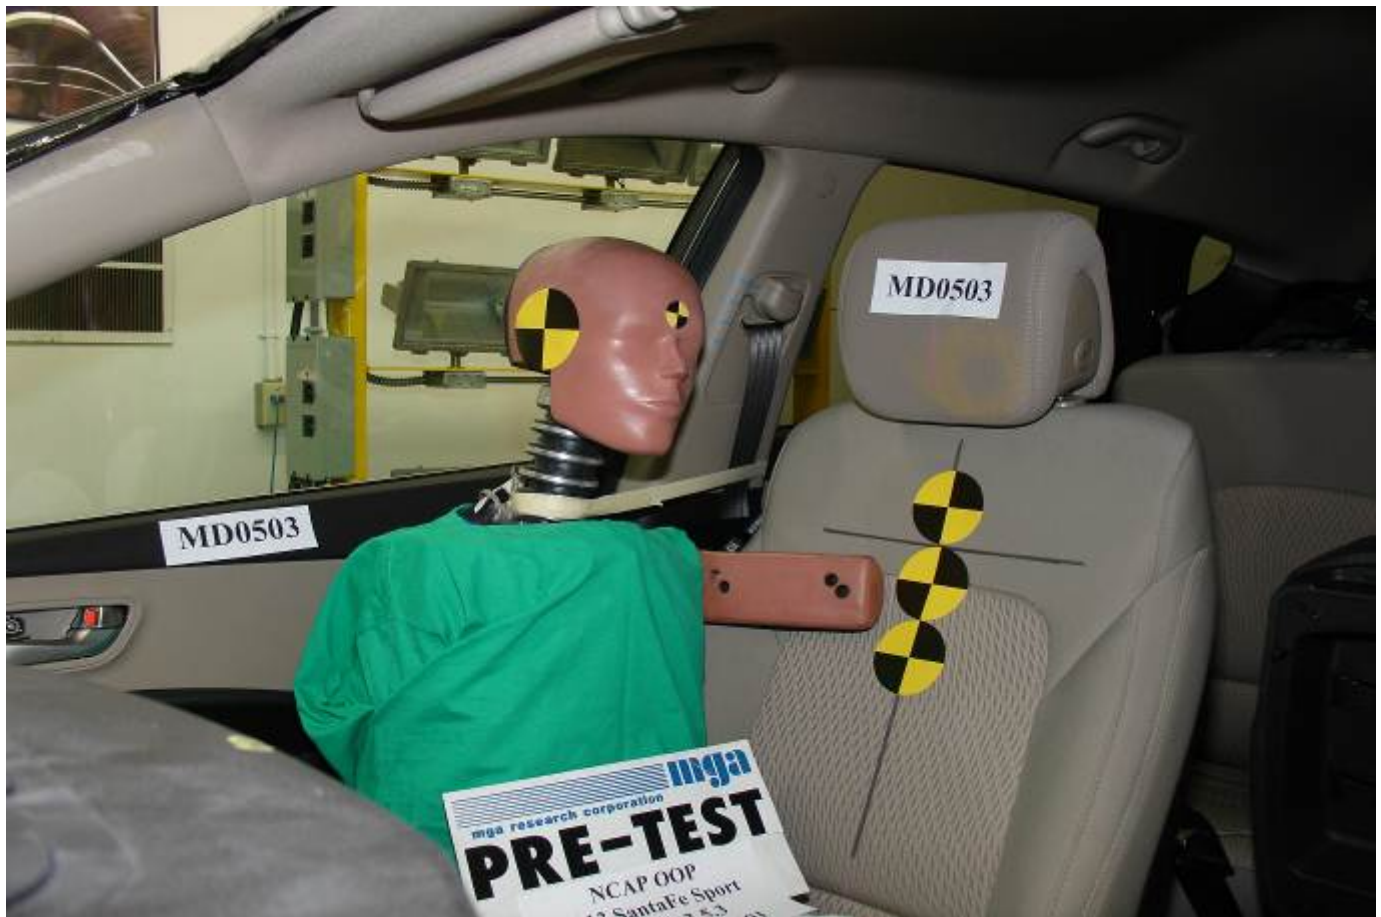
Pre-Test SID-IIs Dummy Left ¾ Front View

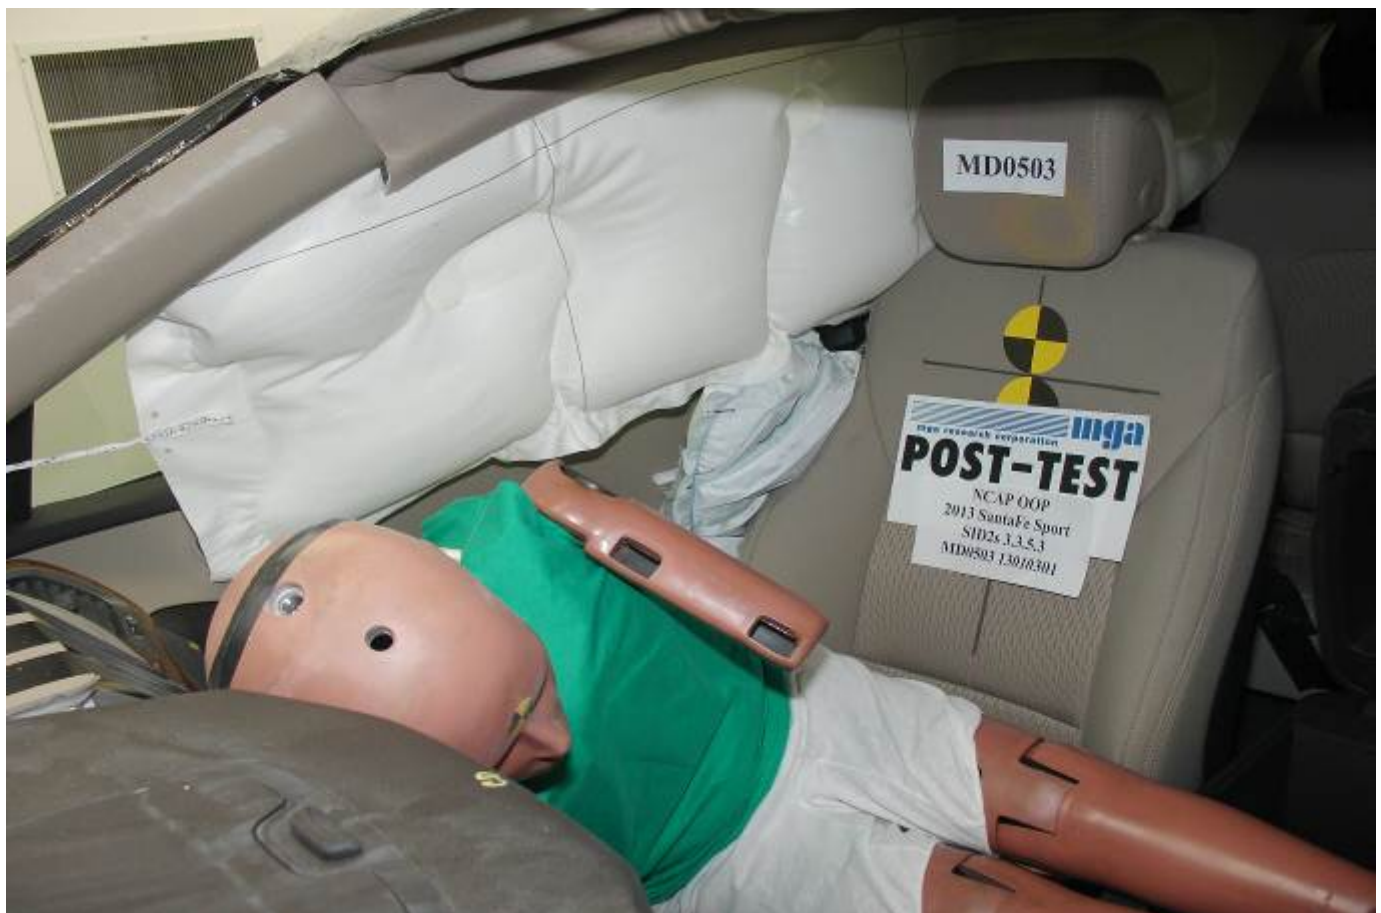
Post-Test SID-IIs Dummy Left ¾ Front View

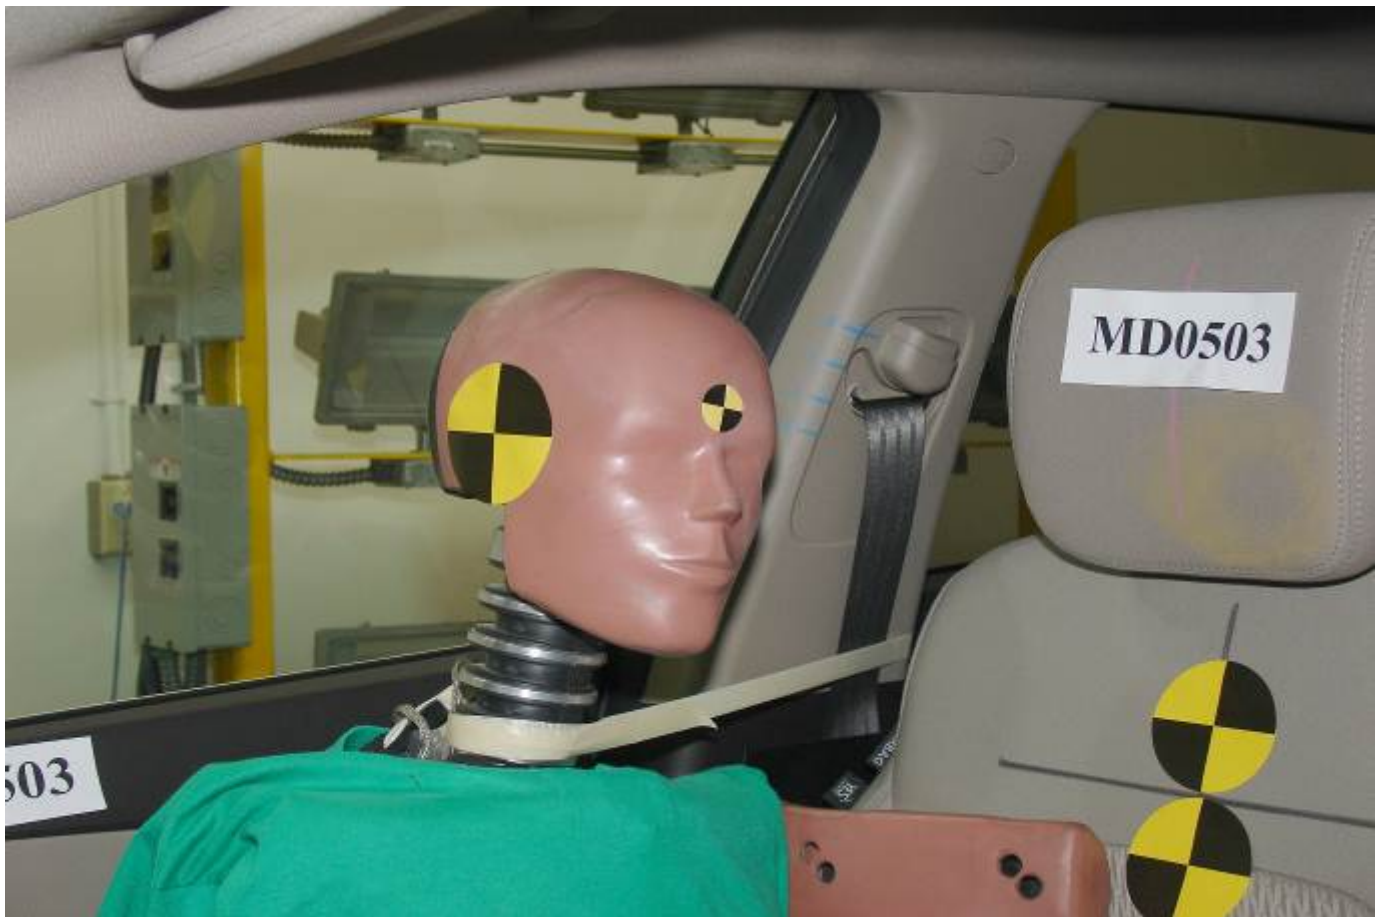
Pre-Test SID-IIs Dummy Left  $\frac{3}{4}$  Front Closeup View

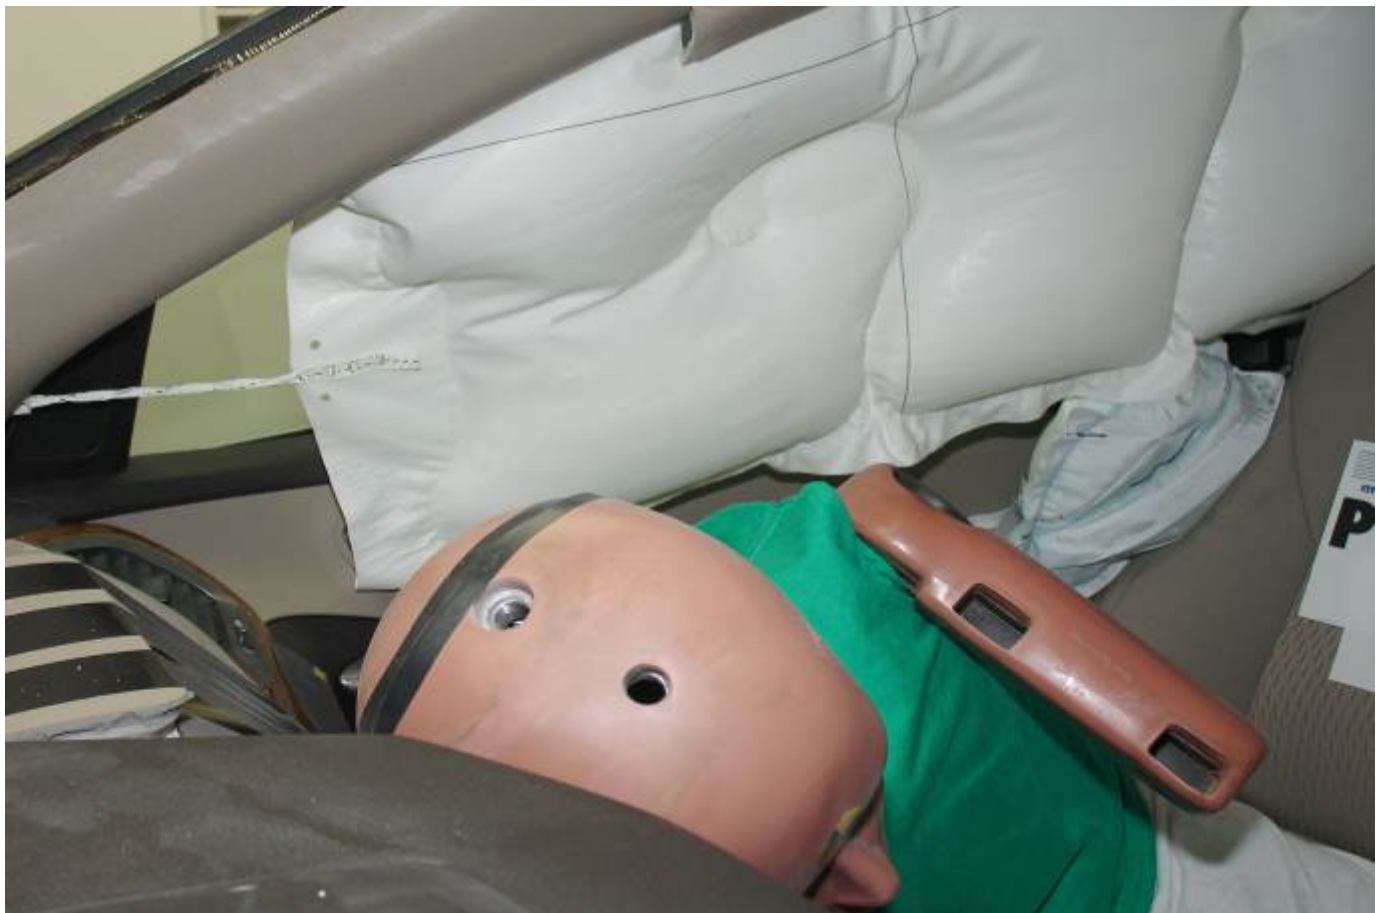
Post-Test SID-IIs Dummy Left  $\frac{3}{4}$  Front Closeup View

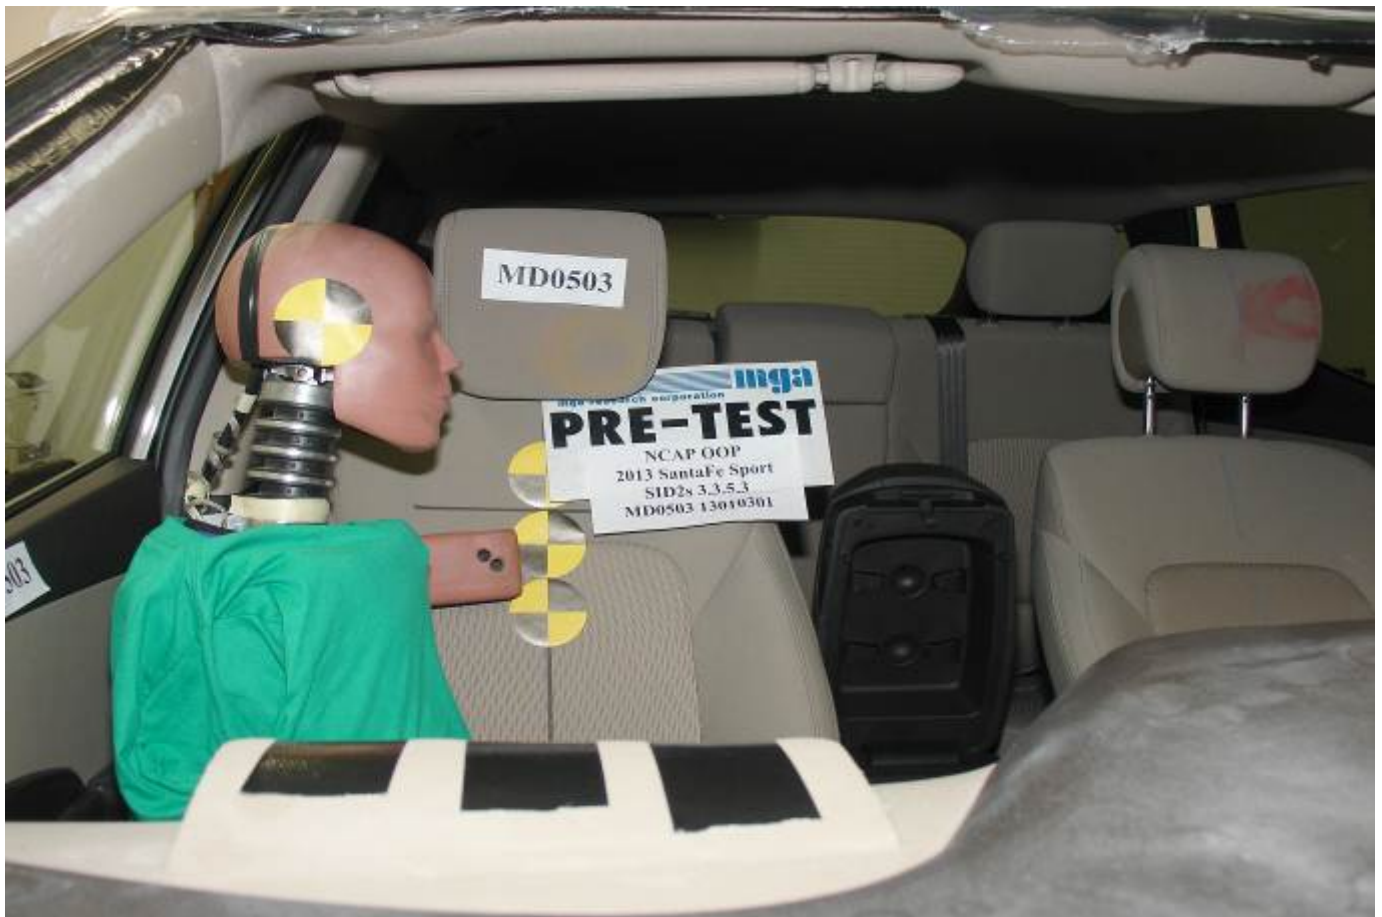
Pre-Test SID-II's Dummy Front View

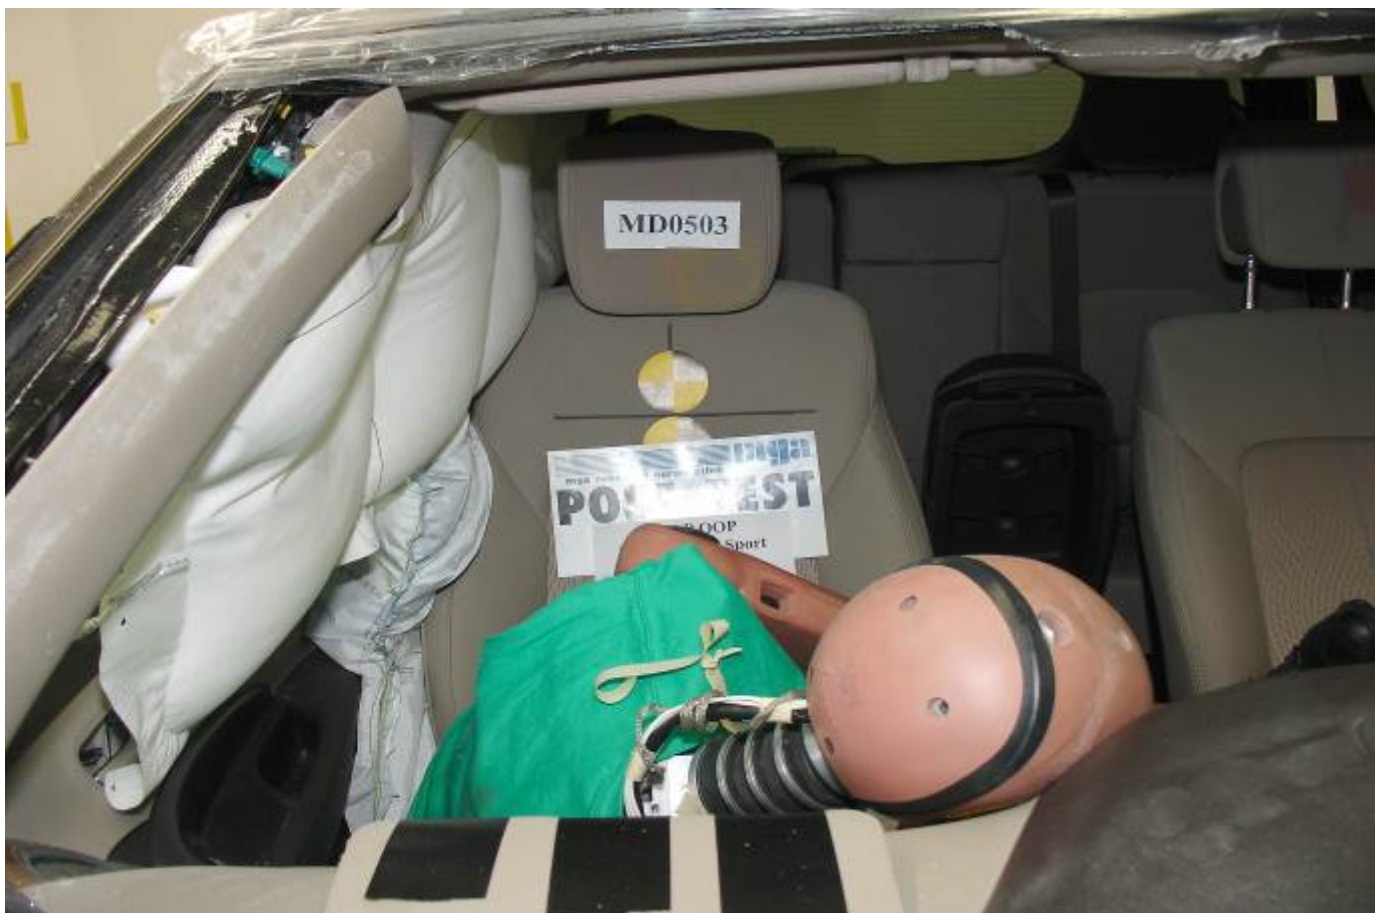
Post-Test SID-II's Dummy Front View

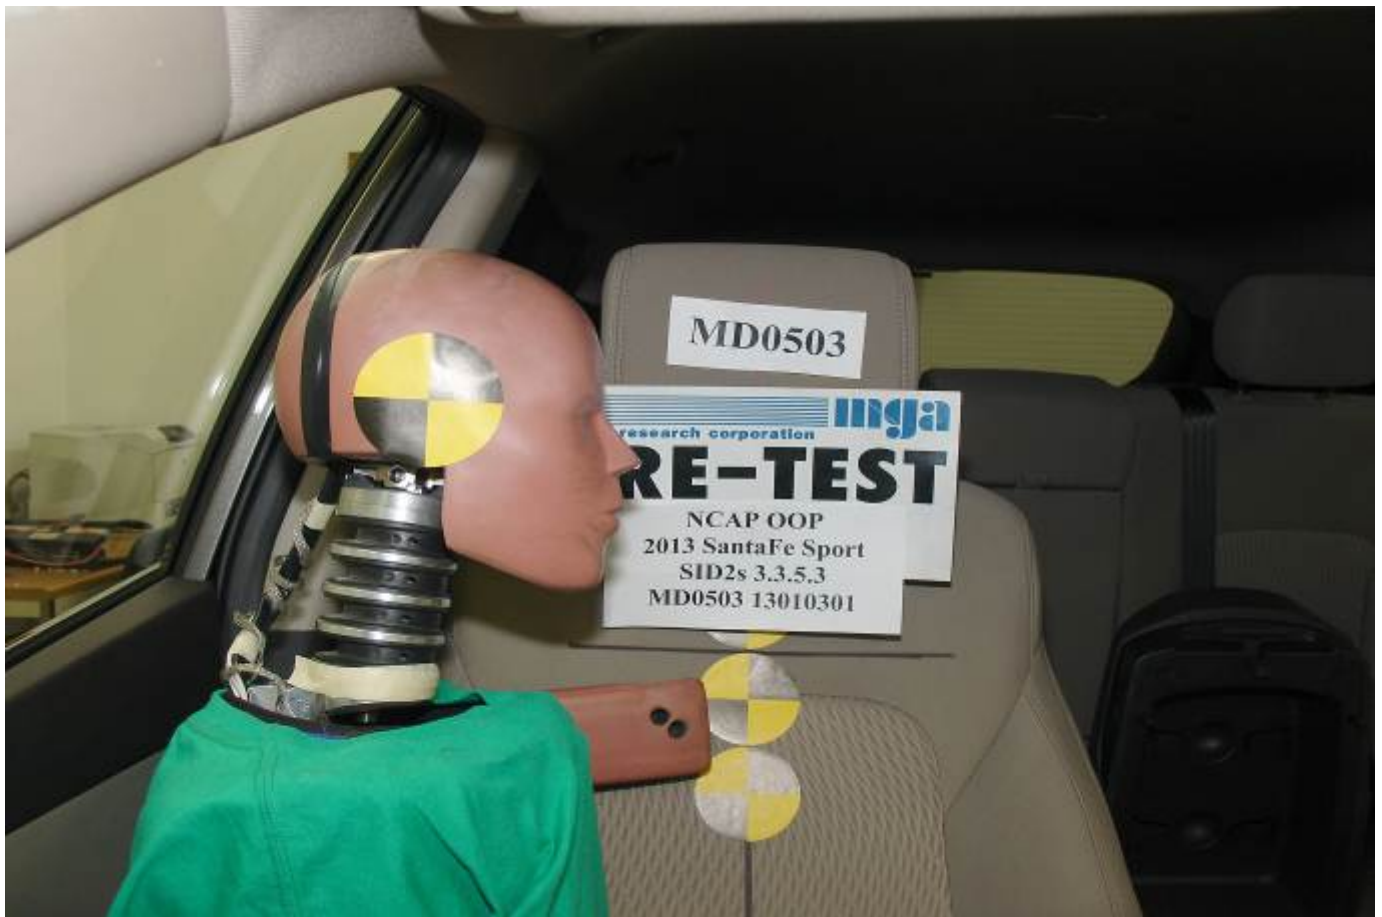
Pre-Test SID-IIs Dummy Front Closeup View

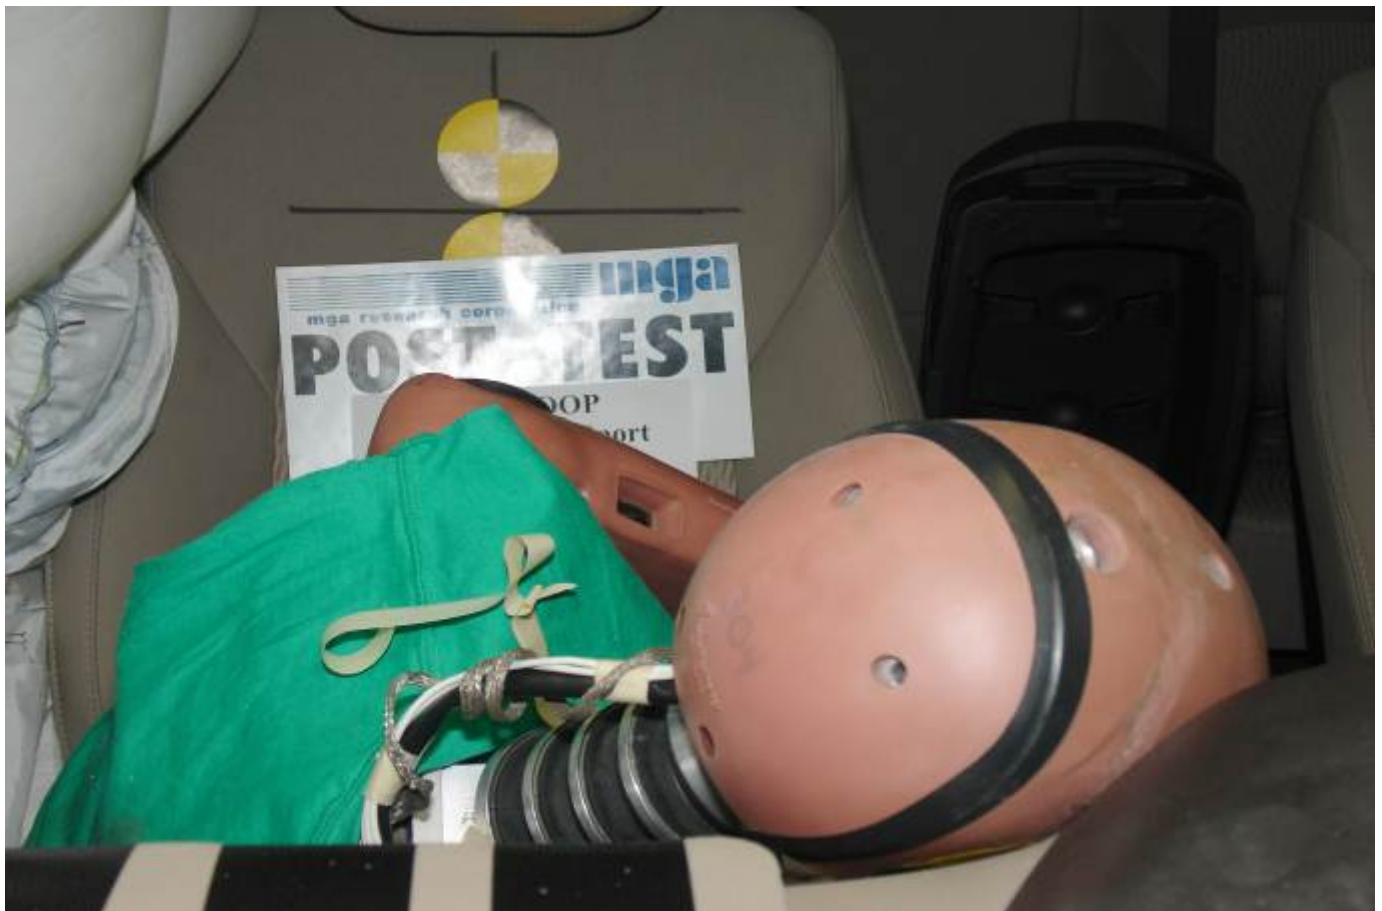
Post-Test SID-IIs Dummy Front Closeup View

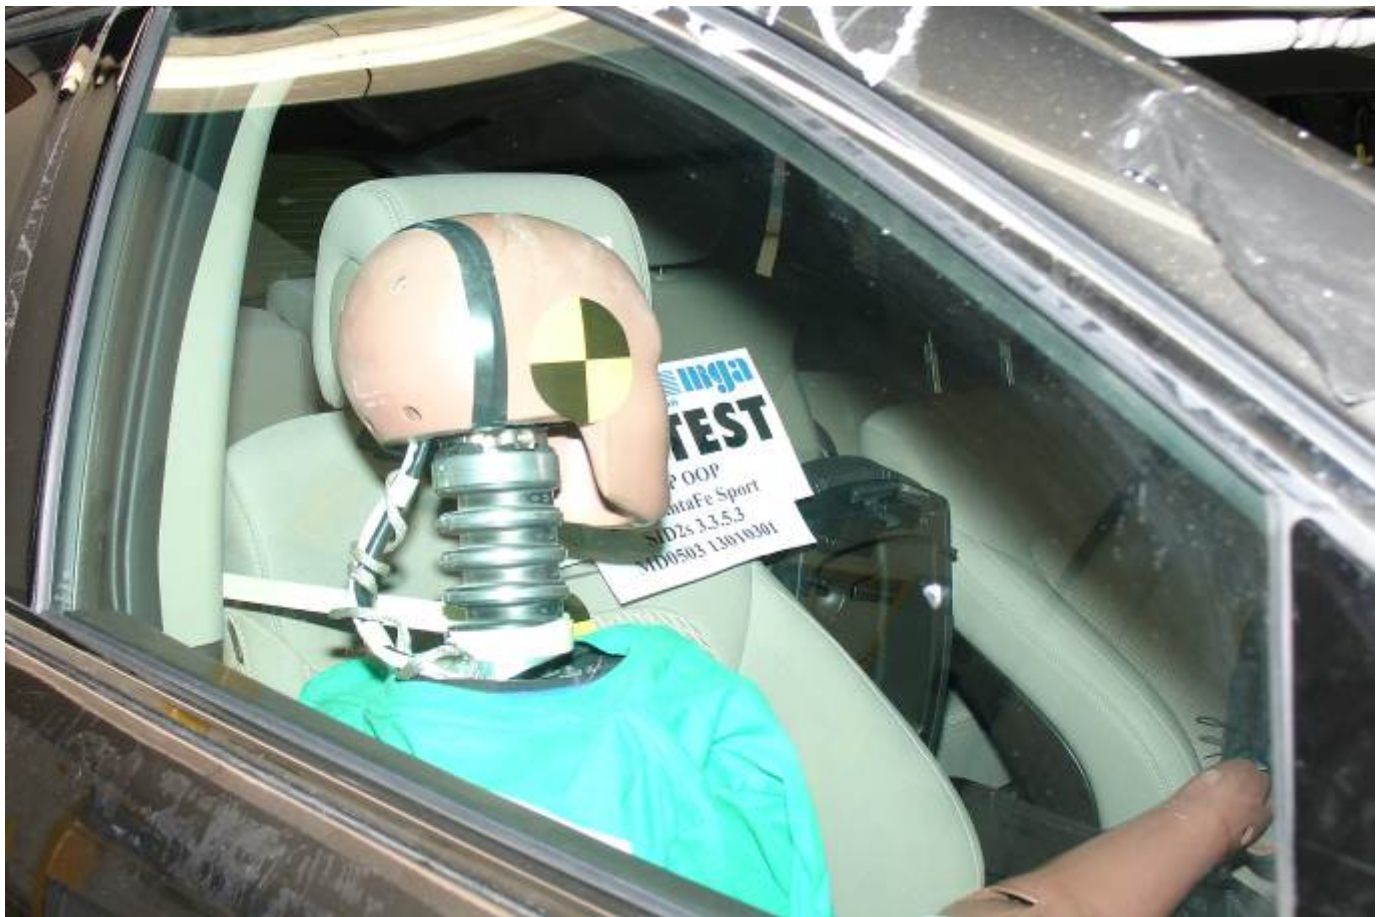
Pre-Test SID-11s Dummy Right 3/4 Front View

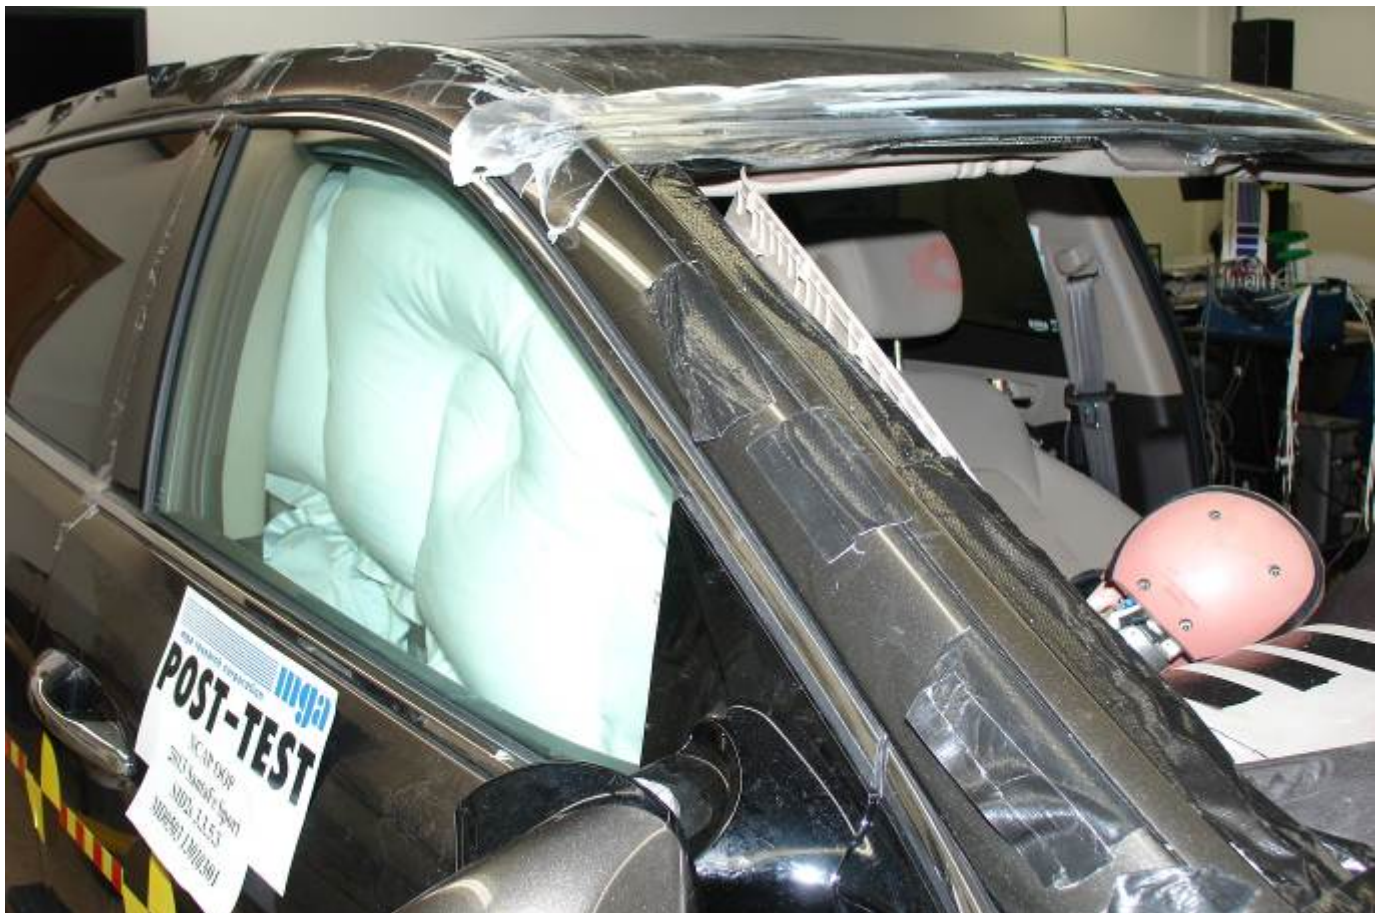
Post-Test SID-11s Dummy Right 3/4 Front View

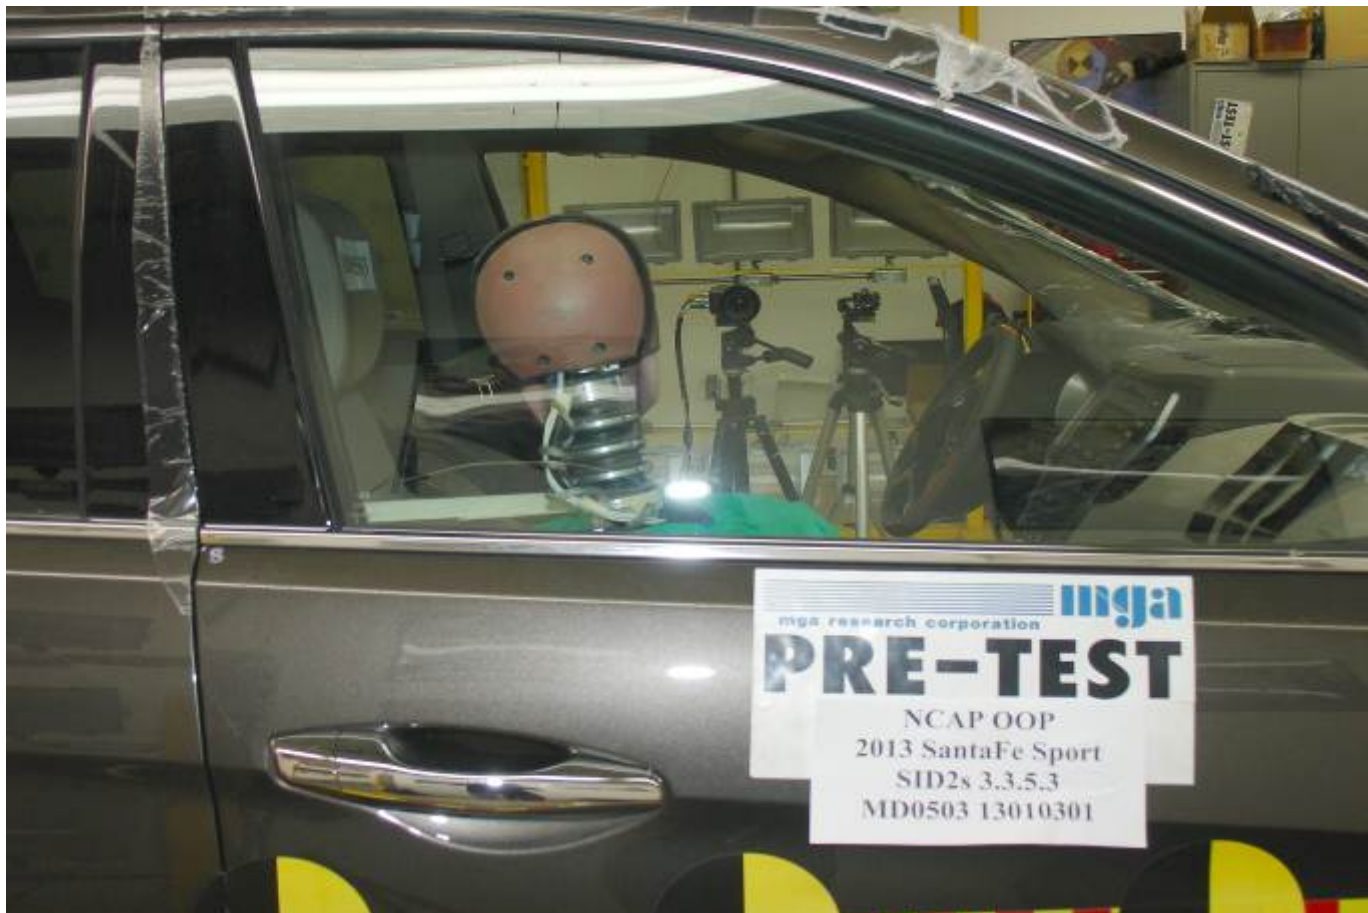
Pre-Test SID-IIs Dummy Right Side View
