**REPORT NUMBER: TWG-MGA-2013-003**

**SIDE AIRBAG OUT-OF-POSITION INJURY  
TECHNICAL WORKING GROUP**

**KIA MOTORS MANUFACTURING GEORGIA, INC.  
FOR HYUNDAI MOTOR COMPANY  
2013 Hyundai Santa Fe Sport AWD SUV  
NHTSA No.: MD0503TWG2**

**FINAL REPORT**

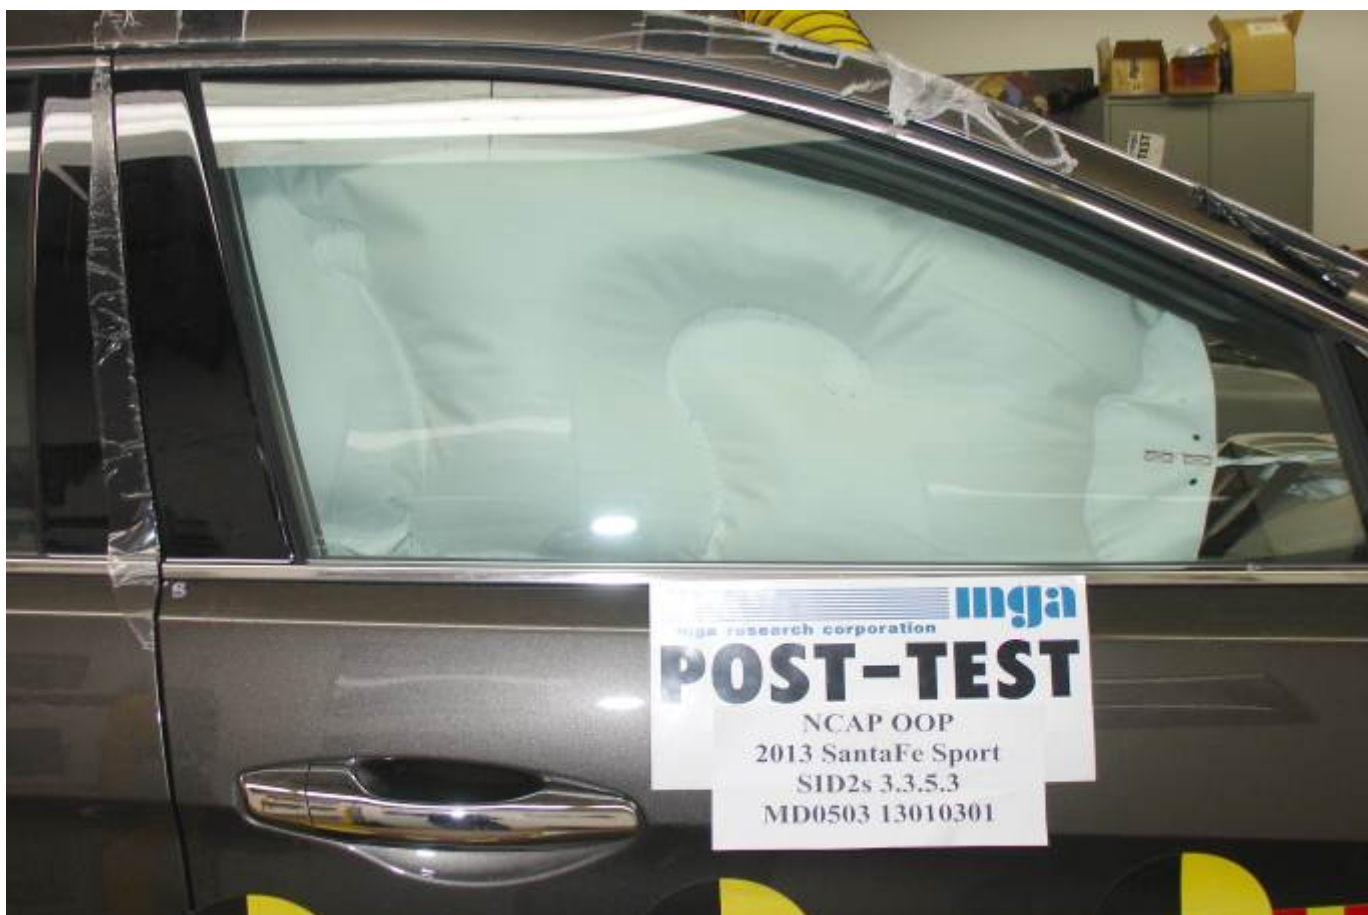
Post-Test SID-IIs Dummy Right Side View

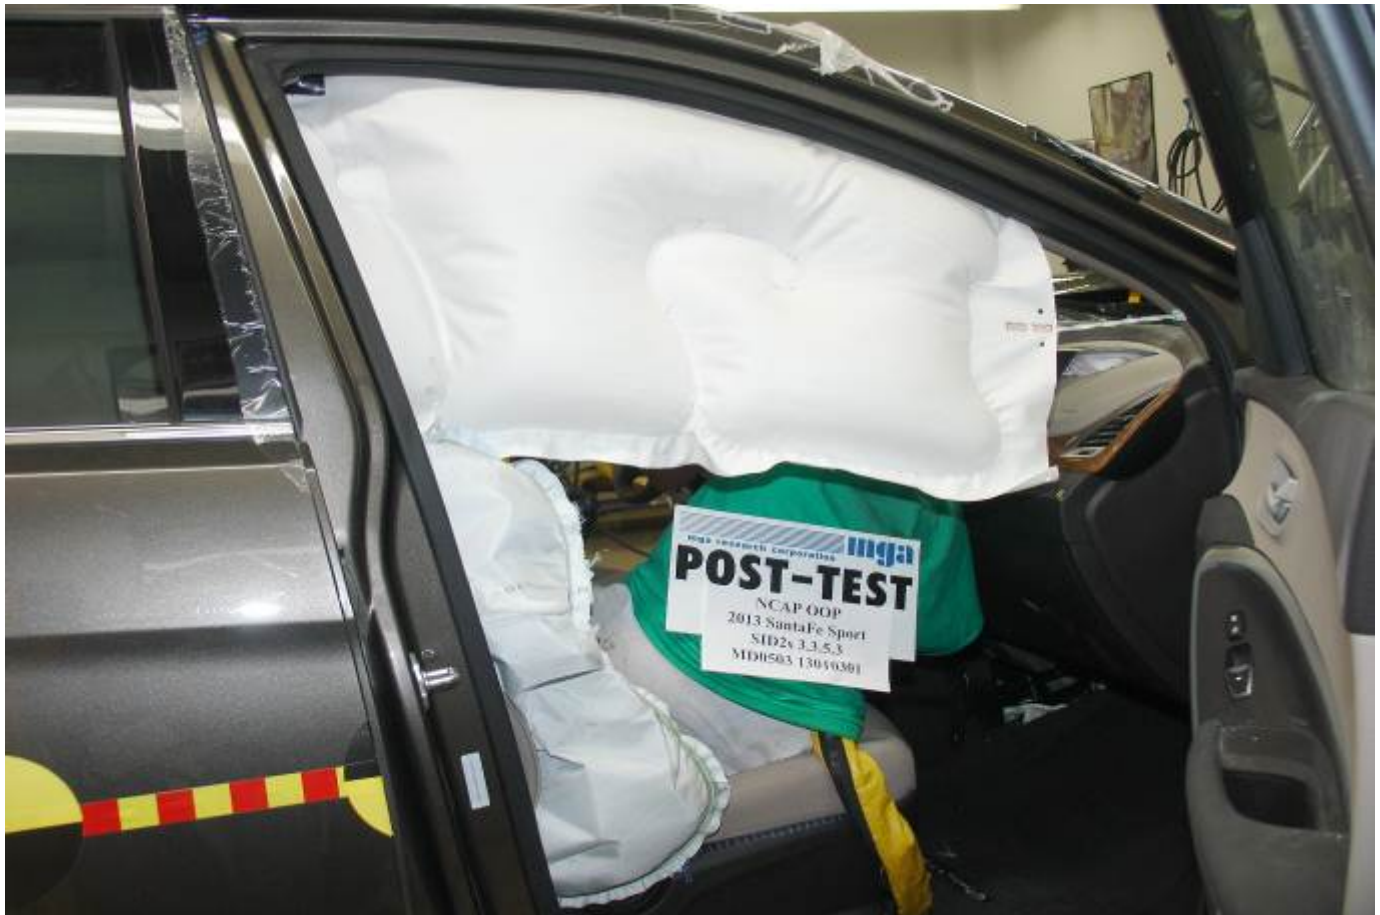
Post-Test SID-II's Dummy Right Side View (Door Open)

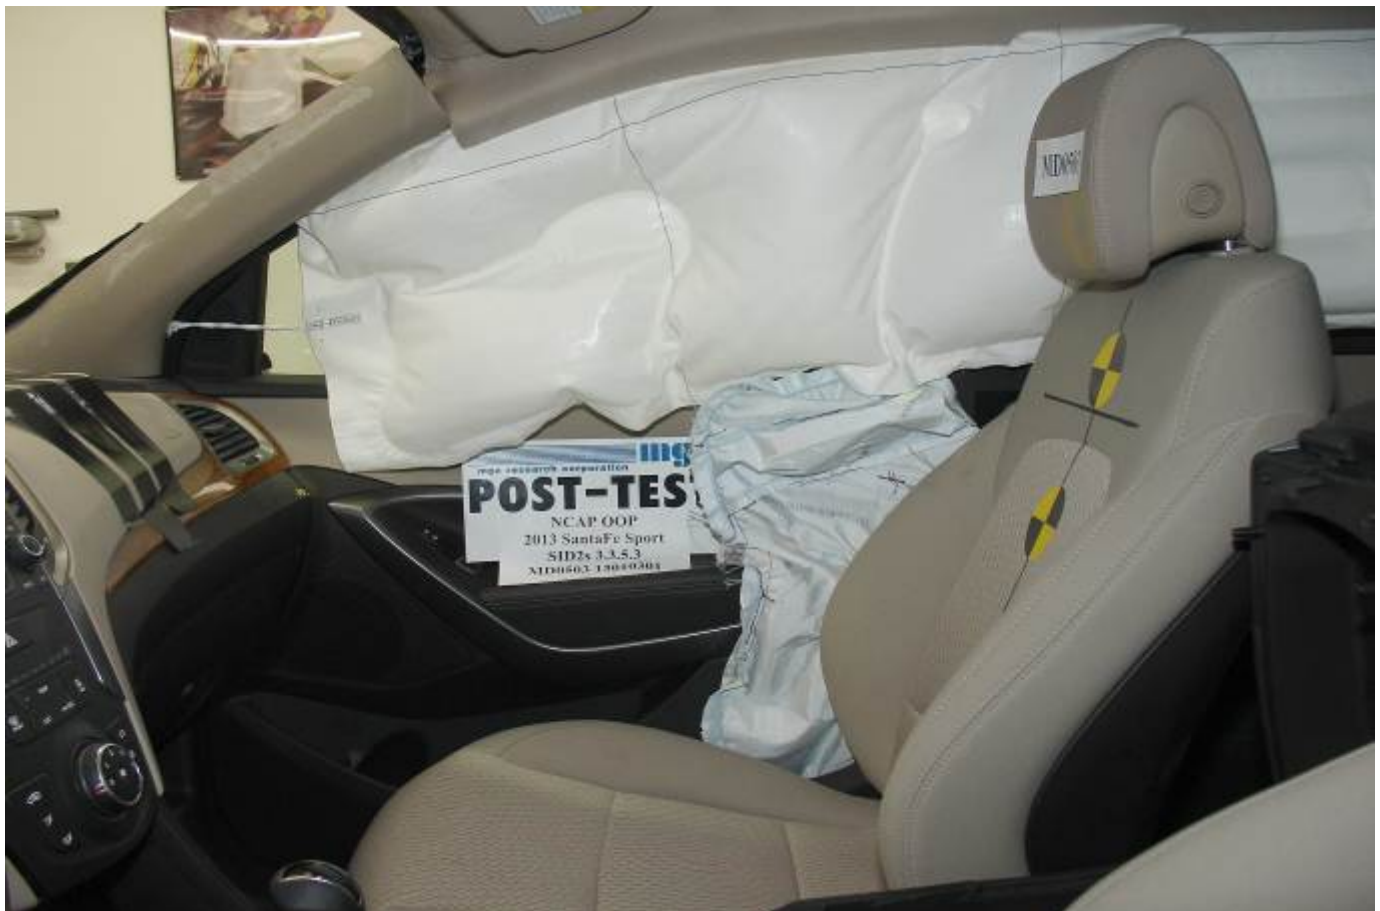
Post-Test Curtain Airbag Left Side View

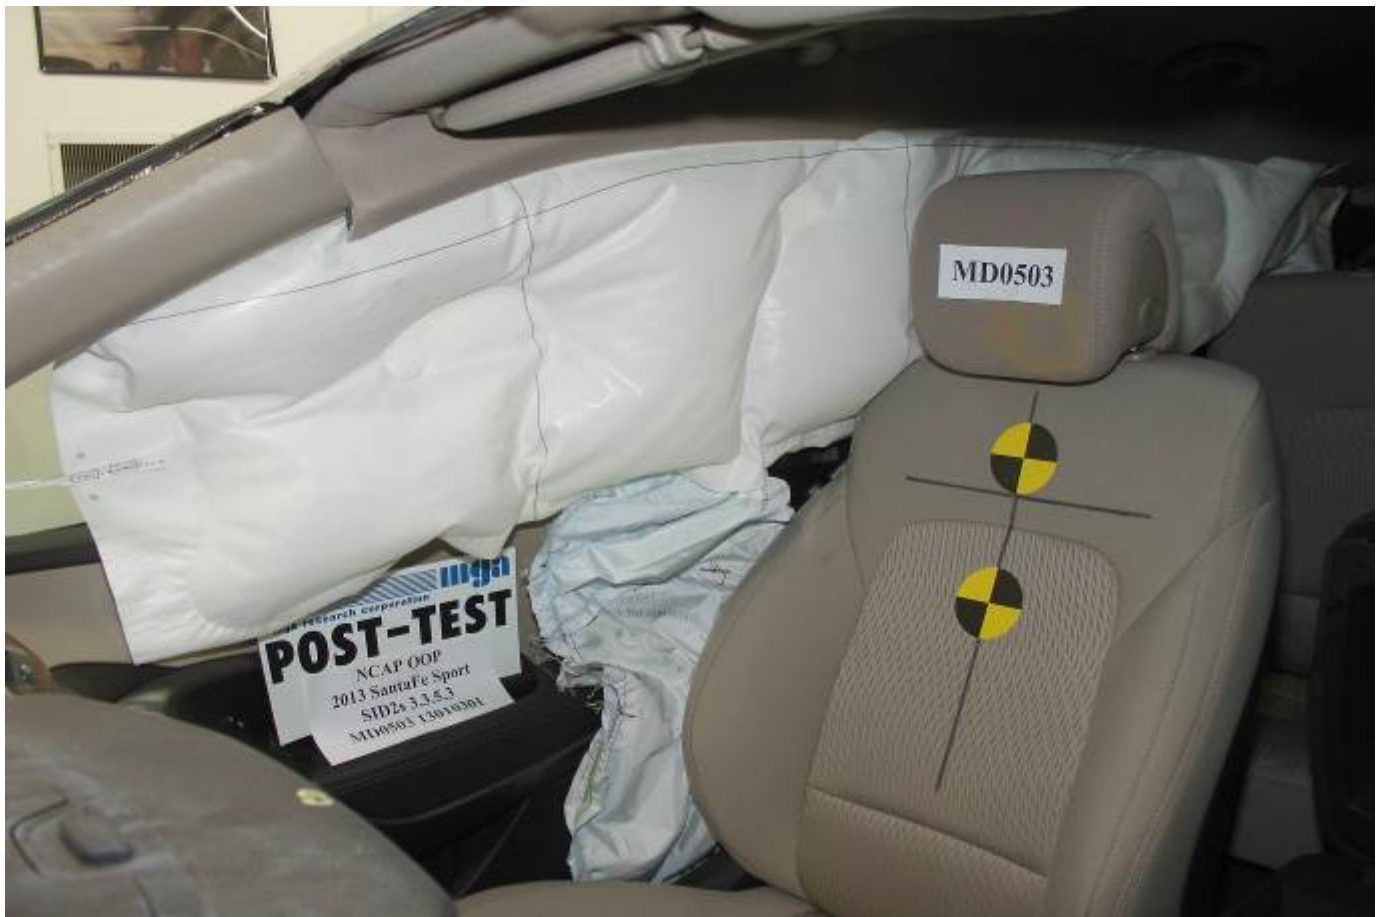
Post-Test Curtain Airbag Left ¾ Front View

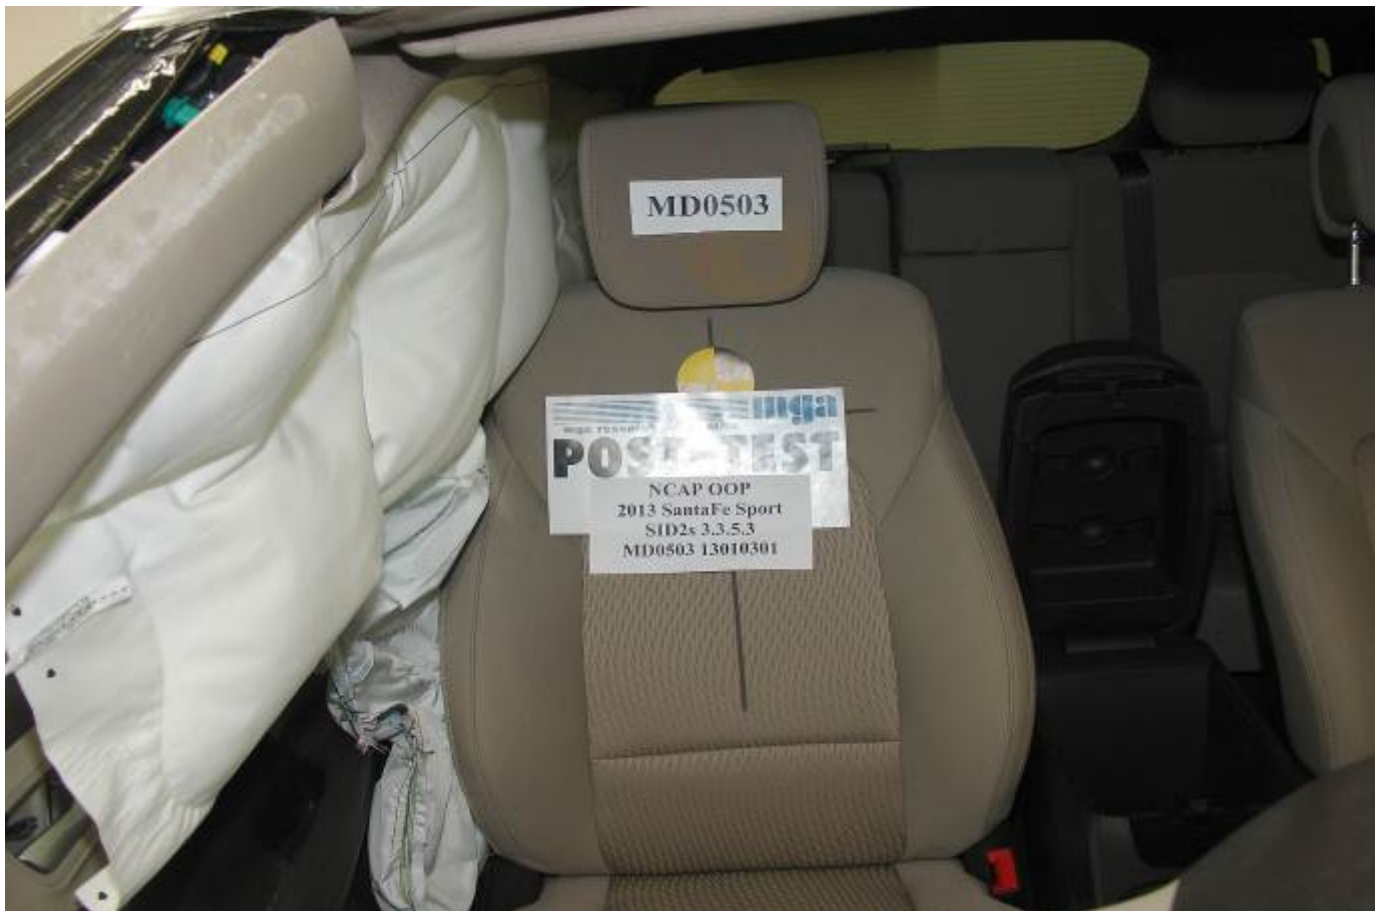
Post-Test Curtain Airbag Front View

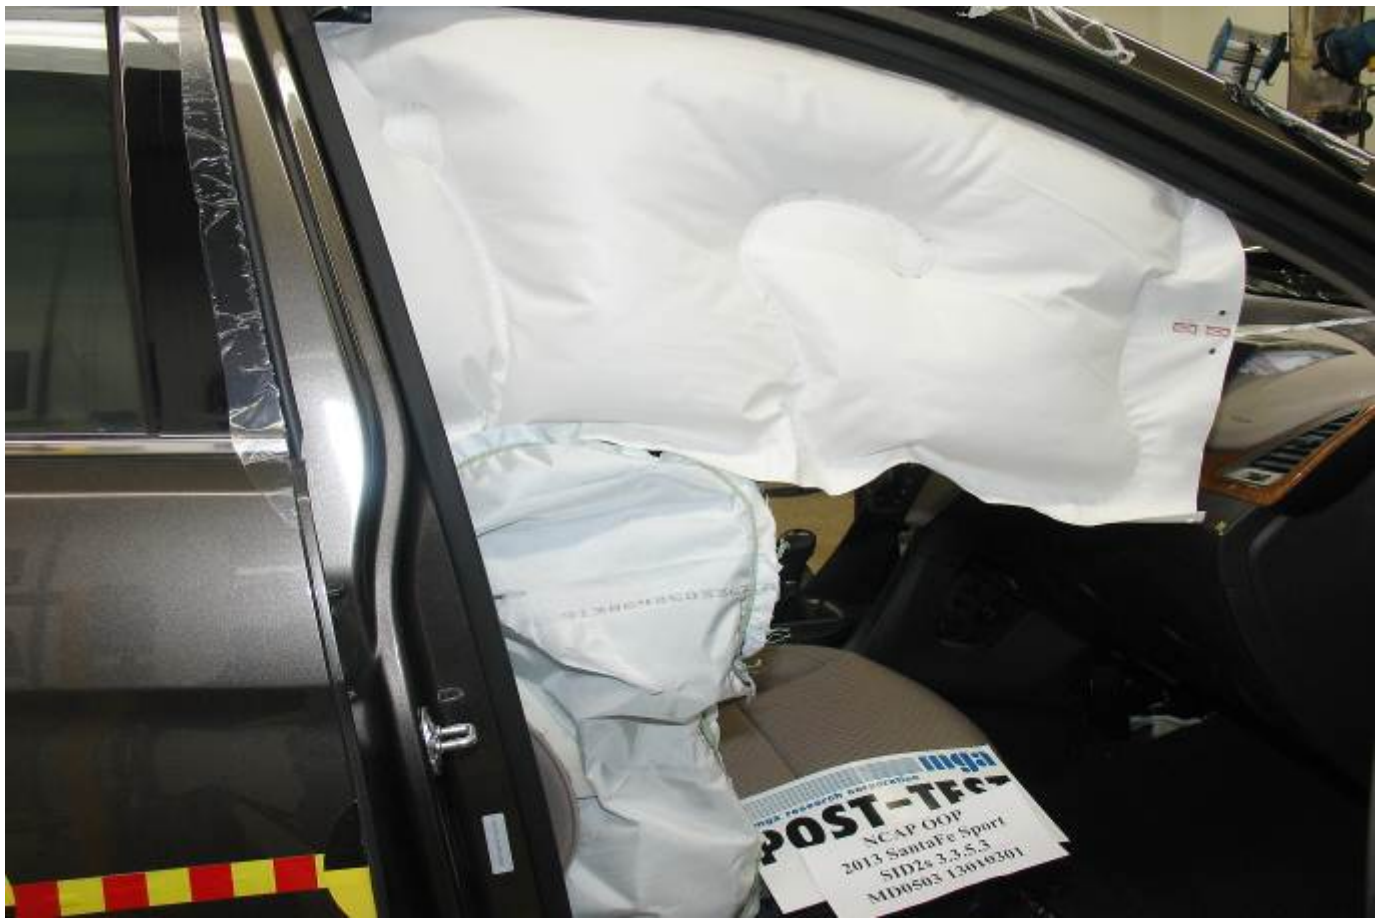
Post-Test Curtain Airbag Right Side View (Door Open)

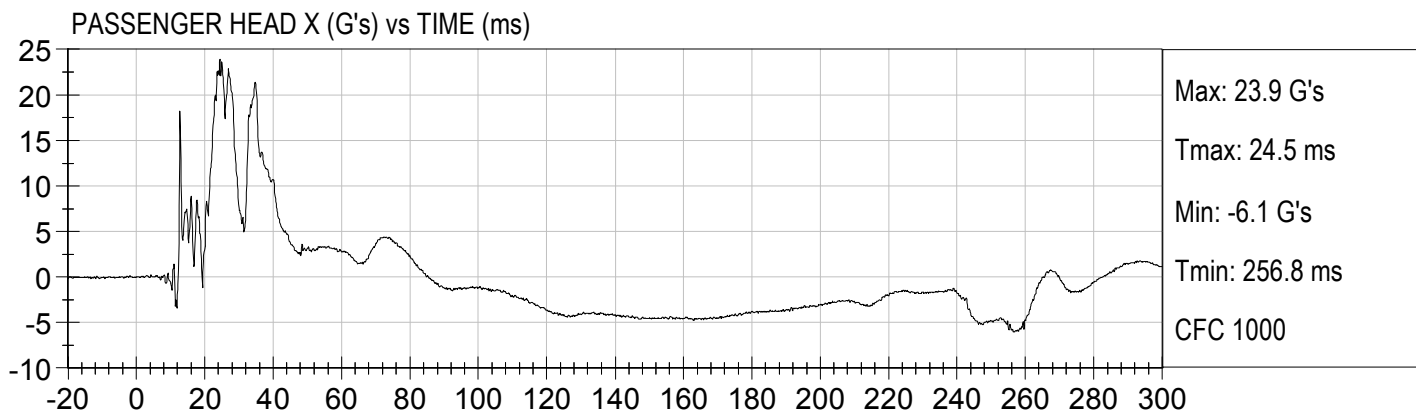
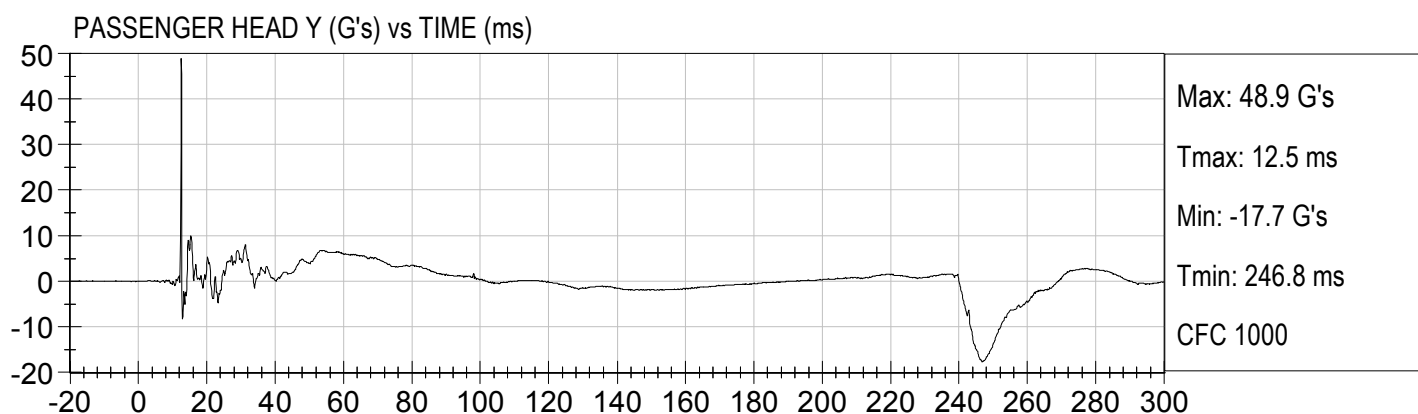
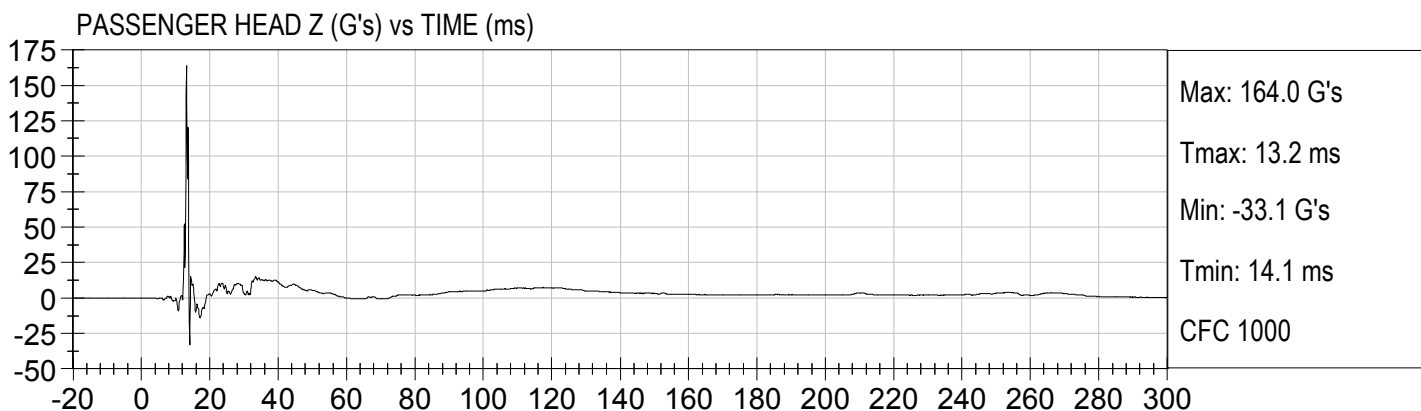
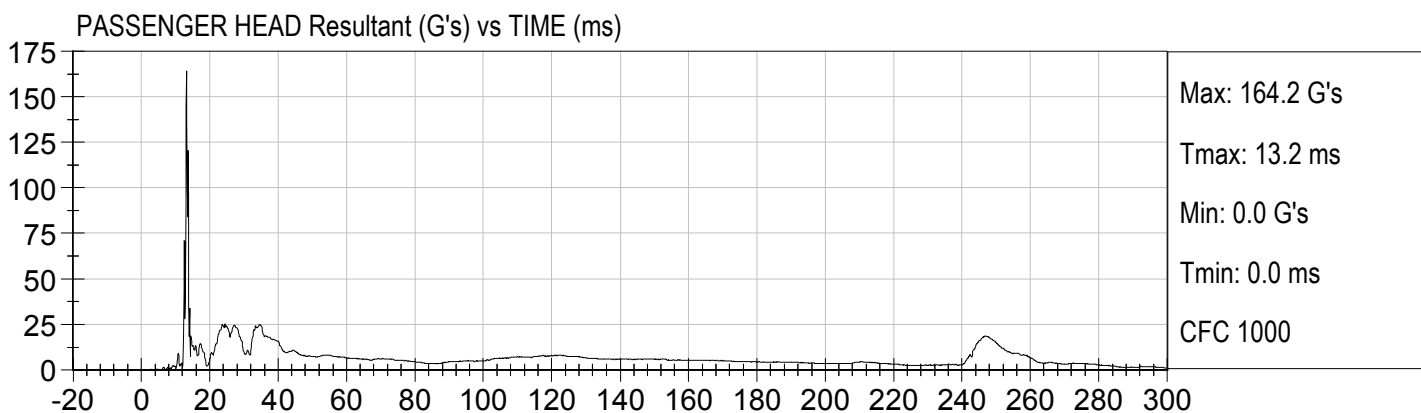
| | | <u>Page No.</u> |
|---|---|---|
| Figure No. 1. | Passenger Head X Acceleration vs. Time | 23 |
| Figure No. 2. | Passenger Head Y Acceleration vs. Time | 23 |
| Figure No. 3. | Passenger Head Z Acceleration vs. Time | 23 |
| Figure No. 4. | Passenger Head Resultant Acceleration vs. Time | 23 |

| | | MAXIMUM VALUE | | | |
|---|---|---|---|---|---|
| Head X | g | 23.9 | 24.5 | -6.1 | 256.8 |
| Head Y | g | 48.9 | 12.5 | -17.7 | 246.8 |
| Head Z | g | 164.0 | 13.2 | -33.1 | 14.1 |
| Head Resultant | g | 164.2 | 13.2 | | |

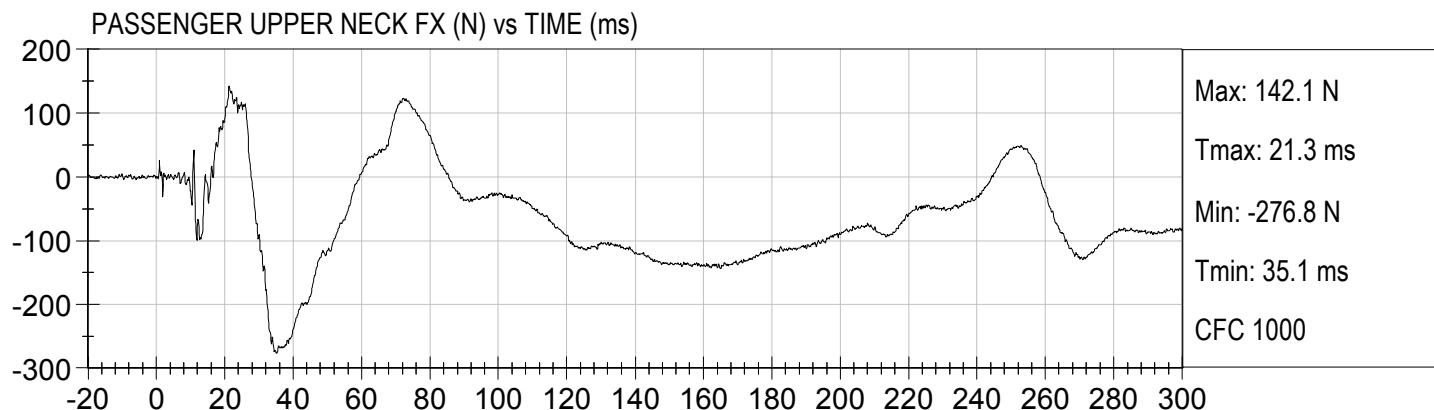
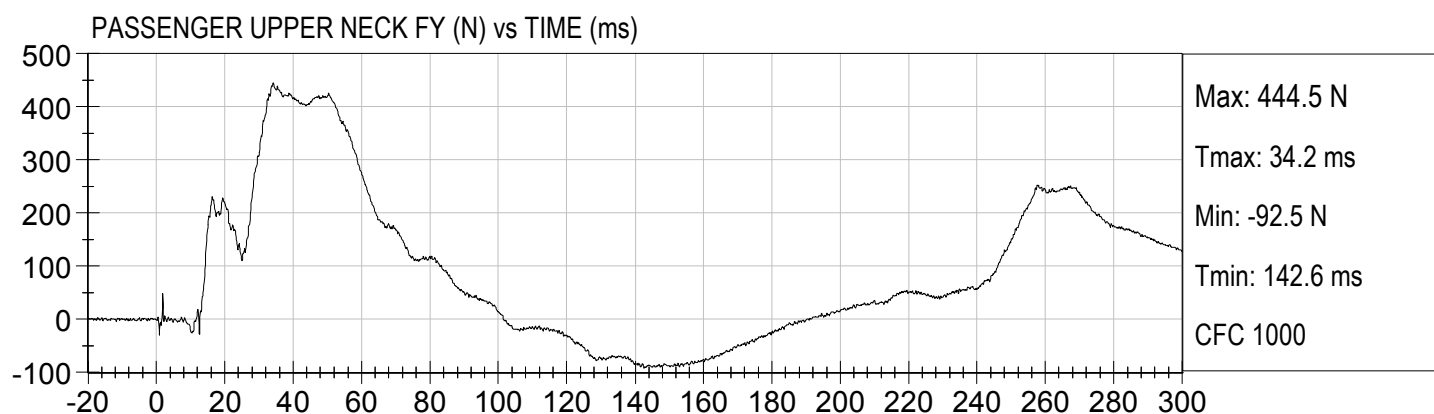
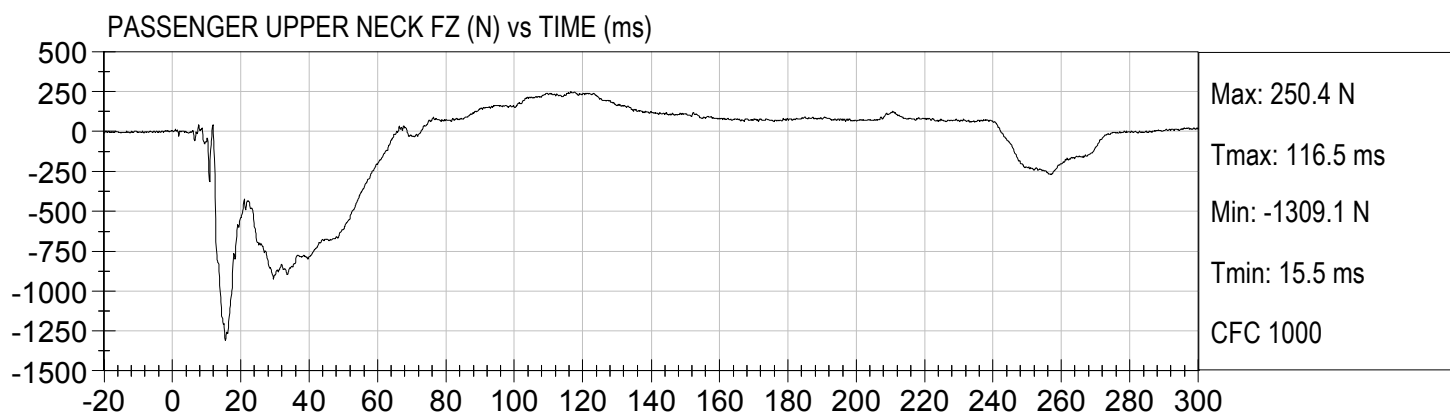
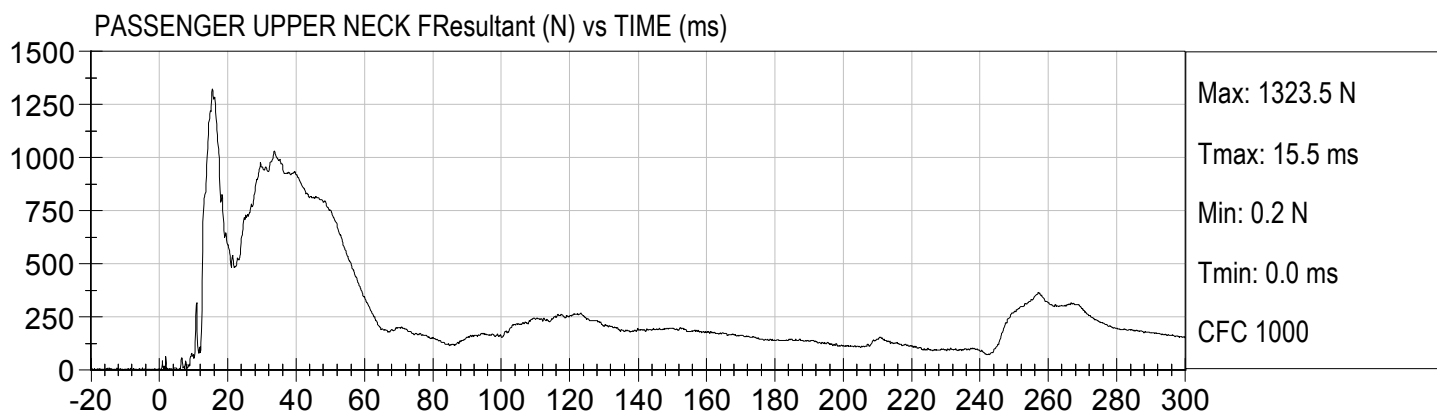
| | | <u>Page No.</u> |
|---|---|---|
| Figure No. 5. | Passenger Upper Neck X Force vs. Time | 24 |
| Figure No. 6. | Passenger Upper Neck Y Force vs. Time | 24 |
| Figure No. 7. | Passenger Upper Neck Z Force vs. Time | 24 |
| Figure No. 8. | Passenger Upper Neck Resultant Force vs. Time | 24 |

| | | MAXIMUM VALUE | | | |
|---|---|---|---|---|---|
| Upper Neck Fx | N | 142.1 | 21.3 | -276.8 | 35.1 |
| Upper Neck Fy | N | 444.5 | 34.2 | -92.5 | 142.6 |
| Upper Neck Fz | N | 250.4 | 116.5 | -1309.1 | 15.5 |
| Upper Neck F Resultant | N | 1323.5 | 15.5 | | |

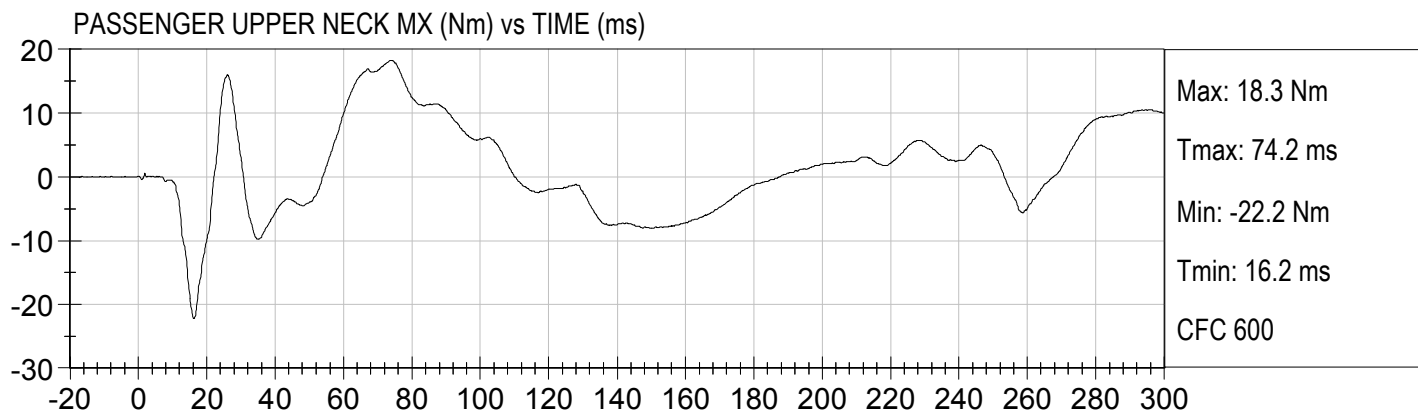
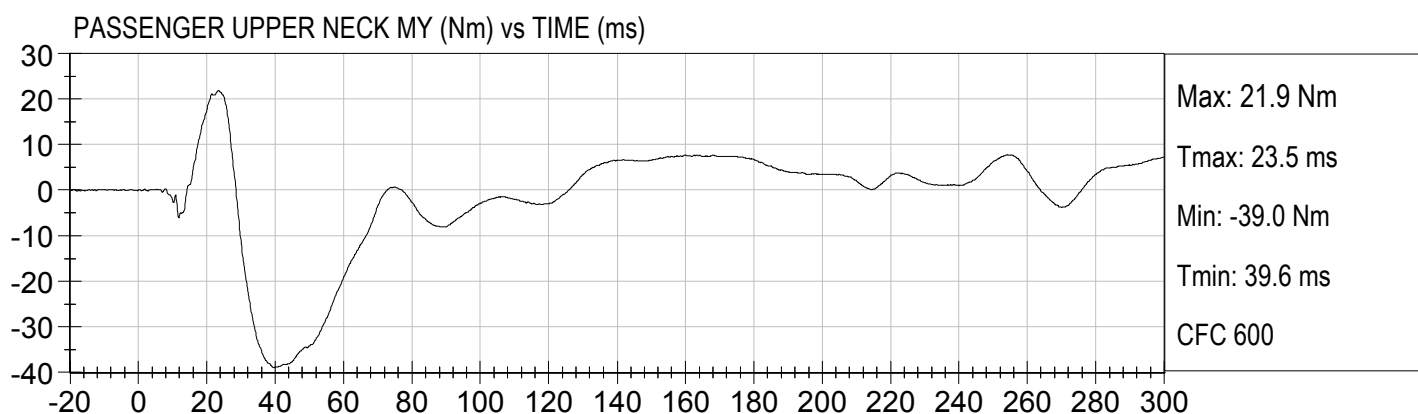
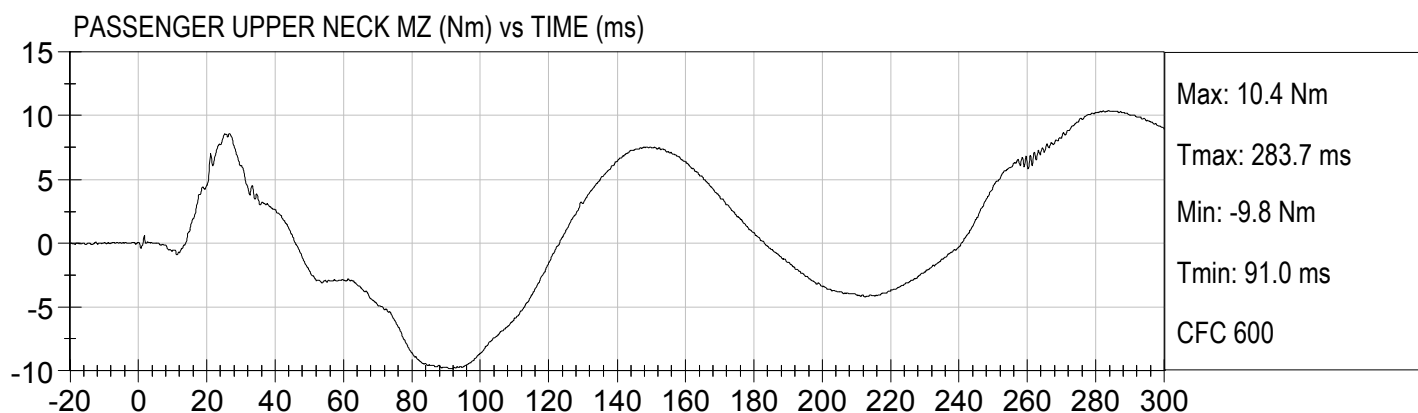
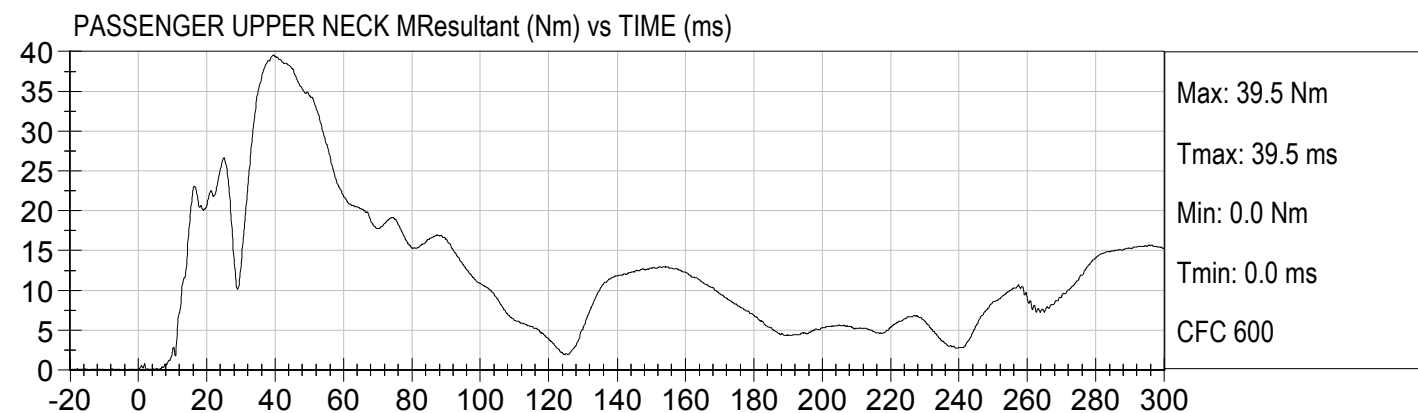
| | | <u>Page No.</u> |
|---|---|---|
| Figure No. 9. | Passenger Upper Neck X Moment vs. Time | 25 |
| Figure No. 10. | Passenger Upper Neck Y Moment vs. Time | 25 |
| Figure No. 11. | Passenger Upper Neck Z Moment vs. Time | 25 |
| Figure No. 12. | Passenger Upper Neck Resultant Moment vs. Time | 25 |

| | | MAXIMUM VALUE | | | |
|---|---|---|---|---|---|
| Upper Neck Mx | Nm | 18.3 | 74.2 | -22.2 | 16.2 |
| Upper Neck My | Nm | 21.9 | 23.5 | -39.0 | 39.6 |
| Upper Neck Mz | Nm | 10.4 | 283.7 | -9.8 | 91.0 |
| Upper Neck M Resultant | Nm | 39.5 | 39.5 | | |

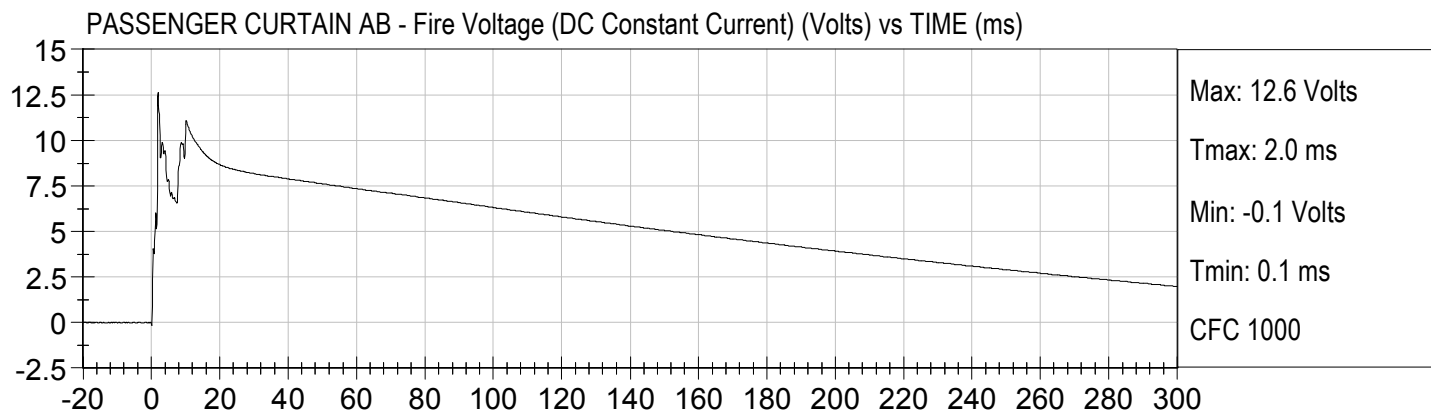
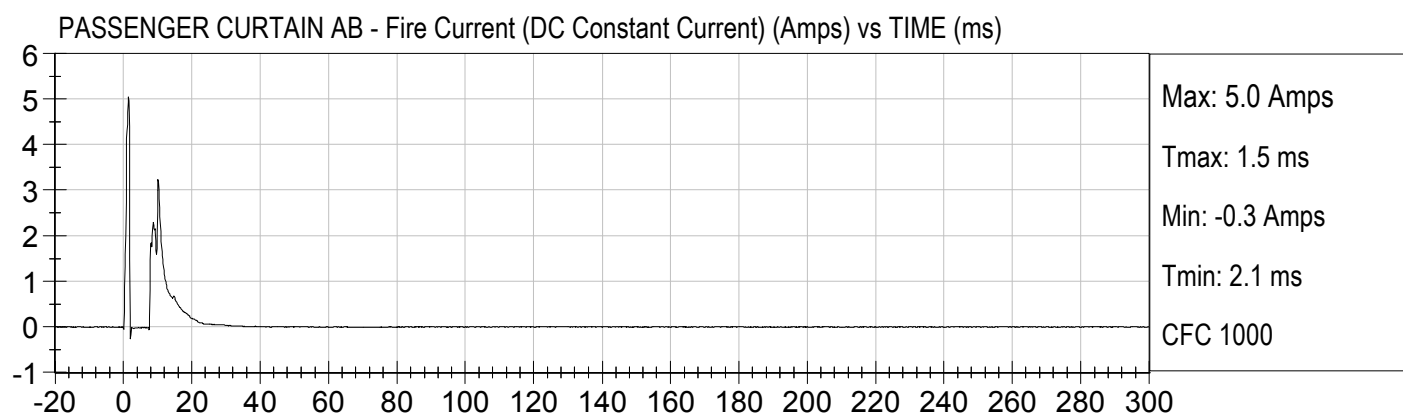
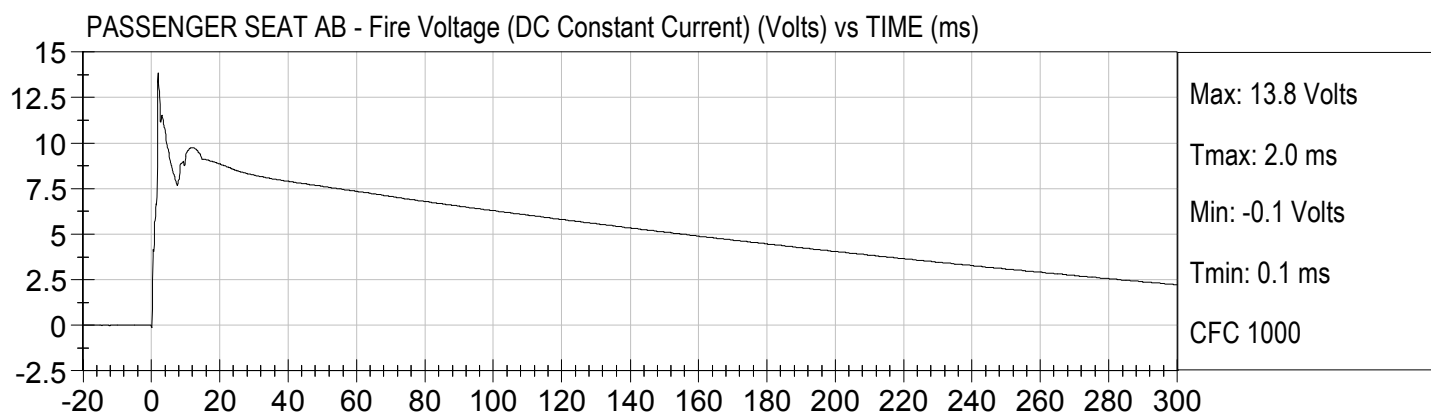
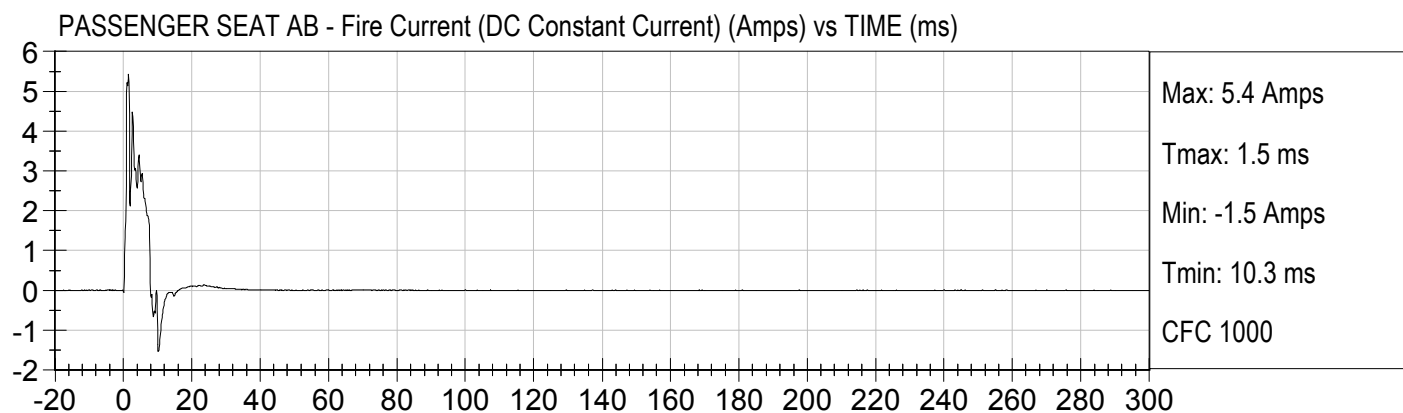
| | | <u>Page No.</u> |
|---|---|---|
| Figure No. 13. | Passenger Curtain Airbag – Fire Voltage vs. Time | 26 |
| Figure No. 14. | Passenger Curtain Airbag – Fire Current vs. Time | 26 |
| Figure No. 15. | Passenger Seat Airbag – Fire Voltage vs. Time | 26 |
| Figure No. 16. | Passenger Seat Airbag – Fire Current vs. Time | 26 |
