**REPORT NUMBER: TWG-MGA-2013-005A**

**SIDE AIRBAG OUT-OF-POSITION INJURY  
TECHNICAL WORKING GROUP**

**GENERAL MOTORS OF CANADA LTD.  
2013 Cadillac XTS AWD 4-Dr Sedan  
NHTSA No.: MD0111TWG2**

**FINAL REPORT**

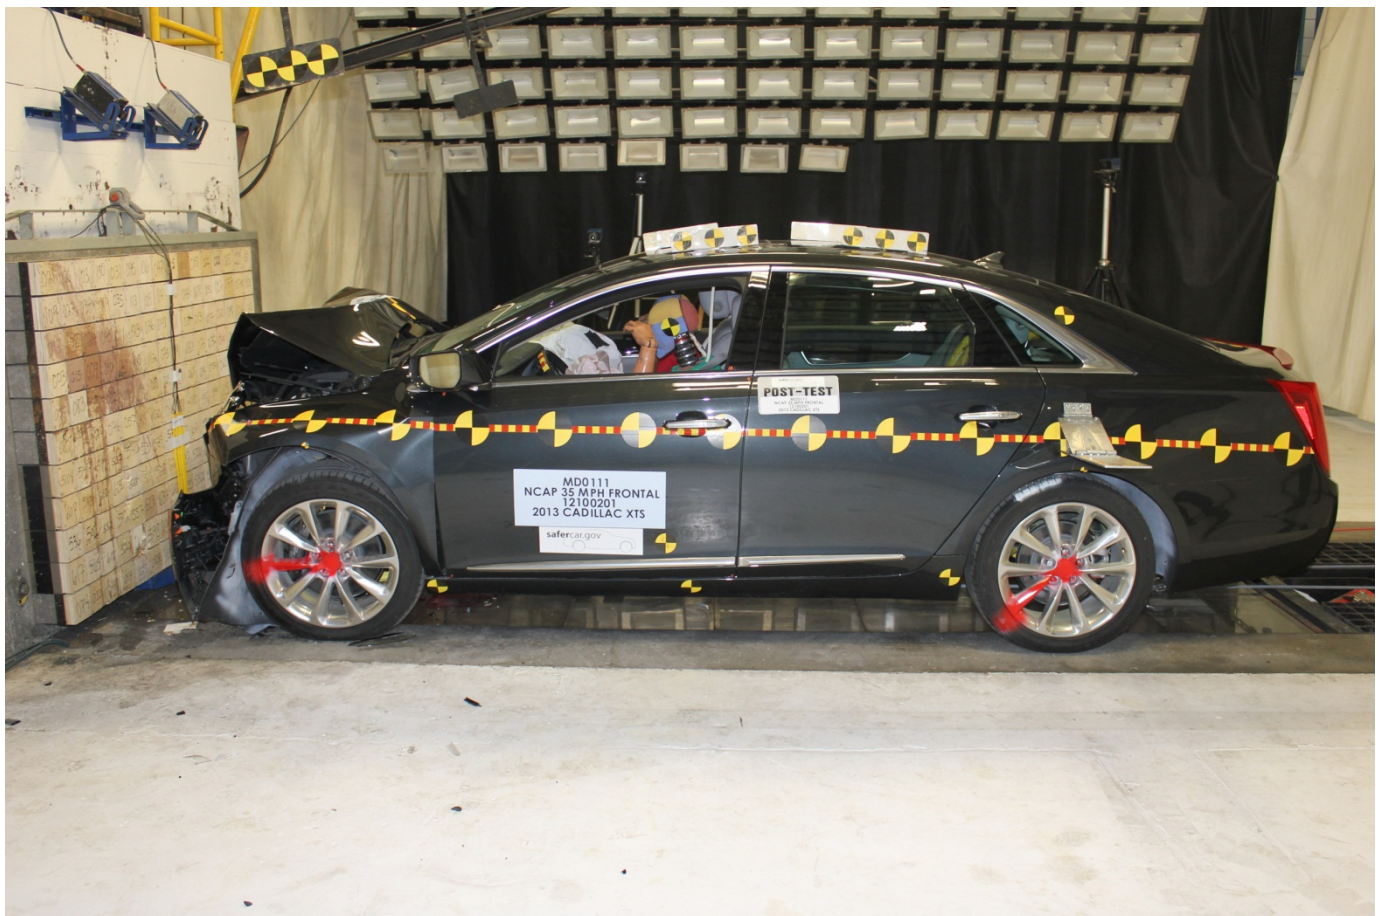
Post-Test Vehicle Left Side View

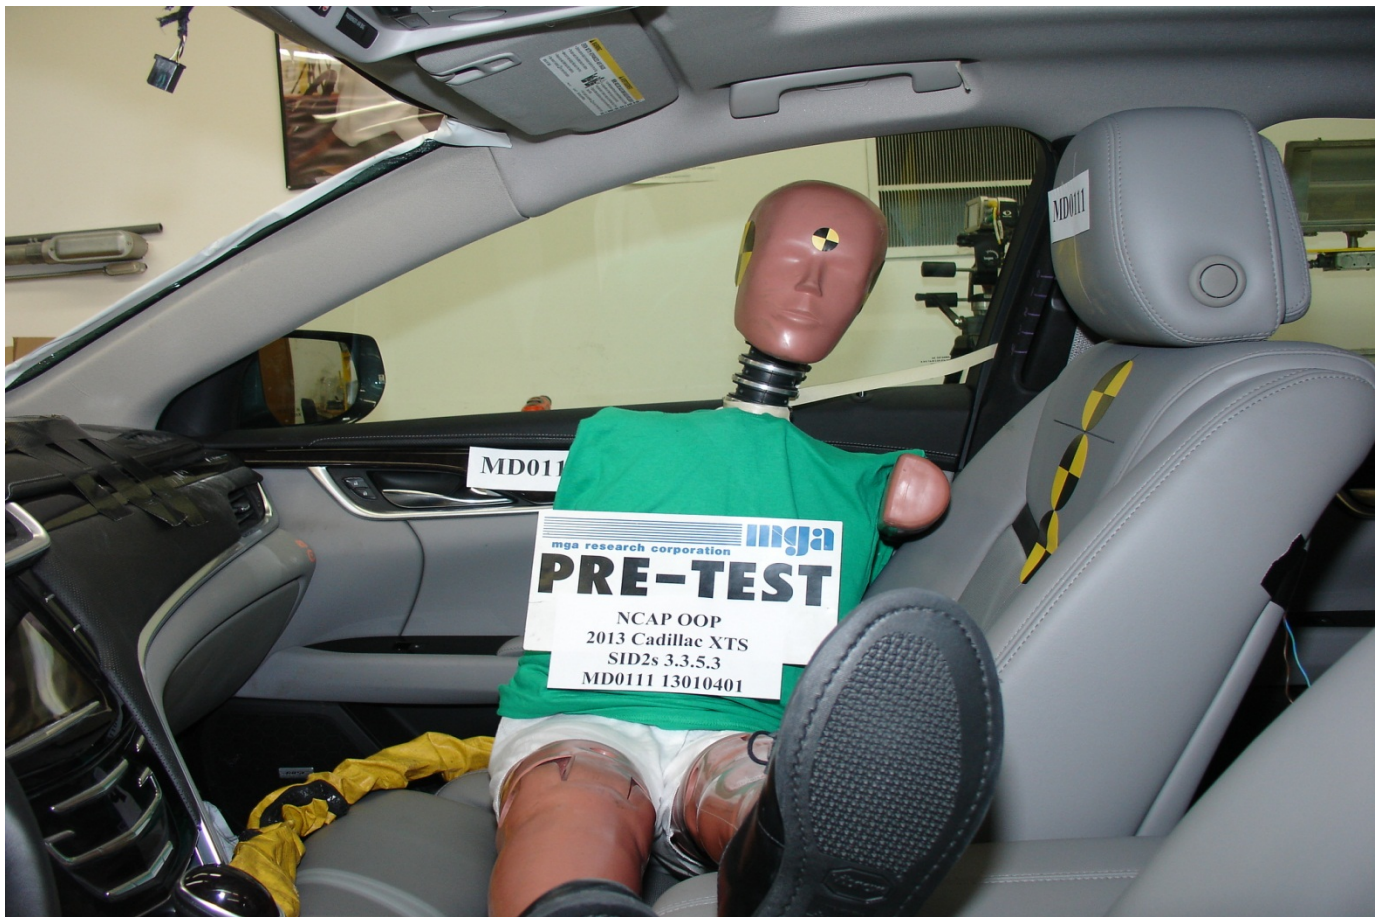
Pre-Test SID-IIs Dummy Left Side View

The SID-IIs dummy was placed in the right front passenger seat facing toward the center of the vehicle with its arm against the seatback. The arm was rotated horizontally in the forward direction with respect to the dummy. The seat track was adjusted forward to minimize the vertical distance between the dummy's head and curtain airbag. The dummy's pelvis was slid outboard until the dummy's back contacted the door trim panel or armrest and the CG of the head was centered in the deployment trajectory of the airbag. The vertical plane through the centerline of the dummy's rib-stiffener and shoulder bolt was parallel to the centerline of the vehicle. Masking tape was wrapped around the dummy's neck bracket to hold the dummy in place.

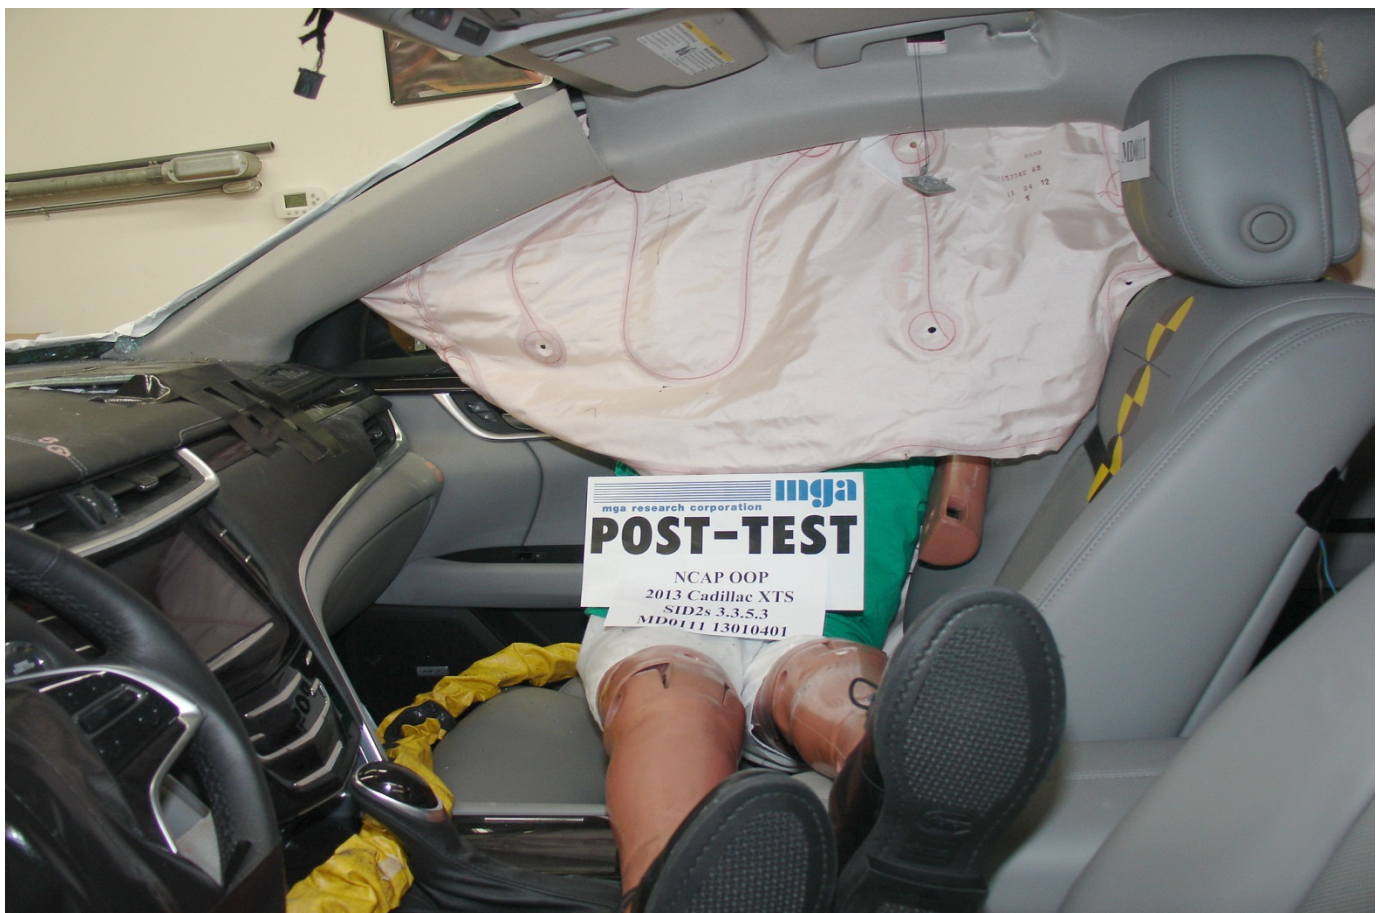
Post-Test SID-IIs Dummy Left Side View

- Curtain airbag to top and front of head
- Curtain airbag to chest
- Torso bag to left torso and left pelvis

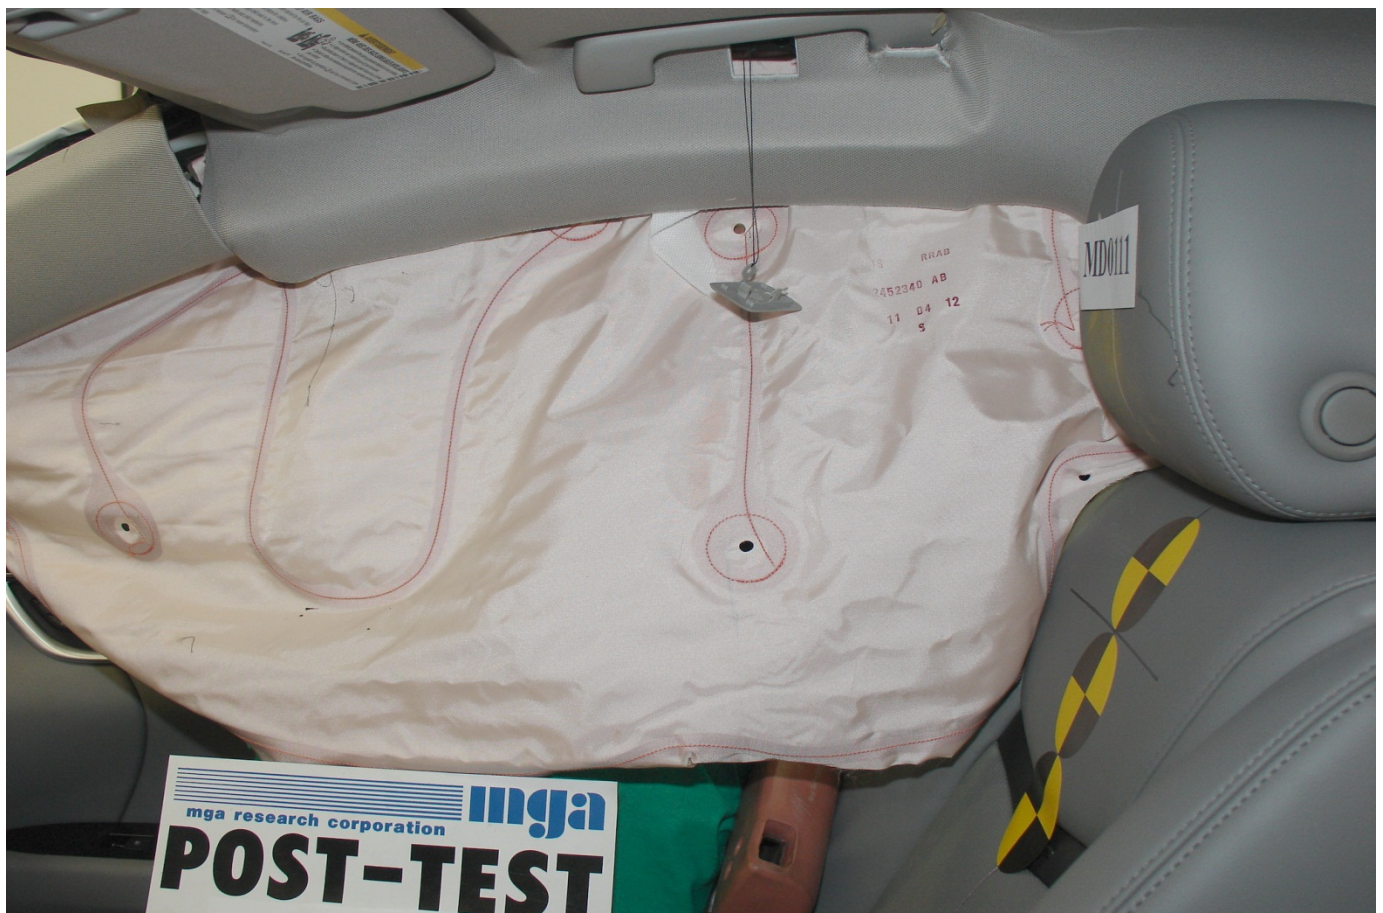
Post-Test SID-IIs Dummy Left Side Closeup View

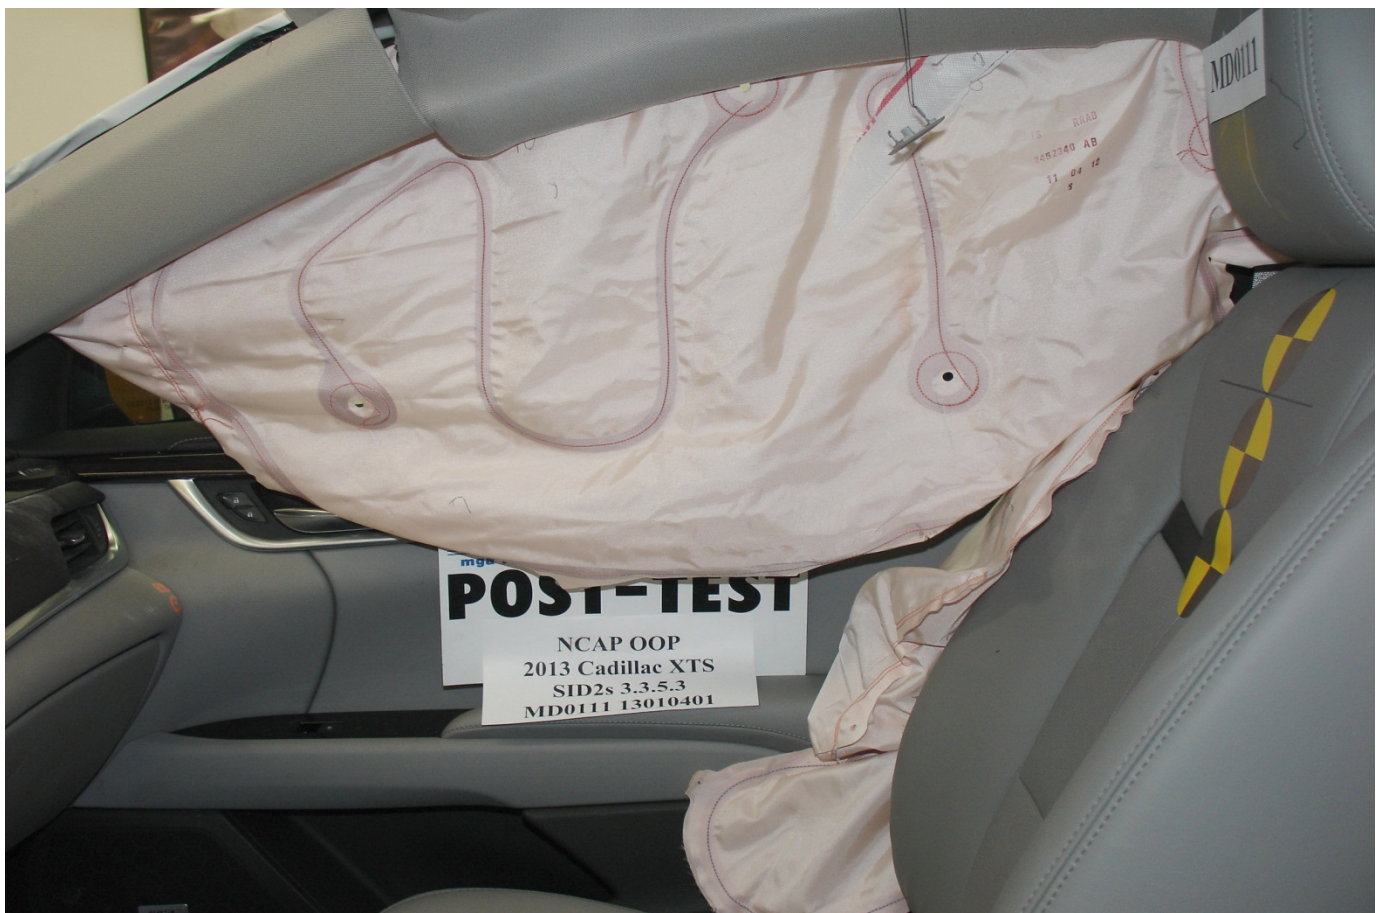
Post-Test Curtain Airbag Left Side View

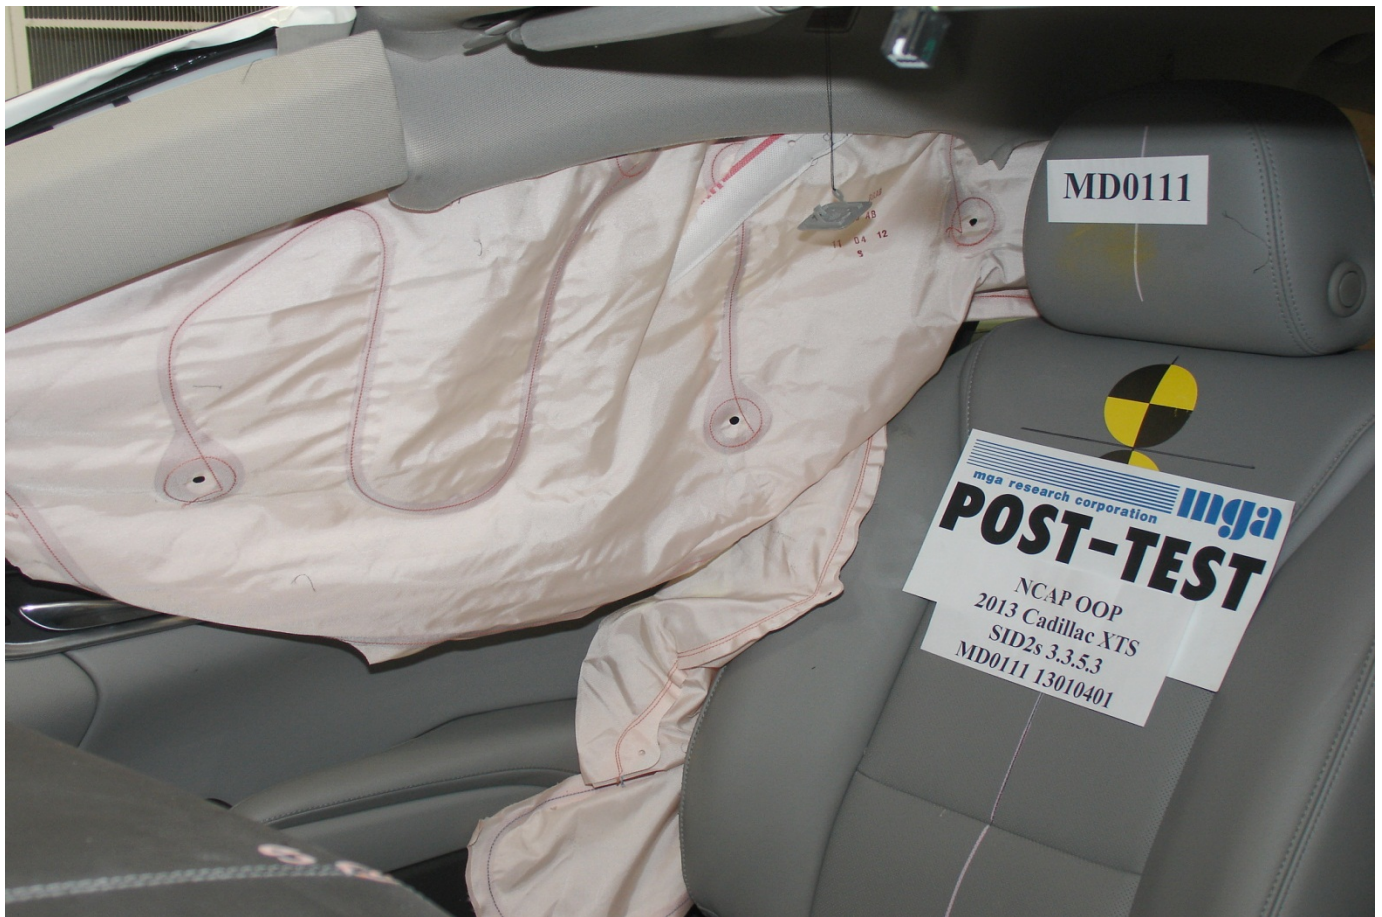
Post-Test Curtain Airbag Left 3/4 Front View

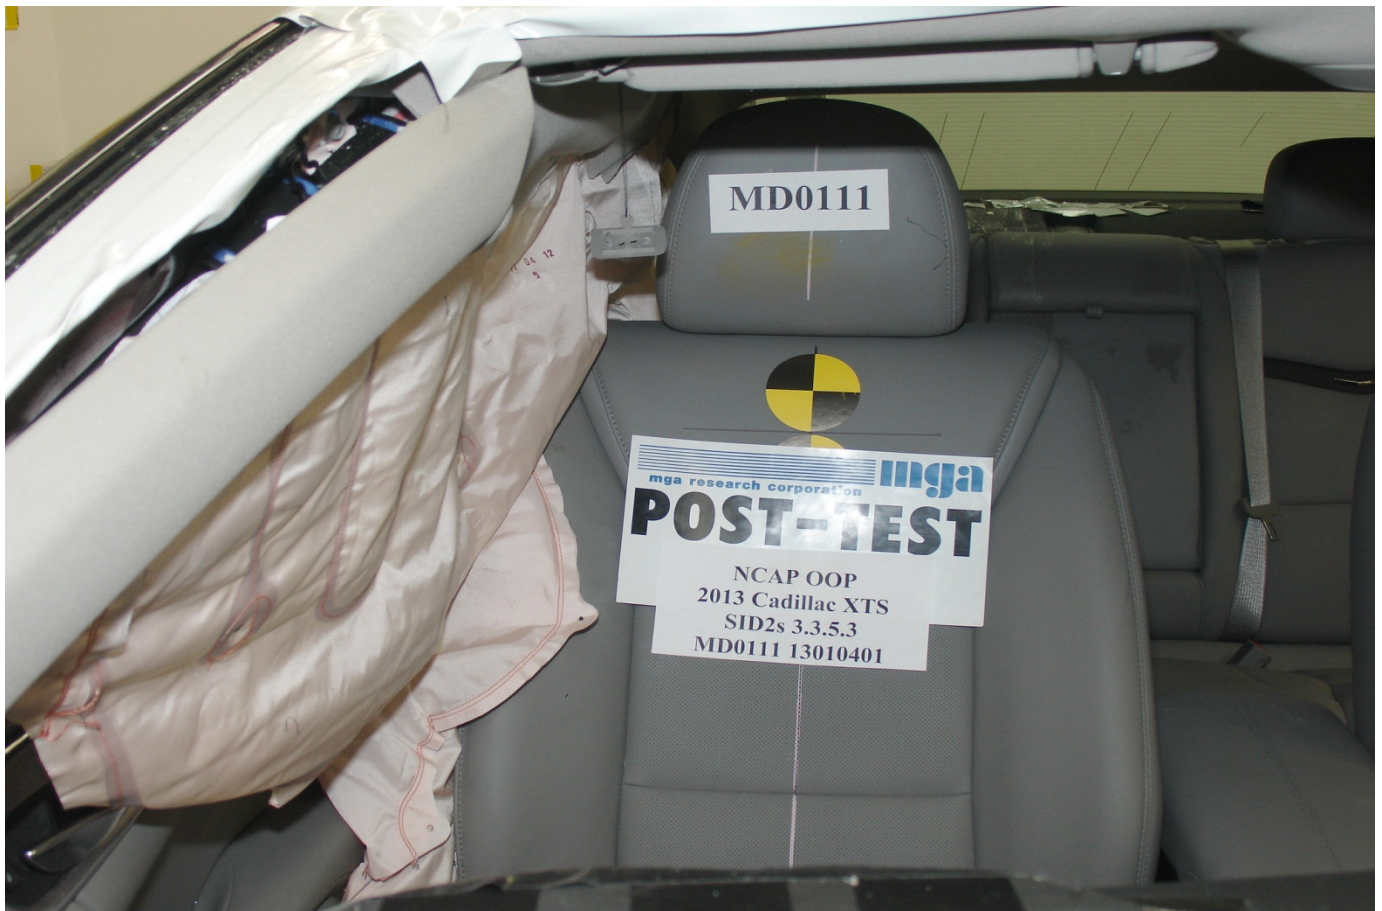
Post-Test Curtain Airbag Front View

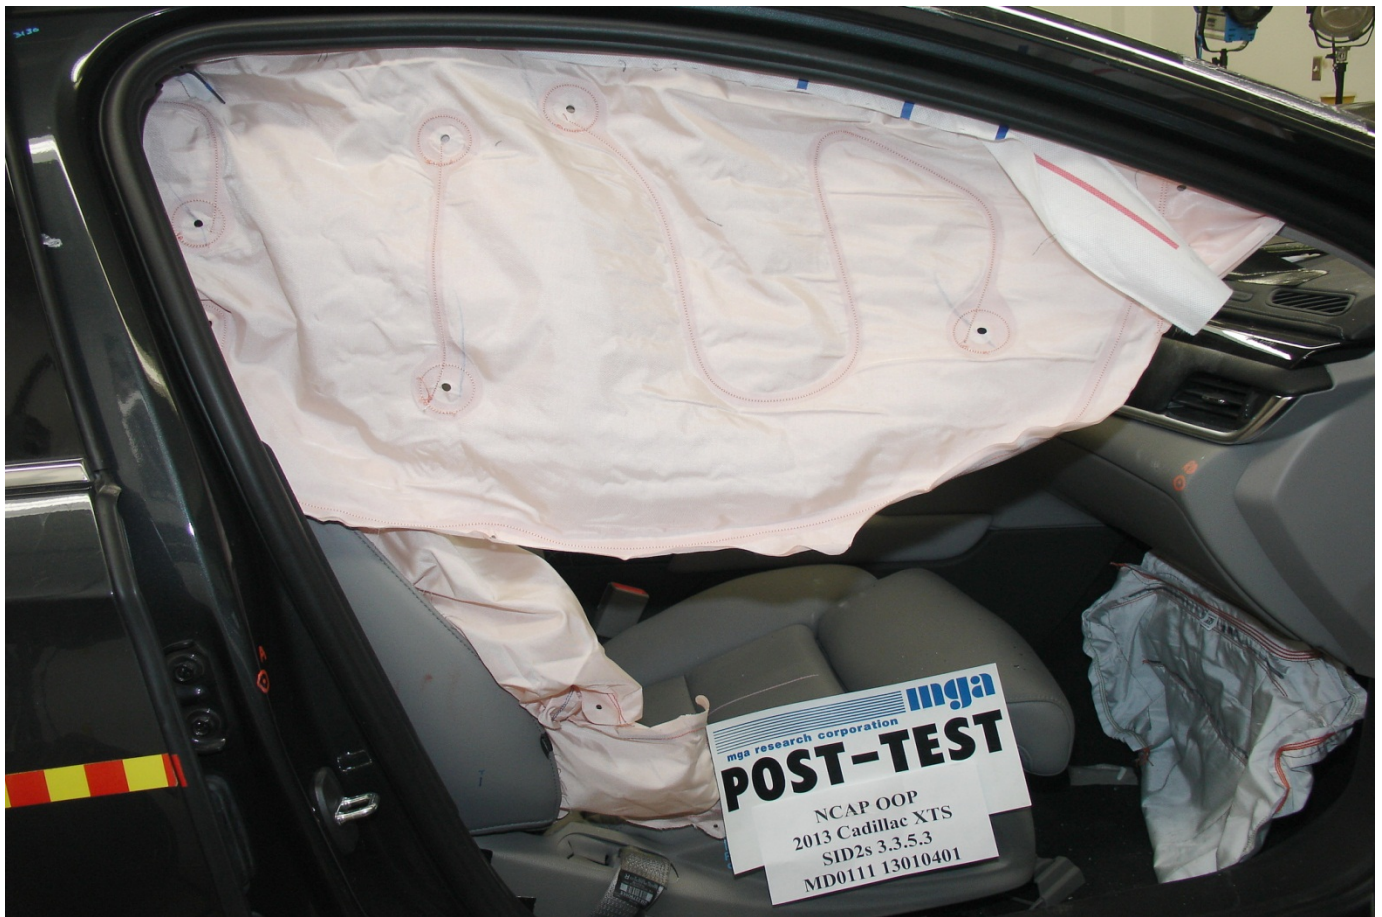
Post-Test Curtain Airbag Right Side View (Door Open)

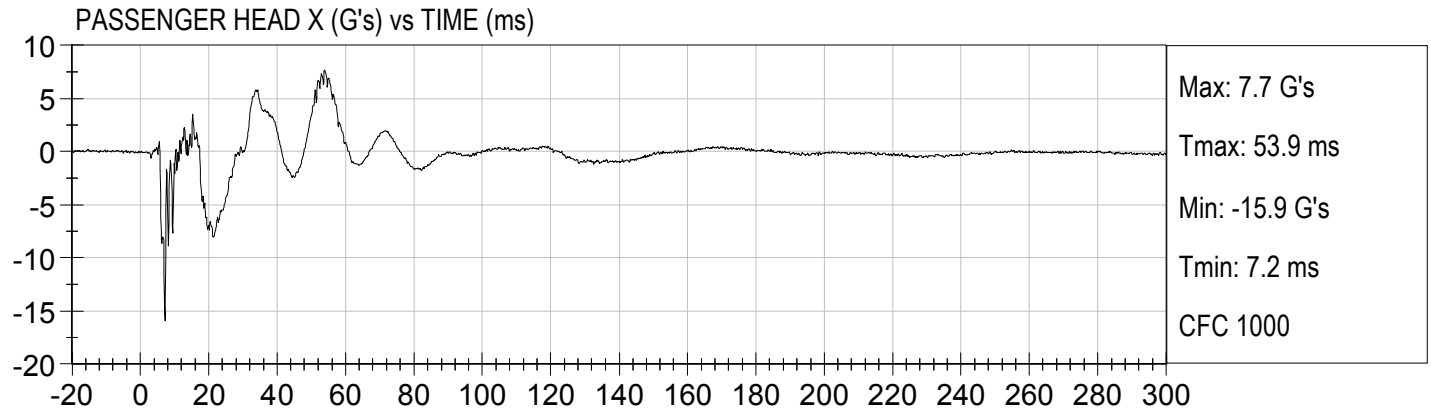
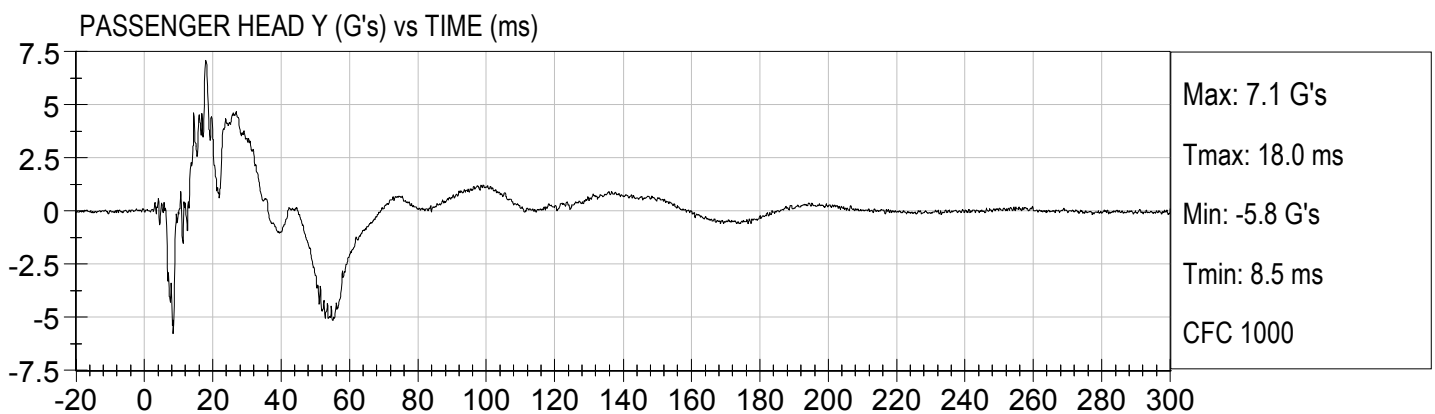
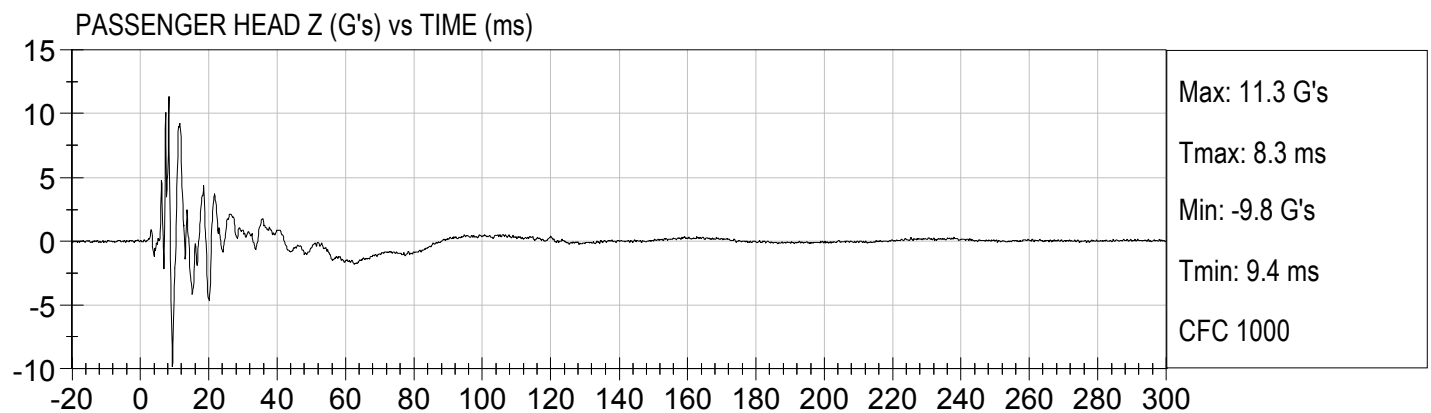
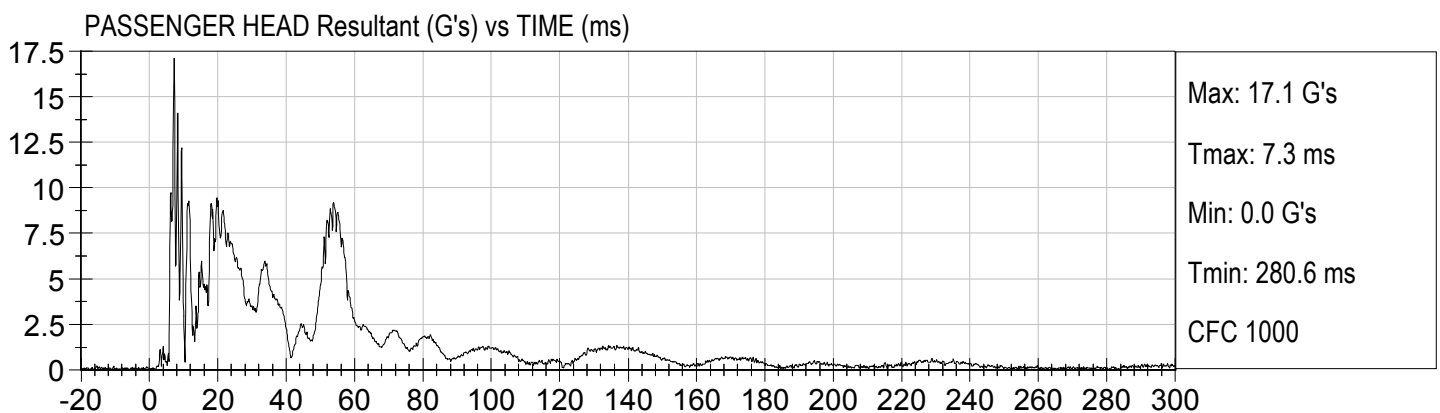
| | | <u>Page No.</u> |
|---|---|---|
| Figure No. 1. | Passenger Head X Acceleration vs. Time | 23 |
| Figure No. 2. | Passenger Head Y Acceleration vs. Time | 23 |
| Figure No. 3. | Passenger Head Z Acceleration vs. Time | 23 |
| Figure No. 4. | Passenger Head Resultant Acceleration vs. Time | 23 |

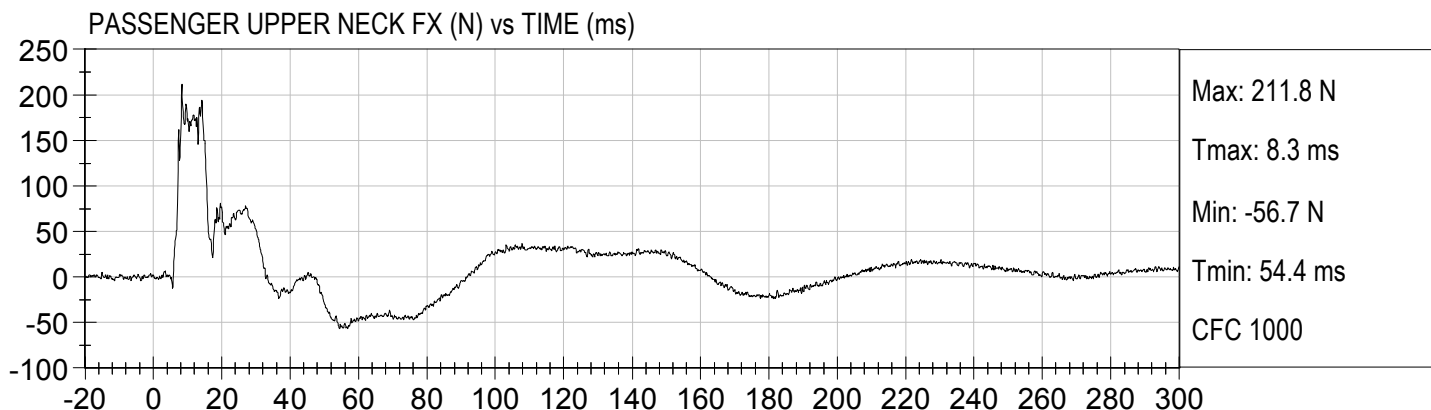
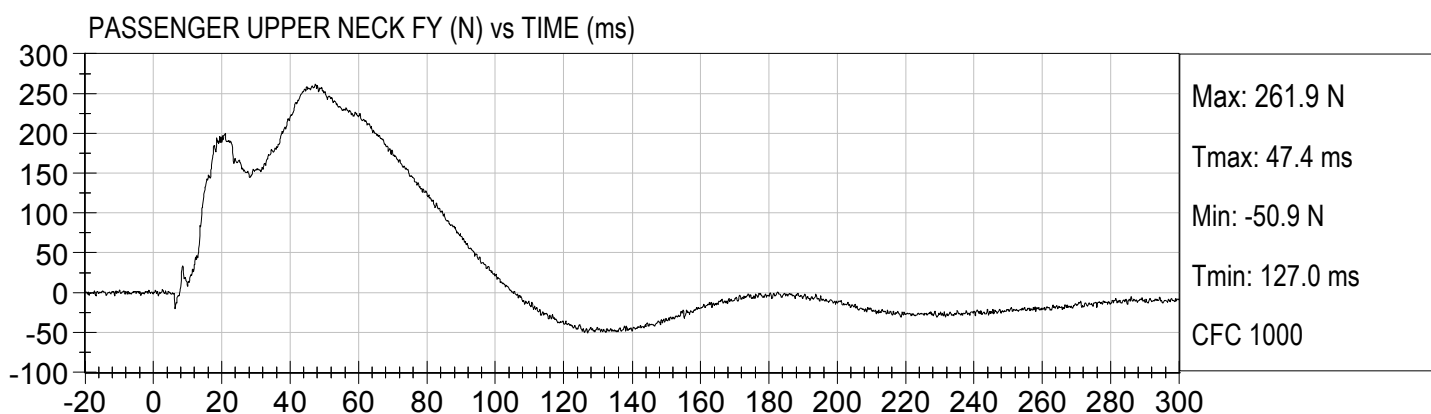
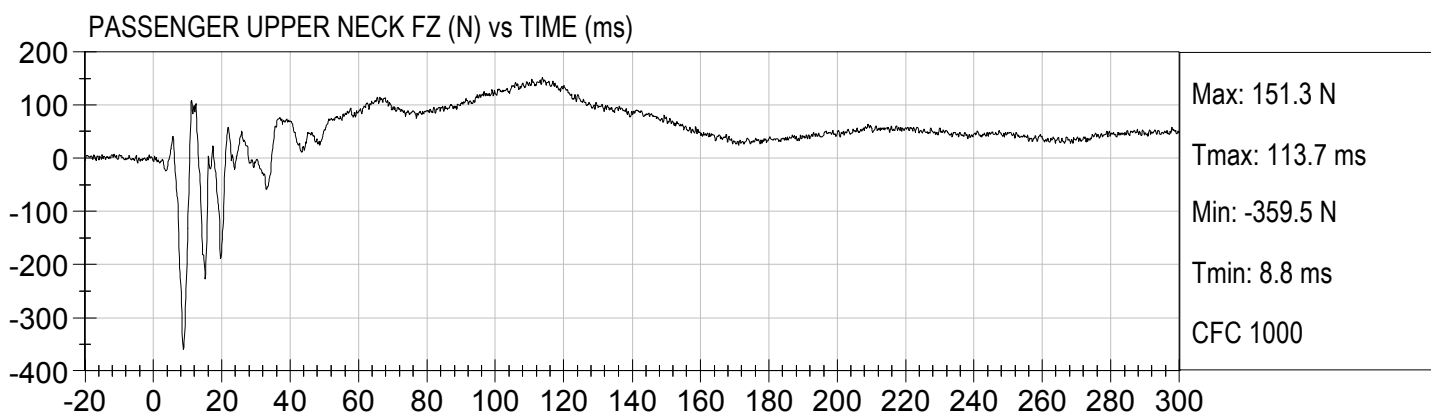
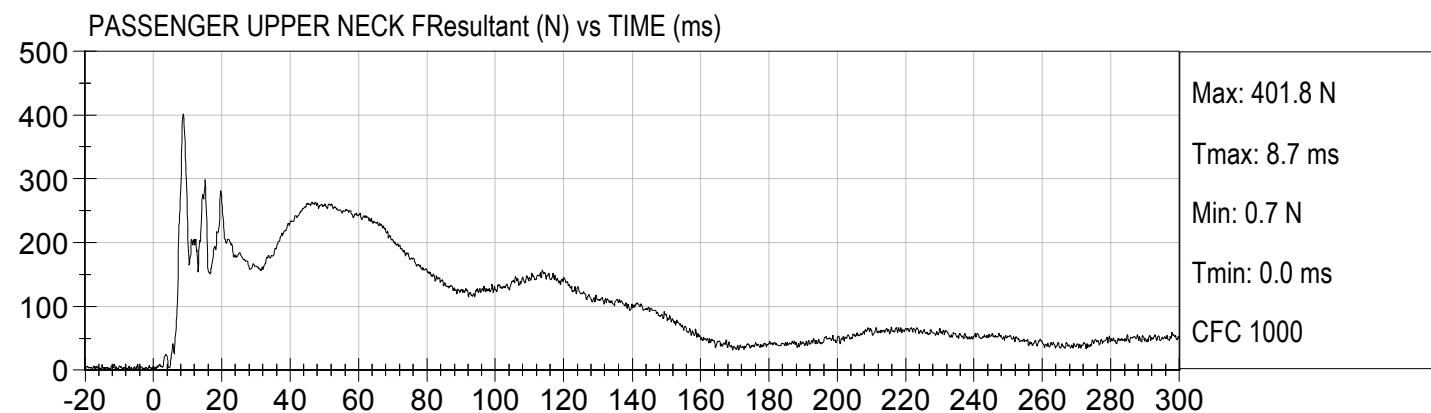
| | | <u>Page No.</u> |
|---|---|---|
| Figure No. 5. | Passenger Upper Neck X Force vs. Time | 24 |
| Figure No. 6. | Passenger Upper Neck Y Force vs. Time | 24 |
| Figure No. 7. | Passenger Upper Neck Z Force vs. Time | 24 |
| Figure No. 8. | Passenger Upper Neck Resultant Force vs. Time | 24 |

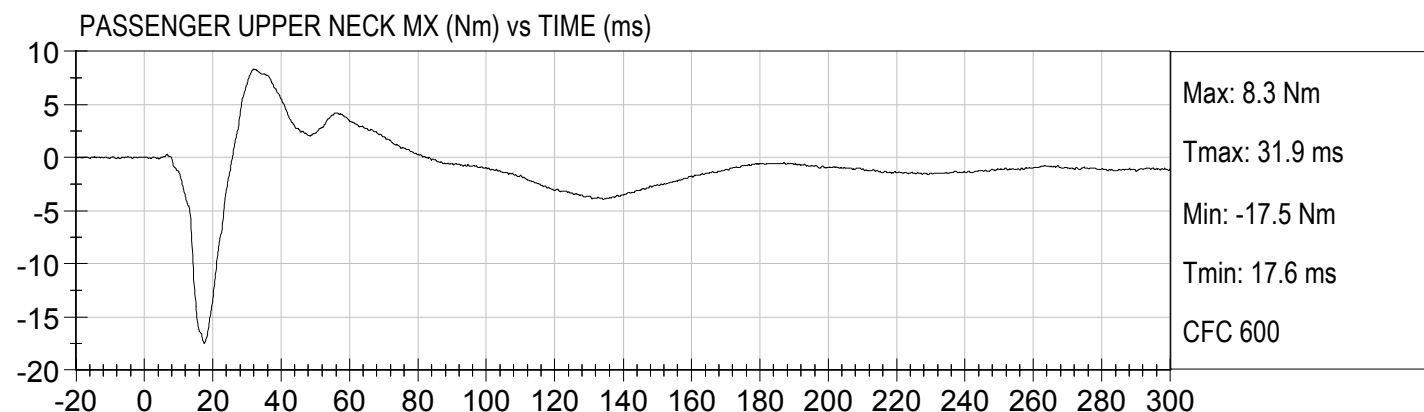
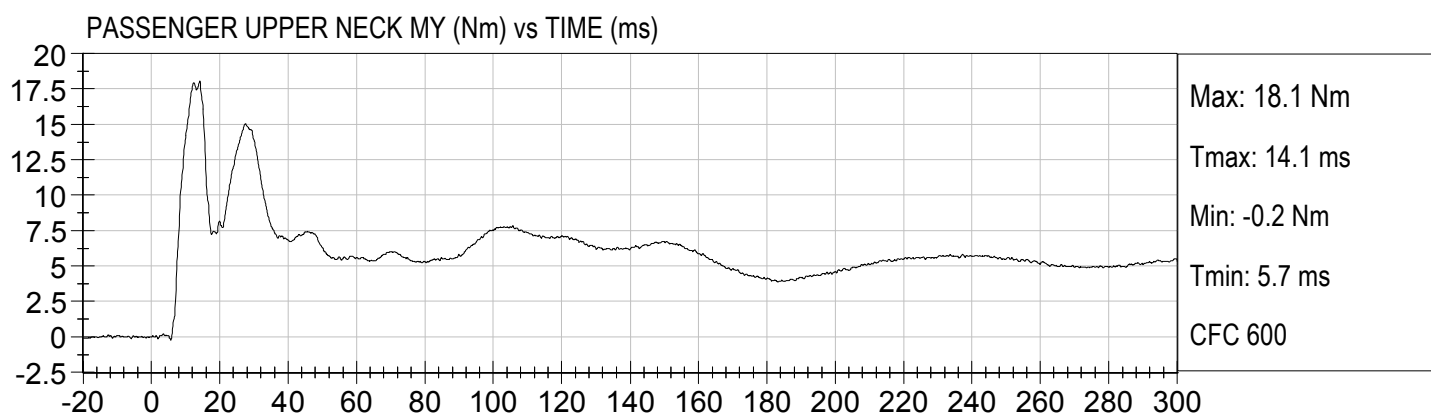
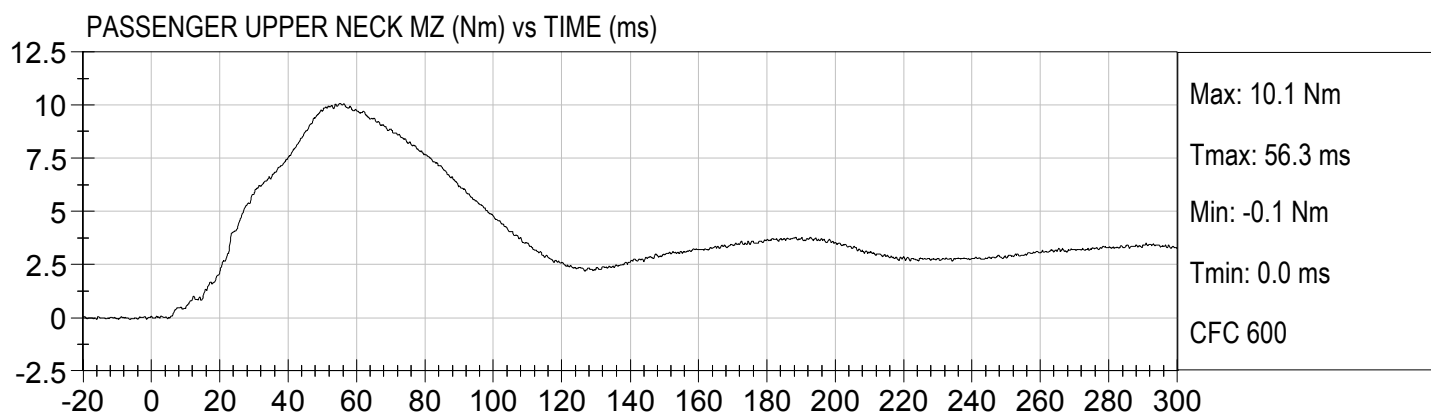
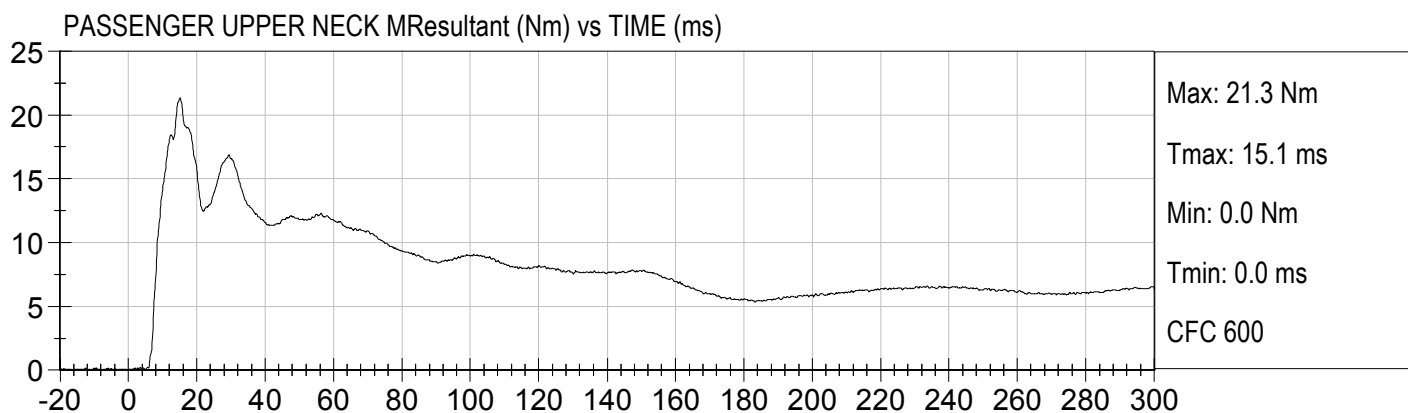
| | | <u>Page No.</u> |
|---|---|---|
| Figure No. 9. | Passenger Upper Neck X Moment vs. Time | 25 |
| Figure No. 10. | Passenger Upper Neck Y Moment vs. Time | 25 |
| Figure No. 11. | Passenger Upper Neck Z Moment vs. Time | 25 |
| Figure No. 12. | Passenger Upper Neck Resultant Moment vs. Time | 25 |

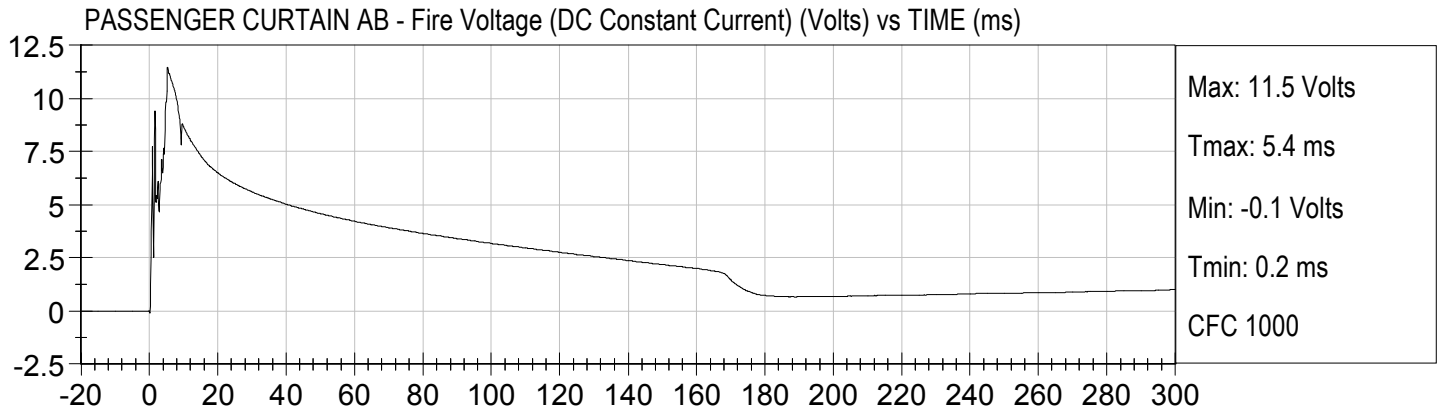
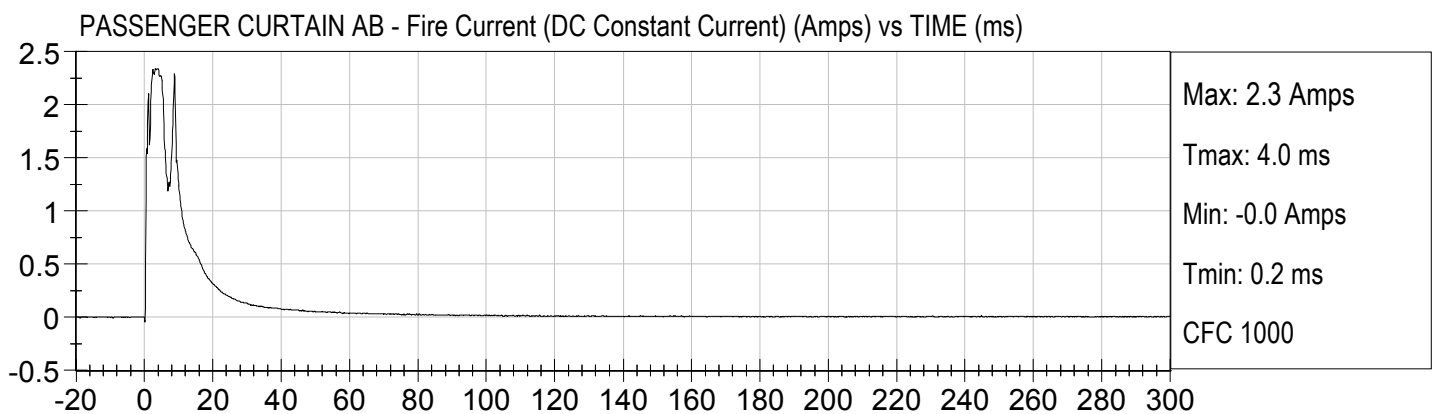
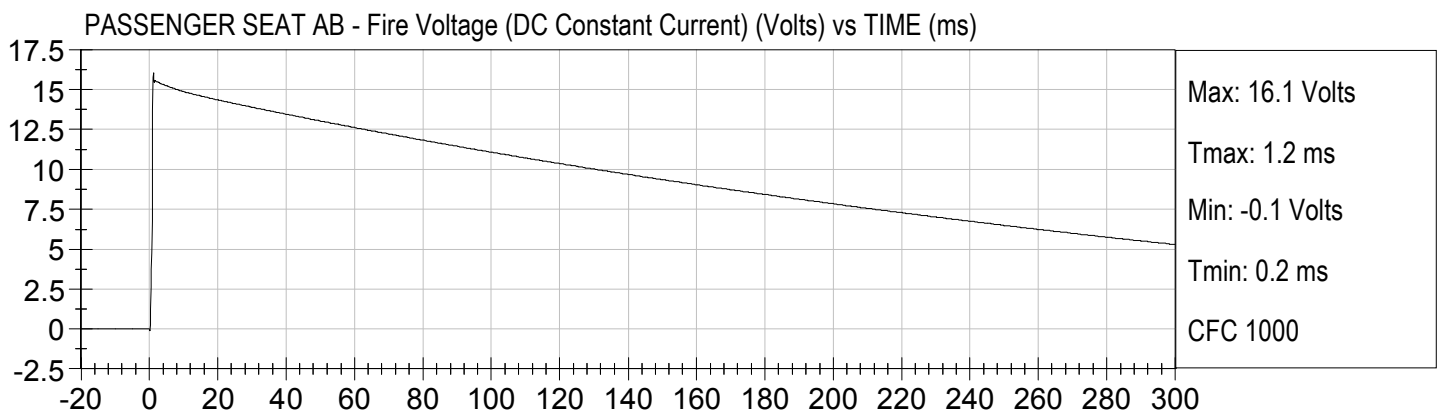
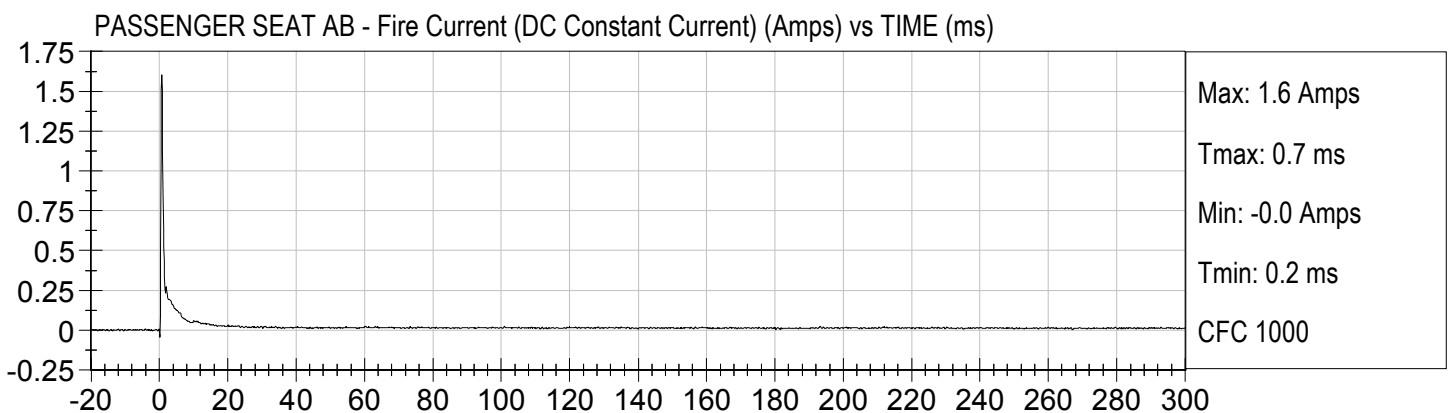
| | | <u>Page No.</u> |
|---|---|---|
| Figure No. 13. | Passenger Curtain Airbag – Fire Voltage vs. Time | 26 |
| Figure No. 14. | Passenger Curtain Airbag – Fire Current vs. Time | 26 |
| Figure No. 15. | Passenger Seat Airbag – Fire Voltage vs. Time | 26 |
| Figure No. 16. | Passenger Seat Airbag – Fire Current vs. Time | 26 |
