REPORT NUMBER: TWG-CAL-13-06

**NEW CAR ASSESSMENT PROGRAM (NCAP)**  
SIDE AIRBAG OUT-OF-POSITION INJURY TESTING

**Ford Motor Co**  
**2013 Ford Focus**  
**Four Door Sedan**

NHTSA NUMBER: MD0213TWG2  
CALSPAN TEST NUMBER: CT2013-06

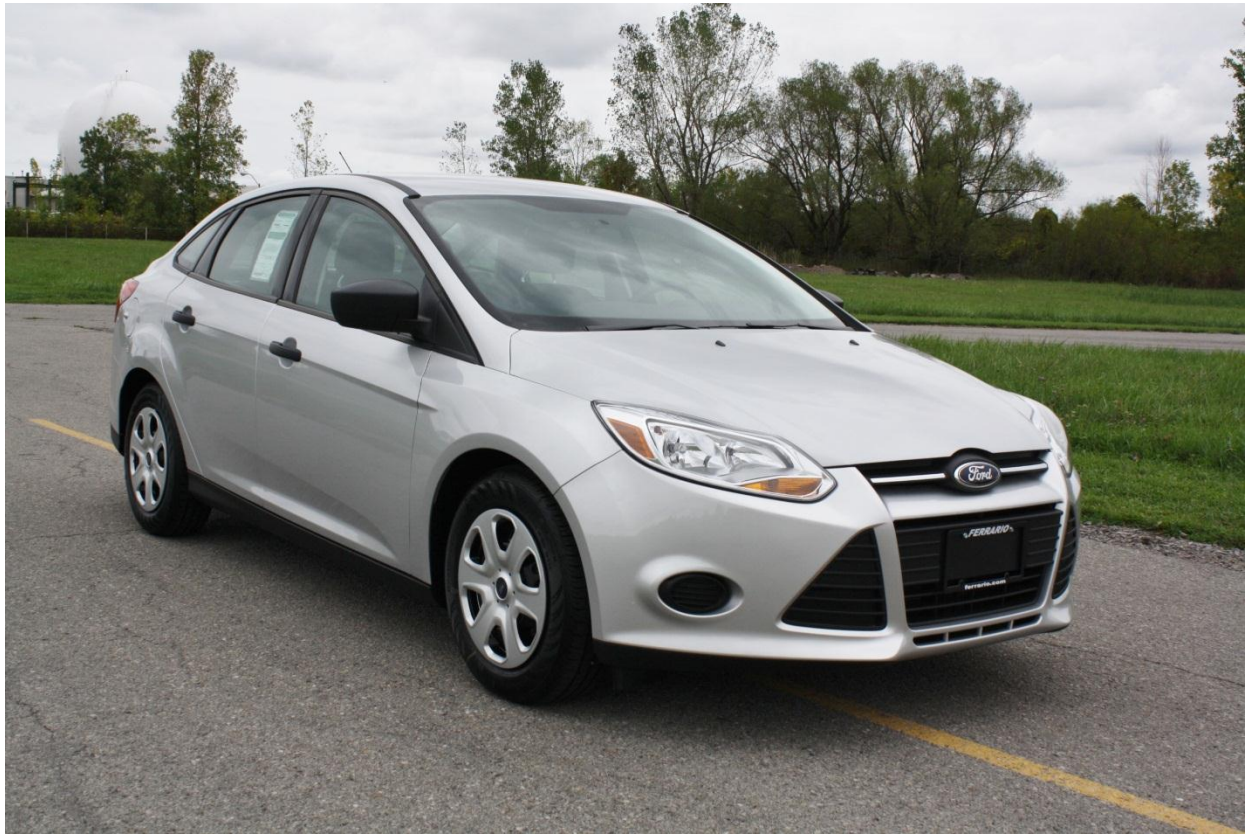
**Figure A-1: Right ¾ Front View of Vehicle, As Received**

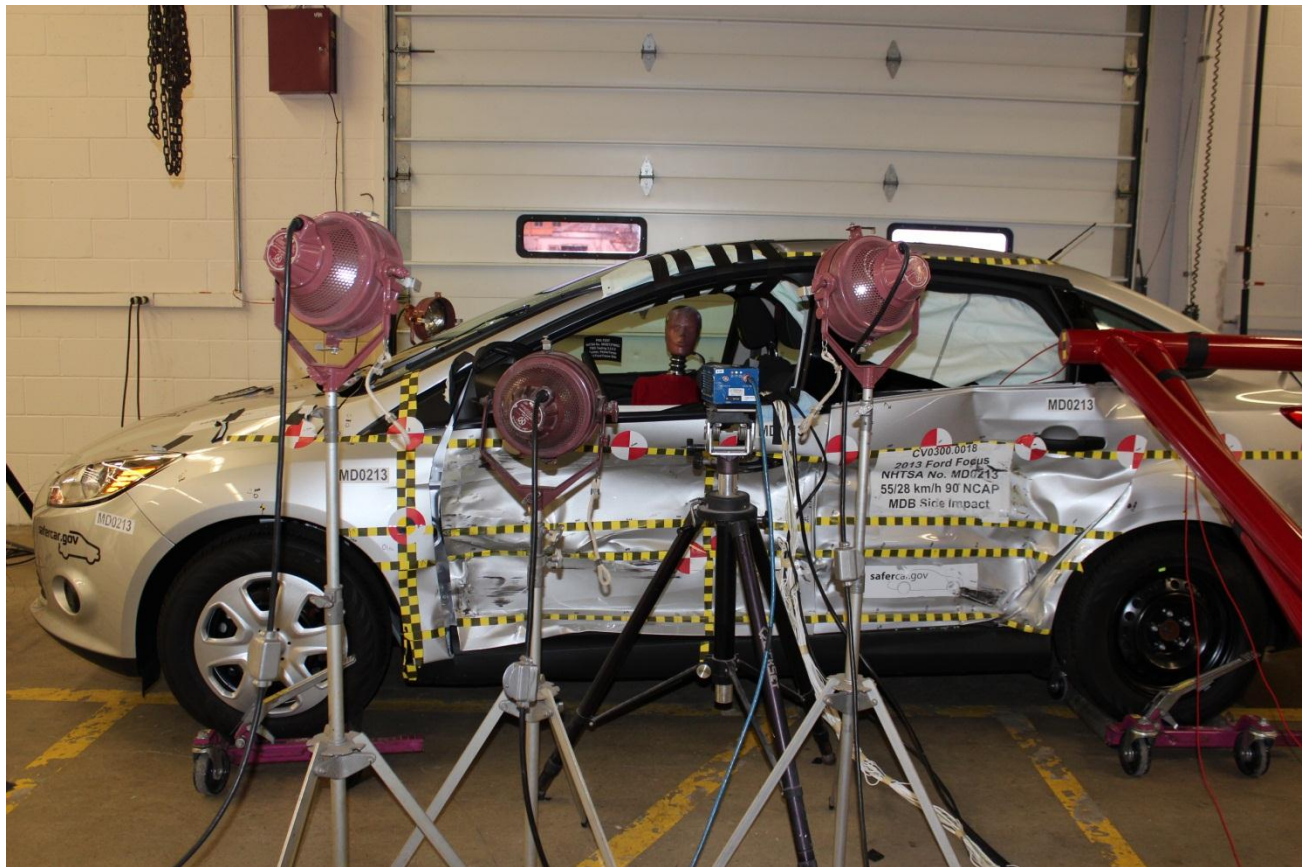
**Figure A-3: Pre-Test Vehicle Left Side View**

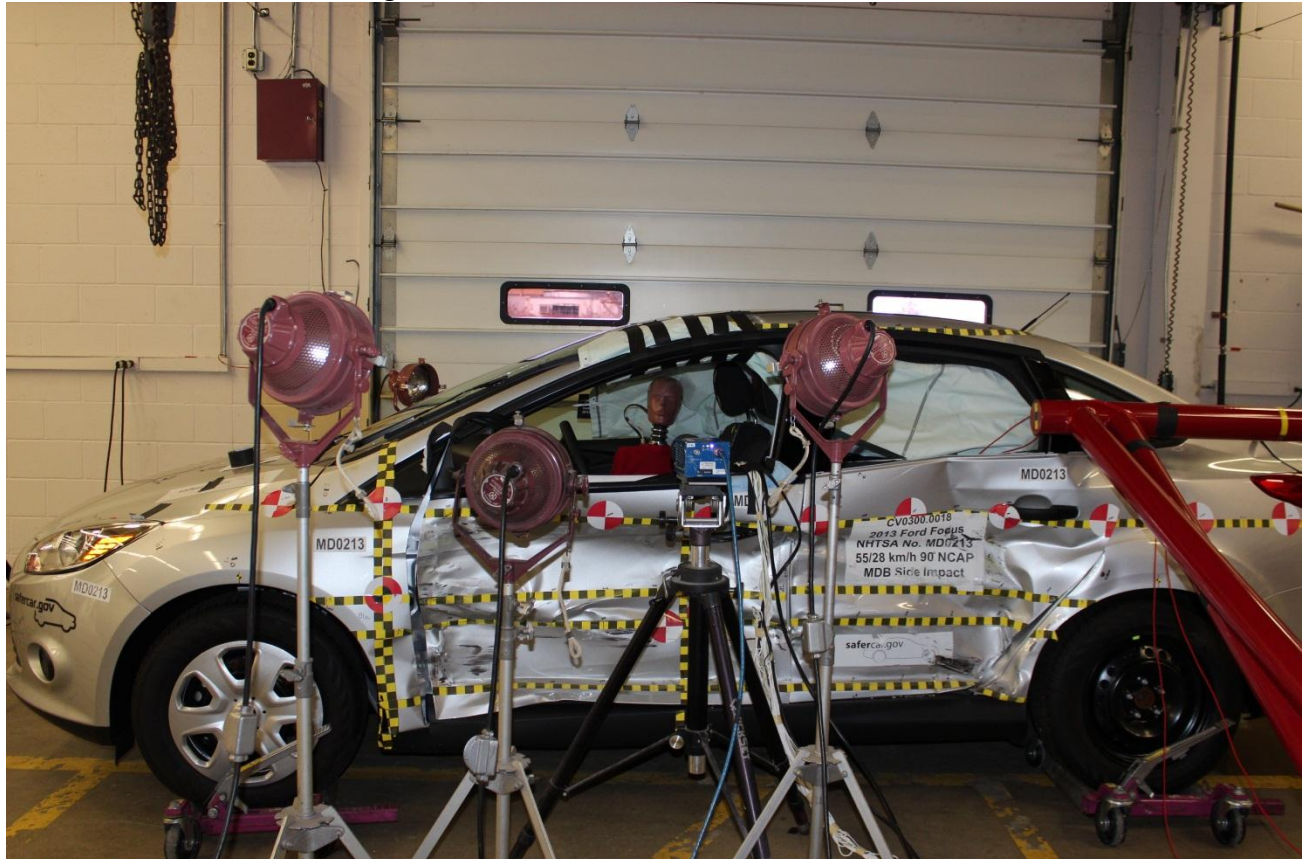
**Figure A-4: Post-Test Vehicle Left Side View**

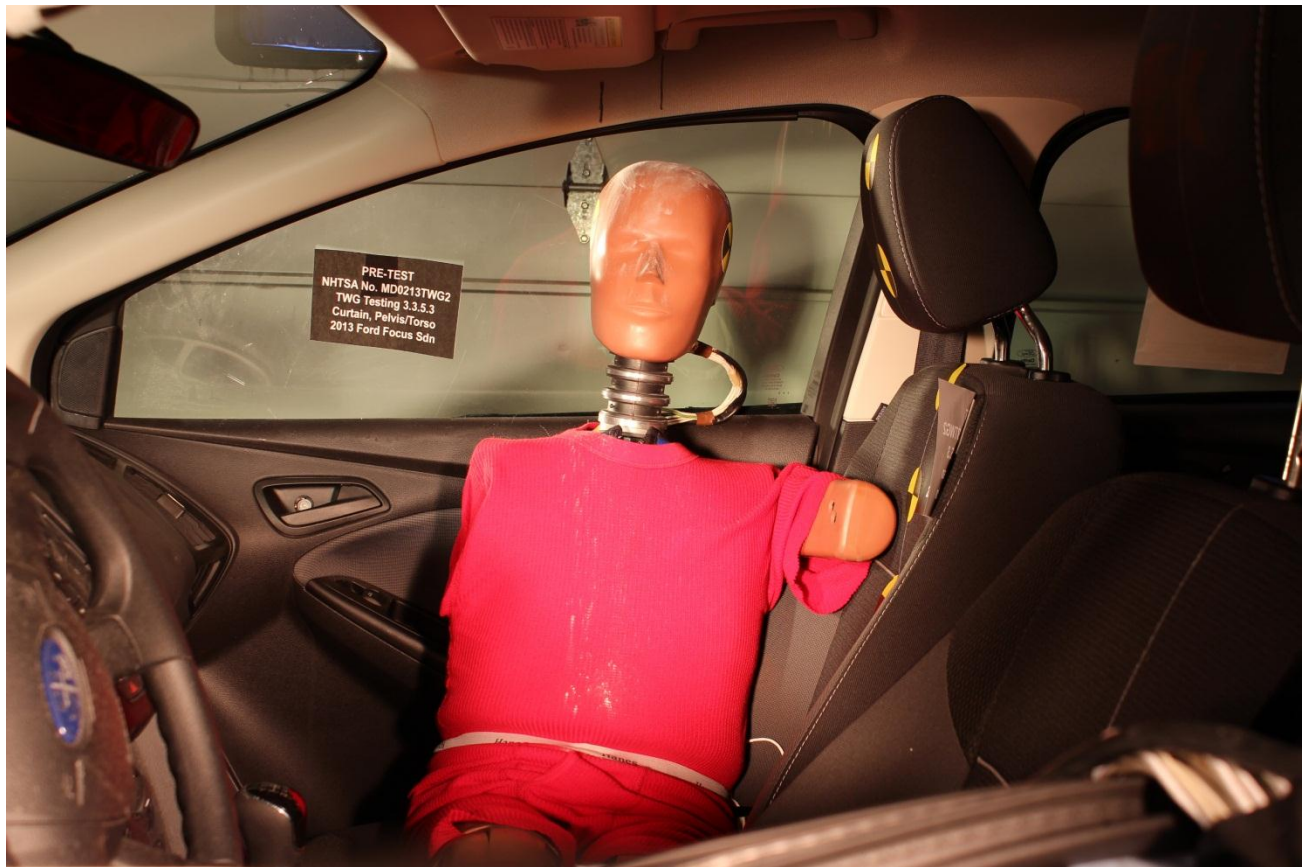
**Figure A-5: Pre-Test 5th female SID-11s Dummy Left Side View**

The 5<sup>th</sup> female ATD was placed with its left arm outstretched against the back of the right front (passenger) seat facing inboard cross car with its legs extended. After consultation with the program sponsor, the seat track was adjusted to locate the head c.g. under the expected deployment location of a head curtain chamber to maximize the airbag to head interaction. The location was determined by observing test data from the previous left side impact test on this vehicle. While keeping the head in neutral orientation, the ATD's pelvis was moved outboard until the dummy's back contacted the door trim panel armrest. The center of gravity of the head was centered in the deployment trajectory of the airbag. The dummy was then moved to maintain the vertical plane through the centerline of the ATD's shoulder bolts parallel to the vehicle centerline. The ATD's arm was bent straight across the back seat cushion. This orientation complies with section 3.3.5.3 of the TWG Recommended Procedures for Evaluating Occupant Injury Risk from Deploying Side Airbags as defined by Lund, et al and the Technical Working Group First Revision dated July, 2003.

| <b>Upper Torso Contact:</b> | Back against door armrest / arm against seat |
| <b>Lower Torso Contact:</b> | Butt on edge of seat |
| <b>Knee Contact:</b> | Console |

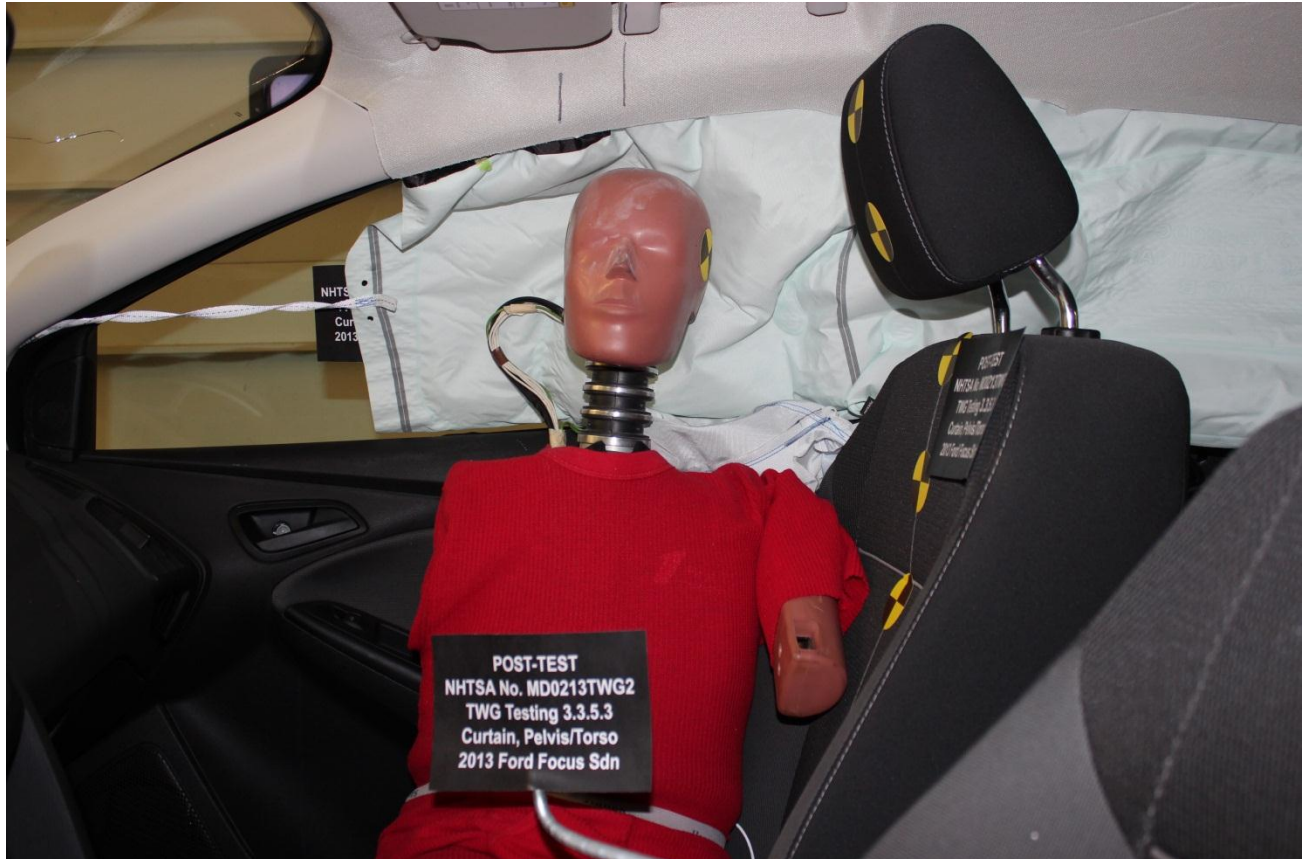
**Figure A-6: Post-Test 5th female SID-11s Dummy Left Side View**

| <b>Head Contact:</b> | Curtain Airbag & Side Head Liner |
| <b>Upper Torso Contact:</b> | Seat/Torso Airbag |
| <b>Lower Torso Contact:</b> | Seat/Torso Airbag |

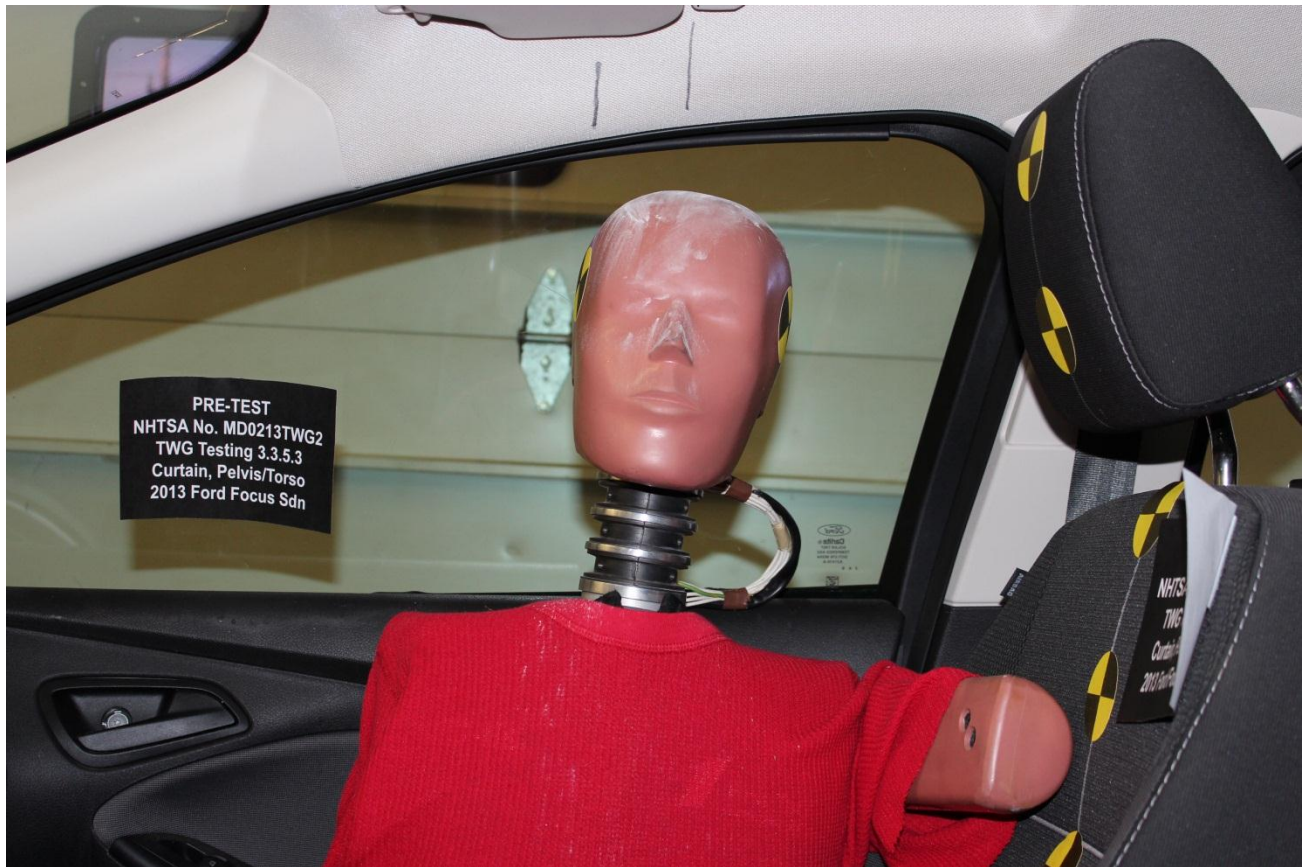
**Figure A-7: Pre-Test 5th female SID-II's Dummy Left Side Close-up View**

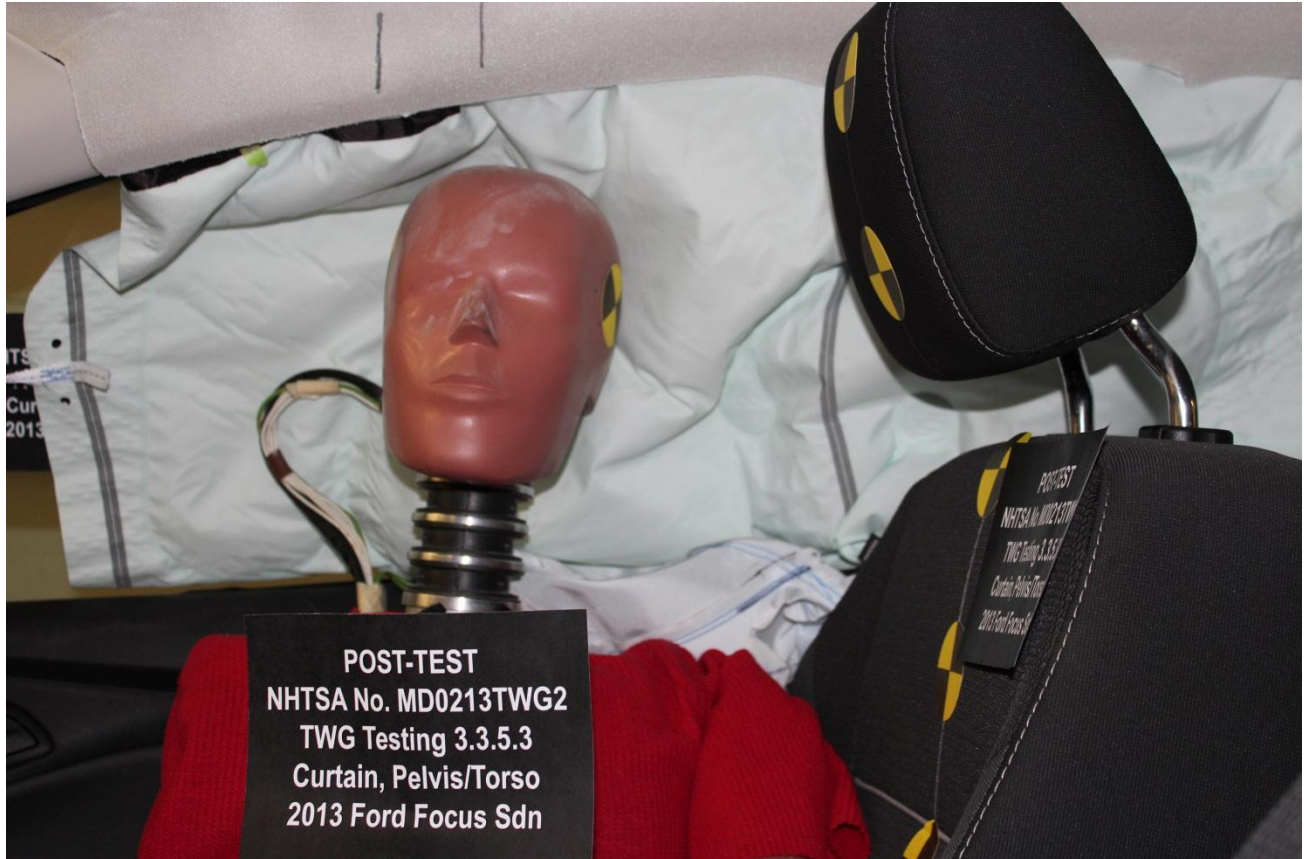
**Figure A-8: Post-Test 5th female SID-II's Dummy Left Side Close-up View**

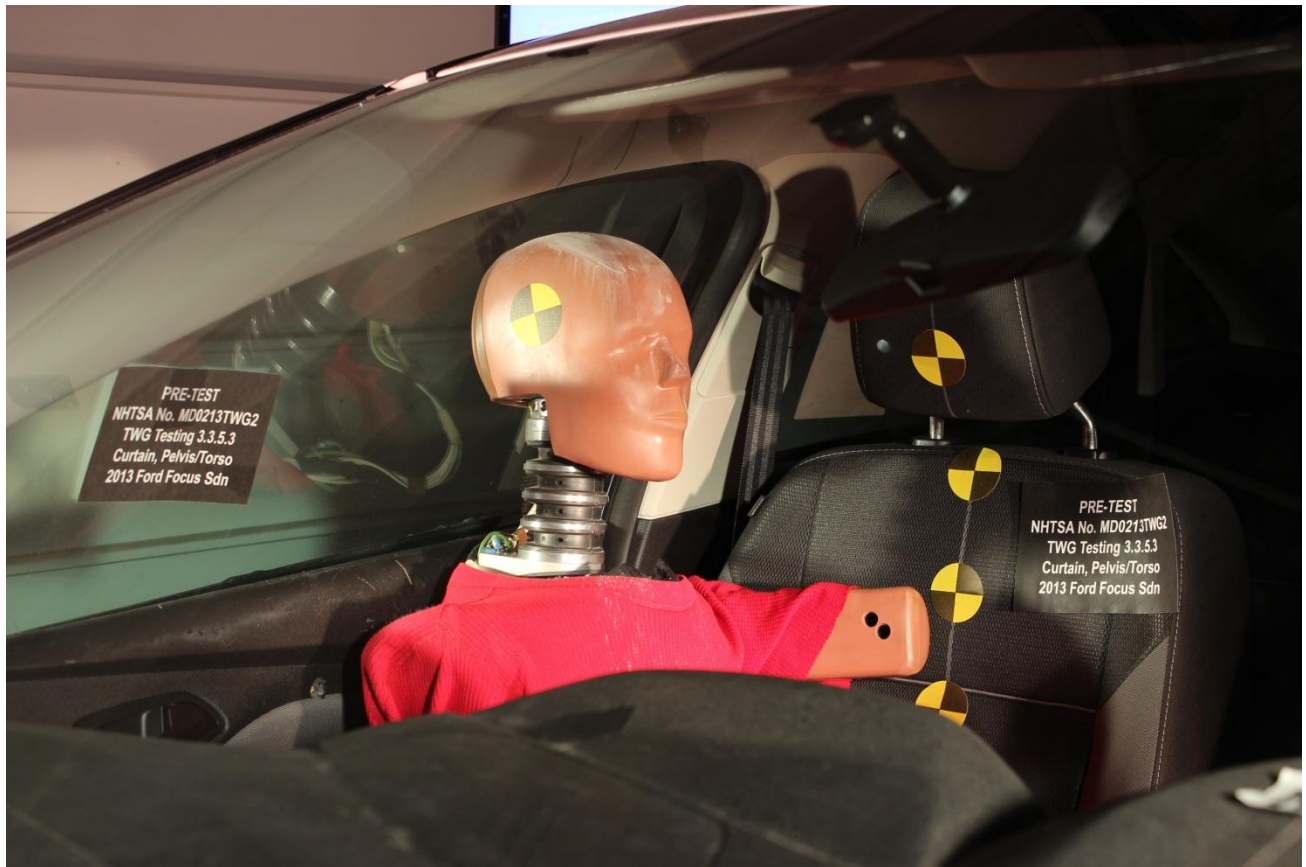
**Figure A-9: Pre-Test 5th female SID-II's Dummy Left  $\frac{3}{4}$  Front View**

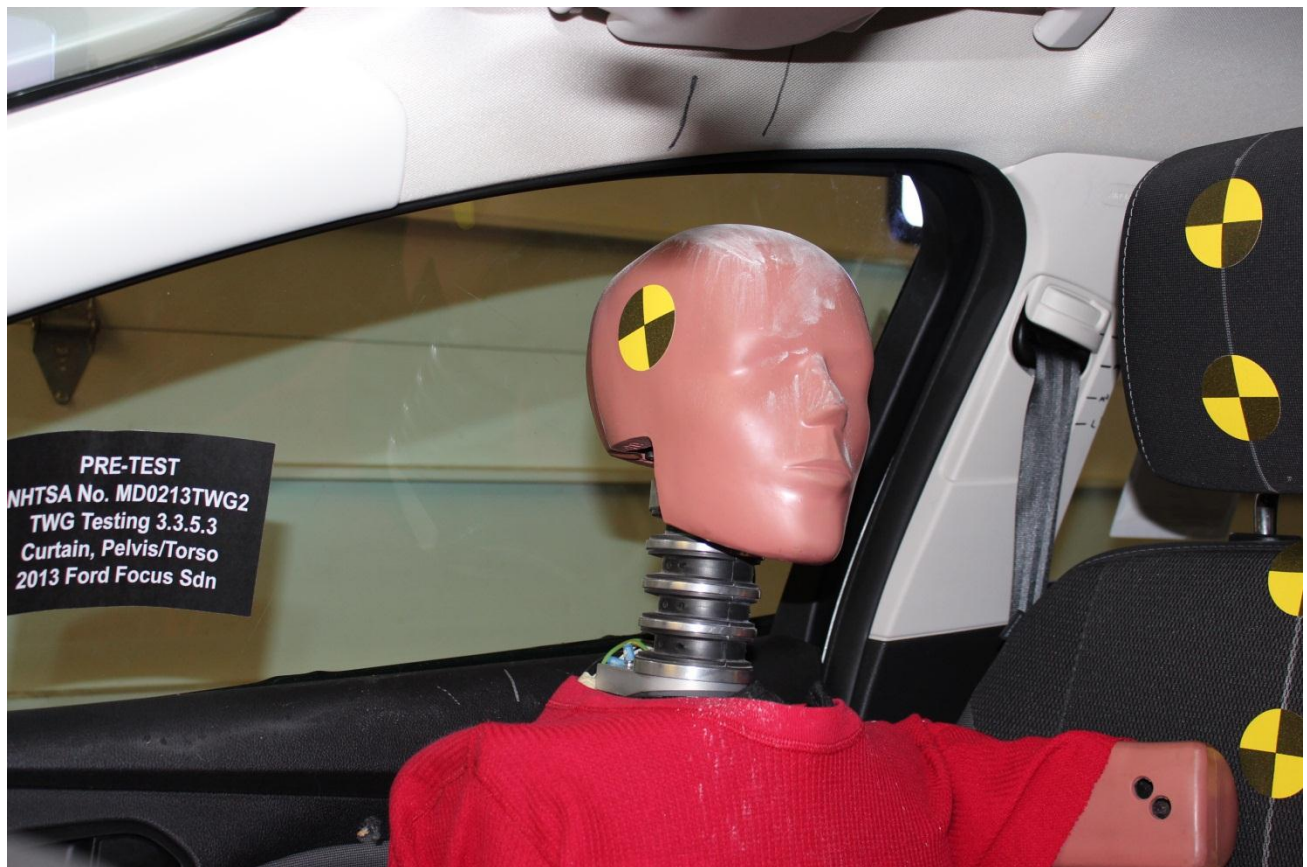
**Figure A-11: Pre-Test 5th female SID-II's Dummy Left  $\frac{3}{4}$  Front Close-up View**

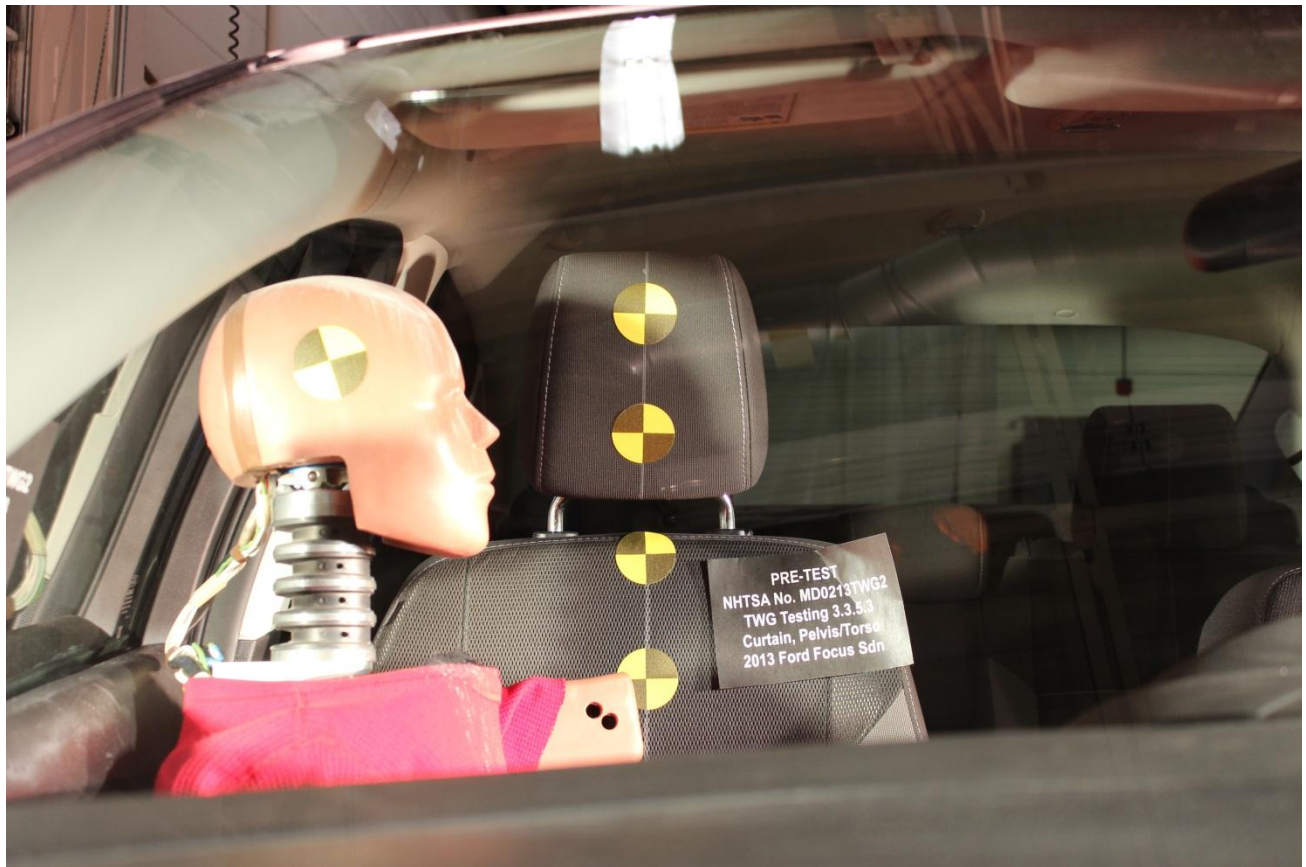
**Figure A-13: Pre-Test 5th female SID-II's Dummy Front View**

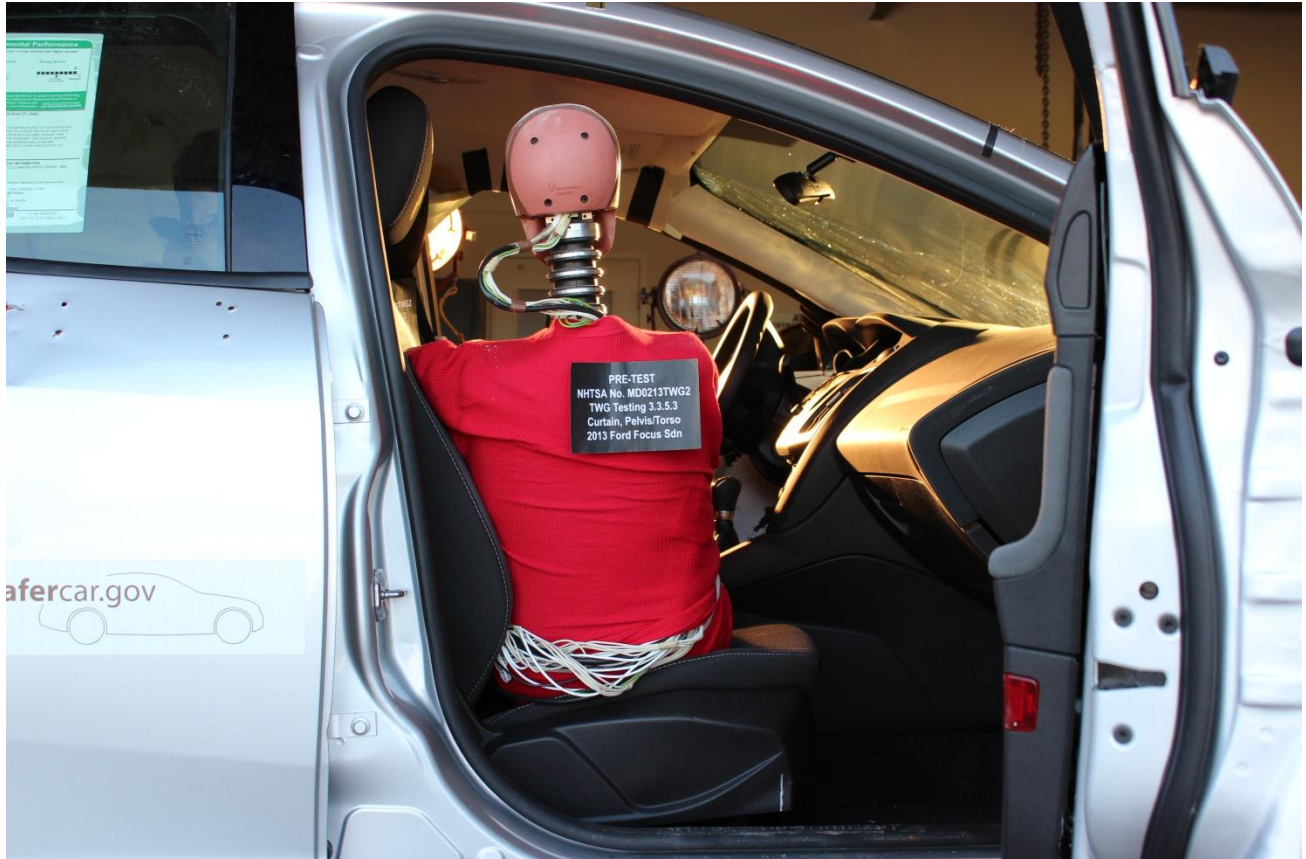
**Figure A-16: Pre-Test 5th female SID-IIs Dummy Right Side View**

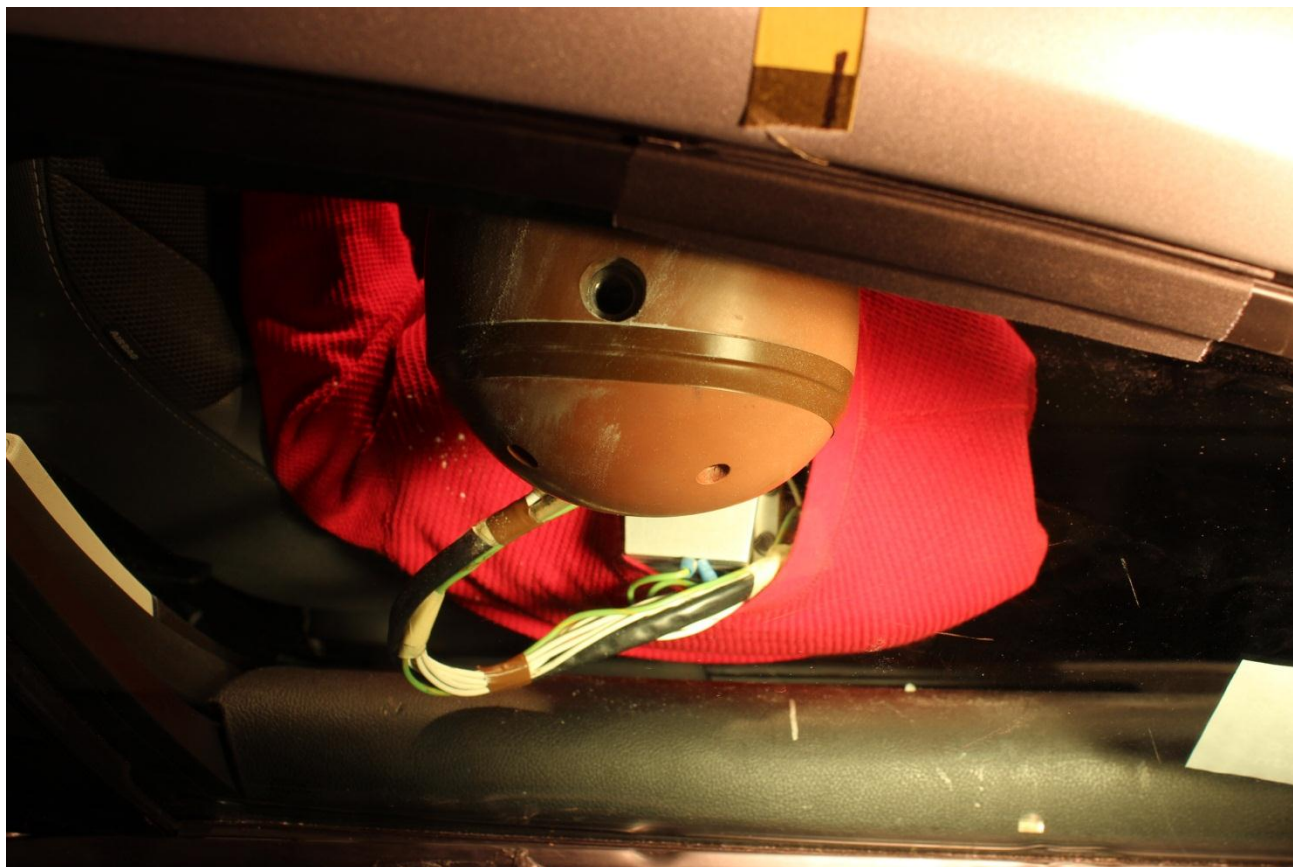
**Figure A-17: Pre-Test 5th female SID-IIs Dummy Right Side Clearance View**

| Seat Back Angle | SA ( ° ) | Value |
|---|---|---|
| Head CG to Door Panel/Side Window | HD (mm) | 165 |
| Head to B-Pillar (cg) | HB (mm) | 200 |
| Head to Roof, Z (top of the head) | HZ (mm) | 42 |

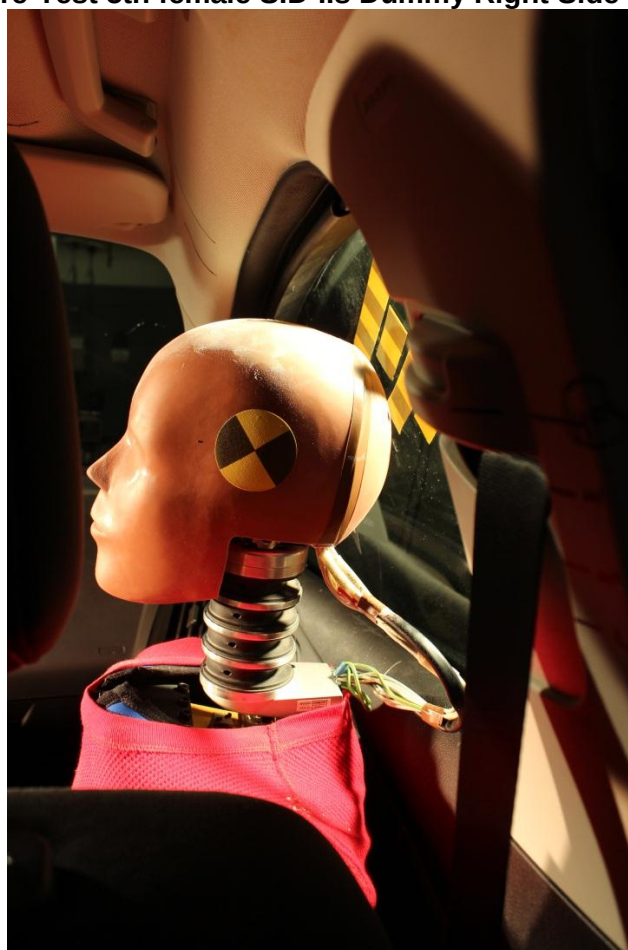
**Figure A-18: Pre-Test 5th female SID-IIs Dummy Rear Right Side Clearance View**

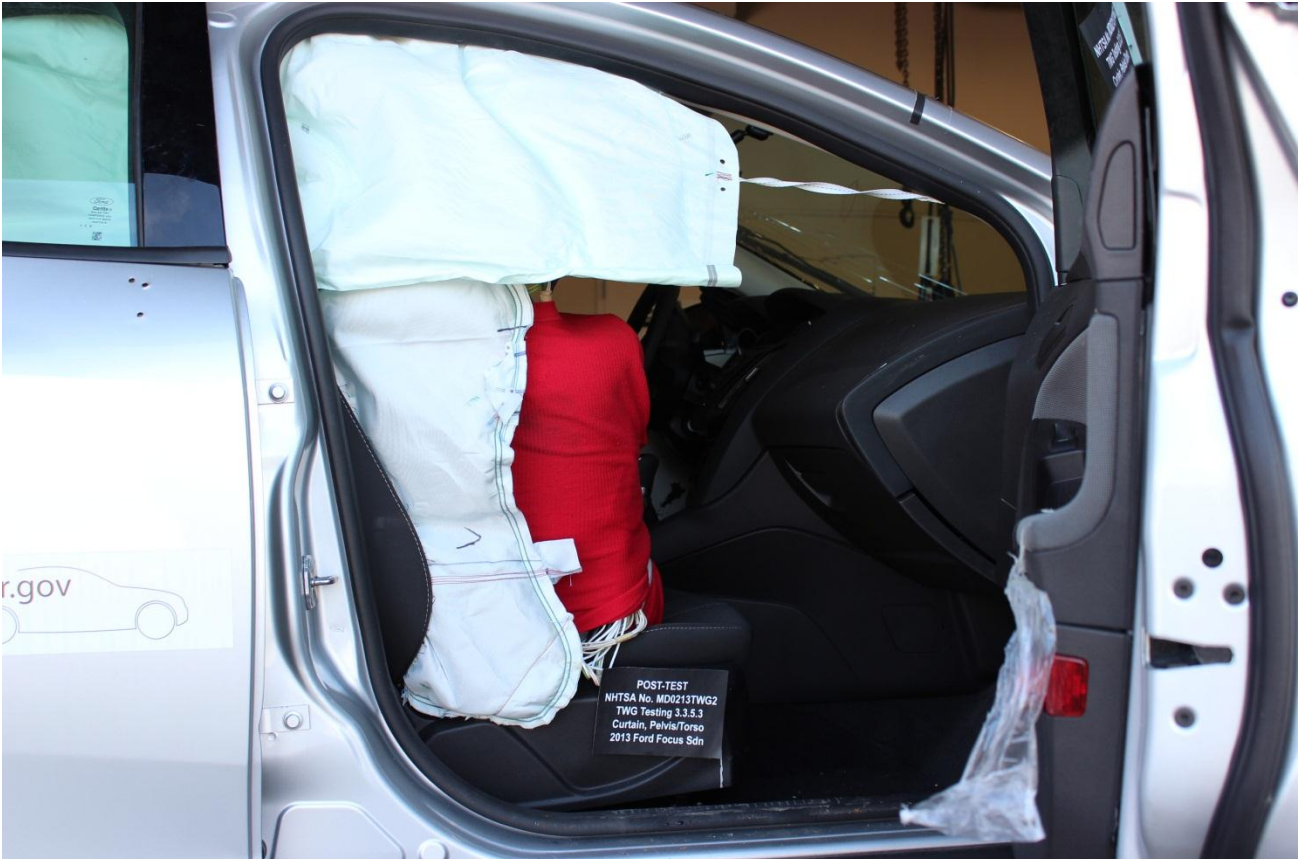
**Figure A-22: Post-Test Curtain Airbag Right Side View**

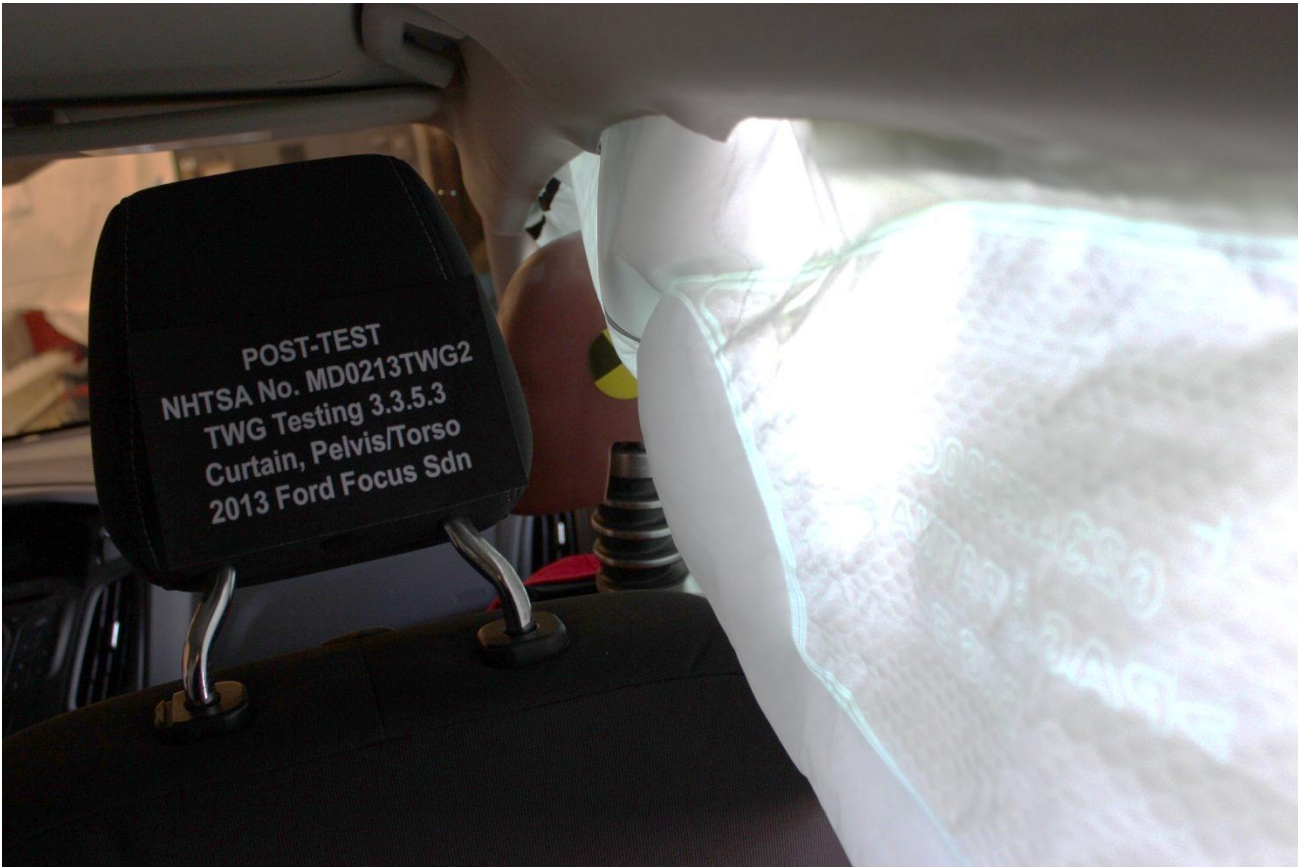
**Figure A-23: Post-Test Curtain Airbag Rear Right Side View**
