REPORT NUMBER: TWG-CAL-13-05

**NEW CAR ASSESSMENT PROGRAM (NCAP)**  
SIDE AIRBAG OUT-OF-POSITION INJURY TESTING

**Chrysler Group LLC**  
**2013 Dodge Dart**  
**Four Door Sedan**

NHTSA NUMBER: MD0305TWG2  
CALSPAN TEST NUMBER: CT2013-05

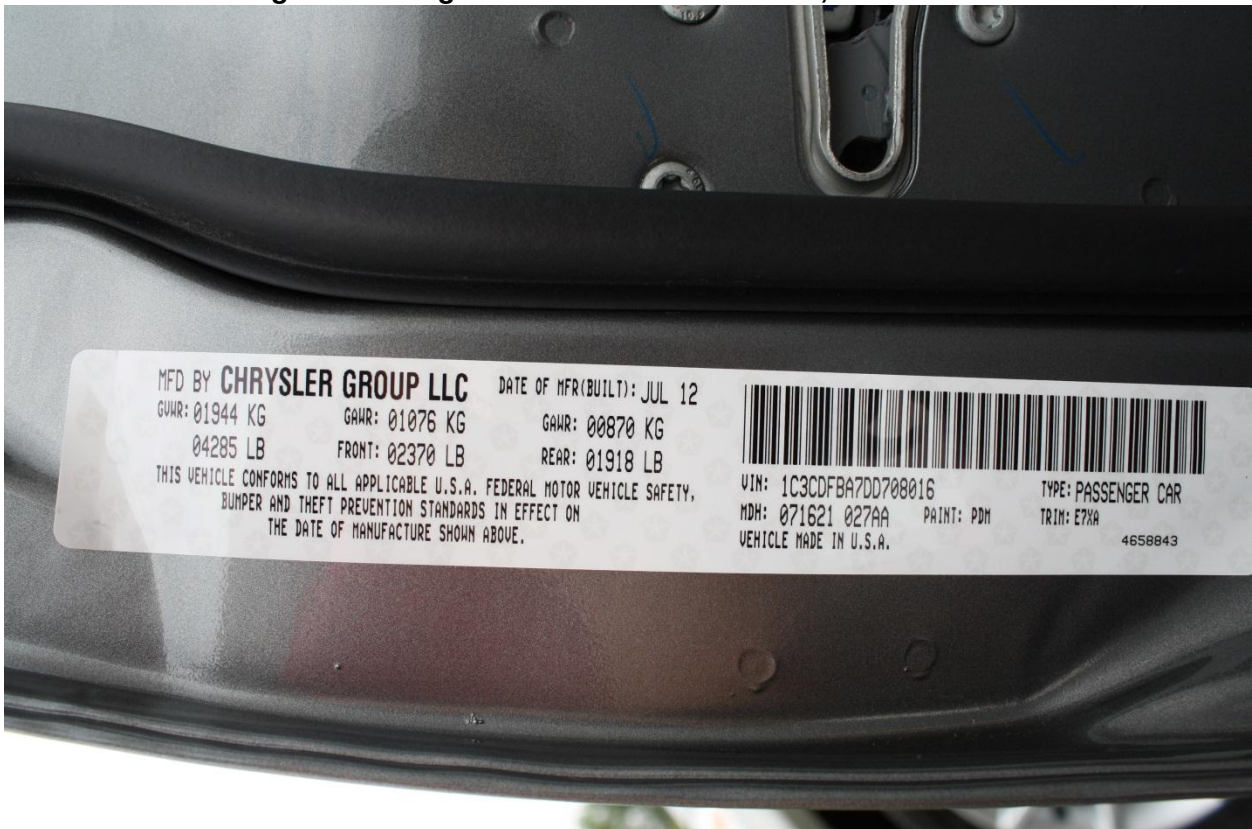
**Figure A-2: Vehicle Certification Placard**

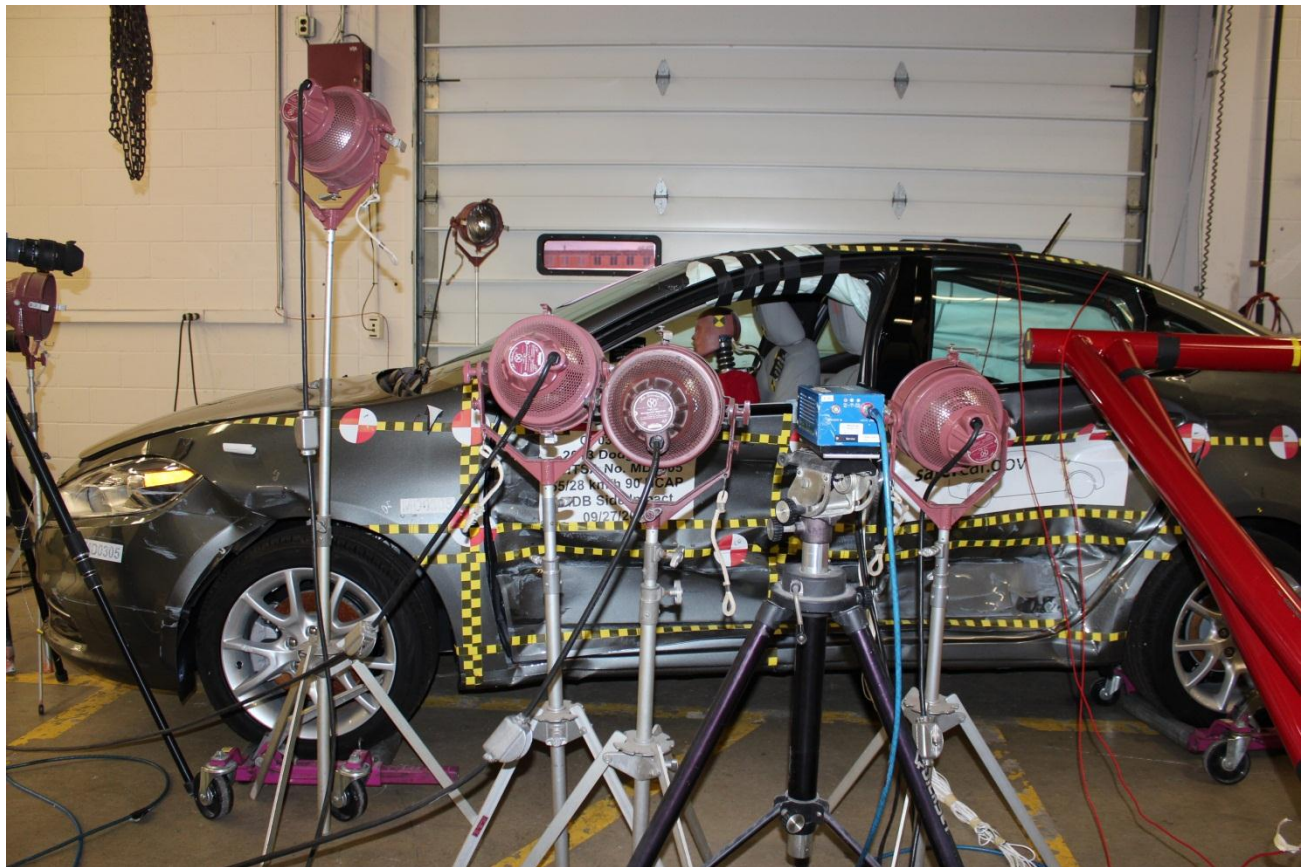
**Figure A-3: Pre-Test Vehicle Left Side View**

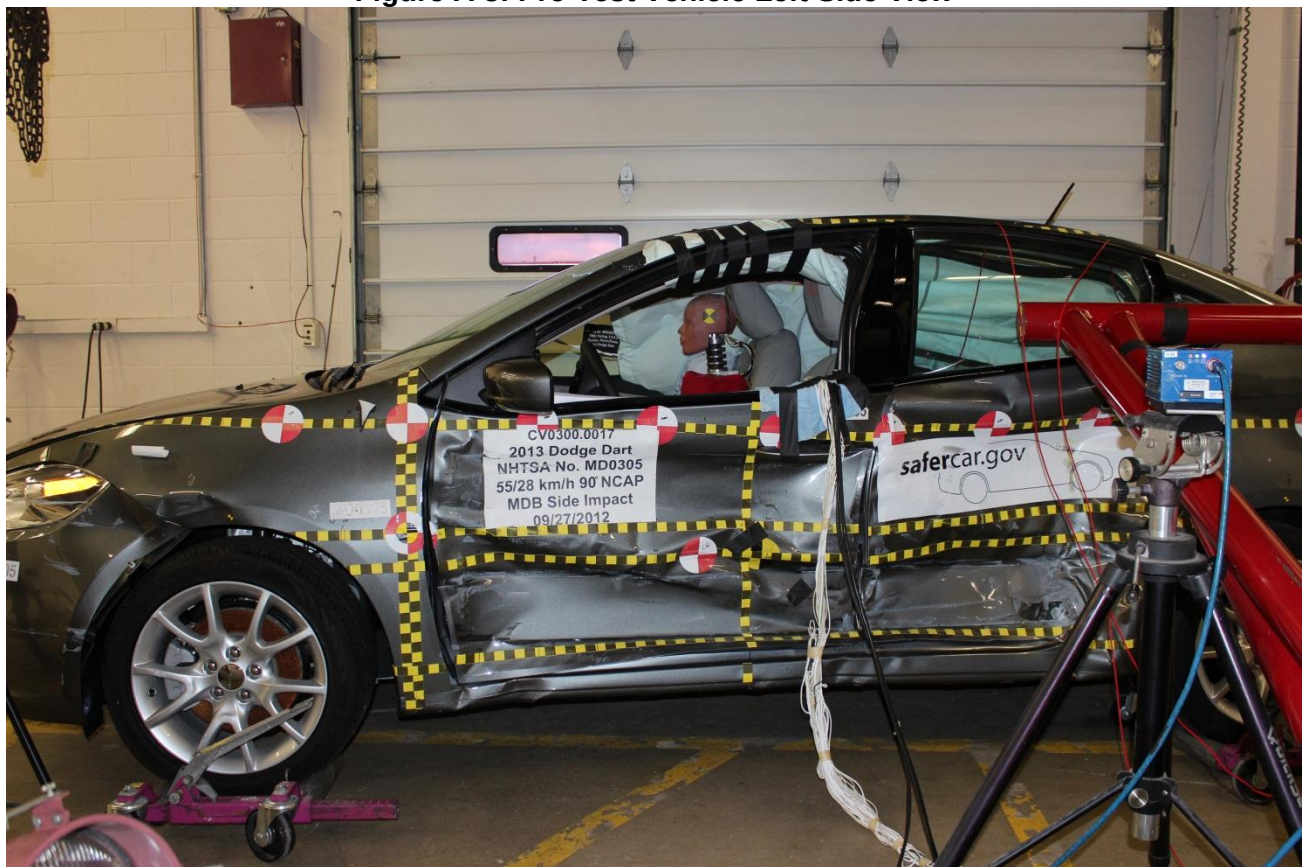
**Figure A-4: Post-Test Vehicle Left Side View**

‡ Vehicle had previously undergone a New Car Assessment Program Side MDB NCAP Test.

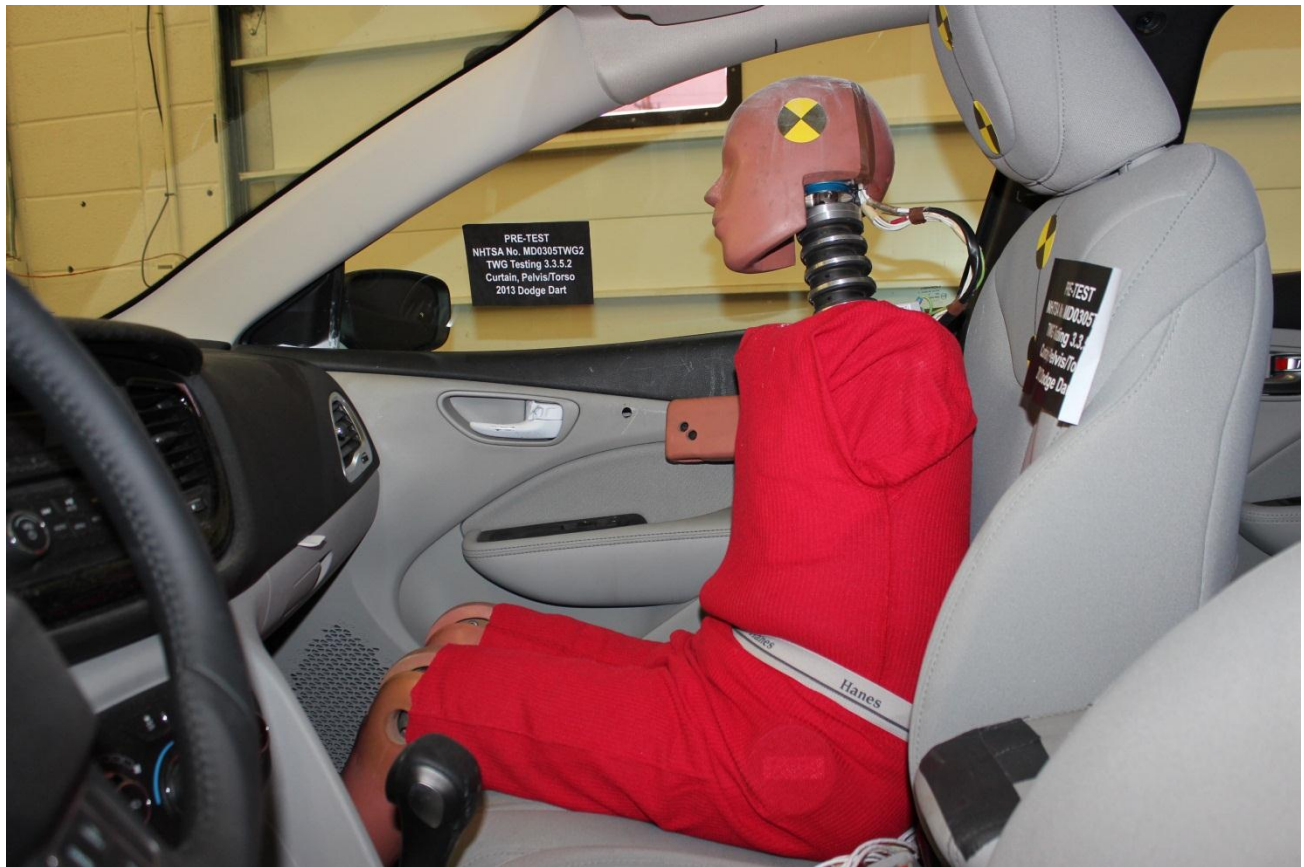
**Figure A-5: Pre-Test 5th female SID-II's Dummy Left Side View**

The 5<sup>th</sup> female ATD was placed with its right arm outstretched against the front (passenger) door facing forward in the car sitting with its legs placed on floor. After consultation with the program sponsor, the seat track was adjusted to locate the head c.g. under the expected deployment location of a head curtain chamber to maximize the airbag to head interaction. The location was determined by observing test data from the previous left side impact test on this vehicle. While keeping the head in neutral orientation, the ATD's was tilted outboard until the dummy's head was positioned under the airbag. The center of gravity of the head was centered in the deployment trajectory of the airbag. This orientation complies with section 3.3.5.2 of the TWG Recommended Procedures for Evaluating Occupant Injury Risk from Deploying Side Airbags as defined by Lund, et al and the Technical Working Group First Revision dated July, 2003.

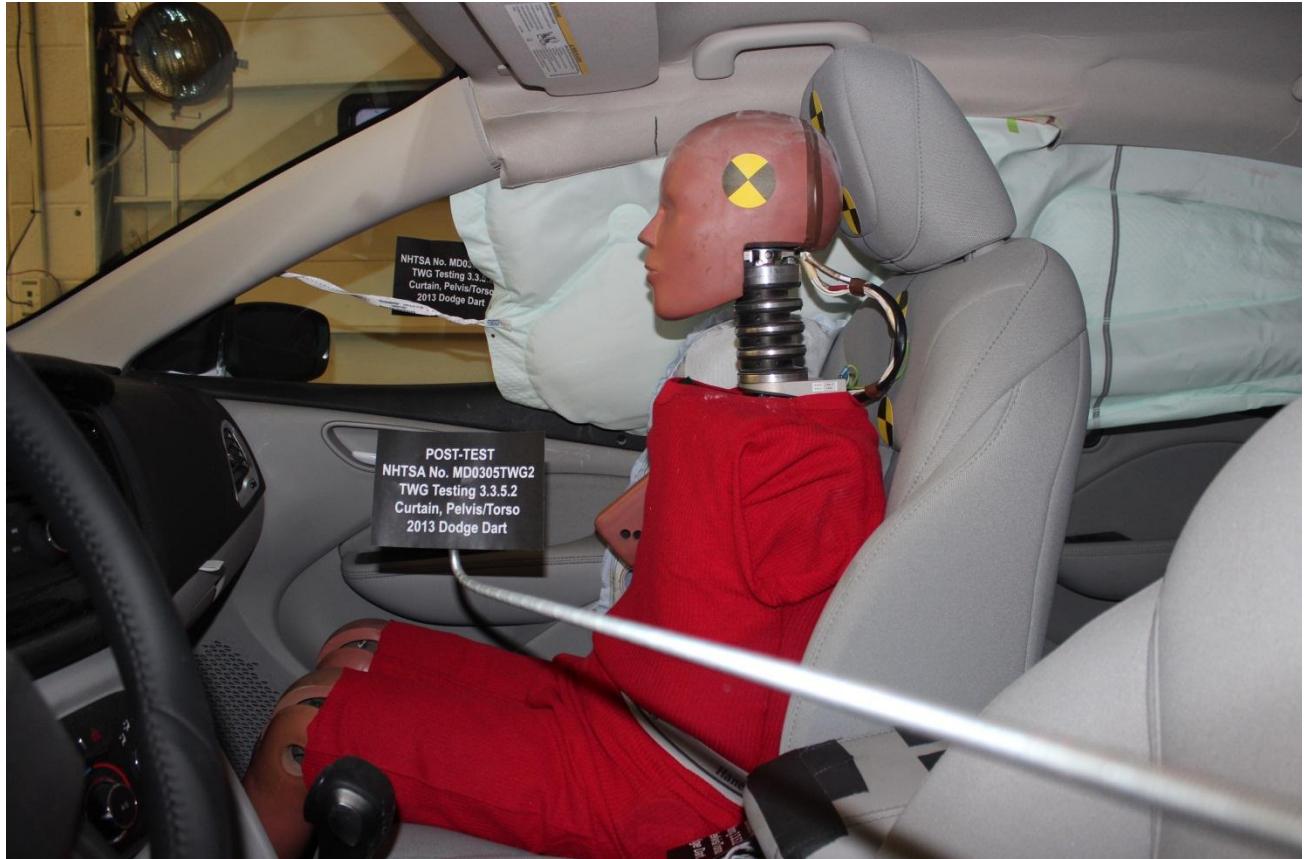
**Figure A-6: Post-Test 5th female SID-II's Dummy Left Side View**

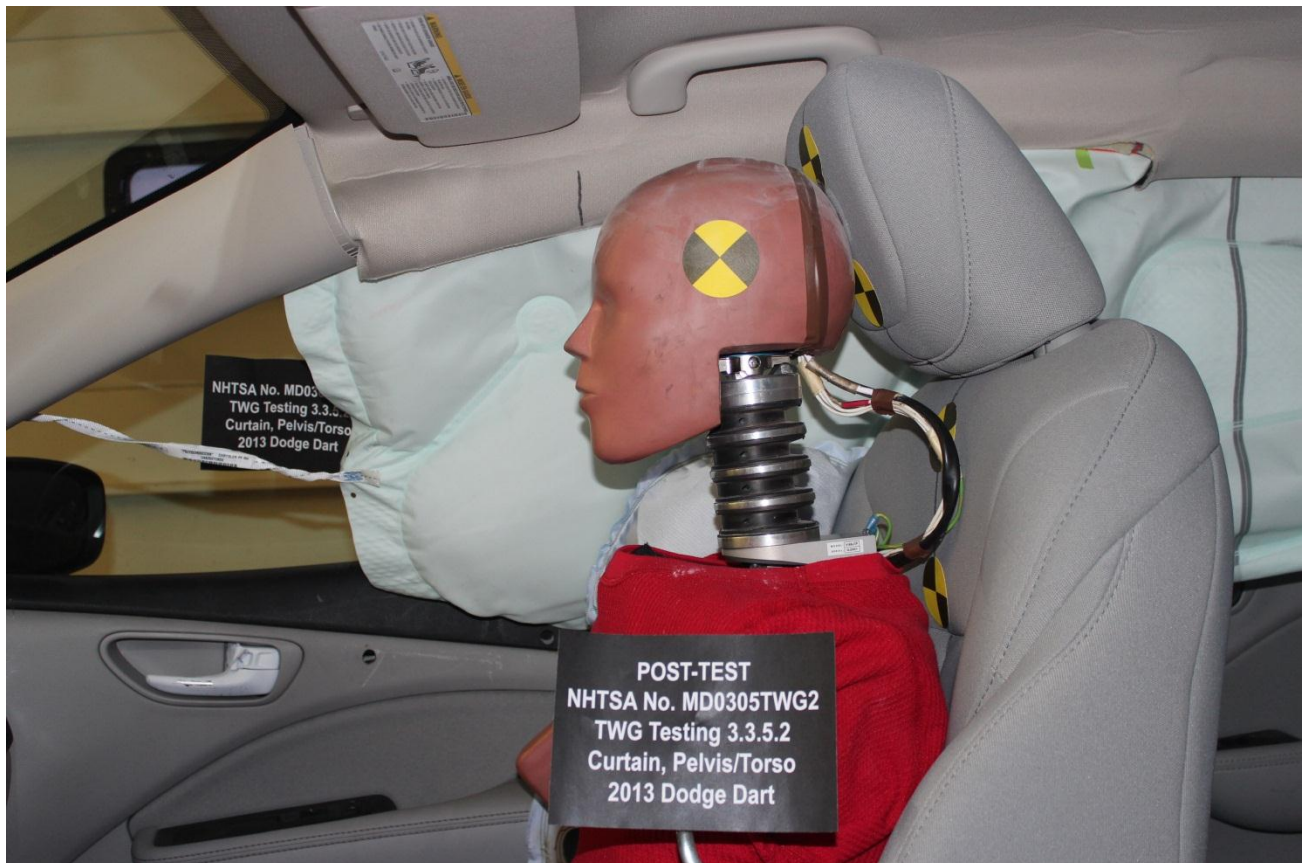
**Figure A-8: Post-Test 5th female SID-IIs Dummy Left Side Close-up View**

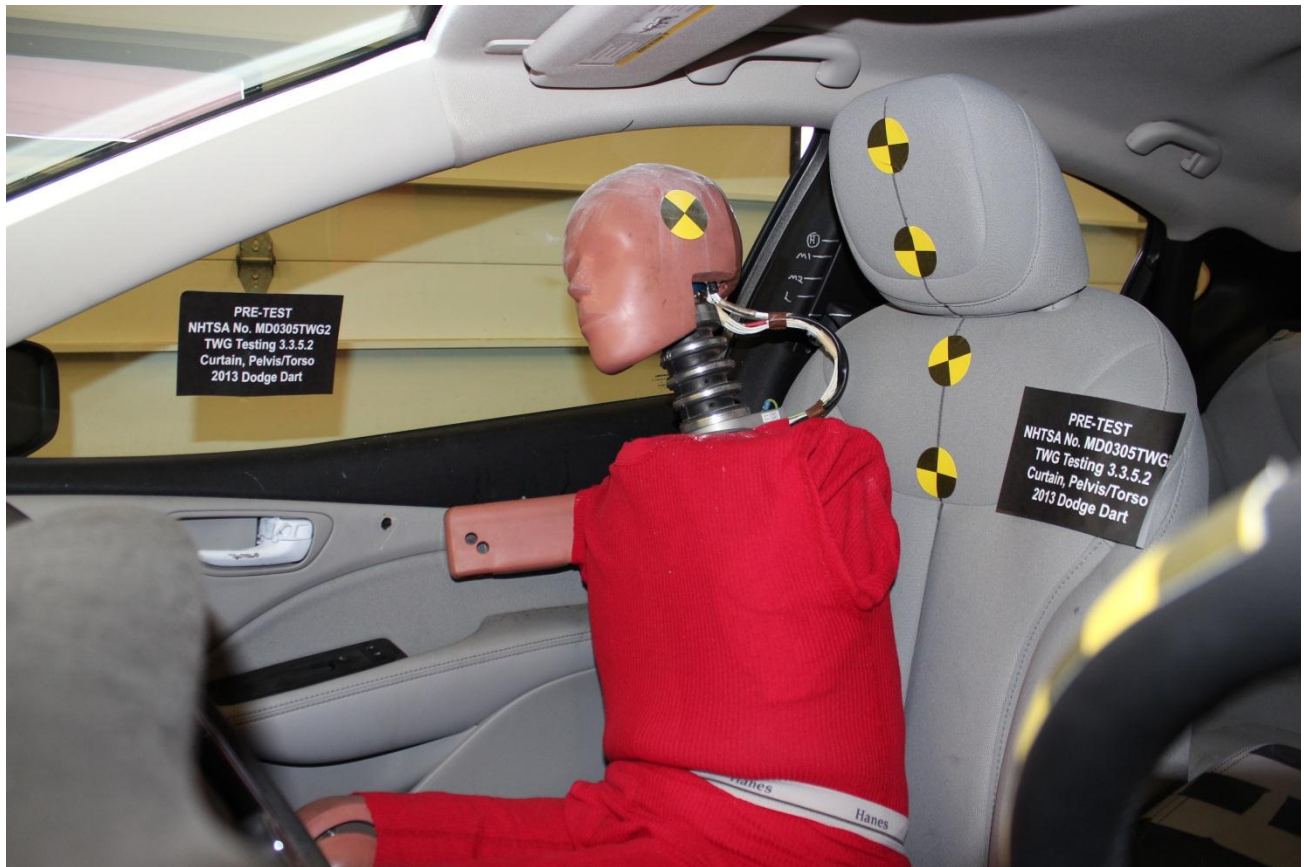
**Figure A-9: Pre-Test 5th female SID-II's Dummy Left  $\frac{3}{4}$  Front View**

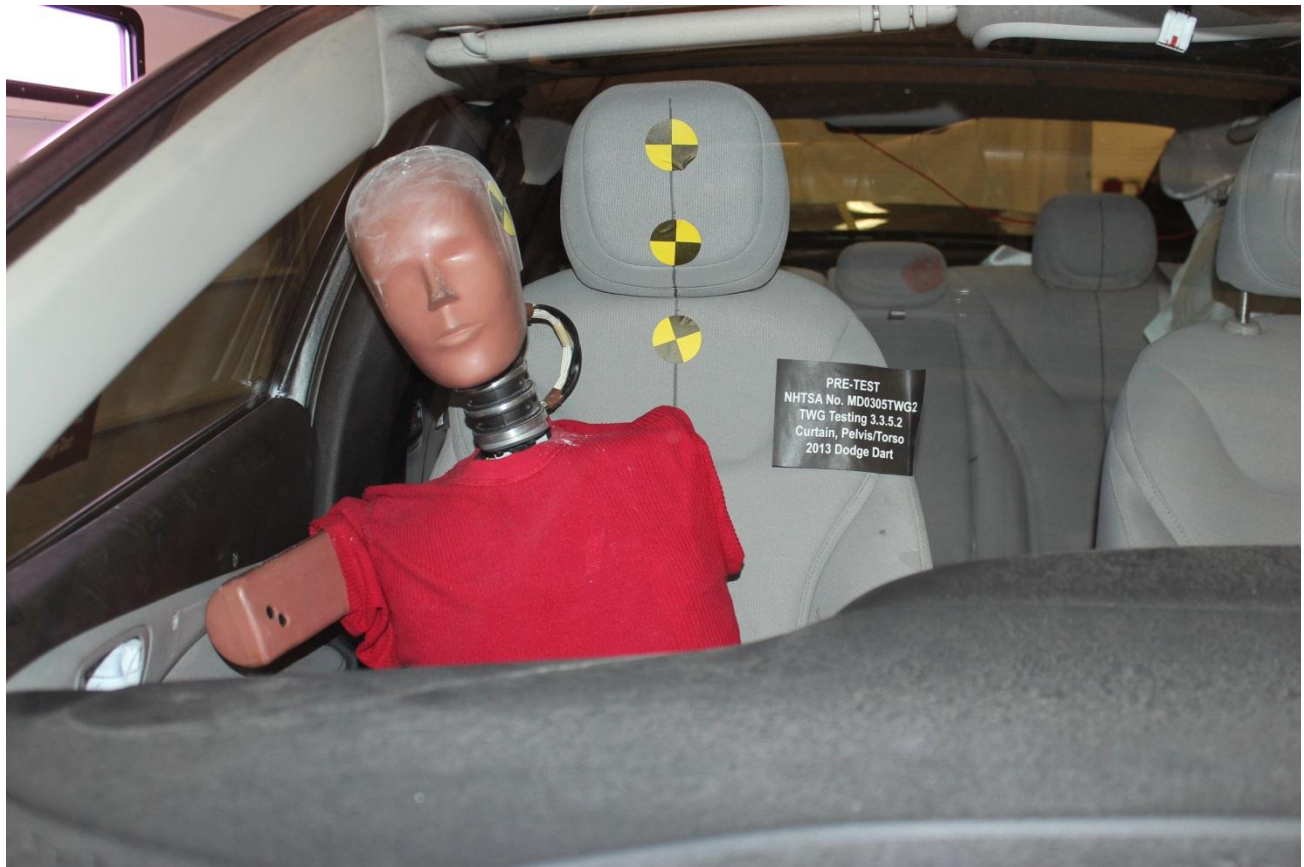
**Figure A-13: Pre-Test 5th female SID-II's Dummy Front View**

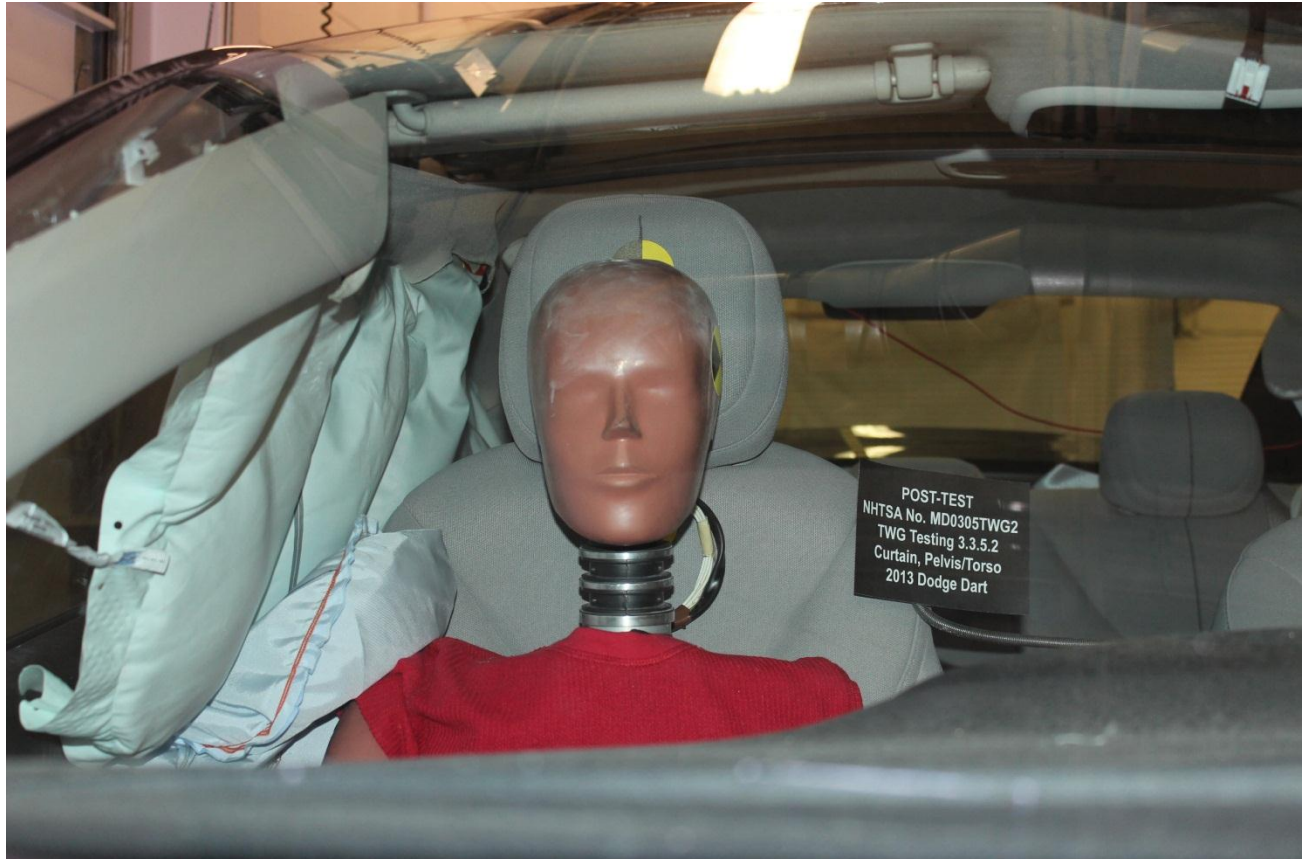
**Figure A-14: Post-Test 5th female SID-II's Dummy Front View**

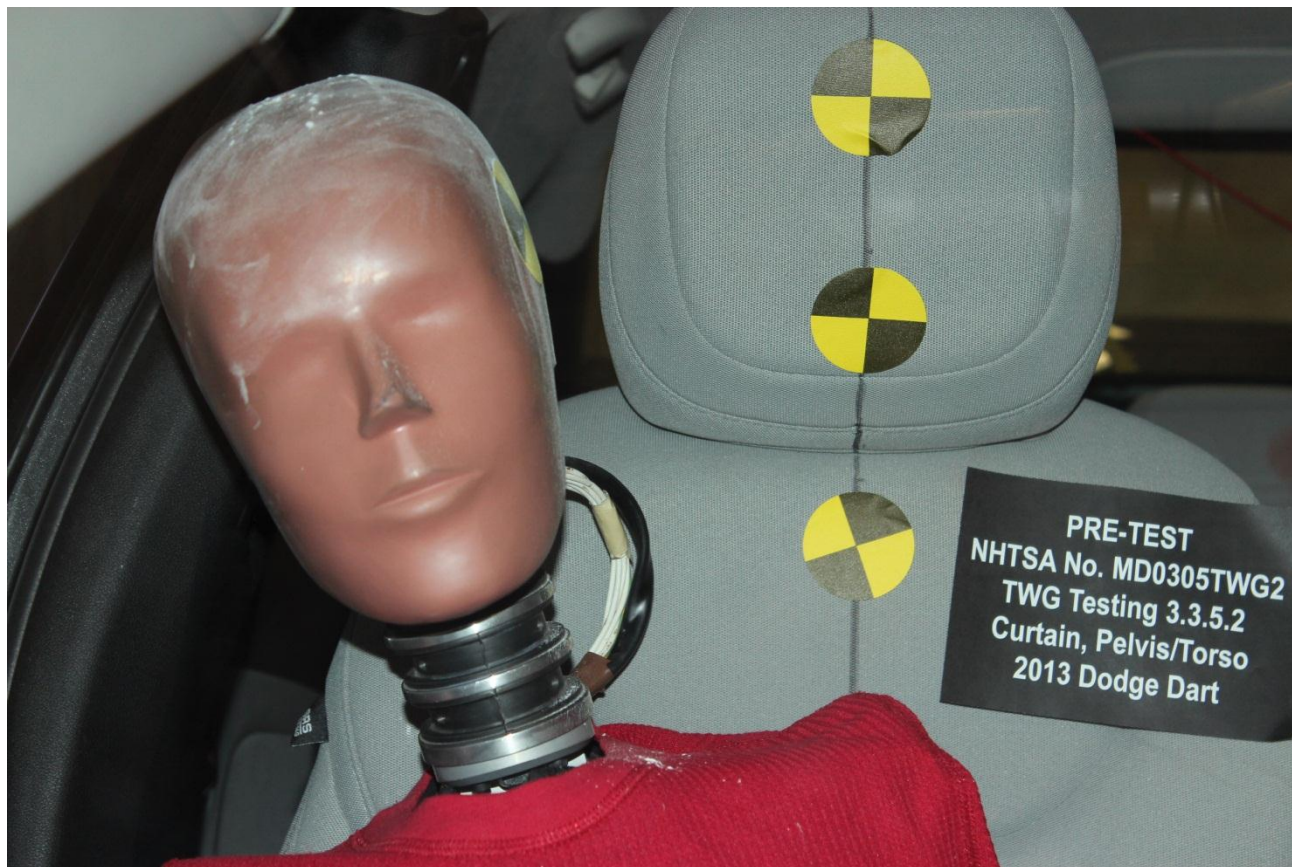
**Figure A-15: Pre-Test 5th female SID-IIs Dummy Front Close-up View**

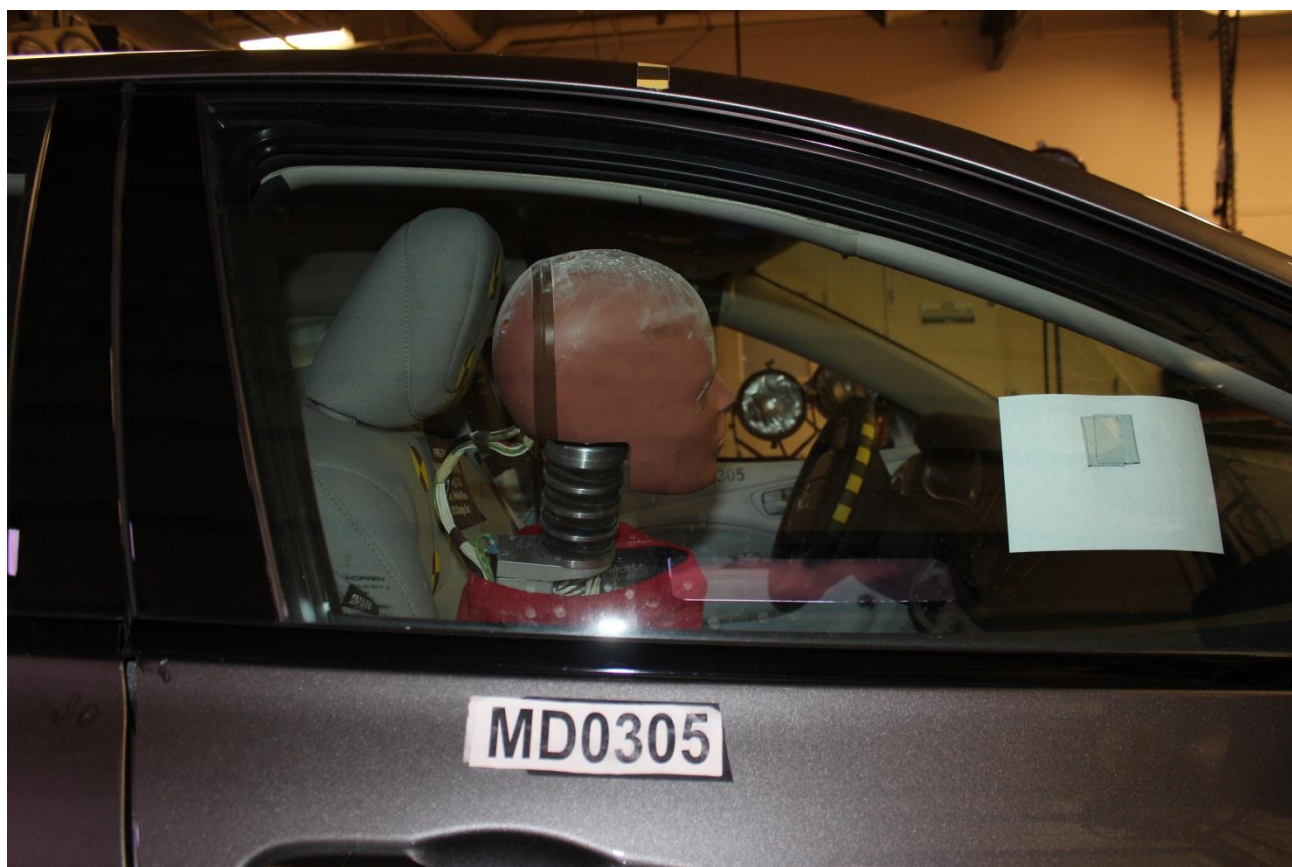
**Figure A-16: Pre-Test 5th female SID-IIs Dummy Right Side View**

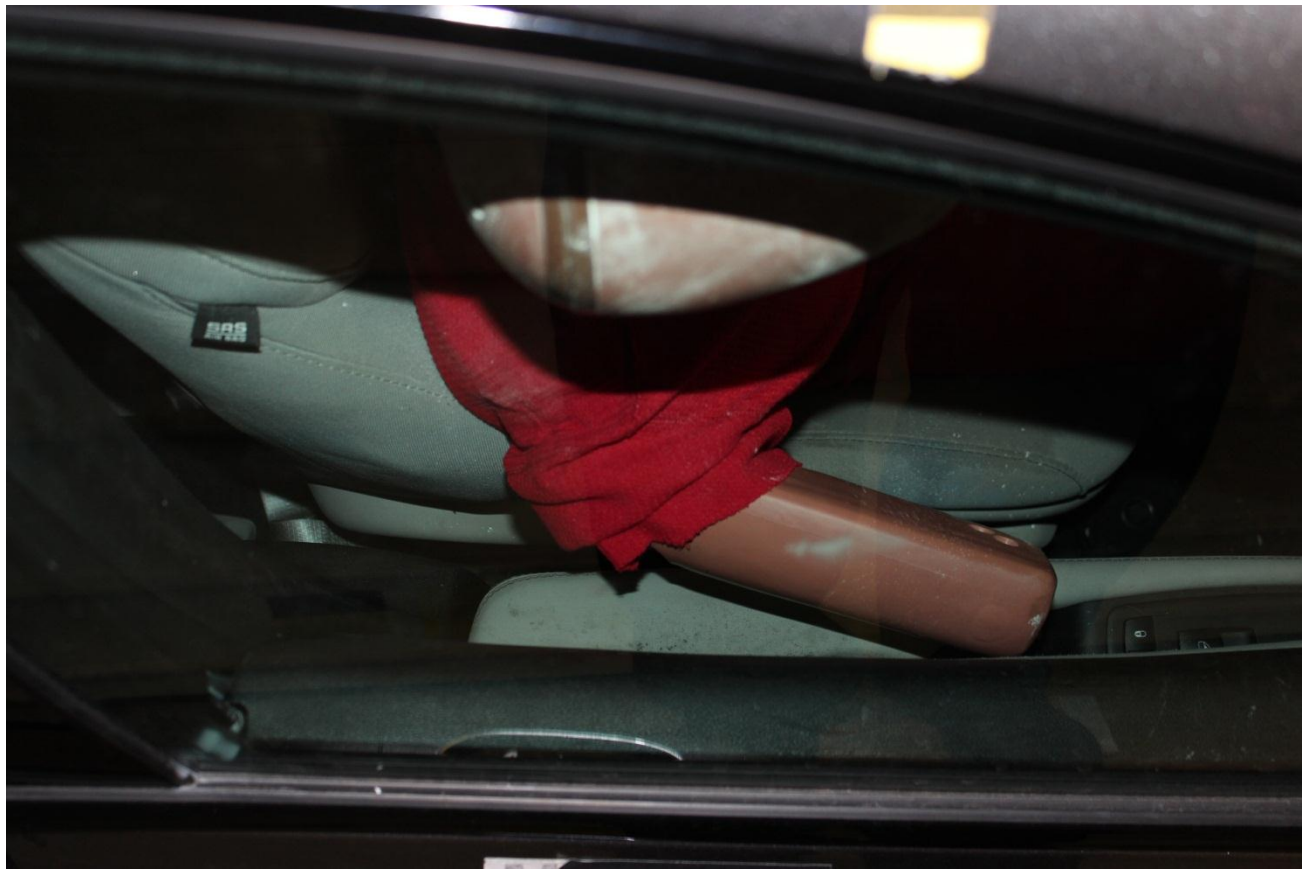
**Figure A-17: Pre-Test 5th female SID-IIs Dummy Right Side Clearance View**

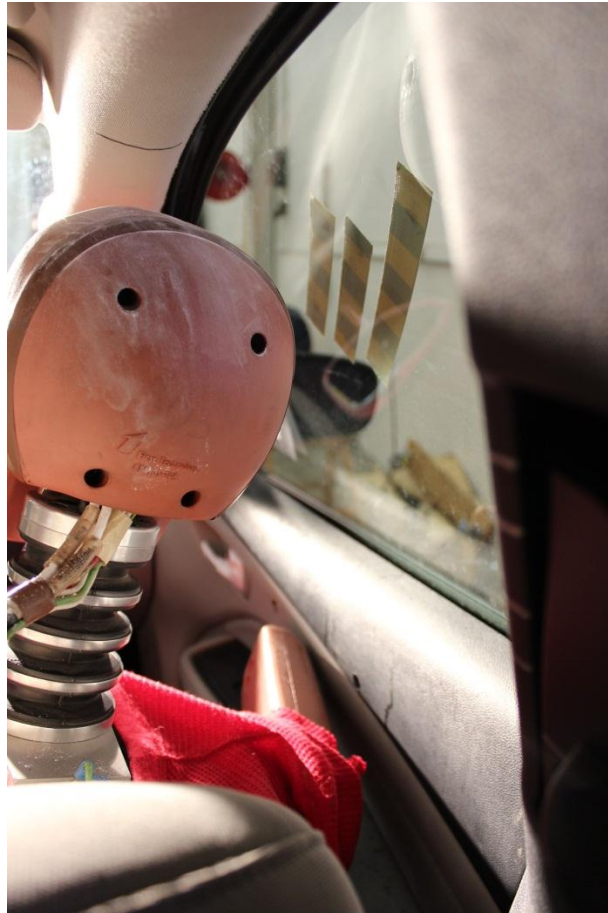
**Figure A-18: Pre-Test 5th female SID-IIs Dummy Rear Right Side Clearance View**

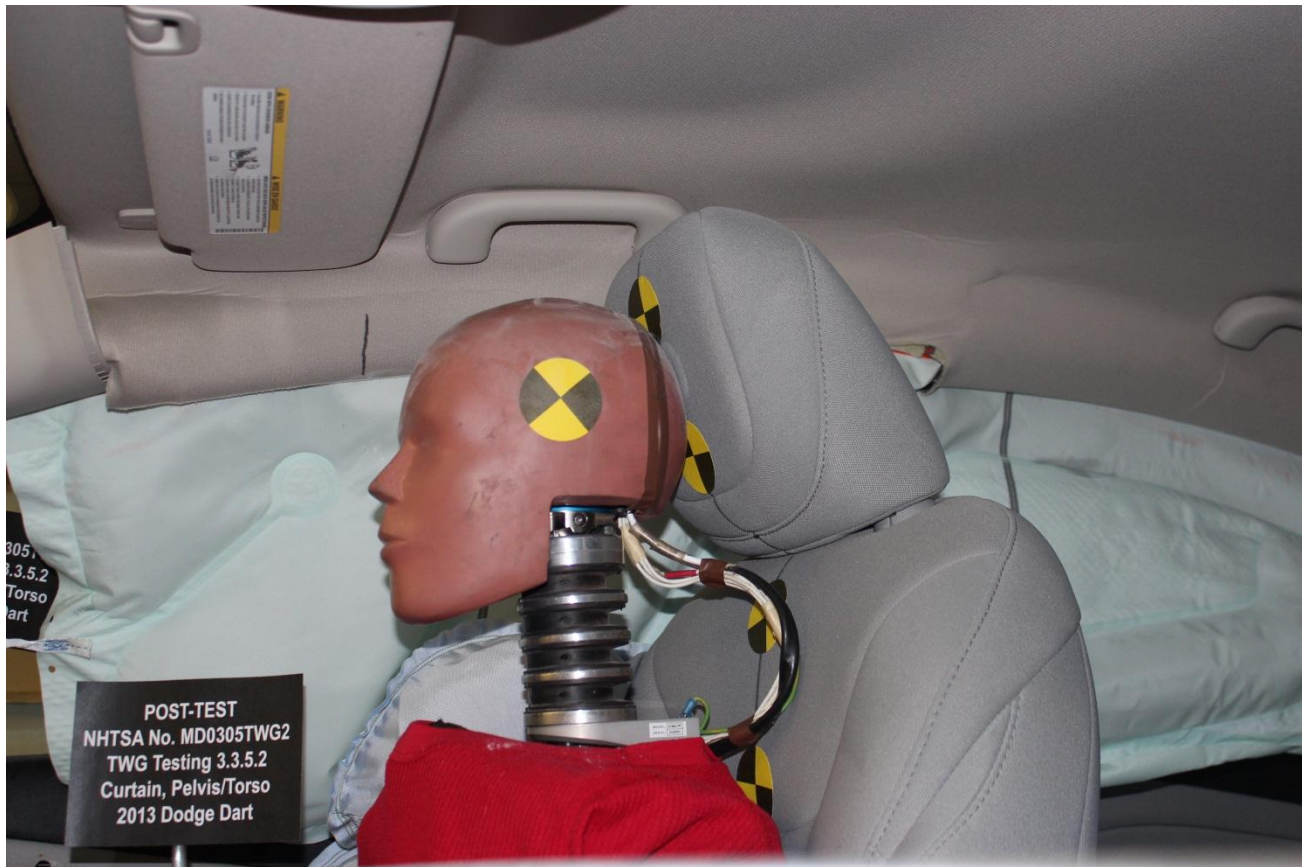
**Figure A-19: Post-Test Curtain Airbag Left Side View**

| <b>Head Contact:</b> | Curtain Airbag |

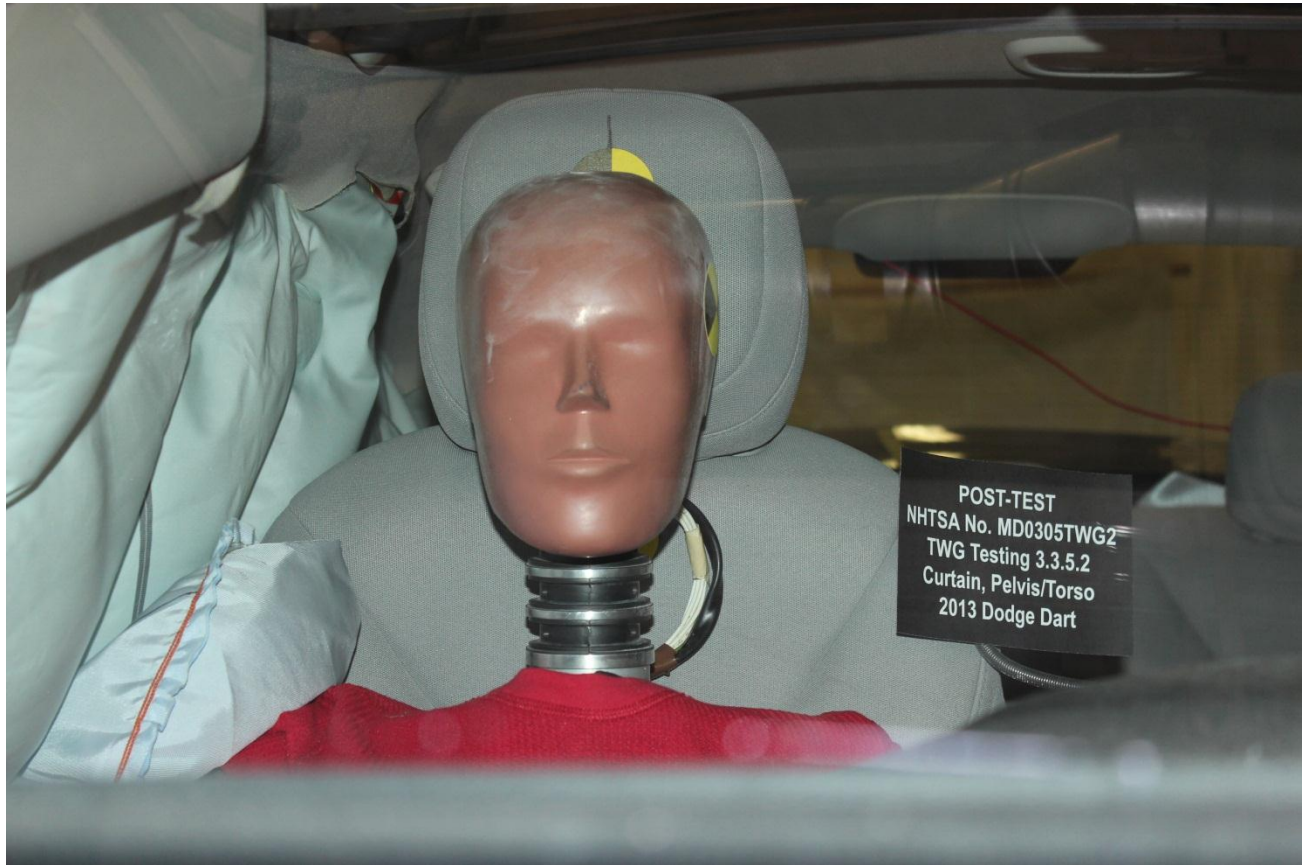
**Figure A-21: Post-Test Curtain Airbag Front View**

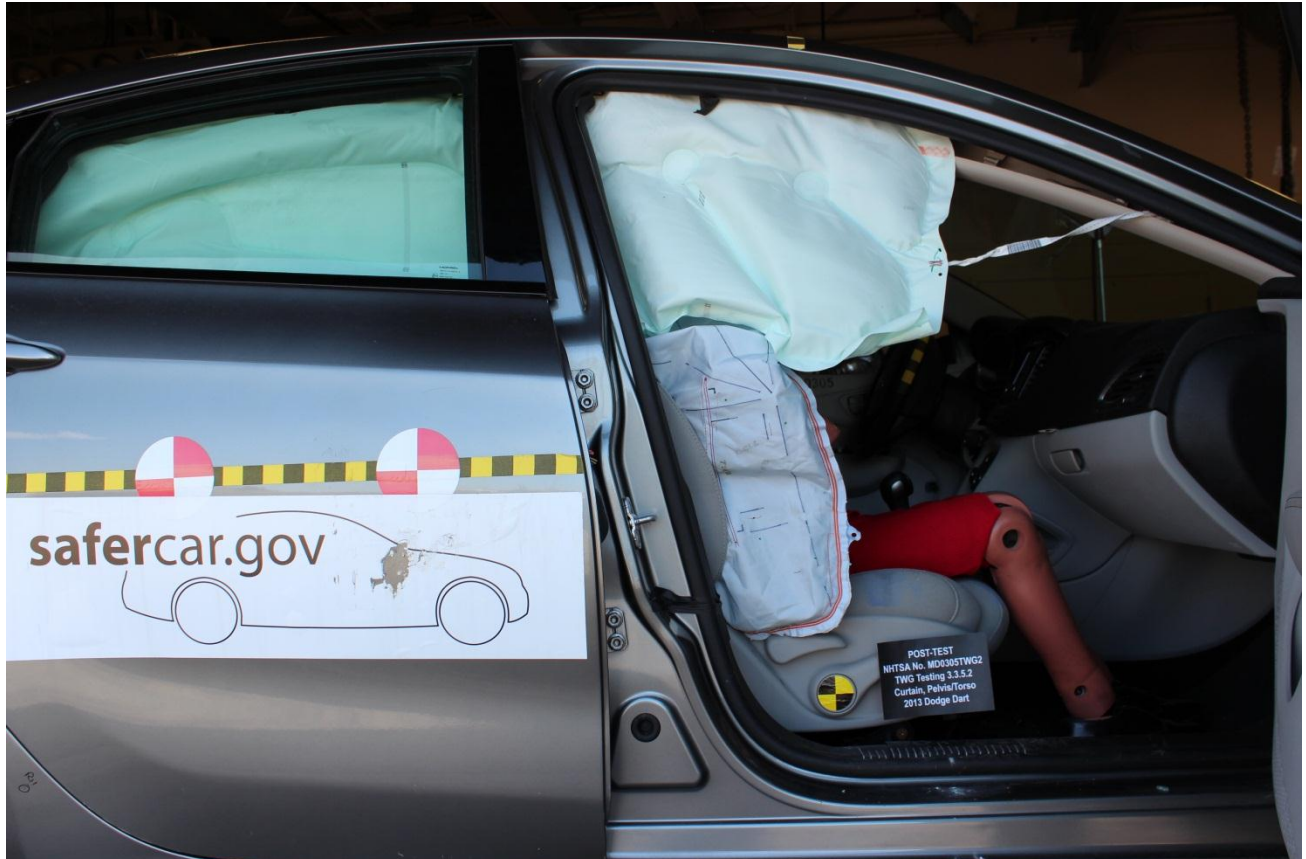
**Figure A-22: Post-Test Curtain Airbag Right Side View**

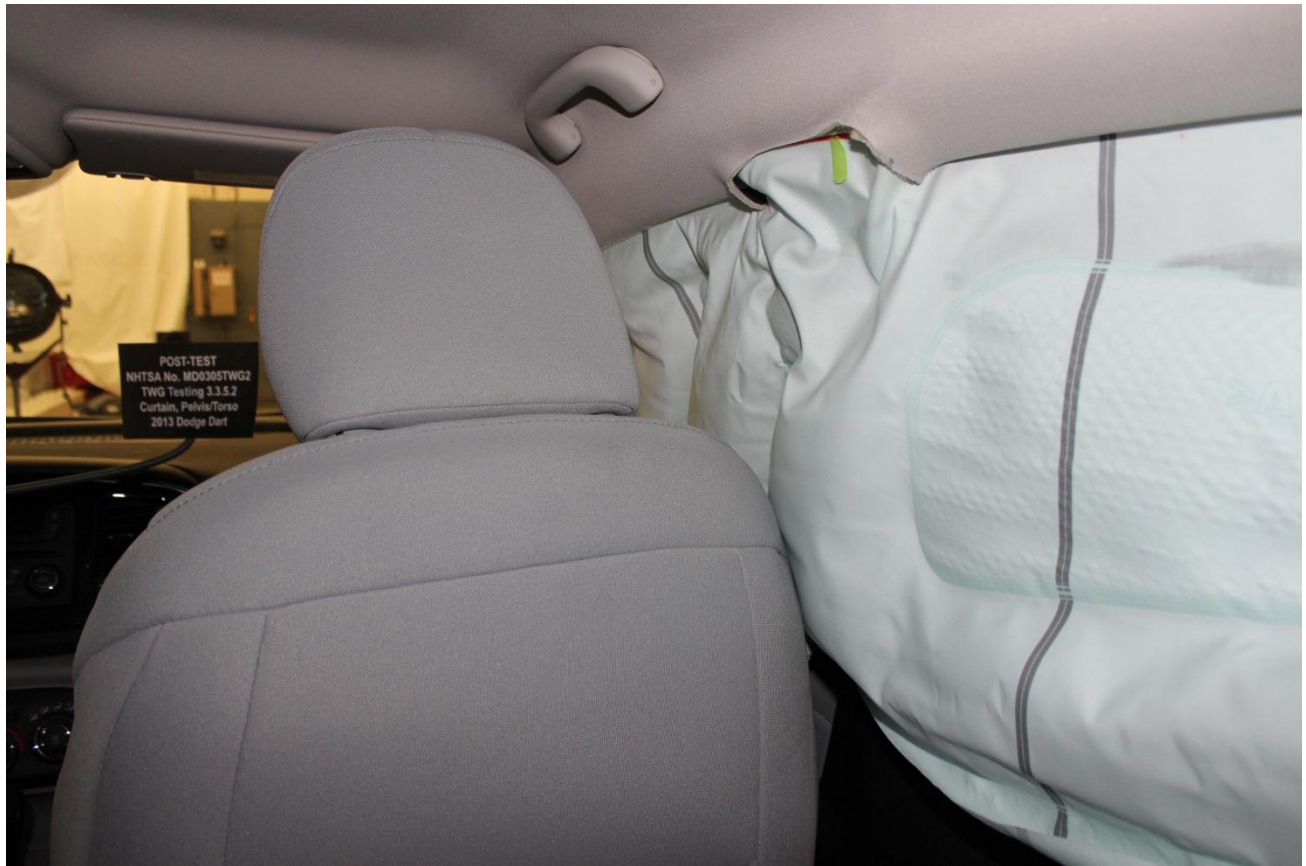
**Figure A-23: Post-Test Curtain Airbag Rear Right Side View**

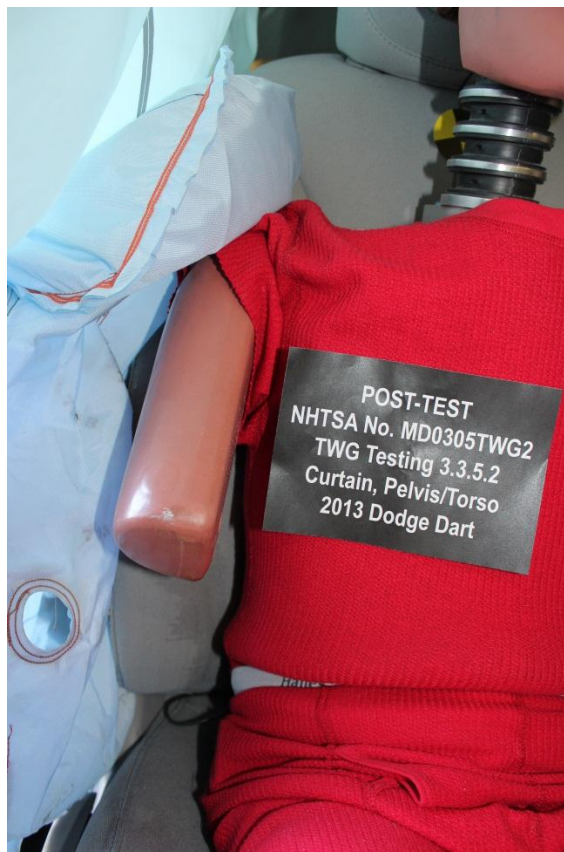
**Figure A-24: Post-Test Curtain Airbag Right Front Side View**

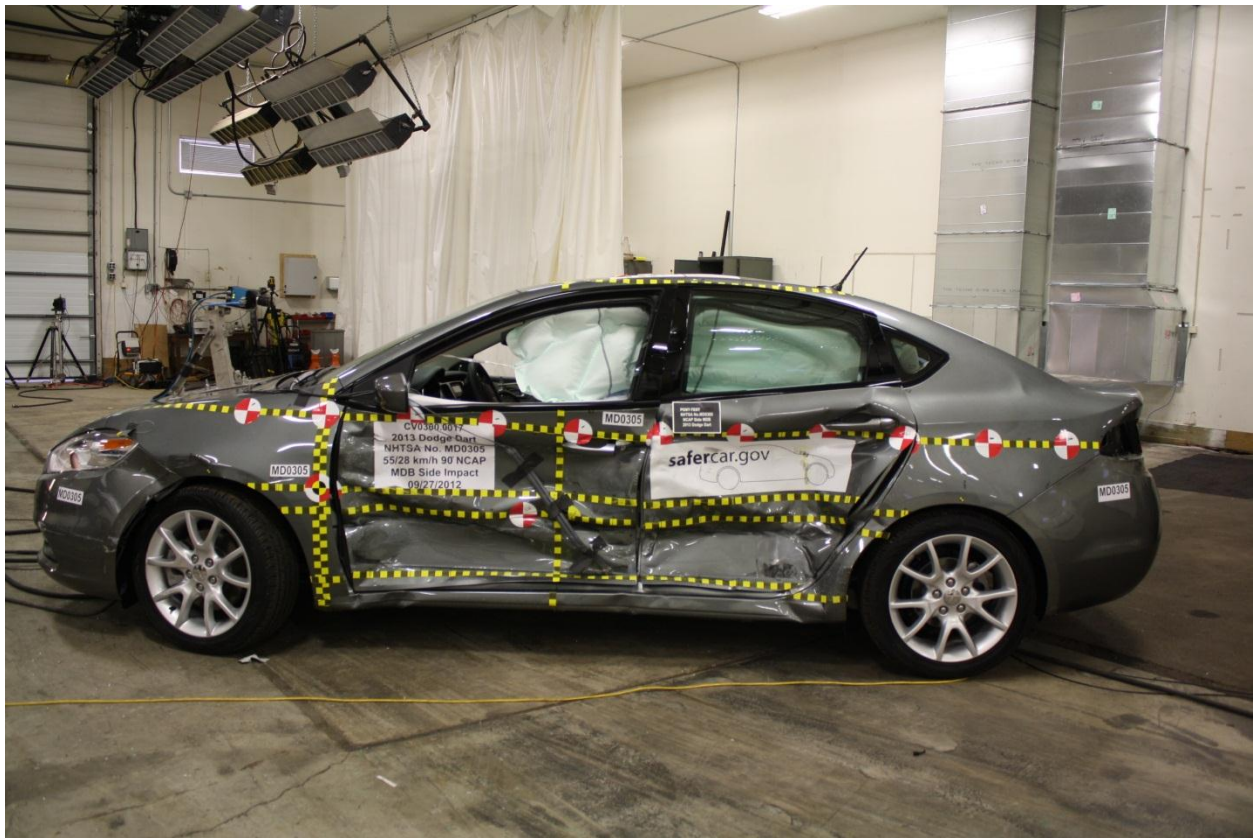
**Figure A-25: Post NCAP Left Side View**
