**REPORT NUMBER: TWG-MGA-2013-008B**

**SIDE AIRBAG OUT-OF-POSITION INJURY  
TECHNICAL WORKING GROUP**

**MERCEDES-BENZ U.S. INTL., INC  
2013 Mercedes-Benz ML350 AWD SUV  
NHTSA No.: MD0509TWG3**

**FINAL REPORT**

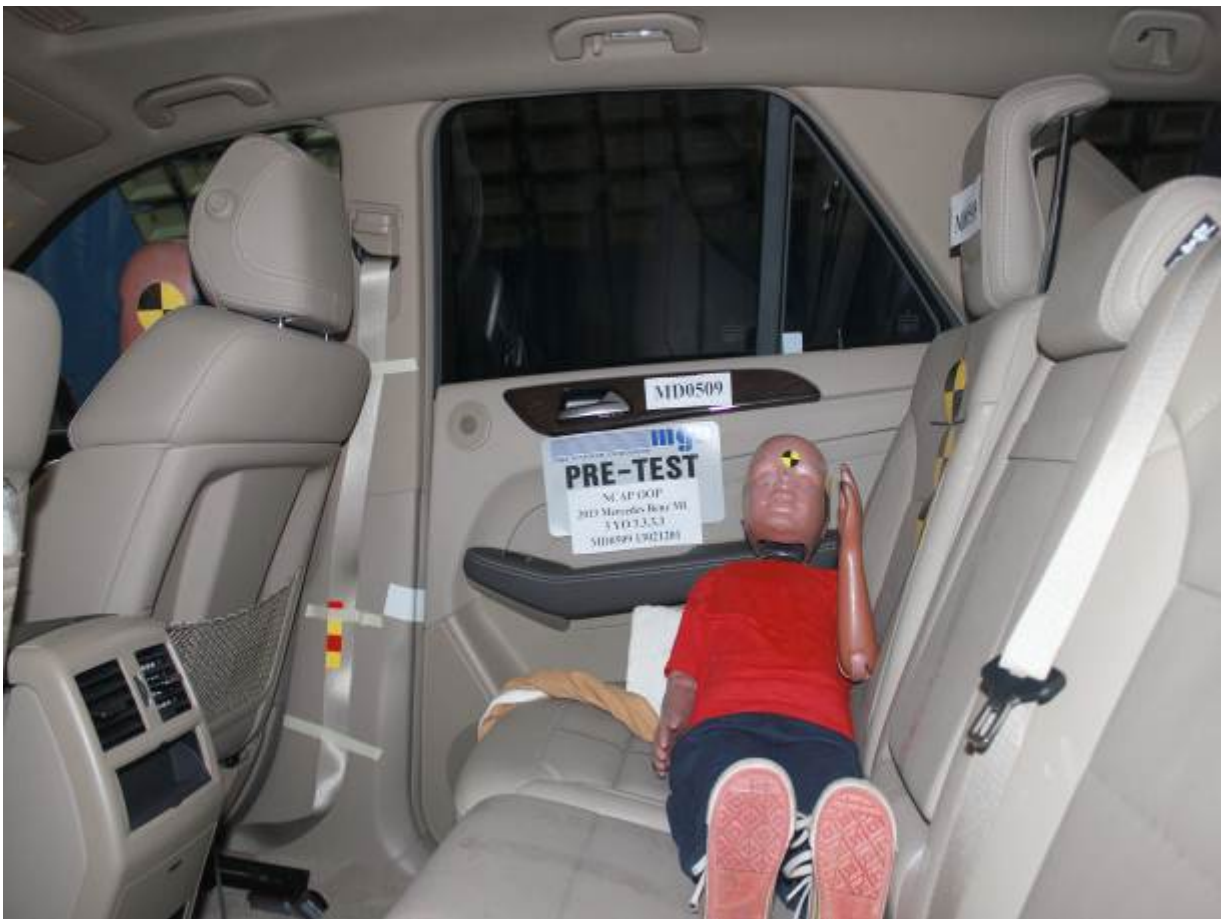
Pre-Test 3-Year-Old Child Dummy Left Side View

The Hybrid III 3-Year-Old child dummy was placed in the right rear passenger seat lying on its back with its arms at its sides so that its rearmost arm contacts the seatback. While bending the dummy at the waist, the dummy was slid outboard until the CG of the head was aligned with the vertical centerline of the airbag module and the head touching the armrest. A wedge-shaped foam block was used to support the dummy's back so that the head remained in a neutral position and does not exert a significant downward force on the armrest. The dummy's arm closest to the front edge of the seat was adjusted so that it was parallel to the torso and was rested on the foam block with the fingertips just touching the seat cushion. The rearmost upper arm was adjusted to an orientation 45 degrees to the upper arm.

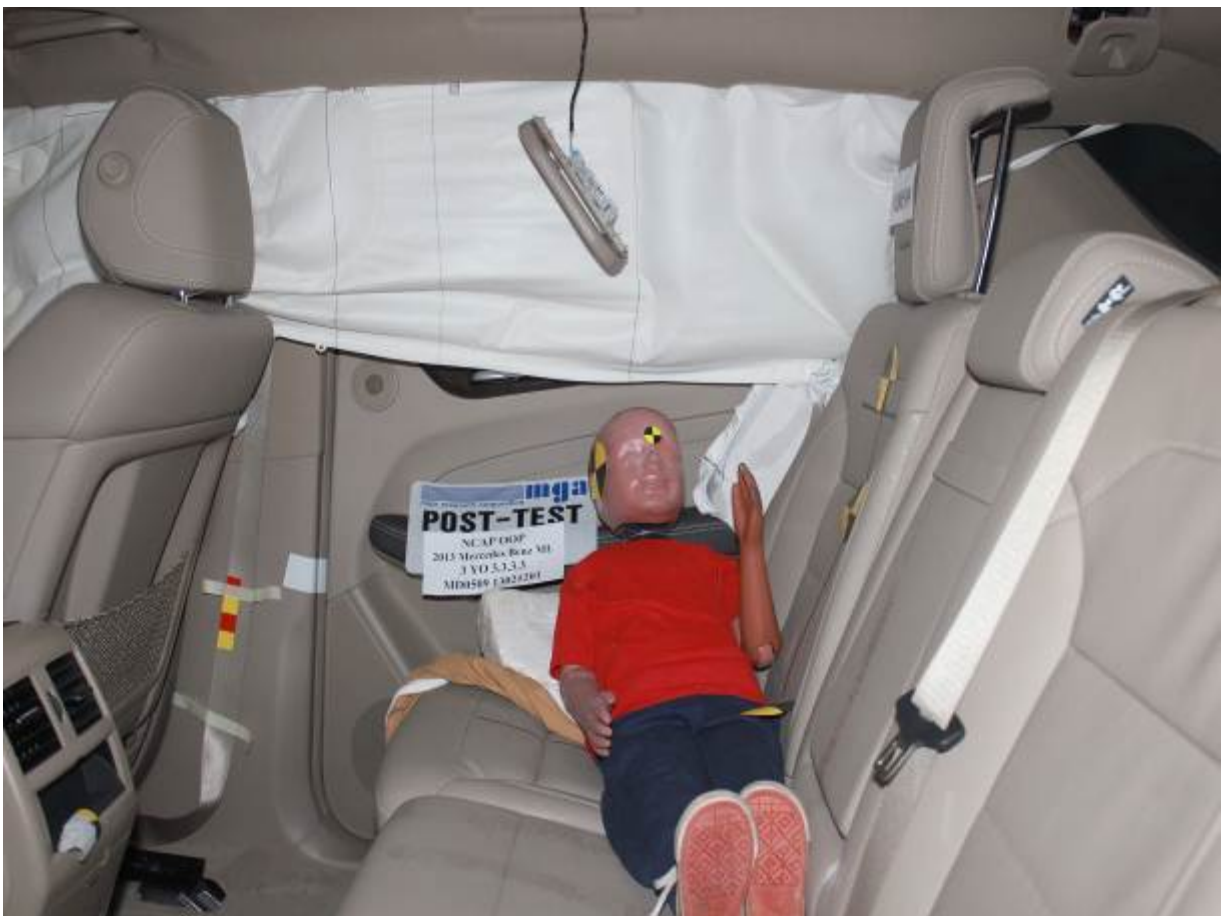
Post-Test 3-Year-Old Child Dummy Left Side View

- Torso airbag to back and left side of head

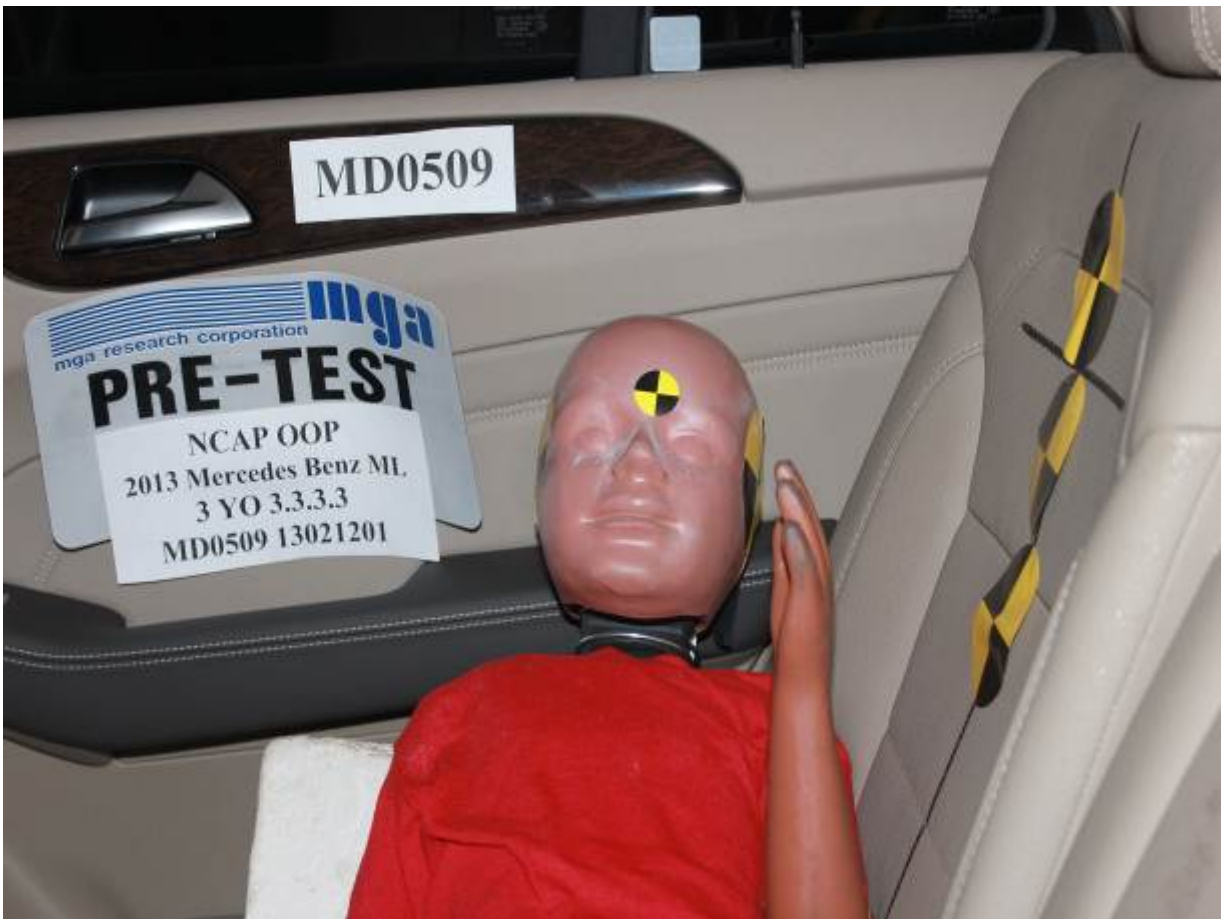
Pre-Test 3-Year-Old Child Dummy Left Side Closeup View

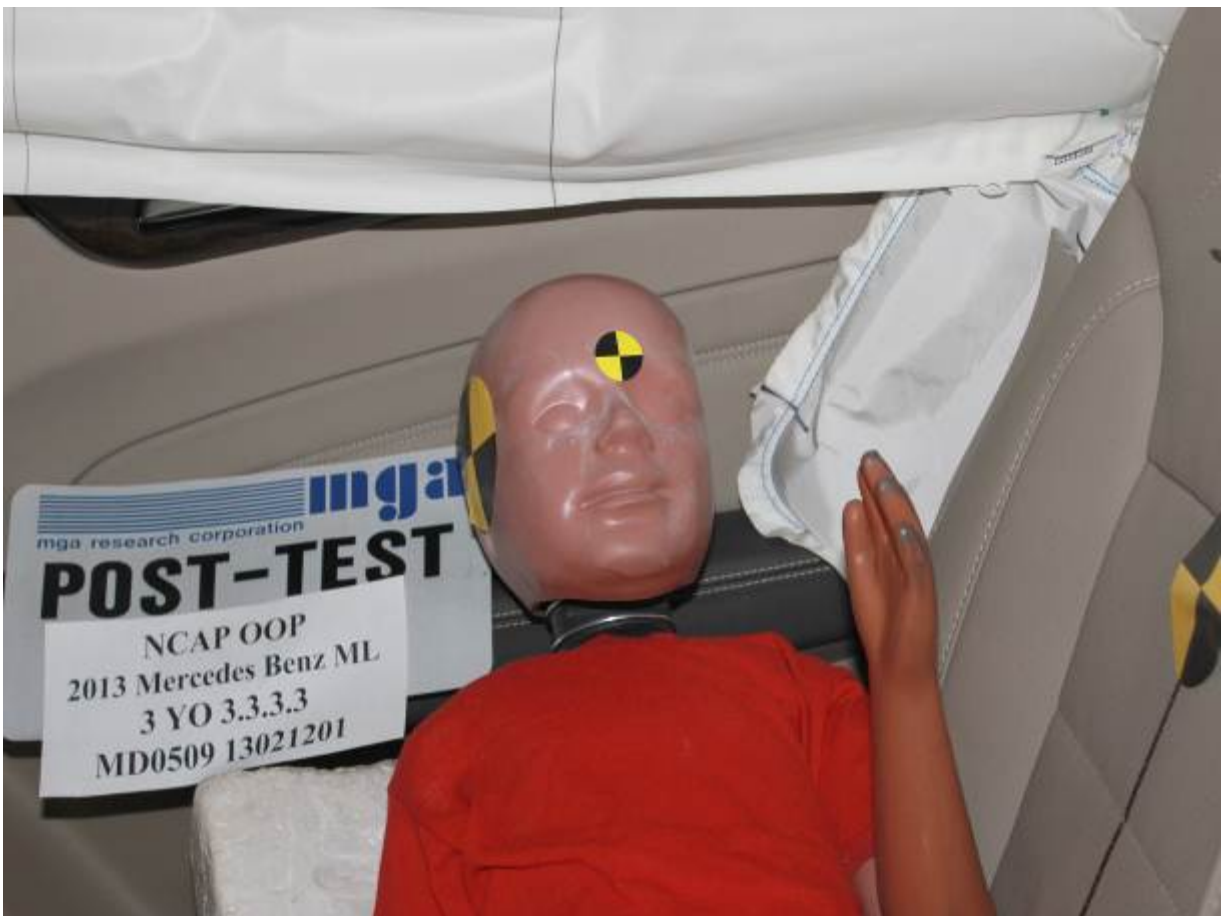
Post-Test 3-Year-Old Child Dummy Left Side Closeup View

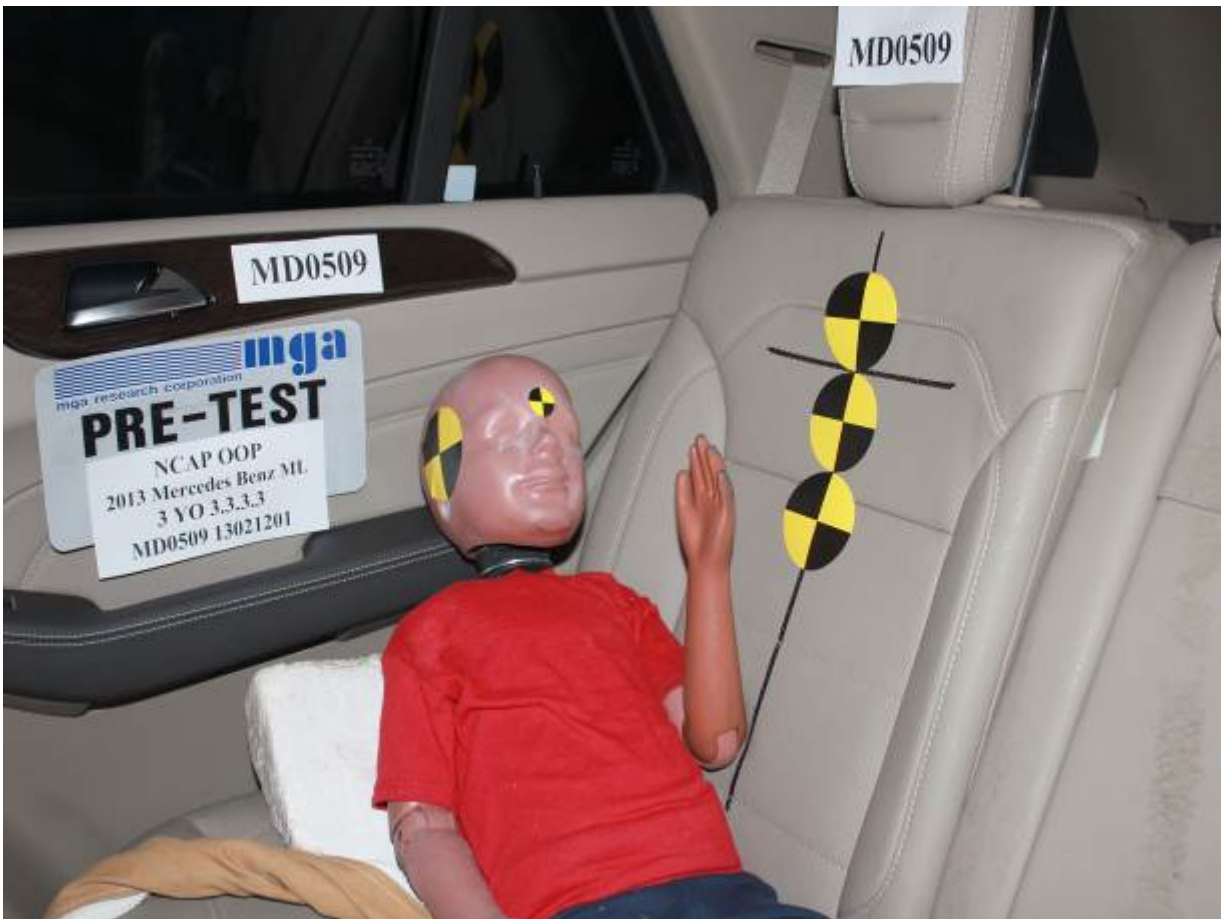
Pre-Test 3-Year-Old Child Dummy Left ¾ Front View

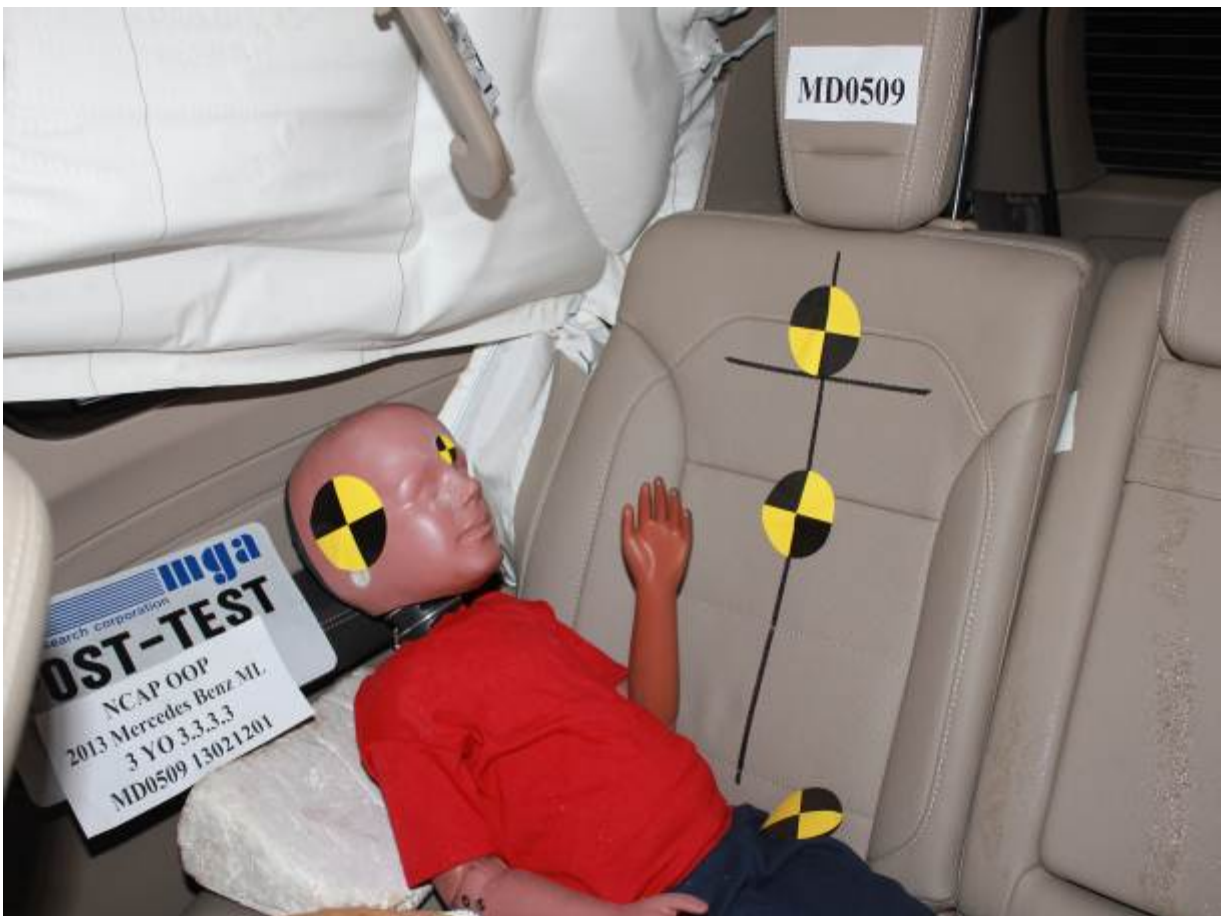
Post-Test 3-Year-Old Child Dummy Left ¾ Front View

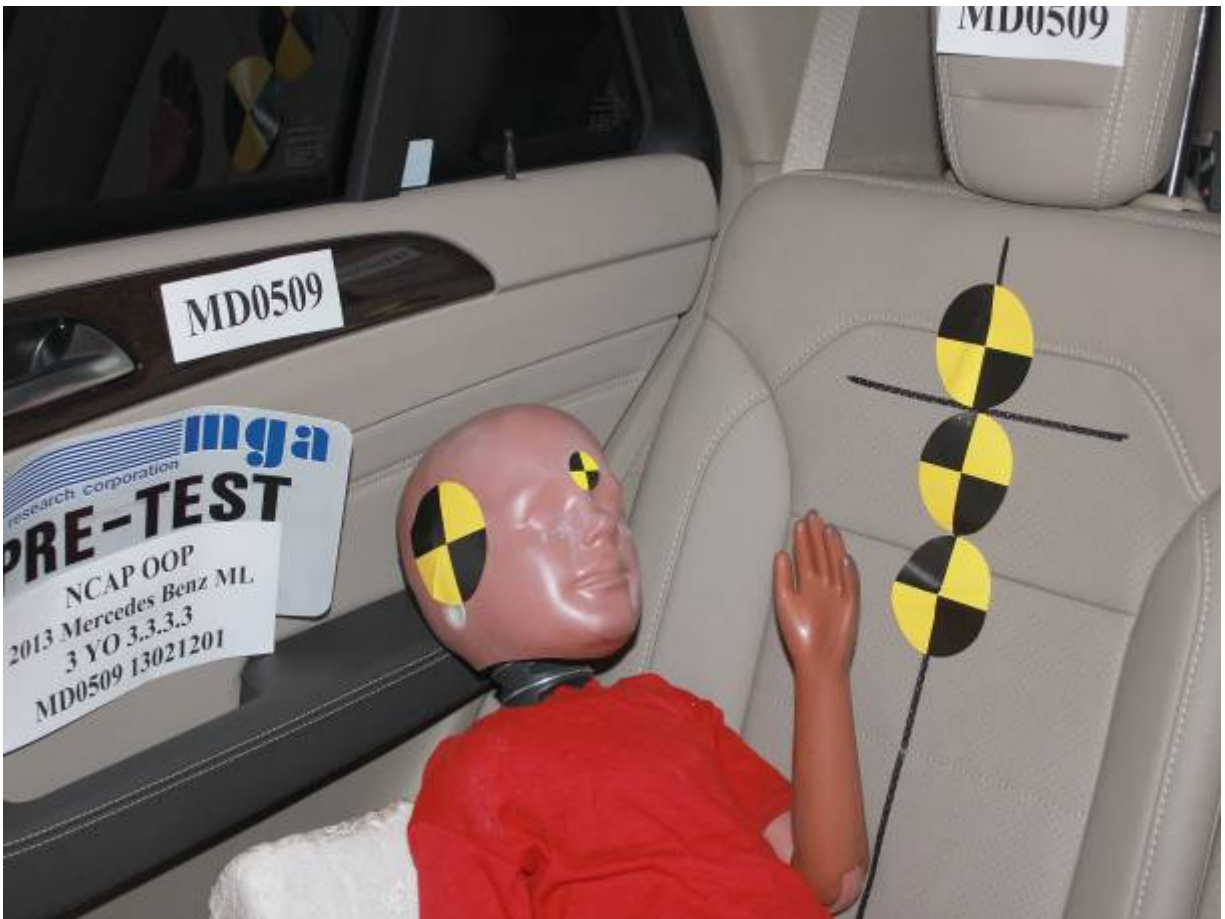
Pre-Test 3-Year-Old Child Dummy Left  $\frac{3}{4}$  Front Closeup View

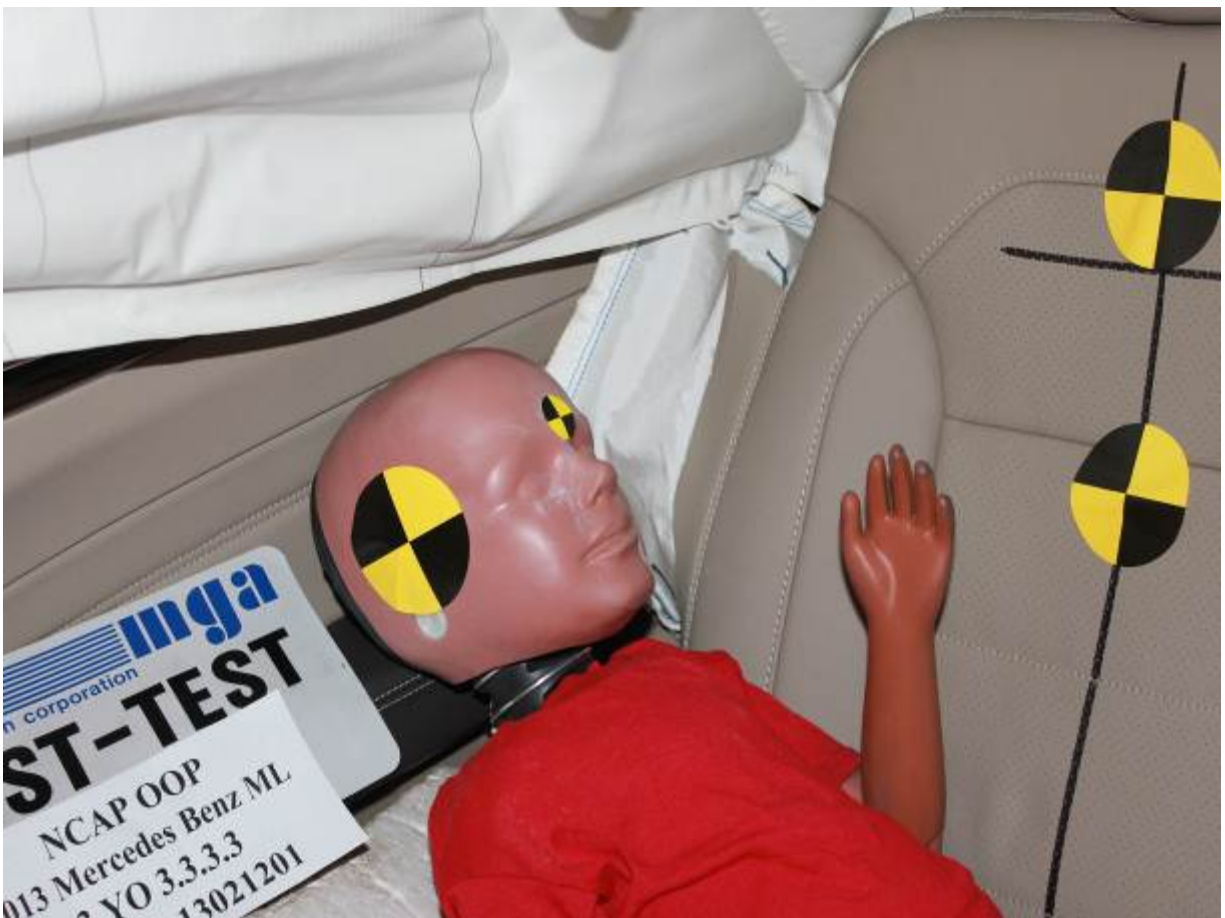
Post-Test 3-Year-Old Child Dummy Left  $\frac{3}{4}$  Front Closeup View

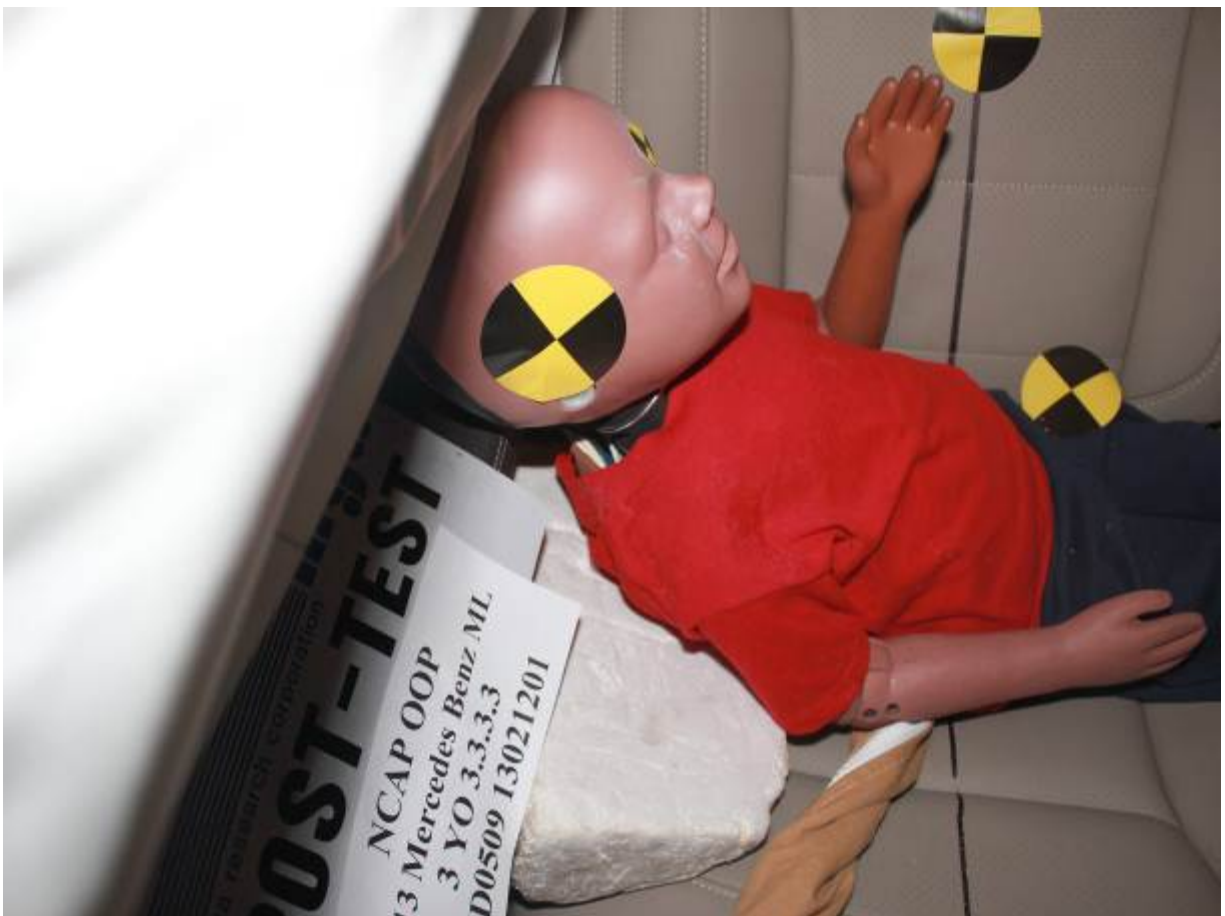
Post-Test 3-Year-Old Child Dummy Front View

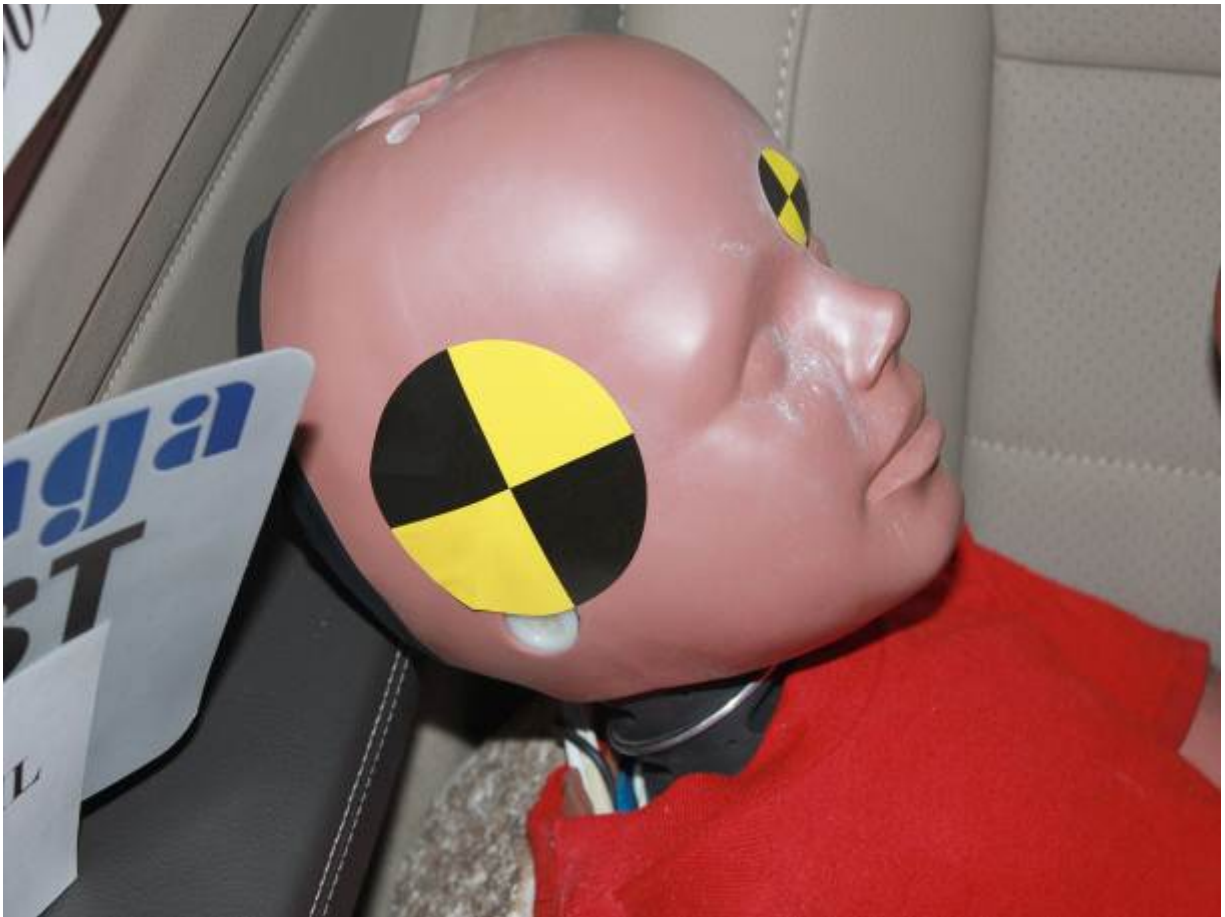
Pre-Test 3-Year-Old Child Dummy Front Closeup View

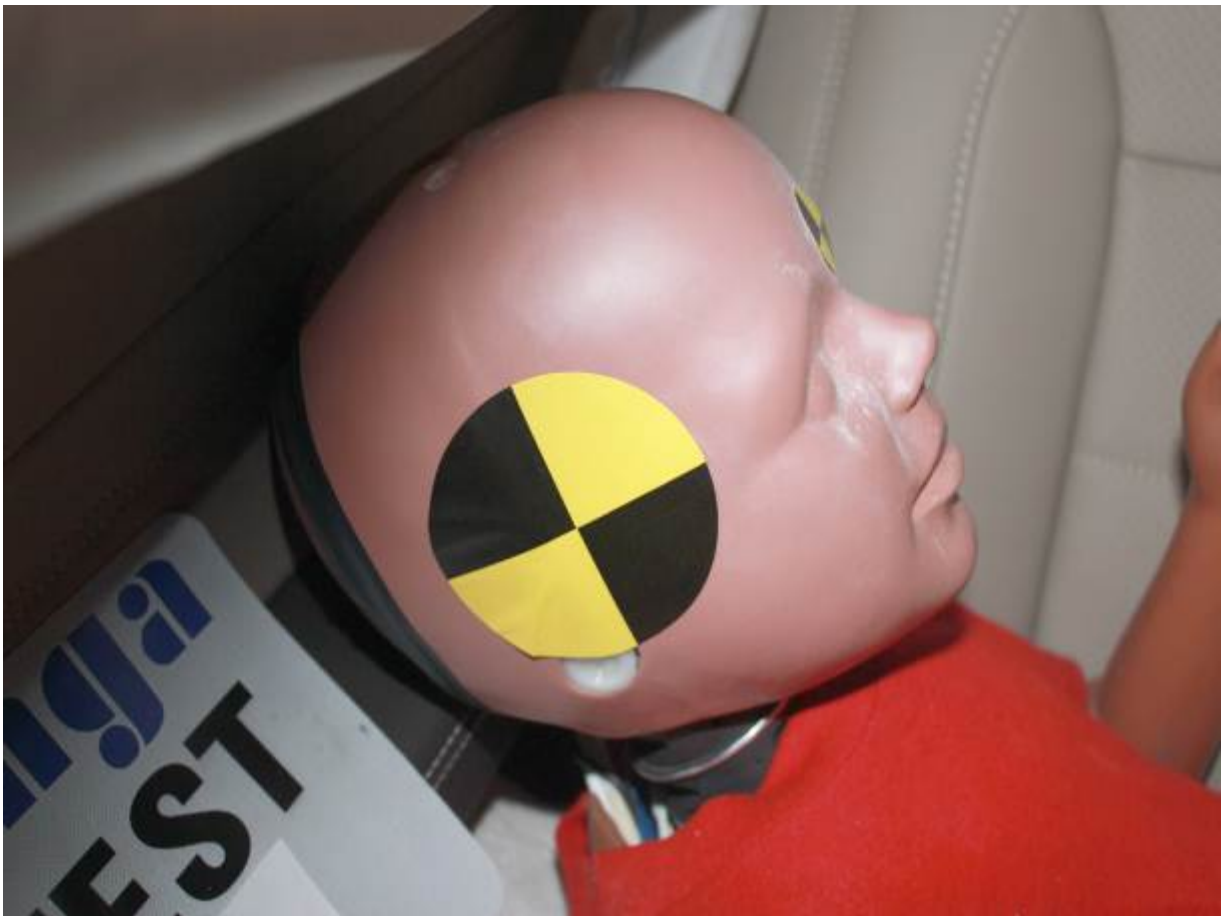
Post-Test 3-Year-Old Child Dummy Front Closeup View

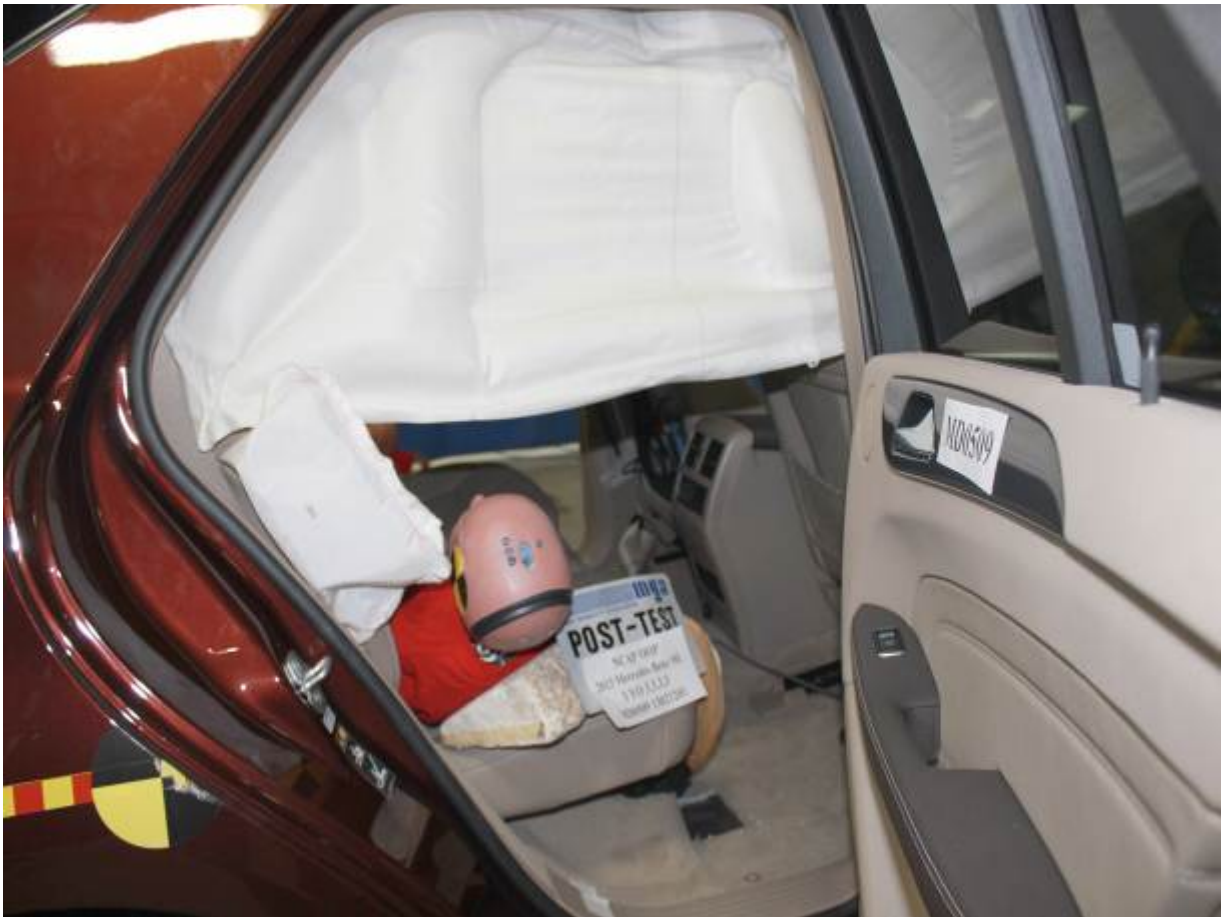
Post-Test 3-Year-Old Child Dummy Right Side View (Door Open)

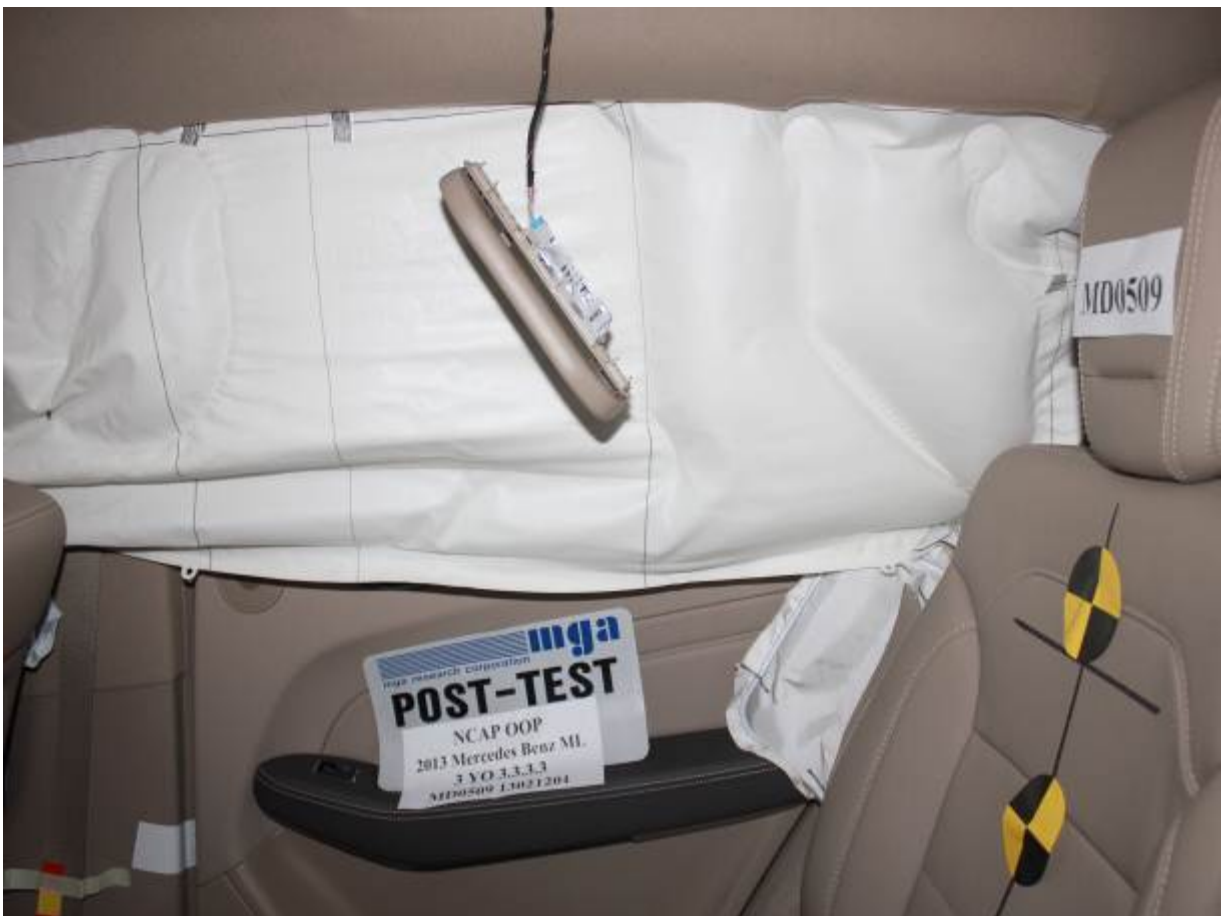
Post-Test Curtain Airbag Left Side View

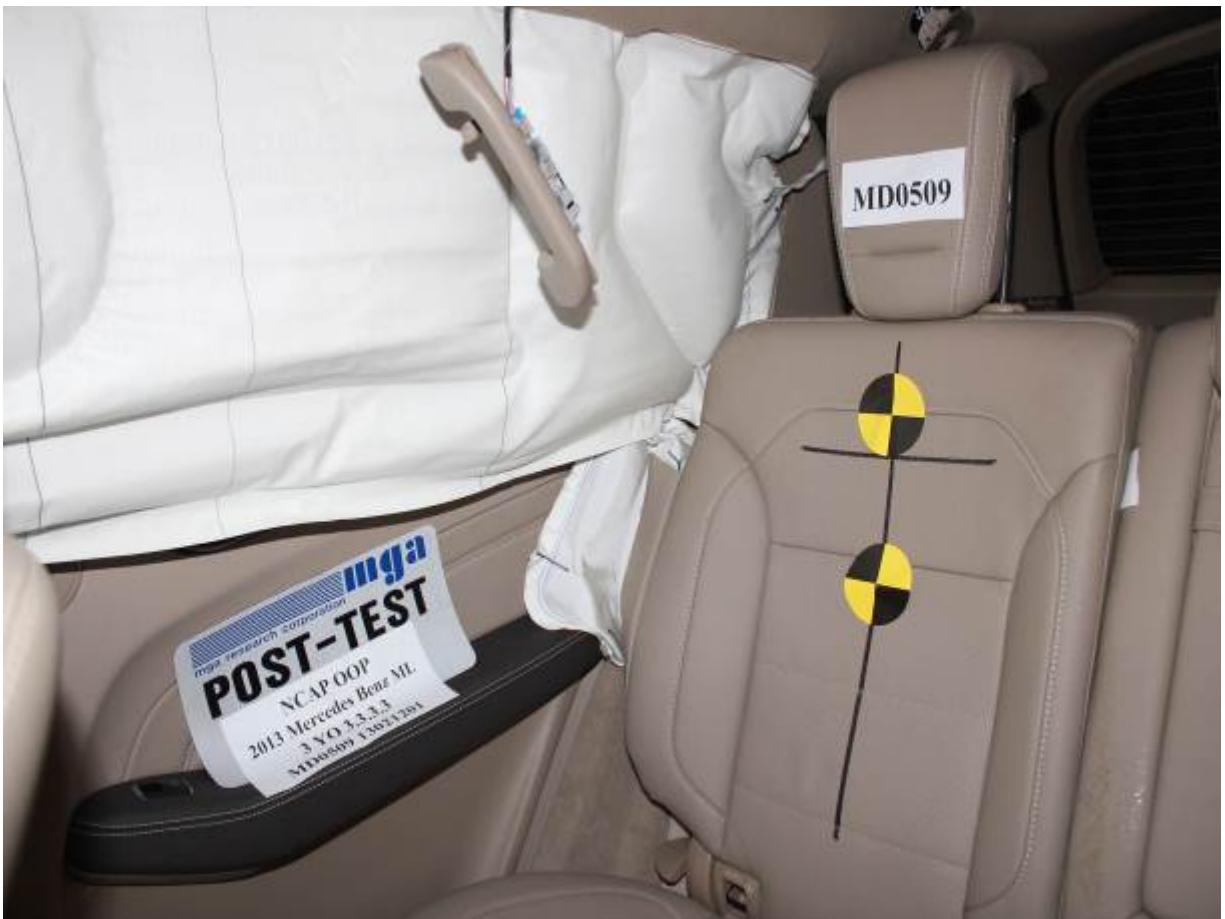
Post-Test Curtain Airbag Left 3/4 Front View

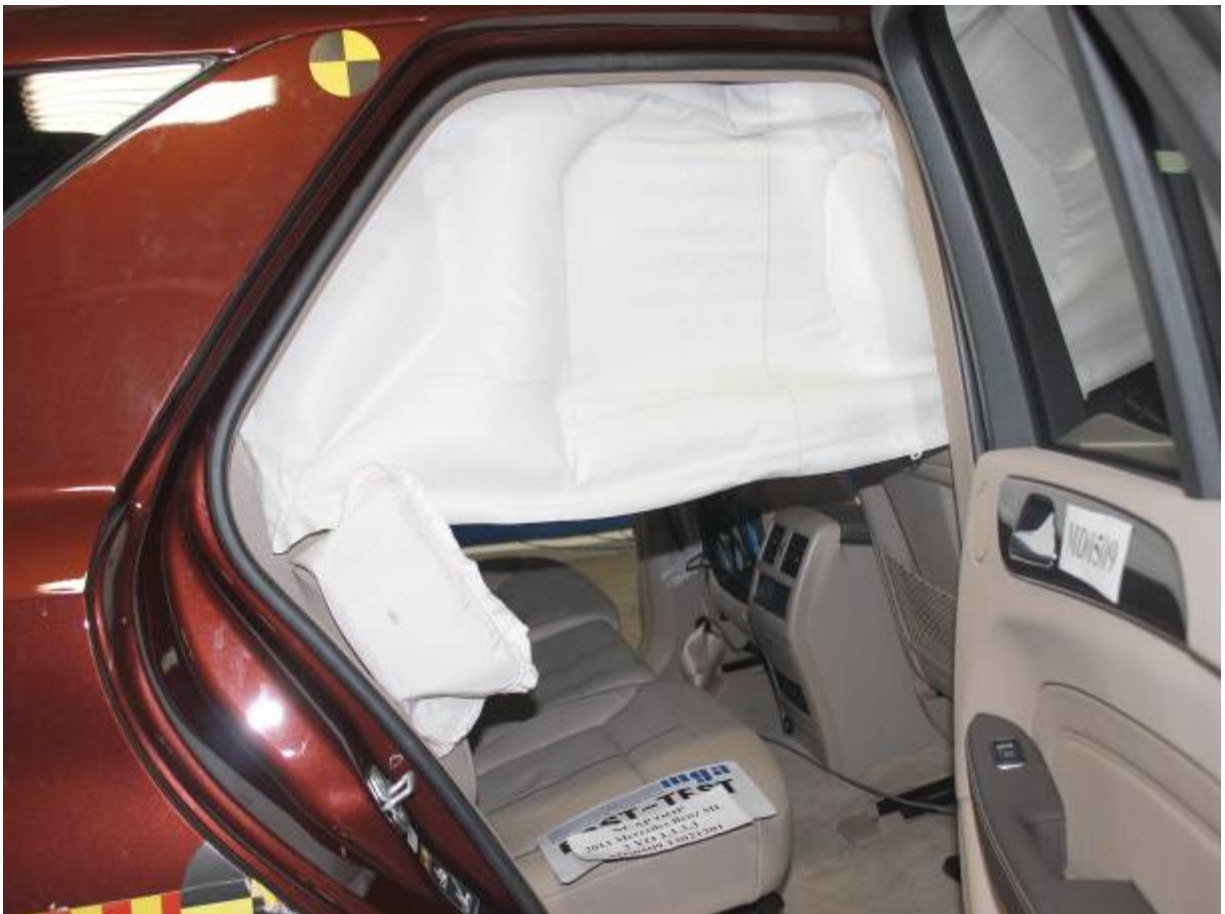
Post-Test Curtain Airbag Right Side View (Door Open)

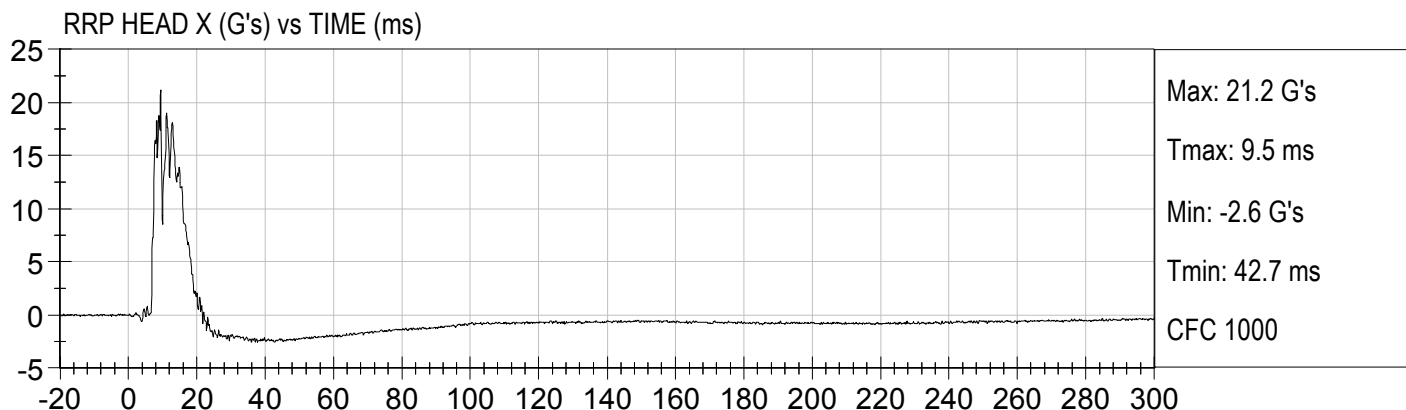
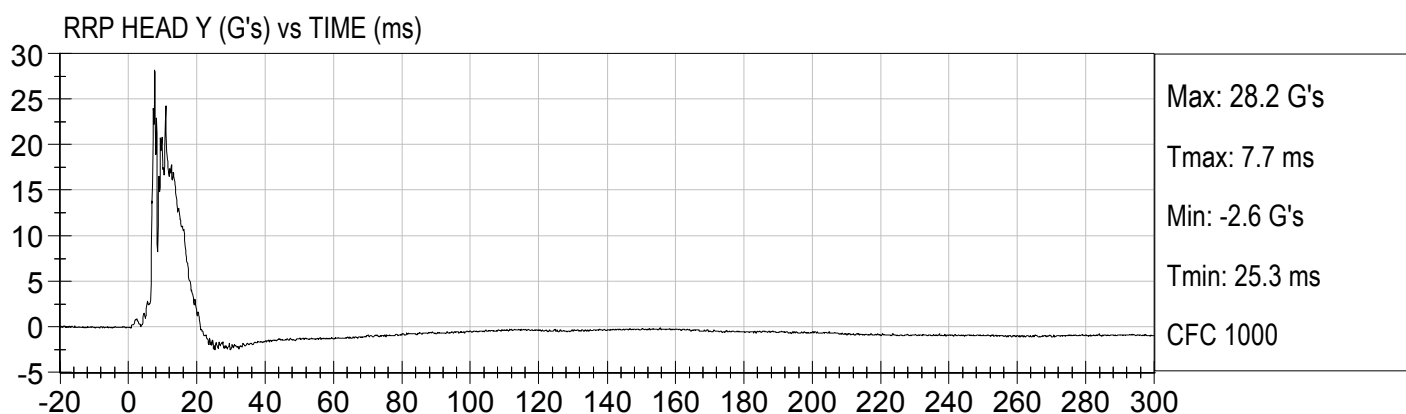
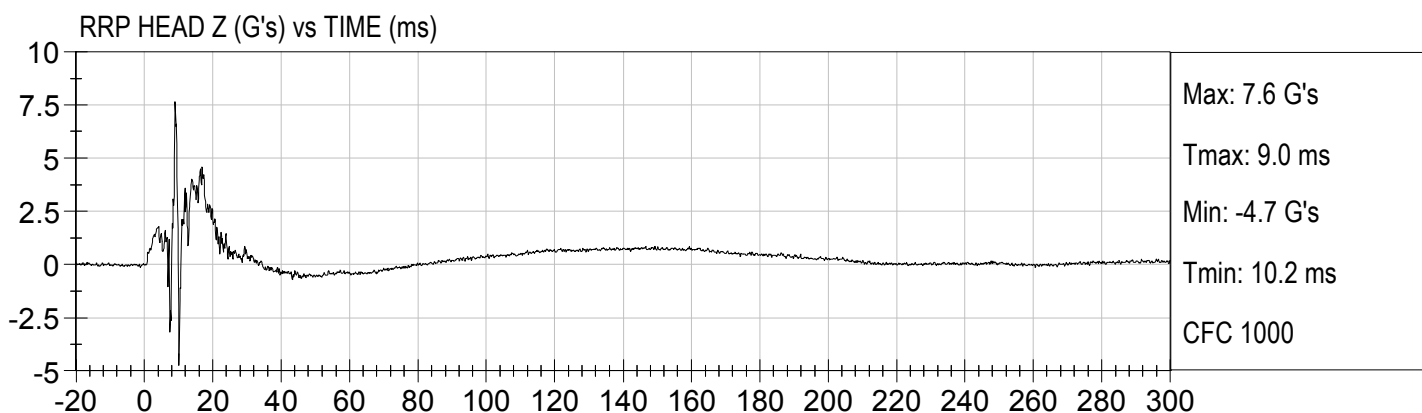
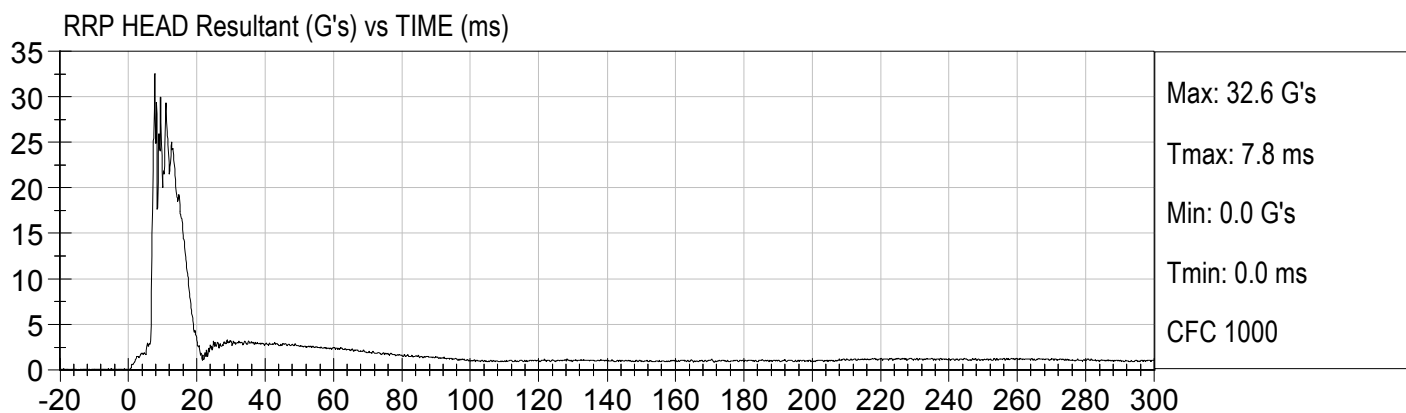
| | <u>Page No.</u> |
|---|---|
| Figure No. 1. RRP Head X Acceleration vs. Time | 20 |
| Figure No. 2. RRP Head Y Acceleration vs. Time | 20 |
| Figure No. 3. RRP Head Z Acceleration vs. Time | 20 |
| Figure No. 4. RRP Head Resultant Acceleration vs. Time | 20 |

| | | MAXIMUM VALUE | | | |
|---|---|---|---|---|---|
| Head X | g | 21.2 | 9.5 | -2.6 | 42.7 |
| Head Y | g | 28.2 | 7.7 | -2.6 | 25.3 |
| Head Z | g | 7.6 | 9.0 | -4.7 | 10.2 |
| Head Resultant | g | 32.6 | 7.8 | | |

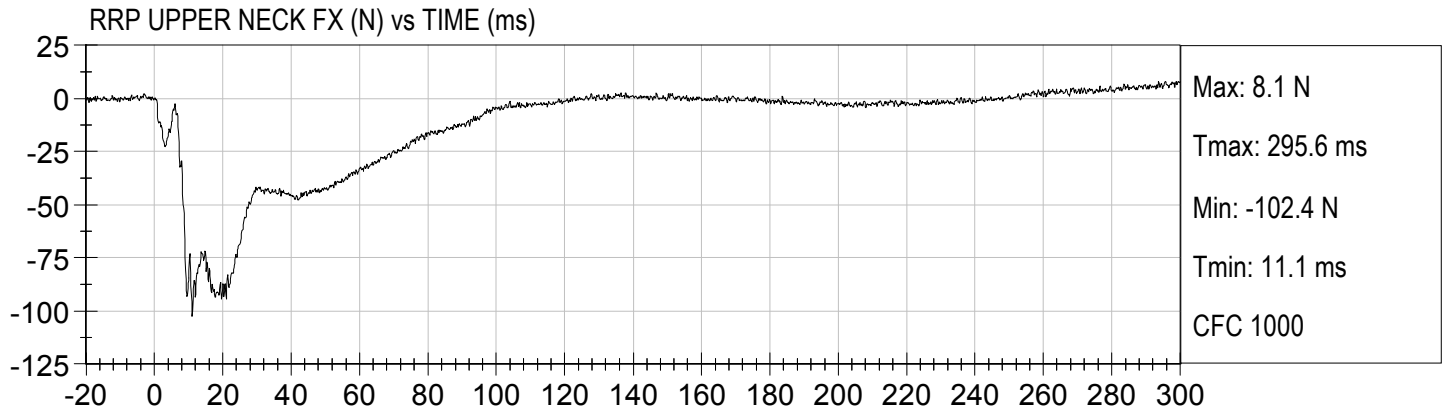
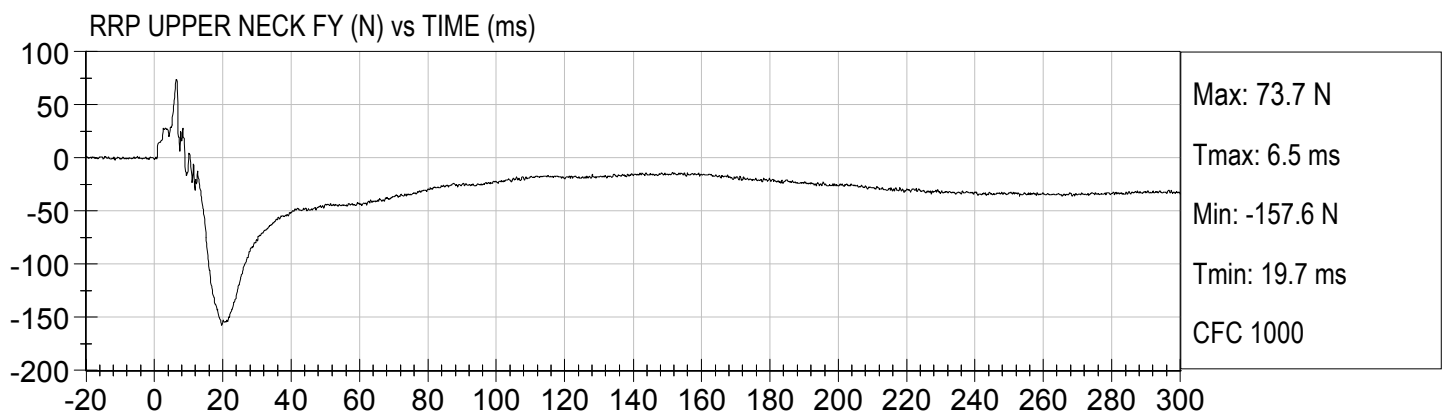
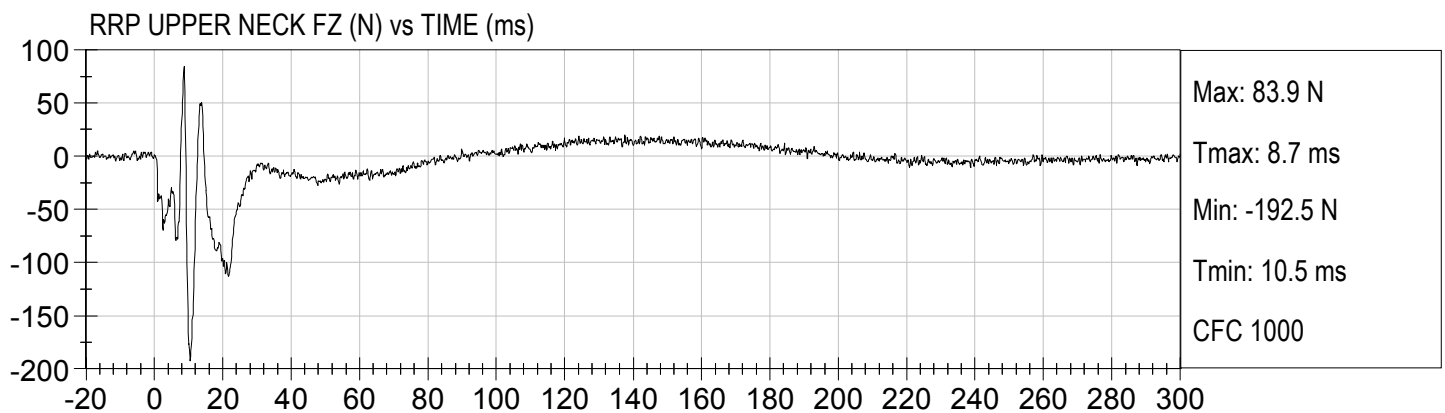
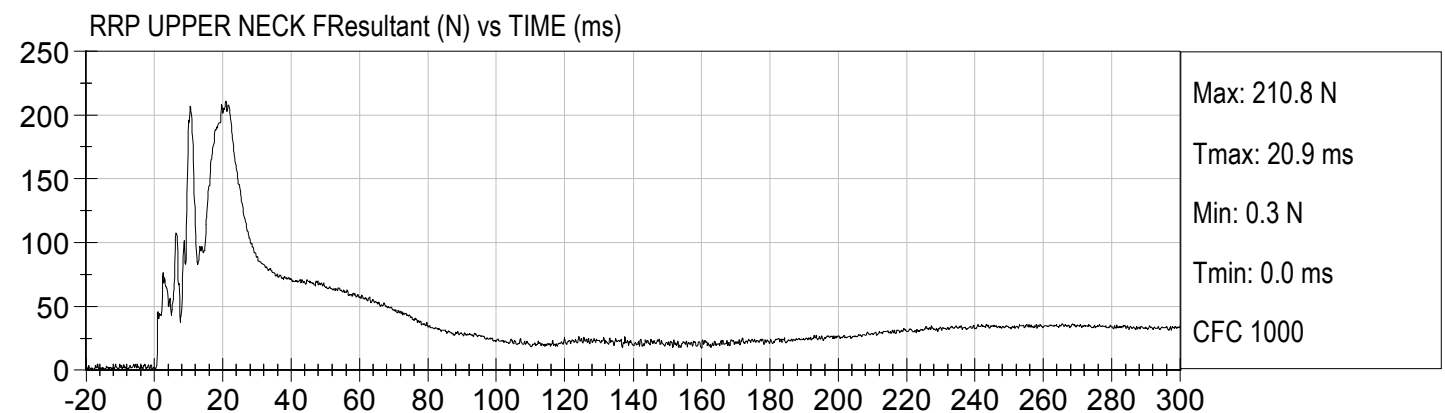
| | <u>Page No.</u> |
|---|---|
| Figure No. 5. RRP Upper Neck X Force vs. Time | 21 |
| Figure No. 6. RRP Upper Neck Y Force vs. Time | 21 |
| Figure No. 7. RRP Upper Neck Z Force vs. Time | 21 |
| Figure No. 8. RRP Upper Neck Resultant Force vs. Time | 21 |

| | | MAXIMUM VALUE | | | |
|---|---|---|---|---|---|
| Upper Neck Fx | N | 8.1 | 295.6 | -102.4 | 11.1 |
| Upper Neck Fy | N | 73.7 | 6.5 | -157.6 | 19.7 |
| Upper Neck Fz | N | 83.9 | 8.7 | -192.5 | 10.5 |
| Upper Neck F Resultant | N | 210.8 | 20.9 | | |
